RESEARCH REPORT SERIES no. 58-2014

HALES HALL,
LITCHMERE LANE, LODDON, NORFOLK
TREE-RING ANALYSIS OF TIMBERS FROM
THE HALL RANGE, BARN, AND BOTHY
SCIENTIFIC DATING REPORT

Alison Arnold and Robert Howard

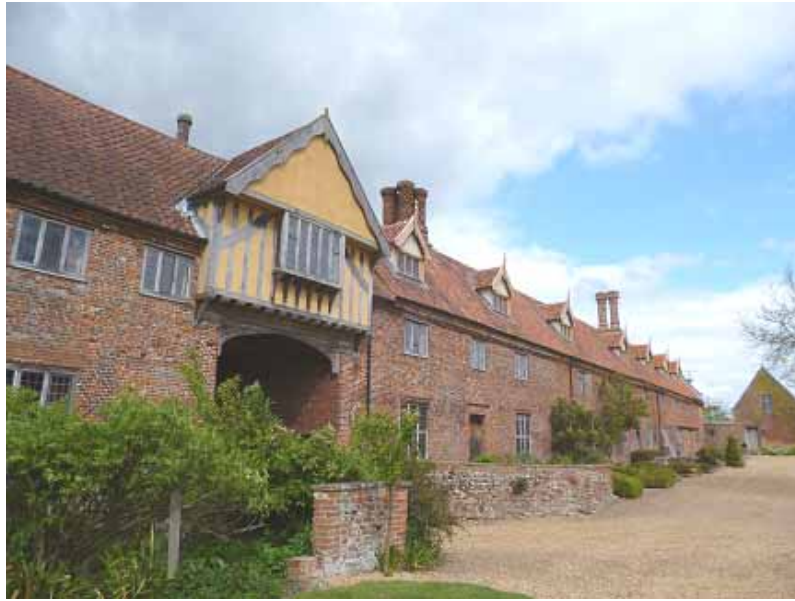
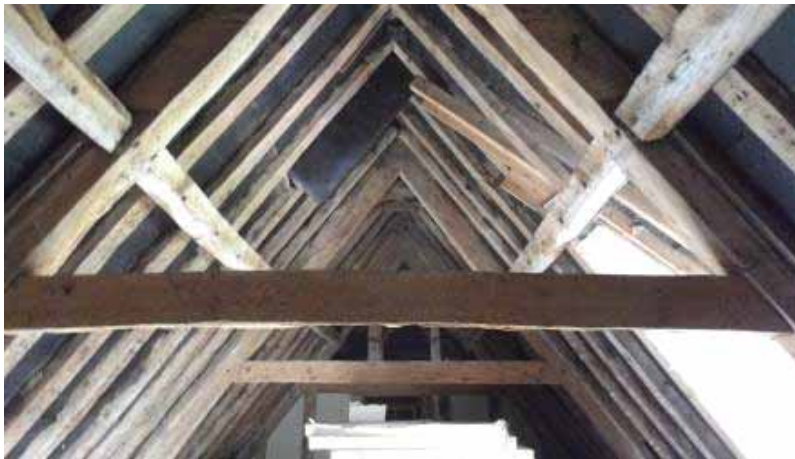
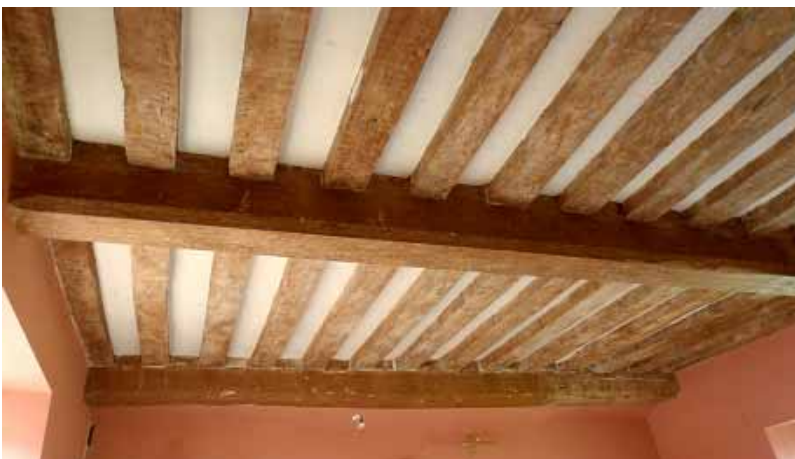
Figure 3a-c: Views of the hall range with its gatehouse (top), its roof (middle) and east-end ground-floor ceiling beams (bottom) (photographs Robert Howard)

Parts of the hall range may have undergone alteration in the seventeenth century, and the roof of the middle section (Fig 4) was replaced in the eighteenth century, this being typical of the period in having lap-jointed collars and butt purlins with tapered tenons sharing single mortises producing diagonal pegging.

The earliest, and apparently only, surviving section of original roof is at the west-end of the hall range above the gatehouse and westward beyond it (Fig 4). The gatehouse has the remains of a crown-post roof, whilst the room to the west has a queen-post roof. The timber of the gatehouse walls is largely a reconstruction of the early 1970s but the original work is easily discernable. The floor and stud partitions of the rest of the building have several modern replacements yet retain a lot of the original timbers. The first floor consists of heavy transverse beams with the common joists jointed to them.

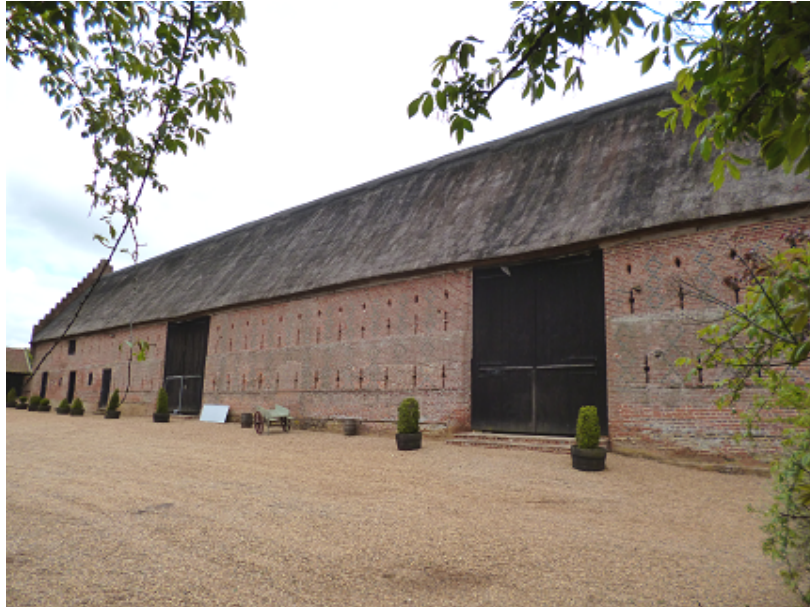
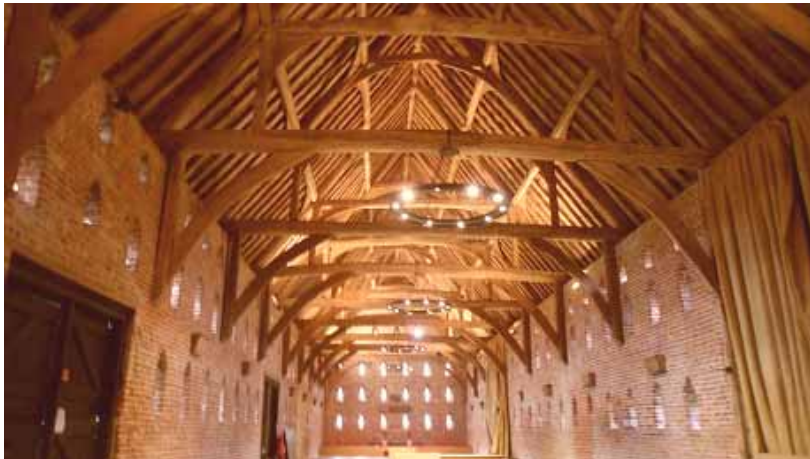
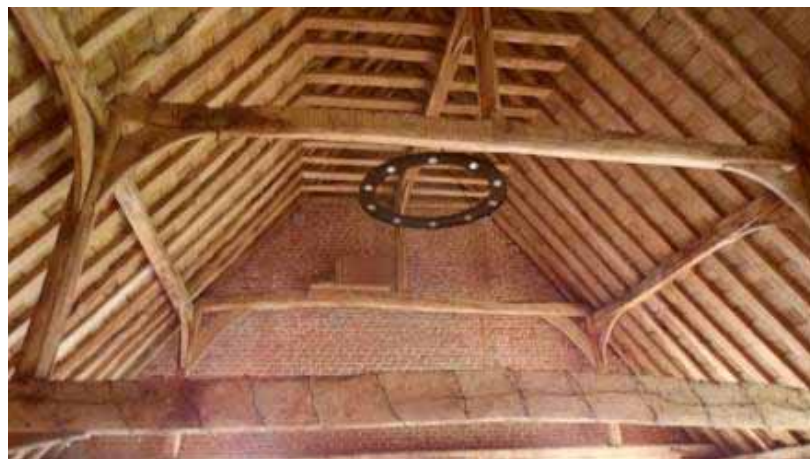
Figure 5a-c: Exterior view of the barn (top), its west-end roof (middle) and queen-post with crown-post roof trusses to easternmost four bays (bottom) (photographs Robert Howard)

The Grade 1 listed barn to the south side of the enclosure (Fig 5) is believed to be the largest and possibly the oldest medieval brick-built barn in England. It is about 170 feet (*c* 52 metres) long and has a continuous 10-bay roof of queen-post trusses. The trusses of a further four bays at the easternmost end of the barn also have crown-posts mounted on the collars, there being a mezzanine in these four bays as well. The east gable-end bay has

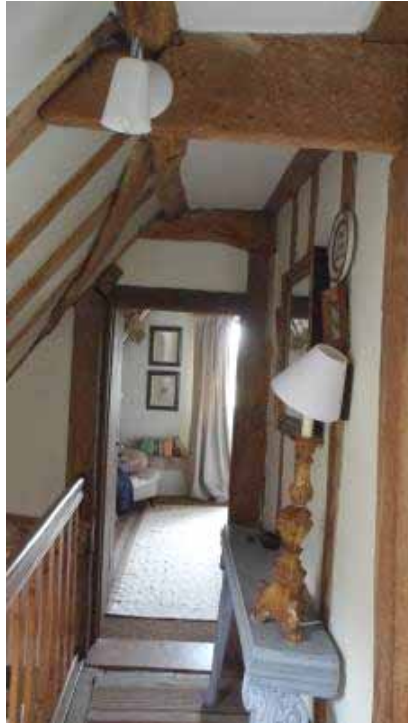
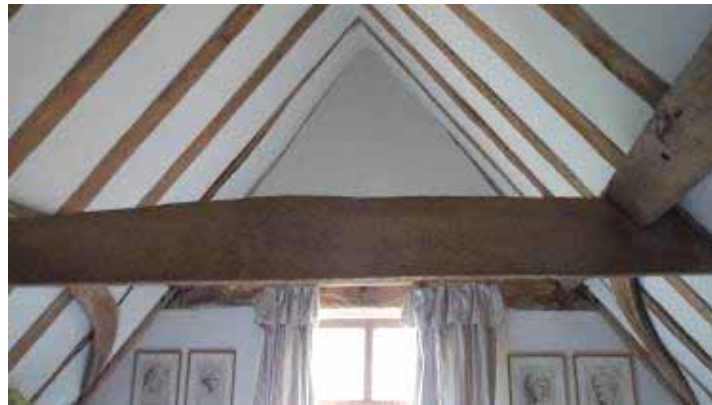
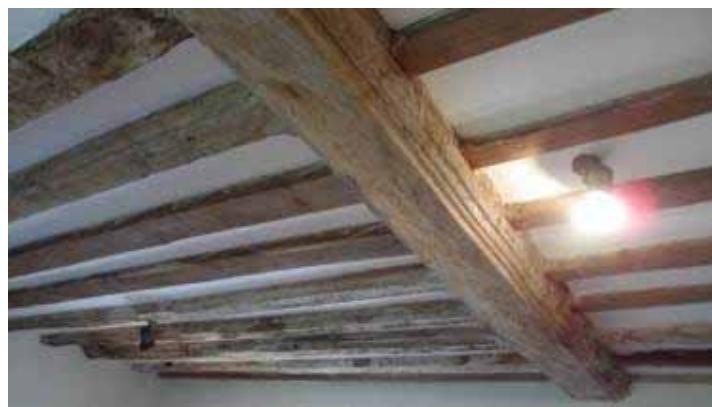
Figure 6a-c: Views of the clasped-purlin roof to the original part of the bothy (top), the roof to the extension (middle) and the ground-floor ceiling to the bothy extension (bottom) (photographs Robert Howard)

To the immediate south-east of the hall range is a small Grade II* listed building, described as a 'small barn' and known as the 'bothy' (Fig 6), which is currently used as domestic accommodation. The bothy is a red and blue brick construction with a steep pantile roof with coped gable ends. This building appears to be of two parts. The west (front) part is believed to be the earlier original structure and is roofed by five clasped-purlin trusses. The east (rear) part is believed to be a later addition and referred to as the 'bothy extension'. It is roofed by common rafter frames. There are also moulded timbers to the ground-floor ceilings of this part, these likely to be reused in their present positions.

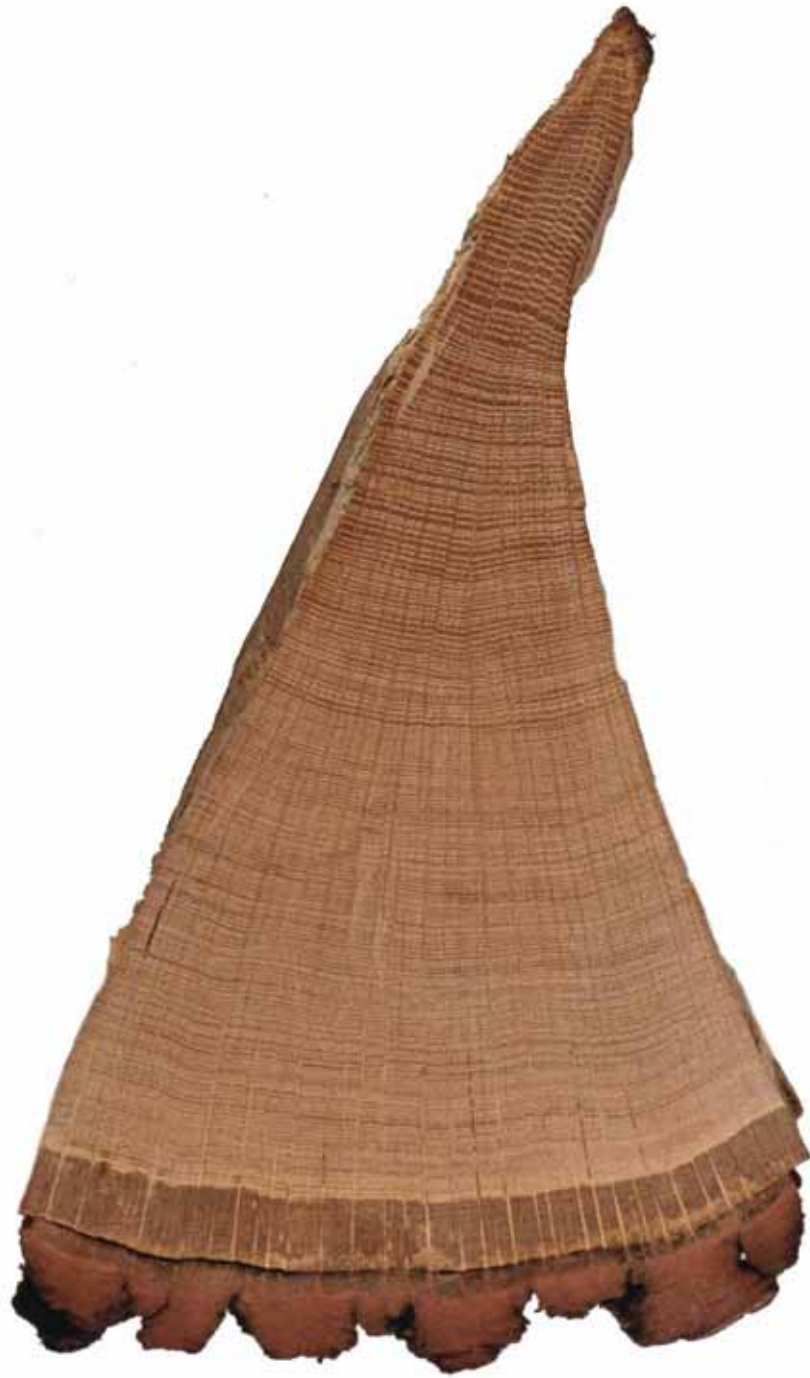
Figure A1: A wedge of oak from a tree felled in 1976. It shows the annual growth rings, one for each year from the innermost ring to the last ring on the outside just inside the bark. The year of each ring can be determined by counting back from the outside ring, which grew in 1976

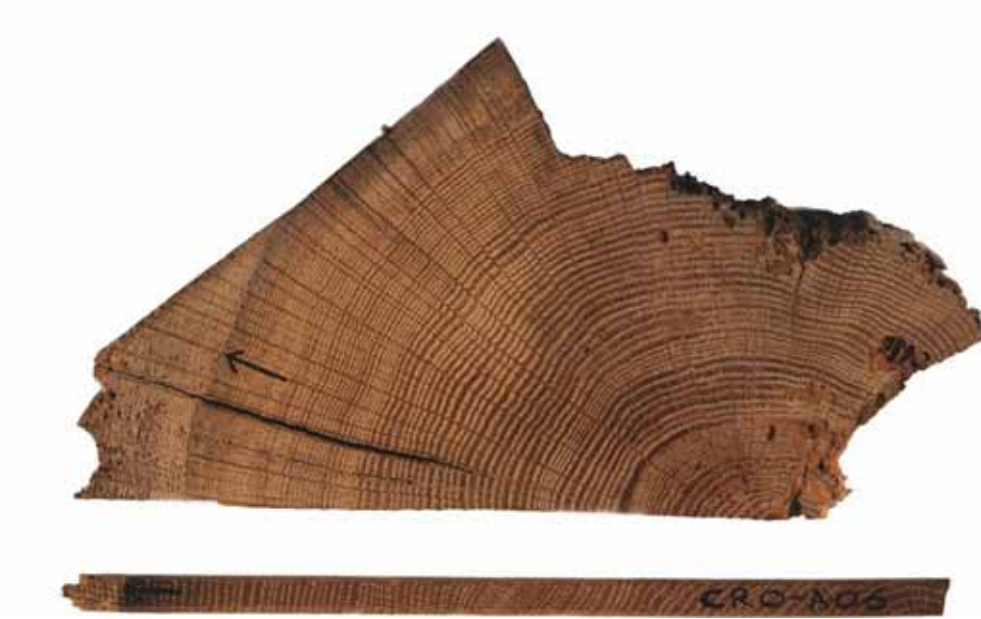
Figure A2: Cross-section of a rafter, showing sapwood rings in the left-hand corner, the arrow points to the heartwood/sapwood boundary (H/S); and a core with sapwood; again the arrow is pointing to the H/S. The core is about the size of a pencil

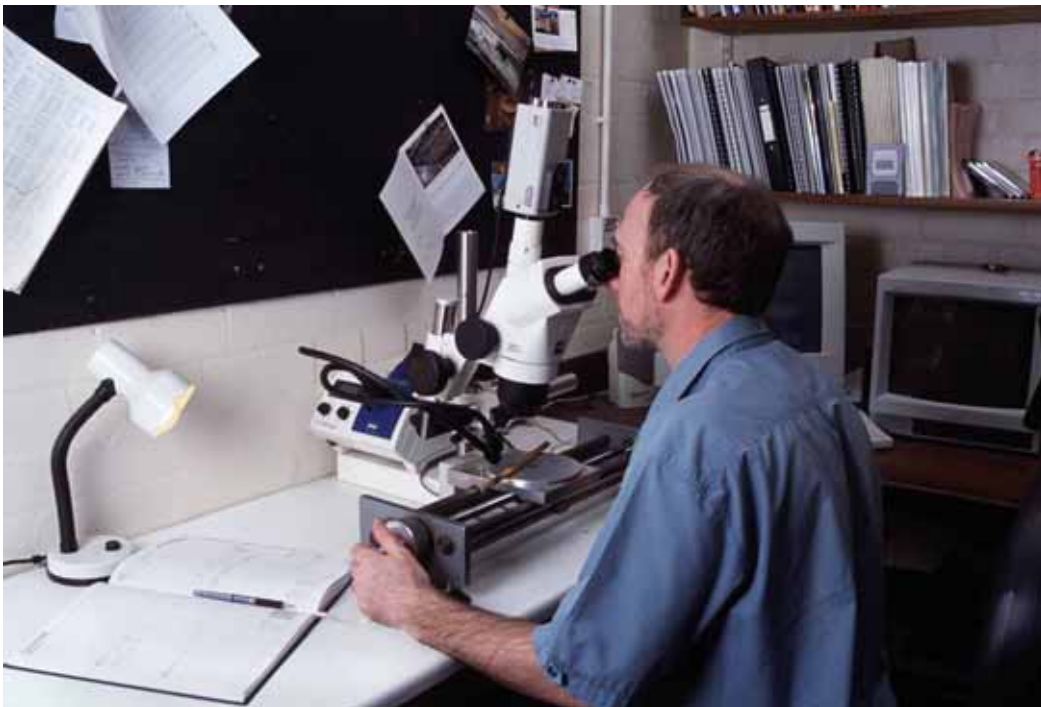
Figure A3: Measuring ring widths under a microscope. The microscope is fixed while the sample is on a moving platform. The total sequence of widths is measured twice to ensure that an error has not been made. This type of apparatus is needed to process a large number of samples on a regular basis

2. **Measuring Ring Widths.** Each core is sanded down with a belt sander using medium-grit paper and then finished by hand with flourgrade-grit paper. The rings are then clearly visible and differentiated from each other with a result very much like that shown in Figure A2. The core is then mounted on a movable table below a microscope and the ring-widths measured individually from the innermost ring to the outermost. The widths are automatically recorded in a computer file as they are measured (see Fig A3).

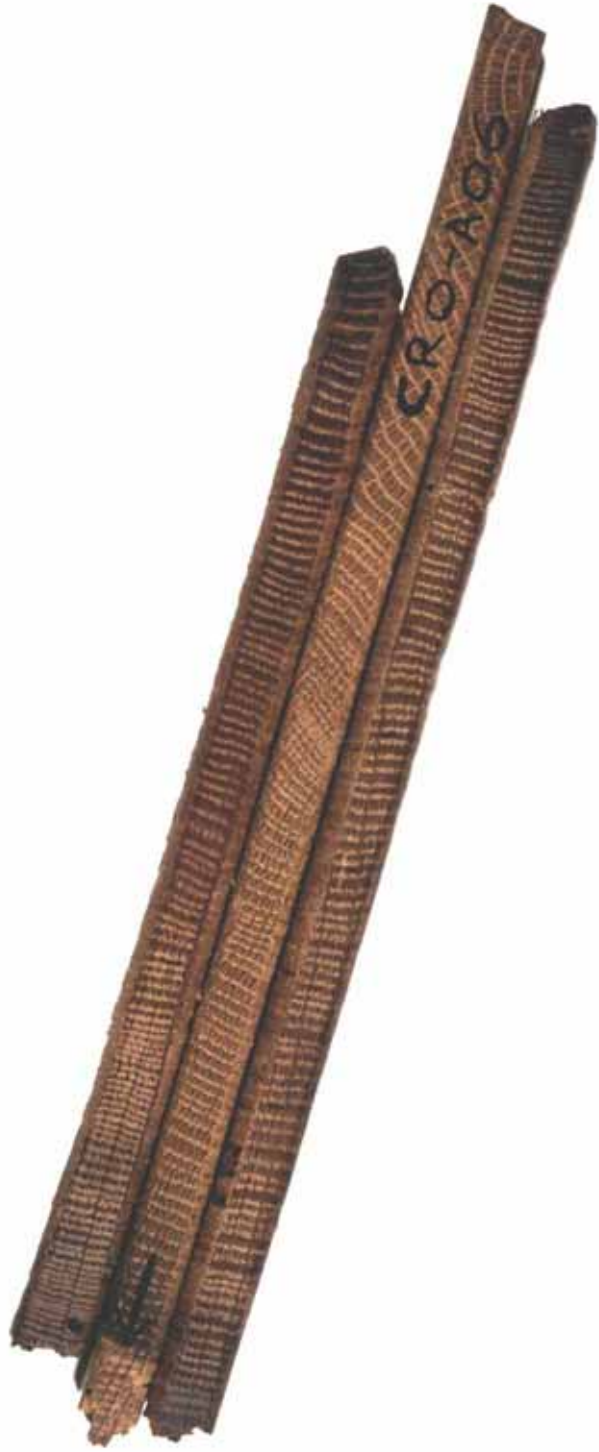
Figure A4: Three cores from timbers in a building. They come from trees growing at the same time. Notice that, although the sequences of widths look similar, they are not identical. This is typical
