# CHURCH OF ALL SAINTS, BERRINGTON, NEAR SHREWSBURY, SHROPSHIRE

## TREE-RING ANALYSIS OF TIMBERS

SCIENTIFIC DATING REPORT

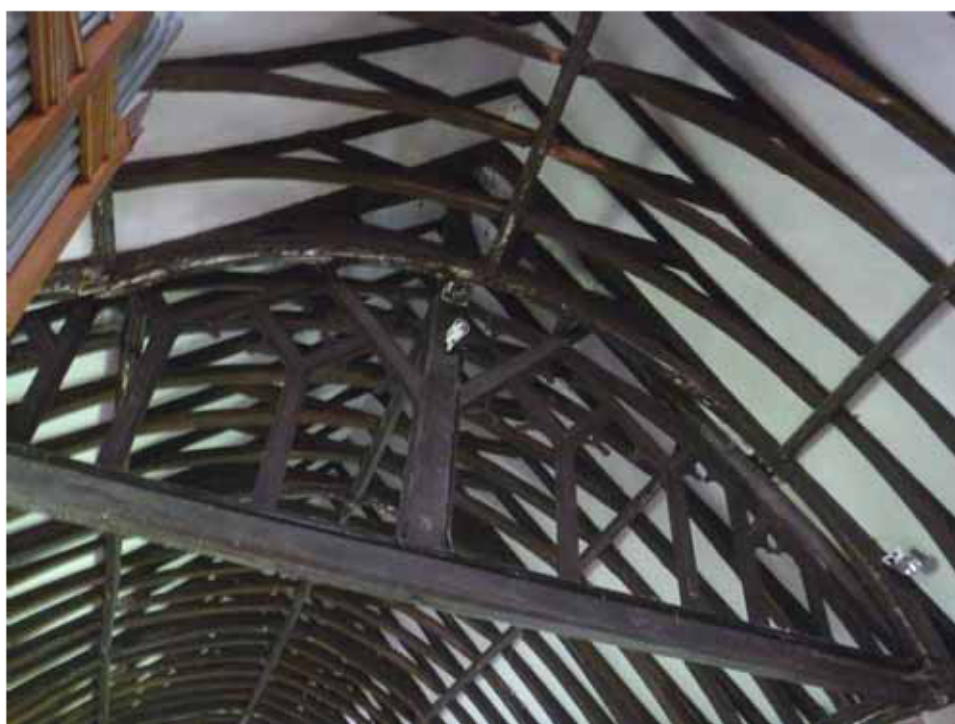
*Figure 4a/b: View of the nave roof (top), looking west to east, and the screen truss at the junction of the nave and chancel roofs (bottom) (photographs Robert Howard)*

The chancel roof comprises twelve close-set, arch-braced, principal-rafter-with-collar frames; the arch braces each composed of an upper and lower section. The nave roof comprises twenty similar, if not identical frames (Fig 4a). The division of the two roofs is formed not only by a change in the level of the north and south wall plates, but also by the position of a much more substantial traceried, tiebeam with kingpost, screen truss to the nave, this truss immediately abutting an arch-braced frame of the chancel (Fig 4b). All frames carry a moulded ridge beam and single purlins to each pitch of the roof.

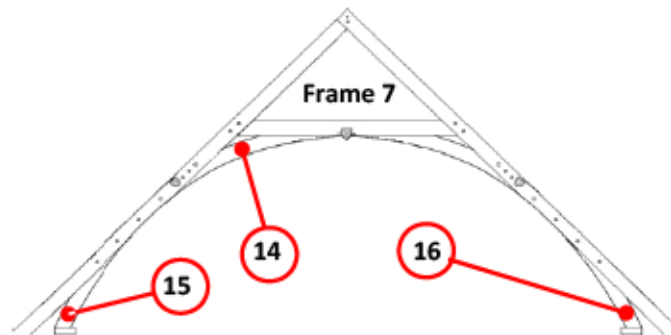
*Figure 5c: The nave roof trusses to show sampled timbers (after Baart Harries Newall, Architects, Shrewsbury)*

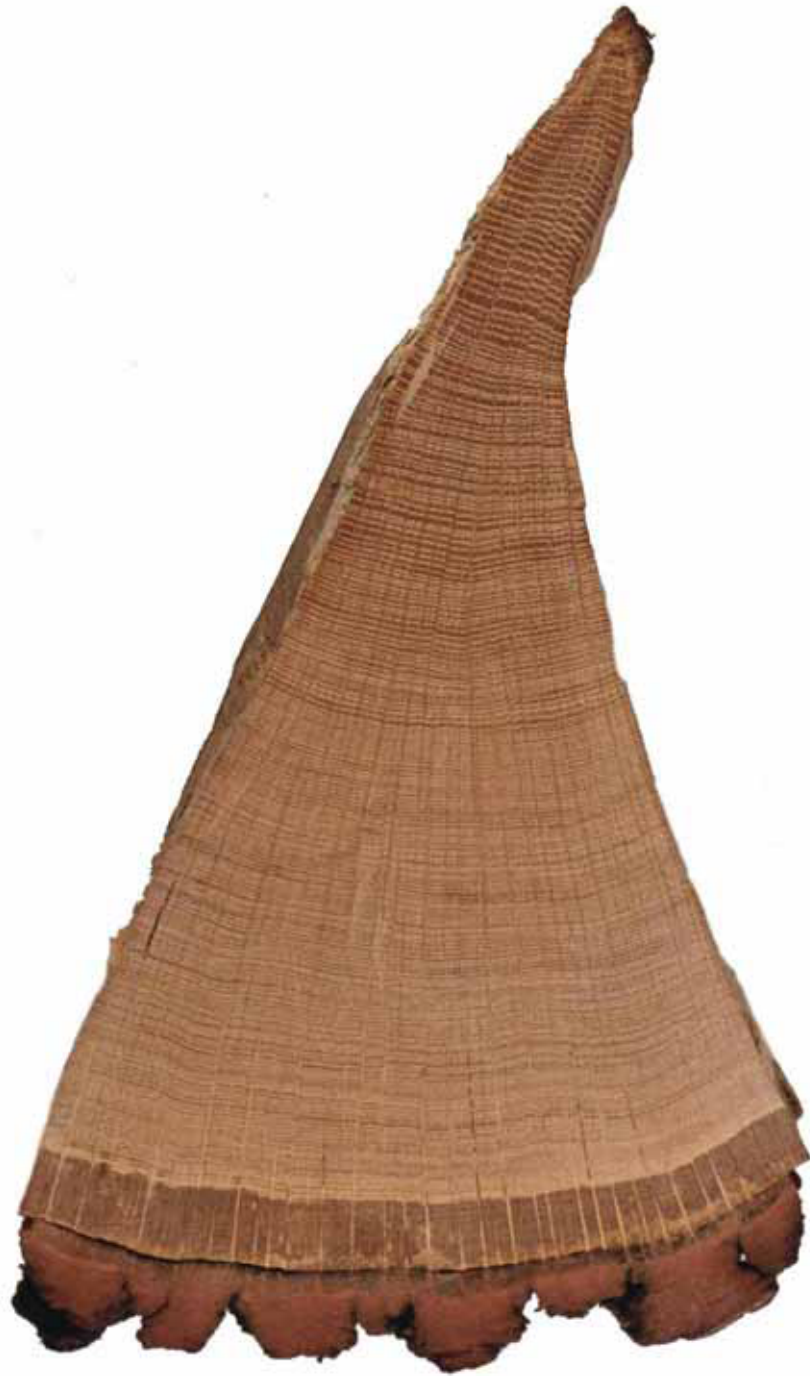
*Figure A1: A wedge of oak from a tree felled in 1976. It shows the annual growth rings, one for each year from the innermost ring to the last ring on the outside just inside the bark. The year of each ring can be determined by counting back from the outside ring, which grew in 1976*

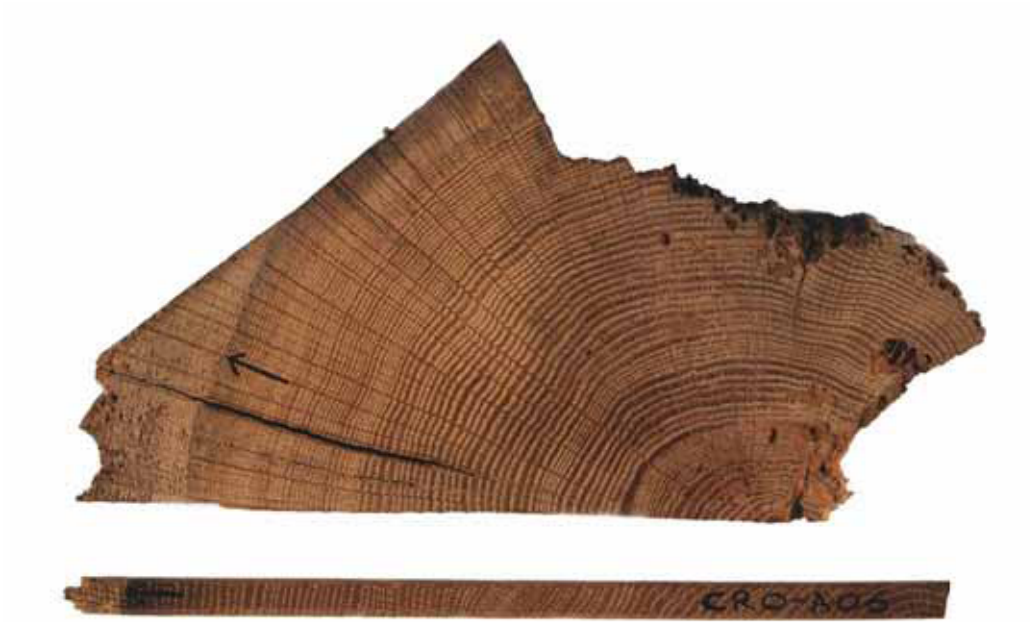
*Figure A2: Cross-section of a rafter, showing sapwood rings in the left-hand corner, the arrow points to the heartwood/sapwood boundary (H/S); and a core with sapwood; again the arrow is pointing to the H/S. The core is about the size of a pencil*

Quite often some, though not all, of the original outer rings are missing on a timber. The outer rings on an oak, called sapwood rings, are usually lighter than the inner rings, the heartwood, and so are relatively easy to identify. For example, sapwood can be seen in the corner of the rafter and at the outer end of the core in Figure A2, both indicated by arrows. More importantly for dendrochronology, the sapwood is relatively soft and so liable to insect attack and wear and tear. The builder, therefore, may remove some of the sapwood for precisely these reasons. Nevertheless, if at least some of the sapwood rings are left on a sample, we will know that not too many rings have been lost since felling so that the date of the last ring on the sample is only a few years before the date of the original last ring on the tree, and so to the date of felling.

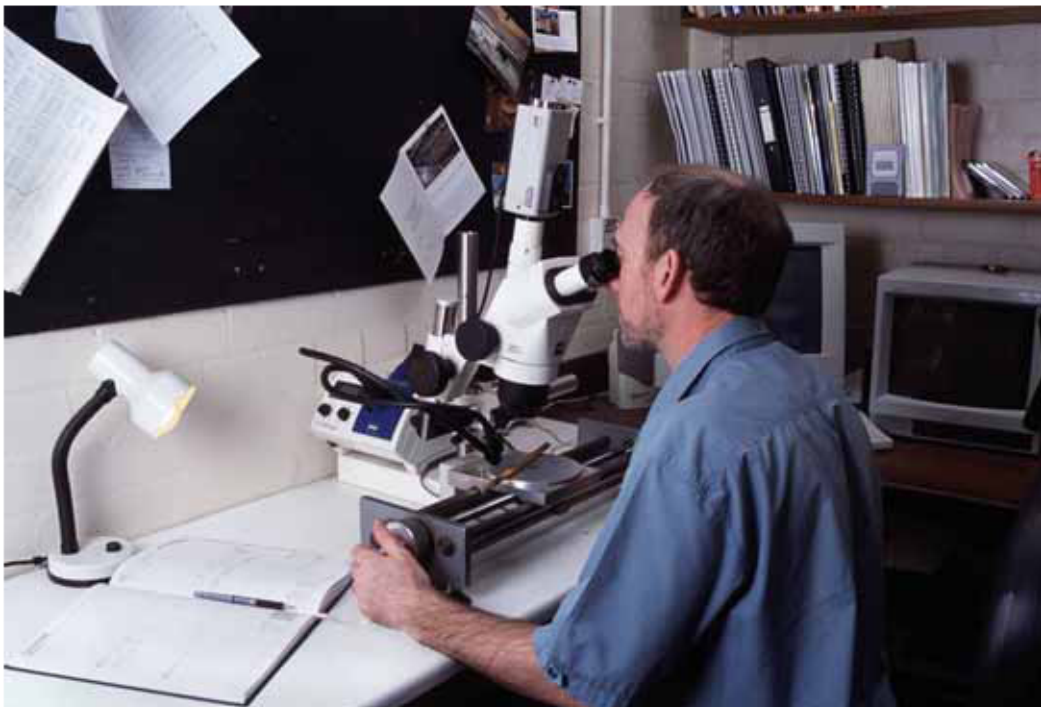
*Figure A3: Measuring ring widths under a microscope. The microscope is fixed while the sample is on a moving platform. The total sequence of widths is measured twice to ensure that an error has not been made. This type of apparatus is needed to process a large number of samples on a regular basis*

2. **Measuring Ring Widths.** Each core is sanded down with a belt sander using medium-grit paper and then finished by hand with flourgrade-grit paper. The rings are then clearly visible and differentiated from each other with a result very much like that shown in Figure A2. The core is then mounted on a movable table below a microscope and the ring-widths measured individually from the innermost ring to the outermost. The widths are automatically recorded in a computer file as they are measured (see Fig A3).

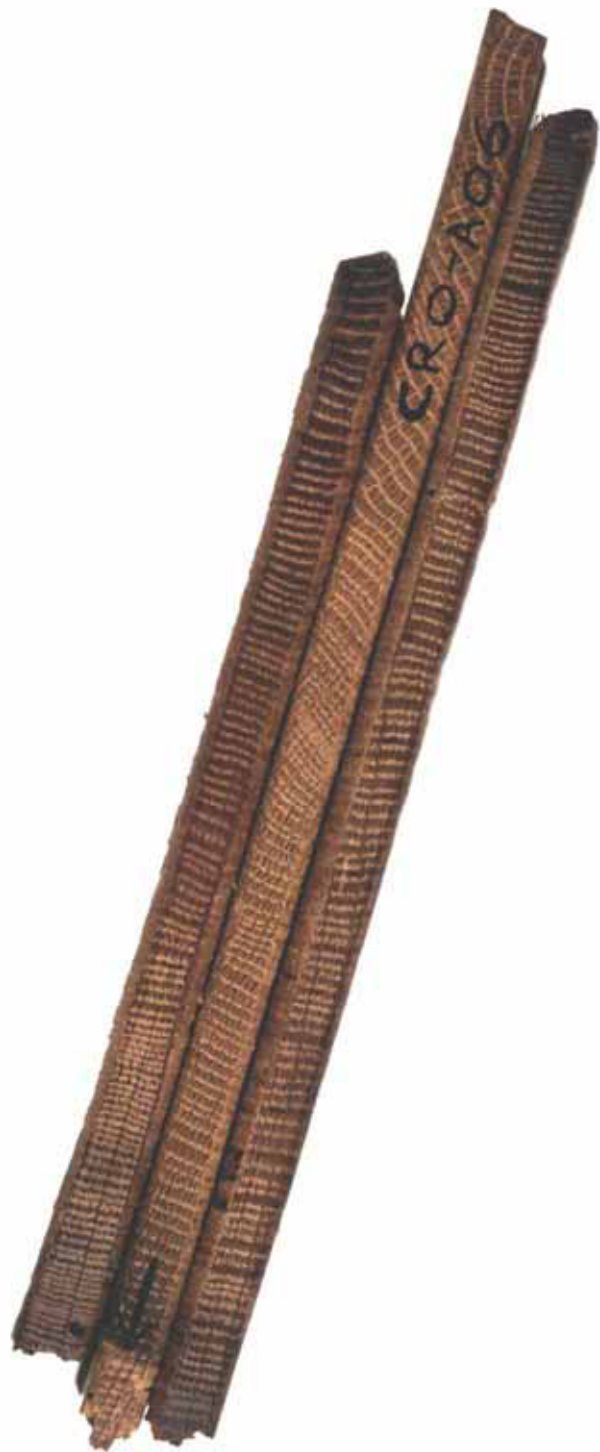
*Figure A4: Three cores from timbers in a building. They come from trees growing at the same time. Notice that, although the sequences of widths look similar, they are not identical. This is typical*
