# CANONS GARTH, HELMSLEY, NORTH YORKSHIRE TREE-RING ANALYSIS OF TIMBERS

# SCIENTIFIC DATING REPORT

# TREE-RING ANALYSIS OF TIMBERS

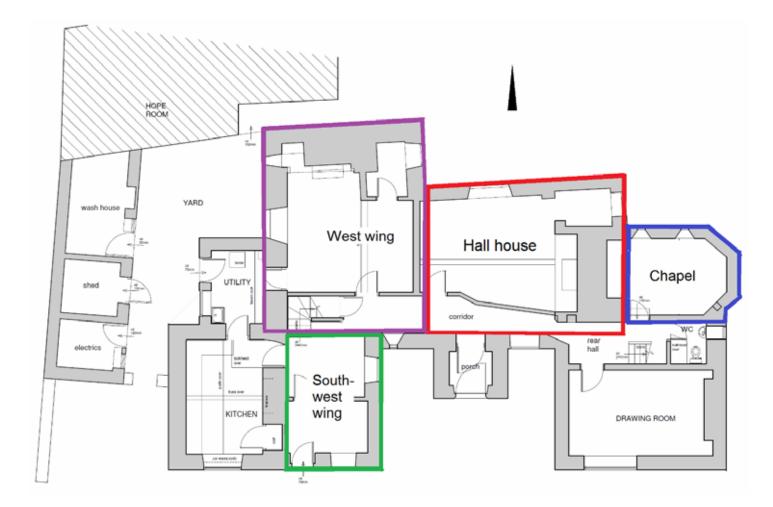
Figure 4: Plan of Canons Garth, showing the areas investigated (Malcolm Tempest Ltd)

The Grade II\* listed Canons Garth lies just to the north-east of Helmsley Church, in the Ryedale district of North Yorkshire (Figs 1–3). At the core of the extant building is the original hall house, thought to have been of base-cruck construction, possibly with a cross-passageway in the western bay (Ryder 2012). To the west of this is a north-south orientated cross-wing which projects slightly to the north of the hall. This wing is believed to have contained the kitchen at ground-floor level. To the south are two projecting wings with the porch between. To the east of the hall is a short wing which houses a chapel on the ground floor (Fig 4).

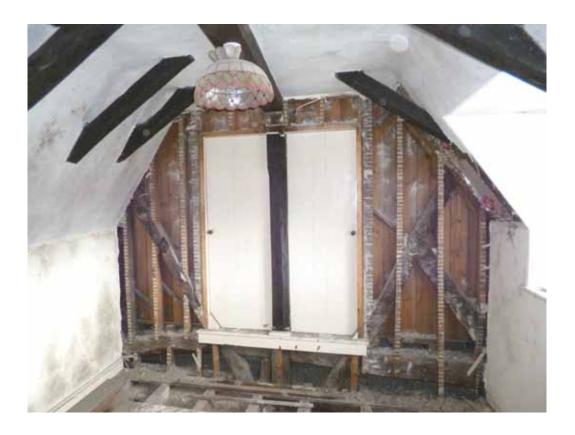
Figure 5: Hall house, roof, truss 1, photograph taken from the west (Alison Arnold)

There are two surviving crown-post roof trusses over this part of the building. These trusses consist of two parallel 'tiebeams', principal rafters, crown post, passing braces, struts, and collars. Between these are common rafters, collars (with bracing between), and collar purlin (Fig 5). This roof is thought to represent one of the earliest surviving roof structures in the north of England and is believed to date to *c* AD 1300.

Eleven of the samples taken from the roof over this part of the building have been successfully dated. Five of the dated samples have complete sapwood and the last-measured ring date of AD 1283, the felling date of the timbers represented. The other six dated roof samples from the hall house all have the heartwood/sapwood boundary ring, which in all cases is broadly contemporary and suggestive of a single felling. The average heartwood/sapwood boundary ring date is AD 1263, allowing an estimated felling date to be calculated for the six timbers represented of AD 1283–1303 (taking into account sample HEL-M07 having a last-measured ring date of AD 1282 with incomplete sapwood), consistent with these timbers also having been felled in AD 1283. Further supporting the suggestion of all timbers having been felled at the same time is the good level of matching seen between samples from this structure, with all grouping together at a value of t=5.0.

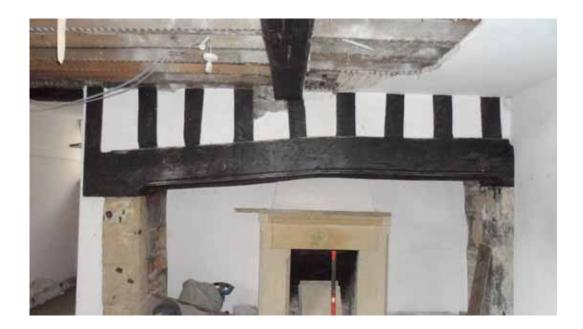
Figure 6: Hall house, smokehood (Alison Arnold)

At first-floor level on the east side, is a very large chimney stack of squared limestone and a hearth with chamfered stone jambs, spanned by a heavy timber bresummer, cut into a flat arch. There are nine stud posts attached to the top of this bresummer (Fig 6). This structure is believed to be sixteenth century in date.

It is unfortunate that of those timbers associated with the smokehood, only the bresummer was found to be suitable for measurement and that this sample is undated. This feature was thought, on stylistic grounds, to be sixteenth century in date and at present this is the only dating evidence available. However, as noted in the introduction, one of the beams associated with the floor frame 'cuts' the smokehood meaning that the smokehood has to be earlier than the floor, now known to be constructed with timber felled in AD 1622–39.

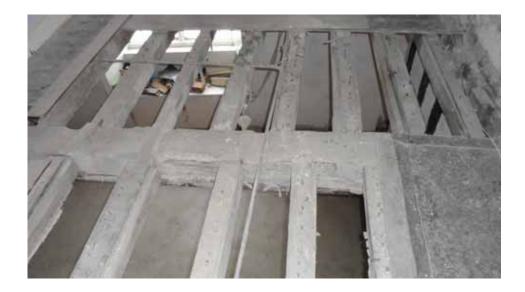
Figure 7: Hall house, first-floor frame, photograph taken from the south (Alison Arnold)

The hall house is thought to have been floored at both first- and attic-floor level in the seventeenth century. Although the exposed attic floor appears to have been replaced, the exposed first-floor structure is historic, consisting of a single large, spine beam with simple stopped chamfers and smaller, squared common joists morticed in to either side (Fig 7). These joists may be reused. The main beam can be seen to interrupt one of the studs of the smokehood (Fig 6).

Eight samples taken from first-floor ceiling joists have been successfully dated. Three of these have the heartwood/sapwood boundary ring, the dates of which suggest two separate fellings. Sample HEL-M15 has the earlier heartwood/sapwood boundary ring date of AD 1531 which allows an estimated felling date to be calculated for the timber represented to within the range AD 1546–71. Two other samples (HEL-M16 and HEL-M20) have later, similar heartwood/sapwood boundary ring dates, the average of which is AD 1599, giving an estimated felling date for the two timbers represented of AD 1622–39. This allows for sample HEL-M20 having the last-measured ring date of AD 1621 with incomplete sapwood.

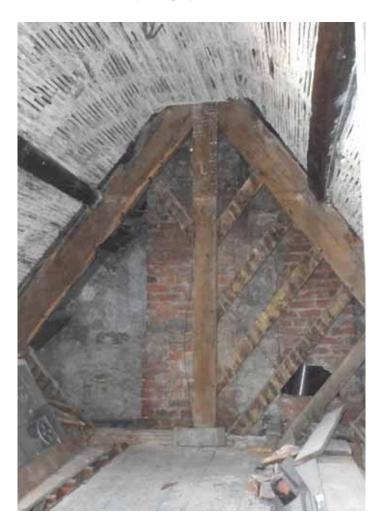
Figure 8: West wing, roof, truss 1, photograph taken from the south (Alison Arnold)

The stripping out of cupboards and partitions has exposed two trusses of this roof. The northernmost truss (truss 1) was obviously a closed truss as evidenced by the struts between crown post and principal rafters (Fig 8). There are purlins running between these trusses. Truss 2 does not have the struts and so was always an open truss. A third truss can be seen in the south gable wall. This roof is thought to be a sixteenth-century reroofing.

Fourteen of the samples taken from the roof of the West wing have been successfully dated. Two of these, HEL-M13 and HEL-M33, have complete sapwood and the last-measured ring date of AD 1622, the felling date of the timbers represented. Sample HEL-M37 matches sample HEL-M33 at the high value of *t*=14.0, with both beams almost certainly being cut from the same tree and hence having the same felling (AD 1622). Four other dated roof timbers have the heartwood/sapwood boundary ring date which is broadly contemporary and suggestive of a single felling. The average of these dates is AD 1594, allowing an estimated felling date to be calculated for the five timbers represented to within the range AD 1609–34, consistent with these timbers also having been felled in AD 1622. There are seven dated roof timbers without the heartwood/sapwood boundary ring dates, but with last-measured ring dates which range from AD 1512 (HEL-M35) to AD 1553 (HEL-M27). All seven of these could also have been felled in AD 1622. The overall good level of crossmatching seen between the samples from this roof adds further weight to the suggestion that all timbers were felled at the same time.

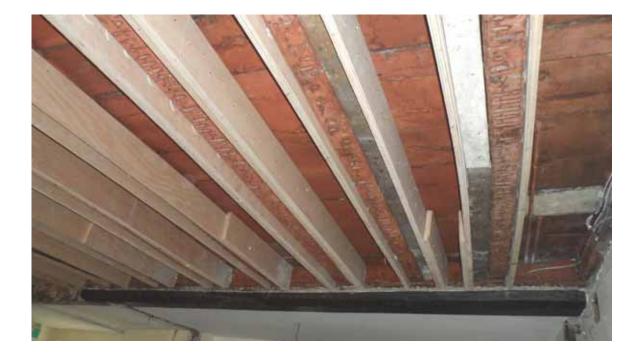
Figure 9: West wing, first-floor frame, photograph taken from the west (Alison Arnold)

The first-floor frame consists of a chamfered north-south spine beam and a series of common joists. It can be seen that the timbers of this floor frame and the underside of the boards were coated with red ochre (Fig 9). The main beam has an empty mortice at its north end.

Six of these beams have been dated. Sample HEL-M39, taken from the spine beam has complete sapwood and the last-measured ring date of AD 1668, the felling date of the timber represented. Sample HEL-M41, from a joist, has the heartwood/sapwood boundary ring date of AD 1599, allowing an estimated felling date to be calculated for the timber represented to within the range AD 1614–39.

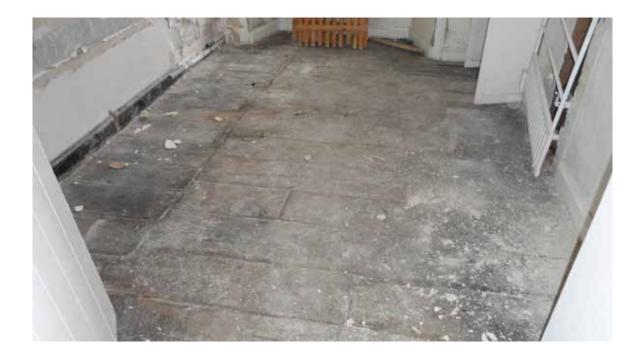
Figure 10: First-floor floorboards, photograph taken from the east (Alison Arnold)

At first-floor level a large number of wide, oak boards of late-medieval or sub-medieval character survive (Fig 10). These are laid north-south and supported by the floor frame below.

The growth patterns of five of the floorboards were successfully dated. None of these boards had the heartwood/sapwood boundary ring but have *terminus post quem* felling dates ranging from AD1535 (HEL-M49) to AD 1577 (HEL-M52). Samples HEL-M48 and HEL-M49 match each other at the high value of t=13.8 and are likely to have been cut from the same tree.

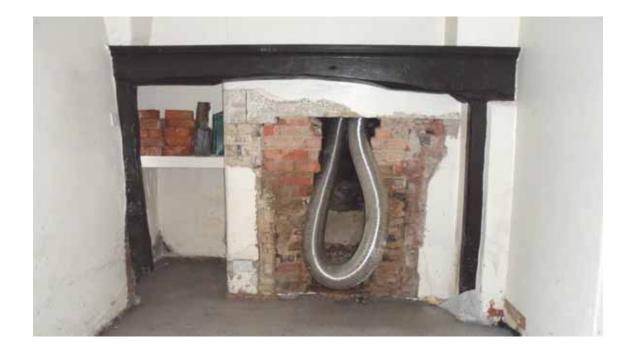
*Figure 11: West wing, ground-floor bresummer and posts, photograph taken from the south (Alison Arnold)*

To the north of the west wing at ground-floor level is a large fireplace which has a large timber lintel supported on timber posts, the eastern one of which looks relatively modern (Fig 11).

The sample taken from this timber has complete sapwood and the last-measured ring date of AD 1629, the felling date of the timber represented.

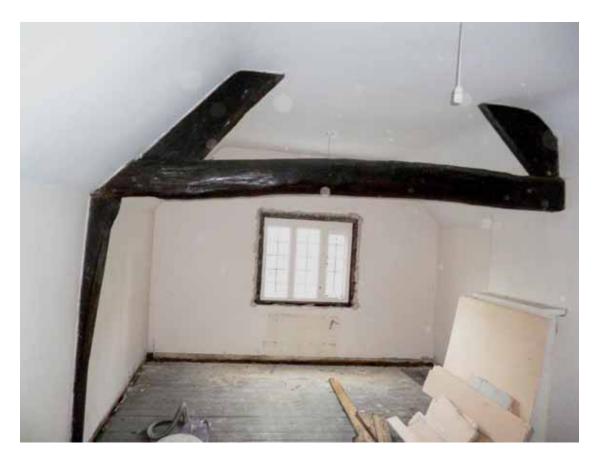
Figure 12: South-west wing, truss, photograph taken from the north (Alison Arnold)

This wing is slightly lower and has three trusses, two to the gable ends and one visible in a first-floor bedroom. This middle truss consists of principal rafters, tiebeam, and post to the east side (Fig 12); a further truss can be seen in the south gable end. There is a single tier of purlins to each side. This wing is thought to be sixteenth century in date.

Seven of the samples taken from the timbers of the roof over this part of the building have been dated. Five of these samples have the heartwood/sapwood boundary ring, which is broadly contemporary and suggestive of a single felling. The average heartwood/sapwood boundary ring date is AD 1531, allowing an estimated felling date to be calculated for the five timbers represented to within the range AD 1551–71. This allows for sample HEL-M58 having the last-measured ring date of AD 1550 with incomplete sapwood.

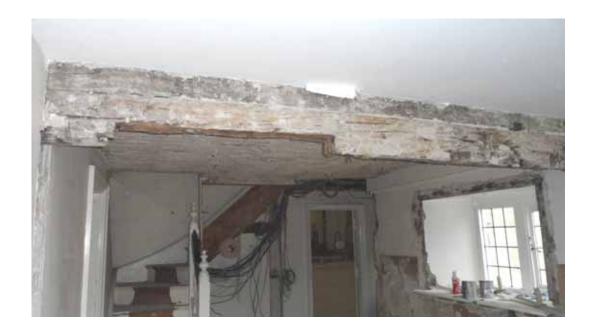
*Figure 13: South-west wing, ground-floor ceiling beam, photograph taken from the south (Alison Arnold)*

A single east-west main floor beam is visible at ground-floor level (Fig 13)

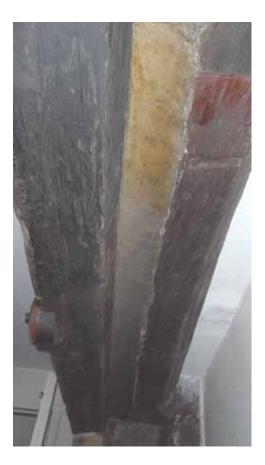
*Figure 14: Chapel, double lintel over ground-floor fireplace, with inner lintel chamfered and stopped towards stack, photograph taken from the south (Alison Arnold)*

There is an old fireplace with chamfered jambs to the west wall of this room. Set into this are two lintels; the one to the back has possibly been reset as it has a large chamfer and concave stops towards the stack (Fig 14). The bedroom directly above the chapel also has a fireplace with chamfered stone jambs and a roughly cambered and chamfered lintel (Fig 15).

Only one of the samples taken from the fireplace bresummers in the Chapel has been successfully dated. Sample HEL-M64, taken from the inner bresummer of the ground-floor

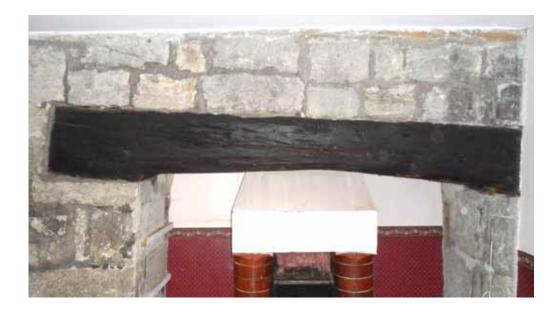
Figure 15: First-floor bedroom, fireplace lintel, photograph taken from the east (Alison Arnold)

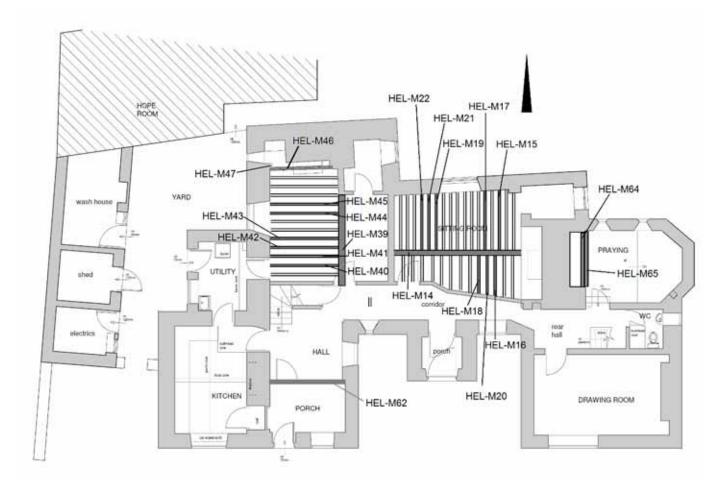
Figure 16: Ground-floor plan, showing the location of samples HEL-M14–22, HEL-M39–47, HEL-M62, and HEL-M64–5 (Malcolm Tempest Ltd)

A total of 59 core samples were taken from timbers of the hall house, west wing, southwest wing, and chapel; the ring width sequences of six floorboards were directly measured using a graticule. Each sample was given the code HEL-M and numbered 1–65. The location of all samples was noted at the time of sampling and has been marked on Figures 16–24. Further details relating to the samples can be found in Table 1.

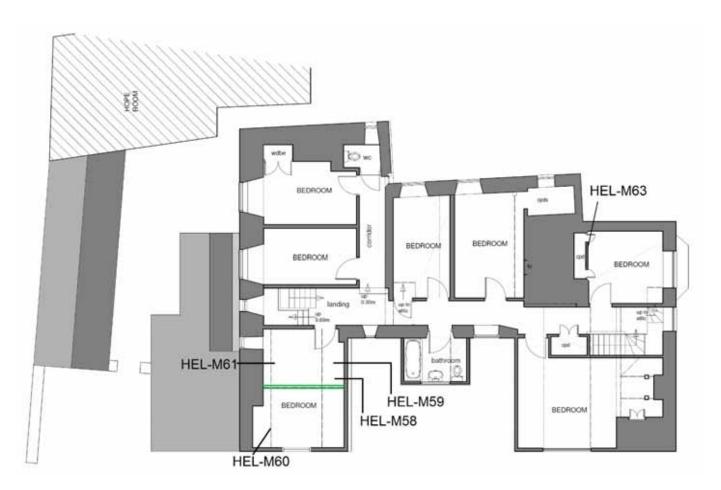
Figure 17: First-floor plan, showing the location of samples HEL-M58–61 and HEL-M63 (Malcolm Tempest)

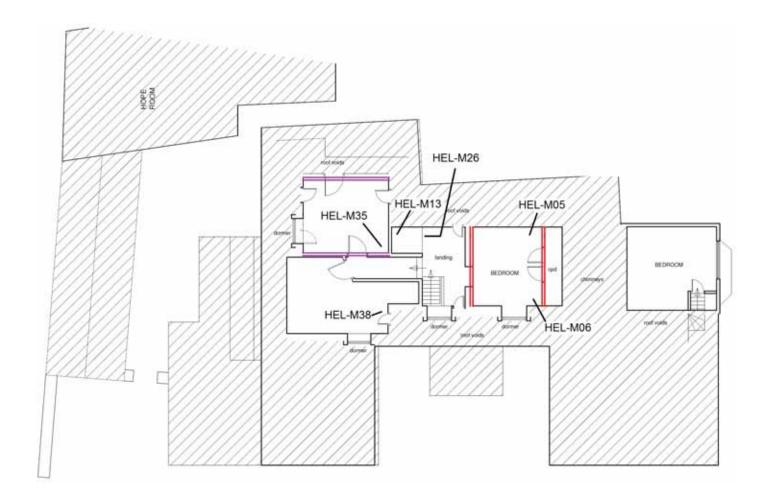
Figure 18: Attic plan, showing the location of samples HEL-M05–06, HEL-M13, HEL-M26, HEL-M35, and HEL-M38 (Malcolm Tempest Ltd)

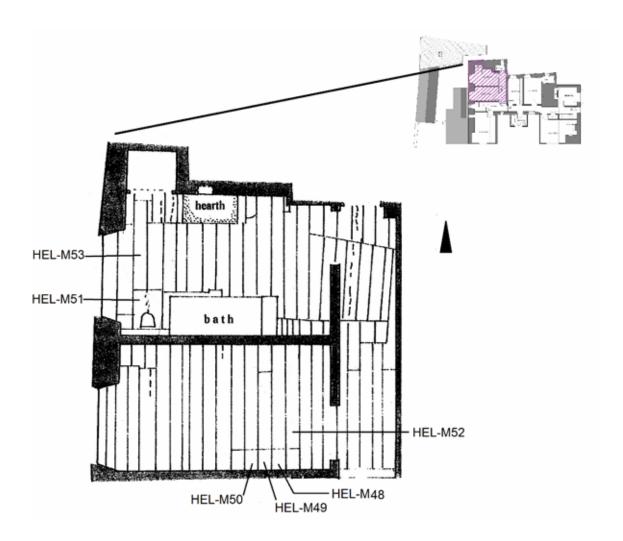
*Figure 19: Plan of old flooring on the first floor, showing the location of samples HEL-M48–53 (Ryder 2012)*

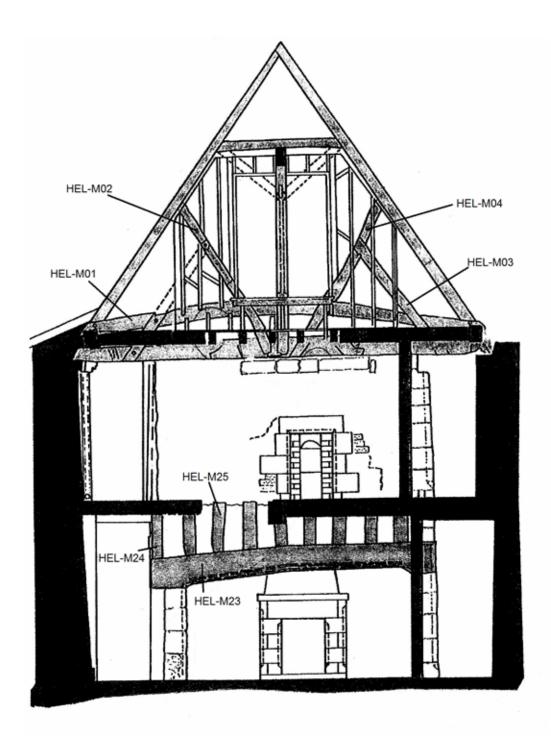
*Figure 20: Section through house looking east, showing location of samples HEL-M01–04 and HEL-M23–5 (Ryder 2012)*

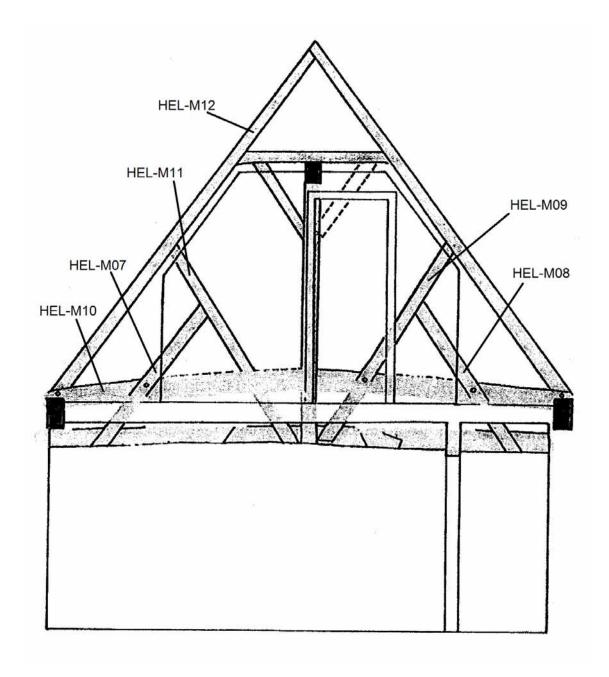
Figure 21: Hall house, truss 2, showing the location of samples HEL-M07–12 (Ryder 2012)

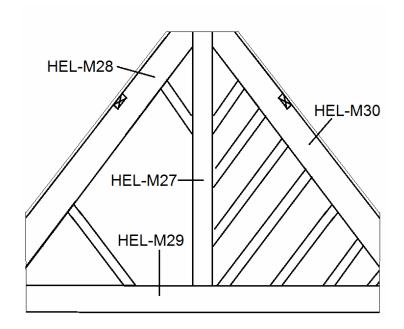
Figure 22: West wing, sketch of truss 1, showing the location of samples HEL-M27–30

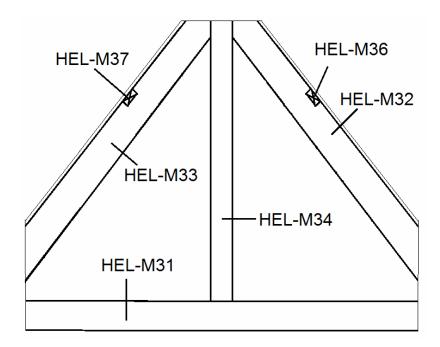
*Figure 23: West wing, sketch of truss 2, showing the location of samples HEL-M31–4 and HEL-M36–7*

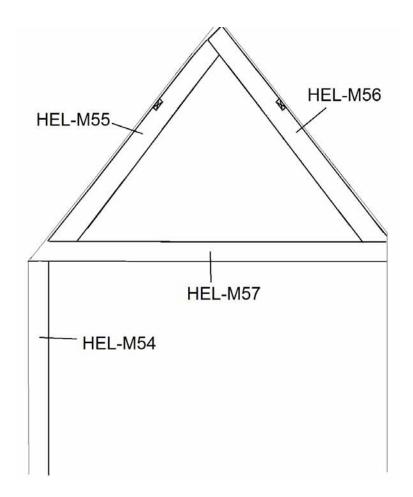
Figure 24: South-west wing, sketch of truss, showing the location of samples HEL-M54–7

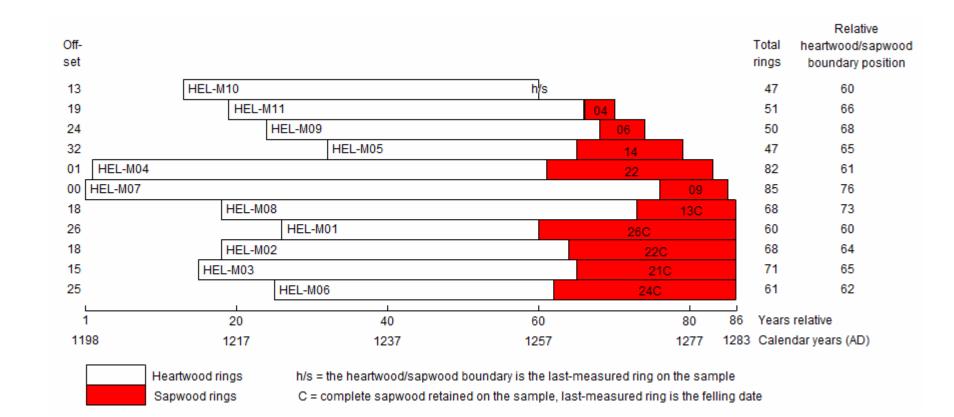
Figure 25: Bar diagram of samples in site sequence HELMSQ01

Firstly, 11 samples taken from the hall house roof matched each other and were combined at the relevant offset positions to form HELMSQ01, a site sequence of 86 rings (Fig 25). This site sequence was compared against a series of relevant reference chronologies for oak where it was found to span the period AD 1198–1283. The evidence for this dating is given by the *t*-values in Table 2.

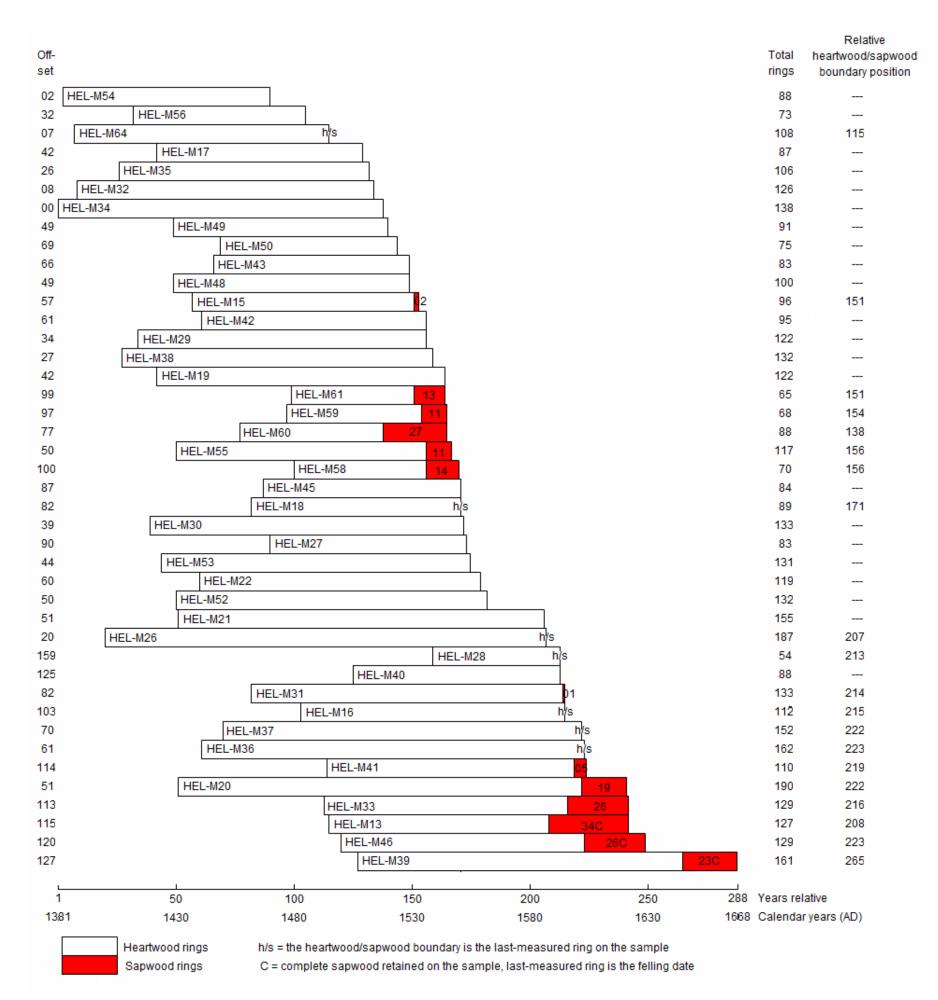
Figure 26: Bar diagram of samples in site sequence HELMSQ02

Forty-two samples, taken from all parts of the building, also grouped and these were combined at the relevant offset positions to form HELMSQ02, a site sequence of 288 rings (Fig 26). This site sequence was found to match consistently and securely at a first-ring date of AD 1381 and a last-measured ring date of AD 1668. Evidence for this dating is given by the *t*-values in Table 3.

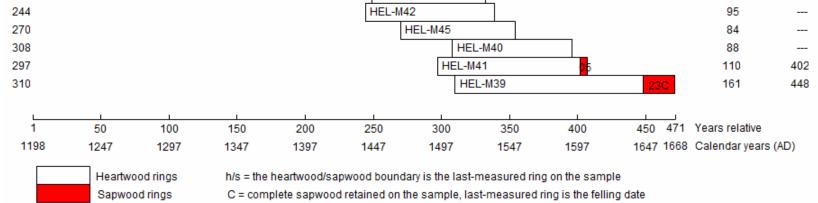
C = complete sapwood retained on the sample, last-measured ring is the felling date

Figure 27: Bar diagram of all dated samples, sorted by area

To aid interpretation the dated timbers from each area have been illustrated separately (Fig 27).

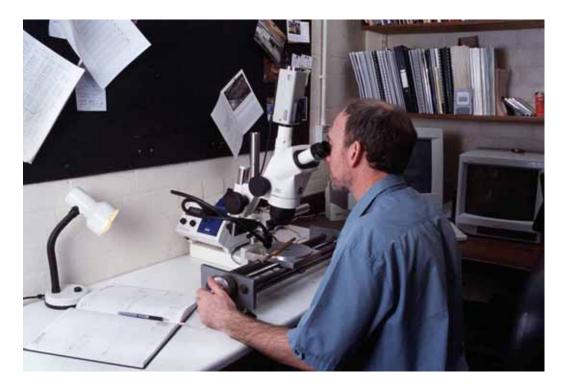
Figure A3: Measuring ring widths under a microscope. The microscope is fixed while the sample is on a moving platform. The total sequence of widths is measured twice to ensure that an error has not been made. This type of apparatus is needed to process a large number of samples on a regular basis

2. Measuring Ring Widths. Each core is sanded down with a belt sander using medium-grit paper and then finished by hand with flourgrade-grit paper. The rings are then clearly visible and differentiated from each other with a result very much like that shown in Figure A2. The core is then mounted on a movable table below a microscope and the ring-widths measured individually from the innermost ring to the outermost. The widths are automatically recorded in a computer file as they are measured (see Fig A3).

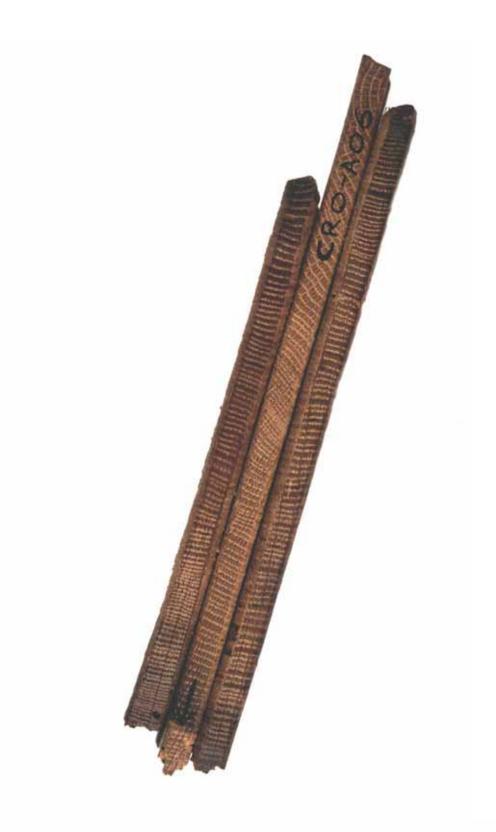
Figure A4: Three cores from timbers in a building. They come from trees growing at the same time. Notice that, although the sequences of widths look similar, they are not identical. This is typical

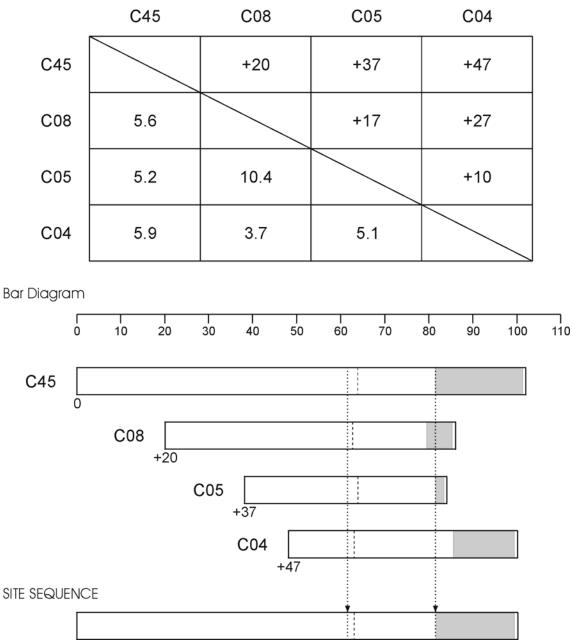
## *Figure A5: Cross-matching of four sequences from a Lincoln Cathedral roof and the formation of a site sequence from them*

The bar diagram represents these sequences without the rings themselves. The length of the bar is proportional to the number of rings in the sequence. Here the four sequences are set at relative positions (offsets) to each other at which they have maximum correlation as measured by the *t*-values. The *t*-value/offset matrix contains the maximum *t*-values below the diagonal and the offsets above it. Thus, the maximum *t*-value between C08 and C45 occurs at the offset of +20 rings and the *t*-value is then 5.6. The site sequence is composed of the average of the corresponding widths, as illustrated with one width.

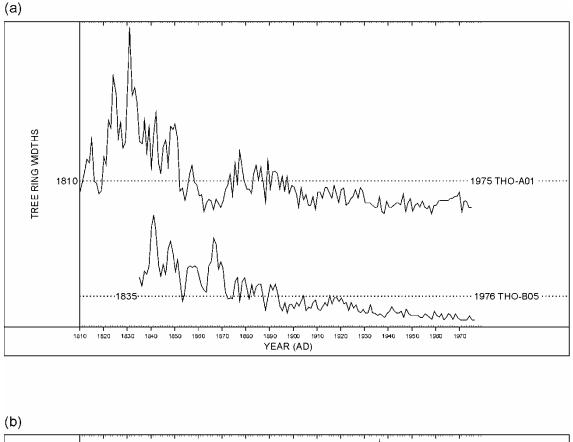
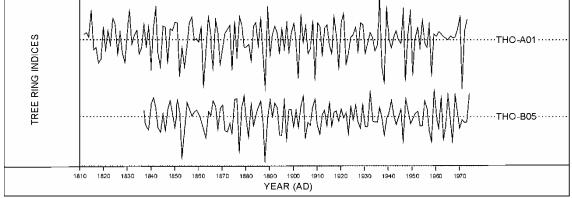
## Figure A7 (a): The raw ring-widths of two samples, THO-A01 and THO-B05, whose felling dates are known

Here the ring widths are plotted vertically, one for each year, so that peaks represent wide rings and troughs narrow ones. Notice the growth-trends in each; on average the earlier rings of the young tree are wider than the later ones of the older tree in both sequences

7. **Ring-Width Indices.** Tree-ring dating can be done by cross-matching the ring widths themselves, as described above. However, it is advantageous to modify the widths first. Because different trees grow at different rates and because a young oak grows in a different way from an older oak, irrespective of the climate, the widths are first standardized before any matching between them is attempted. These standard widths are known as ring-width indices and were first used in dendrochronology by Baillie and Pilcher (1973). The exact form they take is explained in this paper and in the appendix of Laxton and Litton (1988) and is illustrated in the graphs in Figure A7. Here ring-widths are plotted vertically, one for each year of growth. In the upper sequence of (a), the generally large early growth after 1810 is very apparent as is the smaller later growth from about 1900 onwards when the tree is maturing. A similar phenomenon can be observed in the lower sequence of (a) starting in 1835. In both the widths are also changing rapidly from year to year. The peaks are the wide rings and the troughs are the narrow rings corresponding to good and poor growing seasons, respectively. The two corresponding sequence of Baillie-Pilcher indices are plotted in (b) where the differences in the immature and mature growths have been removed and only the rapidly changing peaks and troughs remain, that are associated with the common climatic signal. This makes cross-matching easier.
