RESEARCH REPORT SERIES no. 70-2014

# MOUNT PLEASANT, DORSET A SURVEY OF THE NEOLITHIC 'HENGE ENCLOSURE' AND ASSOCIATED FEATURES

Martyn Barber

NGR: SY 7099 8992

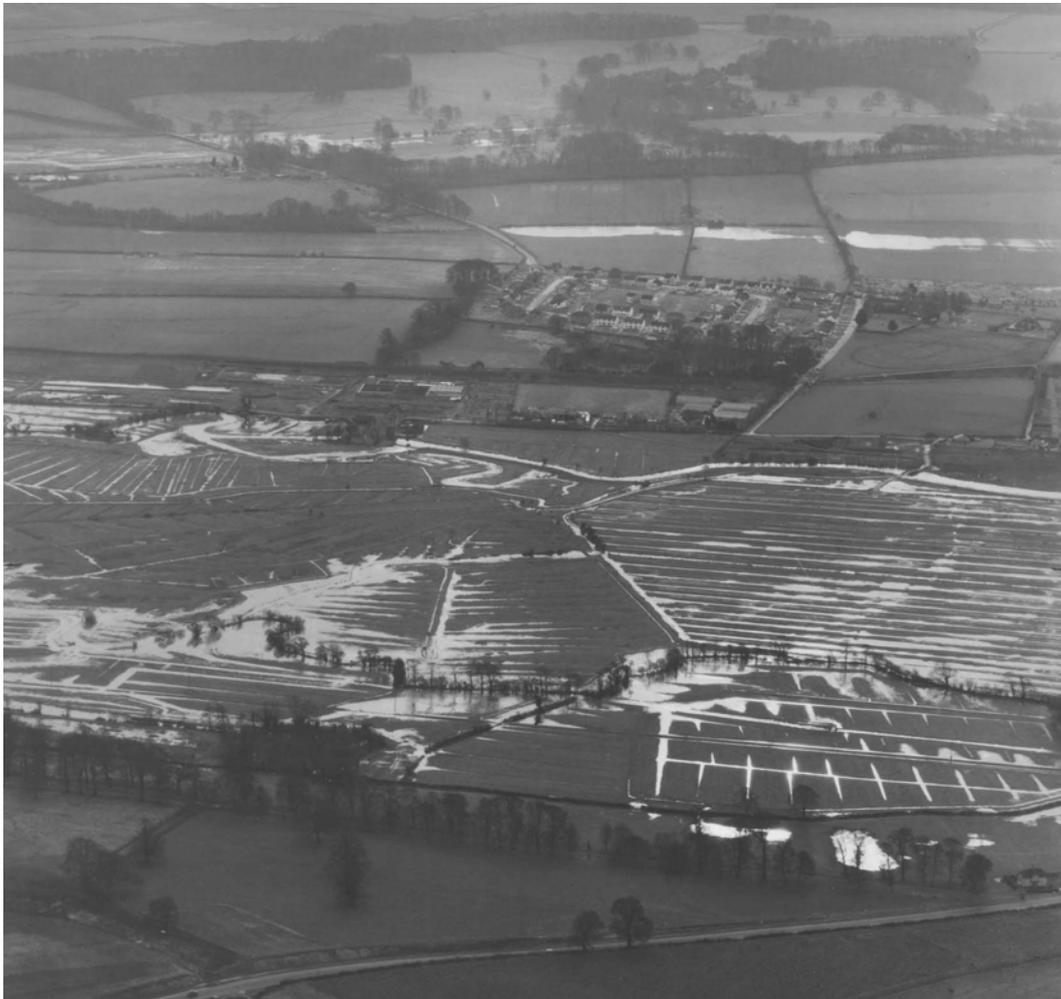
*Fig. 1 – An oblique view of Mount Pleasant and its environs, viewed from the north. Mount Pleasant itself is just left of centre. In the foreground are flooded water meadows associated with the From, while further flooding can be seen to the south, including flooded water meadows associated with the South Winterbourne. Conquer Barrow is partially visible beneath the trees just above the centre of the photograph. 58/RAF/2687/0413 24 January 1959 English Heritage RAF Photography.*

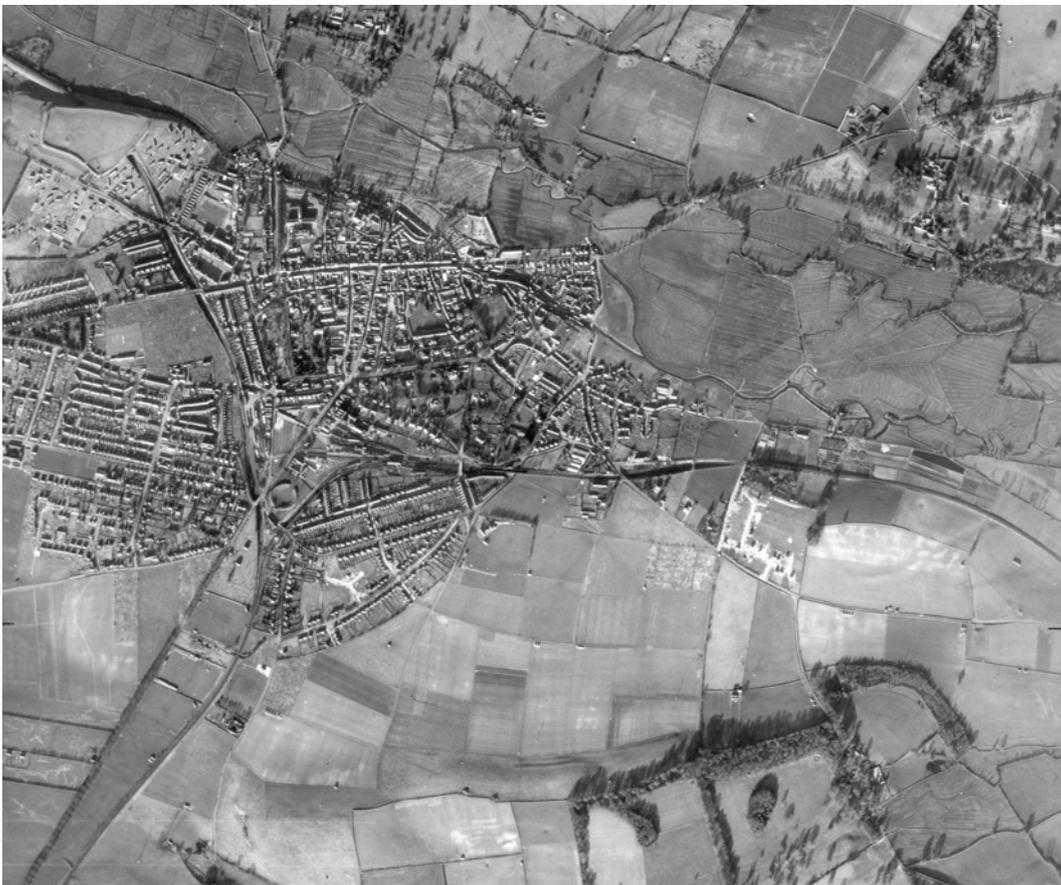
*Fig. 2 – The broader environs of Mount Pleasant, which can be seen to the right of centre. Left of centre, within Dorchester, are the earthworks of Maumbury Rings. Top left is Poundbury Iron Age hillfort. RAF 540/1775/0148 15<sup>th</sup> January 1956. English Heritage RAF Photography.*

Located circa 1.8 km due west of Mount Pleasant, Maumbury Rings (AMIE uid 451848) survives as a substantial earthwork within Dorchester (Fig. 2), though it owes its survival chiefly to its re-use and re-building in the Roman period, when it was converted into an amphitheatre.

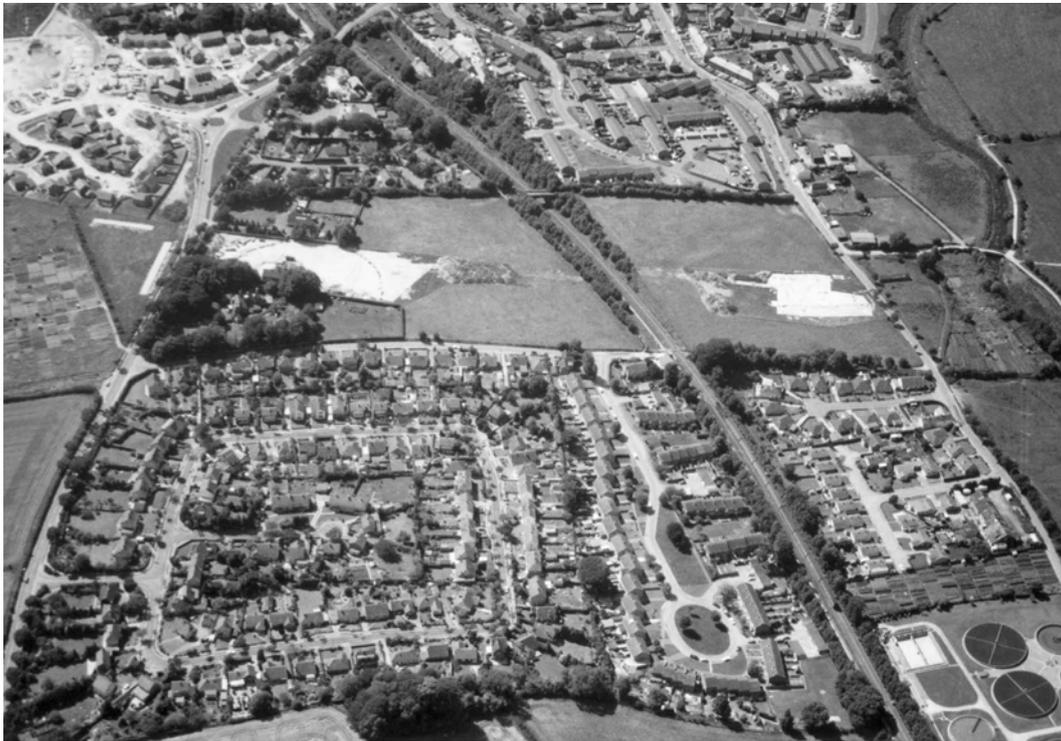
*Fig. 3 – Left of centre, the Flagstones enclosure in the process of excavation. At the foot of the photograph, again just left of centre, are the trees which obscure Conquer Barrow. JRB 3425/08 10<sup>th</sup> July 1987.*

This is a substantial Neolithic ditched enclosure (AMIE uid 983955) located just 400 metres west of Mount Pleasant (Fig. 3). Around half of it was excavated in 1987-88. The enclosure itself appears to have been near circular in shape, around 100 metres in

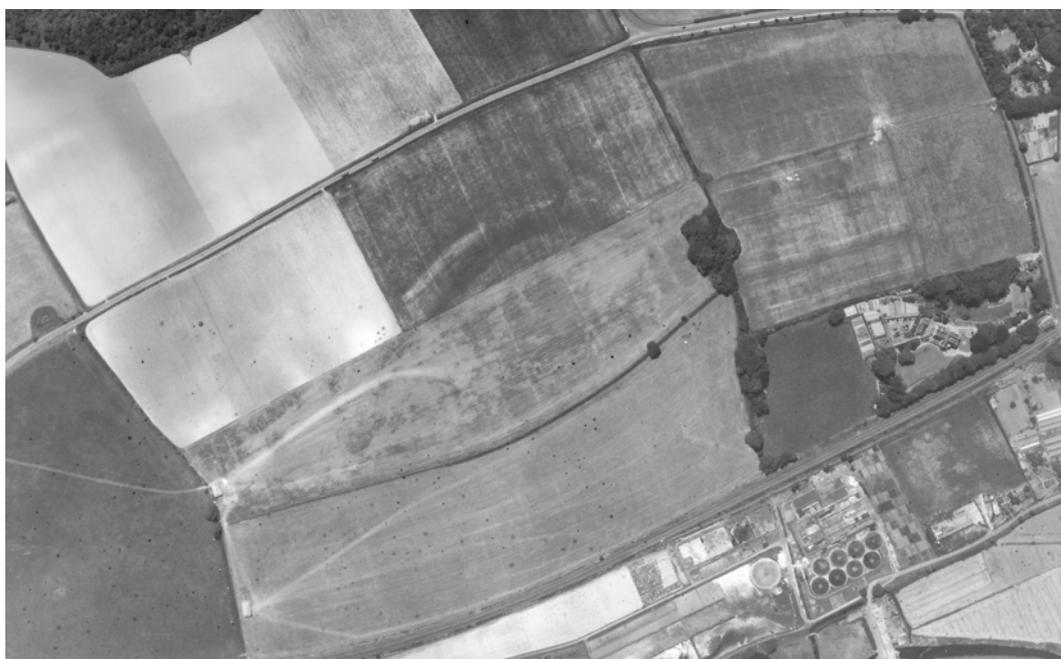
*Fig. 4 – Extract from an RAF vertical from 1949, part of the run examined by the RCHME in the search for the 'mound' allegedly spotted by Atkinson. No mound is visible, and neither is the penannular ditch around 'Site IV'. However, part of the palisade, not discovered until 1969, is clearly visible. RAF 58/271/5131 28<sup>th</sup> June 1949. English Heritage RAF Photography.*

by Wainwright (1979, 4: RAF 58/271/5130, 28<sup>th</sup> June 1949 – the overlapping pair of Fig. 4). The southwestern and southeastern sectors are also visible on two oblique views in the English Heritage Crawford Collection taken in the 1930s (Fig. 11).

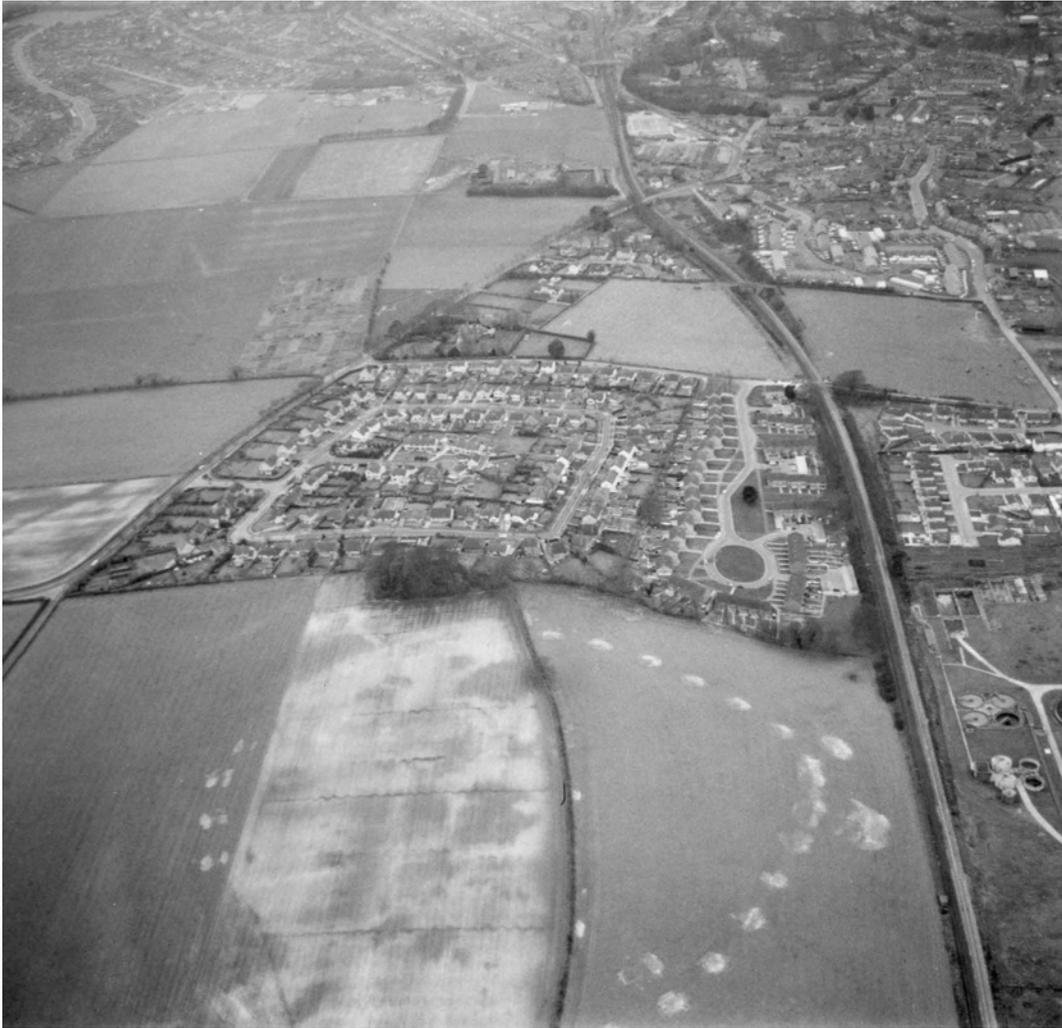
*Fig. 5 – Surface traces of Wainwright's trenches, as photographed a few months after his excavations ended. The course of the palisade is particularly clear. SY 7089/2/772 11<sup>th</sup> December 1971 6566/7.*

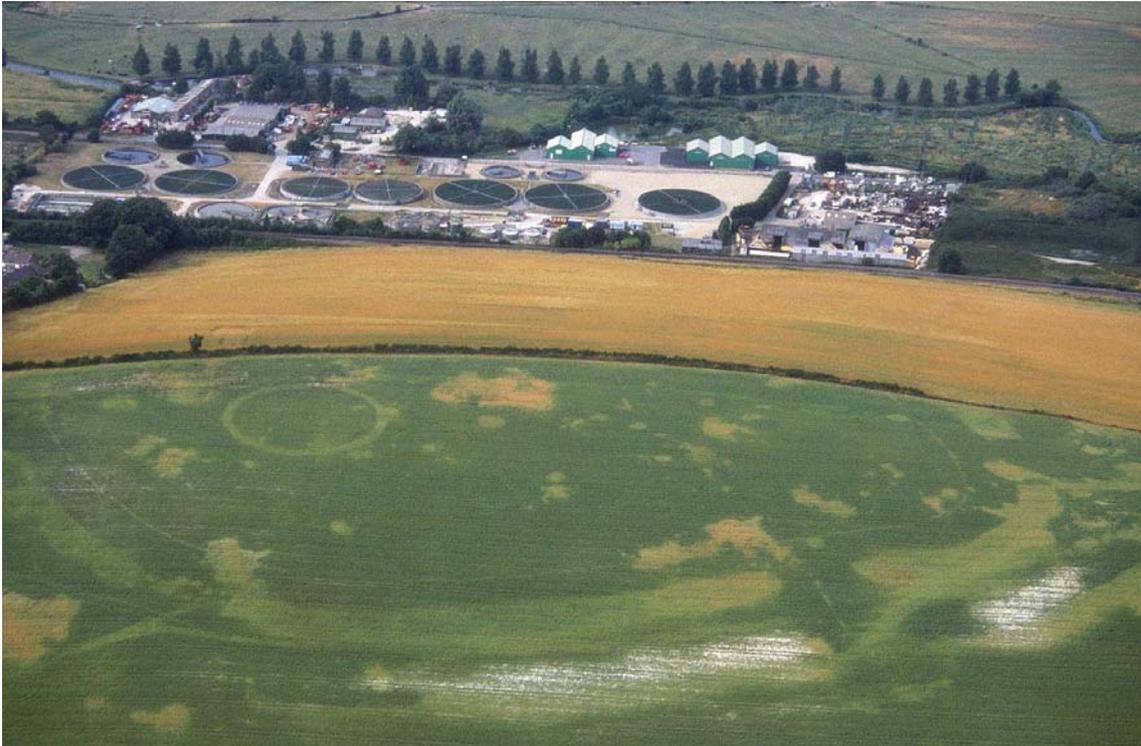
*Fig. 8 – One of Francesca Radcliffe's oblique views, this one from the summer of 1996 clearly showing the 'new' southwestern entrance, which can be seen towards the bottom left, with the irregular pit-like features visible between the ditch terminals. 'Site IV', the palisade, and other features discussed below are also showing clearly. FR 198-30, 5<sup>th</sup> August 1996, © Francesca Radcliffe.*

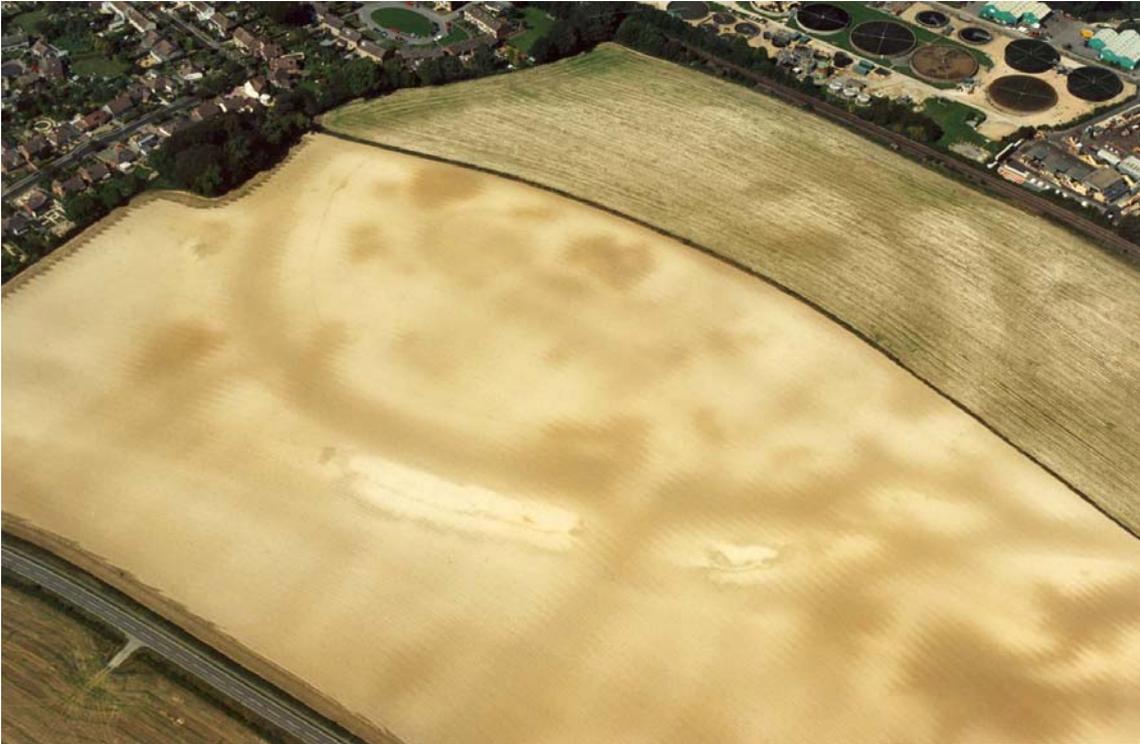
*Fig. 9 – The earthworks photographed in 2004. The possibly heightened sections of bank are clearly visible, as are their terminals, with the axial scar running through the longer section. The line of the 1986 pipeline can also be seen passing very close to the southern edge of the bank. English Heritage Archives 23601/32 1<sup>st</sup> September 2004.*

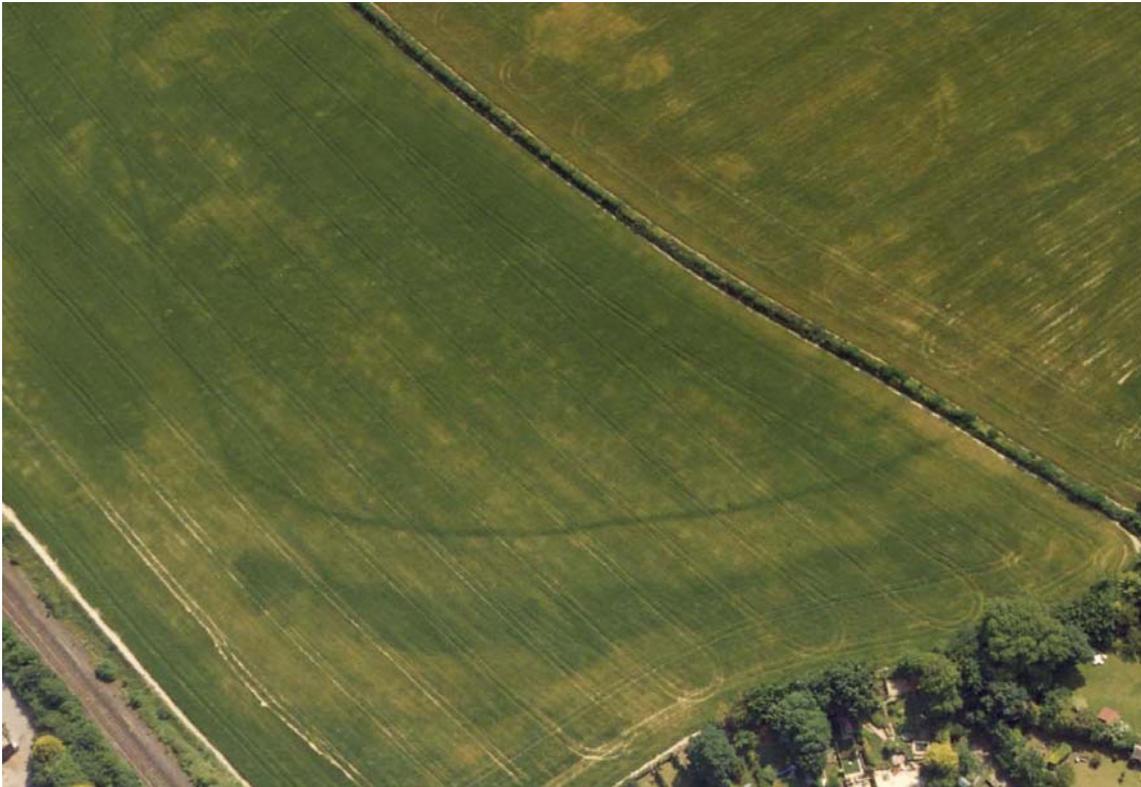
*Fig. 10 – Extract from an oblique taken in 2000, looking roughly southeastwards across the enclosure from the northwest. The palisade and enclosure ditches are showing particularly clearly, while ‘Site IV’ is also visible towards top right. Note here the possible length of narrow ditch running parallel to the palisade, just below and right of centre. The feature has, to date, only been seen on photographs taken on this day in 2000. English Heritage Archives NMR 18766/12 28<sup>th</sup> June 2000.*

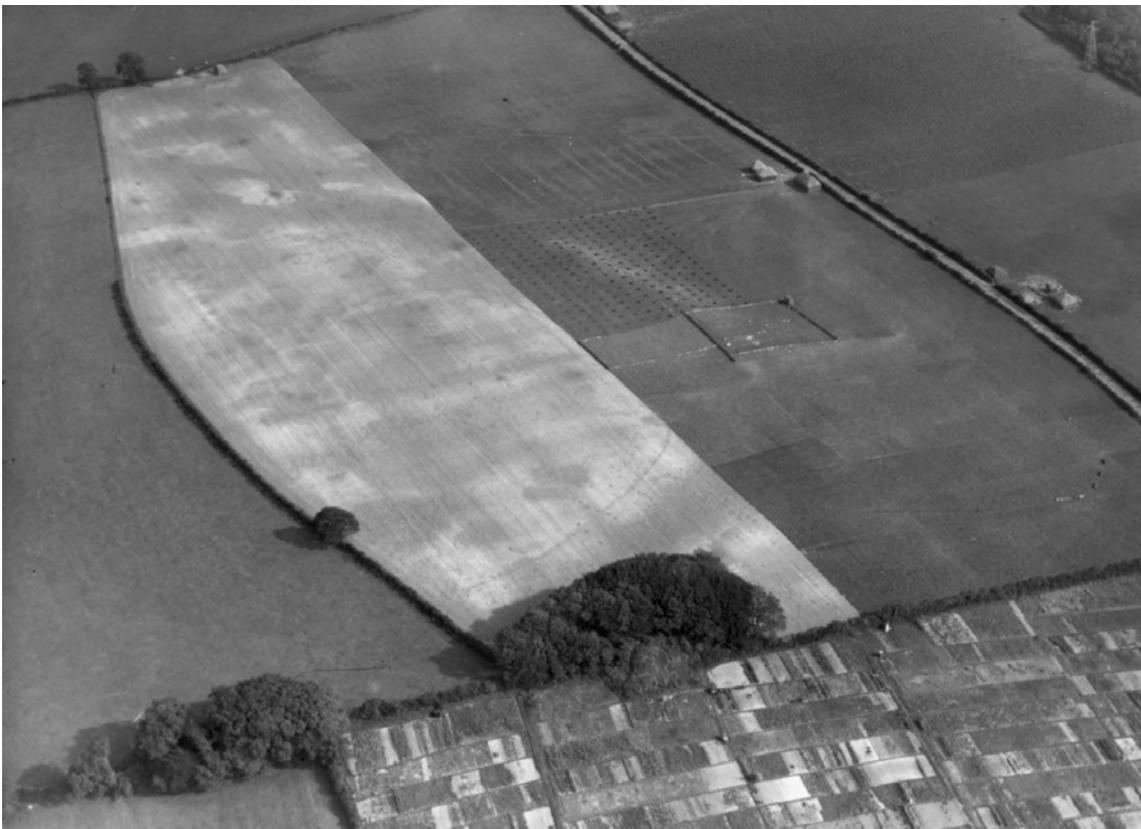
*Fig. 11 – An oblique view dating from somewhere between 1933 and 1939, part of the Crawford Collection held by the English Heritage Archive. The line of the palisade is clear, ‘Site IV’ less so. English Heritage Archive SY 7189/2 1933-39/375.*

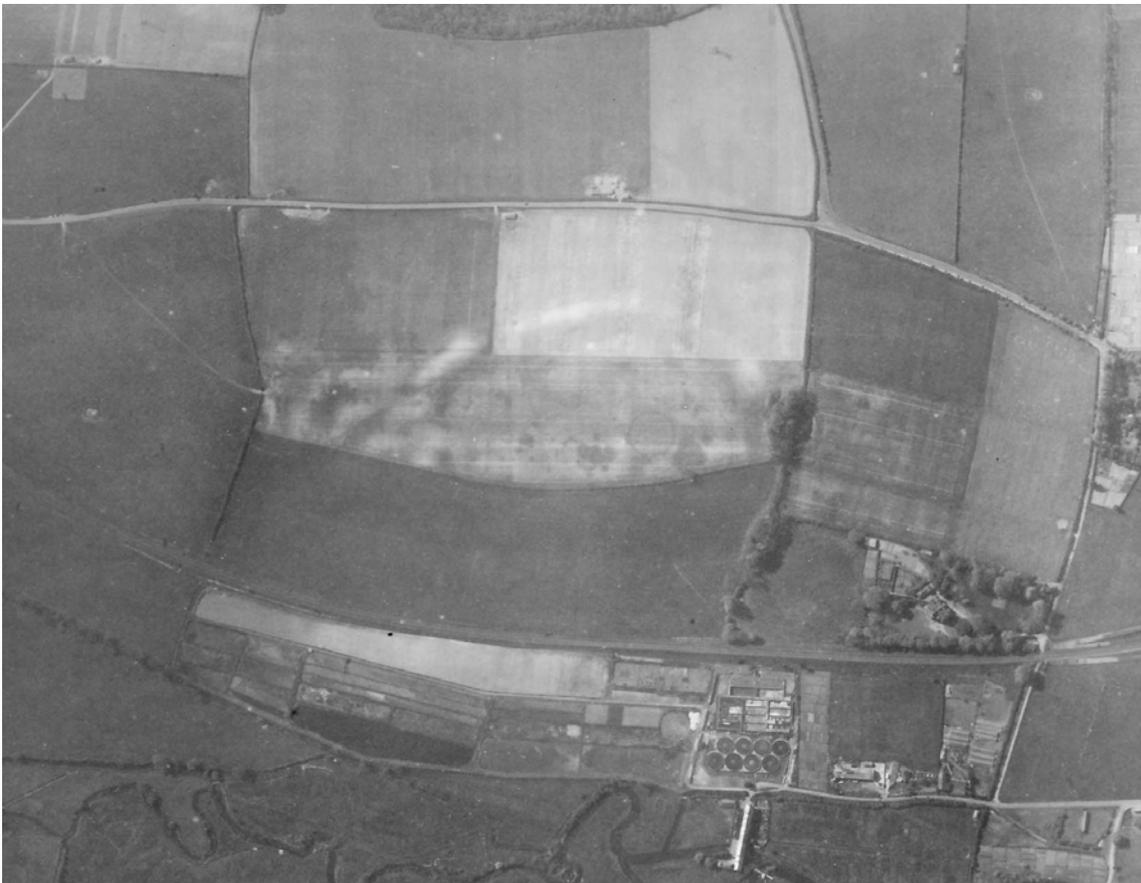
*Fig. 12 – The penannular ditch of 'Site IV', among other features, as captured by the RAF in 1948. Extract from RAF 541/7/3085 7<sup>th</sup> May 1946, English Heritage RAF Photography.*

April 1948, 7<sup>th</sup> May 1948 (Fig. 12) and 15<sup>th</sup> January 1956, as well as on Ordnance Survey verticals taken on 14<sup>th</sup> April 1968 (see Appendix I for full photo references).

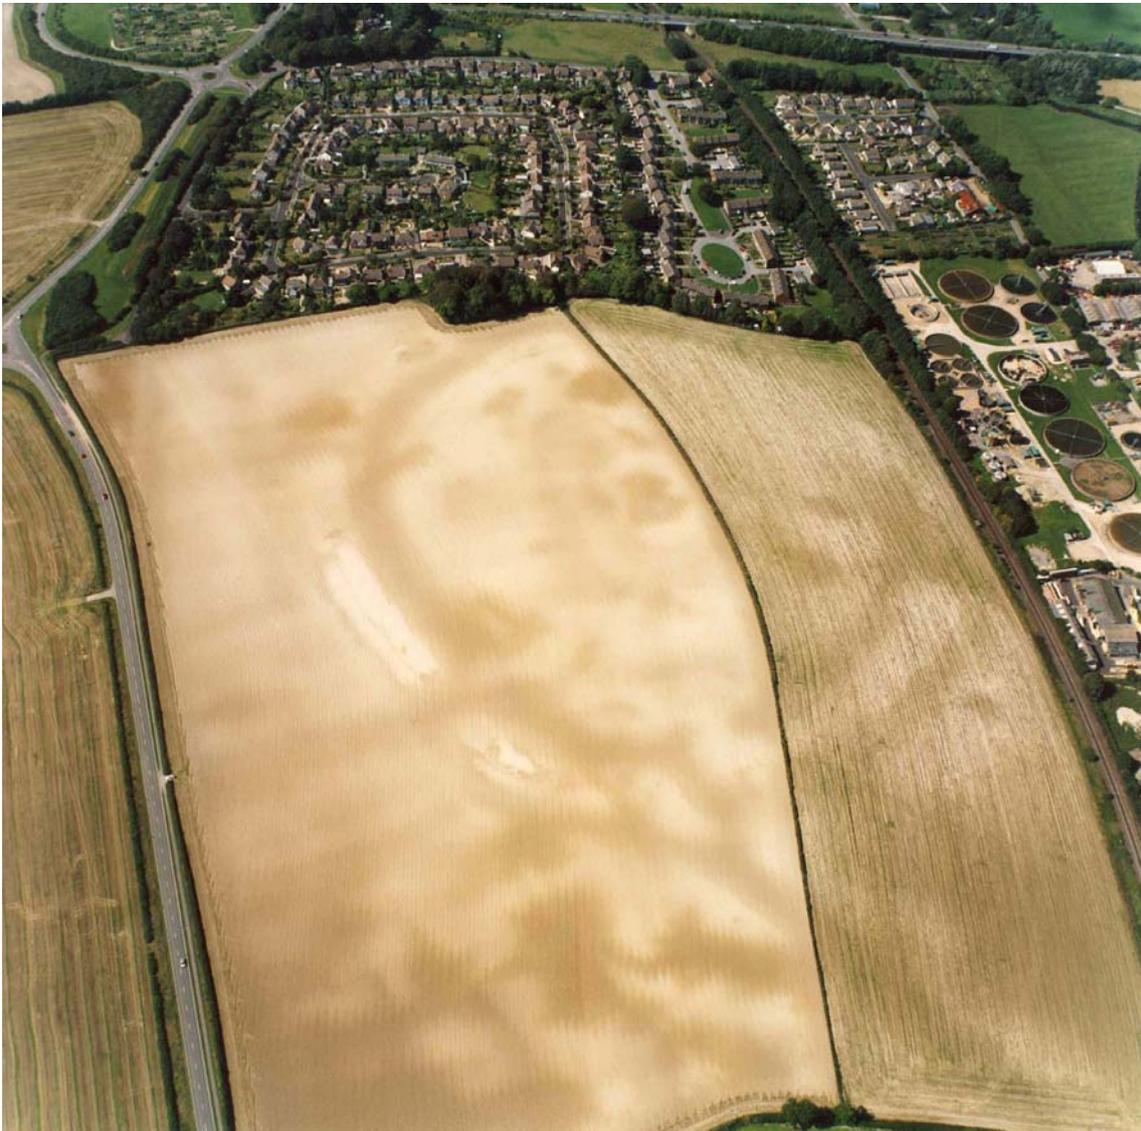
*Fig. 13 – traces of the 'approach' as well as the outer ditches and other features captured in 2004. English Heritage Archive 23704/21 1<sup>st</sup> September 2004.*
