# Church of St Helen, South Wheatley, Nottinghamshire

# Tree-ring Analysis of Timbers from the Bellframe and Supporting Structure

Martin Bridge

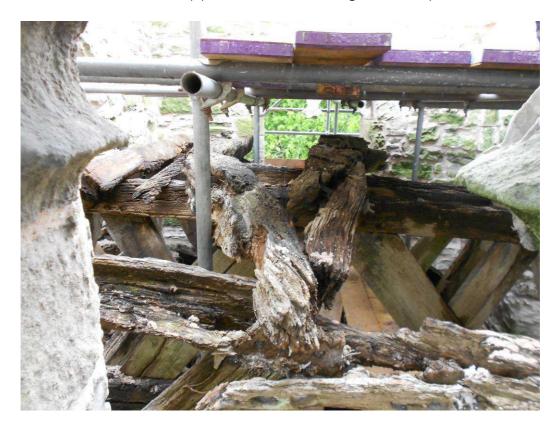
Figure 2: Photograph of the old roof timbers lying on top of the bellframe (Tim Allen)

The brief for the dendrochronlogical study of the Church of St Helen included some old roof timbers that had collapsed and were resting on the bell frame (Fig 2), as well as a fragment thought to have come from a medieval timber screen (Fig 3). However, the roof timbers were judged to have too few rings and were too degraded to warrant sampling, whereas the screen timber simply contained too few rings to be sampled.

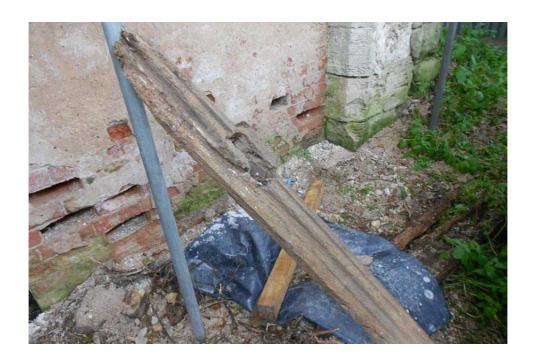
Figure 3: Fragment, possibly from a medieval timber screen (Tim Allen)

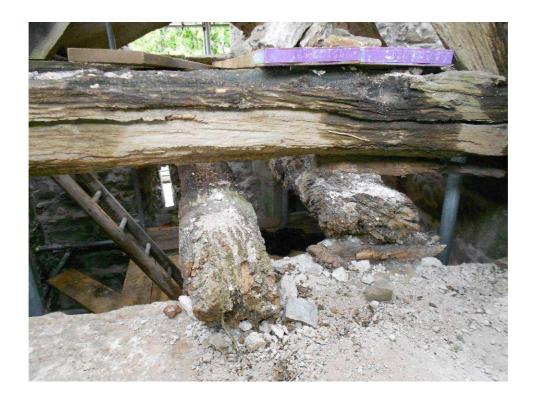
Figure 4: Two of the support beams to the bell frame (Tim Allen)

Two long support beams running north-south were assessed (Fig 4), and the one lying more centrally was sampled, along with a short support bracket lying diagonally across the south-west corner of the tower. Various timbers of the bellframe were assessed as being potentially good for dendrochronological analysis, having sufficient rings and some traces of sapwood, and thus, nine timber elements were sampled. Basic information about the samples taken is presented in Table 1. Figures 5 and 6 show the basic layout of the frame and an indication of the general form of the four cross frames of the bell frame. Sample swbf07 at only 35 years would generally be considered too short for further analysis, however, visual analysis of its ring width pattern, backed up by one strong statistical match (Table 2) meant that it was considered suitable for inclusion on this occasion, and hence all 11 samples were analysed.

The two samples from the support beams yielded relatively short sequences that did not cross-match with each other or the sequences from the bellframe itself. They could not be dated independently, and therefore the support frame remains undated.

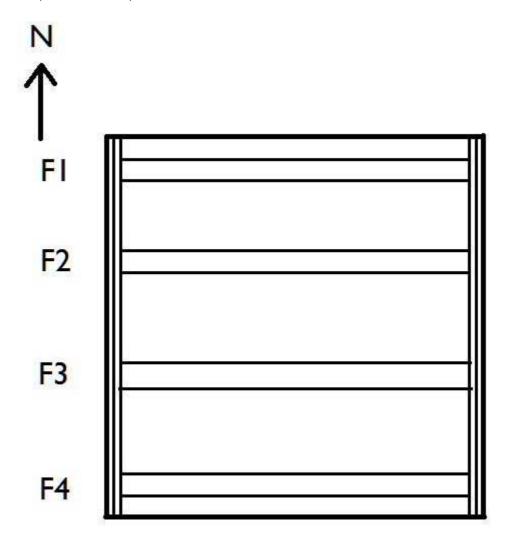
Figure 5: Sketch plan of the arrangement of frames in the tower

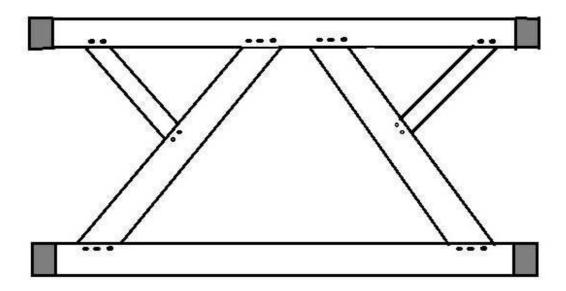
Figure 6: Sketch of the form of the four cross frames of the bell frame
