Tennyson Down, Totland, Isle of Wight

Analytical earthwork and aerial survey

Analytical earthwork survey and aerial survey

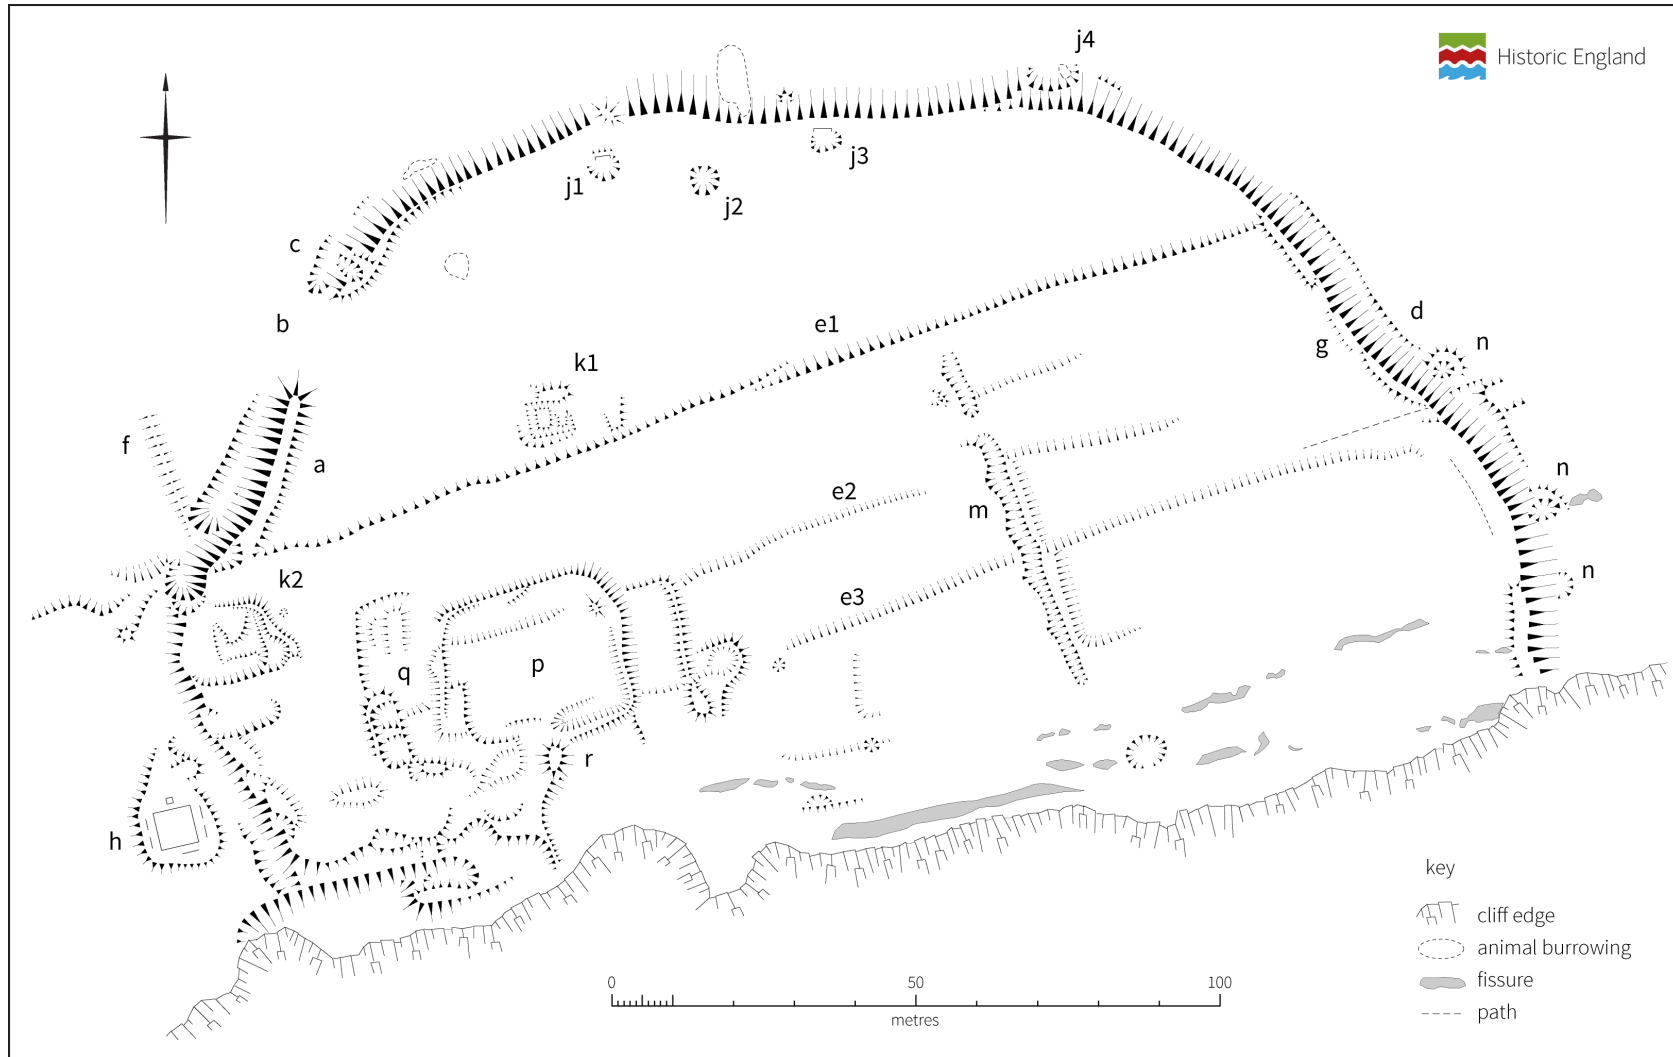
Figure 2 Analytical earthwork survey, reduced to 1:1250 from the original survey scale of 1:1000.

The main earthwork comprises an oval enclosure defined by a bank and external ditch, an unknown portion of which (but possibly up to almost half) has been lost by cliff erosion. The plan of the enclosure is not a regular oval; it is somewhat angular on the west side and includes some slight re-entrants. The bank survives around the whole of the remaining circuit, though for much of its length it is visible only as an outward-facing scarp, and is up to 1.5m high maximum externally, 0.4m high internally. The ditch survives as a visible feature only for relatively short lengths on the east and west sides and is nowhere more than 0.3m deep externally; no doubt it survives as a sub-surface feature to the north but has been covered by hillwash. The best preserved section of the enclosing earthworks is on the north-west side (a) where for a distance of about 30m the bank stands 1.5m high externally and 0.4m internally, fronted by the ditch surviving 0.2-0.3m deep. Elsewhere the bank survives only 0.8-1.2m high. The reason for the differential survival of the enclosing bank may be attributed at least in part to activity in subsequent phases.

A gap in both bank and ditch on the north-west perimeter (**b**), immediately adjacent to the best preserved sector of the bank, might represent an original entrance, though it is rather wide at over 10m; the bank and ditch on either side seem to have well-formed terminals. A trench cutting into the front face of the bank just to the north-east of this gap (**c**) looks like an antiquarian excavation, in which case it is apparently unrecorded; the trench is less than 0.5m deep and has a slight bank of spoil, no more than 0.3m high, on its north-eastern flank. There are no other gaps in the surviving circuit but there is possibly a blocked entrance on the east side where there is a slight re-entrant in the line of the enclosing earthworks and there are bull-nosed ends to the inner scarp of the bank with a lower scarp between them (**d**). If this was an entrance it would have been somewhat narrower than that at (**b**).

At some point after the abandonment of the enclosure a field system seems to have been laid out across its site. This consists only of a series of slight banks and lynchets. At least three east-north-east to west-south-west aligned lynchets (**e1**, **e2** and **e3**) cross the site and in some cases can be seen to overlies the earlier enclosure, though nowhere is the relationship entirely clear. The northernmost lynchet (**e1**) is the most substantial and stands up to 0.5m high; the others are slighter and nowhere more than 0.3m high. At least one north-south bank (**f**), surviving about 0.2m high, is visible immediately to the west of the enclosure but it is possible that in some places the earthworks of the enclosure itself were utilised to form north-south elements of the system; this might account, for instance, for the survival of short lengths of backscarp (**g**) to the enclosure bank on the east side between two of the lynchets (coincidentally on either side of the postulated blocked entrance (**d**)). The best preserved enclosure earthworks at (**a**), on the north-west side, may owe their preservation to different land use within one field here. Lynchet (**e1**) can be seen extending beyond the enclosure to the west for some distance but not to the east (though aerial photographic evidence suggests that it did extend for a short distance in that direction). The other lynchets seem to be confined to the area of the enclosure.

This phase incorporates all other earthworks on site, which where they are in relationship with the enclosure or field system are always later, though they are certainly not all contemporary with one another. For instance, there is a low plinth surrounding Tennyson's Monument (**h**), which is presumably associated with the erection of that Monument or is the remains of the mound supporting the former beacon, which is shown on the 1st and 2nd edition OS 25" maps. Others, as noted, are possibly or certainly of Second World War date. A series of four hollows on the

northern flank of the site (**j1**, **j2**, **j3** and **j4**) are up to 0.5m deep maximum; at least two of these (**j1** and **j3**) contain concrete platforms 2.45m long. One, and perhaps two, layouts of trenches lie higher up the slope forming tight rectangular arrangements (**k1** and **k2**); of these (**k1**) is the better preserved, consisting of sharply defined trenches while (**k2**) is rather spread and amorphous. Faint traces of an anti-glider trench (**m**) survive no more than 0.2m deep. (Other glider trenches on site, visible on historic aerial photographs, are no longer clearly distinguishable on the ground due to subsequent erosion by tracks and paths – see aerial survey section below – but others further to the east on the slope of the down are still clearly visible).

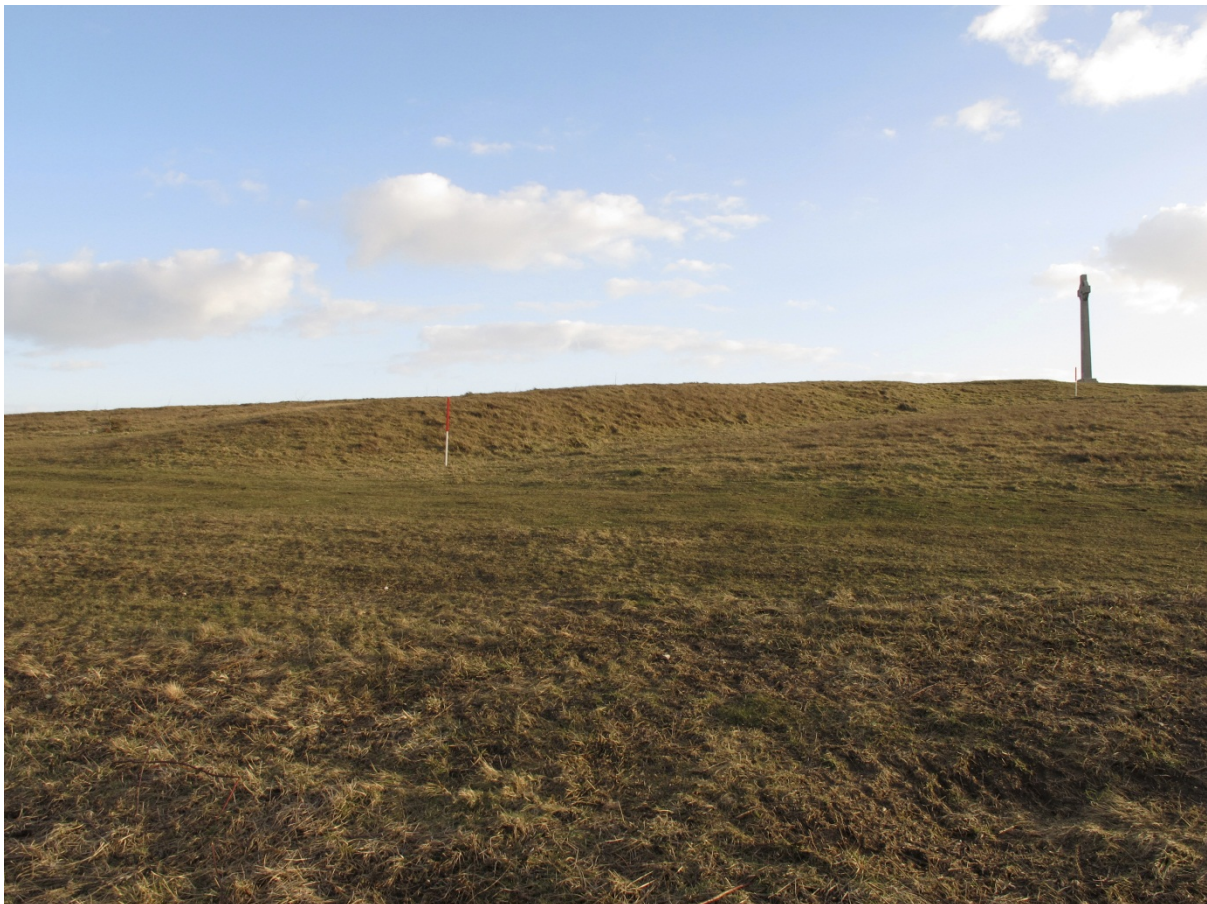
Figure 3 The best-preserved section of earthwork (a), viewed from the north-west; entrance (b) is at the extreme left. Mark Bowden © Historic England.

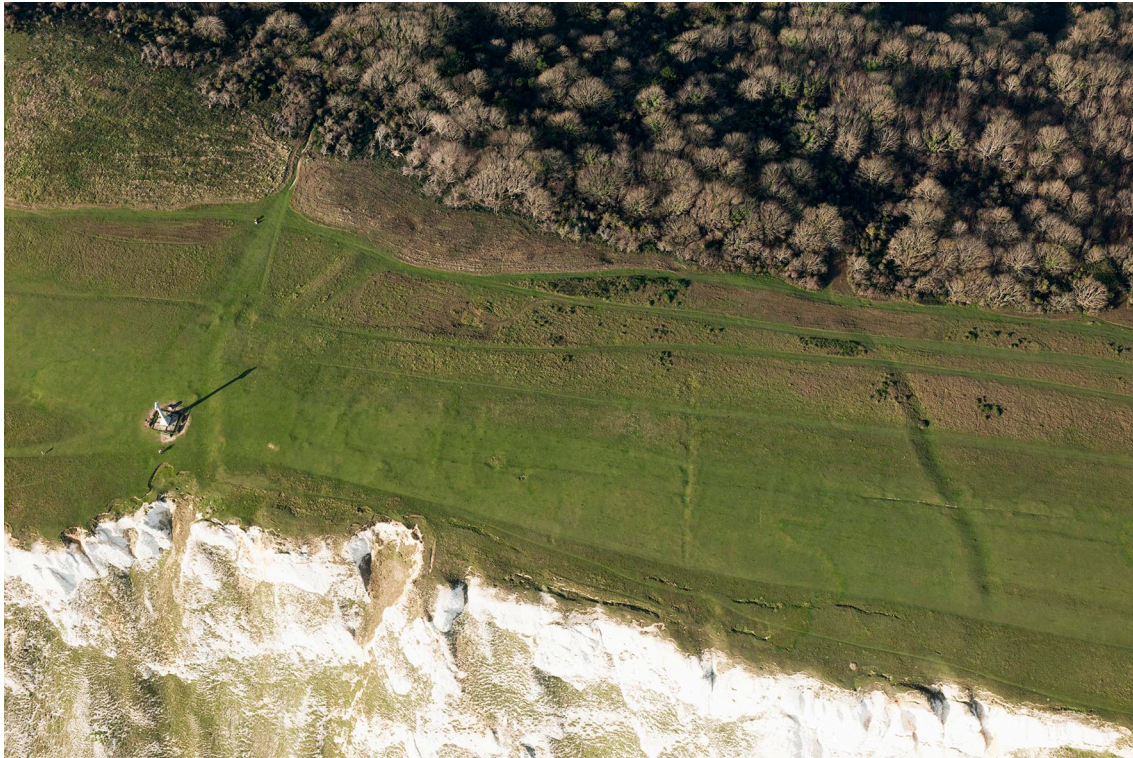
Figure 5 The enclosure from the air. Note the scrub clearance along the edge of the woods. EHA 29201_36 31-OCT-2014. Damian Grady © Historic England.

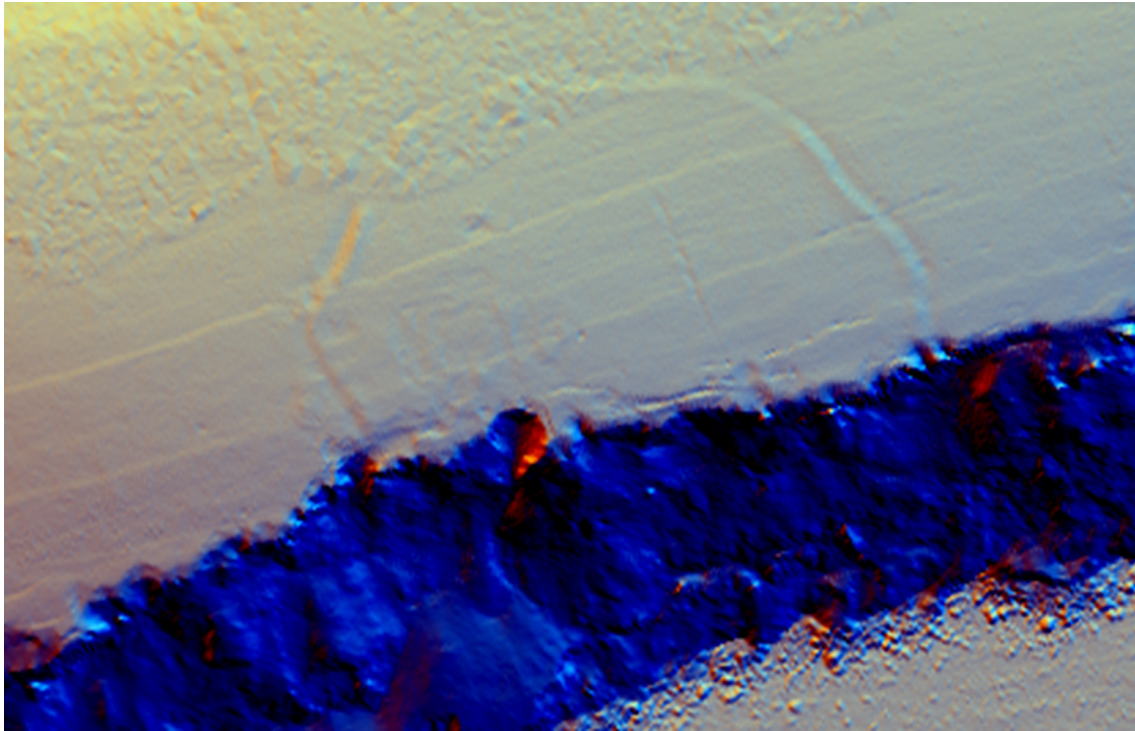
Figure 6 A 16-direction hill shade visualisation of lidar data. Source data: SZ2385_DTM_1m Environment Agency 2009 copyright 2015. All rights reserved.

As previously mentioned, examination of lidar data drew attention to the fact that the more substantial earthworks formed part of an enclosure that extended into the woodland to the north. As part of the aerial photographic and lidar survey described here, multiple visualisations of the Environment Agency 1m digital terrain model (DTM) lidar data were created to aid interpretation of the earthworks beyond the area surveyed on the ground. The 16-direction hill shade visualisation provided an accurate model and good basic overview of earthworks on Tennyson Down (Fig 6).

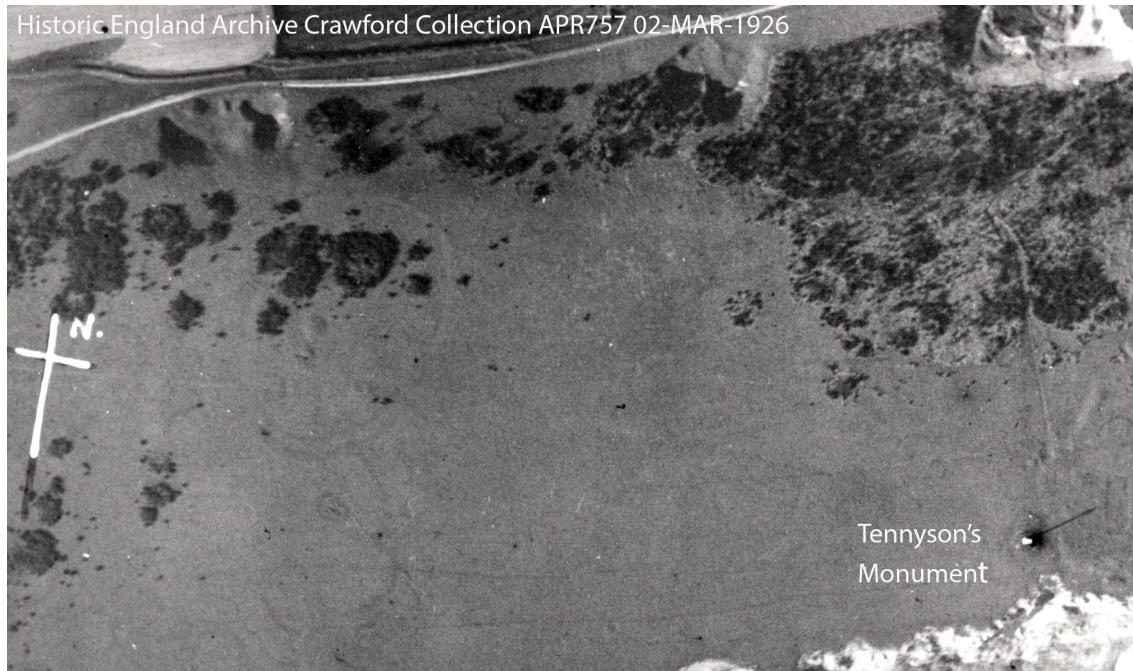
Figure 7 The enclosure surrounding the barrows to the north-west of Tennyson's monument. Extract of SZ3285_1 X721 CCC APR757 02-MAR-1926 English Heritage Archive Crawford Collection.

The English Heritage Archive has an aerial photograph of the area to the west of Tennyson's Monument taken by RAF No. 10 Group on 2nd March 1926 that was acquired by OGS Crawford for his collection. This aerial photograph records the earthworks of an oval enclosure surrounding two Bronze Age burial mounds (National Record of the Historic Environment Monument (NRHE) 459416, National Heritage List for England 1010511, 1015623, Scheduled Monument Old County Numbers I of W 31a and 31b). The enclosure is not visible on later aerial photographs or lidar, nor in the Historic England or National Trust monument records. It is not clear if any remains still survive above ground although the round barrows survive as earthworks.

One historic aerial photograph from the Crawford Collection and dating to the 1920s (when the Down was almost entirely clear of scrub woodland) shows another oval enclosure just to the west of and surrounding the barrows (NRHE Monument 459416, NMR: SZ 38 SW 19) that were excavated by the Rev John Skinner in the early 19th century. The enclosure does not seem to survive as an earthwork into the post war period but there is no clear explanation of why or how it may have been levelled, when compared to other earthworks nearby. The

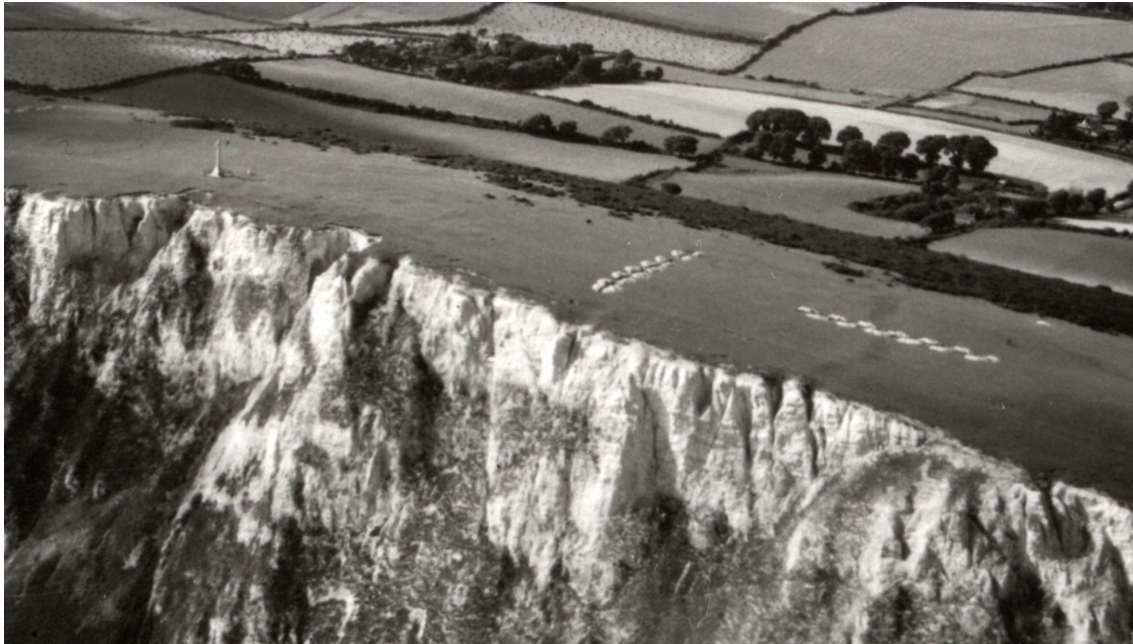
Figure 8 A military oblique aerial photograph of the area to the east of Tennyson's Monument showing the Second World War anti-landing obstacles overlying the earlier earthworks. RAFS454 H53 1416 29-AUG-1941 Historic England RAF Photography.

The aircraft obstructions had various forms, usually linear arrangements of ditches, mounds or poles, and were intended to impede landing of enemy aircraft. On Tennyson Down, the obstructions varied slightly in length and form but were laid out, perpendicular to one another, at fairly regular intervals. They comprised short lengths of ditch, measuring 5-7m, flanked by mounds of chalky spoil to form obstacles measuring between 60m and 120m (Fig 8).

There were two Second World War anti-landing obstacles east of Tennyson's Monument within the area surveyed on the ground and these were mapped from aerial photographs (Fig 9). The best preserved of the two (**m** on the earthwork plan Fig 2) extends NNW-SSE across the field banks in the eastern end of the main enclosure (left hand obstacle on Fig 8). The second obstacle, now virtually indistinguishable on the ground, was perpendicular to the other, and extended across the eastern bank of the main enclosure (right hand obstacle on Fig 8). Two further aircraft obstructions were mapped from aerial photographs, either side of the area surveyed on the ground (Fig 9), and they survive as low earthworks.

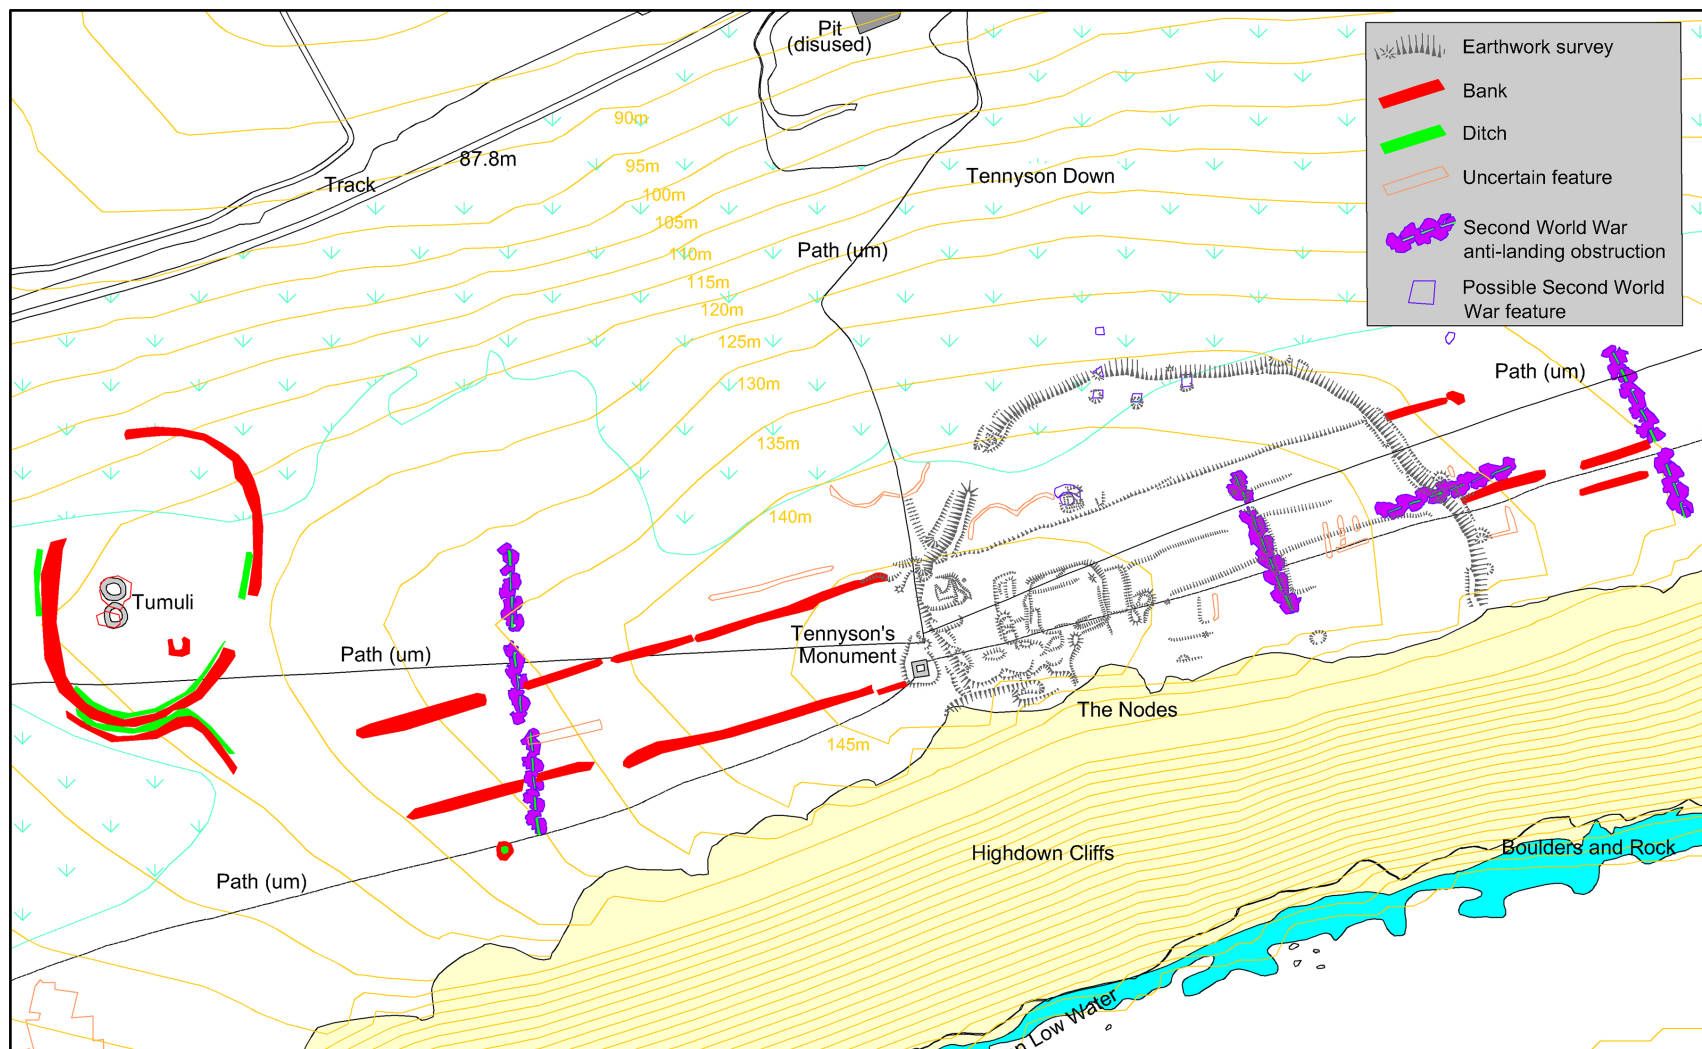
Figure 9 Map of archaeological features seen on aerial photographs and lidar in relation to earthwork survey. Base map © Crown Copyright and database right 2015. All rights reserved. Ordnance Survey Licence number 100024900.

The mapping from aerial photographs and lidar shows that some of the Phase 2 field banks (e1, e3 on the earthwork plan) extend to the east and west of the main enclosure. The numerous modern paths which criss-cross the area show as changes in vegetation and in some places as slight scarps. The slight scarps equating to paths were mapped from various sources so they could be discounted as archaeological features.

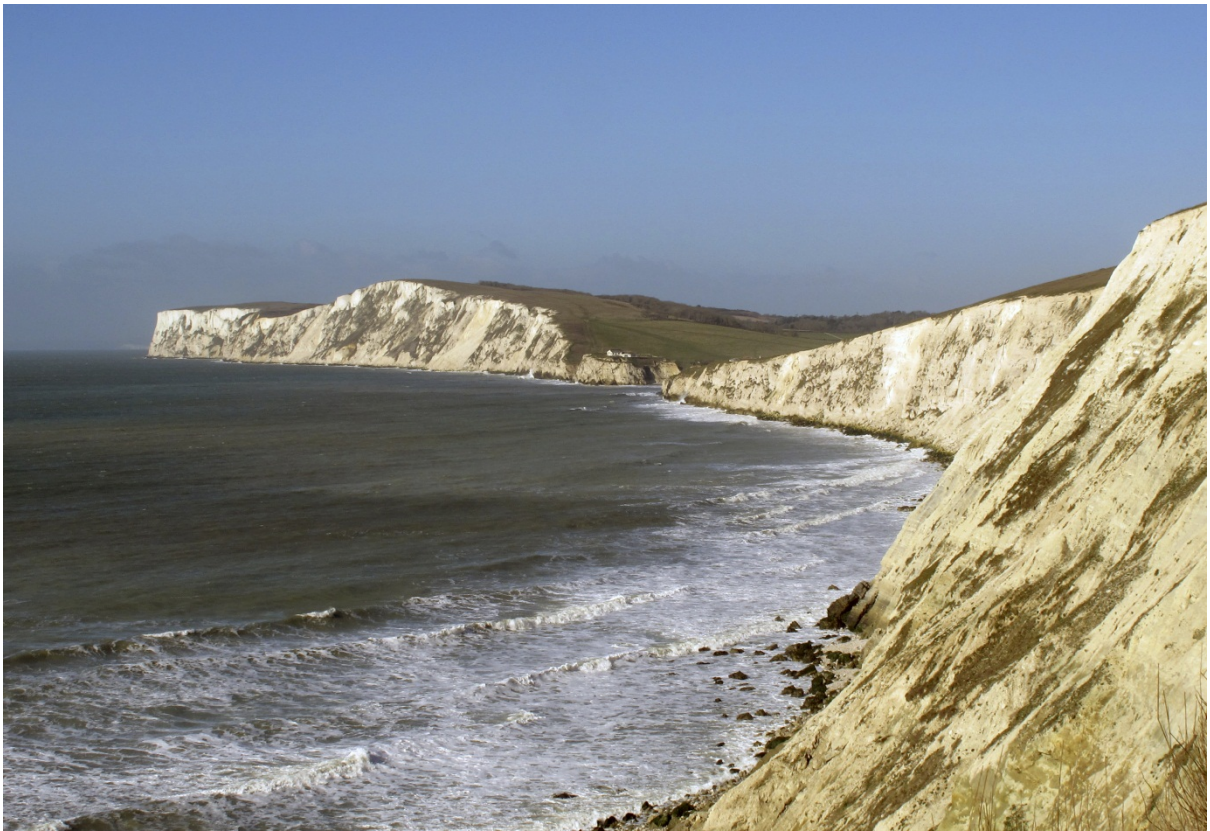
Figure 10 Tennyson Down is the highest point beyond the low ground which lies to the right behind Freshwater Bay and extends to Yarmouth; streaks of clean white chalk indicate recent cliff falls. Mark Bowden © Historic England.
