RESEARCH REPORT SERIES no. 61-2014

# DAUBENEYS, HIGH STREET, COLERNE, WILTSHIRE

## TREE-RING ANALYSIS OF TIMBERS

SCIENTIFIC DATING REPORT

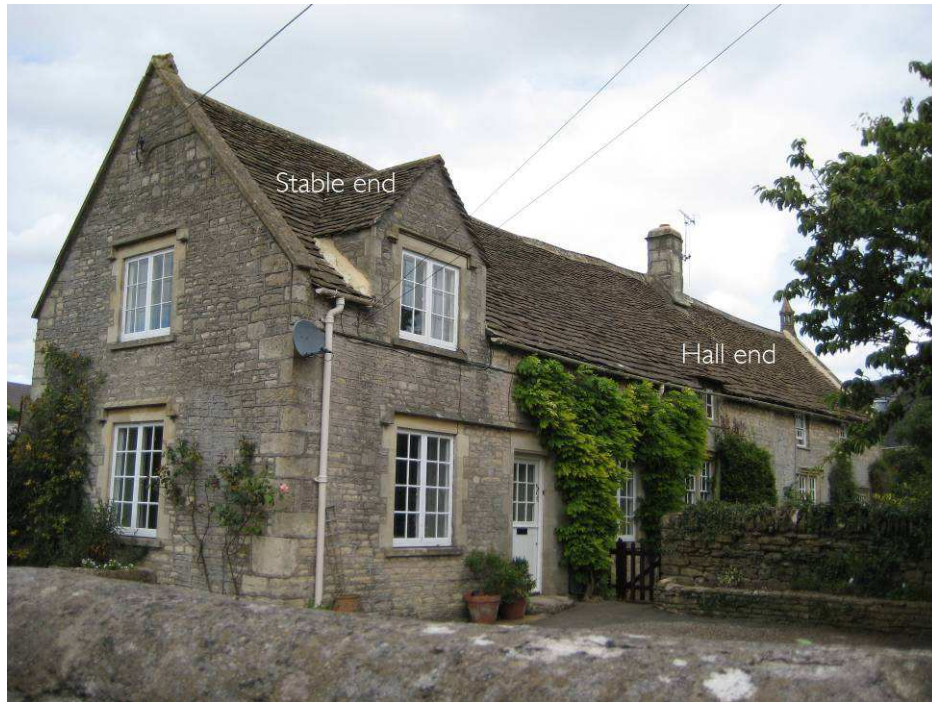
Figure 3: West gable end and south front of Daubeney's (Matt Hurford)

Daubeney's, a Grade II\* listed building, lies in the centre of the village of Coleme, immediately north of High Street and west of Silver Street (Figs 1 and 2). The building is aligned broadly north-east to south-west but for the purposes of this report it has been described as being aligned east to west. Thus, the south elevation, the main front, faces the High Street. The following information is taken from the WBR report (2012).

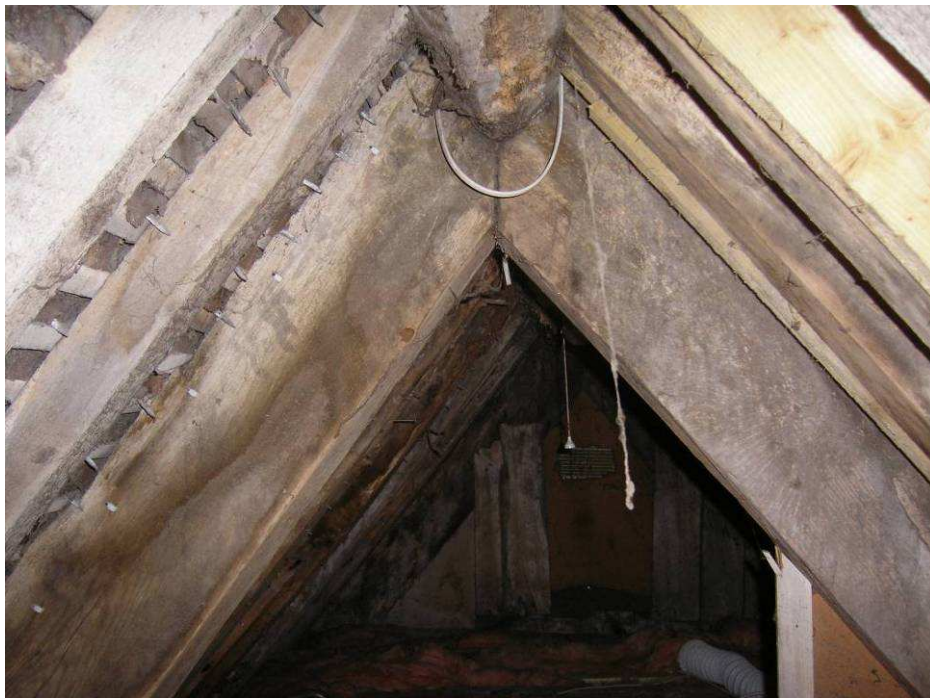
Figure 4: The hall end, truss E east face (Matt Hurford)

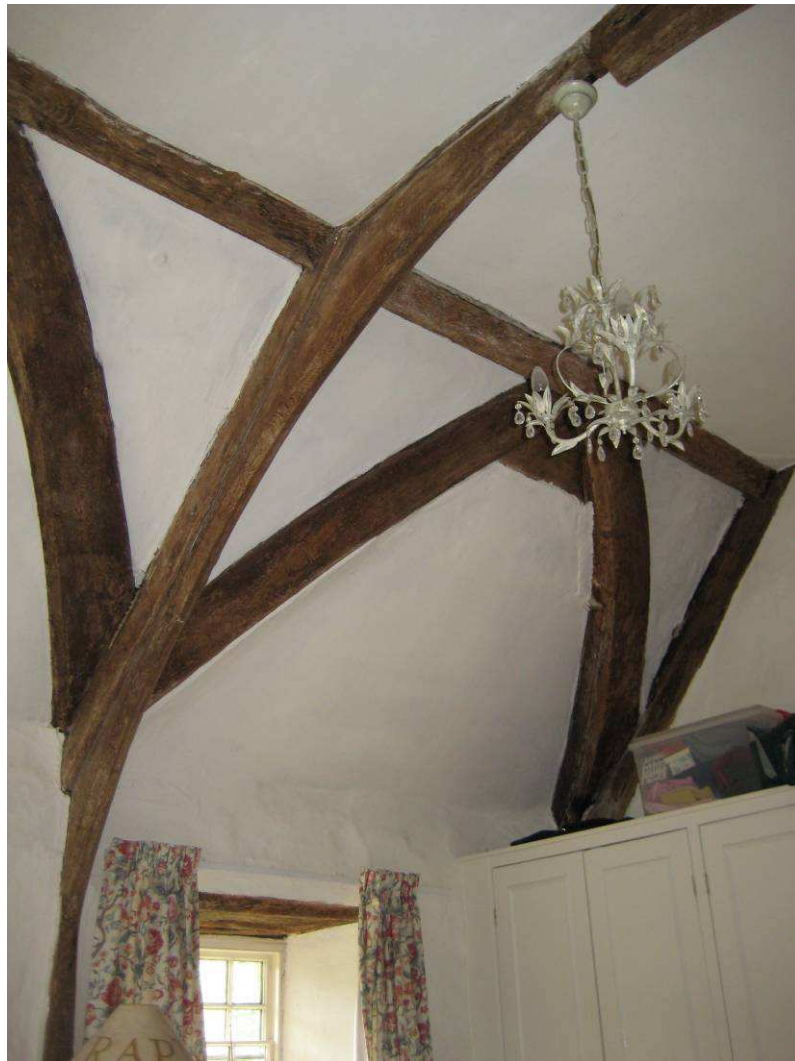
*Figure 5: The hall end, open truss B in the solar, viewed looking south-west (Matt Hurford)*

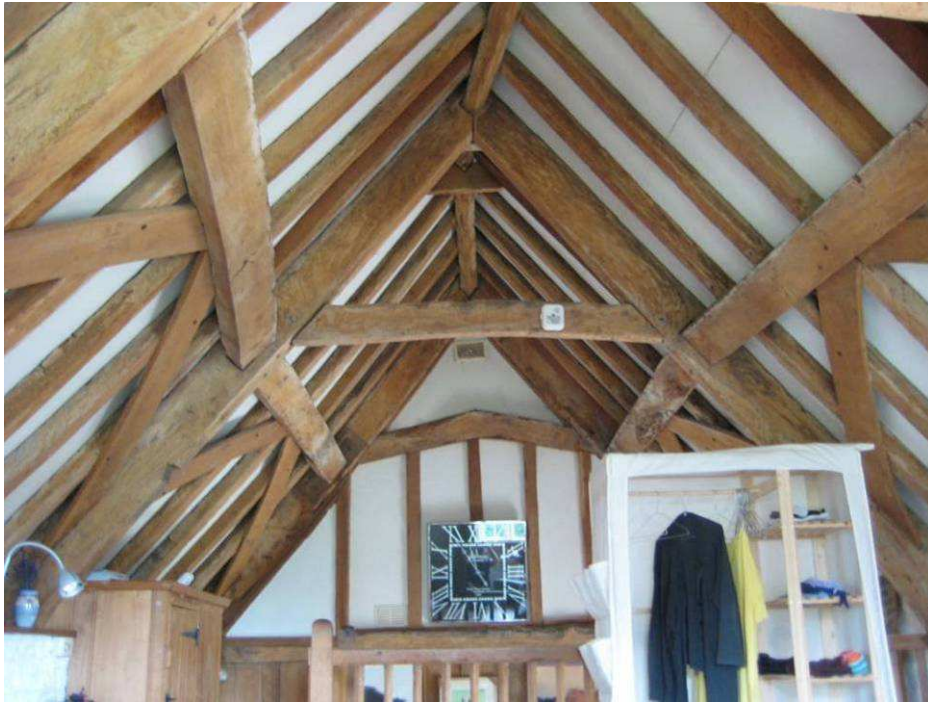
*Figure 6: The stable end roof viewed looking east (Matt Hurford)*

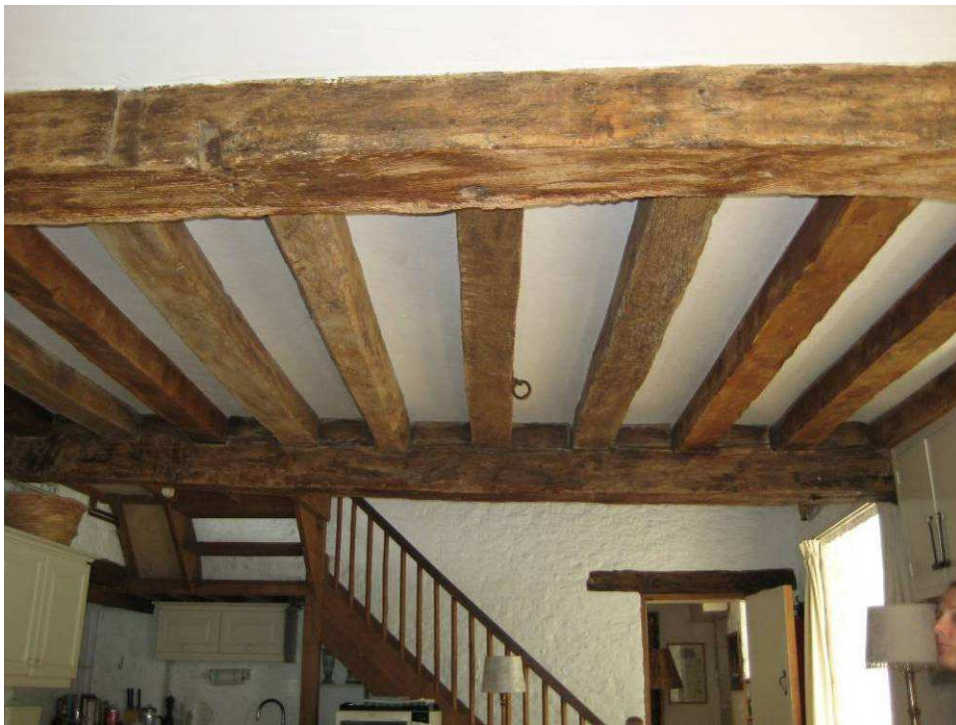
*Figure 7: The stable end ceiling viewed looking east (Matt Hurford)*

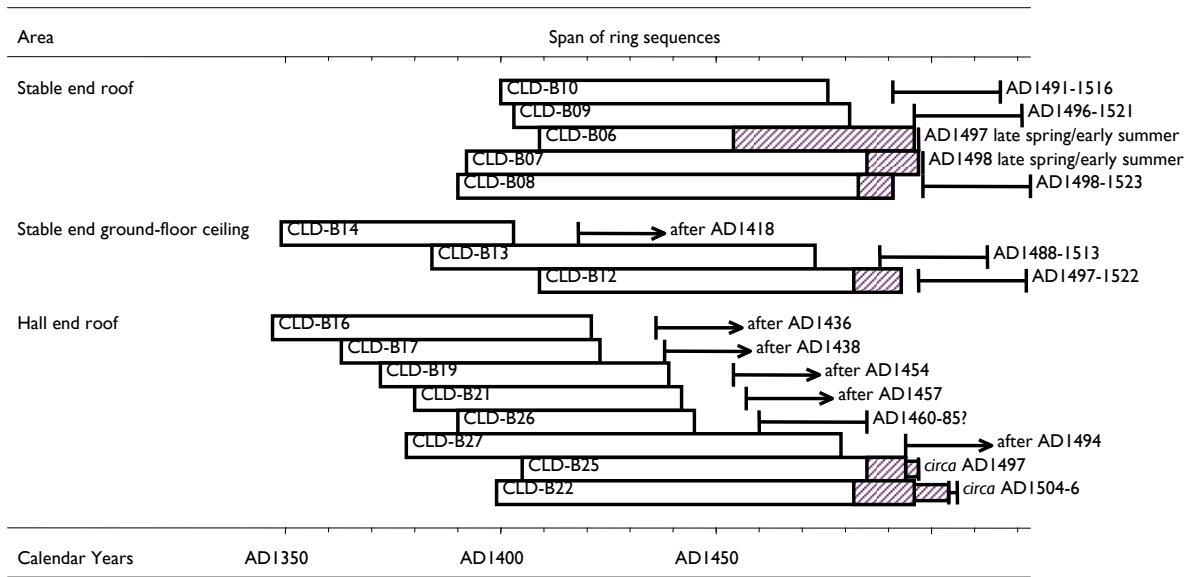
Figure 18: Bar diagram of the samples in site chronology CLDBSQ01 and their individual felling dates. White bar = heartwood rings; hatched bar = sapwood rings; narrow bar = unmeasured rings

The analysis resulted in two groups (15 samples and 5 samples) being formed. The samples of each group cross-matching with each other as shown in Tables 2 and 3 and Figures 18 and 19. During this analytical process a possible match ( $t = 5.00$ ) to the group of 15 samples was noted for CLD-B14. This was confirmed by the dating evidence obtained for this individual sample when it was compared to an extensive range of reference chronologies for oak (Table 4). CLD-B14 was therefore combined with the 15 other grouped series at the indicated offsets to form site chronology CLDBSQ01, this having an overall length of 151 rings (Fig 18). The dating evidence for site chronology CLDBSQ01 when the date of the first ring is AD 1347 and the date of its last ring is AD 1497 is presented in Table 5.

The dated site chronology, CLDBSQ01, comprises eight samples from the stable end and eight samples from the hall end (Fig 18). To aid interpretation the two ends of the building are dealt with separately below. For consistency the sapwood estimate used in all of the dendrochronological reports on individual buildings with this project is the Nottingham Tree-ring Dating Laboratory estimate of 15–40 (95% confidence range).

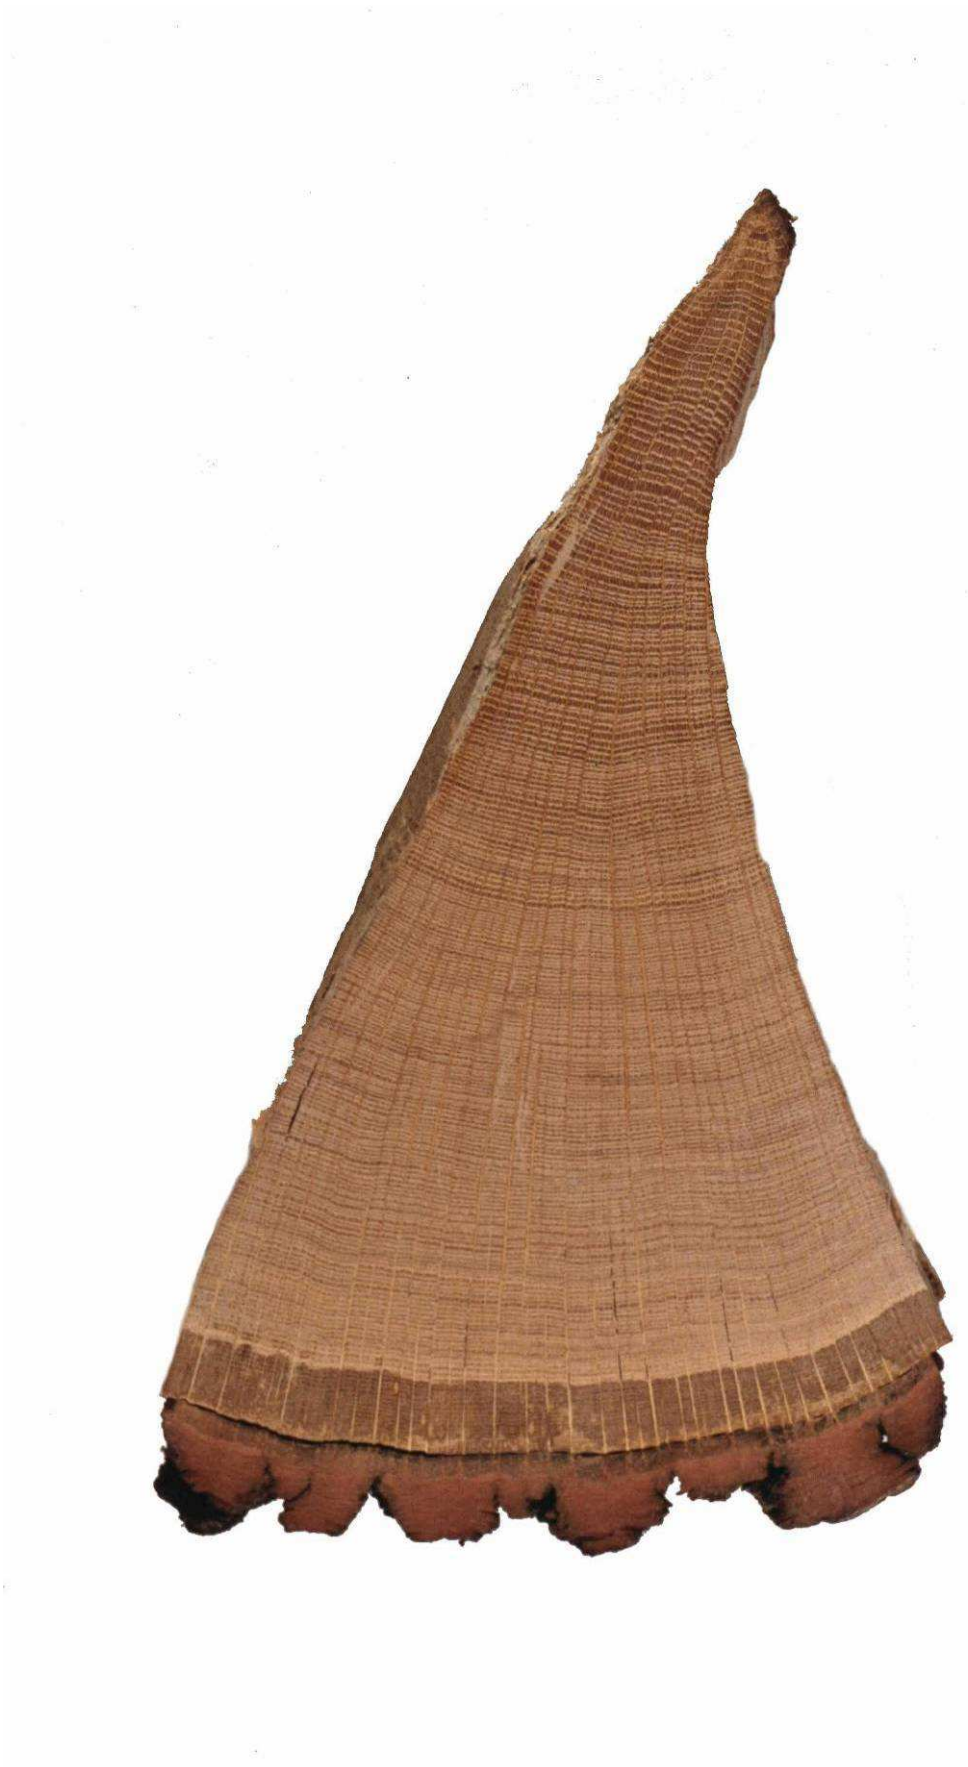
*Figure A1: A wedge of oak from a tree felled in 1976. It shows the annual growth rings, one for each year from the innermost ring to the last ring on the outside just inside the bark. The year of each ring can be determined by counting back from the outside ring, which grew in 1976*

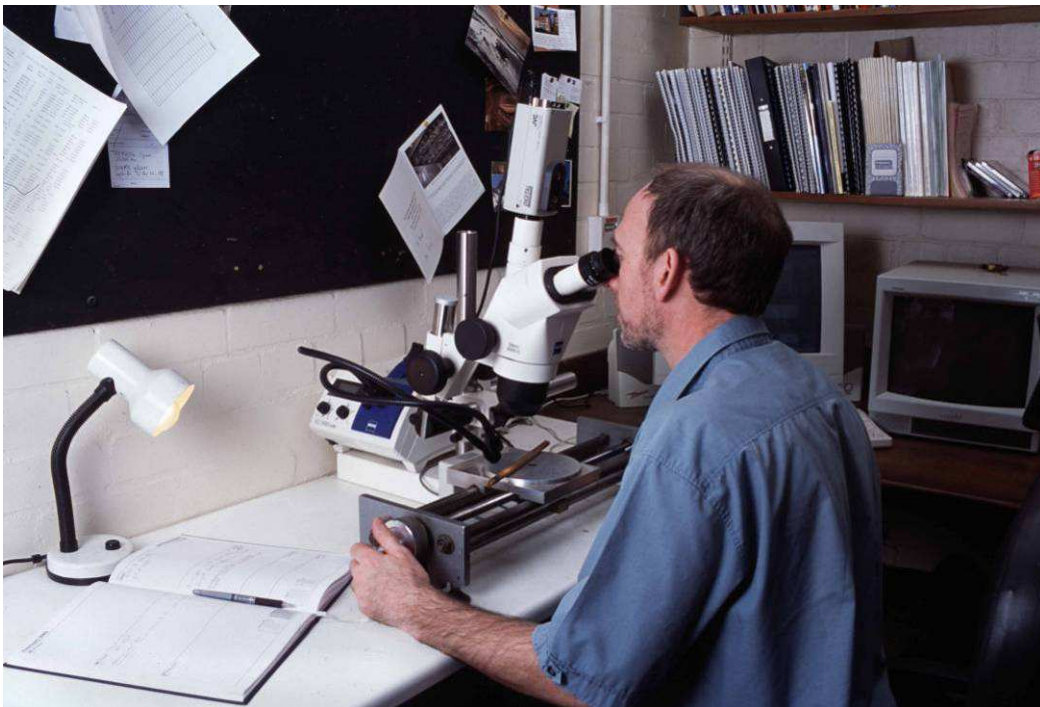
*Figure A3: Measuring ring widths under a microscope. The microscope is fixed while the sample is on a moving platform. The total sequence of widths is measured twice to ensure that an error has not been made. This type of apparatus is needed to process a large number of samples on a regular basis*

**2. Measuring Ring Widths.** Each core is sanded down with a belt sander using medium-grit paper and then finished by hand with flourgrade-grit paper. The rings are then clearly visible and differentiated from each other with a result very much like that shown in Figure A2. The core is then mounted on a movable table below a microscope and the ring-widths measured individually from the innermost ring to the outermost. The widths are automatically recorded in a computer file as they are measured (see Fig A3).

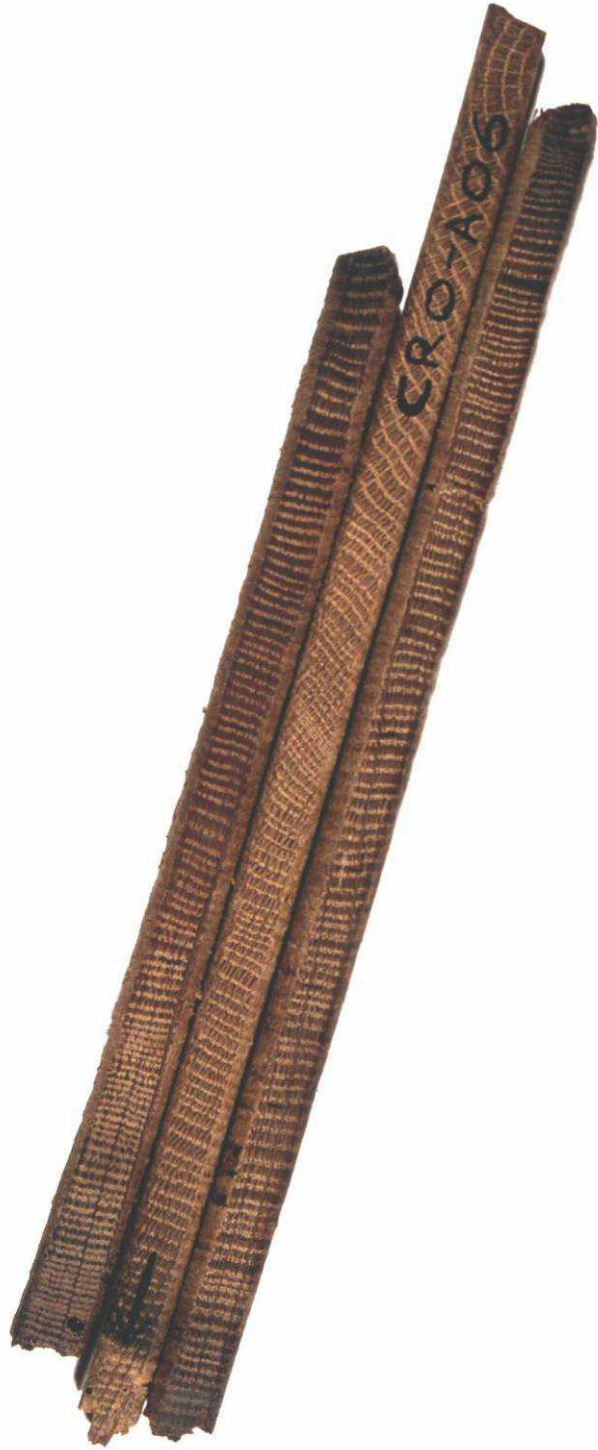
Figure A4: Three cores from timbers in a building. They come from trees growing at the same time. Notice that, although the sequences of widths look similar, they are not identical. This is typical
