# OLD MANOR HOUSE, CHURCH LANE, WEST LAVINGTON, WILTSHIRE

## TREE-RING ANALYSIS OF TIMBERS

SCIENTIFIC DATING REPORT

Research Report Series 66-2014

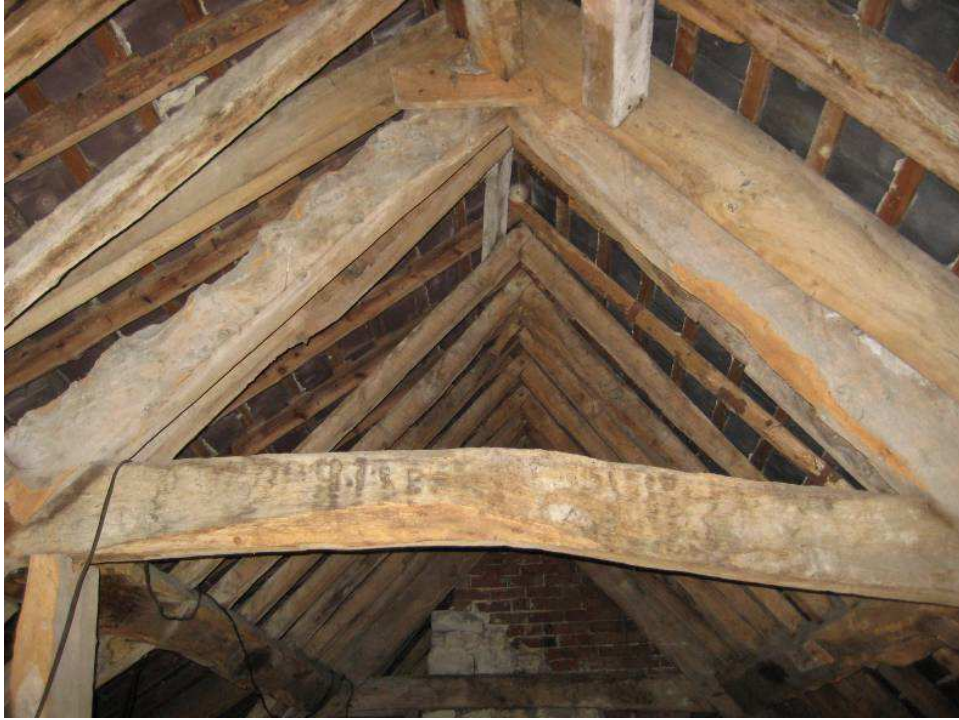
Figure 5: Hall truss 7 viewed looking east (Matt Hurford)

The roof over this part of the building is of collar and principal-rafter type; the collar of truss 8 being straight, whilst that of truss 7 is cambered (Fig 5). Truss 6, at the junction with the west wing, has arch brace and collar mortices. There are two tiers of trenched purlins to the east end, a single tier of purlins in the centre section, and two tiers of purlins to south side of the west end; some appear to be replacements. The common rafters are a mixture of primary and reused timbers (perhaps from the same source as those timbers of the west cross-wing – see below). Stylistically the hall is thought to date to the early part of the sixteenth century.

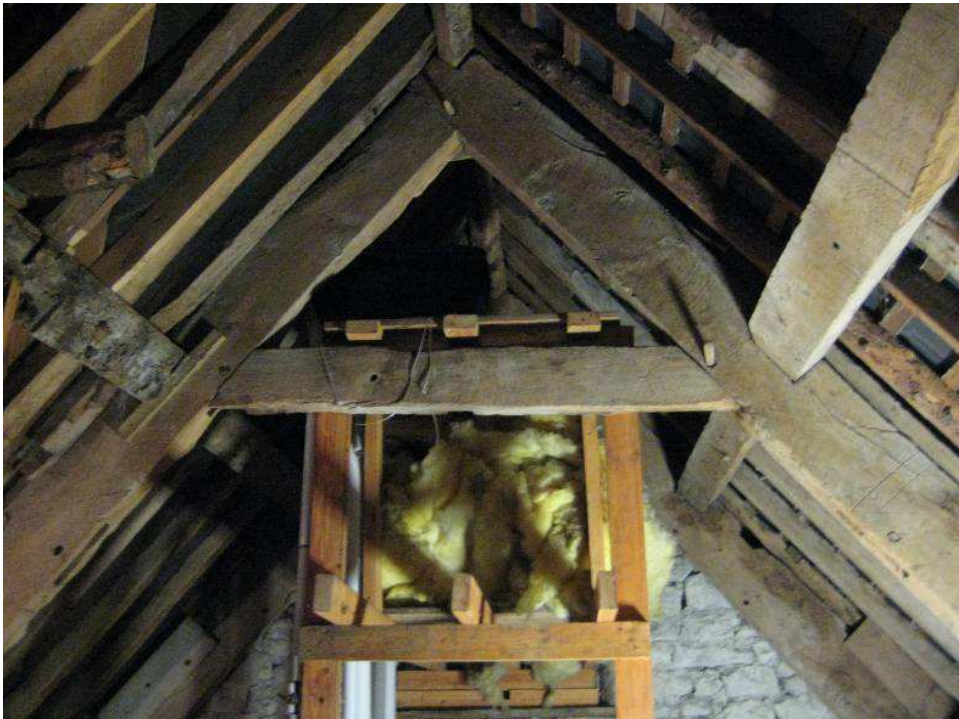
Figure 6: East wing truss 2 viewed looking north (Matt Hurford)

This roof is also of collar and principal rafter type. The principal rafters of both trusses 1 and 2 (Fig 6) have mortices for arch braces, however, these are not mirrored on the straight collars, which appear to be reused. There are two tiers of trenched purlins and there is some evidence for the previous existence of windbraces as demonstrated by the housing on a purlin but also the suggestion of housing on a principal rafter from truss 2. Stylistically the east cross-wing is also thought to date to the early part of the sixteenth century.

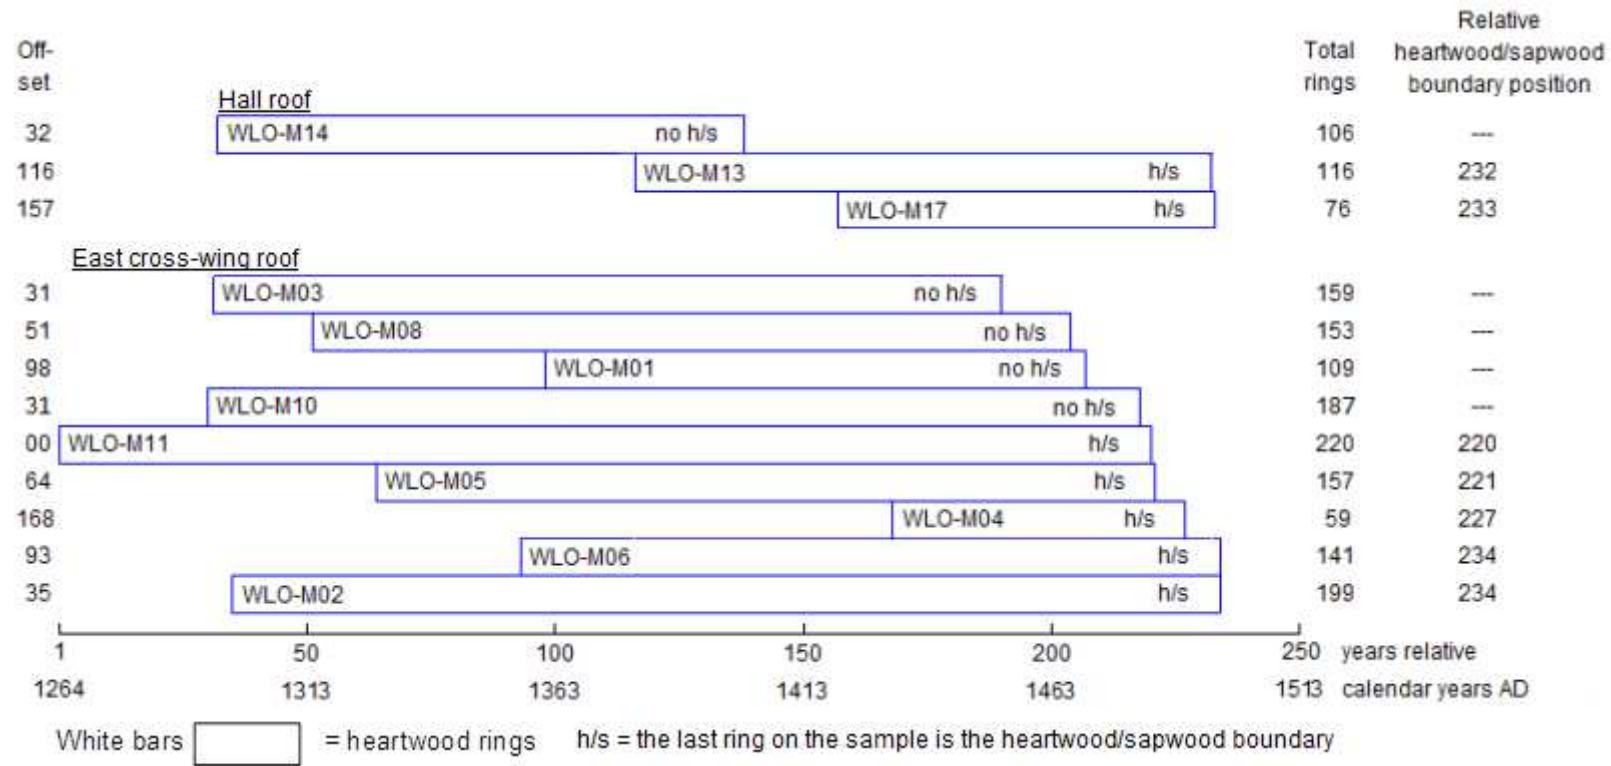
Figure 15: Bar diagram of the samples in site chronology WLOMSQ01

The hall roof is represented by three dated samples and the east cross-wing roof by nine dated samples (Fig 15).

All twelve dated timbers from both roofs are clearly broadly coeval. The very high level of cross-matching (Table 2) implies that all the timbers form a coherent group and are probably part of the same felling programme dating to AD 1507–32 based on an overall average heartwood/sapwood boundary date of AD 1492.

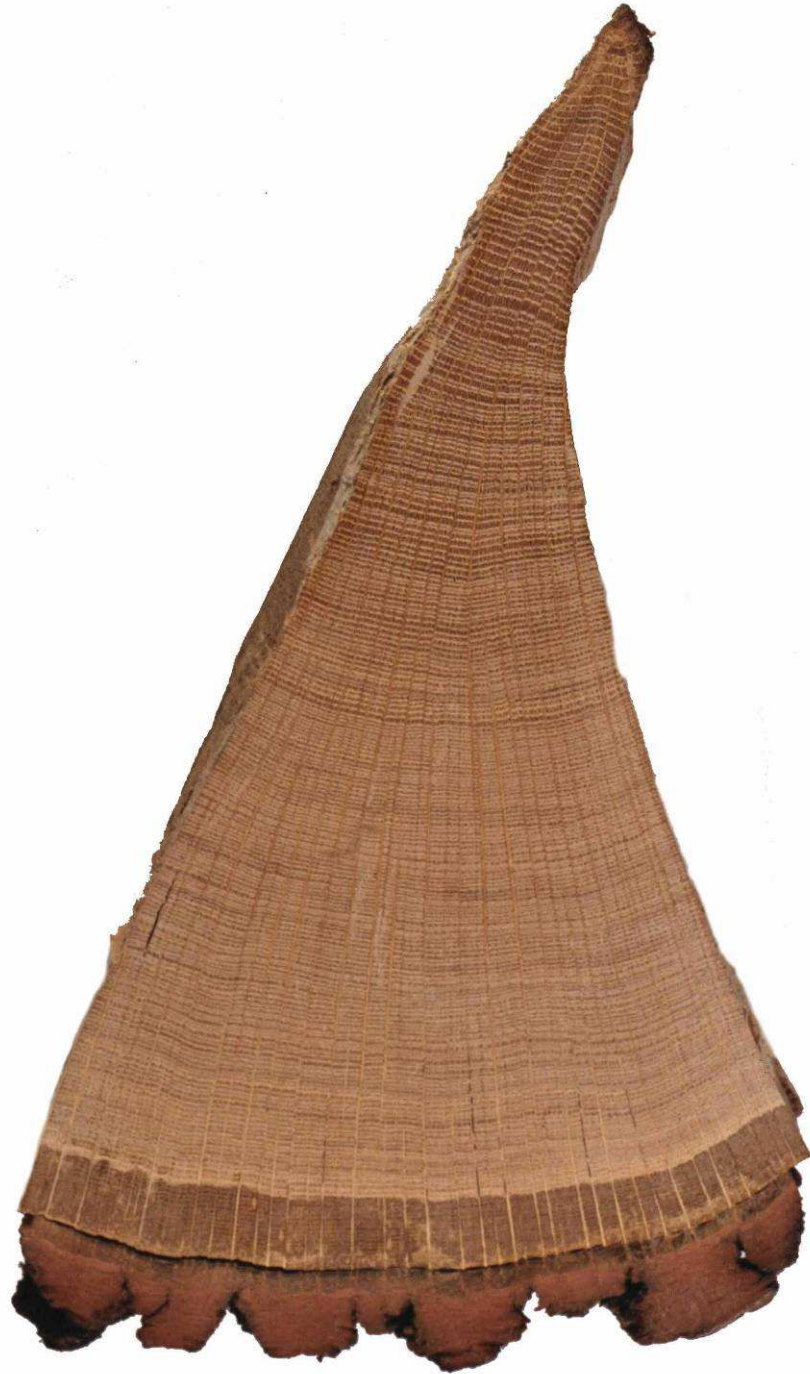
*Figure A1: A wedge of oak from a tree felled in 1976. It shows the annual growth rings, one for each year from the innermost ring to the last ring on the outside just inside the bark. The year of each ring can be determined by counting back from the outside ring, which grew in 1976*

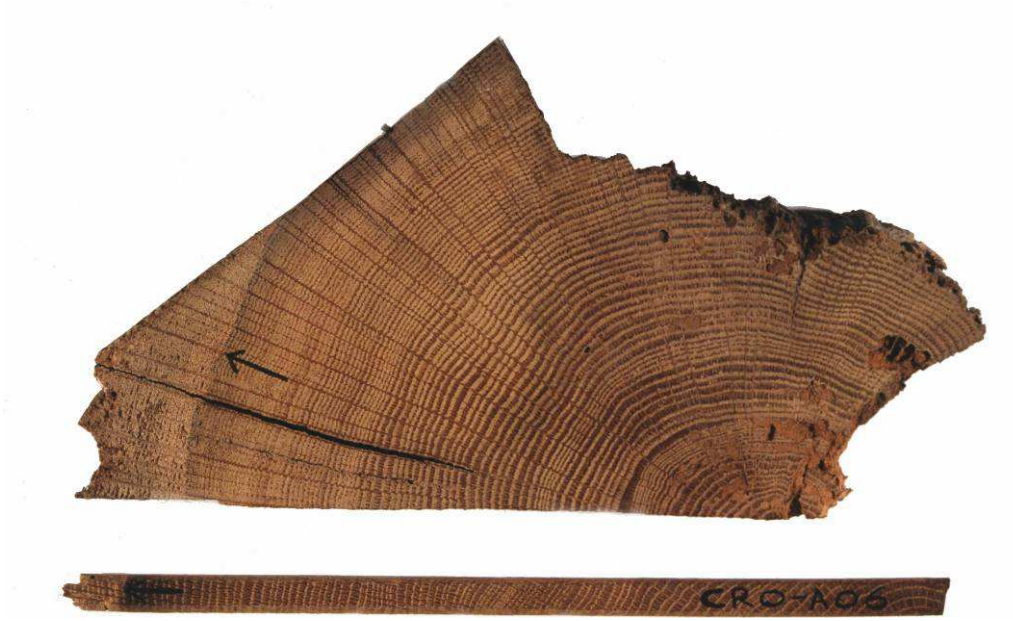
Figure A2: Cross-section of a rafter, showing sapwood rings in the left-hand corner, the arrow points to the heartwood/sapwood boundary (H/S); and a core with sapwood; again the arrow is pointing to the H/S. The core is about the size of a pencil

Quite often some, though not all, of the original outer rings are missing on a timber. The outer rings on an oak, called sapwood rings, are usually lighter than the inner rings, the heartwood, and so are relatively easy to identify. For example, sapwood can be seen in the corner of the rafter and at the outer end of the core in Figure A2, both indicated by arrows. More importantly for dendrochronology, the sapwood is relatively soft and so liable to insect attack and wear and tear. The builder, therefore, may remove some of the sapwood for precisely these reasons. Nevertheless, if at least some of the sapwood rings are left on a sample, we will know that not too many rings have been lost since felling so that the date of the last ring on the sample is only a few years before the date of the original last ring on the tree, and so to the date of felling.

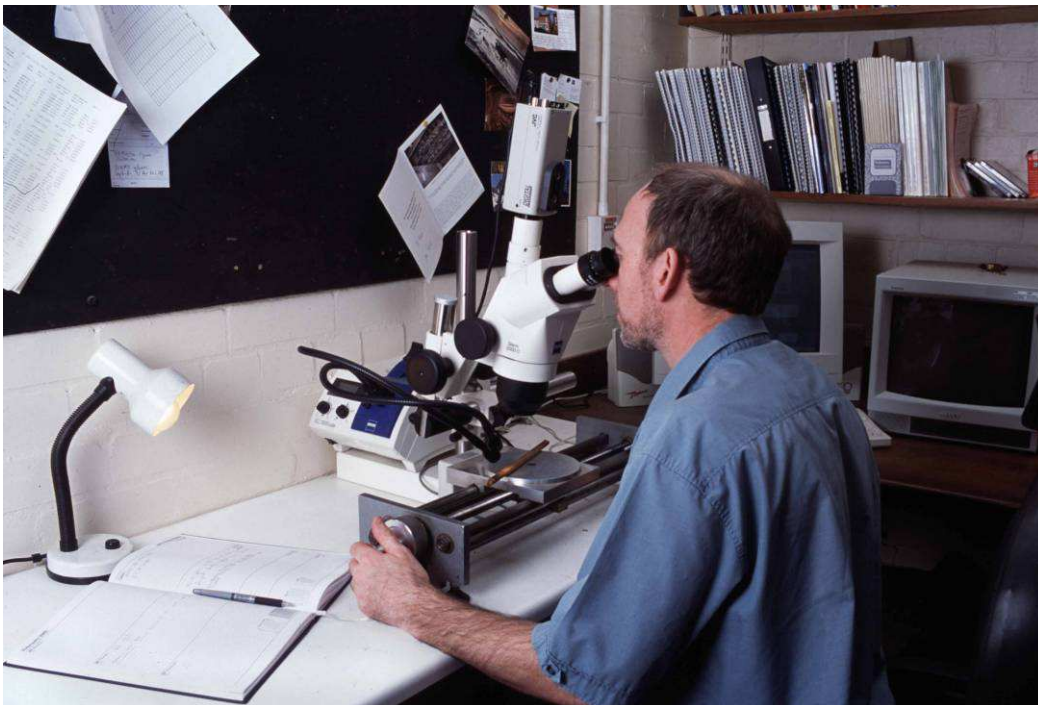
Figure A3: Measuring ring widths under a microscope. The microscope is fixed while the sample is on a moving platform. The total sequence of widths is measured twice to ensure that an error has not been made. This type of apparatus is needed to process a large number of samples on a regular basis

**2. Measuring Ring Widths.** Each core is sanded down with a belt sander using medium-grit paper and then finished by hand with flourgrade-grit paper. The rings are then clearly visible and differentiated from each other with a result very much like that shown in Figure A2. The core is then mounted on a movable table below a microscope and the ring-widths measured individually from the innermost ring to the outermost. The widths are automatically recorded in a computer file as they are measured (see Fig A3).

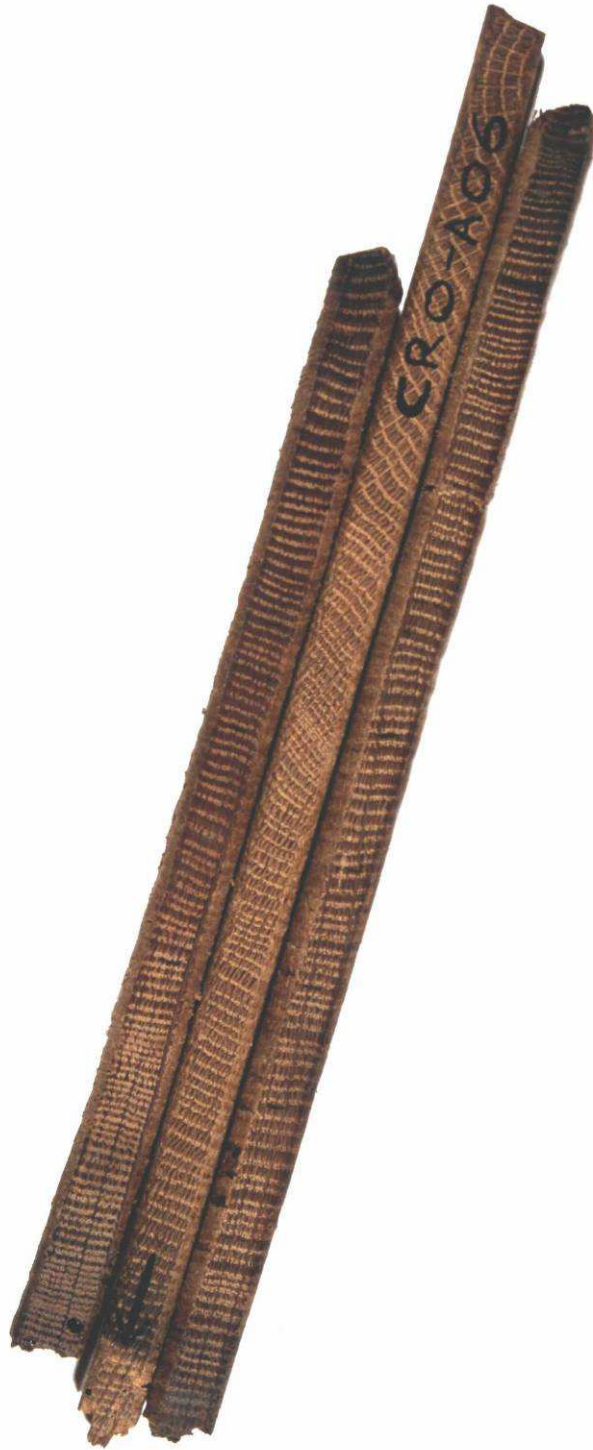
Figure A4: Three cores from timbers in a building. They come from trees growing at the same time. Notice that, although the sequences of widths look similar, they are not identical. This is typical
