The Riding House, St Giles House, Wimborne St Giles

Building Investigation

**THE RIDING HOUSE
ST GILES HOUSE
WIMBORNE ST GILES, DORSET
BUILDING INVESTIGATION**

NGR: SU 03303 11700

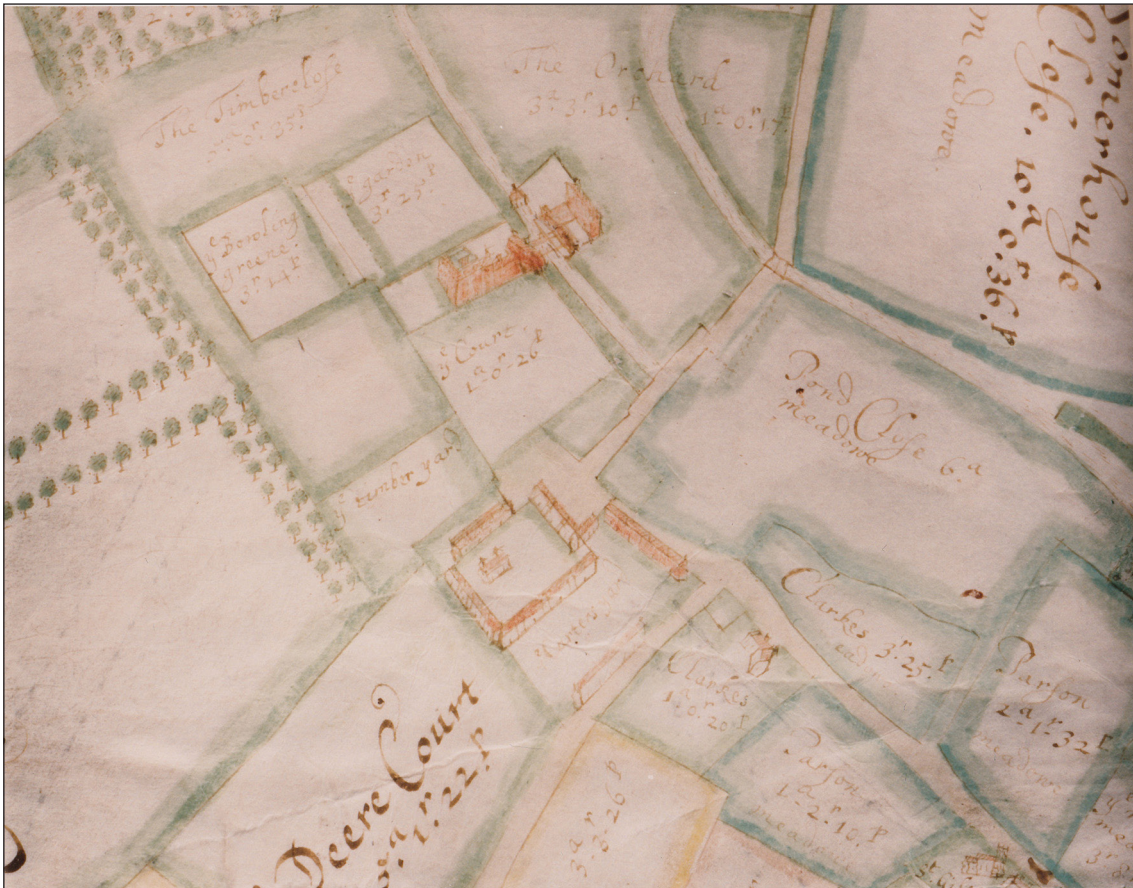
Figure 1: Estate map of 1659 showing the Home Farm complex towards the bottom (AA050724 © Historic England, photograph: Peter Williams).

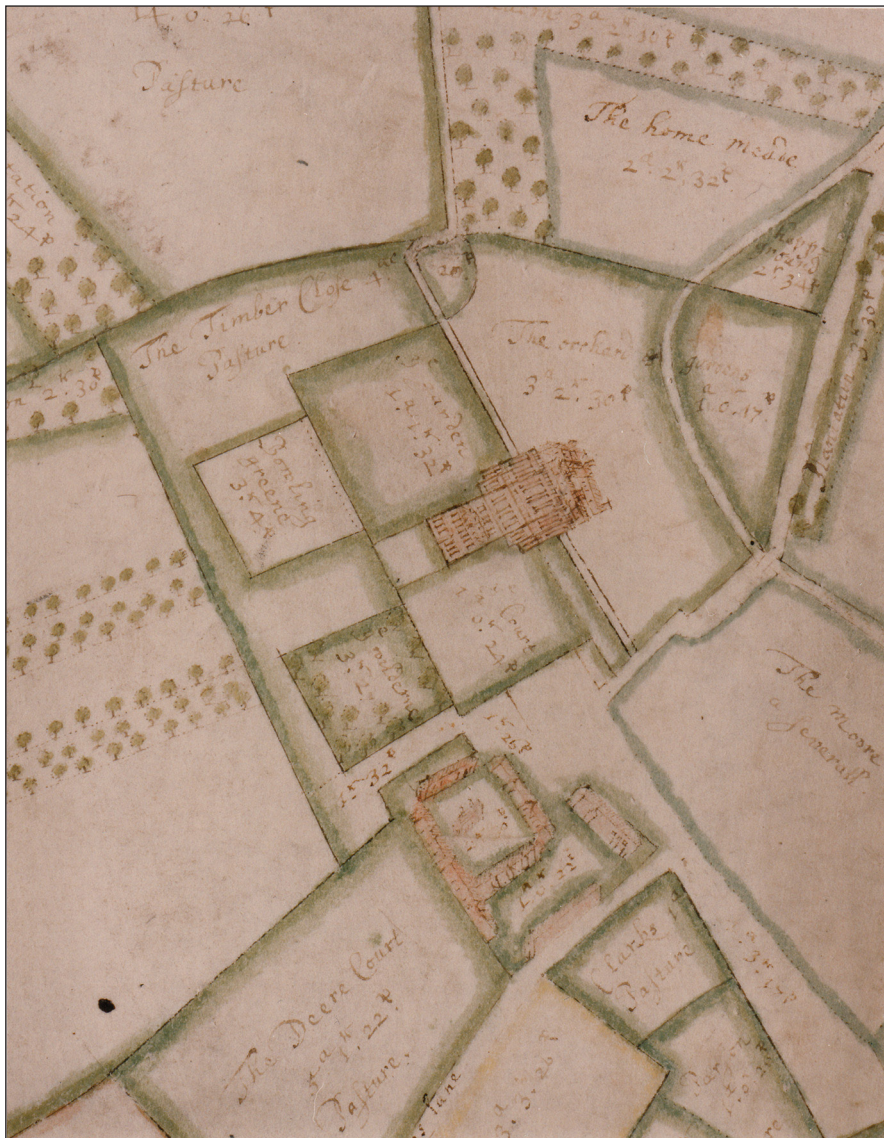
Figure 2:
Estate map of
1672, showing
the transformed
main house
and alterations
to the home
farm complex
(AA050726 ©
Historic England,
photograph: Peter
Williams).

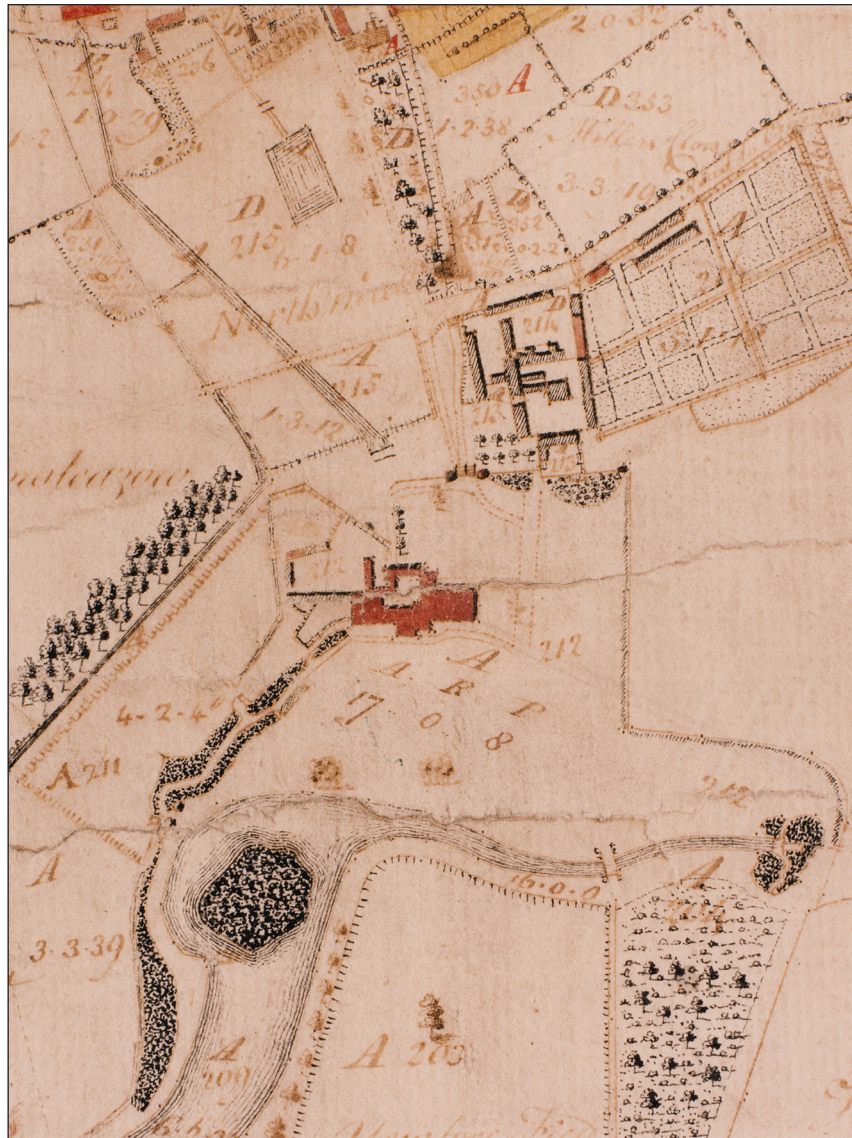
Figure 3: 1788 Estate map showing the home farm complex north of the main house (AA050729 © Historic England, photograph: Peter Williams).

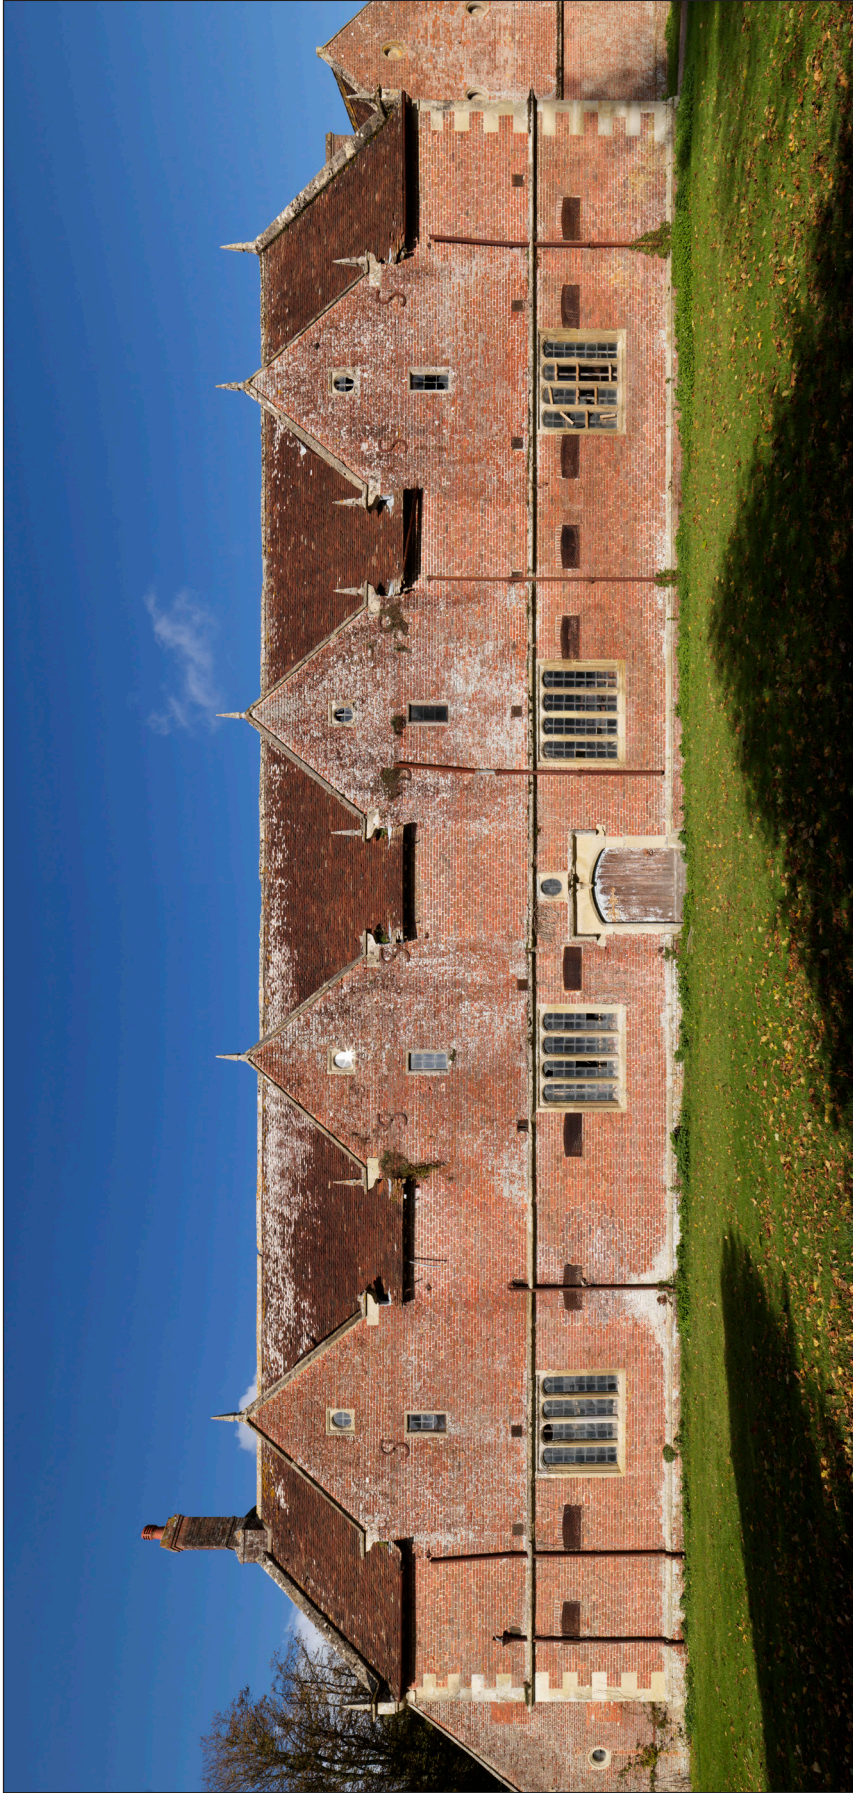
This represents the principal phase of construction of the extant building. On the basis of stylistic and documentary information this has been ascribed to the early 17th century. This date is confirmed by the dendrochronological analysis which produced a consistent felling date from the principal components of the buildings of AD1616, with construction suggested to be within a year or two of that date (Bridge forthcoming). As constructed it comprised a nine-bay, two-storey building of brick with stone dressings. The principal entrance was on the south elevation of the building, which also represents the main façade (Figure 5). This elevation is dominated by the four wide bays with gables rising above them, which alternate with 5 shorter bays with eaves. At ground-floor level the building has a series of four four-light mullion windows, each sitting directly under one of the gables. The lights have elliptical heads, with ovolo mouldings to the mullions and jambs. A continuous stone string course runs across the elevation acting as a hood mould to each of the ground-floor windows. This is not at the same height as the internal floor, but appears to have been placed lower to give the elevation a more regular appearance. There is also a brick plinth running along the building with an ogee-moulded capping.

Figure 5: South elevation (DP166137 © Historic England, photograph: James O. Davies).

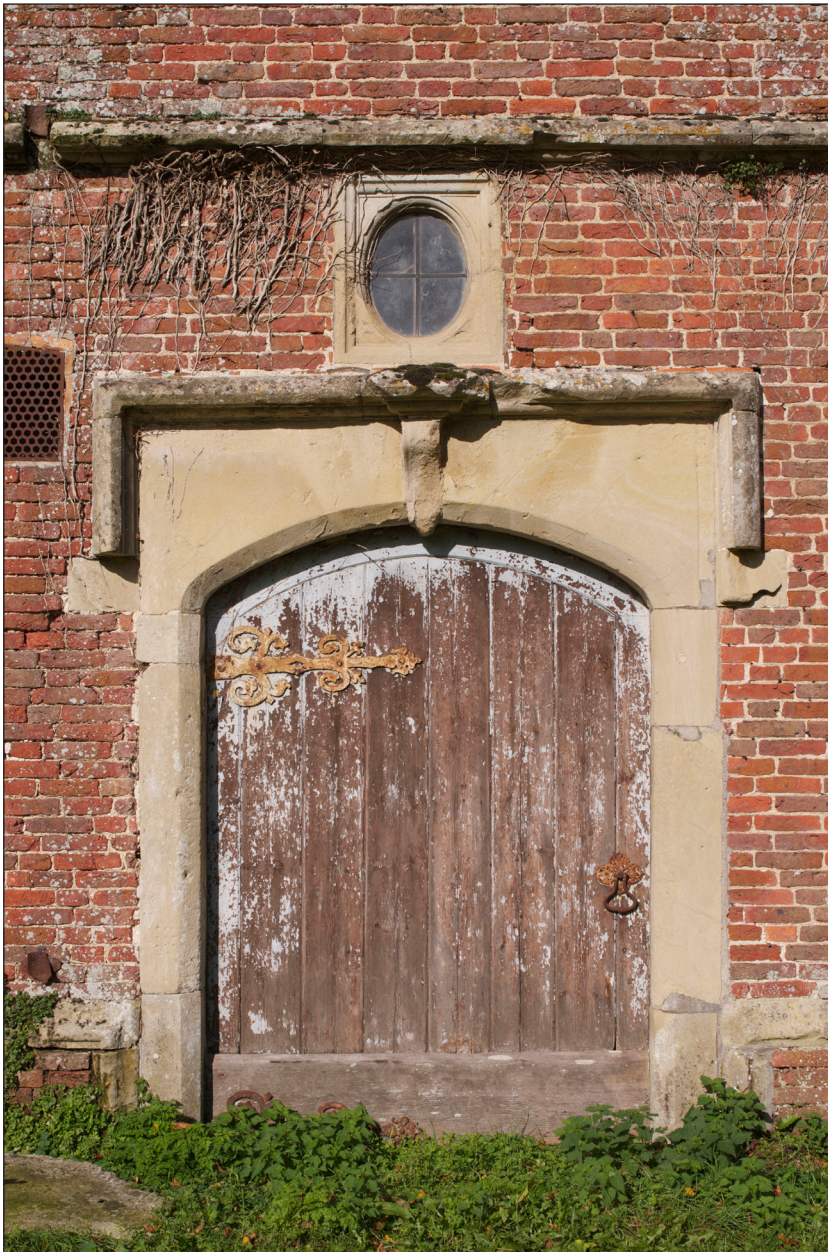
The extant doorcase appears original, but has been relocated (Figure 6). Originally it appears to have sat further west, in the third bay from the west, where there are two vertical rows of queen closers visible, with corresponding joints in the brickwork of matching proportions to the doorcase and its overlight (Figure 7). The form of the door case shows a classical influence in the building with a simple chamfer profile to the jambs and the elliptically-arched head, and a projecting console keystone which rises to the hood mould. The hood mould itself runs around the outer edge of the stone head of the doorcase. It has projecting label stops which have been struck back, but which appear originally to have formed a small lip in the same profile as the main hood. Above the hood mould there is a small stone overlight with an oval window set in a sunk stone panel. Above the stringcourse the first floor of the elevation appears originally to have been largely without features. Of the four square-headed windows currently visible the central two may be original. The easternmost window at this level is certainly an insertion (see discussion of the interior below). The upper floor was therefore principally lit by the small oval windows in the four gables, which take the same form as that over the principal entrance. These would have provided only limited light – which may indicate that the first floor of the building was not heavily used. Each gable is supported on ogee-curved stone kneelers, with stone capping, and with three obelisk finials at the

Figure 6: Relocated doorway on the south elevation (DP136166 © Historic England, photograph: James O. Davies).

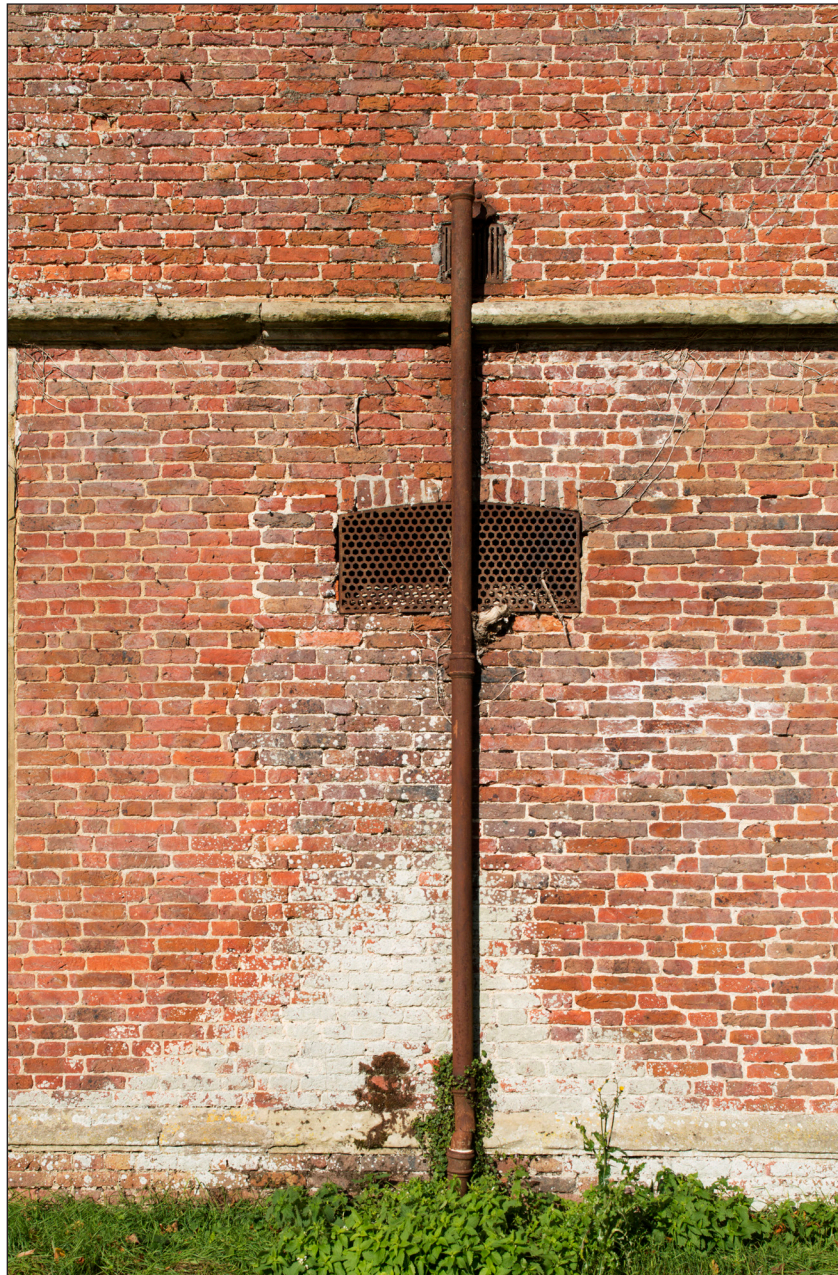
Below the inner edge of both first-floor window sills there are rows of queen closers which run from three courses below the sill down to the stringcourse. Elsewhere in the building these are typically associated with original window or doorway

Figure 7: Original position of the south doorway, as indicated by disruption in brickwork and queen closers to the west (DP166174 © Historic England, photograph: James O. Davies).

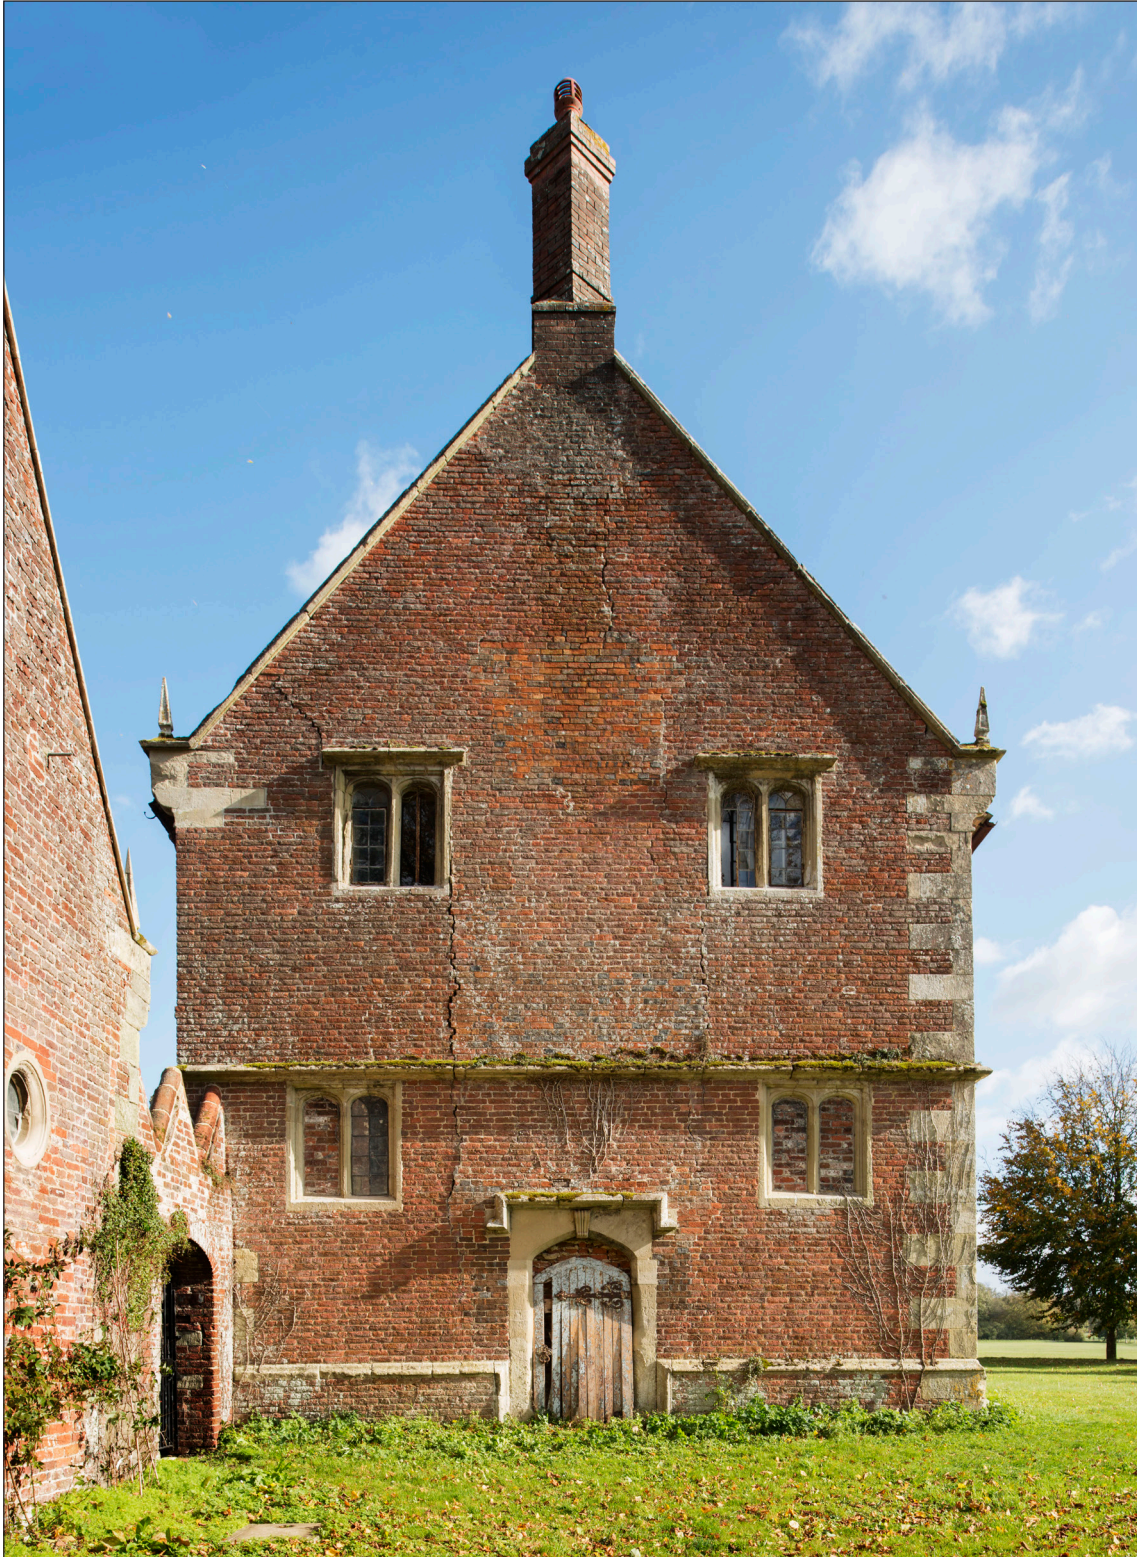
The west elevation of the building has smaller, two-light versions of the larger windows on the south elevation (Figure 8). There are two windows at high level on the ground floor, with two further openings at first-floor level. Although the lights are now blocked with brick at ground floor level they may have originally lit a ground floor room at this end (see discussion of the north elevation below). The upper windows still light a small chamber at first-floor level; although this has been heavily modified (see below) it probably represents a similar arrangement to the original.

Figure 8: West elevation (DP166171 © Historic England, photograph: James O. Davies).

Above the first-floor window openings an area of blocking sits equidistant between the lintels of the two windows (see Figure 8). This presents a much more clearly defined original opening, probably blocked when the chimney was inserted. The original form of this is not clear, but its proportions appear similar to the extant windows to either side. Sitting at a slightly higher level than the windows to either side it may have lit the upper area of the first floor, which was perhaps partitioned from that below (see internal description). The gable end of the building has shaped kneelers, obelisk finials at the bases of the gable and a moulded stone capping. It was probably originally finished with a further obelisk finial, as is still the case at the east end of the building, the current chimney being a later insertion.

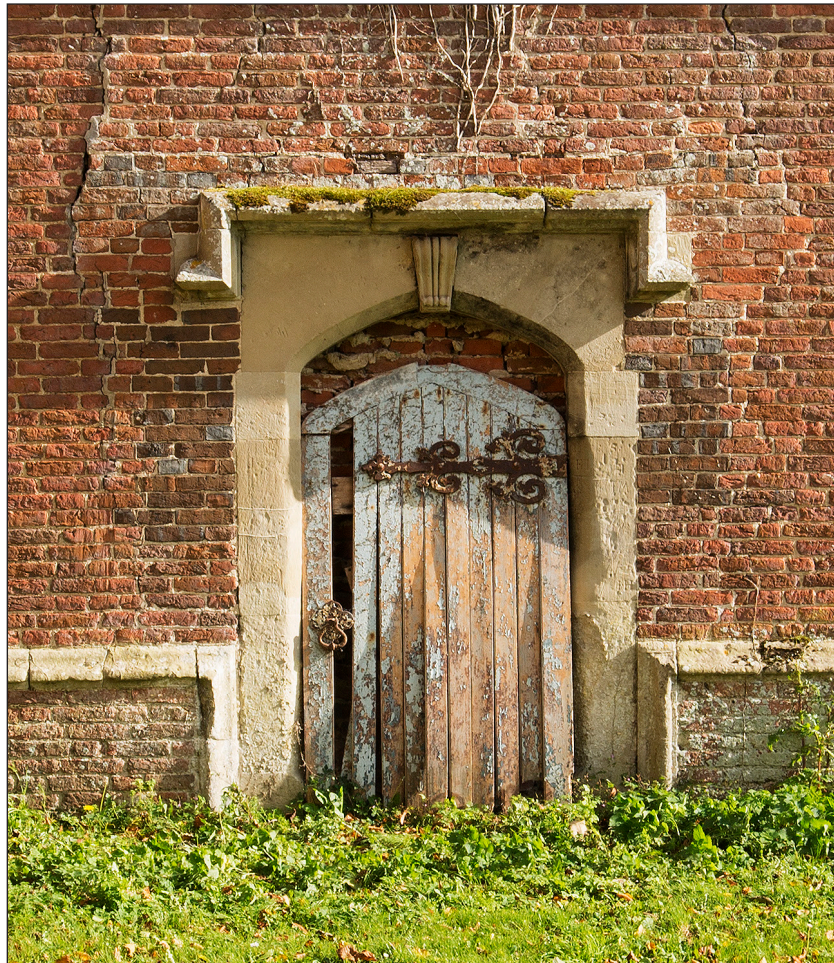
Figure 9: detail of the west doorway, showing poor alignment of the stones of the doorhead with the jambs (DP166171 crop © Historic England, photograph James O. Davies).

The doorcase now sitting in the centre of the west elevation is similar to that on the south elevation and may represent an original feature. It has similar detailing as that to the south elevation, particularly in the plain chamfered jambs and head, the projecting key stone, and the hood mould. One distinctive difference is the survival

of moulded decoration on the front of the keystone, which may have eroded from the same feature on the south elevation doorway. The poor fit of some of the stonework however suggests that it has been altered, particularly in the way the stones of the door head sit slightly inwards from those of the jamb (Figure 9). The hood moulding also appears poorly jointed, and the camber of the doorway head is much steeper than that to the south elevation. Visible around the upper sections of the doorway are brick infill sections which suggest that the current door position may in fact be inserted into an original opening, possibly a window. However, if this is the case then the opening was wider, and lower, than the surviving windows of this elevation. The precise form and function of this opening, and its relationship to the doorcase remains uncertain.

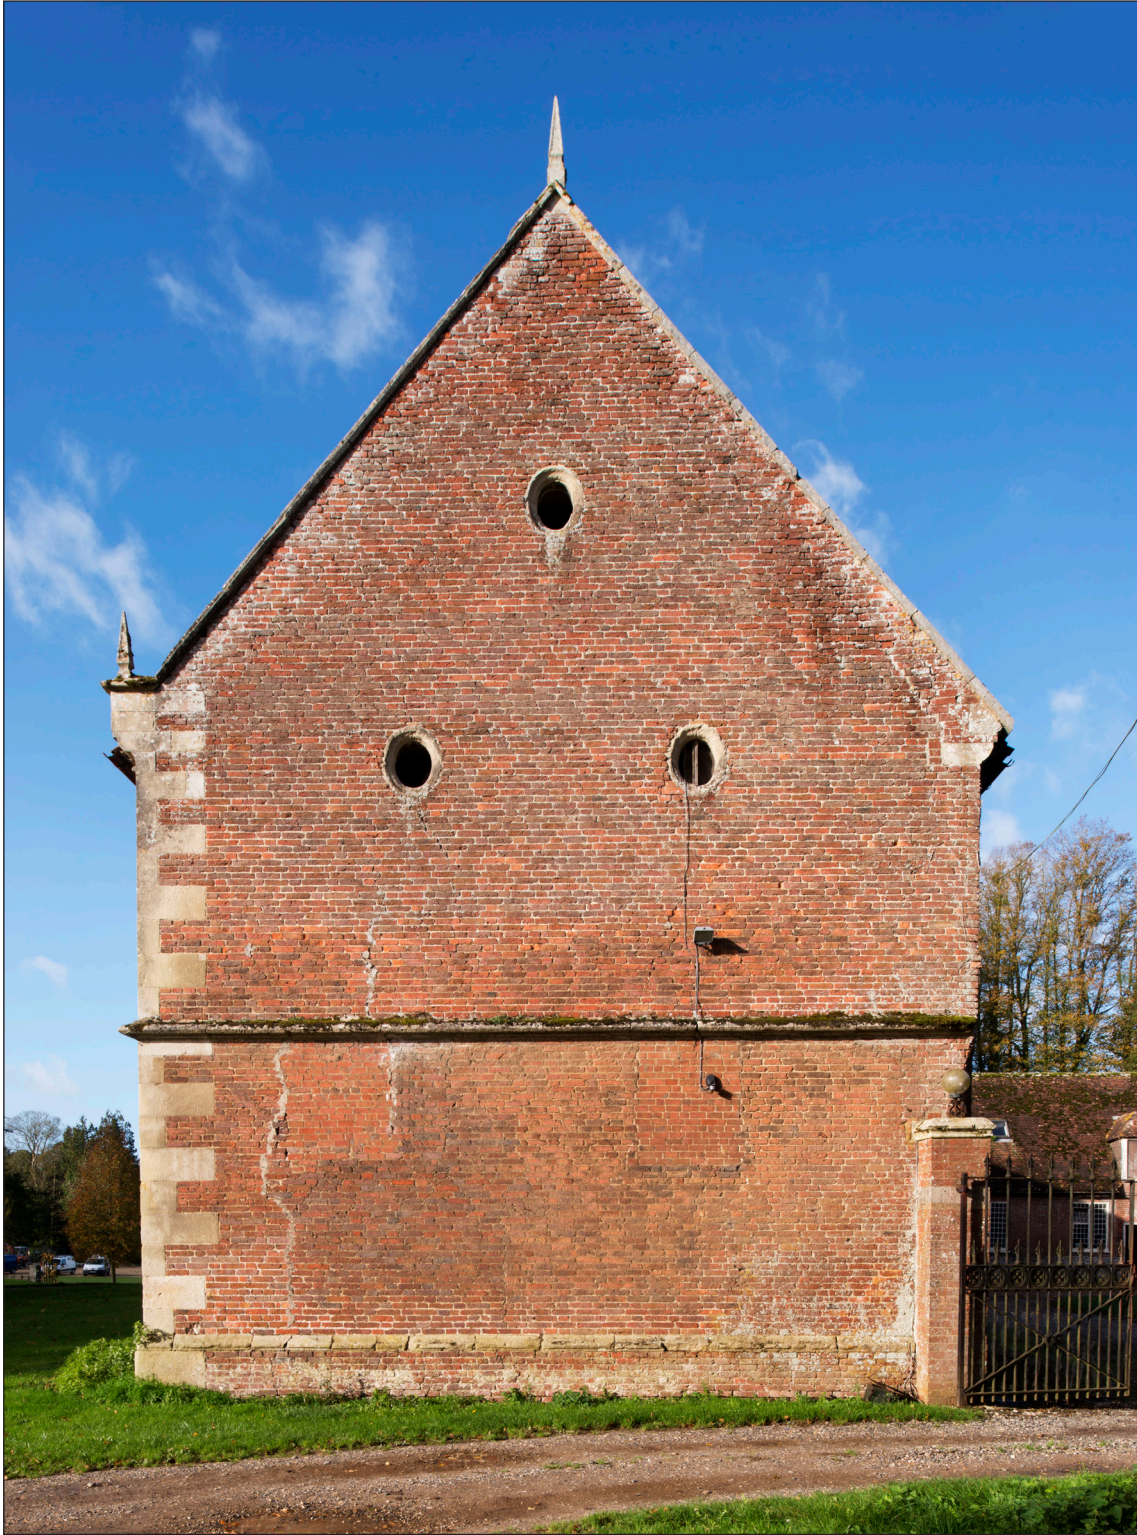
Figure 10: East elevation (DP166144 © Historic England, photograph: James O. Davies).

The east elevation matches that to the west in its detailing, including the mid-level stone stringcourse for example (Figure 10). Its features differ in some significant ways however. There are two areas of brick infill indicating the position of two original high-level ground-floor window openings. The proportions of these infill areas match those on the west elevation, and it is likely that the windows took the same form. Just south of the centre of the elevation a row of queen closers is visible associated with a large area of patched in brickwork to its south. Although this patching has obscured the form of this opening it is suggested that this may have formed a small doorway at this end of the building. It cannot have been of the same proportions as that on the south elevation however, as its position, partly below the southern of the high-level window openings, would not have allowed for a doorcase of the same height. It may have formed a small side entrance, away from the principal elevations that fronted towards the main house. At first-floor level there are three unglazed ox-eye stone openings. These are original, and indicate that originally the upper storey of the building at this end had a different function than that to the west. The form of the upper gable matches that to the west, with a moulded stone capping, and three obelisk finials.

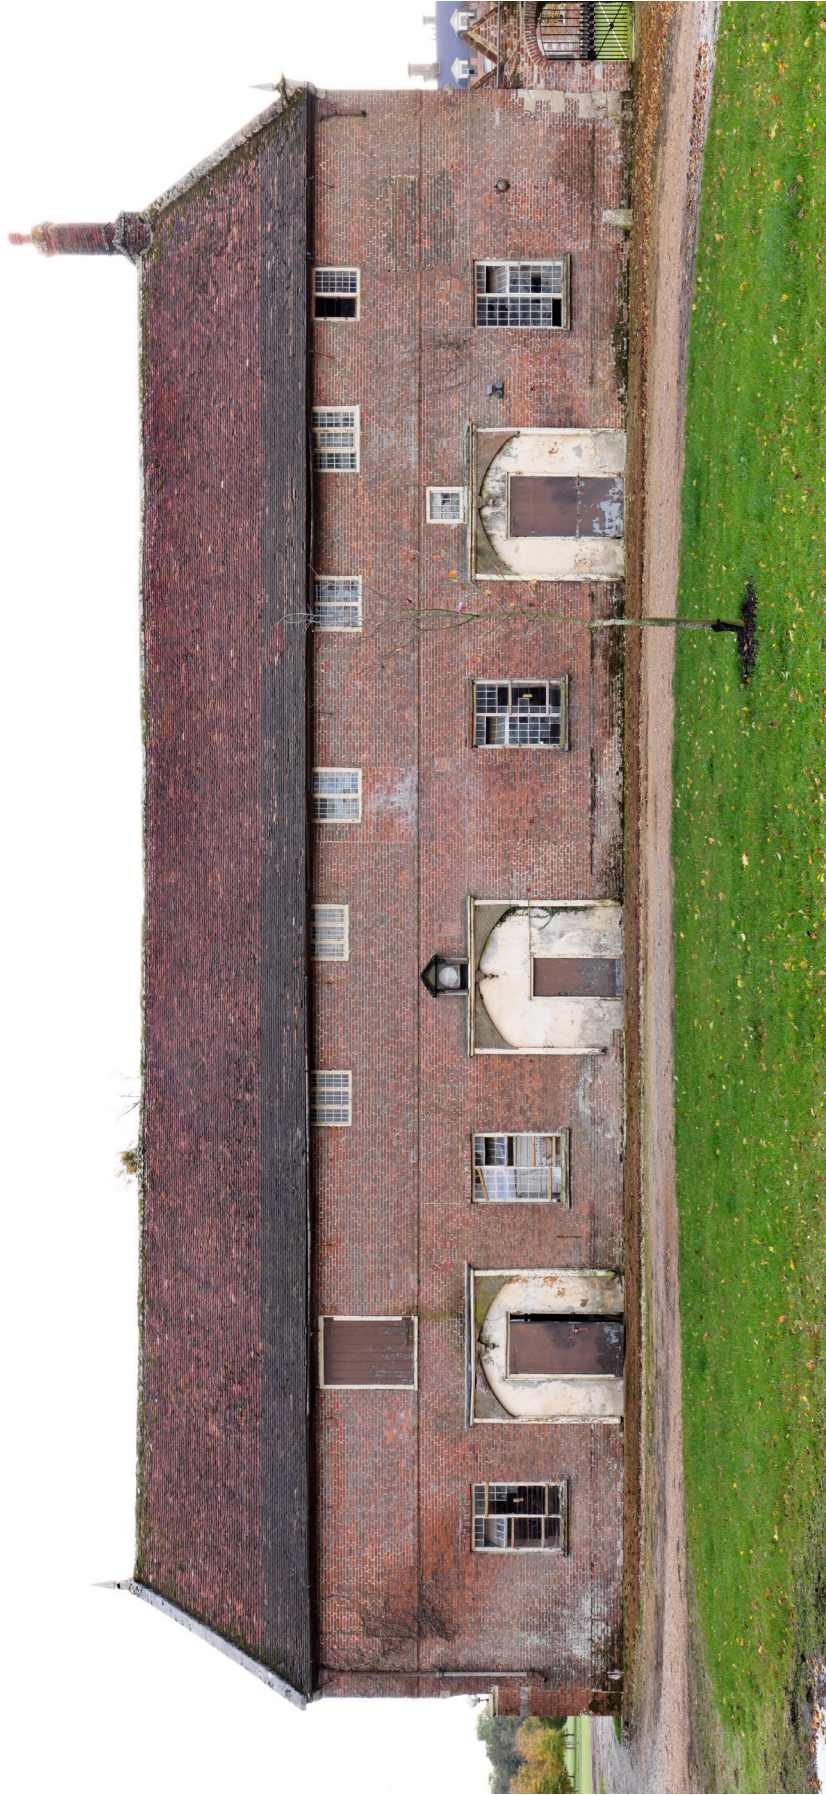
Figure 11: North elevation (DP166142 © Historic England, photograph: James O. Davies).

The north elevation is considerably plainer than that to the south, reflecting its less prominent position facing into the farm courtyard (Figure 11). A brick plinth, with no stone moulding, runs along the base of the elevation and a brick plat band marks the internal first-floor level, which means it sits higher than the moulded stone stringcourse on the other elevations. This feature strongly suggests that, notwithstanding the lower stringcourse on the other elevations, the current floor level is original. This is further confirmed by the position of the only extant original opening on this elevation, the taking in door towards the east of the elevation, which sits directly above the plat band. This feature appears originally to have been matched by a further taking in door towards the centre of the elevation, although this has now been infilled to create a window opening. The remainder of the openings at this level are later insertions.

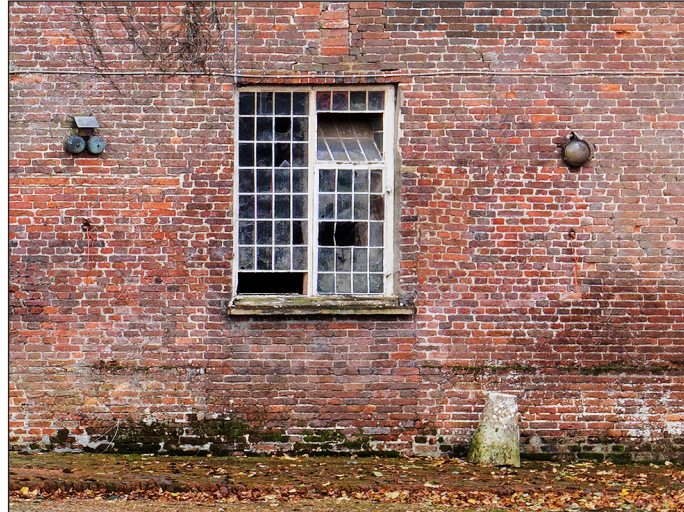
Immediately below the plat band a series of small infilled openings are visible regularly spaced along the elevation. Internally these are concealed by plaster, but they may represent the position of small vents, which were often provided directly over the top of stalling to help the circulation of air within a stable (as with the inserted, later, examples on the south elevation). Towards the western

Figure 12: Position of original door opening, indicated by rows of queen closers and infill brickwork (DP166142 crop (c) Historic England, photograph: James O. Davies).

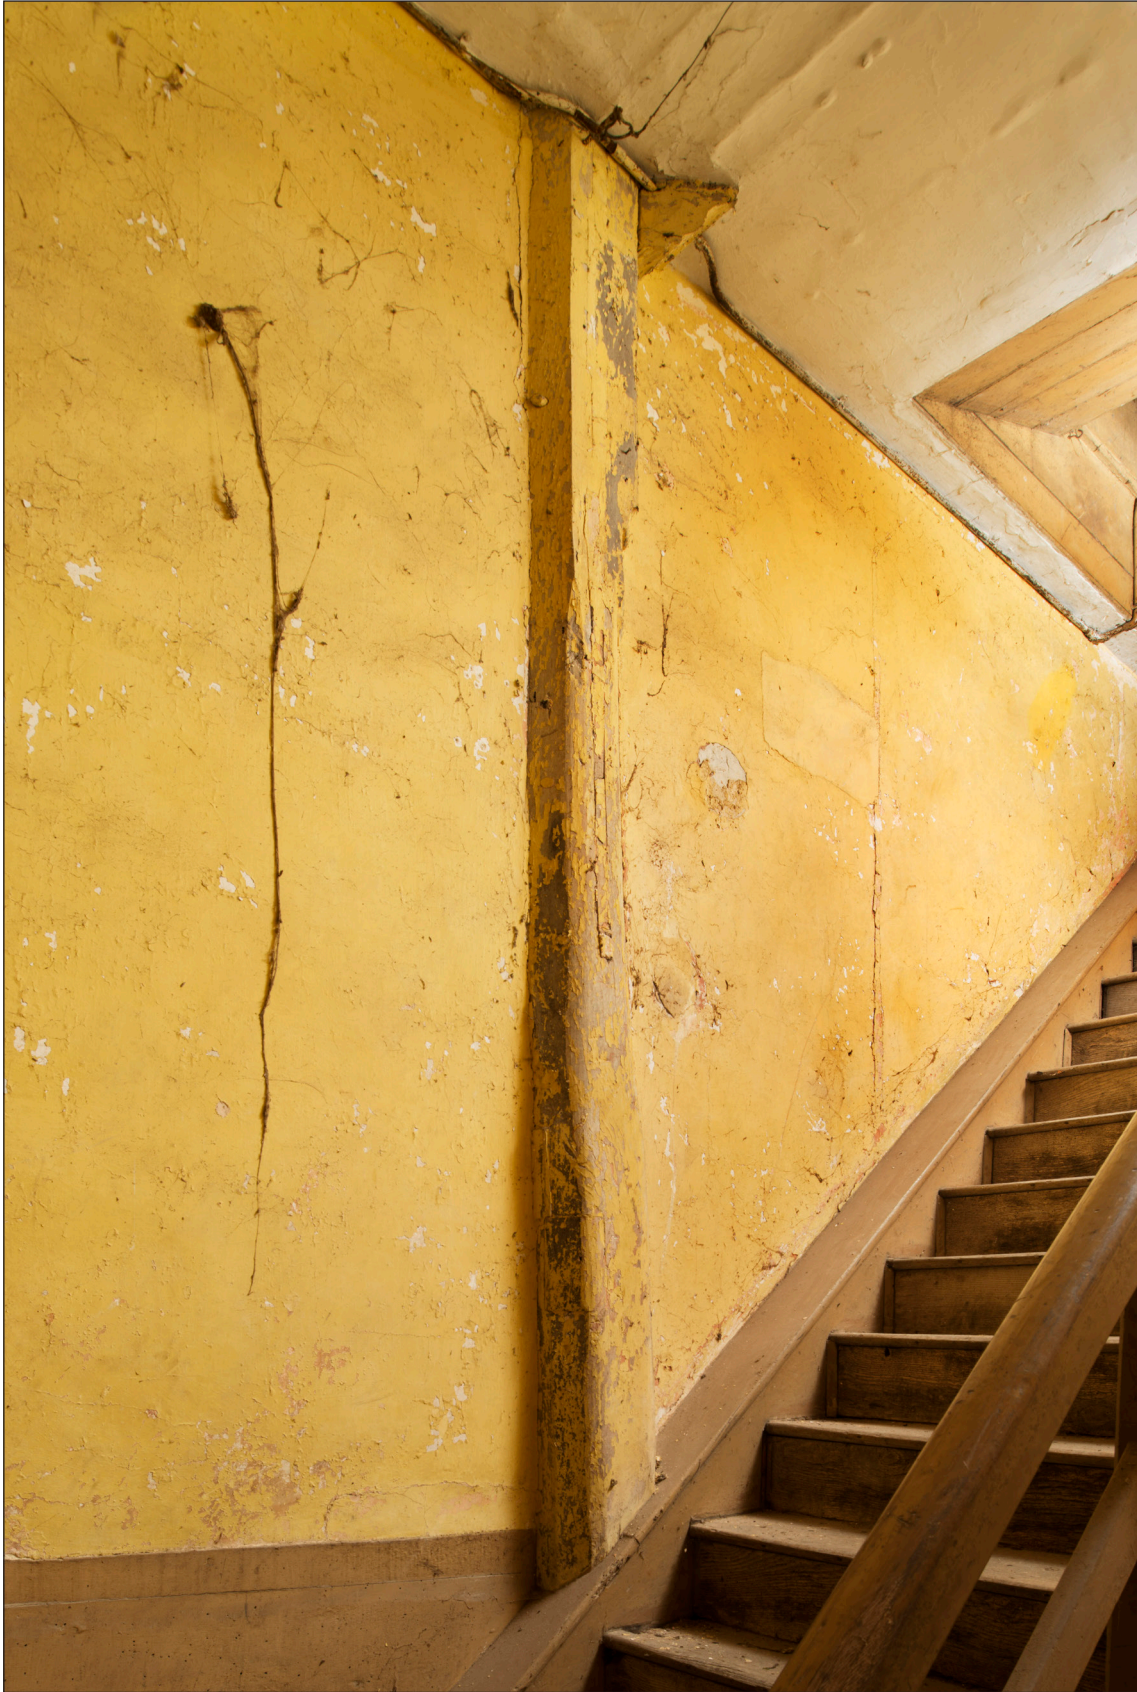
Figure 13: Stable arcade post surviving in the wall between the east stable and the stair (DP166162 © Historic England, photograph: James O. Davies).

stair (Figure 13). The early date of this post is indicated by the form of the moulding visible on its southern face with a decorative chamfer terminating in a scroll and vase stop with a faceted end (Figure 14). There is no corresponding chamfer to the northern side of the post, which indicates that the 'fair' face of this feature fronted south. In both the east and west faces of the post a series of redundant mortices are visible. Those to the west could be closely observed and measured. The largest of the mortices on the western face measures some 0.99m in height and sits at the same height as the chamfer (Figure 15). There is a series of five redundant peg holes in the north and south sides of the post corresponding to this mortice (Figure 16). Although the eastern side could not be closely observed the redundant mortice appears to be of the same proportions (Figure 17). Fixed to the top of the post on the southern side is a short section of moulded timber forming part of a cornice (Figure 18).

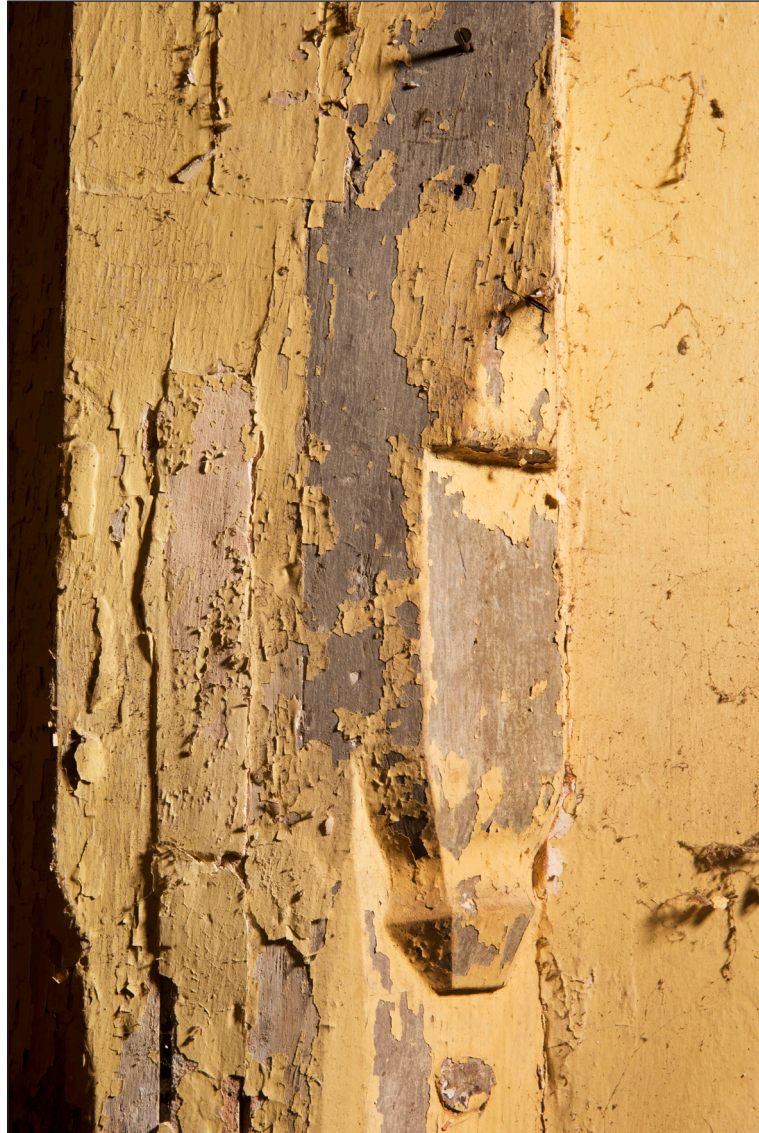
Figure 14: Detail of the chamfer stop on the post (DP166158 © Historic England, photograph: James O. Davies).

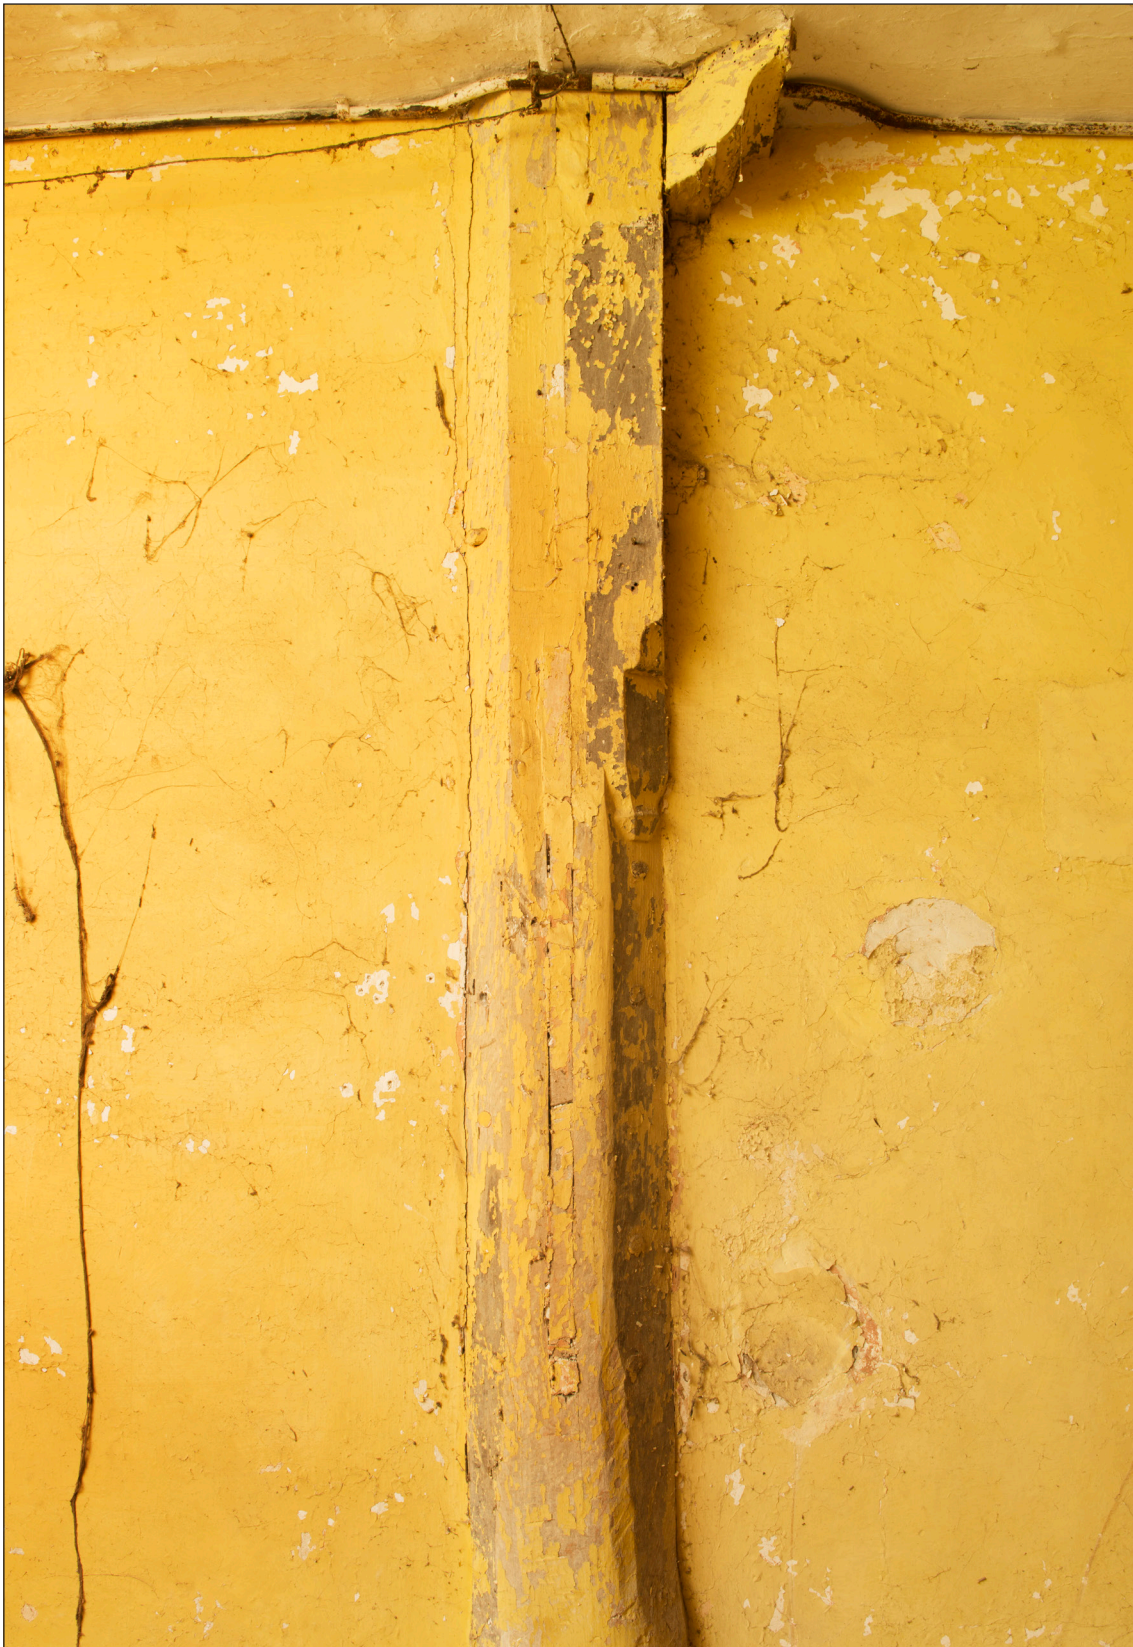
These features taken together appear to indicate that the post originally formed part of a longer feature, the position and size of the mortices suggesting that this took the

Figure 15: Detail of the side of the post, showing the infilled mortice measuring 0.99m in height (DP166161 © Historic England, photograph: James O. Davies).

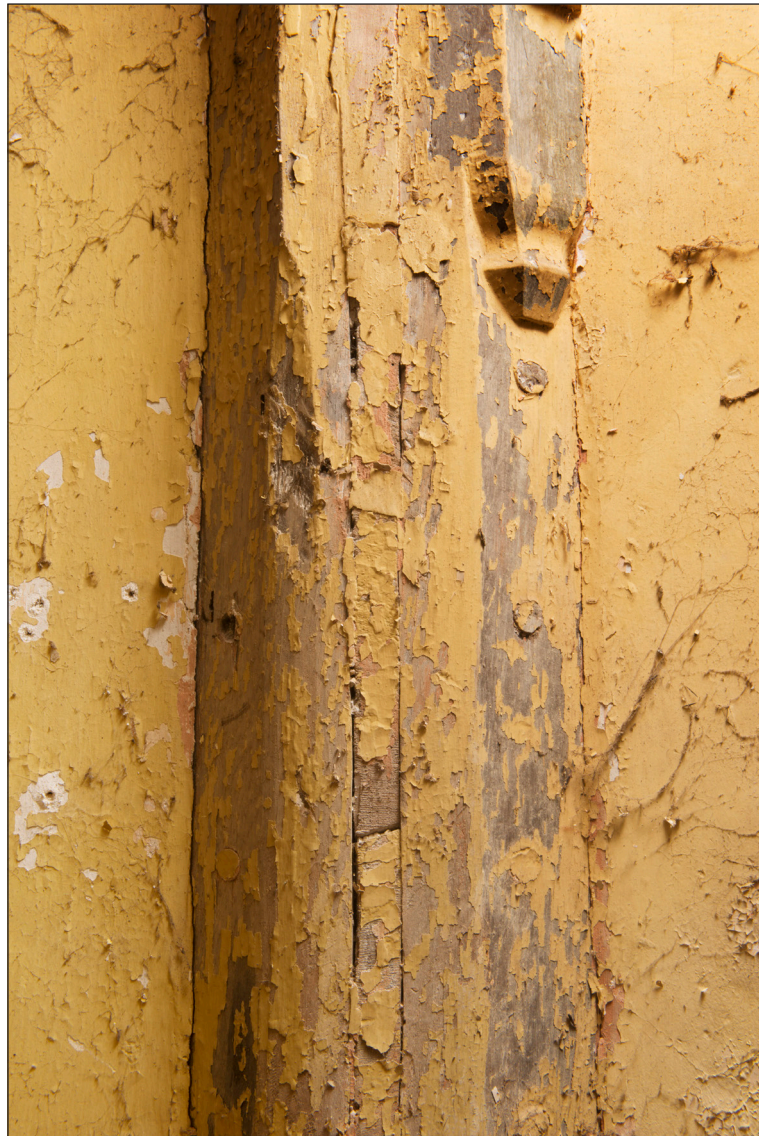
Figure 16: Detail of the upper section of the mortice showing some of the pegs to either side formerly holding it in place (DP166159 © Historic England, photograph James O. Davies).
