The Riding House, St Giles House, Wimborne St Giles

Building Investigation

**THE RIDING HOUSE
ST GILES HOUSE
WIMBORNE ST GILES, DORSET
BUILDING INVESTIGATION**

NGR: SU 03303 11700

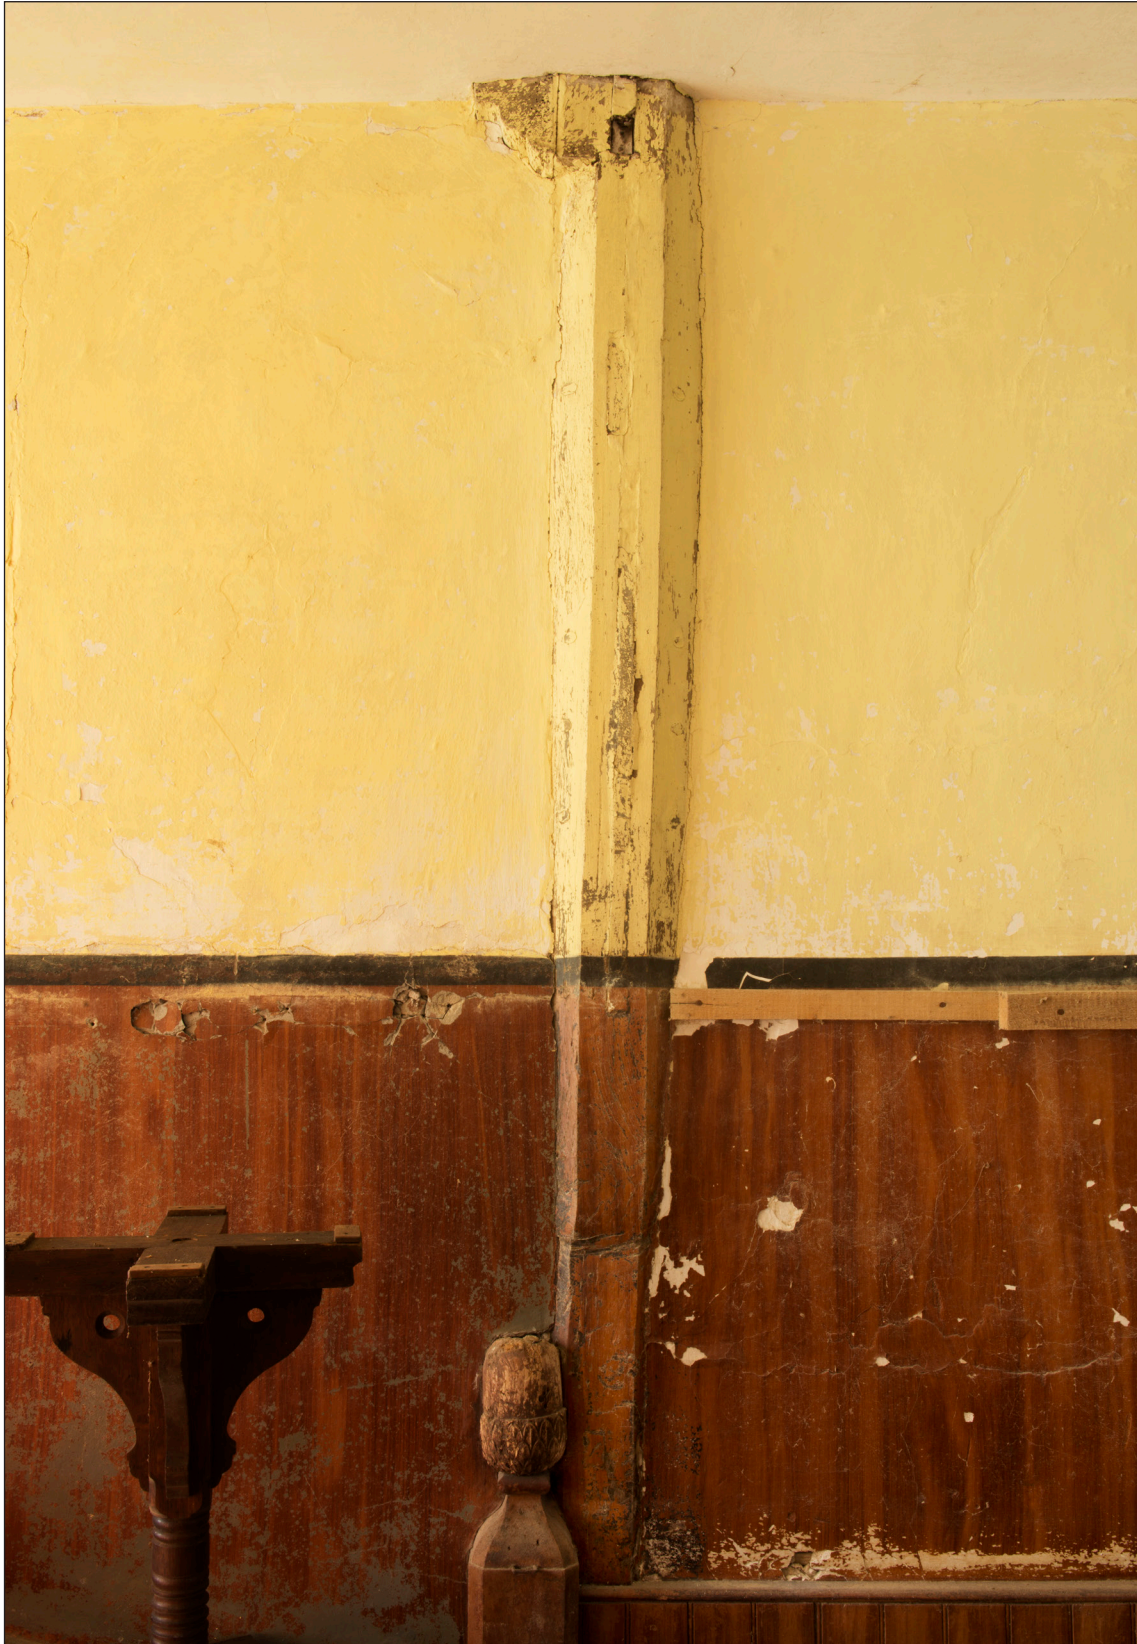
Figure 17: The surviving post as visible from the east stable (DP166185 © Historic England, photograph: James O. Davies).

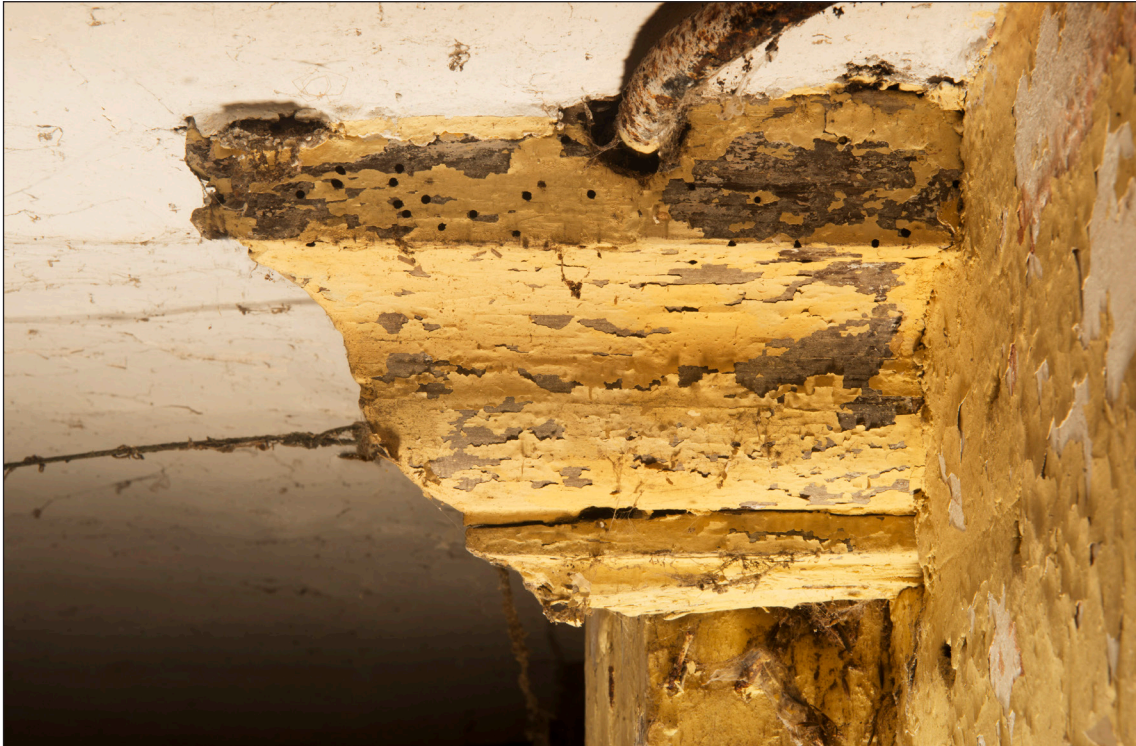
stair (Figure 13). The early date of this post is indicated by the form of the moulding visible on its southern face with a decorative chamfer terminating in a scroll and vase stop with a faceted end (Figure 14). There is no corresponding chamfer to the northern side of the post, which indicates that the 'fair' face of this feature fronted south. In both the east and west faces of the post a series of redundant mortices are visible. Those to the west could be closely observed and measured. The largest of the mortices on the western face measures some 0.99m in height and sits at the same height as the chamfer (Figure 15). There is a series of five redundant peg holes in the north and south sides of the post corresponding to this mortice (Figure 16). Although the eastern side could not be closely observed the redundant mortice appears to be of the same proportions (Figure 17). Fixed to the top of the post on the southern side is a short section of moulded timber forming part of a cornice (Figure 18).

Figure 18: Small surviving section of cornice attached to the southern side of the post (DP166160 © Historic England, photograph: James O. Davies).

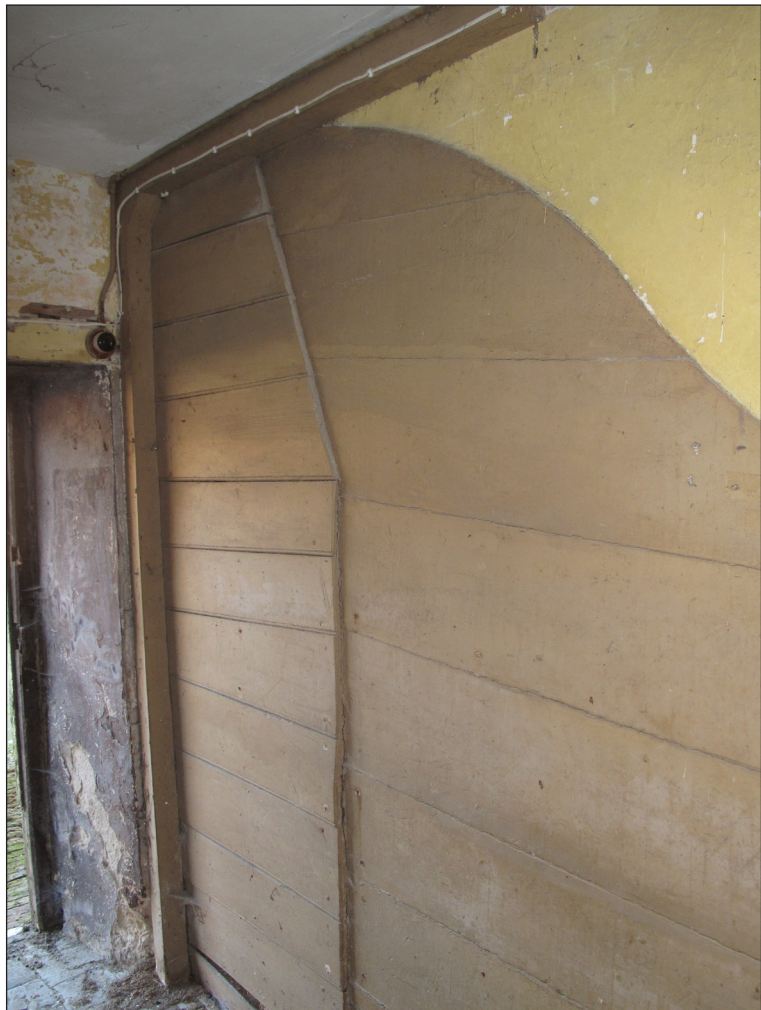
Sitting north of the post, and possibly tenoned into it at its southern end, is a single stable partition, which again has been used to form part of the wall between the stairway and the east stable (Figure 19). This feature might be assumed to have been repositioned, but its relationship to the post, and the gap at its northern end which would allow for a hay rack or other feeding arrangement, suggests that it may in fact be *in situ*. This feature is relatively undiagnostic in terms of date. It may relate to a phase of alteration prior to the significant changes which turned the building arrangement around (see below), but it is also possible that it is original.

Figure 19: Stable partition surviving in wall between east stable and stair, apparently connected to the post at its southern end (© Historic England, photograph: Rebecca Lane).

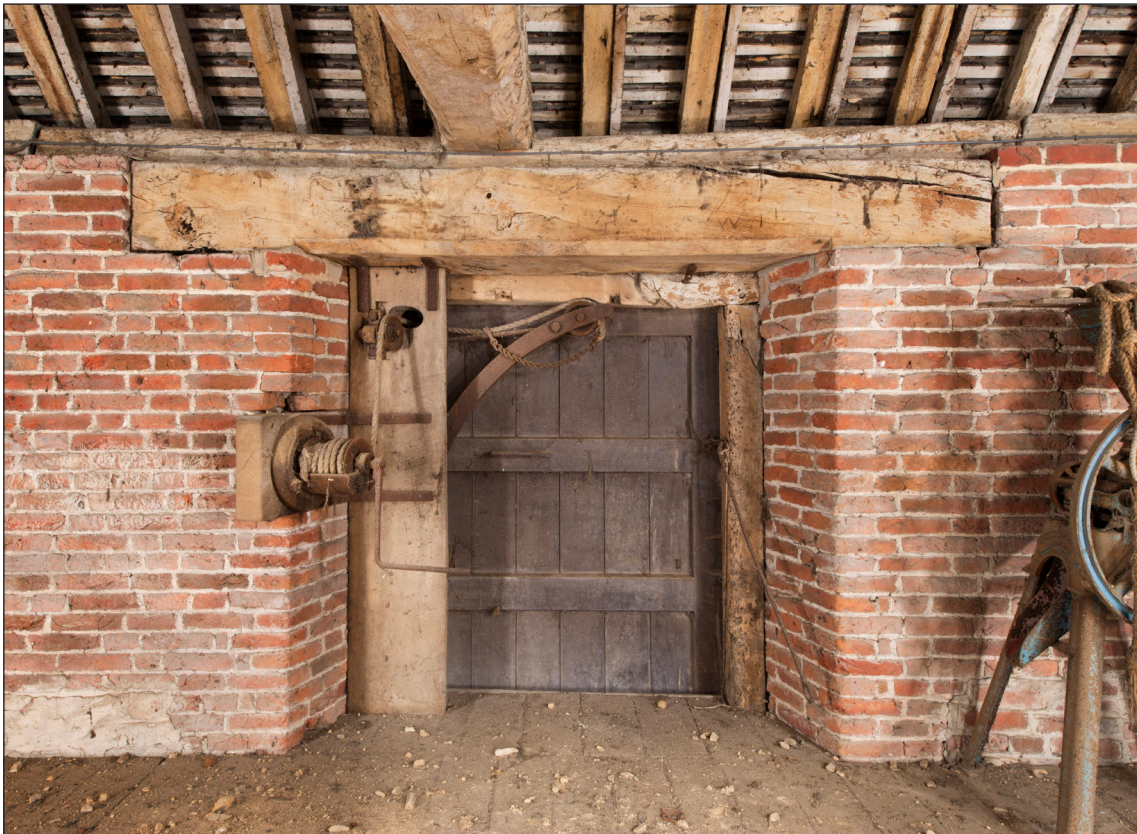
Figure 20: The original taking-in door in the north elevation (DP166168 © Historic England, photograph: James O. Davies).

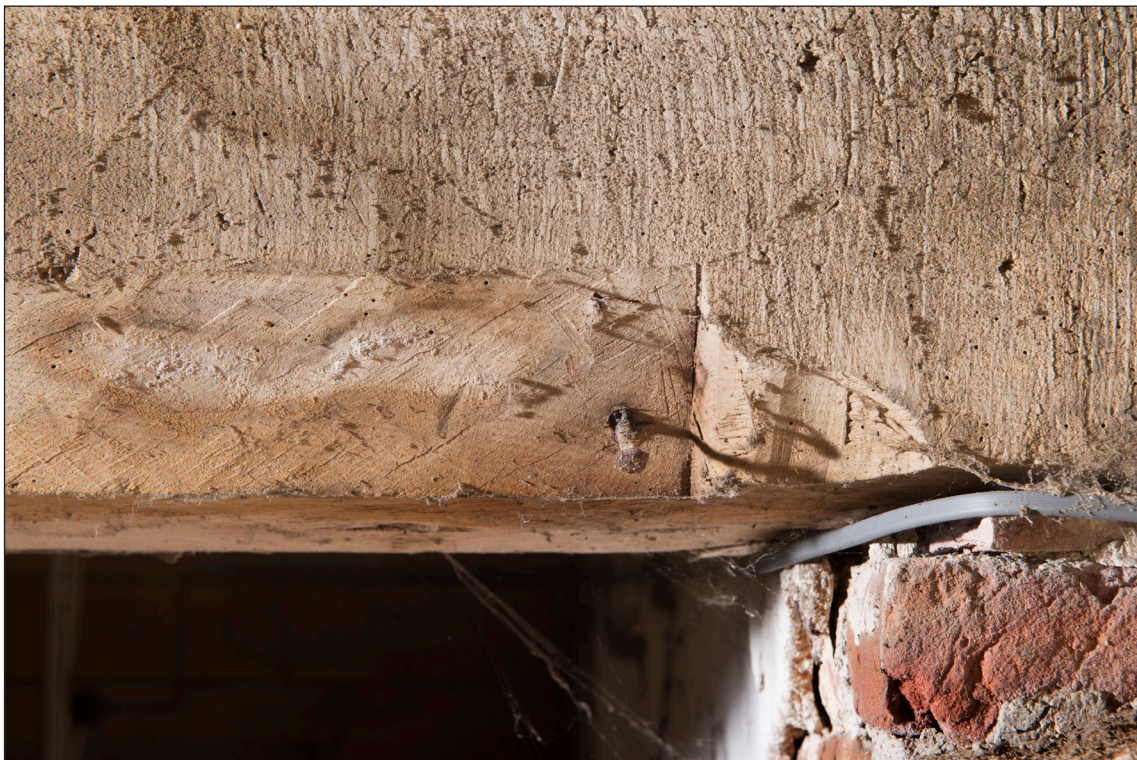
Figure 21: Detail of chamfer stop (DP166178 © Historic England, photograph: James O. Davies).

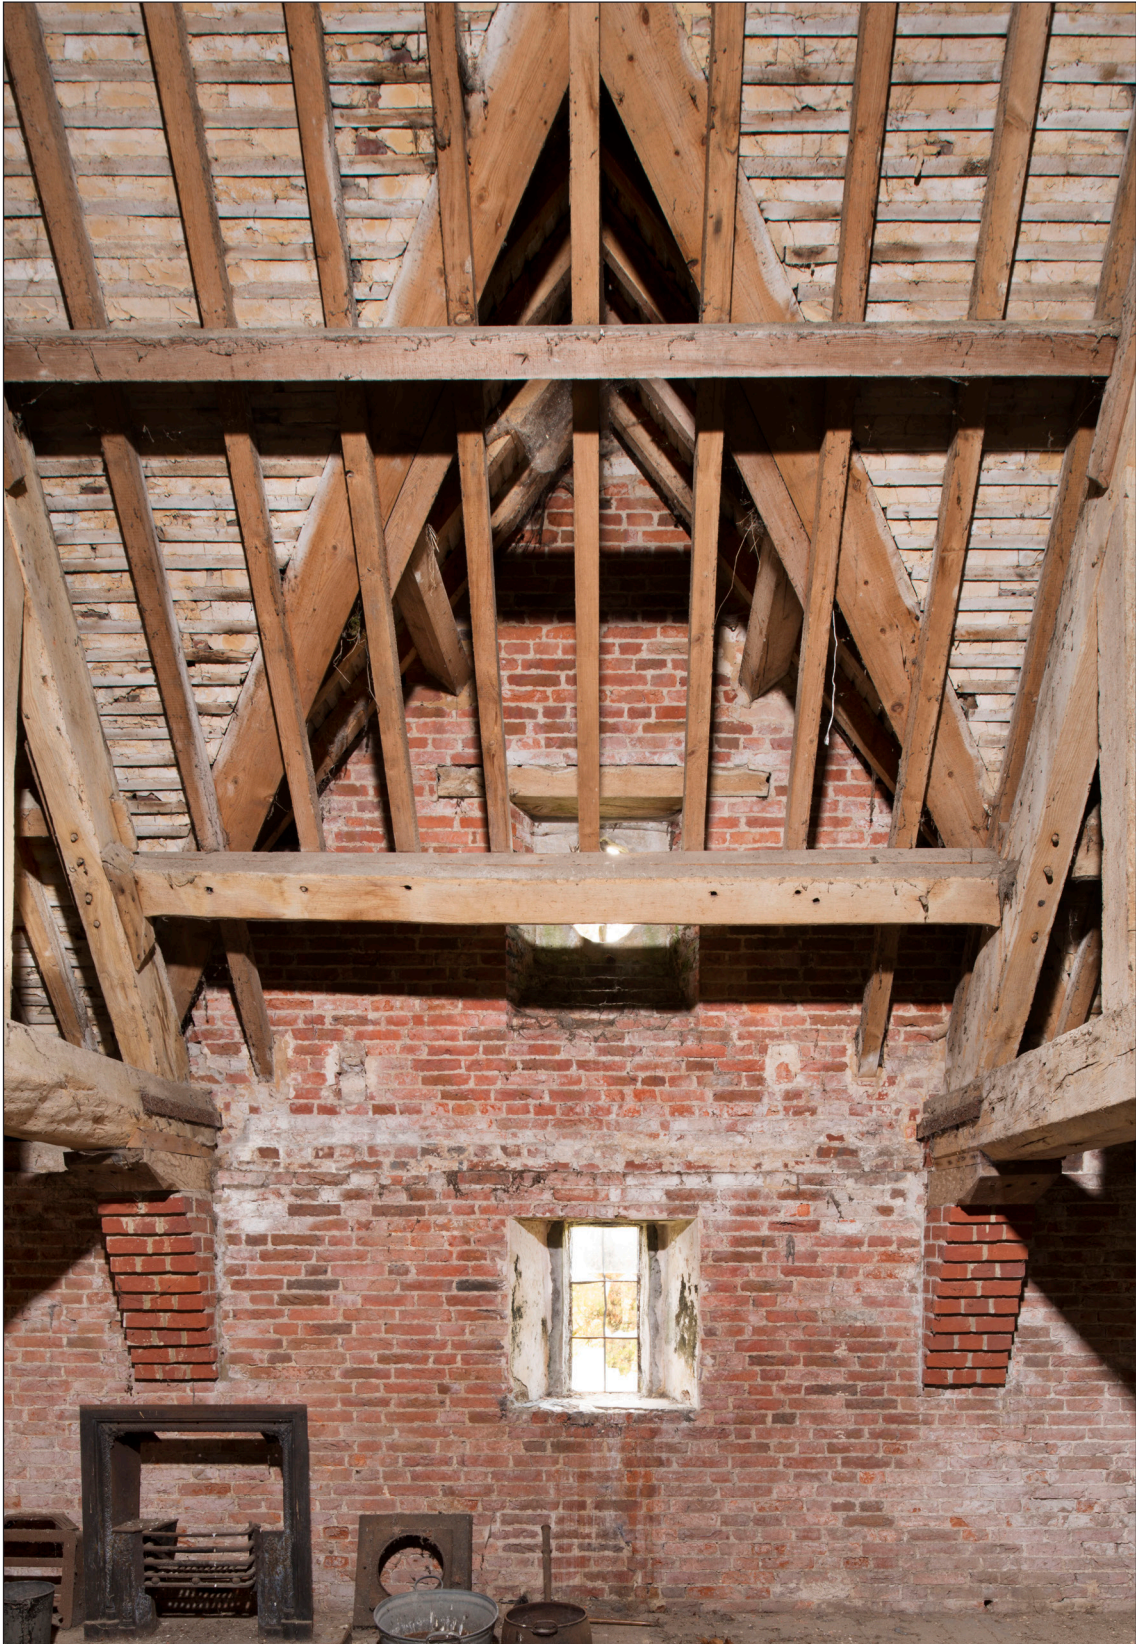
Figure 22: Interior of the eastern gable end showing the original high level opening with its timber lintel, and the inserted window opening below (DP166166 © Historic England, photograph: James O. Davies).

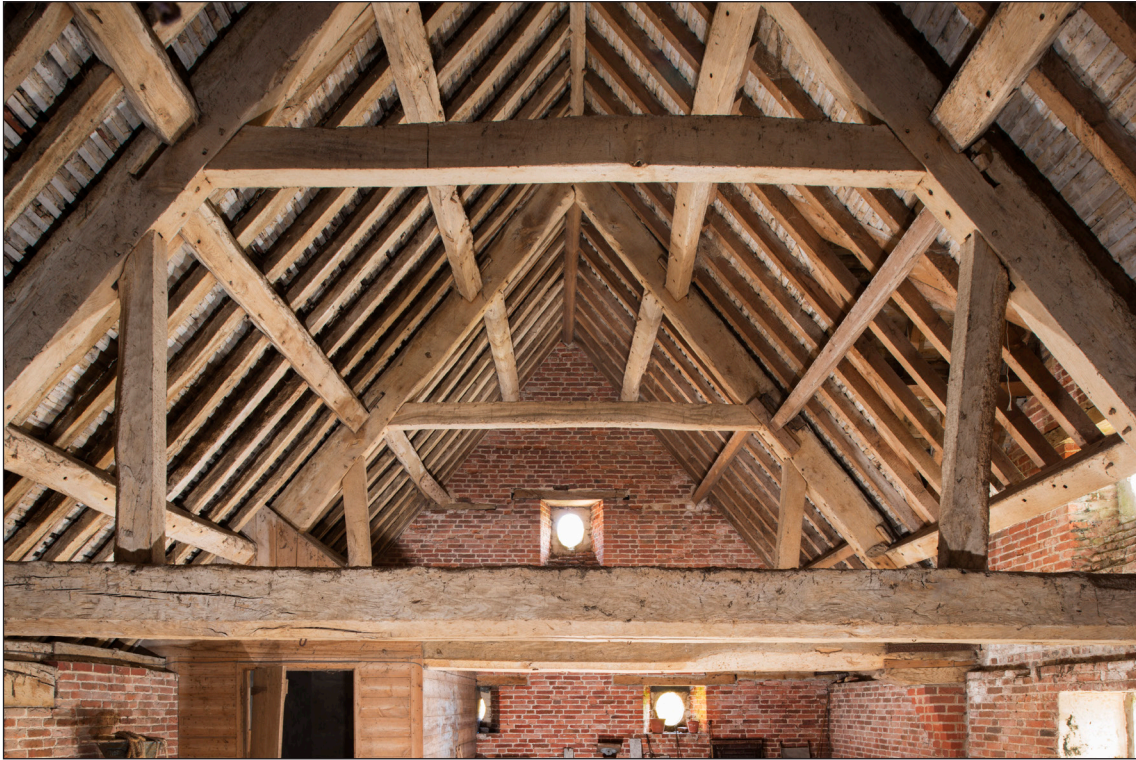
Figure 23: Roof structure looking east (DP166167 © Historic England, photograph: James O. Davies).

other trusses are partly visible via the open area over the ceiled-in western section of the first floor. The roof structure is formed of 8 collar trusses, with queen struts rising to support the principal rafters (Figure 23). The trusses support a staggered butt-purlin roof, although some of the purlins and all of the common rafters appear replaced. Where visible the bases of the tie beams are chamfered with scroll stops to both ends (Figure 24). The remaining five trusses have been subject to more alteration, but appear to have originally taken the same form.

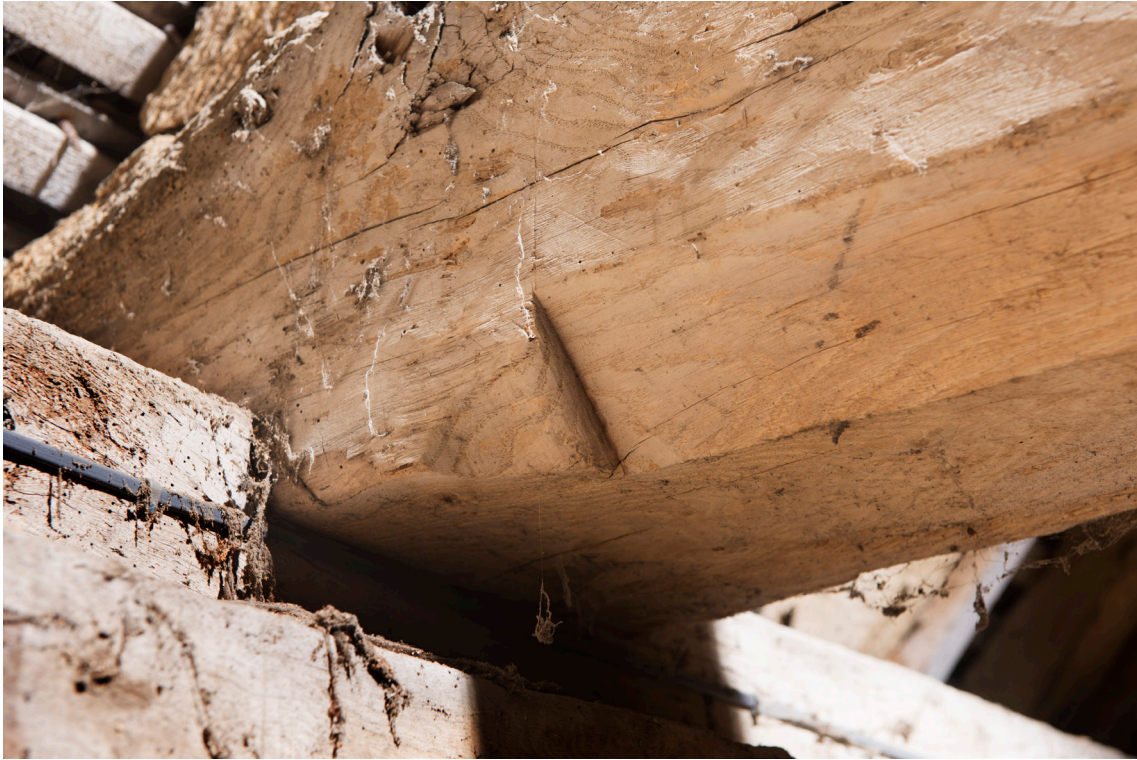
Figure 24: Detail of chamfer stop on tie beam (DP166177 © Historic England, photograph: James O. Davies).

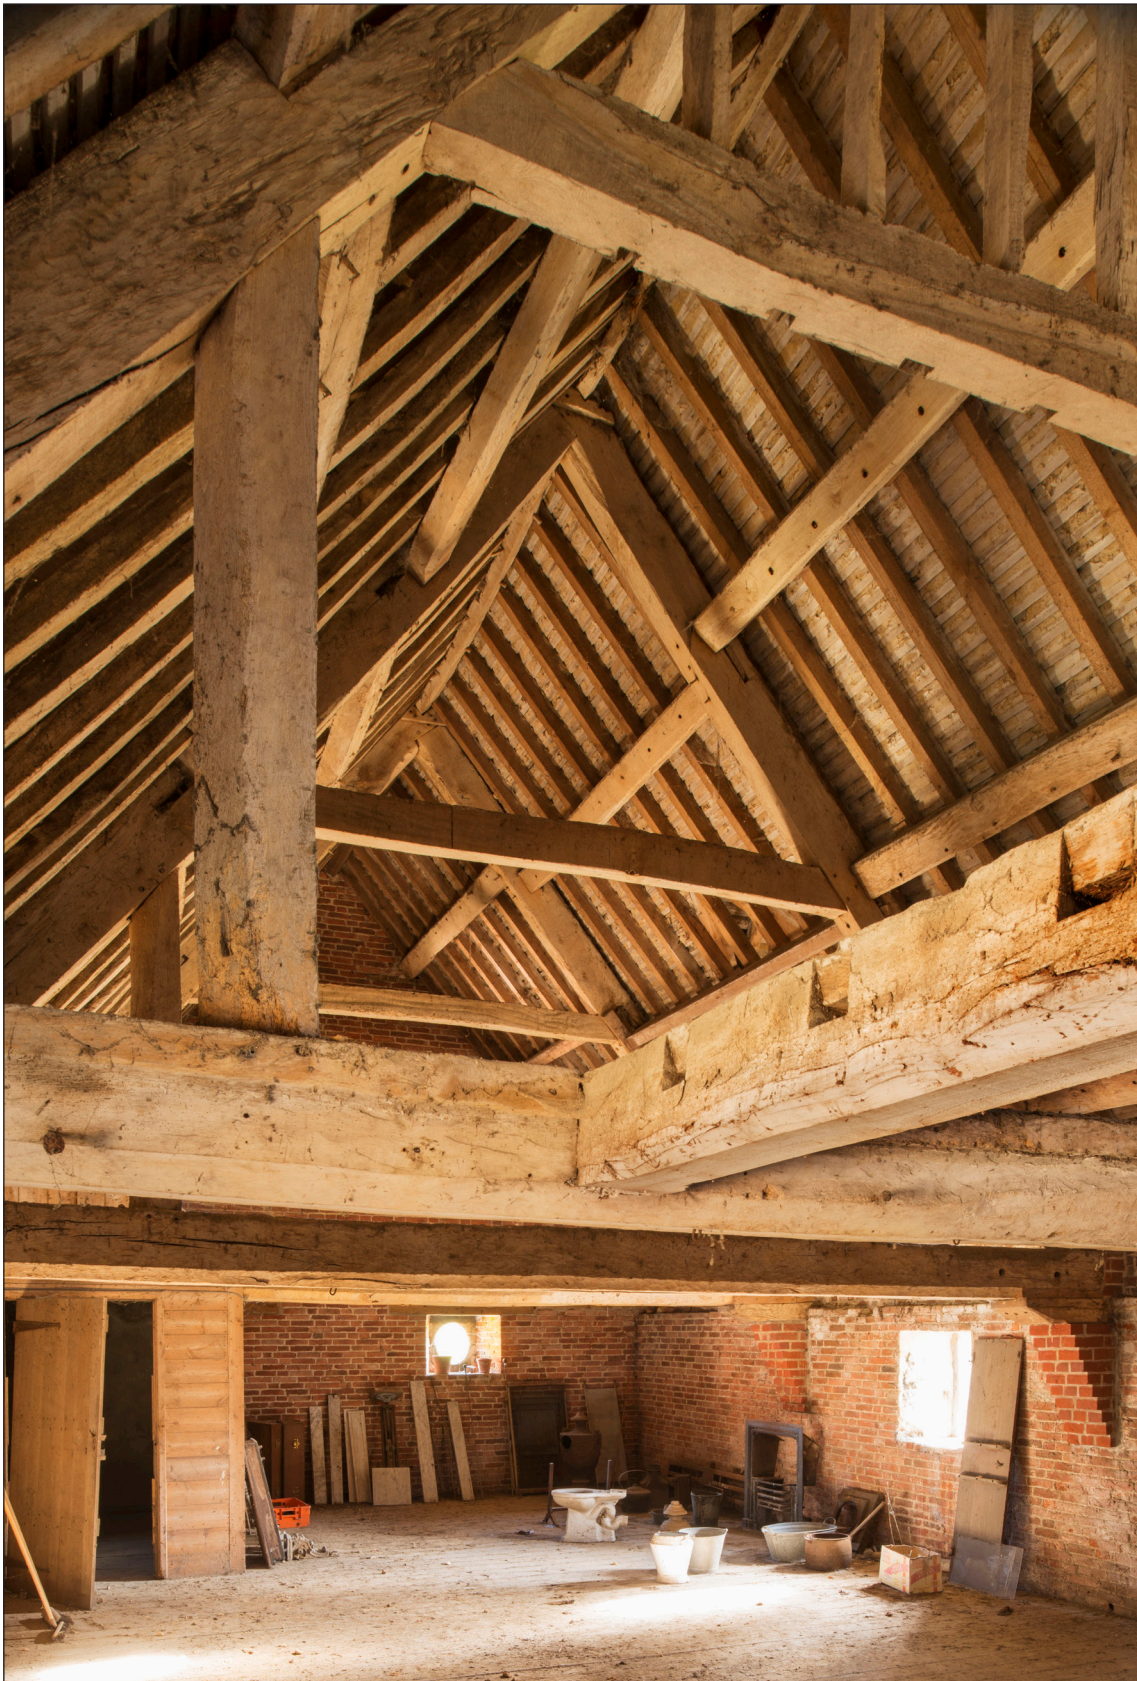
Now part of the area open to the roof, the fourth bay from the west has a spine beam running through the northern half of the bay, spanning the space between the tie beams (Figure 25). This has scroll stops which match those of the original tie beams to either side indicating that it is probably contemporary with them and therefore with the construction of the building. It also has redundant seatings for joists on its north and south faces, indicating that it supported an additional floor which must originally have covered at least this bay. The truss dividing this bay from that to the east has a series of vertical timbers of relatively thin scantling, and poorly finished, lapped between the collar and the apex of the roof (Figure 26). Redundant seatings on the upper side of the tie beam and the lower edge of the collar indicate that a similar arrangement previously existed between the tie beam and collar. Where these timbers survive there is no evidence for any infilling— the timbers have no grooves or stave holes and there is no evidence of daub or plaster on the truss itself. This appears to have formed an open screen arrangement at this upper level therefore. There is no evidence for any flooring on the trusses to the east of this, and

Figure 25: Roof structure looking southeast showing original spine beam (DP166163 © Historic England, photograph: James O. Davies).

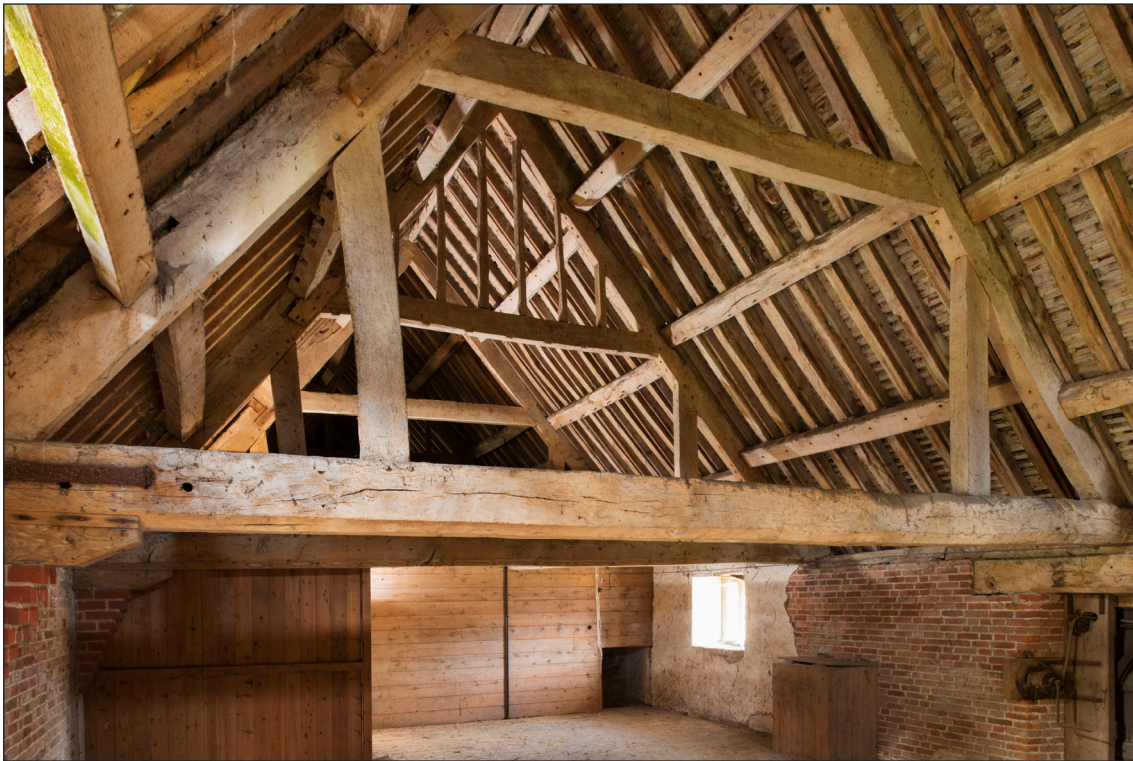
Figure 26: Roof structure looking northwest showing partition timbers above the collar of the central truss (DP166163 © Historic England, photograph: James O. Davies).

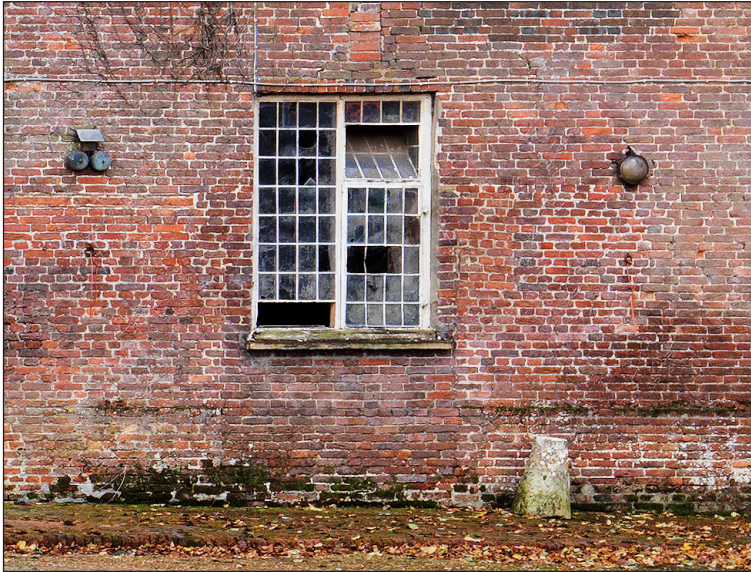
Figure 27: Detail of one of four 18th century windows inserted into the north elevation (DP166142 crop © Historic England, photograph: James O. Davies).

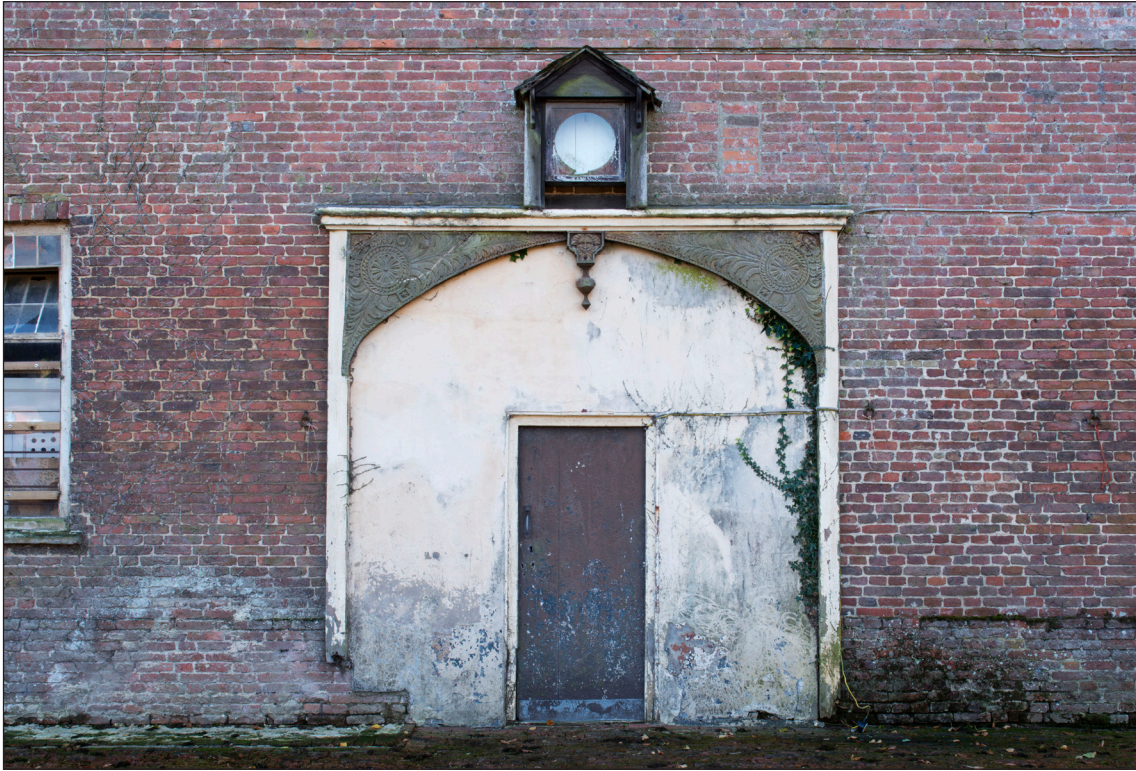
Figure 28: Detail of extant central doorway on the north elevation, showing blocked earlier doorway to the right of the plastered section (DP166147 © Historic England, photograph: James O. Davies).

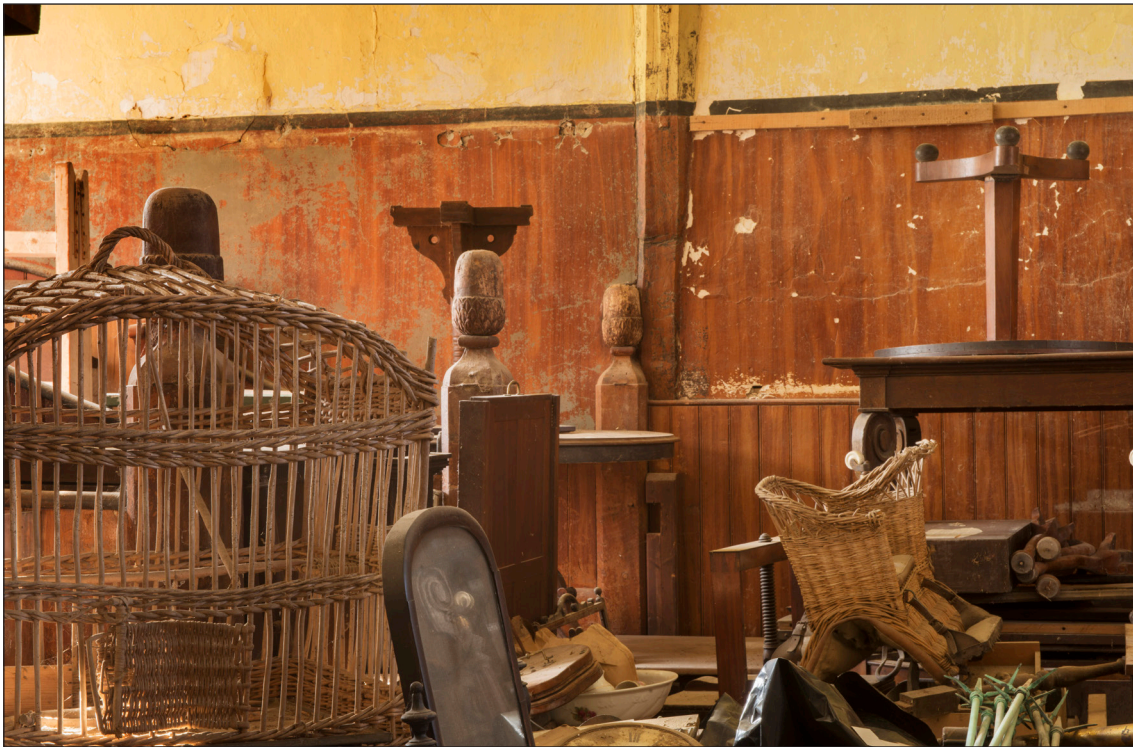
Figure 29: Surviving stalling visible in the east stable, acorn finails marking the end of each bay (DP166187 © Historic England, photograph: James O. Davies).

The principal element surviving from this phase is the early stabling in the eastern stable (Figure 29). This comprises four stall partitions with acorn finials at their northern ends (Figure 30). Associated with this is the flooring in this area, which comprises herring bone brick under the stalling, sloping towards a central drain, with stretcher-laid brick in the passageway area to the north. The stalling has been replaced at the eastern end, but probably originally continued to the eastern wall of the building, as the spacing provided would have allowed for two further partitions creating seven stalls in all. The layout of the area west of this is not clear, although the provision of both a central and west doorway in the north elevation could suggest some further subdivision in this area.

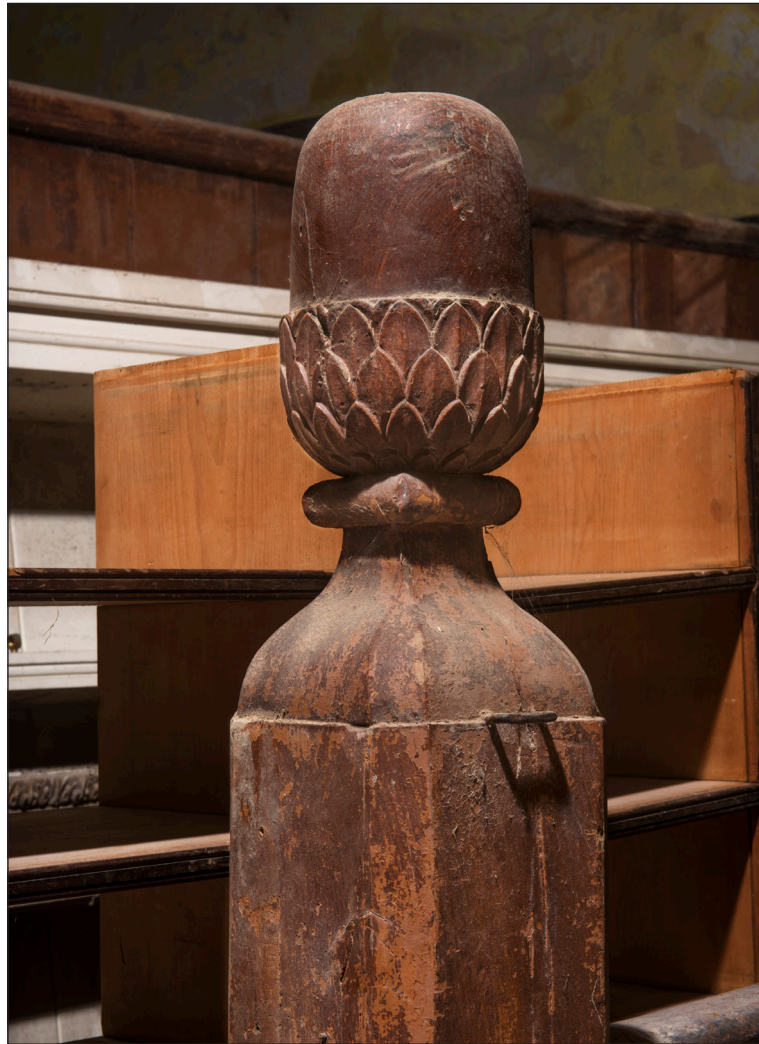
Figure 30: Detail of one of the acorn finials in the east stable (DP166183 © Historic England, photograph: James O. Davies).

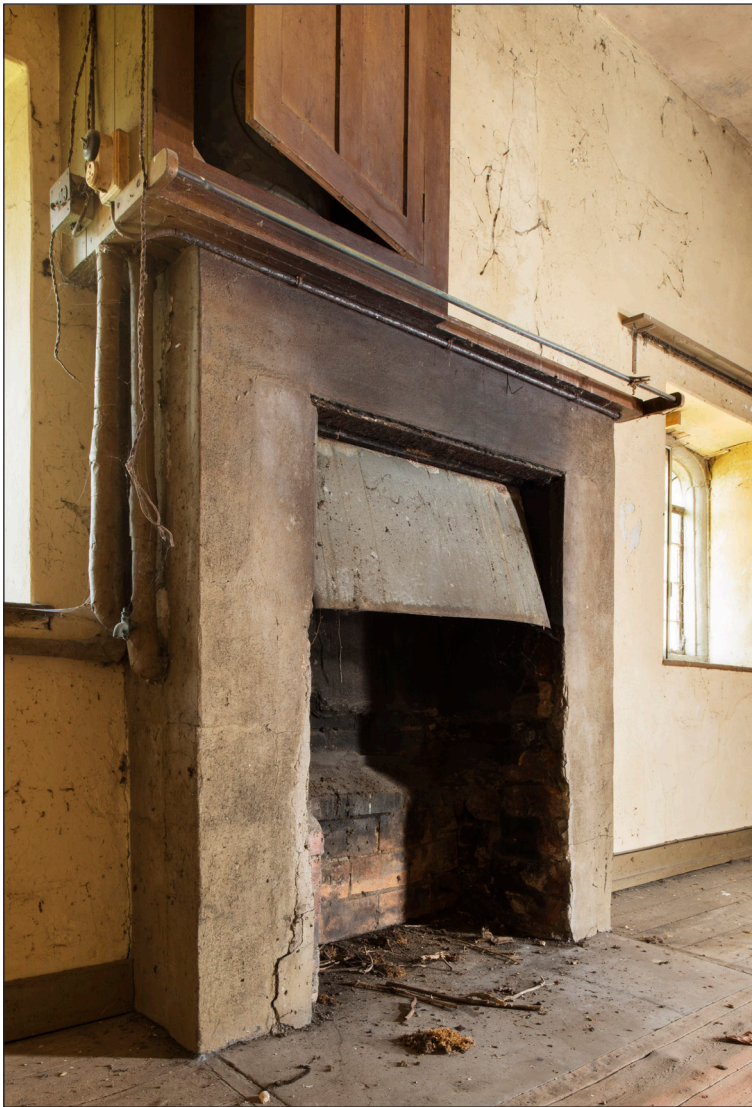
Figure 31: Detail of the fireplace in the 1st floor western room (DP166170 © Historic England, photograph: James O. Davies).

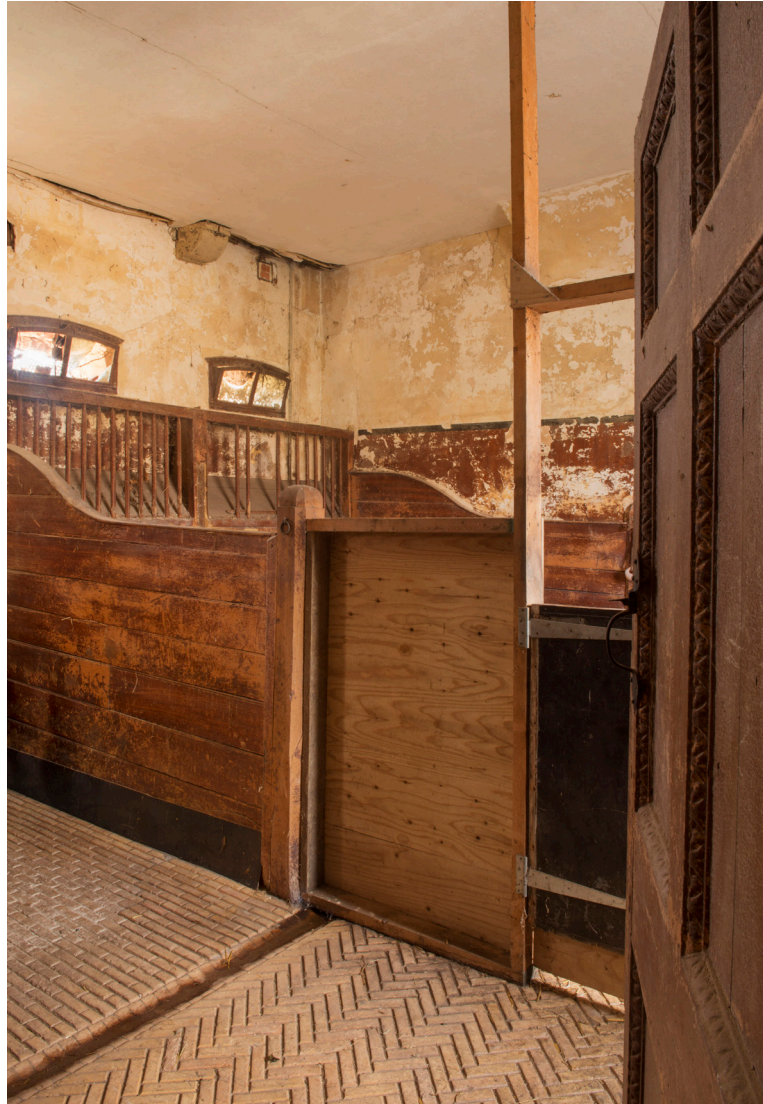
Figure 32: Detail of 19th century stalls in the western stable area (DP166190 © Historic England, photograph: James O. Davies).

At ground-floor level 19th century changes are represented internally only, with one section of stabling appearing to survive from this phase. The central section of the western stable has three 19th century stall partitions, two of which have been incorporated into later partition walls (Figure 32). These are plainer than the earlier examples (see phase two), with squared chamfered posts at their northern ends and no finials. Some associated hay racking also appears contemporary with the stalls.

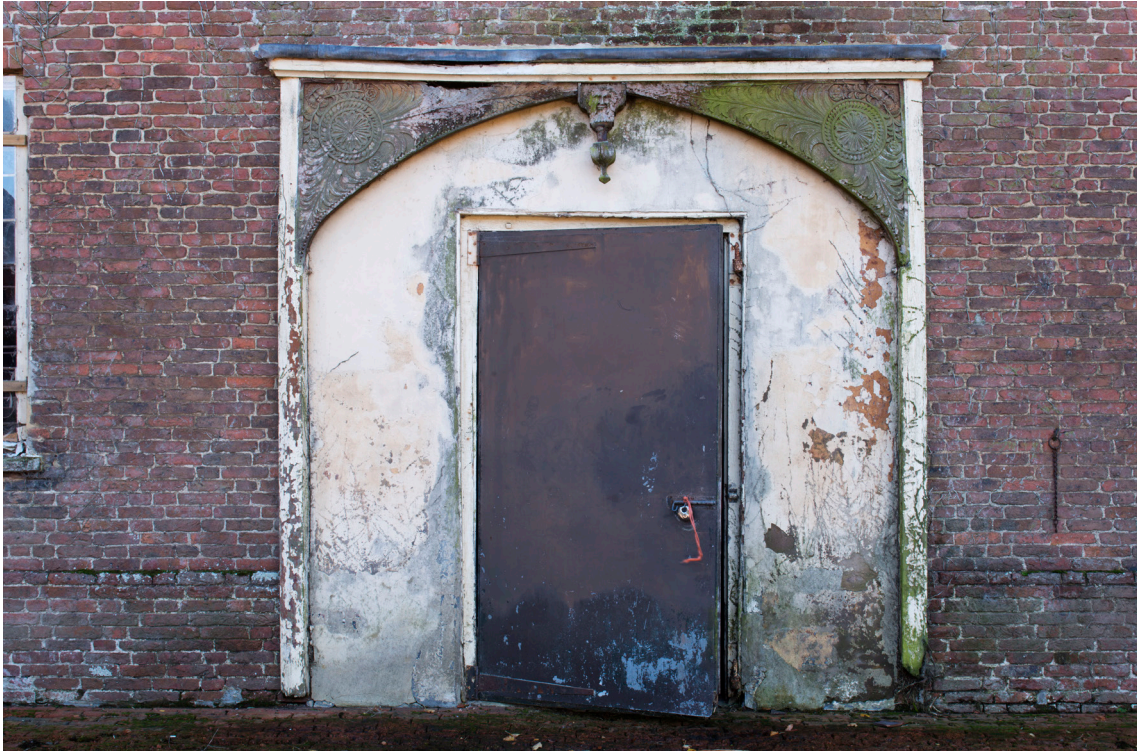
Figure 33: Detail of door surround to east stable door (DP166146 © Historic England, photograph: James O. Davies).

Externally this phase may be reflected in the replacement of many of the window frames, and possibly also the doors on the north elevation. It is suggested therefore that the creation of the distinctive framing to the doorways, including the relocated spandrels, may also be associated with this phase (Figures 33 and 34; and see

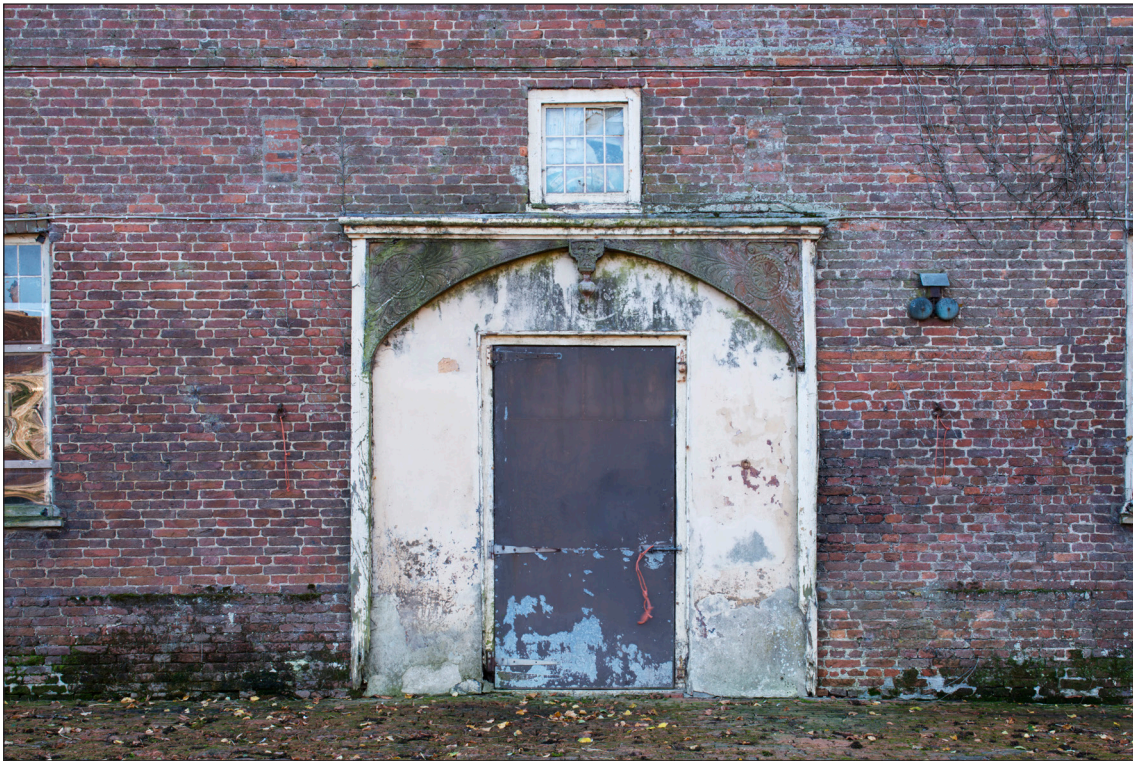
Figure 34: Detail of door surround to west stable door (DP166148 © Historic England, photograph: James O. Davies).

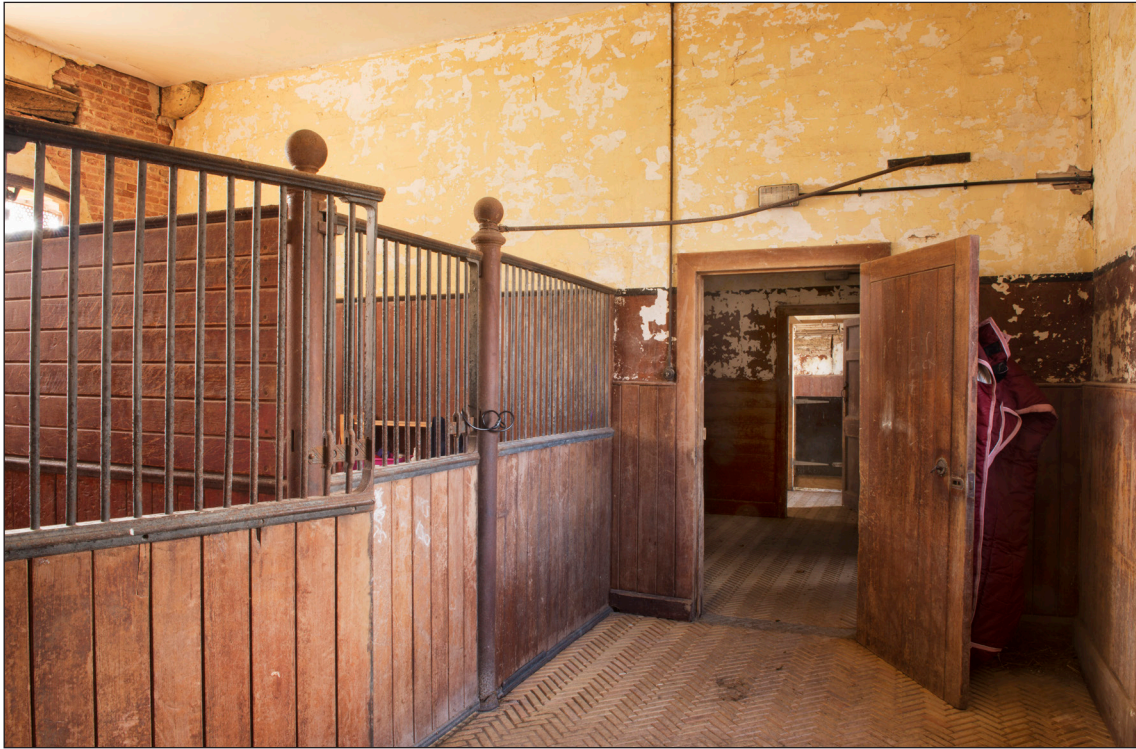
Figure 35: Detail of late 19th or early 20th century stabling in the central stable area (DP166188 © Historic England, photograph: James O. Davies).

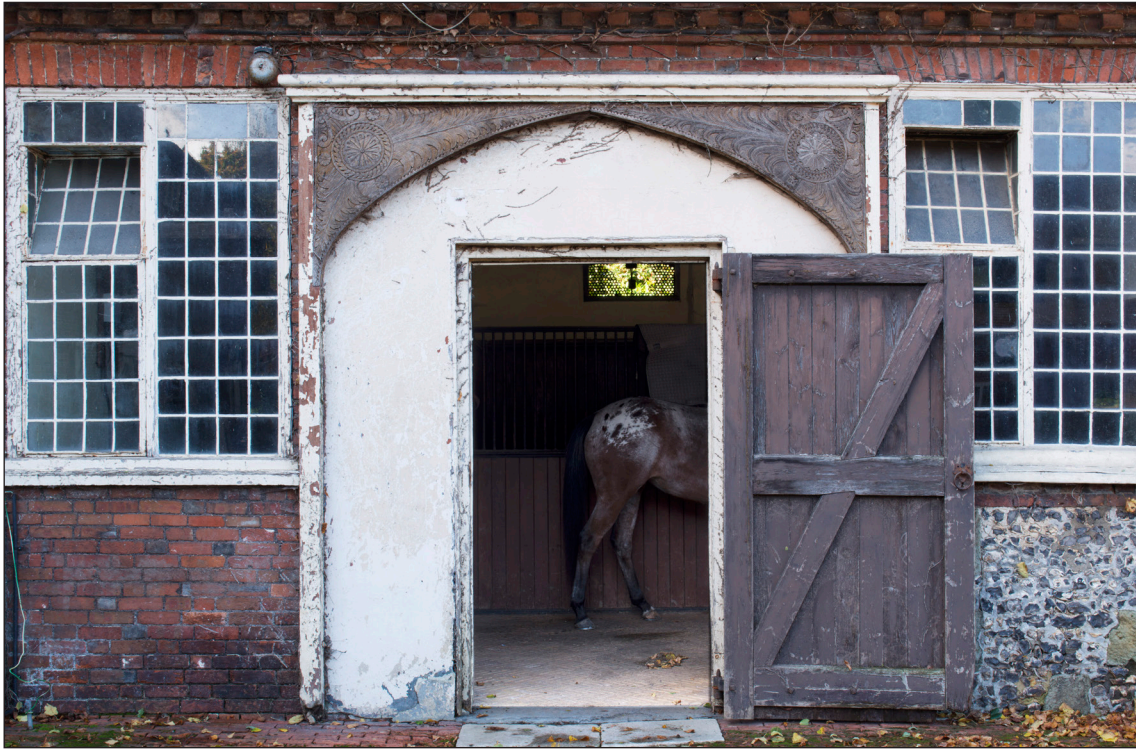
One of the most distinctive features of the building are the three sets of decorative timber spandrels attached to the north elevation of the building within late 19th or early 20th century frames. These are matched with a set around the southernmost doorway on the west barn, and a further set which are currently in store but which previously sat against the archway on the 19th century cottages in the east range (Figures 36 and 37). All five sets are elaborately carved, with carving to the front of the panels only. Each spandrel has a centrally set rosette motif, with fern-leaf fronds extending towards the centre of the arch and downwards towards the post. Two sets (on the east and central doorways of the 'riding house') have animal masks set in the corners of the spandrel with further fronds extending from their mouths. Two sets (on the west barn and east groom's house) have scrolls in their corners and the final set (on the west doorway of the 'riding house') has human faces framed by wings. Four of the five arches have central drop pendants with grotesque faces. Although a suggestion for the date the spandrels were placed on the outside of the building has been put forward, no date for the spandrels themselves has been given. The evidence relating to these is conflicting, and on balance they have not been assigned to a phase within the evolution of the building. There are three possible options for the origins of these features:

Figure 36: Detail of spandrels over the stable doorway on the western range (DP166149 © Historic England, photograph: James O. Davies).
