The Riding House, St Giles House, Wimborne St Giles

Building Investigation

**THE RIDING HOUSE
ST GILES HOUSE
WIMBORNE ST GILES, DORSET
BUILDING INVESTIGATION**

NGR: SU 03303 11700

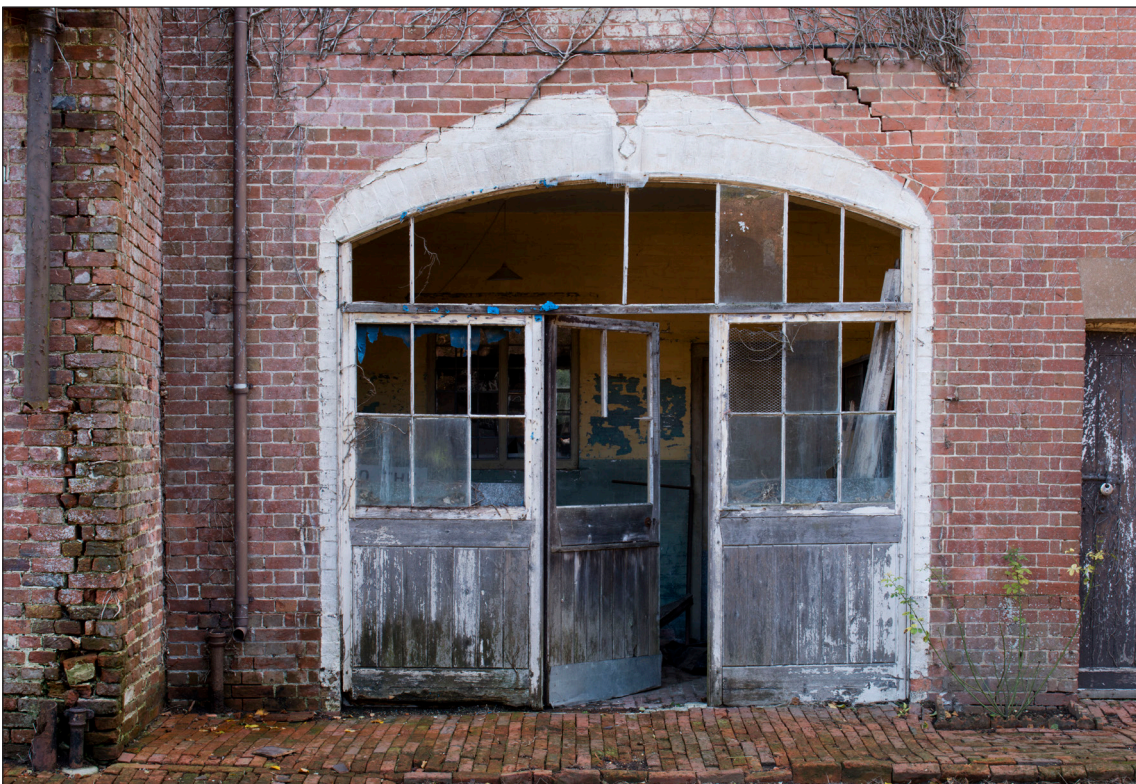
Figure 37: Former position of spandrels over doorway on the Grooms' House (DP166145 © Historic England, photograph: James O. Davies).

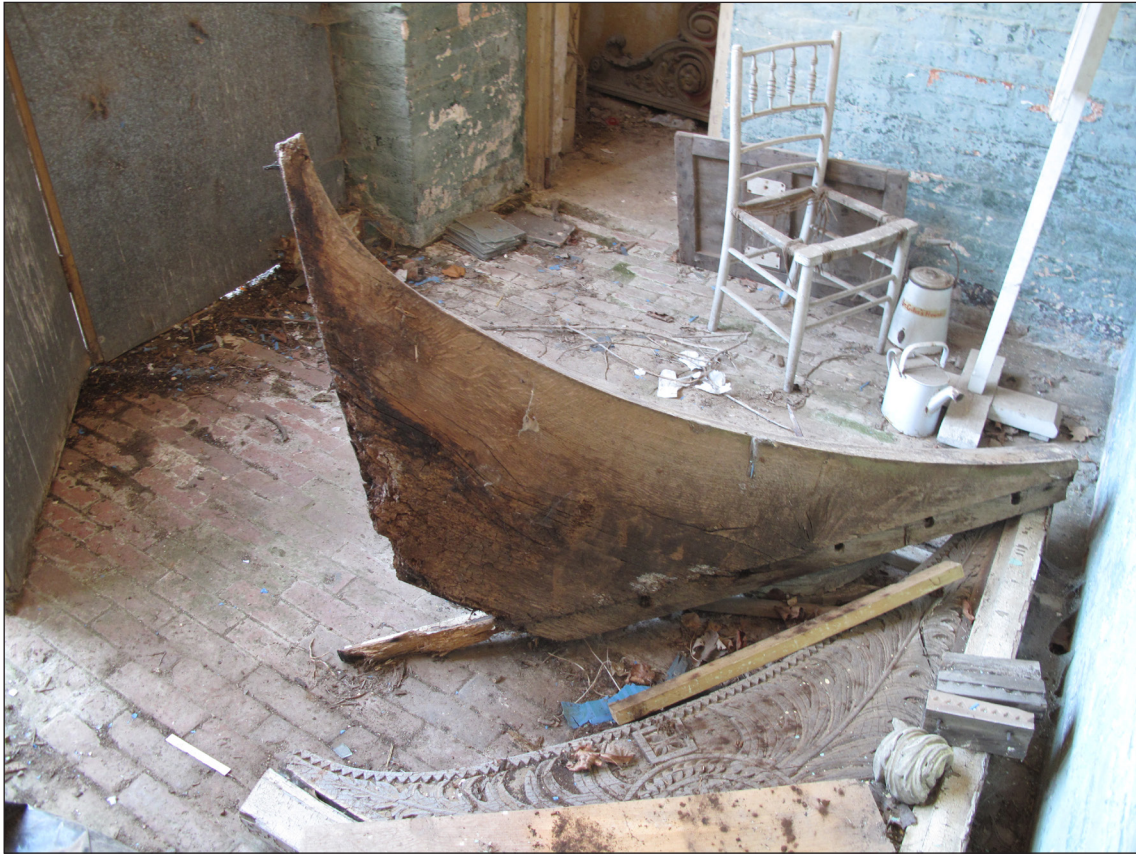
Figure 38: Rear of spandrel currently located inside the lobby of the Grooms' House, showing tenon with peg holes along the long side of the timber (© Historic England, photograph: Rebecca Lane).

There are a number of pieces of evidence that need to be considered in relation to these options. One is that the two spandrels currently in storage, and therefore available for close inspection, have large redundant tenons along their upper edges, with five corresponding redundant peg holes (Figure 38). The sides of these spandrels show signs of also having had tenons which have been sawn off (Figure 39). The loose drop pendant similarly has a large tenon with two peg holes. These features clearly do not relate to their current positioning within later softwood frames, and strongly suggest that they were created to sit within a large, framed structure. A further consideration is that the spandrels are 0.99m in height, which is the same height as the largest of the redundant mortices in the *in situ* post within the current building. These two pieces of evidence strongly suggest that the

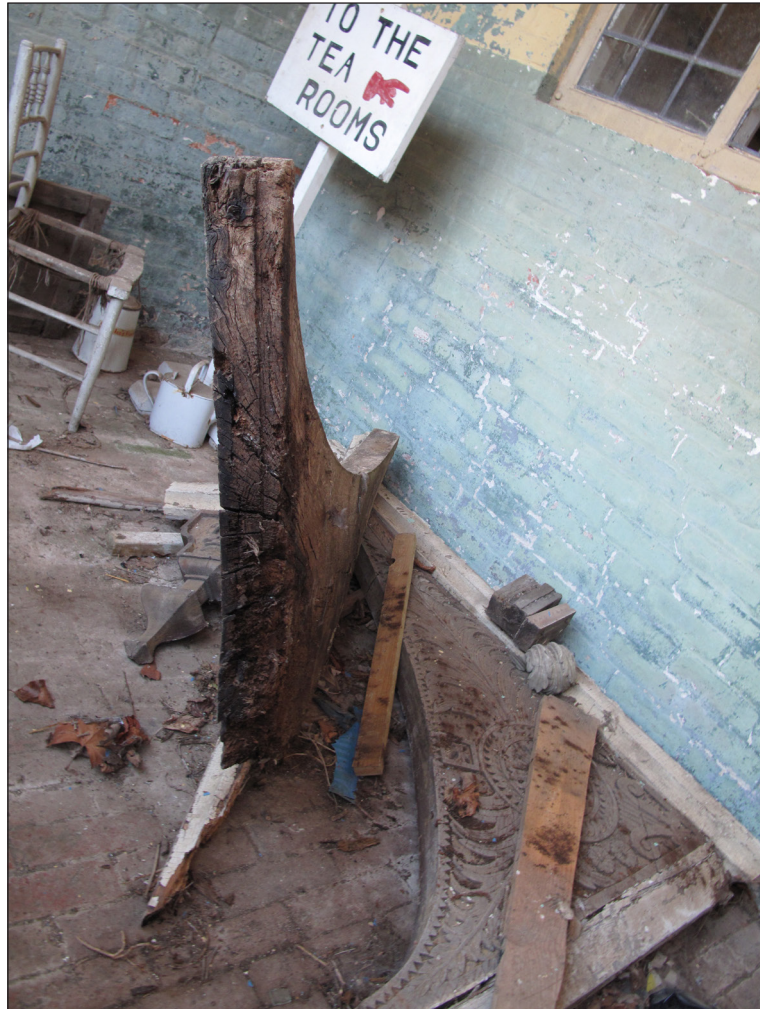
Figure 39: Side of spandrel, showing indications of a sawn off tenon (© Historic England, photograph: Rebecca Lane).

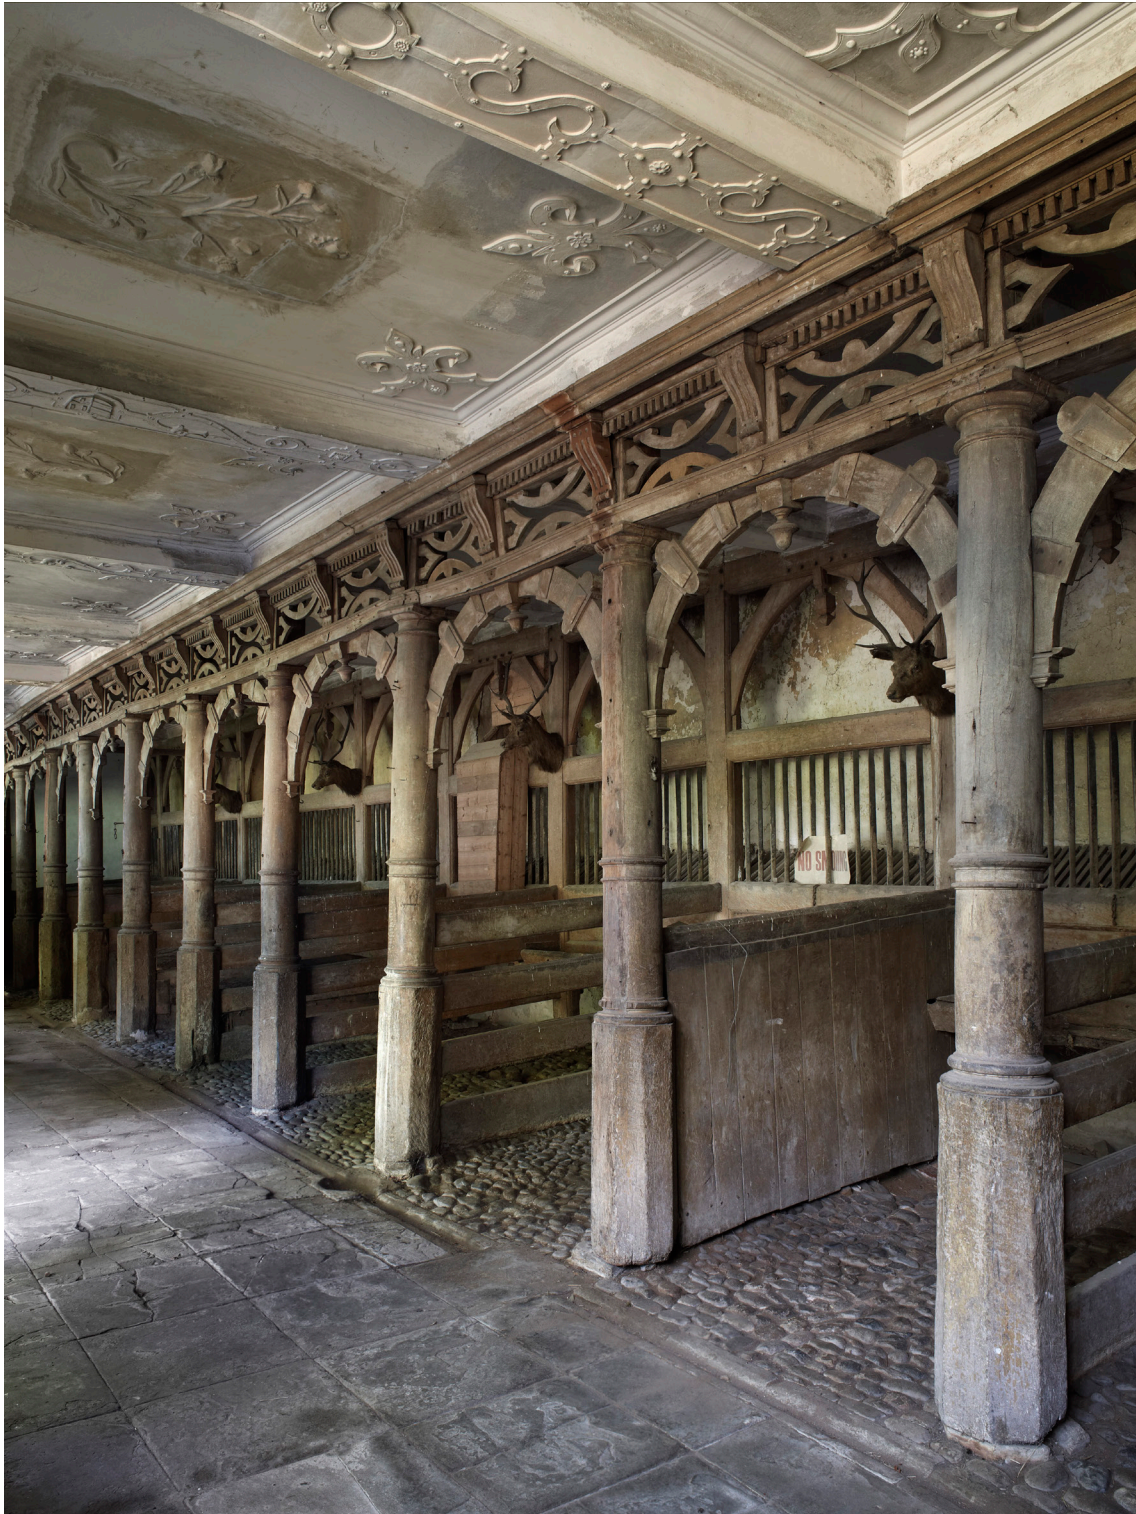
Figure 40: Stable arcade surviving at Peover Hall, Cheshire (Photograph reproduced courtesy of Angelo Hornack).
