# Reginald Farrer's Rock Garden, Clapham, North Yorkshire: Analytical Survey and Assessment

**Analytical survey and assessment**

To inform the future repair and management of the garden and pond, in 2015 Historic England undertook an accurate measured survey and analytical assessment of the fabric, layout and history of the garden; this report presents the results of that work.

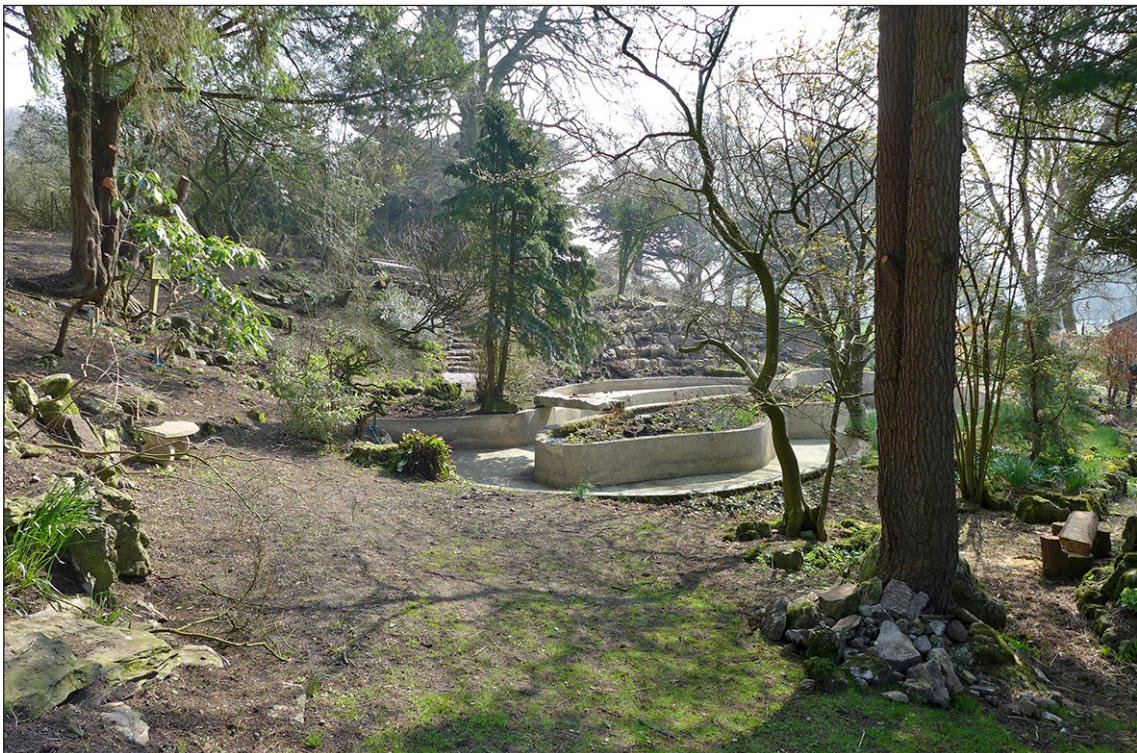
Figure 3: Reginald Farrer's rock garden and pond, looking east. © Historic England/Rebecca Pullen, 9th April 2015.

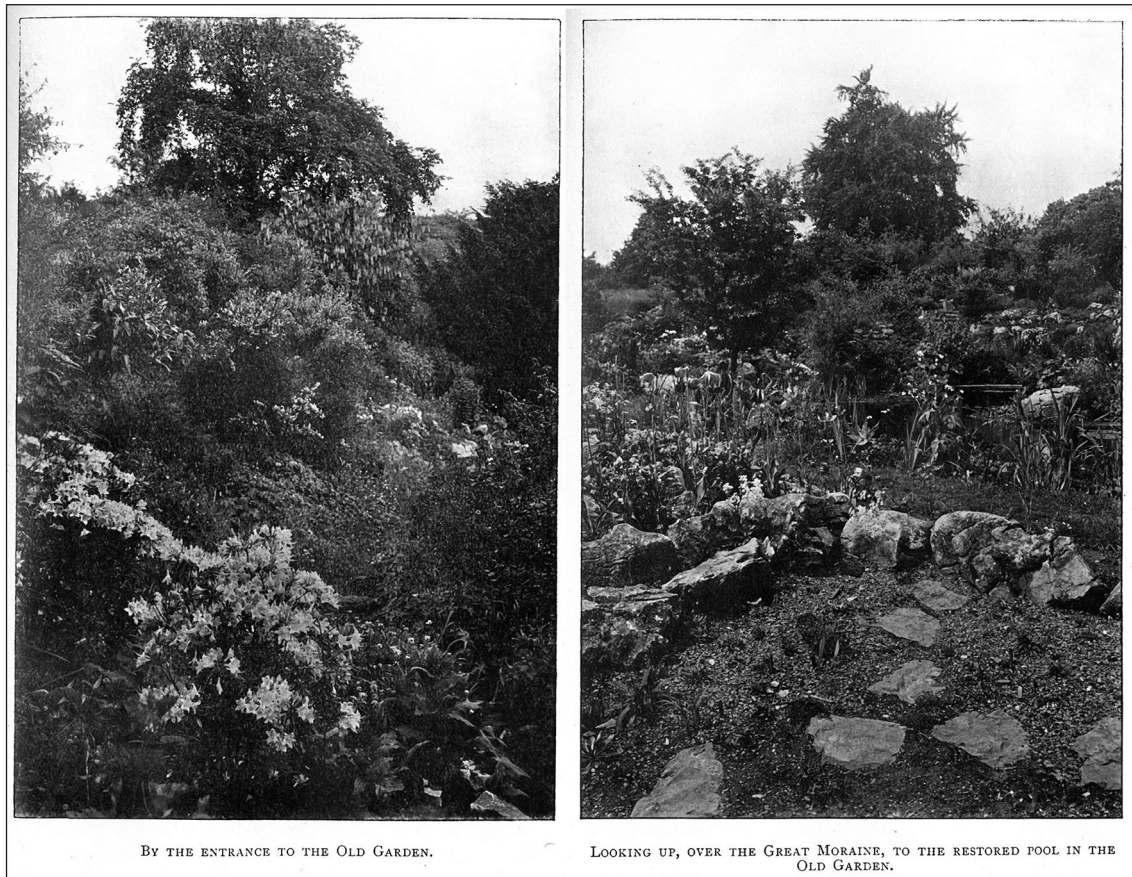
Figure 5: Photographs of the Ingleborough rock garden from Farrer's 1909 book *In a Yorkshire Garden*; (left) published opposite p194, and (right) opposite p218. Copyright expired.

Three useful contemporary photographs of the rock garden were published in Farrer's own books, *My Rock Garden* (1907) and *In a Yorkshire Garden* (1909), showing: a glen in the 'Old Garden', the thickly vegetated western entrance to the 'Old Garden', and the restored pond viewed from across the 'Great Moraine' to its south<sup>43</sup> (Figure 5; see Figure 15). In addition, the *Reginald J. Farrer Collection* within the archive of the Royal Botanic Garden Edinburgh (RBGE) includes a photograph album containing a single page of images of the rock garden from 1914-

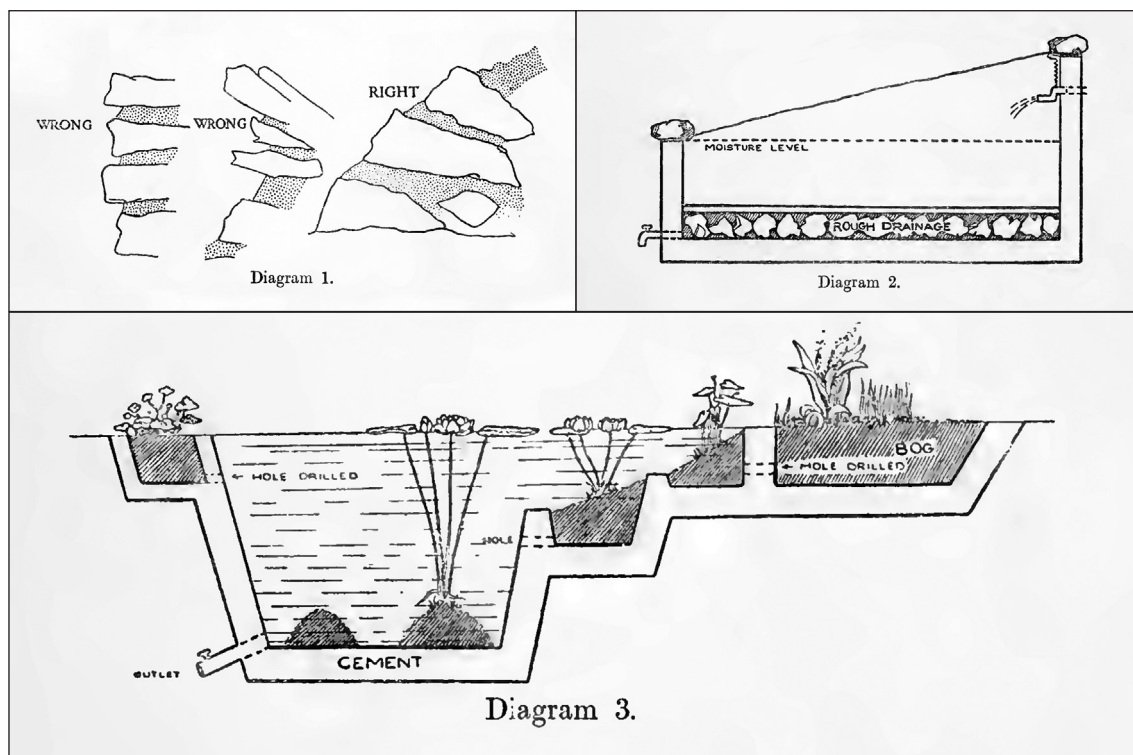
Farrer's 1907 work, *My Rock-Garden*, gives a good early insight into Farrer's feelings about how a rock garden should ideally be constructed to replicate nature; he could not tolerate ill thought out heaping of stones: 'Nature stratifies, Nature doesn't bristle her stones about like the quills of the porcupine'.<sup>47</sup> Furthermore, the last of Farrer's instructive garden books to be released – *The English Rock-Garden*, published in 1919 – provides an introductory best-practice guide with diagrams for those wishing to create their own rock garden in his approved form, presented as a prelude to a comprehensive encyclopaedia of alpine plants. The notes and diagrams in this volume bear a close resemblance to the form of rockery and pond construction found in the Clapham garden (Figure 6).

Figure 6: Instructive diagrams from Farrer's 1919 book *The English Rock-Garden*, showing close resemblance to the construction methods used in the Ingleborough rock garden. The illustrations show (clockwise from top left): the ideal construction of a rock face, an example of a successful below-ground watering system, and the preferred use of secondary troughs around pond margins; published on pages xxxi, xxxvii and xxxix. Copyright expired.

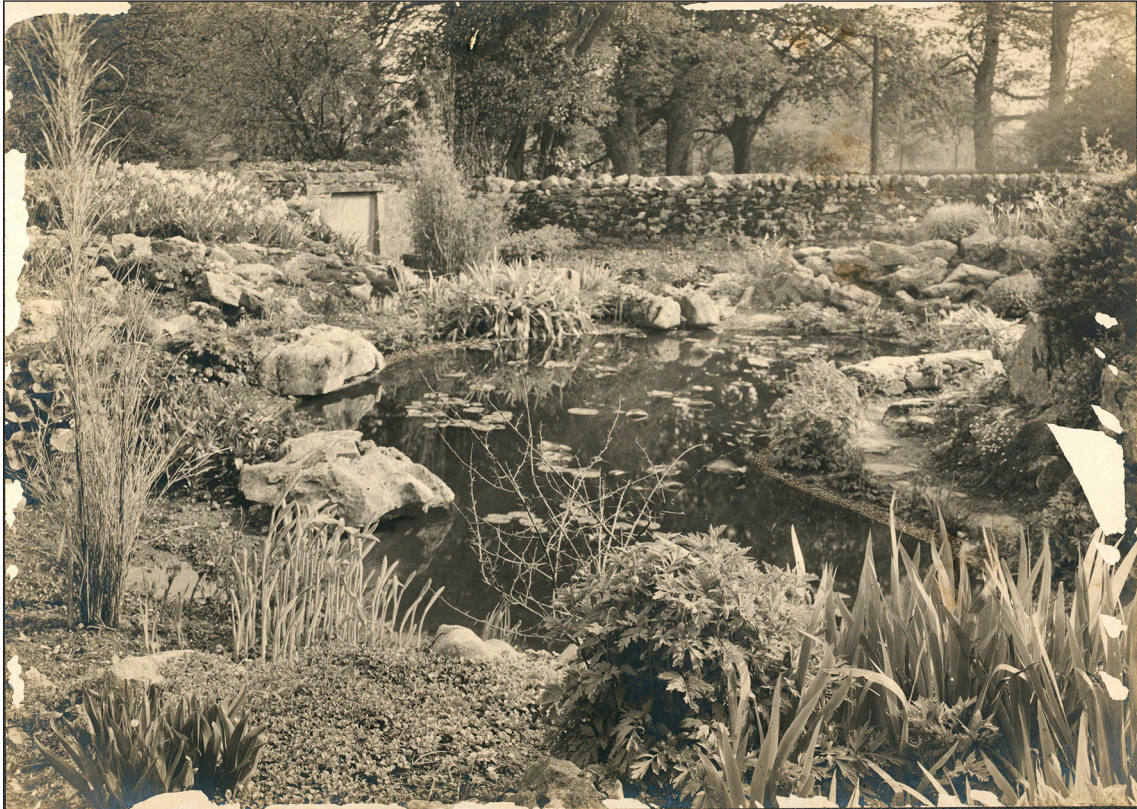
Figure 8: The rock garden display area within Craven Nursery (no precise date, but taken within the first quarter of the 20th century). GB235 RJF/2/2/5 © the Farrer Family Collection, c/o the Royal Botanic Garden Edinburgh Archive.

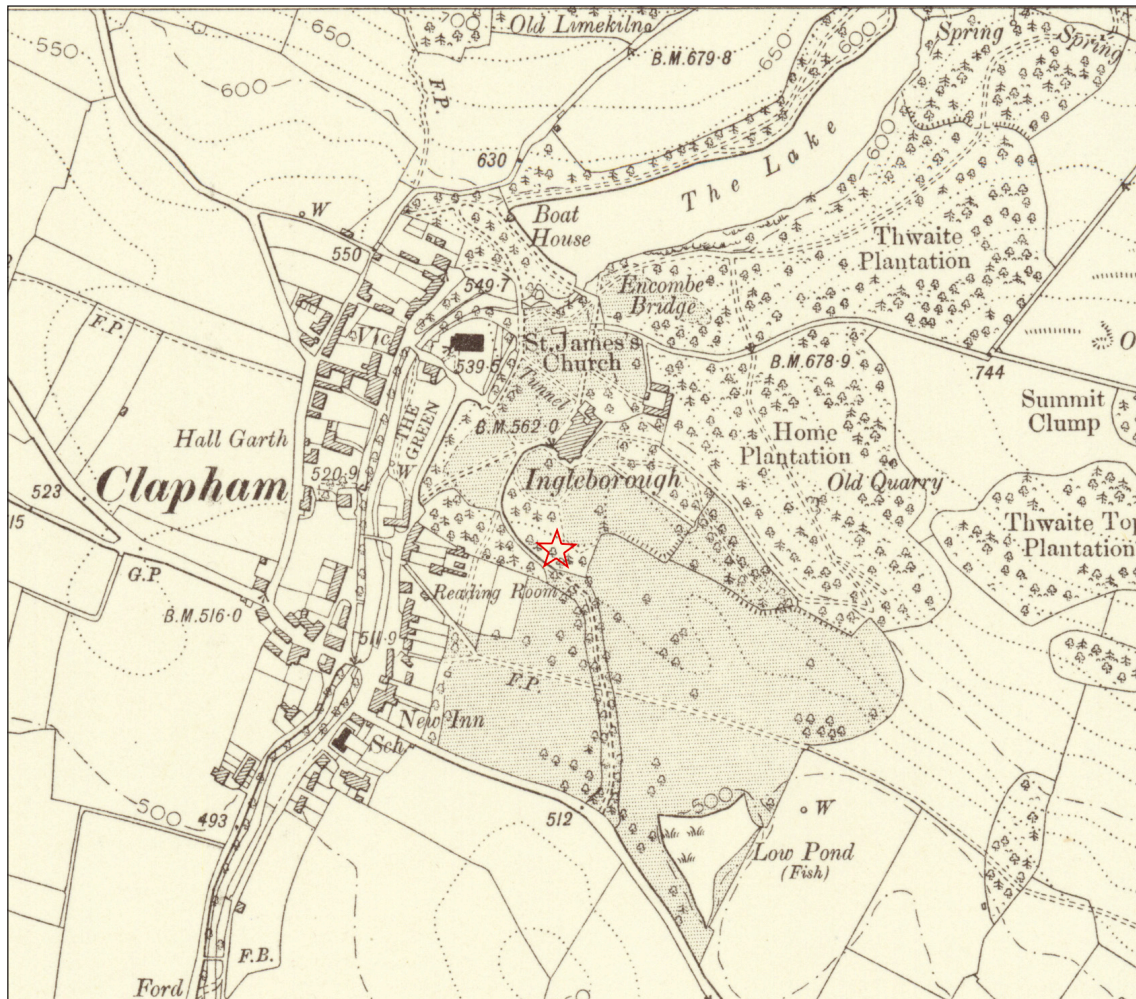
Figure 9: Extract from the 1910 6-inch Ordnance Survey map of Clapham (sheet CXIII SE), showing the route of the driveway from the south up to Ingleborough Hall, and with the rock garden location marked by a red star. Reproduced from the original by permission of the National Library of Scotland.

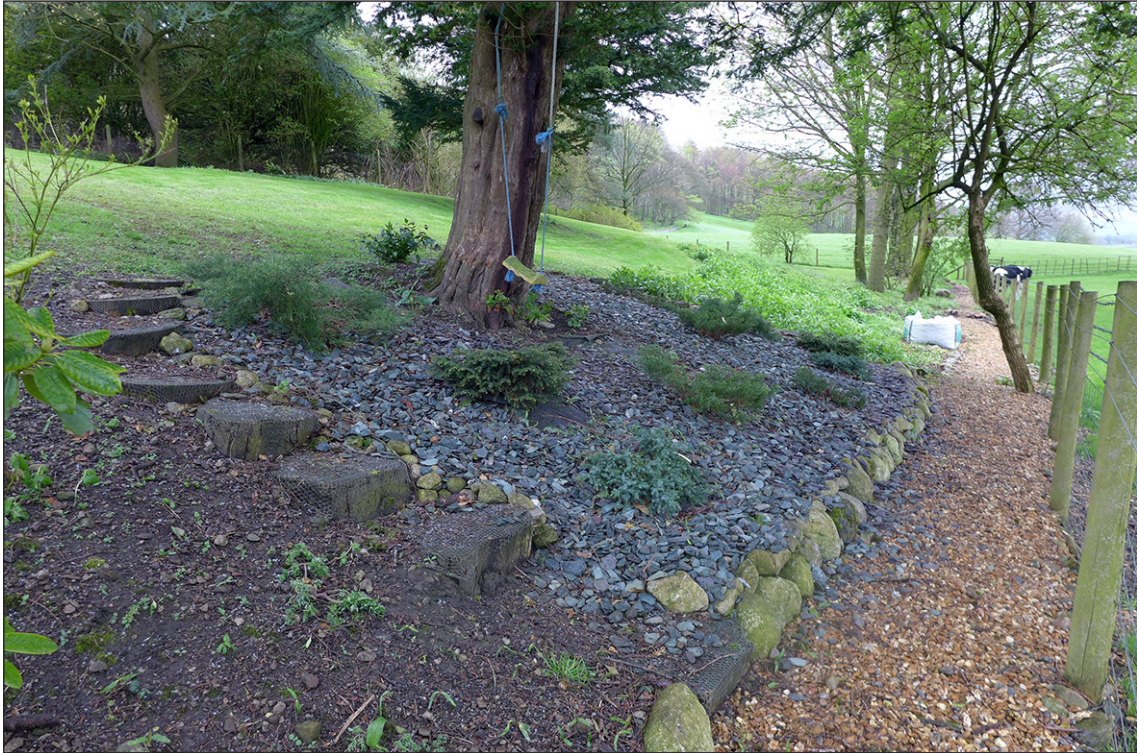
East of the quarried 'bite', the natural bank continues as a steep south-facing grassy natural slope [5] that gradually reduces in height until it nearly levels out at the far eastern end of the fenced property boundary of Shamba. A firm area covered in slate chips and partially edged with limestone cobbles might denote the position of a former bed, and a gravelled path runs along the base of the slope (Figure 10). There

Figure 10: The eastern extension of the garden, looking east. © Historic England/Rebecca Pullen, 29th April 2015.

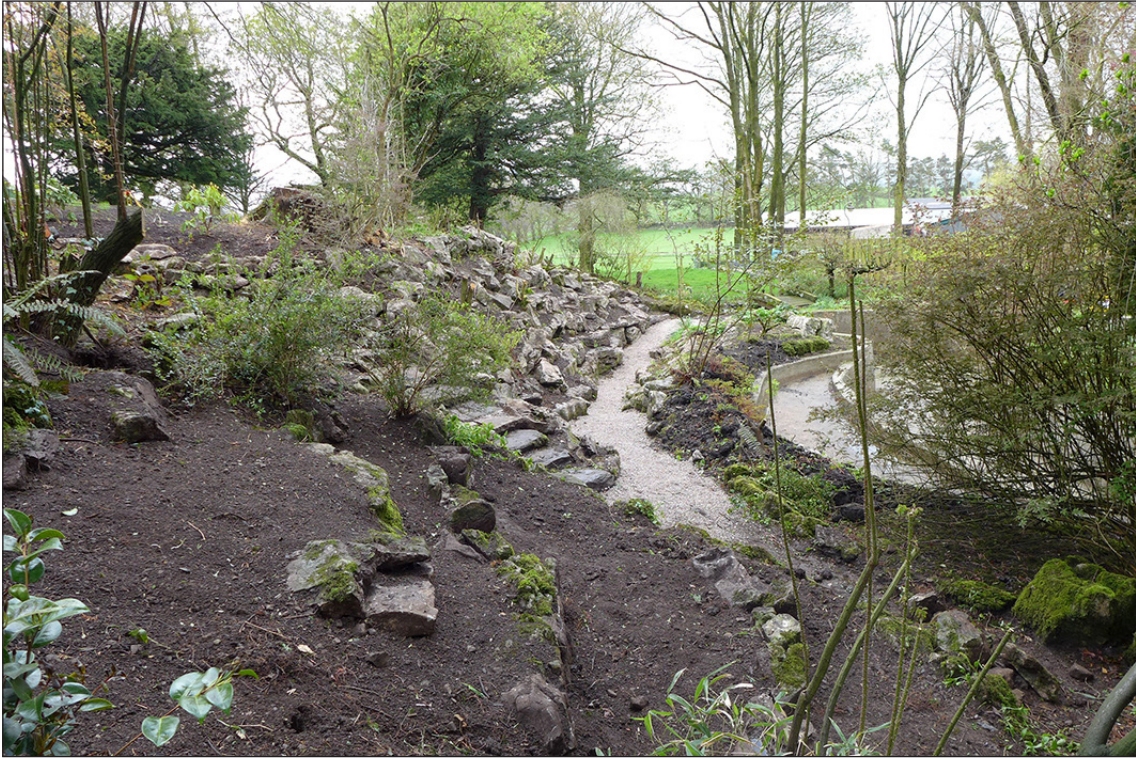
This loosely terraced portion of the bank is bisected by Farrer’s ‘stream’ – a now dry rock and concrete cascade to the pond (the stream and pond are described below) – and effectively ends at an imposing set of flag-stone steps, that curve up through a deeply-cut gouge in the bank with revetments of water-worn limestone blocks on both sides (Figure 12). By appearance these east steps seemed to have been recently refurbished or remade; however, the present owner confirmed that they unexpectedly uncovered the steps in situ beneath a thick build-up of soil and leaf-mould.<sup>79</sup> As

Figure 11: Farrer's 'Torrid bank' and rock face beyond, looking south-east. © Historic England/ Rebecca Pullen, 29th April 2015.

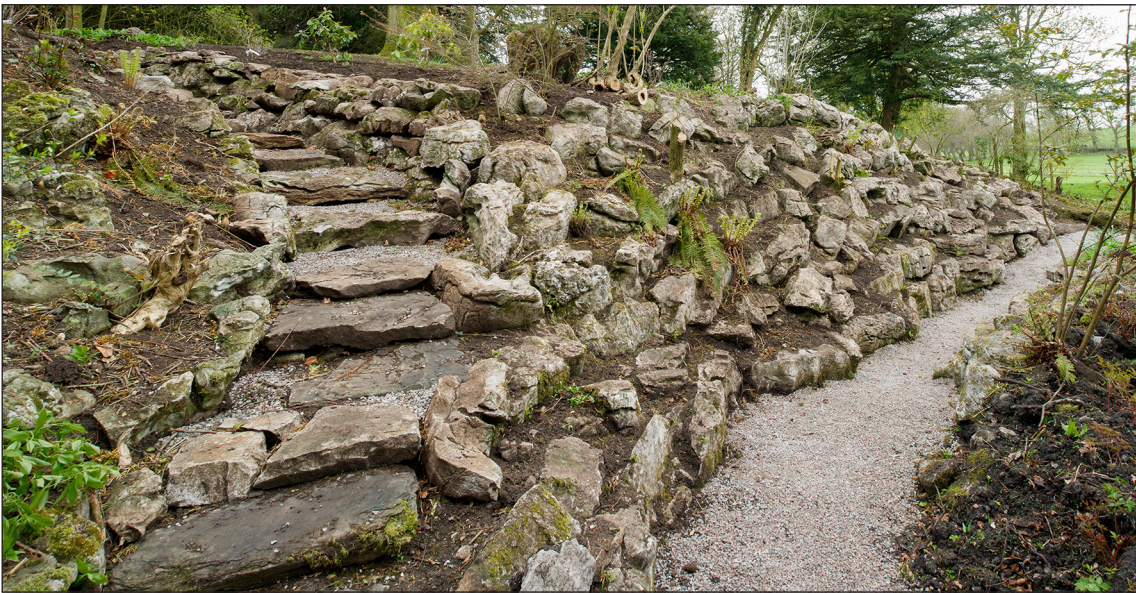
Figure 12: The east steps and the rock face, looking south-east (note the horizontal arrangement of the lowest tier of limestone blocks). DP169007 © Historic England/Alun Bull, 28th April 2015.

Immediately south of the larger eastern steps the bank has been turned into a more solid rock face, which Farrer described as his 'limestone cliffs'.<sup>84</sup> Seven tightly-packed stepped tiers of horizontally-laid, water-worn limestone blocks have been carefully stacked to follow the slope of the quarried bank (see Figure 12).

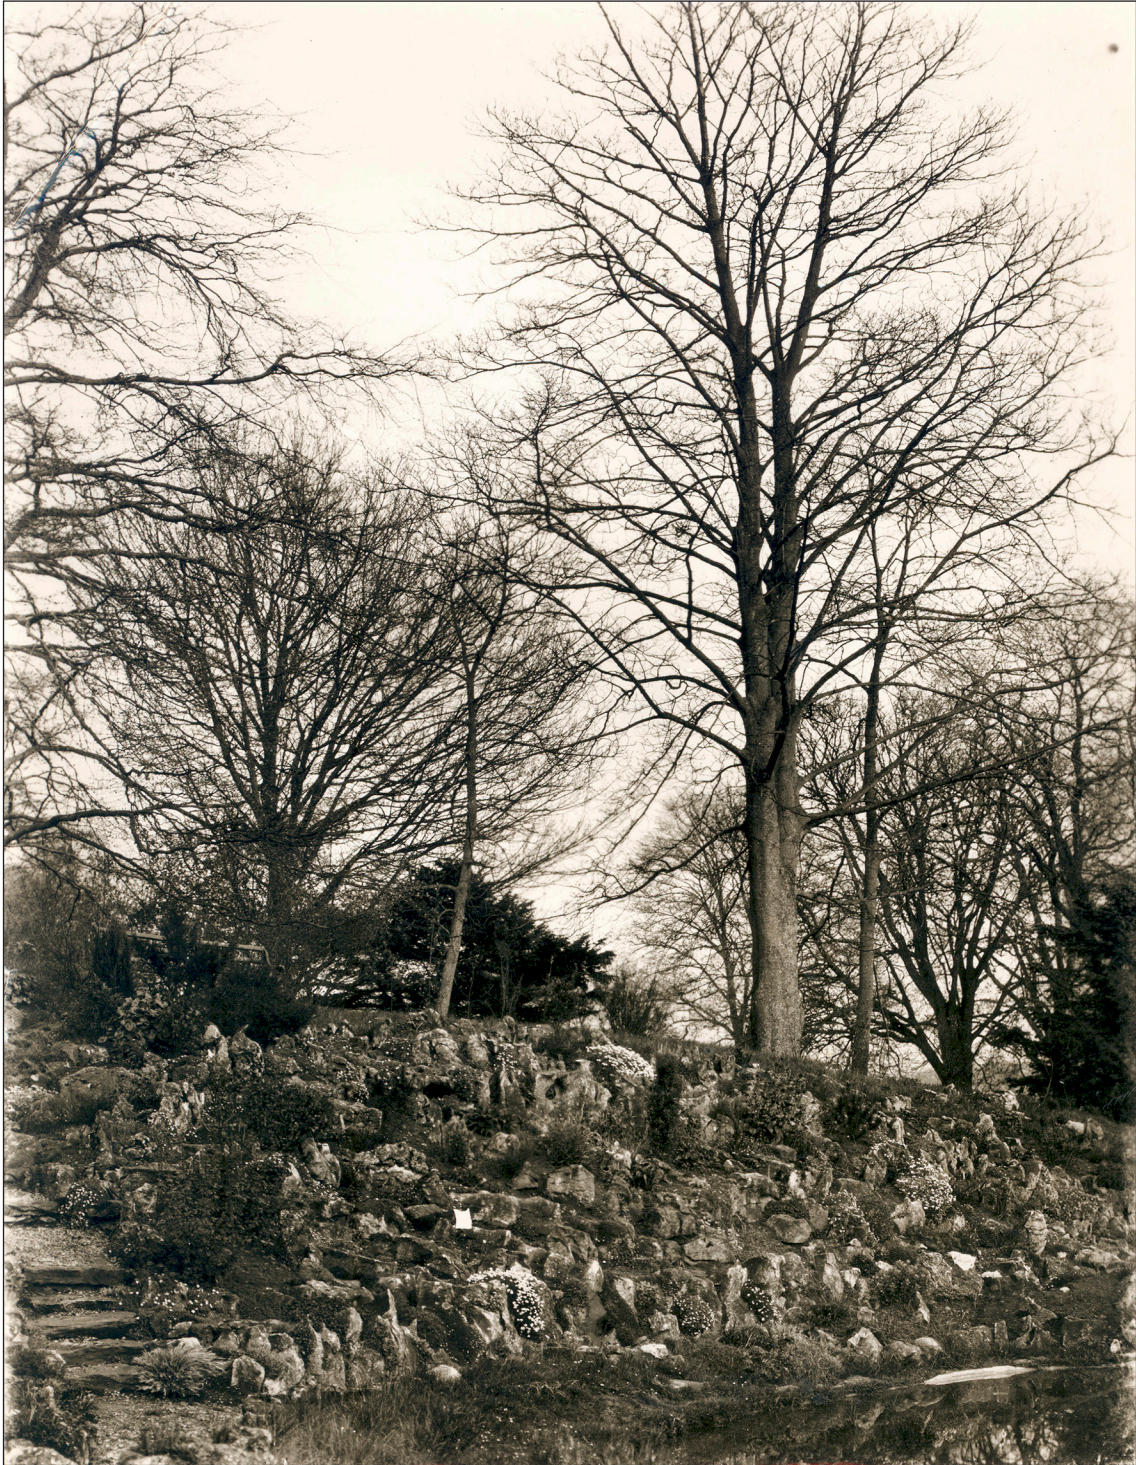
Figure 13: The east steps and rock face (note the vertical arrangement of the lowest tier of limestone blocks). GB235 RJF/2/2/6 © the Farrer Family Collection, c/o the Royal Botanic Garden Edinburgh Archive.

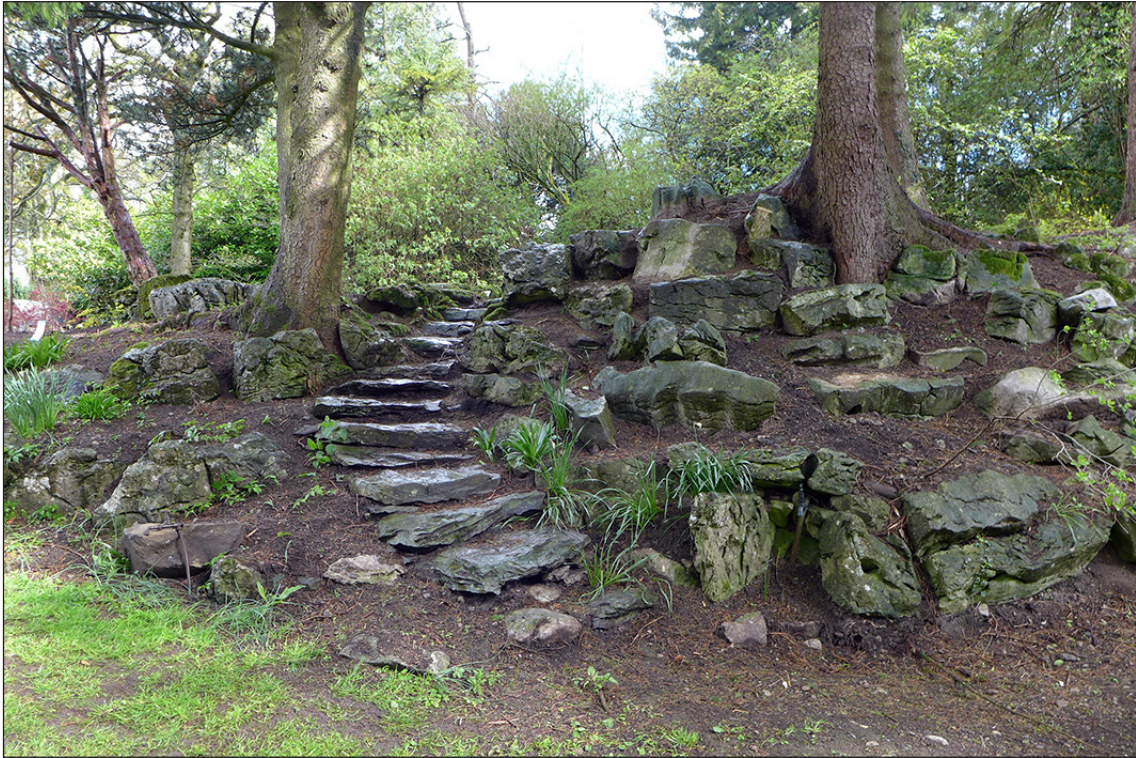
Figure 14: The stone steps at the west end of Farrer's 'Torrid bank', with metal taps relating to the buried irrigation system protruding from the base of the bank on either side, looking north. © Historic England/Rebecca Pullen, 29th April 2015.

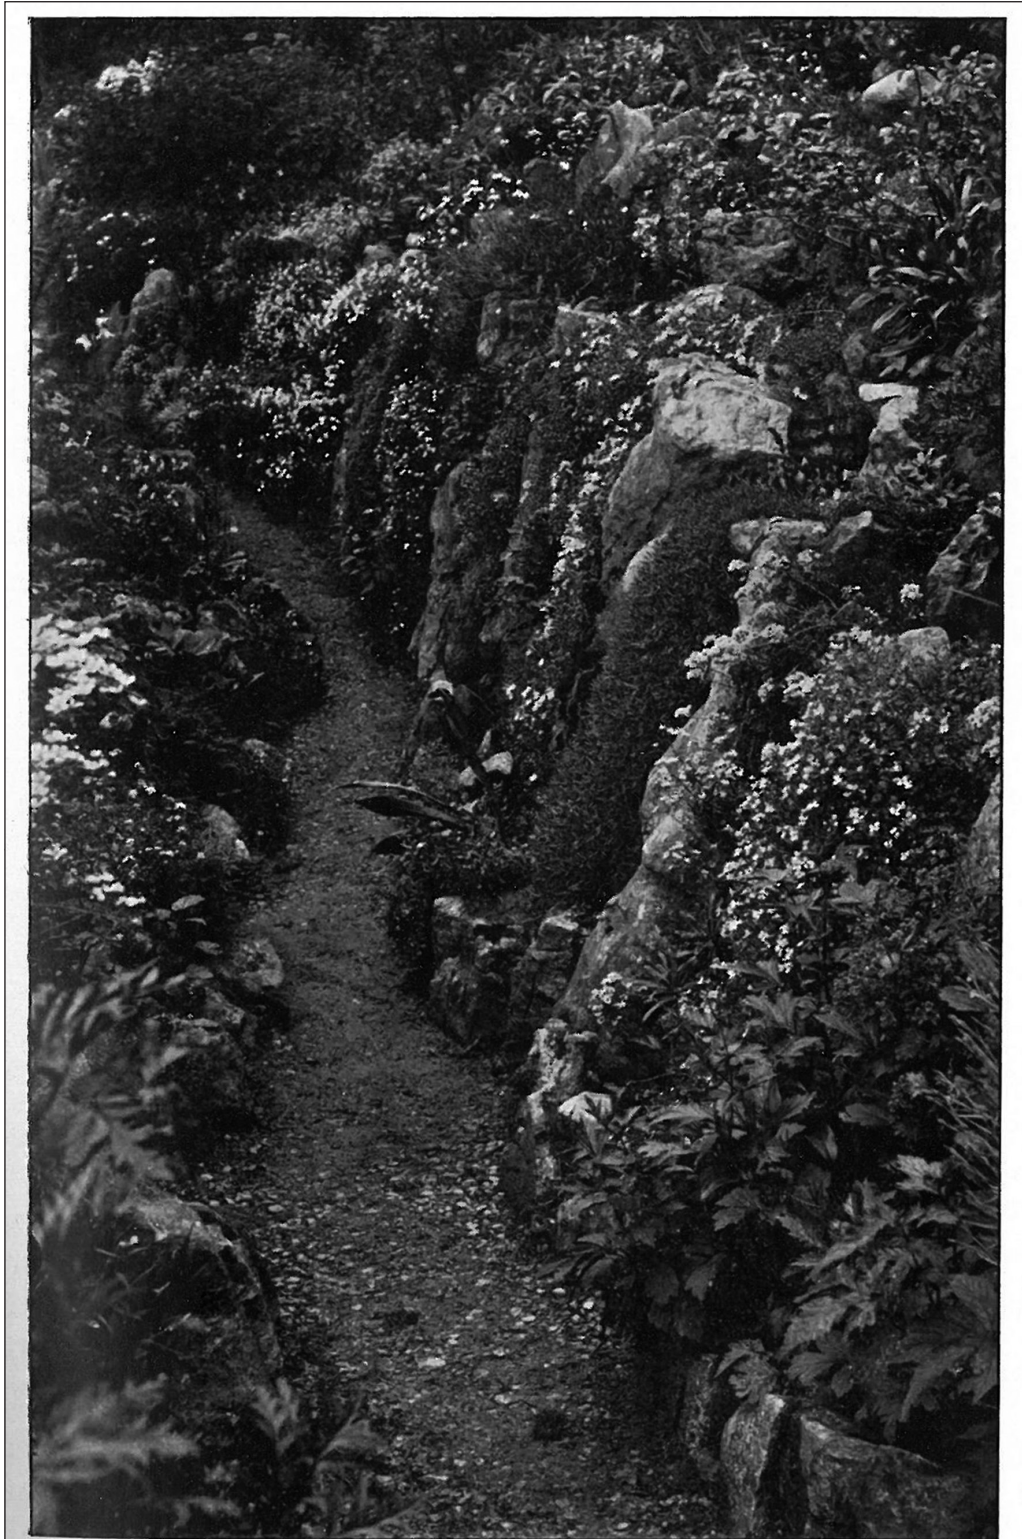
**A GLEN IN THE OLD GARDEN.**

Figure 15: Photograph from Farrer's 1909 book *In a Yorkshire Garden*, showing the base of the rock face with the stones stood on end, before Farrer had adopted the current horizontal arrangement; published opposite p18. Copyright expired.

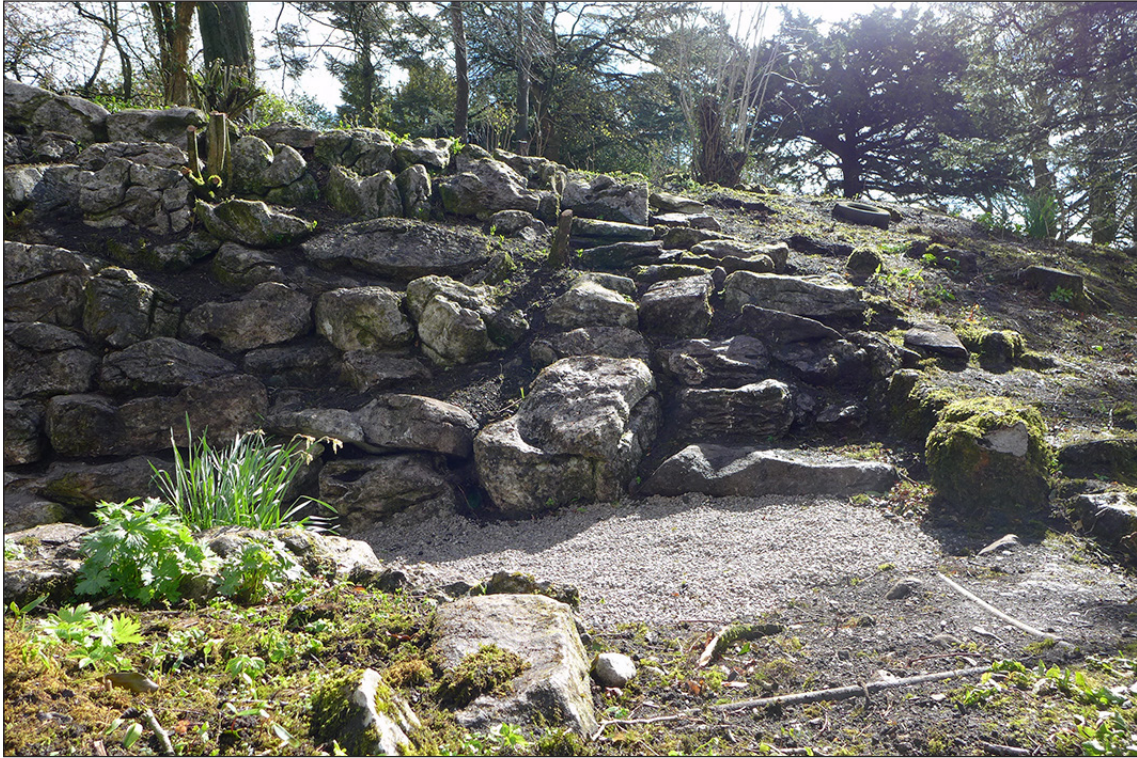
Figure 16: The blocked steps at the south end of the rock face, with a clear stretch of pipe relating to the buried irrigation system visible following a right-angled course across the surface in the foreground, looking east. © Historic England/Rebecca Pullen, 29th April 2015.

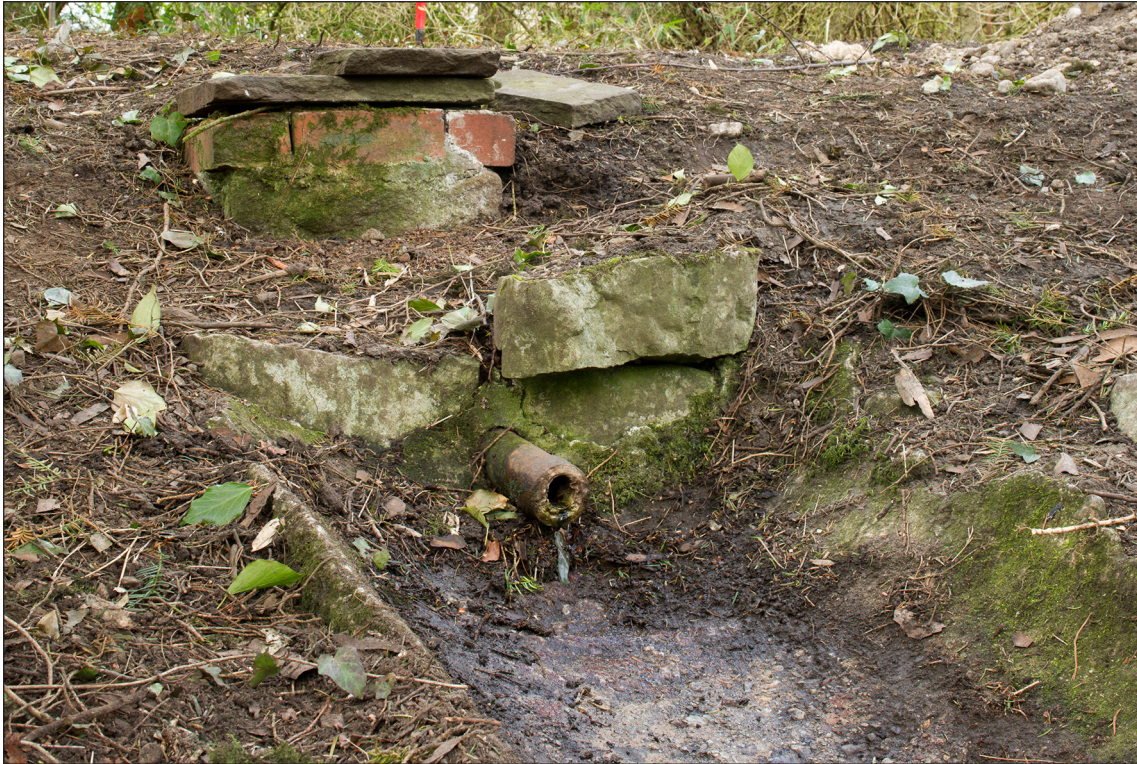
The source of the 'stream' is a broad iron pipe (7mm diameter) exiting from a square brick manhole housing a stopcock, constructed near to the top of the bank (Figure 17). The original square sandstone manhole cover, with a circular central hole and an incised lip to hold a metal grate, survives lying close to the brickwork, albeit cracked into three pieces (Figure 18).

Figure 17: The brick manhole, iron pipe and concrete channel at the 'source' of the waterfall. DP168982 © Historic England/Alun Bull, 28th April 2015.

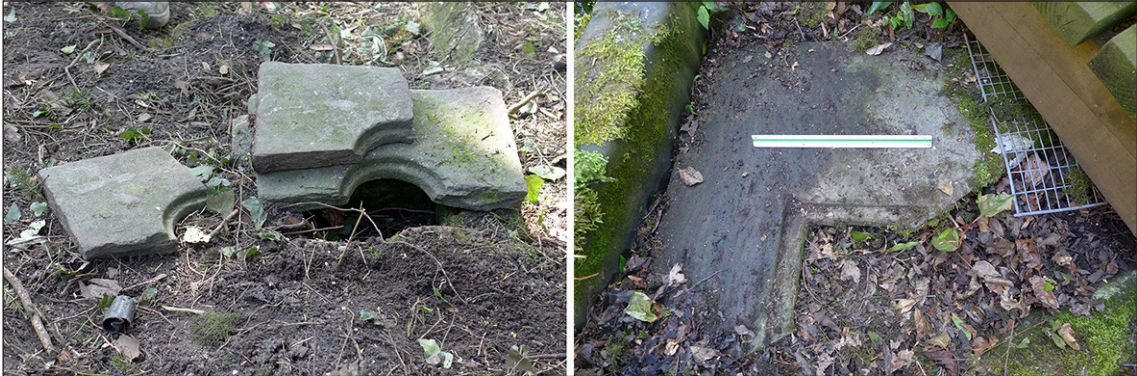
Figure 18: Surviving stone drain caps found in the garden: (left) found close to the manhole at the top of the waterfall, and (right) found close to the manhole at the end of the pond outlet. © Historic England/Rebecca Pullen, (left) 29th April 2015 and (right) 10th June 2015.

As well as an encouraging coherent reflection of Farrer's design still being identifiable in the garden today, there is also a surprising survival of smaller structural elements, sometimes ex-situ – such as stone drain caps, which may be refitted or used to inform the design of replacements.

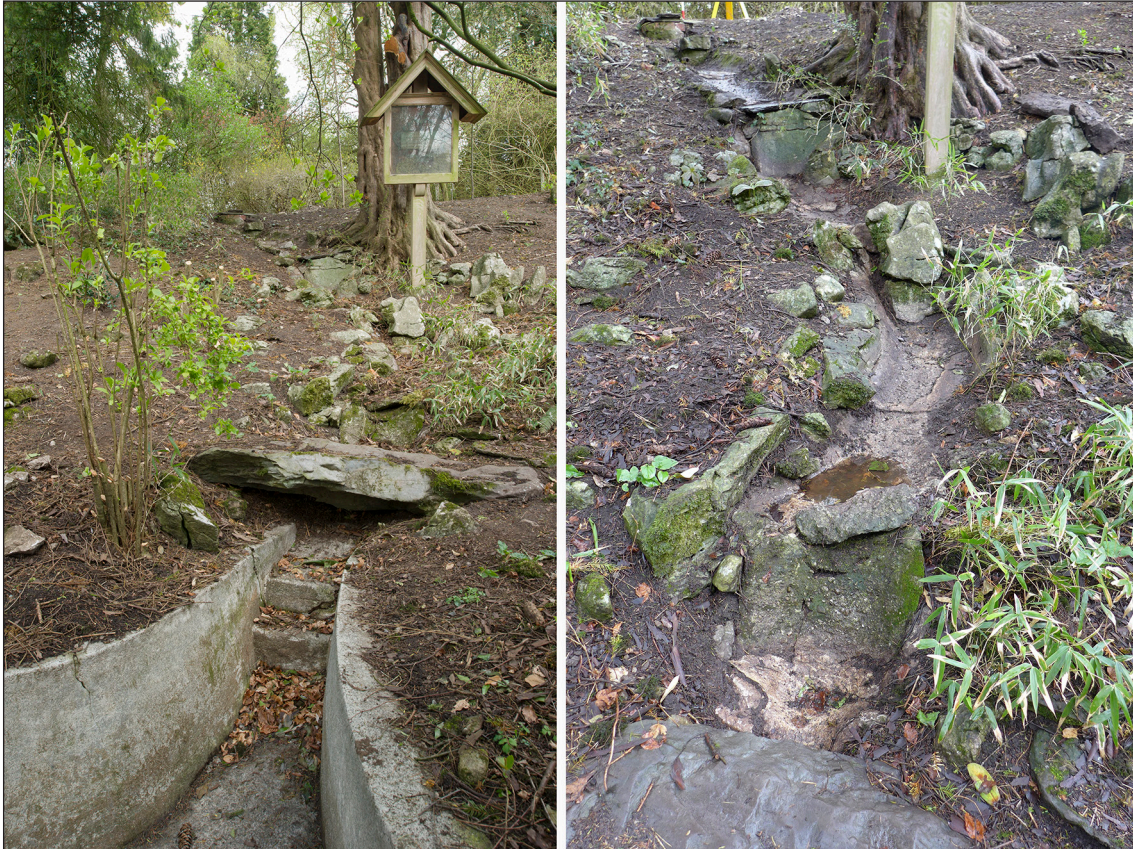
and partially sealing-in a number of small-to-medium limestone pieces that variously form higher sides to the channel in some places, and create small waterfalls and pools in its base in others (Figure 19; *see* Figure 33). Although the fabric appears to be largely in situ, the concrete chute that forms the bed has been cracked and twisted in several places by expanding tree roots, soil subsidence and, perhaps, frost damage.

Figure 19: Farrer's 'stream', showing (left) the full cascade from the brick manhole down to the 'block-bridge' at the pond's inlet, and (right) a detail of the central section showing limestone pieces set into the crude concrete channel, looking north-east. © Historic England: (left) DP168959/Alun Bull, 28th April 2015, and (right) Rebecca Pullen, 29th April 2015.

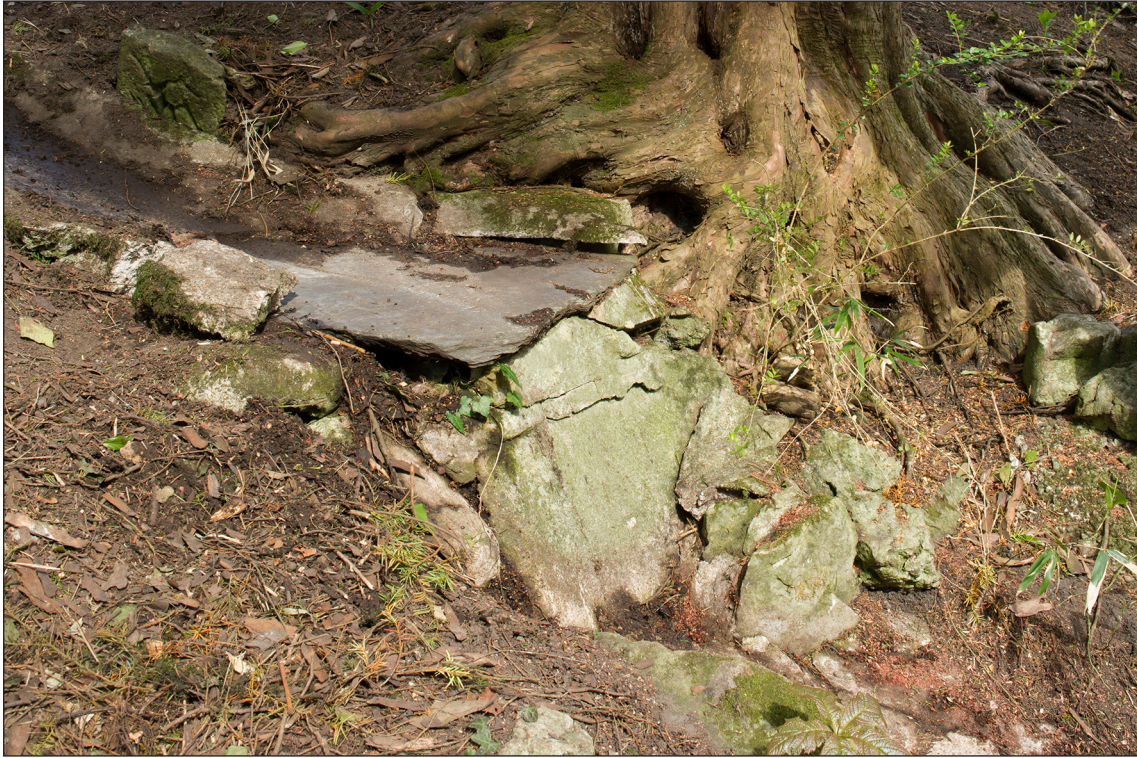
Figure 20: Detail showing the slate overhang within the channel of Farrer's 'stream' (note how the expanding roots and trunk of the adjacent yew tree are starting to push up beneath the concrete and stone). DP168981 © Historic England/Alun Bull, 28th April 2015.

above the halfway point of the stream laid horizontally with a slight overhang above a steeper drop to create a small but dramatic waterfall: Farrer's 'bold cascade'<sup>90</sup> (Figure 20). The second is a large, flat-topped, piece of local 'calliard',<sup>91</sup> positioned across the mouth of the pond inlet to form Farrer's 'block-bridge' (see Figure 19). The section of the stream bed beside the slate slab is where swelling roots of the adjacent yew tree have caused visible splitting and upheaval of the concrete.

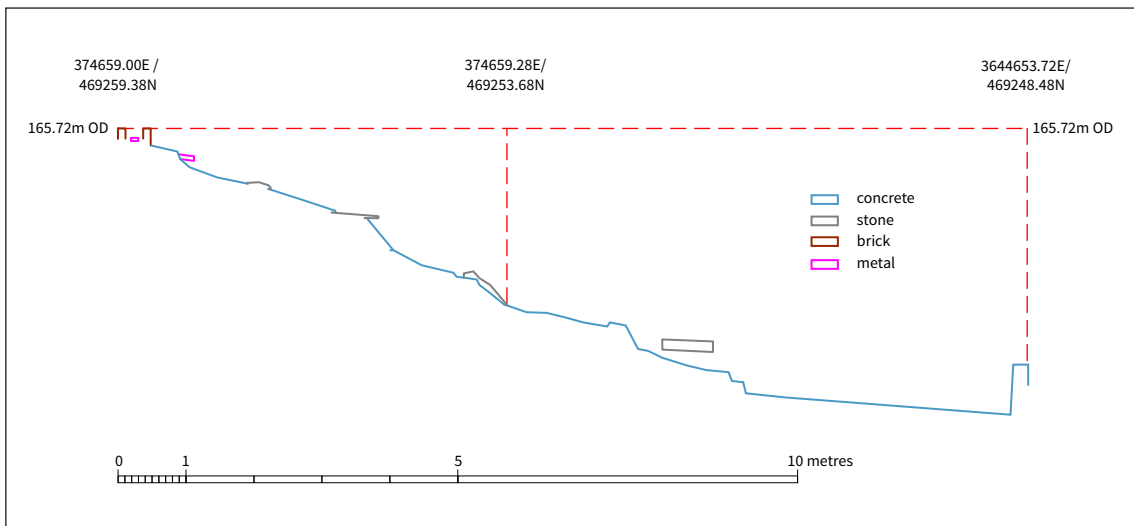
Figure 21: Schematic measured profile along the channel of Farrer's 'stream', created from the survey data. The profile line is also marked in plan on the main survey drawing. © Historic England/drawn by Rebecca Pullen.

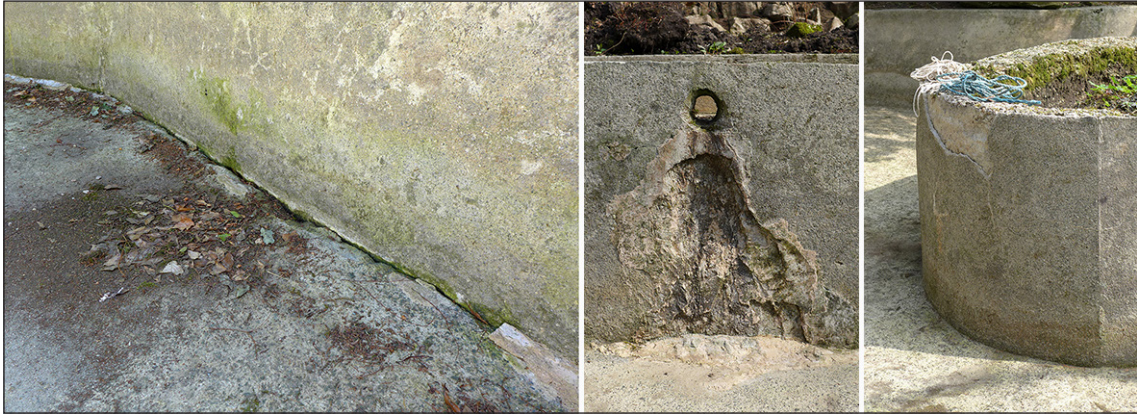
The design of the whole rock garden seems to pivot around the large elongated sub-oval concrete pond at its centre. This is in part because the pond is currently dry and its empty state makes it much more starkly visible than was originally intended. The pond is no longer able to hold water; it requires effective but sympathetic restoration to make it watertight again. There are significant cracks forming between the base of the pond and its concrete walls, and in several areas the concrete walls are suffering from spalling, probably as a result of exposure and frost damage (Figure 22).

Figure 22: Details showing the deterioration of the concrete pond: (left to right) cracks forming between the wall and the base, with remnants of the unsuccessful mortar repairs; wall surface damage beneath the south example of two drainage holes between the bog garden and the pond; patches where render has flaked off the wall surface of the north end of the pond's central island. © Historic England/Rebecca Pullen, 9th May 2015.

The current condition of the pond structure is clearly a concern; at present it is unable to hold water and is suffering from surface frost-damage in several places. At the time of visit for the Clapham village conservation area appraisal in 2010, the concrete surfaces of the pond were mossy<sup>127</sup> and it is possible that subsequent power-washing has caused further surface weakness. The pressure of roots of the large *Carpinus* tree close to the southern end of the pond is also an issue, the tree being an extremely rare, possibly unique, example for this country. It is possible that some form of unobtrusive revetment may be required to support the wall from within the pond; it may also be advisable to propagate from the rare tree in case more drastic remedies are ultimately required. The outlet pipe in the base of the pond is also likely to require refurbishment in order to enable occasional full-drainage for maintenance purposes - a task that Farrer saw as necessary, and had the output pipe inserted for that reason.<sup>128</sup>

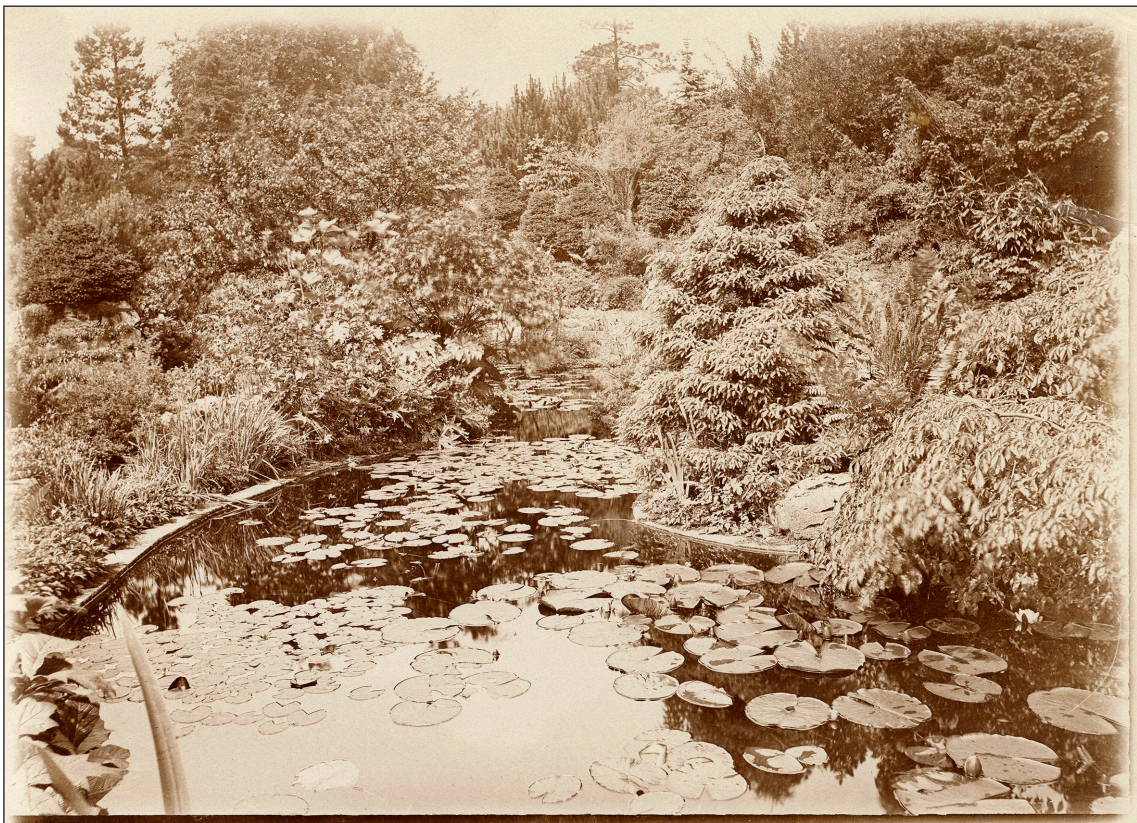
Figure 23: Historic photograph showing the pond filled with water and the garden lushly planted, looking north-west from the south end of the pond. GB235 RJF/2/2/5 © Farrer Family Collection at the Royal Botanic Garden Edinburgh, reproduced by kind permission.

In Farrer's day this 'kidney-bean-shaped pond'<sup>93</sup> would have been filled to the top with water and planted to mask the tops of the walls. A number of historical photographs show the pond nestled amongst dense planting and the brim covered by pond lilies<sup>94</sup> (Figure 23; see Figure 7). At its maximum the pond measures about 18.5m x 8m, with its long axis aligned close to north-south. An island is centrally positioned inside the pond, aligned north-south so that its footprint is roughly parallel with the outer pond wall. A pond and island in this position formed part of Farrer's earliest incarnation of the garden in 1894, but the current pond and island are probably the result of Farrer's stated remaking of the cement-walled pond in 1908.<sup>95</sup> In 1909 Farrer was in the process of digging over and replanting the island, and described his intention to plant taller species such as Asters and Irises at the north end, and low flat planting of Primulas, grown flush with the water level, at the south end.<sup>96</sup>

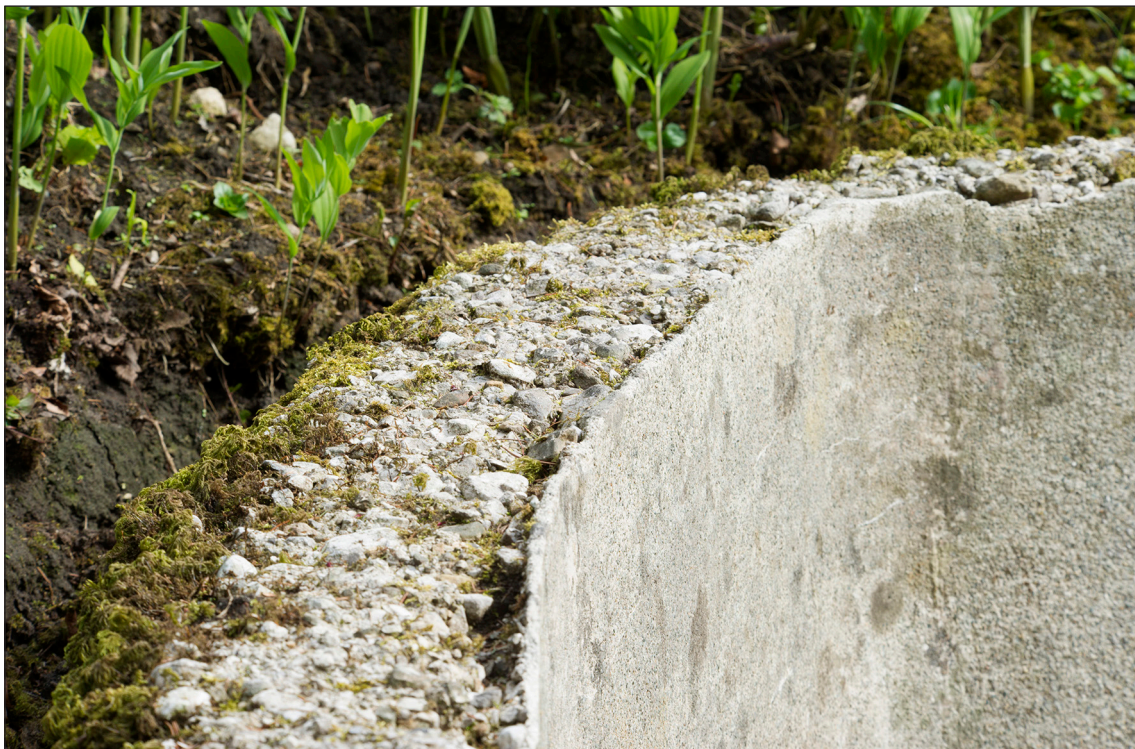
The pond's base and walls are composed of coarse, pebble-rich concrete (lain and presumably shuttered), masked with a thin, smooth cement render. The inner composition can be clearly seen along the top of the walls of the pond island where there is no render-finish (Figure 24); the top edge of the perimeter wall of the pond has been neatly rendered around the full circuit (*see* Figures 26 and 27). The narrow fissures opening up between the base of the pond and the foot of the pond walls appears suggest the two only just meet: that is, the base has not been constructed as a raft much wider than the superstructure, neither have the walls been constructed with foundations much deeper than the upper surface of the base. Without expert inspection this has not be confirmed. In places an attempt has been made to seal these cracks with thin fillets of a pinkish mortar, which is now falling away (*see* Figure 22). Staged construction of the pond base is implied by the presence of pouring seams; there are also a couple of unrelated narrow cracks appearing in the base. Near to the north end of the pond a fairly crude flight of three concrete steps, beginning well below the intended water level, provided access into the pond for cleaning and maintenance purposes [10].

Figure 24: Detail showing the composition of the concrete wall of the pond island. DP168965 © Historic England/Alun Bull, 28th April 2015.

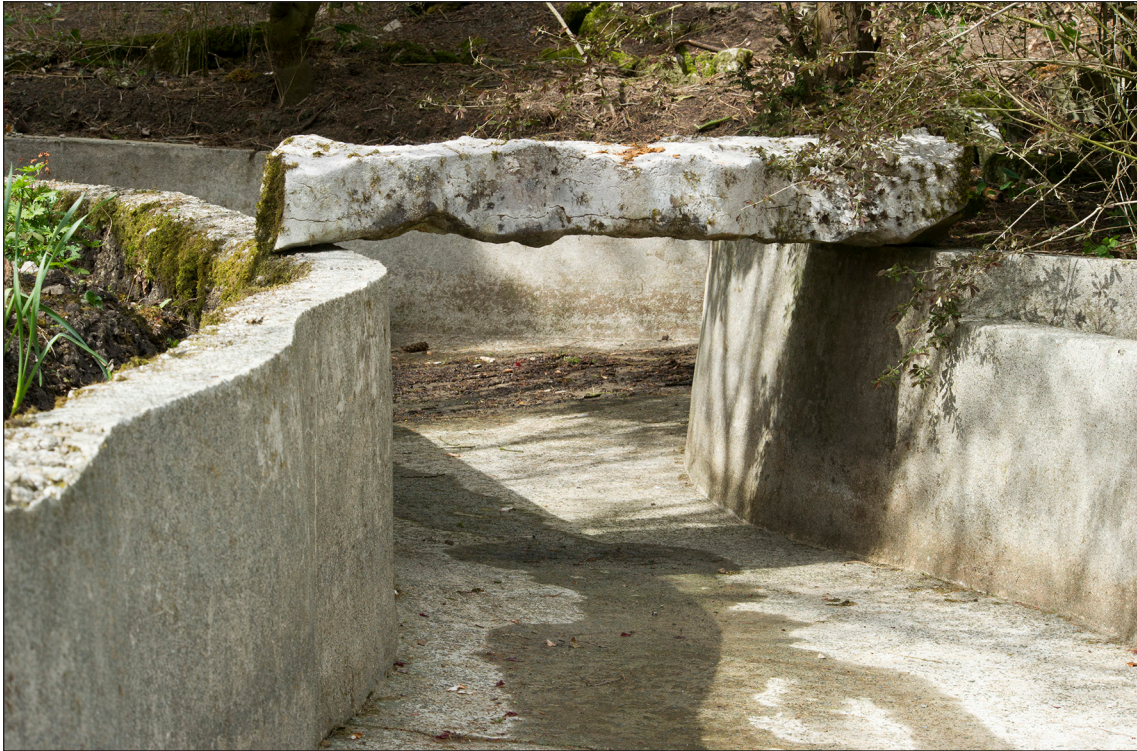
Figure 25: The limestone slab creating a bridge between the outer edge of the pond and the island, looking north. DP168970 © Historic England/Alun Bull, 28th April 2015.
