# Reginald Farrer's Rock Garden, Clapham, North Yorkshire: Analytical Survey and Assessment

**Analytical survey and assessment**

To inform the future repair and management of the garden and pond, in 2015 Historic England undertook an accurate measured survey and analytical assessment of the fabric, layout and history of the garden; this report presents the results of that work.

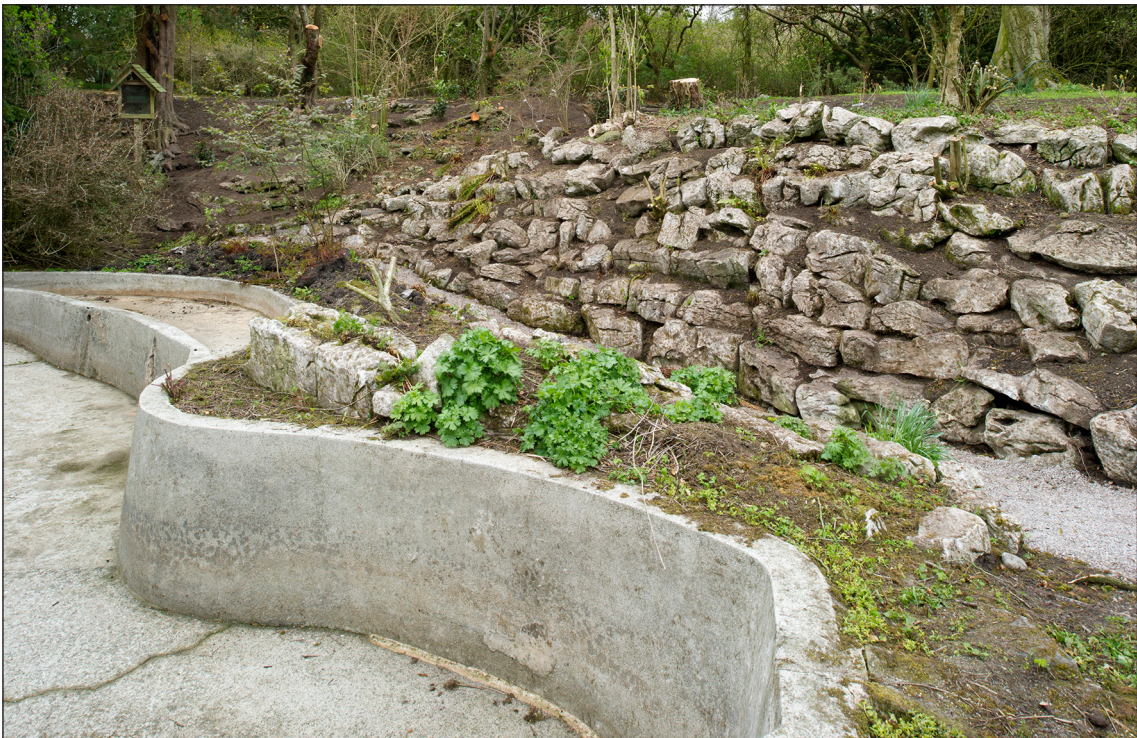
A further extension to the pond exists in the form of a shallow, crescent-shaped concrete shelf appended to the outer eastern edge of the pond [11], which would have housed a bog garden that was designed to be kept moist by water shared with the pond. Part way along the communicating wall between the pond and the bog garden are two horizontal circular drainage holes (each 70mm in diameter) linking the two (Figure 26; *see* Figure 22). Unfortunately, since the pond has been empty, these holes have acted as drainage inlets, rather than outlets, and consequently the internal face of the pond wall below the holes is suffering from considerable spalling,<sup>97</sup> probably the result of frost action.

Figure 26: The concrete shelf of the bog garden, with communicating drainage holes (far left), and the rock face beyond, looking north-east. DP168994 © Historic England/Alun Bull, 28th April 2015.

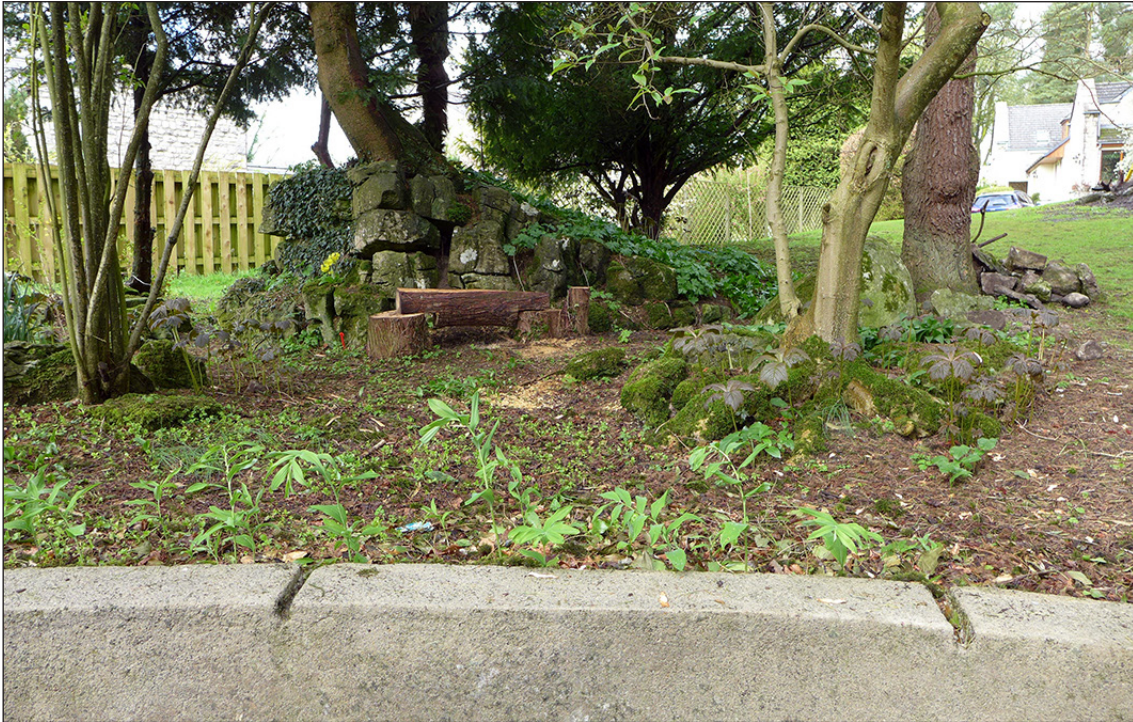
Figure 27: Two of the numerous drainage slots in the top of the wall of the pond, with Farrer's 'mountain-mass' centred in the background, looking west. © Historic England/ Rebecca Pullen, 29th April 2015.

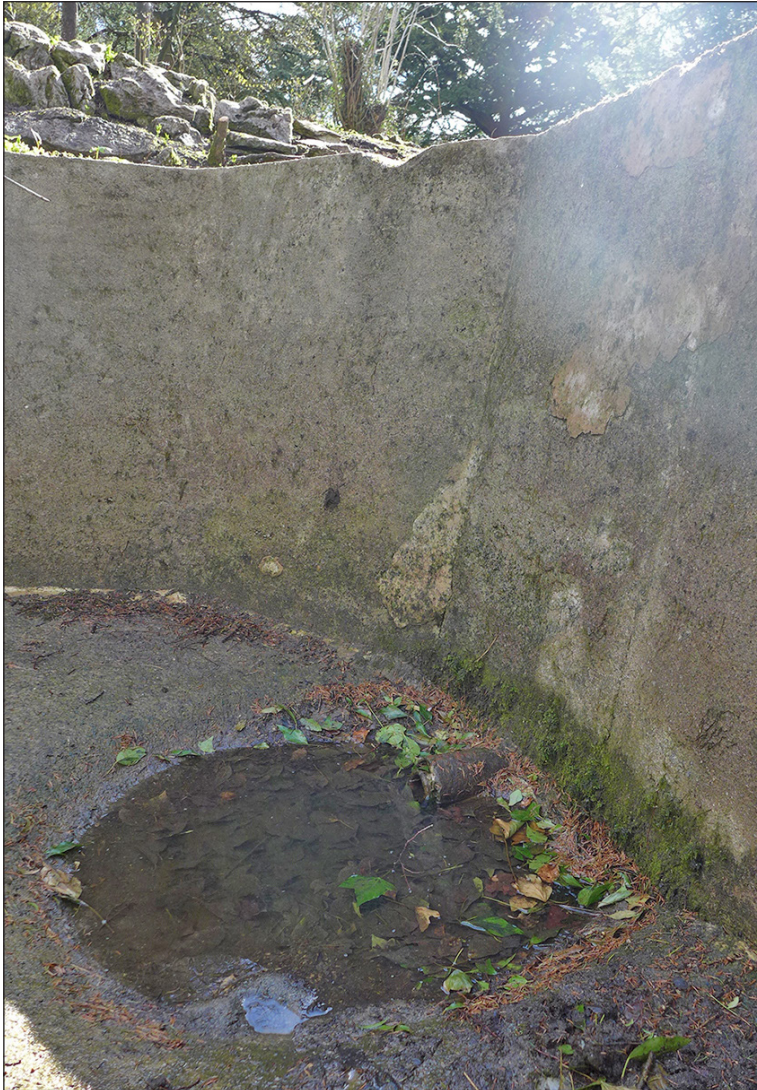
Figure 28: The dip in the top lip of the pond wall (top centre) and the inserted drainage pipe and hollow at the base of the south end of the pond (foreground), looking south-east.  
© Historic England/ Rebecca Pullen, 29th April 2015.

of similar date to the waterfall channel, neither of which were thought original.<sup>99</sup> This feature is certainly in a poor condition; however, it is not entirely implausible that it dates from Farrer's day. Without more informative documentary evidence, or the opinion of an expert in historic concrete, the feature should not be completely dismissed as modern.

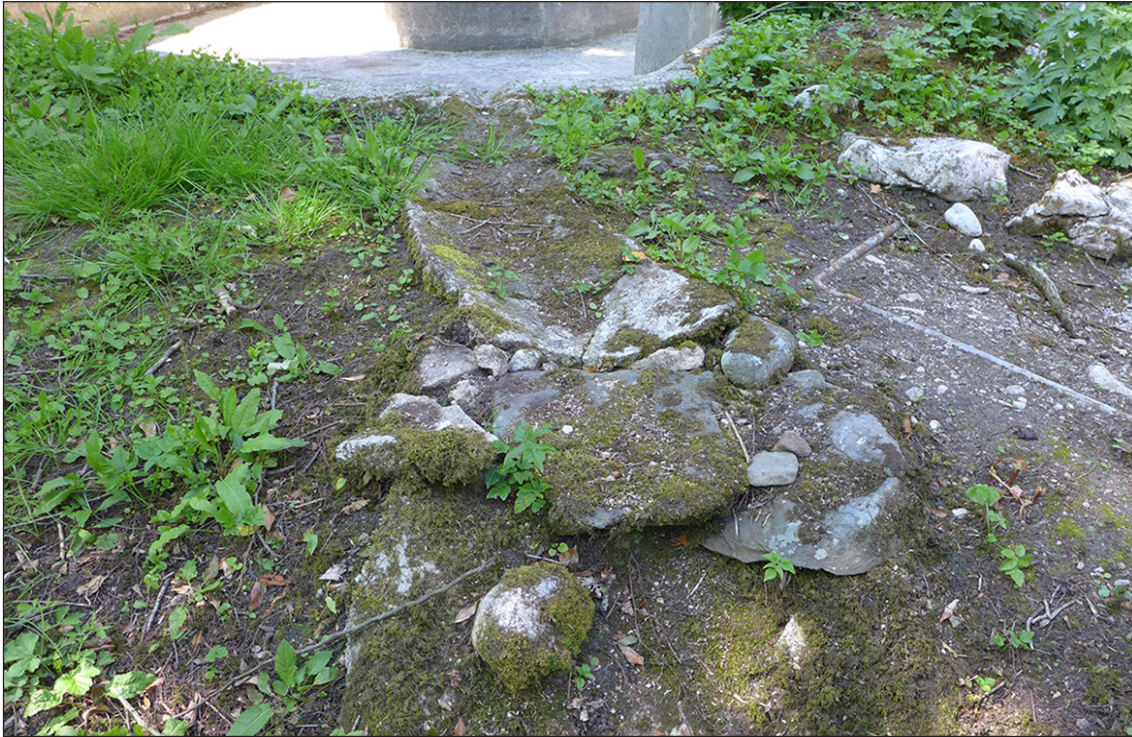
Figure 29: The upper portion of the pond outlet channel, looking north-west towards the pond. © Historic England/ Rebecca Pullen, 10th June 2015.

tree root systems have caused shifting and cracking of the concrete channel; and of course, it is not connected to any water source. Likewise, the short concrete channel forming the overflow outlet at the south end of the pond is coming apart in places and no longer feeds directly into a soak-away or manhole; this will need to be addressed if water is returned to the pond.

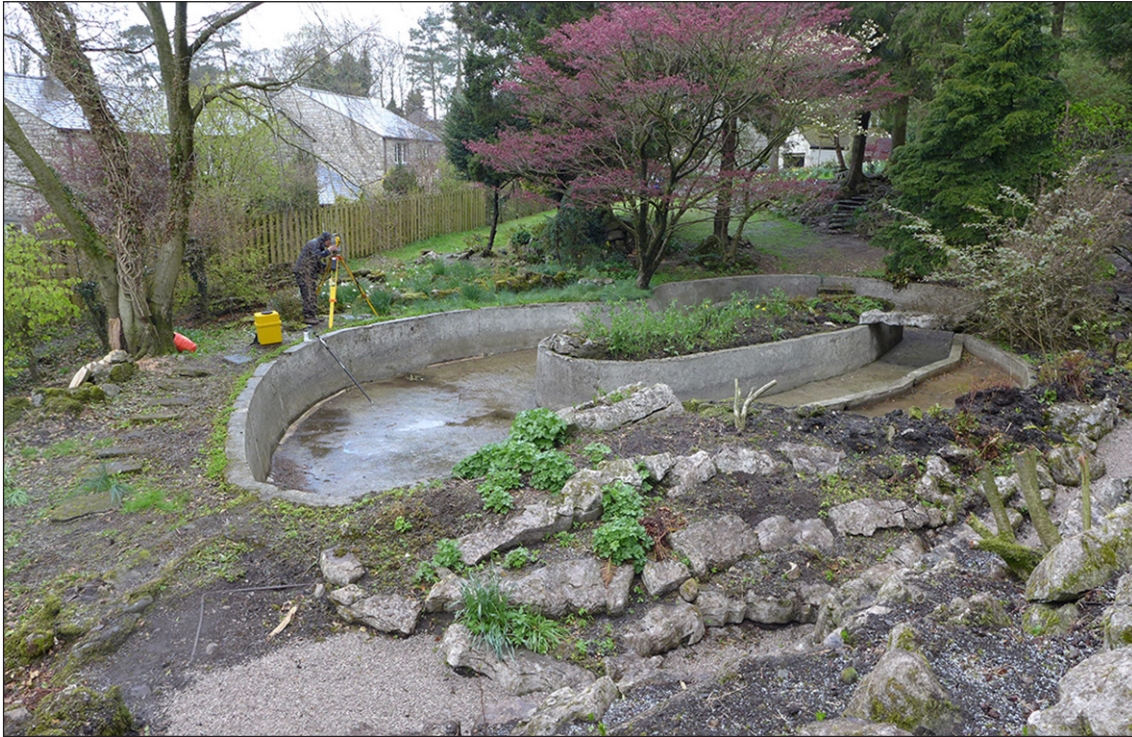
Figure 30: The pond with the gentle scarp marking the position of Farrer's 'Great Moraine' visible falling away from the pond edge at the left side of the image, and the rare *Carpinus* tree standing in the top left, looking west. © Historic England/ Rebecca Pullen, 29th April 2015.

The area of Farrer's great moraine is also not in the best condition - the surface of the scree appears to be concealed beneath a thin covering of moss and soil; however, no intrusive investigation has been undertaken to confirm this.

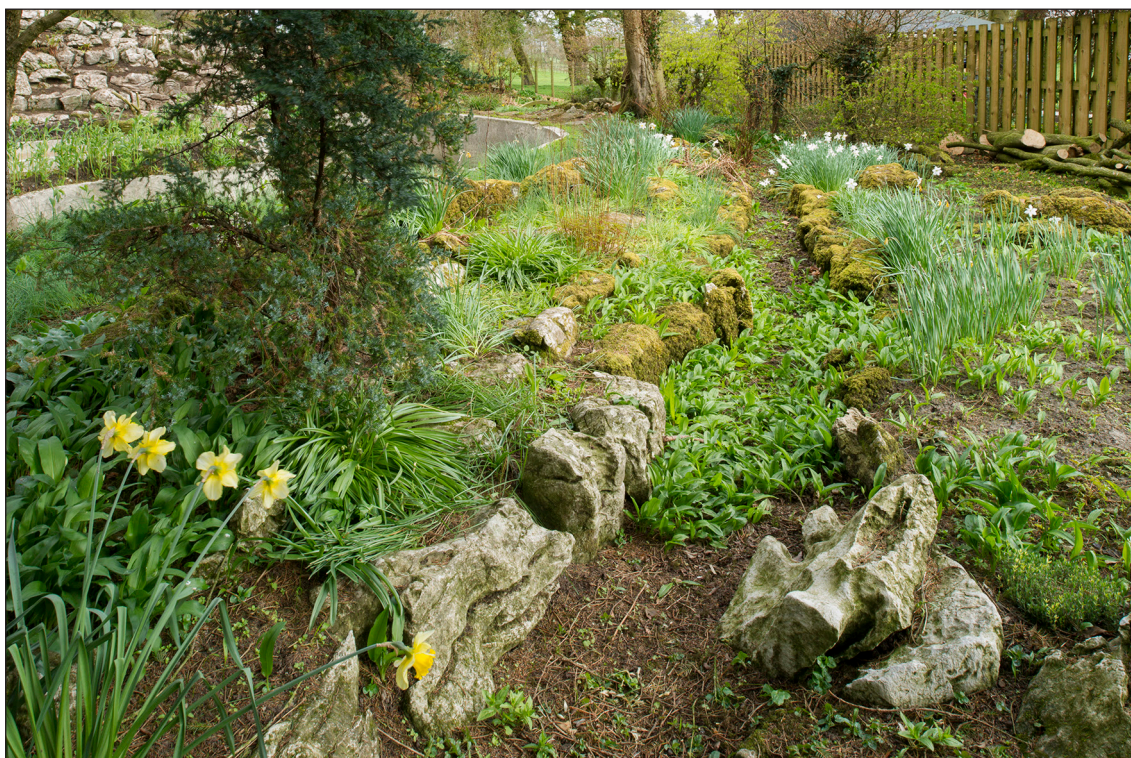
The area west of the pond is largely occupied by two low, limestone-edged beds, separated by a narrow path (Figure 31). This area is described by Farrer as ‘a richly hollow piece of ground, often overflowed by the pond’<sup>109</sup> – probably intentionally, given the presence of the narrow drainage slots in the top of the pond wall, and Farrer’s keen belief in creating marsh fringes or bog gardens around naturalistic water-gardens.<sup>110</sup> At the southern end of the smaller, eastern bed a pair of stone steps connects between the flag-stone path along the top of the edge of the pond and the lower areas beside the beech hedge.

Figure 31: The limestone-edged planting beds, with further limestone blocks distributed within them, looking south. DP169002 © Historic England/ Alun Bull, 28th April 2015.

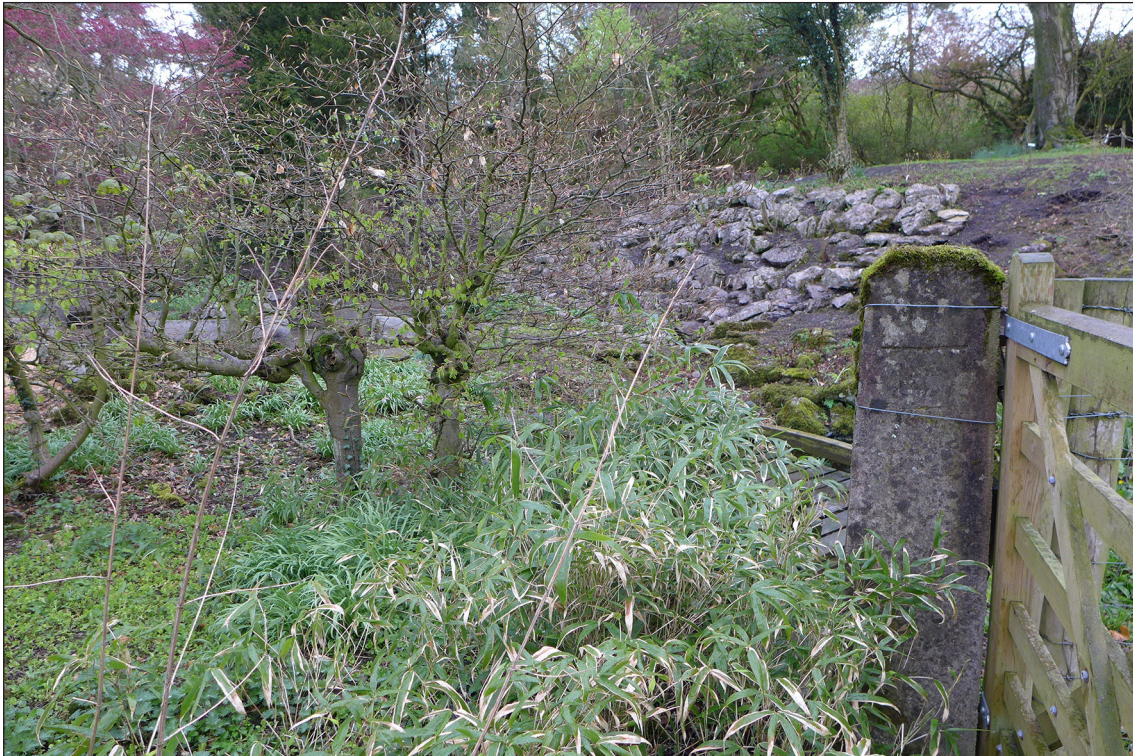
Figure 32: Remnant stretch of the old beech hedge line (left) and the northern end of the two stone gateposts, looking north. © Historic England/ Rebecca Pullen, 29th April 2015.
