# Dee House, Chester An Investigation and Assessment

Research Report Series 005-2016

**DEE HOUSE  
LITTLE ST JOHN STREET  
CHESTER**

**AN INVESTIGATION AND ASSESSMENT OF THE  
EARLY 18TH CENTURY HOUSE AND 19TH CENTURY  
CONVENT SCHOOL**

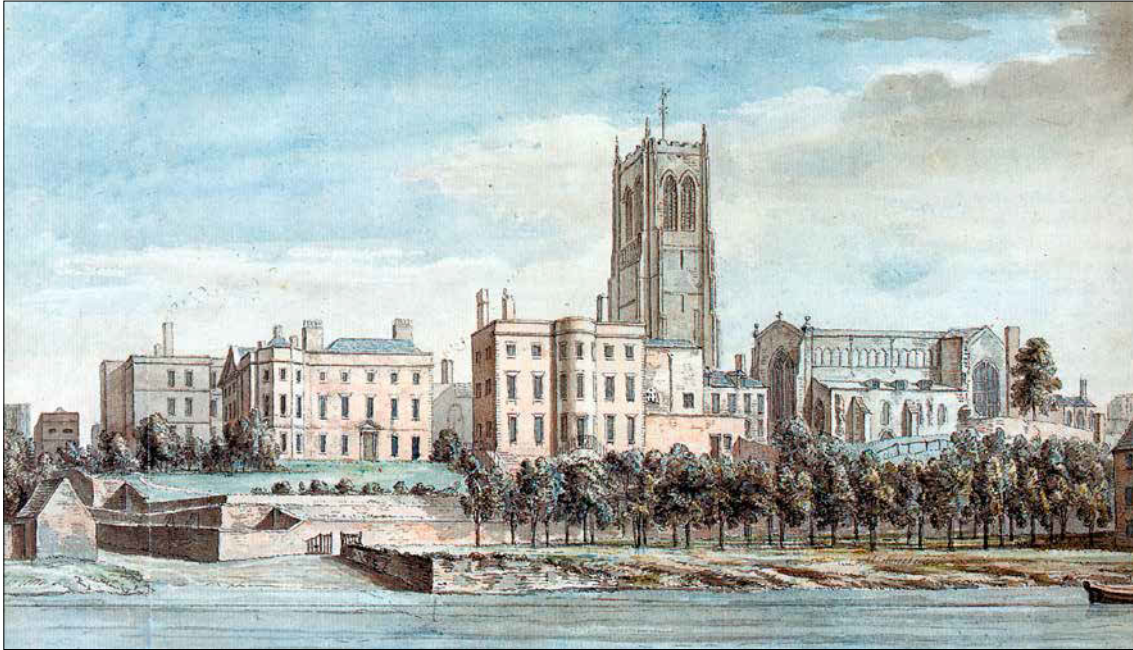
Figure 3: Depiction by Moses Griffith of St John's Church and The Groves (credit: Grosvenor Museum, Chester).

detached pair,<sup>7</sup> or was at times larger and more complex during the 18th century.<sup>8</sup> A depiction of Dee Bank by Moses Griffith dating from the second half of the 18th century also implies a more extensive house than the surviving early fabric suggests (see Figure 3). On the 1745 plan the property is entered from the southern end of St John's Lane and its address would have been St John's Lane rather than the diminutive Dee Lane which flanks its entirety to the west. The label 'Mr. Comberbacks' appears against the full length of the eastern edge of the property and, because names given elsewhere on the plan usually correspond to specific buildings and indicate ownership, it seems likely that 'Comberbacks' applies to the adjacent house and not specifically to the area of generic stippling, also applied to much of the rest of the city, over which it is written. No other buildings are depicted or named on St John's Lane, nor does the name Comberbach, or 'Comberback', appear elsewhere on the map.

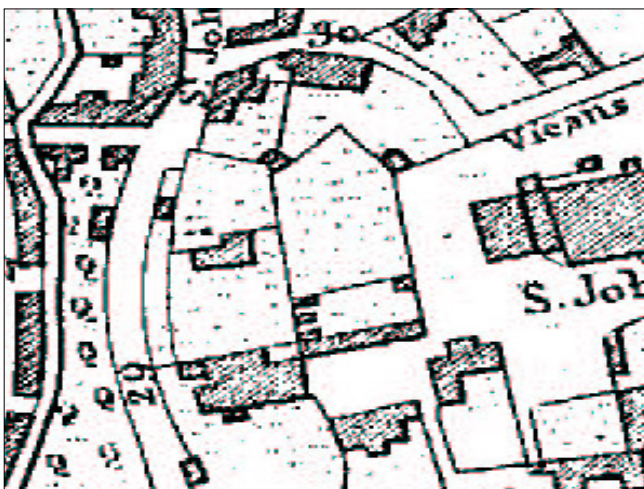
Figure 4: Detail from John Stockdale's 1796 plan of Chester (reproduced courtesy of Cheshire Archives & Local Studies).

A building with a footprint which does match that of the extant early fabric is depicted on Murray and Stuart's 1791 map of Chester<sup>14</sup> and a building with an L-shaped plan, correctly orientated, also appears on Stockdale's map of 1796 (Figure 4),<sup>15</sup> although Neele's plan of 1809<sup>16</sup> shows the building with the same footprint as Hunter's, as does Neele's plan of 1817,<sup>17</sup> suggesting perhaps that both the 1809 and 1817 depictions were derived from Hunter. John Wood's map of 1833<sup>18</sup> (Figure 5) shows an L shape with certainty, but here it is apparently subdivided into three units and has a shallow southward projection from the western part of the south elevation (which concurs with Griffith's depiction). The oval carriage drive to front and formal gardens to rear appear largely unchanged from de Lavaux's and Hunter's maps. Thomas's map of *circa* 1853,<sup>19</sup> the year before the acquisition of Dee House by the Faithful Companions of Jesus, shows a building with an L-shaped footprint which closely matches that of the earliest phase of the extant building, lacking, as it does, the southward projection from the service wing shown by Griffith and Wood. McGahey's depiction of Dee House on his view from a balloon of 1855<sup>20</sup> (Figure 6), however, is puzzling as it appears to contradict both near-contemporary cartographic evidence and the earliest phase of the extant structure. McGahey shows a house with

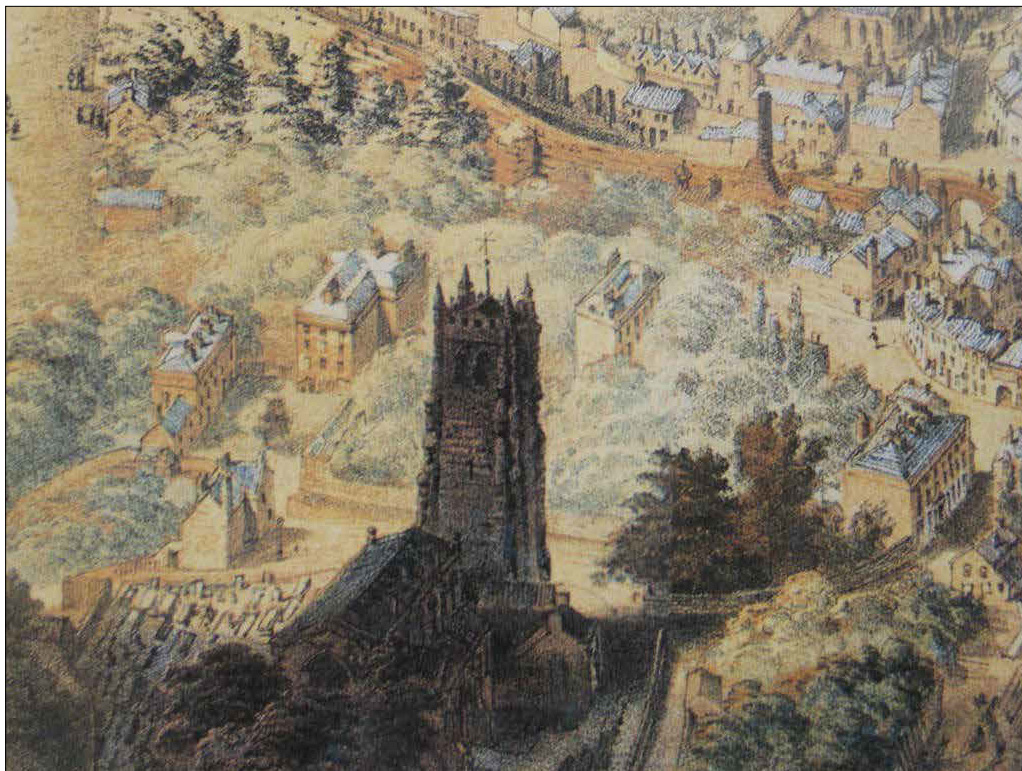
Figure 6: Detail from John McGahey's 1855 view of Chester from a balloon (reproduced courtesy of Cheshire Archives & Local Studies).

a narrow but regular rectangular plan which is three storeys high and has a long, six-bay north elevation, the ground floor of which is completely obscured by tall trees which also hem the house in on all sides. The oval carriage drive at the front, the coach house and stable block to the west and the formal garden to the south – all prominent features of the convent grounds which are shown on earlier and later maps – are also omitted in favour of an extensive arboreous mélange, arousing a reasonable degree of scepticism regarding this depiction as a reliable record.

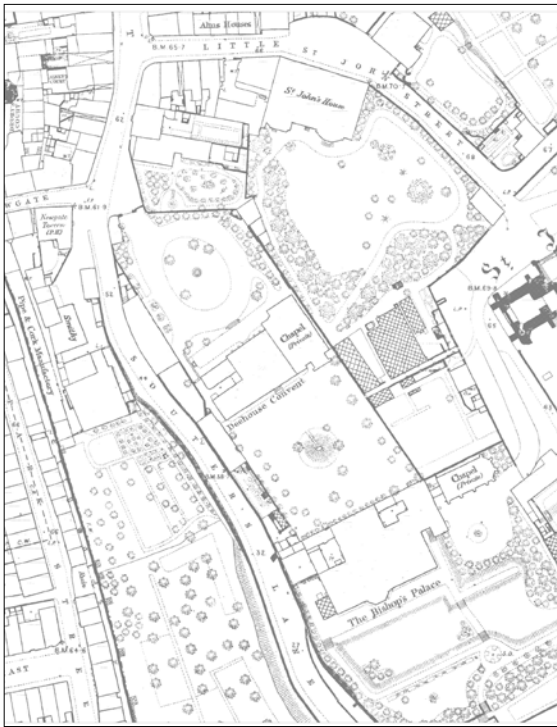
Figure 13: Detail from Ordnance Survey 1:500 scale town plan of Chester published in 1875 (© Crown Copyright [and database rights] 2016. OS 100024900).

elsewhere have cambered brick heads and stone sills, those on the ground floor of the east elevation set flush with the wall. The openings are alternating two- and three-light timber mullion-and-transom windows. These are original features and the fact that they are chamfered and stopped links them stylistically with elements of the chapel block. Since this building appears on the Ordnance Survey map published in 1875 (see Figure 13) it seems likely that it forms part of Edmund Kirby's work for the Convent.<sup>61</sup>

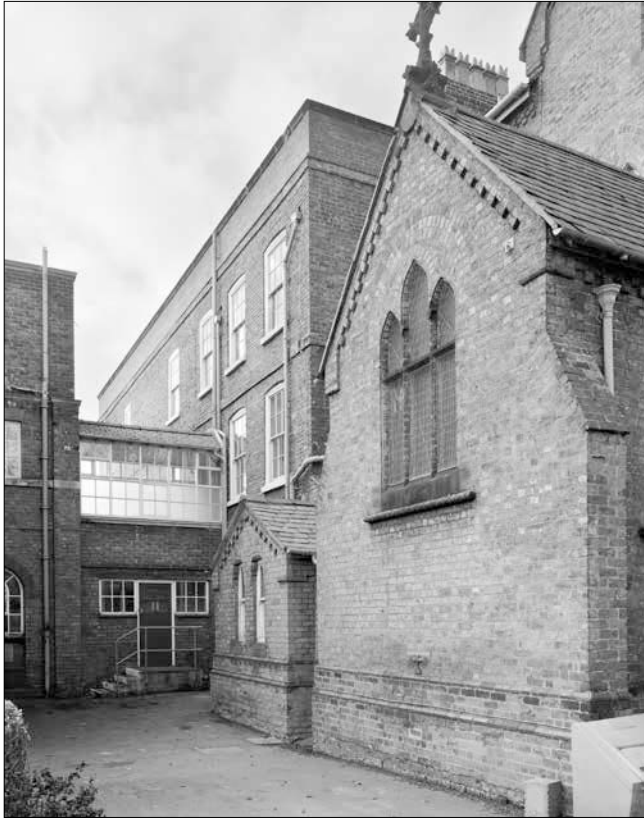
Figure 15: Part of the rear range at Dee House in 1991 (BB91/26351 © Historic England, photograph: Bob Skingle).

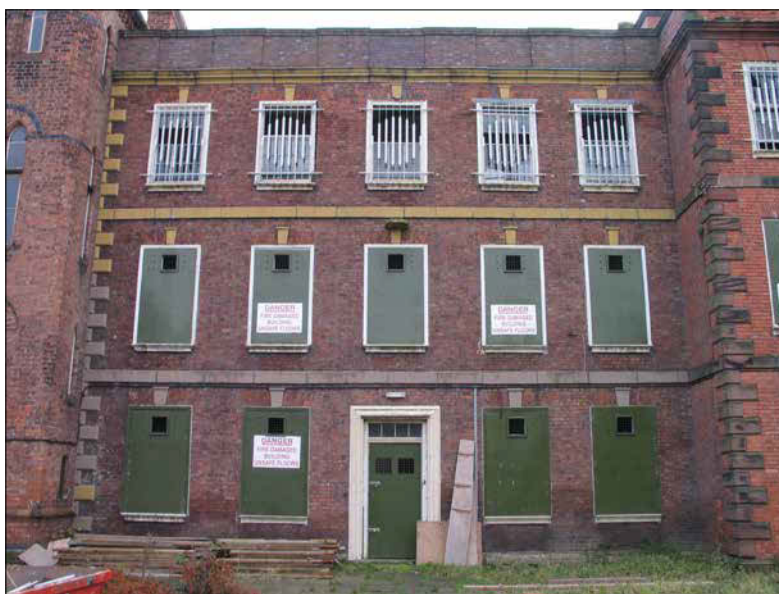
The front elevation (Figure 16) is five bays wide and broadly symmetrical, with two windows placed either side of the entrance and corresponding rows of five windows on each floor above; these levels are demarcated by platbands. There are also four windows below ground level on the front elevation of the house, these designed to light the cellars. Though not immediately obvious, careful scrutiny confirms that the windows are more widely spaced to the east of the front door, giving more generous proportions to the higher-status rooms held within this side of the main block. The windows have flat brick arches of gauged brick with imitation mortar joints on many of the splayed heads – a refinement applied for aesthetic reasons and indicative of high levels of craftsmanship and attention to detail. On the ground floor the

Figure 16: The front of the original house (© Historic England, photograph: Adam Menuge).

keystones are slightly broader than those on the floors above, and the openings themselves are marginally squatter on the second floor than on the floors below. The sills are uniformly moulded throughout, but at least three on the ground floor and another on the first have been replaced with pre-cast concrete substitutes.

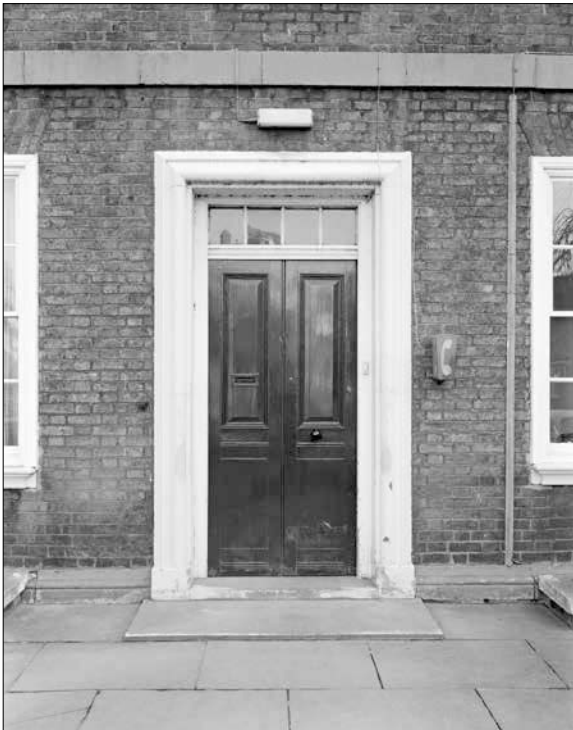
The door surround has a bolection moulding (Figure 17), suggesting a date probably no later than about 1730. The plinth is moulded too, but in a simpler fashion. The quoins are chamfered where visible on the north-eastern edge of the original frontage, though they are partially covered by the 1867 chapel block which protrudes forward at this side (Figure 18) and obscures the corner. The quoins on the north western corner of the original building are completely covered by the later 19th-century extension which abuts on this side, as are those on the western elevation of the main block and the northern elevation of the service wing. The eaves cornice of the main block is moulded in a manner quite distinct from the mouldings on the sills, plinth and door-surround, being comprised of a cyma above a cavetto. The coping to the parapet is moulded also, but with a double fascia. The parapet – which, as mentioned before, is rebuilt – recedes and projects in direct correspondence with the succession of windows on the floors below. The roof cannot be seen from the ground, other than a low apex glimpsed above and between the first two bays from the east, but, viewed from above, the main house can be seen to now have a double-span, partially-pitched roof, the eastern span being hipped to the front and rear, while the service wing has a pitched roof of one and a half spans.<sup>49</sup>

Figure 17: Bolection moulding on the original front entrance in 1991 (BB91/26352 © Historic England, photograph: Bob Skingle).

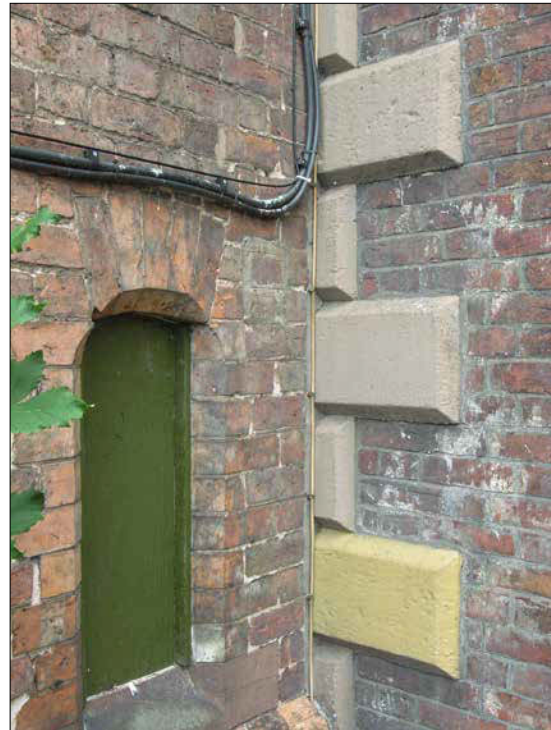
Figure 18: Partially concealed quoins at the north-east corner of the original house (© Historic England, photograph: Adam Menuge).

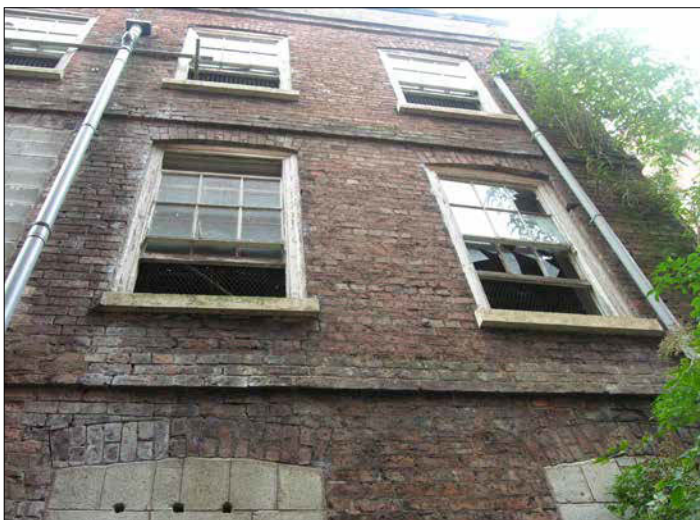
The fenestration of the rear elevation (Figure 19) does not match that of the front. There are seven window bays, of which just four correspond to the five-bay front of the main block. A small ground-floor window between bays three and four, as one looks from east to west, originally gave light to a room just off the kitchen inside, henceforth to be termed the 'parlour'.<sup>50</sup> To the west of this the three remaining bays extend across the back of the service wing, each with a regular, vertical sequence of windows on the ground, first and second floors. In common with the front elevation, the window openings across the rear of the building are shorter on the second floor than on the floors below. The windows on the eastern two bays are unaltered, but the head and jambs of the ground-floor window opening on the third bay appear to have been rebuilt (the segmental arch that was here has been replaced with a straight head), possibly at the same time as this opening was being altered to serve as a doorway. Above, the window opening on the first floor has been widened towards the right, indicated by the fact that it is slightly broader than the segmental arch that heads it and perhaps also by the lack of a sill, though there is no obvious sign to confirm the removal of this feature. After the small window between bays three and four, the fourth bay takes us back to regularity, though there is a sill missing from the window on the ground floor, and the general ratio of wall to window is greater here than at bays one and two. The fifth bay is regular too, despite its first-floor window opening having been slimmed down and shifted slightly to one side, while the second-floor window has been blocked completely. Much rebuilding has taken place at ground-floor level between bays six and seven, but it seems fair to assume that the newly constructed parts simply replicate what was there before.<sup>51</sup> To the right of the ground-floor window on bay seven there is a straight joint, which could indicate that the opening has been narrowed.

Figure 19: Window bays at the rear of the original house (© Historic England, photograph: Adam Menuge).

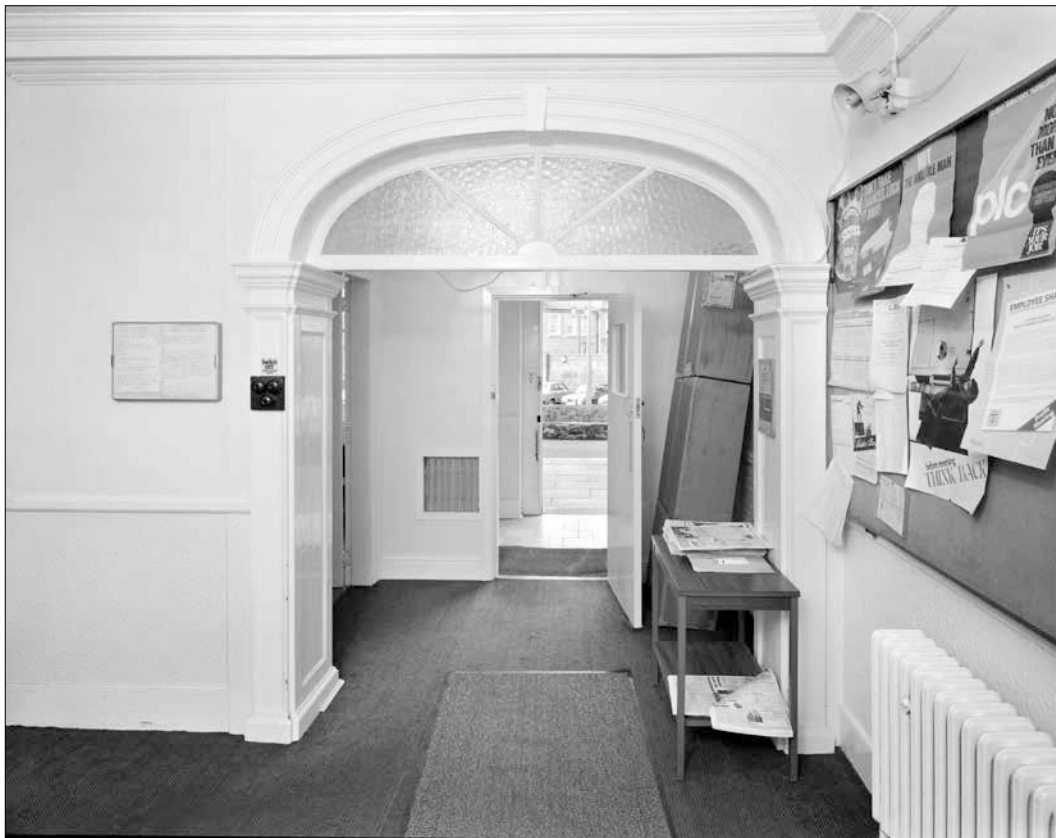
Describing in sequence what we know of the original character of the ground-floor rooms, the front door of the house opens onto a small lobby or **entrance hall** with a moulded cornice. On entering, one is faced by a large archway (Figure 20) immediately to the south, offering a grand frame to the main stair-hall (though a flimsy partition with a door has been inserted in recent times, obscuring any sort of clear view). The arch is semi-elliptical, with a moulded and keyed archivolt set on cyma-recta-moulded, sunk-panelled jambs – essentially panelled pilasters with entablatures on top instead of plainer impostes. The sunk-panels on the cheeks of the opening make use of simpler ovolo mouldings.

Figure 20: Stair hall archway in 1991 (BB91/26353 © Historic England, photograph: Bob Skingle).

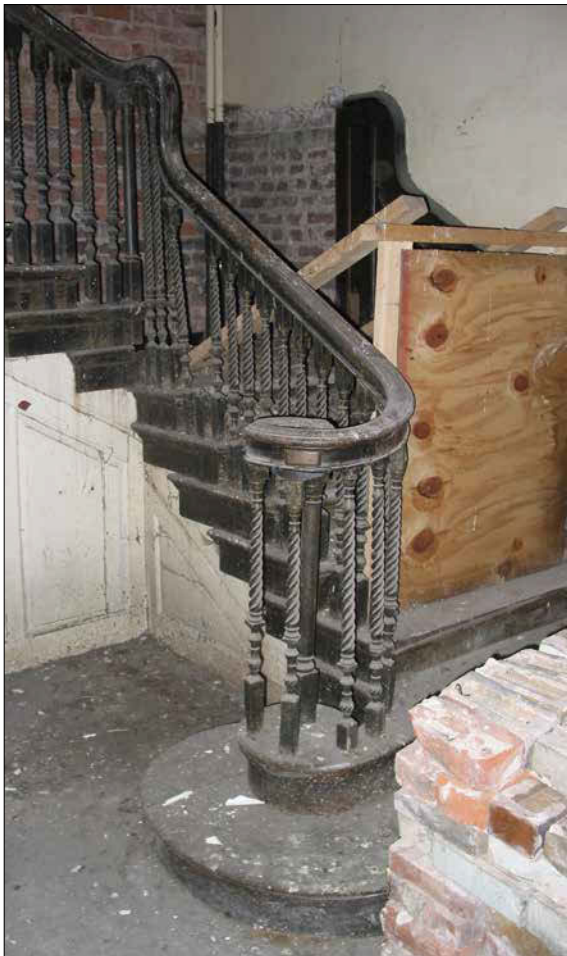
The most striking original feature in the **large stair-hall** is the staircase itself (Figure 21). Open-string and constructed entirely of wood, it rises over three flights around the open well via two quarter landings. At the curtail step and each of the three landings there are column newels with Tuscan heads, with three twisted-shaft balusters per tread, each with oblong knops and urn-shaped pedestals. Each tread has a rounded-edge nosing with, just below, a cyma-recta moulding and a small bead – embellishments that return along the cheek. The handrail has mirrored torus mouldings along the upper edges and astragals lower down. It traverses the landings using serpentine ramps, with the supporting balusters adjusted in their successive heights so as to negotiate steeply rising corners. Typically among 18th-century staircases, the dado-rail running parallel to the handrail at Dee House mimics precisely the upwards course of its partner and is identical to one half-side of it in terms of mouldings. Below the dado-rail the wooden panelling is raised and fielded, as it is too with the soffit and boxing beneath the staircase. The large window lighting the staircase is not original, built as it is into a straight joint. What appear to be the arched heads of two blocked windows can be seen towards the top of the wall,

Figure 21: The main staircase (© Historic England, photograph: Adam Menuge).

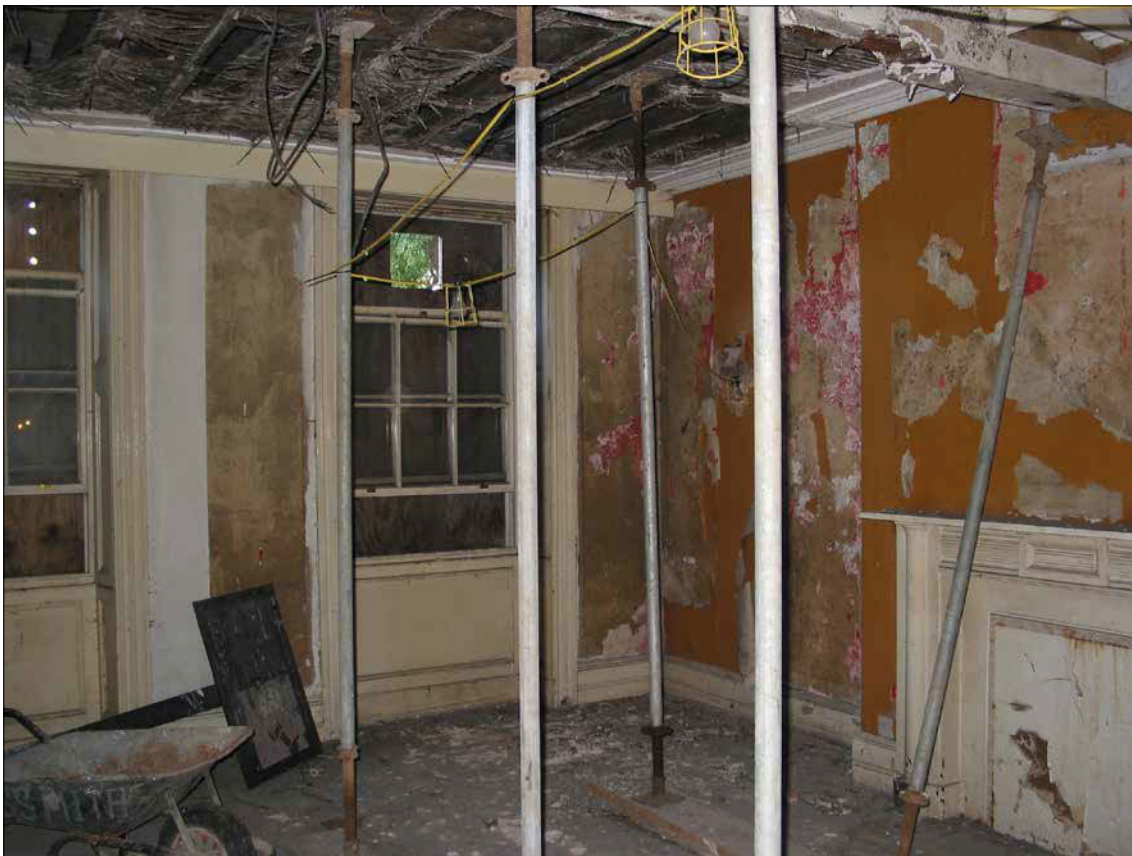
Scars on the eastern wall of the large stair-hall indicate that the **drawing room** (Figure 22) was entered originally through a doorway, now blocked, directly opposite the foot of the stair. Owing to a comprehensive 19th-century remodelling, few of the room's original 18th-century features remain, but the positions of the window openings at the front of the house and the fireplace on the eastern wall are unchanged, even if the windows themselves, their surrounds and the chimney-piece are all later replacements. The plaster-on-reeds ceiling is original too.

Figure 22: The drawing room (© Historic England, photograph: Adam Menuge).

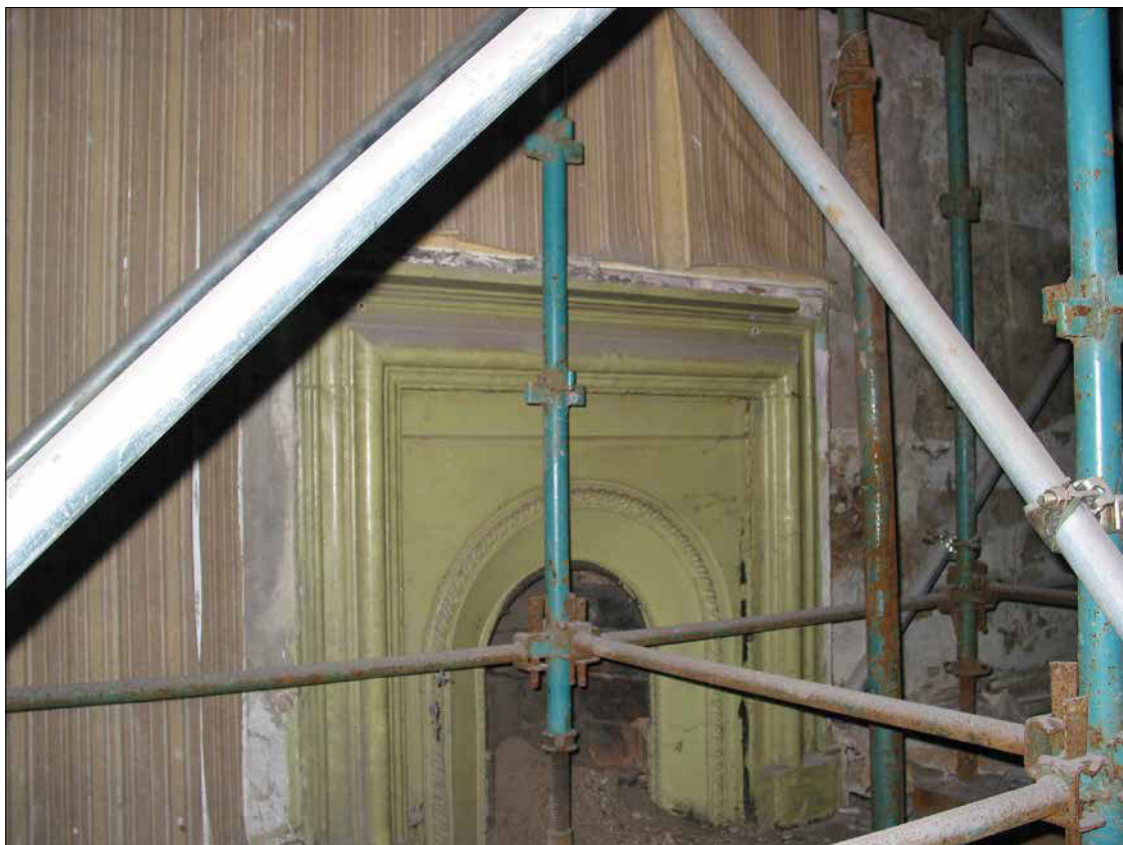
Though radically truncated in the early 19th century in terms of overall dimensions, the **dining room** retains many of its original fittings. Most striking amongst these is the bolection-moulded chimney-piece on the eastern wall (Figure 23), though it should be noted that this has been moved in response to said truncation – the fire-surround sits asymmetrically on the chimney-breast, though it does now occupy a central position within the room as a whole. The window openings on the back wall and the small service doorway on the wall to the west retain their original positions, with the doorway opening onto the stair corridor at the rear of the house and ultimately giving access to and from the kitchen. The doorway has a cyma-recta-moulded and beaded architrave, most probably original.

Figure 23: Fireplace in the dining room (© Historic England, photograph: Adam Menuge).

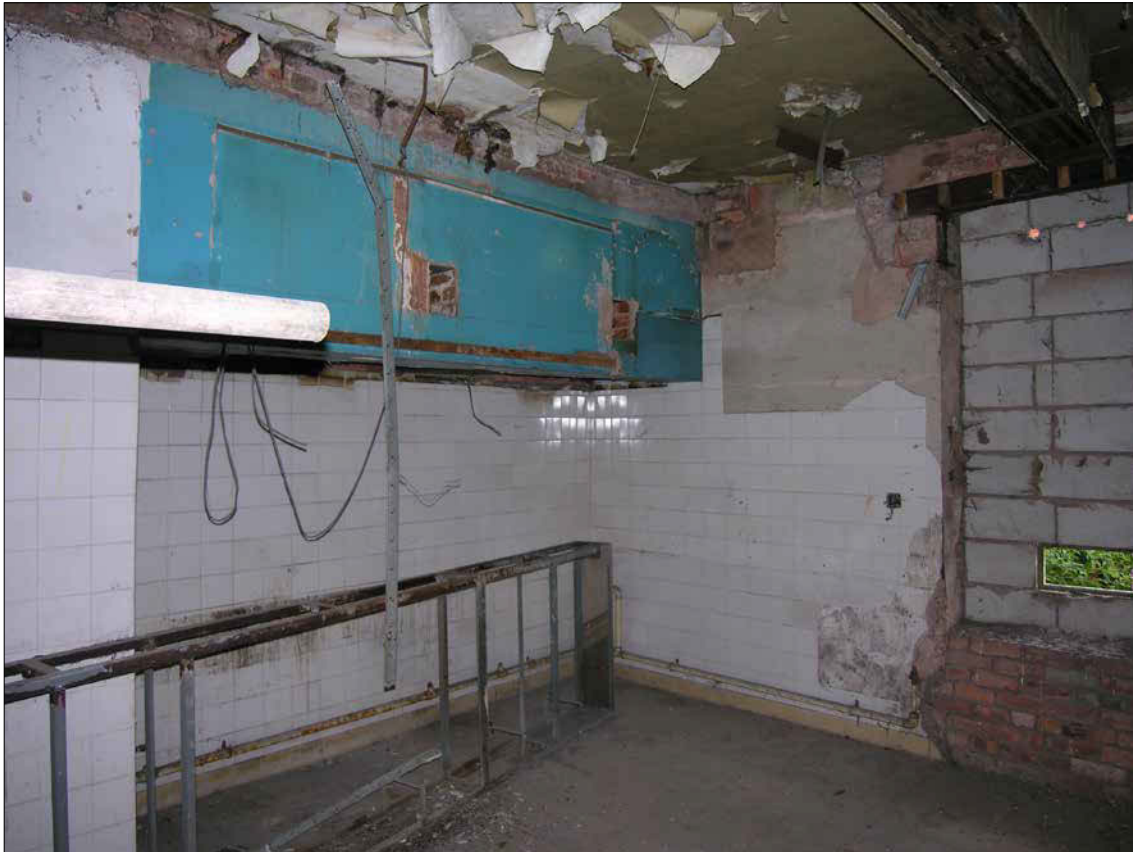
gives nothing away as to the positions of the north-facing windows that may once have been here; an examination of the brickwork beneath the plaster would be needed in order to discover this information. A brick-built cooking area is located within the very large fire recess on the eastern wall of the kitchen (Figure 24). The kitchen ceiling is plaster on laths, with no direct evidence to suggest it was ever plaster on reeds, though it probably was.

Figure 24: Cooking area in the kitchen (© Historic England, photograph: Adam Menuge).

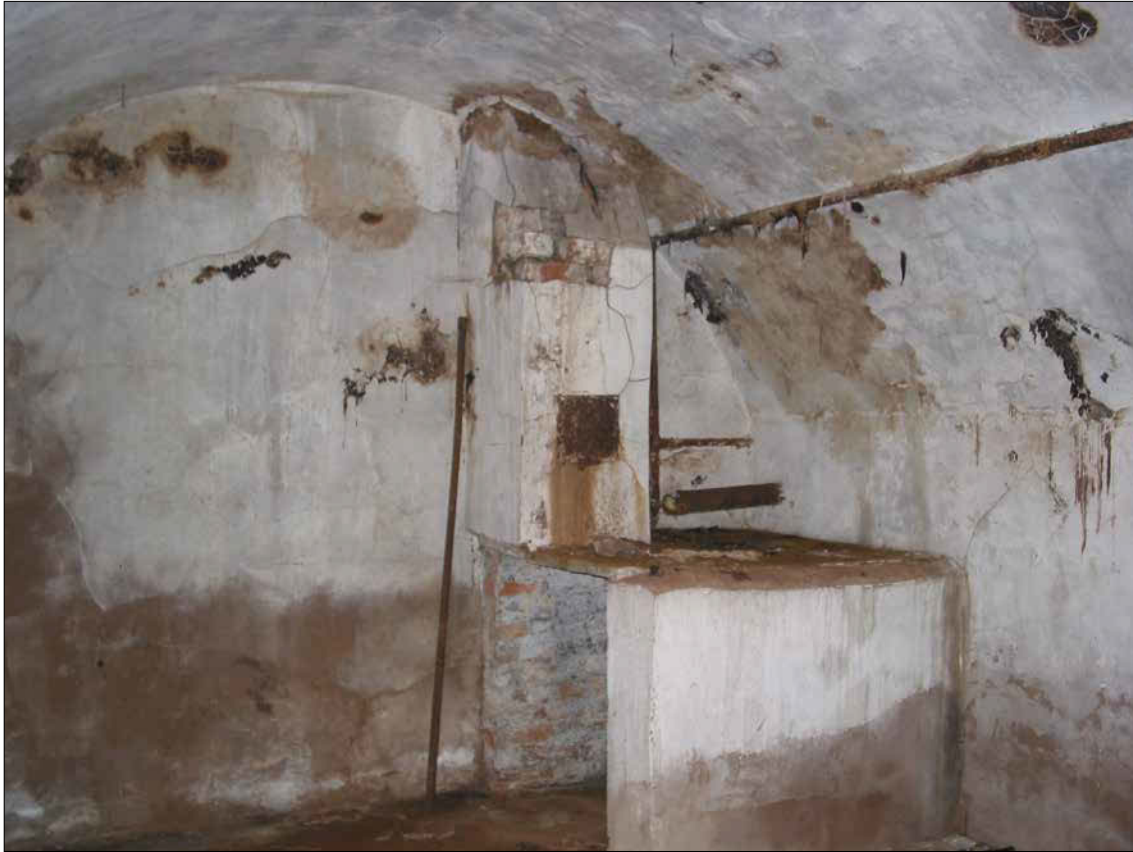
The cellar-stair, which descends directly beneath the second flight of the main stair to the first floor, was reached through a doorway just inside the original entrance to the kitchen, on the northern wall. This stair is made of stone and sets visitors down in the **cellars**, at the western end of a long, narrow chamber, aligned from west to east and taking in the entire width of the main body of the original house. The northern wall of this chamber aligns with the southern wall of the study on the floor above and continues as far as the southern edge of the drawing room fireplace. To the north of the first cellar-chamber, and linked by a doorway directly beneath the archway upstairs, a second chamber takes up the remaining space to the front of the house, with a third, slightly smaller chamber to the east of this, behind a wall running beneath the line of the drawing room's western wall. Chambers two and three are each served by two light-wells, these placed below ground level on the front elevation of the house. With no discernible sources of heat, rubble stone walls and vaulted brick ceilings presumably to reinforce the cold, and given the proximity of the kitchen upstairs, it seems most likely the cellars were used to store food (Figure 25).

Figure 25: Cellar beneath the original house (© Historic England, photograph: Adam Menuge).

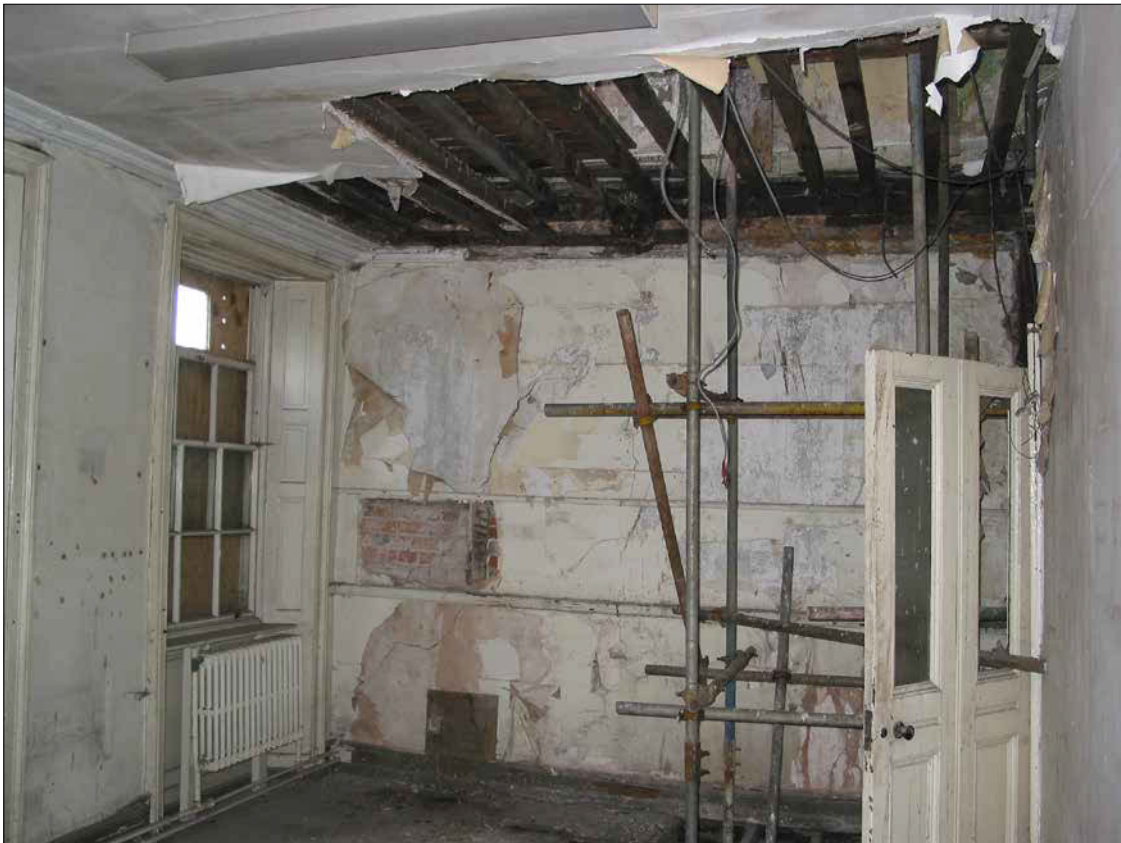
**Bedroom one** (Figure 26) is entered through a door at the eastern end of the room's southern wall. It has three north-facing windows and was originally heated by a fireplace on the wall to the west, but this is currently blocked and its surround has been removed. Original or later 18th-century fixtures within the room include the architraves on the door leading through from the landing, these featuring cavetto, cyma-recta and cyma-reversa mouldings. The architraves on the middle window of the northern wall are 18th-century too, though the mouldings here are organised differently from those on the door. The shutters belonging to the middle window date from the same century, as does the soffit, this being square rather than splayed like those to the 19th-century windows either side.

Figure 26: Bedroom 1 on the first floor (© Historic England, photograph: Adam Menuge).

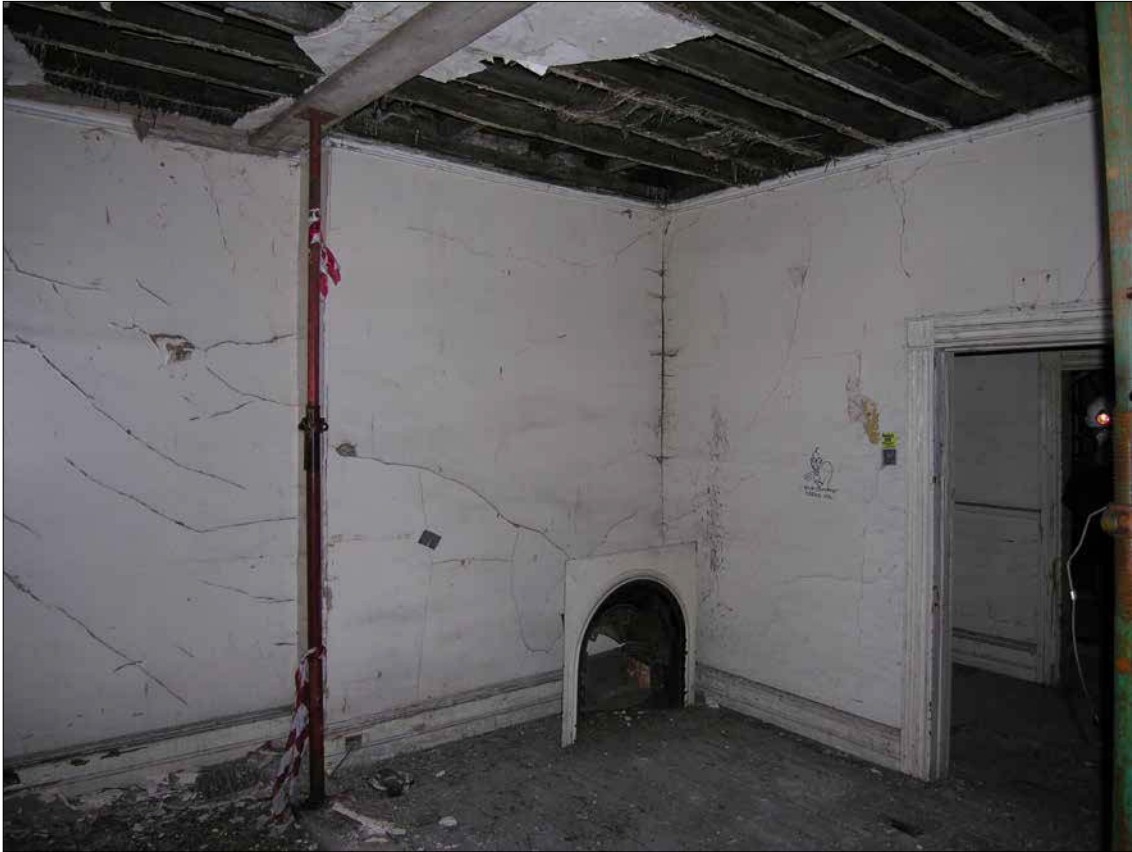
In **bedroom two** (Figure 27) a partition has been inserted to the north of what was once the southern wall in order to form a corridor between this room and bedroom three. Originally bedroom two was entered directly from the landing, through the doorway that now gives access to the corridor. None of the woodwork relating to this door is original, however. Bedroom two is now entered through the doorway in its southern wall, which obviously is contemporary with the insertion of the partition and the forming of the corridor. However this does seem to intimate that the shallow recess on the south side of the corridor is in fact original to the bedroom to the north. Very few original features remain in bedroom two itself. The two north-facing windows are in their original positions, but the related joinery is entirely 19th-century. A pair of beams, probably of 18th-century date, running east

Figure 27: Bedroom 2 on the first floor (© Historic England, photograph: Adam Menuge).

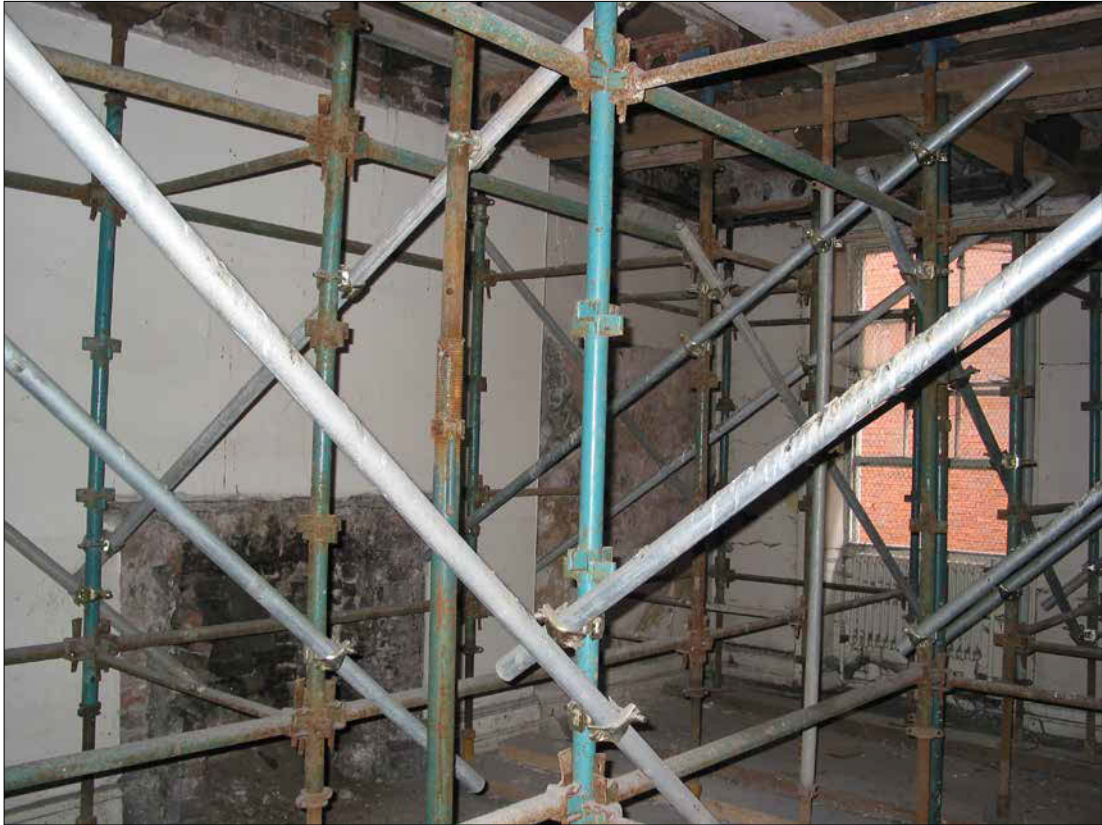
**Bedroom three** (Figure 28) originally had a door at the northern end of its western wall, giving direct access to and from the landing; this door is now blocked. The shallow recess along the room's northern wall is original, as are the positions of the pair of south-facing windows, these each topped on the inside by timber lintels – a standard feature of the period for buildings with brick arches externally. None of the decorative joinery is original, however. Indeed the only other 18th-century features that remain in the room are two beams running from north to south and terminating in a huge, secondary timber made of pine, which runs from east to west. The rest of the ceiling has been removed. Inconsistencies in the brickwork at the top of the chimney-breast indicate that it has been widened at some point in the past, most probably in response to re-arrangements in the dining room directly below, which took place in the late-1860s; the current position of the fireplace corresponds to the chimney-breast as widened. Half of the wall that once separated bedroom three from the stair-landing to the west has been removed, enabling us to see the composition of what remains: studwork with brick infill panels.

Figure 28: Bedroom 3 on the first floor (© Historic England, photograph: Adam Menuge).

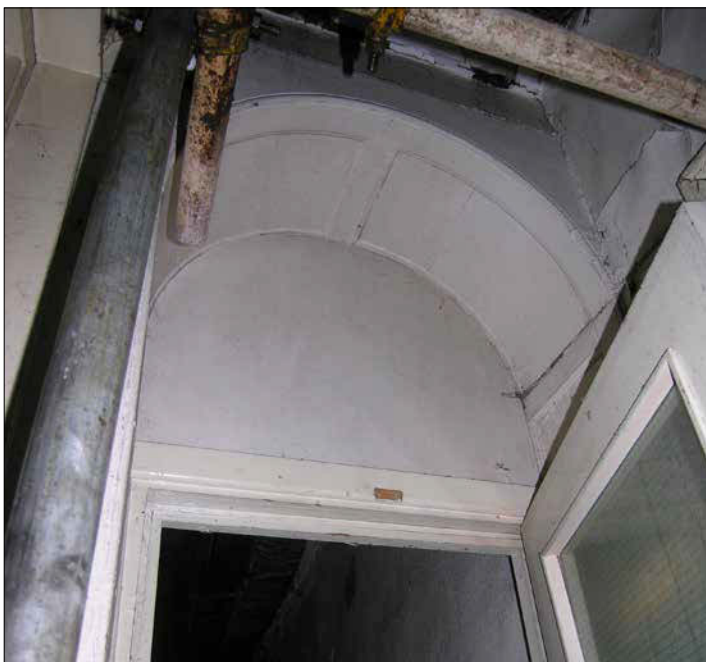
The soffit of the archway that separates the **stair-landing** from the corridor leading to bedrooms four and five is panelled (Figure 29) – a refinement that cogently illustrates the differences in function between the rear wing of the house on this floor and the service wing on the floor below, where the corresponding archway is plain. Little or nothing else that remains in the room is original.

Figure 29: Panelled archway between the stair-landing and the rear first-floor corridor (© Historic England, photograph: Adam Menuge).

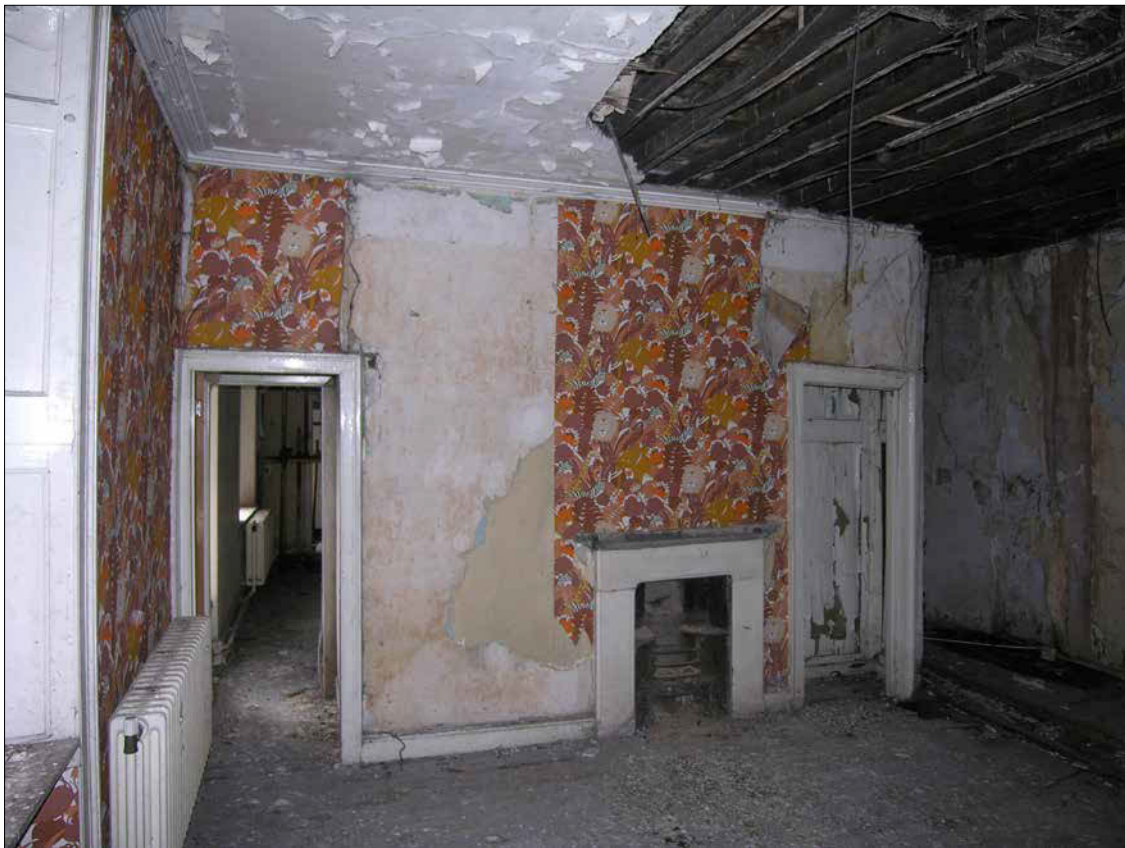
As well as conforming to its original layout, **bedroom four** has more 18th-century fittings than any other room in the house. The doorways and window openings all remain in their original positions, as does a cupboard slightly to the north of the fireplace (Figure 30), and the joinery that goes with these features is almost exclusively of the 18th century. Interestingly, the mouldings on the architraves of the doors to the corridor, to bedroom five and to the cupboard are identical to those found on the middle window of bedroom one, which very probably confirms this as the original decorative treatment. The four-panel doors in bedroom four are all 18th-century too, though that leading to the corridor has had its two top panels replaced with glazing. There are two large, L-shaped hinges on the room-side of this door and appropriately plain, sunk panels, whereas those on the corridor-side are raised and fielded; this would seem to corroborate the decorative hierarchy that once existed between the semi-public passageway and the adjacent, essentially private bedrooms.

Figure 30: Bedroom 4 on the first floor (© Historic England, photograph: Adam Menuge).

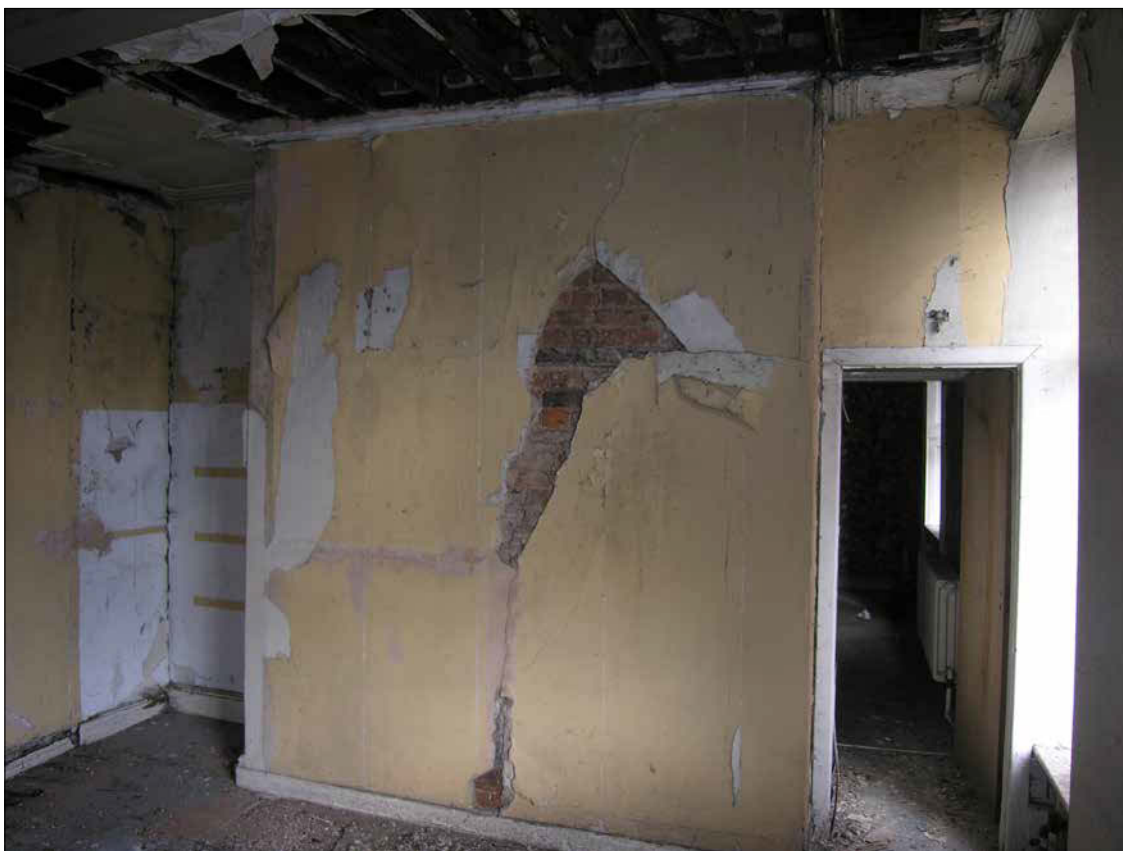
The western wall of **bedroom five** (Figure 31) once formed the outer wall of the house, so we can say with some certainty that the doorway at the southern end of this wall is not original, though it may possibly have been a window at one time. The same applies to the matching doorway, now blocked, at the northern end of the same wall. Bedroom five was entered through a doorway to the north of the fireplace, but this arrangement was superseded by the extension of the adjacent corridor in the later 19th century. Segmental arches of alternating headers and stretchers indicate that the room would once have had two windows on its northern wall (now the north wall of the corridor). This is confirmed by the remnants of two large sandstone sills. The windows overlooked ground to the west of the building's main body – the same ground, in fact, that would have been visible from the large windows of the main stair-hall – and were seemingly designed with languid surveillance in mind; supporting bricks in the corners show where seat-shelves would once have been placed. The only element in the room itself that remains from the 18th century is the ceiling, which is composed of plaster on reeds and is fully under-drawn.

Figure 31: Bedroom 5 on the first floor (© Historic England, photograph: Adam Menuge).

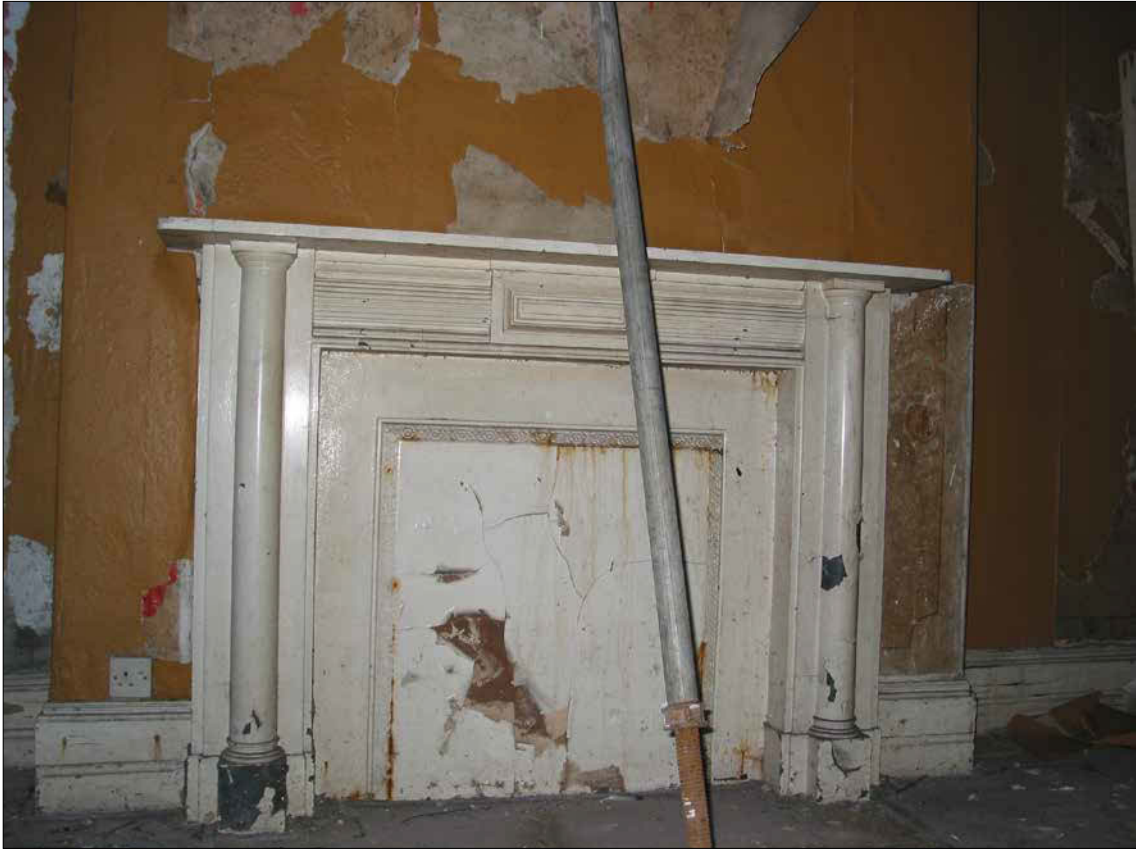
The **drawing room** witnessed the most changes during the early 19th century, with all of the room's joinery replaced, the original entrance opposite the main stair blocked and a new doorway inserted, giving access from the eastern wall of the entrance hall, just to the right as one enters the front door of the house. The surround to this door is synonymous with the early 19th-century joinery still found throughout the drawing room. It consists of architraves with reeds and an ogee moulding, but instead of being intercepted by plinths, as is often the case with architraves of the period, the mouldings run all the way to the floor, and there are two undecorated, sunk blocks at the top corners. The two windows on the north wall have, in addition to similarly decorated architraves, moulded and sunk panel rises, splays and soffits. The top edge of the room's skirting incorporates an ogee moulding similar to that found on the door and window architraves, and there is a large, reeded insert half way down the fixture's primary plane. The cornice also dates from the early 19th century. It consists mainly of reeds, these running along the flat of the ceiling. The fireplace (Figure 32) is of the period too and incorporates Tuscan pilasters and a frieze of pulvinated reeds, these set in panels either side of a raised and moulded oblong centrepiece.

Figure 32: Early-19th-century fireplace in the drawing room (© Historic England, photograph: Adam Menuge).
