# Dee House, Chester An Investigation and Assessment

Research Report Series 005-2016

**DEE HOUSE  
LITTLE ST JOHN STREET  
CHESTER**

**AN INVESTIGATION AND ASSESSMENT OF THE  
EARLY 18TH CENTURY HOUSE AND 19TH CENTURY  
CONVENT SCHOOL**

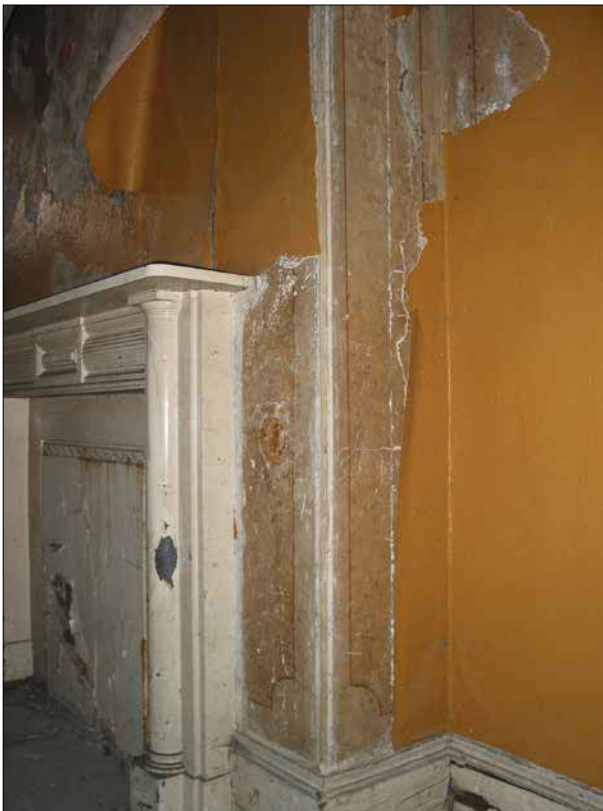
Arguably the most remarkable addition to survive in the drawing room is the scheme of applied decoration, which consists of imitation panelling along the walls, with quadrants in the various corners, all painted in subtle tones of ochre and red (Figure 33). On the north wall the panels are interspersed between the windows, while on the east and west they pay heed, respectively, to the fireplace and the doorway. The decoration may be taken, with caution, as an indicator for the date of the remodelled drawing room, with the interior design specialist Ian C. Bristow noting the way in which 'this treatment of the wall with applied panels found parallel expression in paint, and (possibly again as a result of Continental influence) became quite common. The use of painted panels surrounded by raised gilt mouldings was mentioned by John Pincot and advocated by George Smith in 1812 and 1826; and gilded pressed-metal strips and corner ornaments such as those still existing in the

Figure 33: Early-19th-century applied decoration in the drawing room (© Historic England, photograph: Adam Menuge).

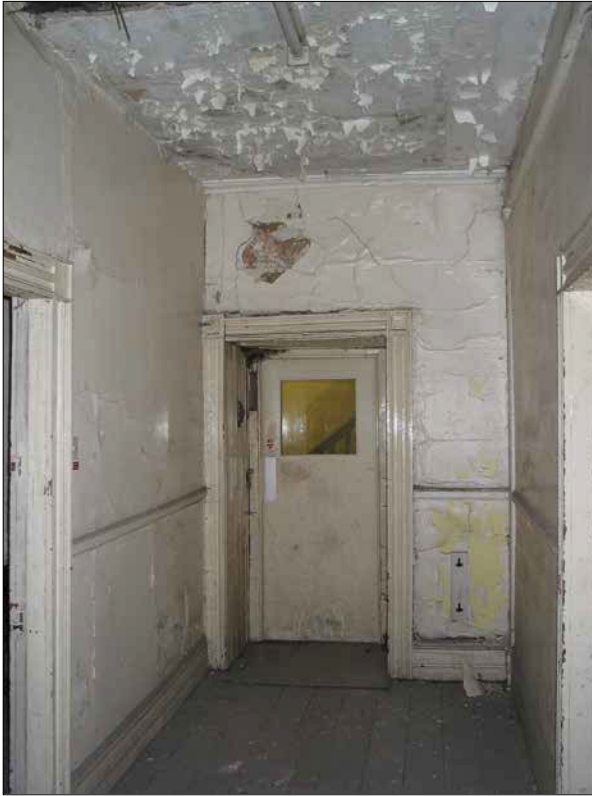
The next stage of the early 19th-century remodelling is exemplified by a **first-floor corridor** (Figure 34) which runs from the landing to the eastern edge of the original house, between bedrooms two and three. The corridor was formed by the insertion of a studwork partition towards the southern end of bedroom two. As well as the doorway from the landing that originally led to bedroom two, the corridor has facing doorways in its northern and southern walls, these giving access to the rooms at the front and back of the house.<sup>56</sup> The doorways have several details in common with the early 19th-century designs found in bedrooms two and three and also in the drawing room downstairs, such as corner blocks and a gathered-reed moulding as part of the architraves, but they also have an echinus moulding – a Greek Revival feature that post-dates the second decade of the 19th century and features nowhere in the other three rooms. This verifies with reasonable certainty

Figure 34: First-floor corridor between bedrooms 2 and 3 (© Historic England, photograph: Adam Menuge).

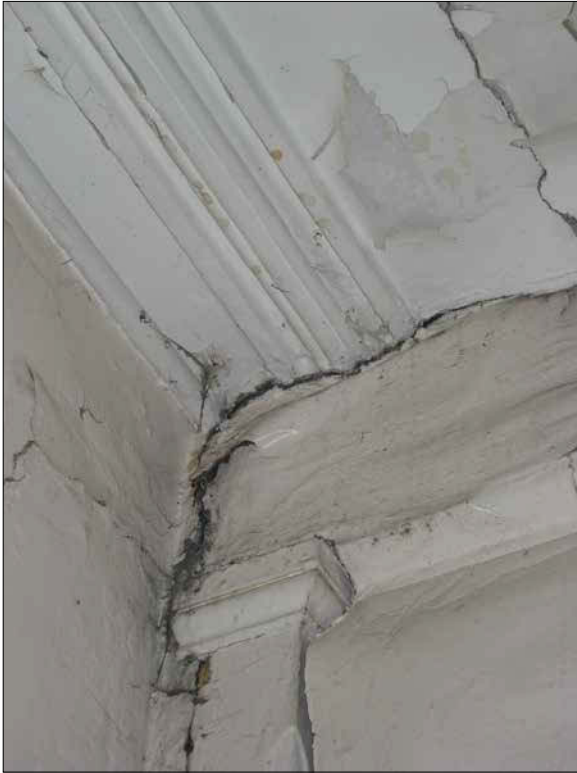
Figure 35: First-floor cornice detail (© Historic England, photograph: Adam Menuge).

**Bedroom four** and **bedroom five** were most probably remodelled at the same time as bedroom one. The cornice in bedroom four has a diminutive version of the same three-part reed moulding found in several other rooms in the house. The motif also forms part of the skirting and there is a reeded scheme of decoration to be seen on the cheeks and basket of the room's fire-grate, as well as a leaf motif on the back that is entirely in keeping with the early 19th-century themes explored throughout the rest of the room. The cornice in bedroom five is similar. Tellingly, though, the skirting in this room, in addition to a torus moulding at the top, has the same chamfered lower part as found in bedroom one.

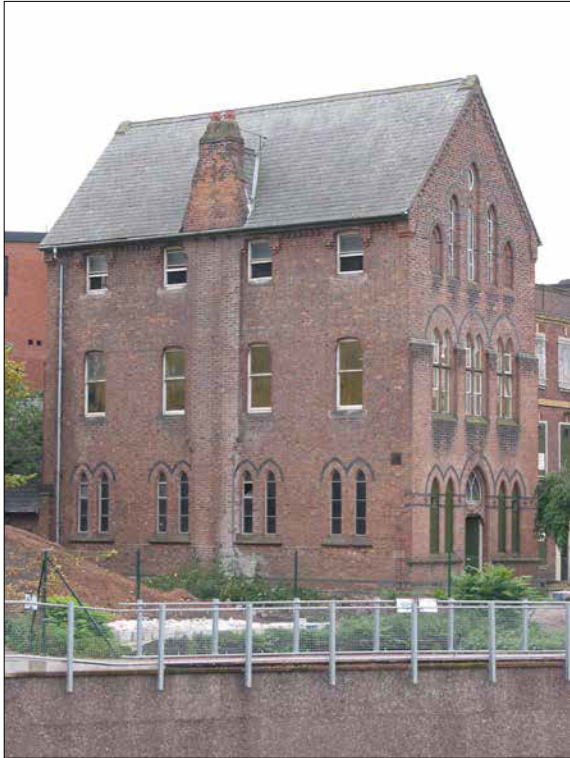
Figure 36: The chapel-wing extension  
(© Historic England, photograph: Adam Menuge).

Moving on to the chapel wing proper (Figure 36), the main body is rectangular in plan, with a stair-turret forming a second, much narrower rectangle immediately adjacent to the original block of Dee House the ground floor marked as 'CLOISTER' on Kirby's plan (see above and Figures 7-9), and a single-storey chancel and adjacent vestry at the southern end. Like the original house, the chapel wing faces north by north-west, but it also has an entirely open elevation to the side, which looks east by north-east. For the sake of convenience these outlooks will henceforth be described as north and east. The building has three storeys, though a half-landing in the staircase, between the ground floor and the first floor of the main block, has been demarcated with its own windows on the front and west elevations of the stair-turret. It is constructed in red brick in Flemish bond, with red St Helens sandstone sills, transoms, springers at the tops of the mullions on the first floor and an apex at the coping of the main part of the roof.<sup>58</sup> Dark blue brick has been used to form framing bands over the windows on the ground, first and second floors, as well as the first- and second-floor windows on the stair-turret. There is also a chamfered band of blue bricks topping the plinth, and a roll set in a cavetto running into pyramid stops at the sides of the main entrance. A band of dog-tooth moulded brick runs just beneath the ground-floor windows, and rows of dentils line the verges on the north gable, as well as the eaves cornice of the stair-turret. The roof is covered in Welsh slate, laid in irregular courses, with ridges of rolled clay.

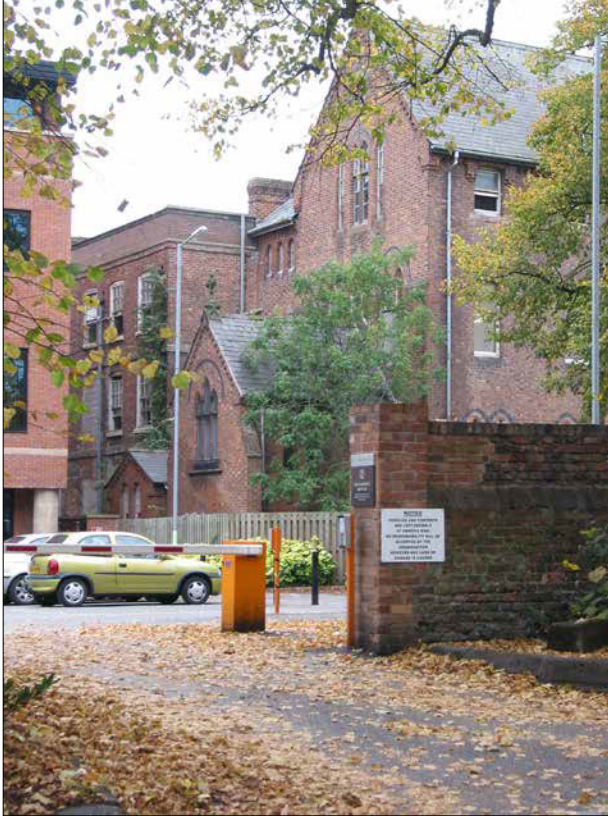
The decorative treatment of the rear elevation (Figure 37) is very nearly as elaborate as that to the front, suggesting that the ground at the back of the building was intended always to be open and accessible. There is the same setting back arrangement at first-floor level as found on the elevation to the north, and the fenestration on the first and second floors is similar too, though slightly simpler in some of its details. The three sets of paired window-openings at first-floor level are precisely the same as those on the front, but slightly smaller. The second floor is different, however, with four pointed-arch window-openings – a pair with transoms flanked by two single lights, all the same size, without the recesses found at the front, meaning that the mandorla at the head of the gable is singled out as a feature in its own right. There is the same dentilled treatment of the eaves as at the front, and the window-openings are framed in similar bands of dark-glazed brick. The windows are iron-framed, again like those to the front.

Figure 37: The rear of the chapel-wing extension (© Historic England, photograph: Adam Menuge).

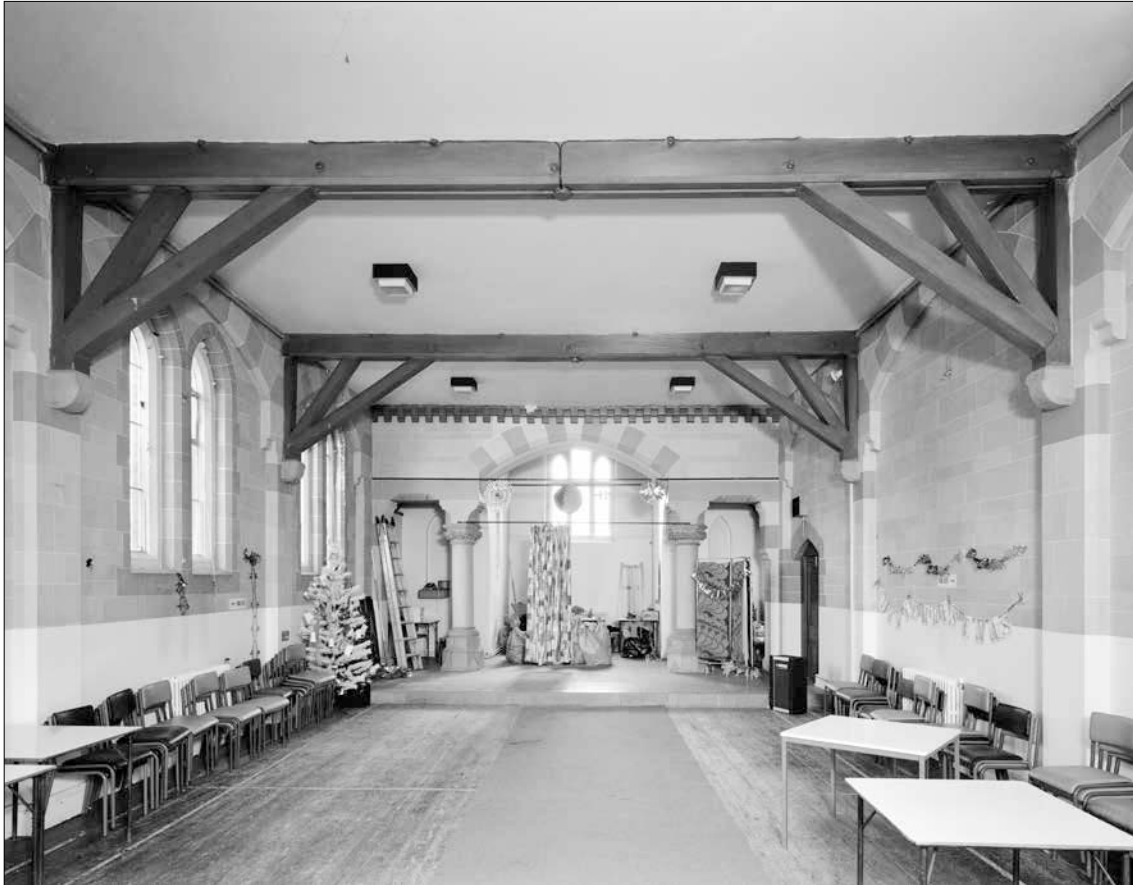
Inside, the ground floor is taken up by a **chapel**, with the altar to the south behind a screen that includes a corbel table along its pointed segmental chancel arch and stone columns to the east and west, these topped by capitals carved abundantly with flowers and single angels above (Figure 38). The angels face the altar, that to the east holding a palm, the one to the west bearing a ribbon with the incised axiom 'SANCTUS'. The chancel arch is flanked by openings with chamfered and carved ashlar lintels, supported by the columns and by pilaster strips which are corbelled out at the tops, beyond which are ledged lancet niches set within the chapel's south wall. The sanctuary occupies a single-storey gabled projection from the centre of the south wall and is lit from the south by a single window of three lancets. The rest of the chapel is lit by windows on the east side of the interior which are placed on panels, these separated by piers. The piers, five per wall in total, have stone corbels on which are carried wooden beams, splayed out, with a flitched beam of Baltic pine

Figure 38: Ground floor of the chapel-wing extension looking south in 1991 (BB91/26355 © Historic England, photograph: Bob Skingle).

just to the north of the chancel arch. There is another corbel table at ceiling-level along the north wall. The walls of the interior are currently plastered and probably always have been so, given the rough way in which the original brick underneath is laid.

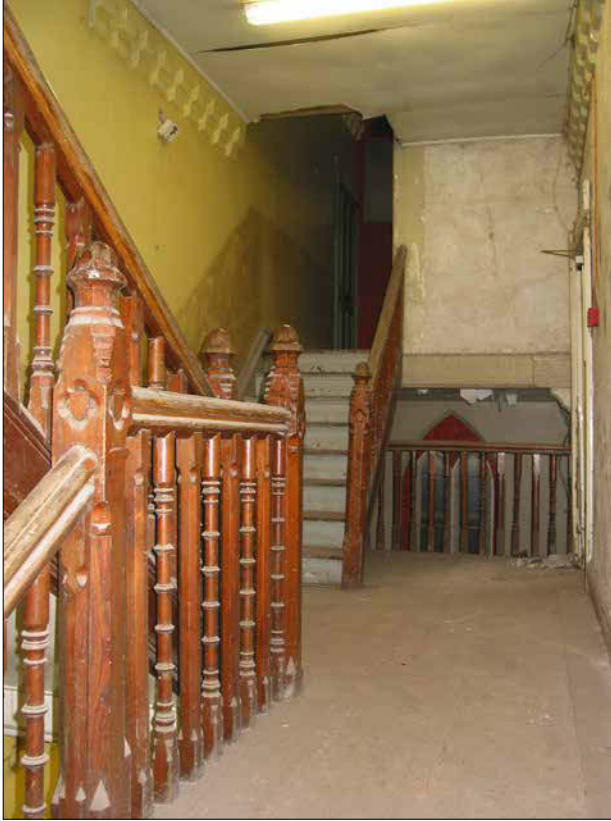
The floors of the extension are connected by a wooden staircase (Figure 39) running up through the **turret** on the west side of the building, which is reached through a large, depressed-arch doorway at the northern end of the west wall of the chapel, on the right as one enters from the front. There is a little pointed-arch niche just inside this doorway on the turret-side, with a basin or stoup for holy water; this allowed residents to cross themselves before entering the chapel. Corbels either side of the doorway indicate the former positions, no doubt, of iconic statuettes. The staircase has alternating turned and chamfered balusters, one each per tread, and chamfered newels with trefoils and domed finials marking the start of each flight on the journey up through the turret. The newels are of oak, the balusters of pine. A moulded oak hand-rail links these elements, while the treads are moulded and made of pine, as is the skirting up as far as the first floor. A simple flush skirting of cement – a material most often associated with areas that are expected to be busy – lines the walls on the floors above.

Figure 39: Staircase in chapel-wing extension (© Historic England, photograph: Adam Menuge).

The staircase splits in two at the half-landing between the ground and first floors, with one flight leading to a first-floor doorway in the eastern wall of the turret at the front of the building, and the other to a doorway in the same wall at the rear. The doorways are straight-headed with chamfered architraves and Gothicising corner posts featuring a variety of splay-cut mouldings. This decorative treatment is uniform for the door and window architraves throughout the rest of the extension. Where they remain, the doors themselves are also generic, with two large upper sunk-panels and smaller ones lower down. There are pyramid stops at the bases of the panels and scroll stops above.

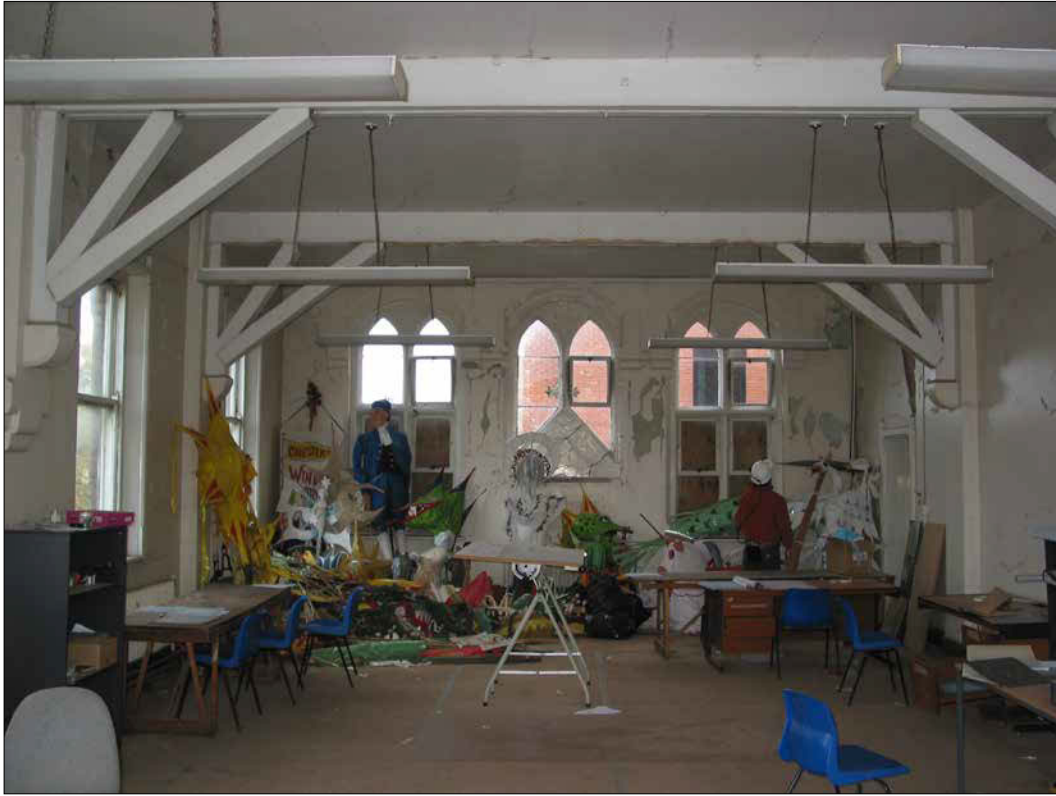
The doorways on the first floor of the turret's eastern wall give two points of access to the main room on this storey, one entrance for children and the other presumably for their teachers; the chamber seems to have been planned as a large and well-lit **first-floor classroom** (Figure 40). It is a single space, its walls lined with piers and panels. The panels to the east hold four timber sash-and-case windows. The piers have stone corbels, on which are held the ceiling-supporting beams, these for the most part pragmatic and undecorated. On the southern wall the windows are paired and have pointed arches, with the gabled head of the back-building outside echoed in a triangular element that pushes up into the middle pair.

Figure 40: First-floor classroom in chapel-wing extension (© Historic England, photograph: Adam Menuge).

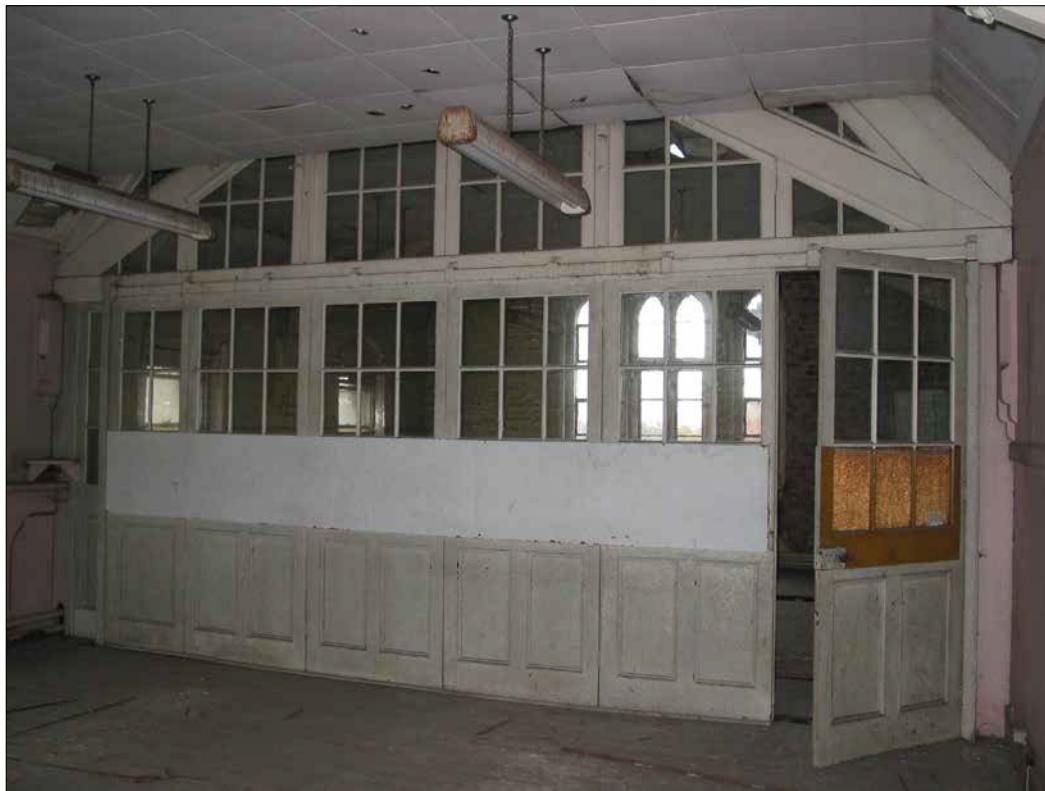
The **second-floor dormitory** (Figure 41) is also accessed via doorways at the front and back of the building, and has the same panels-and-piers arrangement to its walls as seen on the floors below. The fireplace on the eastern wall has a chamfered lintel over shouldered jambs, with splay-cuts running down the outer edges of these cheeks. Looking up through gaps in the later tiled ceiling, one can see that

Figure 41: Second-floor interior of chapel-wing extension (© Historic England, photograph: Adam Menuge).

the original eaves treatment is stepped with round-sided bricks. The roof trusses above this are scissor-braced, with a saltire-shaped iron fixing where they join in the middle. The upper ends of the scissor-braces dovetail with the principal rafter and are secured by an iron strap.

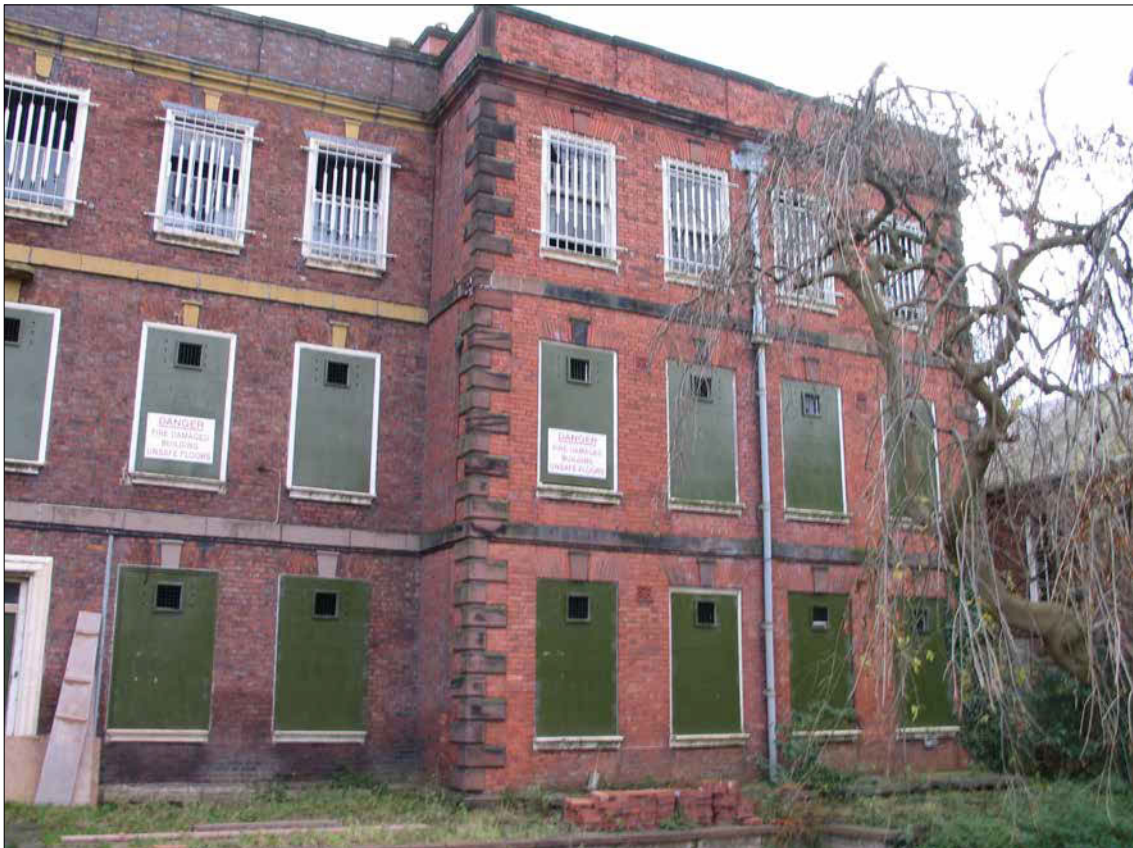
Figure 42: Late-19th-century extension to the west of the original house (© Historic England, photograph: Adam Menuge).

with which it is constructed is brighter and more orange in colour than the dark red brick of the house. There are ventilation openings with decorative terracotta covers between the windows on each floor, whereas the original has no such provision. The spaces between these windows are regular and precise (three headers, two stretchers), in contrast to the pragmatic variations found adjacent. The left jamb of the eastern-most windows and the right jamb of those furthest to the west have closing bricks; the corresponding windows on the original building do not. Most of the stone details (the plinth, the keystones, etc.) remain unpainted on the extension, though it should be noted that the paint seen on the adjacent 18th-century dressings may not necessarily be original. Interestingly, the stone sills on the extension – one of the few elements here that have been painted – have block endings, in correspondence with the concrete replacements on the original building rather than the stone sills first inserted. The later building has also been provided with an elaborate rainwater hopper of cast iron between the heads of the middle windows on the second floor, with a box-section down-pipe (replaced with a circular pipe lower down the building) running to a drain on the ground.

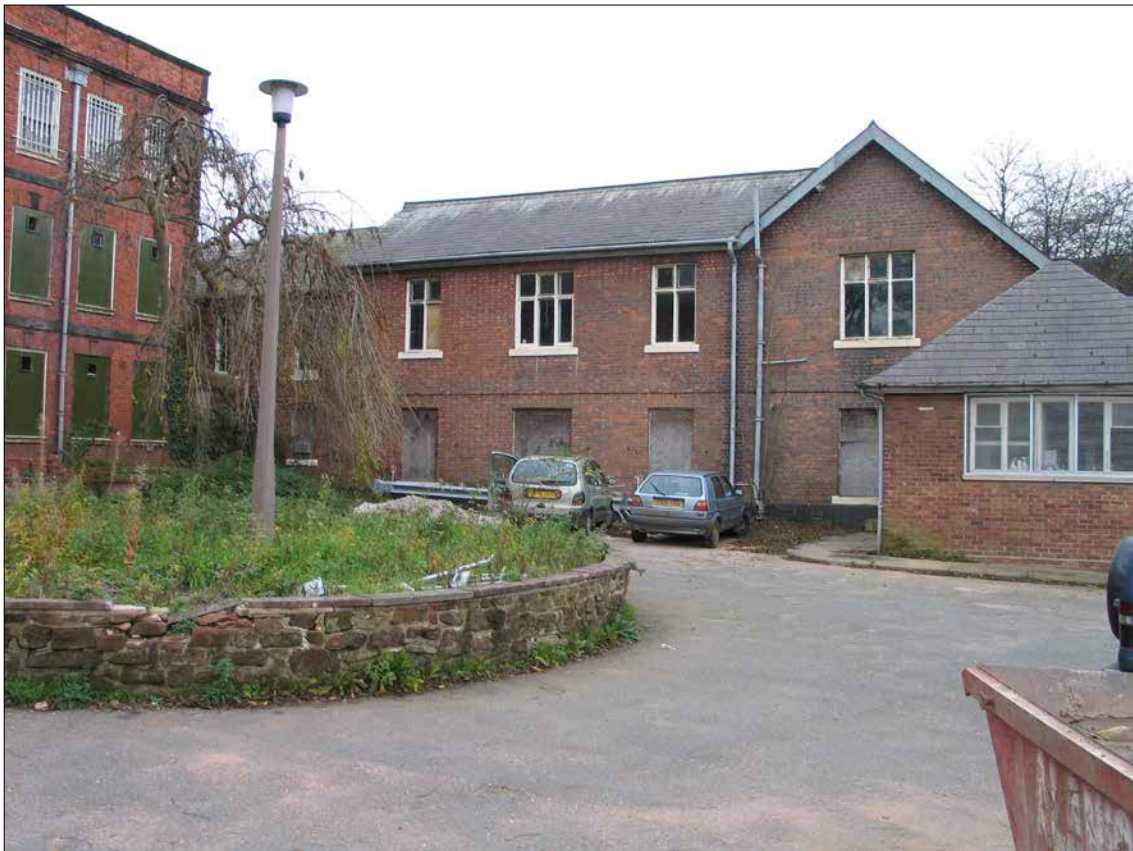
The earliest part of the present range, occupying the centre, consists of two storeys and five bays, of which the southern three are in line, the next is gabled to the east as a cross-wing and the northernmost takes the form of an outshot continuing the slope of the cross-wing gable (Figure 43). The plan tapers towards the northern end, respecting the curved alignment of Souter's Lane. The brickwork is in Flemish bond and is closed at the southern end of both main elevations, where a later building abuts. On the western elevation, as already noted, it overlies earlier masonry (Figure 44), but on the eastern elevation it stands on a chamfered plinth of blue brick. In the south gable wall, now largely removed, there was a large first-floor window, of which the two-centred arch (or possibly the relieving arch) survives. The openings

Figure 43: Range along Souter's Lane from the east (© Historic England, photograph: Adam Menuge).

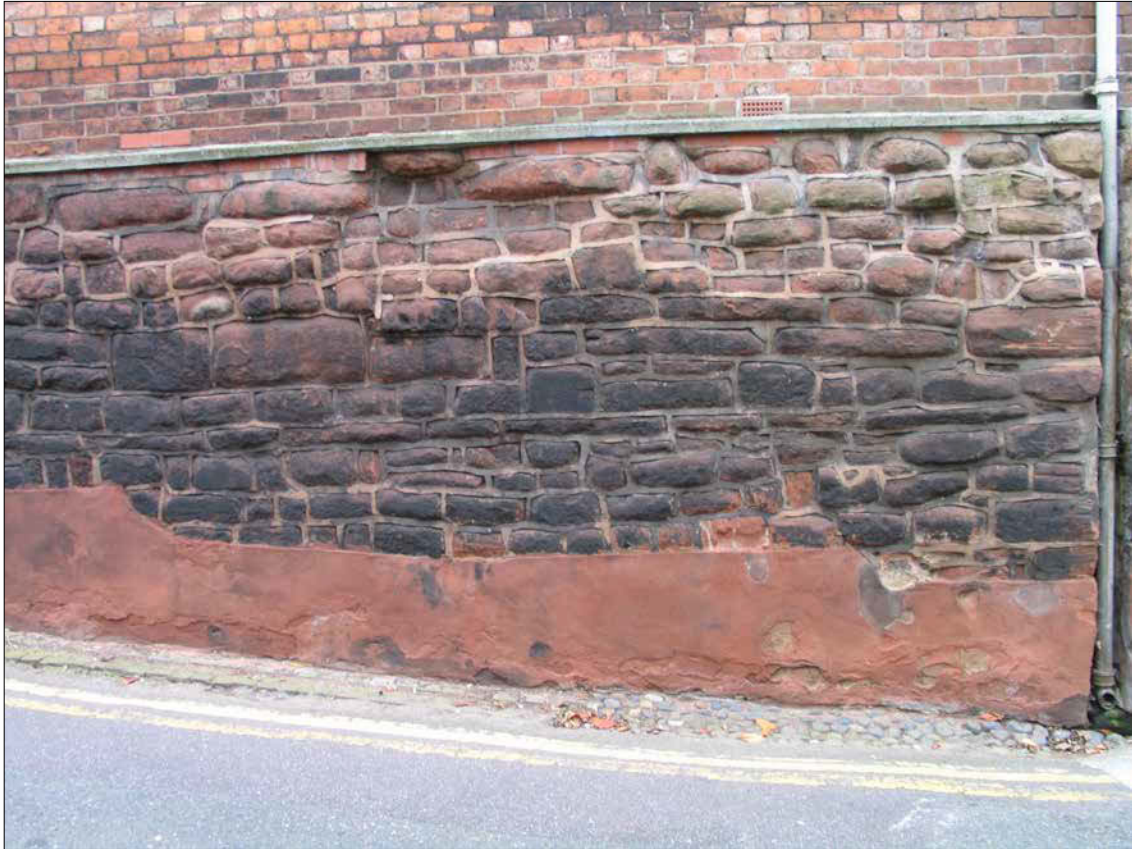
Figure 44: Early masonry underlying range along Souter's Lane (© Historic England, photograph: Adam Menuge).

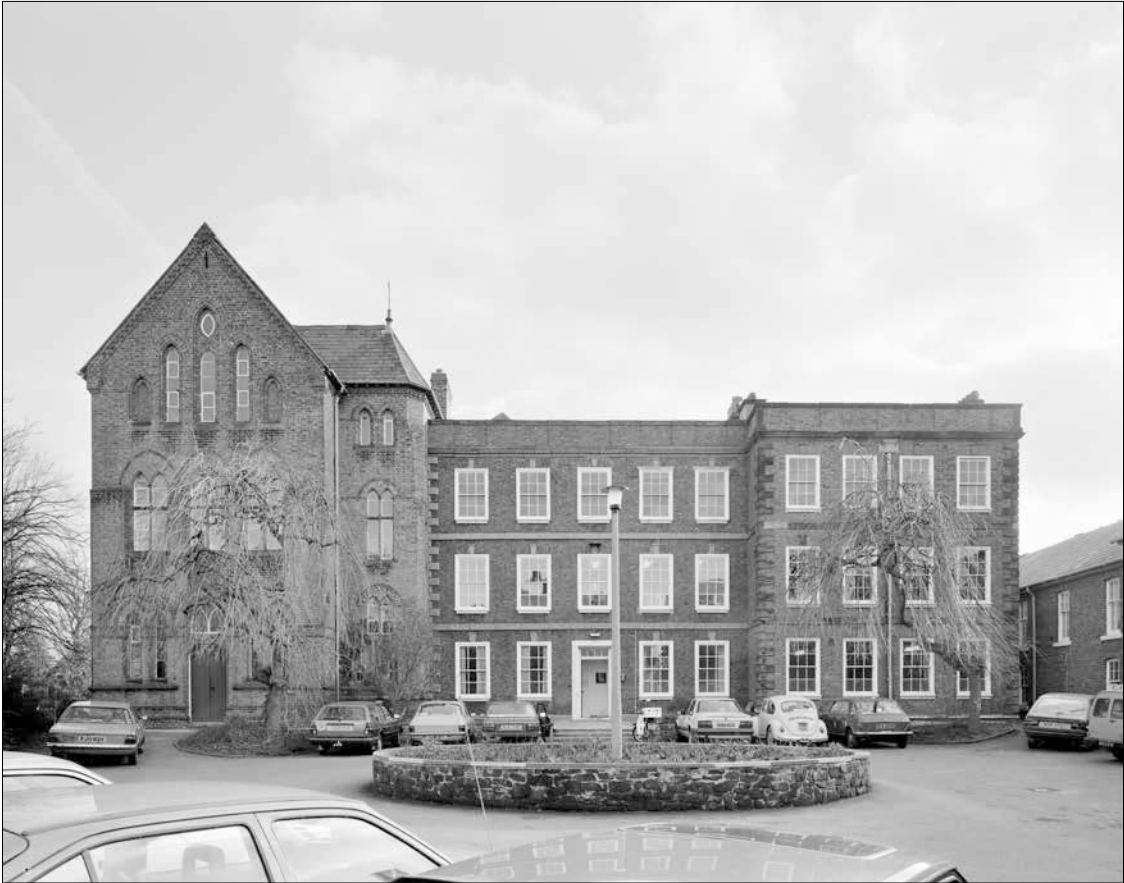
Dee House has its own particular story to tell but it also reflects the twin characteristics – ecclesiastical enclave and villa suburb – which emerged during the 18th century. Today its history and significance are better appreciated and we can see how both Dee House and the particular characteristics of its setting have their roots in the disposition of the Roman town, of the amphitheatre outside the walls and of the resulting street pattern. With the earlier loss of both The Archdeacon's House and St John's House (demolished in 1958 to make way for the excavation of the amphitheatre) Dee House and the Old Palace (the latter unoccupied but in good condition at the time of writing) stand together as the last reminders of the fine residences which once constituted 'Dee Side' (Figure 45).

*Figure 45: Dee House photographed from the north in 1991 before falling into decay (BB91/26343 © Historic England, photograph: Bob Skingle).*
