Watgrove, Great Chalfield, Wiltshire Earthwork Survey

Research Report Series no. 91-2015

WATGROVE, GREAT CHALFIELD, WILTSHIRE

EARTHWORK SURVEY

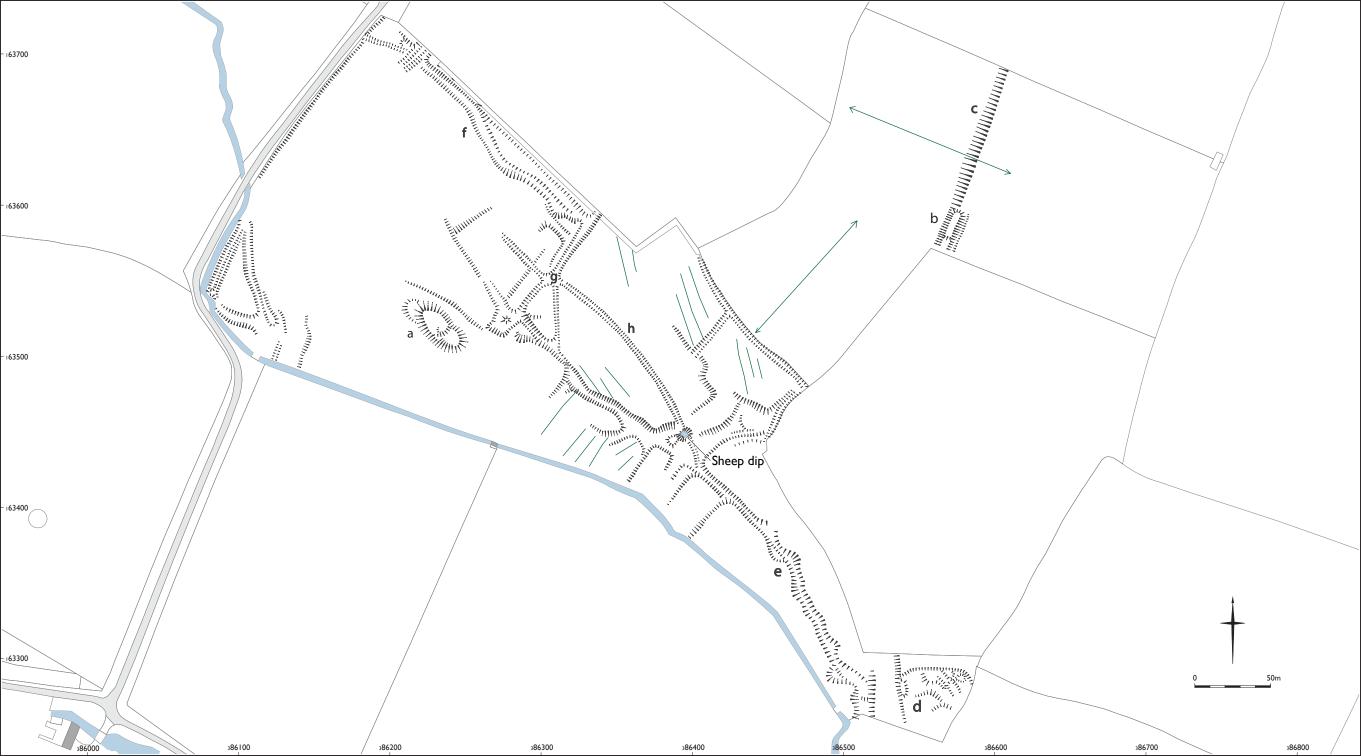
Figure 4 (inset facing): General survey plan of Hargrove (reduced from 1:1,000)

A spread oval mound (Figure 4, a), which lies close to a spring head and the former course of the Lenton Brook, may be the earliest feature in Watgrove. It measures approximately 45m long x 25m wide and stands up to 0.7m high, yet it has been overlooked in the past due to its indistinct profile and the absence of any surrounding ditch. The date and purpose of the mound is uncertain, but it does not appear to be a natural feature, since it lies isolated on a level floodplain and is not consistent with the surrounding topography. It is possible that it is composed of up-cast material from adjacent water management features (see below). However, its location, its size, plan and general form raise the possibility that it could be the remains of a prehistoric burial mound. The distribution of Neolithic long barrows in Britain shows a noted and widespread focus on rivers and watercourses, a pattern which is reflected in Wiltshire. Similarly, Bronze Age round barrows tended to avoid higher ground in favour of lower slopes. Within the wider West Wiltshire project area, a number of ring ditches have been recorded lying on floodplains in close proximity to water, often at the confluences of rivers and streams, suggesting that a riverine location was significant in their siting (Carpenter & Evans 2014, 14-16). Parallels with the mound at Great Chalfield may be found in ploughed-out features recorded as

In Crooked Wood Lays, there is a further mound (b on Figure 4). It is sub-rectangular in plan, c30m long x c8m wide and stands approximately 0.3m high. A narrow surrounding ditch is evident on all but its southern end, where it is truncated by the current field boundary. The mound has been constructed on top of a lynchet (c), which is a prominent feature bisecting the field and the ridge-and-furrow overlies both lynchet and mound (see below pp12-13).

In the far eastern tip of Watgrove, which extends as an elongated spur, a small complex of earthworks (d on Figure 4) was discovered lying close to the Lenton Brook. These earthworks comprise two well-defined sub-rectangular platforms (Figure 8, a), the remains of three larger platforms (Figure 8, b) with short lengths of hollowed access-ways (Figure 8, c) running between them. All are set

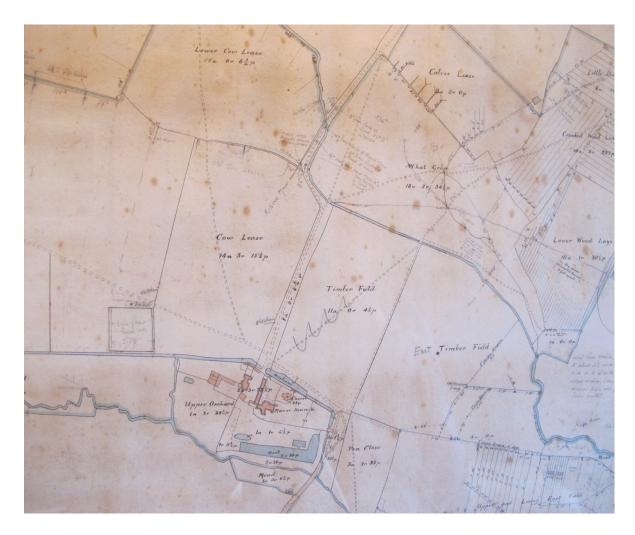
Figure 3: Estate map of Great Chalfield in 1834 showing the manor house and its surroundings (reproduced by kind permission of Mr Robert Floyd)

Figure 3: Estate map of Great Chalfield in 1834 showing the manorial complex and its immediate surroundings (reproduced by kind permission of Mr Robert Floyd).

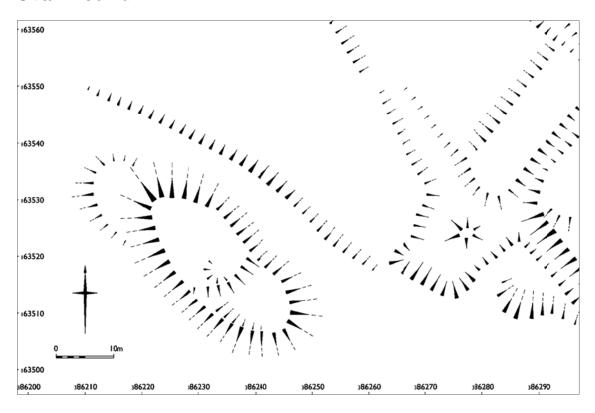
Figure 5: Detail of the oval mound

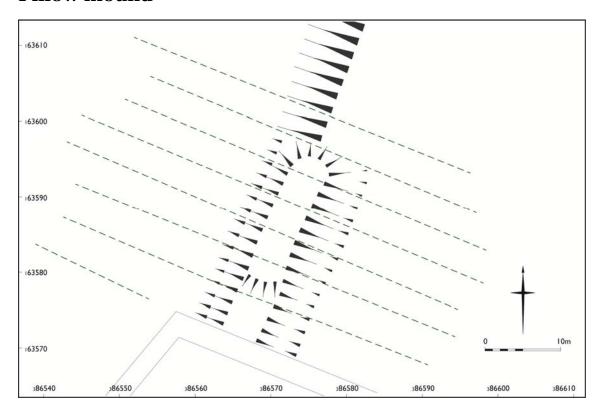
Figure 6: Detail of the pillow mound, lynchet and ridge and furrow in Crooked Wood Lays.

The existence of this mound was already known by the National Trust but it was not recorded in the National Record of Historic Environment (AMIE) and its purpose and origins were not clear. Its sub-rectangular plan and its general form are highly characteristic of a pillow mound, which would have formed part

of a rabbit warren of medieval or post-medieval date. Construction of pillow mounds on top of former field boundaries appears to have been common practice and is seen elsewhere, for example on Minchinhampton Common and Barrington, Gloucestershire (Smith 2002, 28). This earthwork relationship clearly demonstrates the antiquity of the field lynchet, which must have been disused by the time the warren was created. The former existence of a rabbit warren in the vicinity is confirmed by the presence of five field names containing the name 'Conygree', immediately to the west, on the estate map of 1794 (Figure 7).

The latest phase of earthworks in Crooked Wood Lays is extensive narrow ridge and furrow. This consists of well-defined straight ridges crossing the field lynchet and the pillow mound described above. In the western half of the field this is aligned at an approximate right angle to the drains depicted in 1834, indicating that it might have been the result of post-drainage cultivation using steam ploughing.

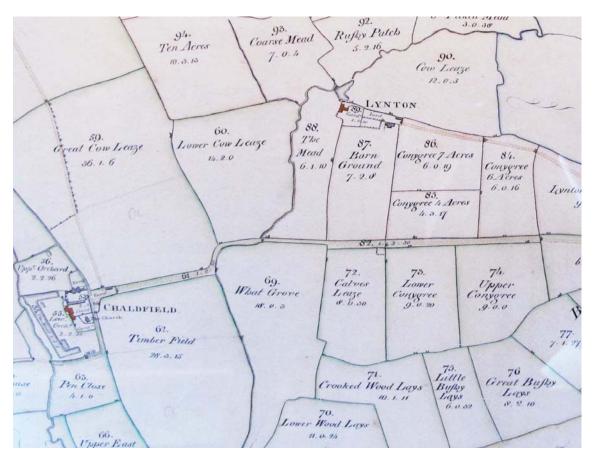
Figure 7: A Map of the Maner and Parish of Great Chaldfield in the county of Wilts belonging to Miss Grace-Elizabeth Neale 1794 (6 chains to one inch). North is to the right of the image (reproduced by kind permission of the National Trust).

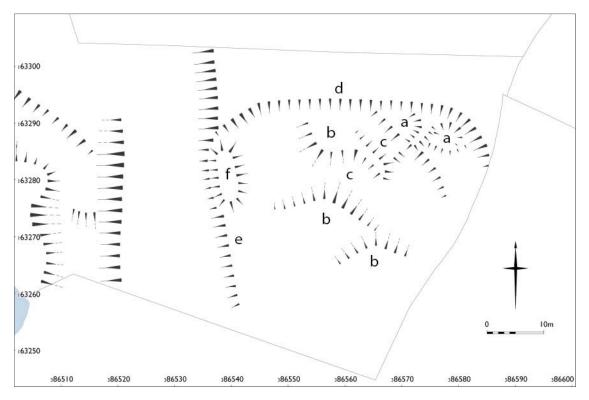
into the natural west-facing slope. The complex is bounded on its northern side by a 0.7m high scarp (Figure 8, d) and an equally substantial lynchet (Figure 8, e) (on its western side. An elongated sub-rectangular mound (potentially the remains of a further pillow mound) (Figure 8, f) partially overlies the lynchet and a veteran oak pollard (Figure 9) stands at its southern end.

Figure 8: Possible settlement earthworks in the eastern tip of Watgrove.

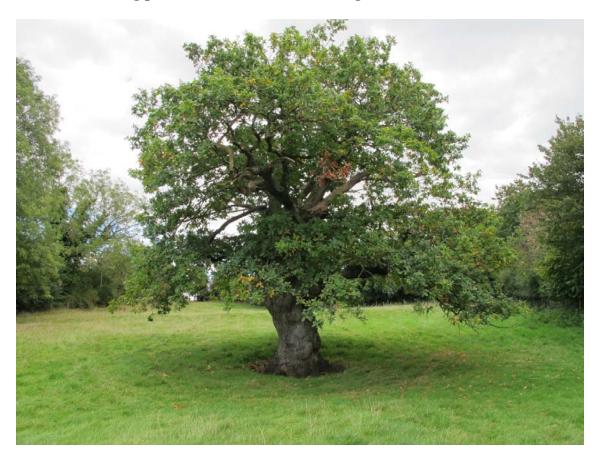
Figure 9: Oak pollard close to possible settlement earthworks at Great Chalfield.

Figure 9: Oak pollard close to possible settlement earthworks.

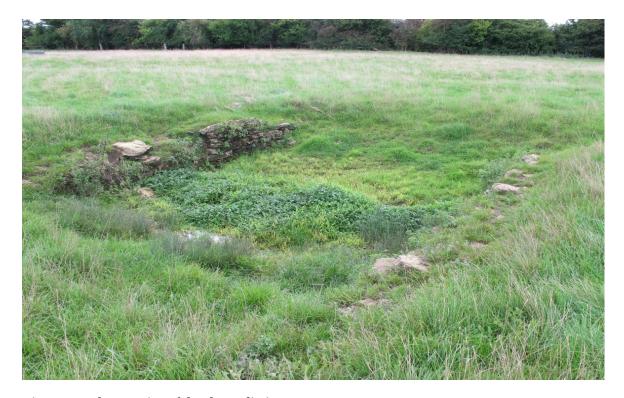
A complex of partially disused water management features is concentrated along the former course of the Lenton Brook (e) which runs through Watgrove. The Brook has been diverted from this original course into an artificial channel skirting the southern boundary of the field. When this was done and the reasons for it are not certain, but it occurred before the earliest detailed map of the area, dated 1794. A shallow channel (f), c0.2m deep and now dry, runs inside the northern-western boundary of the field before joining a further channel at right angles. Its western end was not traced beyond the boundary of Watgrove, but it appears to lead from the point where the Lenton Brook has been diverted to its new course along the field's southern boundary, so it is likely to represent a further part of the original course of the stream through Watgrove. It continues south-east until it meets four other radiating channels at (g). One of these channels, (h), by-passes a further section of the dry stream course but re-joins it after flowing through a sheep dip. The remains of the sheep dip, which was dry

at the time of the survey, remain as a well-defined sub-square depression with two of its sides riveted by dry-stone walling. Further masonry structures in Watgrove are stone bridges which provide access across the water channels. The date of these bridges is extremely difficult to determine, however the position of the main crossing points have remained unchanged since at least1794.

Figure 10: The remains of the sheep-dip in Watgrove.

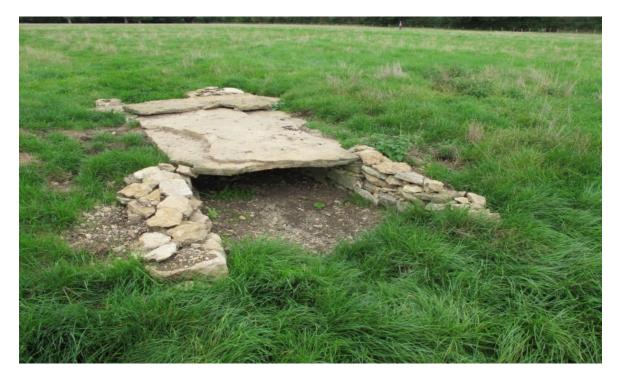
Figure 11: A stone bridge crossing a water channel in Watgrove

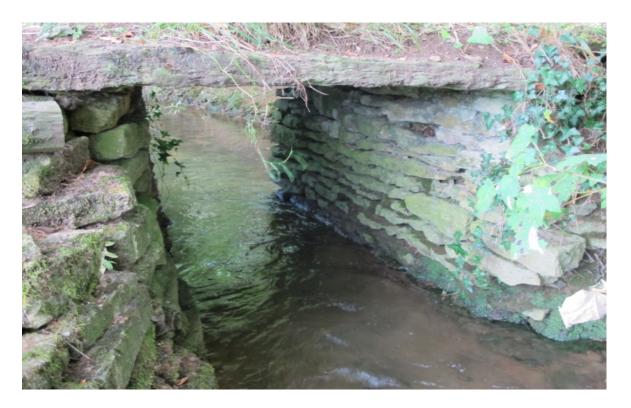
$\label{eq:figure 12:Abridge over the re-aligned Lenton Brook which forms the southern boundary of Hargrove.$

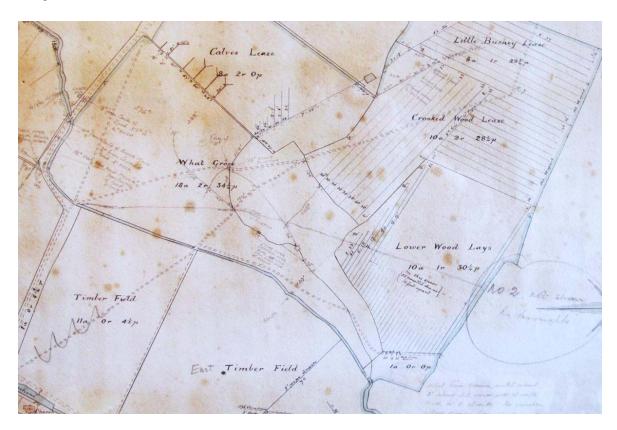
Vestiges of smaller channels over much of the field may be the result of later sub-surface drainage (see Figure 13). The field continued to be the subject of intensive water management schemes into, at least, the 19th century (Figure 13), although the purpose of the multiplicity of channels and drains is not obvious today. The alignment of channel 'f' suggests that it brought water from the Lenton Brook onto the field and that via a complex of further channels, it ultimately supplied the sheep dip. This complex of features utilizing the old stream course, including the old sheep dip, was either intended to be filled with water periodically or it pre-dates the diversion of the Brook. It is possible that some of the earthworks functioned as a crude form of water meadow, with the re-aligned section of the Brook serving as a main drain. Although the system bears no resemblance to the complex bedworks found in the chalk valleys of Wiltshire, the field has been identified as a water meadow by local sources (eg Bradford-on-Avon Museum) and Great Chalfield has a potentially significant

Figure 13: Extract from an estate map of 1834, showing details of drainage work in Watgrove and surrounding fields (reproduced by kind permission of Mr Robert Floyd).
