Codnor Castle, Castle Lane, Codnor, Derbyshire

Tree-ring Analysis of Oak Timbers from the Farmhouse and Barn

Alison Arnold and Robert Howard

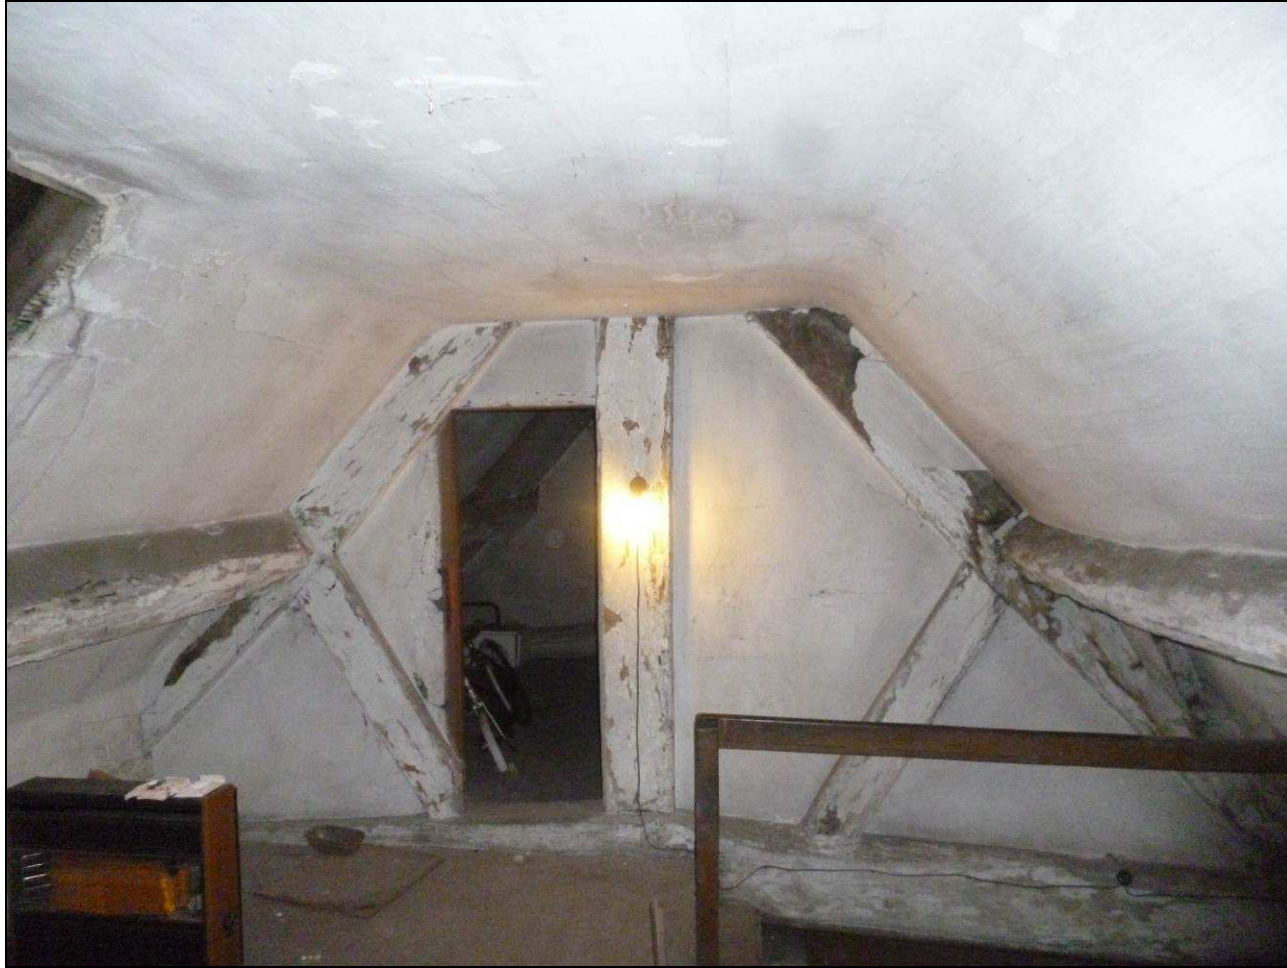
Figure 5: Farmhouse, primary roof, truss 1, photograph taken from the south (Robert Howard)

The northern section of the farmhouse is believed to represent the original, or primary, building (Fig 4). The roof over this part of the house consists of two visible principal rafter and tiebeam trusses with the southernmost one (truss 2) being closed with 'herringbone' style framing and the central one (truss 1) having raking struts and king post (Fig 5). The first-floor frame is exposed at ground-floor level in the living room (Fig 6) and the entrance hall and comprises a main east-west beam from which runs a single main north-south beam, which in turn holds the common joists.

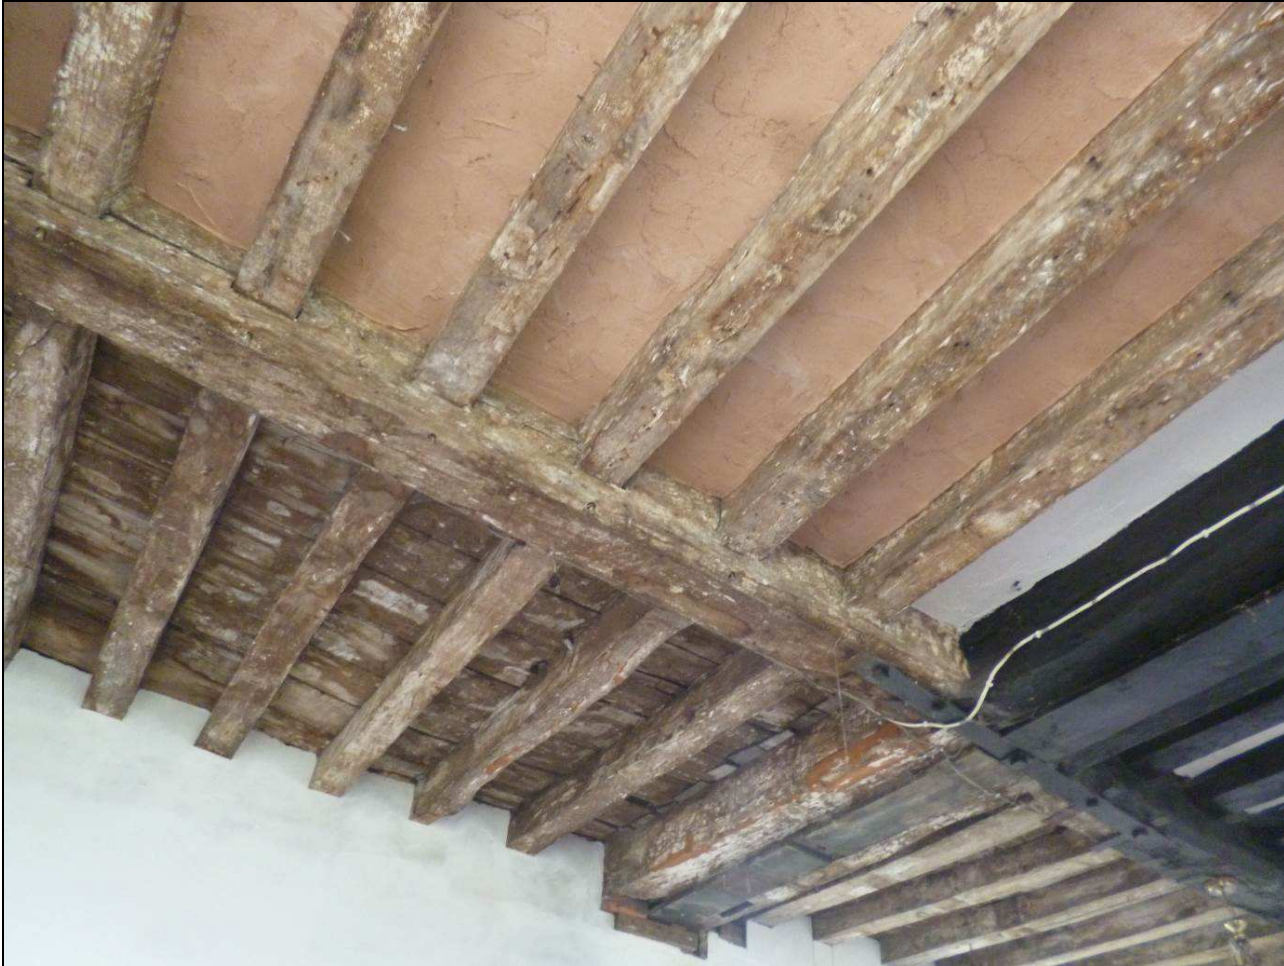
Figure 6: Farmhouse, primary floor frame (left of photograph), photograph taken from the north-west (Robert Howard)

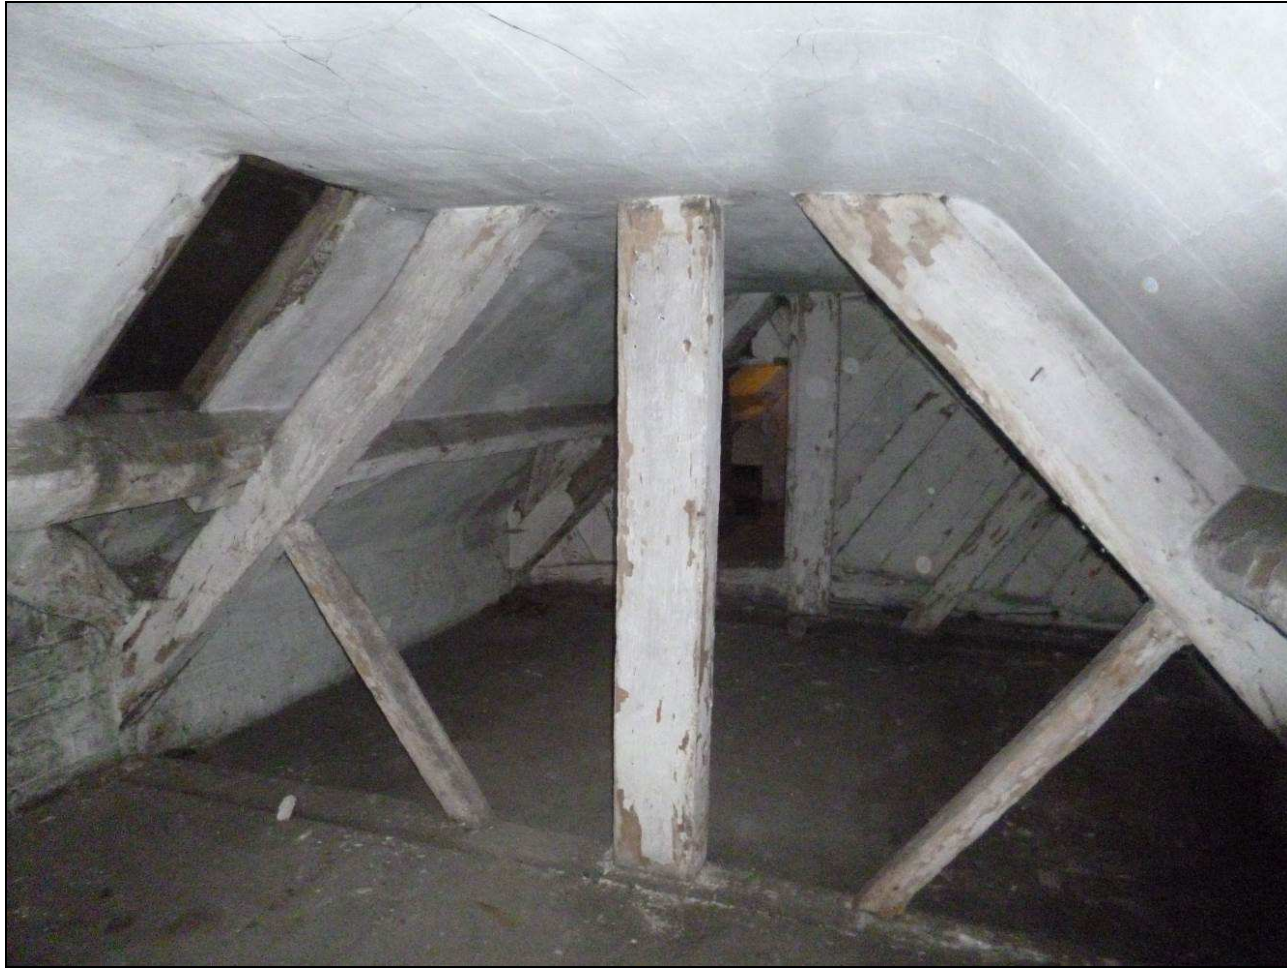
Figure 7: Farmhouse, southern extension roof, truss 4 in foreground, photograph taken from the south (Robert Howard)

The roof over this section of the farmhouse is of three trusses, with the first truss of this phase (truss 3) set immediately adjacent to truss 2 in the northern older section. All trusses have principal rafters, tiebeams, king posts, and raking struts (Fig 7). There are a single set of purlins between the trusses. The first-floor frame of the southern extension is also visible at ground-floor level. There is an east-west main beam immediately adjacent to the east-west beam of the primary building from which runs a north-south main beam which holds the common joists (Fig 8).

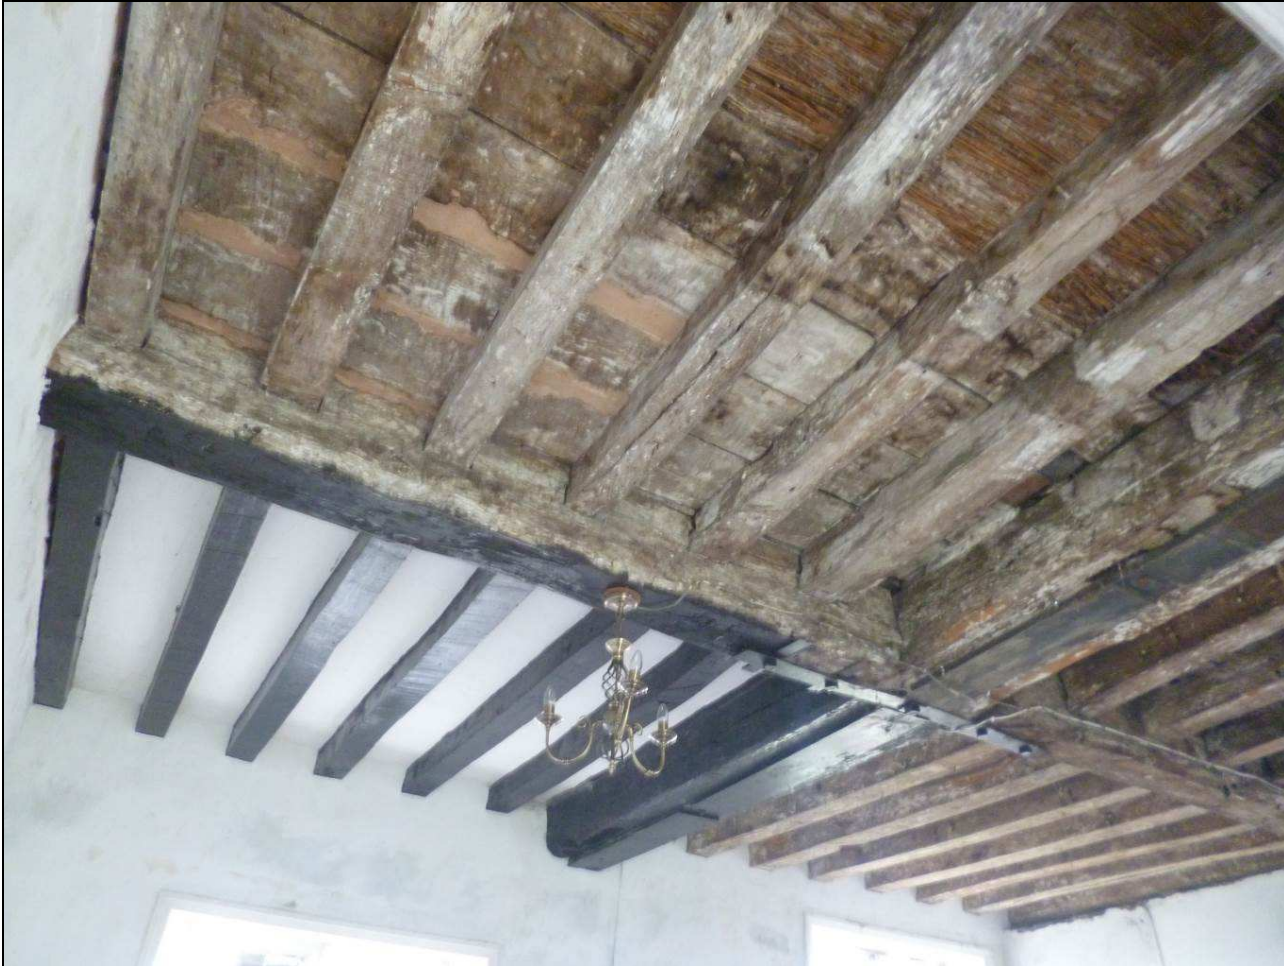
Figure 8: Farmhouse, southern extension floor frame (left of photograph), photograph taken from the south-east (Robert Howard)

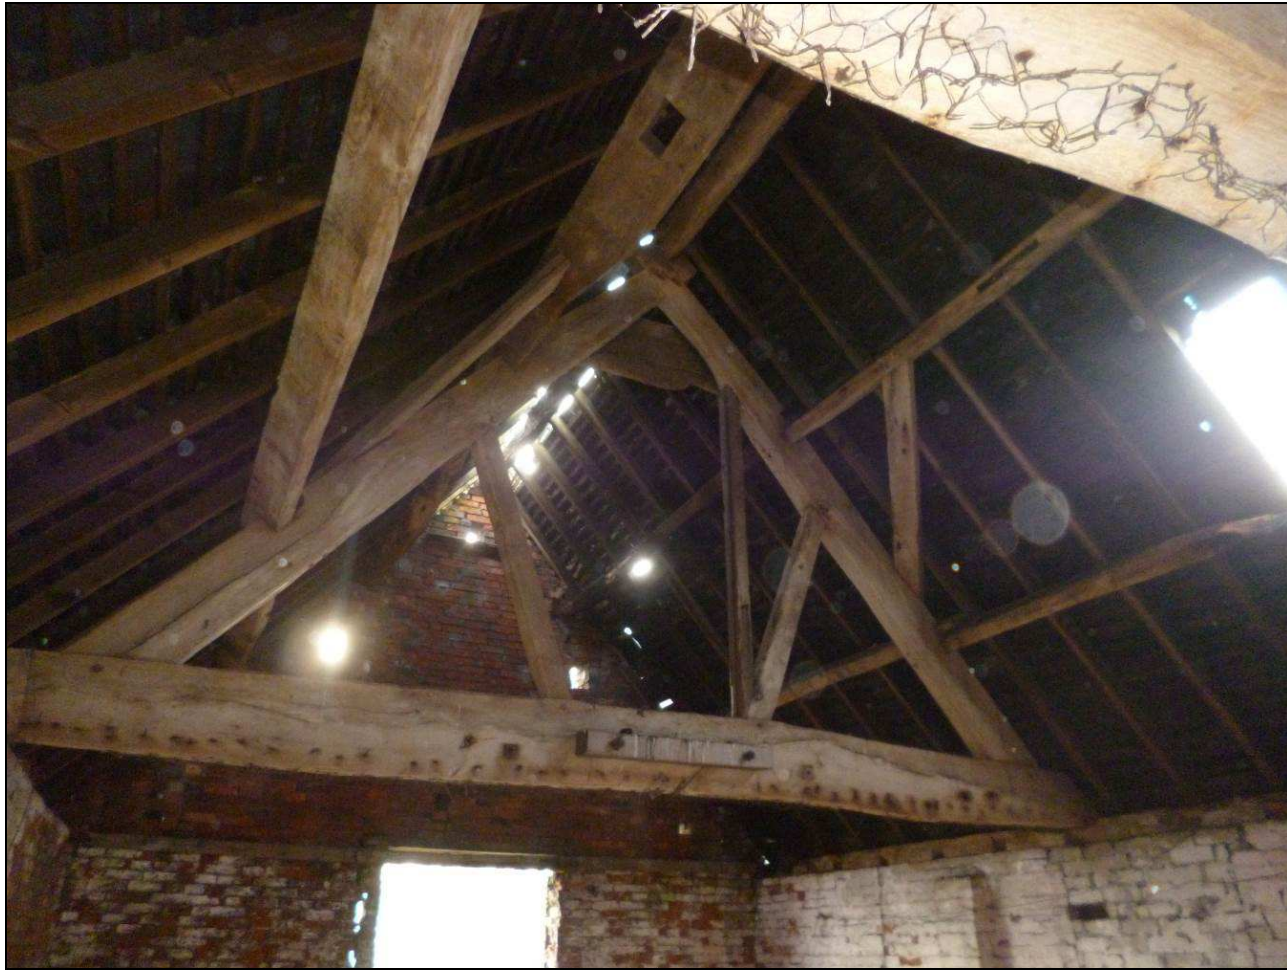
Figure 9: Barn, truss 2, photograph taken from the north (Robert Howard)

The roof comprises of two principal rafter and tiebeam trusses, two bays being separated by a wall only, with raking struts from the tiebeams to the principals. There are two purlins to each slope in the southern two bays (a single set in the northern two bays) with straight braces running from the upper purlins to the principal rafters (Fig 9). The northern two bays only have a single set of purlins though. It is noticeable that many of the timbers show clear signs of reuse. The first-floor frame is exposed at ground-floor level and comprises four east-west main beams, carrying north-south joists (Fig 10). The joists of bay 3 do not sit in the original housings.

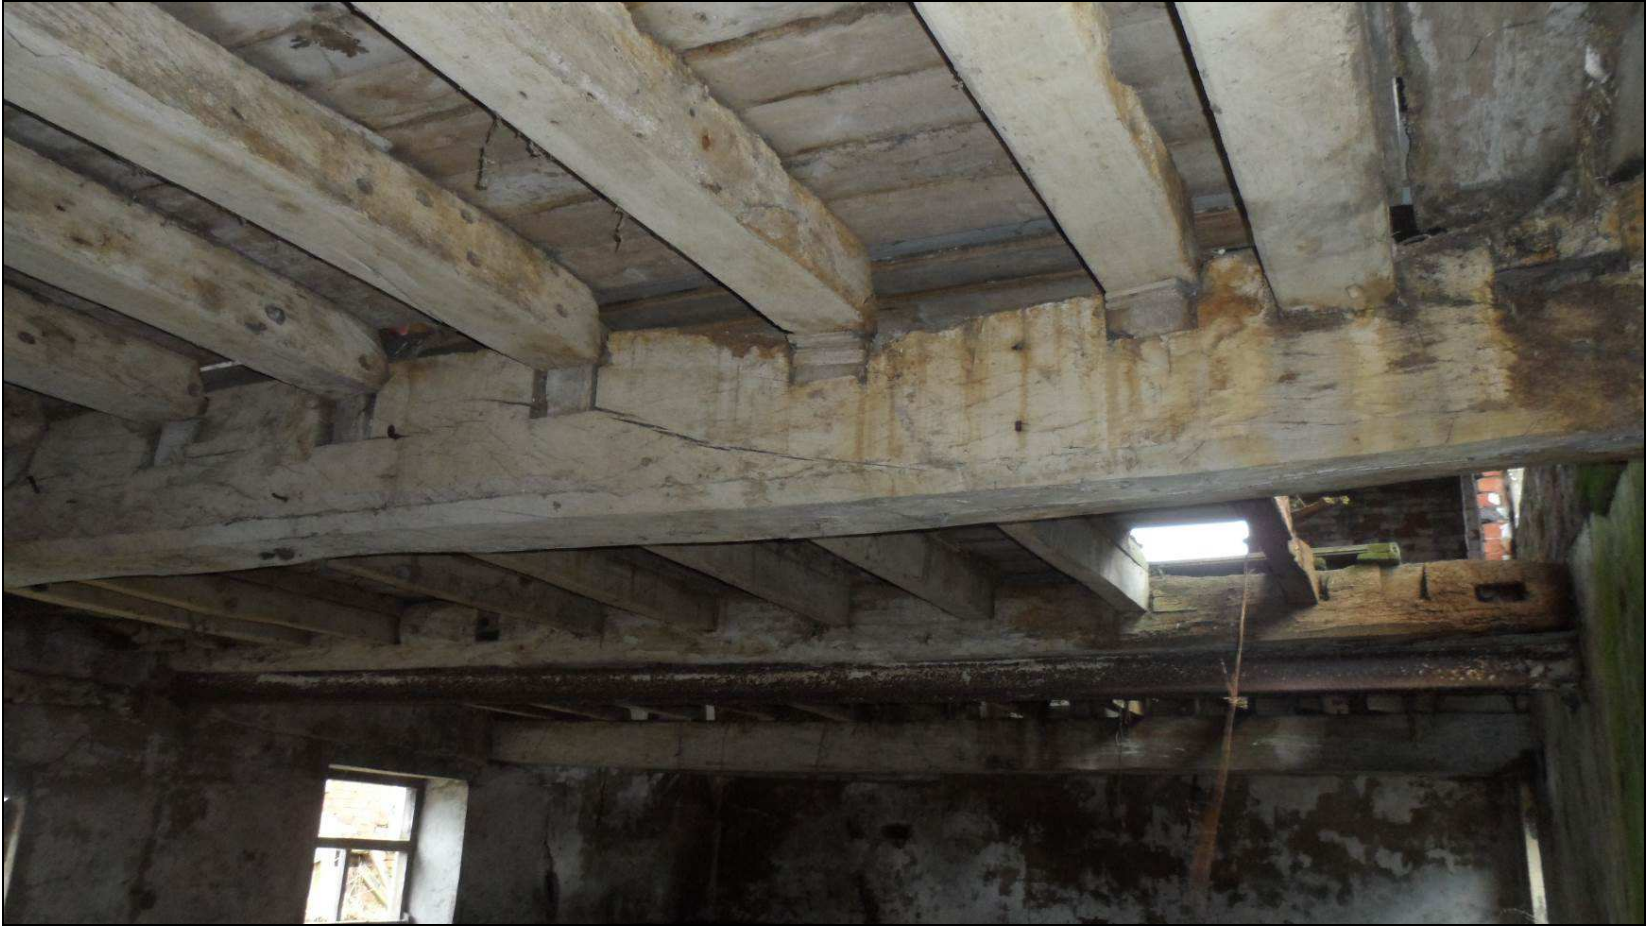
Figure 10: Barn, floor frame with beam 2 and bay 3 in the foreground; it can be seen that the joists of bay 3 do not sit in the original housings, photograph taken from the north (Alison Arnold)

The earliest of these fellings is represented by four samples (COD-C47, COD-C48, COD-C49, and COD-C52) from joists. The average heartwood/sapwood boundary ring date of AD 1599 gives an estimated felling date for these joists of AD 1617–39. This allows for sample COD-C49 having a last-measured ring date of AD 1616 with incomplete sapwood. Sample COD-C50, also from a joist, does not have the heartwood/sapwood boundary ring and so an estimated felling date range cannot be calculated for it, except to say that with a last-measured ring date of AD 1576 the timber represented has a *terminus post quem* for felling of AD 1591. Whilst it could in theory represent the inner section of a long-lived tree felled in AD 1727 (see below), it appears far more likely that it was felled in the early-seventeenth century. This interpretation is supported by the overall level of similarity between it and the other early-seventeenth century timbers from this floor frame. Four of these dated joists are from bay 3 where the joists do not sit in the original housing in the main beam.

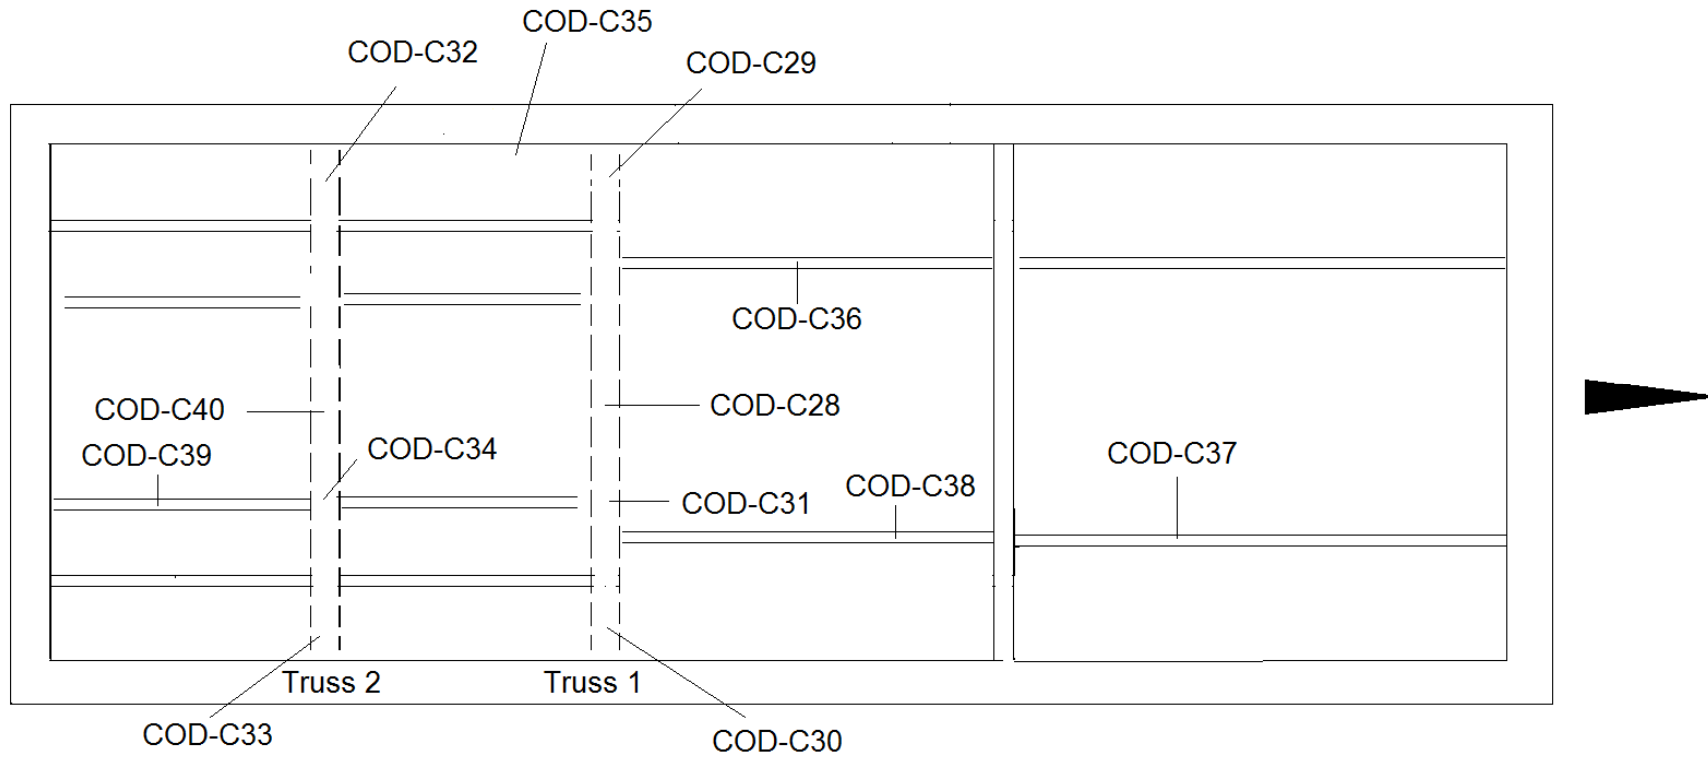
Figure 14: Sketch plan of the roof of the barn, showing the location of samples COD-C28–40

A total of 54 timbers from the floors and roofs of the farmhouse and barn was sampled by coring. Each sample was given the code COD-C and numbered 01–54. The location of all samples was noted at the time of sampling and has been marked on Figures 11–15. Further details relating to the samples can be found in Table 1. Trusses and floor beams have been numbered from north to south in both the barn and the farmhouse, with other timbers being numbered on an east-west basis as appropriate.

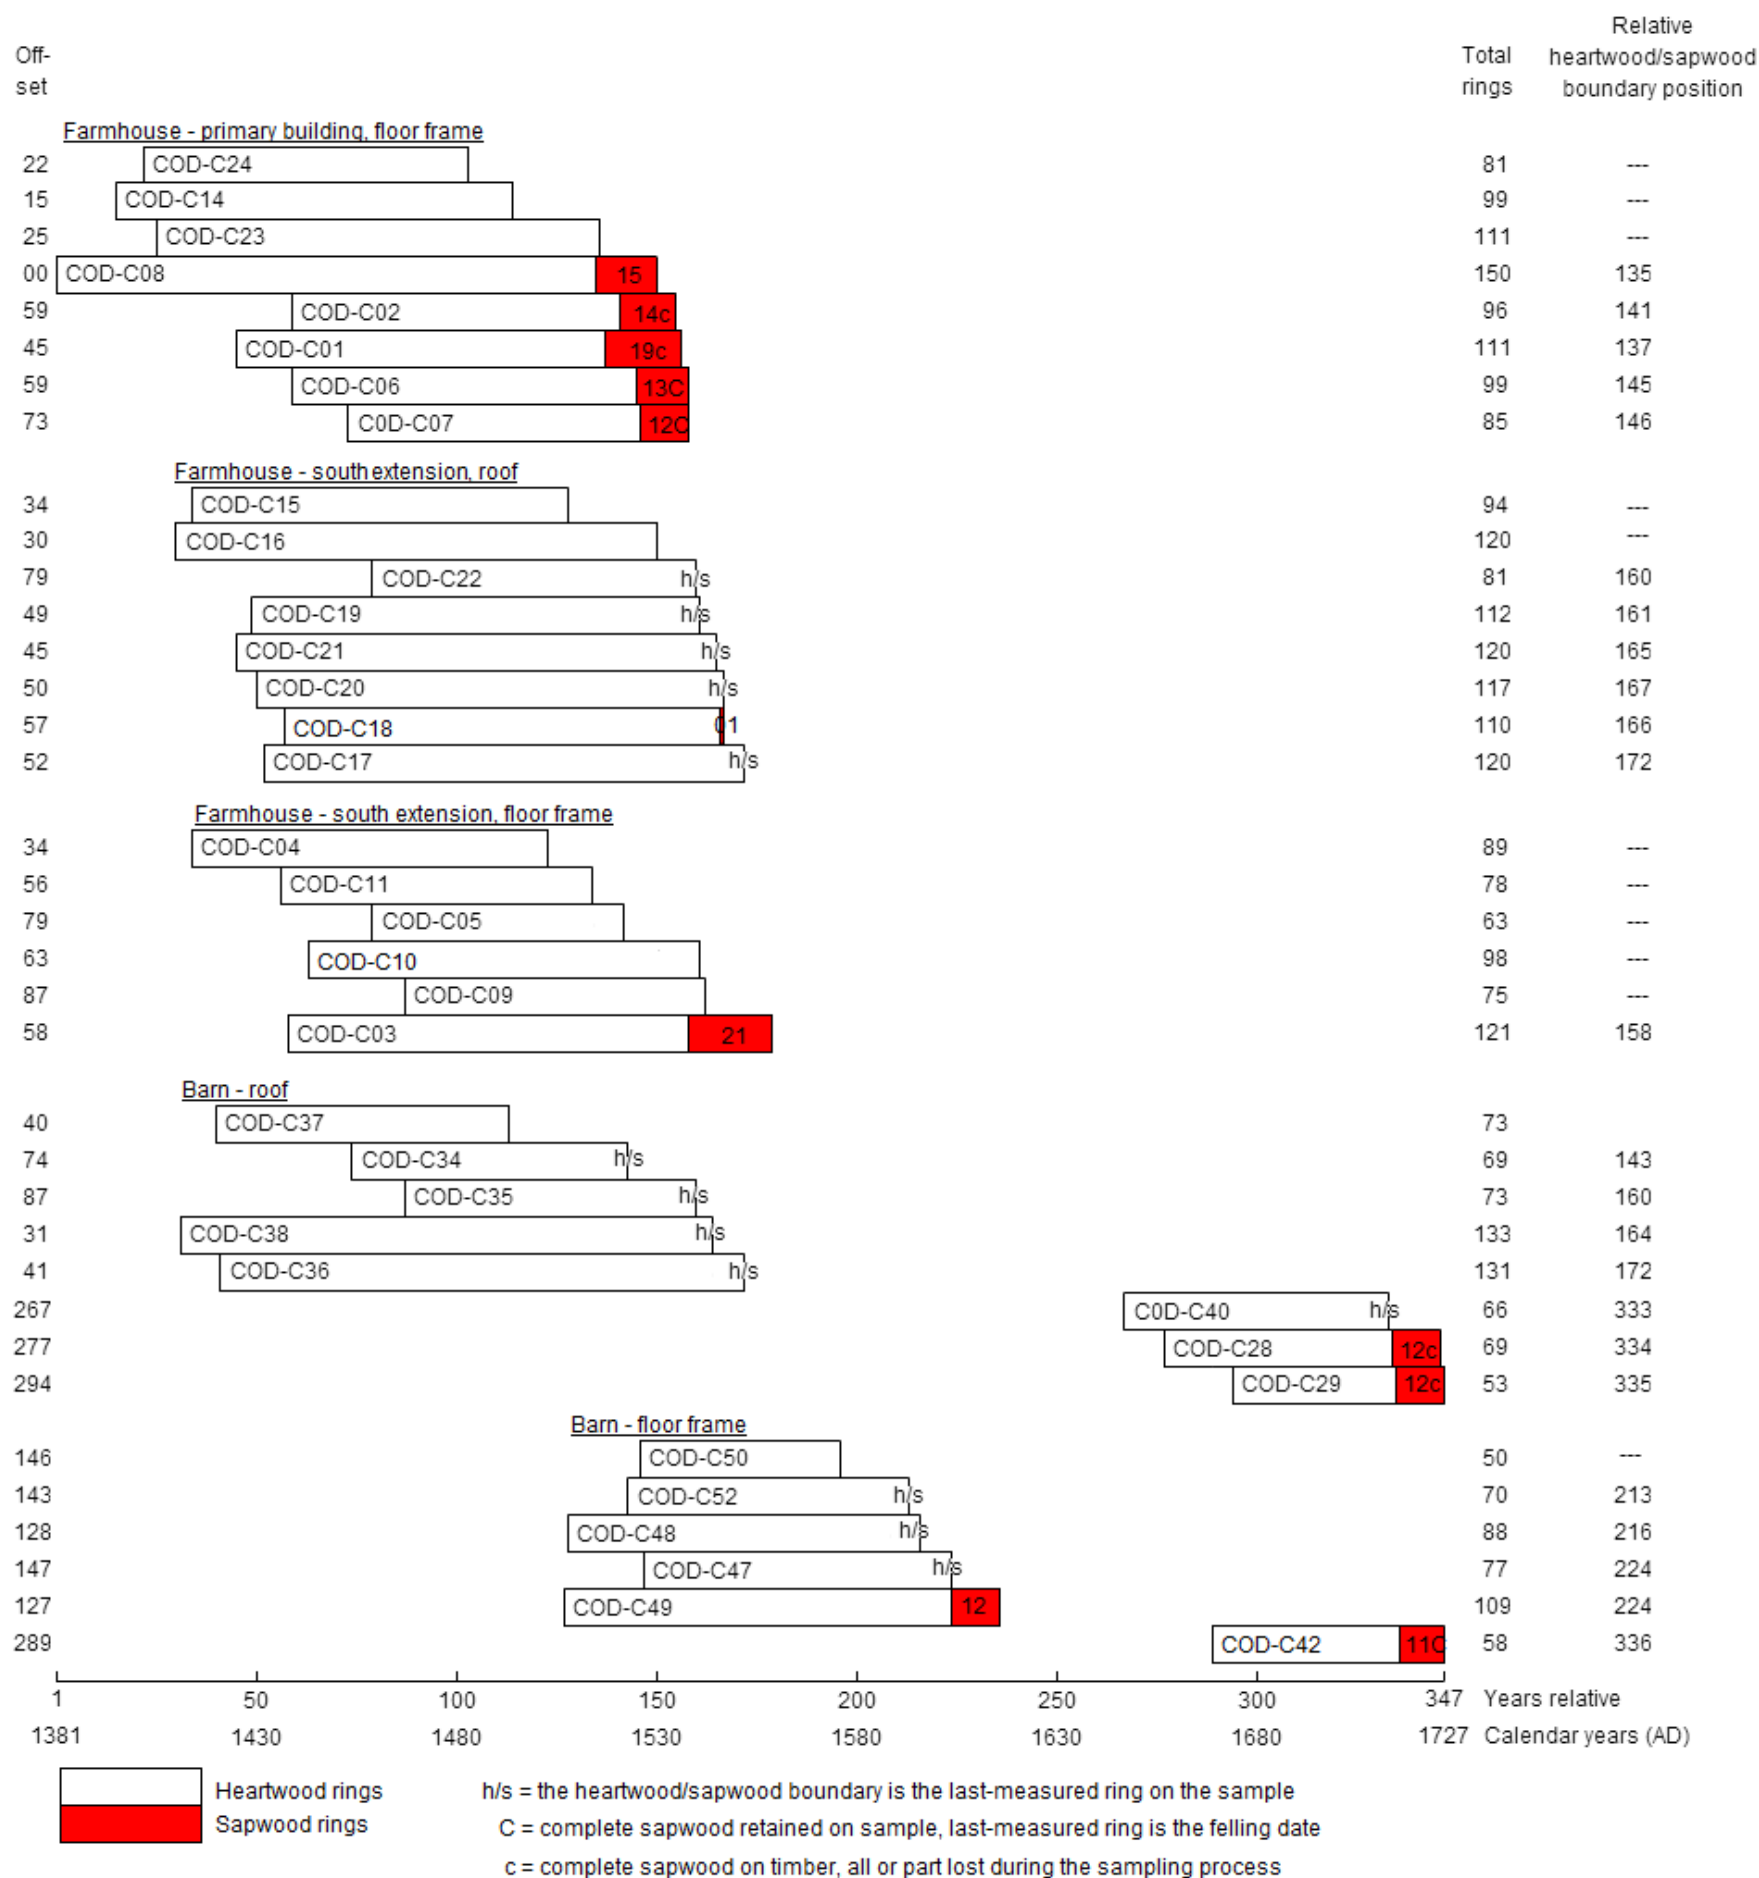
Figure 20: Bar diagram of all dated samples, sorted by area

Tree-ring analysis has resulted in the successful dating of 36 timbers from both the barn and farmhouse. To aid interpretation each area is dealt with separately below and illustrated in Figure 20. Felling date ranges have been calculated using the estimate that mature oak trees in this region have 15–40 sapwood rings (95% confidence range).

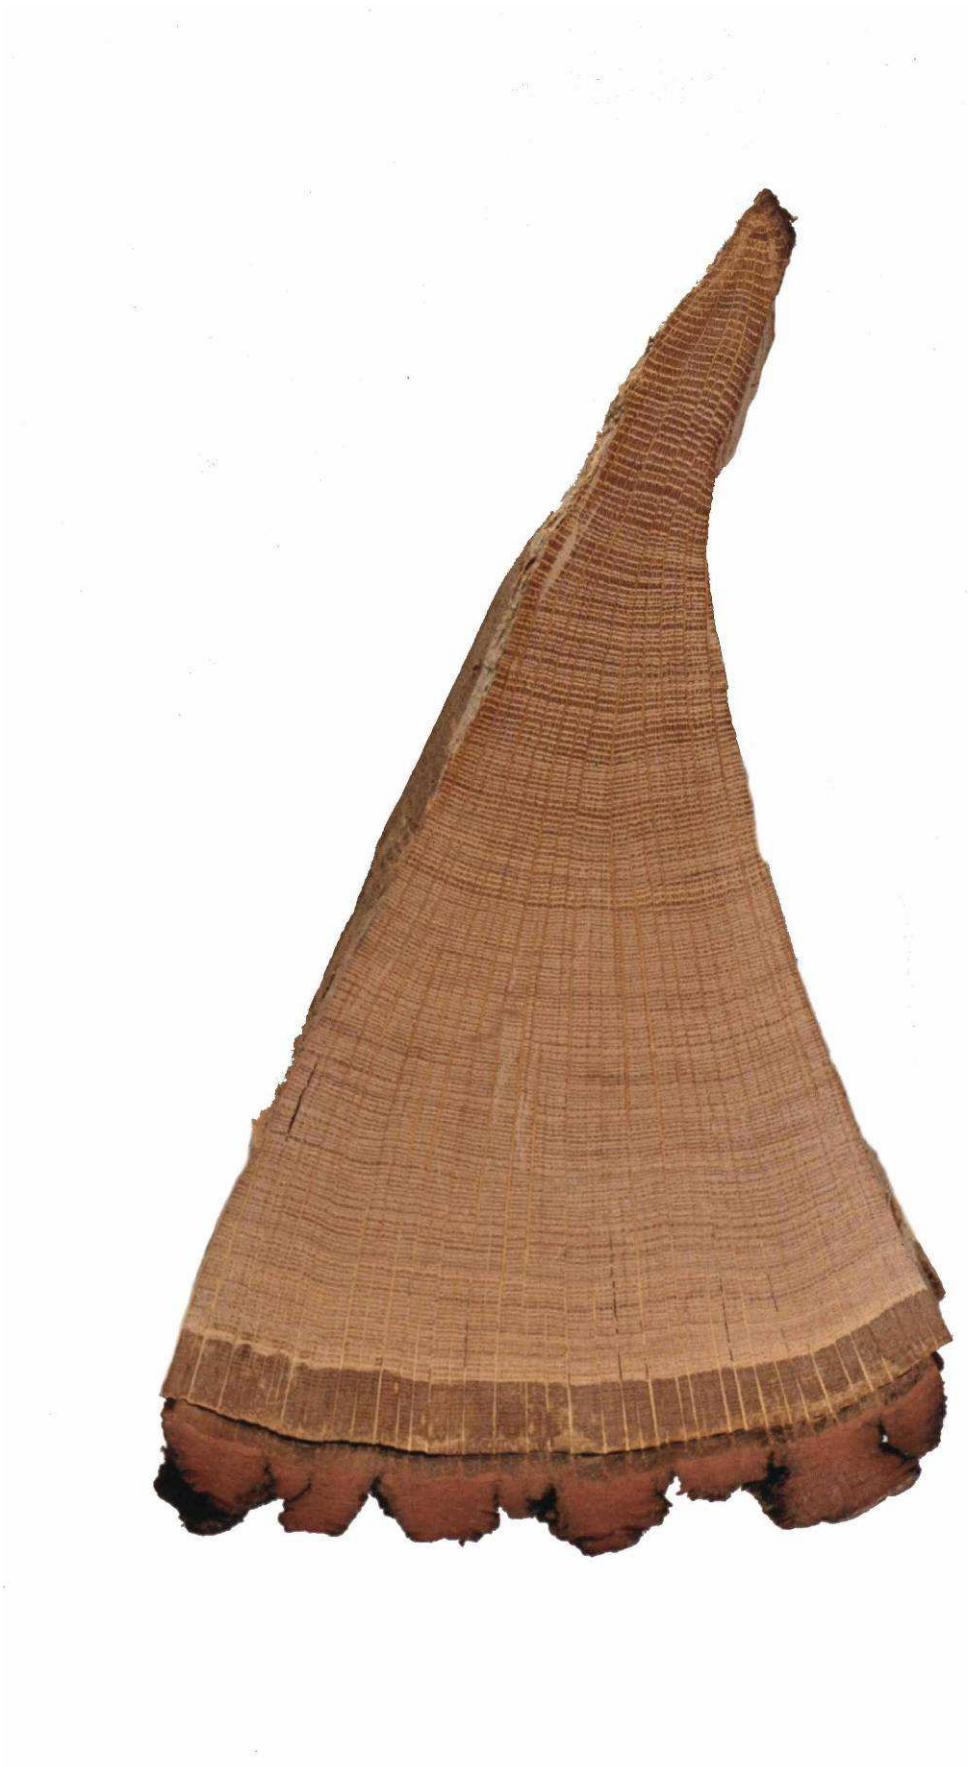
Figure A1: A wedge of oak from a tree felled in 1976. It shows the annual growth rings, one for each year from the innermost ring to the last ring on the outside just inside the bark. The year of each ring can be determined by counting back from the outside ring, which grew in 1976

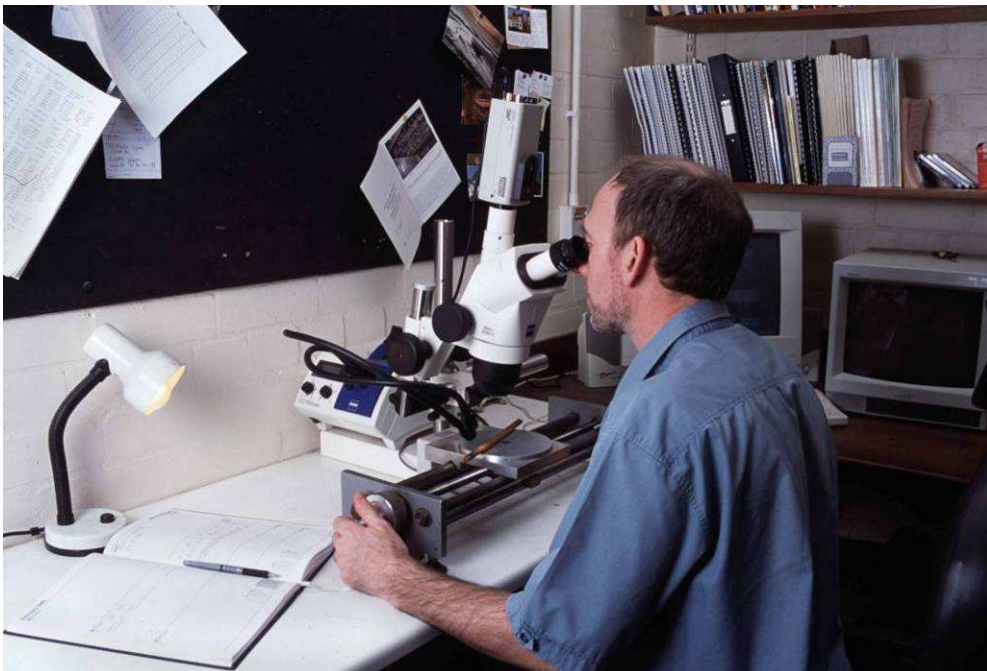
Figure A3: Measuring ring widths under a microscope. The microscope is fixed while the sample is on a moving platform. The total sequence of widths is measured twice to ensure that an error has not been made. This type of apparatus is needed to process a large number of samples on a regular basis

2. Measuring Ring Widths. Each core is sanded down with a belt sander using medium-grit paper and then finished by hand with flourgrade-grit paper. The rings are then clearly visible and differentiated from each other with a result very much like that shown in Figure A2. The core is then mounted on a movable table below a microscope and the ring-widths measured individually from the innermost ring to the outermost. The widths are automatically recorded in a computer file as they are measured (see Fig A3).

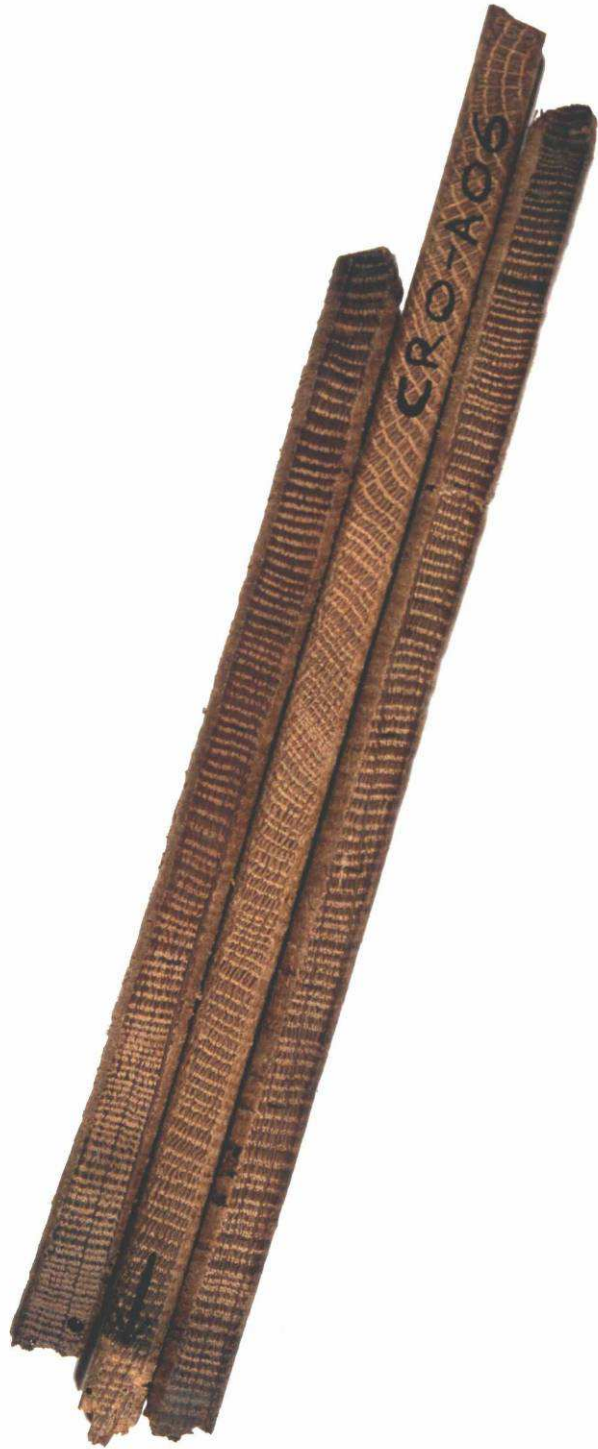
Figure A4: Three cores from timbers in a building. They come from trees growing at the same time. Notice that, although the sequences of widths look similar, they are not identical. This is typical
