Somerton Castle, Castle Lane, Boothby Graffoe, Lincolnshire

Tree-ring Analysis of Oak Timbers

Alison Arnold and Robert Howard

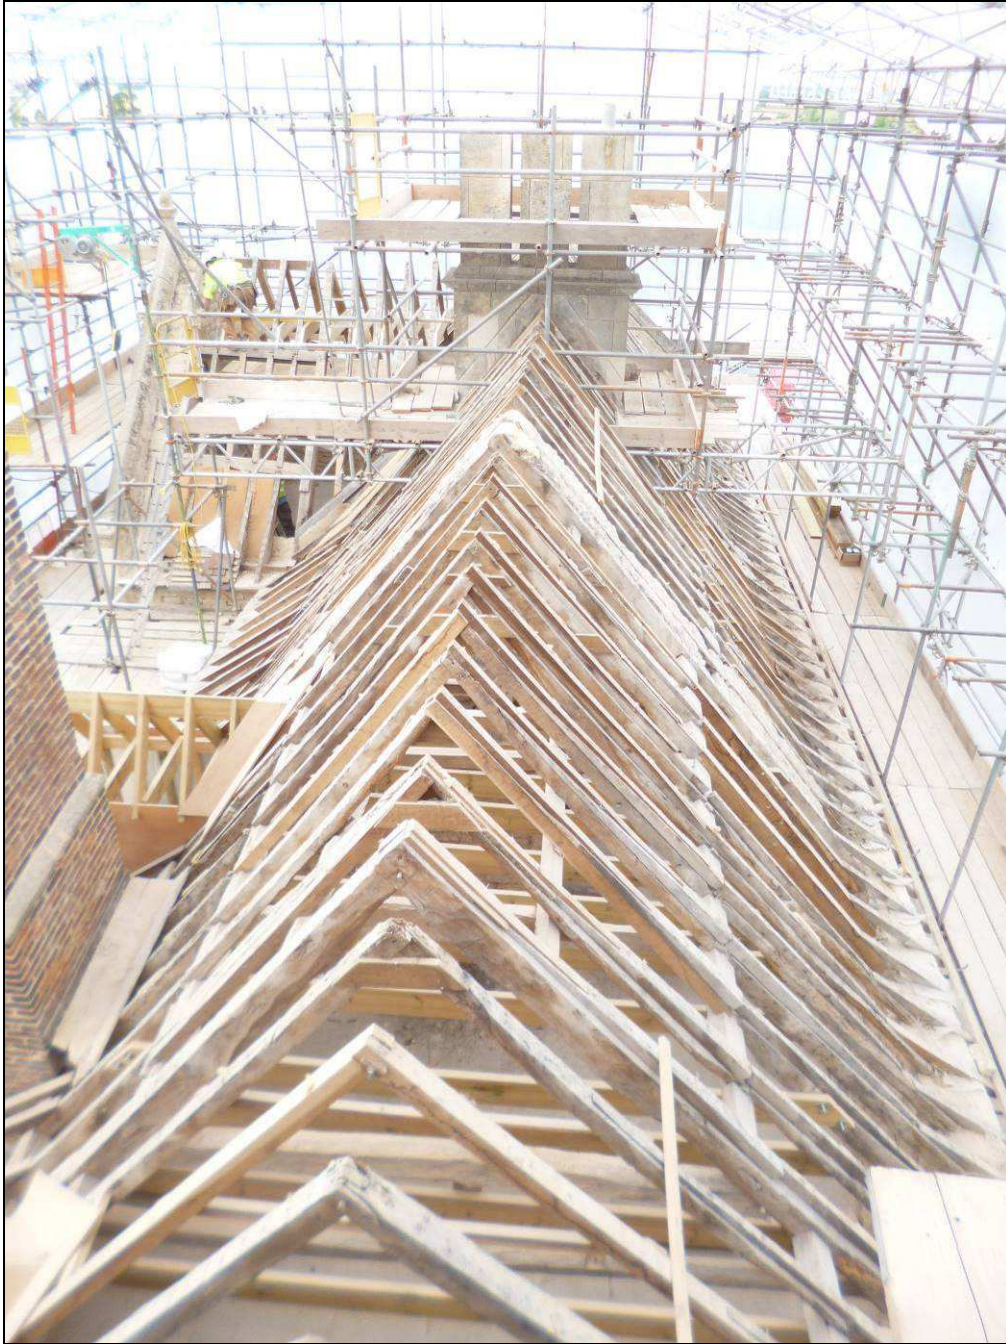
Figure 4: Main range (foreground) and west wing roofs, photograph taken from the east (Alison Arnold)

Located to the west of the south-east tower is a two-storey plus attics, three-bay range, built of course rubble (Fig 3). The roof over this part of the building comprises principal rafter and collar trusses supporting a single tier of staggered purlins (Fig 4). Exposed timbers of the first floor consist of three main bridging beams, between which are common joists, whilst at ground-floor level only two main bridging beams and a small number of joists are visible (Fig 5). Other

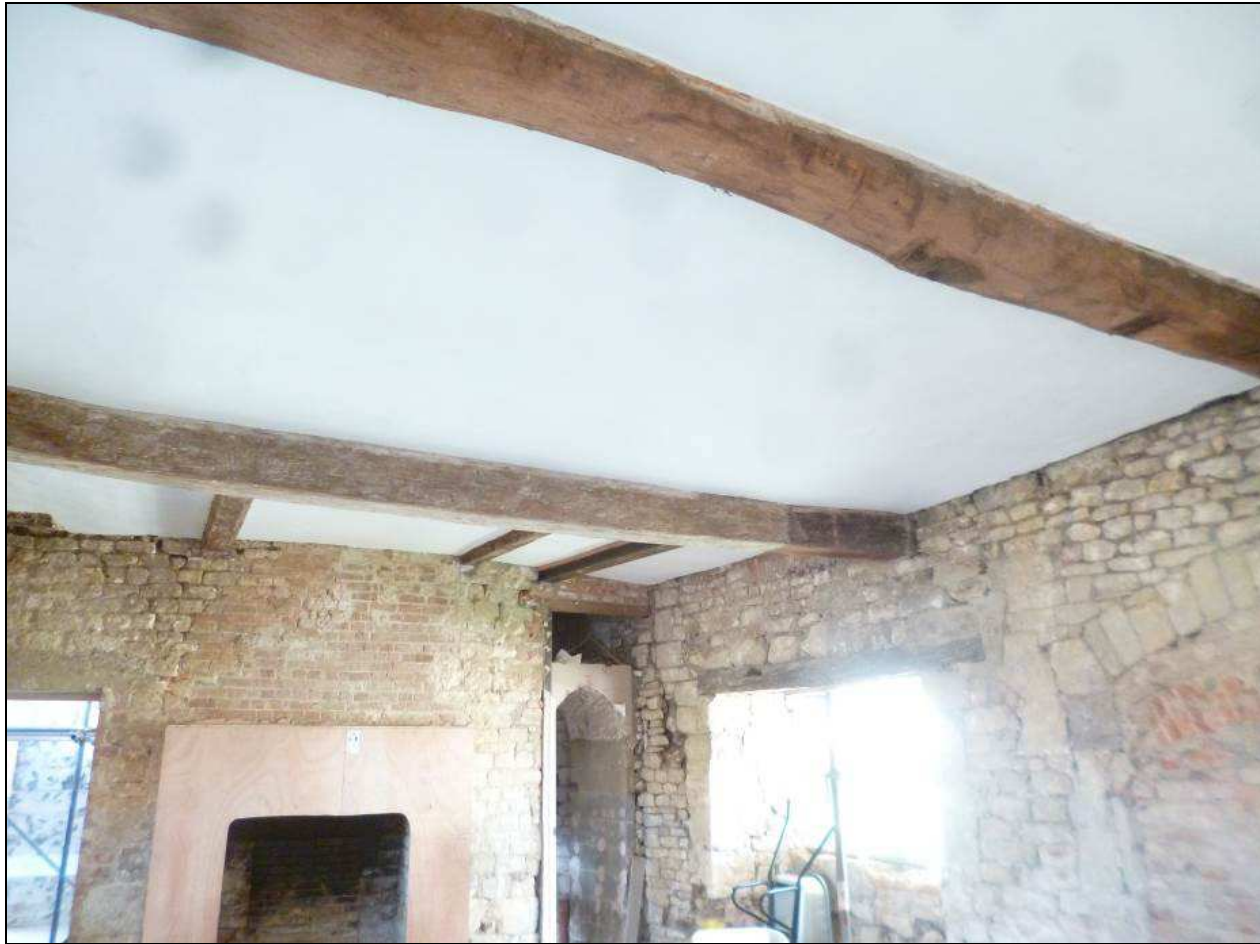
Figure 5: Main range; ground-floor ceiling, photograph taken from the west (Alison Arnold)

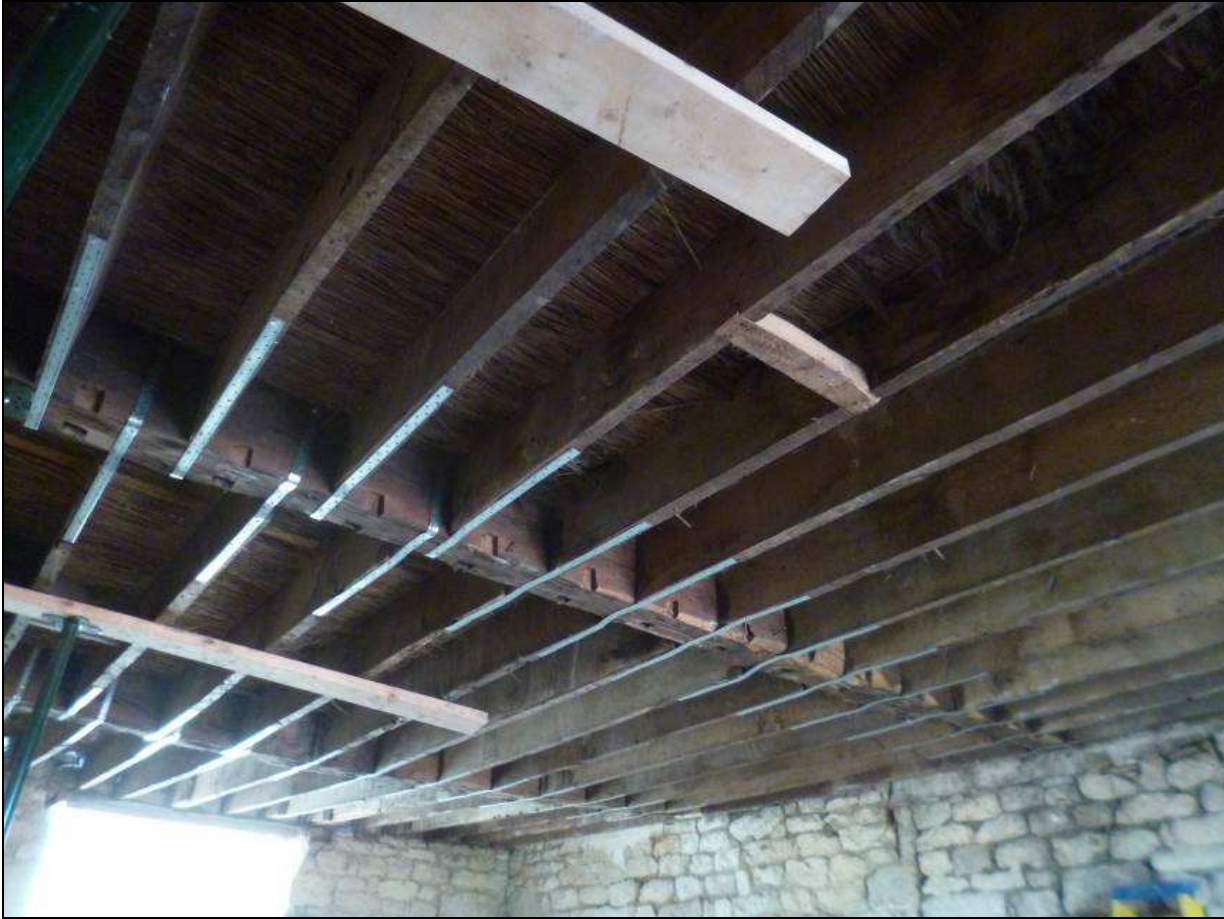
Figure 6: West wing, ground-floor ceiling, photograph taken from the north (Alison Arnold)

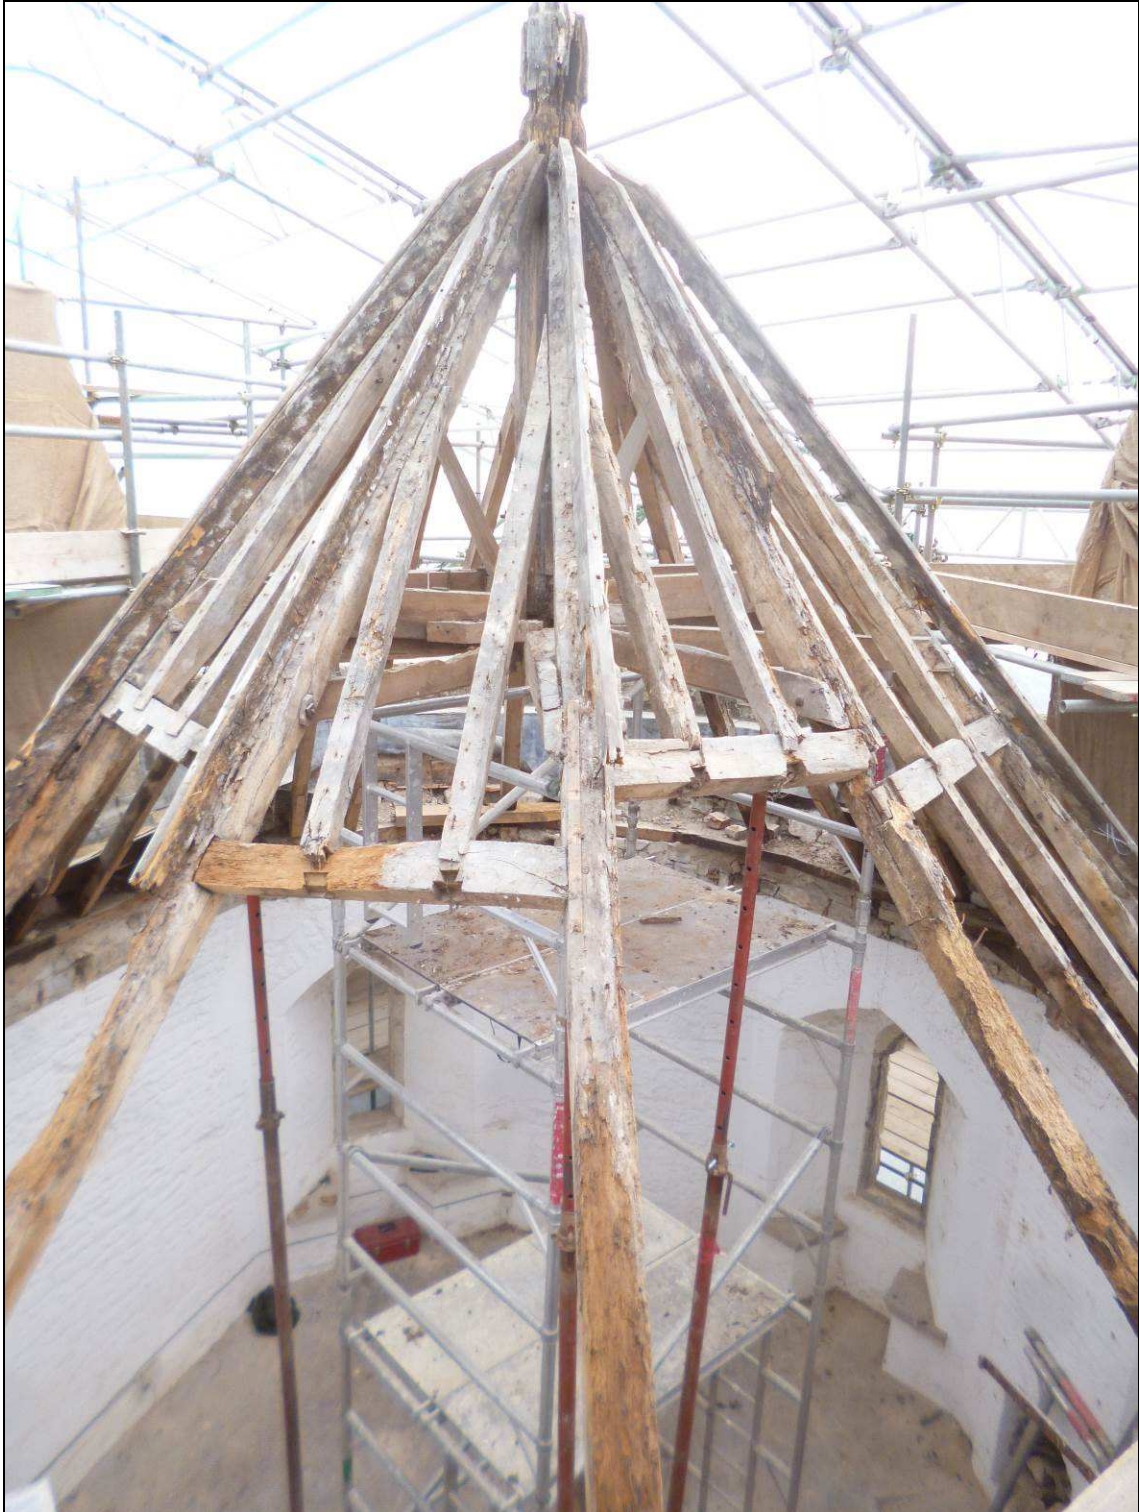
Figure 7: South-east tower roof, photograph taken from the north-west (Alison Arnold)

The roof over the south-east tower is conical in shape (Fig 7) and has previously been tree-ring dated as being constructed using timber felled in the range AD 1757–82, demonstrating a re-roofing of the tower in the second half of the eighteenth century (Arnold and Howard 2015). There are two ceiling beams visible at first-floor level (Fig 8); as there was reported to be no timberwork in this tower in AD 1601 these are also likely to be associated with the later alterations to the castle.

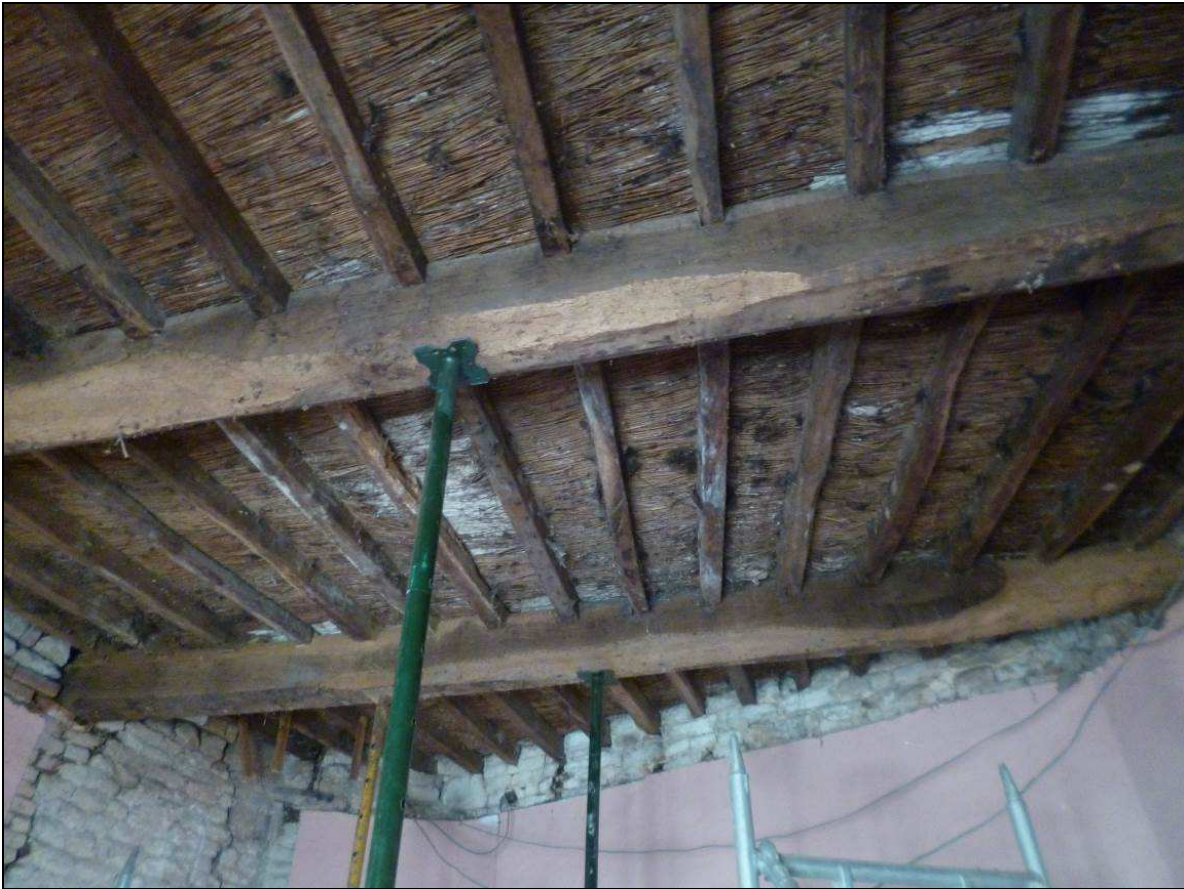
Figure 8: South-east tower ceiling, photograph taken from the south (Alison Arnold)

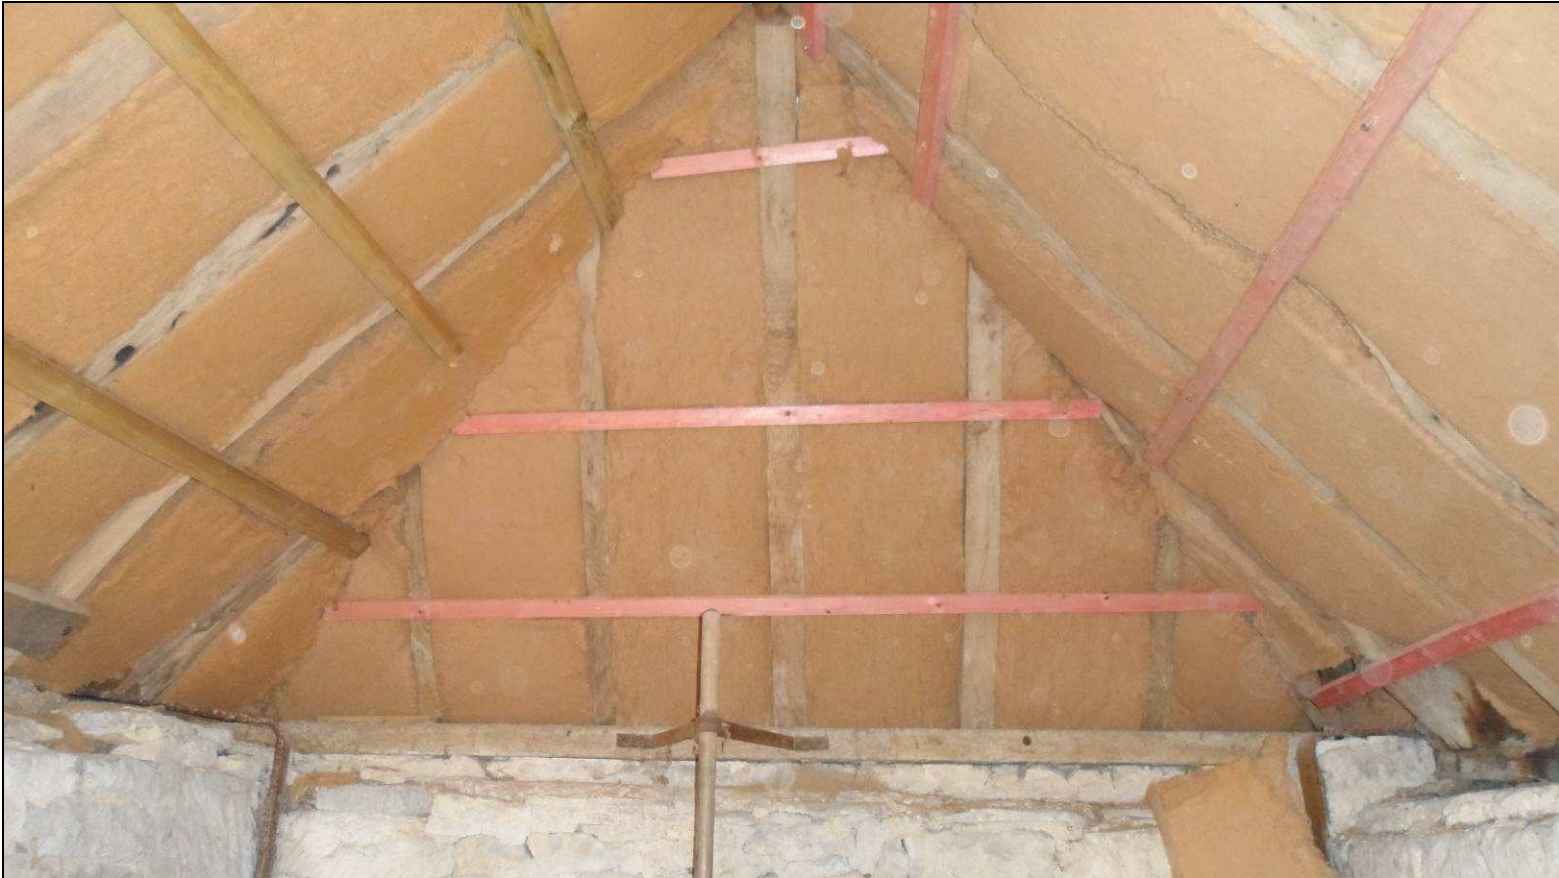
Figure 9: Garderobe roof, photograph taken from the north (Alison Arnold)

Between the south-east tower and the main range is a small garderobe (Fig 3), the hipped roof of which comprises common rafters and hip rafters sitting on wall plates (Fig 9). The date of this roof is unknown but it is thought likely to be seventeenth century or later.

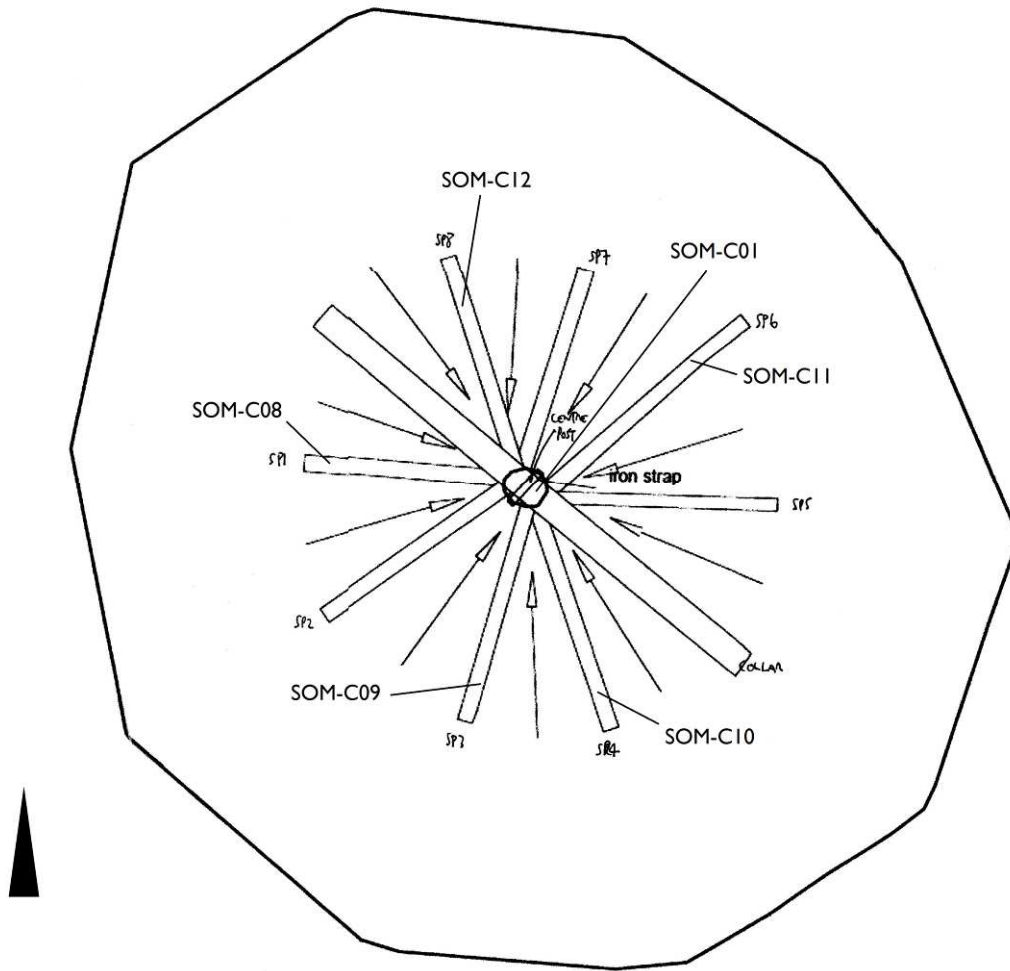
Figure 10: Plan of the tower timbers, showing the location of samples SOM-C01 and SOM-C08–12 (after Hoare Ridge & Morris)

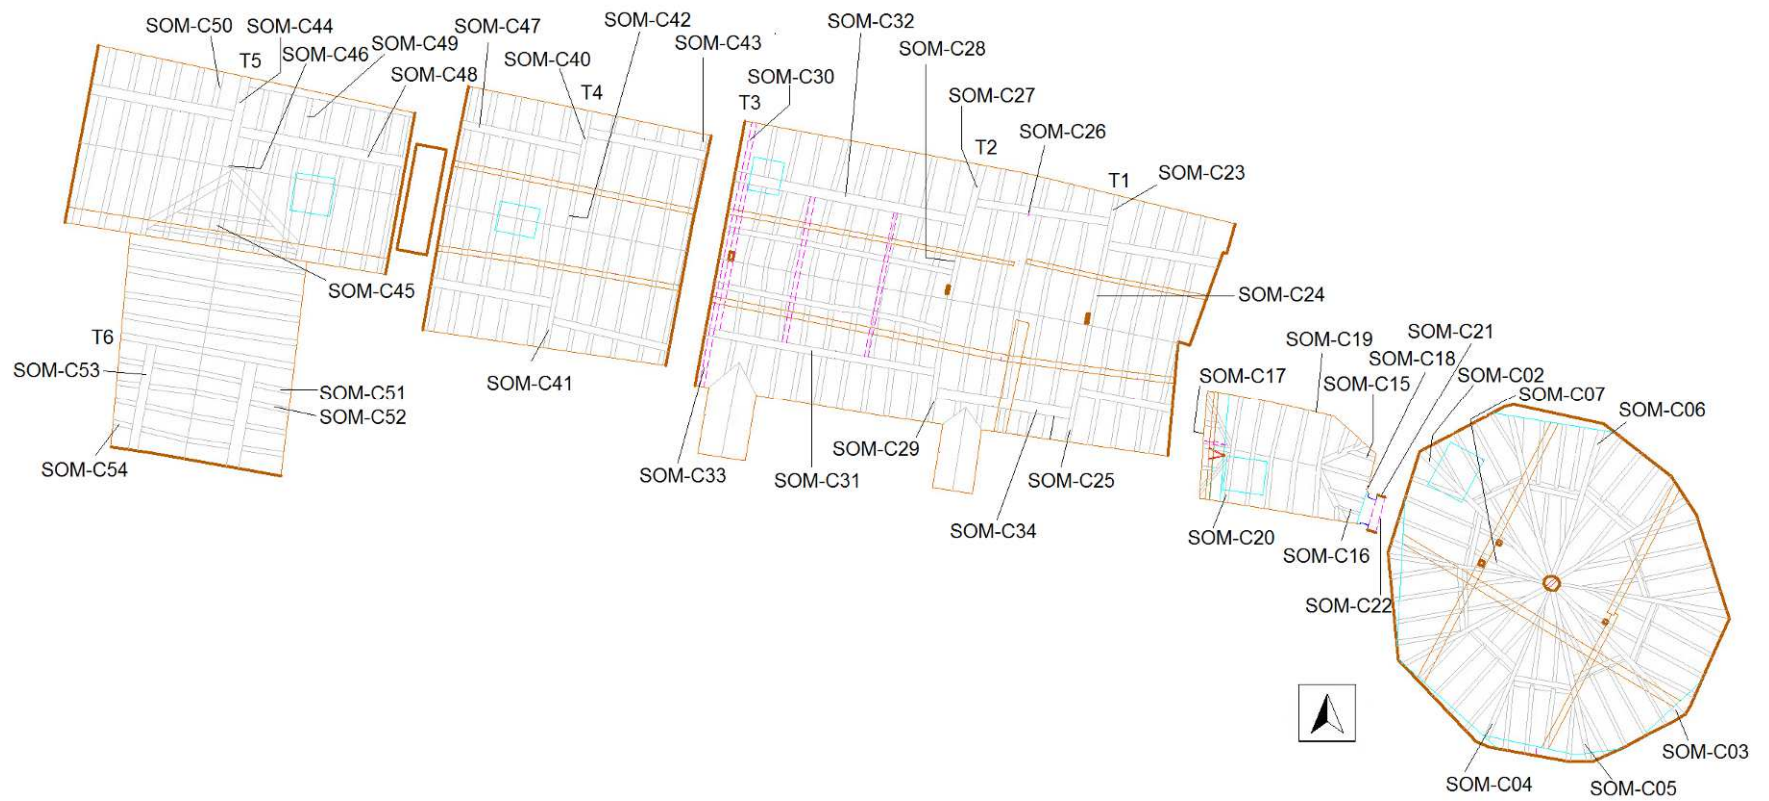
Figure 11: Roof plan, showing the location of samples SOM-C02–07, SOM-C15–34, and SOM-C40–54 (after FAS Heritage)

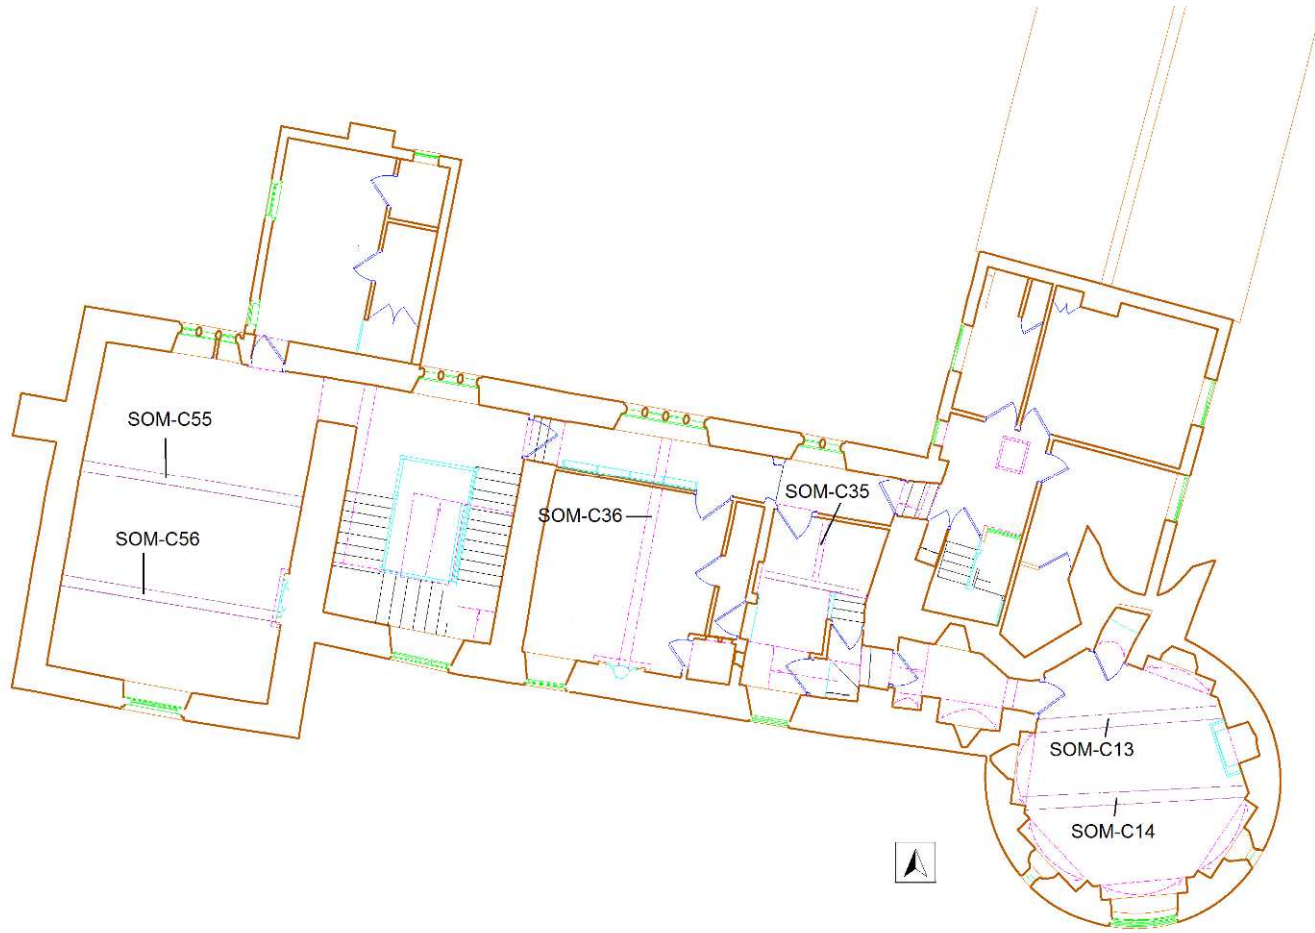
Figure 12: First-floor plan, showing the location of samples SOM-C13–14, SOM-C35–36, and SOM-C55–56 (after FAS Heritage)

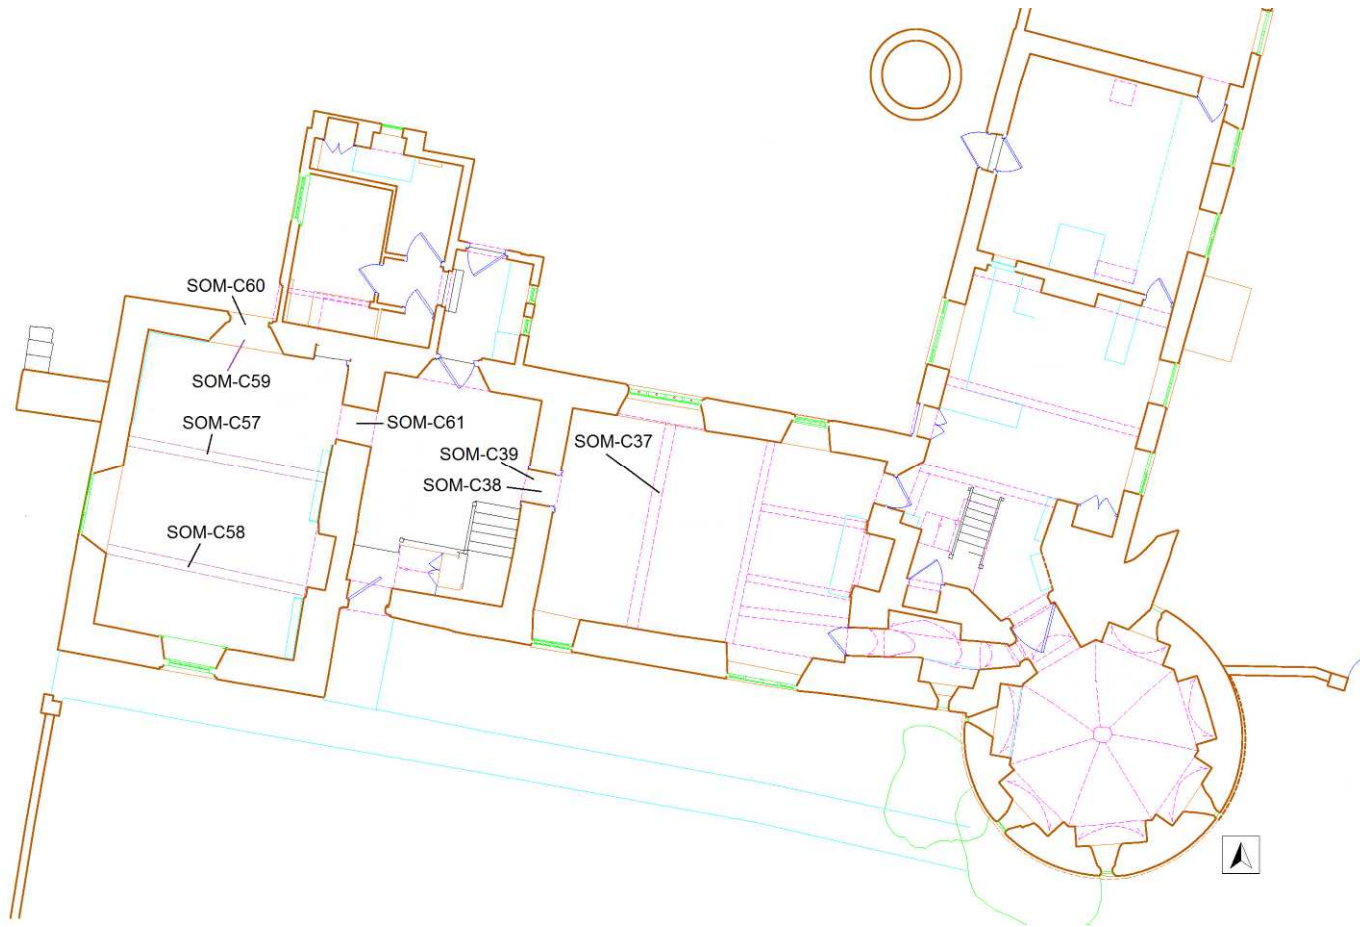
Figure 13: Ground-floor plan, showing the location of samples SOM-C37–39 and SOM-C57–61 (after FAS Heritage)

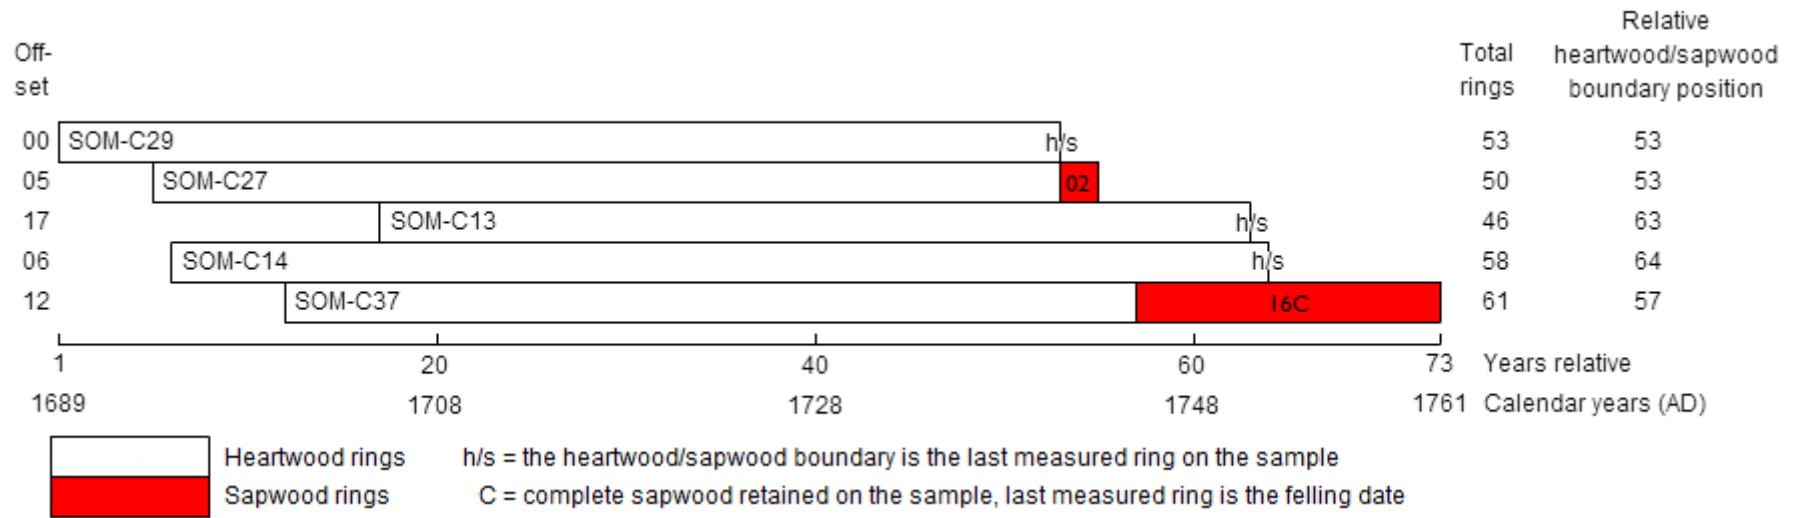
Figure 17: Bar diagram to show the relative positions of samples in site sequence SOMCSQ04

Five samples, from the south-east tower and the main range grouped to form SOMCSQ04, a site sequence of 73 rings (Fig 17). This site sequence was compared against a series of reference chronologies for oak where it was found to span the period AD 1689–1761. The evidence for this dating is given in Table 5.

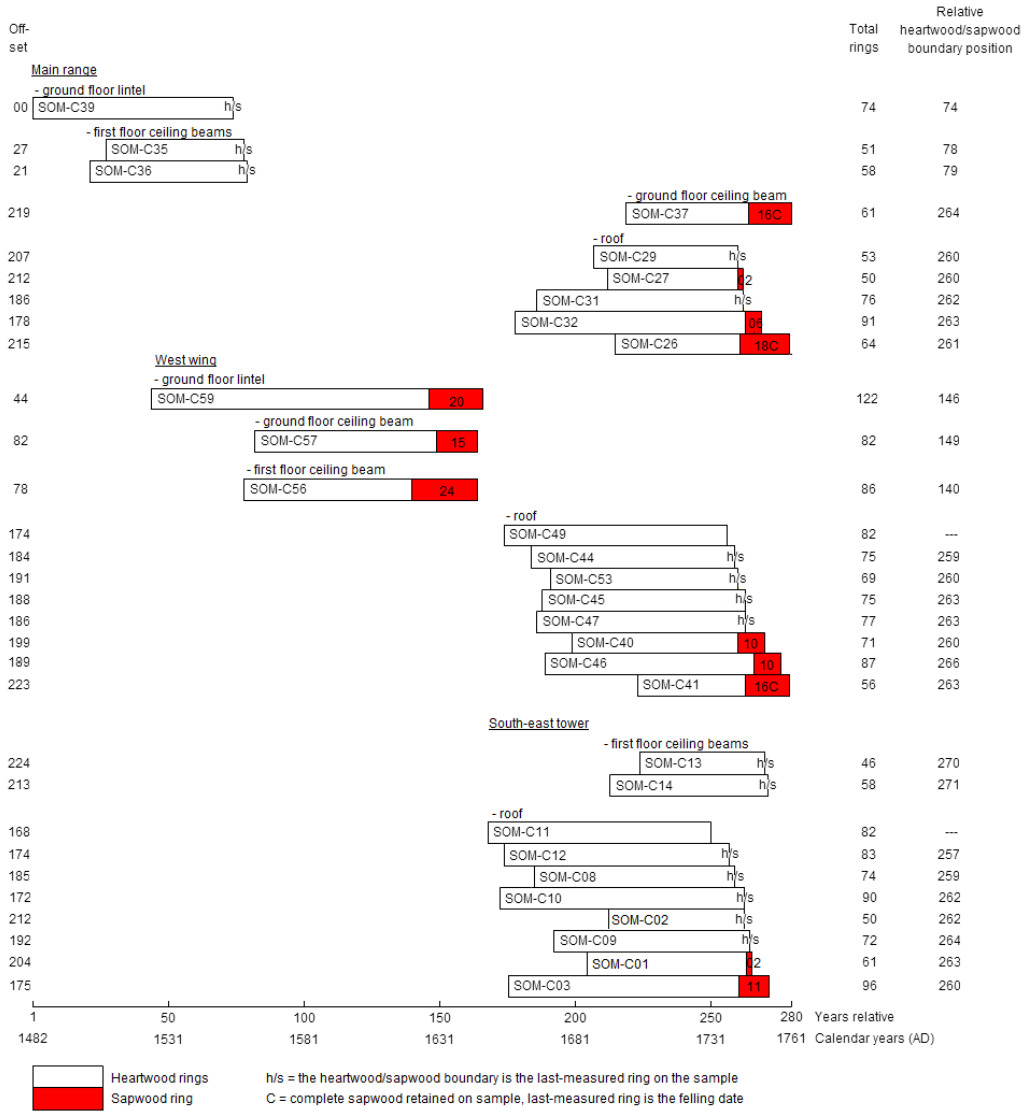
Figure 20: Bar diagram of all dated samples, sorted by area and element

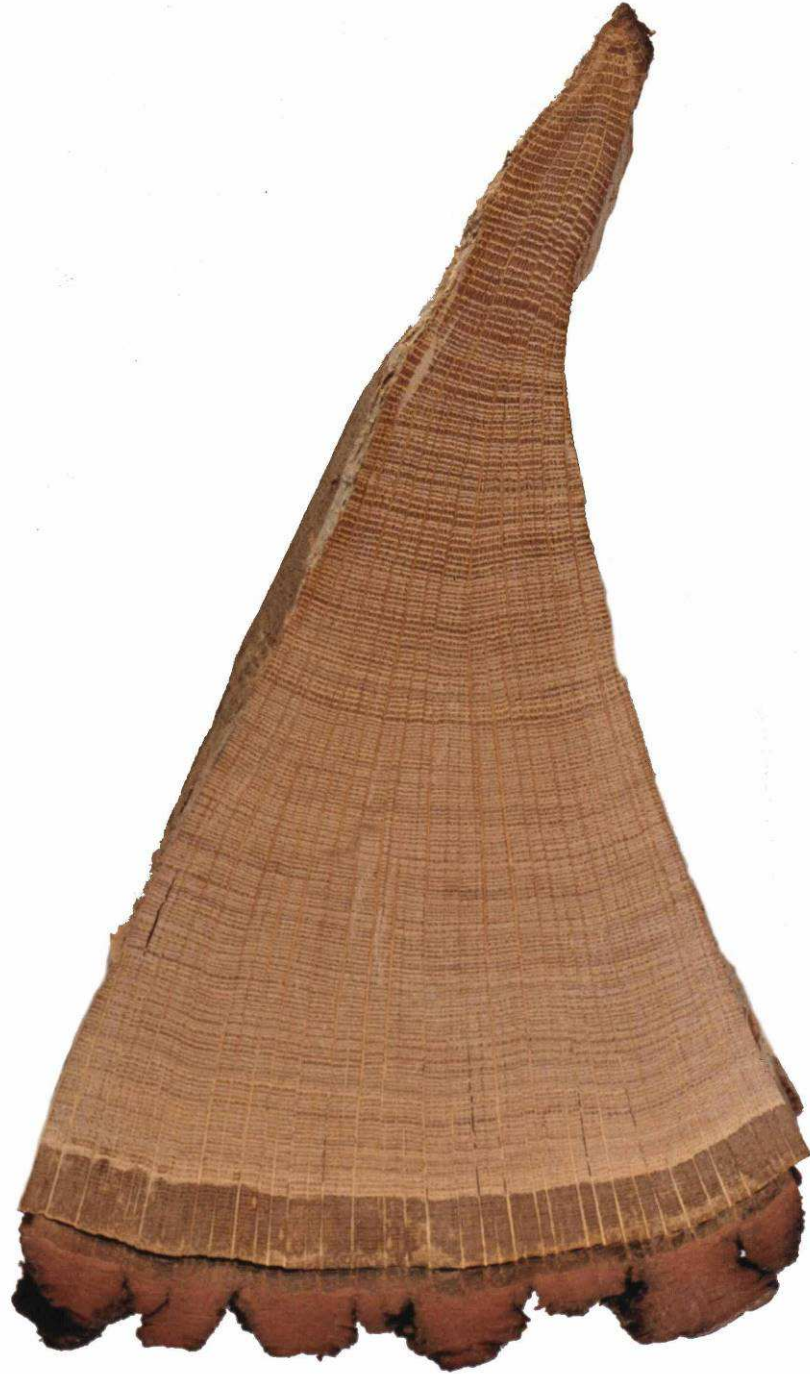
Figure A1: A wedge of oak from a tree felled in 1976. It shows the annual growth rings, one for each year from the innermost ring to the last ring on the outside just inside the bark. The year of each ring can be determined by counting back from the outside ring, which grew in 1976

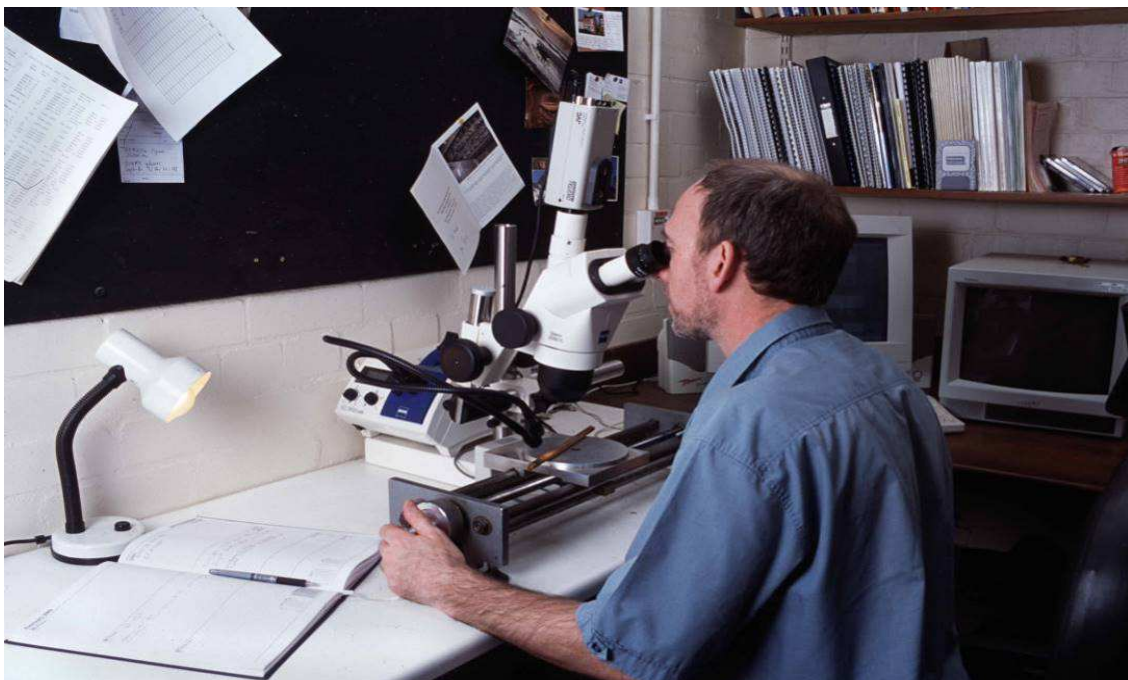
Figure A3: Measuring ring widths under a microscope. The microscope is fixed while the sample is on a moving platform. The total sequence of widths is measured twice to ensure that an error has not been made. This type of apparatus is needed to process a large number of samples on a regular basis

2. Measuring Ring Widths. Each core is sanded down with a belt sander using medium-grit paper and then finished by hand with flourgrade-grit paper. The rings are then clearly visible and differentiated from each other with a result very much like that shown in Figure A2. The core is then mounted on a movable table below a microscope and the ring-widths measured individually from the innermost ring to the outermost. The widths are automatically recorded in a computer file as they are measured (see Fig A3).

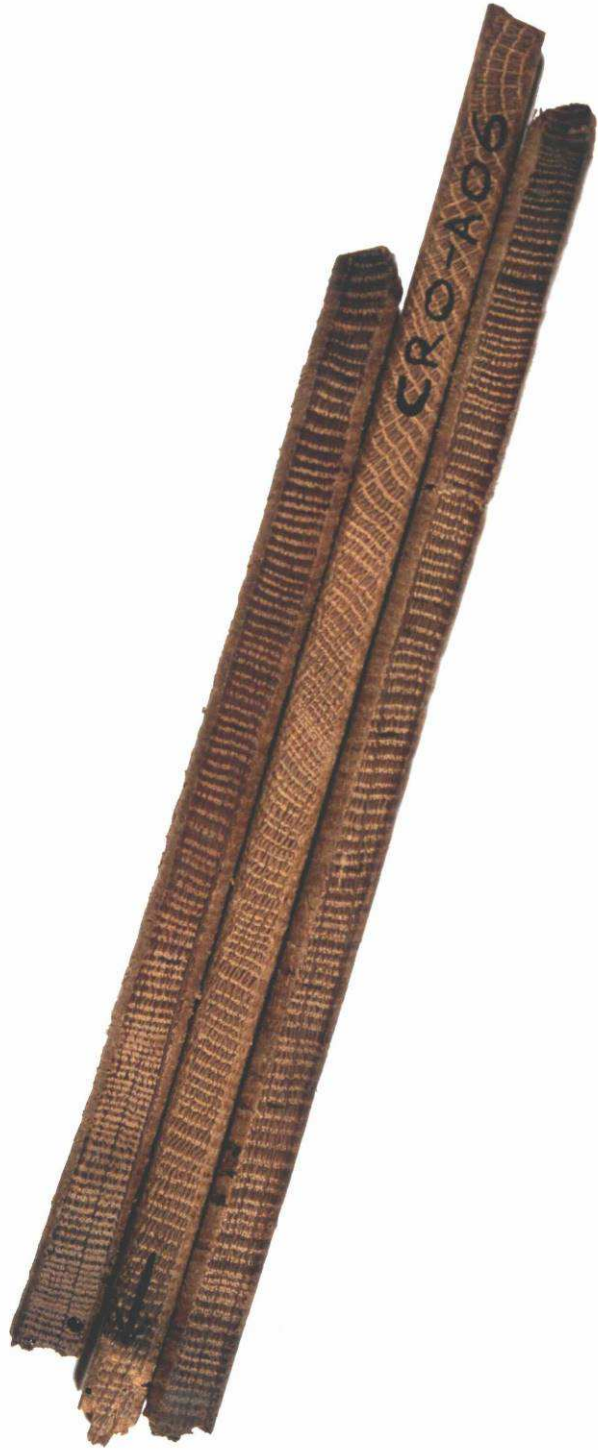
Figure A4: Three cores from timbers in a building. They come from trees growing at the same time. Notice that, although the sequences of widths look similar, they are not identical. This is typical
