Historic Places Investigation

# Tintagel Castle and Island, Cornwall: Archaeological Survey Enhancement

## ARCHAEOLOGICAL SURVEY ENHANCEMENT

NGR: SX 049 891

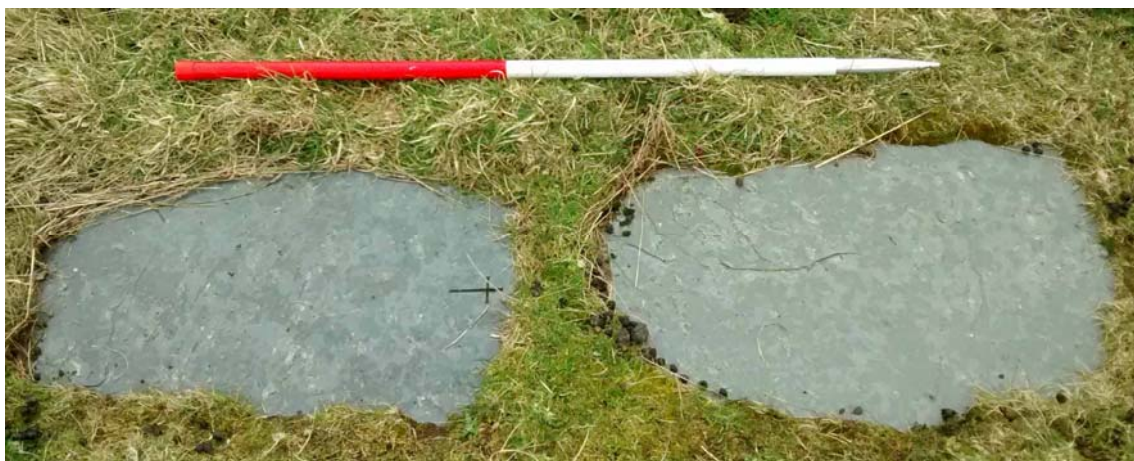
001 'Arthur's Bed' – a probable medieval grave; now filled in and marked by two slate slabs, one incised with a small cross (Fig 4).

*Fig 4: 'Arthur's Bed'*

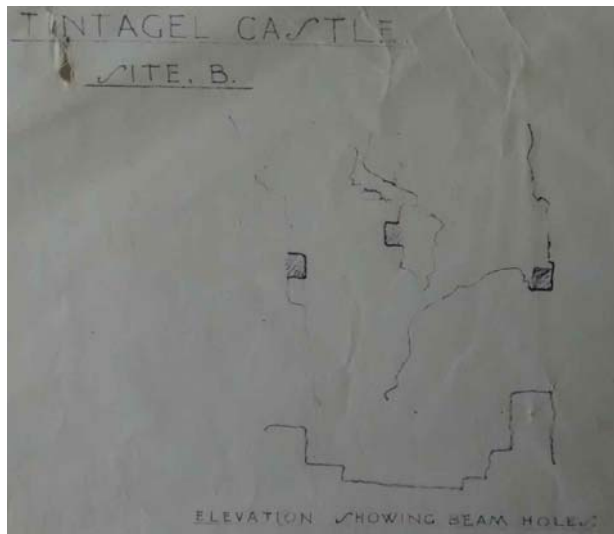
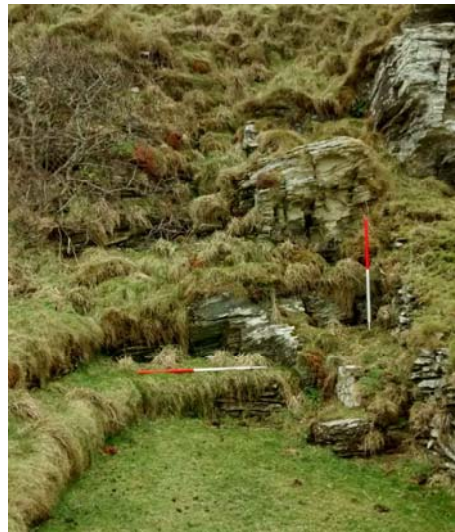
012 A small structure with walls standing up to 0.9m high and built into natural outcrop; there is an internal ledge 0.3m high; walling to the east is grass-covered and 0.2m high (no visible stonework). A drawing (MP/TIN 0032) in the Radford archive includes an elevation showing three 'beam holes' in the rock face at the west end of this building (Figs 6 and 7); however, these are natural fissures in the rock, apparently chosen out of many potential candidates because they form a shallow 'gable' or ridge shape; the 'slot' that would form the ridge would be over 2m further west from the apparent end of the building because there is a substantial ledge in the natural rock face.

*Figs 6 and 7: archive drawing (MP/TIN 0032) of the elevation of the west end of building 012 and view of the same elevation in 2015*

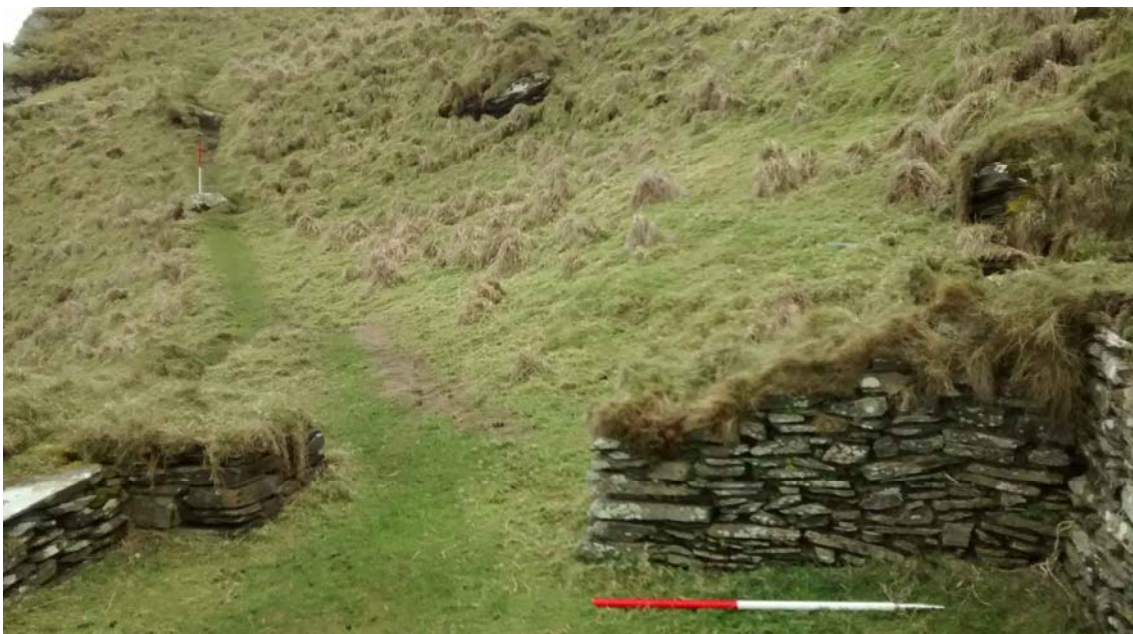
*Fig 8: Site C, area 017 looking north from the interior of 024; the edge of Trenches C17, C15, C7 cut in the 1990s can be seen running along the slope to the right and then down to the far ranging rod*

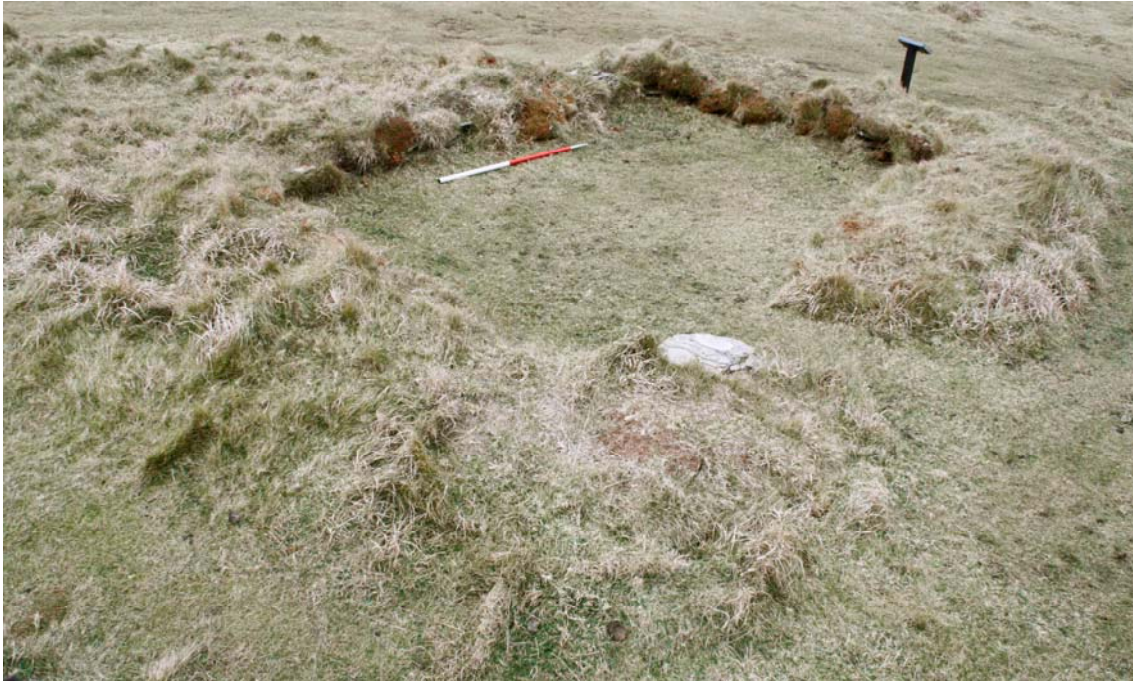
028 Sub-rectangular structure as shown on 1984 plan; walls 0.3m high and 0.6m wide (Fig 9). This building is shown complete on the interim report plan (Radford 1935, pl LV) but for its north-east corner, indicating that it was one of the first excavated on Site D. This building was, erroneously, interpreted as a ‘gun house’ (Thomas 1993, 52); as reconstructed it resembles a Bodmin Moor-style shepherd’s hut or shieling (Pete Herring pers comm).

*Fig 9: building 028*

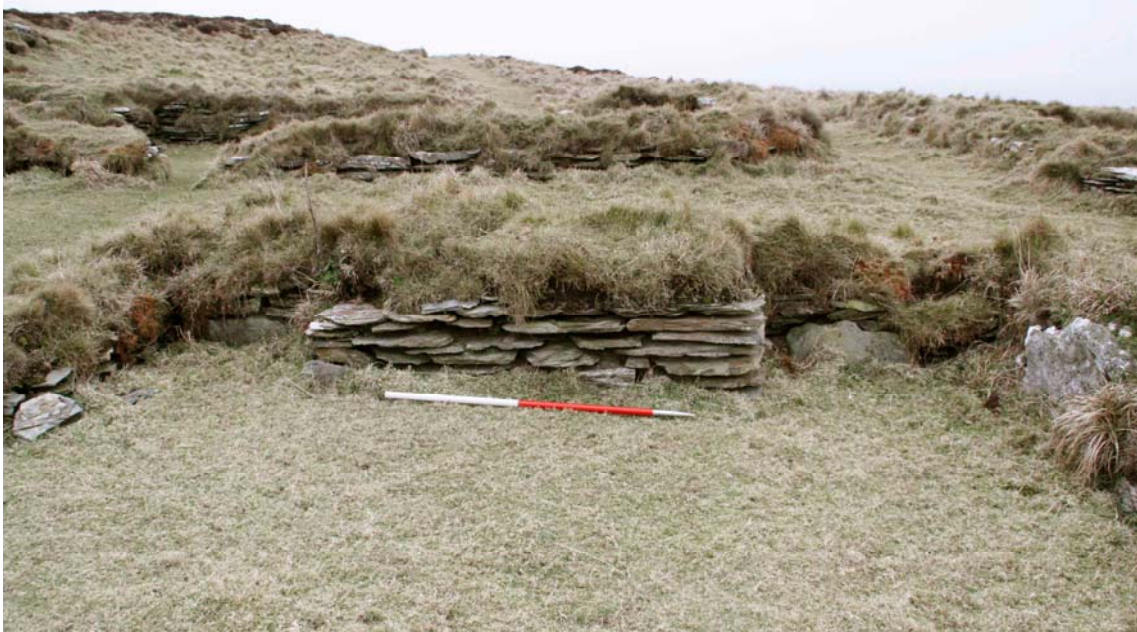
032 As depicted on 1984 survey; an L-shaped structure with walls a maximum of 0.6m high; there is possible slight evidence for a continuation of the south wall. There is a stone-built structure (Fig 10) placed centrally against the west wall, 1.8m wide and 0.5m deep, of unknown function (not apparently a hearth); this feature is not shown on Radford's 1962 version of the plan (fig 2) but the south wall is shown as being the same length as the north wall. An additional spread linear scarp running north-south, a maximum of 0.4m high, was supplied in 2015; this is possibly a geological feature but could be of archaeological origin; it is overlain by 032, indicating that it predates it.

*Fig 10: interior of building 032 showing the unexplained 're-constructed' structure against the west wall; buildings 029 and 030 lie beyond*

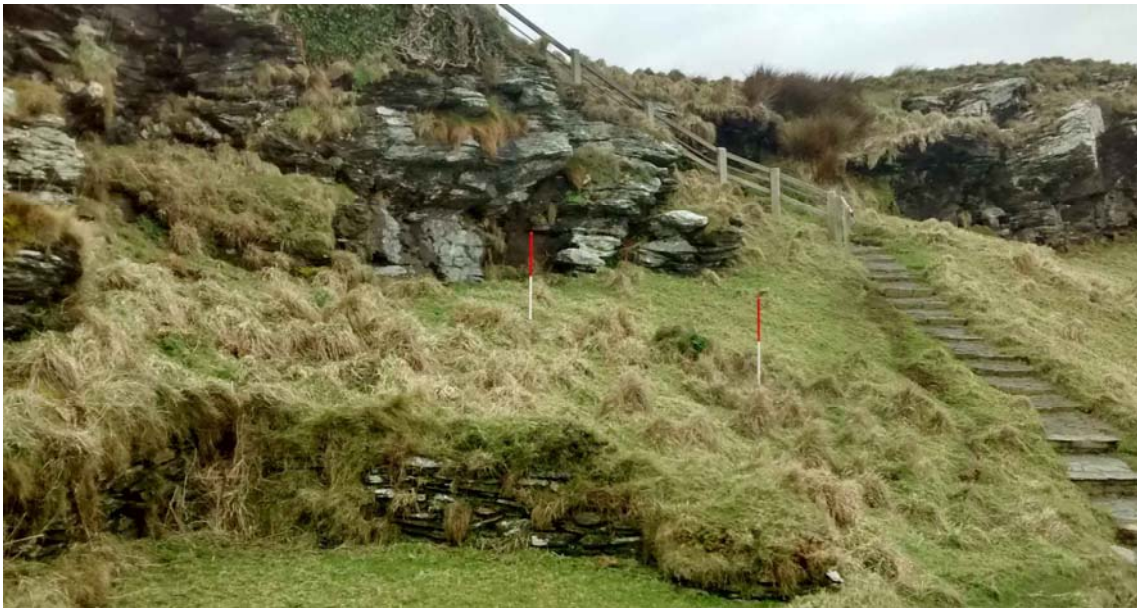
walls are much lower and possibly all reconstructed. The slope to the west could conceal more buildings and the scar of Radford's trench G/1 is visible here (but not surveyed) (Fig 11).

*Fig 11: west end of the reconstructed building on Site G; the ranging rods mark the scar of Radford's Trench G/1*

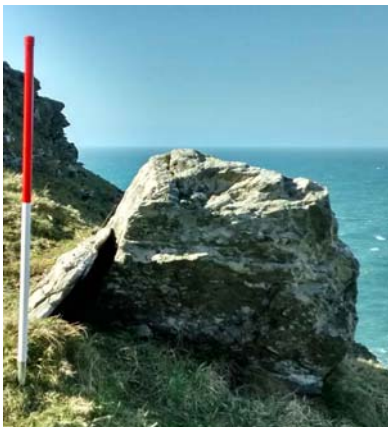
*Fig 12: two upright slabs of rock at the east end of Site G. Radford's Trench G/4 was at this location*

048 Two upright slabs of rock (Fig 12); the maximum height of the larger slab is 1.4m. Radford's trench G/4 was probably cut to examine these slabs.

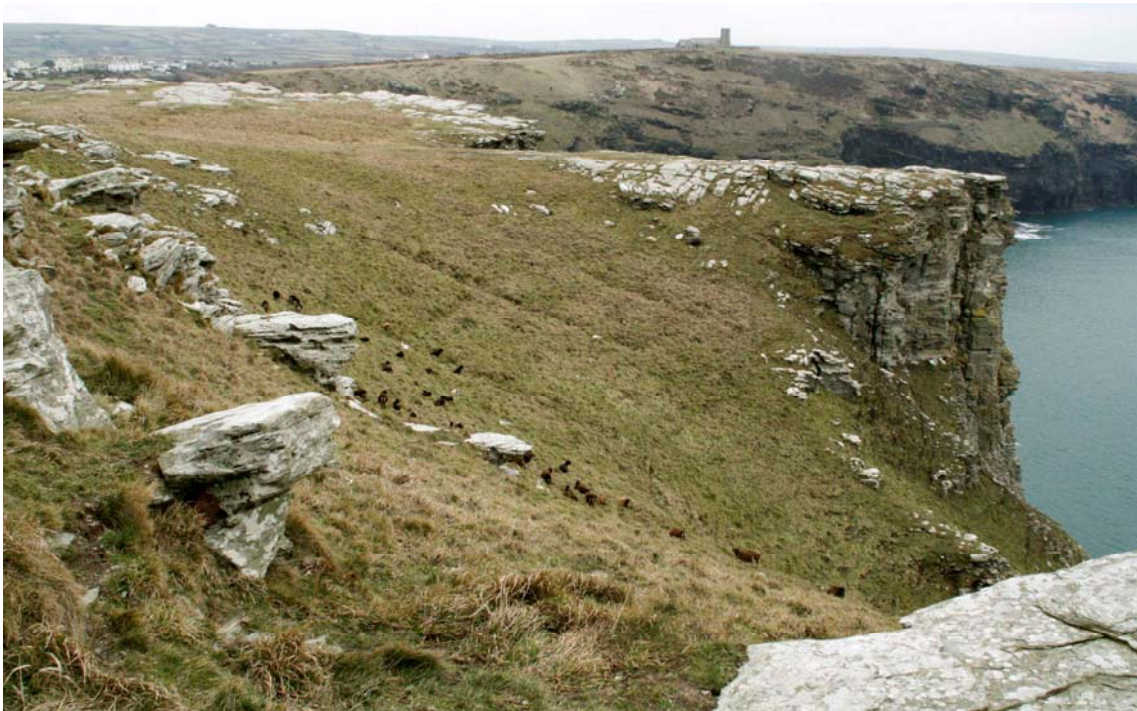
075 An array of trenches, about 0.3m deep, on a steep west-facing slope (Fig 14); there is no sign of spoil (which was presumably spread downslope); these are probably prospecting trenches from an episode of lead mining (*see* Discussion). The stone symbol shown on the 1984 survey within one trench is a block of granite. (These features were identified by Thomas as a 'vestigial field system' (1993, 45) but this is not convincing.)

*Fig 14: mineral prospecting trenches on the western slopes of the Island*

supposed 'field system' identified by Charles Thomas and Etienne Rynne (Thomas 1993, 45) on the west-facing slope of the Island (see Fig 14) as well as a number on the plateau. Wherever these features are in relationship with other earthworks they are demonstrably later. Also on the plateau is a small hollow (121) which Thomas identified as a 'caretaker's hut' belonging to Phase II (1993, 92, fig 73). However, careful examination suggests that this might be the head of a mine shaft with a small penumbra of spoil (see Fig 16). Whether these remains relate to the 19<sup>th</sup>-century mining or to unrecorded earlier mining ventures is unknown; they do suggest, however, the possibility that there might be a longer history to mineral extraction at Tintagel – mineral lodes at Tintagel were known by the end of the 16<sup>th</sup> century (Thomas 1988, 43).

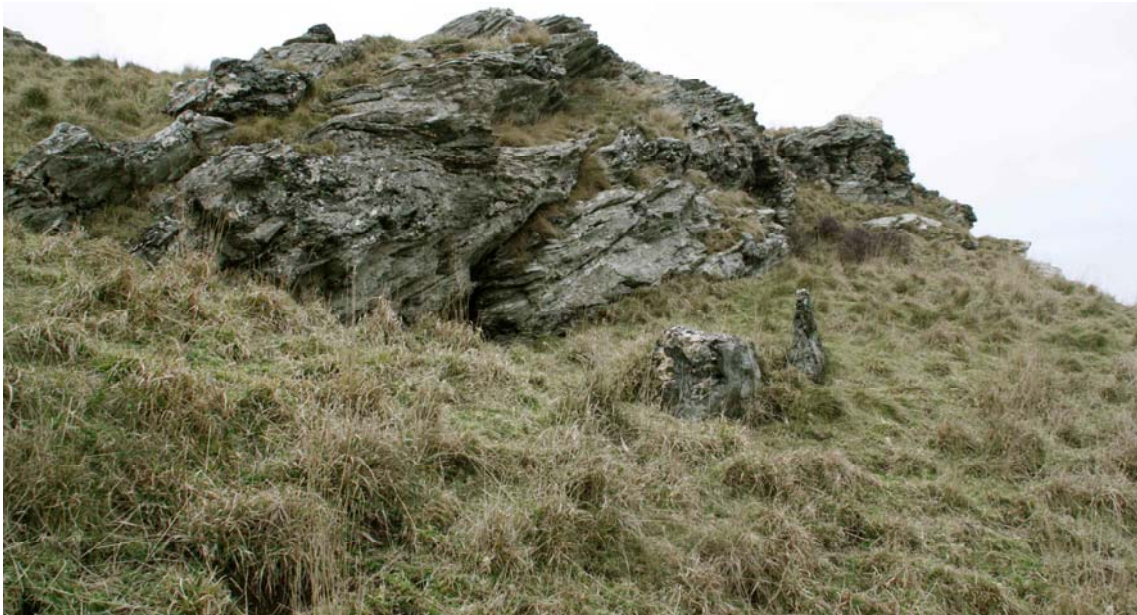
082 Scoop or platform against a rock face, marked by two upright granite blocks at the front (south) edge (Fig 15), suggesting that this is more than just a quarry; possibly a building or other structure.

*Fig 15: two small upright stones mark the front of platform 082, set against an outcrop on the southern slopes of the Island*

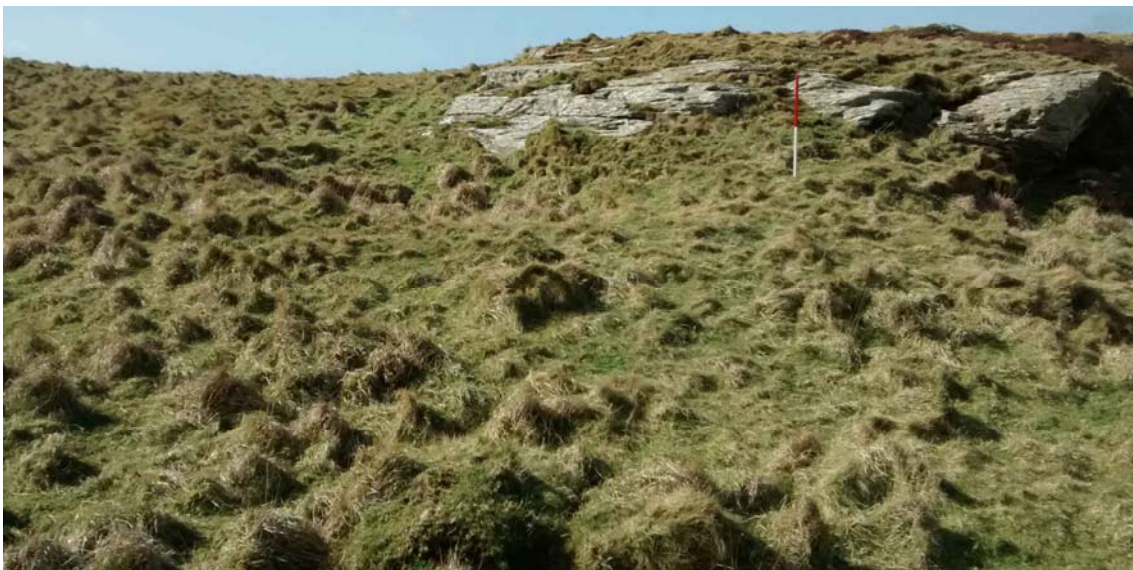
121 A small irregular hole, 0.6m deep, lying within a broader hollow up to 1.6m deep against the southern end of a rock outcrop (Fig 16); there is what could be a band of upcast or spoil to the east, up to 1.4m high; this is possibly a mine shaft (*see Discussion*).

*Fig 16: hollow 121 is to the left of the ranging rod at the foot of the outcrop; the upcast lies in the foreground and to the right*

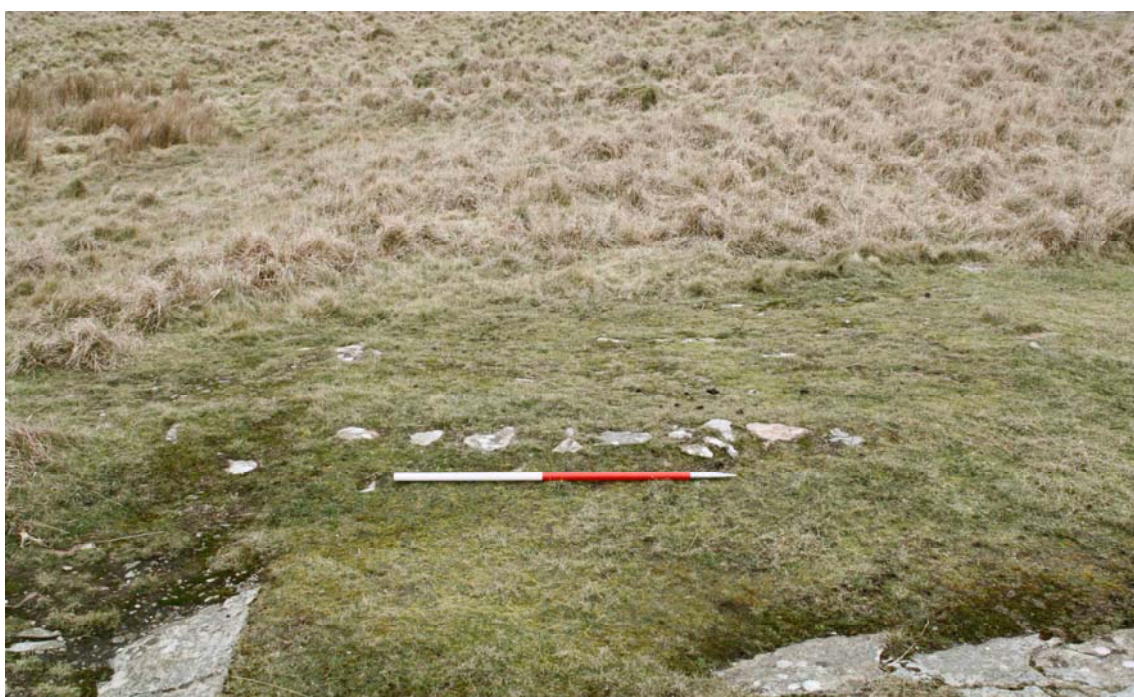
194 A rectangular area defined by stone rickle and scarps on the 1984 survey is now visible as an earthwork up to 0.2m high, its southern end defined by exposed stone, as shown in 1984 (Fig 17); this is probably a 2-celled building.

*Fig 17: stone rickle defining the southern end of building 194, possibly the same feature as that illustrated by Thomas (1993, fig 61); the building platform can just be distinguished running under the tussocky grass to the north*

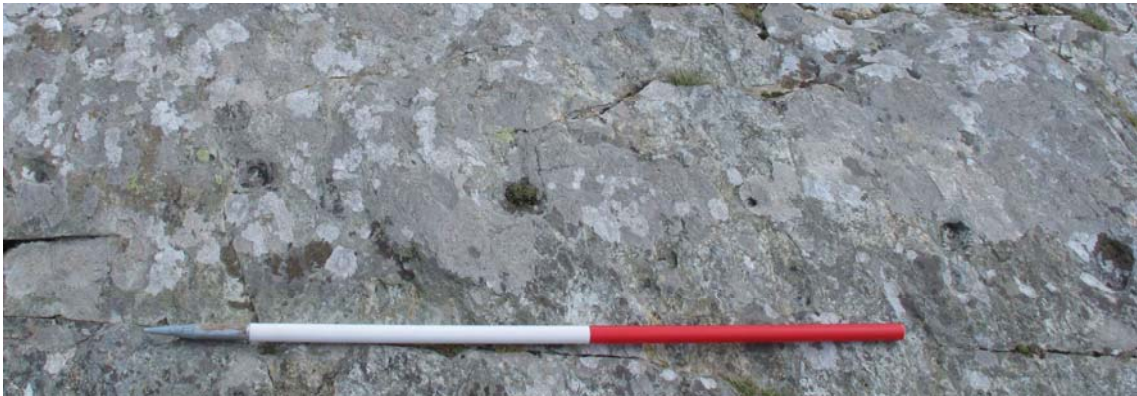
Possible stake holes seen by previous researchers were noted at two points on the south-western side of the plateau. One group was recorded by mapping grade GPS (Fig 18 – *see also* Thomas 1993, fig 71). A second group was only noted later and photographed (Fig 19); this is the group shown by Barrowman *et al* (2007, fig 23) where they are described as ‘above Site C’ though they are actually close to ‘King Arthur’s Footprint’ on the southern edge of the plateau.

*Fig 18: stakeholes surveyed near the south-western point of the plateau*

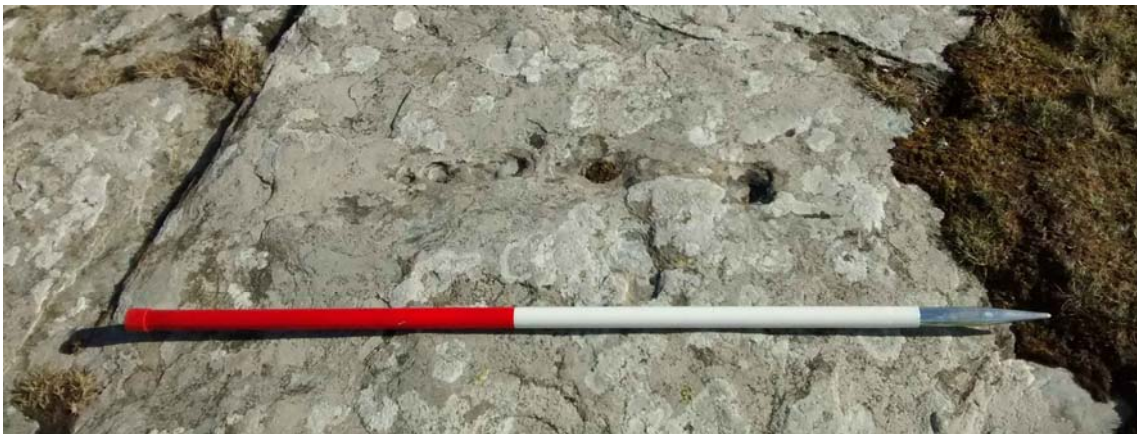
*Fig 19: stakeholes near ‘King Arthur’s footprint’*

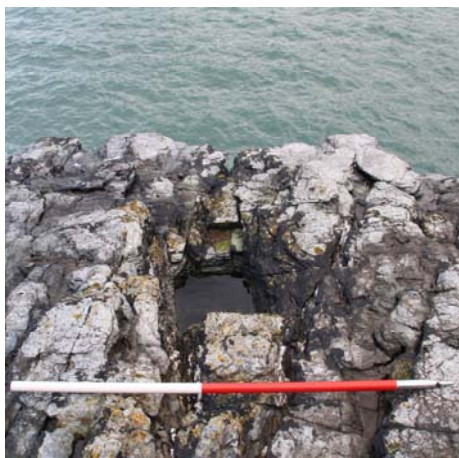
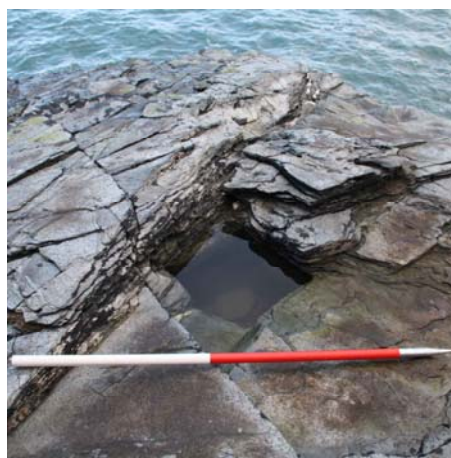
The Iron Gate is a natural quay – a rock platform with a vertical drop into deep water. It is protected on the landward side by a 13<sup>th</sup>-14<sup>th</sup>-century wall (Thomas 1993, 40-3); proposed gun positions are shown on Grenville’s 1583 plan, though no gun platforms are visible. There are two square-plan holes cut into the rock at the outer corners of the quay, probably for timber mooring posts (Figs 20 and 21). Other facilities for working and mooring vessels, probably of a later date, can be seen elsewhere around the Haven (see Herring 2016). Thomas proposes an ingenious etymology for the name Iron Gate (1993, 43) but there is nothing inherently unlikely about the idea that the arch in the medieval wall was once filled by an iron gate.

*Figs 20 and 21: rock-cut holes for timbers at the outer corners of the Iron Gate quay*

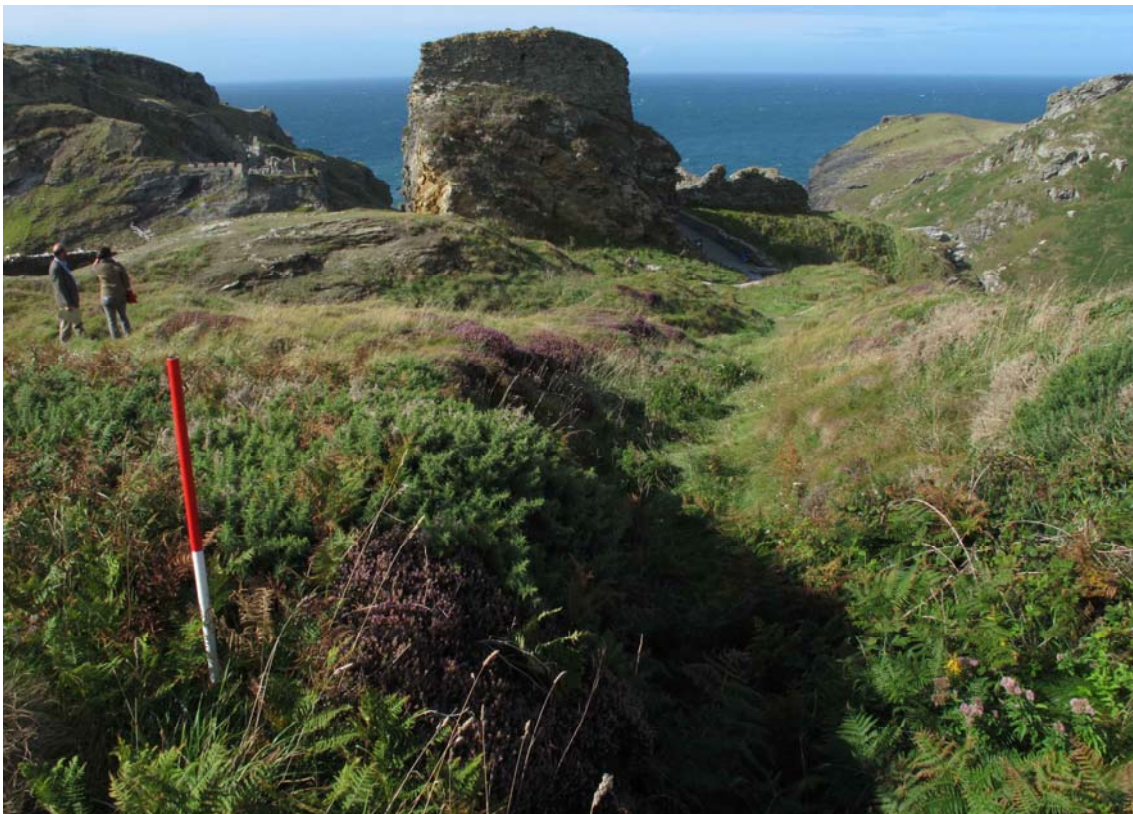
*Fig 22: medieval hollow way 197 approaching the castle entrance to the right of the Upper Ward; the later hollow way 198 comes in beyond the figures on the left and behind this is the natural mound 200, the top of which seems to have been levelled; the barbican-like mound 199 can just be seen at the end of 197*

Earthworks outside the Upper and Lower Wards (Fig 22) were checked in more detail and some – mounds and hollow ways – were supplied in outline with mapping-grade GPS. (The Great Ditch and the external ditch of the Lower Ward were not studied,

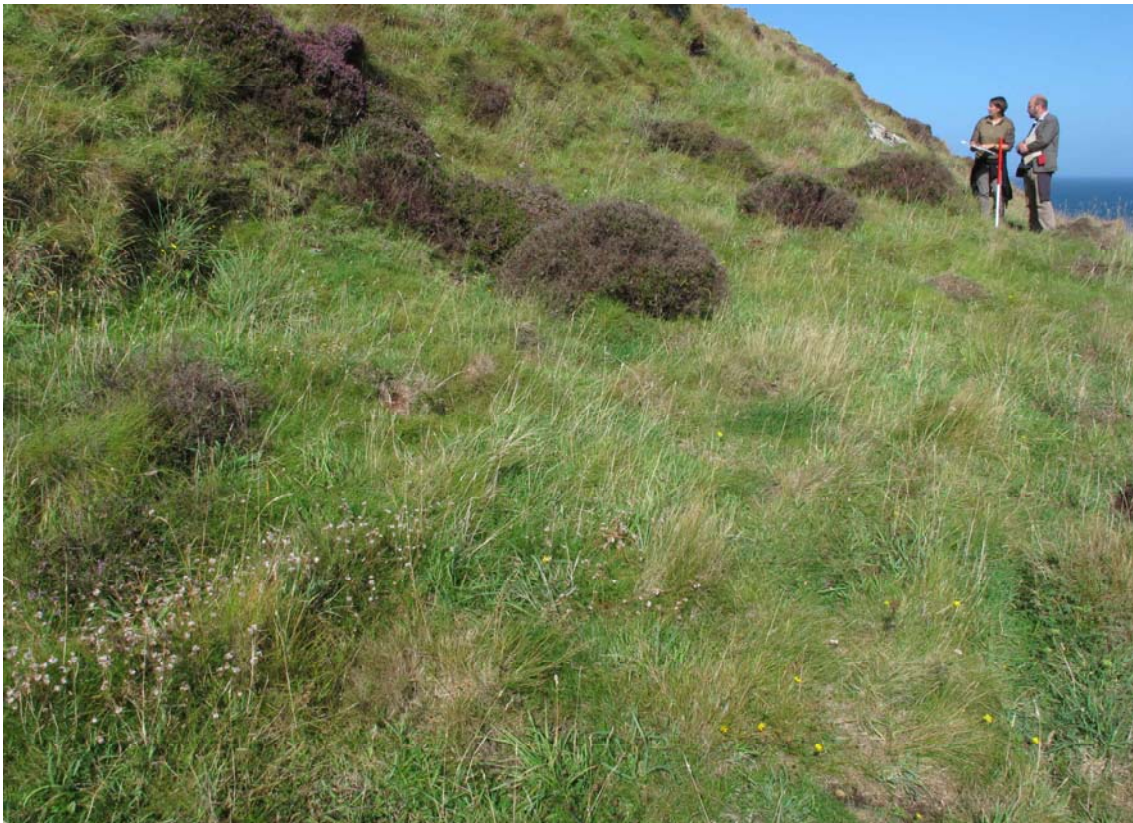
The excavators emphasised that the buildings on the Lower Terrace of Site C were ‘far from substantial’ and that they were lower status or storage buildings, peripheral to the core activity on site (ibid, 121-2). This reflects the contrast between the ‘courtyard’ arrangement of some buildings on the plateau and the elongated forms on the terraces.

*Fig 23: the Lower Terrace of Site C in 2014*

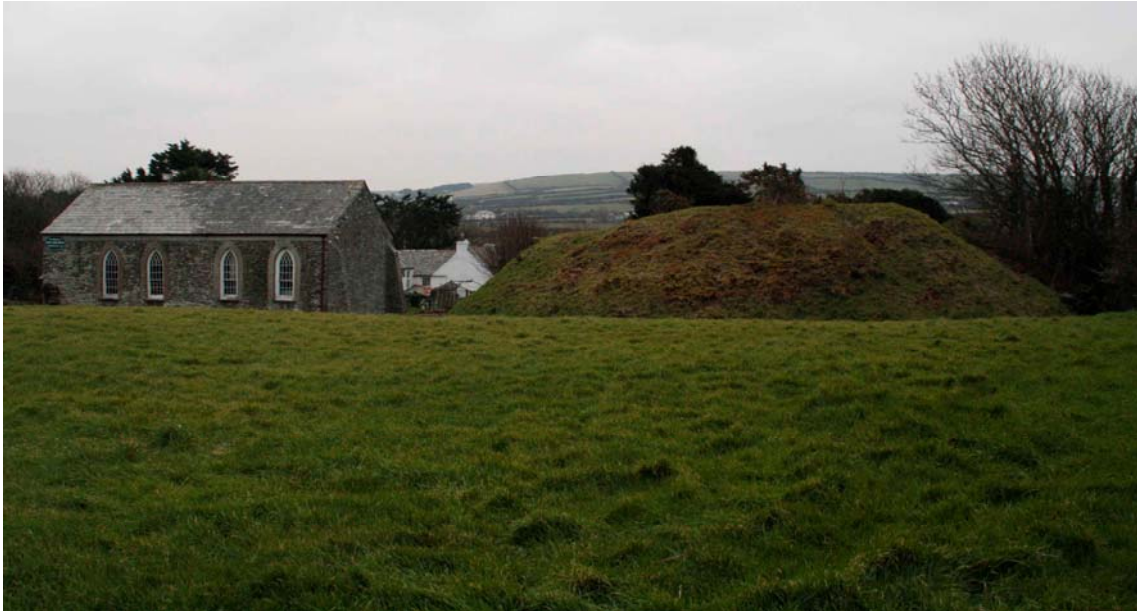
*Fig 24: the motte of Bossiney Castle, the seat of previous owners of Tintagel*

Richard went to some trouble to acquire Tintagel in the first place, at an early stage in his career, exchanging the manor of Bossiney (Fig 24) for three apparently more desirable manors (Thomas 1993, 12, 17). He then expended much resource in building a castle at Tintagel of no clear military value. This can only be explained on the grounds

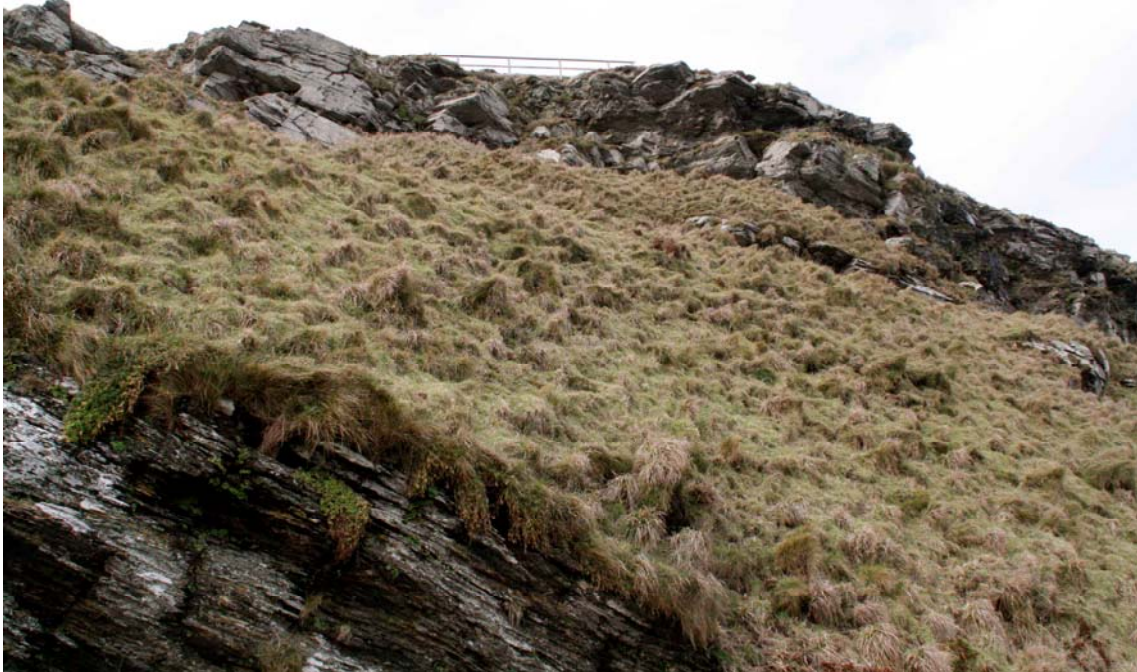
*Fig 25: looking up to the east end of the chapel, which is marked by the modern fence*

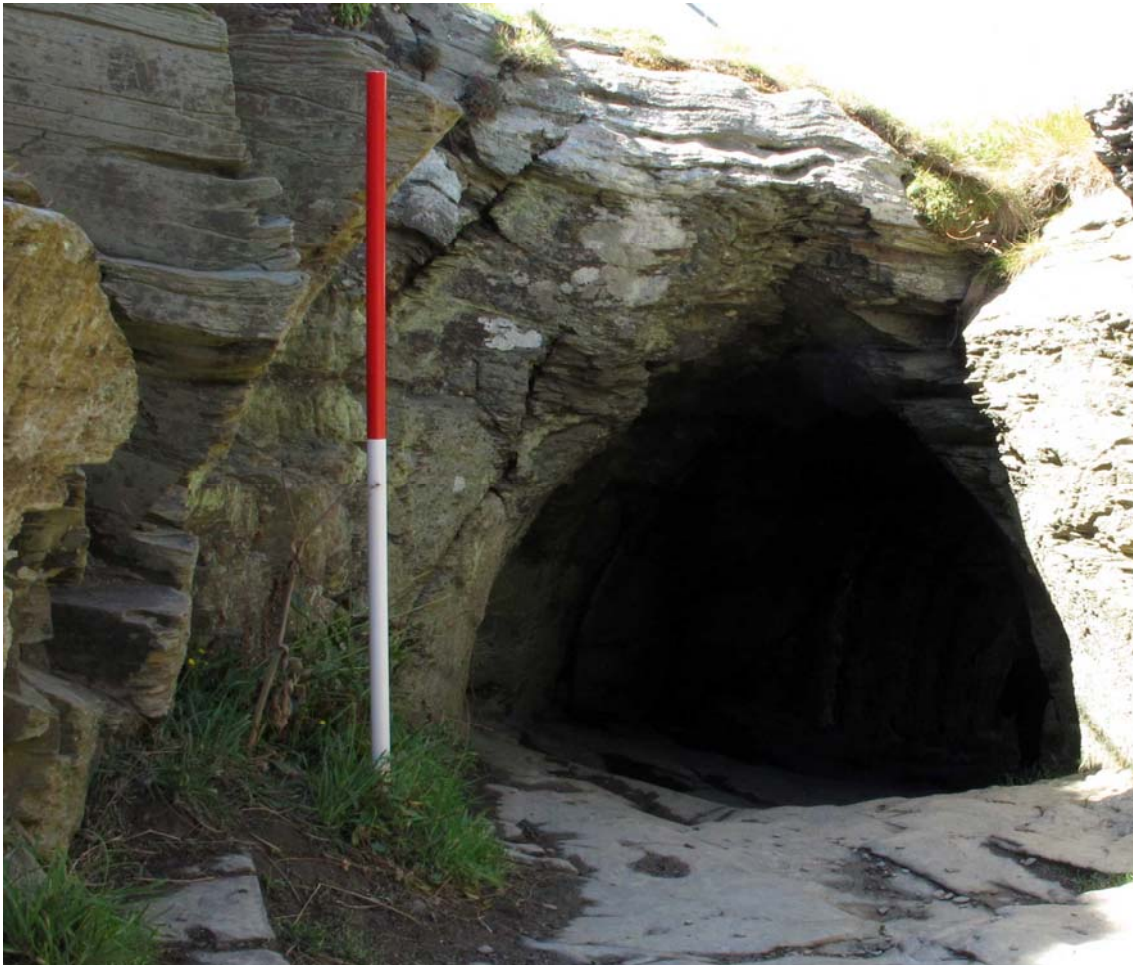
Cut with metal tools, the Tunnel has an arched profile (Fig 13 *and see* Fig 26). It is 1.7-2.4m wide at the base and 1.5-1.9m high. It has been cut in a series of curves (almost bowl shapes), perhaps to make it appear natural. The ends have fallen in and now only the central section is roofed. Claims have been made for various architectural features (door post slots, beam holes – e.g. Thomas 1993, 46-7, fig 36) but most of these are either unconvincing or are demonstrably natural fissures of the vesicular rock into which the upper part of the Tunnel is cut. Whether it was intended as a tunnel or as a cave roofed in at the upper end is now uncertain (*see* Discussion below).

*Fig 26: the 'Tunnel'*

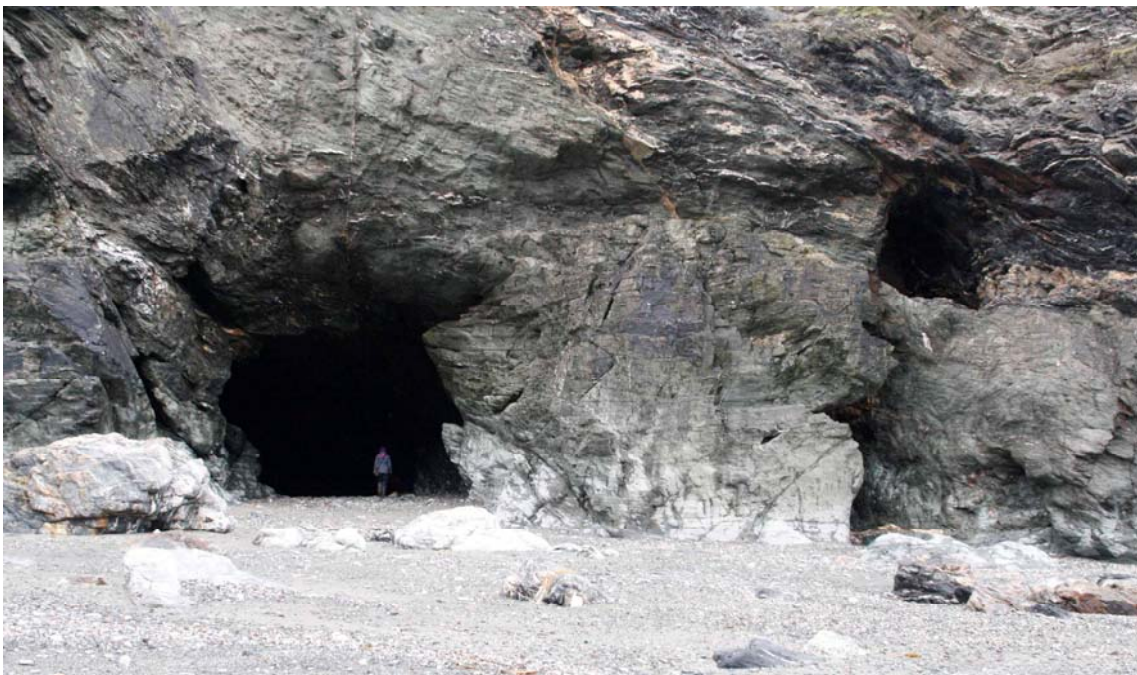
*Fig 27: the mine adit to the right with the scar of the walkway passing across the top of Merlin's Cave to the left*

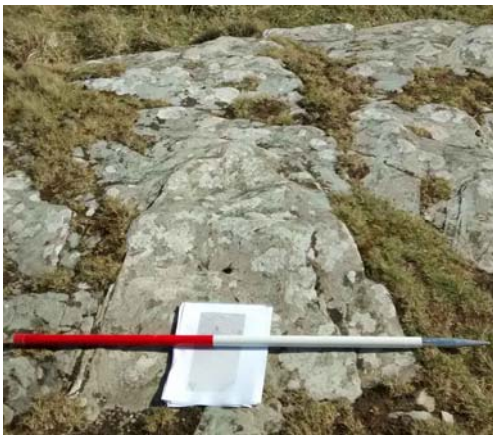
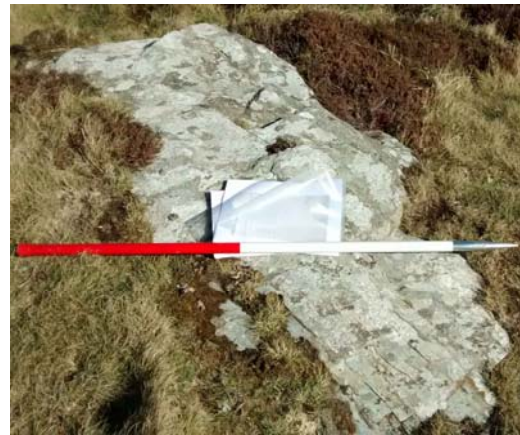
Two survey markers from one of the previous surveys (1988) were found and photographed in 2015 (Figs 28 and 29): survey point 13 (SX 04902.311 89054.046: 80.14mOD) and survey point 26 (SX 04907.300 89102.800: 82.14mOD).

*Figs 28 and 29: survey points 13 and 26 from the 1988 survey marked by iron pins in bedrock*
