# Wythenshawe Hall, Manchester. Assessment of Historic Window Glass

David Dungworth

A survey of fire-damaged historic window glass at Wythenshawe Hall which included the *in situ* chemical analysis of 347 individual panes confirmed that much of the glass had been produced in the 17th century (or earlier) and was probably contemporary with the construction of the hall.

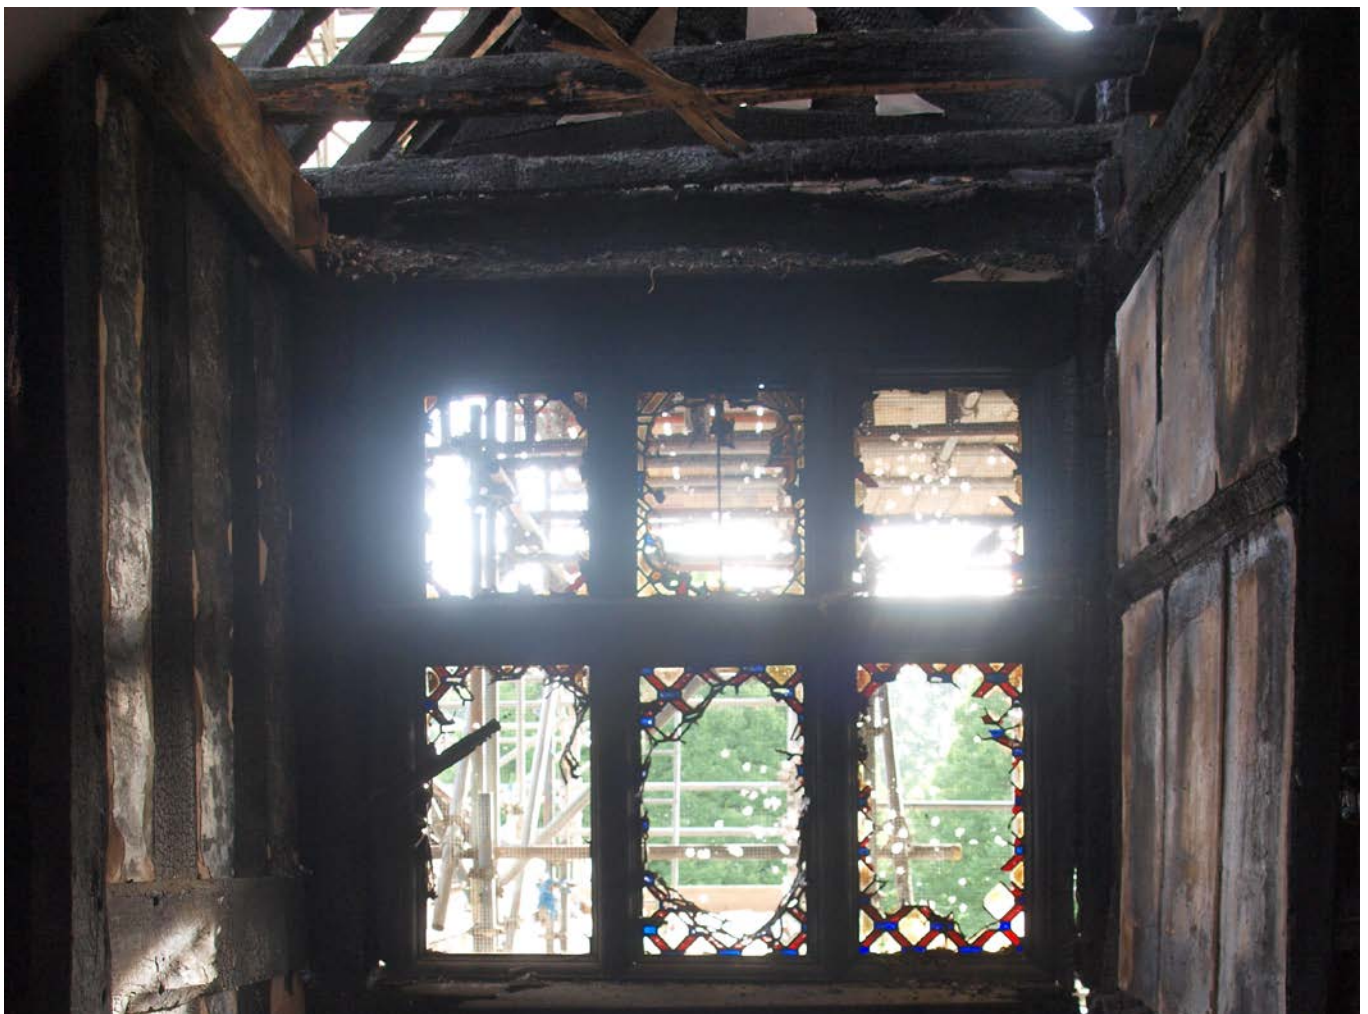
Figure 1. Wythenshawe Hall, window F9 showing extensive fire damage

The fire damage at Wythenshawe Hall (Figure 1) provided the opportunity to collect small samples of broken glass which could be analysed using pXRF (Table 2) and using laboratory-based techniques (Table 3). These samples were analysed using a Bruker Tornado EDXRF and an Oxford Instruments X-ray detector attached to a scanning electron microscope (SEM-EDS). These samples were prepared and analysed using methods described in numerous other reports (*eg* Dungworth 2009). The sixteen samples included one medieval forest glass (sample WH14), six high-lime, low-alkali (HLLA) glass and nine Leblanc soda glasses. The nine Leblanc soda glass included only two examples with the low levels of iron (0.2–0.3wt% Fe<sub>2</sub>O<sub>3</sub>) usually associated with plain (‘white’) glass of this period. In others panes the iron levels were considerably higher (~1wt% Fe<sub>2</sub>O<sub>3</sub>) and this

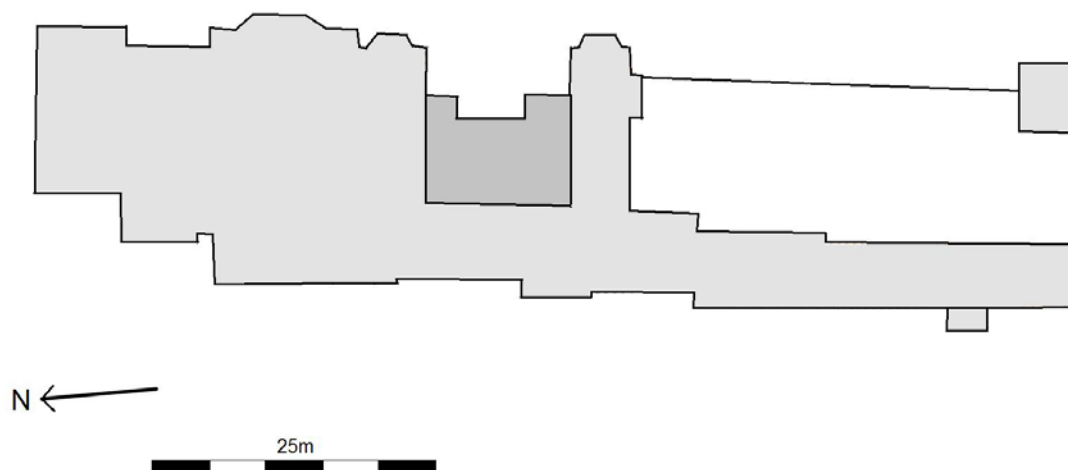
Figure 2. Plan of Wythenshawe Hall showing the historic core (darker grey)

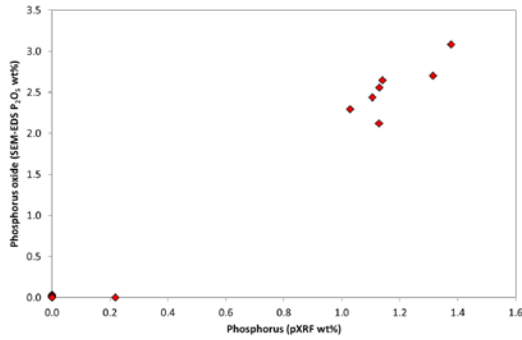
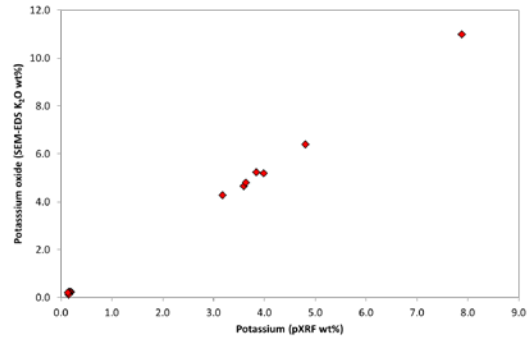
The results of the pXRF and laboratory-based analyses show a good correspondence between the two methods (Figures 4–7). In most of the cases where no phosphorus was detected using pXRF, this element could not be detected using the laboratory-based instruments (sample WH08 is the sole exception — a soda-lime-silica glass with little or no phosphorus but the pXRF result indicated the presence of 0.2wt% phosphorus). The comparison of pXRF and laboratory-based results suggests that the pXRF samples with high levels of arsenic are probably slightly over estimated.

Figure 4. Plot of pXRF and laboratory-based analytical data (phosphorus) for Wythenshawe window glass

Figure 5. Plot of pXRF and laboratory-based analytical data (potassium) for Wythenshawe window glass

Figure 6. Plot of pXRF and laboratory-based analytical data (arsenic) for Wythenshawe window glass

Figure 7. Plot of pXRF and laboratory-based analytical data (strontium) for Wythenshawe window glass

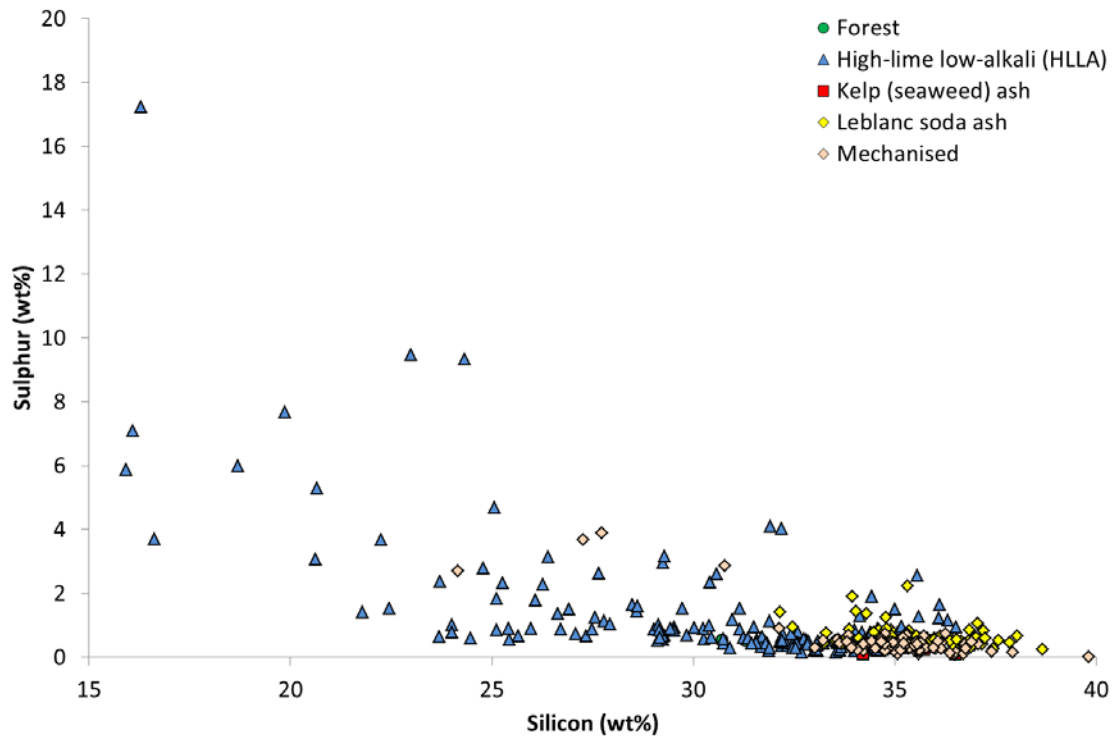
While the levels of sulphur detected (Figure 8) in most panes are typical for historic window glass (*ie* <1wt%) a significant number of analysed panes yielded sulphur concentrations in the range of 1–17wt%. The levels of sulphur detected in these panes reflect the corrosion of the glass rather than the original composition of the glass as manufactured.

Figure 8. Silicon and sulphur content of the analysed window glass (pXRF)

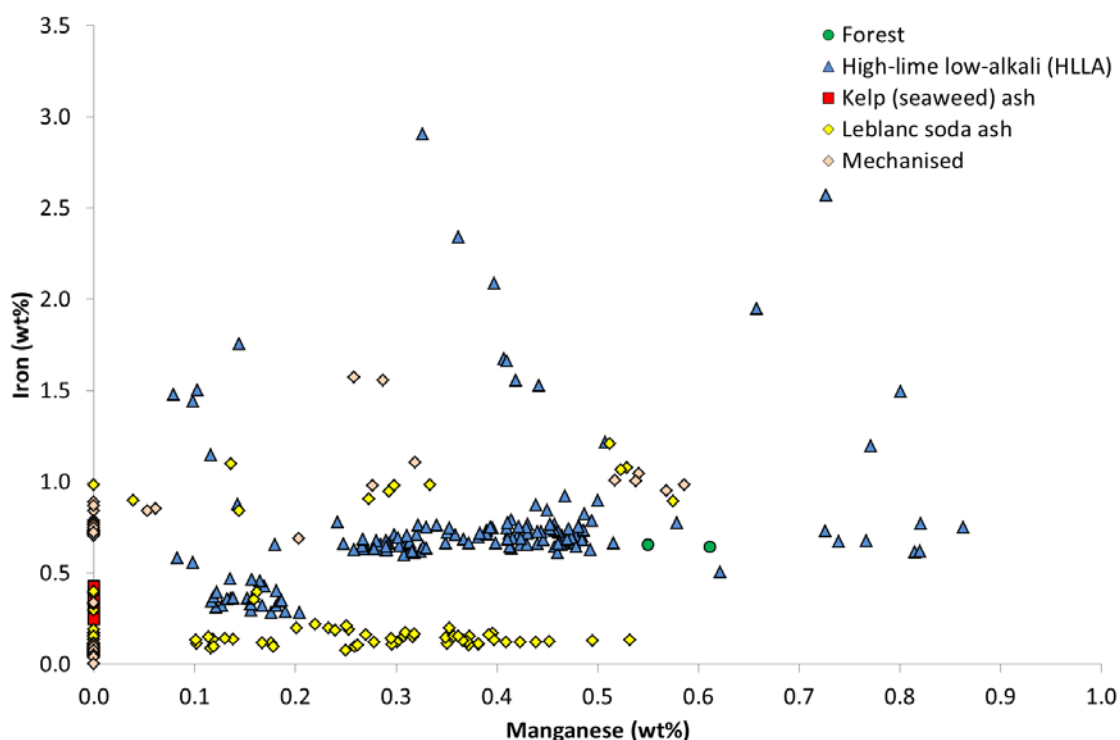
The levels of iron detected using *in situ* pXRF varied considerably (Figure 11). In some cases the concentrations of iron matched contemporary plain window glass (cf Table 1); however, in some cases the levels of iron detected were much higher than would be expected. Some later glasses were deliberately produced with elevated levels of iron in order to produce ‘antique’ glass. The unpainted, plain window glass in F7 (see Figures 12–14) includes 55 panes of Leblanc soda ash and mechanised glass: of which 14 contain low levels of iron (0.15–0.35wt%) but 41 have much higher iron concentrations (0.7–1.6wt%).

Figure 11. Iron and manganese content of the analysed window glass (pXRF)

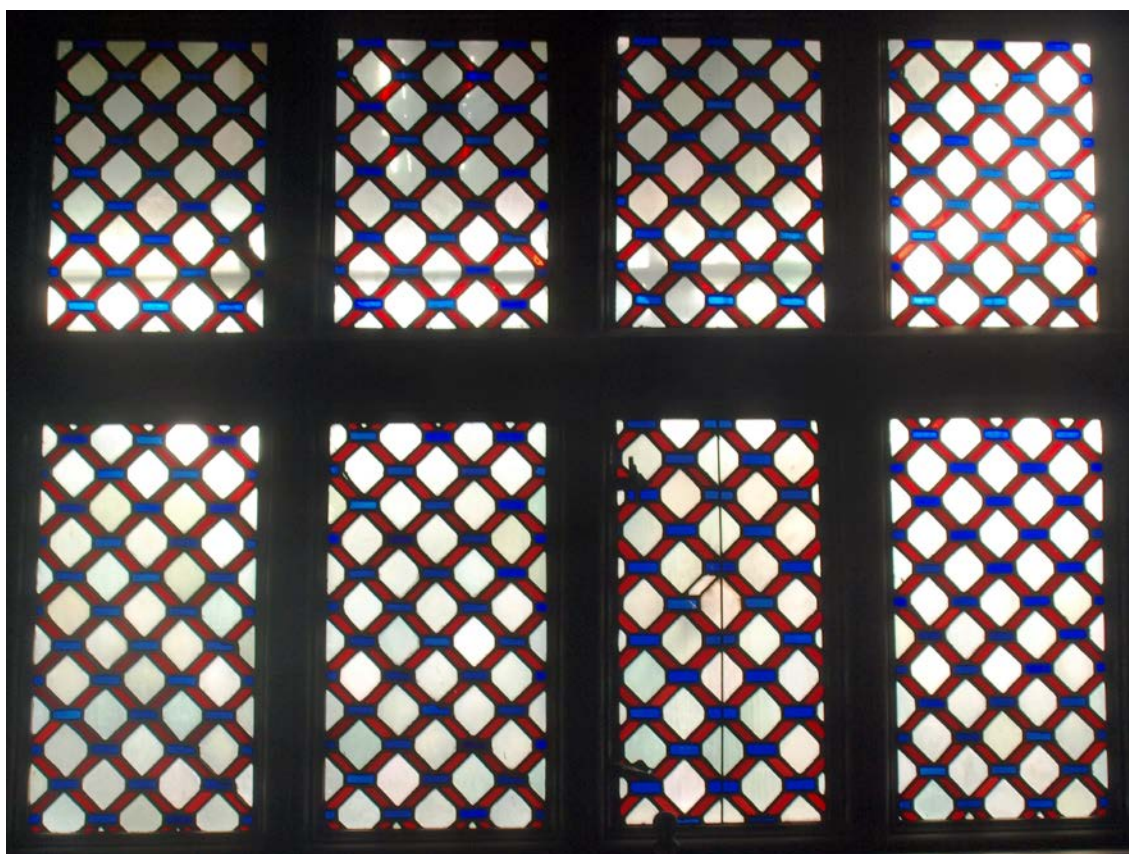
Window F7 comprises eight lights each formed of diamond-shaped panes of white (*ie* nominally colourless) glass with borders of red- and blue-coloured glass (Figure 12). The pXRF survey included each of the whole (or near whole) white panes in the four lower lights (L5–L8 from left to right). Access to the upper four lights was not possible and the coloured panes were too small to allow reliable pXRF analysis.

Figure 12. Wythenshawe Hall Window F7

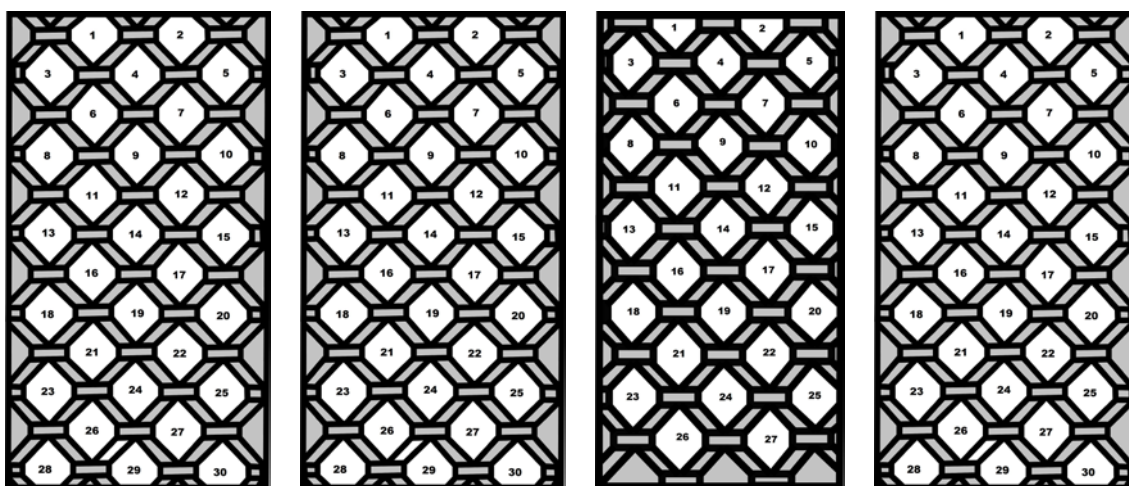
The analysis of 117 panes from Lights L5–L8 showed that one was Perspex while all the rest were made of glass. Two panes are tentatively identified as forest glass, approximately half of the glass panes could be identified as HLLA glass, and the remaining glass included five panes of kelp glass, 16 of Leblanc soda ash glass and 35 of mechanised glass. The high proportion of HLLA panes suggests that the

surviving window was probably constructed before the beginning of the 18th century. The presence of two panes of forest glass suggests that these panes were manufactured prior to the late 16th century. These two panes could have formed part of a glazing scheme installed during the original construction of the Tudor hall in 1540. It is also possible that the two panes of forest glass were re-used in a slightly later window. HLLA glass does not seem to have been produced in Britain prior to the late 16th century (Dungworth and Clark 2004); however, it was produced earlier on the continent and was imported for some glazing projects. Some of the coloured late medieval window glass in England does seem to be HLLA and was imported (Dungworth *et al* 2011). The HLLA in window F7 is all plain or 'white' glass and is perhaps slightly more likely to have been produced in England. If this tentative suggestion is accepted, then this glass would have been produced (and installed) no earlier than the late 16th century. The presence of five panes of kelp glass shows that repairs were carried out at some stage during the 18th century (or early 19th century). Similarly the Leblanc soda ash and mechanised panes attest to repair later in the 19th century and/or 20th century.

Figure 13. Wythenshawe Hall Window F7 showing the numbering for the analysed panes in the lower four lights (lights L5–L8)

Figure 14. Wythenshawe Hall Window F7 (L5–L8) showing the panes coloured to indicate the type of glass (green = forest; blue = HLLA; red = kelp; yellow = Leblanc soda ash; beige = mechanised; white = miscellaneous (Perspex); grey = not analysed)

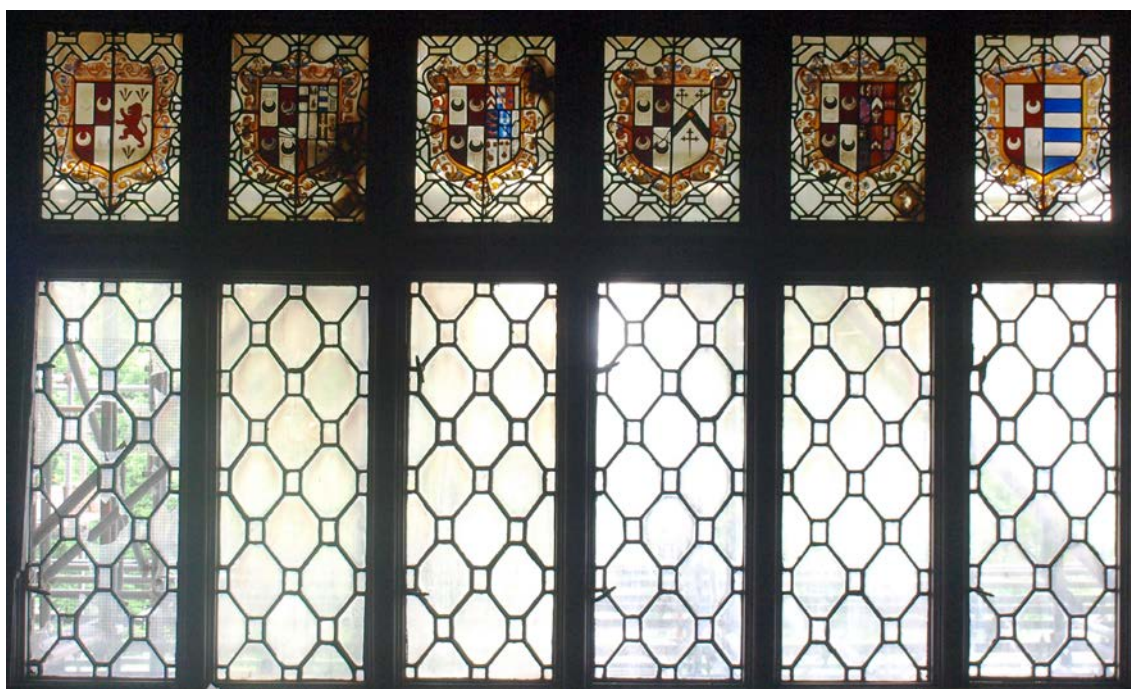
Window F8 comprises twelve lights arranged in two rows (Figure 15). The upper six lights (L1–L6) contain coloured and painted heraldic glass in lead comes. The most common motif in the heraldic glass is four crescent moons (signifying the Tatton family). The lower six lights (L7–L12) are all plain glass with ferrous metal glazing bars.

Figure 15. Wythenshawe Hall Window F8

The six upper lights of heraldic glass each show a heraldic shield at the centre with a border composed of decorative scroll elements (in blue and yellow-orange) on a background of diamond panes with rectangular borders (in a similar arrangement to Window F7, but entirely in ‘white’ glass’). The decoration uses a wide range of glass painting techniques. Some panes are composed of glass coloured (*eg* blue) throughout by the use of metal oxides (‘pot metal’), while some are coloured (*eg* red) just on one surface by the application of a thin layer of intensely coloured glass (‘flashed glass’). In several instances the flashed layer has been selectively abraded to produce regions of red and white colour in the same pane of glass (*eg* the *croissants de lune* in light L4, see Figure 25). Other panes contain an additional colour by the use of enamel or glass paint (examples include both blue and red). The use of coloured enamels in decorated glass in England dates from the 16th century onwards. The scroll borders show extensive use of silver stain to produce regions of yellow-orange colour. The final technique used to decorate the glass is the application of *grisaille* or black glass paint; this was used to provide thin outlines for figurative designs as well as patterned backgrounds.

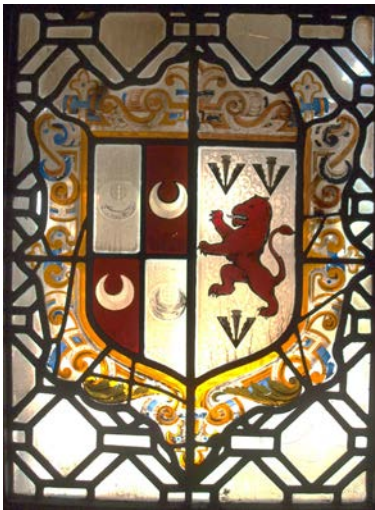
Light 1 (Figures 16–19) shows extensive repair and replacement of the original glass: eight out of the fourteen analysed panes are HLLA glass but the other six are later (18th and 19th centuries). The two panes of *croissants de lune* with white moons on a red background (P11 P12) are Leblanc soda glass (c1835–c1930). In this instance the red areas have been produced by painting red enamel and leaving the crescent moon unpainted (with a black *grisaille* outline). This contrasts with many other lights in this window where red flashed glass was selectively abraded. A similar technique (*ie* the use of enamel rather than abrading flashed glass) has been employed on P14 to produce the rampant lion. The composition of this pane suggests that it was made sometime after c1930.

Figure 16. Window F8L1

Figure 17. Window F8L1, panes analysed

Figure 18. Window F8L1, colour-coded by type of glass (see caption for Figure 14)

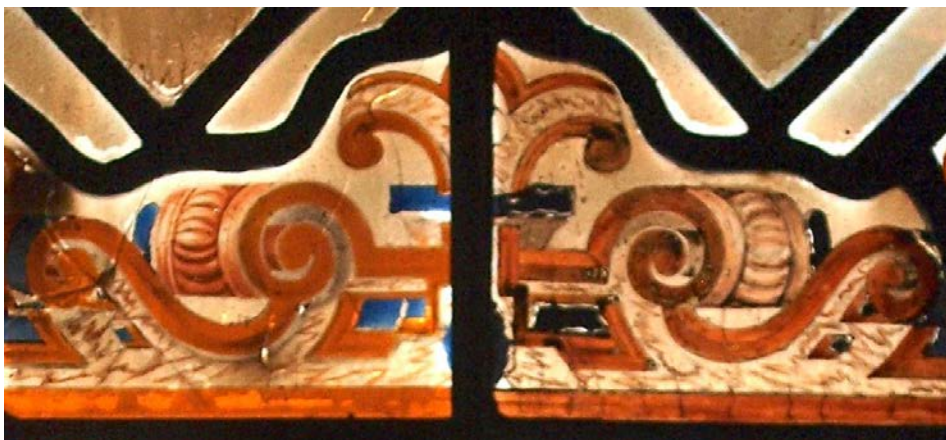
Figure 19. Window F8L1, panes P5 (right) and P8 (left) showing the later repair on the right executed using black rather than blue enamel

Two of the panes of border scrollwork in this light (P5 and P9) are later repairs. A close examination of the execution of the decoration on these panes shows differences with the original HLLA panes (P6–8). The original panes are decorated by outlining features with grisaille and filling in selected areas with silver stain (yellow-orange) or blue enamel. The later repairs have been painted by a less skilled artist who has been unable to colour selected areas with a blue enamel and has instead coloured these areas black (Figure 19).

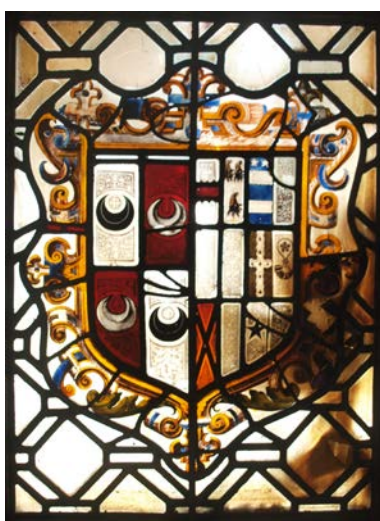
Light L2 (Figures 20–22) is composed almost entirely of HLLA glass and pXRF analysis showed a limited repair (c1835–c1930) to three panes on the right half of the shield (P14–16). The two panes of *croissants de lune* with white moons on a red background (P11 P18) have been produced by selectively abrading areas of red flashed glass (in contrast with the enamel painting of light L1).

Figure 20. Window F8L2

Figure 21. Window F8L2, panes analysed

Figure 22. Window F8L2, colour-coded by type of glass (see caption for Figure 14)

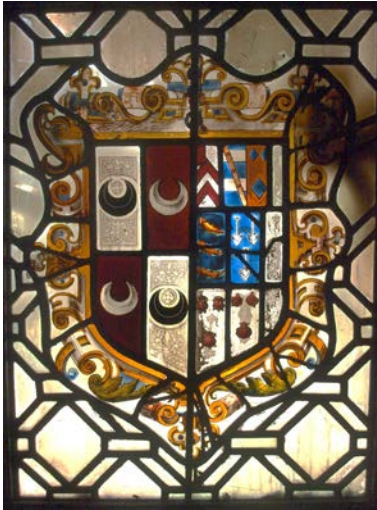
Light 3 (Figures 23–25) contains a large proportion of HLLA glass with the only identified repairs being two of the plain diamond panes at the top. One of these was replaced c1835–c1930 (P2) and the other after c1930 (P1).

Figure 23. Window F8L3

Figure 24. Window F8L3, panes analysed

Figure 25. Window F8L3, colour-coded by type of glass (see caption for Figure 14)

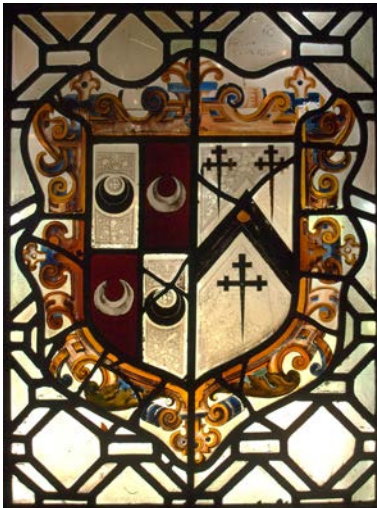
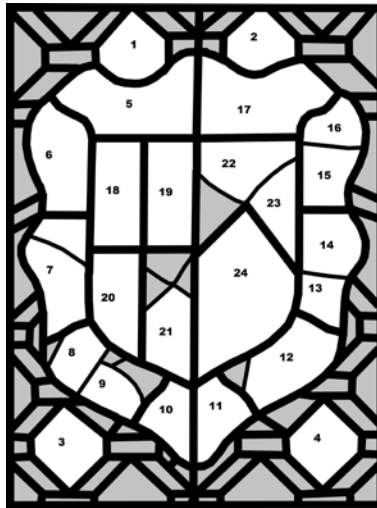
The use of pXRF analysis on Light 4 (Figures 26–29) indicates a similar history with a single repair to a plain diamond pane in the bottom right corner (P4).

Figure 26. Window F8L4

Figure 27. Window F8L4, panes analysed

Figure 28. Window F8L4, colour-coded by type of glass (see caption for Figure 14)

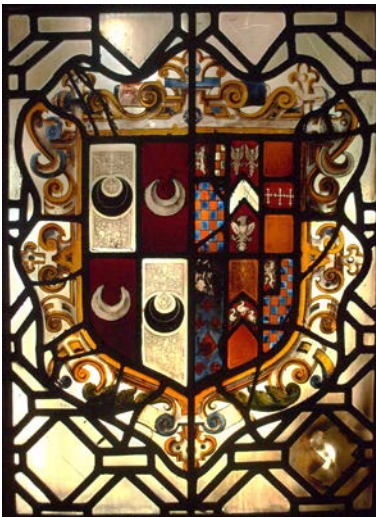
Figure 30. Window F8L5

Figure 31. Window F8L5, panes analysed

Figure 32. Window F8L5, colour-coded by type of glass (see caption for Figure 14)

Light L5 (Figures 30–32) is composed largely of HLLA glass and pXRF analysis showed limited repair to three panes but each was likely to have been carried out at a different time. A plain diamond pane at the top right (P2) is a kelp glass and would have been inserted c1700–c1835; while that on the top left (P1) was inserted after c1930. The repair to part of the heraldic shield (P19) was carried out c1835–c1930.

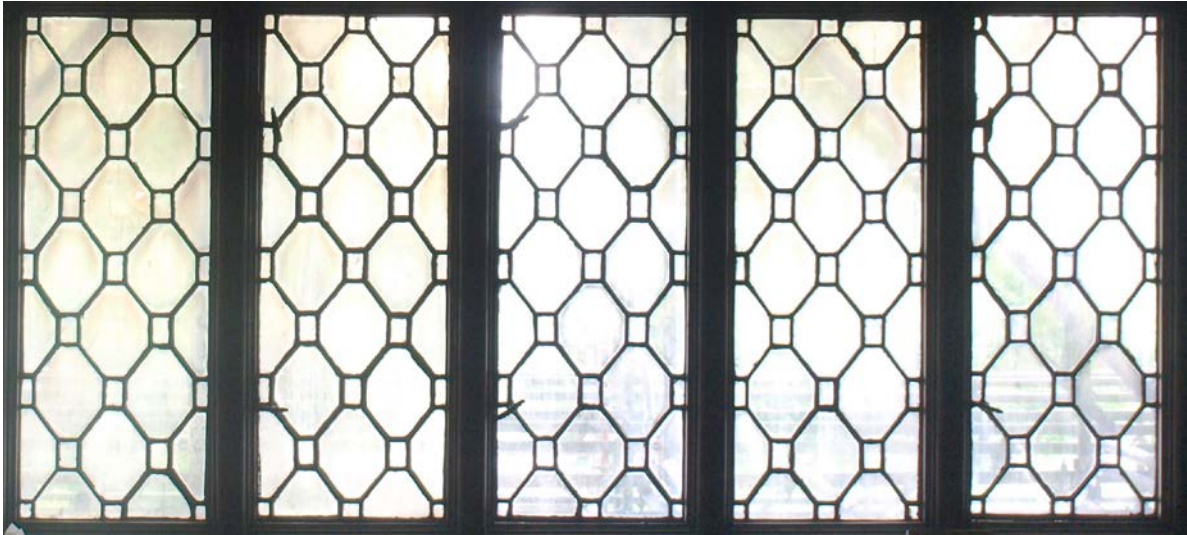
The lower lights in window F8 are all of plain (colourless) glass (Figure 36). The glass is held in ferrous metal glazing bars and so the entire scheme is likely to date to the late 18th century or later. The pXRF analysis (Figure 37) showed that all of the glass is Leblanc soda ash (c1835–c1930) or mechanised glass (c1930 onwards). It is likely that the window was first produced in the period c1835–c1930 and the mechanised glass represents later repairs. There are variations in the composition of the Leblanc soda ash glass and the mechanised glass which suggest

several periods of repair and replacement. Most of the Leblanc soda ash glass contains levels of arsenic which would indicate manufacture in the middle of the 19th century (c1835–c1870); it is likely that this represents the original glass in this window. All of the analysed glass in these lights contains low levels of iron that are typical of plain glass of the 19th and 20th centuries; this contrasts with the extensive use of ‘antique’ glass in window F7 (see above).

Figure 36. Wythenshawe Hall Window F8 lower lights (L8–L12). NB light L7 (to the left) has been omitted as it was too damaged (and obscured by wire mesh) to analyse

Figure 37. Wythenshawe Hall Window F8 showing the panes coloured to indicate the type of glass (yellow = Leblanc soda ash; beige = mechanised; white = miscellaneous (Perspex); grey = not analysed)

The six lower, plain lights in F8 contain only 19th- and 20th-century glass this glazing was probably designed and installed in the middle of the 19th century.

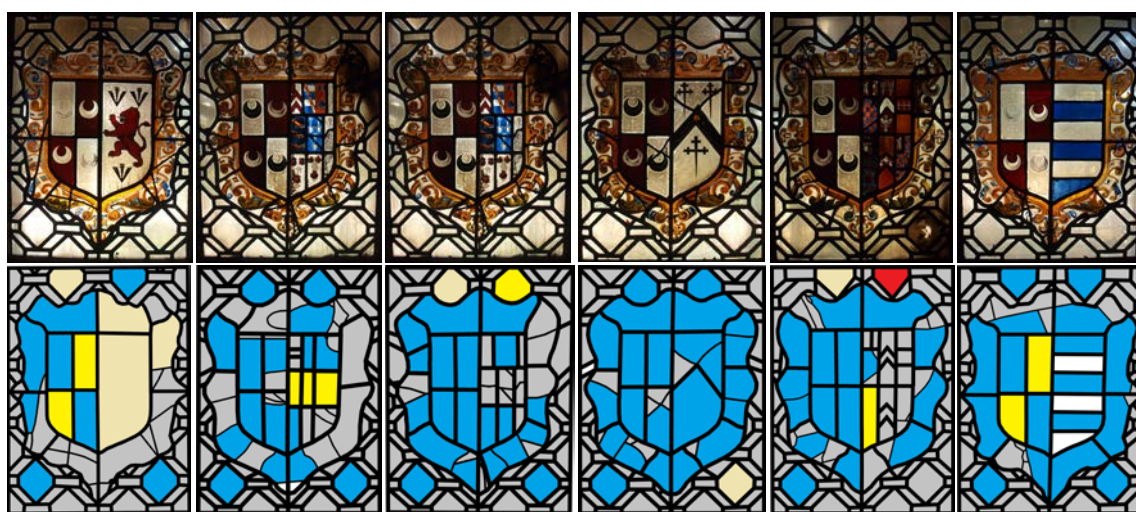
The six heraldic lights in window F8 are largely composed of high-lime, low-alkali (HLLA) glass and were probably made in England between c1567 and c1700 (Figure 38). This type of glass was manufactured on the continent at an earlier period and it is possible that the window was produced before c1567 using imported glass. In addition, the pXRF analysis detected several panes of medieval forest glass (produced between c1300 and c1567) in F7 and F9 which could have formed part of an earlier glazing of the Hall. It is possible that small amounts of this medieval glass were re-used and incorporated into slightly later windows. Nevertheless, it is also possible that this glass was provided during a period of window glass restoration using a completely different source (cf Dungworth and Girbal 2011). The pXRF analysis of these lights shows that there has been some later repair to each light and that this took place in the 17th, 18th, 19th and 20th centuries (Figure 38).

*Figure 38. Wythenshawe Hall Window F8 (L1–L6) showing images of the windows and schematic colour-coded representations to indicate the type of glass (blue = HLLA; red = kelp; yellow = Leblanc soda ash; beige = mechanised; white = miscellaneous (flint glass); grey = not analysed)*
