Church of St Edward and the Market Place, Leek, Staffordshire Geospatial Survey of Standing Medieval Crosses

Research Report Series 051-2016

**Church of St Edward and the Market Place
Leek
Staffordshire**

Geospatial Survey of Standing Medieval Crosses

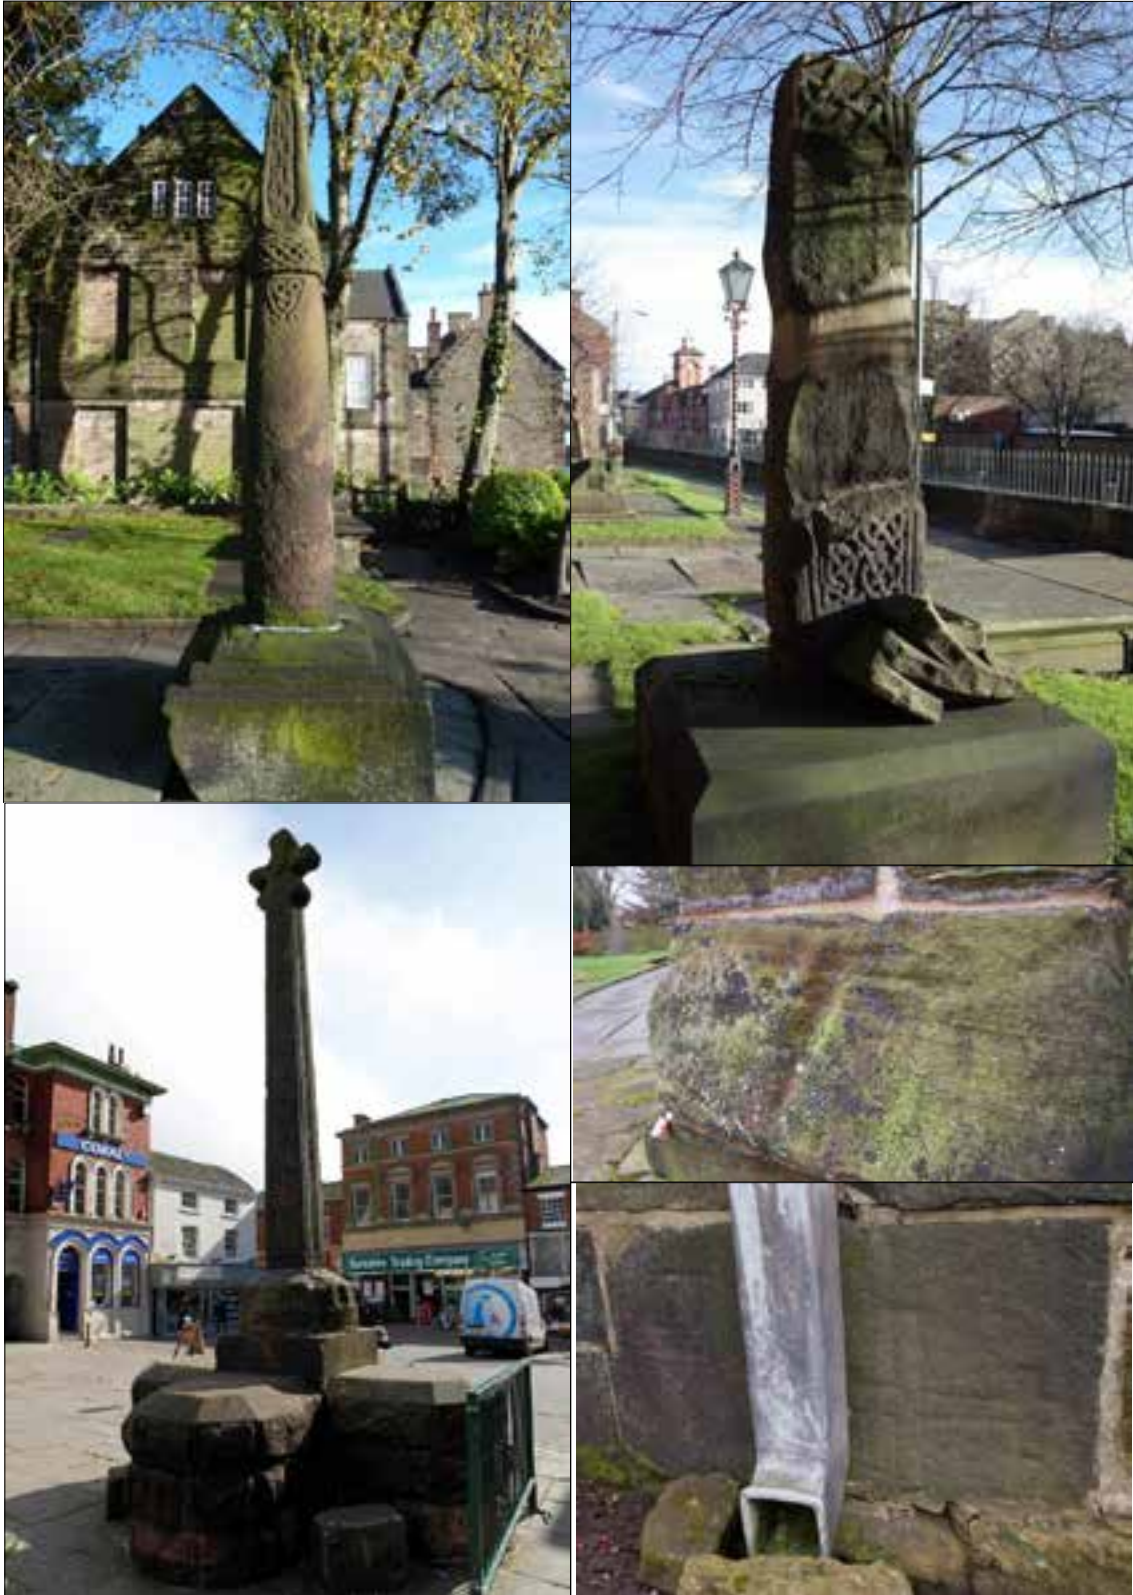
Figure 1: (Top left) Anglo-Saxon cross UID 1012656 with rounded shaft. (Top right) reconstructed Anglo-Saxon cross UID 1012657. The fragments at the base do not belong to the cross. (Bottom left) later medieval market cross in Leek marketplace. (Bottom right) arrow sharpening grooves and a Norman grave cover from the exterior walls of St Edward's church. Images not to scale.

The cross on the eastern side (UID 1012656) comprises a rounded shaft with small carved patterns on three sides, with a gradual taper to a prominent circular collar featuring interlace carving, reflecting Scandinavian tradition. Above this, the cross shaft becomes rectangular, featuring further interlace carving on each panel, leading up to the broken remains of a cross head that is believed to have been destroyed

The Anglo-Saxon cross presently situated nearer to the church (UID 1012657) was restored from pieces found lying in the churchyard and re-erected in 1885 (Pape 1946-7, 38). It had previously faced variable amounts of damage and wear, although interlaced carvings are still visible on some sides and a runic inscription is located on the lower part of the shaft (Sidebottom 2015). The original positions of both Anglo-Saxon crosses is unknown, however it is presumed that they were separately located in the landscape to serve as meeting places for worship before St Edward's church was built on this site (Cleverdon 2015, 2).

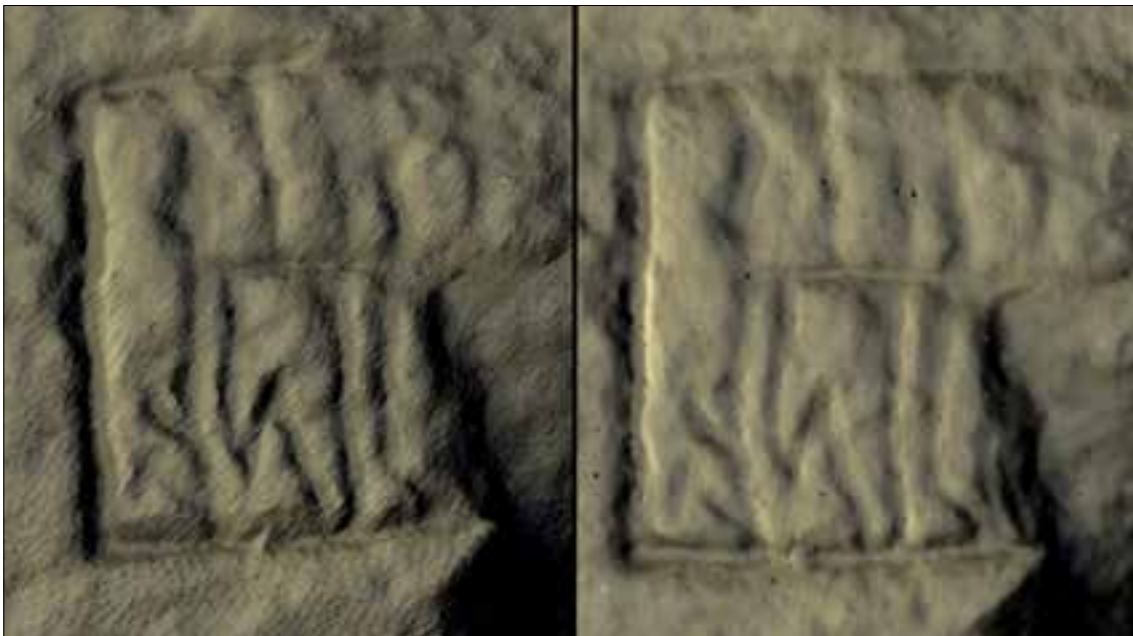
Figure 5: Virtual raking light from the left side of both PTM images. Left: PTM image from laser scan data. Right: PTM image from SfM photogrammetry. Note how the depths of the shadows are greater from the laser scan data, and the better clarity of several of the lower line of runes, although striping features across the surface. The symbol on the bottom left looks substantially different between the datasets.

From visual analysis of the PTM files alone, it is clear that the clarity of the runes varies depending on the angle of raking light from both datasets. When the light is positioned to the left side, the inscription looks more deeply incised on the laser scan model, as deeper and darker shadows are cast over its surface (figure 5). However, raking light from above the carvings defines the runes better in the photogrammetric model, as the stippled and grainy surface of the laser scan model appears more noisy, making them more difficult to discern (figure 6).

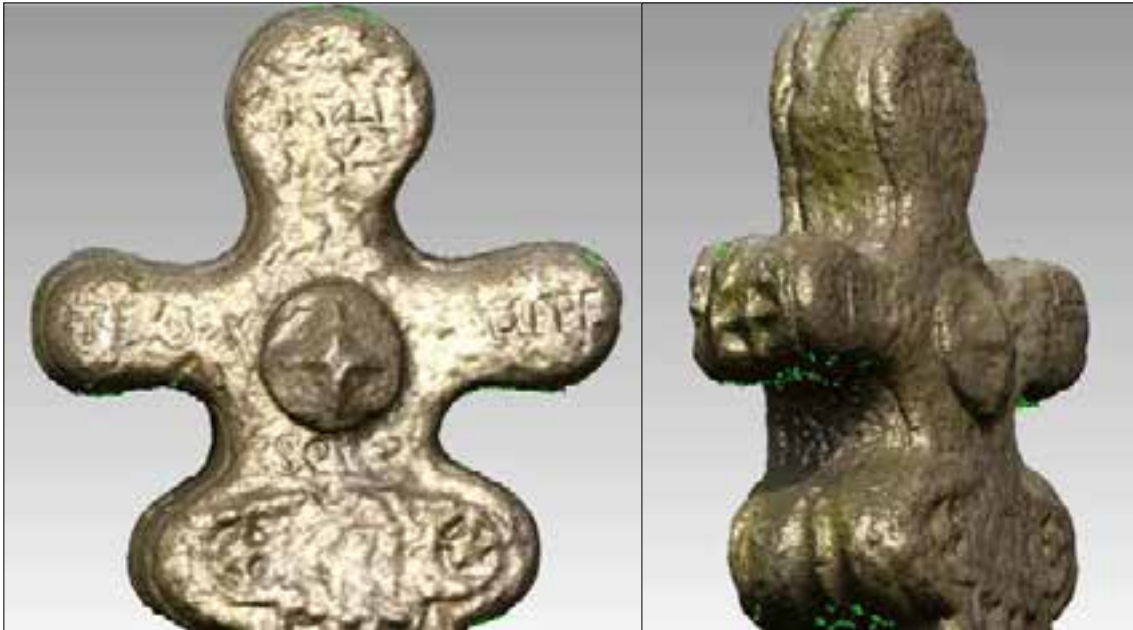
Figure 10: (Left) south-facing side of the market cross head, viewed in Geomagic with virtual lighting to highlight the engravings and carved decorations on the cross arms. (Right) the left side cross arm features an engraved cross encased in a circle, on its end. The green areas indicate gaps in the mesh, where 3D data was missing.

The motif of a wheeled cross is carved on the ends of the horizontal cross arms, the centre of both faces of the cross, and on either side of an oval collar below the cross head, suggesting these were original decorations. It is possible that two concentric circles and a star-like motif on the northern face could be original features, however, the substantial erosion on both faces makes this difficult to confirm without closer

On the southern face of the cross, several inscriptions are present; on the top cross arm are some ambiguous uppercase letters. The right arm features an inscription that appears to read 'CLIFFE', but the weathered condition of the cross makes it difficult to determine if any preceding letters exist. Directly below the central cross-in-circle are more Latin letters, potentially reading 'E S e'. It is possible that the oval-shaped collar below the cross head contained a date, between the two wheeled-cross decorations, but weathering has obscured this and it is not visible on the 3D model.

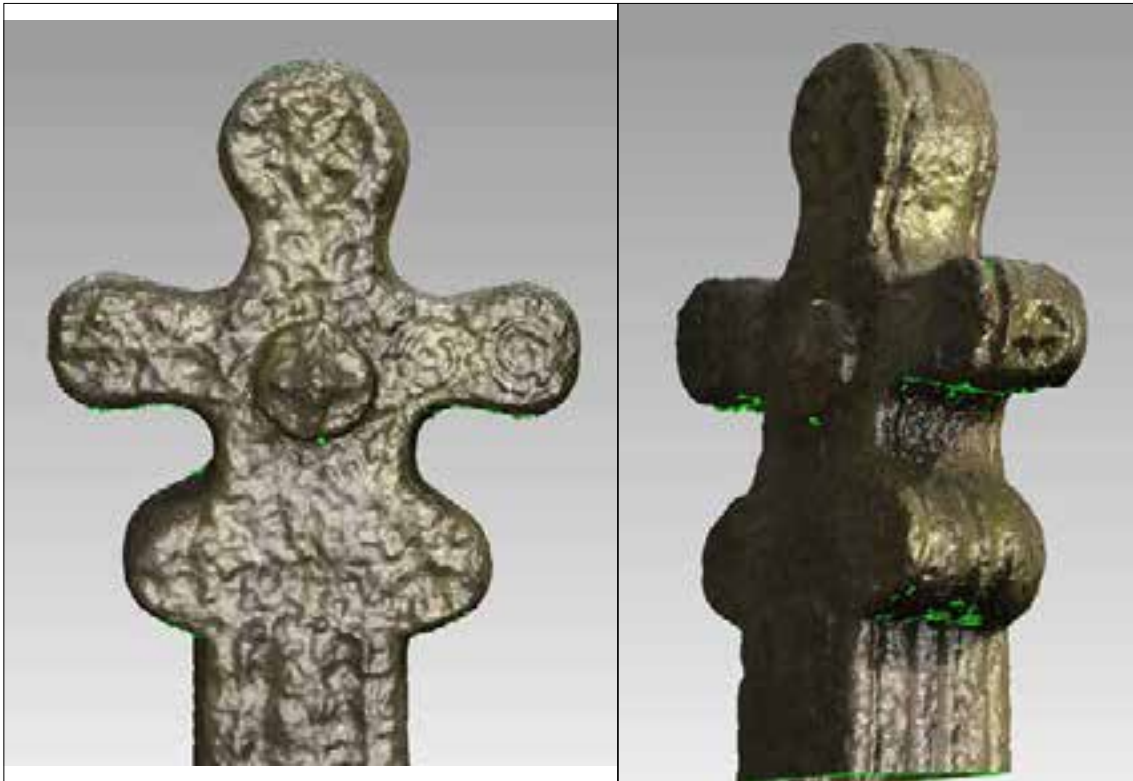
Figure 11: (Left) north-facing side of the market cross head, in Geomagic. Note the two concentric circles on the right cross arm, and the star-like motif on the upper cross arm. (Right) an engraved cross within a circle mirrors a similar decoration on the other horizontal cross arm, potentially suggesting these decorations were carved at the same time.

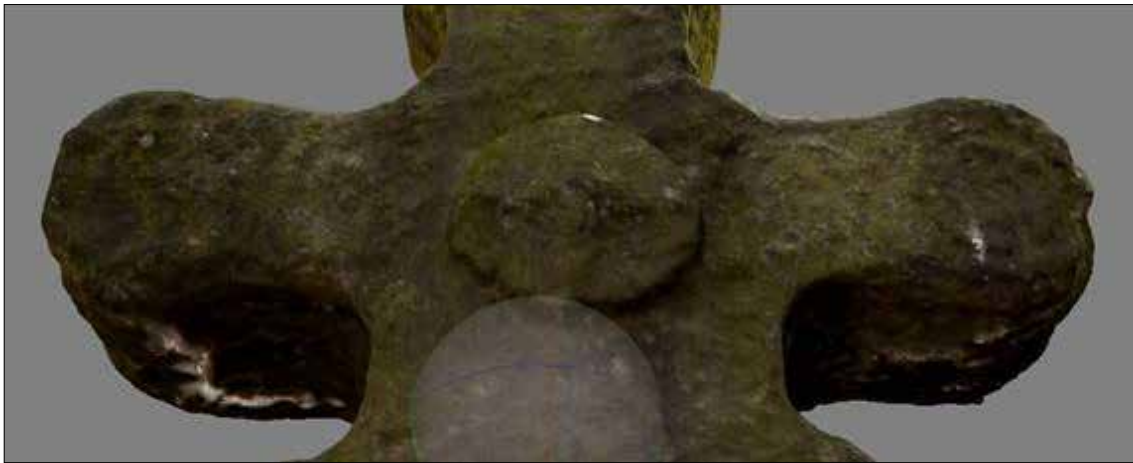
Figure 13: SFM model of the market cross. Note the uneven texture of the undersides of the cross arms, and also a rather pixelated area on the right cross arm, from a lack of photos and high resolution imagery.

Similar conditions persisted when the photography of this cross taken from the telescopic mast, although the use of the shutter-priority setting allowed sharp images to be taken. Whilst this was highly beneficial, a compromise had to be made in using this setting rather than aperture-priority, in that the photography taken from height was slightly less sharp than that taken from ground level, although it was not out of focus. Despite this problem, the resulting 3D meshes and textures were of an even quality throughout, apart from the undersides of the cross arms (figure 13). This however, was to be expected in the SFM processing, as little of the photography was able to capture these difficult to reach areas.

With the strong winds that faced the team while on site, it was clear the resolution of the images acquired was the best that could be achieved within the timeframe and cost of the project. Placing barriers around the busy pedestrianised area around the market cross, and erecting scaffolding to provide a steady base for aperture-priority photography from height would have been costly and a logistical challenge. It can therefore be concluded that the quality of the 3D meshes and textures generated was the best that the fieldwork conditions could allow.
