Chysauster, Gulval, Cornwall: analytical earthwork survey

Olaf Bayer

NGR: SW 4723 3502

A Level 3 analytical earthwork survey of Chysauster Ancient Village, Gulval, near Penzance, Cornwall was undertaken by Historic England on behalf of the English Heritage Trust in late January and early February 2016. The survey recorded a number of earthwork features predominantly of Iron Age and Romano-British date associated with the fogou and courtyard house settlement. Features included: a possible enclosure associated with the fogou; a series of lynchets of probable Iron Age date underlying the core of the courtyard house settlement; and a field system associated with the Romano-British courtyard house settlement. Evidence of post-medieval tin prospecting, quarrying and agricultural improvement was also recorded, as were spoil heaps from twentieth century archaeological excavations. The survey has situated archaeological features inside the Chysauster Guardianship area within earlier surveys of its environs, enabling them to be discussed in their landscape context.

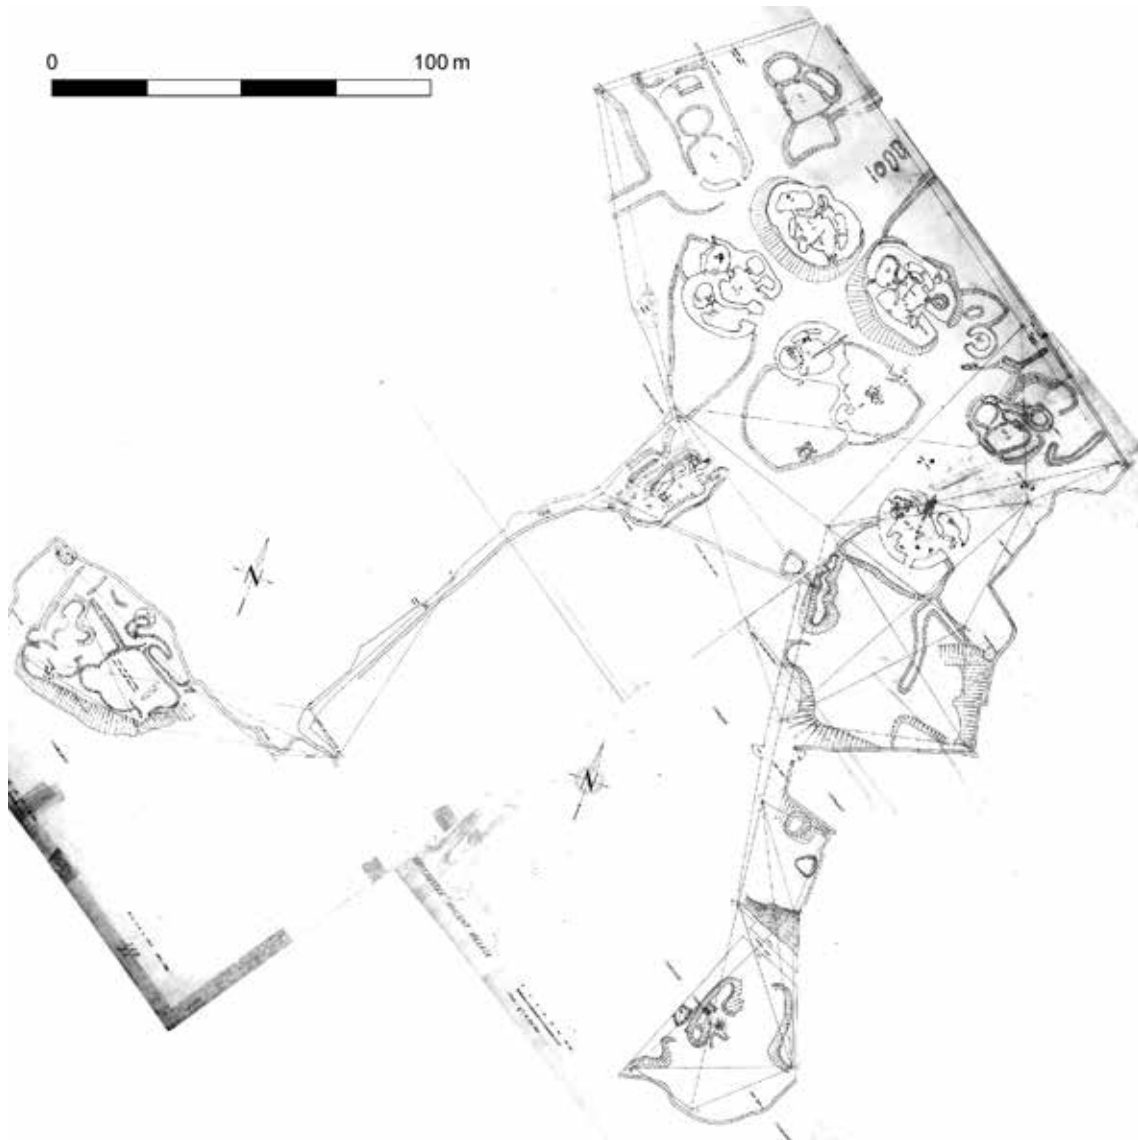
Figure 11. Ministry of Works 1956 plan of Chysauster (Historic England – ref MP/CHY0023 and MP/CHY0023).

In 1956 the Ministry of Works undertook a further survey of the now enlarged Guardianship area (Fig 11). This 'wishbone' shaped survey was conducted by three unidentified surveyors (with the initials BJS, EA and UHC) at a scale of approximately 1:200. Within the core of the courtyard house settlement this survey records a similar range of features and level of detail to that seen in Copplestone and Singleton's 1931 plan, with the addition of further detail within the now excavated House 9. The principal additions to the new survey are a number of features in the south-east and south-west 'wings' of the enlarged Guardianship area including the

A low mound to the east of the fogou chamber (F5), shown as an area of 'loose stones' and two 'holes' on the Ministry of Works (1956b) plan, is considered more likely to result from nineteenth or twentieth century disturbance, than to constitute surface evidence of a further fogou chamber.

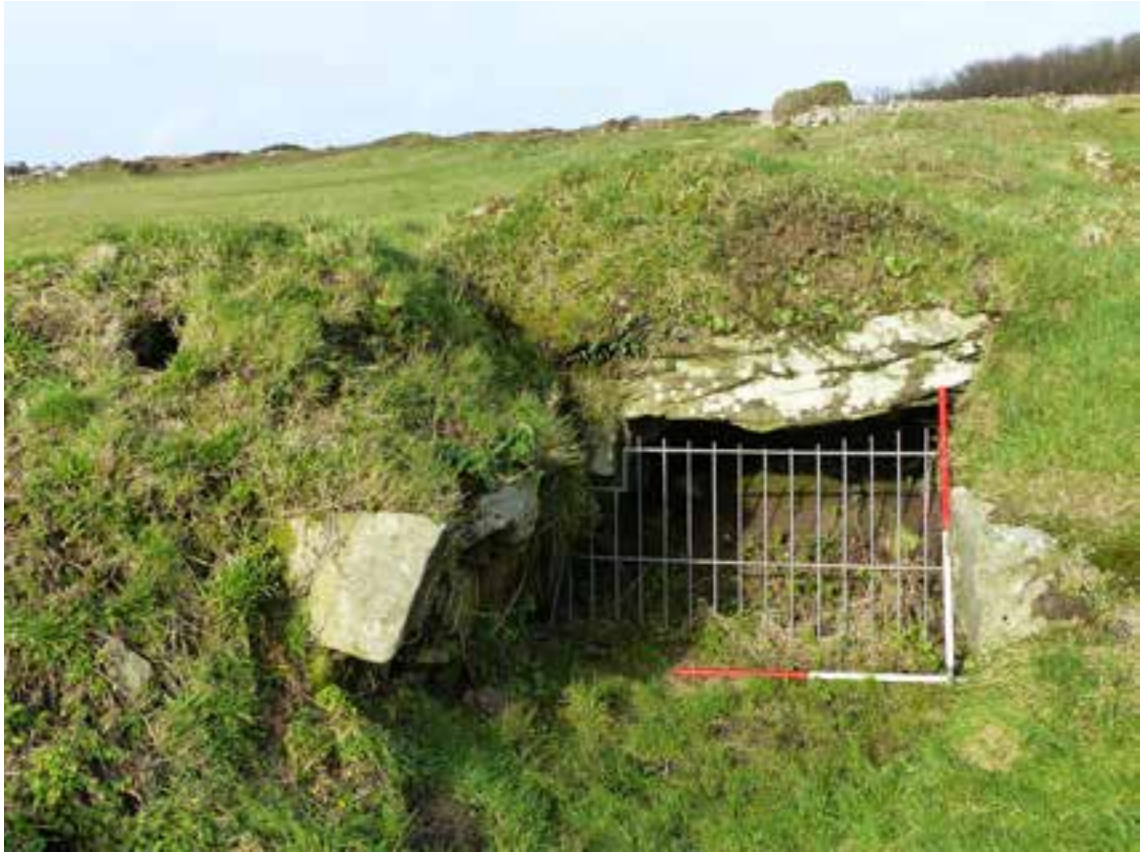
Across: Figure 16 (top). The fogou - 1m scale, view to north (© Historic England, photograph Sharon Soutar)

Fogou (Fig 16; *see also* Fig 45)

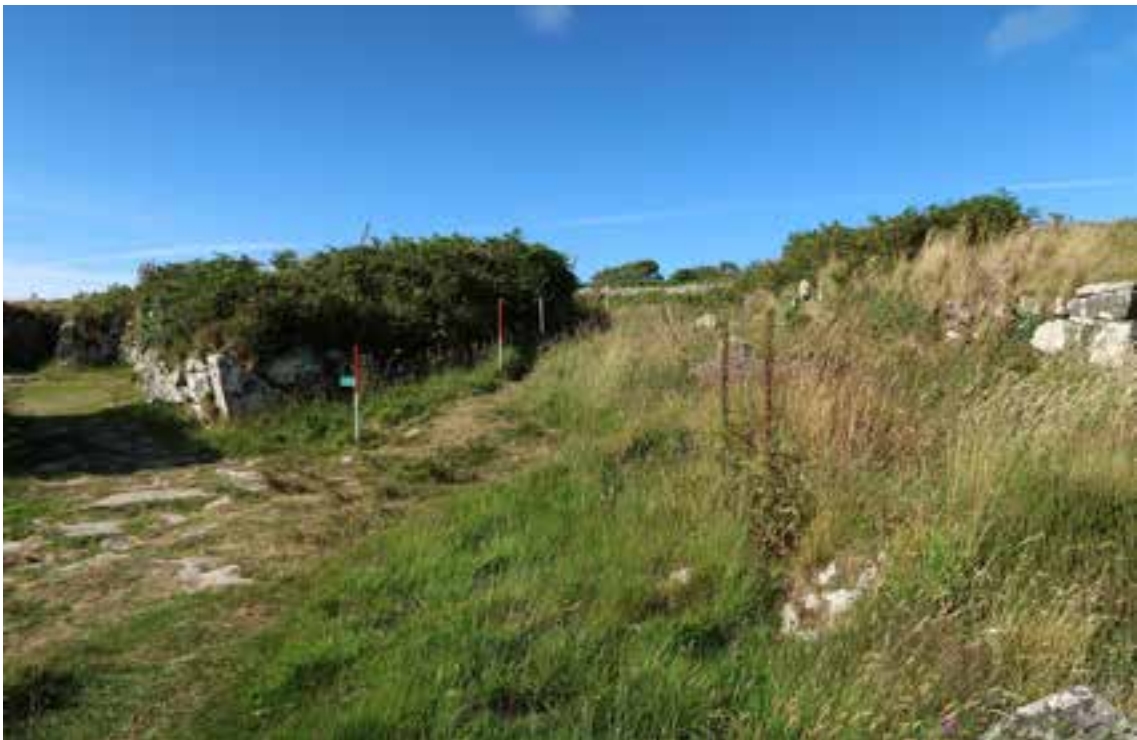
Figure 19. Lynchet 1.3 underlying houses 4 and 6, view to north-east
(© Historic England, photograph Olaf Bayer).

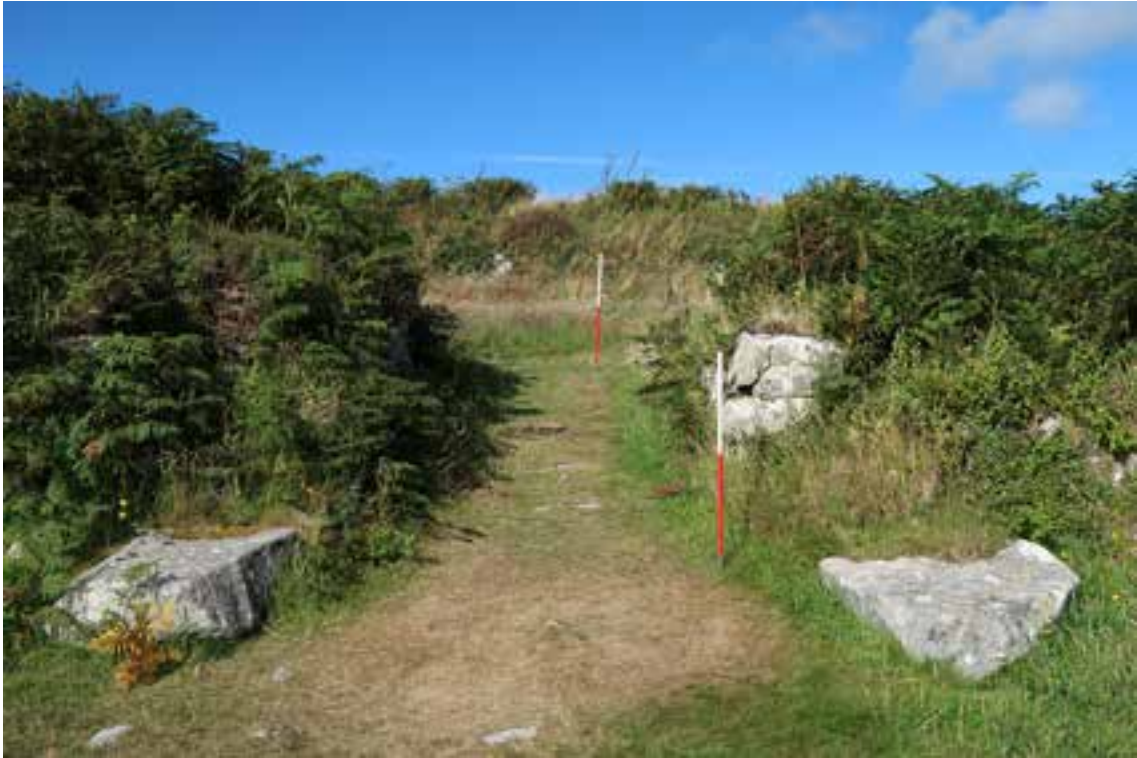
Figure 20. Lynchet 2.3 underlying the entrance to House 5, view to north-east (© Historic England, photograph Olaf Bayer).

can be seen in the drop of over 1m from exterior to interior at the entrance to the courtyard (see Fig 20). There is a similar east to west fall along the wall-line connecting House 5 with House 5a. It is suggested that this is caused by House 5/5a being constructed over lynchet 2.

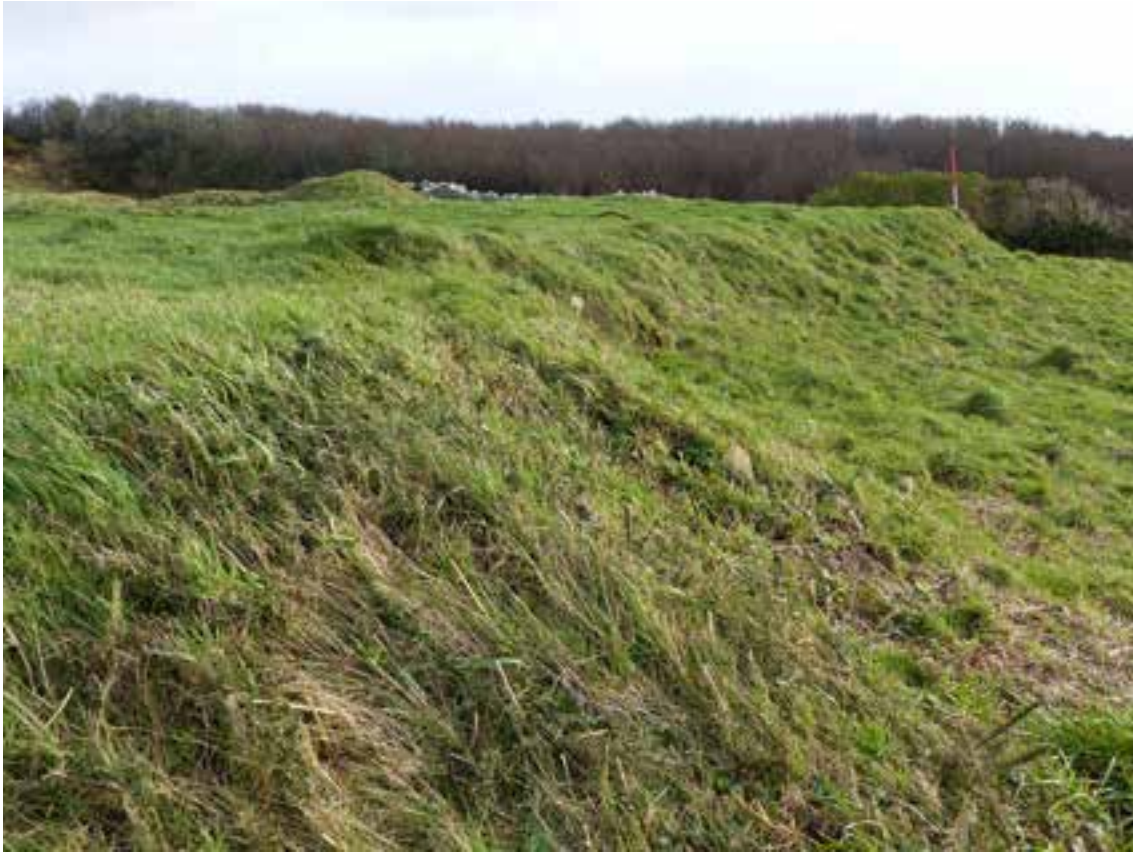
Figure 21. Lynchet 6.5, view to south-east (© Historic England, photograph Sharon Soutar).

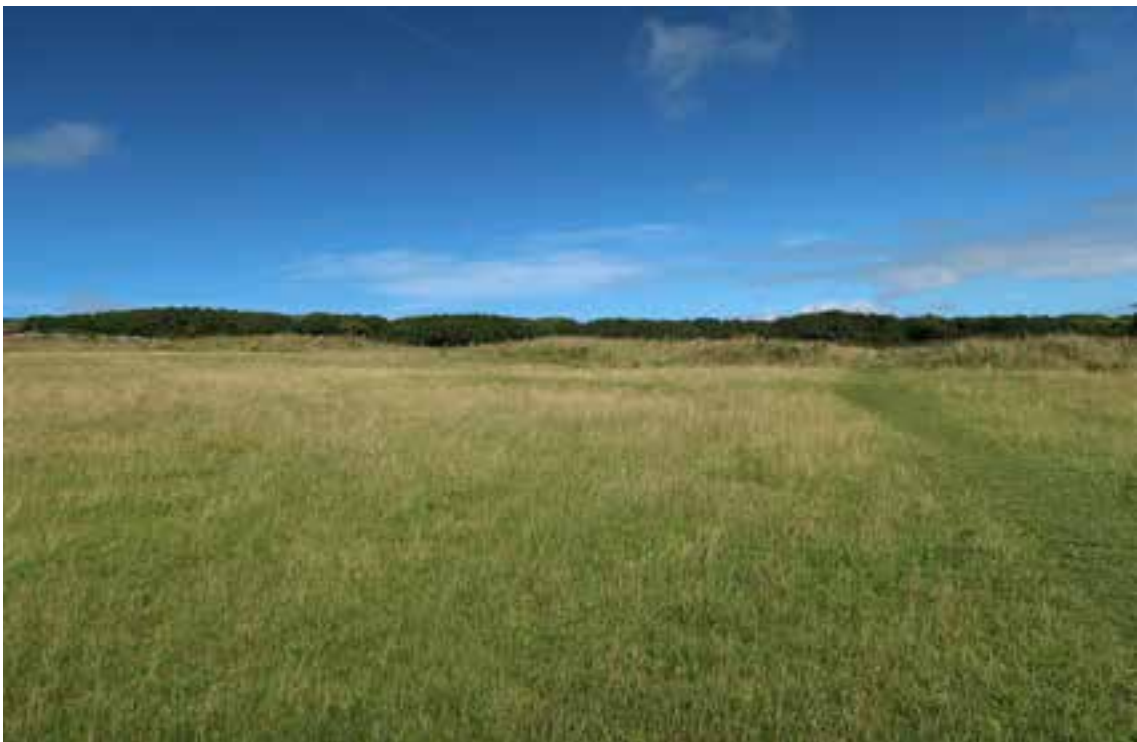
Figure 22. Lynchet 12.1 - 1m scale, view to east (© Historic England, photograph Olaf Bayer).

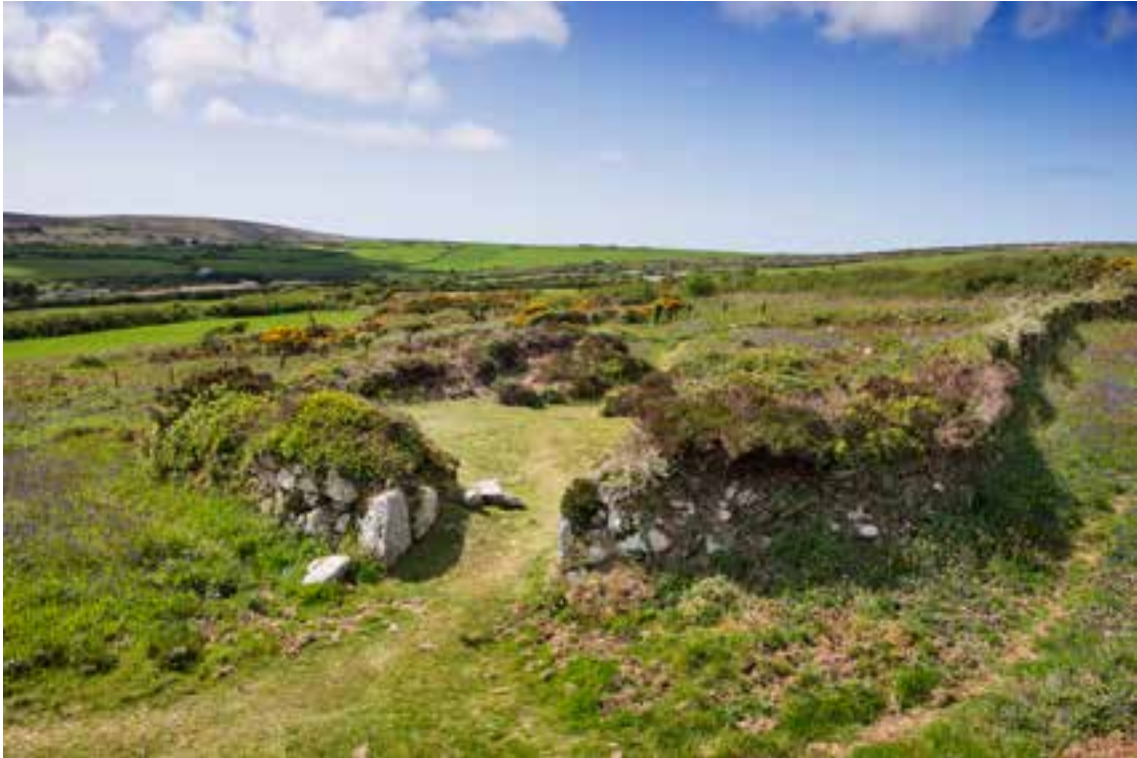
Figure 23. Courtyard House 1 – view to north (DP181440 © Historic England, photograph James O. Davies).

Although substantially cleared of vegetation, House 1 is unexcavated and lies at the far northern edge of the site. Given its proximity to the northern and western site boundaries it is difficult to get a full impression of House 1's relationship with surrounding features. This is particularly the case due to the overgrown nature of the areas immediately outside the site to the north and west. Its wall lines have also been reused by post-medieval field boundaries (Hencken 1928 and 1933), potentially altering its appearance.

Linear feature (1.1) spans from the western edge of House 1 to the current site boundary and continues beyond the Guardianship area in a sweeping curve to the north-west. Feature (1.2) is a low terrace wrapping around the western edge of the house. It survives to a height of 0.5m and abuts boundary (1.1). Curvilinear feature (1.3) also abuts boundary (1.1) and hints at a small enclosure appended to the southern-western corner of House 1. It is suggested that walls (1.4) and (1.5), which cross the northern site boundary into the wider landscape, are in their current form more recent additions to the house. However, it is possible these features fossilise an enclosure appended to the northern edge of House 1. Feature (1.6), a slight and

fragmentary earthwork immediately to the east of House 1, suggests that the eastern edge of the structure may be terraced into the base of the lynchet upslope (see Fig 45 feature 1.1).

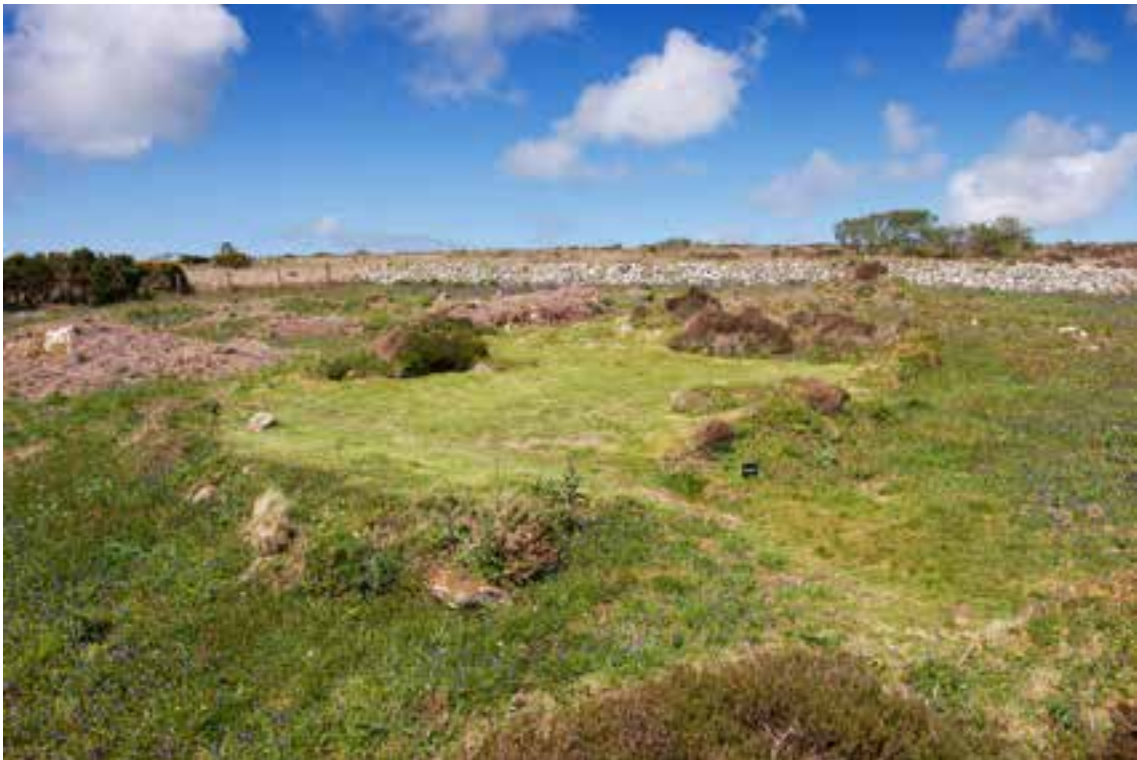
Figure 24. Courtyard House 2 – view to north-east (DP181439 © Historic England, photograph James O. Davies).

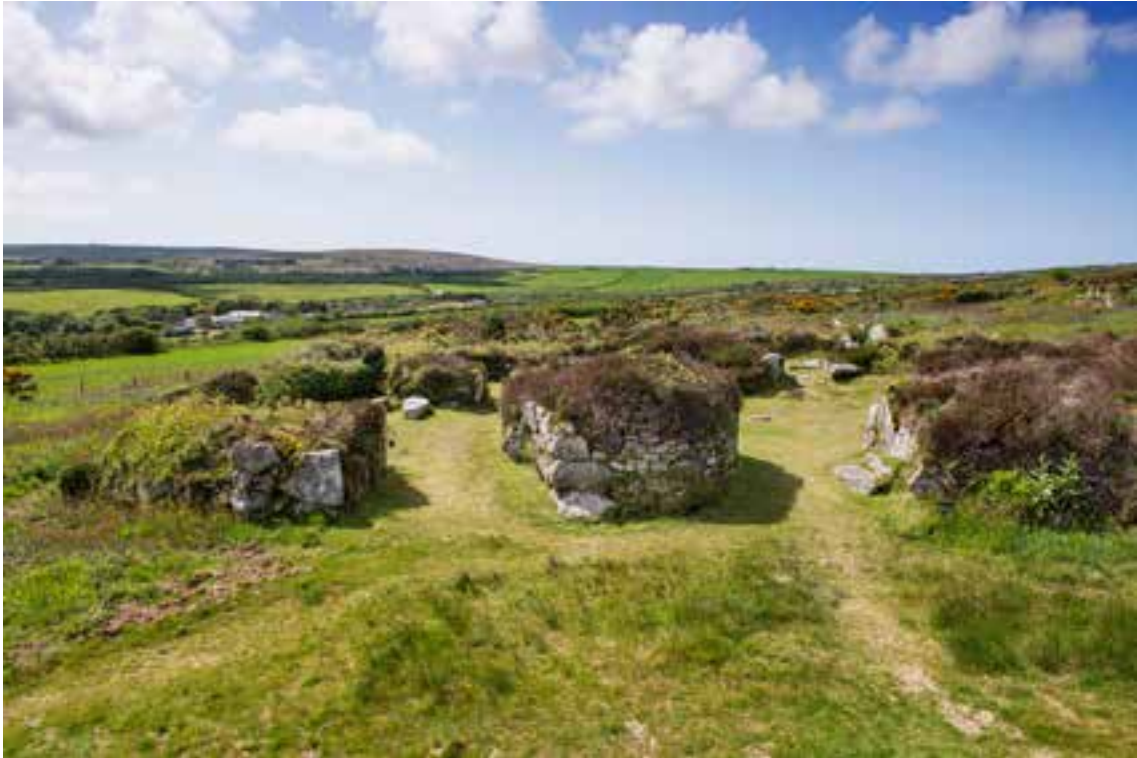
Figure 25. Courtyard House 3 – view to north-west (DP181443 © Historic England, photograph James O. Davies).

House 3 is located between Houses 1, 4 and 5. The northern edge of House 3 appears to have been terraced (3.1) into the foot of the southern extent of lynchet 1. Internally there is a drop of approximately 1m between the floor levels in the north-eastern and south-western sides of the house. It is suggested that this is caused by lynchet 2 underlying the eastern edge of the structure. House 3 is associated with a series of external enclosures to the west and south-west defined by features (3.2) and (3.3). Understanding the full extent of the enclosures to the south-west is complicated by the proximity of the site boundary.

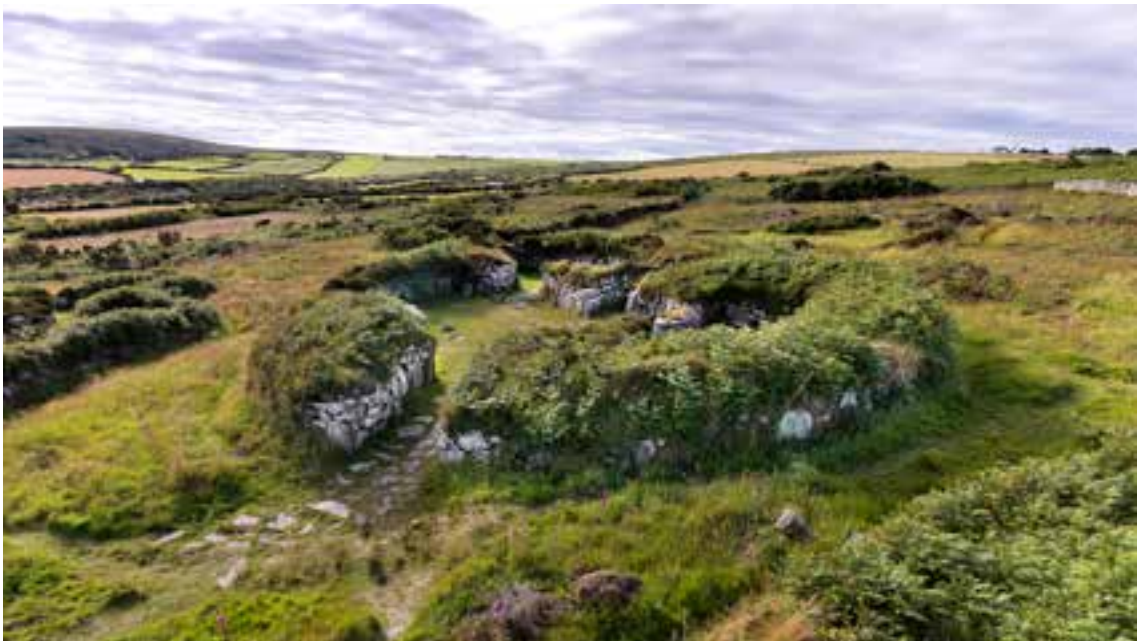
Figure 26. Courtyard House 4 – view to north-west (DP181641 © Historic England, photograph James O. Davies).

House 4 is located between Houses 2 and 6. There is a marked north-east to south-west drop (over 1m) in floor levels within House 3. This is most obvious with the step up from the courtyard into the rooms on its northern and eastern edge, and the step down from the courtyard into the small cell on its south-western edge. It is suggested that this is caused by the north-eastern edge of the building being constructed over lynchet 1. The western edge of the house is built on a substantial platform (4.1).

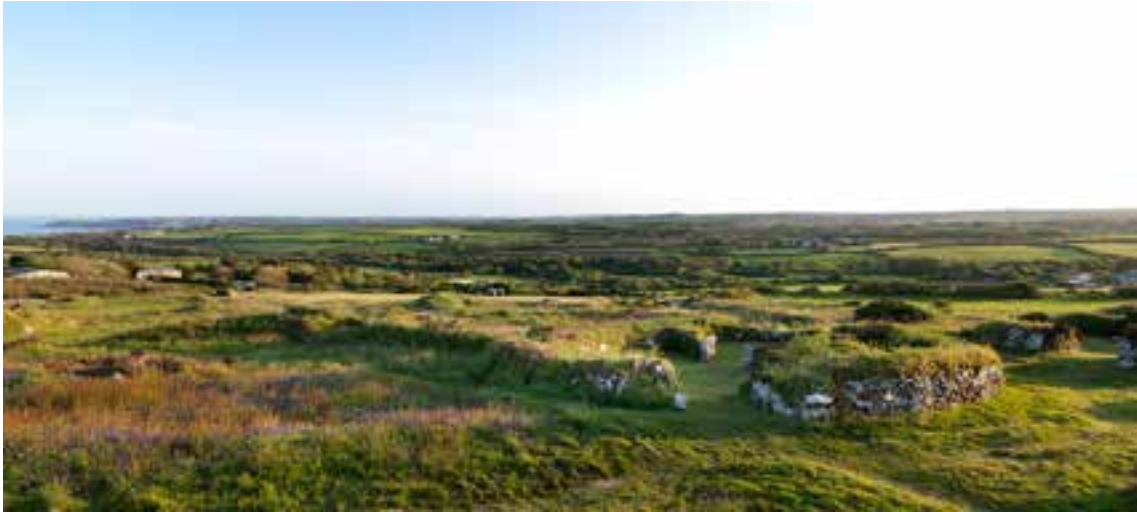
Figure 27. Courtyard House 5 – view to south-west (DP181397 © Historic England, photograph James O. Davies).

House 5 (Fig 27 and 28)

House 5 lies at the core of the courtyard house settlement. Again there is a marked north-east to south-west drop in levels inside this structure. Within House 5 this

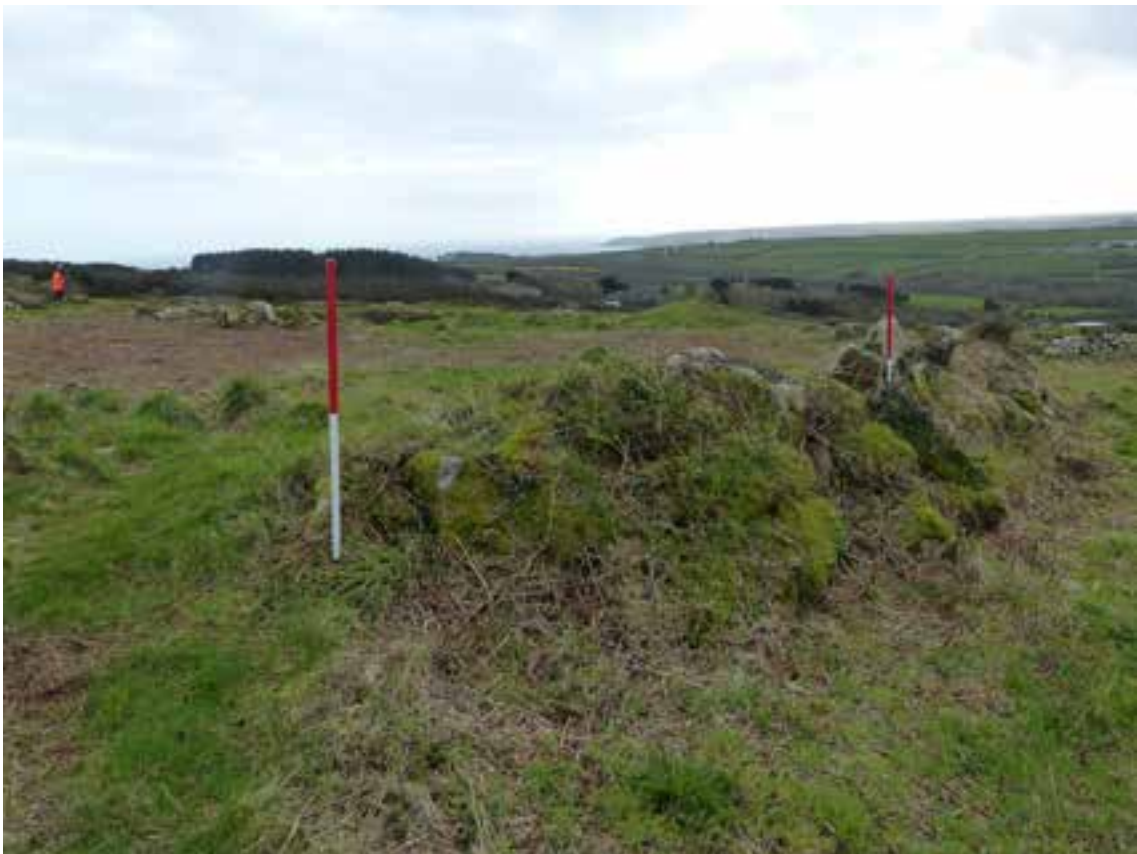
Figure 28. Enclosure 5.2 appended to the south-west side of Courtyard House 5 (© Historic England, photograph Sharon Soutar).

Externally House 5 is associated with two small enclosures (5.1) to the north and north-west, a larger enclosure to the south-west (5.2), (5.3) to the east (Fig 28) and (5.4) to the north. Several small earthworks suggest some subdivision of enclosure (5.3). The lynched downslope edge of enclosure (5.3) indicates that it was cultivated. Much of the outer limits of enclosure (5.3) are reused by post-medieval boundaries (see Fig 48 features 1 and 2).

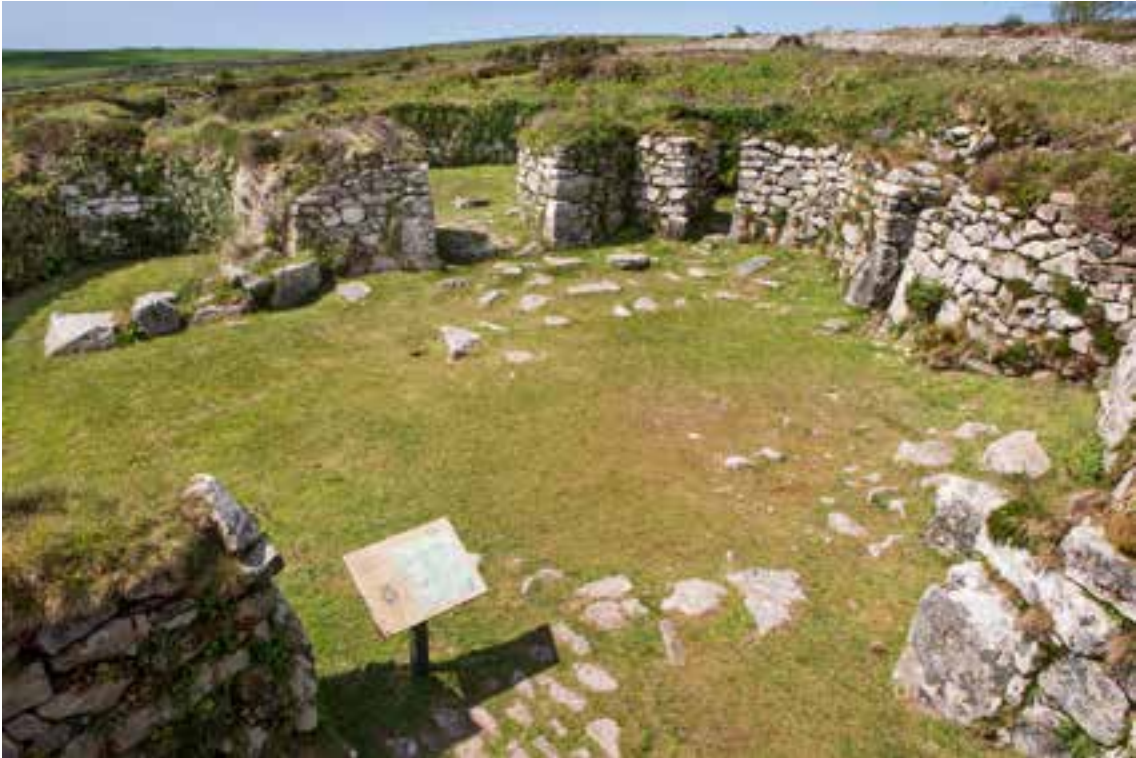
Figure 29. Courtyard House 6 – interior view to north-east (DP181430 © Historic England, photograph James O. Davies).

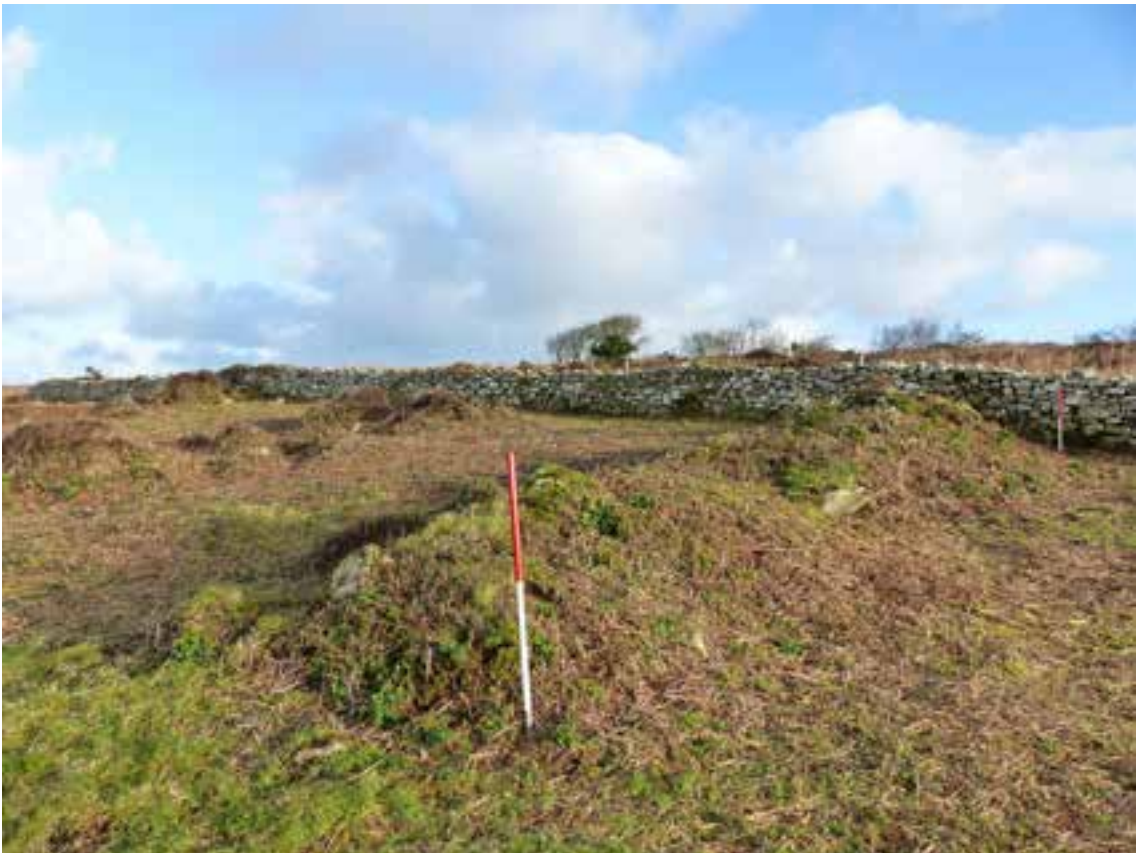
Figure 30. Bank 6.5 appended to the north-east side of Courtyard House 6 (© Historic England, photograph Sharon Soutar).

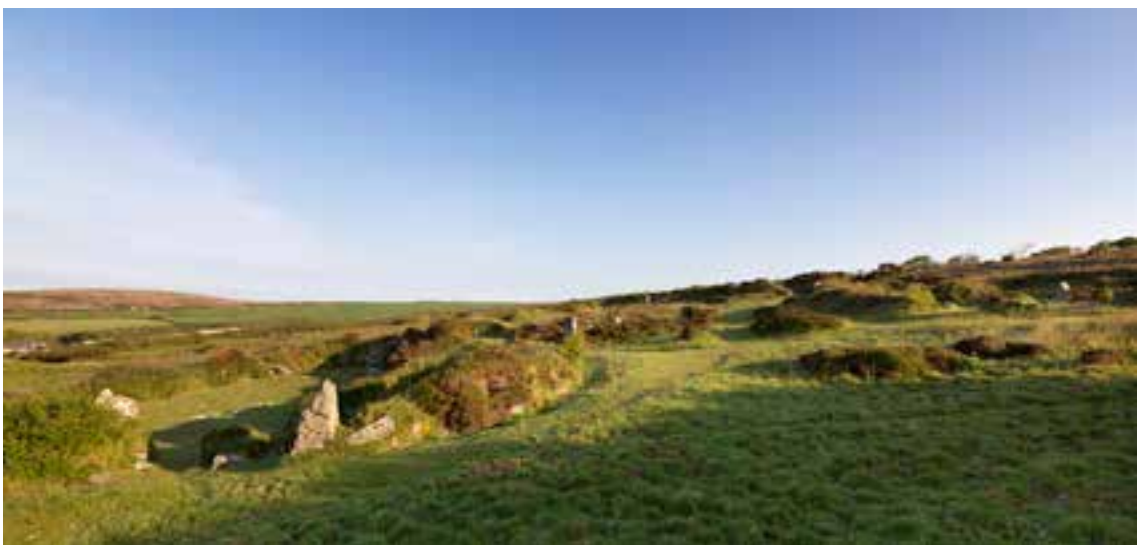
Figure 31. Courtyard House 7 – view to north-west (DP181411 © Historic England, photograph James O. Davies).

House 7 lies to the south of Houses 5 and 8. On its western edge the house appears to have been built on a platform (7.1) approximately 0.8m high, while on its north-eastern edge it appears to have been cut into the slope (7.2). It is suggested that lynchet 2 underlies the house, accounting for a fall of approximately 0.5m between the surface of the rooms to its north and the surface of the courtyard.

Externally House 7 is associated with a large enclosure running down slope to the south-west, crossing lynchet 3 and ending at lynchet 6. The limit of this enclosure is defined by a combination of low banks (7.3) and lynchet 7 on its western and southern sides. A group of low boundaries (7.4) approximately 0.3m in height form a series of small rectilinear plots to the south of lynchet (4.3). Their chronological relationship with enclosure (7.3) is uncertain. Elements of (7.4) appear to extend to the east of enclosure (7.3).

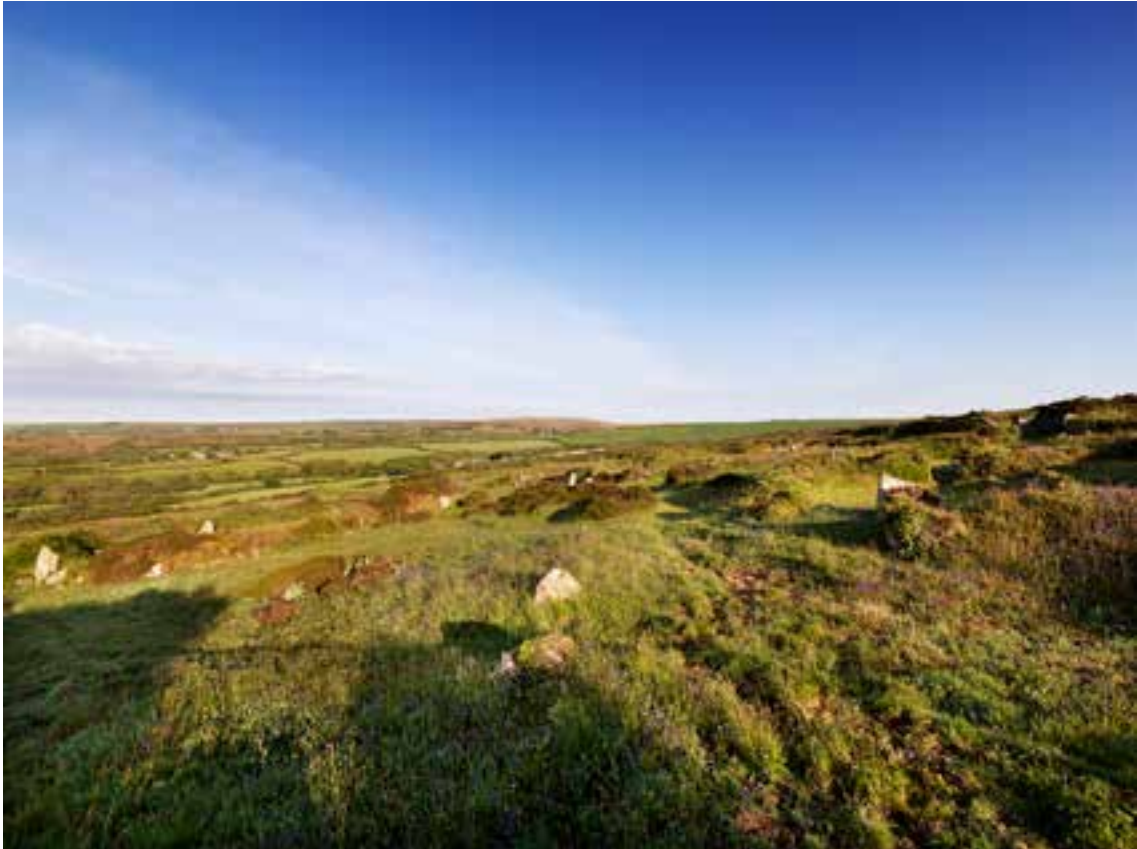
Figure 32. Courtyard House 8 – view to north-west (DP181412 © Historic England, photograph James O. Davies).

House 8 (Fig 32)

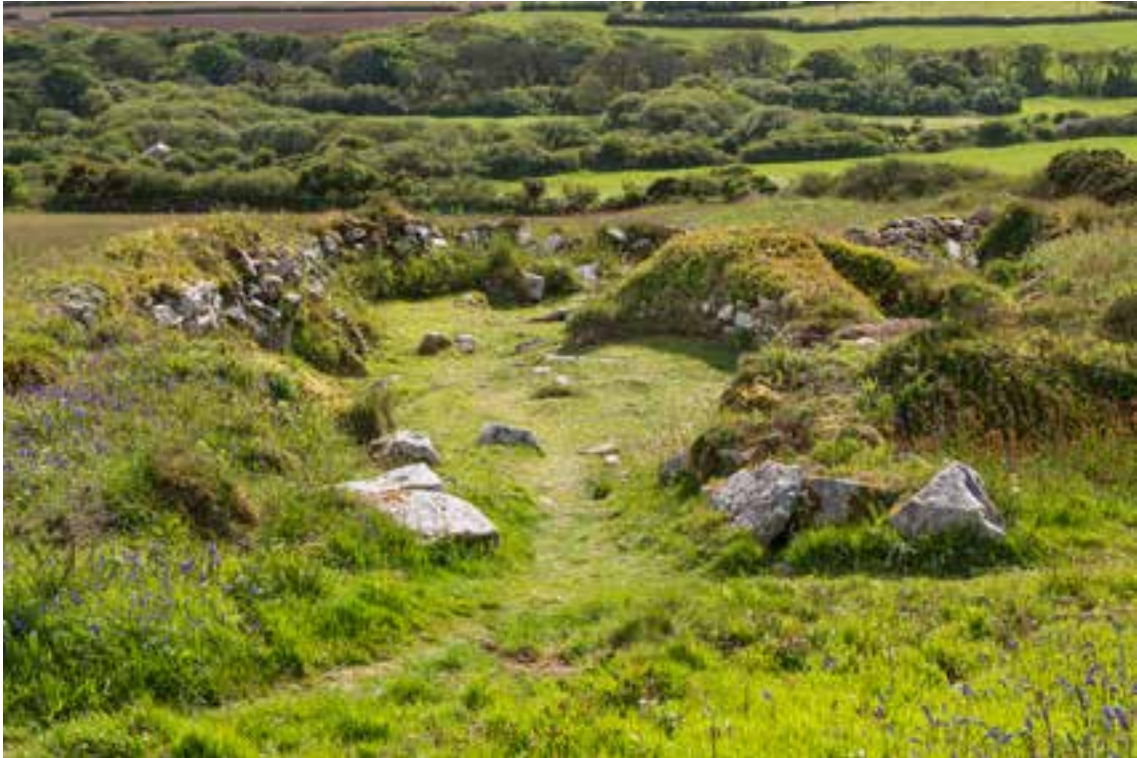
Figure 33. Courtyard House 9 – view to south-west (DP181460 © Historic England, photograph James O. Davies).

House 9 (Fig 33)

House 9 lies immediately south-west of the abrupt corner in the Guardianship area's western boundary. This house is the most atypical within the core of the neucleated settlement, and several factors complicate the interpretation of this structure. Firstly a stone hedge bank (*see* Fig 48, feature 2) overlies and potentially reworks much of the southern wall. Secondly, until at least the late 1970s, this area saw heavy footfall, being located at the northern end of the hollow way which provided the principal access to the core of the Guardianship area. The pre-1980s ticket kiosk was located

inside the large round room (9.2). Identification of associated features or appended enclosures is hindered by the house's proximity to the edge of the site and excavation spoil heaps (see Fig 49, features 14 and 16). The house is built on top of lynchet 6 and it is possible that feature (9.5) is a constructed platform for the house. A clear long room (9.3) and small round room (9.4) exist on the northern edge of the building. Both rooms open to the south into a possible courtyard (9.1). Immediately to the west are the more fragmentary remains of a further large round room (9.2).

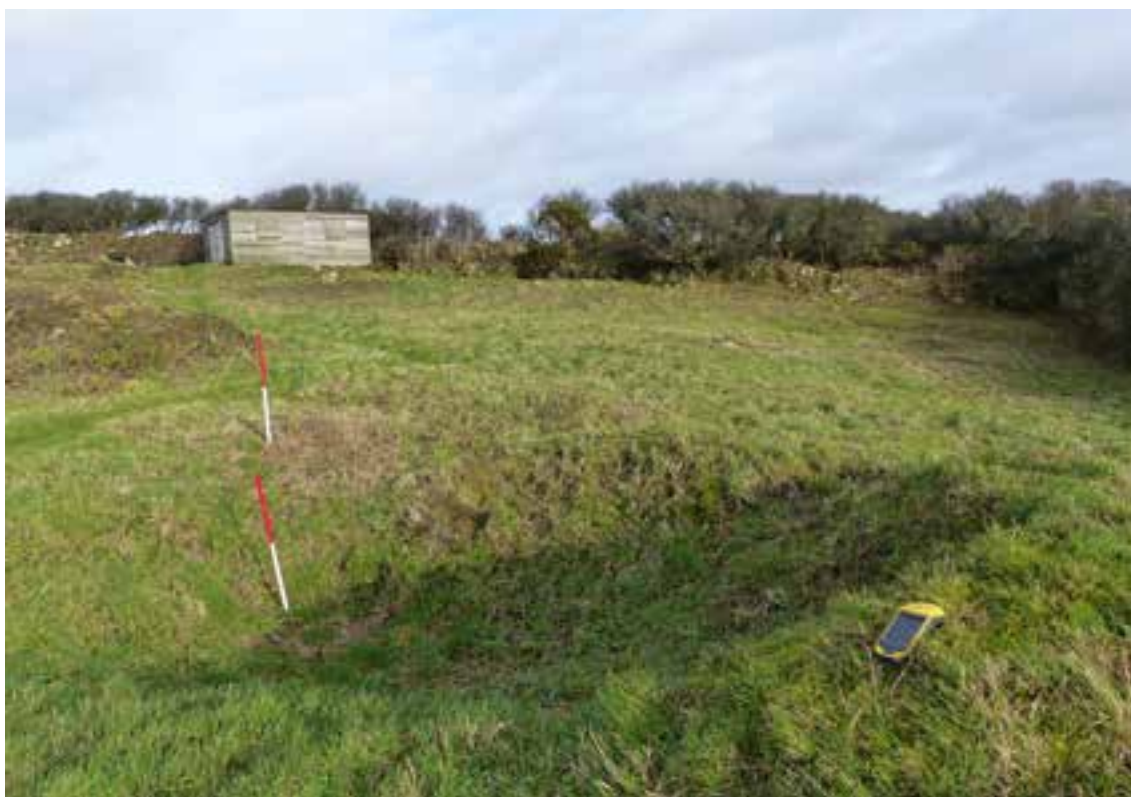
Figure 34. Prospection pit 5, view to north-east (© Historic England, photograph Sharon Soutar).

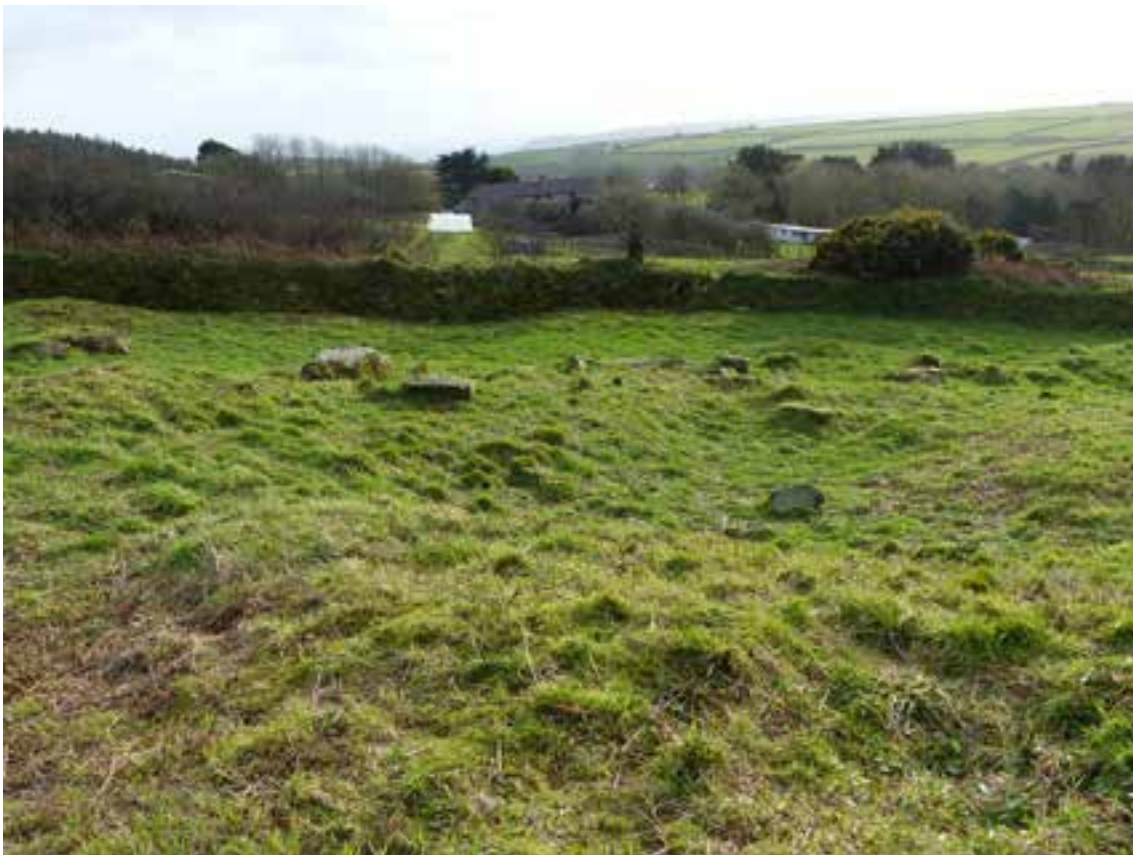
Figure 35. Rubble spread south of quarries 9 and 10 – view to south (© Historic England, photograph Sharon Soutar).

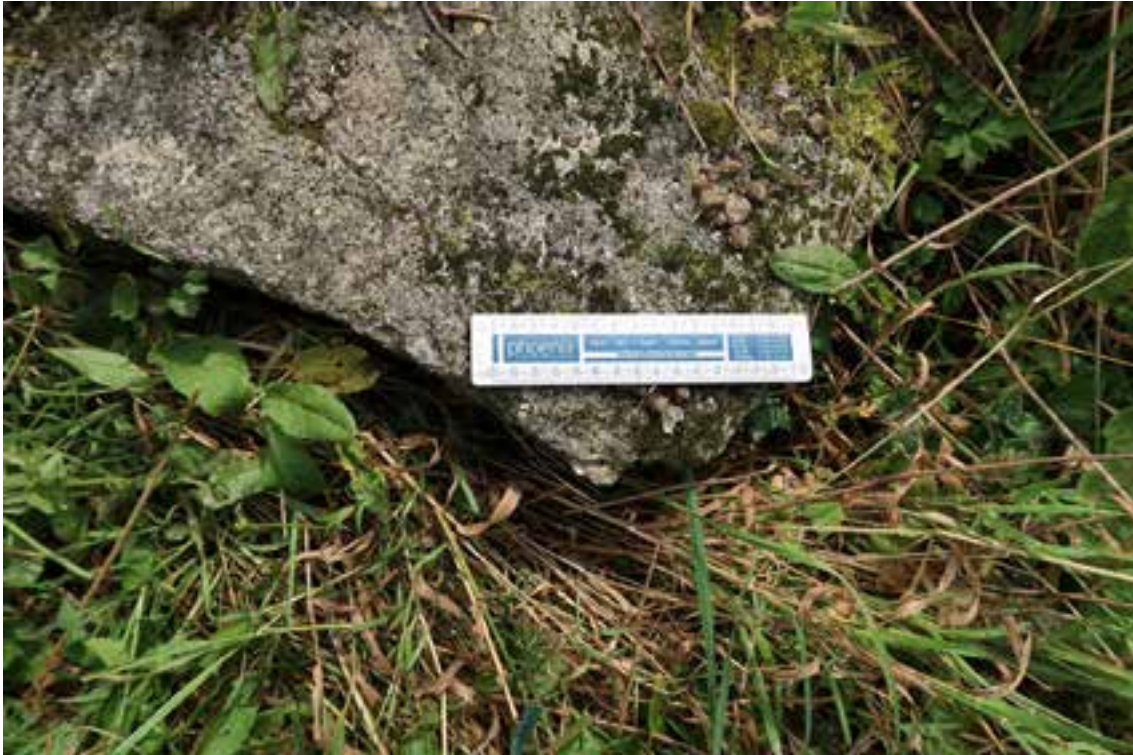
Figure 36. Granite block with traces of a drilled charge hole from rubble spread – 15cm scale
(© Historic England, photograph Olaf Bayer).

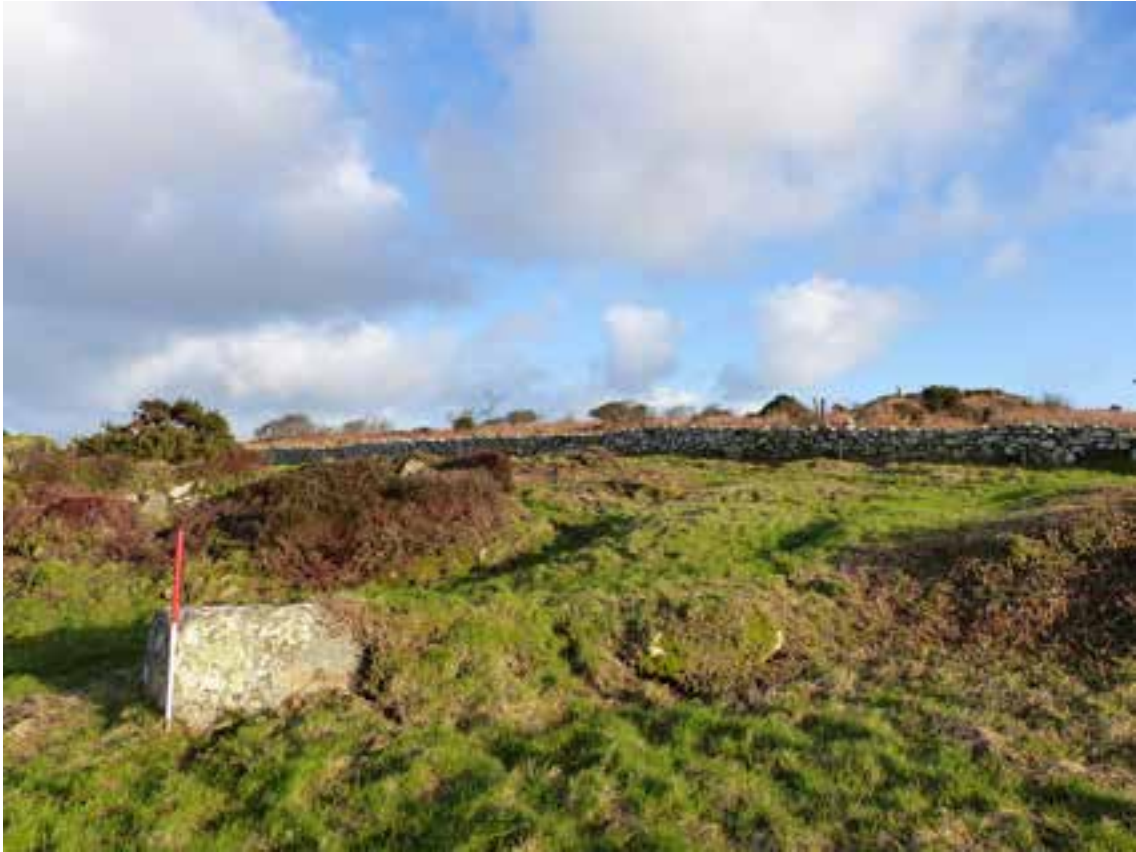
Figure 37. Removed boundary 2 running under the north-east site boundary, view to north (© Historic England, photograph Sharon Soutar).

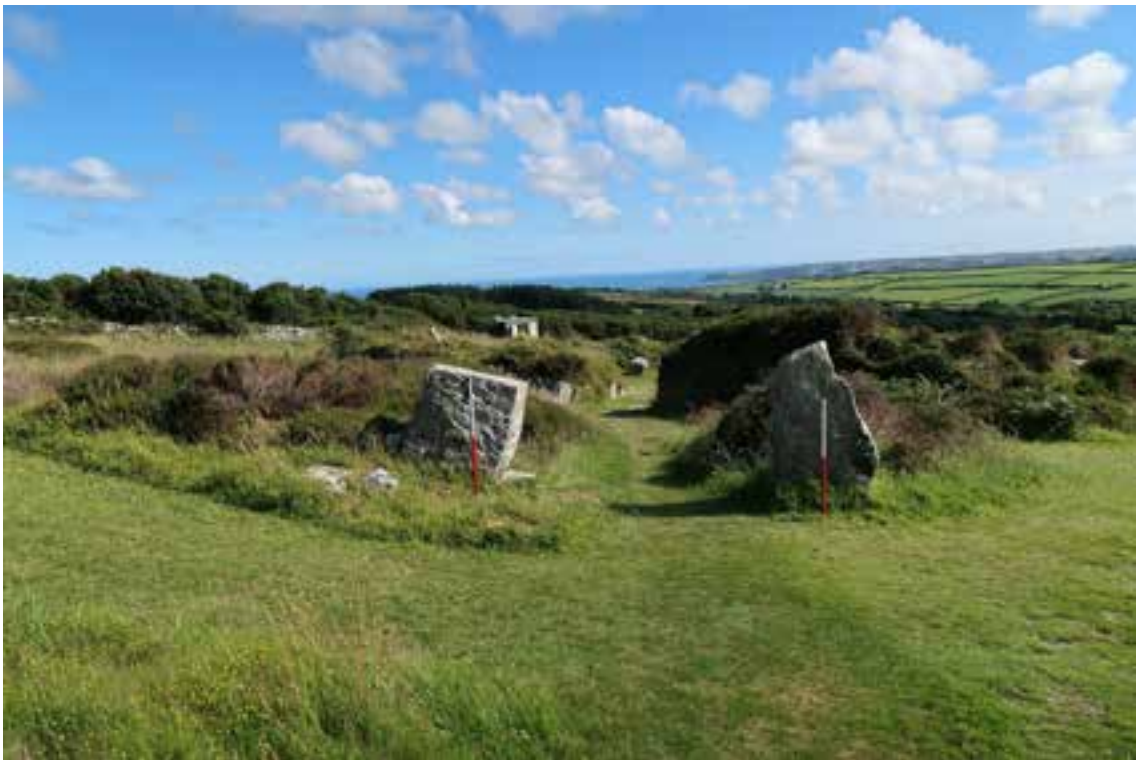
Figure 38. Gateway 3.1 in removed boundary 3. The post on the left appears to have been blasted/split, view to south (© Historic England, photograph Olaf Bayer).
