Chysauster, Gulval, Cornwall: analytical earthwork survey

Olaf Bayer

NGR: SW 4723 3502

A Level 3 analytical earthwork survey of Chysauster Ancient Village, Gulval, near Penzance, Cornwall was undertaken by Historic England on behalf of the English Heritage Trust in late January and early February 2016. The survey recorded a number of earthwork features predominantly of Iron Age and Romano-British date associated with the fogou and courtyard house settlement. Features included: a possible enclosure associated with the fogou; a series of lynchets of probable Iron Age date underlying the core of the courtyard house settlement; and a field system associated with the Romano-British courtyard house settlement. Evidence of post-medieval tin prospecting, quarrying and agricultural improvement was also recorded, as were spoil heaps from twentieth century archaeological excavations. The survey has situated archaeological features inside the Chysauster Guardianship area within earlier surveys of its environs, enabling them to be discussed in their landscape context.

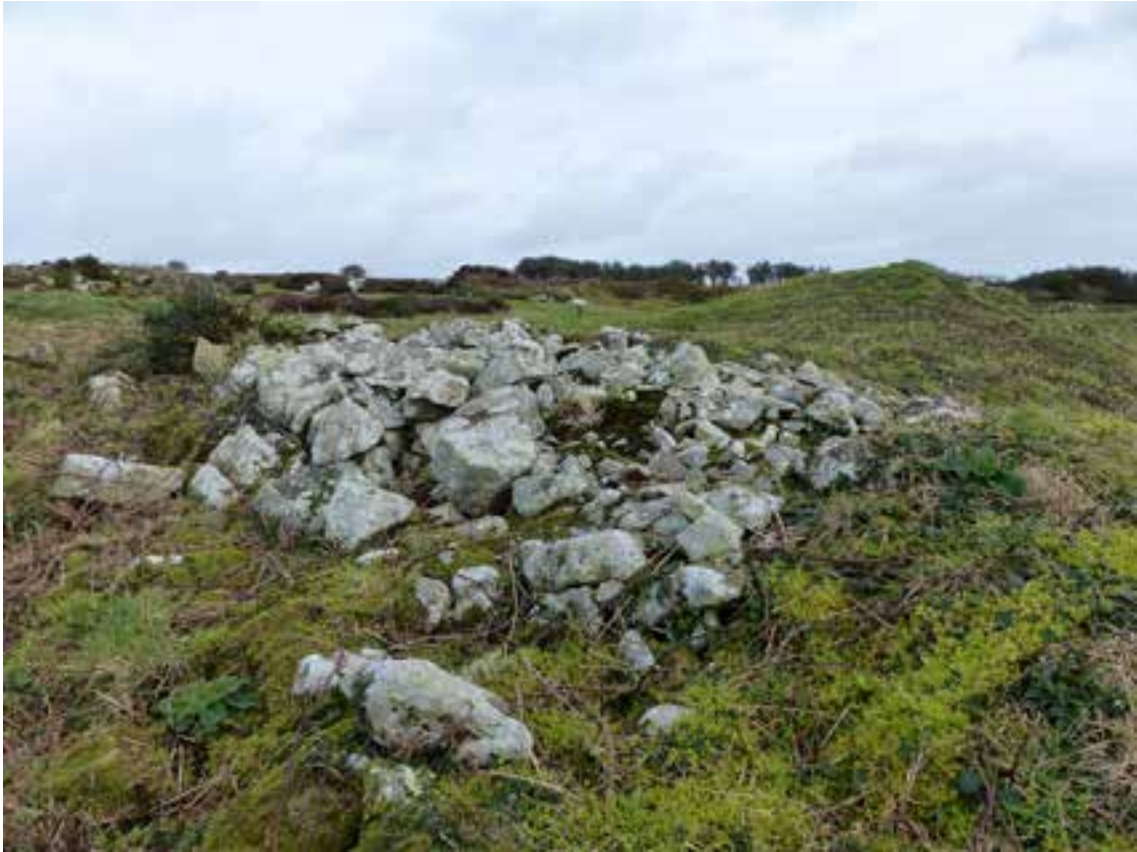
*Figure 39. Spoil heaps 14.1 (fore ground) and 14.2/14.2 (back ground) – view to east
(© Historic England, photograph Sharon Soutar).*

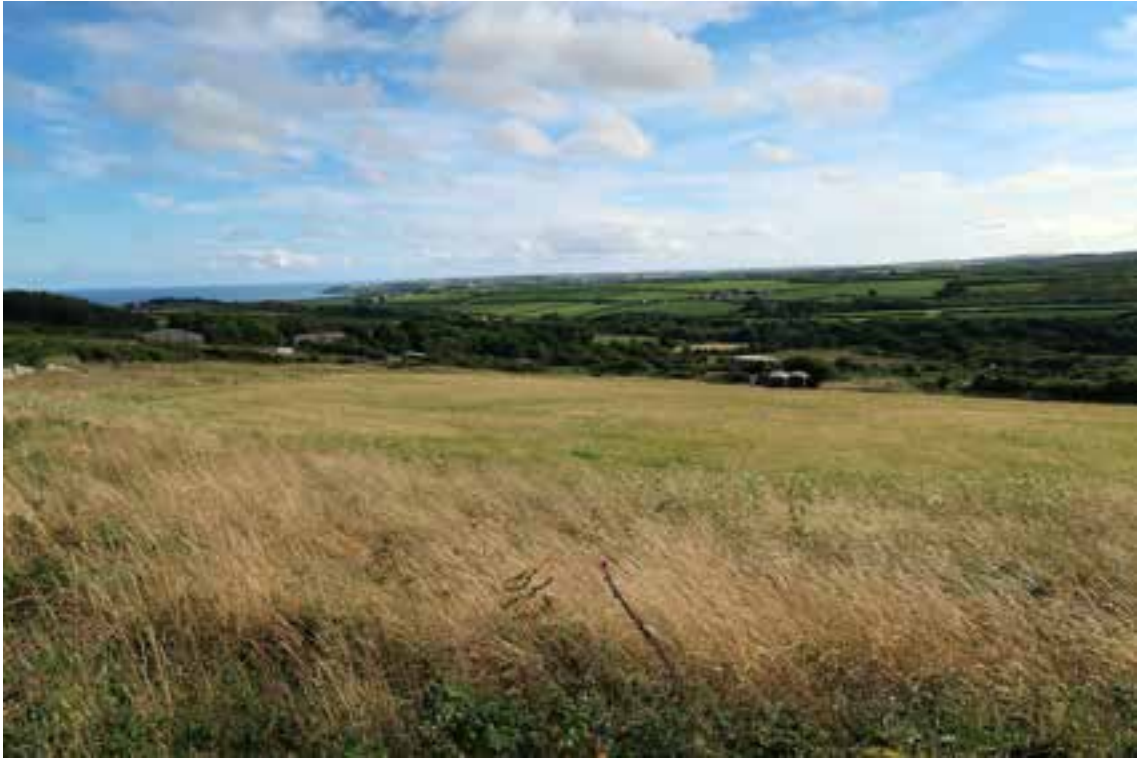
*Figure 40. The southern field showing limit of cultivation 3 . 4 and 5 – view to south
(© Historic England, photograph Olaf Bayer).*

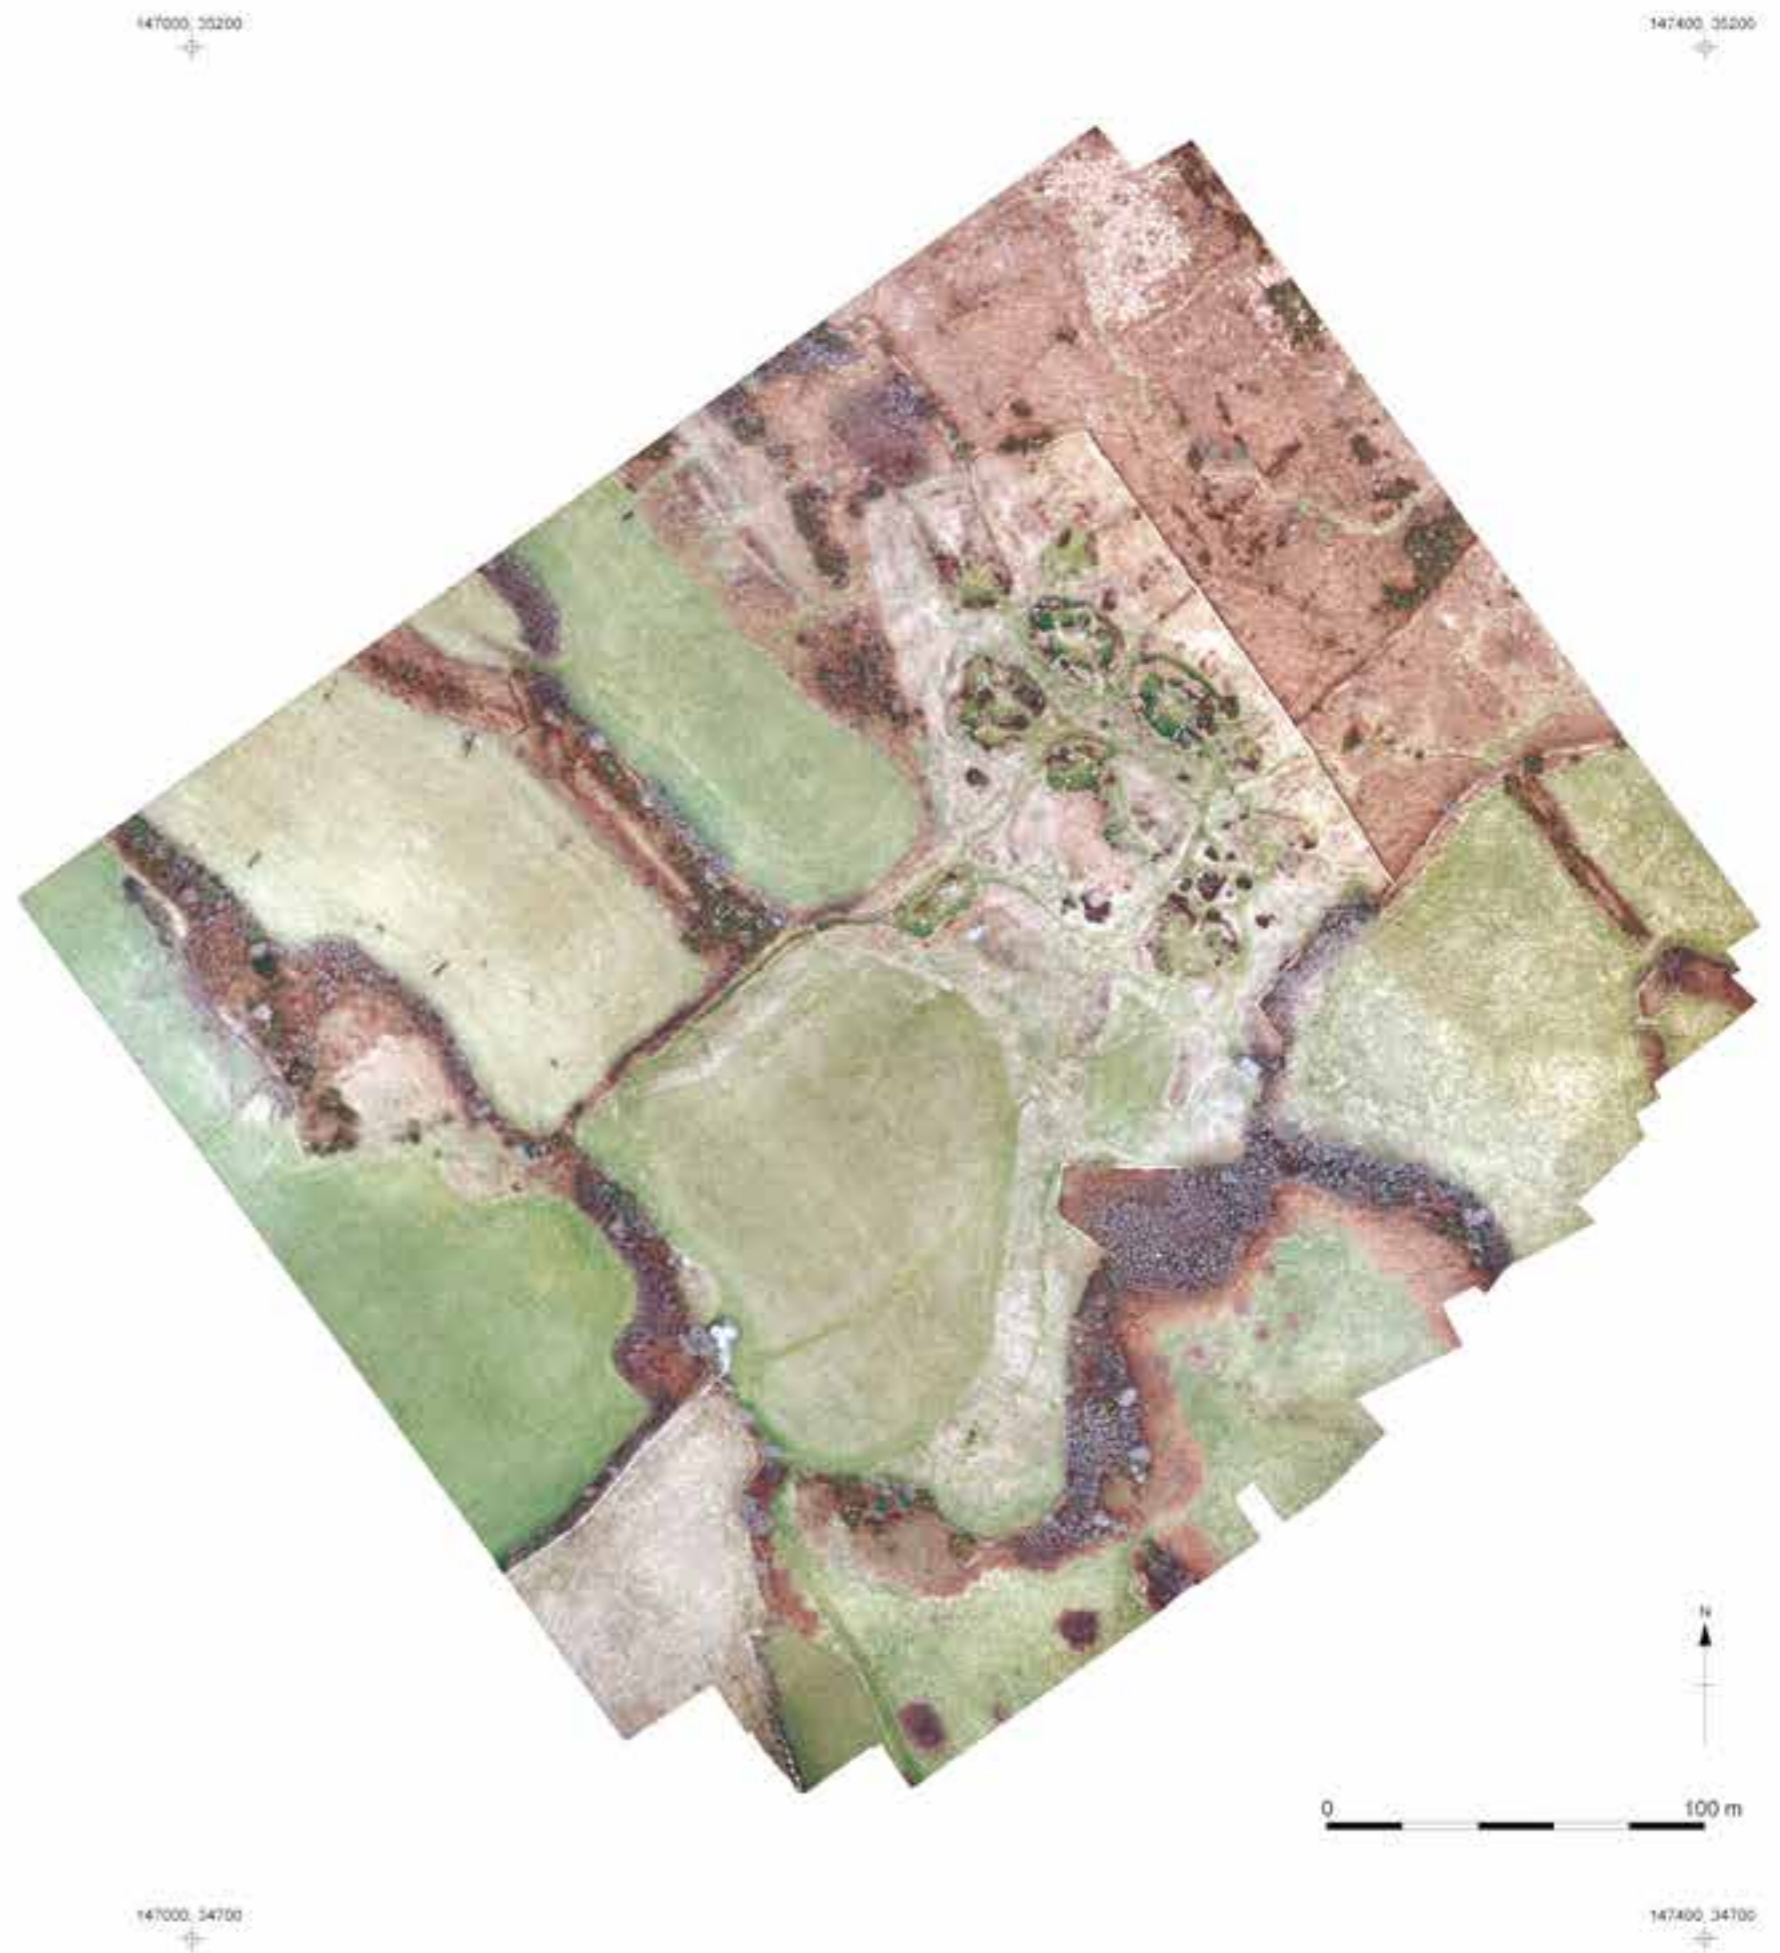
Figure 53. Orthophoto derived from Intelligent Mapping Solutions (2016) photogrammetric data. Shown at 1: 2000
