# Assessing the Impact of Trench Arch Drainage Systems on Archaeological Remains in Churchyards

**Final Report**

**Client: Historic England**

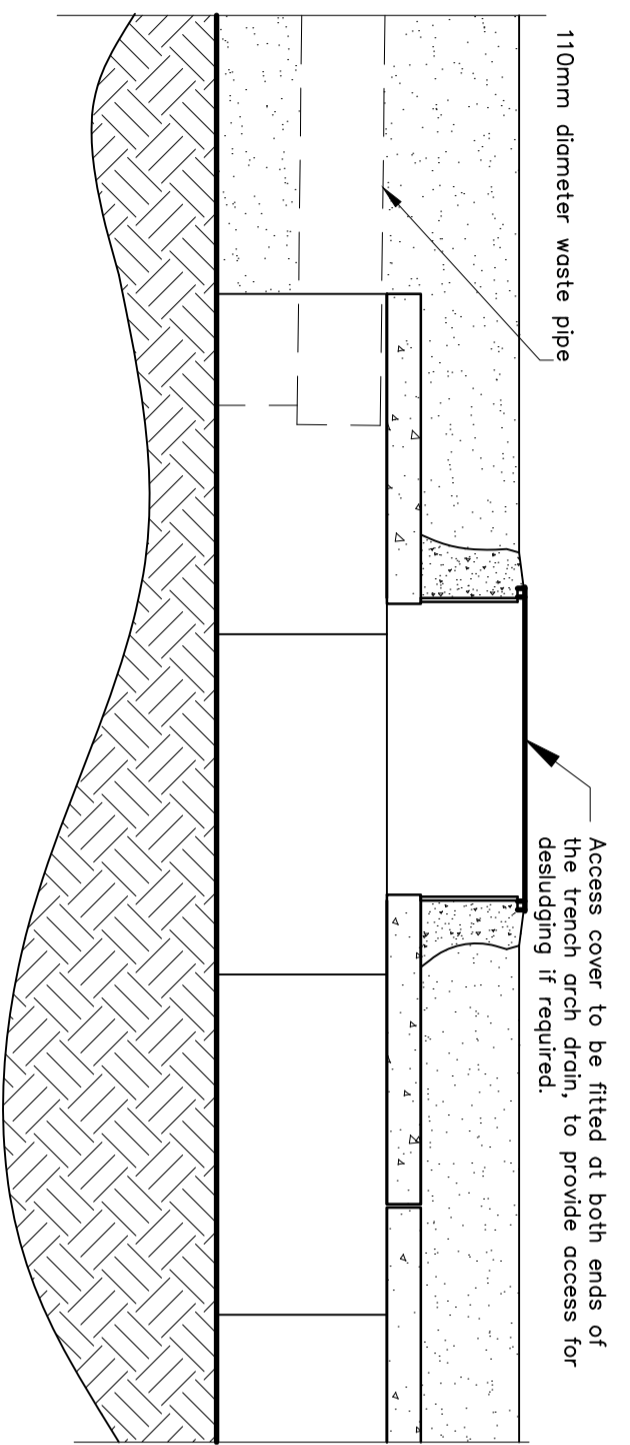
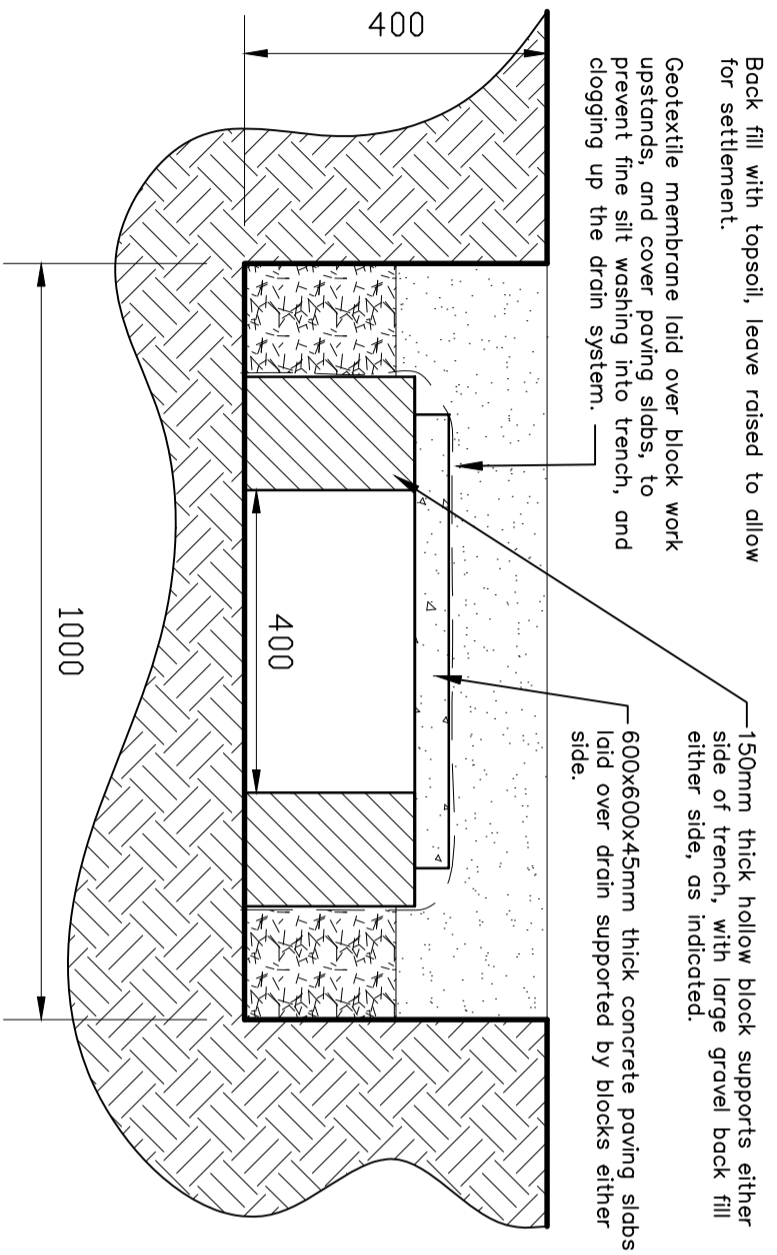
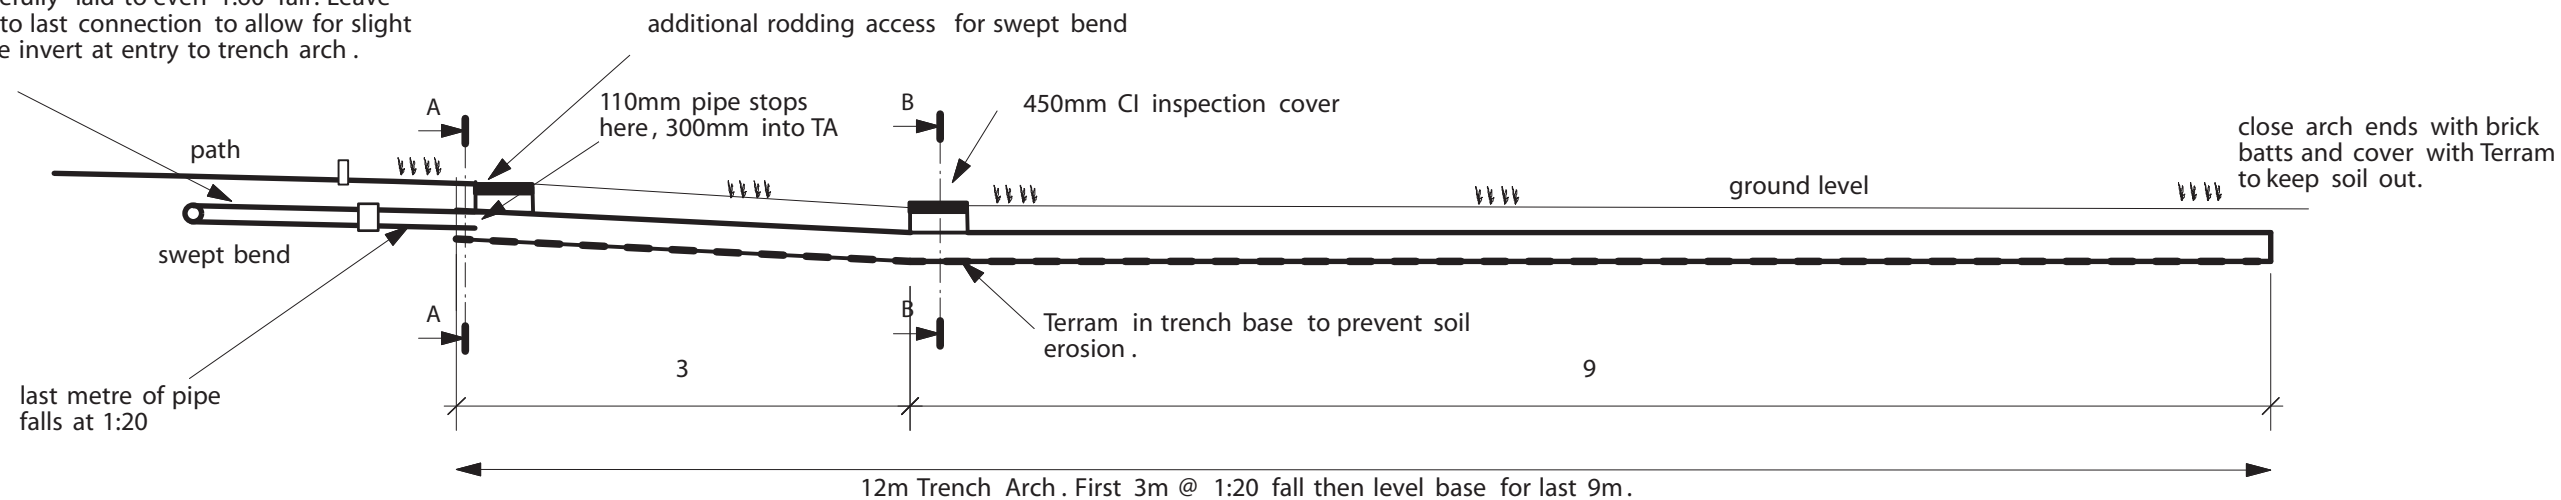
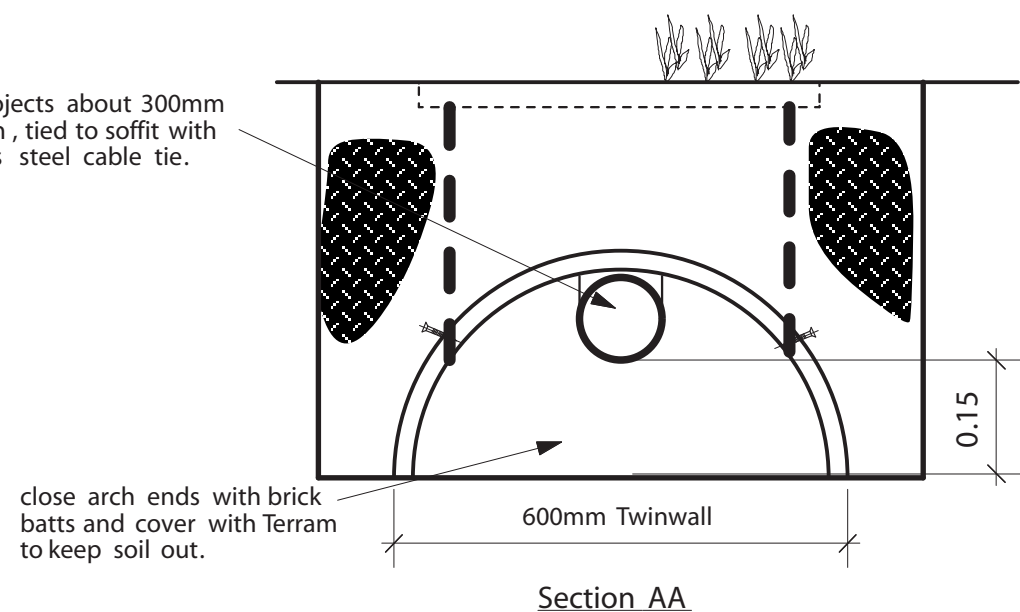
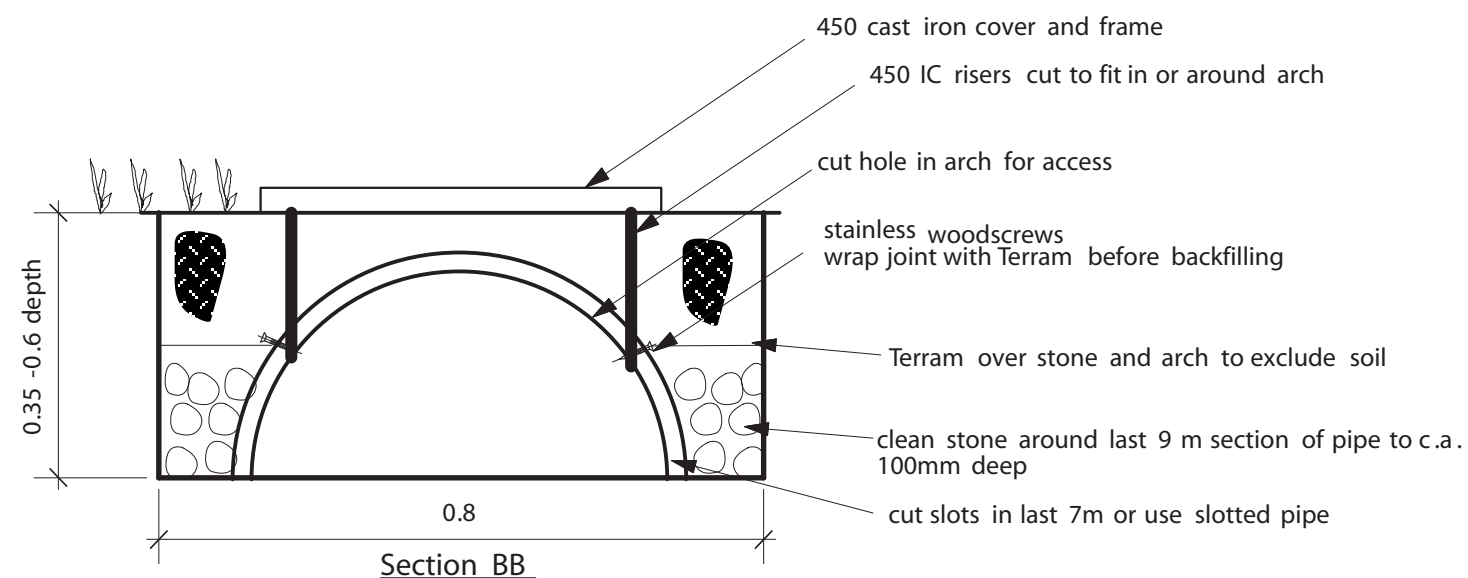
Figure 1: Drawings of a standard TAD, with inspection chamber

110mm diameter waste pipe

Access cover to be fitted at both ends of the trench arch drain, to provide access for desludging if required.

### Long section through trench arch drain

Trench base is to fall at a gradient of 1:20 for the first 4 to 6 M. One metre before the end of the trench is to be almost flat, and the final metre of the trench is to rise at a gradient of 1:5. When excavating be careful not to smear or compact the base. The length of the trench arch drain is to be determined on site following a percolation test.

Back fill with topsoil, leave raised to allow for settlement.

Geotextile membrane laid over block work upstands, and cover paving slabs, to prevent fine silt washing into trench, and clogging up the drain system.

Approximate levels to check feasibility based on 300mm cover at start of drain run (400 should be possible) - mark out on site before commencing excavation .  
Trench arch should ideally be no deeper than 600mm .

110mm drain . Carefully laid to even 1:60 fall . Leave pipe trench open to last connection to allow for slight adjustment of pipe invert at entry to trench arch .

pipe projects about 300mm into arch , tied to soffit with stainless steel cable tie.

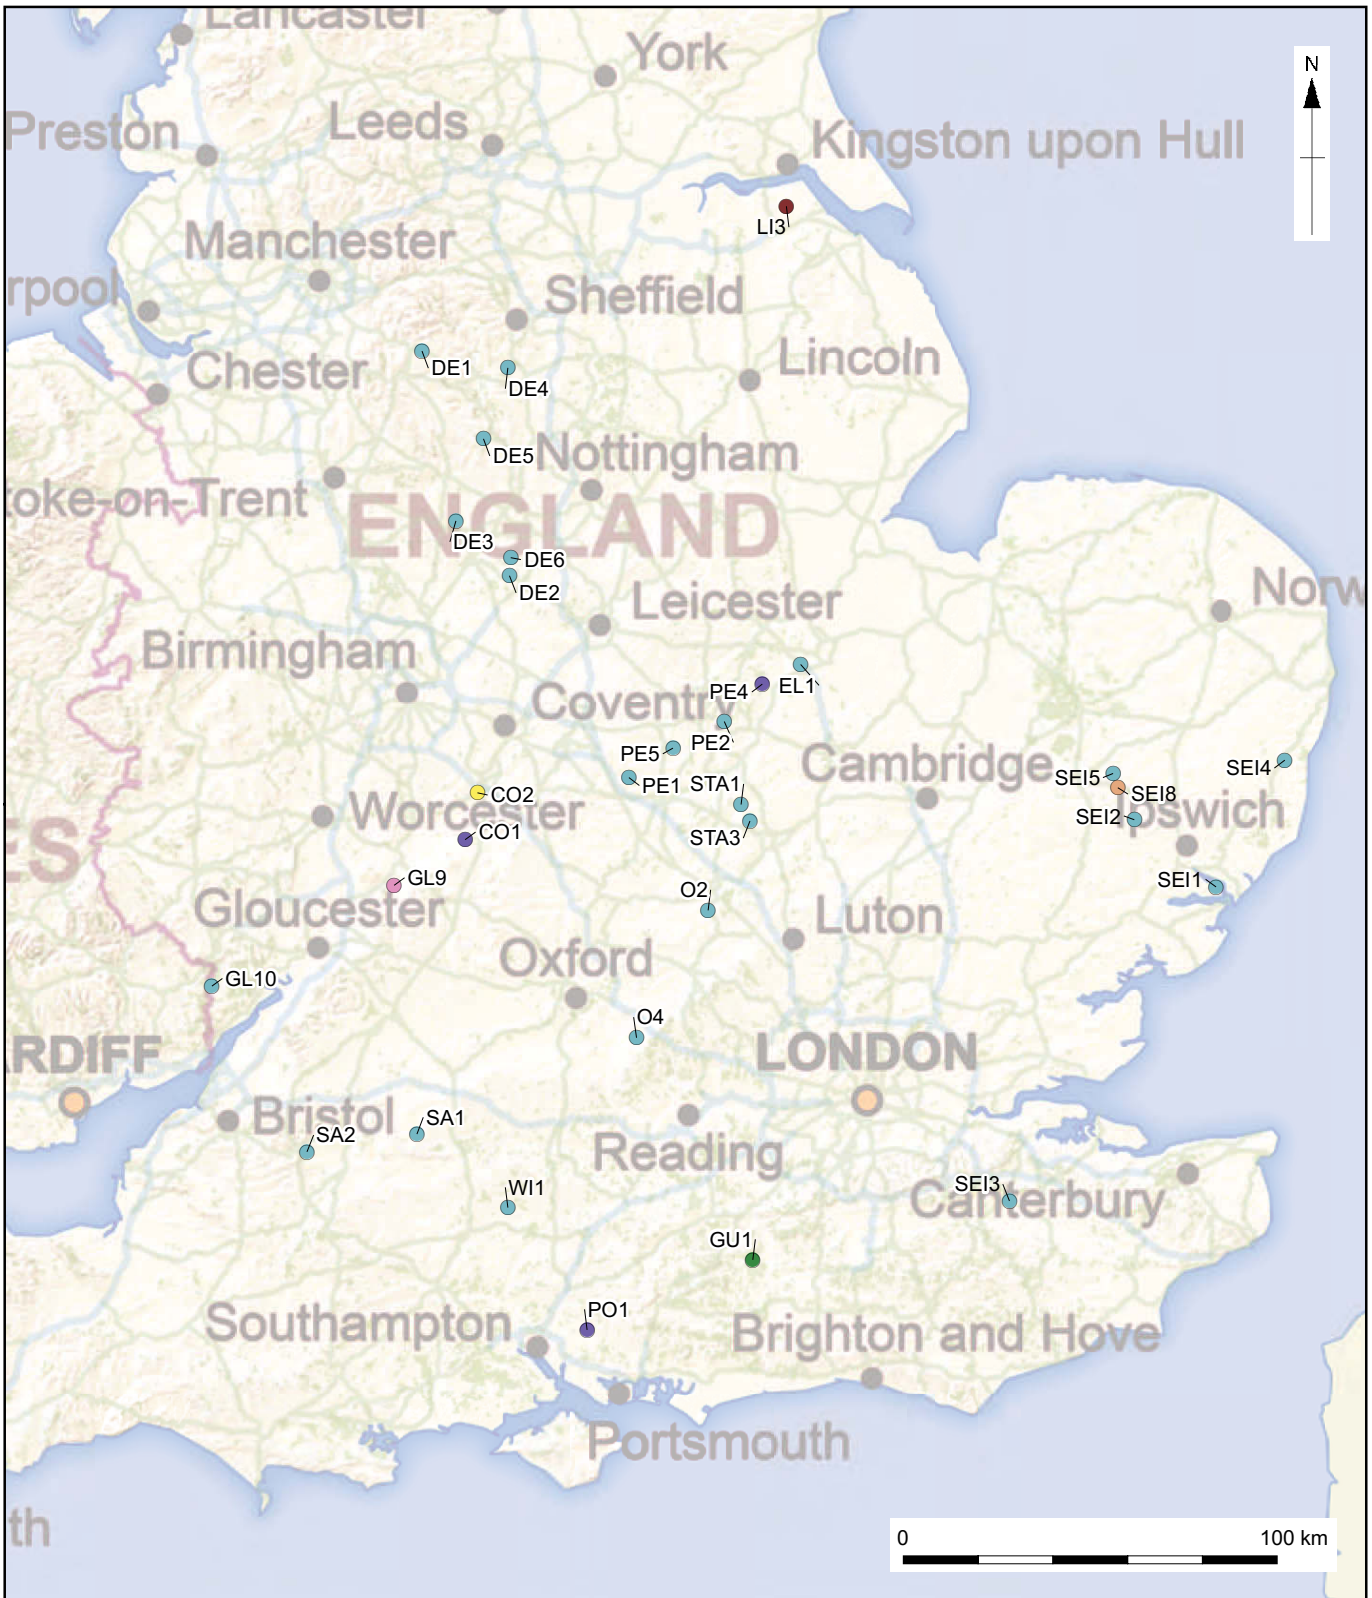
Figure 10: Distribution of TADs design variations identified in this study

- 1 - The basic TAD form is retained, but the width and depth of the excavated trench, as well as the gradient of the trench base may differ from the recommendations

- 2 - The basic TAD form is retained, but a double drainage chamber is constructed (i.e. three parallel rows of hollow concrete blocks capped by two rows of paving slabs)

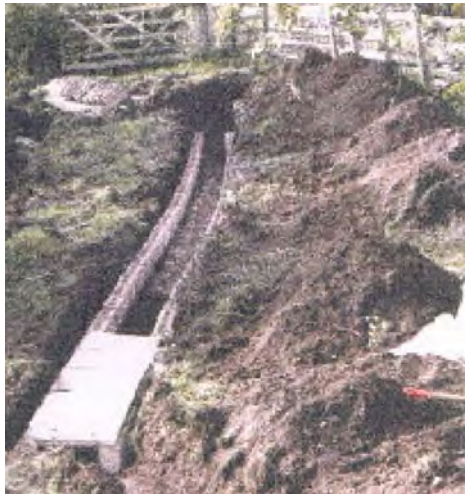
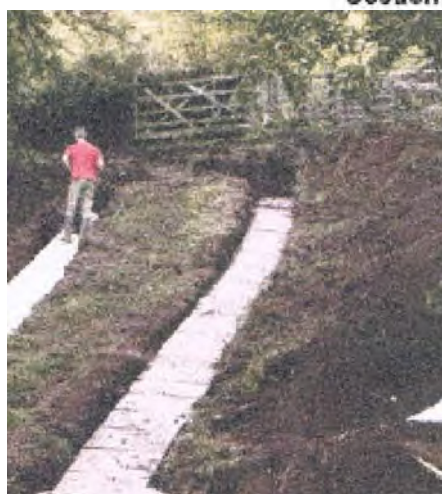
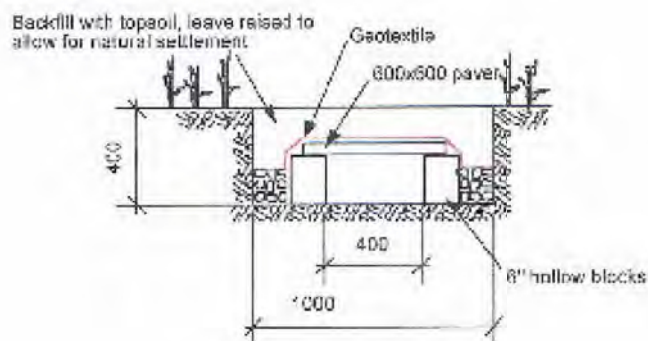
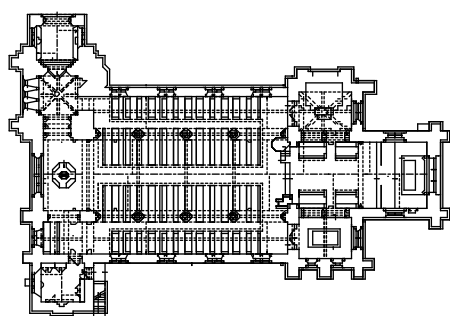
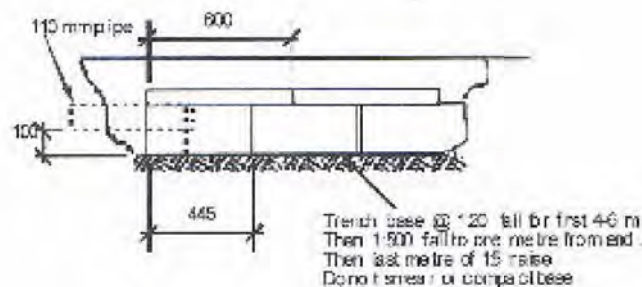
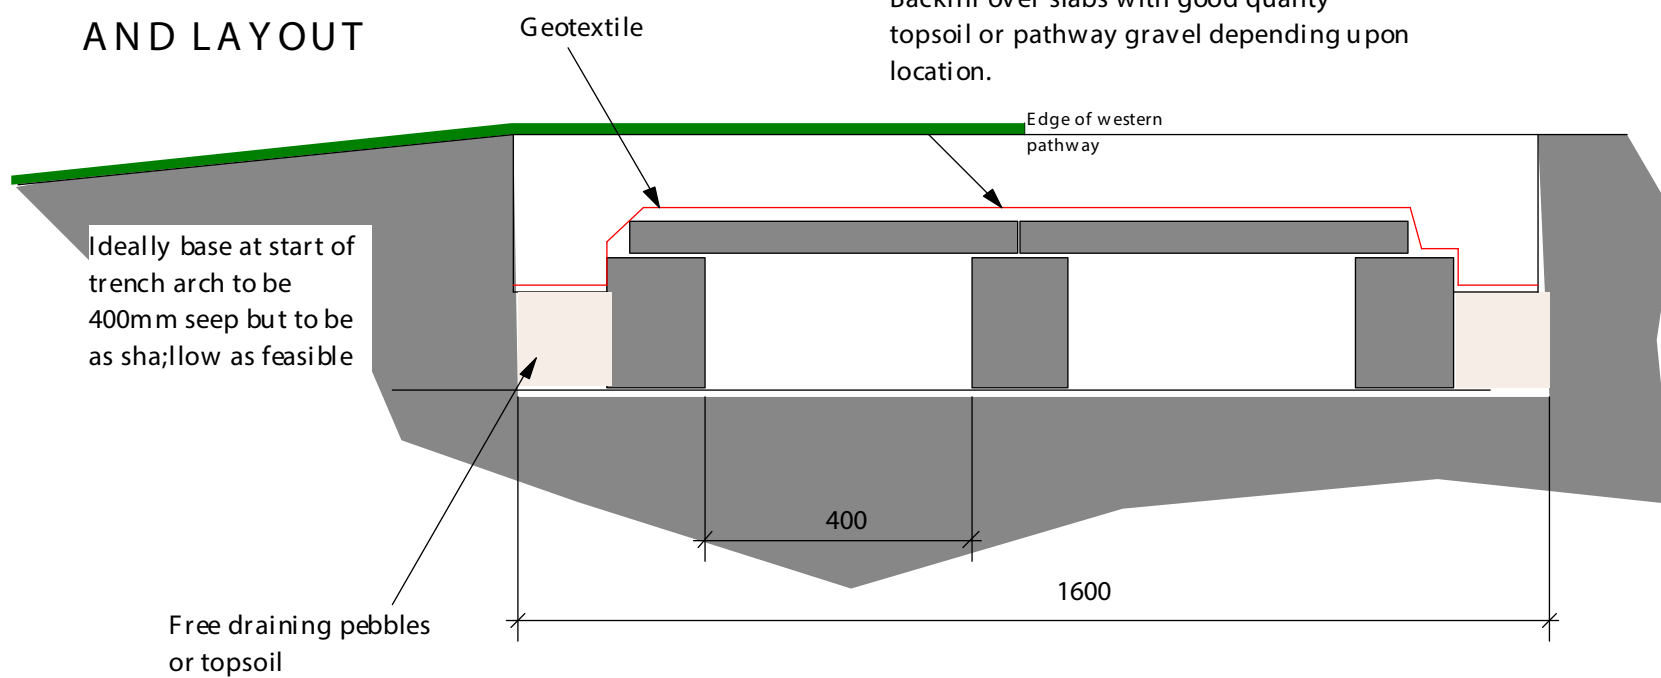
Figure 17b

Last 1m rises at 1:5

SECTION THROUGH TRENCH ARCH DRAIN

Section across trench arch

NOTE This detail shows a typical single width trench. Here, two side by side trenches are required, see drawn detail.

Section along trench

50mm x 600mm x 600mm heavy duty paving slabs set onto hollow concrete blocks with 300mm wide perpend joints. Backfill over slabs with good quality topsoil or pathway gravel depending upon location.

One example of TAD Type 2 was observed in the Diocese of Coventry, at All Saints church in Sherbourne (Fig 17). The excavated trench was 1600mm wide, but only 400mm in depth. However, all other aspects of the construction follow the Elemental Solutions methodology.
