Historic Places Investigation

Haltwhistle Golf Course, Greenhead Carlisle Glenwhelt Leazes Temporary Camp: Aerial Assessment

NGR: NY 6560 6560

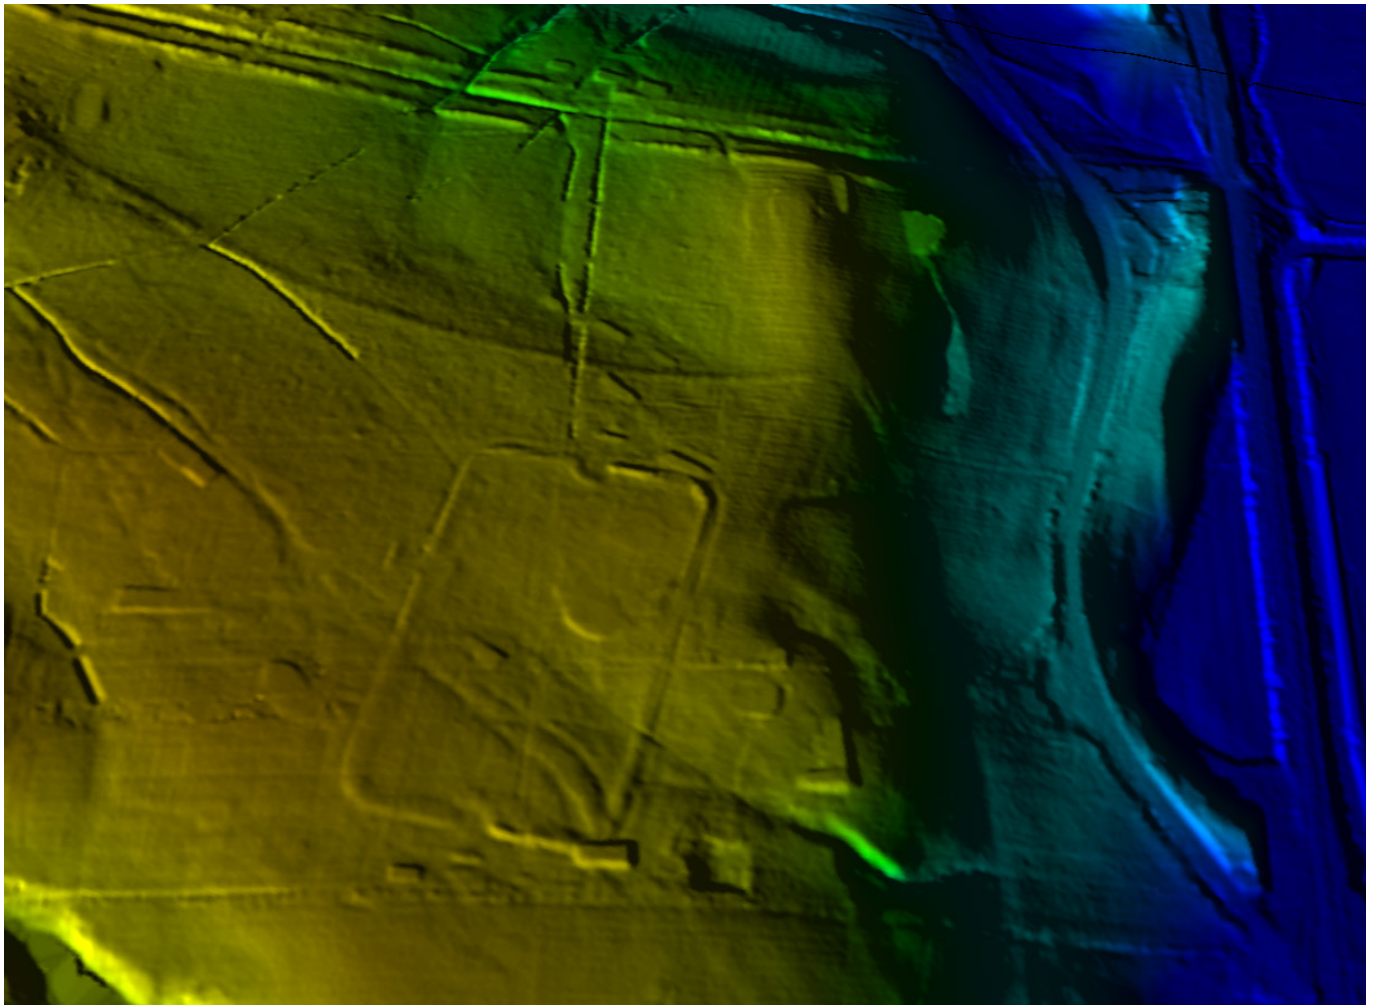
Cover. Lidar DTM model of Glenwhelt Leazes camp. ©Historic England; source Environment Agency.

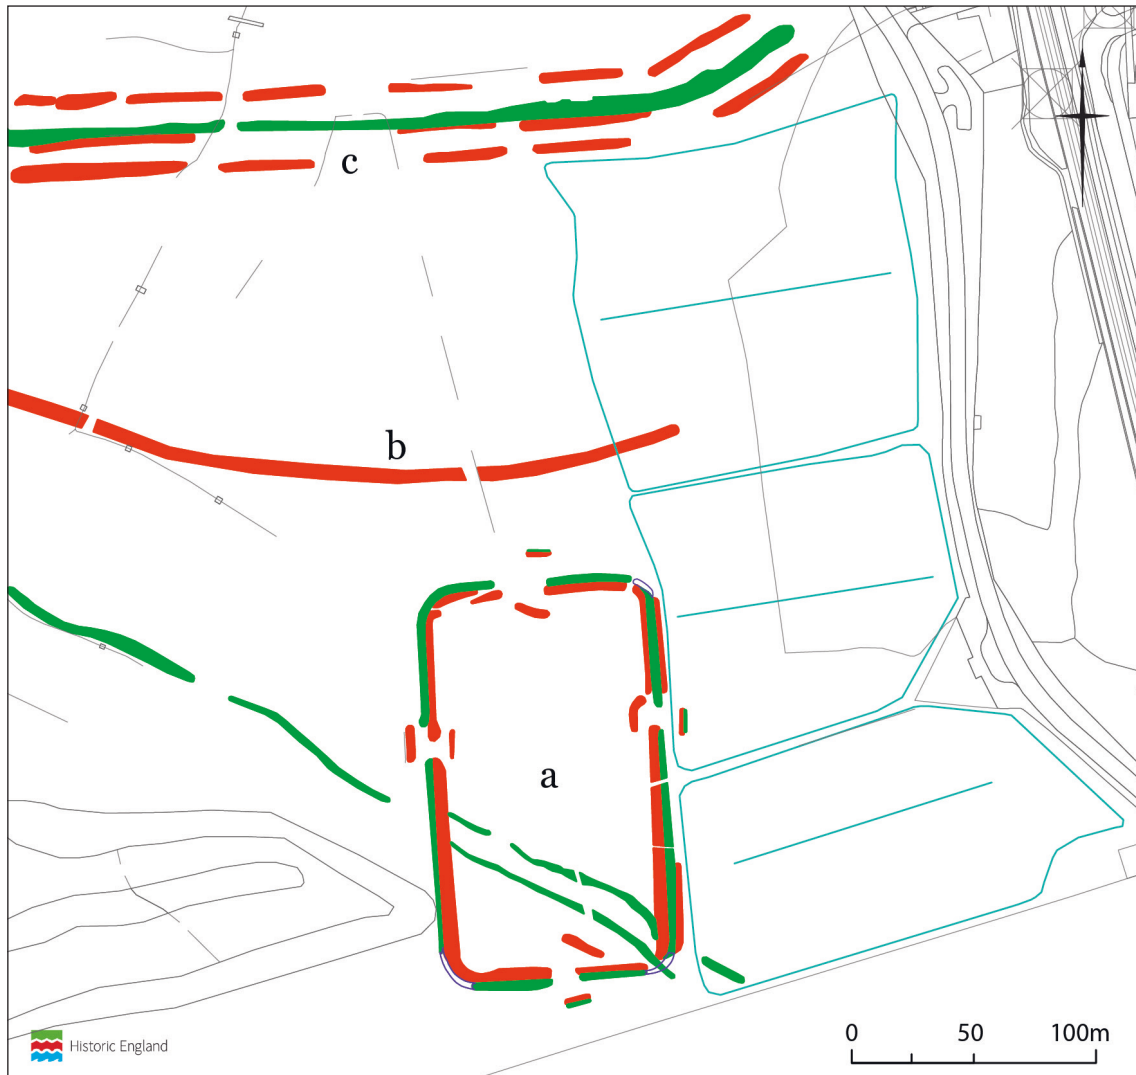
Located at 165m OD, Glenwhelt Leazes is situated in a fairly prominent position commanding clear views of the surrounding landscape (RCHME 1995, 102). The camp (Fig 2) appears to be easily accessible on its north, west and southern approach however there is a steep drop to the east where the ridge on which the site is located is truncated by the Tipalt Burn. The camp encloses an area of 1.2 hectares and is rectangular in plan with rounded corners, typical of the playing card shape commonly associated with Roman camps. It is formed of an internal bank and external ditch with four opposing entrances, one in each side, and is oriented directly north-south. The northern and southern entrances are located centrally, however the east and west entrances are situated a third of the way down the north-south orientated banks forming the sides of the monument. The entrances comprise an external short traverse with an internal clavicula. These are defensive features with the short linear traverse designed to obscure the entrances to the fort, controlling the approach to the site, with the curved bank of the clavicula forcing the direction of movement into the camp. This combination of entrance features is particularly unusual with only two examples identified in the RCHME survey (RCHME 1995, 12-13). The second example, Chapel Rigg, is situated 1km further west along the escarpment on which Glenwhelt Leazes sits and it may be that the similar morphology is indicative of contemporaneity between the sites.

Fig 2: Mapping of the camp (a) and associated features including Stanegate (b) and the Vallum (c). Banks are shown in red, ditches in green and purple line depicts features levelled since the earliest photography. © Historic England. Base map © Crown Copyright and database right 2017. All rights reserved. Ordnance Survey Licence number 1000190.

The camp is situated approximately 50m south of Stanegate Roman road, an east-west route way linking Corbridge to Carlisle which pre-dates the Wall and associated features (Margary 1957, 117). It is fairly well preserved along this stretch and can be seen as an agger as it crosses the golf course, although the raised road surface is less clearly defined where truncated by golf course features. Further to the west, beyond the limit of the study area, the route of the road can only be traced as a wider ploughed-out mound. There is no archaeological evidence to identify the relationship between the road and the camp. There is a change in the direction of Stanegate to the west of the camp. While this could suggest that the course of the road was avoiding the camp it may alternatively relate to an easier crossing of the Tipalt Burn and is therefore not necessarily indicative of the camp pre-dating the road (RCHME 1995, 103).

Running parallel to Stanegate, the Vallum which served to demarcate the militarised zone of the Wall, can be seen as a distinct earthwork comprising stretches of ditch flanked by two large banks on either side with intermittent narrow irregular banks, possibly re-cutting upcast, directly along the edge of the ditch scarp. The ditch is fairly continuous across the study site, except where truncated by modern field boundaries or drainage ditches, however the banks are less consistent in their preservation. North of the vallum can be seen the line of Hadrian's Wall as a subtle ditch, further to the west it is more marked in appearance where the northern scarp reportedly has a height of 1.2m (*see* Fig 6). Between Hadrian's Wall and the Vallum is the projected route of the Roman Military Way which potentially follows the course of the road to the golf club house although no trace either side of the road was visible from either aerial photography or lidar.

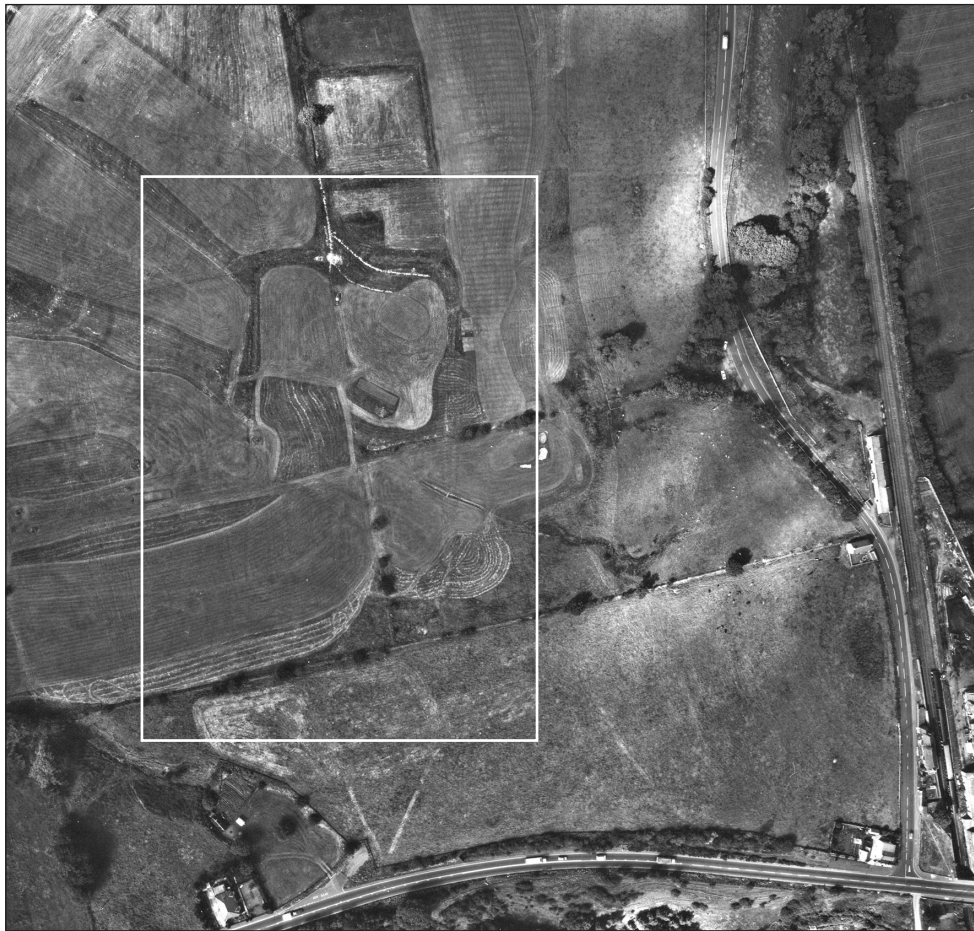
Historic and current land uses have led to fairly poor preservation of the camp earthworks. A series of photographs from 1966 to 1985 records the development of the golf course and its impact upon the camp. It is possible to track the attrition of the monument and link it clearly with the development of the golf course. Whilst the site was scheduled in 1928, it is clear from the photography that the western side of the monument is fairly subtle and the camp would have been difficult to identify at the time of implementation and it is likely that the land owners were unaware of its significance.

Figure 3: Detail of golf course with the location of the camp outlined. HSL/UK/78033 1833 28-JUL-1978 ©Crown copyright. Historic England Archive.

The northern entrance is the best preserved as it is located, for the most part, between golf course features. The traverse is clearly defined whereas the clavicula is less distinct but still discernible. A north-south boundary running through the monument was met by an east-west boundary to form a T junction which divided the interior of the camp into three sections. The north-south boundary appears to have truncated the western side of the northern entrance, avoiding the traverse and impacting upon the western side of the clavicula. These two boundaries are visible on the 1st edition 1:10,560 OS mapping (surveyed 1861, published 1865). By the time of the 3rd edition (revised 1920, published 1925) the north south boundary no longer continues across the centre of the monument, however south east corner of the monument is still partitioned off and this boundary is maintained until 1978 (Fig 3).

This division of the interior protected this corner of the monument from the original golf course which slowly encroached on the monument during the 1970s as the boundaries were no longer maintained. The clavicula is also impacted upon by the fairway of the 16th hole. Over time, the area surrounding the 16th green has got wider and has impinged upon the tail of the clavicula. This appears to have slightly reduced the edge of the earthwork at this location possibly due to increased activity in the area from mowing and walking. The repeated traffic over the very subtle feature by the widening of the fairway appears to have caused further erosion.

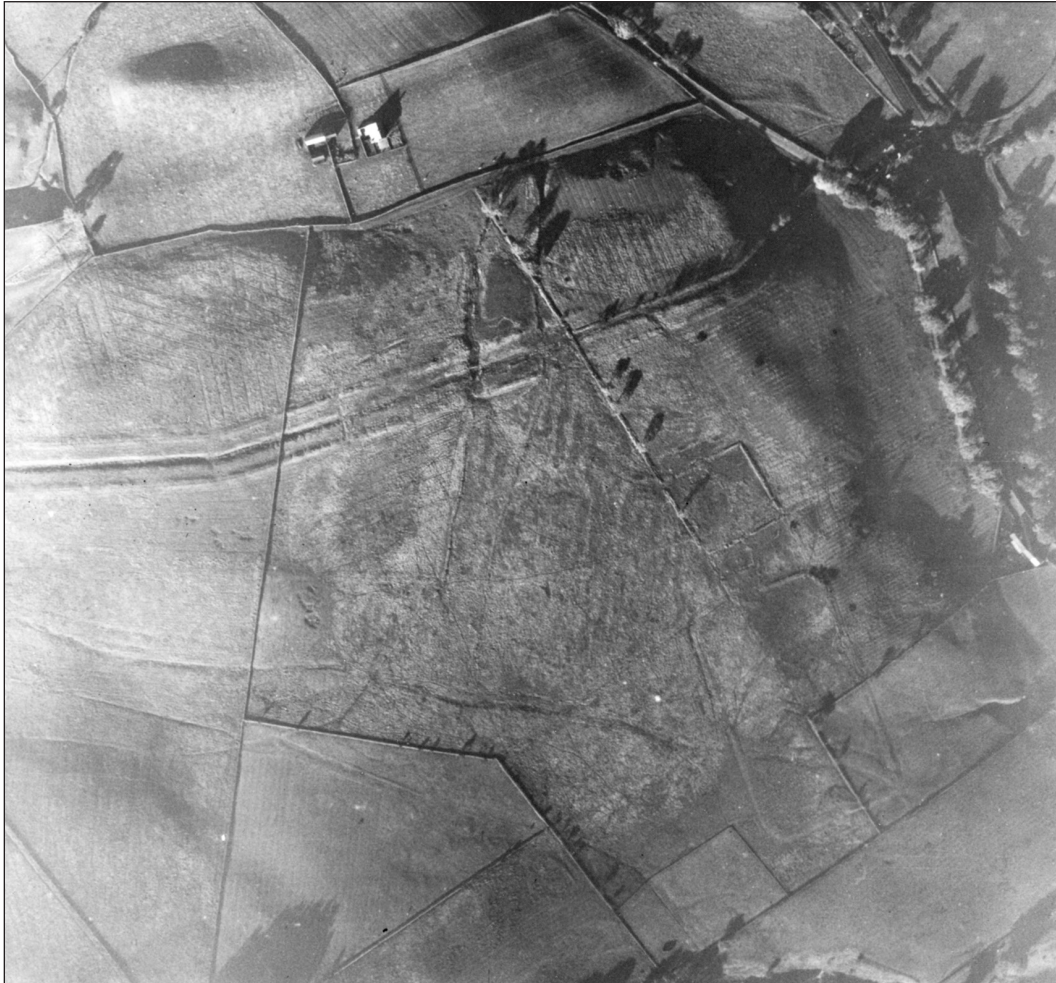
Fig 4: Before the establishment of the golf course. RAF/26/AC 9913 22-OCT-1930 Historic England RAF Photography.

The north-east corner of the monument historically has been the best preserved. There is a small pathway which is cut through the north edge by the corner, this is not shown on any mapping but can be seen on photography dating to the 1930s (the earliest photographic source addressed), and may have been originally caused by human footfall (Fig 4). This break in the earthwork appears to have been reused and recut in later dates, potentially as access to the golf course. In photography from 1975, the path appears more distinct with more defined edges. By this time the course had developed over the majority of the interior and it may well have been maintained as a path from this point on. The 15th tee is located immediately north of the north-east corner of the camp and considerable levelling can be identified on the lidar.

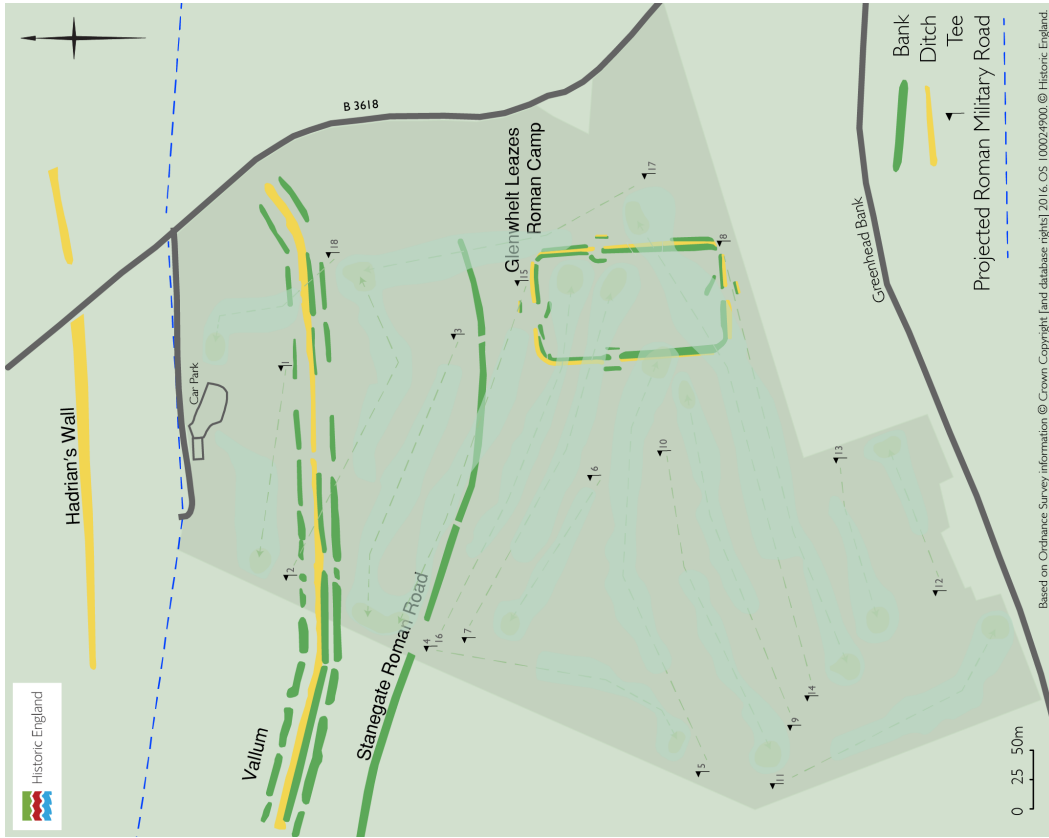
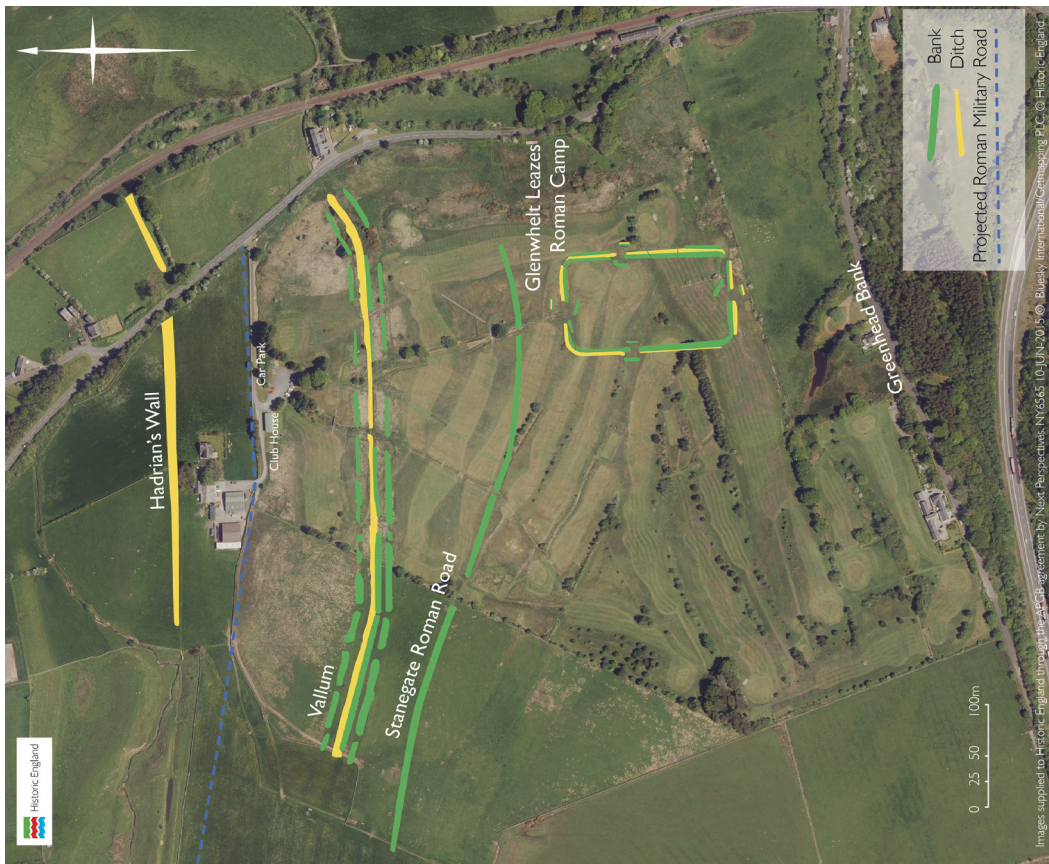
The widespread use of Google Earth has meant that, in general, audiences are more familiar with seeing local landmarks from an aerial perspective. The first plan generated used orthophotography as the basis of the mapping. This provides a wide range of contextual information including the layout and landscaping of the course and its wider environment as well as the mapped archaeology. The second design was simpler in appearance. Key features such as main routes were transcribed from Ordnance Survey mapping, the extent of the golf club was highlighted and the golf course was mapped from 2015 orthophotography. On both plans, the location of the tees was indicated to help visitors situate themselves in relation to the course.

With the aim of the plan to not only identify the location of the site but the significance of the camp, it was decided that it would be best to depict and label well known archaeological features in order to visually articulate the significance of the camp within a recognisable archaeological landscape. Whilst the first image may be considered to be the more engaging one, and therefore the best suited to demonstrate the site and its location to a visitor audience, the camp appears somewhat distinct from its landscape as it overlies the background photography. The second image shows the camp underlying the golf course, which is shown as a transparency, and makes it readily apparent where the course impacts upon the monument. This sense of how the course and the camp interact is particularly helpful for heritage management purposes as it clearly demonstrates, on a measurable plan where the golf course features impact upon the monument.

Fig 6: A comparison of the two drawings produced for the interpretation board. The first image displays the mapping of the Roman features over orthophotography (provided by APGB) and the second includes mapping of the golf course layout.

There is the intention for an interpretation board to be erected at the site in order to inform visitors and possibly generate a sense of interest and ownership of the camp remains amongst members of the golf club and locals alike. In order to assist with this a number of versions of the mapping, designed to best articulate the form and location of the camp, were produced in order to determine the best way to communicate the site to a non-archaeological audience (Fig 6). For these plans, mapping was simplified and reduced to depict only Roman features on a two-tone plan depicting banks in one colour and ditches in another. This will be accompanied by descriptive text, identifying the features of the camp, surrounding archaeology and the significance of the site.
