Norton Hall Barn, Hall Lane, Stanton Street, Suffolk

Tree-ring Analysis of Oak Timbers

Research Report Series 35-2017

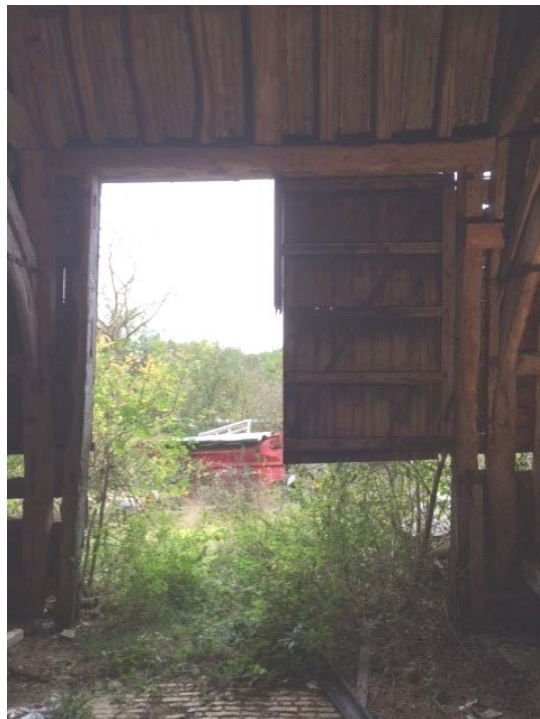
Figure 6: Doorway D1, photograph taken from the east (Alison Arnold)

One of these, NRT-N34, has complete sapwood and the last-measured ring date of AD 1626, the felling date of the timber represented. This sample was taken from the south post of doorway D1. Sample NRT-N33, from the north post of doorway D1, matches NRT-N34 at a value of $t = 11.0$, a level high enough to suggest both timbers may have been cut from the same tree and hence were felled at the same time in AD 1626.

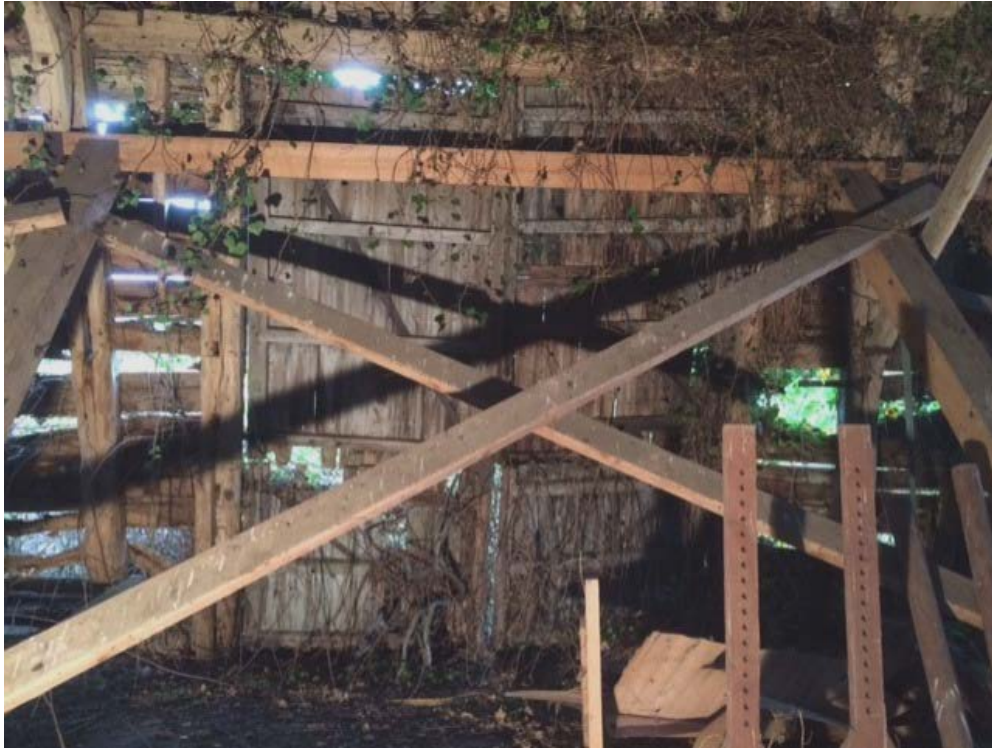
Figure 7: Doorway D2, photograph taken from the east (Alison Arnold)

Samples NRT-N35 and NRT-N36 taken from the north and south posts of doorway D2 have also been dated. The dates of the heartwood/sapwood boundary rings differ by only nine years and, with an average of AD 1610, an estimated felling date of AD 1625–50 is therefore obtained for these two posts.

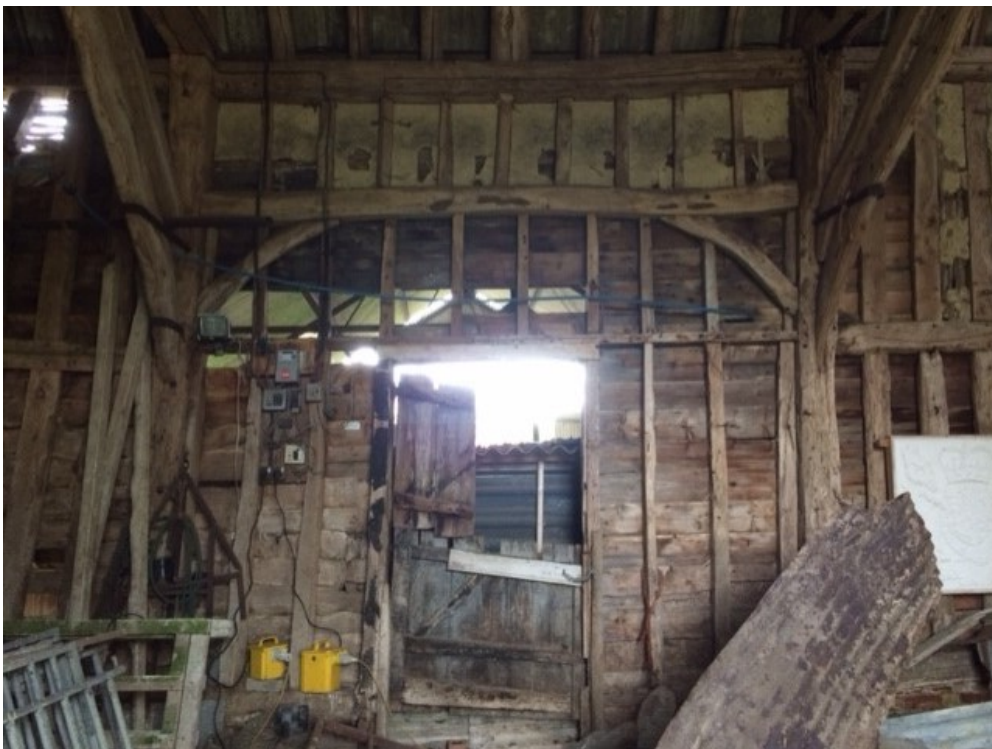
Figure 8: Doorway D3, photograph taken from the west (Alison Arnold)

Only one of the samples from doorway D3 has been successfully dated. Sample NRT-N25, taken from a cross-rail, has the heartwood/sapwood boundary ring date of AD 1612, giving an estimated felling date for the timber represented of AD 1627–52.

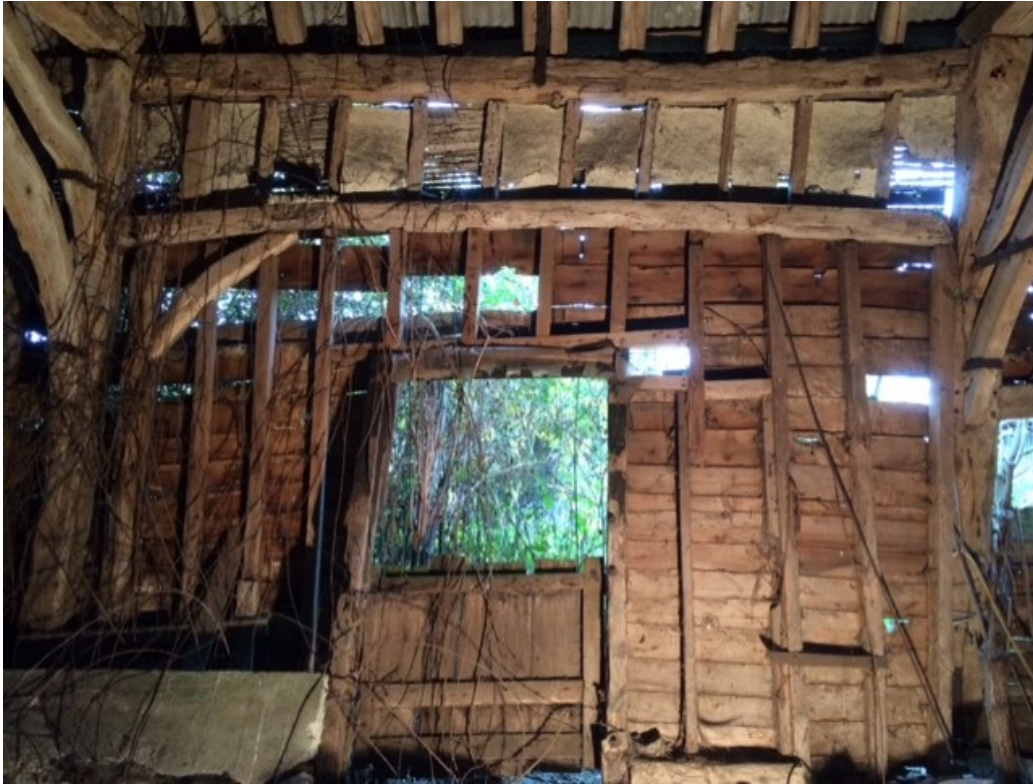
Figure 9: Doorway D4, photograph taken from the west (Alison Arnold)

Samples from a cross rail (NRT-N31) and stud (NRT-N32) from doorway D4 have been dated. Both of these samples have the heartwood/sapwood boundary, the dates of which vary by 14 years. The average heartwood/sapwood boundary is AD 1598, allowing an estimated felling date range to be calculated for these two timbers of AD 1613–38.

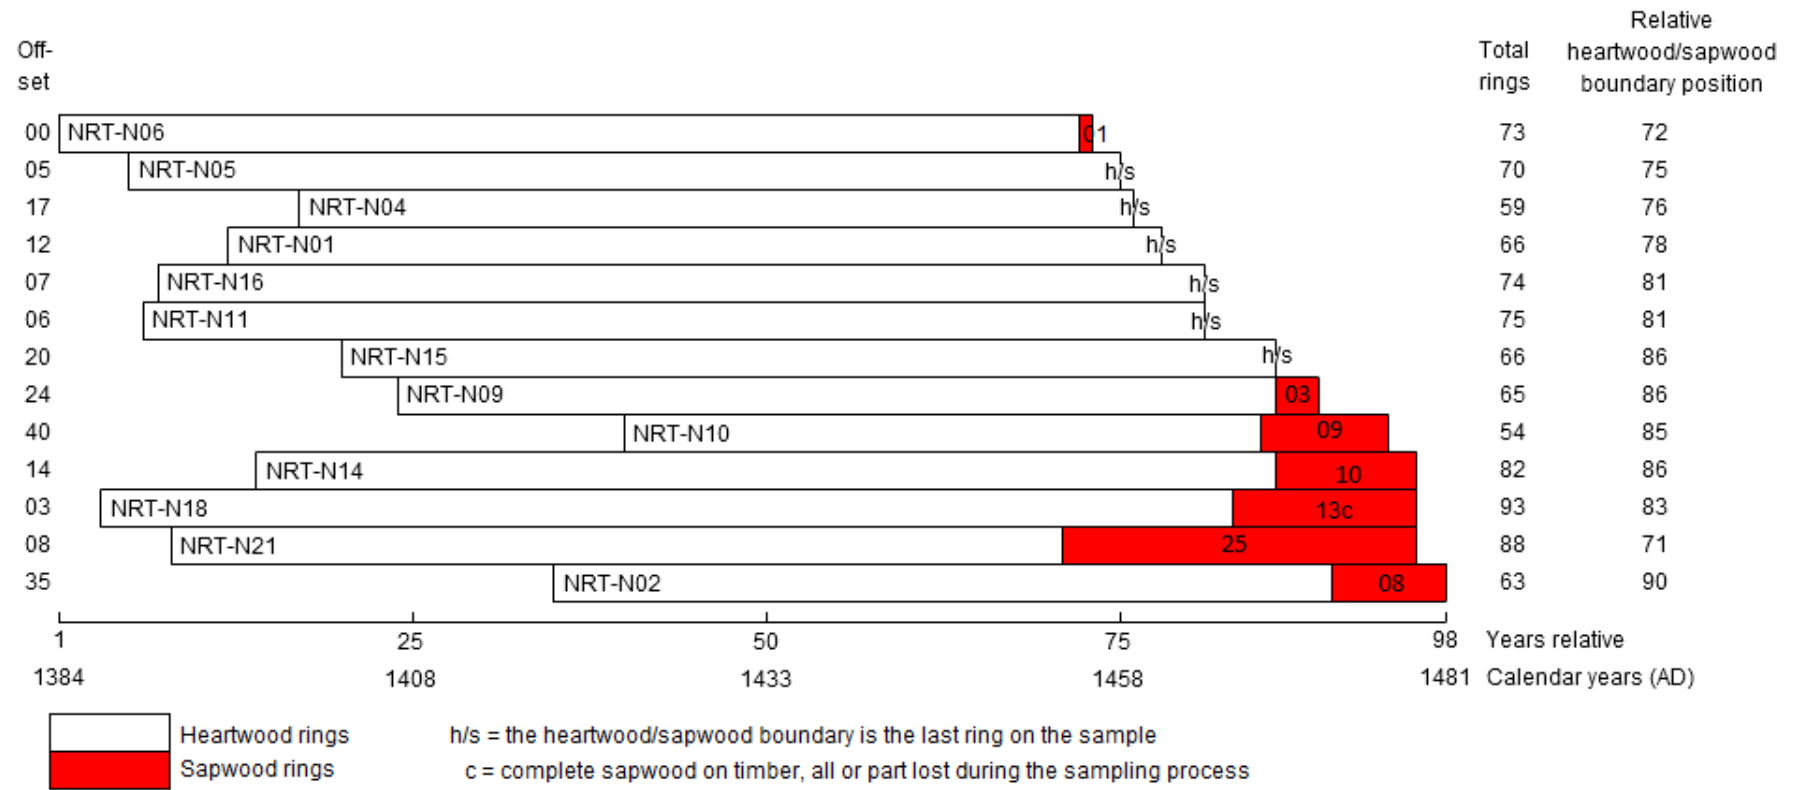
Figure 18: Bar diagram to show the relative position of samples in site sequence NRTNSQ01

Firstly, 13 samples matched each other and were combined at the relevant offset positions to form NRTNSQ01, a site sequence of 98 rings (Fig 18). This site sequence was compared against a series of relevant reference chronologies for oak where it was found to match consistently and securely at a first-ring date of AD 1384 and a last-measured ring date of AD 1481 (Table 2).

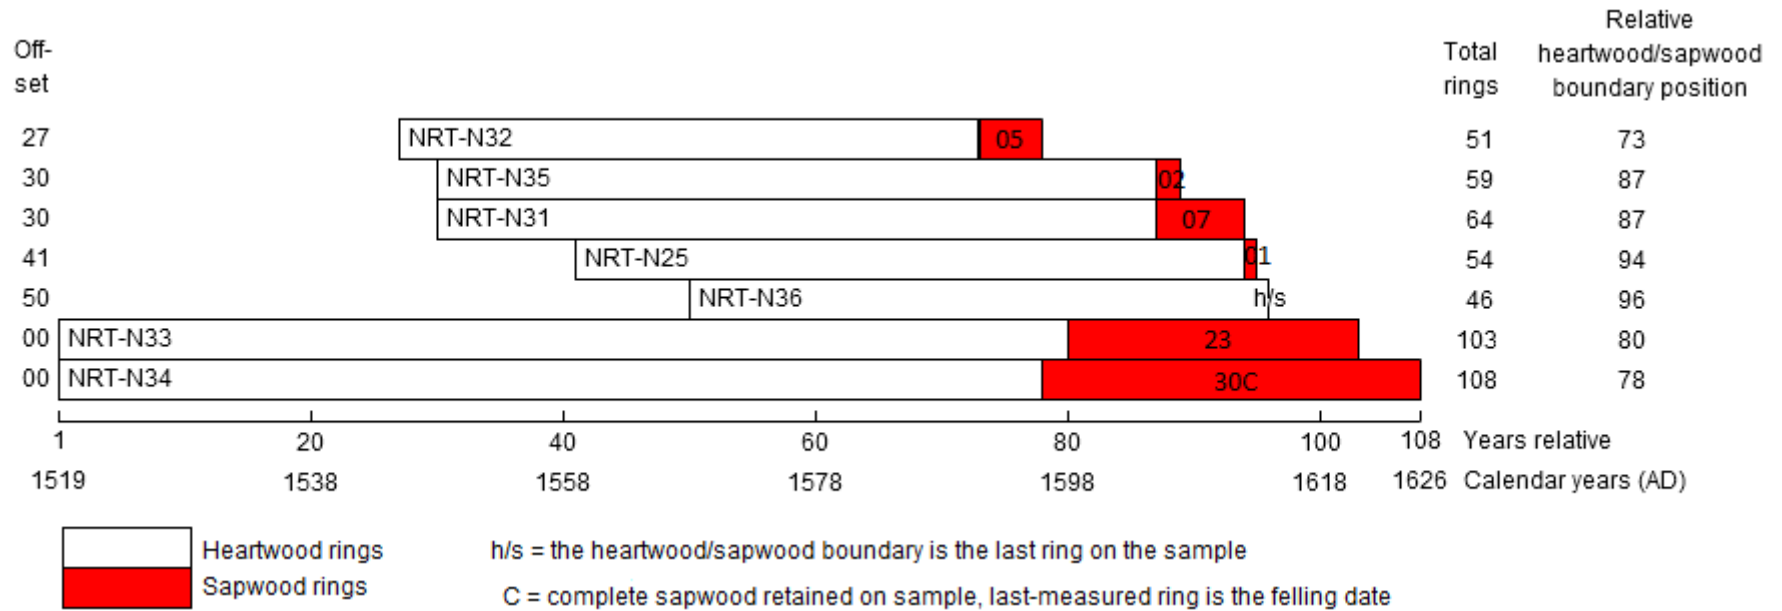
Figure 19: Bar diagram to show the relative position of samples in site sequence NRTNQ02

Secondly, seven samples matched and were combined at the relevant offset positions to form NRTNSQ02, a site sequence of 108 rings (Fig 19). This site sequence was also compared against a series of relevant reference chronologies where it was found to span the period AD 1519–1626 (Table 3).

It is unfortunate that the third site sequence, containing samples taken from two studs thought to be associated with the primary construction phase, is undated. These two samples have the same relative heartwood/sapwood boundary ring position (Fig 19), which suggests both samples were felled at the

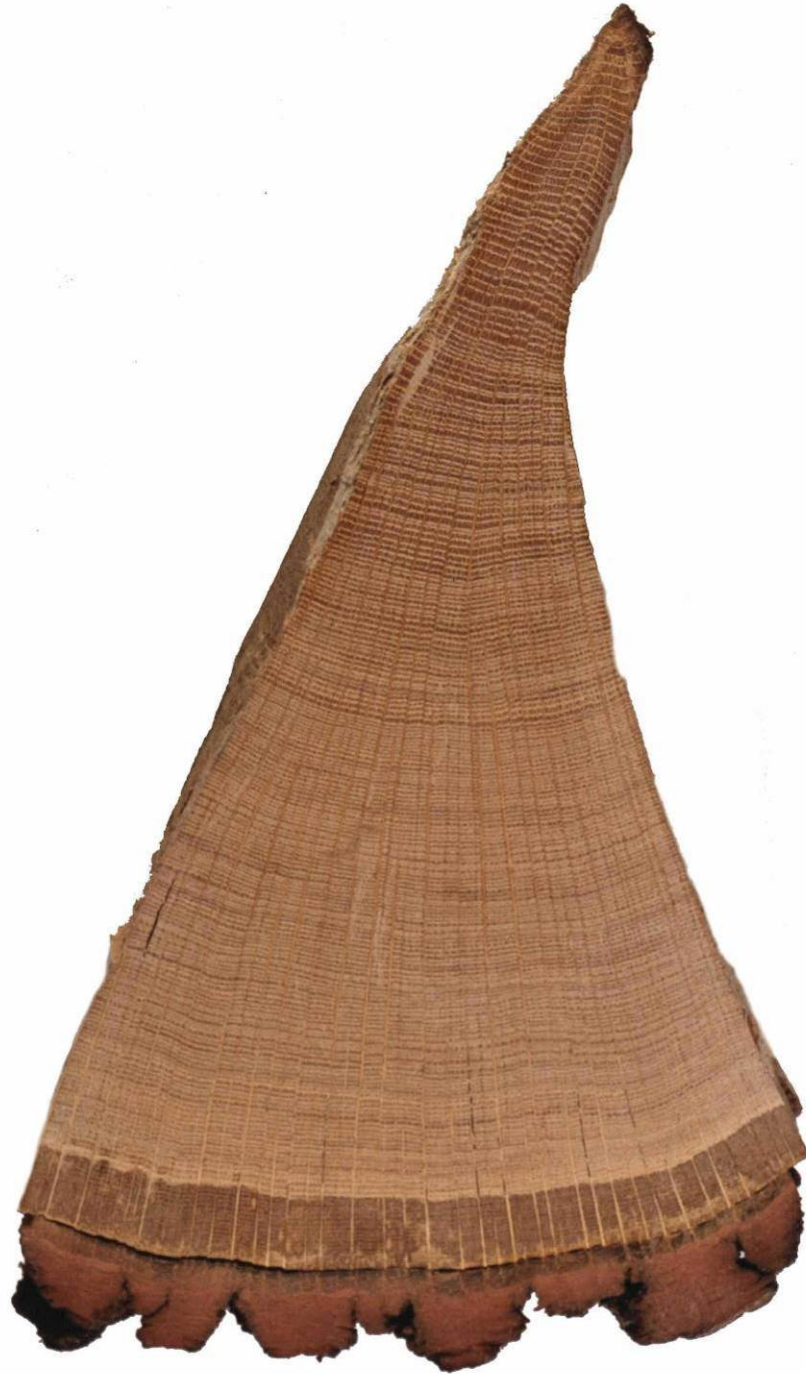
Figure A1: A wedge of oak from a tree felled in 1976. It shows the annual growth rings, one for each year from the innermost ring to the last ring on the outside just inside the bark. The year of each ring can be determined by counting back from the outside ring, which grew in 1976

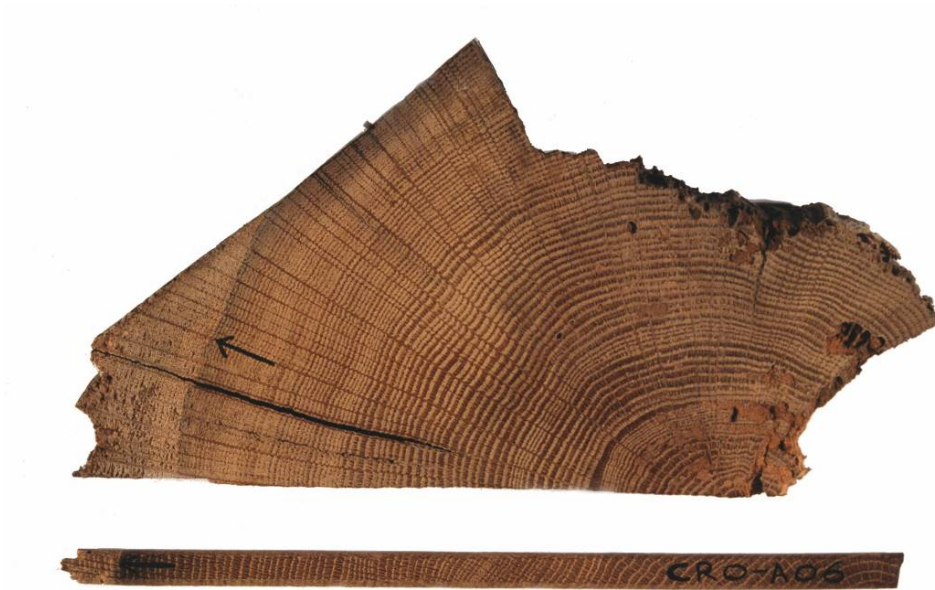
Figure A2: Cross-section of a rafter, showing sapwood rings in the left-hand corner, the arrow points to the heartwood/sapwood boundary (H/S); and a core with sapwood; again the arrow is pointing to the H/S. The core is about the size of a pencil

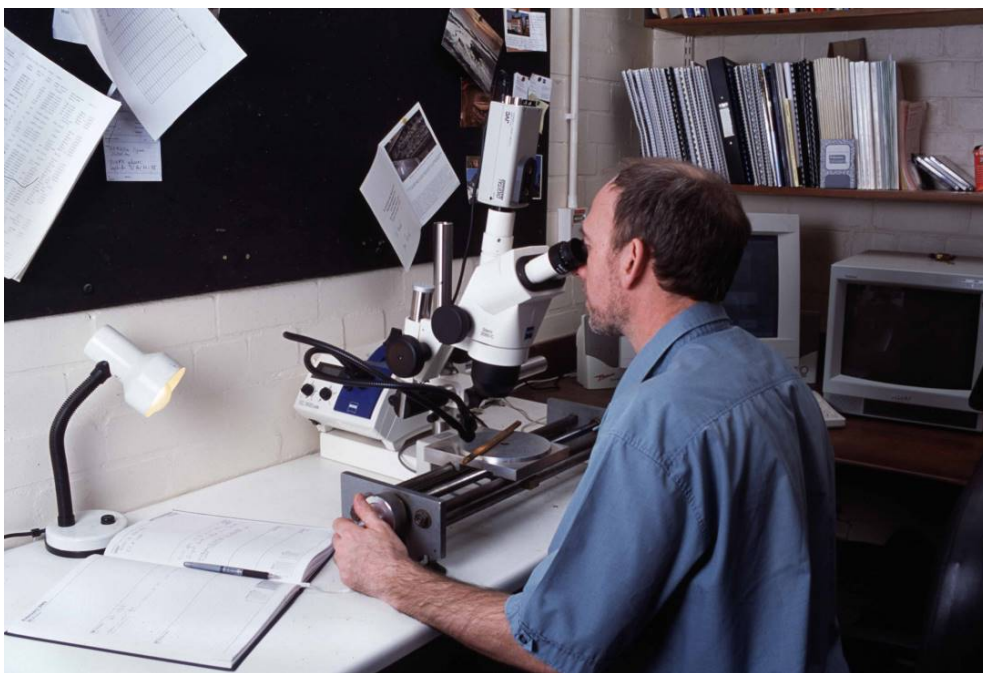
Figure A3: Measuring ring widths under a microscope. The microscope is fixed while the sample is on a moving platform. The total sequence of widths is measured twice to ensure that an error has not been made. This type of apparatus is needed to process a large number of samples on a regular basis

2. Measuring Ring Widths. Each core is sanded down with a belt sander using medium-grit paper and then finished by hand with flourgrade-grit paper. The rings are then clearly visible and differentiated from each other with a result very much like that shown in Figure A2. The core is then mounted on a movable table below a microscope and the ring-widths measured individually from the innermost ring to the outermost. The widths are automatically recorded in a computer file as they are measured (see Fig A3).

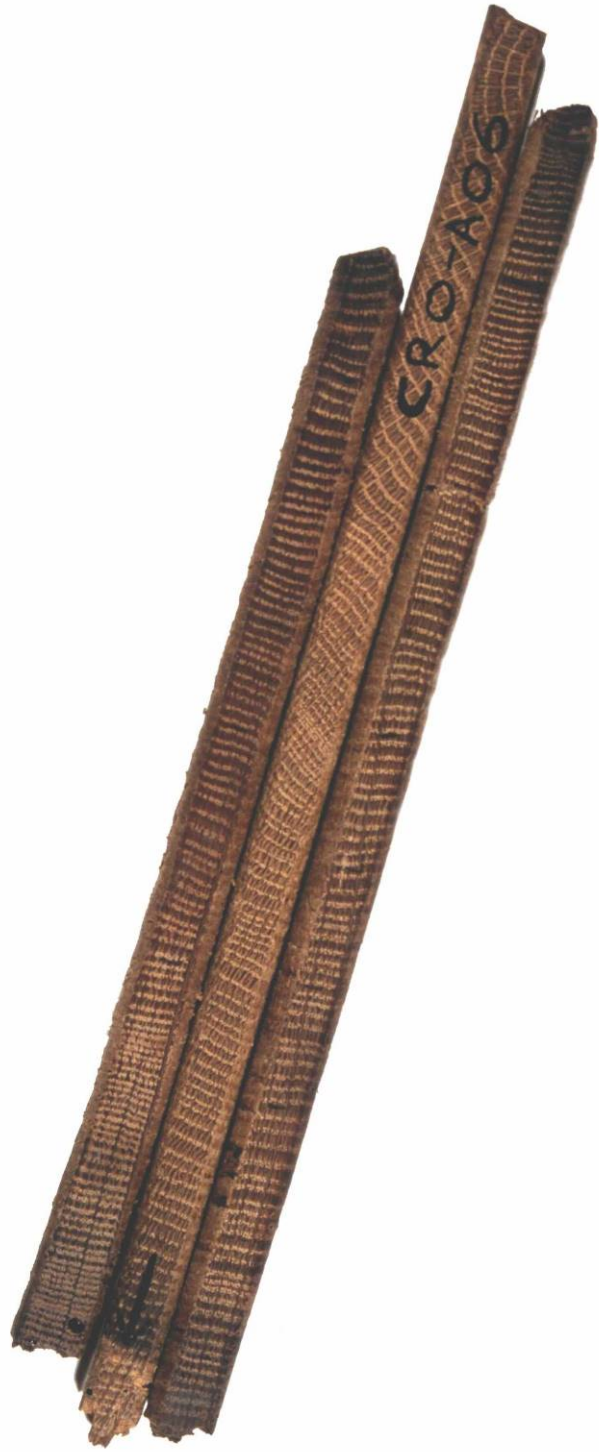
Figure A4: Three cores from timbers in a building. They come from trees growing at the same time. Notice that, although the sequences of widths look similar, they are not identical. This is typical
