# Hilborough moated site, Breckland, Norfolk: Archaeological survey

Research Report Series 34-2018

NGR: TL 8266 9943

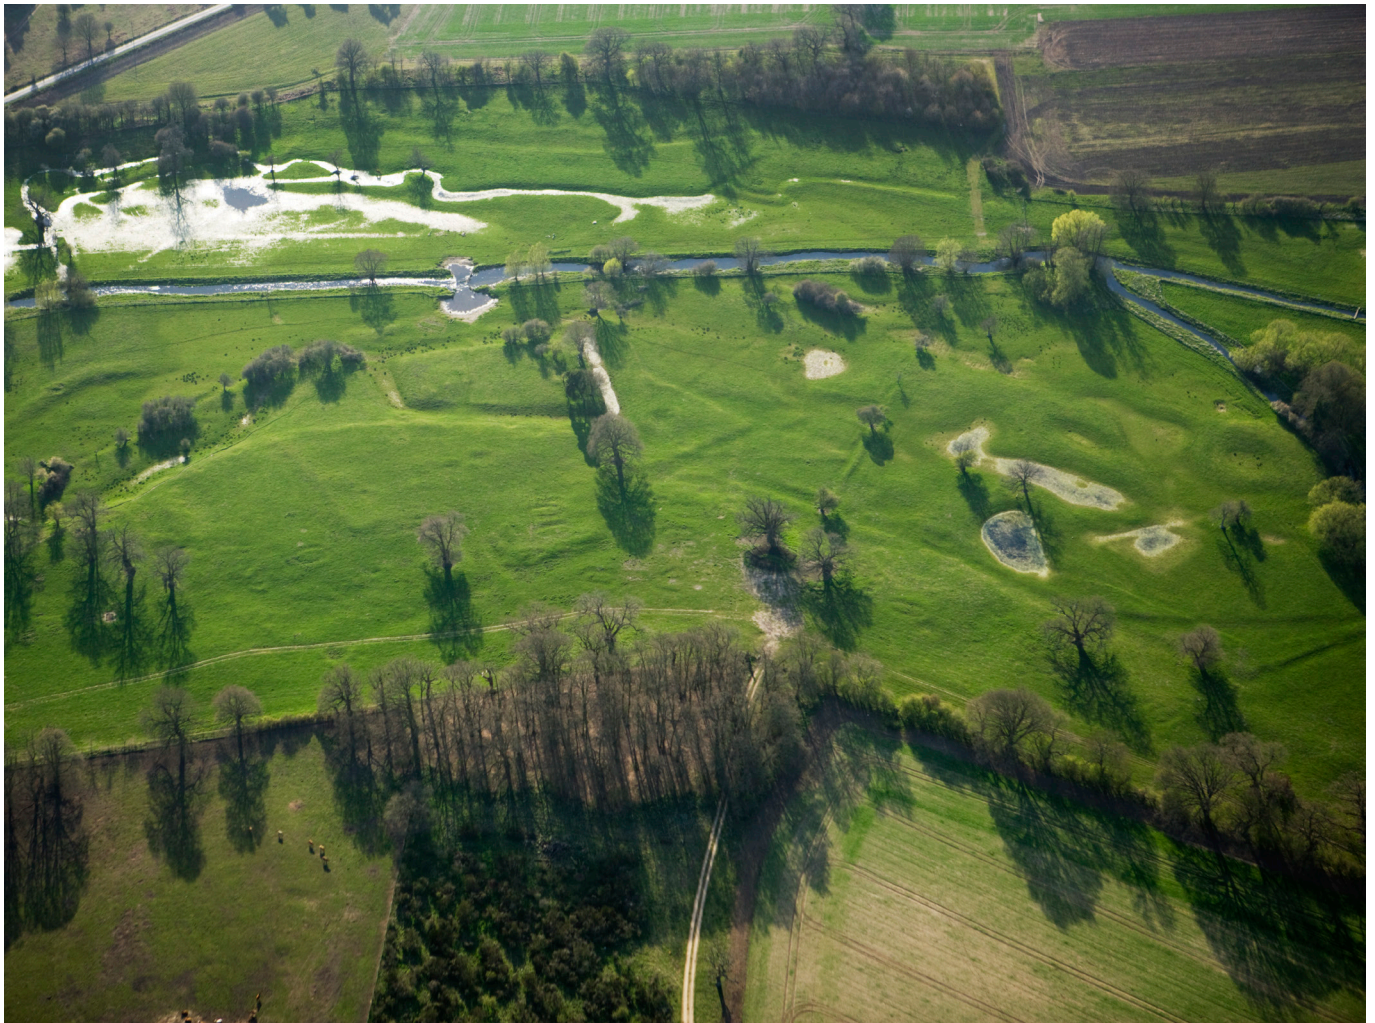
An aerial view of the site from the east, the moat is visible just above left of centre (Damian Grady © Historic England HEA 26670\_036 16-APR-2010)

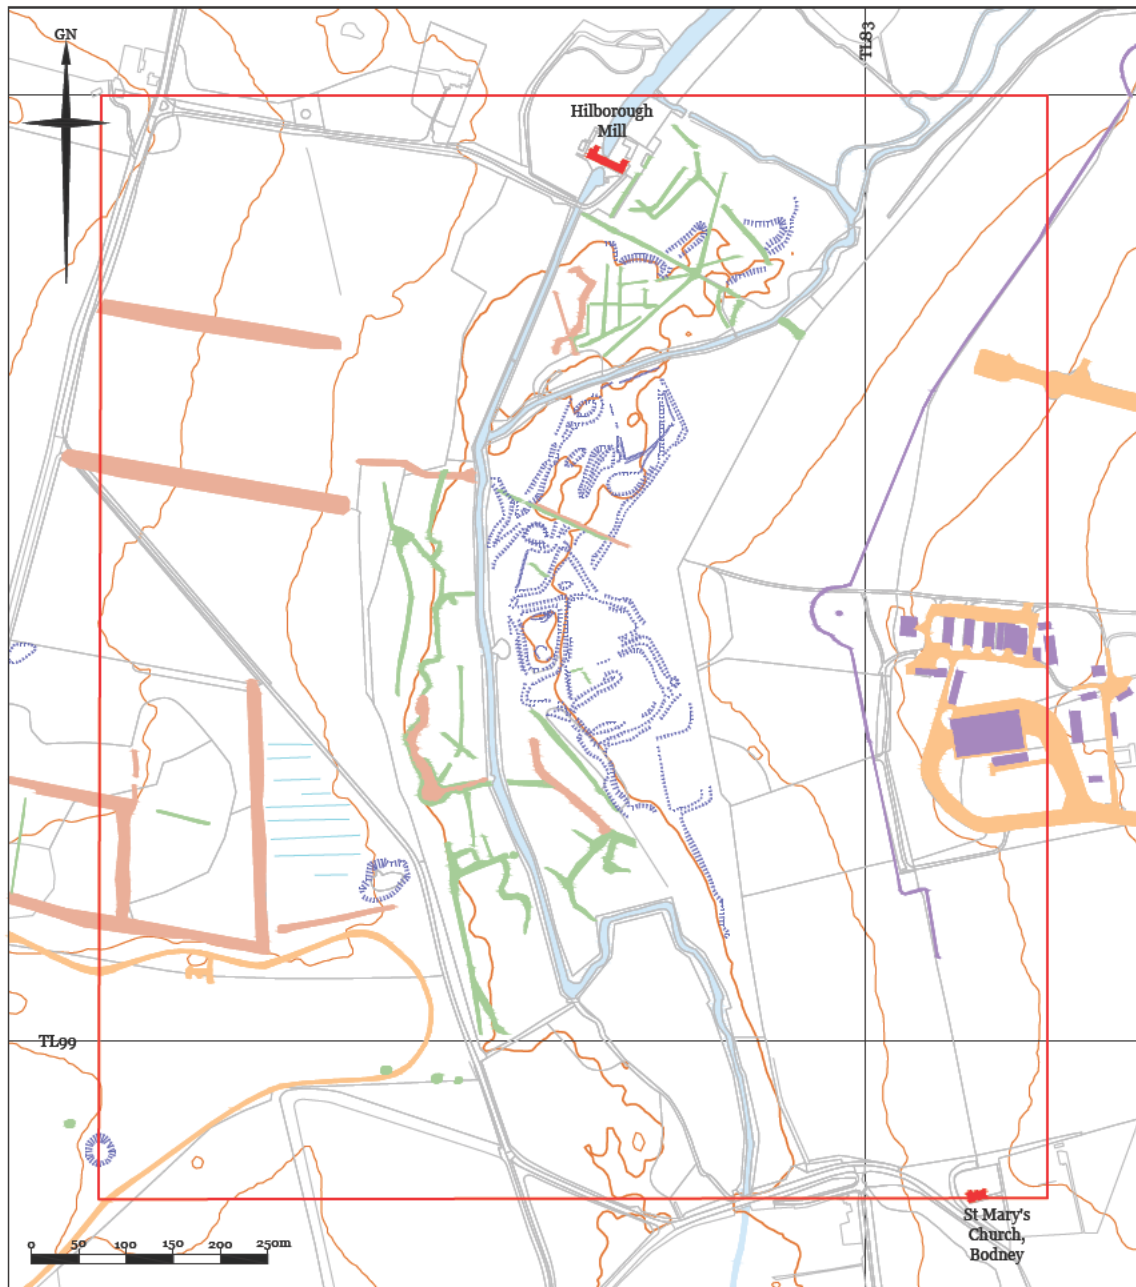
The majority of negative features plotted (shown in green on Figure 2), lie on or adjacent to the valley floor. To the south-west of Hilborough Mill is a group of these features as well as a few others shown with 'T' hachures. There appear to be two distinct types. Some are slightly broader and less regular and can be seen around the mill with a branch running off to the south-east, with two isolated examples to the south of this. The others are straighter, narrower and more uniform and mainly lay to the south of the mill. The former appear to be older and one of the second type can be seen to overlie them. Some form what may have been an enclosure or by-pass channels around the site of Hilborough Mill, but this doesn't sit well with the current mill buildings (of 1809, see above) suggesting that there may have been an earlier mill on this site. The later, straight features are not of a single phase. Some relate to existing field boundaries or are coherent enough with these to suggest former boundaries. Others sit slightly awkwardly with these and may therefore be earlier, perhaps related to meadow drainage, though probably not floated water meadows. A straight, narrow positive feature to the south-west of these is likely to be a field boundary bank. A broader, more sinuous, positive feature here appears to underlie the boundary bank; it is most likely to be an earlier boundary. What appear to be broader elevated areas, perhaps truncated in places, are indicated by 'T' hachures in this area.

Figure 2 – The aerial photograph and lidar mapping, 5m contours (the 20m OD contour enhanced to indicate the flood plain), 1:8000 at A4. Red rectangle is the study area. Large earthwork features, principally visible on lidar, shown with blue ‘T’ hachures; negative features such as ditches in green; positive features such as banks in salmon; cyan lines indicate ridge and furrow; former structures in purple; other features in orange (Fiona Small © Historic England, Modern Ordnance Survey mapping: © Crown Copyright and database right 2018. All rights reserved. Ordnance Survey Licence number 100024900)

To the south of this area, to the west and south of the moated site, the negative features are less dense and clear stratigraphy is not visible. Again, some are broader and more irregular and others are narrower and straighter suggesting different phases of activity. Most are likely to be either field boundaries, drainage or both, with the more sinuous examples perhaps palaeo-channels. There are few coherent

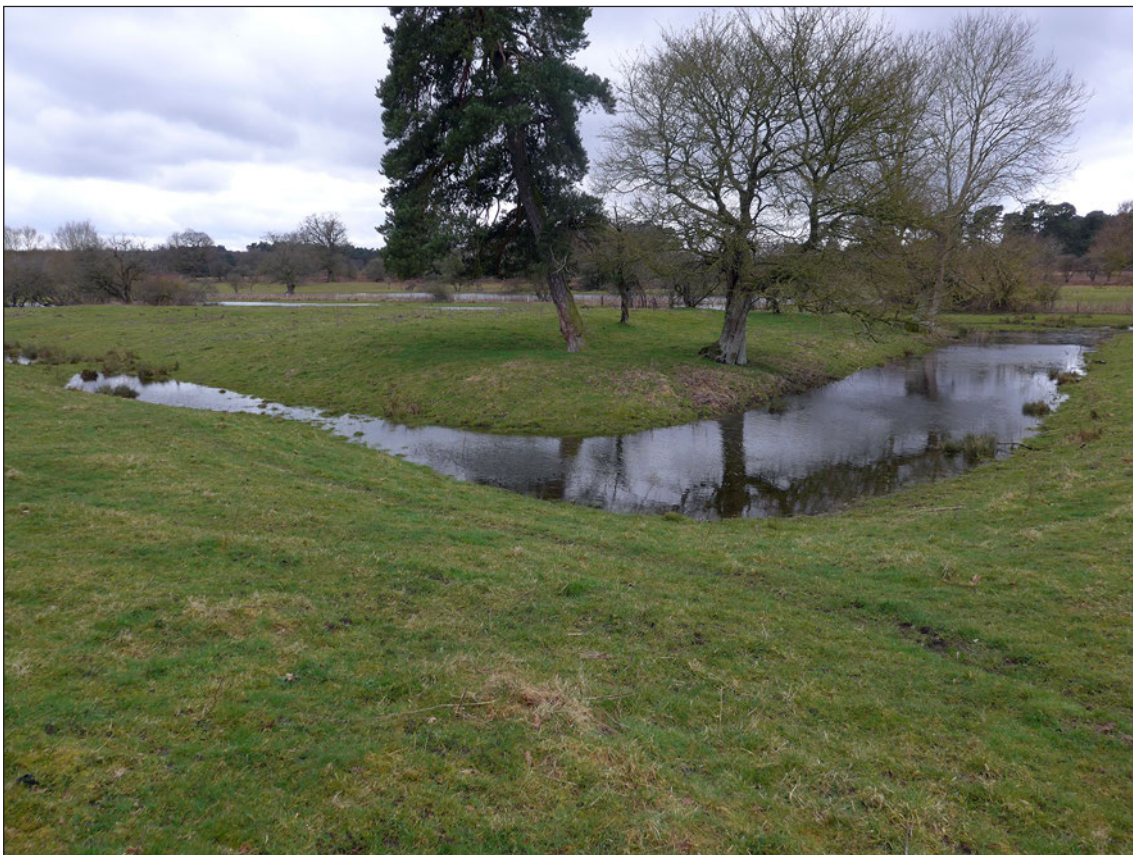
Figure 4 – The moat at the time of survey, viewed from the north-east (Magnus Alexander © Historic England)

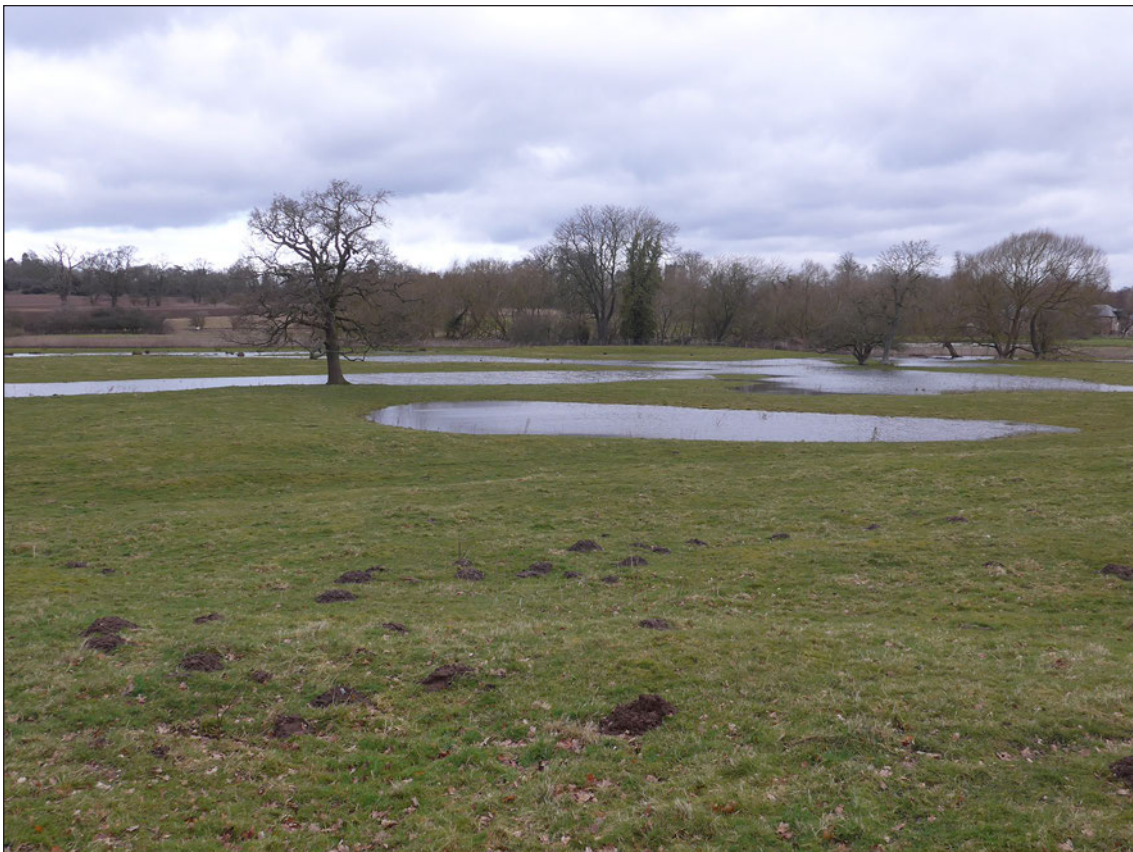
Figure 5 – The area to the north of the moat at the time of survey from the south-east a little off the valley floor; [10] lies to the left foreground, [15] in the middle distance slightly to the right of centre, [17] in the lower centre, and [11] runs across the foreground in front of this (Magnus Alexander © Historic England)
