## The Moot Hall, Appleby-in-Westmorland

### An Investigation and Assessment of Significance

Marion Barter and Dan Elsworth

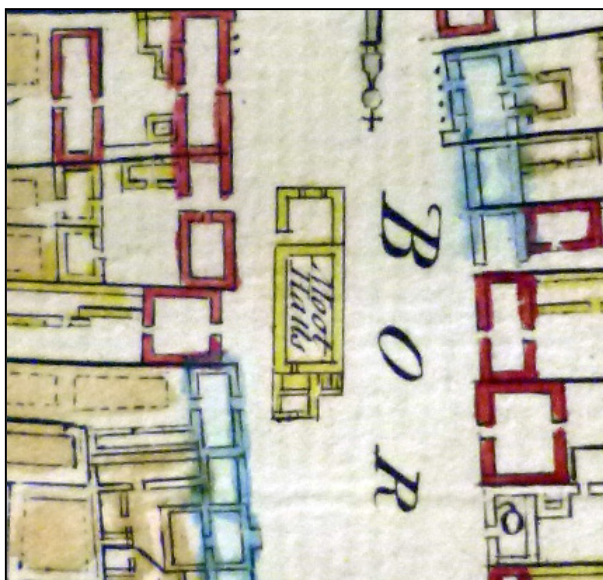
*Fig 1: 1754 Plan of Appleby (CASK, WDHOT/2/33/42, Box 33; photograph by Marion Barter)*

The earliest cartographic evidence for the Moot Hall is the 1754 plan of Appleby,<sup>2</sup> annotated 'Moot Halls'. This shows the building plan in three parts; the principal range is shown as a single large space with a small opening in the south wall. Abutting the south gable wall are outbuildings, the larger against the west part of the wall, sub-divided by a partition. To the east of this is a small outbuilding or perhaps a staircase. At the north end the plan shows a squarish addition, with a doorway on the west side and two small openings to the north wall.

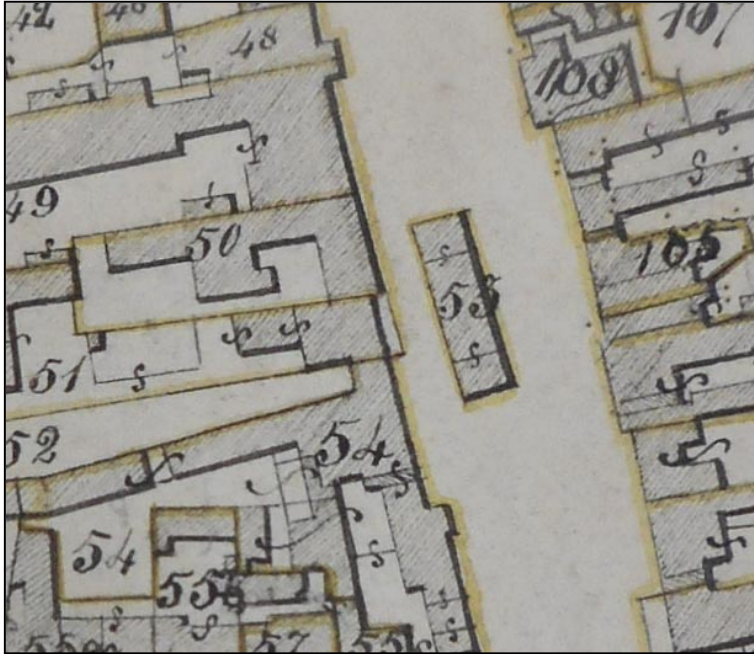
Fig 2: 1843 tithe map (CASK WDRC/8/26)

The 1843 tithe map shows the Moot Hall with the footprint subdivided into three parts, probably representing the north range, the principal range and the south staircase and flanking outbuildings shown in Fig 3.<sup>3</sup>

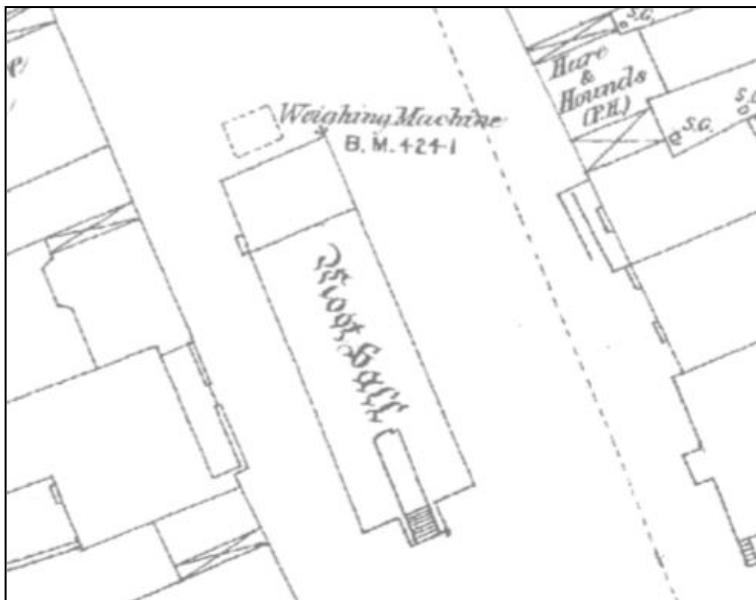
Fig 3: 1st edition OS map, surveyed c1858, 1:500 (© Crown Copyright [and database rights] 2018. OS 100024900)

The first accurate mapping is provided by the Ordnance Survey; the 1:500 sheet surveyed in c1858 shows the principal building and the later north range. An axial staircase and outbuildings are shown to the south, with a void below the staircase shown as a linear space; the line of the south gable wall of the principal building is not

marked.

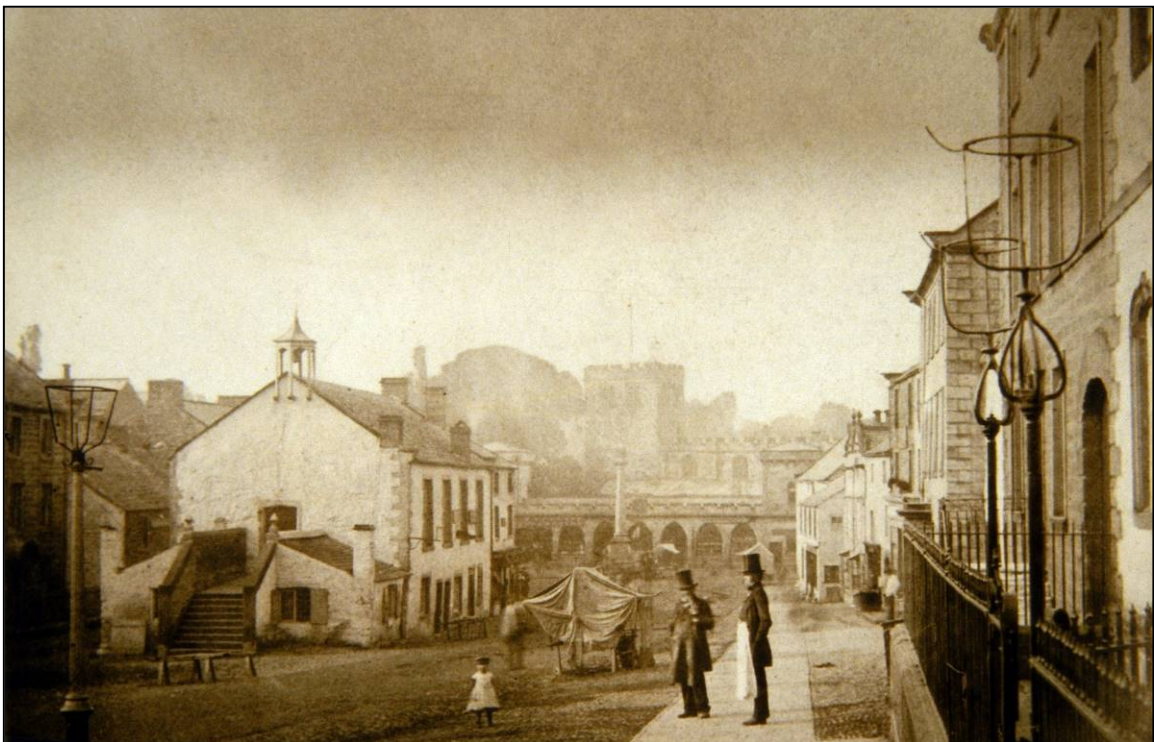
*Fig 4: The Moot Hall in c1860s, from the south  
(courtesy of Appleby-in-Westmorland Society)*

Late 19th and early 20th century OS maps record successive arrangements for the external staircase at the south end of the building, but photographs and engravings provide more detail. Views taken in the 1860s include a photograph taken from the south by Helmut Petschler, of 1865, which shows the butchers' shambles as masonry structures. A view of a similar date, from the south-east depicts the Moot Hall in more detail (Figure 4), with a stone external staircase with large landing, flanked by matching single-storey outbuildings, both with corner chimney stacks. The eastern of these outbuildings is shown without an external door and was presumably accessed via a doorway in the gable-end wall of the principal range.

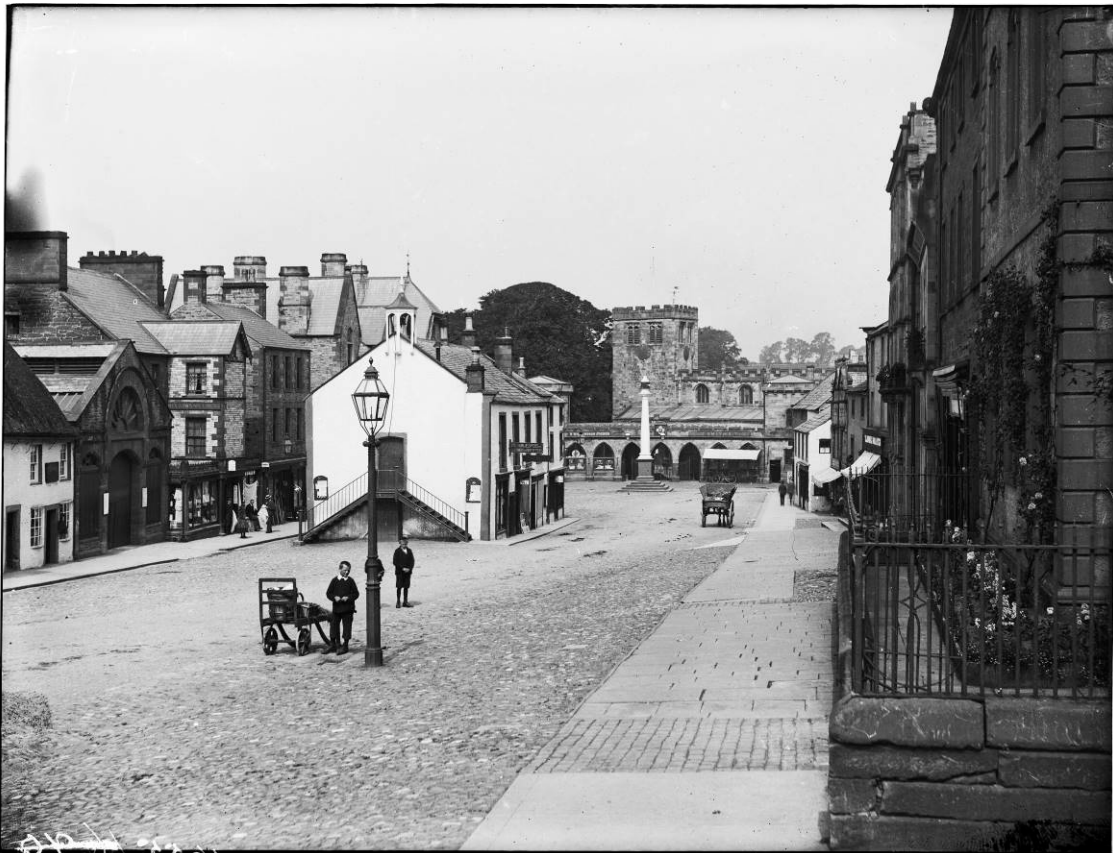
*Fig 7: c1898, showing the iron steps built in the 1880s (© Historic England, HEA Ref BF007554, image cc 76\_00076)*

A photograph of c1898 from the south east, shows the iron stairs built on the south gable end in the 1880s, to replace the stone steps and outbuildings. By this date, shopfronts have been inserted on the east elevation of the principal building in place of smaller windows. The bellcote with its finial is shown on the gable, but the datestone over the first floor doorway does not appear to be *in situ*.

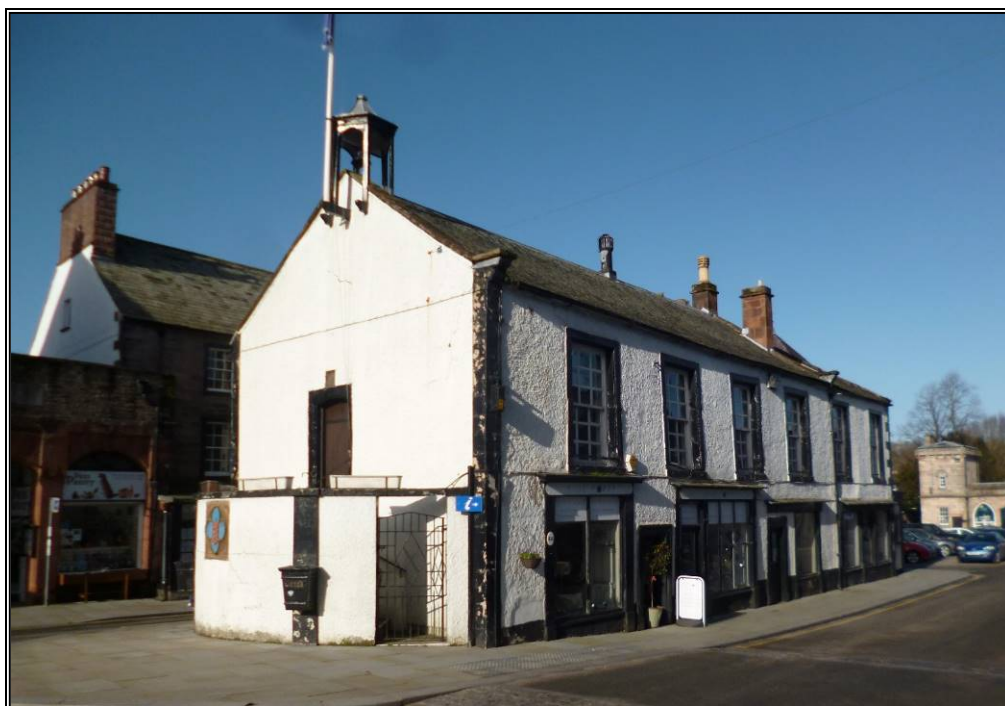
*Fig 11: The south and east elevations with the principal 4-bay range to left and later north range to right (© Historic England, photograph: Marion Barter)*

The Moot Hall comprises three elements of which the principal range is the most substantial and contains the earliest fabric (Figure 11). The rectangular range is aligned roughly north-south, towards the north end of Boroughgate and set to the west side of this wide main street. A narrow secondary street runs along the west side of the building, with a wider section of Boroughgate to the east, onto which the ground floor shop fronts face. The range is approximately 14.6m long and 7.4m wide. The two-storey range is constructed of rubblestone, finished in rough cast render painted white. Its overall style is characteristic of Cumbria Georgian architecture, where 'polite' features such as sash windows and quoins are combined with rough cast render, a vernacular building material. Where masonry is visible on the inner face of the south gable end, in the roof space, it consists of roughly coursed rubblestone; a buff sandstone used for the primary phase and a later phase of mainly red sandstone relating to the raising of the gable wall and eaves. The external dressings are of sandstone ashlar, now mainly painted with black gloss paint; chamfered doorways, plain stone architraves to upper floor sash windows, quoins to the south corners, coped verges with kneelers and shopfronts. There is no plinth or string course. The roof is laid with graduated courses of Westmorland slate, with a lead roll and a metal ventilator to the ridge. There is now one chimney stack, on the east pitch to the north; historic photographs show several stacks serving flues on this range.

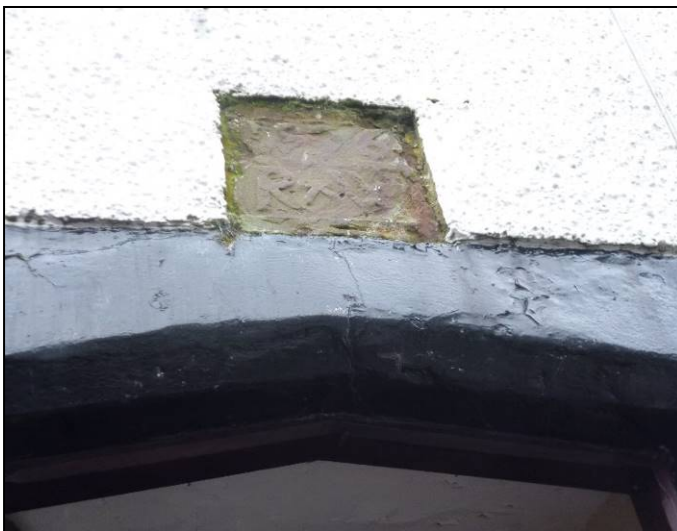
The sandstone datestone over the door bears the date 1596/RW (Figure 12); it is not known to whom the initials relate. The lettering is now eroded but was recorded by RCHME in 1934, noting that 'it was found in an outbuilding before the southern steps were remodelled some years ago, and the date and doorway with it were reset in their present position'.<sup>52</sup> The datestone is not depicted on

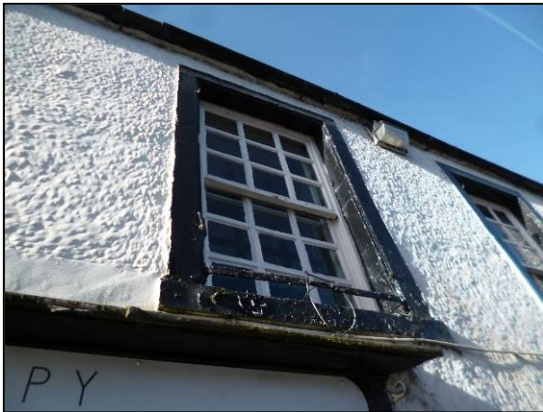
*Fig 14: sash windows to Council Chamber  
(© Historic England, photograph: Marion Barter)*

are modern. Each window has a total of eighteen panes (nine panes per sliding sash) and the thick glazing bars are ovolo-moulded to the inner face (Figures 14 & 15). There are no horns to the meeting rails and the sash boxes are largely behind the architraves. The design of the windows, the glazing bar detail and the horizontal proportions of the panes are characteristic of the decades between 1690 and 1740, but no firm date has been found in records such as the accounts. None of the sash windows align with any of the ground floor openings. The eaves are plainly treated, without a moulded cornice; cast-iron half-round gutters are fixed to simple wrought iron brackets.

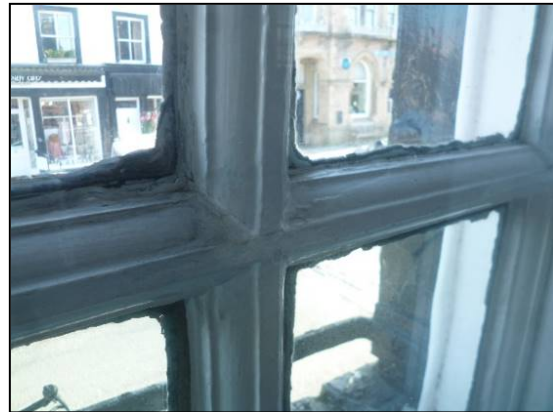
*Fig.15: detail of ovolo-moulded glazing bars  
(© Historic England, photograph: Marion Barter)*

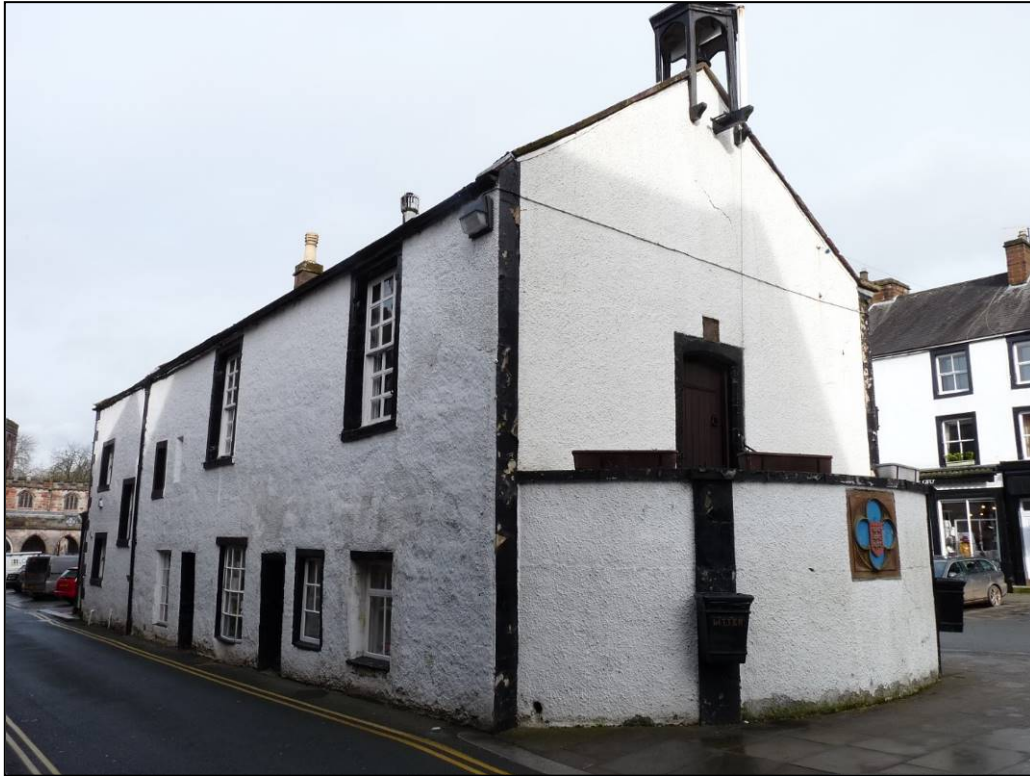
*Fig 16: the west and south elevations of the main range, with the north range to far left (© Historic England, photograph: Marion Barter)*

The west elevation (Figure 16) differs from the east elevation with an irregular pattern of small windows and doors, to the ground floor and only two sash windows to the first floor; its informal character suggests a lesser status. Towards the south end of the elevation are two windows of similar size related to shop Number 66, with 19th or 20th century joinery; the southern of the two has no jambs, but the northern has a plain stone architrave. North of the latter shop, Number 65 has a narrow door with four-centred head and chamfered surround, similar in style and date to the south door; this has a late 19th or early 20th century part-glazed door, no longer in use. North of the door is a sixteen-pane bow window with slender glazing bars, below a painted stone lintel; the window's character suggests it dates from the first half of the 19th century. Number 64 has a narrow door similar in scale and character to that to Number 65; this also has a part-glazed door no longer in use. To its north is a fixed light 12-pane windows with slender glazing bars, but no visible architrave or lintel; this may also be 19th century.

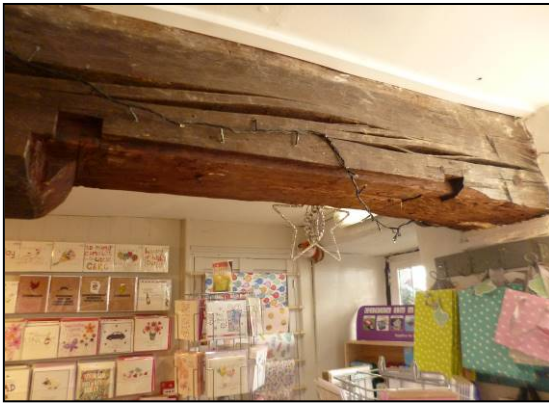
*Fig 17: south beam in Number 66, altered for a doorway, from the south (© Historic England, photograph: Marion Barter)*

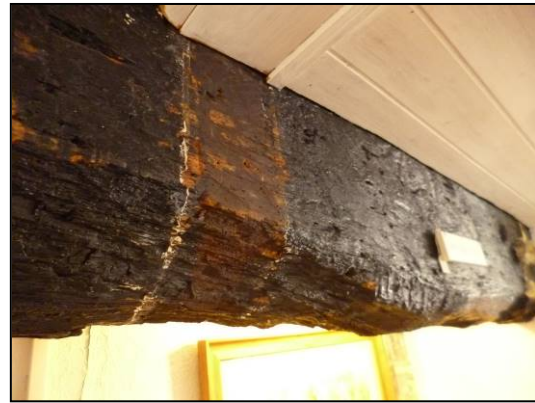
*Fig 18: position of former partition on beam in Number 65 (© Historic England, photograph: Marion Barter)*

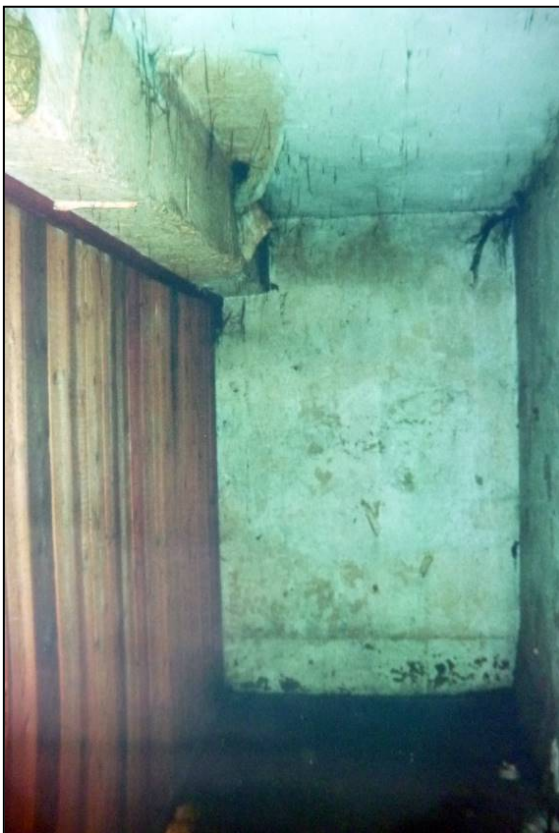
*Fig 19: the interior of the gallery from the west, with roof truss tie-beam to top left (Appleby Town Council collection)*

a pair of timber posts; the posts have fluted front faces and chamfered arrises to the north face, characteristic of the 19th century (Figure 21). The interpretation of this feature as a gallery is difficult; the structure of the front face suggests a gallery, but the low height of the feature's floor in relation to the ceiling limits standing-room, there is no sign of a gallery front with a space above, nor clear evidence for a means of access. Access may have been via ladder or steps from the north side, where there is lintel over a possible blocked opening (see Figure 49). The plaster ceiling and the painted tie-beam to the north side of the void retain fragments of historic wallpaper, currently displayed in the mayor's parlour; the Whitworth Gallery was consulted on the wallpapers and advise that they span a period between the mid 19th century and c1900. The wallpapers suggest that the space was in use in the mid 19th century but not re-decorated after the turn of the century (Figures 19 & 20). It appears to have been sealed as part of remodelling to the mayor's parlour in the early 20th century.

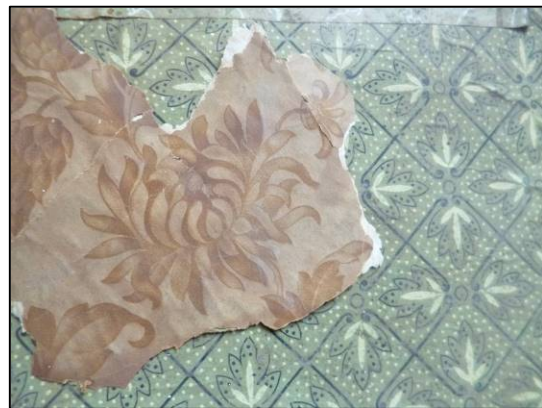
*Fig 20: a green mid-19<sup>th</sup> century block-printed wallpaper and a later floral 'sanitary' paper, c1900 (top)*

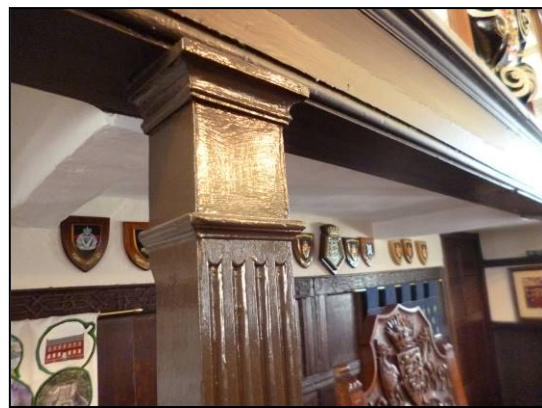
*Fig.21: gallery front and column details (bottom) (© Historic England, photographs: Marion Barter)*

The partition between the chamber and the mayor's parlour is constructed of timber and lined with wainscot panelling on the south face, with a decorative carved frieze of inter-laced strapwork, of late 16th or early 17th century date. To the east and west ends of the partition oak panelled doors lead into the mayor's parlour, fitted as part of remodelling in the 1920s. The doors have modern furniture. Above the panelling is a full-width gallery, over the central mayor's chair; the date of this feature is not known, although the front south face has been fitted with oak picture rails matching others in the room, of the 1920s. The low plaster ceiling to the soffit of the gallery is supported on a structure consisting of plastered north-south joists carried on a front beam, supported on

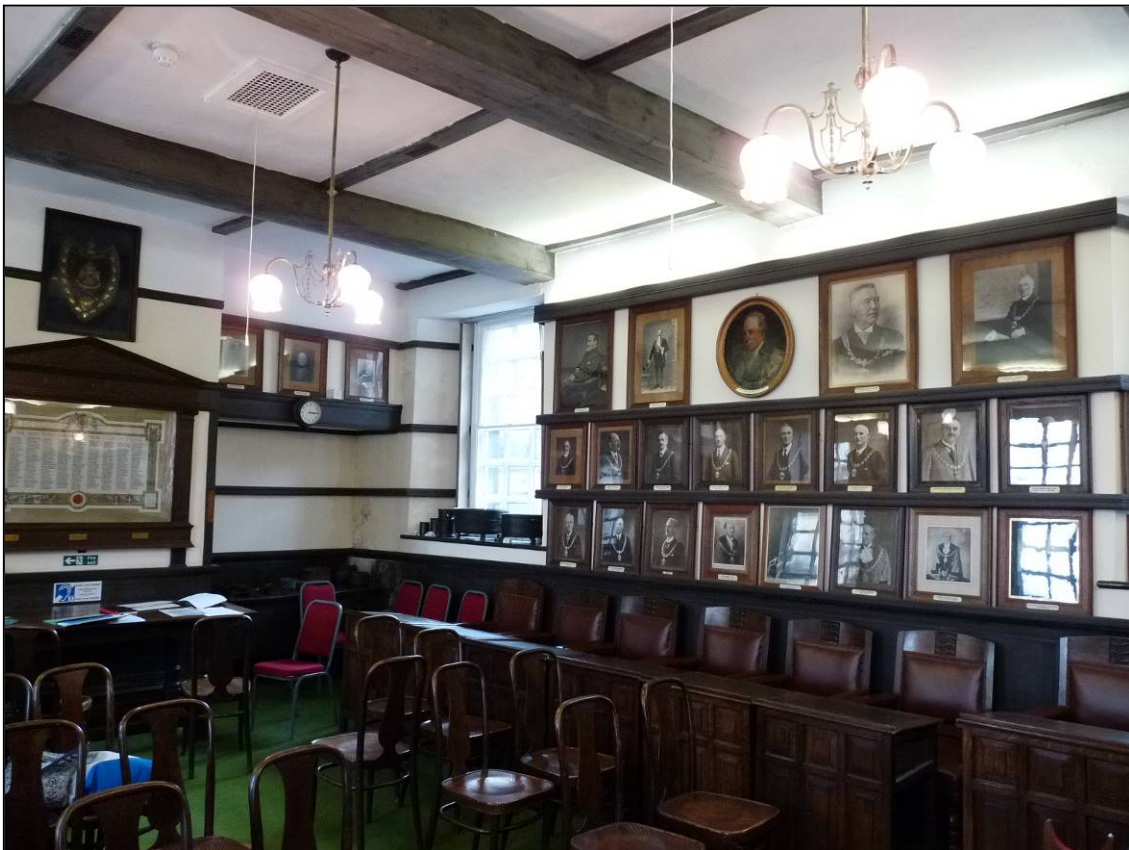
*Fig 22: The council chamber from the north-east with the south lobby to the left*

The council chamber (Figure 22) is lit by large sash windows, three along the east wall, and two to the west wall. Each window has ovolo-moulded glazing bars and nine panes to each sash. The sashes are heavily painted and not currently operational; secondary glazing in aluminium frames has been fitted to the inner face of each window. Two phases of pulley wheels for lifting sash

weights on cords (missing) are *in situ*, near the top of each sash box; the smaller upper wheel is wooden and probably the earliest, with a later, metal wheel set below. These pulley wheels relate to the lower sashes; it is probable that the upper sash did not slide (double-sliding sashes were not usual until the middle of the 18th century). Each window has a plastered splayed reveal and a painted window board; the two sashes to the west are set slightly higher on the wall than the east windows. The walls are plain plastered, scored with lines to resemble ashlar, above an applied dado of embossed paper such as 'Lincrusta'. Above the dado, the walls and the window reveals are fitted with oak rails to display framed portraits of borough mayors, in three tiers; these features probably relate to early 1920s alterations.

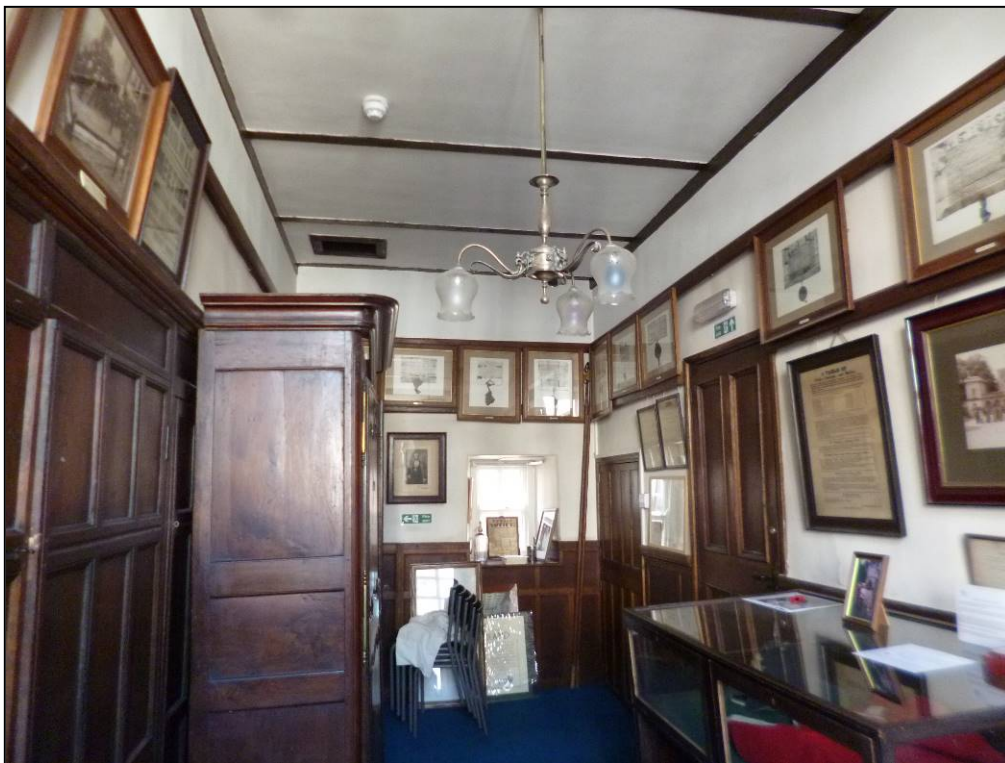
*Fig 23: mayor's parlour from the east with re-set panelling to left and an inserted doorway to right (© Historic England, photograph: Marion Barter)*

**The mayor's parlour** (Figure 23) occupies the north bay of the first floor, separated from the council chamber by a timber partition below the north roof truss. The narrow rectangular room is lit from the east by one 18-pane sash window, matching those to the council chamber. There is a small sash set low on the east wall, with late 20th century joinery. The room is entered from a doorway on the north wall, inserted in 1970 when the north range was altered. Before this, the room may have been only accessible via the council chamber. The north face of the south partition wall is fitted with shallow cupboards for ceremonial robes; the hinged doors are made of wainscot panelling in oak; the east door is a re-used section of 17th century panelling, said to be from a farmhouse in Kirkby Stephen.<sup>56</sup> The west doors are panelled with oak made to match, probably as part of a re-fitting in the 1920s. The two oak panelled doors into the chamber are of a similar date. The walls are lined with an oak dado with plaster above, fitted with oak picture rails similar to those in the council chamber; framed historic photographs, a copy of the 1754 plan and other borough memorabilia are displayed. Towards the west end of the north wall is a deep wall cupboard used to store borough regalia and other objects; the cupboard may be in the position of a blocked window and is below a higher blocked window visible in the roof-space above the ceiling.

The room has an inserted flat ceiling with applied timber decoration, probably part of alterations in the 1920s; a small hatch to the south-west side of the ceiling gives access to the space above the ceiling, which is constructed of pine joists supporting lath and plaster. The floor boards are hidden below carpet. The metal and glass pendant light fitting is similar to the more elaborate fittings in the council chamber, which may date from the 1920s.

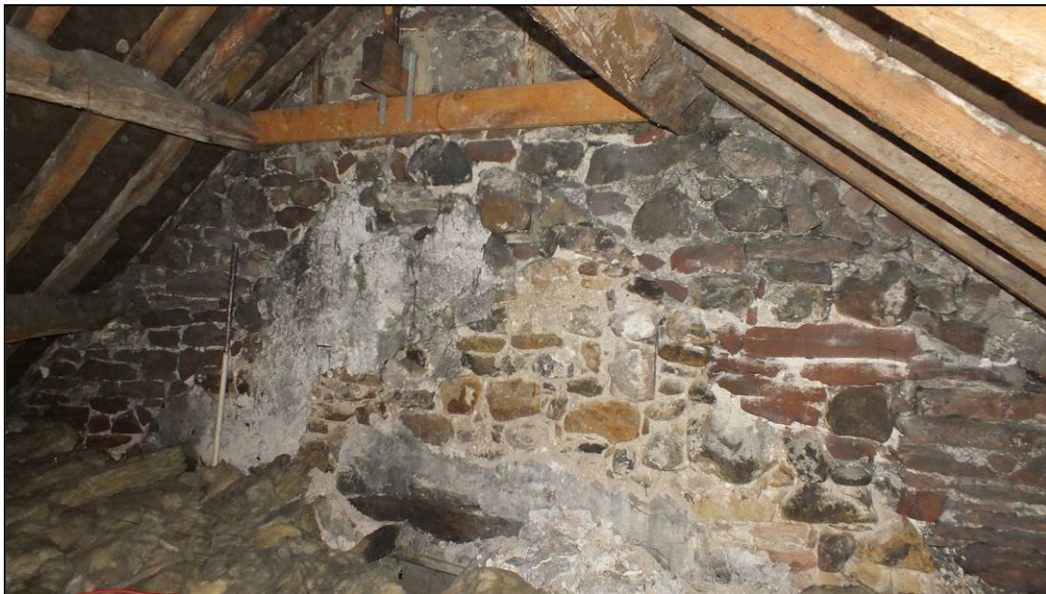
Fig 24: The south gable showing the change in wall height, viewed from the north-west  
(© Historic England, photograph: Dan Elsworth)

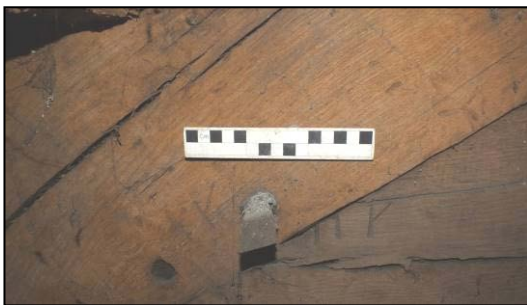
Fig 26: Carpenter's marks on east side of Truss 1, viewed from the north (© Historic England, photograph: Dan Elsworth)

The floor of the roof space is covered with insulation and was not accessible at the time of the survey. The level of the roof space floor in Bay 1 is raised relative to the rest of the floor, due to a historic ceiling at the level of the lower purlins. The collar of truss 1 is slightly cambered and relatively thick compared to the rest with a range of carpenter's marks on the north face, of two phases (Figure 25). The earlier of these comprise a chiselled 'IIγ' at the west end of the collar where it meets the principal rafter, which has been cut where the collar has been reused, with a further 'Iγ' on the adjacent part of the principal rafter (Figure 26). The latter is one of the timbers dated by dendrochronology to AD 1571-1596. Just above these marks is a set of chiselled 'I' numerals, probably later, to both the collar and principal (Figure 27) which also occur where the principals meet, with a small timber fillet inserted at the apex (Fig.28). At the east end there was a chiselled 'II' on the principal rafter where it meets the collar and 'III' on the collar (Figure 29).

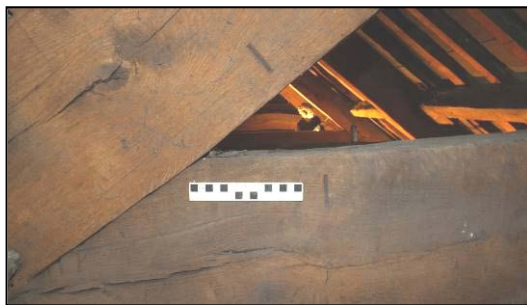
Fig 27: Carpenter's marks on east side of Truss 1, from the north (© Historic England, photograph: Dan Elsworth)

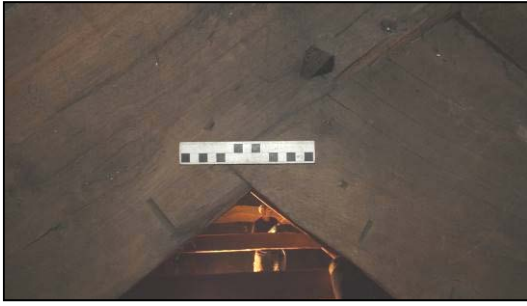
Fig 28: Carpenter's marks at apex of Truss 1, viewed from the north (© Historic England, photograph: Dan Elsworth)

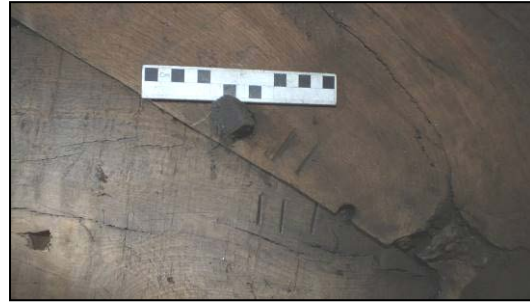
Fig 29: Carpenter's marks on west side of Truss 1, viewed from the north (© Historic England, photograph: Dan Elsworth)

Against the north face of Truss 1 is a rough stud, fixed to the collar; this forms part of a partition between the council chamber and the mayor's parlour, visible in Bay 2, from the south. The west half of the partition is roughly built of brick and the east side comprises vertical timber posts, roughly finished, that connect to a horizontal joist that forms the south edge of a ceiling. The spaces between the timbers are very crudely infilled with hand-made bricks (Figure 29).

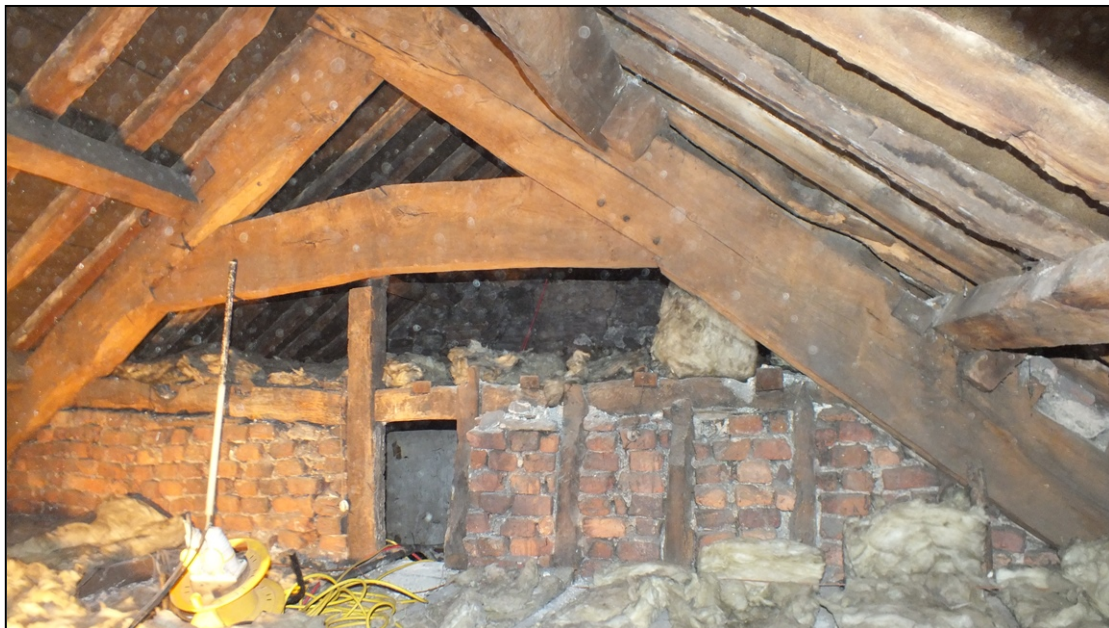
Fig 30: The south face of Truss 1, showing the timber stud partition with brick infill (© Historic England, photograph: Dan Elsworth)

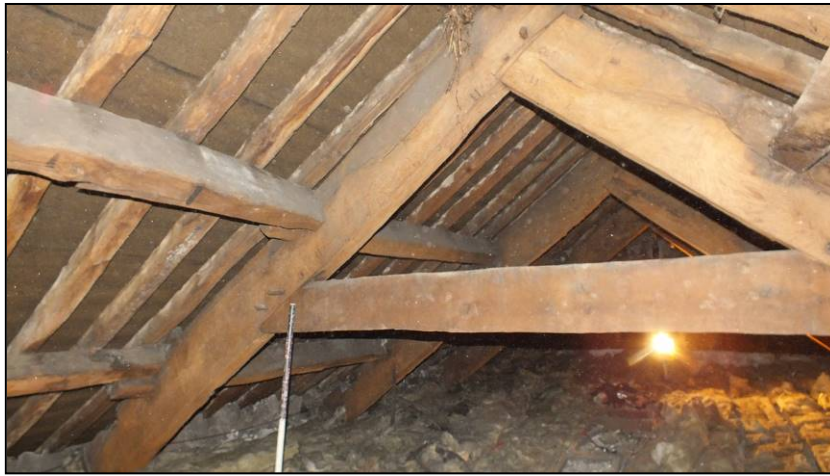
Fig 31: Truss 2, viewed from the north-west (© Historic England, photograph: Dan Elsworth)

Truss 2 has a lighter collar than Truss 1, with no camber; a small fillet of timber has been added at the apex of the principal rafters (Figure 31). The truss has carpenter's marks on the north face with a chiselled 'II' at the junction of the collar and principal rafter as well as a shallower 'IIγ'. Numeral 'II' is chiselled into the top of each principal, with a small square notch is cut into the west principal. The west side of Truss 2 has numerals 'III' and 'II' at the junction between the collar and principal (Figure 32). There are earlier empty slots for

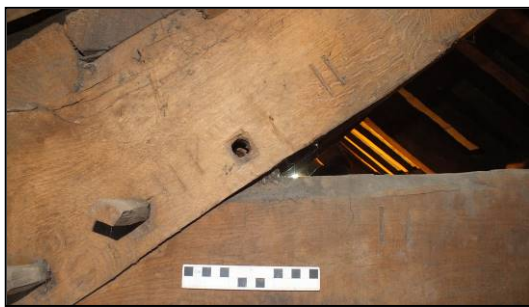
Fig 32: Carpenter's marks at the east end of Truss 2, viewed from the north (© Historic England, photograph: Dan Elsworth)

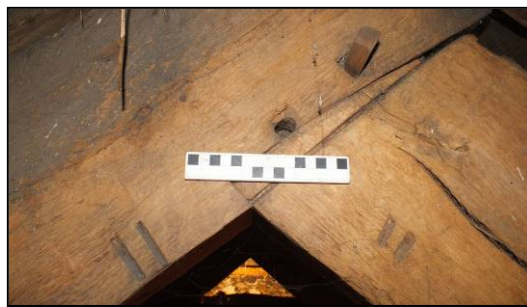
Fig 33: Carpenter's marks at the apex of Truss 2, from the north (© Historic England, photograph: Dan Elsworth)

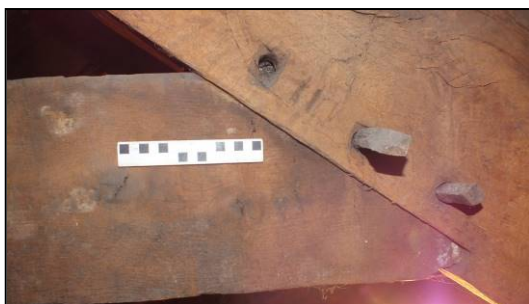
Fig 34: Carpenter's marks at west end of Truss 2, viewed from the north (© Historic England, photograph: Dan Elsworth)

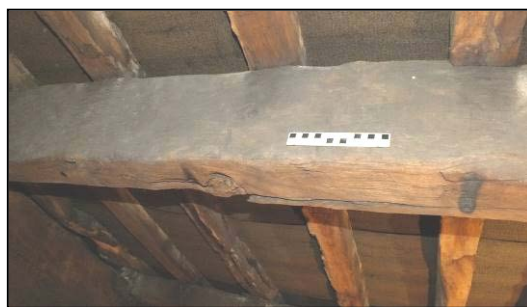
Fig 35: Taper burn marks on purlin on the east side of Bay 2 (© Historic England, photograph: Dan Elsworth)

purlins at the lower end of each principal and on the east side of Bay 2 one of the purlins is obviously reused and has several taper burn marks along one face (Figure 35). There is also an earlier and now disused access hatch, on strap hinges, to the floor of Bay 2 (Figure 36).

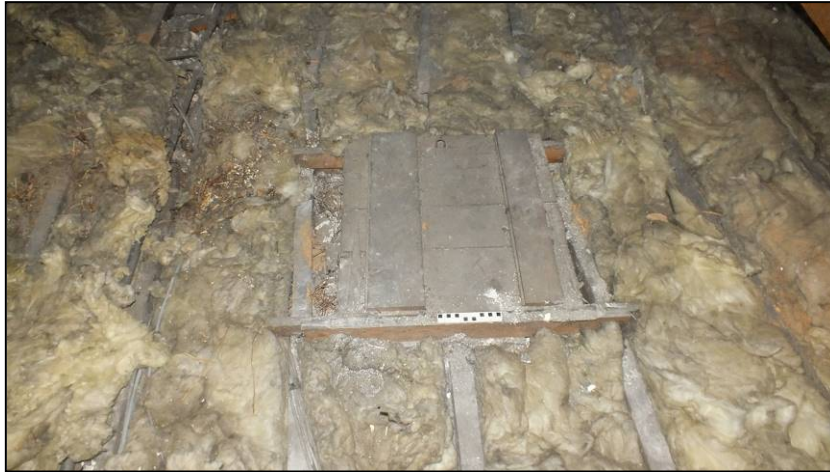
Fig 36: Disused hatch in the floor of Bay 2, viewed from the north  
 (© Historic England, photograph: Dan Elsworth)

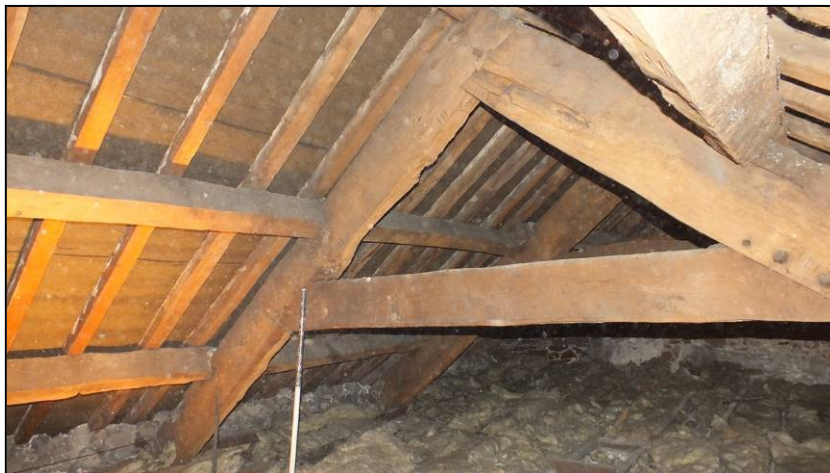
Fig 37: Truss 3, viewed from the north-west  
 (© Historic England, photograph: Dan Elsworth)

Truss 3 is of a similar form to Truss 2 (Figure 37); carpenter's marks chiselled into the north face comprise the numeral 'III' at the east and west junction between the collar and principal rafters (Figures 38 and 40) and, and to the apex of the principals (Figure 39). Empty slots for earlier purlin positions on the principals, indicate that the roof has been reconfigured. The collar appears to be a re-used floor joist, with a row of lap joint slots to the south face (Figure 41).

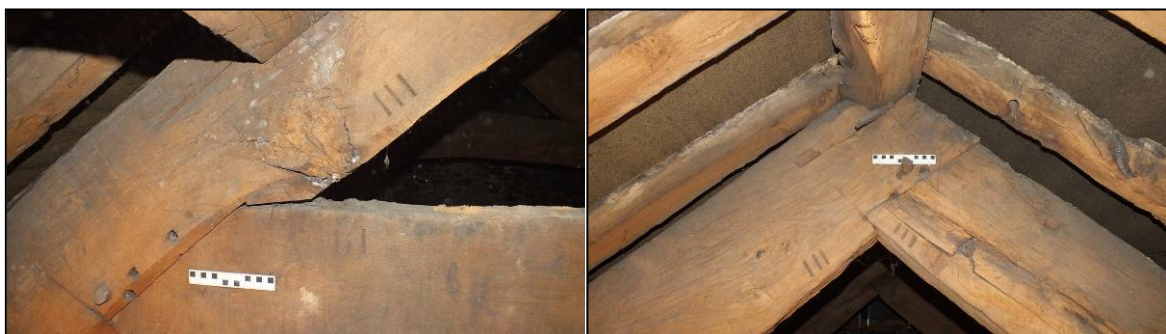
Fig 38: Carpenter's marks at the east end of Truss 3, viewed from the north (© Historic England, photograph: Dan Elsworth)

Fig 39: Carpenter's marks at the apex of Truss 3, viewed from the north (© Historic England, photograph: Dan Elsworth)

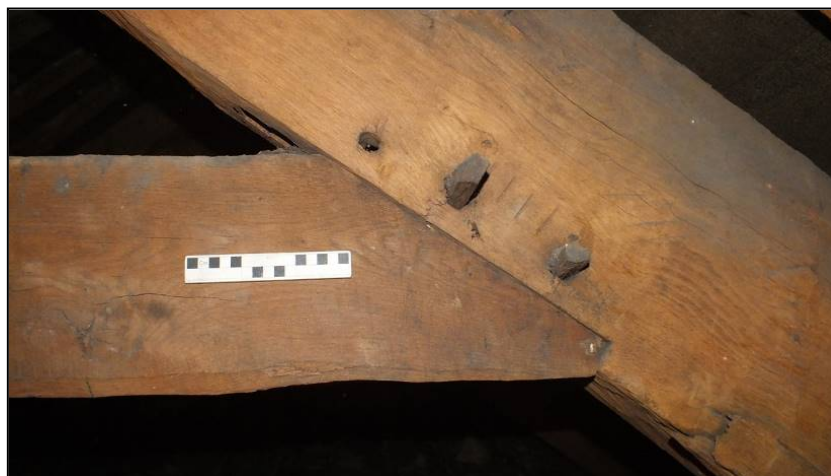
Fig 40: Assembly marks at the west end of Truss 3, viewed from the north (© Historic England, photograph: Dan Elsworth)

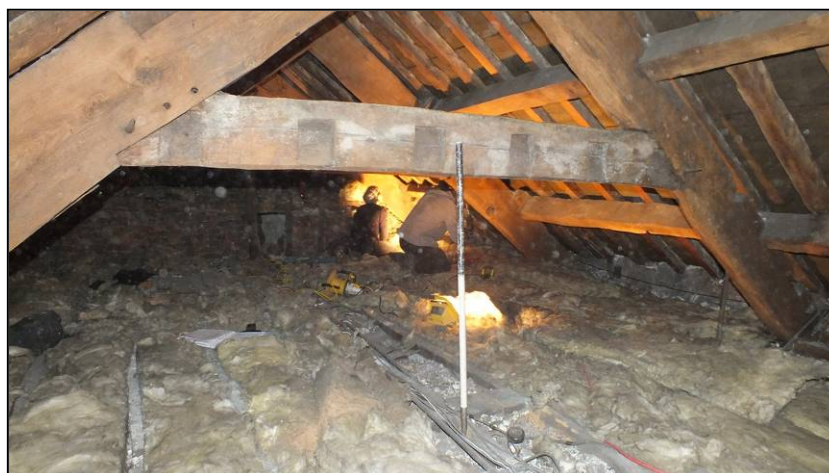
Fig 41: The re-used collar of Truss 3, viewed from the south-west (© Historic England, photograph: Dan Elsworth)

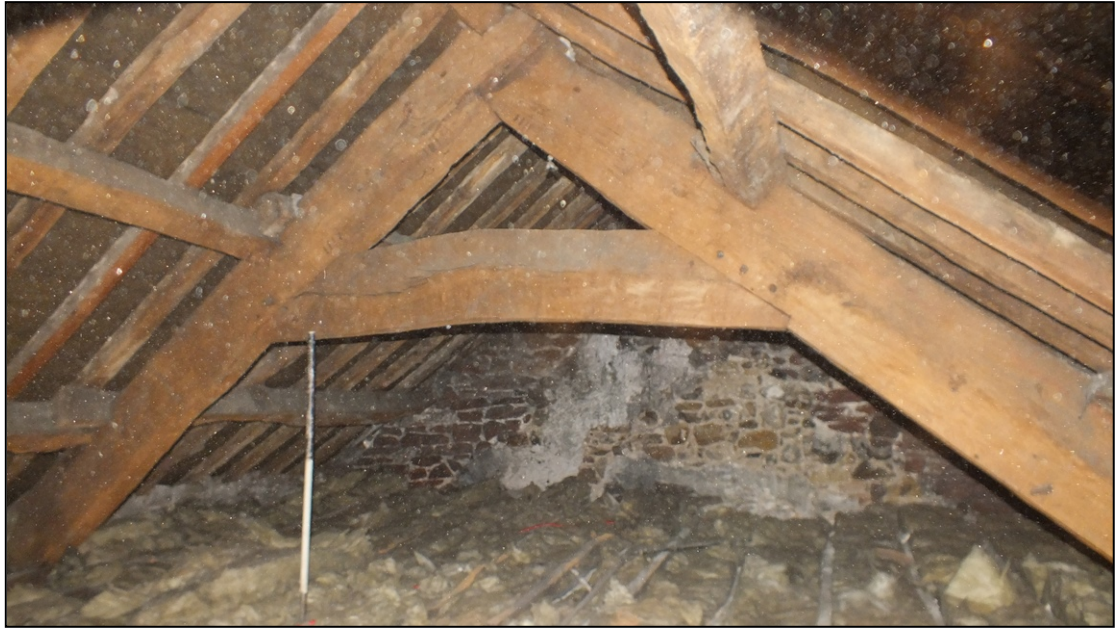
Fig 42: Truss 4, viewed from the north-west (© Historic England, photograph: Dan Elsworth)

Truss 4 is similar to Truss 1, with a similar heavy, cambered collar. Like Truss 1, a small fillet of timber has been inserted at the junction of the principals (Figure 44) both of which are from trees felled in the period AD 1571-1596. The north face has a chiselled numeral 'IIII' on the east side, where the collar meets the principal rafter (Figure 43), and at the junction of the principals (Figure 44), but numeral 'I' on the west side (Figure 45). On the south face it has a further 'Iy', although upside down and slightly truncated where the collar has been cut down, and a chiselled 'IIII' at the junction of the collar and principal on the west side (Figure 46). In Bay 5 there are at least three re-used purlins with rows of empty lap joint slots (Figure 47), one of which was also dated by dendrochronology to the period AD 1571-1596.

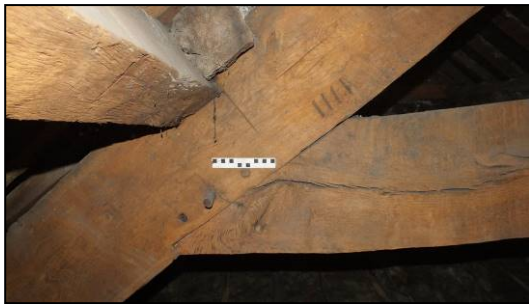
Fig 43: Carpenter's marks at the east end of Truss 4, viewed from the north (© Historic England, photograph: Dan Elsworth)

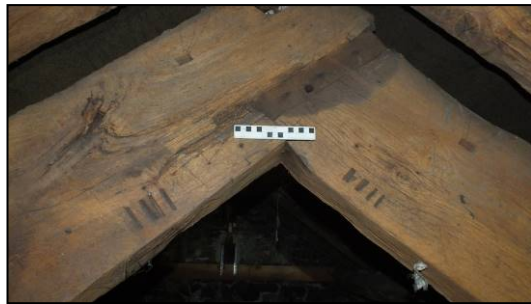
Fig 44: Carpenter's marks at the apex of Truss 4, viewed from the north (© Historic England, photograph: Dan Elsworth)

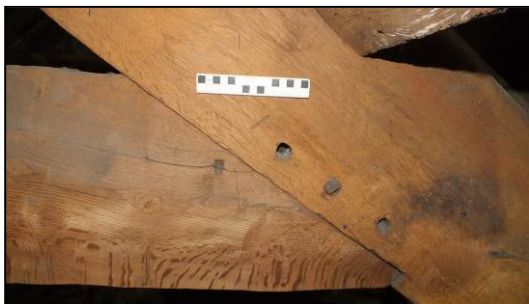
Fig 45: Carpenter's marks at the west end of Truss 4, viewed from the north (© Historic England, photograph: Dan Elsworth)

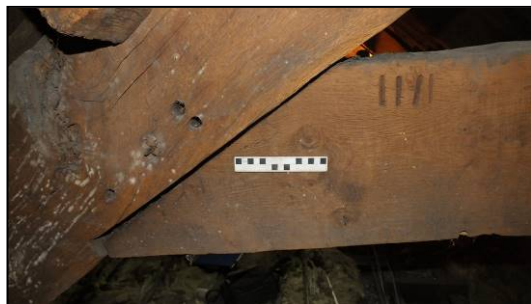
Fig 46: Carpenter's marks at the west end of Truss 4, viewed from the south (© Historic England, photograph: Dan Elsworth)

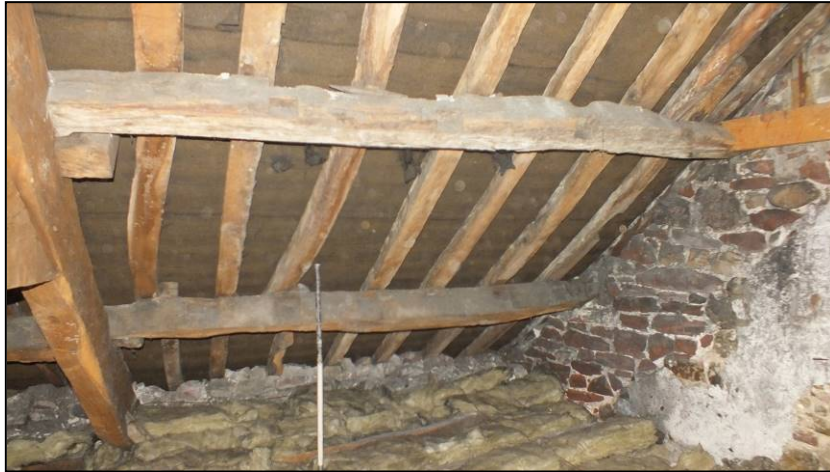
Fig 47: Re-used timbers forming purlins on the east side of Bay 5, viewed from the north-west (© Historic England, photograph: Dan Elsworth)

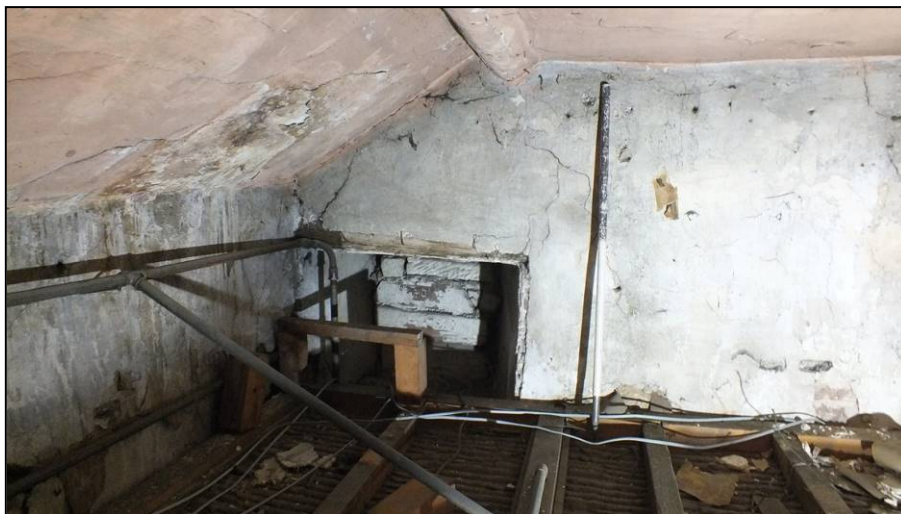
Fig 48: The western blocked window in the north elevation of the space above the current ceiling of the Mayor's Parlour, viewed from the south

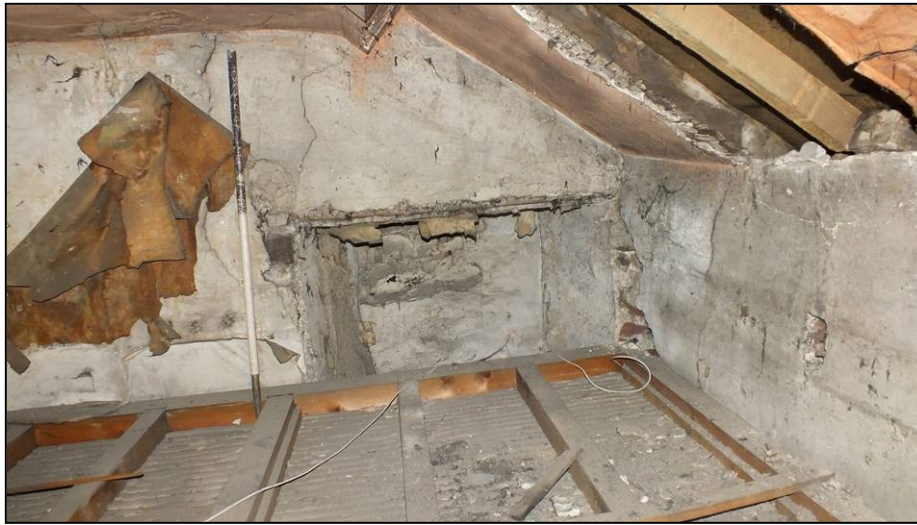
**Fig 49: The eastern blocked window in the north elevation of the space above the Mayor's Parlour, viewed from the south (*© Historic England, photograph: Dan Elsworth*)**

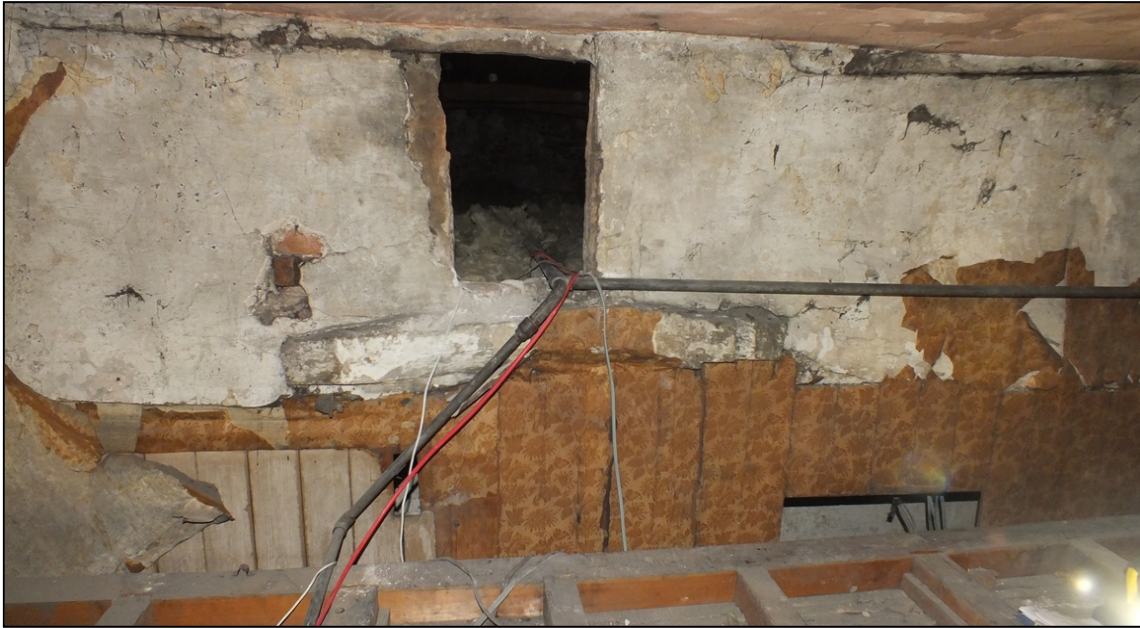
Fig 50: The south elevation in the space above the Mayor's Parlour showing access into the attic above the council chamber in the timber partition wall, viewed from the north  
(© Historic England, photograph: Dan Elsworth)
