## The Moot Hall, Appleby-in-Westmorland

### An Investigation and Assessment of Significance

Marion Barter and Dan Elsworth

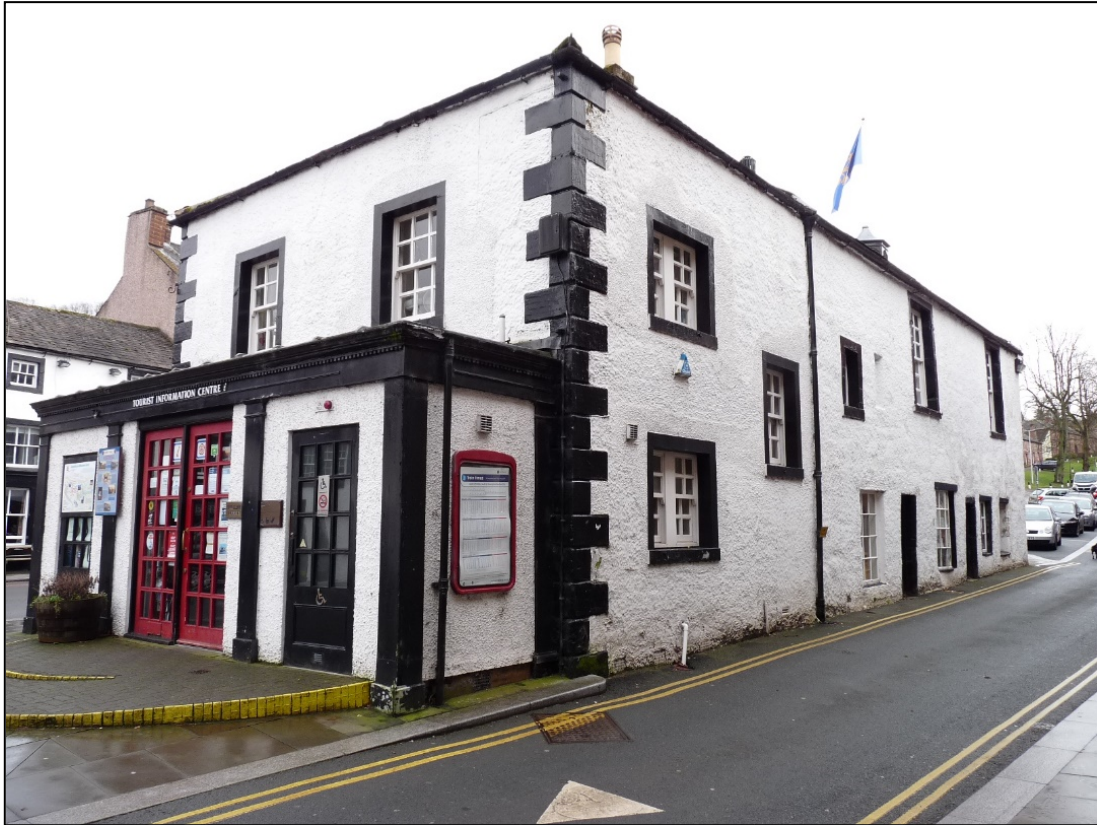
*Fig 51: the north range from the north-west (© Historic England, photograph: Marion Barter)*

The range (Figure 51) is approximately 5.5m long (north-south) and 7m wide (east-west). The walling is obscured by rough cast render painted white, but is likely to consist of sandstone rubblestone. The north corners are finished with rusticated sandstone quoins, painted black, like other details. No straight joints are visible at the junction between this range and the principal range. The range has no plinth, string course or eaves cornice. The roof is laid with graduated Westmorland slates, with sandstone ridges; the roof is hipped to the north.

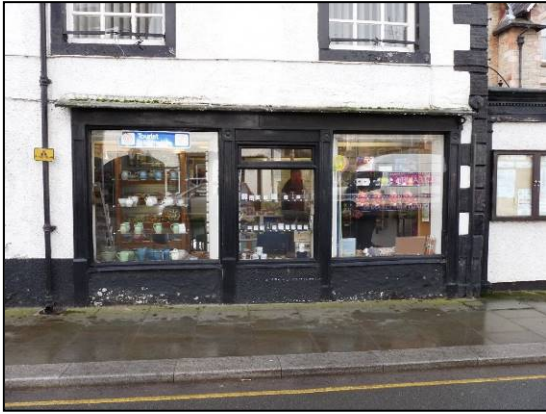
*Fig 52: shopfront to North Range, east elevation (© Historic England, photograph: Marion Barter)*

The east elevation has a double shop front to the ground floor consisting of a central doorway flanked by shop windows (Figure 52 and Figure 53); the doorway and shop windows are framed by moulded timber pilasters with paterae, and a fascia. The stall risers below the windows are rendered. The doorway has been disused since 1970 when a window was inserted in its place, above a new rendered stall riser. The character of the shop front and the classical details of the joinery are characteristic of the late Georgian period in the early 19th century.

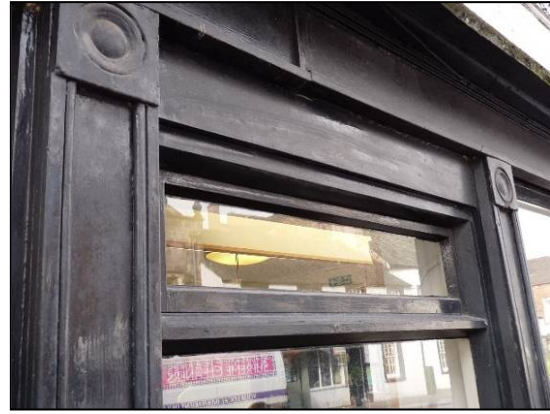
*Fig 53: shopfront details include paterae and moulded pilasters, typical of the early 19th century (© Historic England, photograph: Marion Barter)*

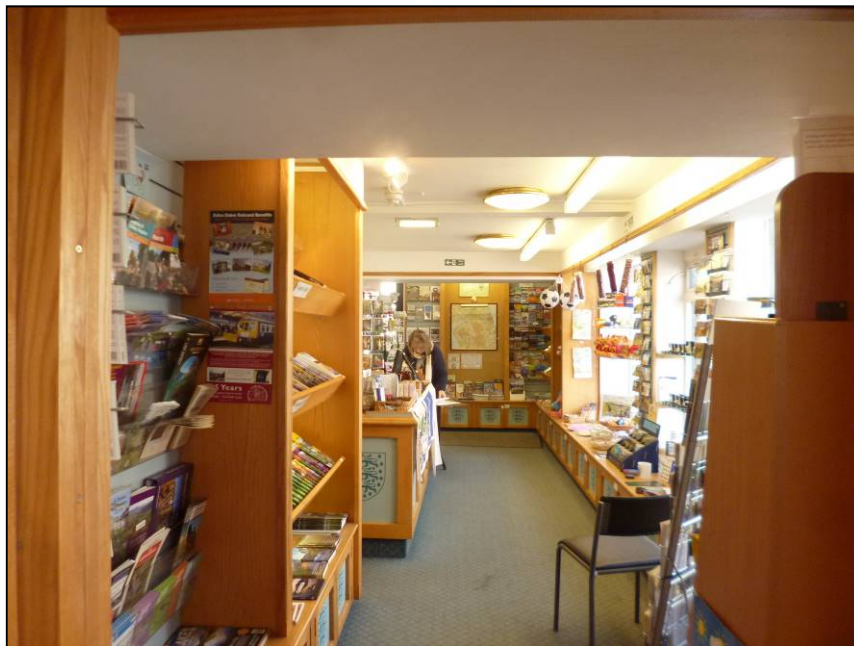
*Fig 54: view from the south into the Tourist Information Centre, from a doorway inserted through the north gable wall of the principal range (© Historic England, photograph: Marion Barter)*

The ground floor of the north range was remodelled in 1970, with new partitions, a staircase and modern finishes, designed by William Binney, the borough surveyor. It is now used as the Tourist Information Centre (Figure 54). The public entrance is from the north, via a porch added in 1970; part of the north wall was removed to form larger openings. A WC for disabled people occupies the west end of the porch, also partly within the north-west corner of the north range. The floor is arranged in two unequal parts, with a larger public area to the east side within the former shop, and a smaller staff area to the west side. The two parts are separated by a stud partition with a sliding flush door. The facilities on the west side include a small kitchen, storage cupboards and a WC, accessed via a narrow passage. The staircase leading to the first floor is at the south end of the west side of the floor; the dog-leg staircase made of timber. The fittings in the Tourist Information Centre were renewed in 1995, with funding from the New Fair Committee. As part of this work, the former shop within the north end of the principal range was fitted as an exhibition space, and a connecting doorway was inserted through the gable wall of the principal range, towards the east end. No historic features are visible within the ground floor of the range.

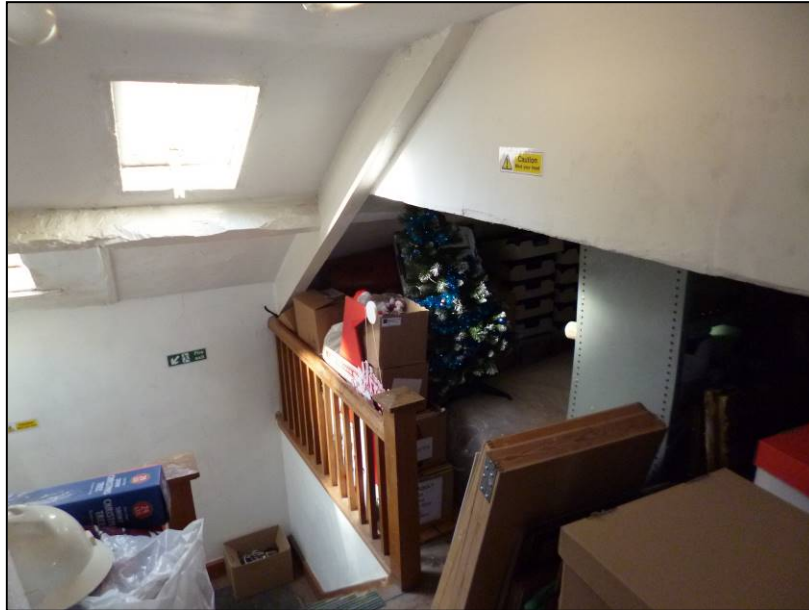
*Fig 56: second floor store in the north range, from the east (© Historic England, photograph: Marion Barter)*

The second floor is reached via the staircase in the south-west corner. The floor is on two levels with a higher level on the east side; this allows for a higher ceiling to the Town Clerk's office, below, installed in 1970. The space is used for storage (Figure 56). The walls and sloping ceiling soffit are plain plastered. The pine roof structure is exposed, with ridges to the hips and a central collar truss; the timbers are lime-washed or painted. The space is lit by metal rooflights, to the east and west pitches.

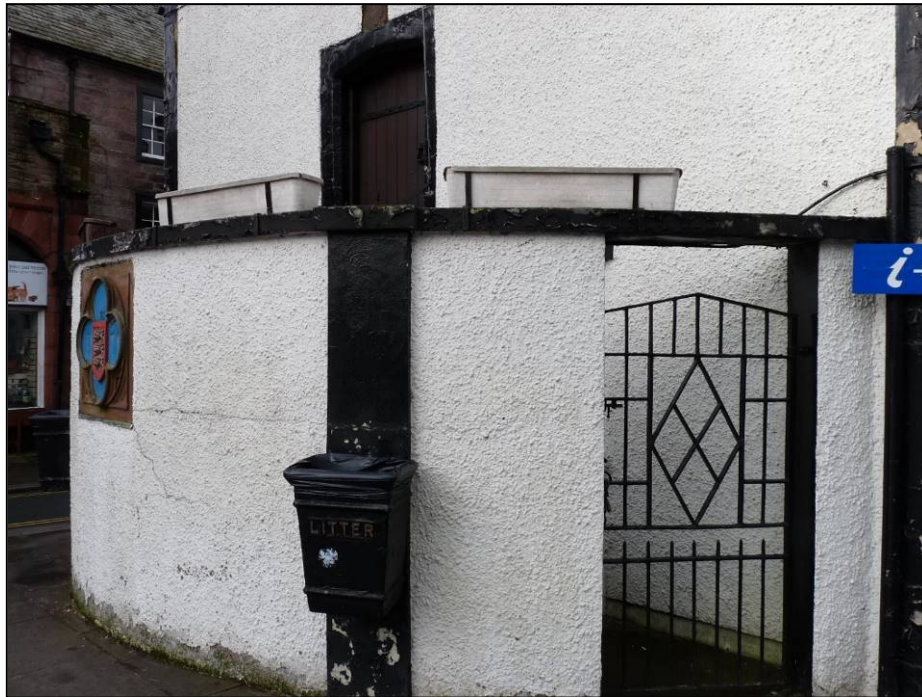
*Fig 57: the screen wall to the external south staircase, from the east (© Historic England, photograph Marion Barter)*

The external south staircase was constructed in 1933, with funds from the late William Hewitson, a former Town Clerk who died in 1927; the date and his gift is recorded on a brass plaque fixed to the flat top of the parapet (Figure 58). The present staircase replaces an iron staircase built in c1886, which had been built in place of an earlier stone structure.

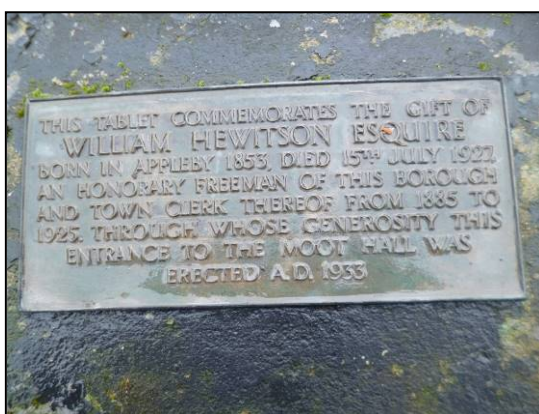
*Fig 58: plaque recording the building of the present staircase in 1933 (© Historic England, photograph: Marion Barter)*

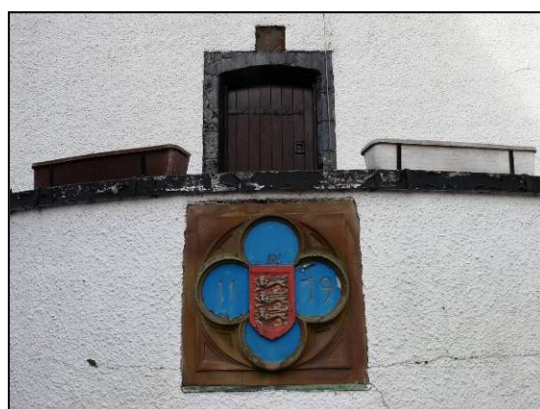
*Fig 59: stone plaque on south wall, with date 1179 (© Historic England, photograph: Marion Barter)*

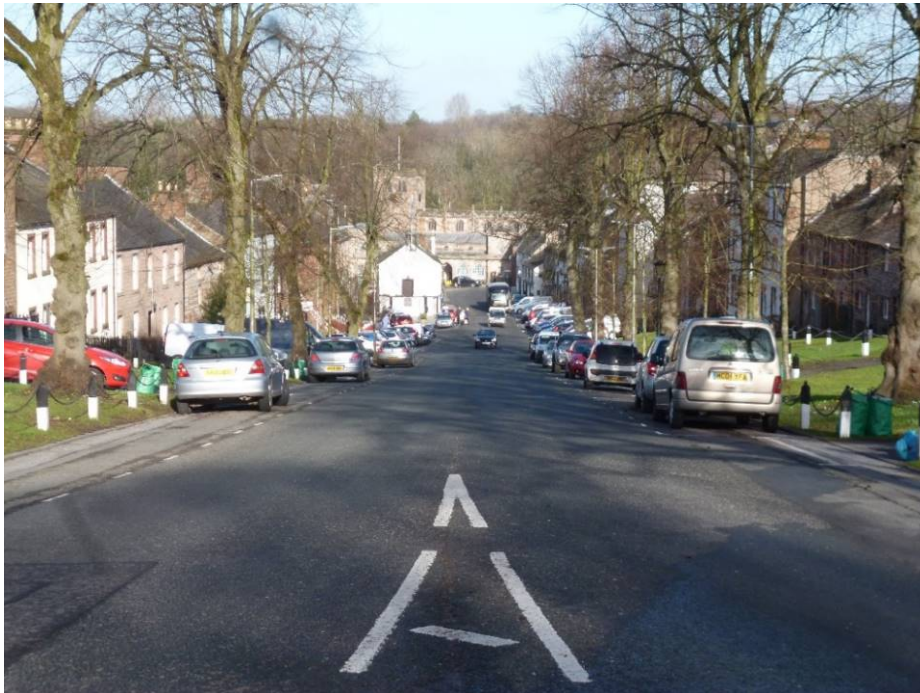
*Fig. 60: view from the north down Boroughgate  
(© Historic England, photograph: Marion Barter)*

The Moot Hall's setting on Boroughgate contributes very positively to the significance of the building. Its relationship to the street and surrounding frontage buildings, to the Church and The Cloisters is little changed. The

building is particularly prominent in views north down the street where the south gable-end is a striking feature in the street scene (Figure 60).
