Snailbeach New Smeltnill, Worthen with Shelve, Shropshire

SNAILBEACH NEW SMELTMILL
WORTHEN WITH SHELVE
SHROPSHIRE

Archaeological and Architectural Investigation

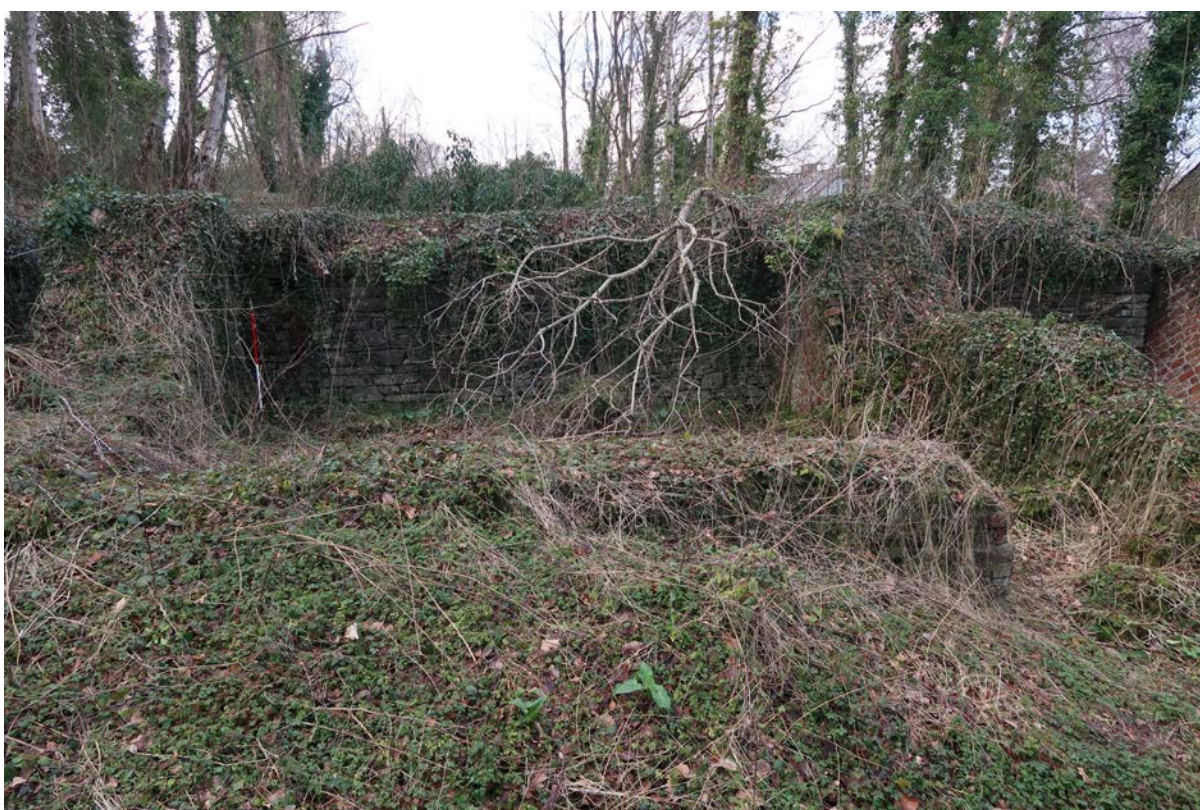
Fig 2: structure (c) at the north-east end of the smelt house, looking south-west

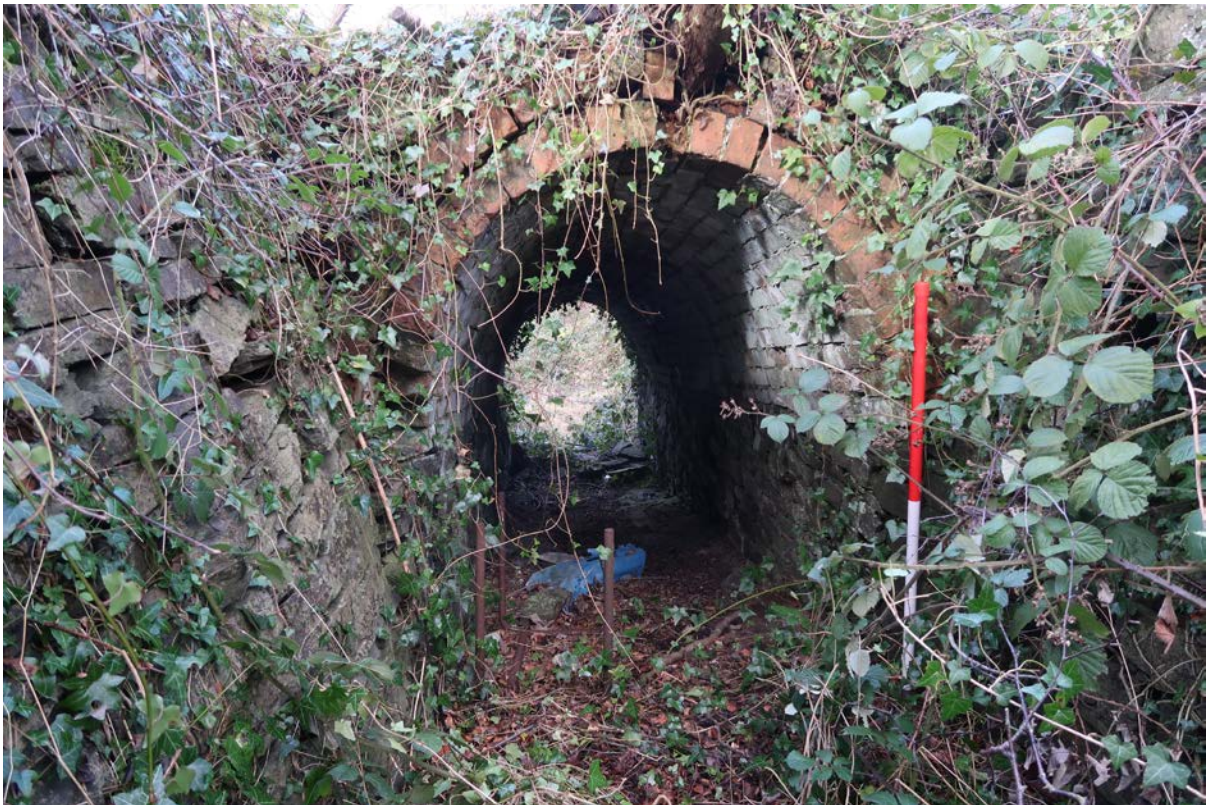
Fig 3: tunnel from pit (d) (foreground) looking north-west to chamber (e)

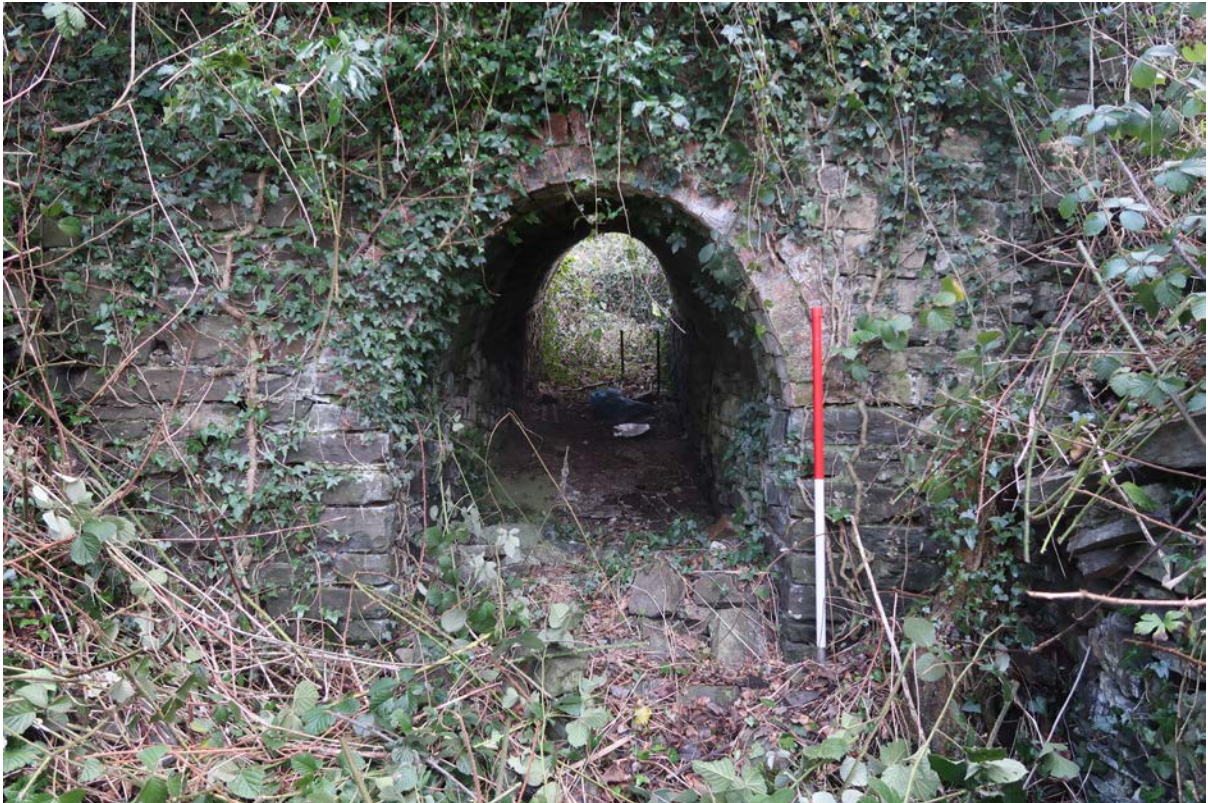
Fig 4: tunnel to chamber (e) (foreground)

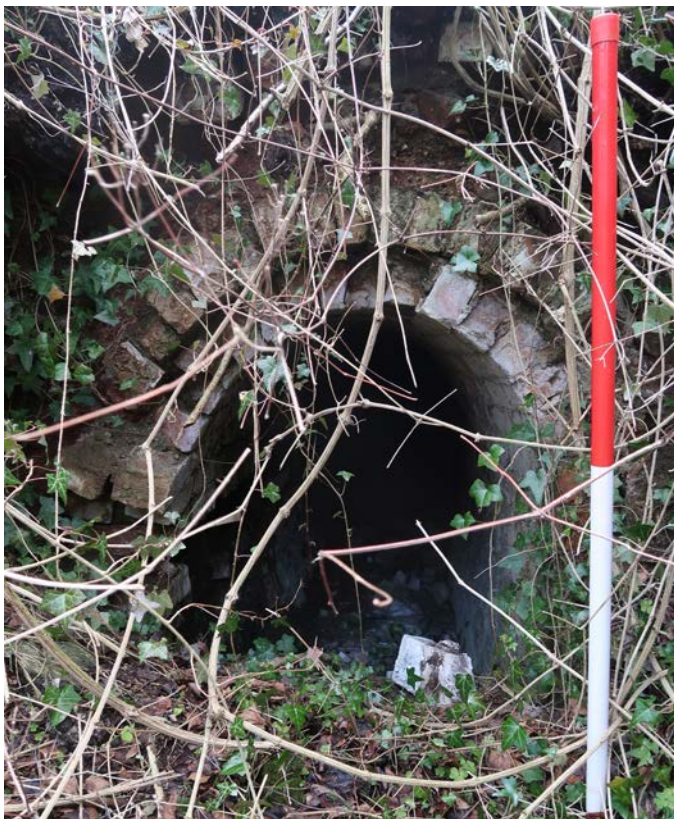
Fig 5: opening of flue (h) in the rear wall of the smelt house

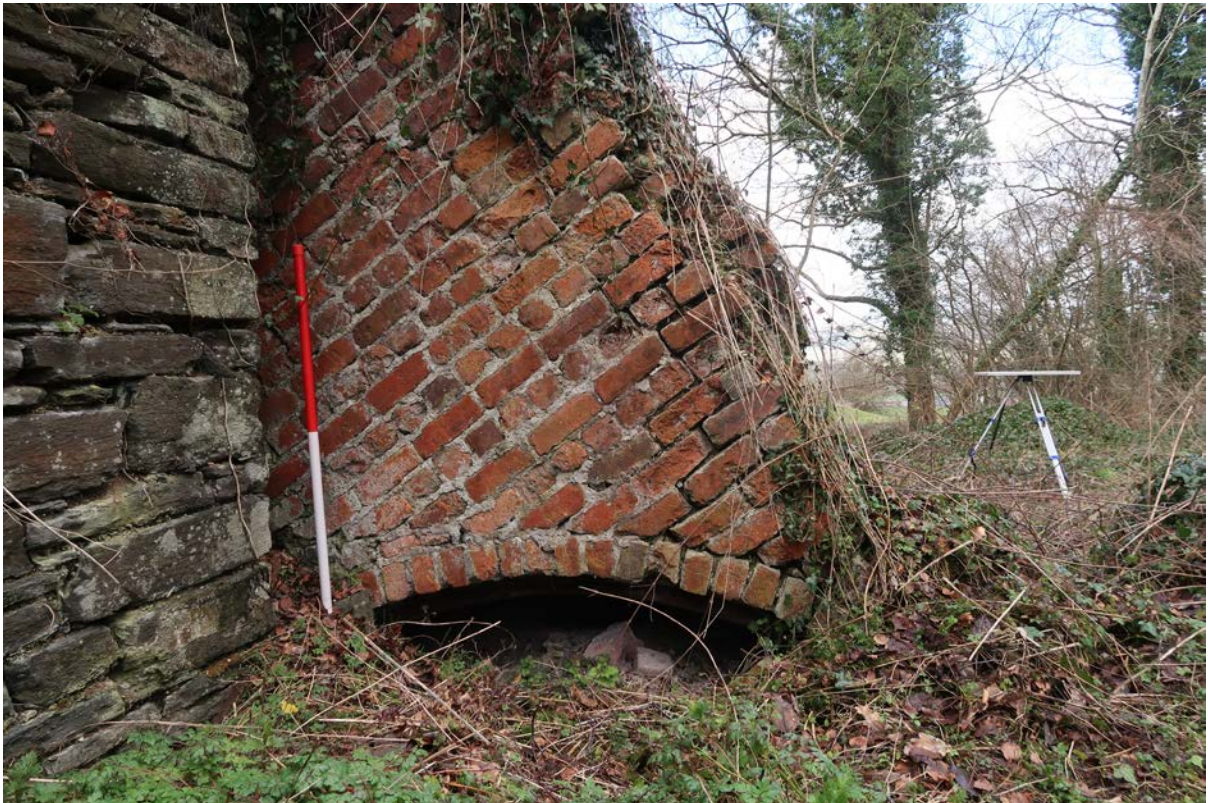
Fig 6: buttress or support for slag mill flue with arched hollow below, looking north-west

The flue from the slag mill was apparently overhead (see above) where it exited the mill; some of its massive brick- and stone-built supports survive (Fig 6). However, built into the bases of these supports and now almost entirely buried are arched openings lined with iron hoops or sheets (Fig 7). The purpose of these openings is unclear – they may be for a second, lower-level, flue. Further to the south, by the eastern corner of the smelt house, this flue met the rising ground level and thereafter ran underground. A length of it has collapsed (**k**).

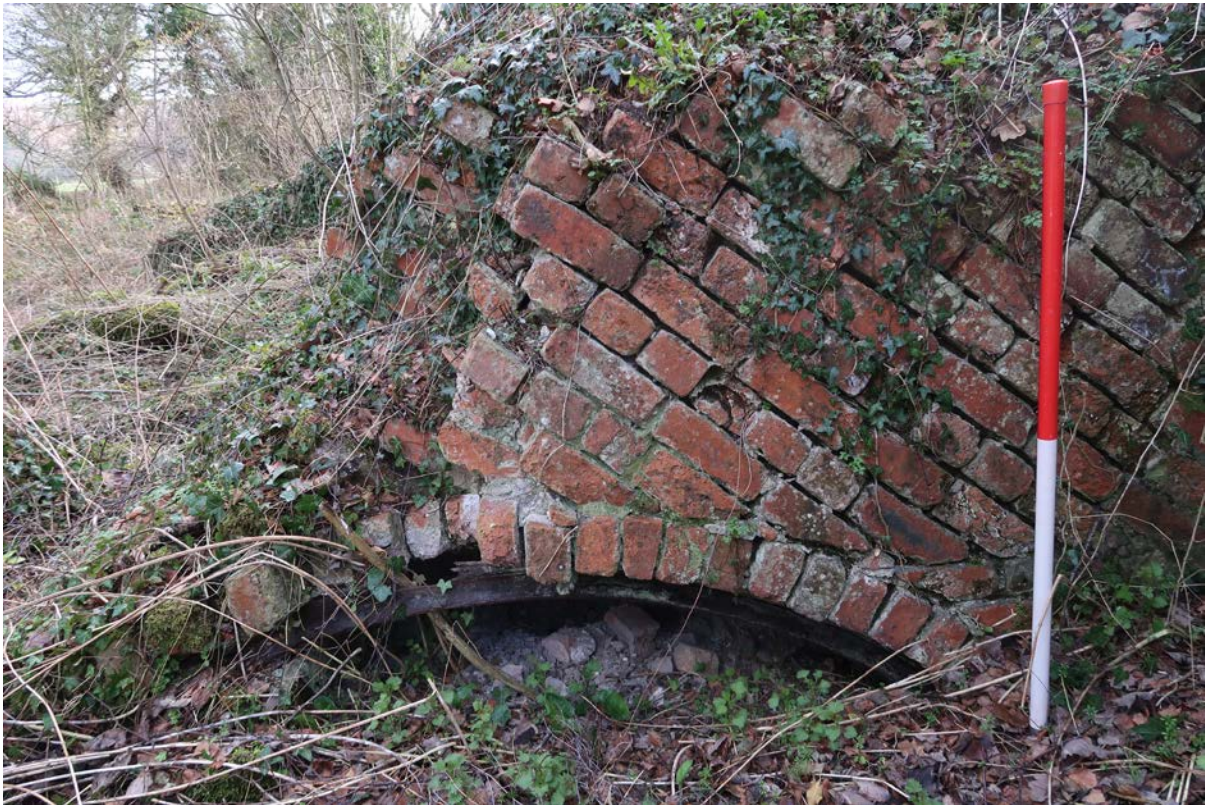
Fig 7: buttress or support for slag mill flue, looking south-east, showing iron lining in arch

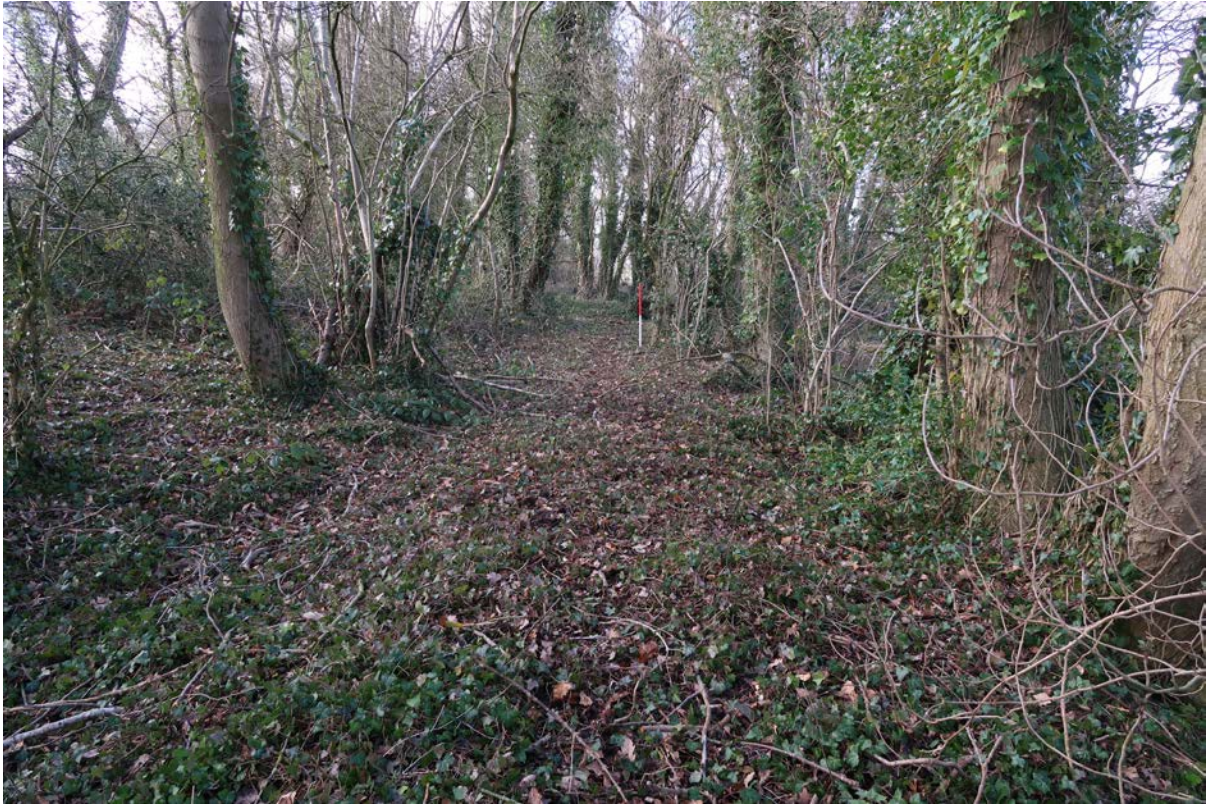
Fig 8; the trackbed of the upper rail line alongside pond 4, looking south-west

The upper line that served the smelt house is visible as a level platform running along the north-western edge of pond 4 with a significant drop of about 2m to its north-west (Fig 8). It must have been carried on a bridge across the slight natural declivity to the west of pond 4, and there are some slight amorphous earthworks at this point. Further to the west it is raised on a slight embankment (q), no more than 0.2m high.

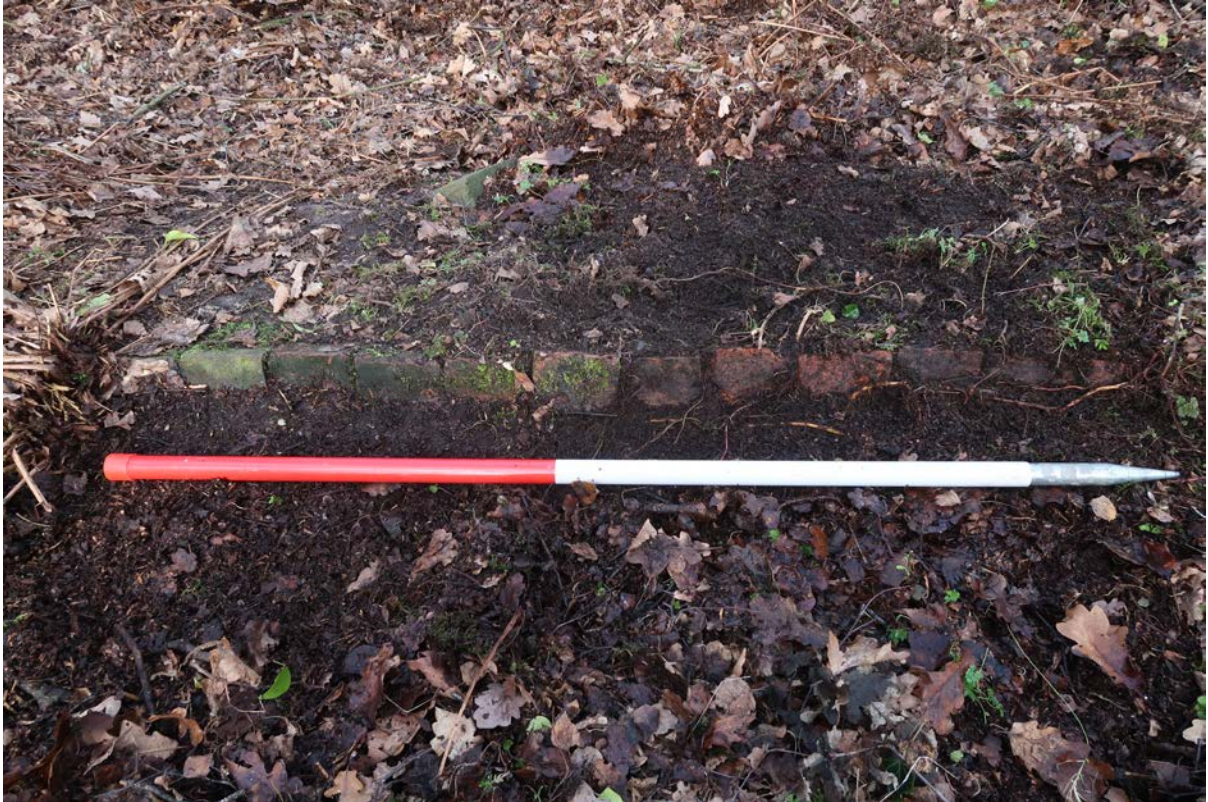
deep. A drain has been cut at its northern corner but not to the full depth of the pond (unless there is an underground pipe). The others are all completely silted and appear as flat areas, distinguished only by their retaining dams, which survive no more than 0.7m high; the scarp marking the upper side of pond 1 is about 1.6m high, however, perhaps because it has been built up to support the railway line which ran along the top of it. There is an inlet at the southern corner of pond 3 (see Discussion below). Part of a brick-built retaining wall is visible on the north-western side of pond 2 (Fig 9). Pond 1 is almost square; the higher ponds are longer.

Fig 9: retaining wall along the northern side of pond 2
