Archaeological Services in Relation to Marine Designation

UC-6, Thames Estuary

Archaeological Report

Ref: 83803.23
January 2015

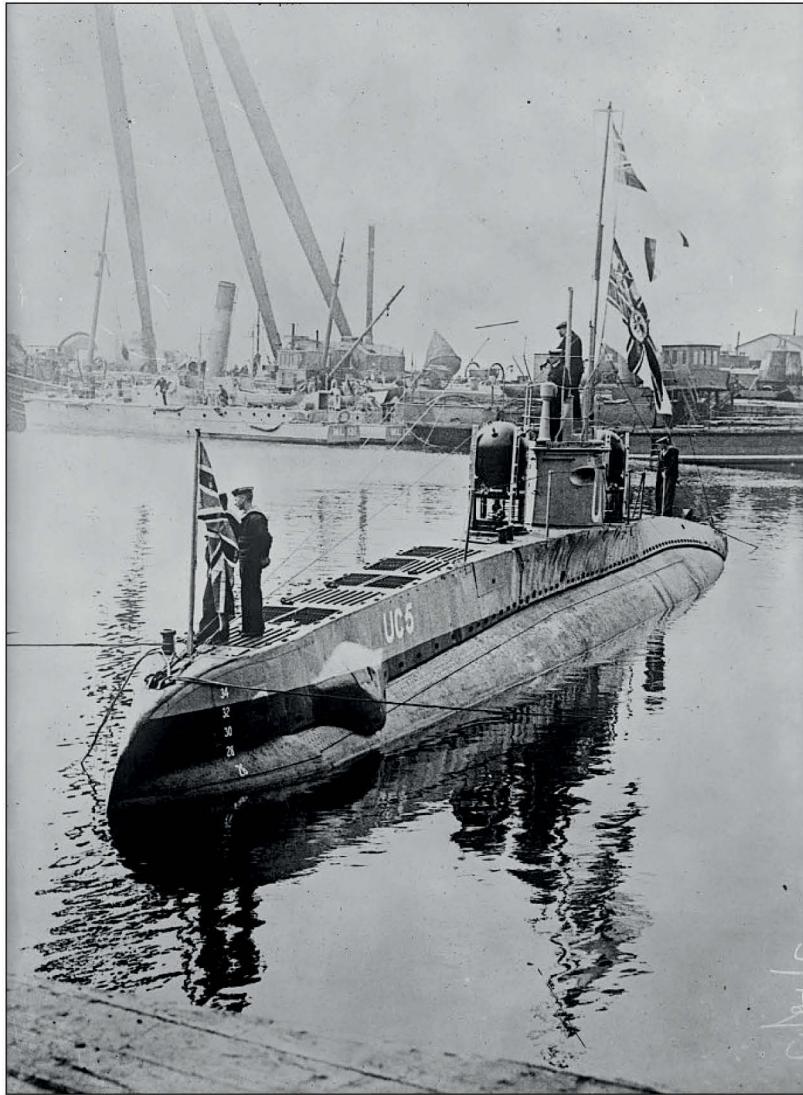
Plate 1: Captured German minelayer of UC5.
 By Bain News Service, Library of Congress Prints and Photographs Division
 Washington, D.C, Public Domain

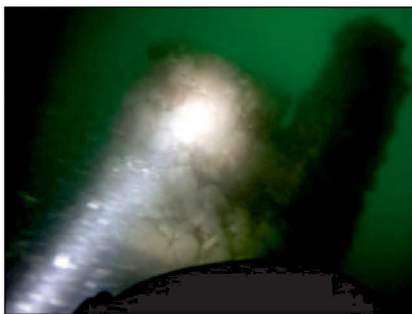
Plate 2: UC6 periscope. Photograph
 by Rob Harrison, Canterbury Divers
