Clifford Castle, Clifford, Herefordshire: Archaeological, Architectural and Aerial Survey and Investigation

Research Report Series 069-2018

NGR: SO 244 056

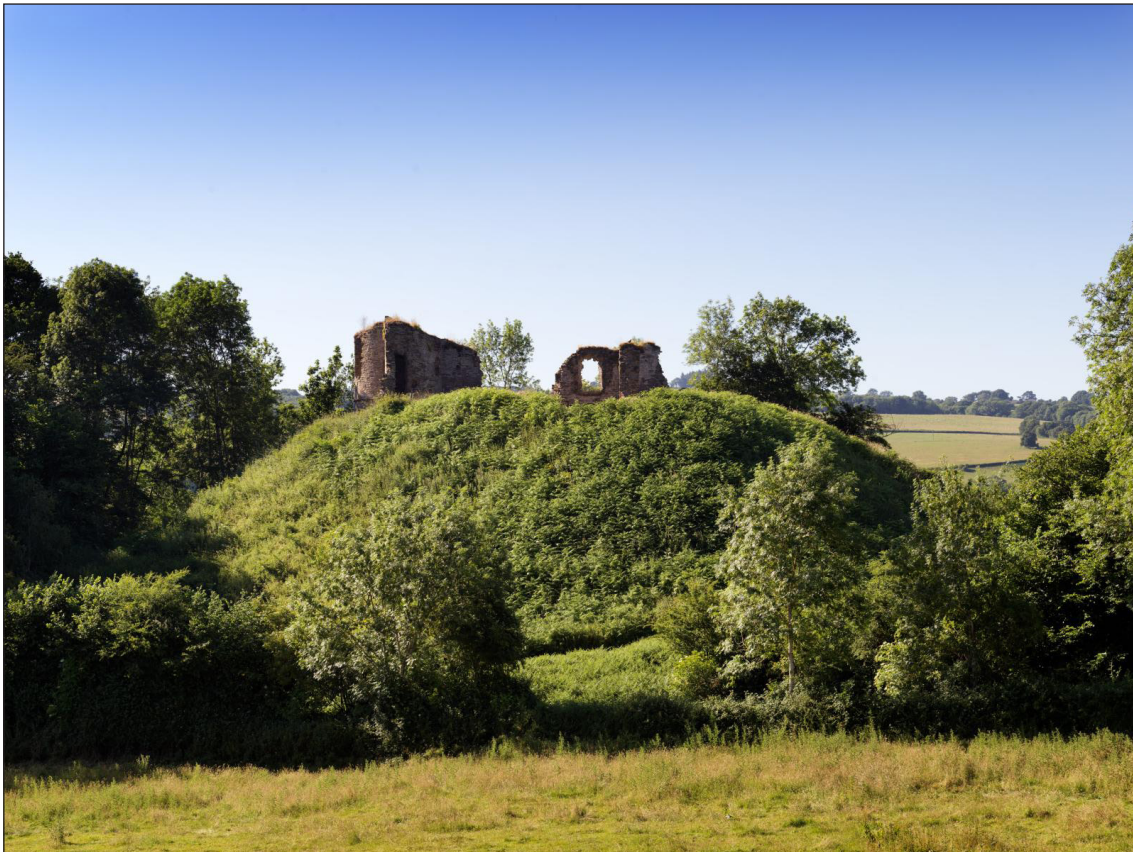
The motte at Clifford is very large and steep-sided (Figure 10 and *see* Figures 8 and 9). It is approximately 17.5m high to the south, approximately 60m in diameter at the base and 30m across at the top. The top now appears to be a rough quadrilateral but was presumably originally circular and has been modified by the addition of masonry buildings in the 13th century. The motte top is now very uneven, largely as the result of 20th-century excavations; a hollow around the edge of the

Figure 10 The profile of the motte viewed from the south (DP220706)

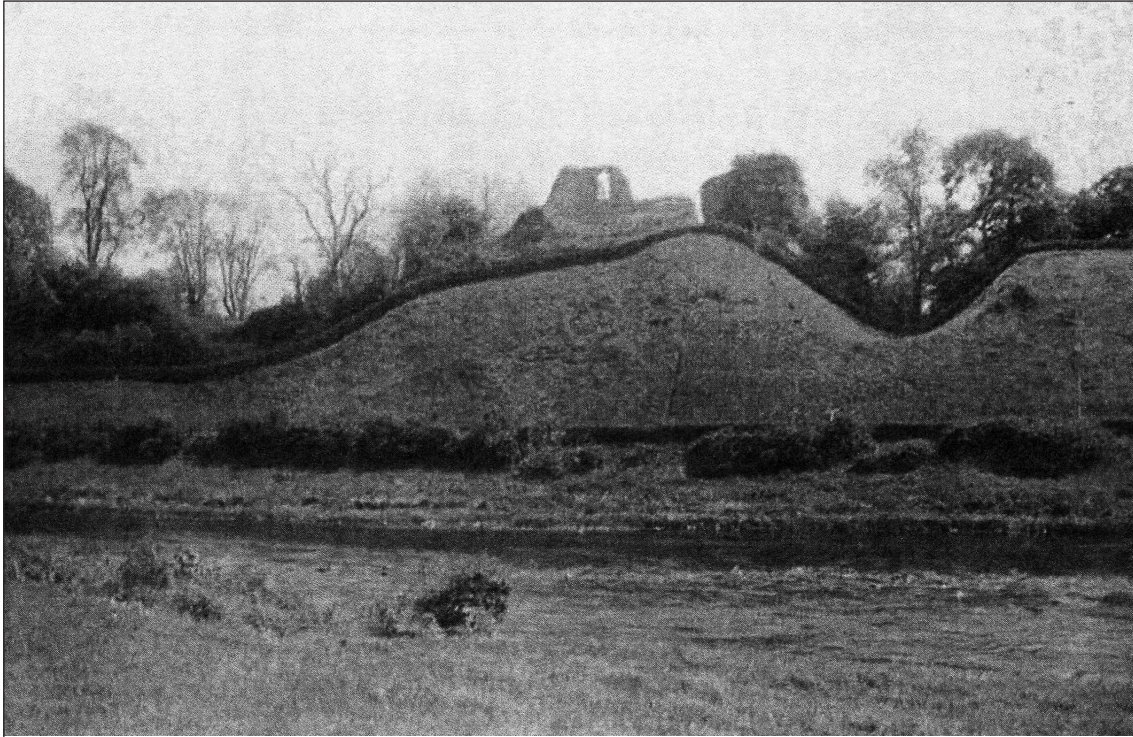
Figure 12 Alfred Watkins' view of the motte, published in the *TWNFC* in 1920. The hedge line along the top of the motte and into the ditches denotes the boundary of the land owned by the railway. Vertical lines just visible on the side of the motte denote the areas of stone revetting. Reproduced by permission of the *TWNFC*.

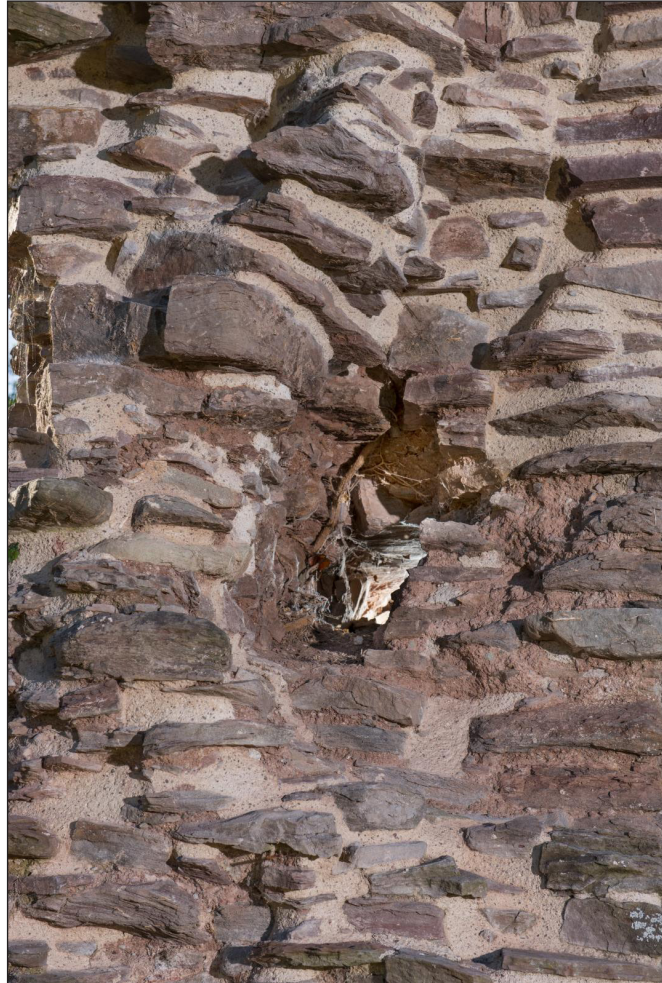
Figure 14 The empty slot in the east wall of the so-called 'hall block' (DP220714).

wall of the hall block at the level of the first floor (Figure 14). This appears to run along the wall (north to south), rather than across it, except where a stone has fallen out of the eastern face providing access to the northern end of the slot. Baker (2018) has observed that the entrance to the hall was probably at the east end of the building, accessed via an external stair, as a single stone from the eastern jamb of the doorway can be identified surviving at first-floor level. It is therefore suggested that the slot might relate to the position of a timber beam which would have projected out beyond the southeast corner of the building in order to support the top of the stair, or perhaps a small landing area in front of the doorway. Such external stairs were frequently provided in castles and other high status residences in the medieval period. Although timber examples now survive rarely, they were probably typically self-supporting. A projecting beam such as this however, would have allowed the stair structure to be tied into the building more successfully than with a completely free-standing structure. Although survivals of such an arrangement are rare, the late 13th century stair at Stokesay Castle, Shropshire within the great hall, rather than external, may represent a comparable arrangement. This has two large beams projecting from the wall face, and braced to the wall below, supporting a small landing in front of the first-floor doorway.

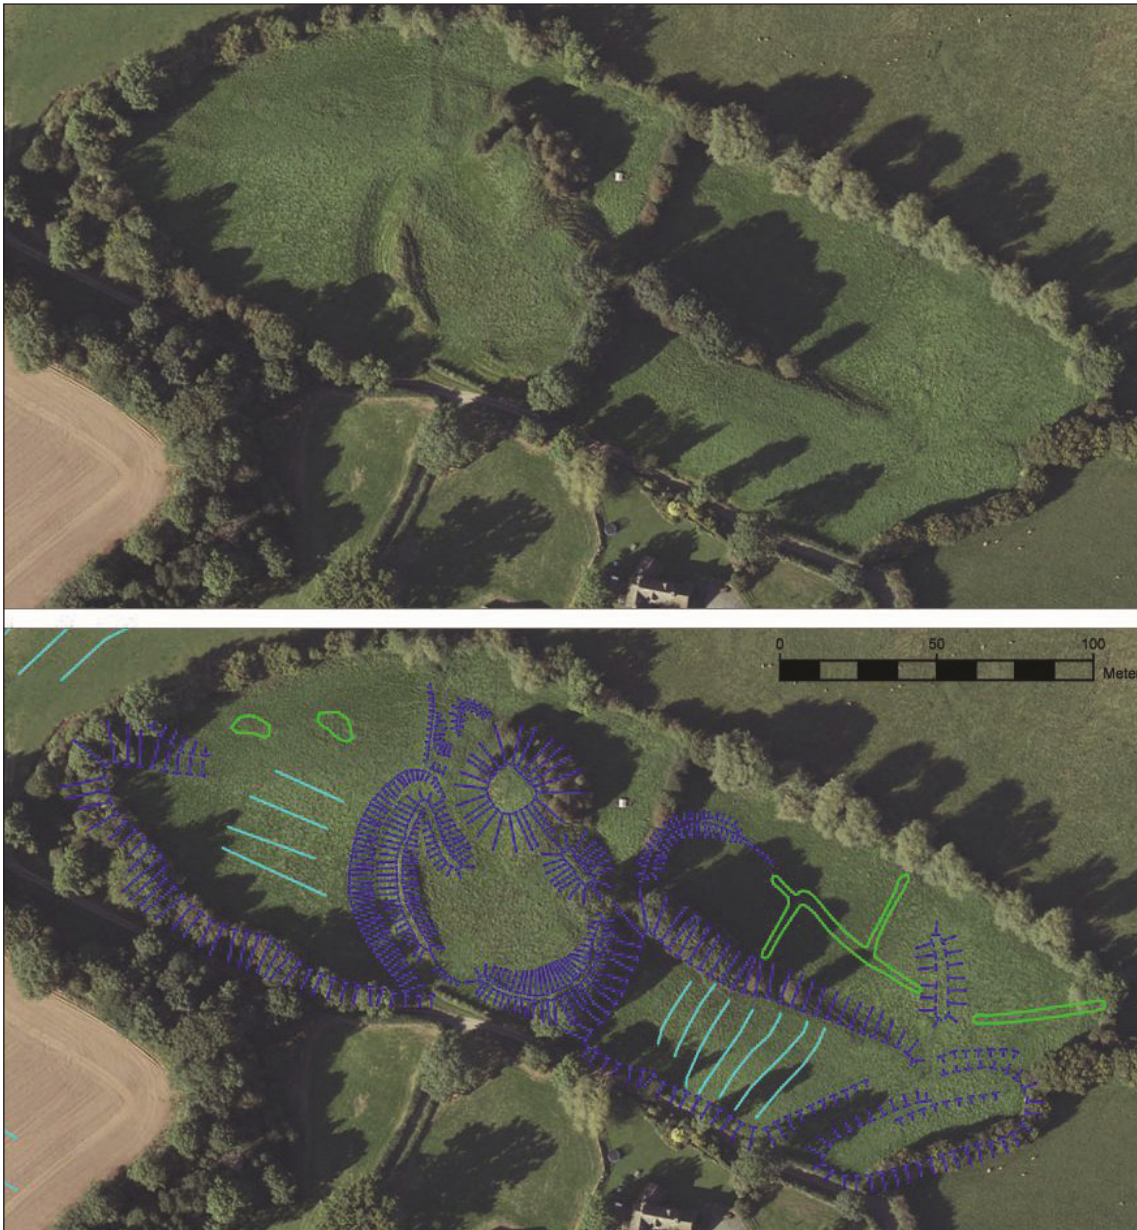
Figure 28 Castleton motte and bailey; showing mapped earthworks overlain on a modern aerial photograph. The square earthwork at the north-western base of the motte, centre top, is highlighted by shadow © APGB SO2845 12-Sept-2009
