The Gatehouse, Caynton Manor, Edgmond, Shropshire: Building Investigation

Research Report Series 70-2018

BUILDING INVESTIGATION

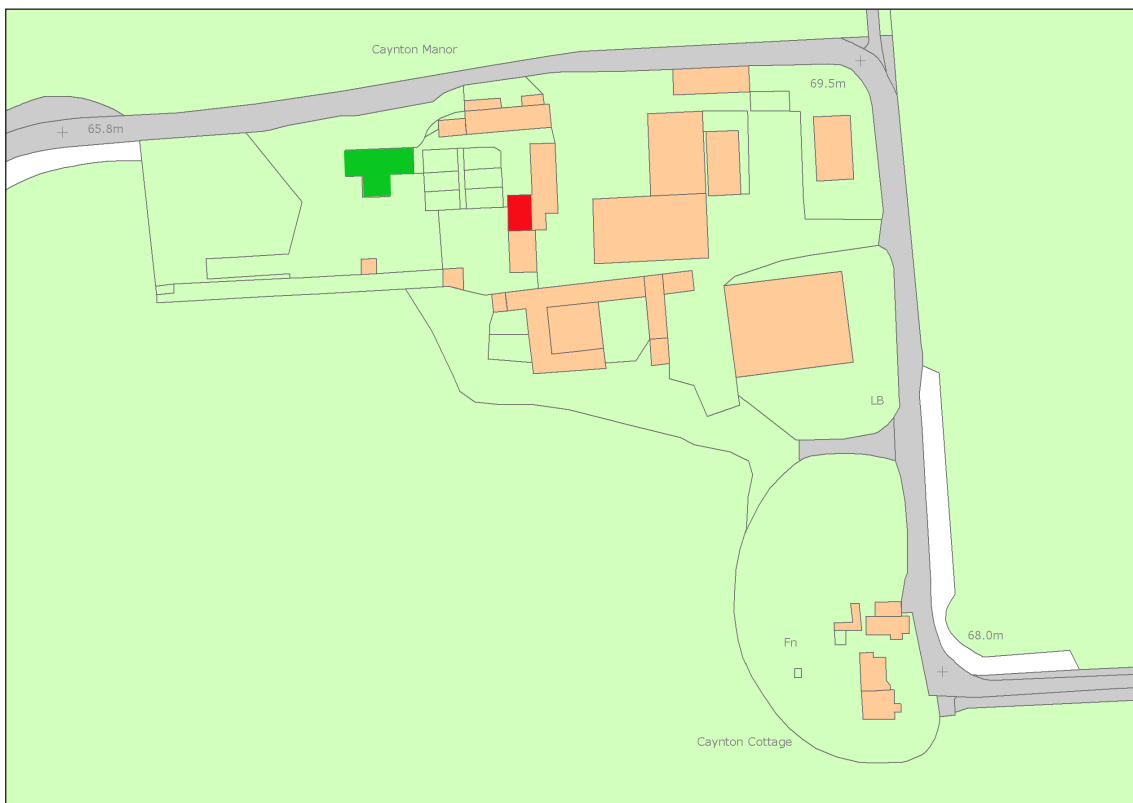
Figure 1: Site plan of Caynton Manor with the house in green and the gatehouse in red (© and database right Crown Copyright and Landmark Information Group Ltd (All rights reserved 2018) Licence numbers 000394 and TP0024.)

The farmstead of Caynton Manor (also known as Old Caynton Manor) is located to the north-west of the village of Edgmond and just to the east of the river Meese. The road from the east approaches the farm via a distinctive kink of two right angles. The reason for this unusual road alignment is not clear, but may relate to the presence of the manorial site from an early date. The house is located to the south of the road with the farm buildings, including the gatehouse, to the east and south-east (Figure 1). There is a historic well to the south of the house.¹ The gatehouse's position relates to the approach to an older, long vanished house about which little is known. It is now surrounded by several farm buildings, two of which abut against its east and

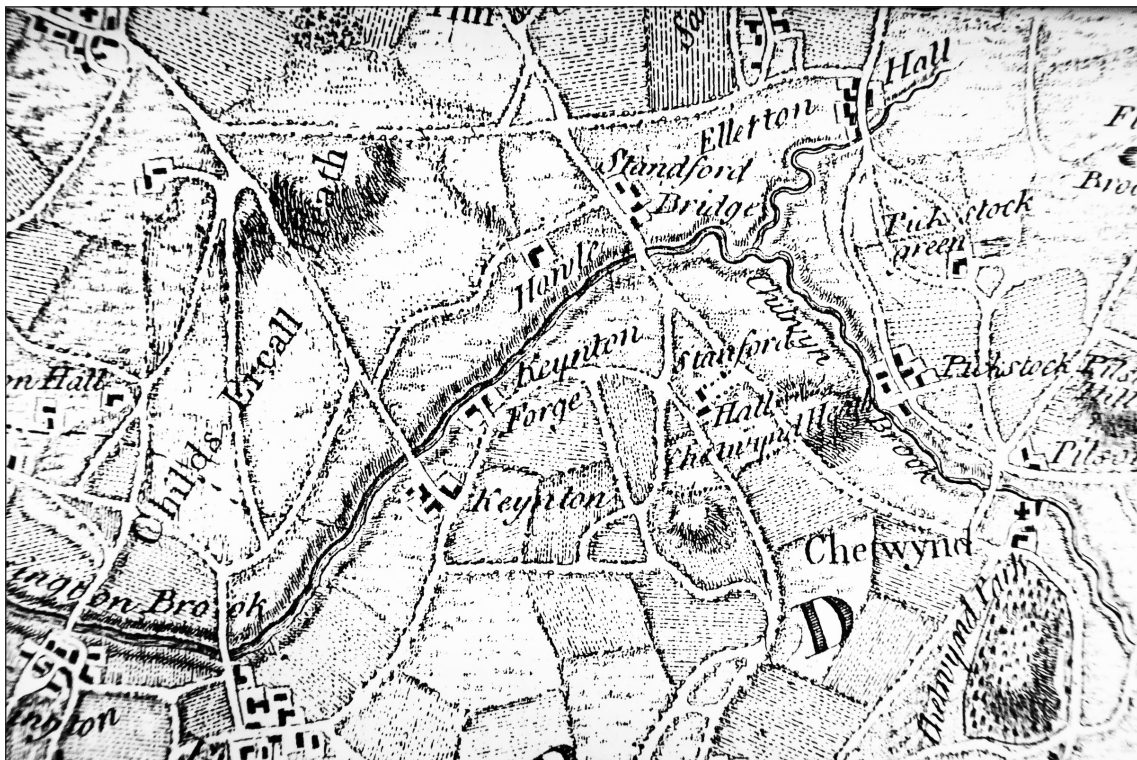
Figure 2: Detail from John Rocque's map of Shropshire, 1752, showing Caynton Manor (labelled 'Keynton') (Shropshire Archives)

By the second half of the 18th century, the manor was owned by the Briscoe family, who still owned it in the 1960s.²⁷ John Rocque's 1752 map of the county depicts a schematic group of buildings at 'Keynton', including one L-shaped building to the north of the road and two L-shaped buildings to its south (Figure 2). Bricks have been reportedly ploughed up north of the road in the late 20th century but there is no evidence that they belonged to the manor house or another building. Rocque's map also shows the current line of the road but with a continuation of the north-south stretch northwards towards 'Keynton Forge'. This northern part of the road which is now reduced to a track might be the explanation for the curious road alignment, although the map is highly schematic and other roads on the map bear little relation to the later road network.²⁸

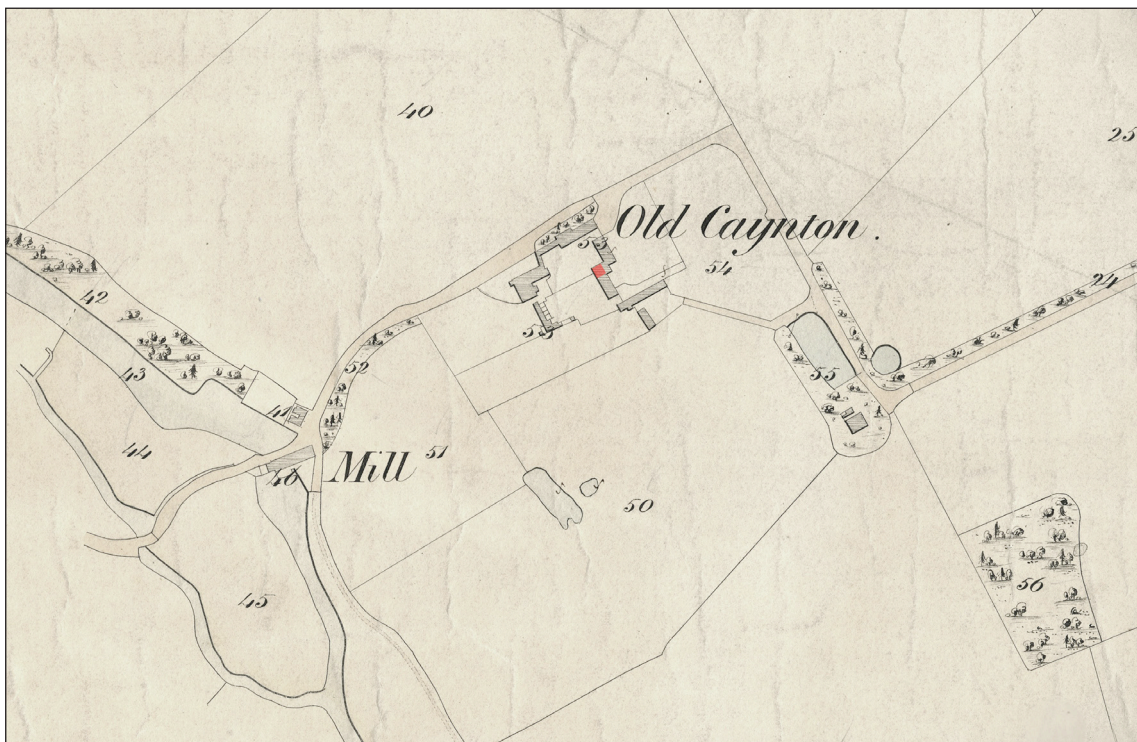
Figure 5: Detail from the tithe map for Caynton in Edmond parish, with the gatehouse highlighted in red (The National Archives, IR 30/29/120)

By the time the tithe map of c 1841 was drawn up, more farm buildings had been erected, including two abutting the gatehouse to the north-east and south (Figure 5). Circular ponds had been created to the east of each of the oblong ponds. Between 1841 and 1880, there was relatively little change in the farmstead, apart from a few small-scale additions (Figures 5 and 6).

According to map evidence, the farm buildings abutting the gatehouse to the east and south were built between c 1829 and 1841 (Figures 4 and 5). At that point the ground-floor windows of the east elevation were bricked up and their mullions removed.

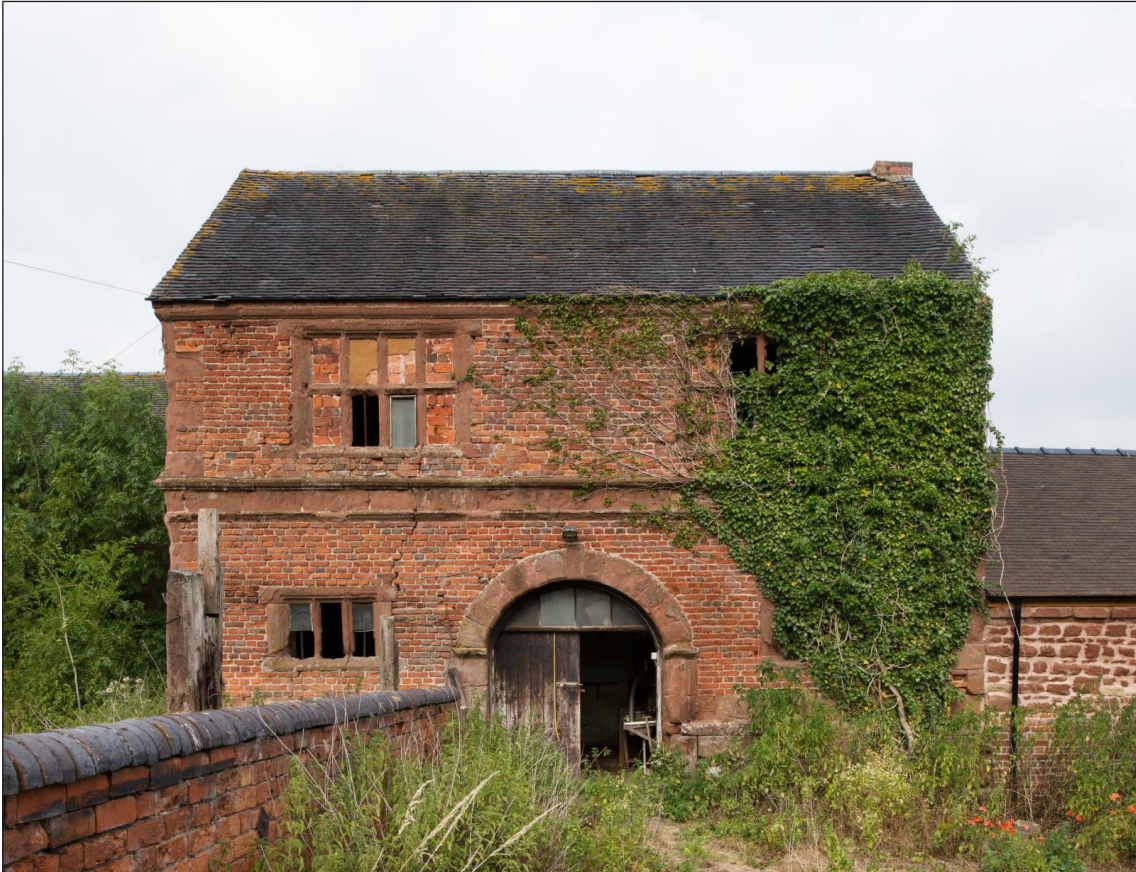
Figure 10: The west elevation (DP220882)

As constructed, the gatehouse was a two-storey, gabled building of brick laid in English bond (Figures 10, 11). Red sandstone was used for the base, the quoins, a frieze above the ground floor, window dressings, the arches of the passageway and the eaves cornice. On each floor of the long elevations were two windows with hollow-chamfer mullions. The ground-floor windows were of three lights, and

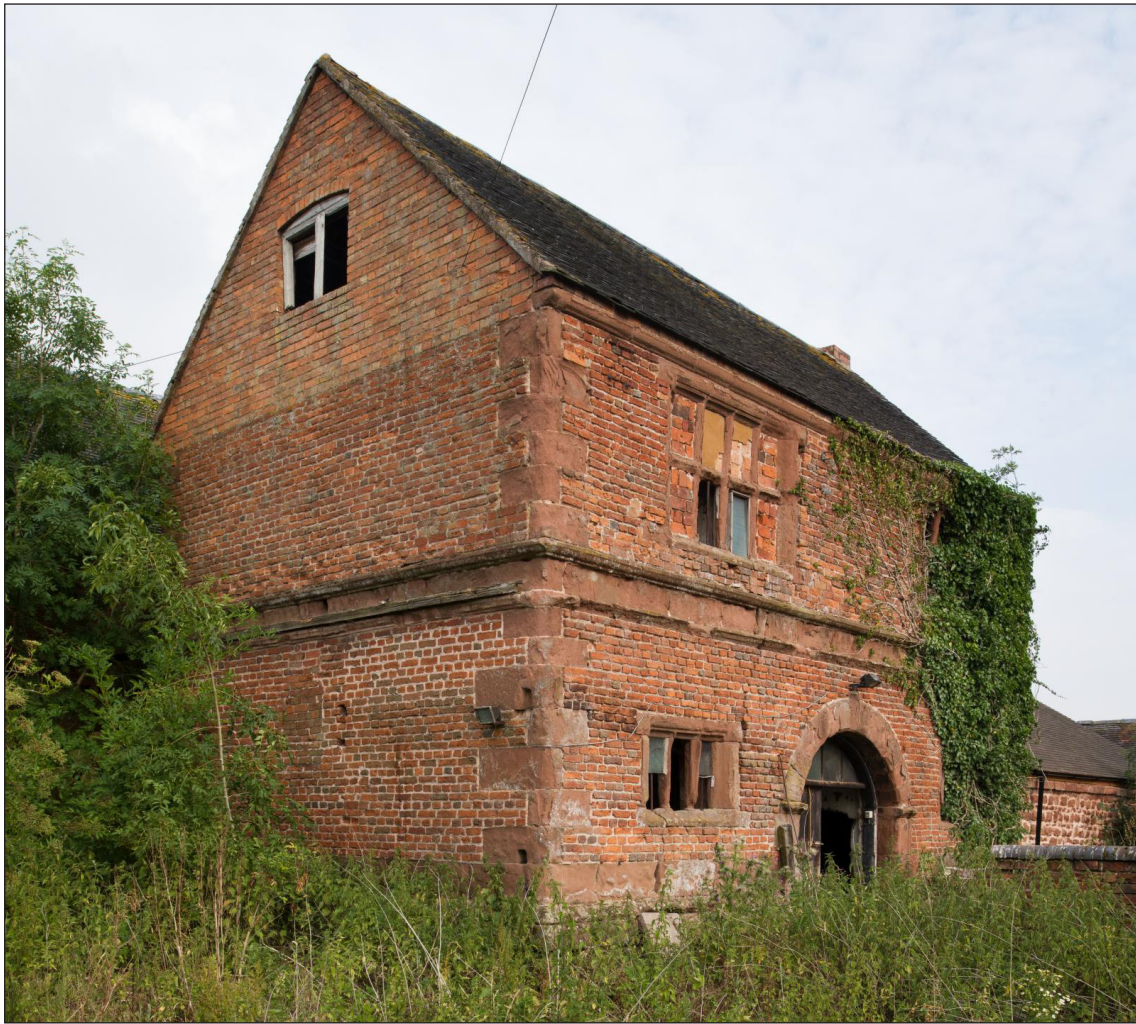
Figure 11: The gatehouse from the north-west (DP220883)

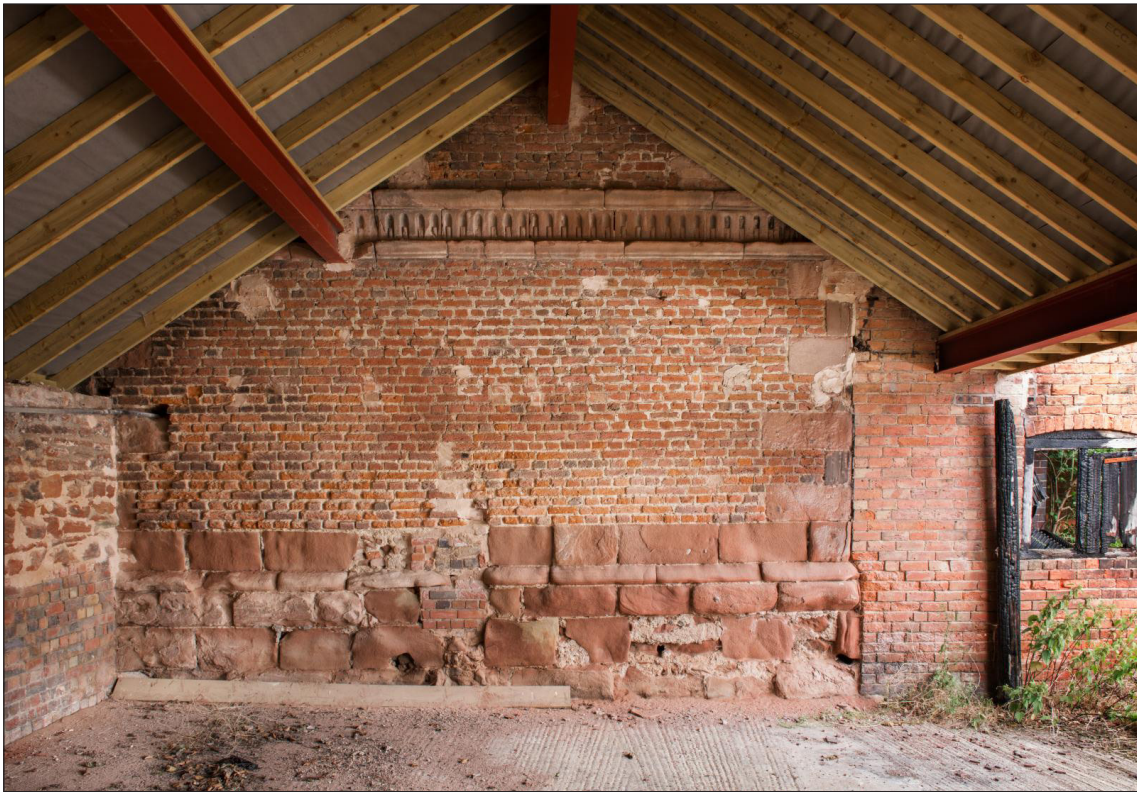
Figure 12: The south elevation with the best-preserved section of the fluted frieze (DP220869)

A frieze with cabled fluting runs around the building, although stone erosion has abraded the detailing somewhat over time where it has been exposed to the elements. Its original form can be best seen on the south elevation where it has been protected by lean-to buildings (Figures 12, 13). Both the north and south elevations are relatively plain, although they have the continuous sandstone base and the frieze. Both have several scars from later, abutting buildings, including low-level disturbances at the centre of the elevations.

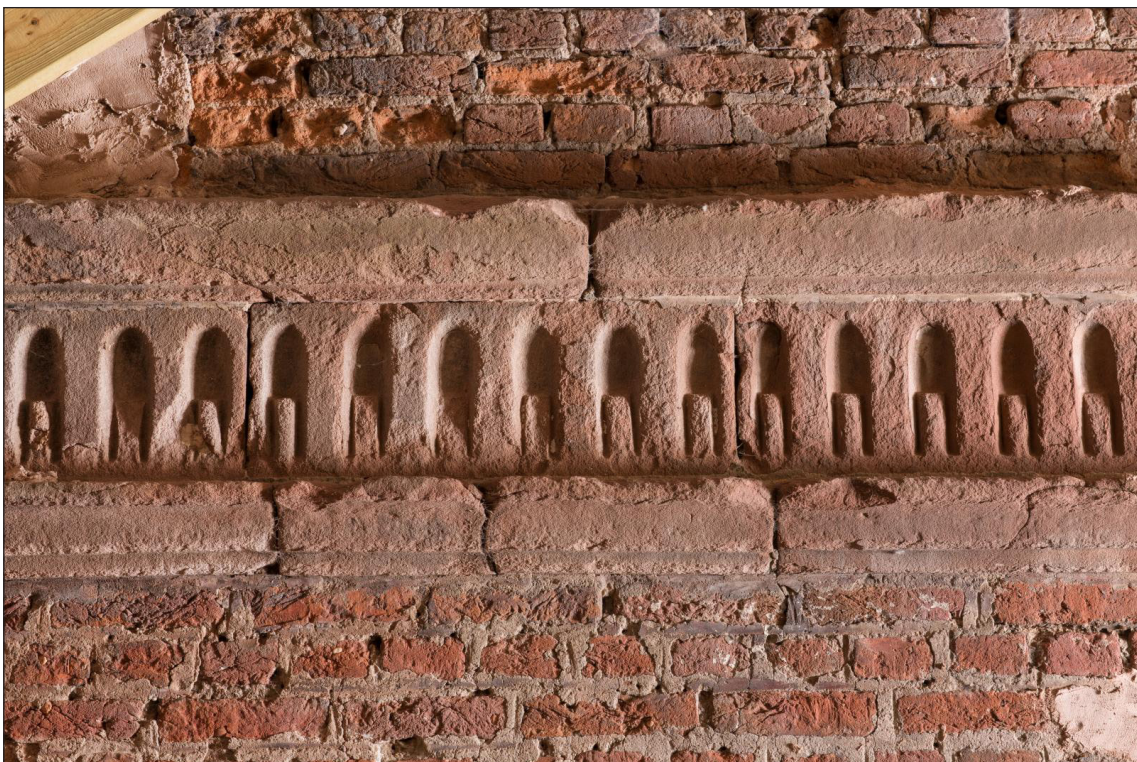
Figure 13: A detail of the frieze on the south elevation (DP220870)

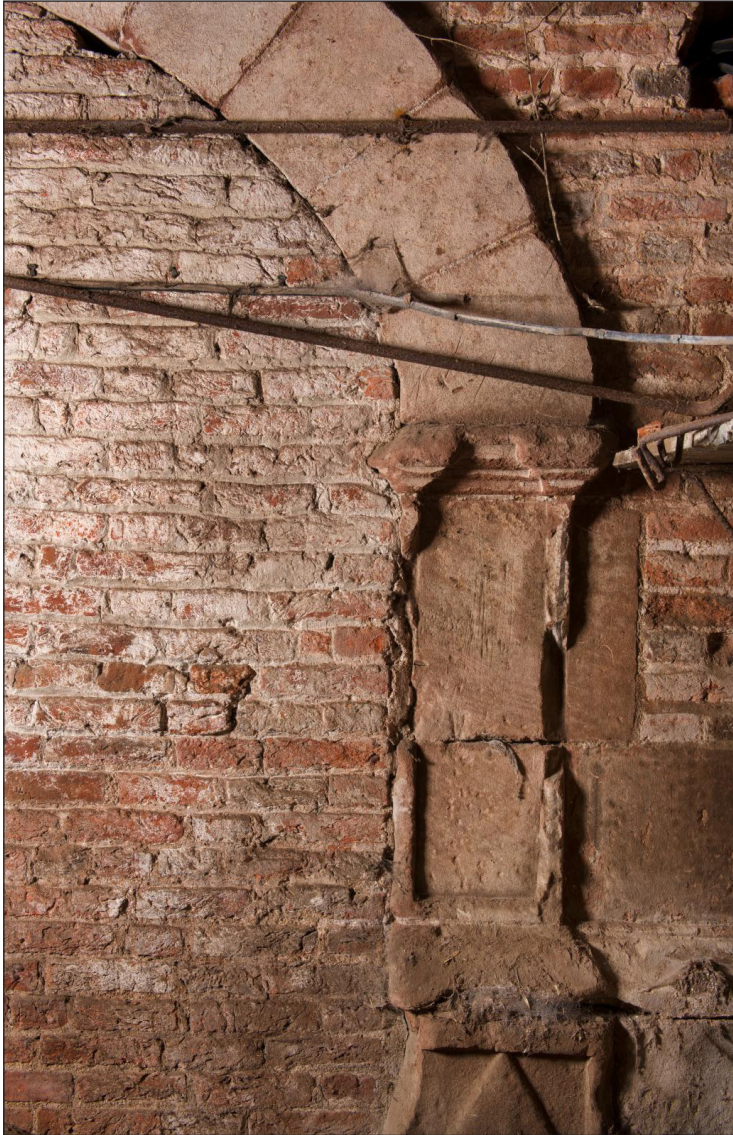
Figure 14: The north jamb of the arch in the east elevation with a moulded impost and a recessed panel above a raised lozenge (DP220872)

The two outer arches sit centrally on the east and west elevations and are identical in detailing. The stonework is relatively plain albeit with a taller keystone at the top of the arch, voussoirs which may have had a simple chamfer, moulded imposts, recessed panels below the imposts, with bases of carved, raised lozenges (Figure 14). The only slight difference in decoration of the west and east elevations is a small truncated pendant to the keystone of the east arch (Figure 15). A third, shallower arch inside the central passage has large pintles on its west face (Figure 16). This face of the internal arch appears to have never had any impost mouldings, rather than losing them in a later alteration. The pintles are not original but are clearly historic and probably continued the presence of doors originally hung on this side. These features, together with the small pendant over the east arch, suggest that the gatehouse's outer elevation was to the east. The doors would have been hung on the west side of the internal arch, opening inwards.

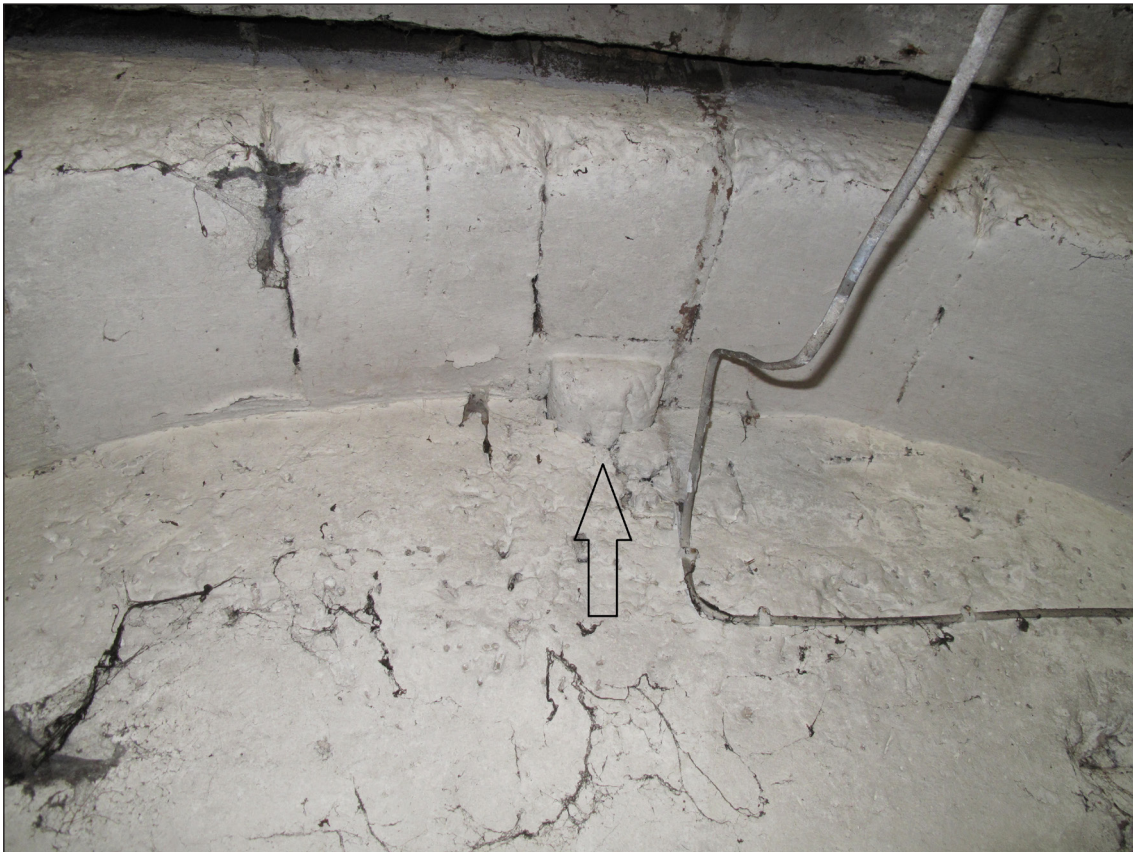
Figure 15: The blocked east arch seen from inside with the keystone pendant (indicated by an arrow) (Rebecca Lane)

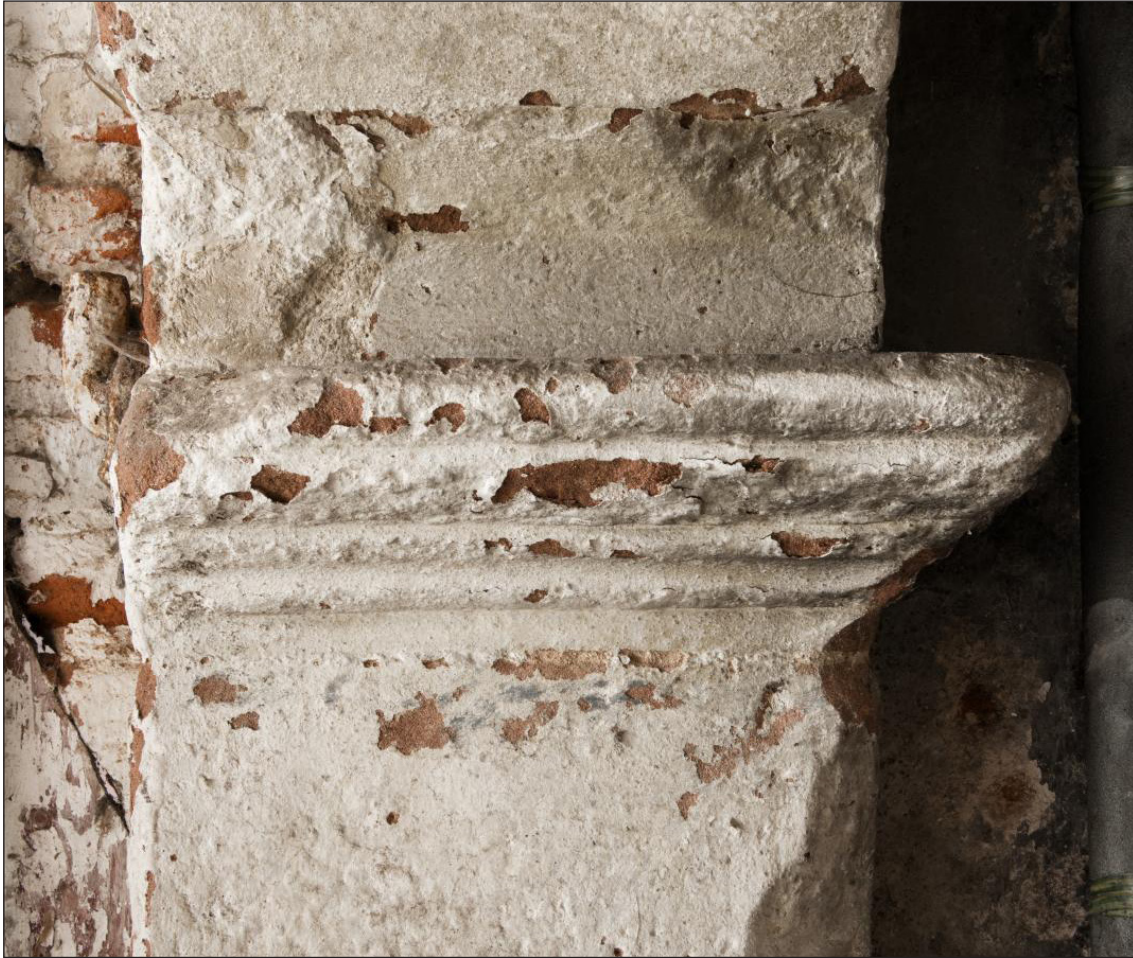
Figure 16: The northern jamb of the internal arch seen from the south, showing the historic pintle and the lack of an impost moulding, both on the west (left) face (DP220867)

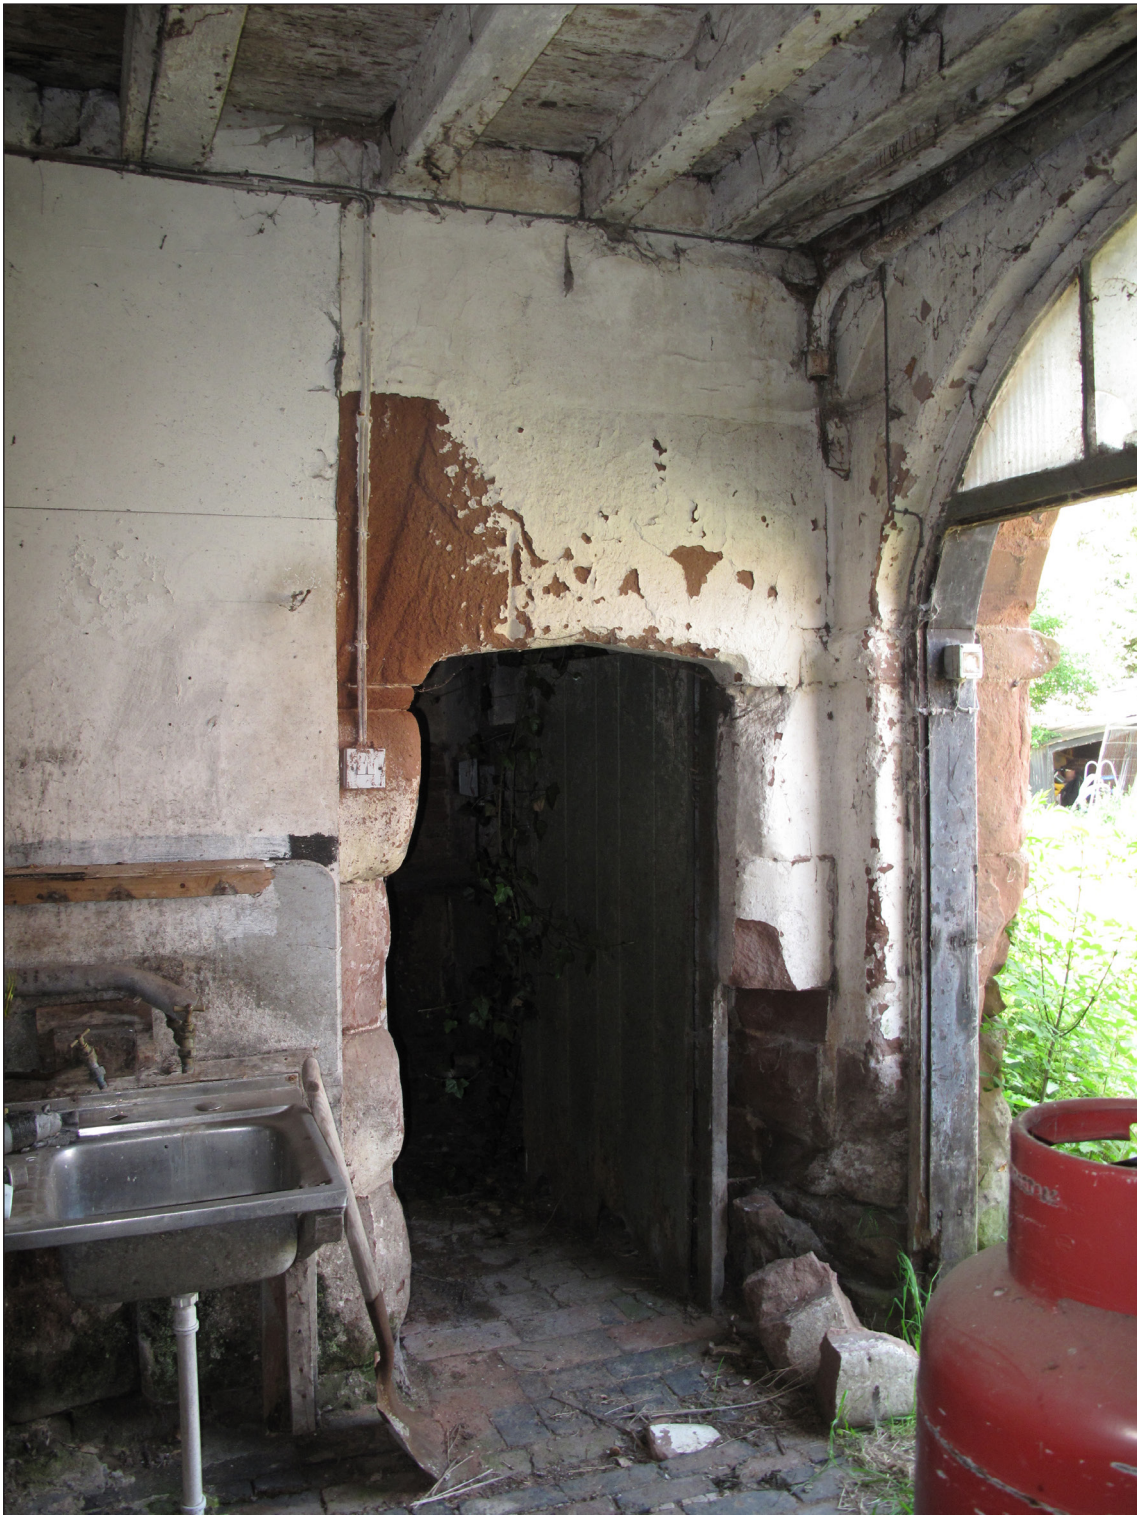
Figure 17: The archway into the ground-floor south room, looking southwest (Rebecca Lane)

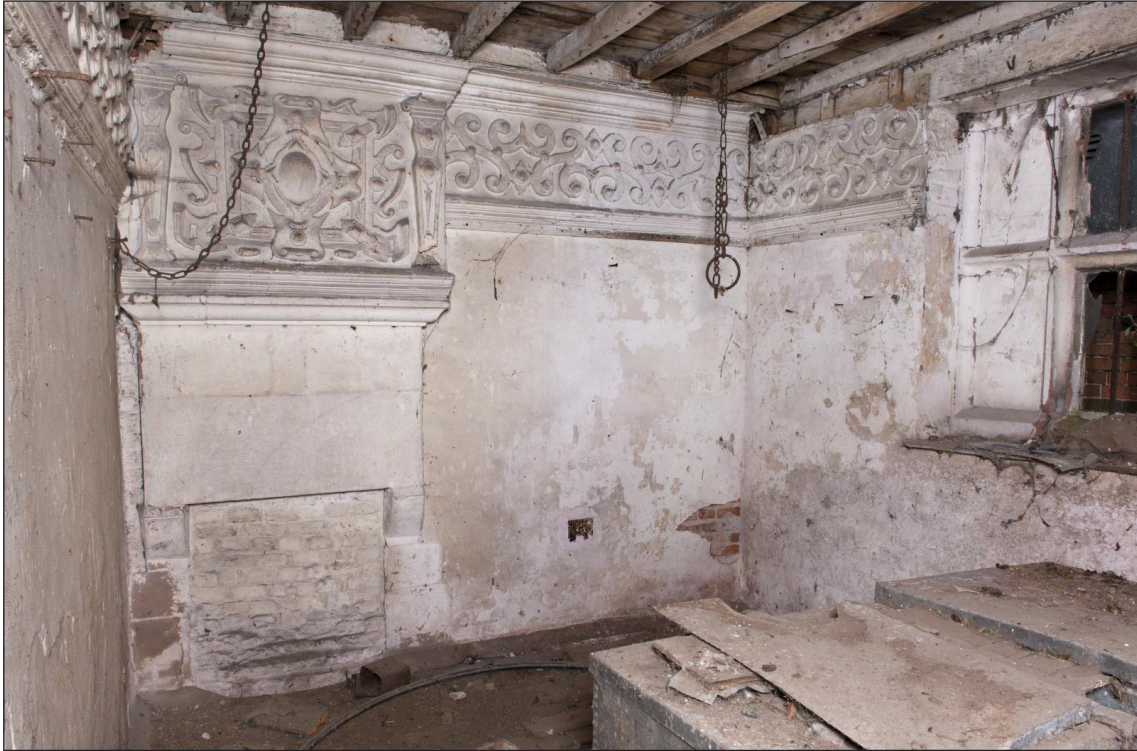
Figure 18: The north wall of the first-floor north-east room with its fireplace and overmantel and the partition to the left (DP220855)

The plain plaster ceiling largely survives in the south room, albeit in poor condition. It seems likely that this is the original ceiling (with later patches), as the cornice is intact and shows no signs of interruptions from abutting beams, for example. The fireplaces of both of the main first-floor rooms are corbelled with a cyma recta cornice at the top; that in the south room also has an opening with a Tudor-style arch with a roll moulding (Figures 18, 19).

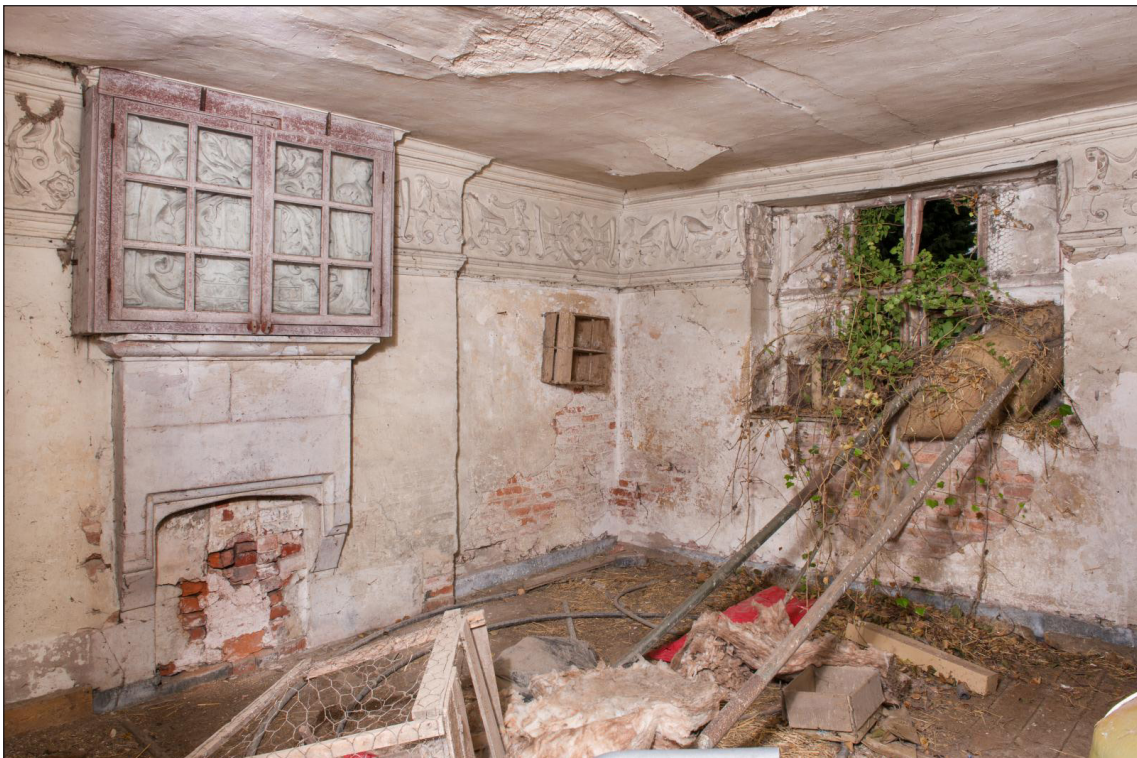
Figure 19: The first-floor south room, looking south-west (DP220850)

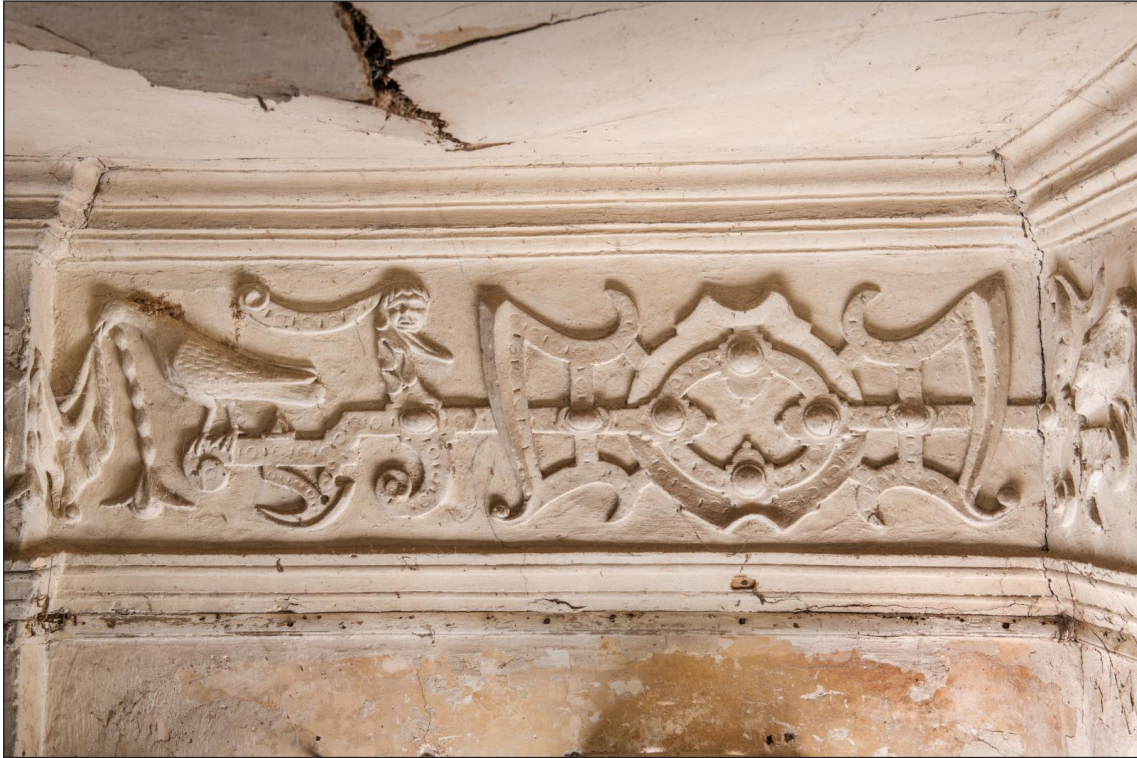
Figure 20: Detail of the plasterwork frieze on the south wall showing the repeating motifs of birds holding swags, S-shaped strapwork and a strapwork cartouche (DP220829)

There is evidence that the plasterwork was not the only kind of decoration in the gatehouse's first-floor rooms. It seems likely that they also featured wall-hangings, hung from nails or hooks in the battens directly below the friezes. The battens can be found in both rooms, with flush and projecting nails, and at least one hook (Figures 20, 30-32).

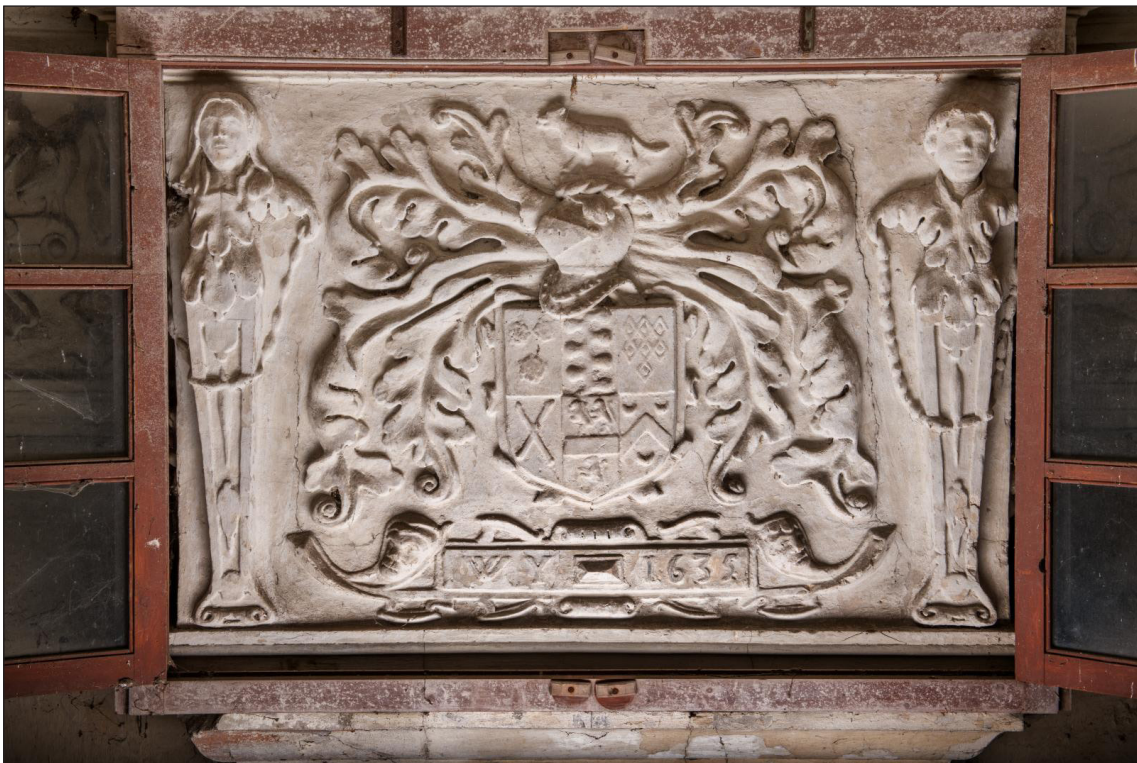
Figure 21: The overmantel in the first-floor south room with the Yonge coat of arms (DP220827)

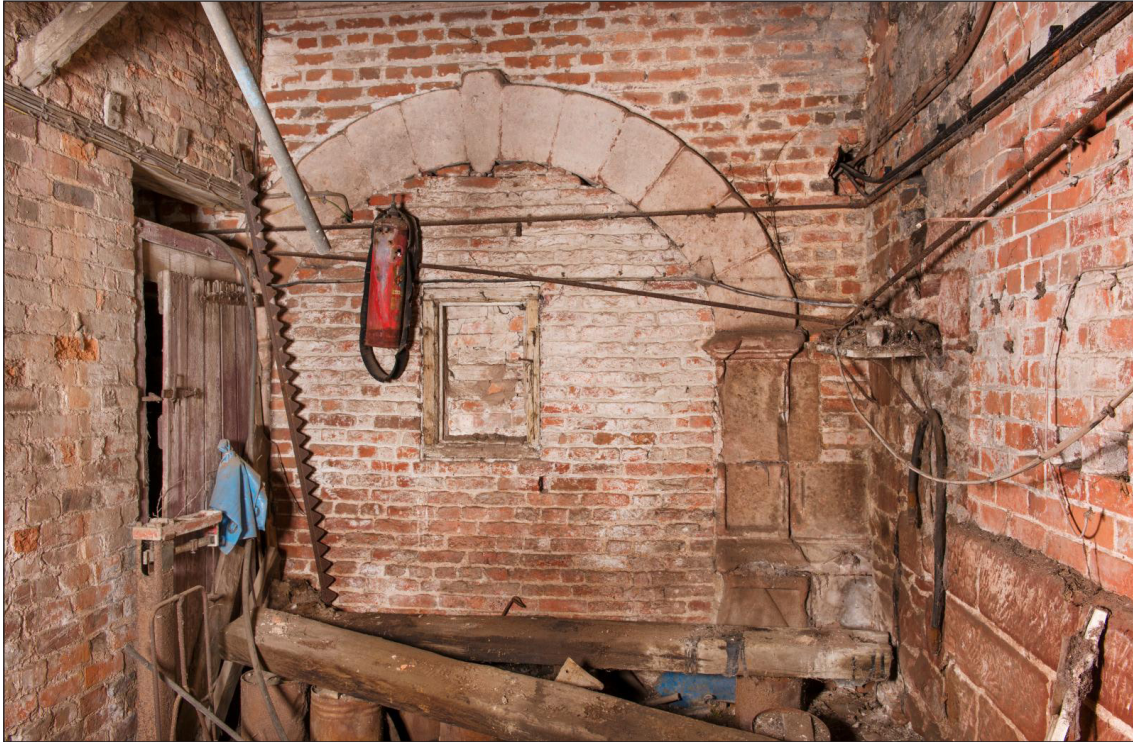
Figure 22: The blocked arch in the east elevation with the later timber window frame (DP220876)

A relatively early change appears to be the blocking of the arch on the east elevation which marked the end of the gatehouse's use as a thoroughfare and the point when it was converted into an enclosed building. The arch was blocked with small, handmade bricks which may date from the 17th or 18th century (Figure 22). A small pegged timber window is set into the bricks; this is now bricked up as well.

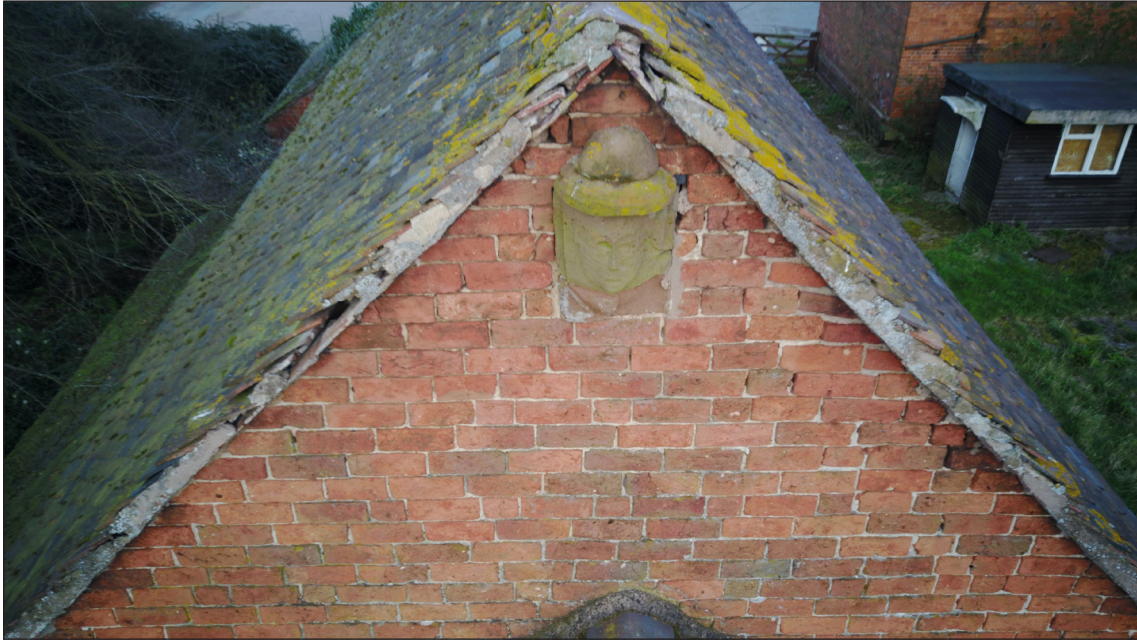
Figure 23: The *ex situ* carved corbel on the west gable of the building to the north of the gatehouse (© Mark Furniss, reproduced with permission)

Other questions, which remain at present unresolved, concern the provenance of the fragments of early fabric on the site. A corbel crudely carved with a human face has been set into the gable of the building to the north of the gatehouse (Figure 23). Its provenance is unknown but it may have been found on the wider site. It seems most likely that it was set into the gable when the building was erected in the early 19th century.

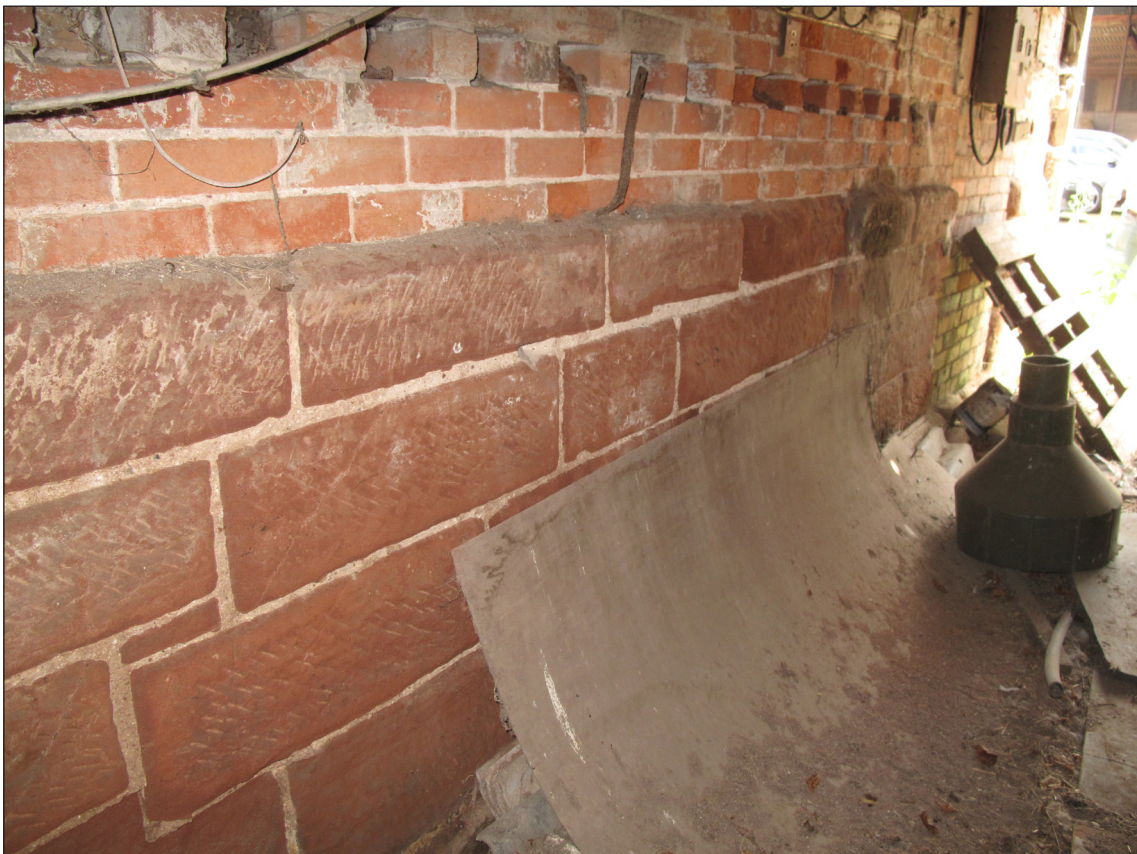
Figure 24: The sandstone base on the interior of the building attached to the east of the gatehouse (Rebecca Lane)

A number of brick farm buildings, including those to the east of the gatehouse, have bases of three or four courses of large, carefully worked red sandstone blocks with tool marks (Figure 24). Some blocks show signs of chipping which may indicate that they were reused, although these are generally on the exterior and might be due to weathering or abrasion. The stones on the interior generally have sharper

edges, yet a closer inspection shows that several differently sized stone blocks were used, sometimes even within one course. Such improvisation tends to support the theory that, like the carved corbel, they were in fact re-used from elsewhere. Several secondary sources have interpreted them as having come from earlier buildings or walls on the site and possibly the historic manor house.⁴⁴ Alternatively, they may be the *in situ* bases of previous farm buildings on the site, possibly timber-framed, which were later rebuilt in brick.⁴⁵ Any such earlier buildings were most likely constructed later than the gatehouse, which was clearly designed as a free-standing building, with windows in the long elevations and, probably, abutting boundary walls to the north and south.

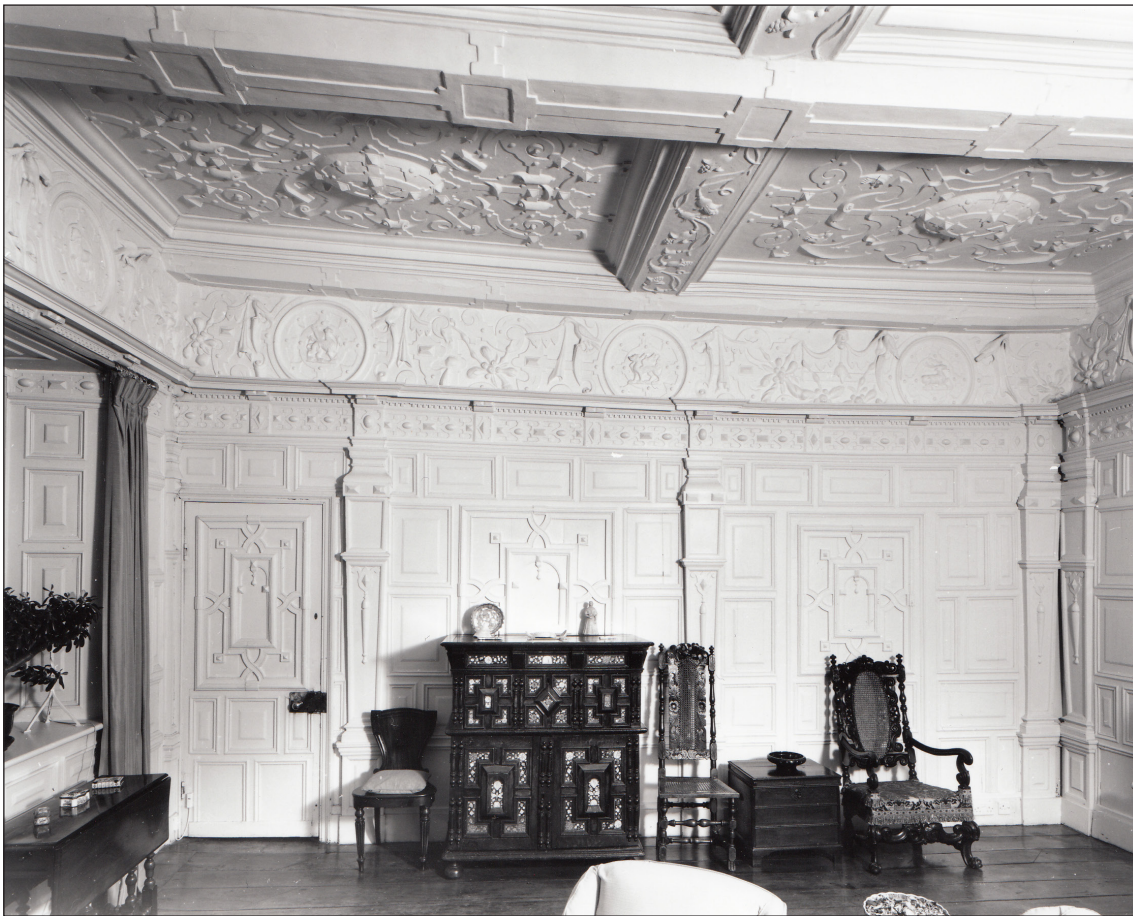
Figure 26: The plasterwork in the drawing room at Benthall Hall, Shropshire; photographed in 1995 (Historic England Archive, BF94928)

The most complete schemes of this group are at Benthall Hall and Abcott Manor. The interiors of Benthall Hall were remodelled in the early 17th century by Lawrence Benthall (inherited 1633, died 1652), including the drawing room with its strapwork ceiling with enriched beams and a frieze (Figures 26-27). The frieze has repeating motifs of roundels filled with strapwork and an animal at its centre. The space between the roundels is filled with further strapwork on which two birds perch, holding tasselled swags which thread through the strapwork. The general pattern remains the same throughout the frieze but the size and shape of the birds varies and in one section a human face or mask is holding part of the swag.

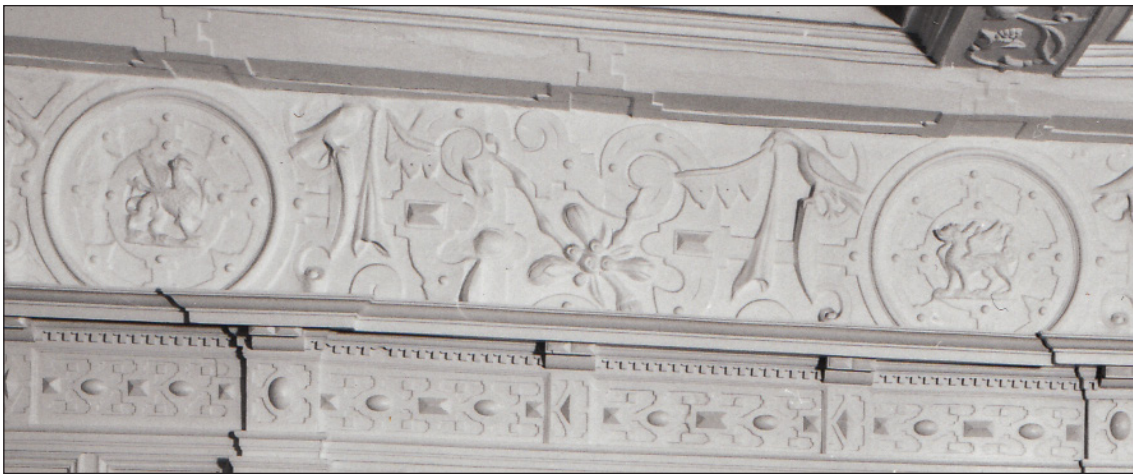
Figure 27: Detail of the frieze at Benthall Hall, Shropshire; photographed in 1995 (Historic England Archive, BF94928)

The motif of birds holding swags in the frieze at Caynton Manor appears to be most closely related to the plasterwork at Benthall Hall and Abcott Manor, due to their combination with strapwork. The Caynton example shows perhaps a greater degree of variation in the shape of the swags and the size and type of bird (Figures 20, 30-32). In general, the pattern is less complex, for example with tasselled swags which hang straight down and do not thread through the strapwork as at Benthall Hall, which also has a kind of cornucopia hanging from the swag (Figure 27).

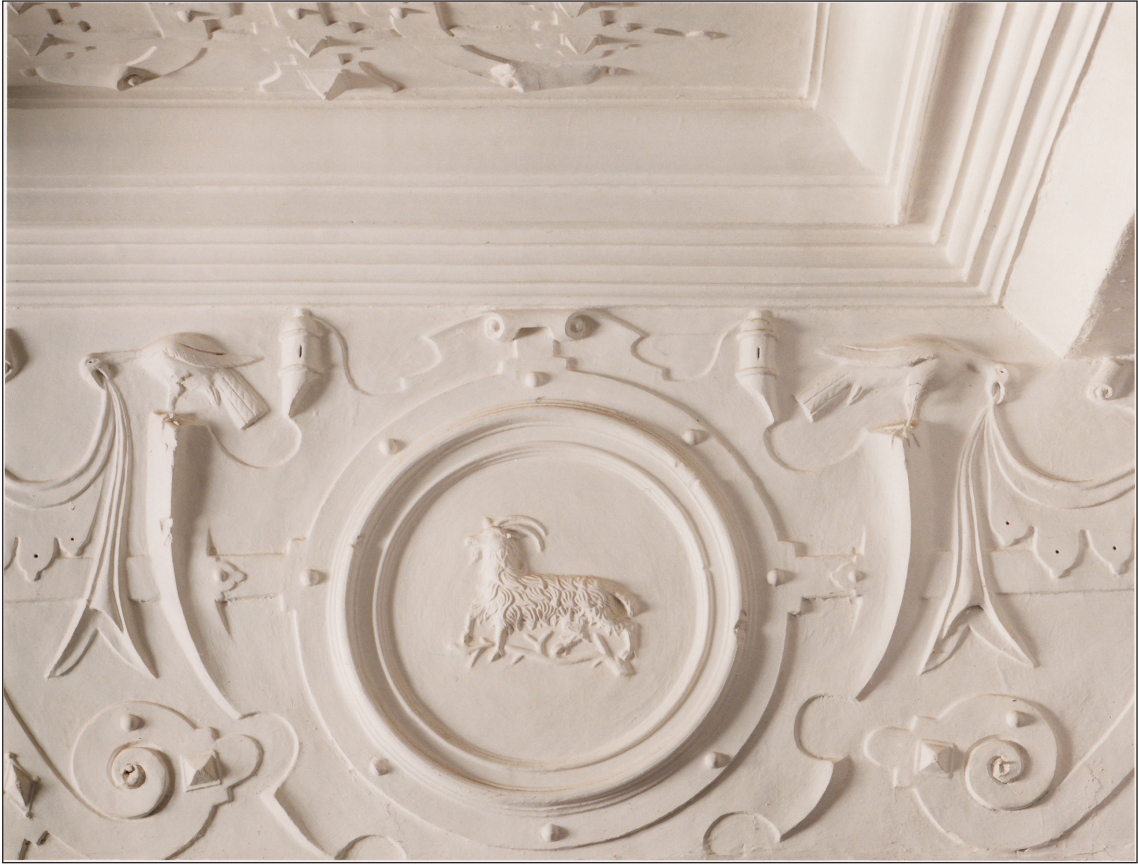
Figure 28: Detail of the plasterwork frieze in the first-floor great chamber at Abcott Manor, Clungunford, Shropshire (Historic England Archive, BF110302, 2K/08829)

Another example can be found at Abcott Manor at Clungunford, in a part of the house which has been stylistically dated to c 1620-30 (Figure 28).⁷⁴ The great chamber on the first floor of the east half of the north range has a frieze which is nearly identical to that at Benthall Hall, although there are small variations: the pattern of the strapwork is slightly different, the medallions are not filled with strapwork, and the birds are bending further forward.
