The Gatehouse, Caynton Manor, Edgmond, Shropshire: Building Investigation

Research Report Series 70-2018

BUILDING INVESTIGATION

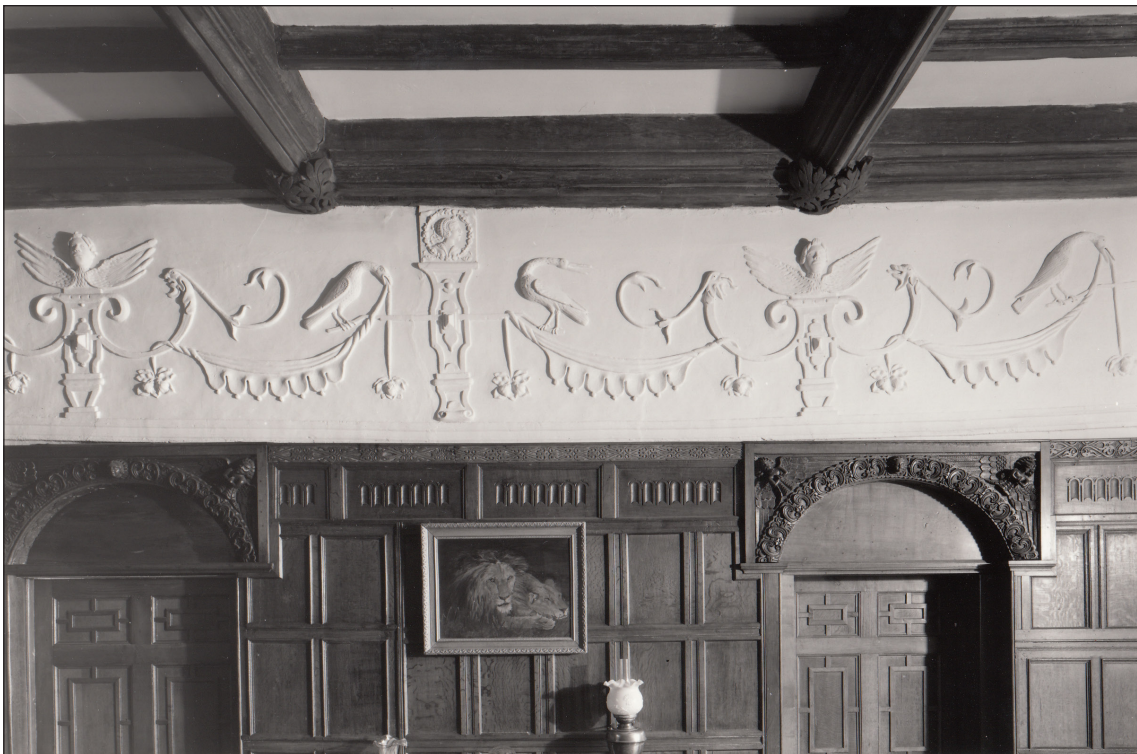
Figure 29: Central section of the plaster frieze in the hall of the Old Council House in Shrewsbury, photographed in 1985 (Historic England Archive, BF035801)

A variation in the motif of the birds holding tasselled swags occurs in the 17th-century plasterwork frieze in the Old Council House in Shrewsbury (Figure 29). The

building dates from the 15th and 17th centuries with early 19th-century alterations and additions.⁷⁸ The entrance hall has a Jacobean fireplace with overmantel, a deep plasterwork frieze on the wall opposite, and a stone ceiling boss over a window with the date '1634' whose authenticity has been questioned.⁷⁹ The room has been altered in connection with 19th-century subdivisions. Neither the wall with the frieze, nor that with the fireplace appears to be original, and both features must have been reinstated. The frieze features the bird motif but here much larger birds face outwards, not inwards, and there are no medallions and very little strapwork.

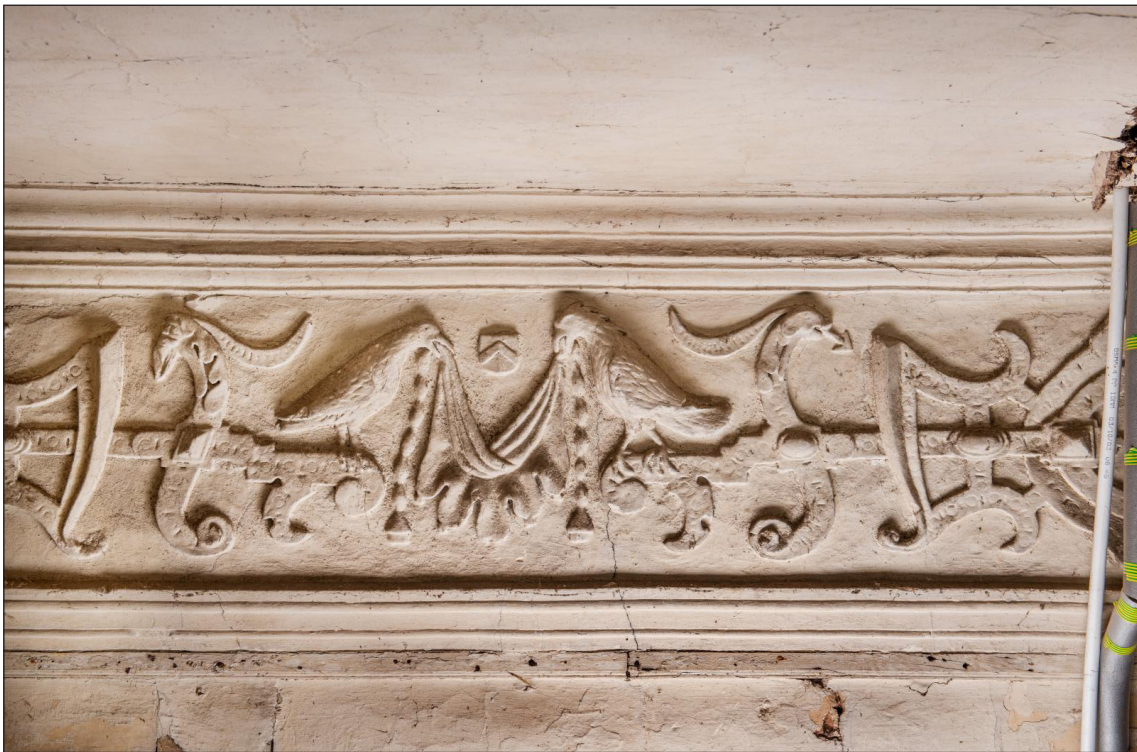
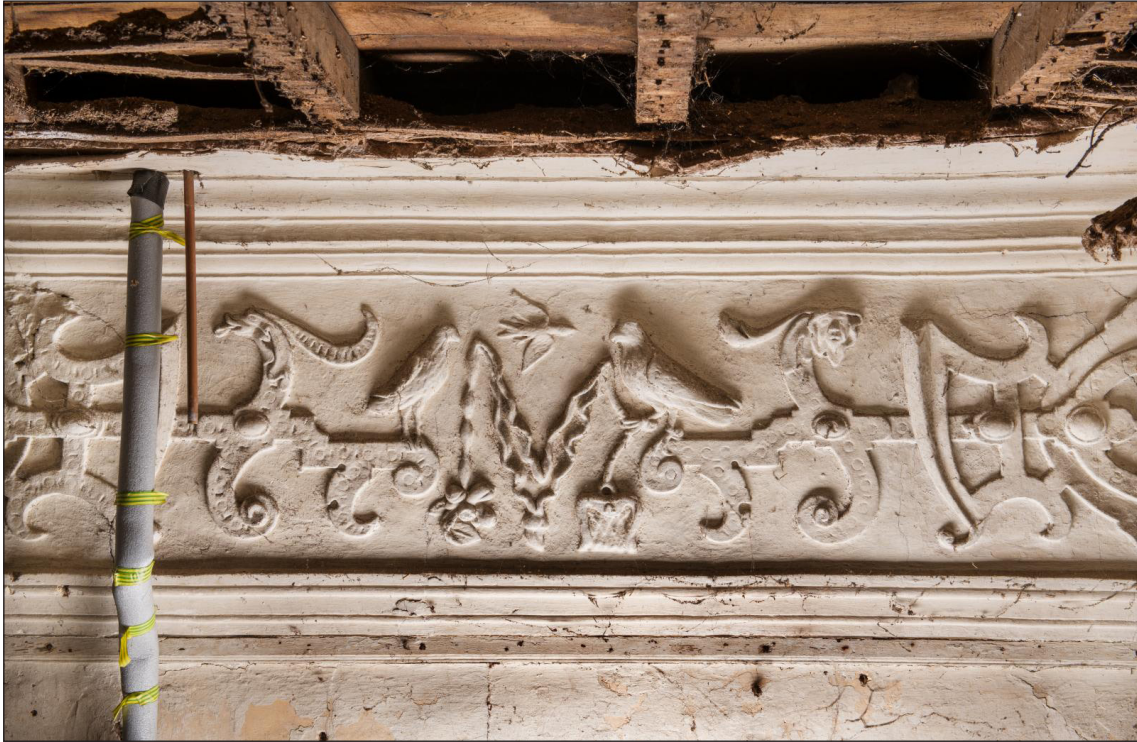
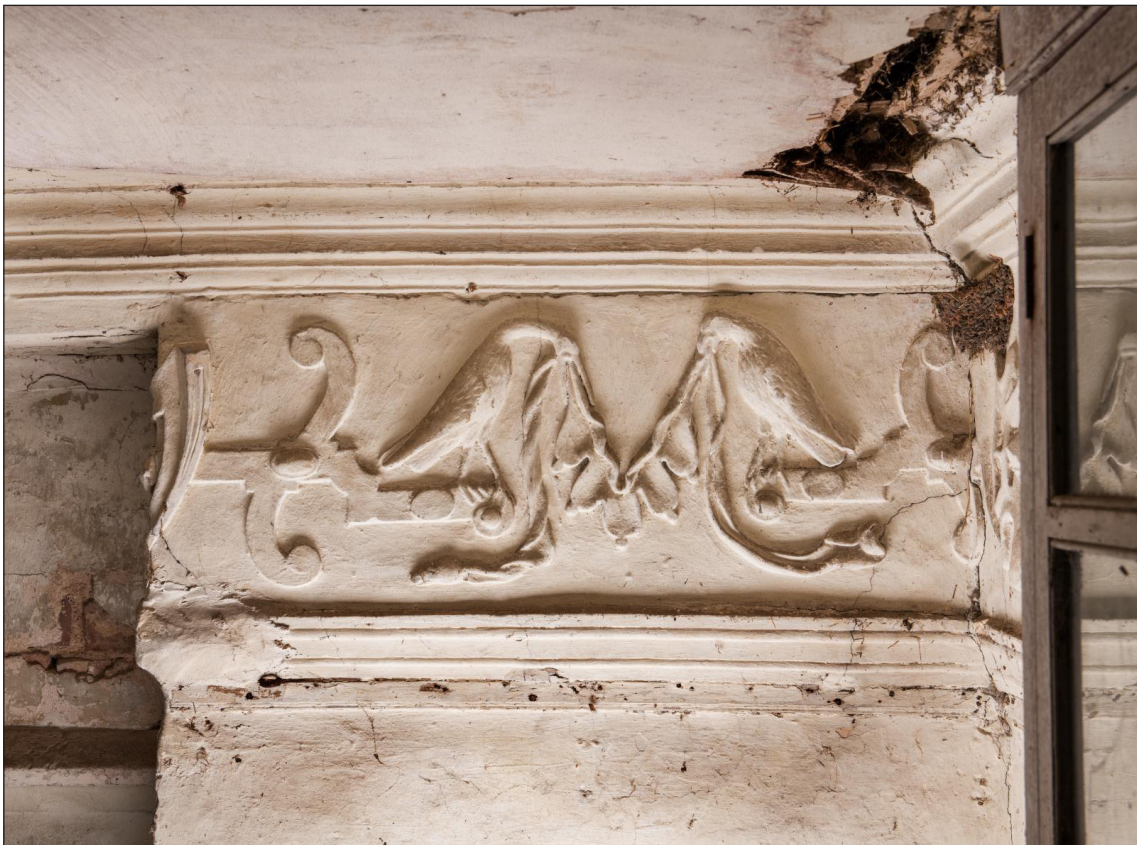
Figure 30: Detail of the frieze on the north wall of the gatehouse's first-floor south room (DP220818)

Figure 31: Detail of the frieze on the north wall of the gatehouse's first-floor south room (DP220820)

Figure 32: Detail of the frieze on the east wall of the gatehouse's first-floor south room (DP220825)

There is evidence that the plasterwork was not the only kind of decoration in the gatehouse's first-floor rooms. It seems likely that they also featured wall-hangings, hung from nails or hooks in the battens directly below the friezes. The battens can be found in both rooms, with flush and projecting nails, and at least one hook (Figures 20, 30-32).
