Historic England

Soft Capping on Ruined Masonry Walls

Chris Wood, Alan Cathersides, Prof Heather Viles

Discovery, Innovation and Science in the Historic Environment

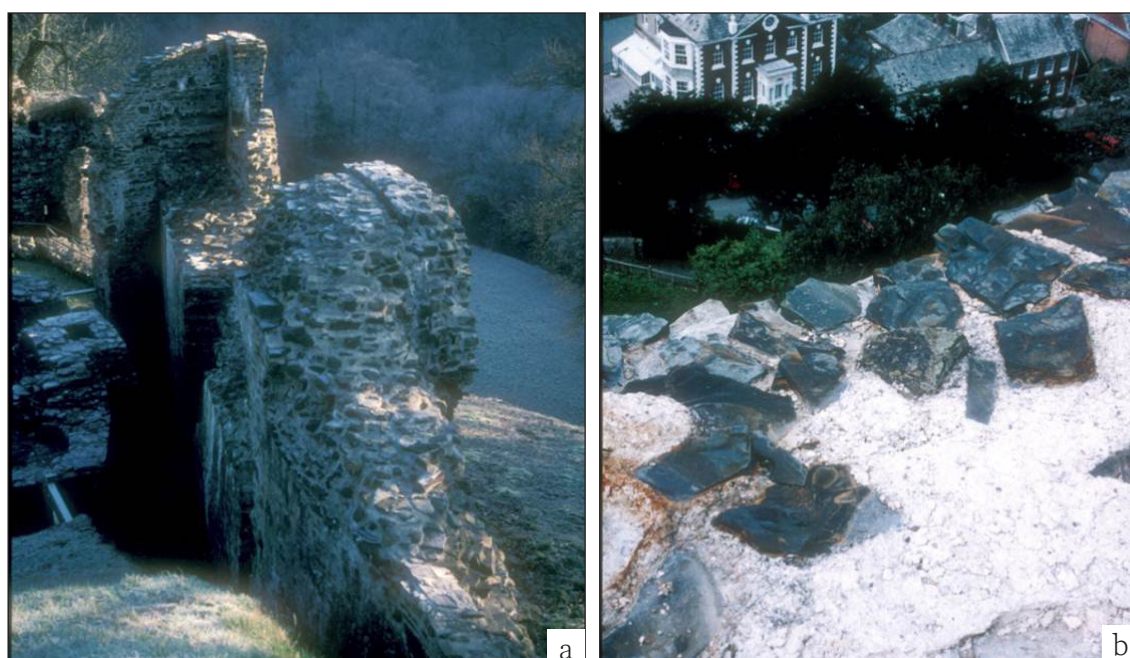
Figure 1.2 Frost damage at (a) Okehampton castle and (b) Launceston Castle.
(both Chris Wood ©Historic England)

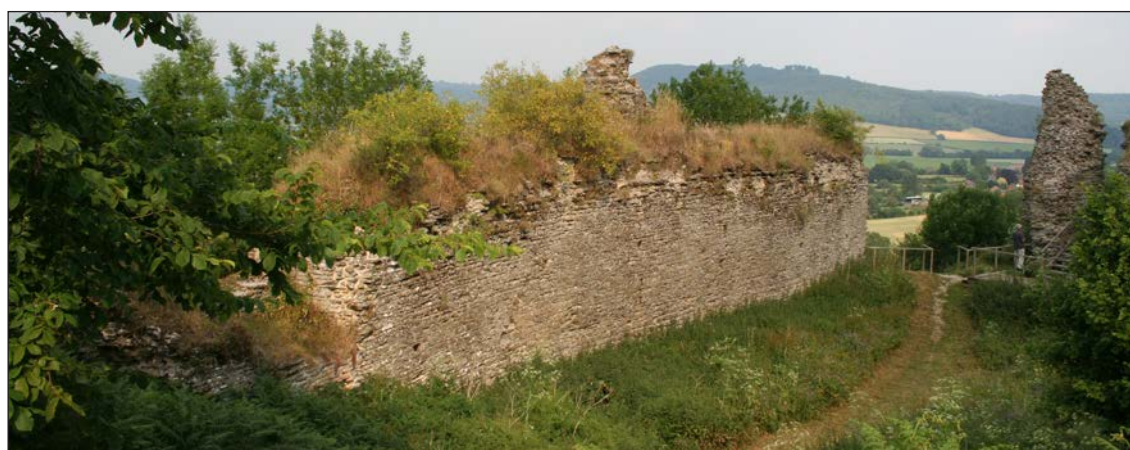
Figure 1.3 Luxuriant natural soft capping growing at Wigmore Castle.
(Chris Wood ©Historic England)

Clearly another solution was needed. Soft capping potentially offered one. It has long been observed that ruins with natural soft caps are often in remarkably good condition. At Wigmore Castle in Herefordshire, for instance, some of the walls survive after several centuries of neglect, even though the castle was built of a relatively poor local mudstone and had lost all its render. It is thought that the luxuriant growth covering these walls enabled them to survive. In Yorkshire, the private owners of Jervaulx Abbey let nature predominate when the ruins were consolidated in the 1980s (Figure 1.4). The walls were covered by a natural soft capping that had seemingly provided protection for centuries (see Figure 1.4 and Figure 1.3). In Ireland, a number of 16th-century ruins with natural soft caps survive. An example of this is the late medieval church of Myross in County Cork. Although it has lost most of its mortar and joints, the walls still remain standing, with little sign of bowing under a thick canopy of grass (Figure 1.5).

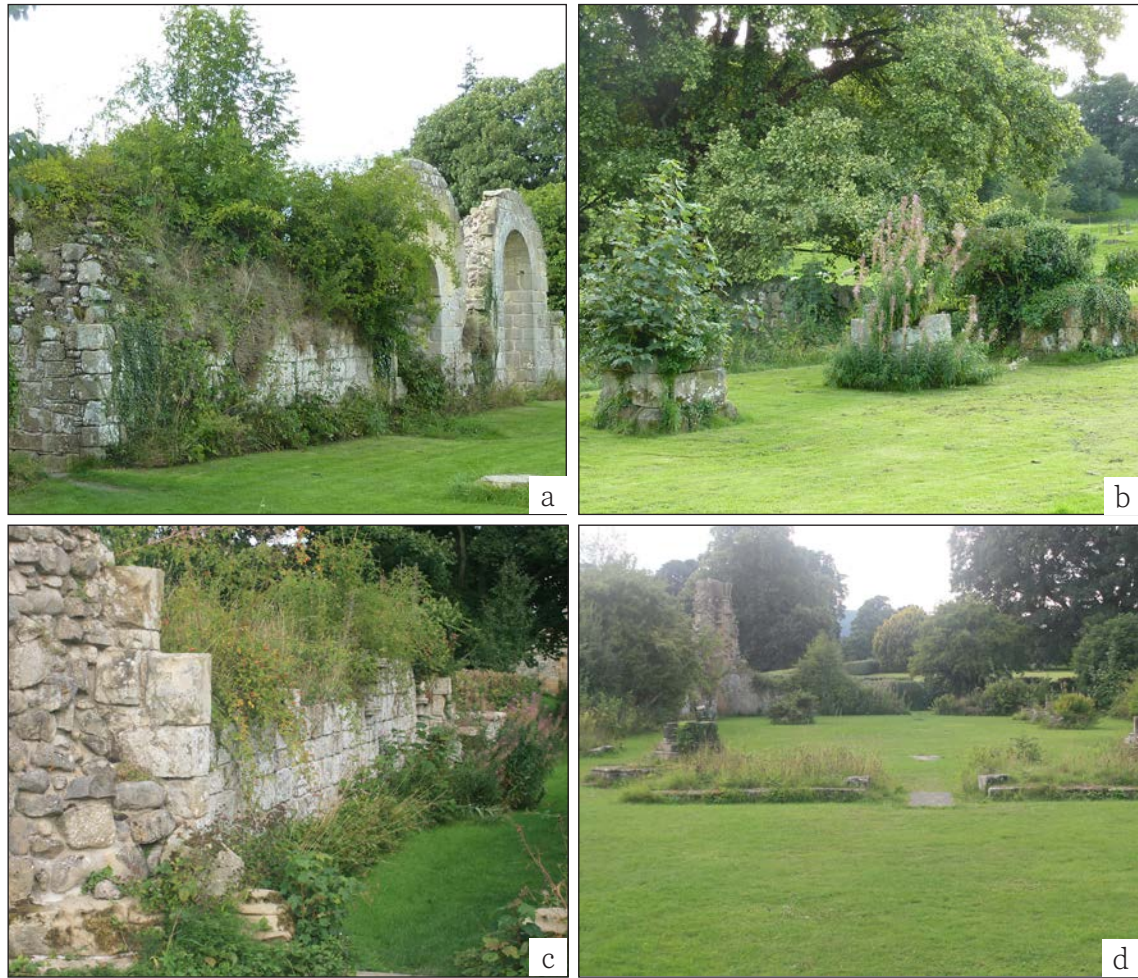
Figure 1.4 (a-d) Natural soft capping and deliberate planting at Jervaulx Abbey.
 (a,c Chris Wood ©Historic England; b, d ©Heather Viles University of Oxford)

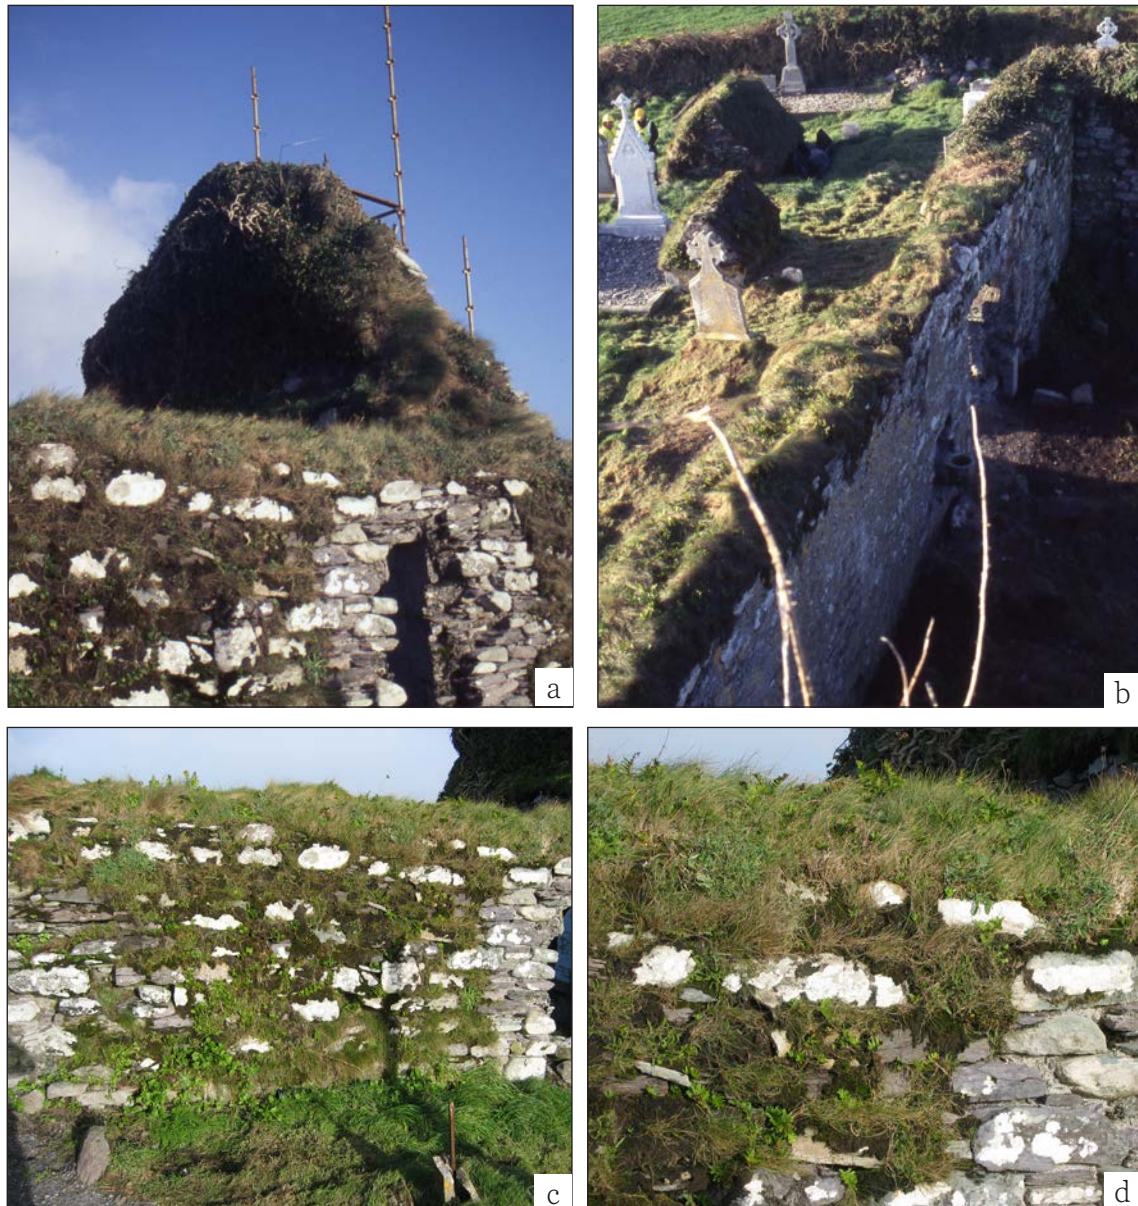
Figure 1.5 (a-d) Natural soft capping at Myross Church, County Cork, Ireland.
 (a-b © Alan Cathersides, c-d Chris Wood ©Historic England)

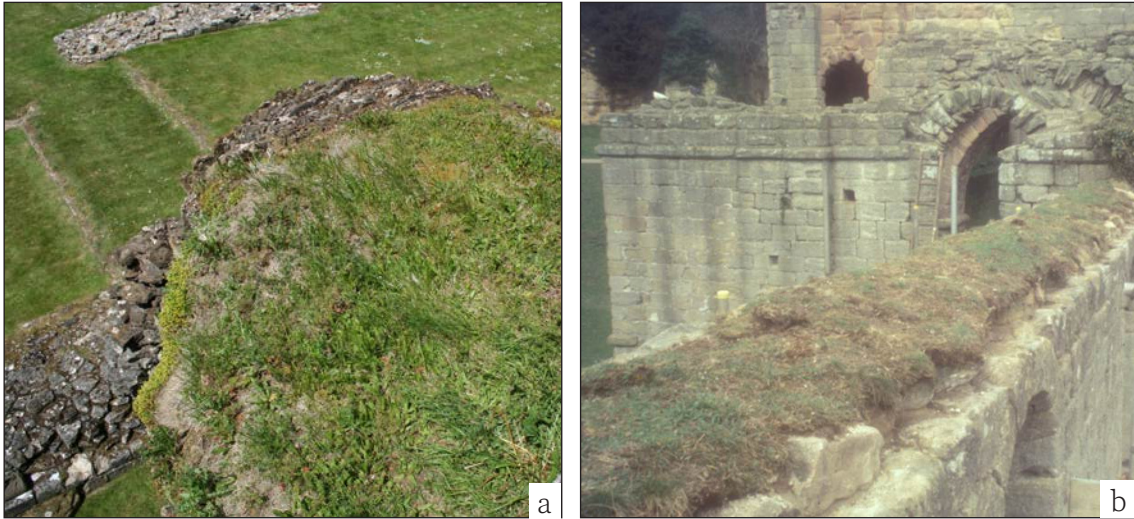
Figure 1.6 (a-b) Soft capping trialled at (a) Kirkham Priory, 1993 and (b) Fountains Abbey in the late 1980s. (a *Chris Wood* ©*Historic England*; b ©*Rory Ogilvie*)

English Heritage started consolidating a variety of ruined sites with soft capping as early as the 1980s. Abbeys, priories, castles and walls have all been repaired in this way. The results have been encouraging. For instance, at Kirkham Priory in North Yorkshire, water percolation was causing significant staining with lime and even large stalactites forming above the vaults. Locally cut turfs were placed above an opening on the cloister side of the western range and above the vaults (at the north end of the western range adjoining the nave, Figure 1.6a). The problems stopped quickly, presumably because the turfs absorbed rain, which would then evaporate.

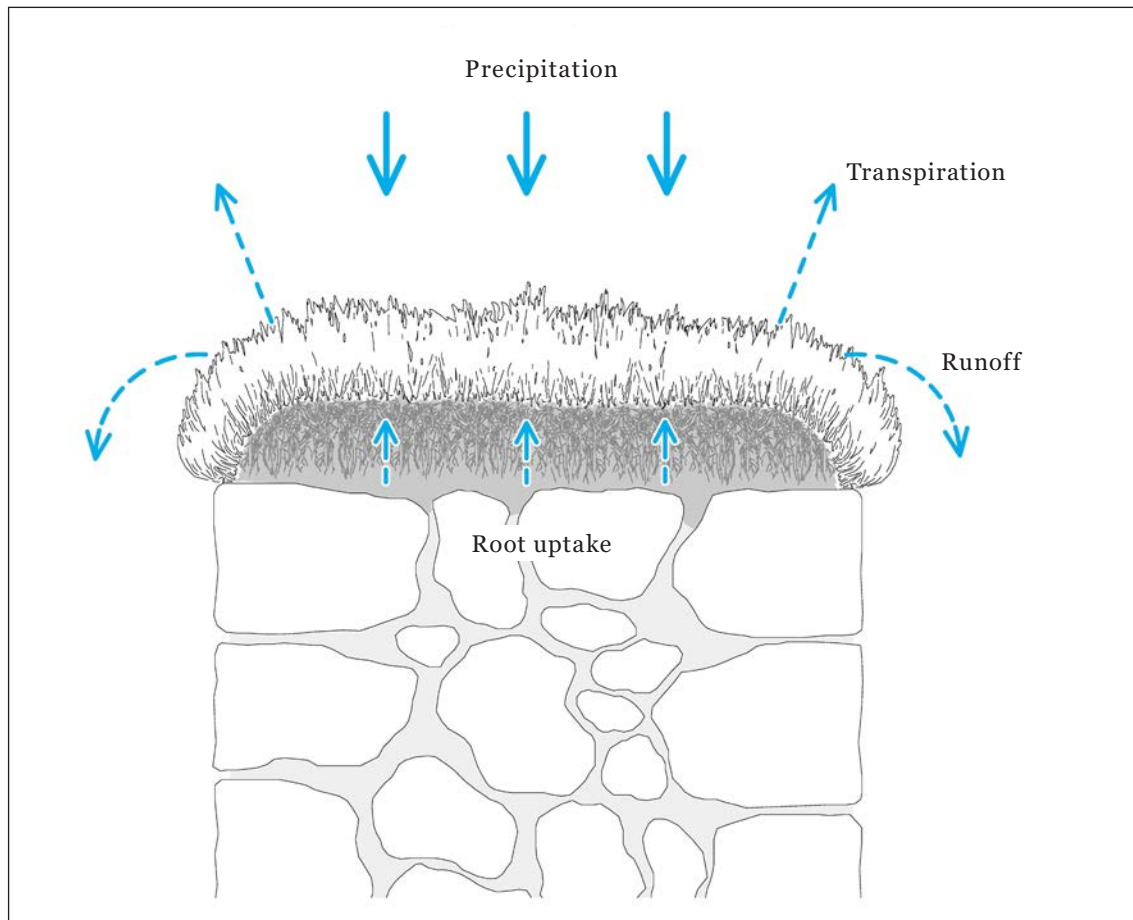
Figure 1.11 Ways in which grass reduces water runoff down the wall face.
 Iain McCaig © Historic England

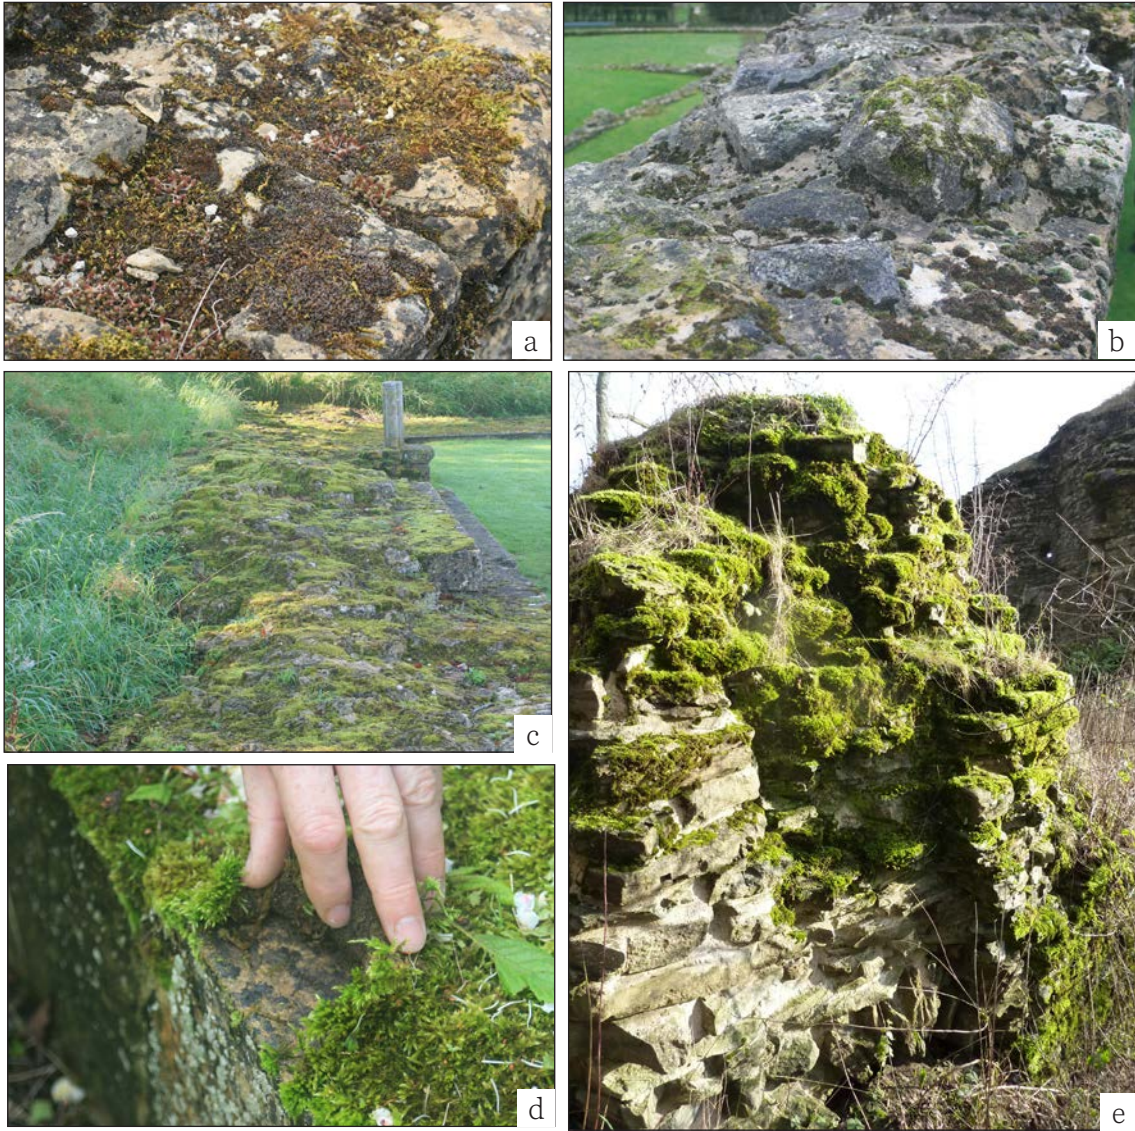
Figure 1.12 Natural growth of lichens and mosses on wall heads. (a-b) Kirkham Priory, (c-d) Hailes Abbey and (e) Wigmore Castle. (a-d) © Alan Cathersides, (e) Chris Wood ©Historic England)

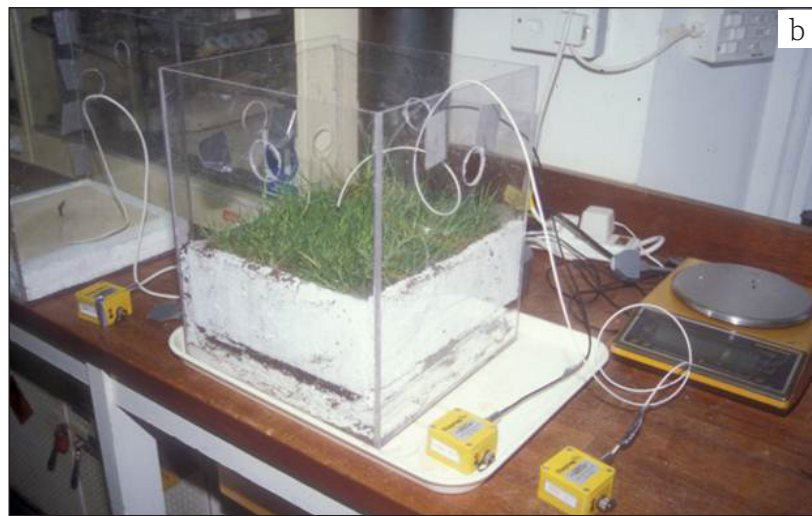
Figure 1.13a, b Experimental set-up with stone and soft capping in Perspex boxes. (a Iain McCaig © Historic England, b Chris Wood © Historic England)

The tests were designed jointly by English Heritage and researchers at the School of Geography and the Environment, University of Oxford. They were carried out between March and May 2000 and described fully in Viles et al. 2002. The tests simulated measured conditions from Hailes Abbey, near Cheltenham, Gloucestershire. The ‘thermal blanketing’ experiments compared soft caps of different depths and soil types with hard caps and bare stone. Temperatures were measured on the stone surface (below the soft and hard caps and on the bare stone) in an environmental cabinet. This cabinet produced controlled cycling of temperature and humidity repeatedly going from conditions found on a cold January night to those on a hot July day. Samples of soft capping, hard capping and bare stone were each set up in perspex boxes (Figures 1.13a-b).

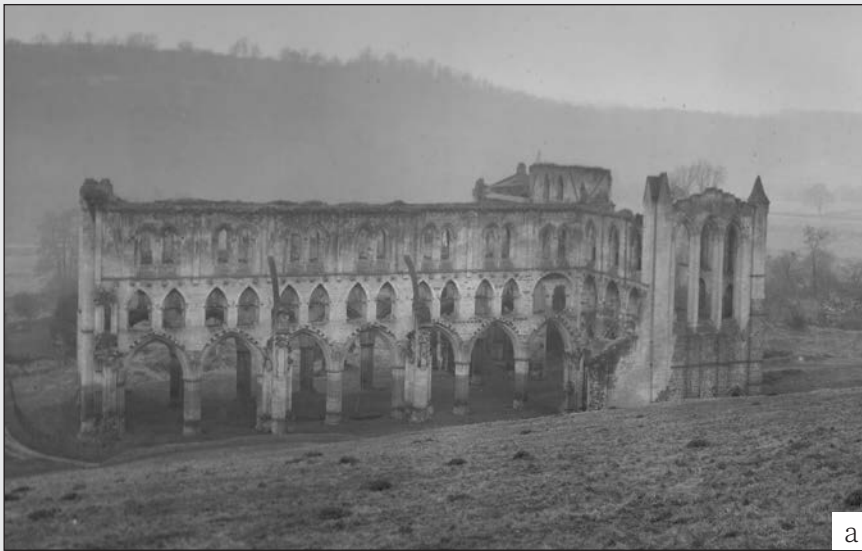
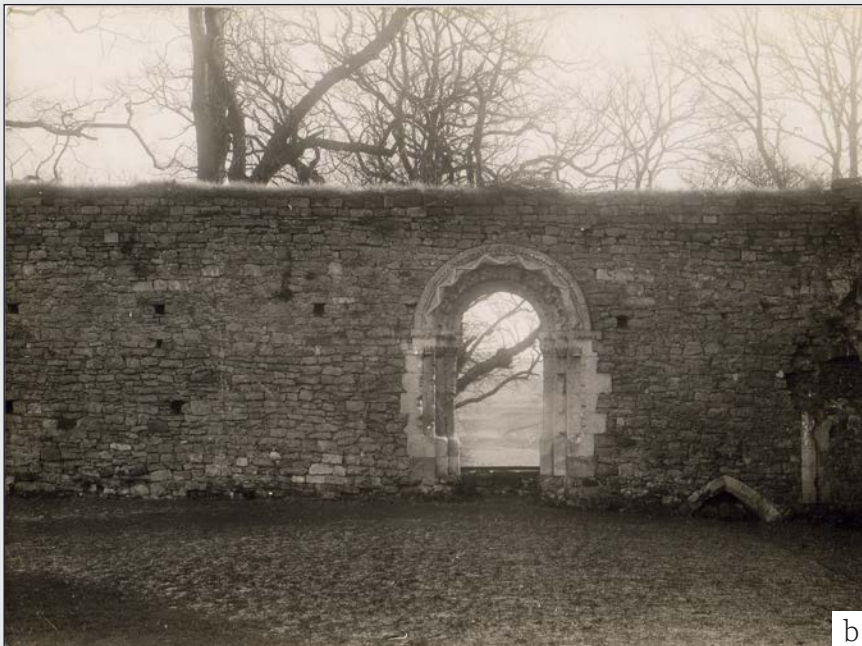
Figure 1.15 (a) Natural capping at Rievaulx, (b) Natural capping at Kirkham reredorter.

However, a look at the photographic and documentary record of some monuments suggests that a liberal interpretation was taken of the mantras of minimum intervention and conserve as found. Clearly, at both Rievaulx Abbey and Kirkham Priory the walls had once been topped with a layer of grass (see Figure 1.15a), which seemed to have helped preserve the walls below. But contemporary correspondence reveals that conservators strove to present these sites as more ‘authentic’ ruins: in other words, robbed of facework and exhibiting the core. The tops of the walls were stripped of their grass layers, no doubt a necessary precursor to consolidating the wall heads, but the works seemed to embrace far more than a conservative repair. At Kirkham the very obvious coursing of the ashlar face stones on the Reredorter (Figure 1.15b) was removed to expose the rough corework behind. The facework and heraldic shield within the spandrel of the vaulted louver were completely removed. Repairs and maintenance sought to present the appearance of ageing, with mortar joints eroded back and the tails of face stones left in the exposed core.

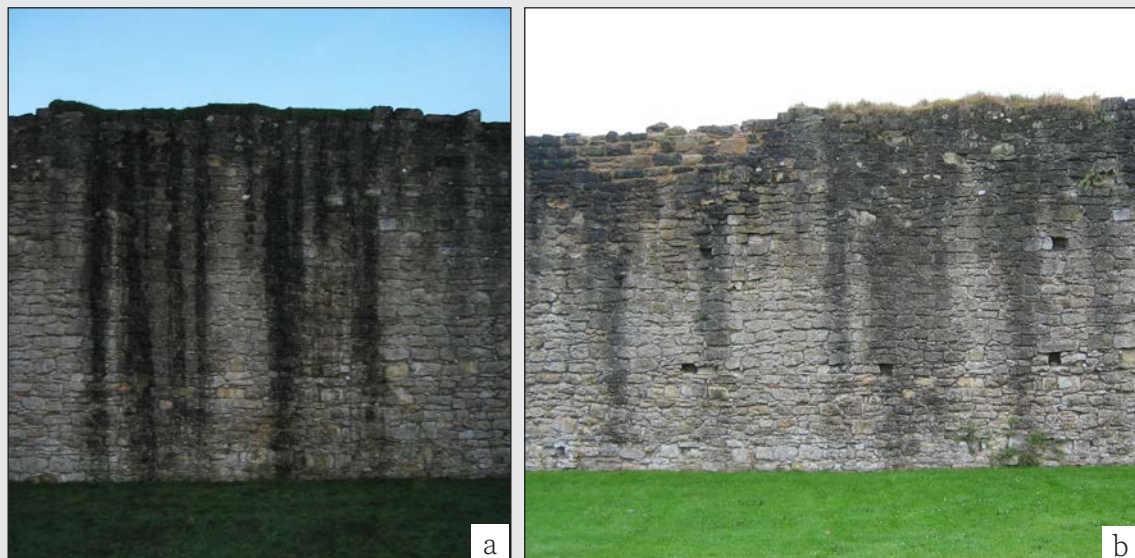
Figure 1.16 (a-b) Streaky walls at Kirkham Priory. *Chris Wood©Historic England*

But it proved difficult to maintain the conserved monuments. Most work – repointing, rendering, grouting and rough racking – was carried out with cementitious mixes, since it had not yet been fully appreciated that these hard mixes eventually hasten deterioration and decay. The repairs of the wall tops were designed to shed water as quickly as possible. However, the result, as shown at Kirkham Priory (Figure 1.16), was to create distinct pathways which became rapidly colonized by Tintenstriche algae (Luttge, 1997), giving the walls a stained appearance even when dry.

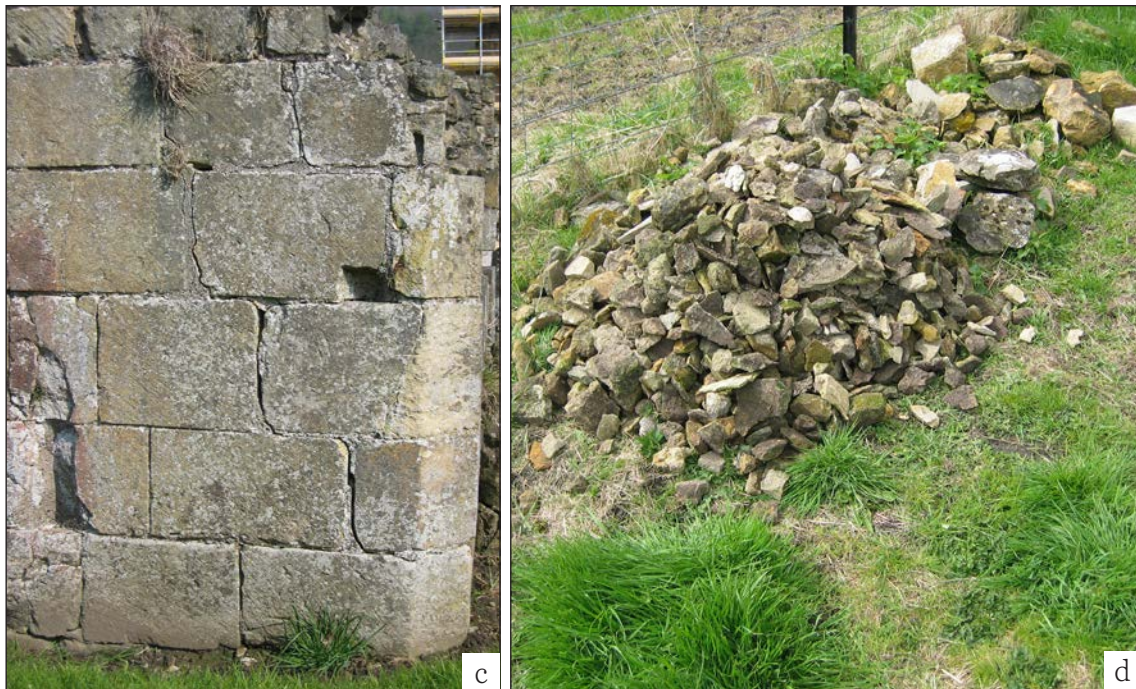
Figure 2.2 Deterioration at Byland Abbey

(c) vertical cracking along joints

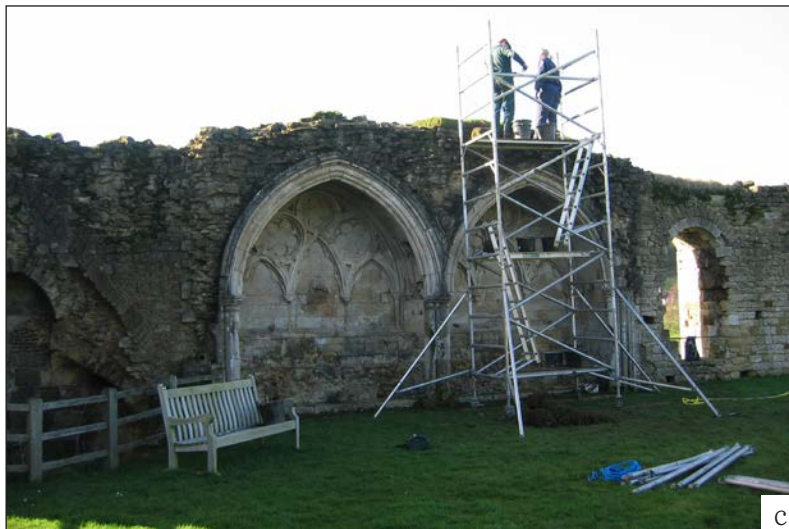
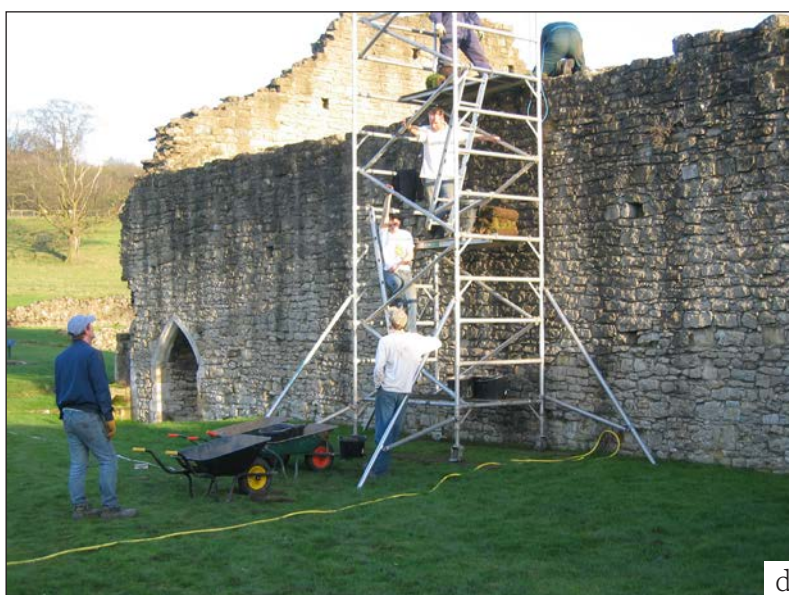
Figure 2.4 c, d
Installation of soft capping on top of the laver alcove on the southwest side of the cloister (test location 1) and on the top of the northeast cloister wall (test location 2) at Kirkham Priory in February 2004. (both ©Heather Viles, University of Oxford)

New soft caps were installed in February 2004 at two test locations (see Figures 2.4c-d and 2.5). The first test location was above the laver alcove, alongside a patch of existing soft capping from the 1980s/1990s (approx. 4 m high), and on a small ledge between the arches at a lower elevation over an area approximately 30 cm long and 15 cm wide (Figure 2.5a). The new soft caps were 10 cm thick, formed from turf cut from the site and slate fragments were added to the soil. The second test location was along a portion of the north-west frater wall with pronounced runoff streaking, where a small section of hard capping had been installed in July/August 2004. As work began, it became clear that the existing hard cap was a cement-based thick layer of about 1 m in depth. Hammer and chisels proved inadequate to remove this, as did Kango road hammers. In the end, quarrying techniques using plugs and feathers were needed to remove the capping. The cap was reconstructed with lime mortar (1 part St Astier NHL3.5: 2½ part graded aggregates (1½ parts Moreleys sharp sand: 1 part Sherburn soft sand)). Reused stone was used where possible, along with other stone obtained from the on-site store.

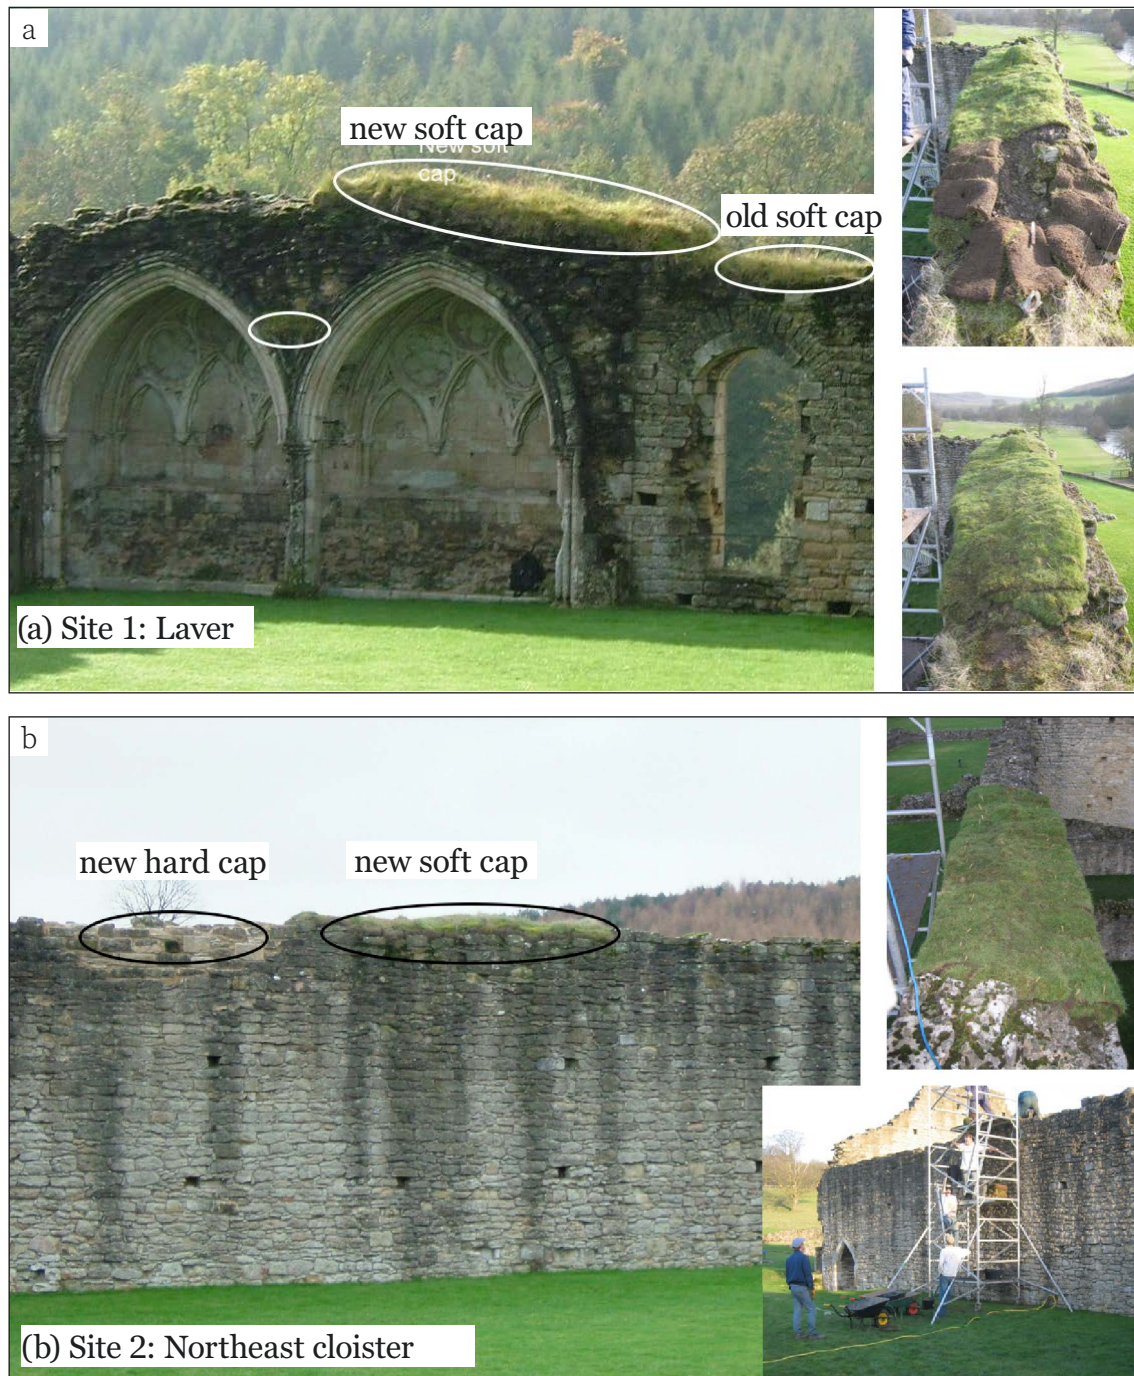
Figure 2.5 Location of newly installed soft capping at Kirkham Priory.
 (a) Site 1, the laver alcove, where a 5 m long (1.3 m wide) section of 10 cm thick soft capping (using local turf and soil containing regolith) was installed on the top of the wall (see insets of installation). A 30-cm (15-cm wide) section was also installed, at the top of the column between the arches (lower white circle).
 (b) Soft capping (3.9 m long, 50 cm wide 10 cm thick soft capping using local turf and soil with regolith) and hard capping (3.9 m, 50 cm wide using lime mortar and stone) on the north east cloister wall, at site 2.
 (all ©Heather Viles, University of Oxford)

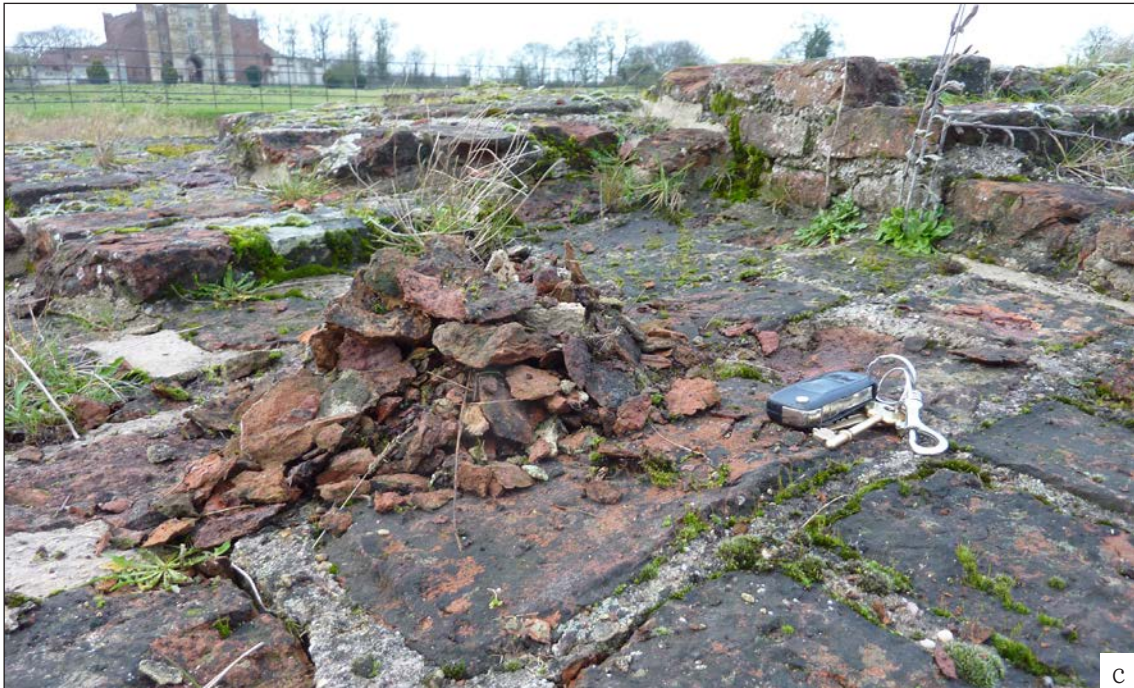
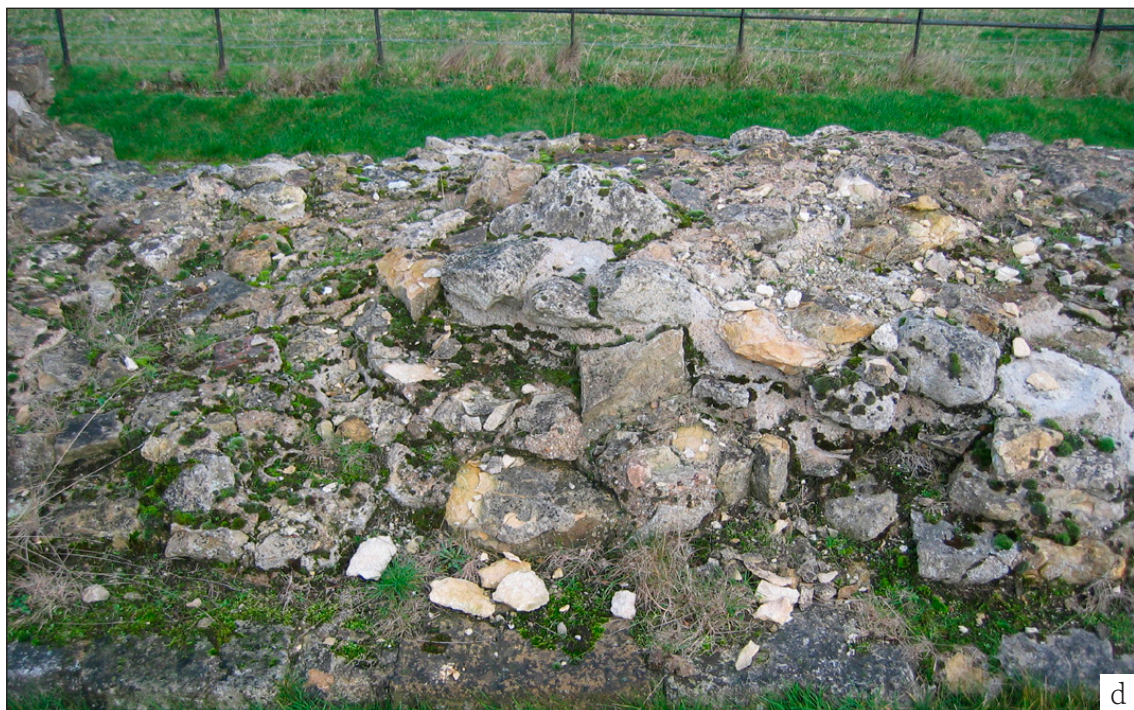
Figure 2.6 c,d Frost damage at Thornton Abbey on (a) brick and (b) stone. Image (a) shows a pile of frost-shattered brick debris swept carefully from the surrounding brick surface. (both ©Heather Viles, University of Oxford)

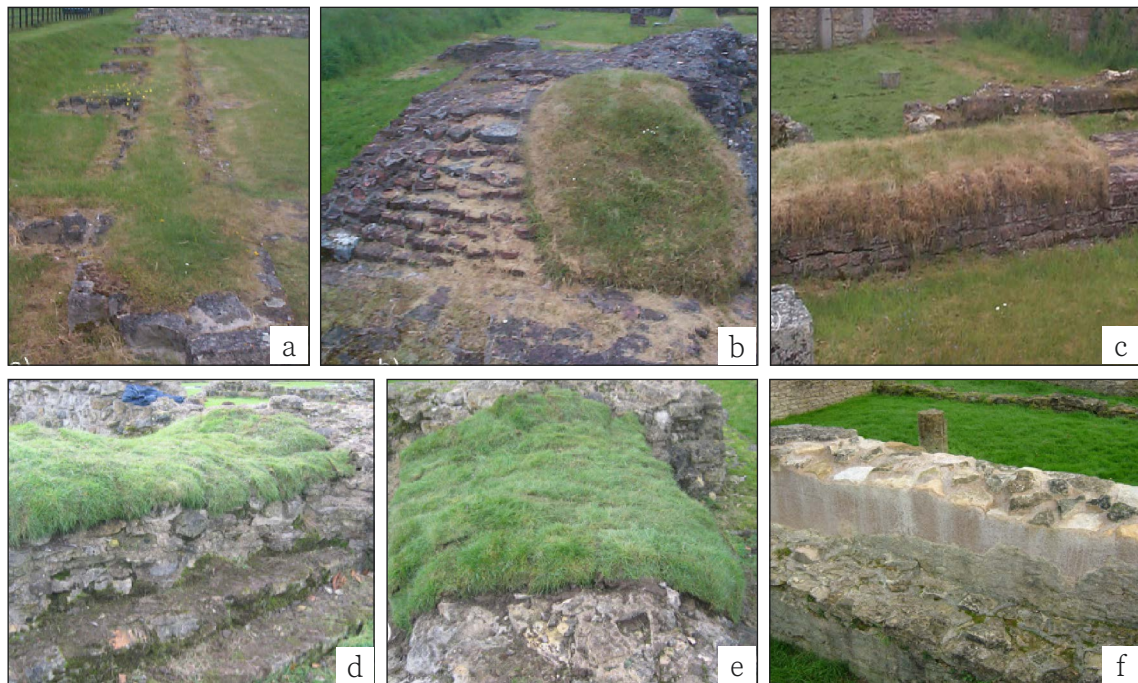
Figure 2.7 The test locations monitored at Thornton Abbey.

(a) An old soft-capped wall, installed in the 1980s.

Soft caps were installed on low walls at three test locations in February 2004 (Figure 2.7). The soft caps were 10 cm thick, made of soil containing regolith and turf cut from the site. The first test location was a sloping fan-shaped brick section on the north wall of the undercroft. The section alongside and immediately to the south was left uncapped for comparison (Figure 2.7b). The second test location was a 60-cm high brick wall with a flat top (Figure 2.7c), while the third test location was a cambered, rough-racked limestone wall (Figure 2.7d, e). A section of limestone wall south west of the Chapter House was hard-capped in July/August 2004 (as shown in Figure 2.7f). Here, the old render that had extended to the top of the wall was lost in the process of removing the existing cement cap (some 20 cm thick). Lime mortar (1part NHL 3.5:3 parts graded aggregate) was used to repair a fracture and complete the hard-capping. Finally, the wall face was re-rendered.

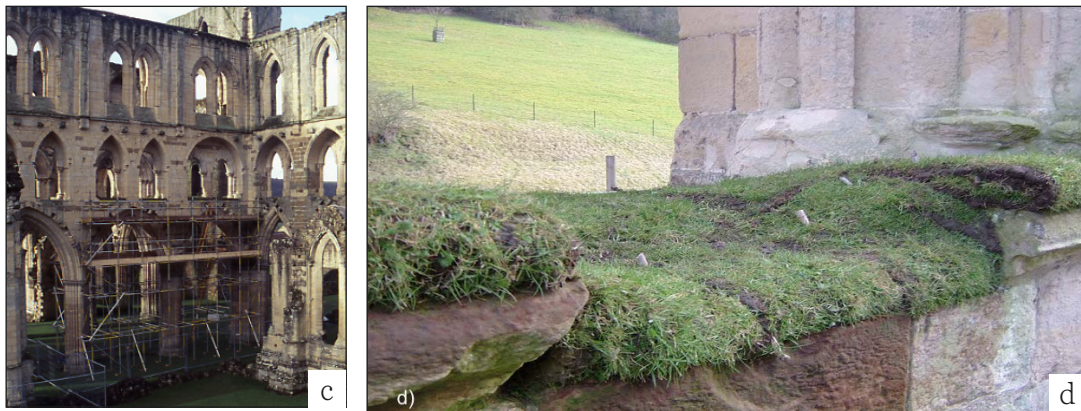
Figure 2.8 c, d The soft capping installed high at triforium level in the wall of the main abbey church nave at Rievaulx. (both ©Heather Viles, University of Oxford)

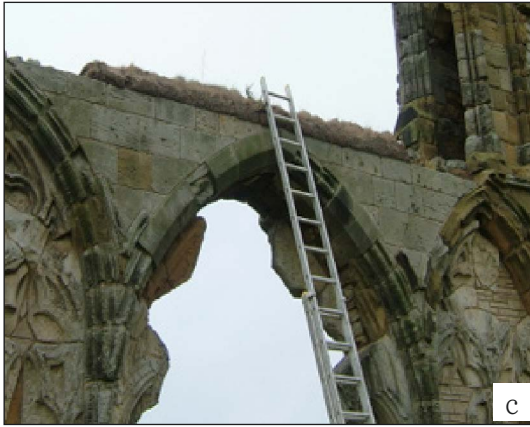
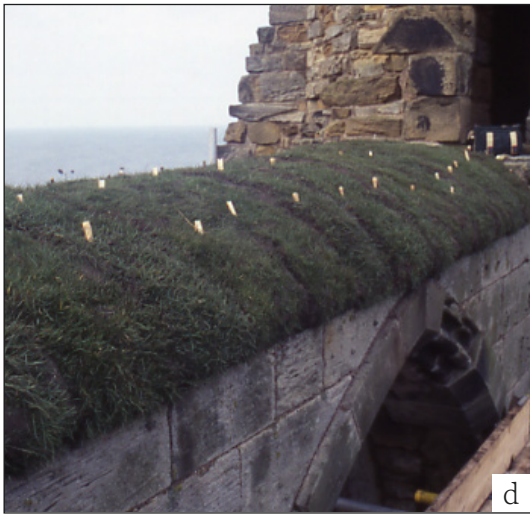
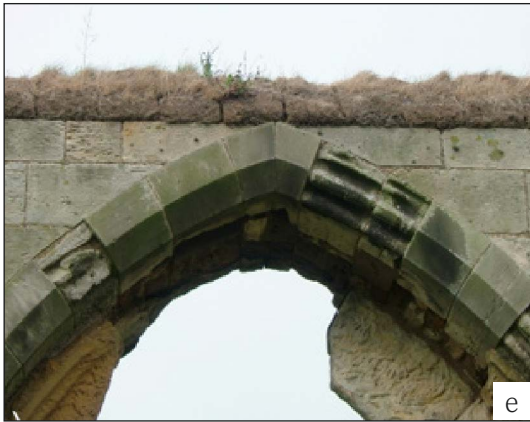
Figure 2.10 c,d,e (left) The soft capping installed at high elevation on the west Front wall at Whitby Abbey. (all ©Heather Viles, University of Oxford)

A high-elevation section of the West Front, which is exposed to wet and windy conditions, over an archway rebuilt following damage in WWI was soft capped in February 2005 (Figure 2.10c,d,e). The aim was to test whether soft capping could survive and protect under windy, coastal conditions (Figure 2.11).

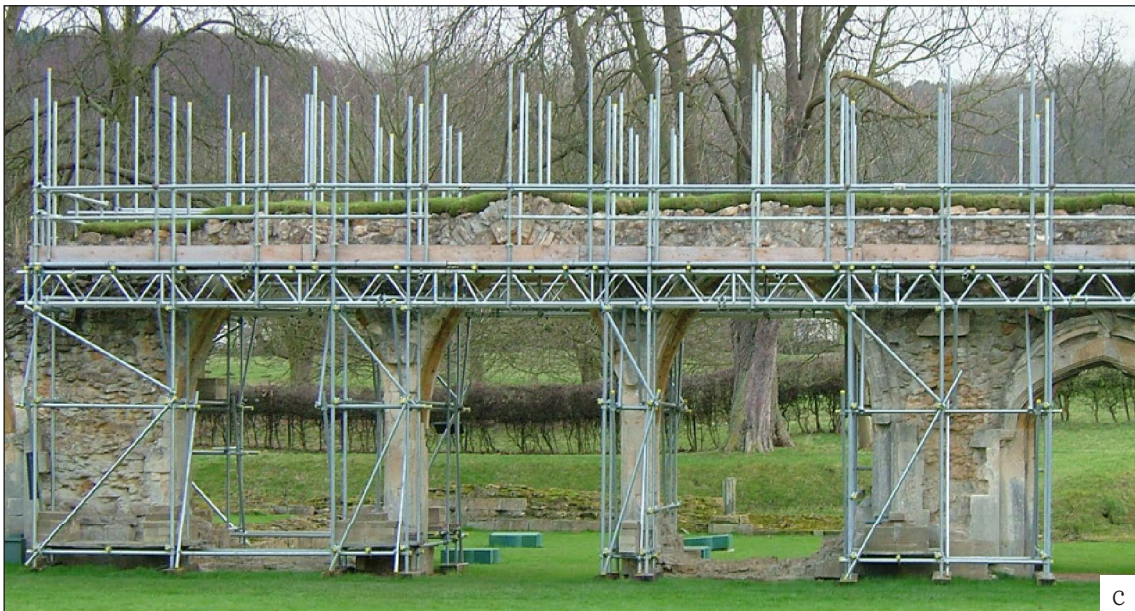
Figure 2.12c Soft capping was installed over the wall head in the east cloister at Hailes Abbey, where previous consolidation and lime mortar repairs had been carried out.
©Heather Viles, University of Oxford

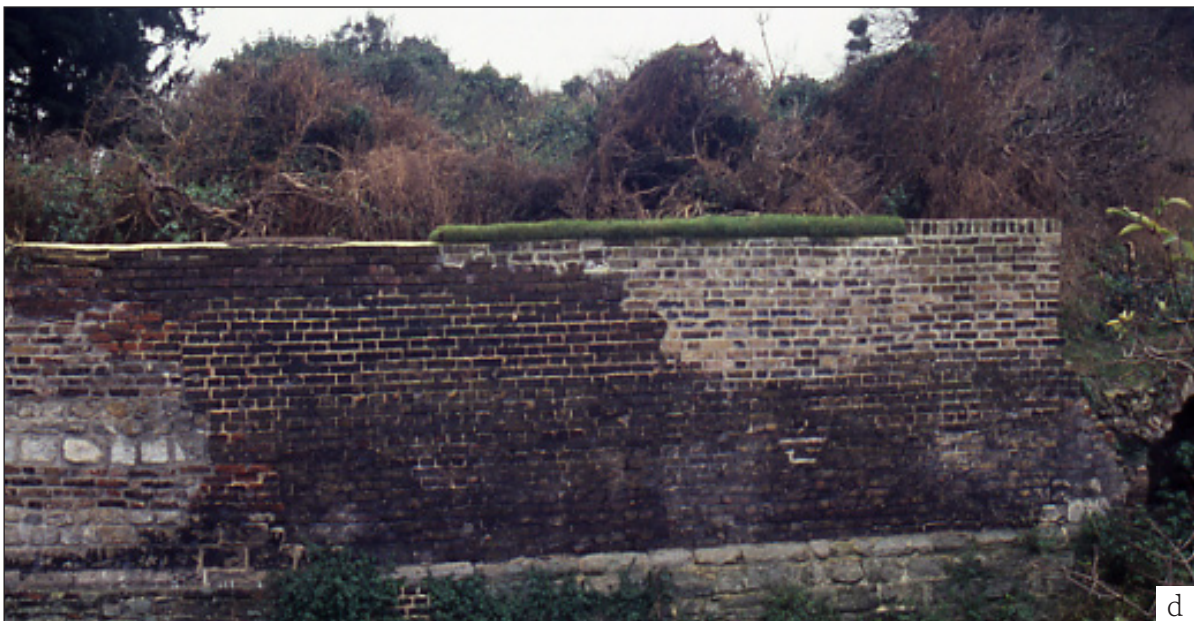
Figure 2.13 Soft capping work at Howbury Moated Site, (c) Site 1 and (d) site 2. (both ©Heather Viles, University of Oxford)

Two areas of narrow wall were soft capped during this project. The first test location was on top of a 3.45-m long by 30-cm thick section, with a consolidated stone wall-top that was considerably eroded and frost damaged and contained loose stonework. A 7.5-cm thick soft cap was installed. The second test location was a 3.9-m long by 37–40 cm wide section composed of brick that had been hard-capped during works in 2001, and had cracked in places. Here a 10-cm thick soft cap was installed. At both test locations two small sections of soil with seed were also emplaced (Figure 2.13c,d).

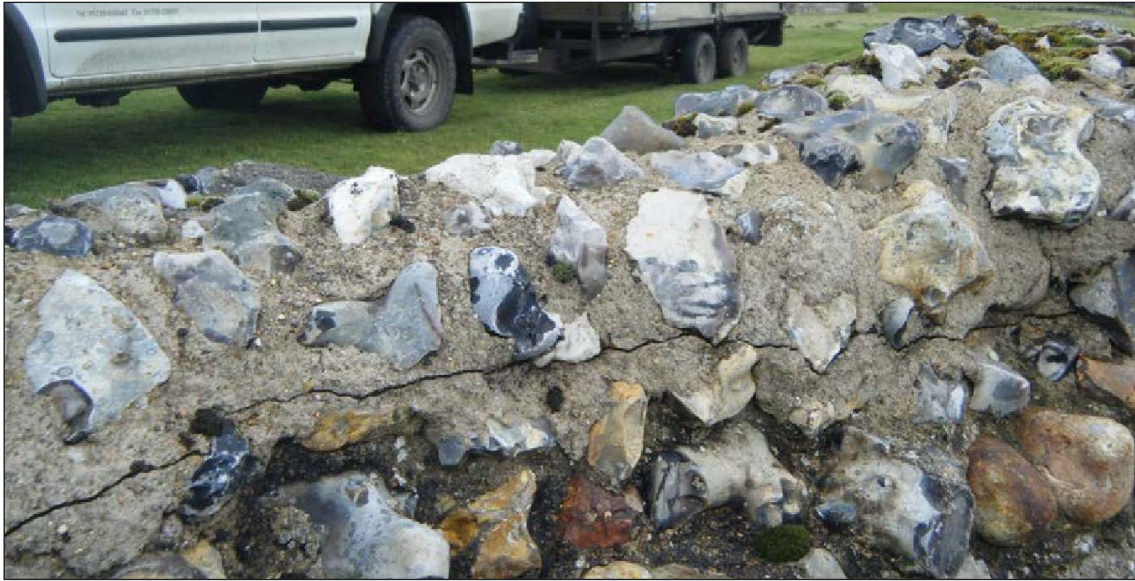
Figure 2.15c Detachment of hard capping from underlying low walls, at Castle Acre Priory in 2012. ©Heather Viles, University of Oxford

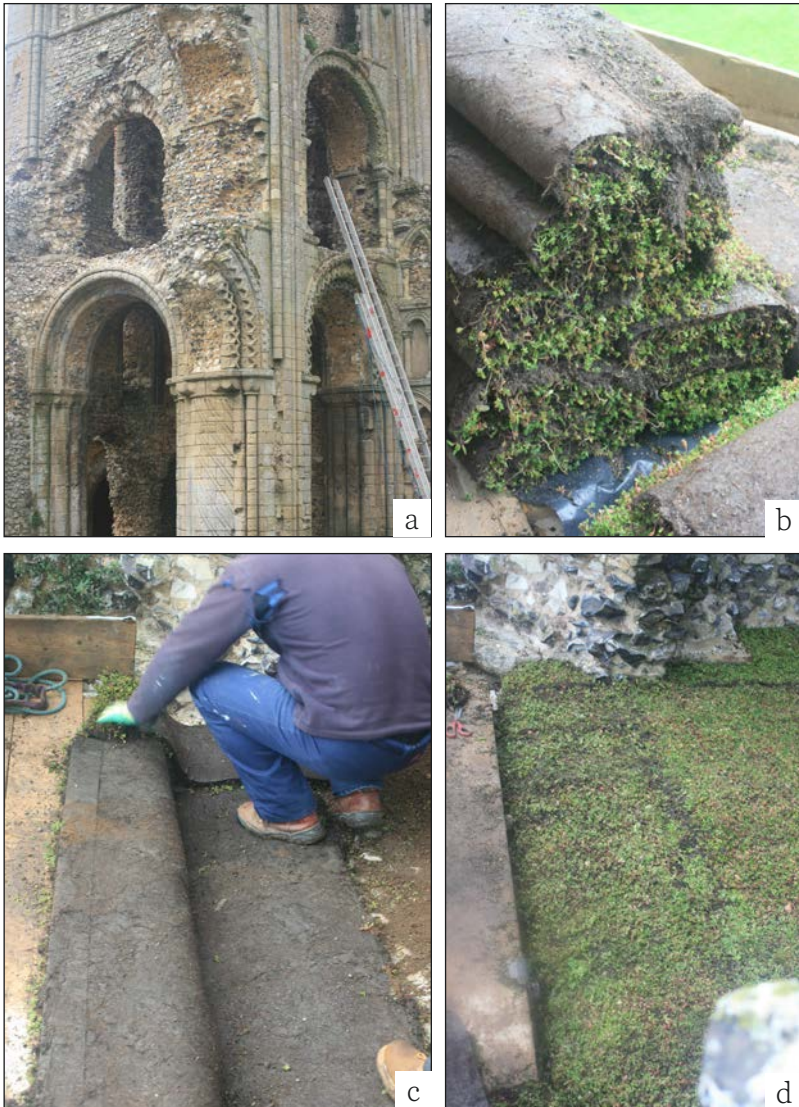
Figure 2.16 (a-d) Sedum-based soft capping installed in the SW Church tower. (a, c, d ©Alan Cathersides, b ©Heather Viles, University of Oxford)

The work was carried out in 2011, and appears to be working effectively (Figure 2.16). By 2013, the sedums appeared to be surviving only towards the edges of the area. By 2015, virtually the whole capping consisted of Pellitory-of-the-Wall (*Parietaria judaica*). This displays the dynamics of soft capping flora, as species suited to the particular conditions dominate. It will be interesting to see if this develops further over time.

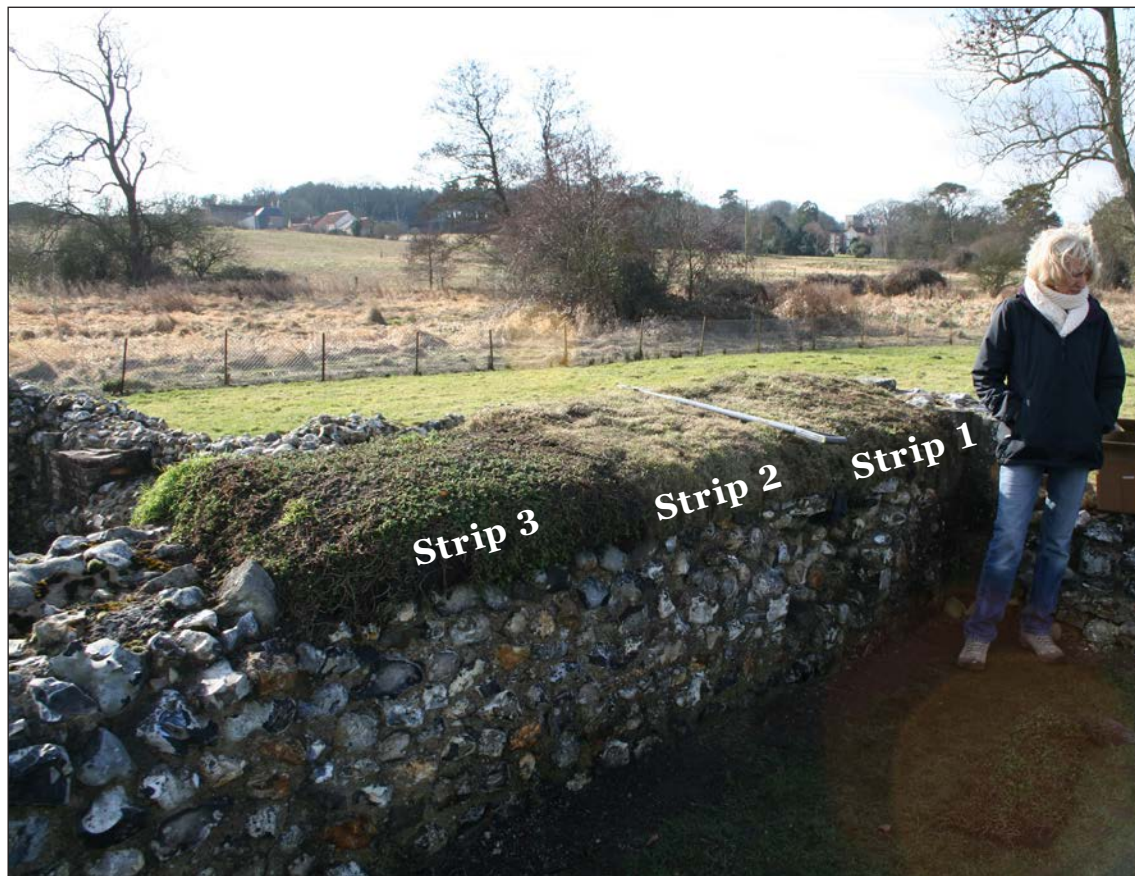
Three c.1-m long strips of soft capping were emplaced on a low (c.1 m high) wall constructed of mixed flint, brick, chalk and other stones (Figure 2.17). Strips 1 and 2 were made of 10-cm thick soil and a cover of turf cut from an adjacent field. Strip 1 also had sedum plugs added to the edges at c.5 cm spacing. Strip 1 had 10-cm thick soil overlain by a sedum mat, with a range of sedums growing in it (identical to the mats used at Godstow Nunnery). The work was carried out in February 2012. Its aim was to test the comparative performance of turf and sedum capping and evaluate the effect of sedum plugs at the edges of turf capping within a dry environment in eastern England. Small tablets of limestone and gypsum, as well as calcite crystals, were also emplaced under the capping, to test whether the soil enhanced chemical weathering.

Figure 2.17 Soft wall caps installed at Castle Acre Priory, February 2012. ©Heather Viles, University of Oxford
