Historic England

Soft Capping on Ruined Masonry Walls

Chris Wood, Alan Cathersides, Prof Heather Viles

Discovery, Innovation and Science in the Historic Environment

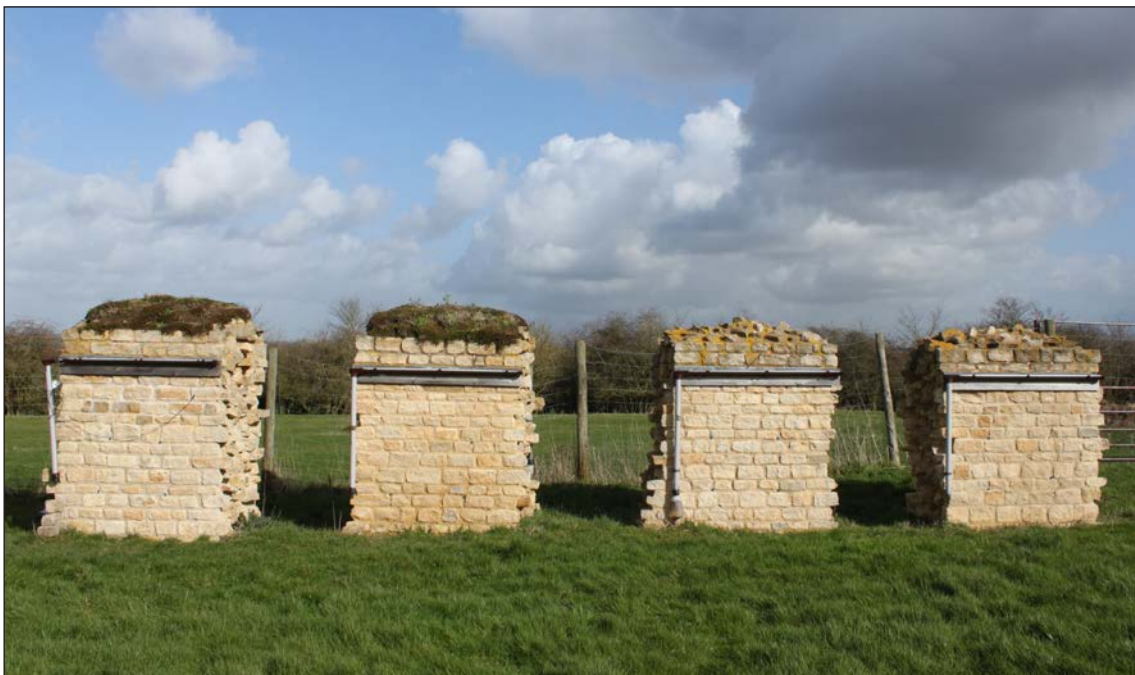
In 2008, four stone walls, roughly 1.5-m long by 1-m wide and 2-m high, were built specifically for this project (as seen in Figure 2.18a). The walls were built on a gently sloping open hillside in a fenced-off compound. The walls were constructed with a central rubble core and finished with either a hydraulic lime or cement cap. Lead flashing and guttering were built into the walls on both sides under the second course from the top, to allow runoff to be collected and funnelled off into downpipes and then into measured containers.

Figure 2.18a Wytham Woods test walls. ©Heather Viles, University of Oxford

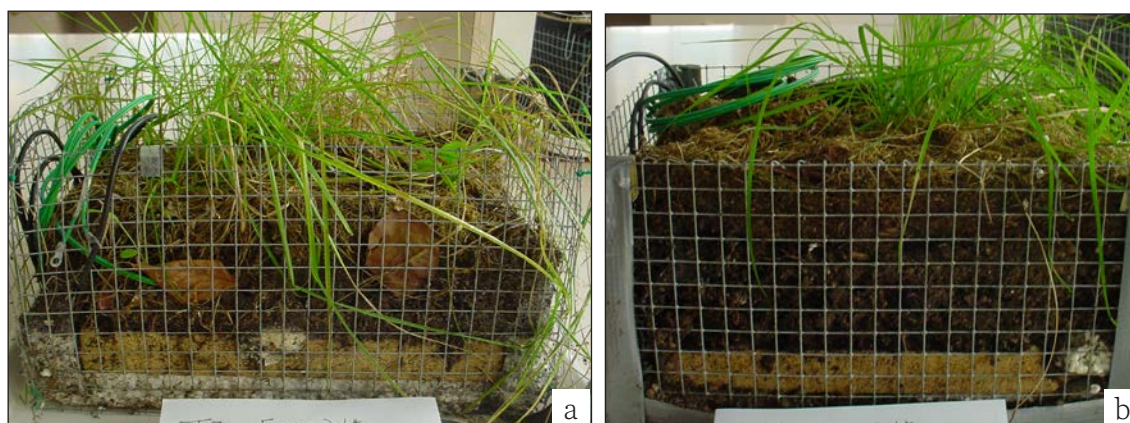
A further experiment was also carried out. This was known as the ‘Long term field experiment’. Three of the boxes were placed on the roof of the School of Geography and the Environment for 1 year (5-cm and 10-cm thick soft caps and 5-cm hard cap) the soft-capped boxes were tested in the environmental cabinet before and after the year-long exposure period to see if there was any change in performance as the cap matured (Figure 3.2).

Figure 3.2 (a) 5-cm and (b) 10-cm thick soft caps after the ‘Long term field experiment’.
©Heather Viles, University of Oxford

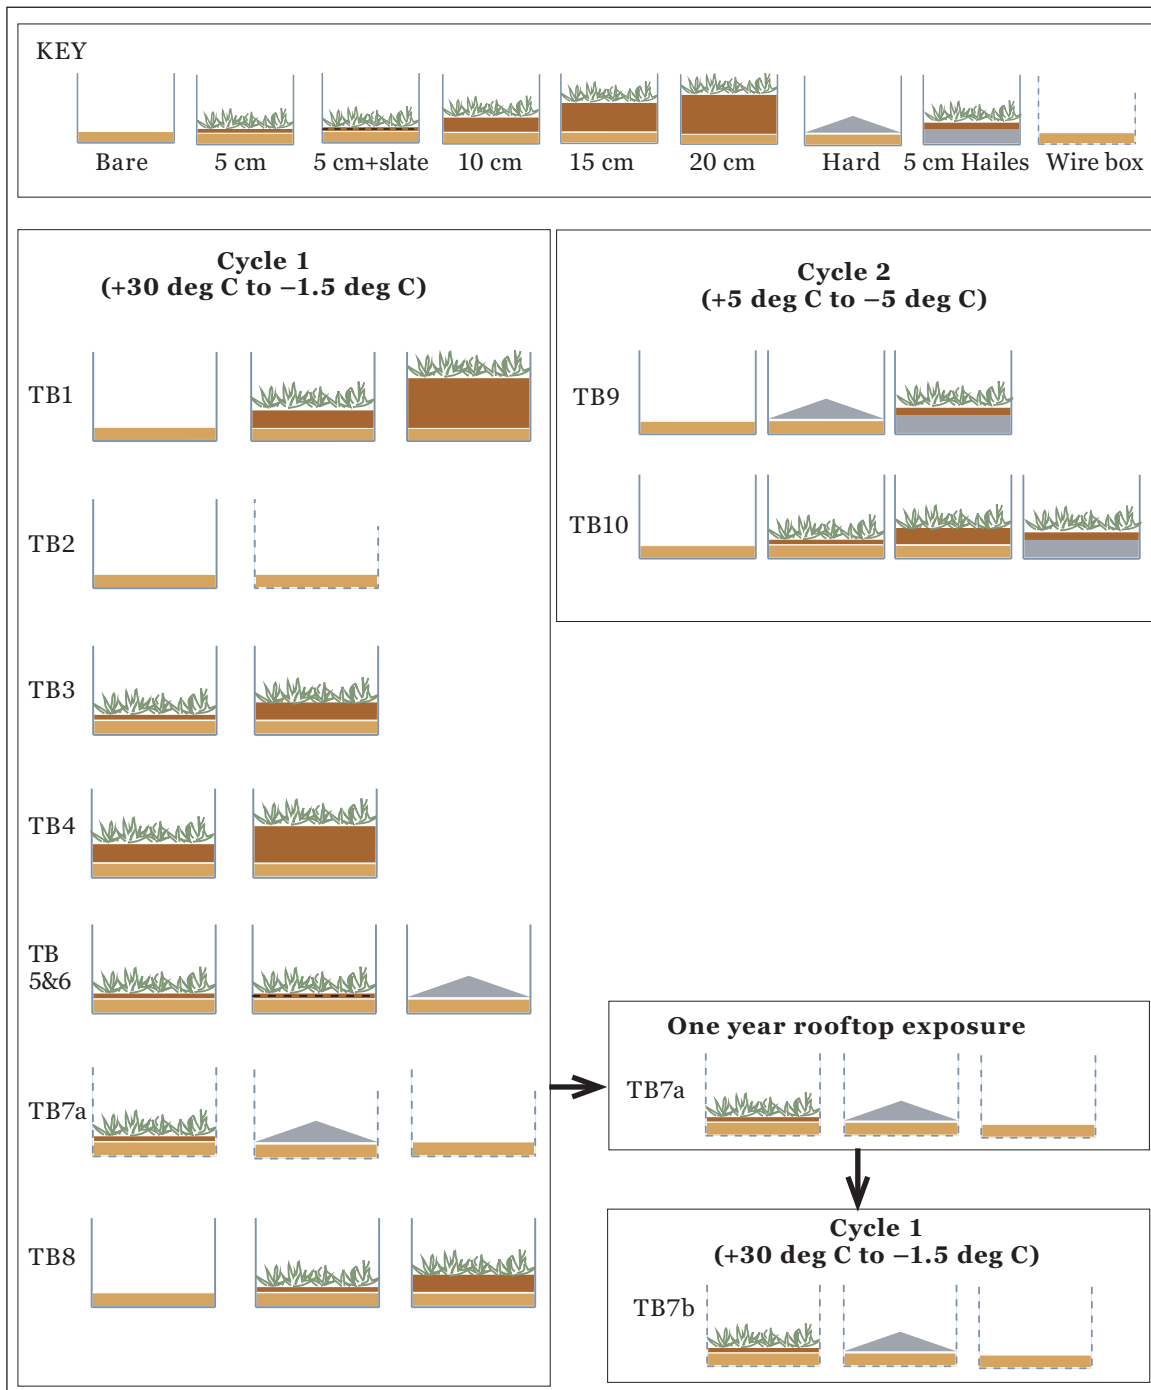
Figure 3.3 Thermal blanket experimental runs.

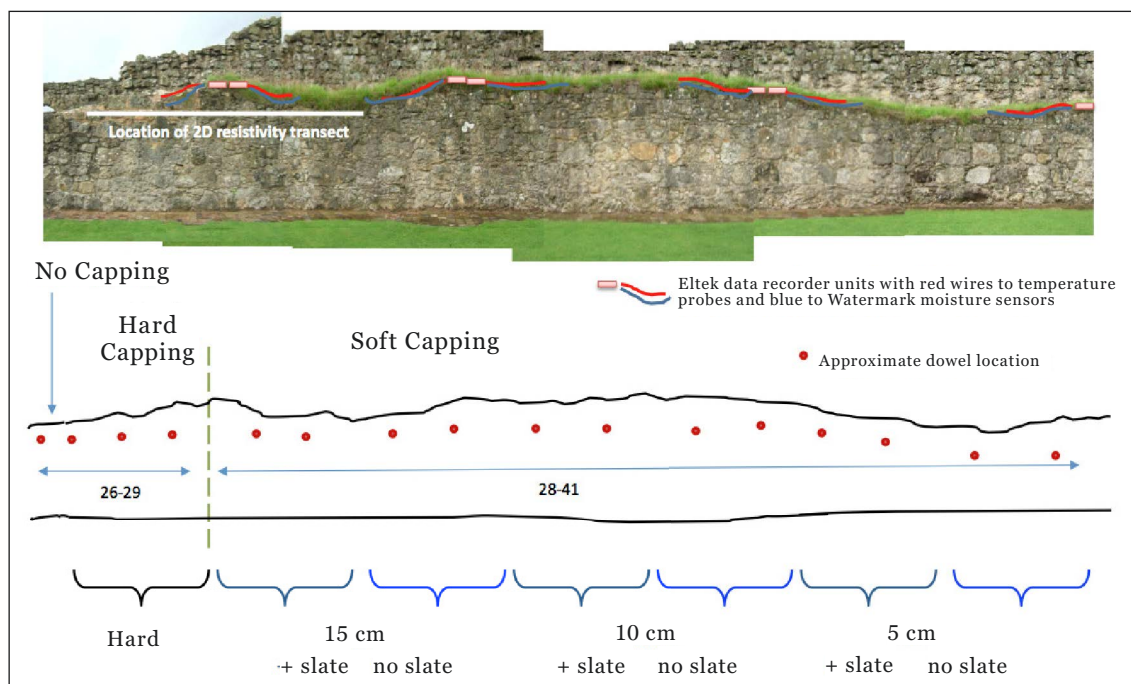
Figure 3.6 Location of the telemetric logging system, 2D resistivity surveys and wooden dowels, east facing side of the lane wall, Byland Abbey. ©Heather Viles, University of Oxford

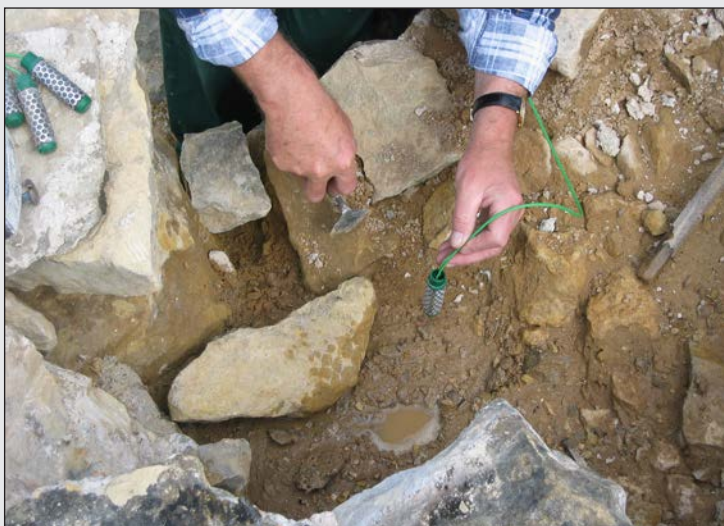
At the Byland site a bespoke telemetric data logging system (Eltek) was connected to small thermistor temperature probes (Campbell) and Watermark soil moisture probes (Irrometer) set to record at 30-minute intervals. Watermark sensors are composed of two concentric electrodes buried in a reference matrix material and surrounded by a synthetic membrane (to protect against deterioration). An internal gypsum tablet provides a buffer against salinity. The Watermark probes are temperature-sensitive, and need a simple temperature correction to be applied. Output in microsiemens can be converted to soil water potential in KPa. The base unit was a 1000 series Squirrel data logger.

Figure 3.8
Emplacement of the Watermark sensor in the hard capping at Byland Abbey. © Chris Wood, Historic England

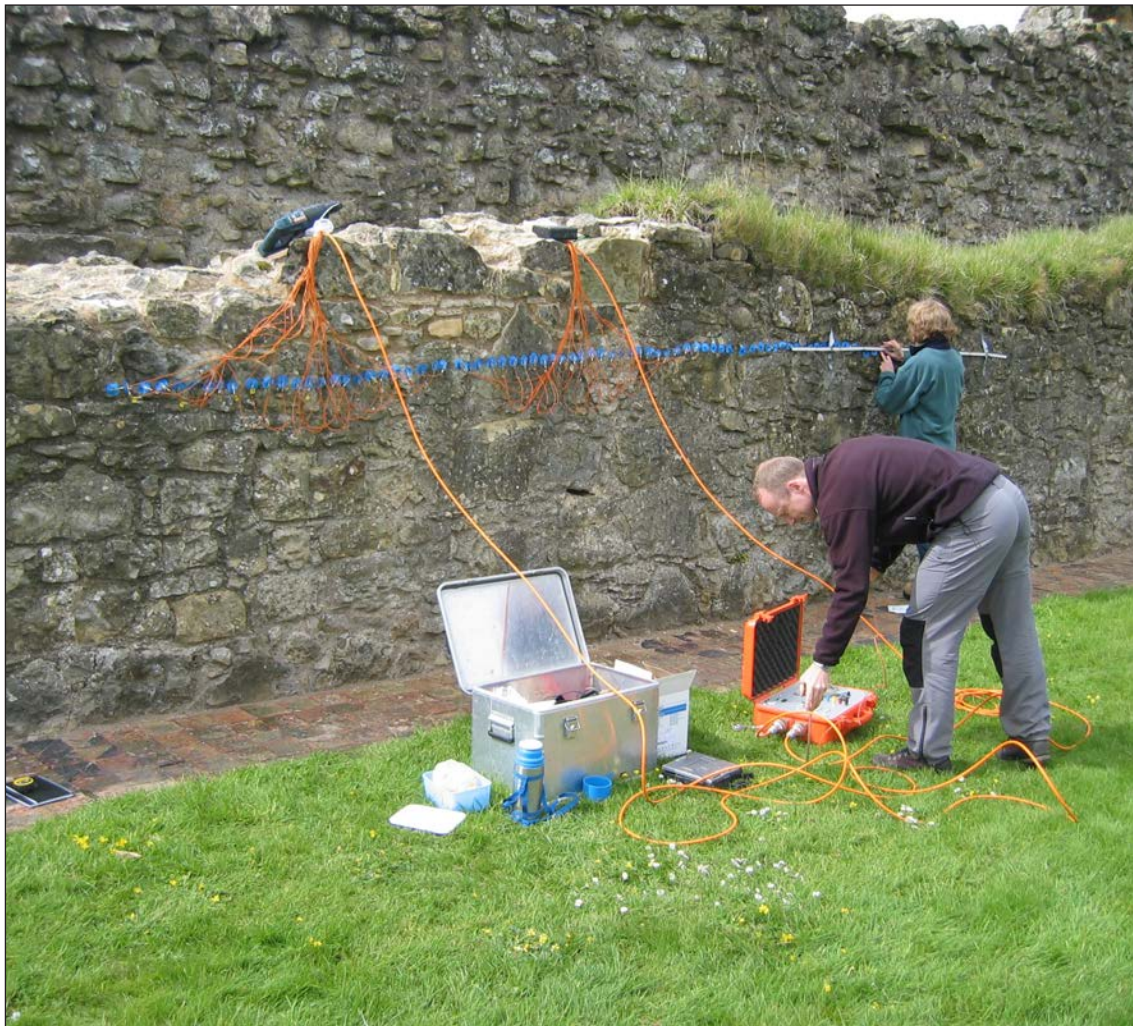
Figure 3.10 2D resistivity survey on the east face of the long test wall at Byland Abbey. The blue dots are adhesive ECG electrodes. The left-hand side is the hard-capped section.
© Chris Wood, *Historic England*

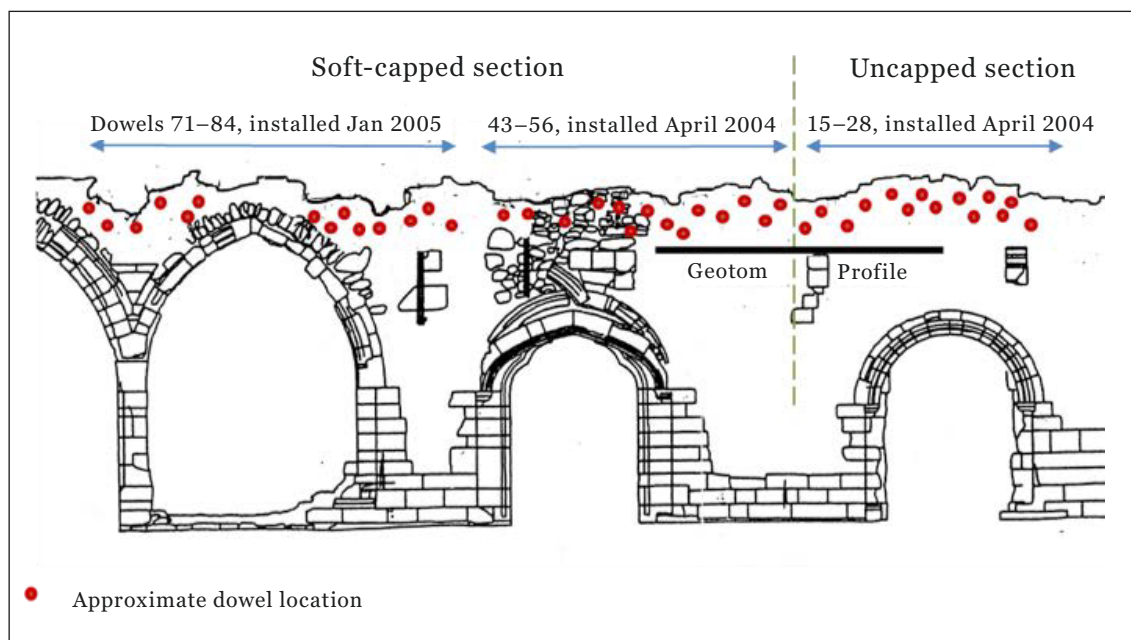
Figure 3.11 Location of wooden dowels and 2D resistivity profile, west-facing side, cloister arches, Hailes Abbey.

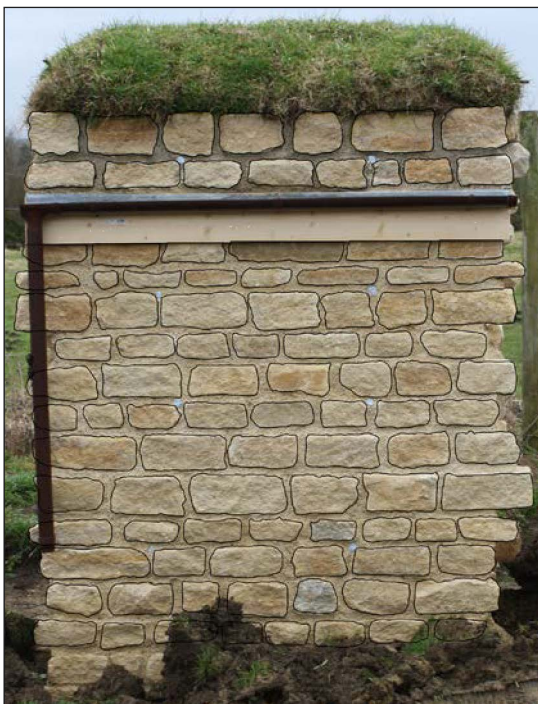
A detailed plan showing the location of each limestone block was drawn up. This was used to enable protimeter readings to be taken at the centre point of each stone block on the survey dates (Figure 3.14). The contour plots of moisture were then recorded with SigmaPlot software.

Figure 3.14 Location of points for Protimeter surveys, July 2009 to January 2012 on wall 1 as an example of the method used on both sides of each wall. ©Heather Viles, University of Oxford

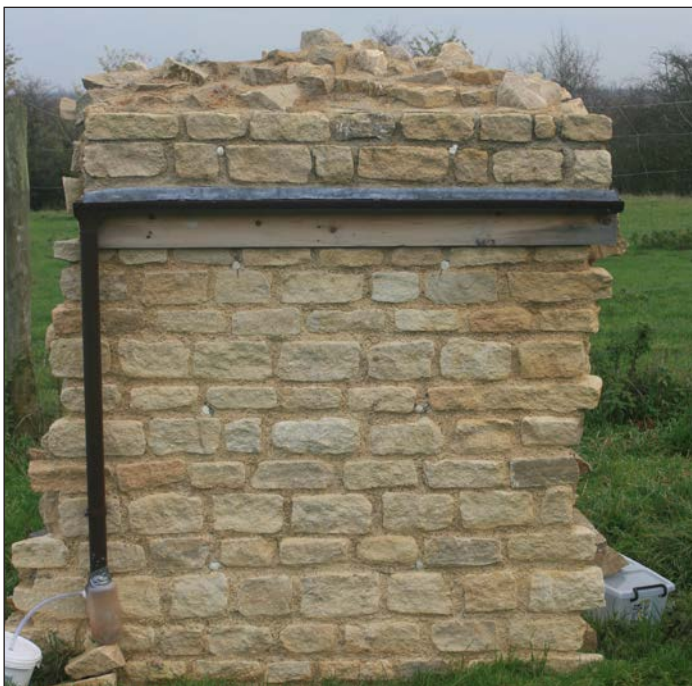
A simple system of lead flashing, guttering and downpipes was developed on the Wytham Woods test walls to test the comparative ability of soft and hard capping to influence water flow down the face. A 2-lb lead flashing was built into the mortar joint two courses below the wall-head on the east and west faces of each wall. Immediately below this flashing, half-round guttering (8 cm wide and 3.5 cm deep) was fixed (see Figure 3.15) to wooden boards. This enabled water to run easily down the face whenever it rained and be collected in the guttering. At the left-hand end of each gutter, a downpipe was installed, which discharged into a securely fixed bottle to collect all the harvested rainwater. (Figure 3.16).

Figure 3.15 Guttering with lead flashing to collect runoff.
©Heather Viles, University of Oxford

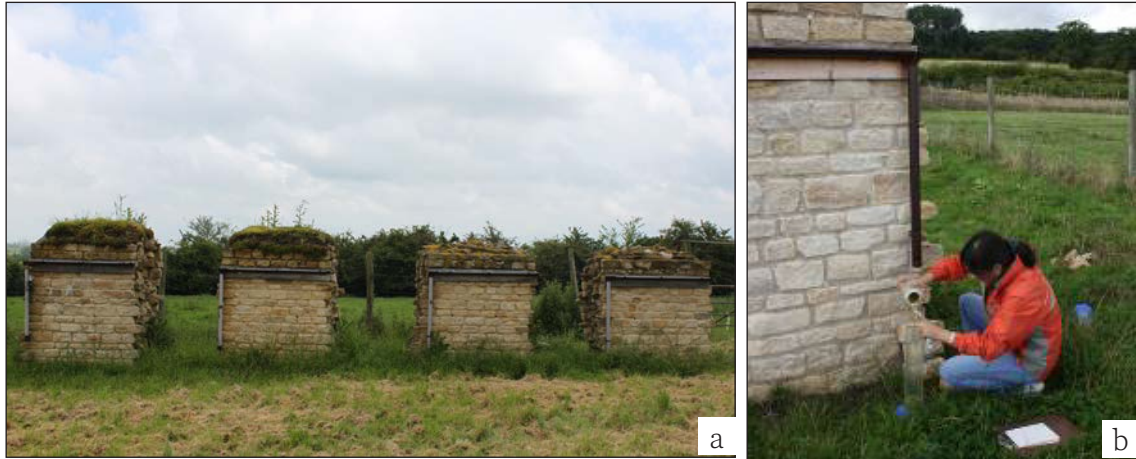
Figure 3.16 (a, b) The test walls with guttering installed, and the set up for collecting runoff in a container, which was then emptied and measured at regular intervals between August 2010 and September 2012. ©Heather Viles, University of Oxford

Two methods were used to evaluate the impacts of soft and hard capping on runoff. First, natural rainfall events were used to measure the response of the walls in the period between August 2010 and September 2012. The bottles were emptied every few weeks, and when possible, after every incidence of heavy rain. The volume of water collected was measured with a measuring cylinder. Sometimes the bottles had filled up before they could be collected, so this method provided a rather imperfect record of rainfall/runoff relations.

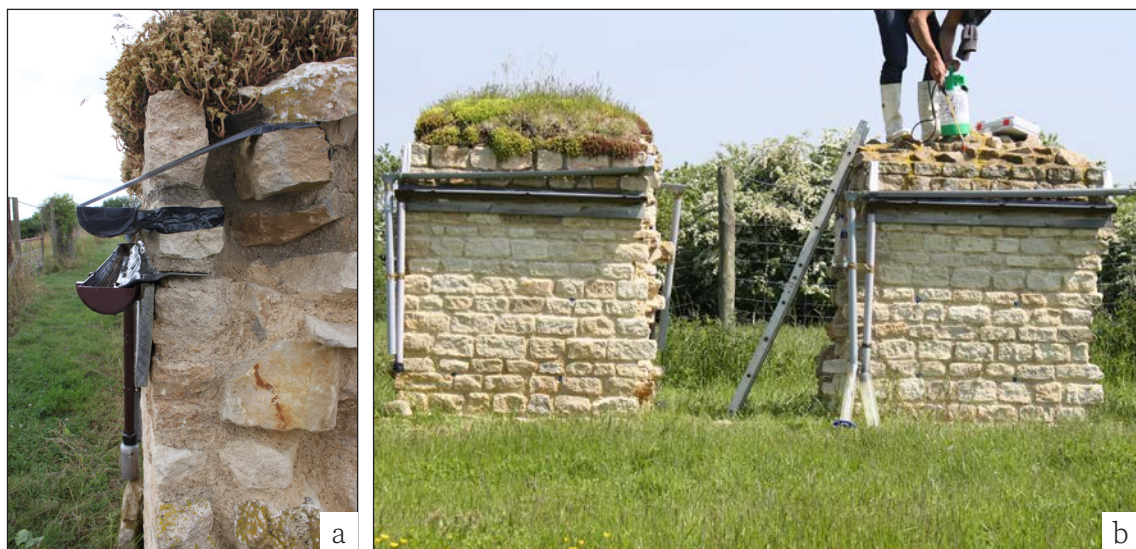
The second method of collecting runoff information utilised a field experimental approach described in detail in Hanssen and Viles (2014). These experiments were carried out during a dry spell in July 2013. In each experiment, 1 litre of water was sprayed with a 5 litre pressurised sprayer over the entire length of one of the wall caps (focusing on a 20-cm wide belt from the edge towards the centre). Each simulation delivered 2.2 mm of rainfall, which is equivalent to an hour of moderate rainfall in England. Five experimental runs were carried out on both sides of the two soft-capped walls, as well as on the cement-capped wall 3, giving a total of 30 experiments. A second gutter (slightly above, and 1 cm further away from the wall than the original gutter) that fed into a separate bottle (Figure 3.17) enabled researchers to monitor both runoff and water shed away from the face. Moisture measurements before and after experimental runs were made with a ThetaProbe soil moisture sensor ML2x (Delta T devices) in the soft capping, and with a CEM handheld moisture meter on the hard-cap surface and all wall faces.

Figure 3.17 (a) Layout of the two-gutter system to collect runoff and shed water separately (b) spraying in action on the cement hard cap. ©Heather Viles, University of Oxford

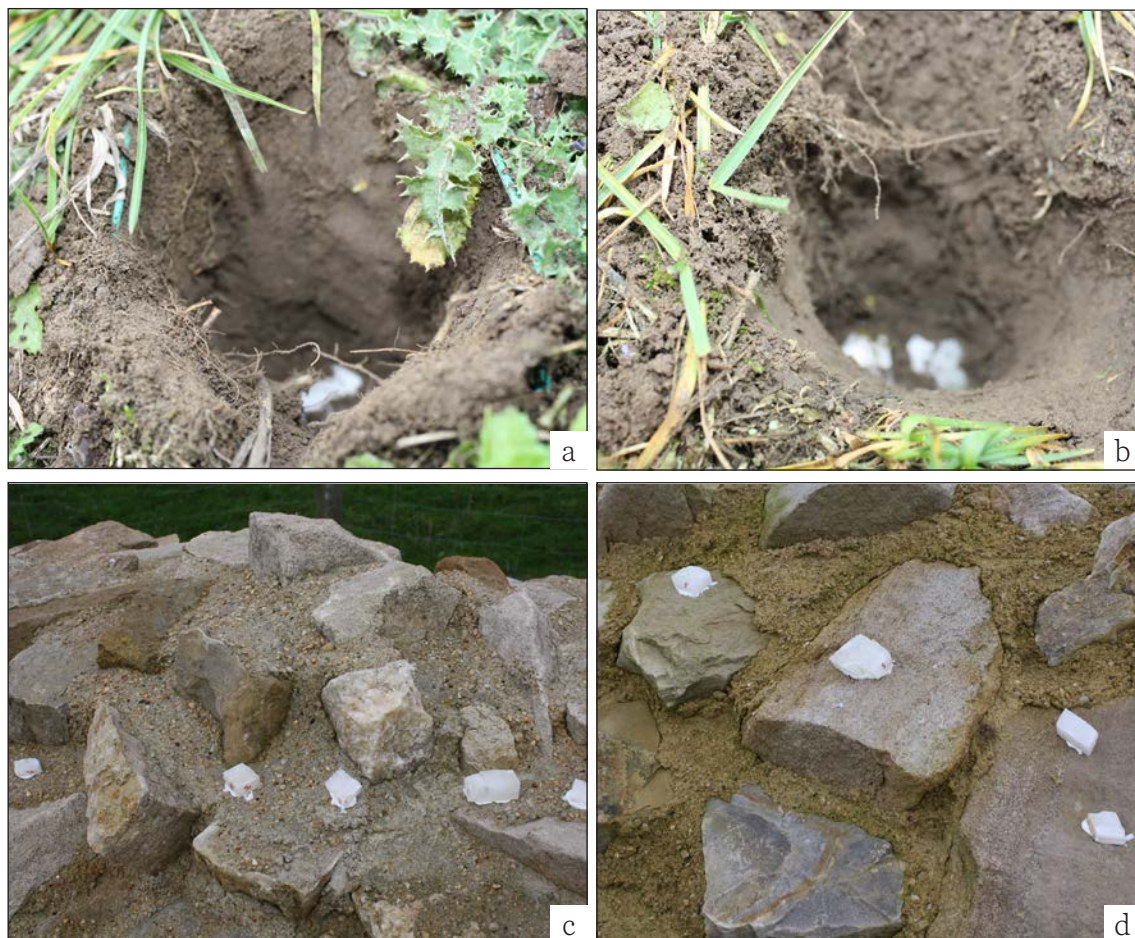
All four test walls were used for this experiment, which was designed to test the relative amounts of chemical weathering occurring on stone in contact with rainfall and stone beneath the soft capping. Twenty calcite crystals (calcite being the major mineral in limestone) were cleaved from large pure crystals to produce fresh-faced crystal of c.2 x 2 x 2 cm dimensions. The crystals were dried, air brushed to remove any surface debris, and weighed on a high accuracy balance (Sartorius, BL120S) to an accuracy of 1/10,000 of a gram. The crystals were then carefully sealed into individual bags and transported to the field site, where 5 were installed on each test wall in November 2010. The crystals were carefully placed at the bottom of the soft capping on test walls 1 and 2 by digging small pits in the soil while they were stuck onto the hard capping of test walls 3 and 4 with bathroom sealant (bathroom sealant provides a semi-permanent bond that should be removable when the experiment ends; see Figure 3.18). All crystals therefore had one face in contact with the underlying stone (or sealant), and 5 faces in contact with soil (in the case of soft caps) or air (in the case of hard caps). Crystals were collected and reweighed in May 2012 after 18 months of exposure to detect any weight loss caused by dissolution of the calcite by soil moisture (in the case of soft caps), or rainfall (in the case of hard caps).

Figure 3.18 The emplacement of calcite crystals at the base of small pits dug in the soft capping on (a) wall 1 and (b) wall 2, and stuck to the top surface of (c) wall 3 and (d) wall 4. See text for further details. ©Heather Viles, University of Oxford

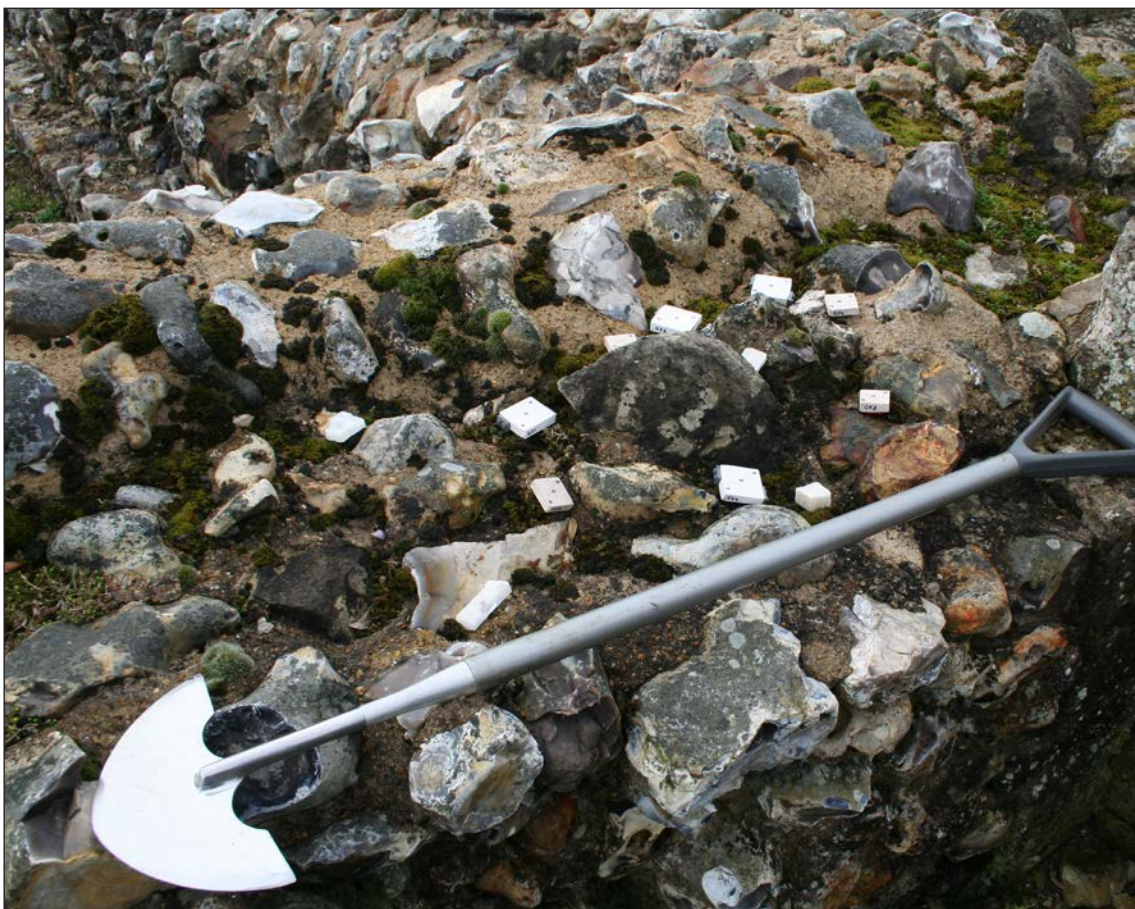
While both the calcite crystals and limestone blocks at Wytham Woods provided some data on likely chemical weathering in soft capping and on hard capping, a fuller field experiment was carried out at Castle Acre Priory. Installation of a suite of test samples of limestone, calcite and gypsum in soft capping and hard capping was carried out on 23rd February 2012. The aim of this experiment was to build on the tentative findings of the calcite crystal experiment at Wytham Woods. As described in Chapter 2, three adjacent 1-m strips of soft capping (turf, turf with sedum plugs, and sedum mat) were installed on a low (c.1 m high) wall constructed of mixed flint, brick, chalk and other stones at Castle Acre Priory. Test blocks of gypsum, limestone and calcite crystals (4 of each per strip) were placed on the wall-head, then covered with soil (Figure 3.20). Four control blocks of each type were placed on higher walls out of sight. A further batch of samples was kept in the lab as controls. The samples were left *in situ* for two years. They were then examined to compare the weathering rates of limestone and calcite (the main mineral component of limestone) covered by soft capping soils to bare stone directly exposed to precipitation. Gypsum, which is known to weather rapidly in wet, acidic conditions and is often used in soil hydrology research, was also used to provide comparative data.

Figure 3.20 Gypsum and limestone blocks and calcite crystals on test strip 3, before covering with the sedum soft capping. ©Heather Viles, University of Oxford

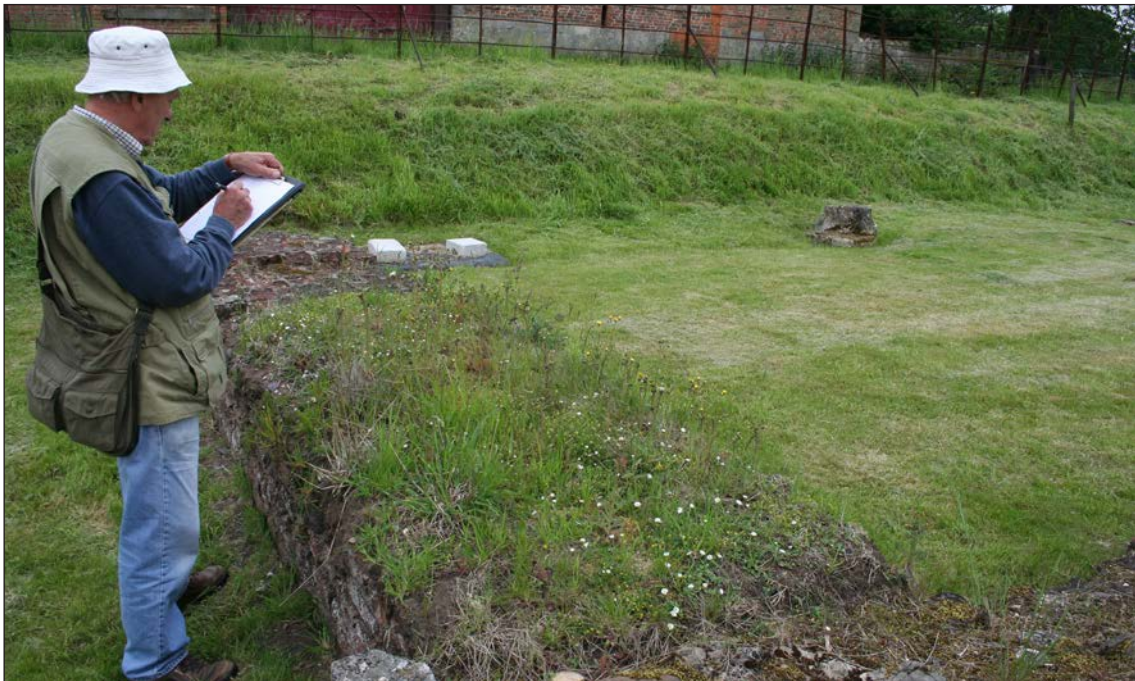
Ecologist John Thompson undertook a vegetation survey when soft capping was installed at Byland, Kirkham and Thornton. He then took another vegetation survey in 2007, in order to assess any species changes in the turfs (Figure 3.22). There were some logistical difficulties with high elevation sites where scaffolding had been removed (and for this reason, areas immediately adjacent to the places from which the turf had been cut/sourced were also examined as part of the survey). A final detailed survey was undertaken in April 2010, with the intention of assessing how the soft capping had performed over 5–6 years. In addition, some observations were made at Whitby.

Figure 3.22 Ecological surveys being carried out at Thornton Abbey.
© Chris Wood, *Historic England*

The vegetation survey used the DAFOR scale (D=Dominant, A=Abundant, F=Frequent, O=Occasional, R=Rare) in compiling species lists and estimating the relative frequency of different plants. In conjunction, the prefix L was used to indicate that the distribution was localized rather than generalised. Nomenclature for species follows Hubbard (1984) and Stace (1991). In 2007, the percentage of remaining living cover was roughly estimated.

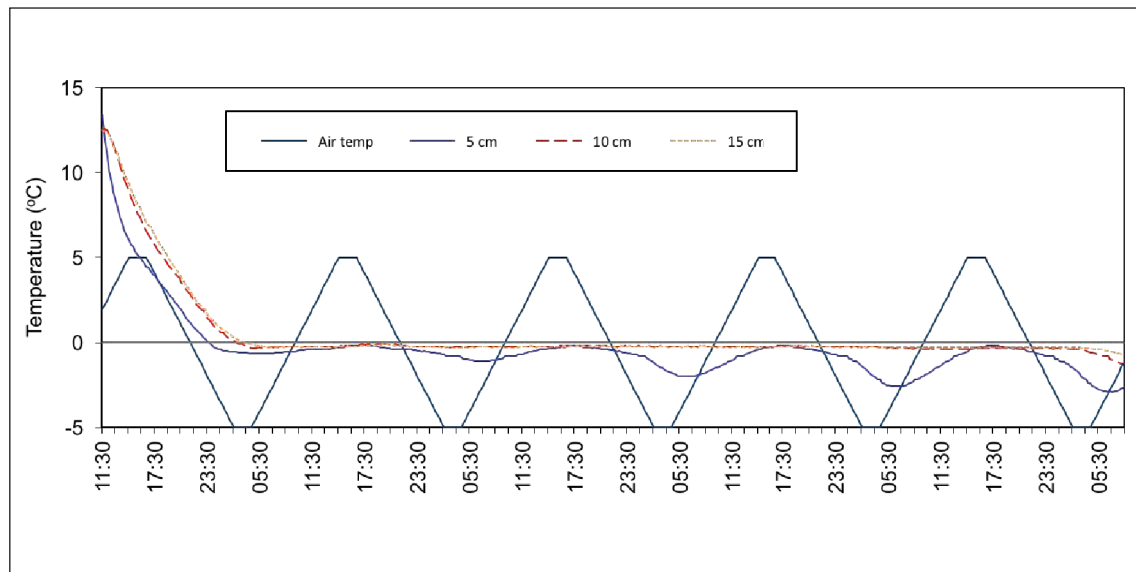
Figure 4.4 Temperatures during the intense thermal cycling experiment for air within the environmental cabinet and under soft caps of 5 cm, 10 cm and 15 cm thickness.

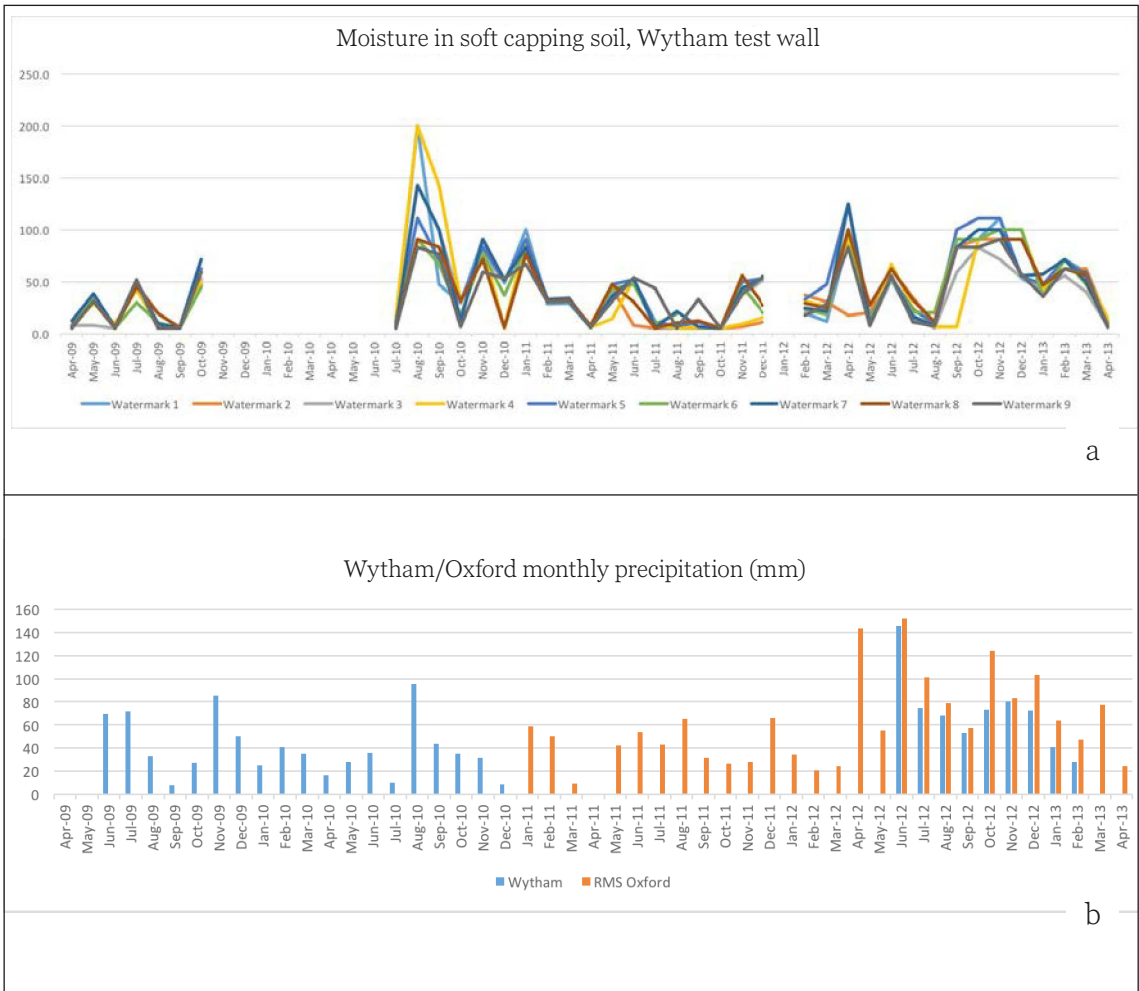
Figure 4.12 (a) Moisture data from soft capping on Wytham Woods test wall 1 from April 2009 to April 2013, (b) monthly rainfall over the same period.

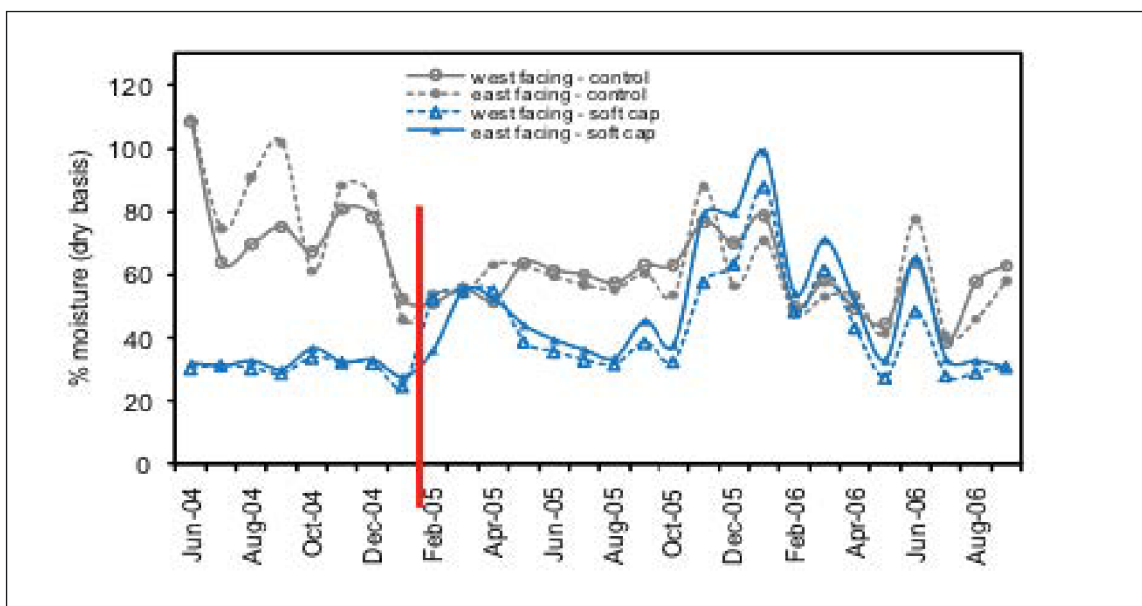
Figure 4.16 Moisture content of wooden dowels (averaged for each set of dowels from all heights within the wall, and across four sections for each dowel), inserted in the mortar in the wall beneath the uncapped (control) and soft-capped sections. The red vertical line marks the date the soft capping was installed.

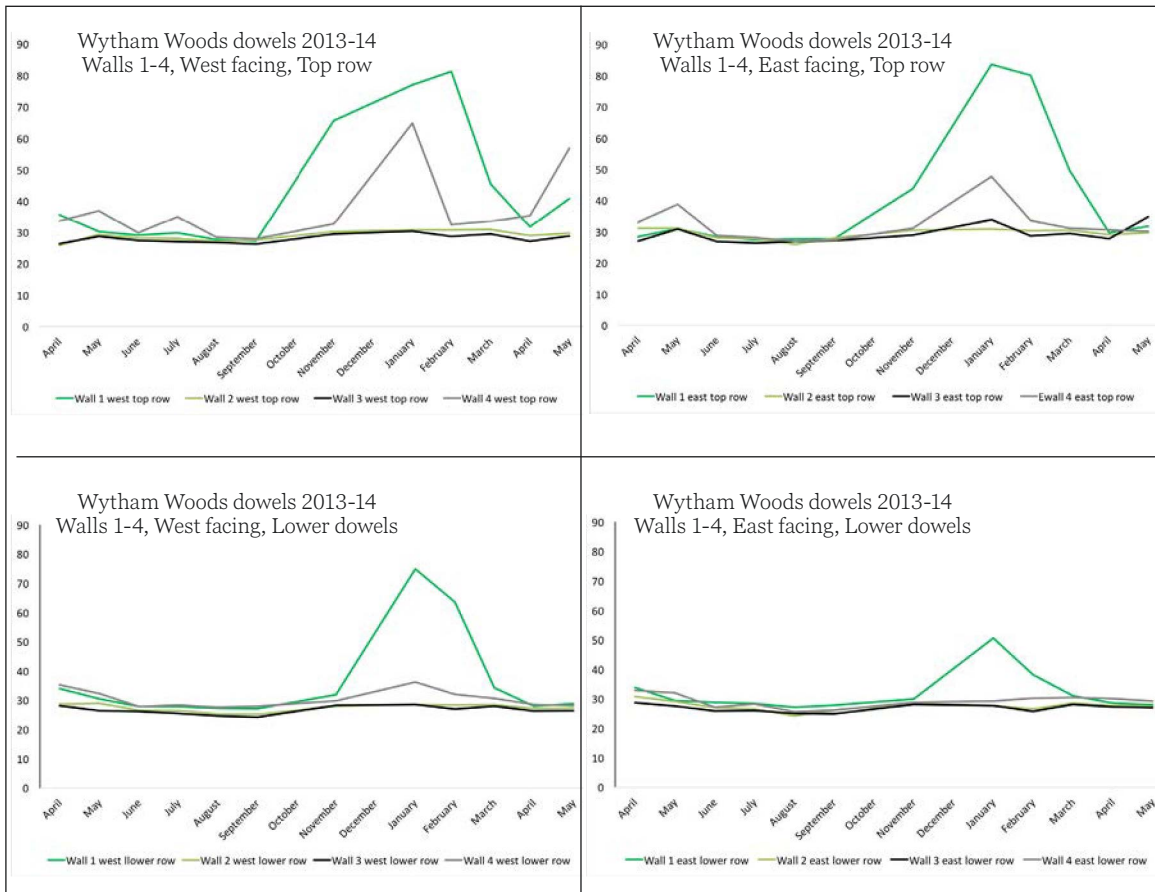
Figure 4.19 Summary dowel data for the upper parts of the Wytham Woods test walls, April 2013 to May 2014.

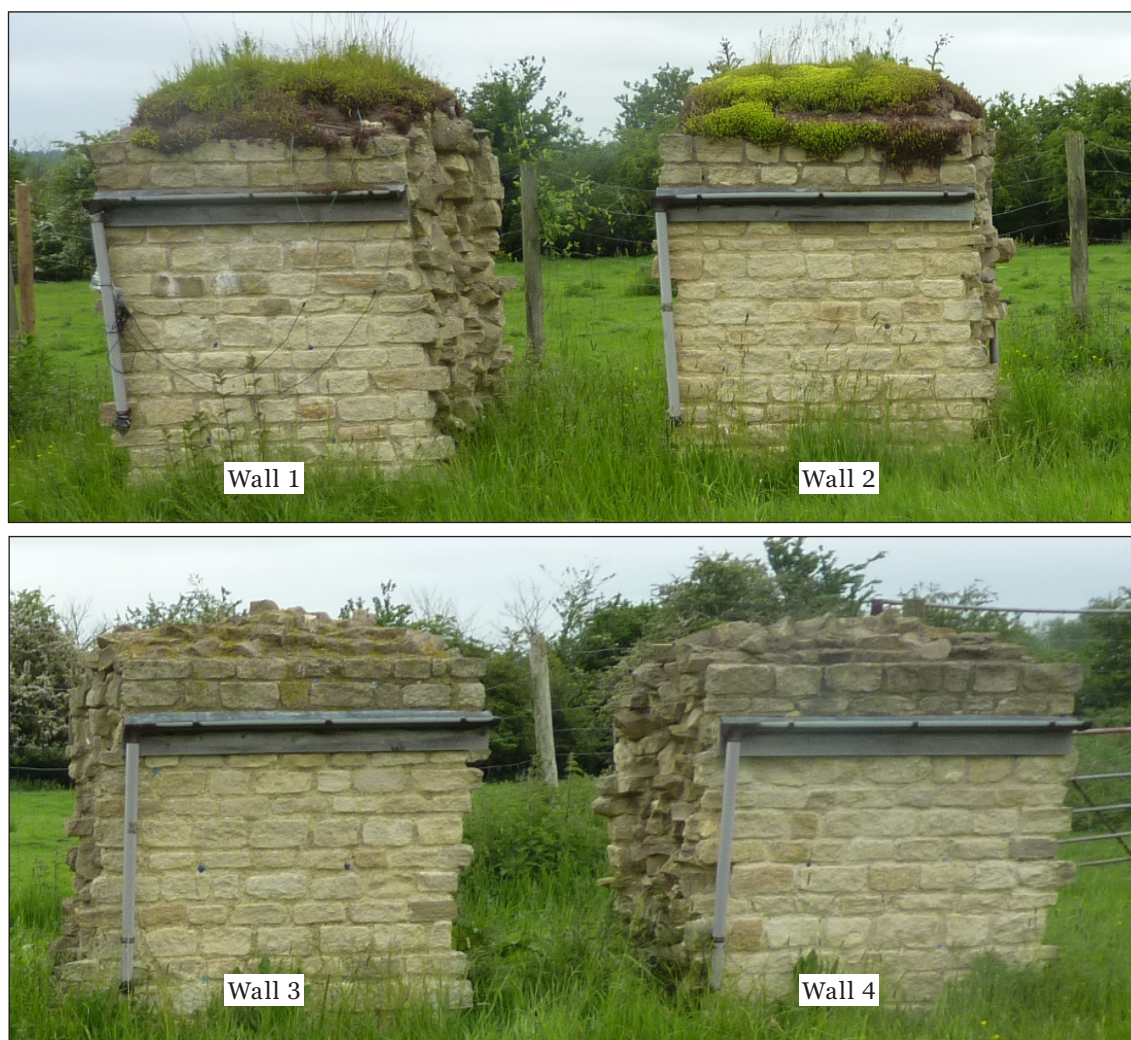
Figure 4.25a compares the water runoff after the simulated rainfall (black bars) with the amount shed (grey bars) from soft-capped walls 1 and 2, and hard-capped wall 3. The most notable finding is the almost 90% reduction in the amount of water running down the face on the two soft-capped walls, in comparison with that running down the hard-capped wall. More water was also shed from the soft-capped walls (up to 115 ml) than the hard-capped wall (negligible amounts). Furthermore, Figure 4.25 b) shows that a much higher proportion of the simulated rainfall was absorbed or evaporated from soft-capped surfaces compared to the hard-capped ones. This was also true of incident rainfall. These results confirm expectations that healthy soft capping should reduce the amount of surface runoff down wall faces. It should also reduce biofouling from algal and other biofilms. Surveys of the walls at Wytham Woods over time illustrate that this has indeed occurred. Dr Vanessa Winchester, a lichen expert, surveyed the lichen flora on the Wytham Woods test walls in August 2012 and found 14 species in all. The top and upper parts of walls 3 and 4 were found to have particularly lush lichen floras, including *Xanthoria parietina*, *Lecanora dispersa*, *Caloplaca citrina* and *Verrucaria nigrescens* (as shown in Figure 4.26).

Figure 4.26 Lichen colonisation on the Wytham Woods test walls.

The field experiments at the Wytham Woods test site (Chapter 4, and Hanssen and Viles, 2014) have provided more conclusive evidence of the shedding role of soft capping. Lichens have colonised wall faces below it, as it provides a stable environment for their growth (see Figure 4.26 of the Wytham Woods test walls). In contrast, the walls under hard capping exhibit no lichen growth, although they are abundant on top. Although lichens have a negligible effect on the longevity and performance of stonework, they are redolent of the natural patina that historic masonry acquires over time. Many observers view this as a quintessential feature.

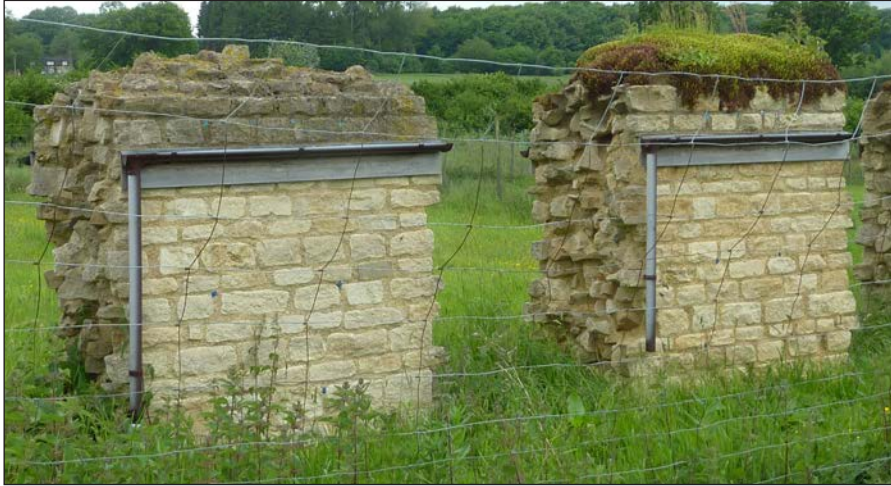
Clear differences in colouration of the upper two courses of the stonework were observed under the soft capping (light) and hard capping (darker), which reflect colonisation by microbial biofilms and lichens on the hard-capped walls (Figure 4.27).

Figure 4.27 Dark colouration on the top two courses of stonework on hard-capped but not on the soft-capped walls at Wytham Woods.

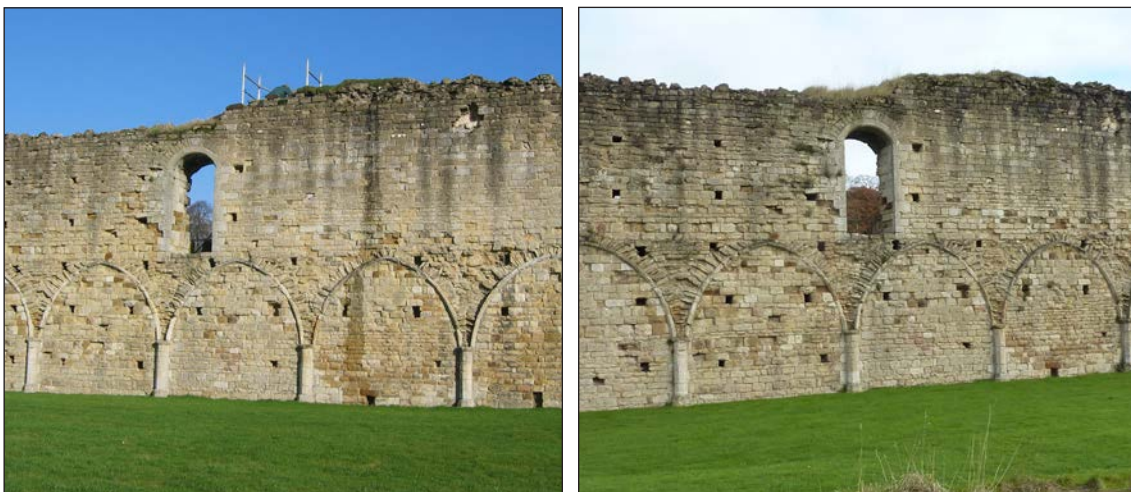
The experimental results from the test walls at Wytham Woods are confirmed by observations at Kirkham Priory. As Figure 4.28 indicates, black streaking is a common feature of many of the high-standing ruined limestone walls at Kirkham Priory. The black colouration results from microbial biofilms (probably algal-dominated) that grow preferentially along pathways where water flows frequently down the walls. In one location where soft capping was installed above such black streaking, observations made during a rainstorm illustrate that water flow was heavily reduced. Over time the biofilms should dieback, and the streaking become less apparent.

Figure 4.28 Streaking at Kirkham Priory in (a) 2014 and (b) 2016.

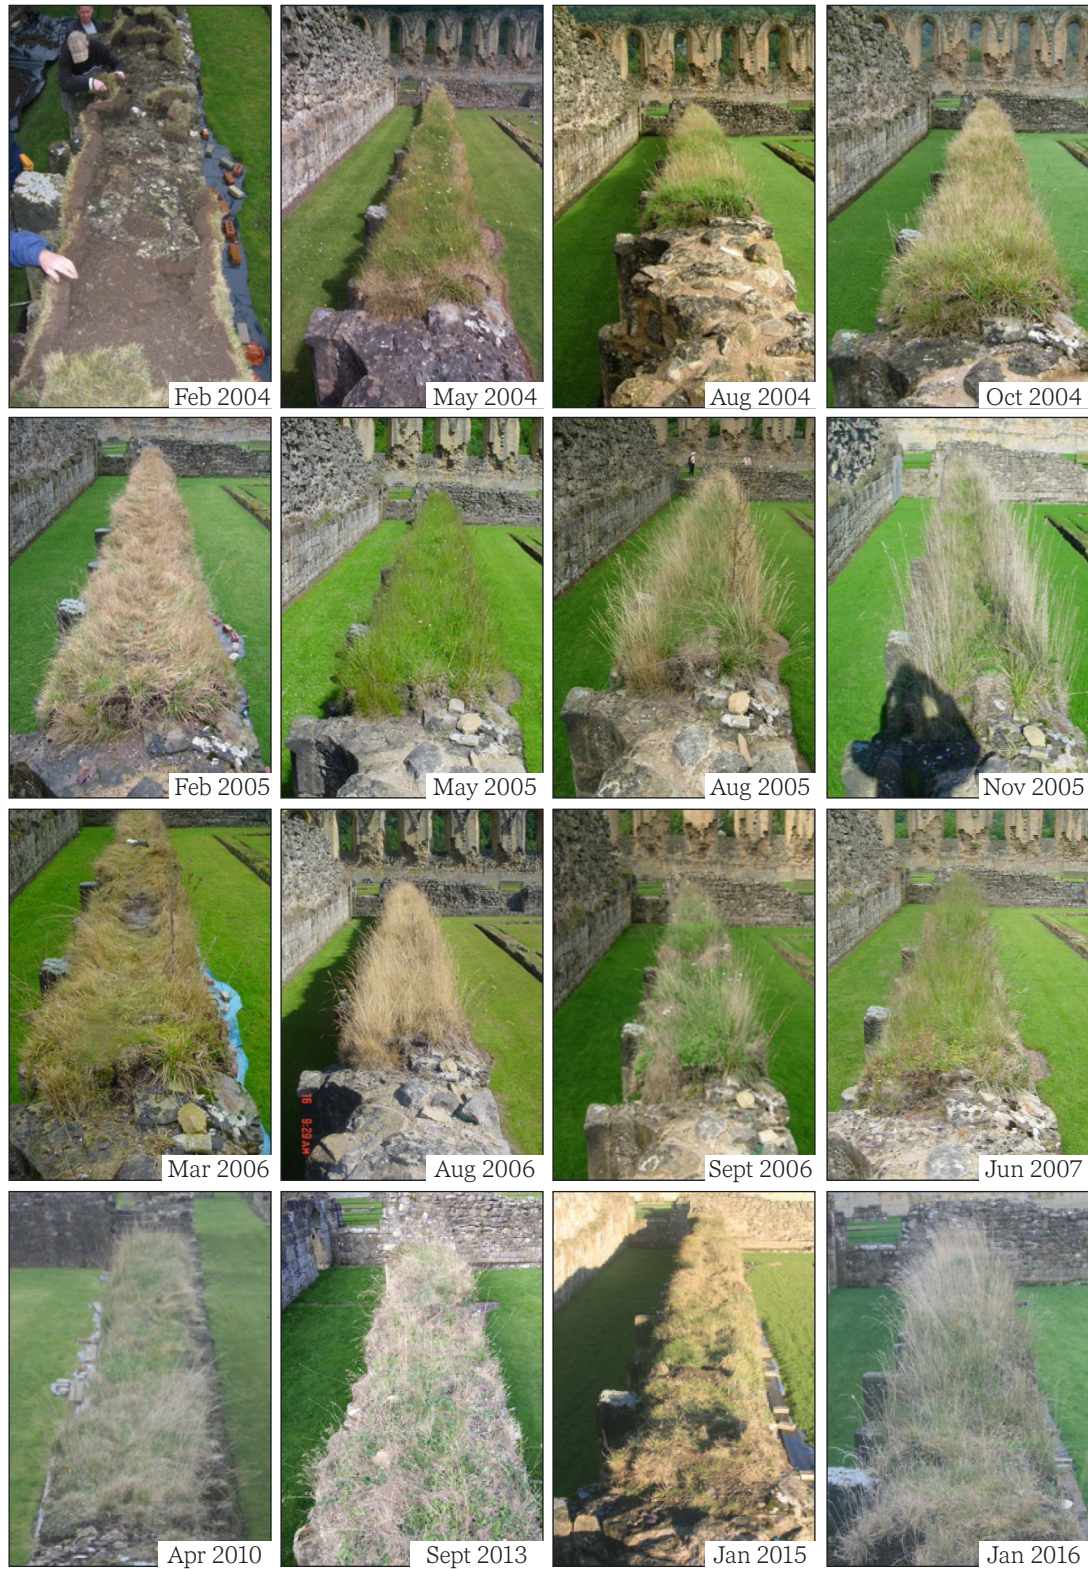
Figure 4.31 Byland Abbey soft capping on the Lane wall (Feb 2004–Jan 2016).
 ©Heather Viles, University of Oxford
