Historic England

Soft Capping on Ruined Masonry Walls

Chris Wood, Alan Cathersides, Prof Heather Viles

Discovery, Innovation and Science in the Historic Environment

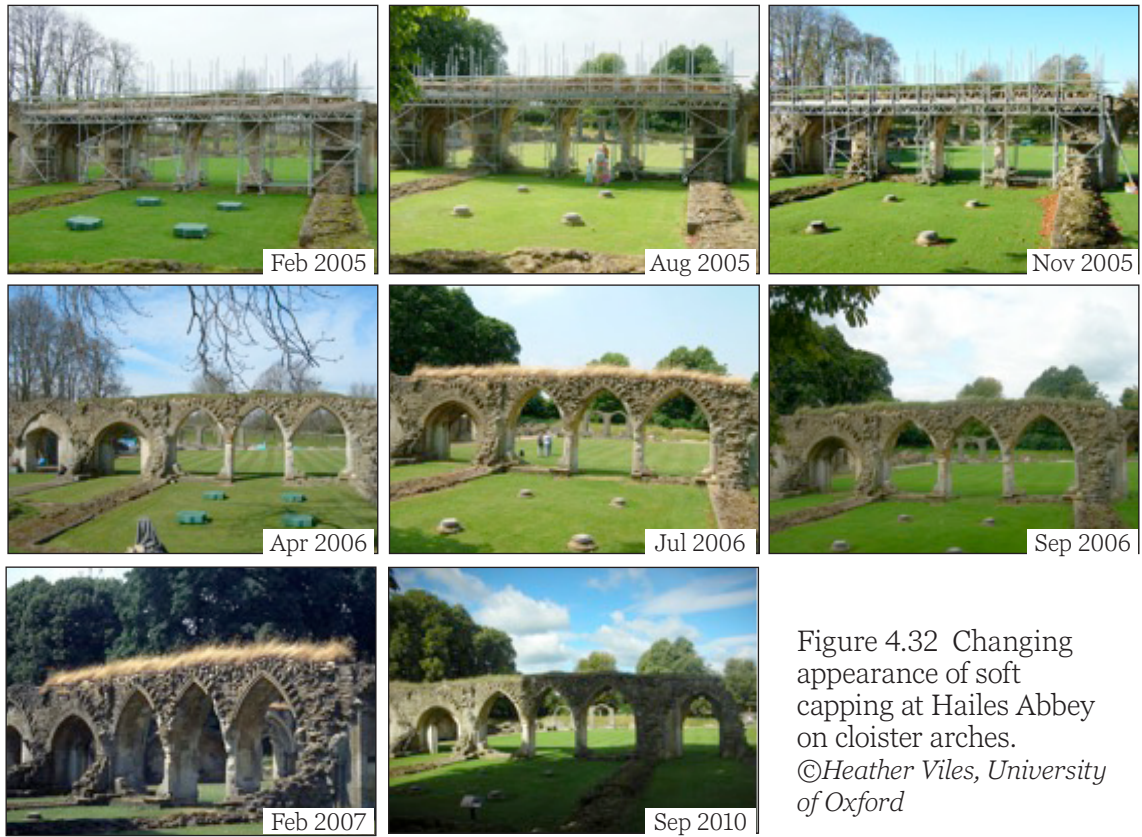
Turf-based capping changes in appearance seasonally (see Figures 4.31 (Byland), 4.32 (Hailes), 4.33 (Thornton) and 4.34 (Wytham Woods)). Lush growth in the growing season is followed by dieback during dry periods, when the entire turf cover can go brown. Wetter periods during the growing season lead to renewed, sometimes luxuriant, growth. Drier years result in poorer growth. The edges of turf-based soft capping experience some erosion, as this is the harshest microenvironment for turf capping. At Hailes Abbey and the test walls at Wytham Woods, the addition of sedum plugs to the edges led to greater stability and reduced erosion. The photo sequences illustrate some episodic growth in other flowering plants, but the capping remains dominated by forbs and grasses.

Figure 4.32 Changing appearance of soft capping at Hailes Abbey on cloister arches.
 ©Heather Viles, University of Oxford

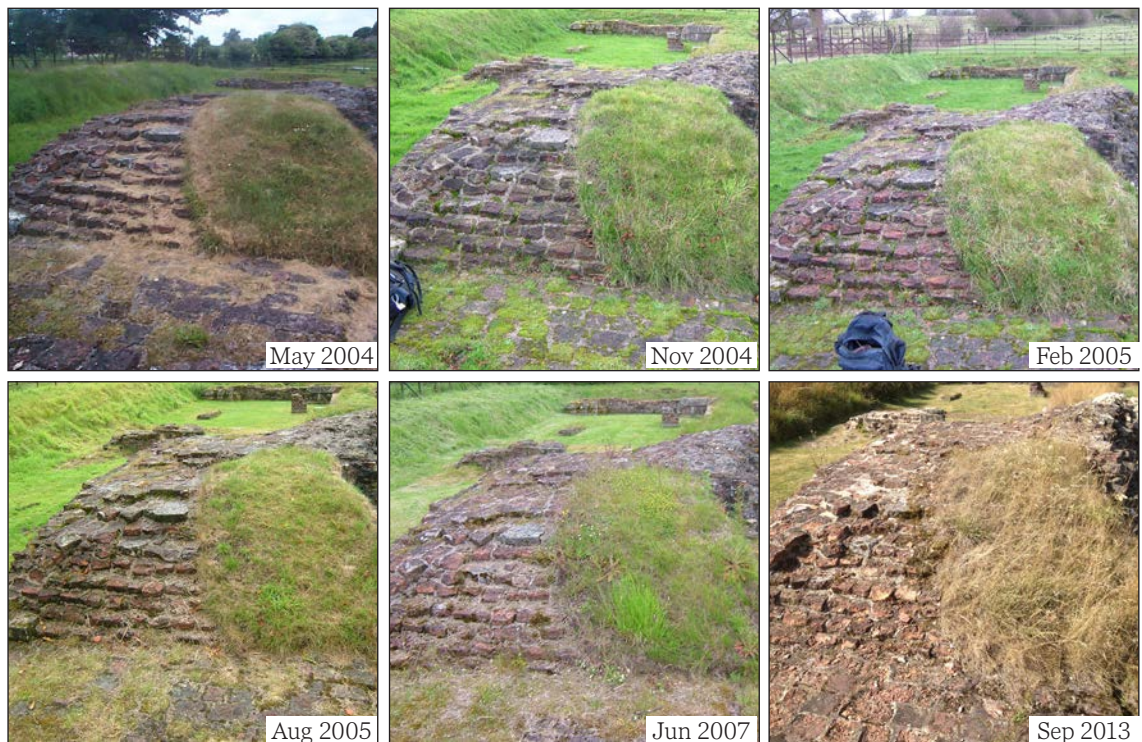
Figure 4.33 Changing appearance of soft capping at Thornton Abbey.
 ©Heather Viles, University of Oxford

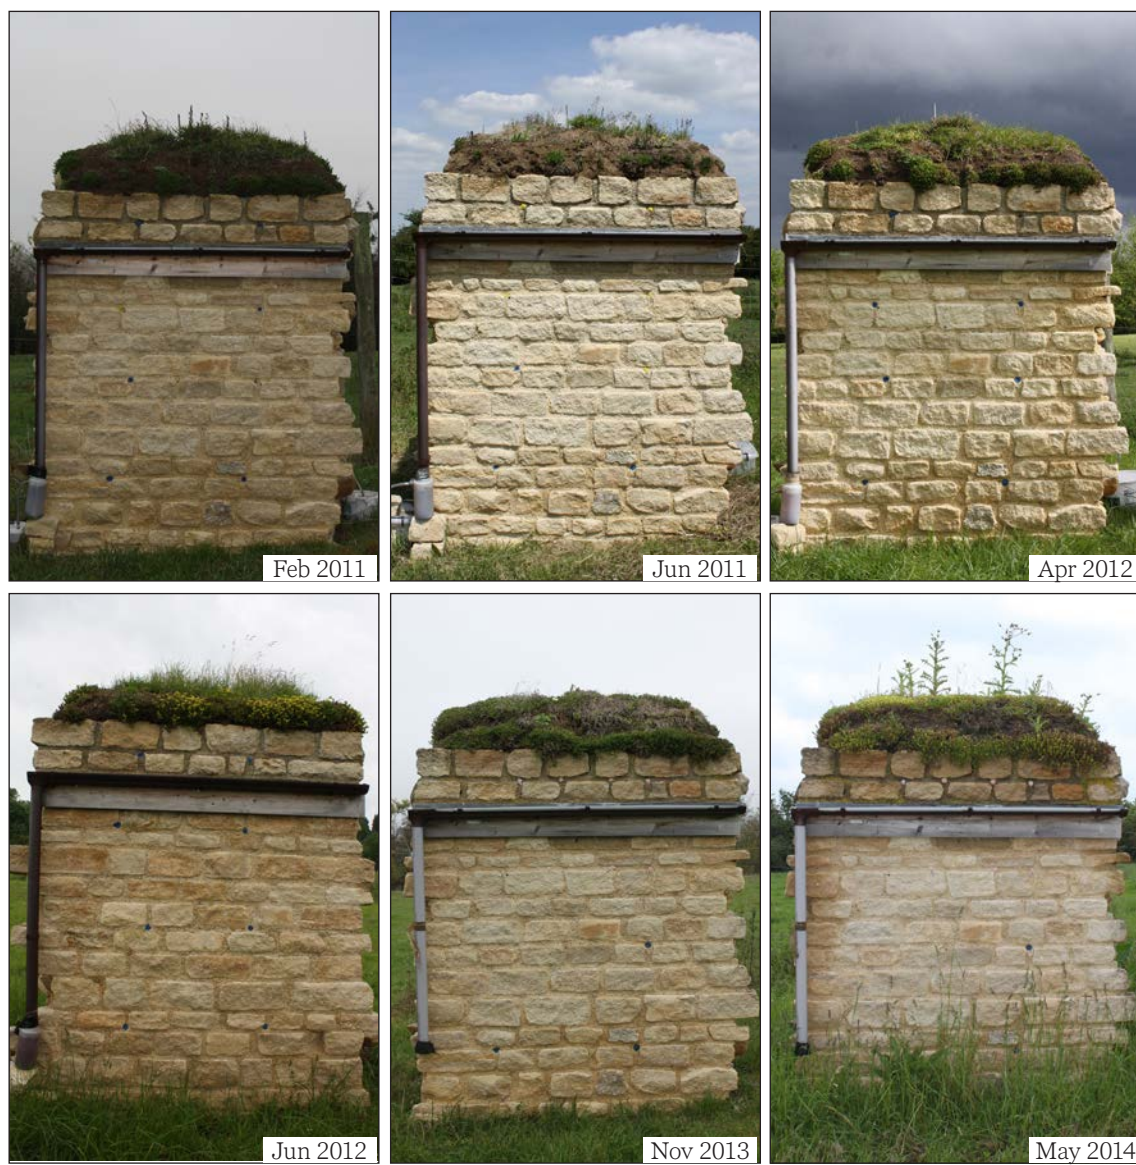
Figure 4.34 Changing appearance of soft capping on the Wytham Woods test walls.
©Heather Viles, University of Oxford

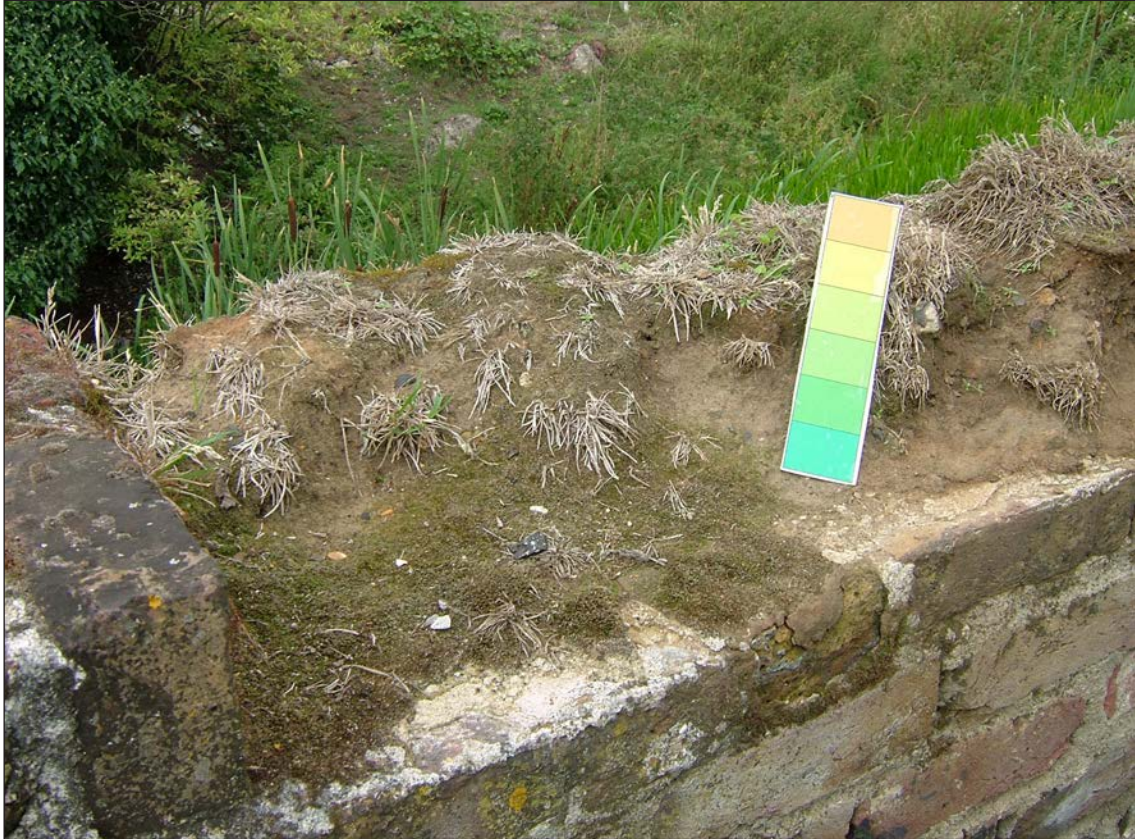
Figure 4.35 Failed soft capping at Howbury moated site (Photo taken in 2010).
©Heather Viles, University of Oxford

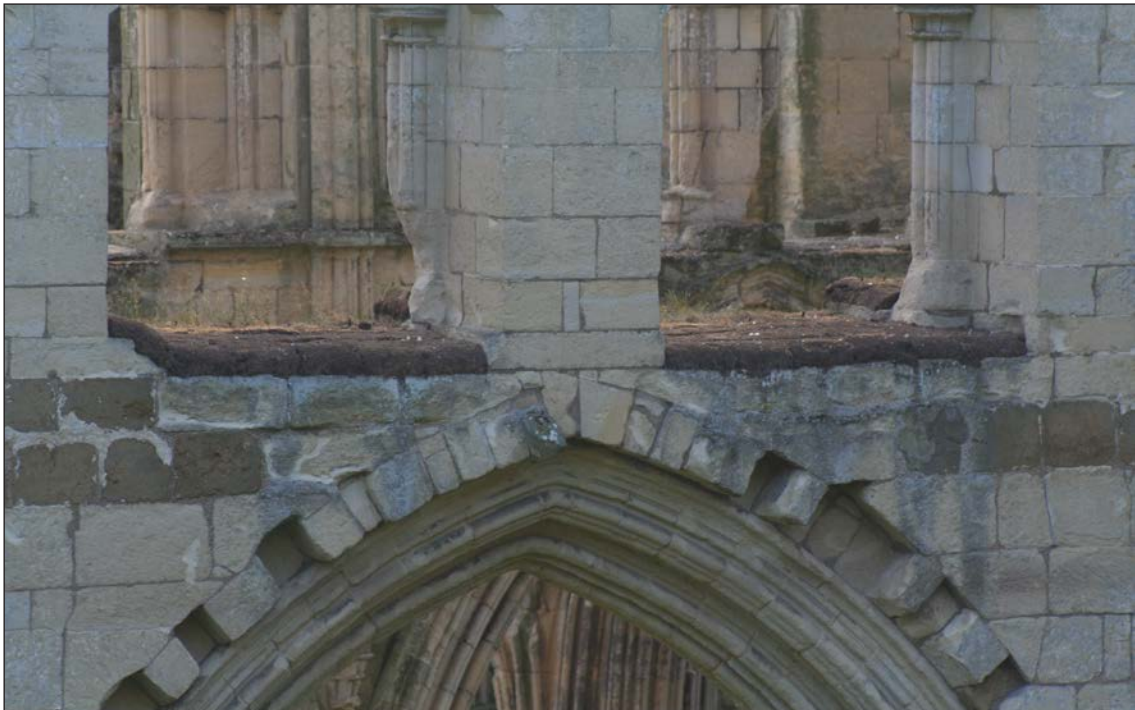
Figure 4.36 Failed soft capping at Rievaulx Abbey. ©Heather Viles, University of Oxford

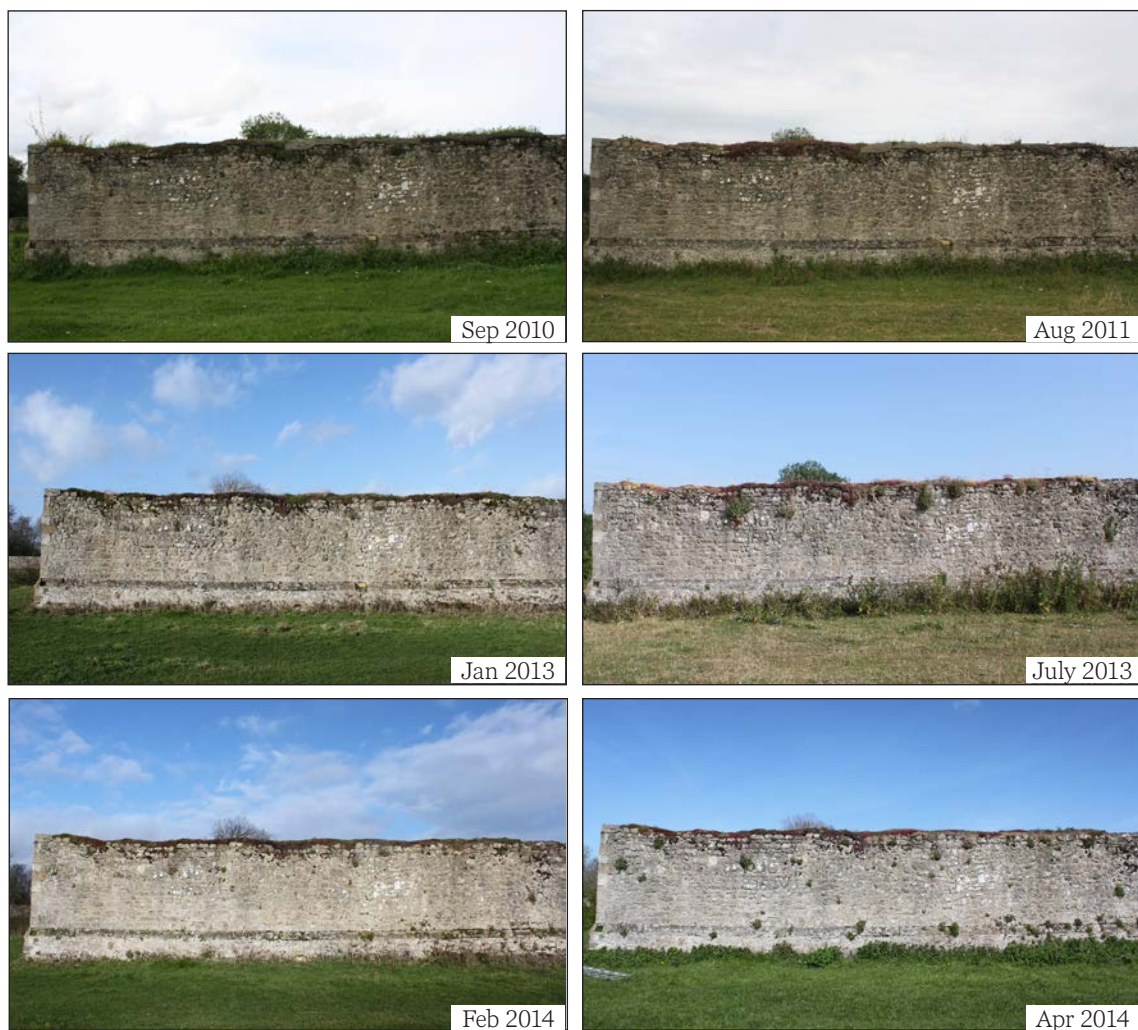
At two sites, a range of different soft capping types was trialled. At Godstow Nunnery commercial turf, sedum mat and seeded mats were compared with the usual locally cut turf. The soft capping types were trialled with and without water-retaining gels. At Castle Acre Priory, local turf-based capping (with and without sedum plugs at the edges) was compared with the same type of sedum mat used at Godstow. Figures 4.37 and 4.38 illustrate how the different cappings evolved visually over time. At Godstow the seeded mat did not perform well, with little growth of the seeds within the mat. The commercial turf also performed poorly.

Figure 4.37 Changes in appearance to grass and sedum soft capping at Godstow Nunnery.
©Heather Viles, University of Oxford

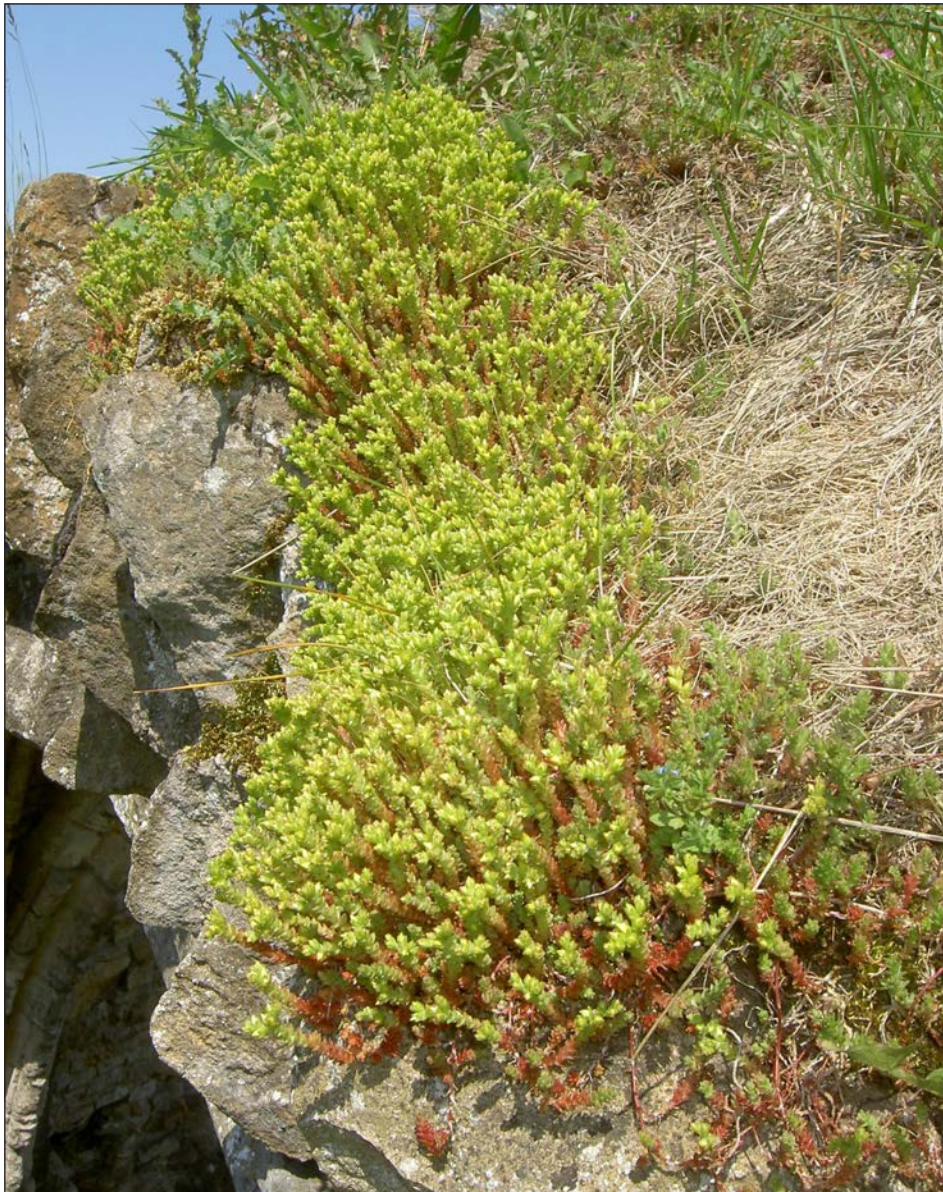
Figure 5.1 Naturally occurring sedums forming stable edges on older soft caps at Kirkham Priory. ©Alan Cathersides

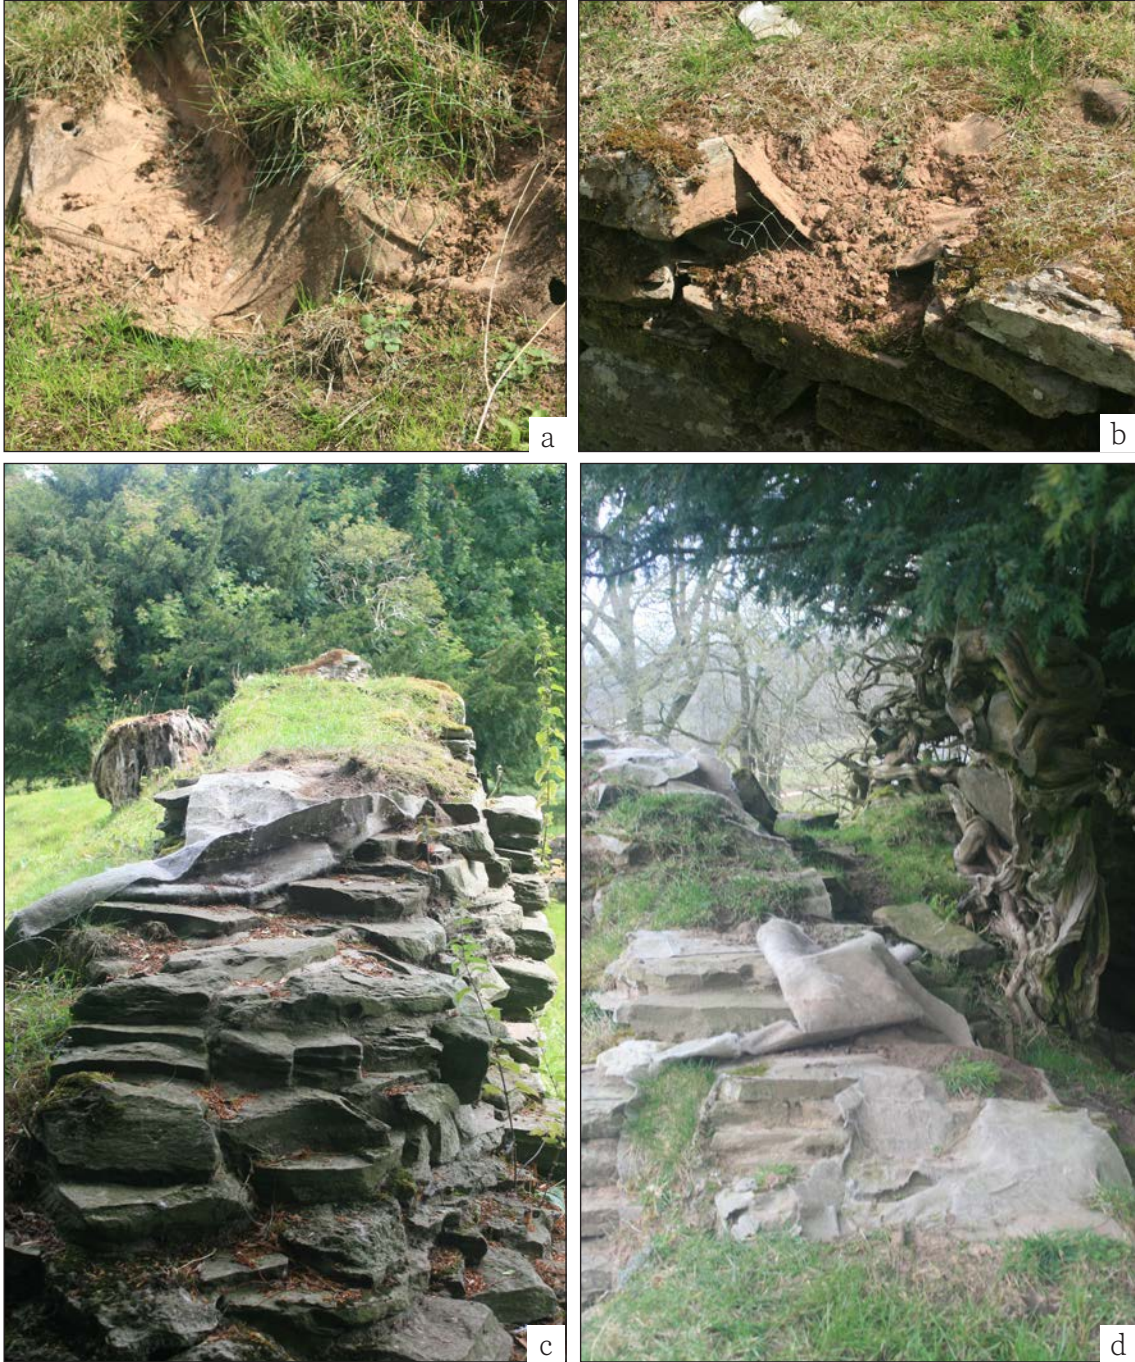
The installation of a membrane beneath soft capping is unnecessary, and may be harmful to its effectiveness in the longer term. Membranes stop fine grass rootlets from getting established in a stone surface. These rootlets eventually grow into a dense mass, just like the tangle of roots which has proved so successful at resisting water penetration at Myross Church in County Cork, Ireland (Figure 1.4). Moreover, the undulating nature of most wall tops means that installing membranes effectively and finishing the edges neatly is difficult. When grass roots cannot connect to a wall top, the soft cap can roll up like a carpet. Membranes and barriers often tend to separate slightly from surfaces. This both looks conspicuous and concentrates the flow of water.

The successful installation and establishment of soft caps on the test walls within this research project has shown that membranes are not needed. Examples of the types of problems encountered with membranes can be seen in Figures 6.1a to 6.1d taken at a site where an early use of soft capping did include a geotextile.

Figures 6.1 (a-d) showing the problems with using membranes on both even and uneven wall-heads. (all ©Alan Cathersides)

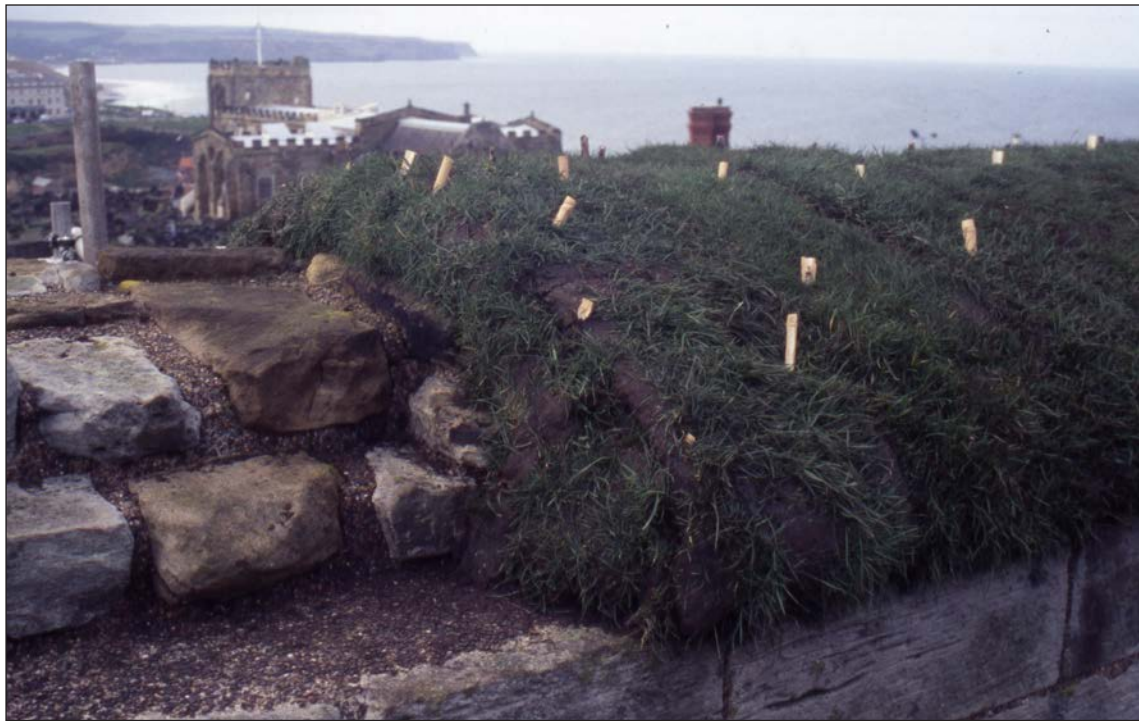
Figure 6.4 When capping steeply profiled edges it is critical to peg the turf in place until it can properly root into the mass of soil beneath. ©Alan Cathersides

6. Finally, pin down the turf using biodegradable pins (split bamboo canes or similar) to ensure individual turf sections do not slip off before they take root (Figure 6.4).

There are only two options for dealing with an uncapped surface with a distinctly stepped profile (Figure 6.4). It is impossible to replicate a step exactly using soft capping because turf will never establish properly on a vertical surface. One is to cap the horizontal surfaces above and below the vertical face, which is left exposed. This will initially retain the stepped appearance (see Figure 6.5 (i)). However, when the grass grows, this profile will be hard to see. Furthermore, this leaves some of the historic fabric exposed. The other option is to ‘ramp’ the soft cap over the step (see Figure 6.5(ii)). This protects the fabric more fully but loses the definition of the step. The height of the wall may be an important consideration, as soft caps on lower walls are much more visible than those at higher levels.

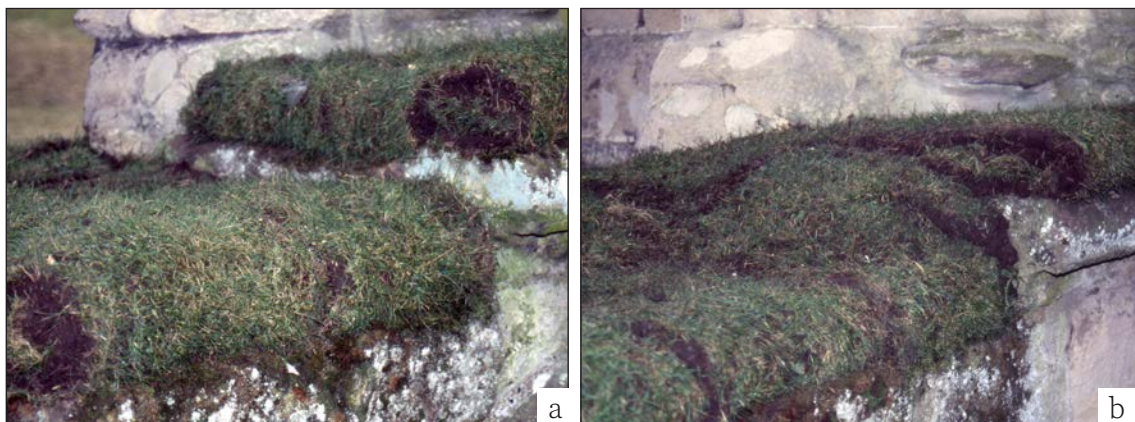
Figure 6.5 (a) soft capping above and below the step initially retains its appearance (right hand side), but this will be lost to some extent as the grass grows, (b) ramping over the step means a loss of definition but increased fabric protection. (both ©Alan Cathersides)

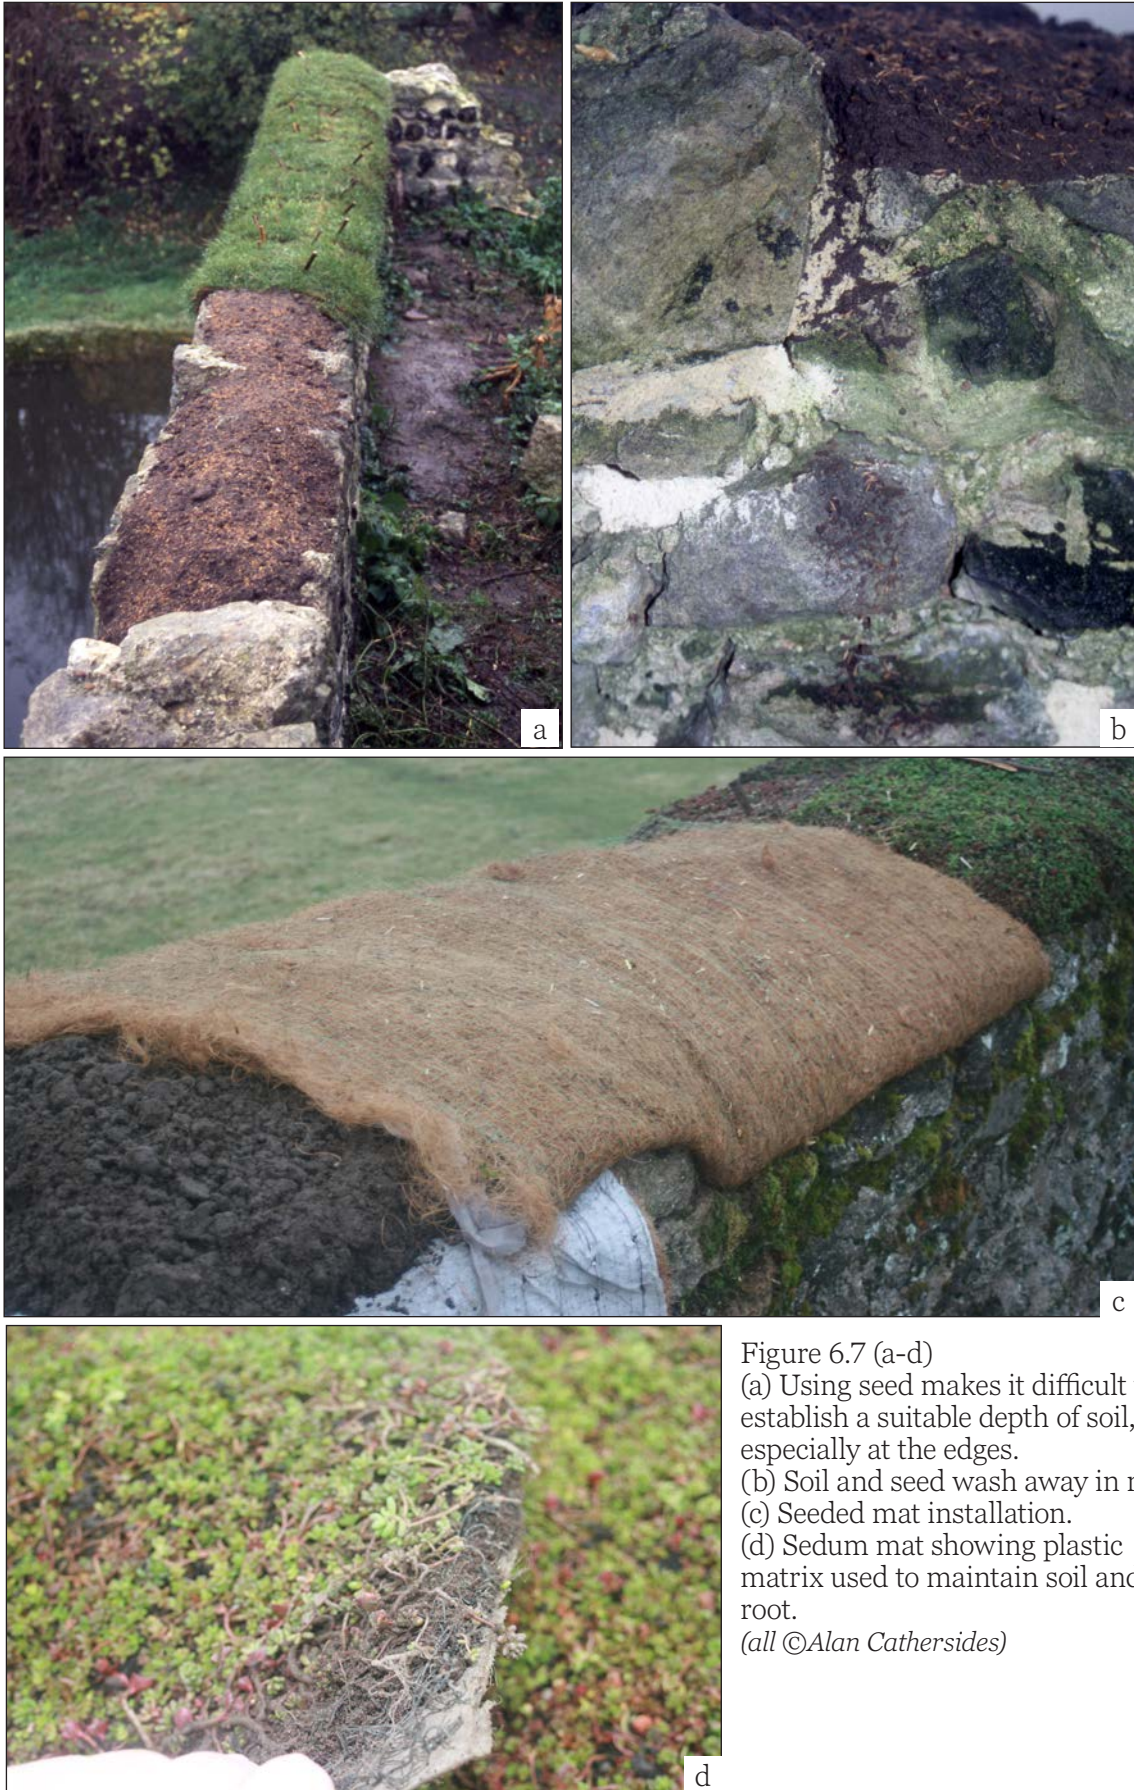
Figure 6.7 (a-d)
 (a) Using seed makes it difficult to establish a suitable depth of soil, especially at the edges.
 (b) Soil and seed wash away in rain.
 (c) Seeded mat installation.
 (d) Sedum mat showing plastic matrix used to maintain soil and root.
 (all ©Alan Cathersides)

Other options to turf for soft caps have been trialled (see Figure 6.7) and include the following.

The advantage with seed is that it is very easy to get a mix of exactly the right sort of drought-tolerant grasses. It is cheaper than turf, and even small amounts of a mix are usually easy to obtain. Seeding has some serious disadvantages, though, and is therefore not recommended. The three main disadvantages are:

As mentioned above, sedum roots do not enable it to be cut as a turf. However, mats of living sedums growing within a soil-filled plastic matrix are readily available, as they are frequently used by the green roof industry. These were trialled at Godstow Nunnery and Castle Acre Priory. The mats are very heavy, and installing them as soft caps in the standard ‘turf’ fashion was difficult work. Furthermore, it is also difficult to trim these mats to fit uneven areas. However, once installed, they did work very well, and at least initially provided a very effective soft cap. Unfortunately, the soil appears to wash out of the plastic matrix at the edges over time, and vegetation cannot grow, which leaves the unattractive matrix on show. The mats are also much more expensive than turf.

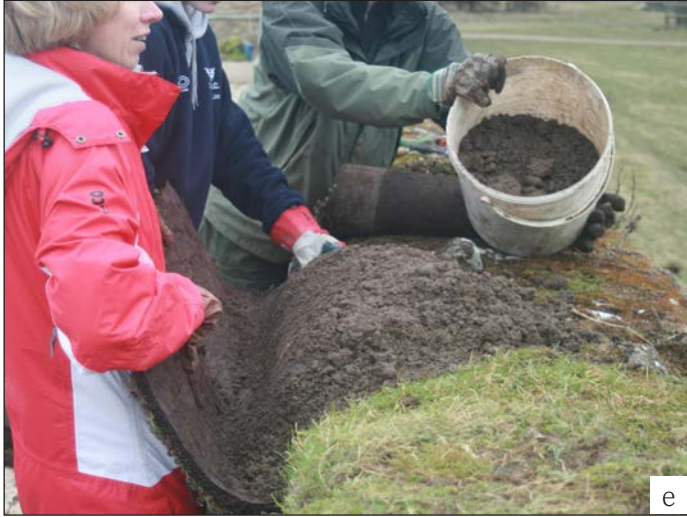
Figure 6.7 (e-h)
 (e) Sedum mat during installation – the heavy weight of the mat makes it difficult to manipulate.
 (f) Sedum mat after installation
 (g) Edges of Sedum mat after.
 (h) Sedum mat after 7 years showing loss of soil and Sedums at edges.
 (all ©Alan Cathersides)

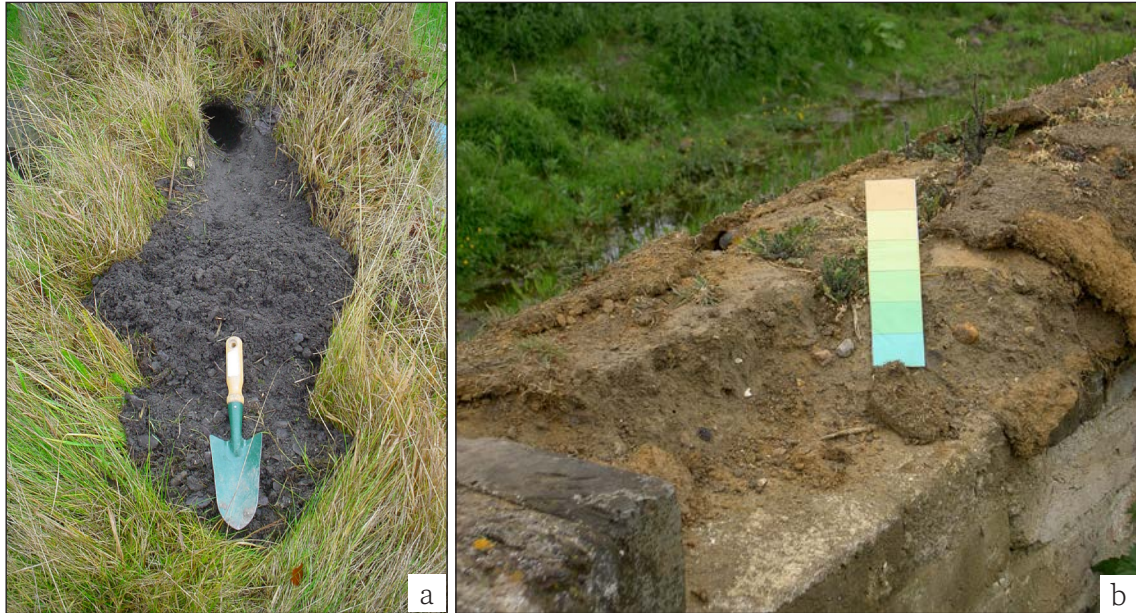
Figure 6.8. (a) A rabbit's trial burrow at Byland Abbey; and (b) damage to the newly installed soft cap at Howbury caused by a fox scrambling up the side of this low wall. (both ©Heather Viles, University of Oxford)

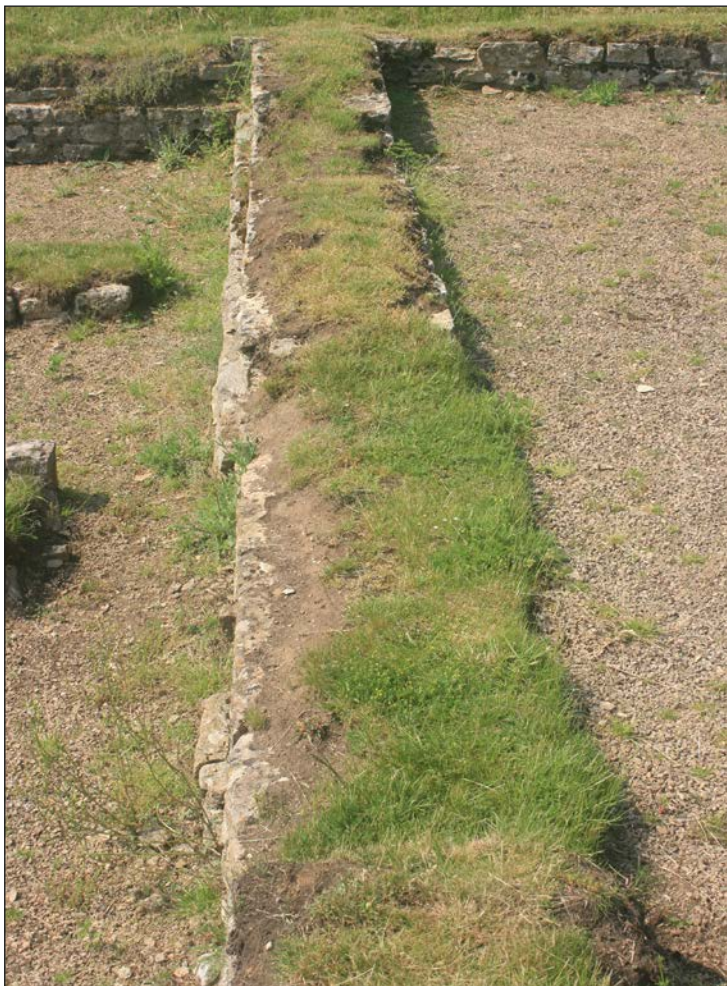
Figure 6.10 Low walls which are soft capped may need periodic repair because of erosion resulting from compaction. ©Alan Cathersides

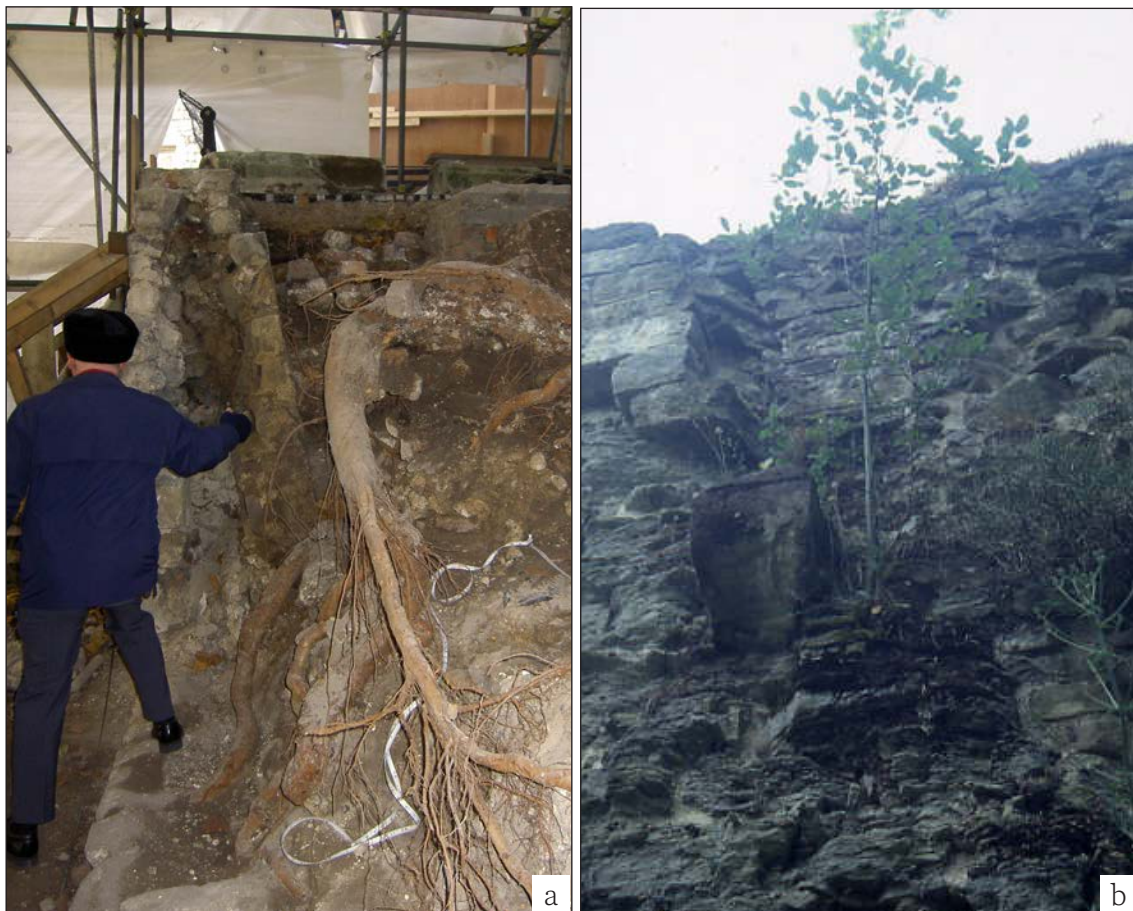
Figure 6.11 Damage to the moat wall at the Tower of London (a) caused by the secondary thickening of tree roots; and a tree growing on an uncapped ledge on a wall at Wigmore Castle (b). (both ©Alan Cathersides)

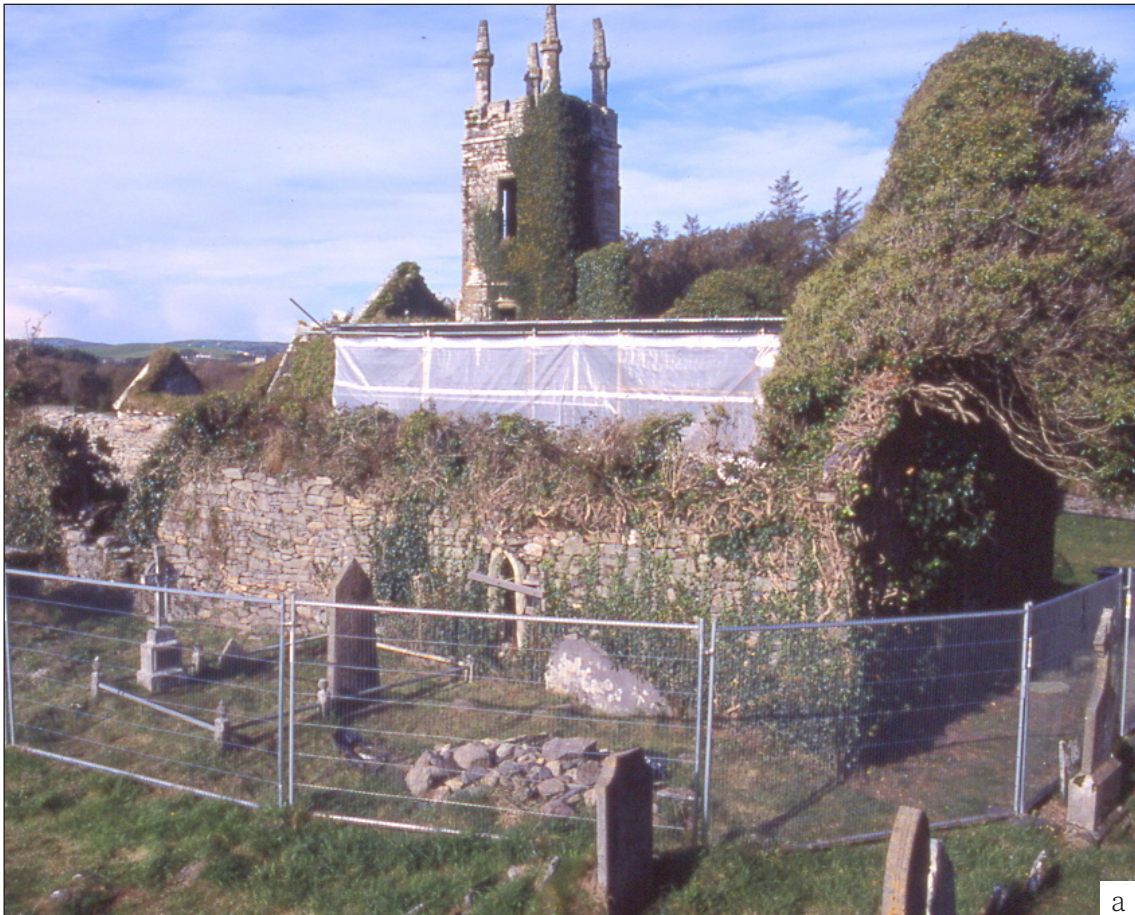
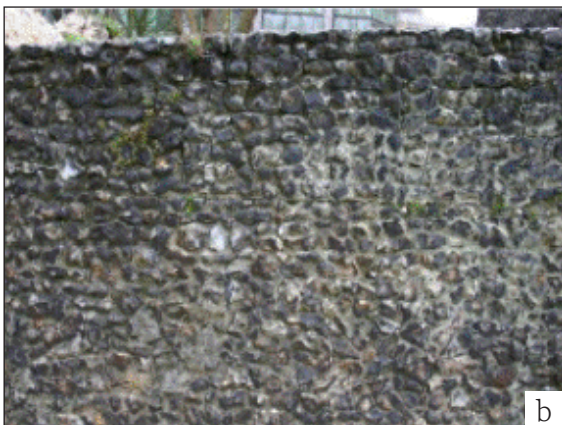
Figure 6.12 (a) An example of a 'natural' site where there has been no previous consolidation and (b) an example of a site where there has been extensive consolidation. (both ©Colin Burns)

New hard caps were constructed for comparative purposes in this research project. They were built on wall-heads at the test sites that had previously been repaired and consolidated with cementitious mixes. An additional justification for this was that virtually all of the monuments that are maintained by the English Heritage Trust have been consolidated at some time in their history (Figure 6.12b).

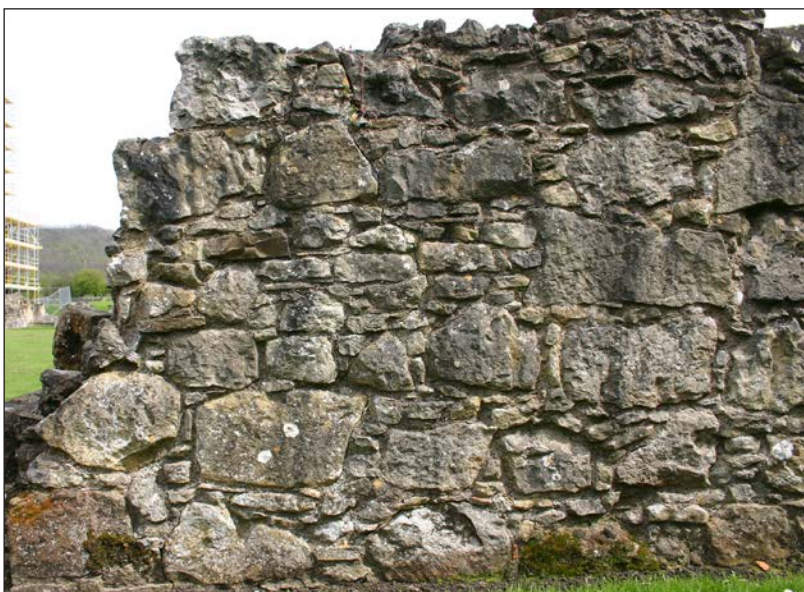
Figure 6.13 Cracking in the wall due to consolidation using cement mortars. © *Chris Wood, Historic England*

Such considered techniques gave way in the 1950s to the use of cements for all consolidation works, as cements require less expertise and time to cure. However, cement mortars have become stronger over time, and thus today are generally inappropriate and damaging when used in the conservation of structures built with lime mortars. It is important to note that even though cement mortars might not be regarded as the best choice for wall head consolidation today, historically their use has helped preserve ruined structures that might otherwise have been lost to continued decay.

The main problems with using cement technologies on structures built with lime mortars relate to their differential thermal expansion (see section 4.2.1.d, which looked at thermal expansion properties of different materials) and permeability characteristics including those of stone. Lime mortar has a much greater coefficient of expansion and permeability than modern cements. Cement capping can in effect create a solid, continuous beam at the wall-head, and thermal movement over an extended period of time will produce shearing between cement and lime, together with cross fracturing of the wall cap. Pointing of faces with cement mortar has a similar effect, which is usually exhibited by fracturing near wall ends/corners, as seen in Figure 6.13. Such fracturing allows rapid rainwater penetration to the softer lime core of the structure and can hasten deterioration. For these reasons, consolidation techniques are increasingly making use of modern lime mortars to better match those used in the original construction.

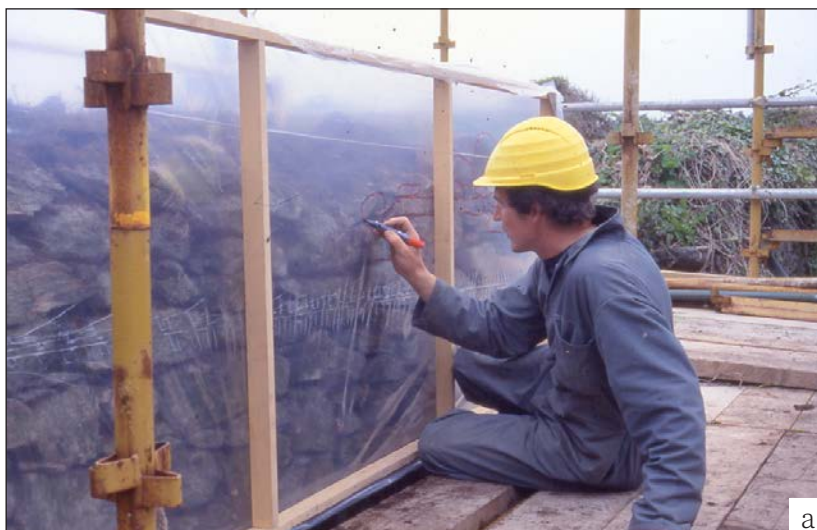
Figure 6.14a-b Using the planning frame to trace the outline of individual stones.
©Colin Burns

2. The exact positions of all face stones and any notable archaeological features on the wall-head should be recorded on a planning frame. This consists of a simple wooden frame on which clear plastic sheeting is attached. This frame must be positioned on pins in the masonry to ensure that it can be realigned precisely into the same position at any given time, and every individual stone and the skyline of the broken wall head traced onto the planning frame to enable an accurate rebuild (Figure 6.14).

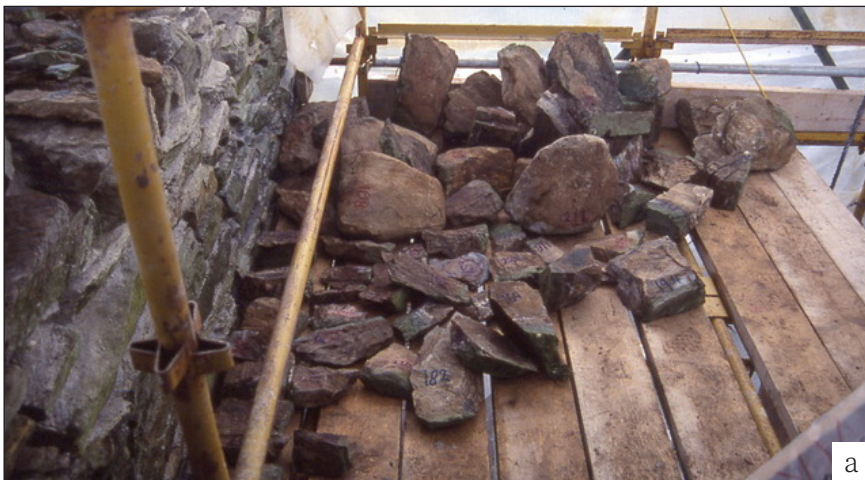
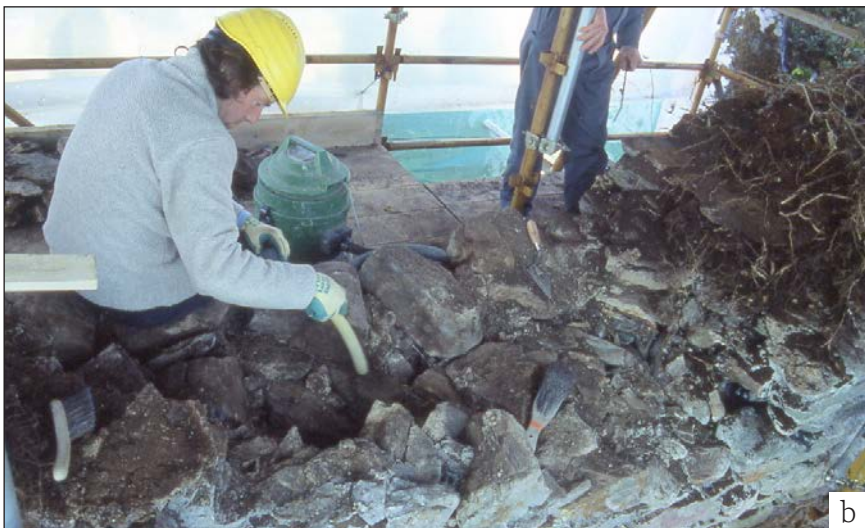
Figure 6.15 (a) Numbering and labelling the face work stones as they are removed from the wall, and (b) removal and cleaning of the core work. ©Colin Burns

3. Dismantling of the wall can now take place. As each face stone is removed, it is numbered with indelible marker or paint in accordance with the planning frame (Figure 6.15). The number is usually written on the top bed of the stone prior to its removal. The only exception to this general rule is the top course, which should be marked on the bottom bed so that the marking is hidden once the wall is rebuilt. This is an important procedure, as it allows the mason to be able to identify the correct stone and its orientation from the pile during the rebuilding process. The removed stones must be cleaned of any residual mortar or soil, washed and then stacked away from the wall, ready for later rebuilding.

4. As the face work is dismantled, the core is removed. These stones must be cleaned of residual mortar and soil before being stacked separately for use in rebuilding the wall (Figure 6.15). It is often virtually impossible to remove all the residual cement from the core work without causing damage to the stones, and consequently, it is often necessary to discard the majority of the core material. During this dismantling process any roots or soil within the walls are removed. It is not necessary to remove all traces of root material, and fine roots can remain deeply buried in the wall, as they are unlikely to survive because of a lack of sunlight. Substantial root systems, however, should be traced down the wall by unpicking the masonry until they are no longer deemed to be a problem.
