Historic England

Soft Capping on Ruined Masonry Walls

Chris Wood, Alan Cathersides, Prof Heather Viles

Discovery, Innovation and Science in the Historic Environment

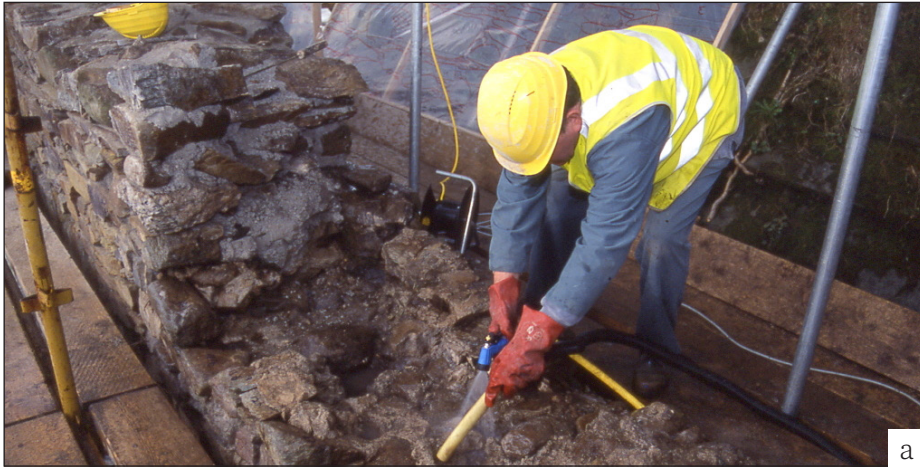
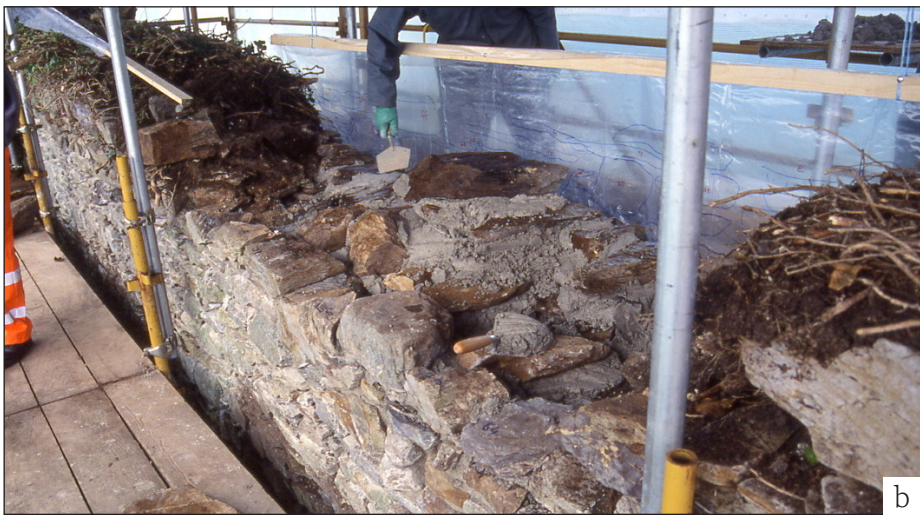
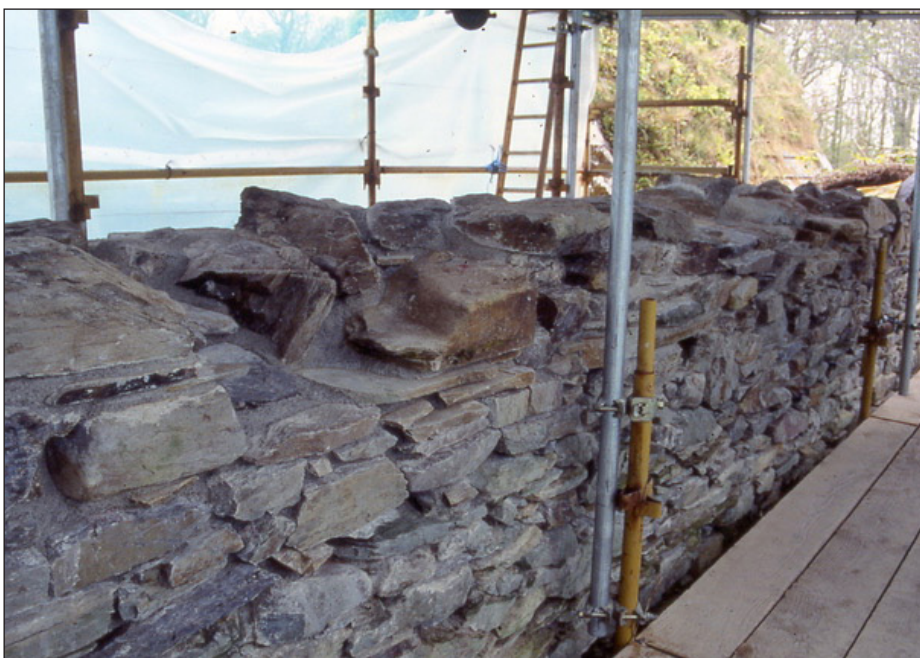
Figure 6.16 (top) (a) Cleaning the surface to prepare it for rebuilding, and (b) starting to rebuild the wall in levels across the wall.
Figure 6.17a,b (bottom) The wall near completion, showing good continuity with the rest of the structure. (all ©Colin Burns)

6. Once dismantling is completed, the exposed wall-head should be prepared for the resetting of the face stones by brushing or hoovering off loose material and washing with clean (potable) water. Rebuilding can then commence, starting with the face work, which should be positioned in accordance with the planning frame. On completion of each facing course, the core work should be installed, thus building across the wall in lifts. This process continues until the final course of face work, at which point the broken wall-head is constructed (Figure 6.16).

7. The relationship between the face work and the core work is critical, especially for the construction of the broken wall-head. It is important that its final formation shows good continuity with the rest of the structure (Figure 6.17). It is generally accepted that the finished wall-head may be modified from the original 'as found' position to avoid rainwater ponding. It is important, however, not to compromise any archaeological features that exist within the masonry. Occasionally, the reintroduction of reclaimed fallen masonry into a wall increases the height of the wall head. A black line, galleting, or similar arrangement can then be introduced to indicate the height of wall before consolidation of the added masonry.

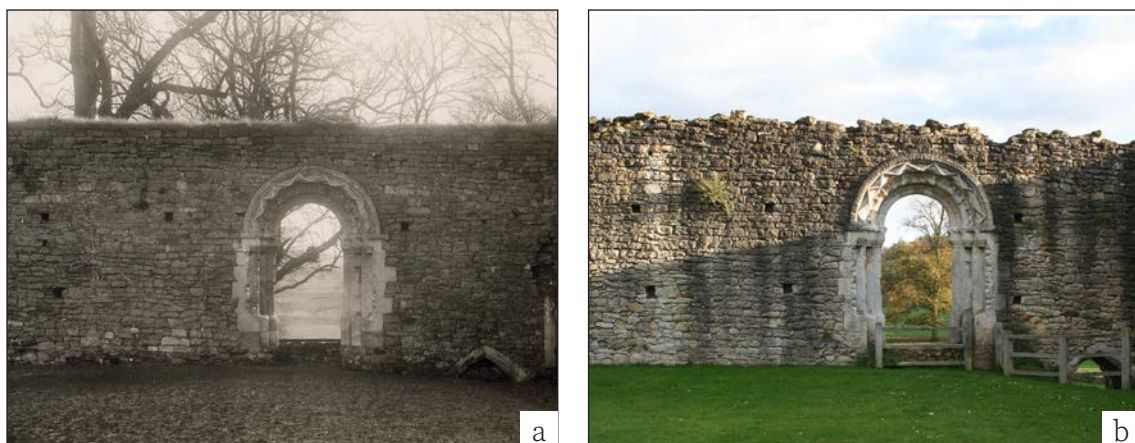
Figure 7.3 (a) Kirkham Priory refectory wall in the early 20th century before consolidation, showing clear coursing lines of the facework and a very flat walltop with a grass cover, and (b) in recent times, without a grass cover and significant alterations to its profile (© Chris Wood, *Historic England*).

19th- and early 20th-century photographs show other examples of natural soft capping on ruined monuments. Vegetation might even have been encouraged to grow in order to enhance a 'picturesque' appearance, as was possibly the case at Kirkham Priory (Figure 7.2a). This 19th-century photograph reveals that the wall was in relatively good condition, especially considering that it had very likely been neglected for four centuries. The medieval tracery too was in very good condition, so the wall-head (including its organic growth) must have conferred protection from the elements. Further along from the laver at Kirkham Priory is the wall of the refectory. Figure 7.3a shows this section of the wall in the early 20th century, prior to the Ministry of Works consolidation programme of the 1920s. The wall had a flat, regular top with a grass cover.

In comparison, Figure 7.3b shows the same location in the first decade of the 21st century. Most of the rubble walling is still intact, although the distinctive coursing is not clear. More significantly, the wall top has been consolidated, leading to significant alteration in its profile, and a significant amount of rebuilding had been carried out. There is considerable black streaking on the wall face in the later photograph; on the earlier photograph there was none. It is likely this streaking is algal colonisation along preferentially wetted flow-paths that have become the focus for runoff after the natural soft capping was removed from the top of the wall.

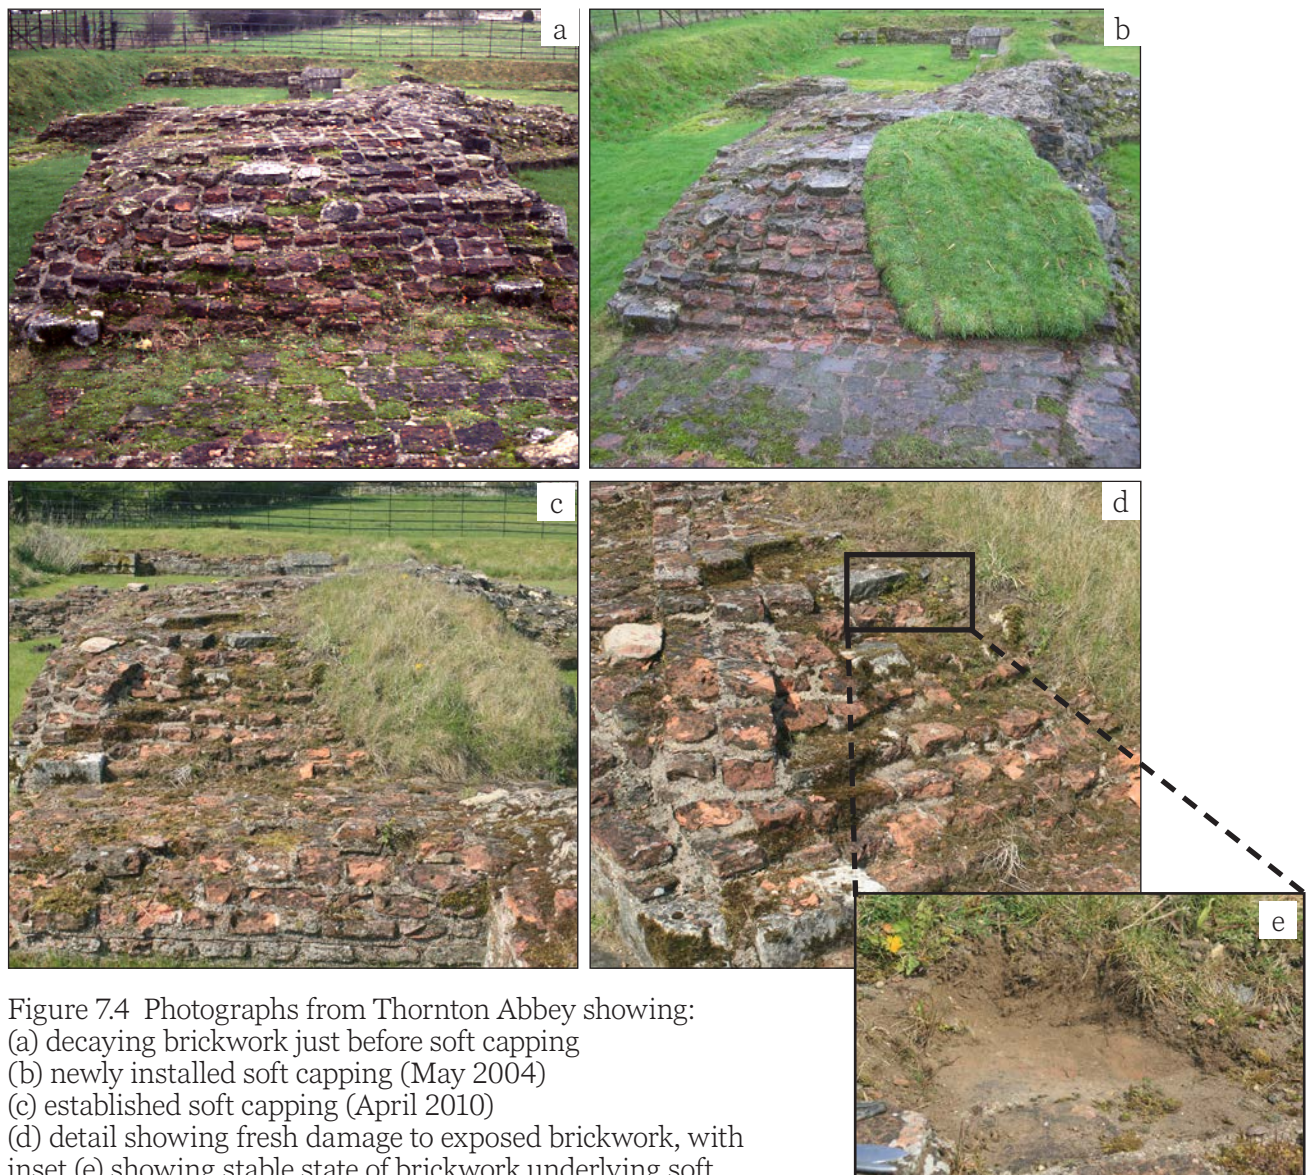
Figure 7.4 Photographs from Thornton Abbey showing:
 (a) decaying brickwork just before soft capping
 (b) newly installed soft capping (May 2004)
 (c) established soft capping (April 2010)
 (d) detail showing fresh damage to exposed brickwork, with
 inset (e) showing stable state of brickwork underlying soft
 capping (April 2010).
 (all ©Heather Viles, University of Oxford)

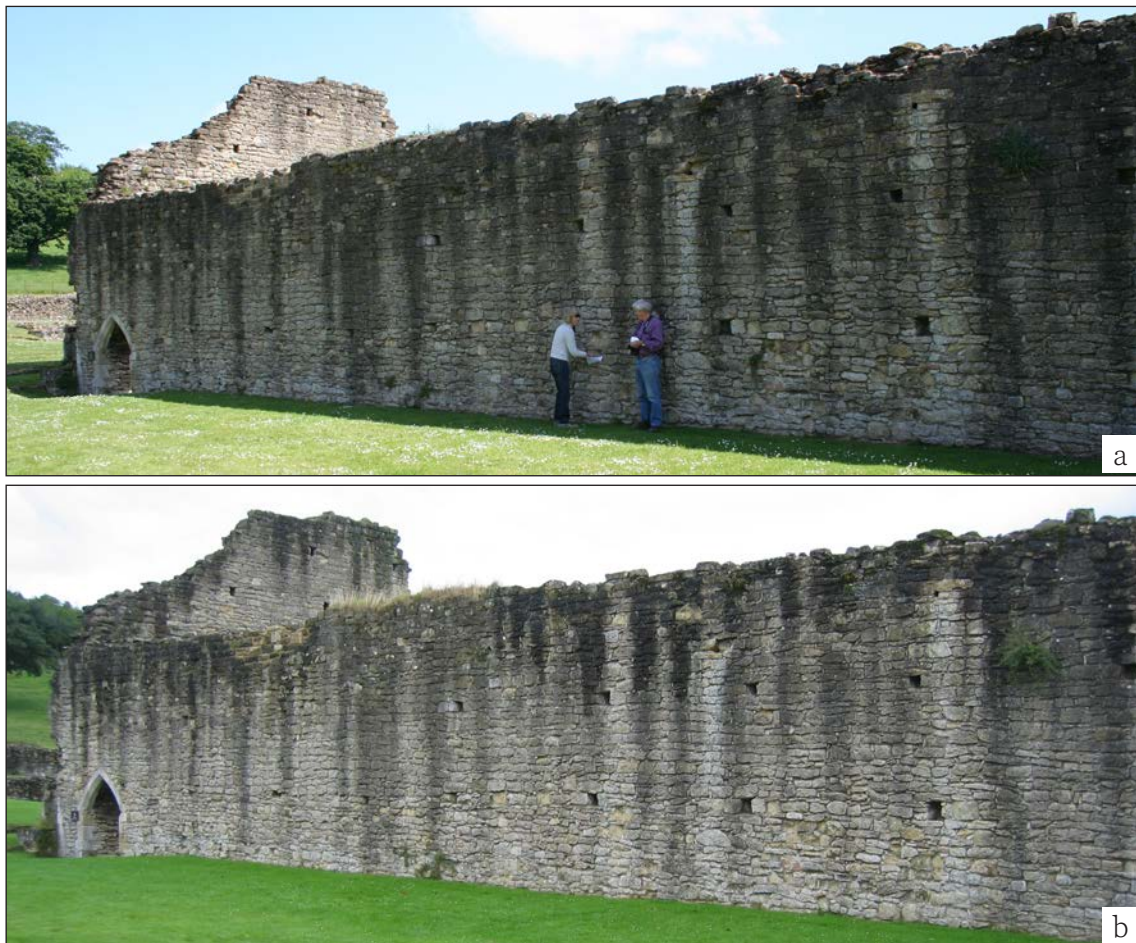
Figure 7.5 Streaking on the wall of the frater (refectory wall) (a) before and (b) 18 months after soft capping was installed. Streaking appears less noticeable after 18 months underneath the soft capped section (black line, image b, just after heavy rain), whilst there is no difference between the hard-capped section and the uncapped areas. (both ©Chris Wood, Historic England)

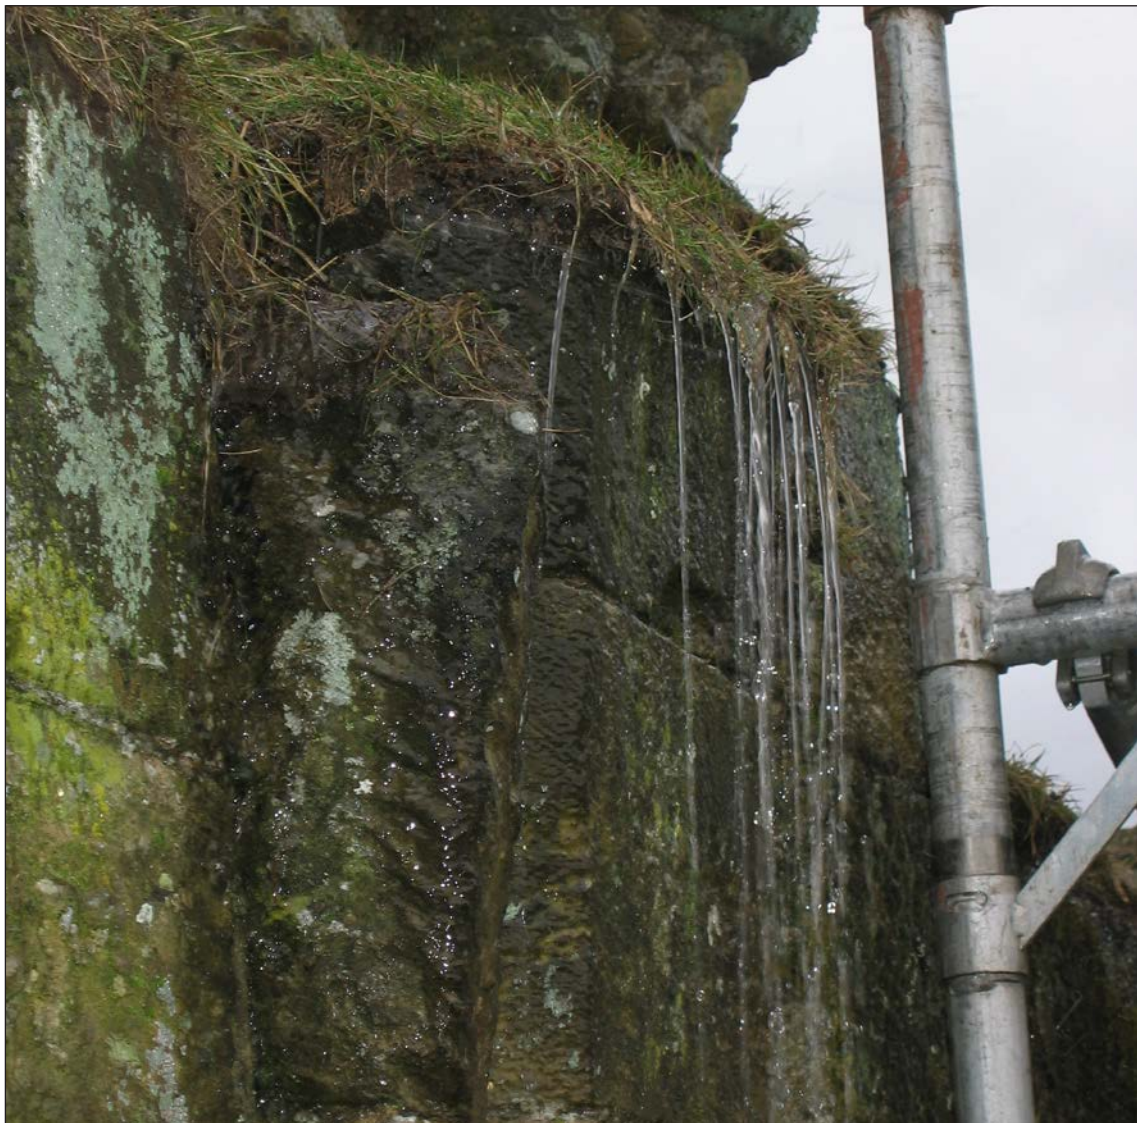
Figure 7.6 The effects of watering newly installed soft capping at Byland Abbey illustrated the water shedding role of even, short turf. ©Chris Wood, *Historic England*

By applying water to new soft capping at Byland Abbey, its potential for water shedding can be seen (in Figure 7.6). While this was not a strictly scientific test, using a watering can and observing the pattern of runoff showed that even short tufts of grass can be effective at shedding water away from the wall face, thus reducing the threat of algal colonisation and unsightly black streaking.

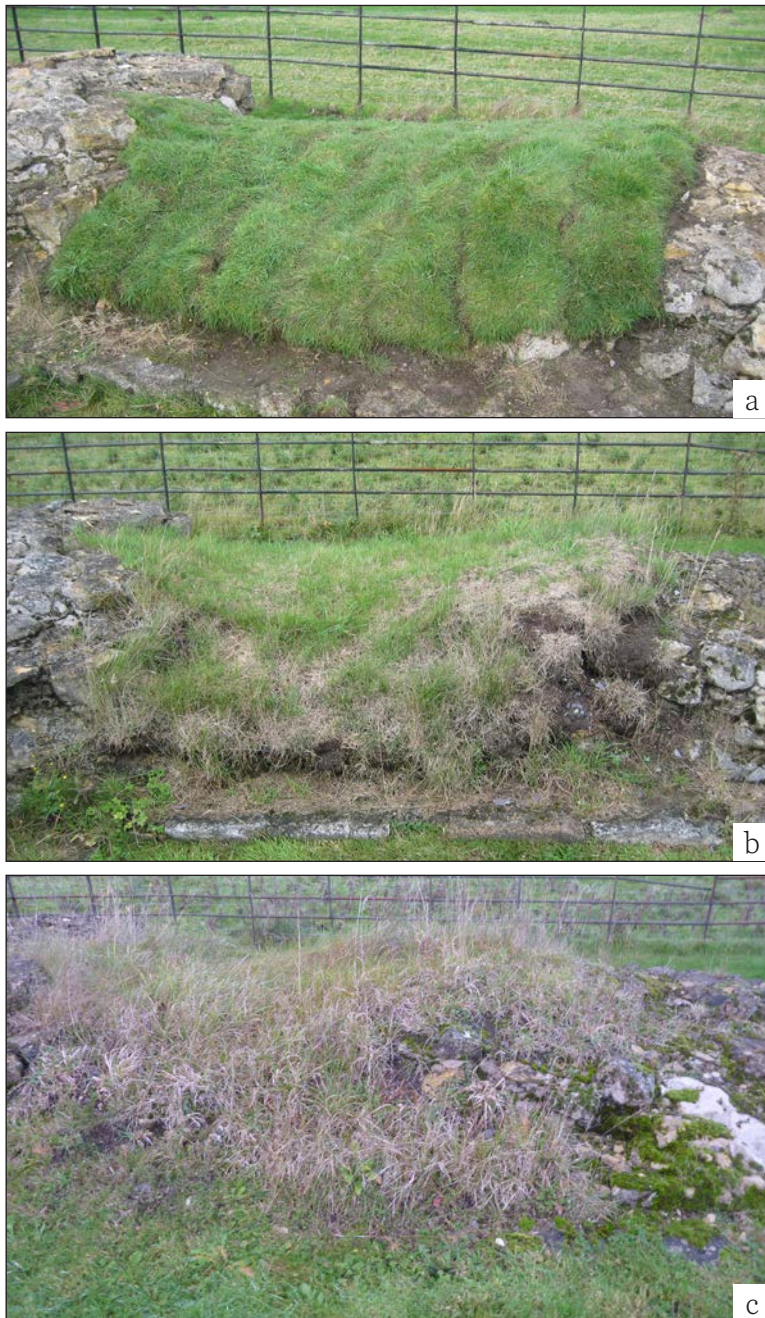
Figure 7.7 One of the soft capped areas at Thornton Abbey, (a) at the time of installation, (b) 18 months after installation, and (c) in November 2016. (all ©Chris Wood, Historic England)

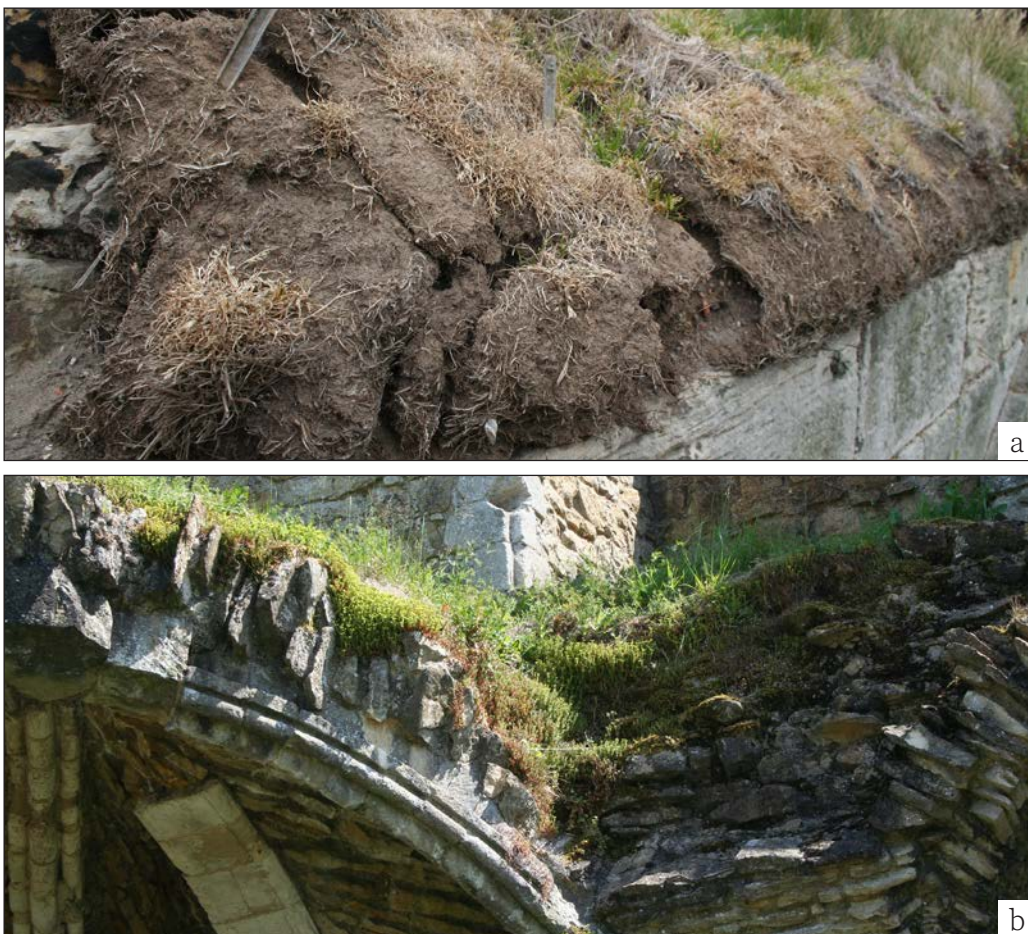
Figure 7.8 Soft capping in a highly exposed position at Whitby Abbey showing decay at the edges (a); and older soft capping at Kirkham Priory showing exuberant growth of sedum along the edges (b). (both ©Chris Wood, Historic England)

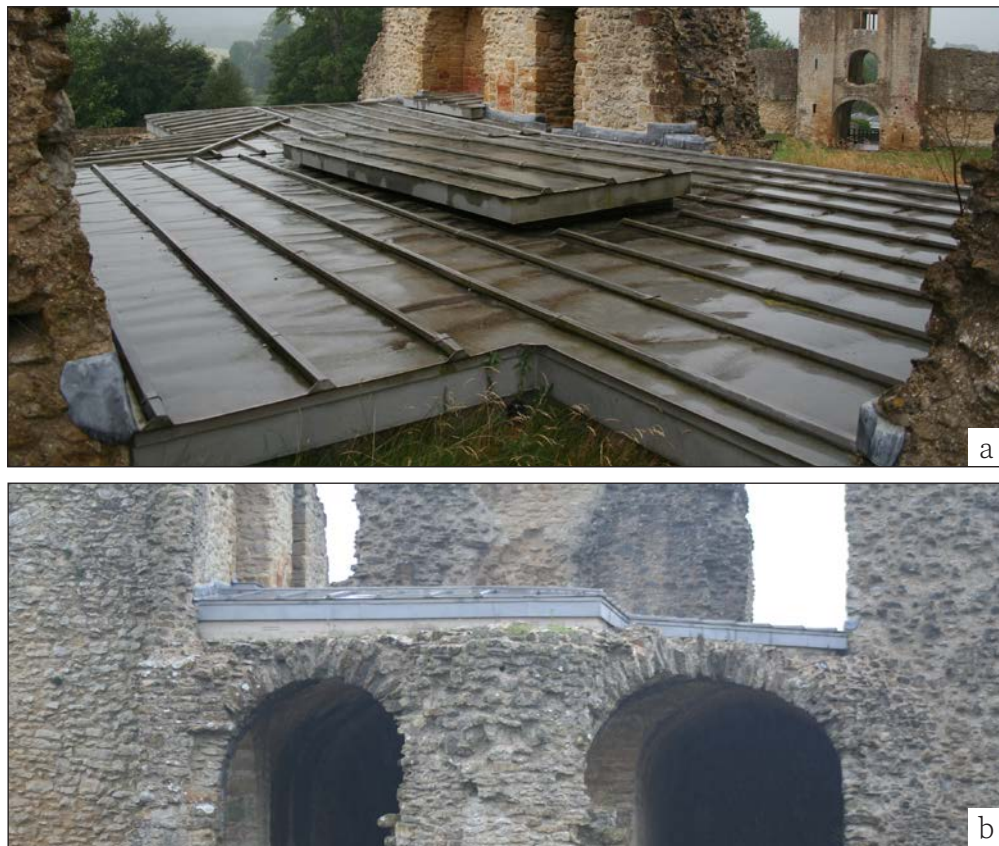
Figure 7.9 A flat zinc roof built at Sherborne Old Castle to tackle problems of water ingress. (both ©Chris Wood, Historic England)

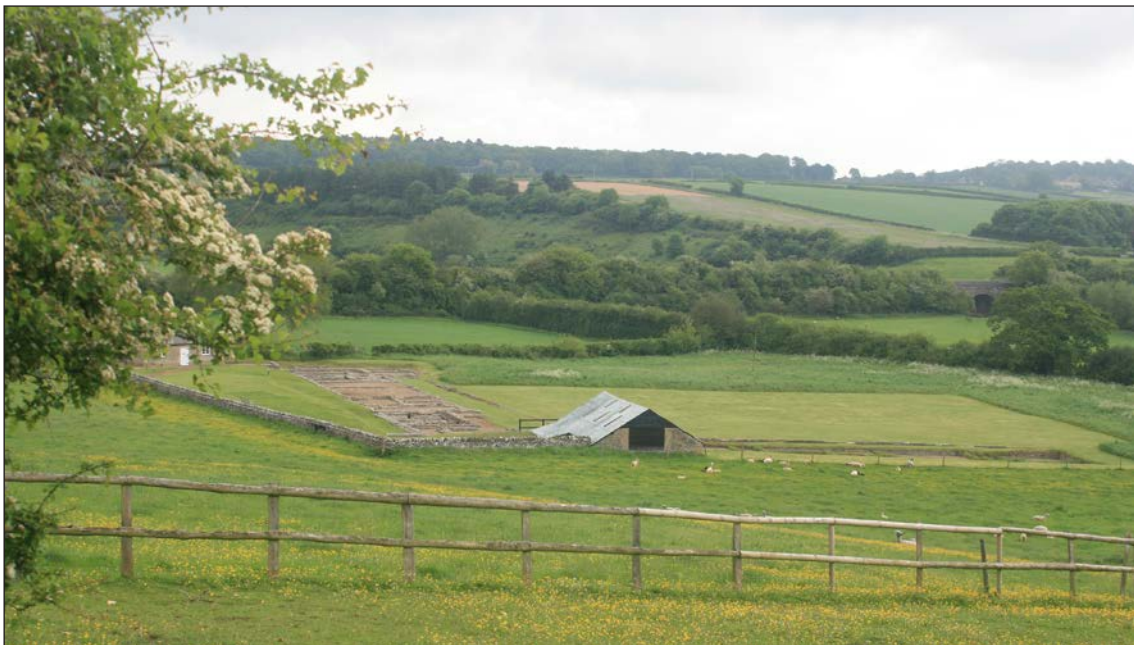
Figure 7.11 North Leigh Roman Villa (near Oxford), showing recent installation of soft capping on half of the site to the right of the roofed building (May 2009). ©Alan Cathersides

Adopting soft wall capping as a conservation technique has potentially huge implications for the appearance and management of historic sites. Soft capping can lead to a major change in the appearance of sites (as shown in Figure 7.11). It is also potentially a much less disruptive intervention than hard capping, and requires much less invasive maintenance and monitoring. The use of soft capping might secure more historic fabric as it is relatively easy to install, and should also contribute to enhanced conservation and biodiversity at heritage sites. Finally, soft capping has proved to be a highly cost effective solution to many conservation problems. And evidence clearly shows it is the natural way to protect walls.

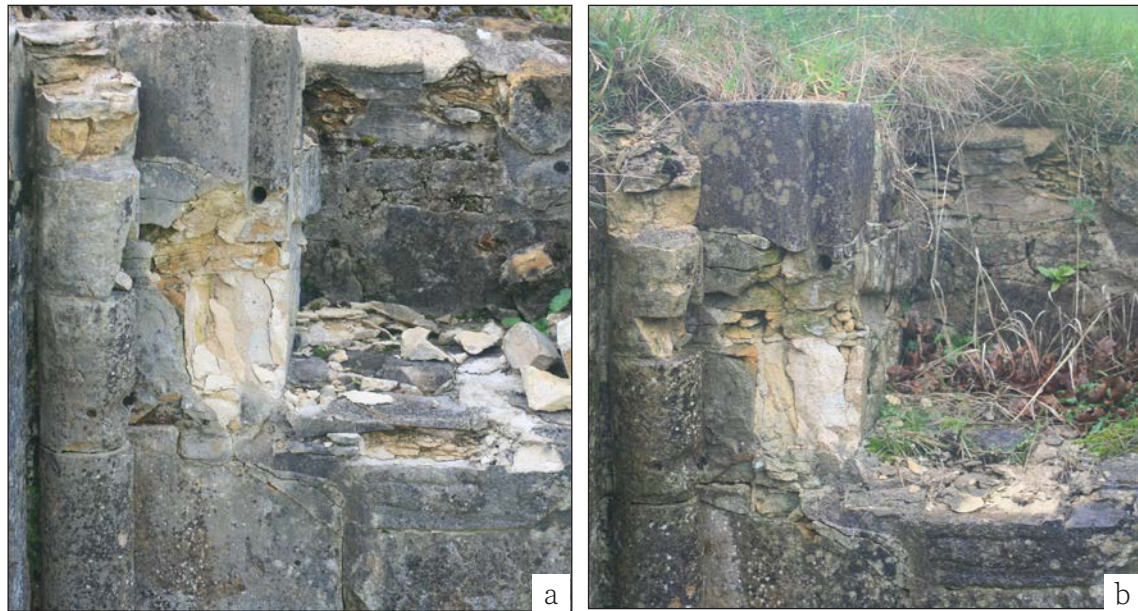
Figure 8.1 Deterioration in small sections of stonework which were not suitable for soft capping. (both ©Alan Cathersides)

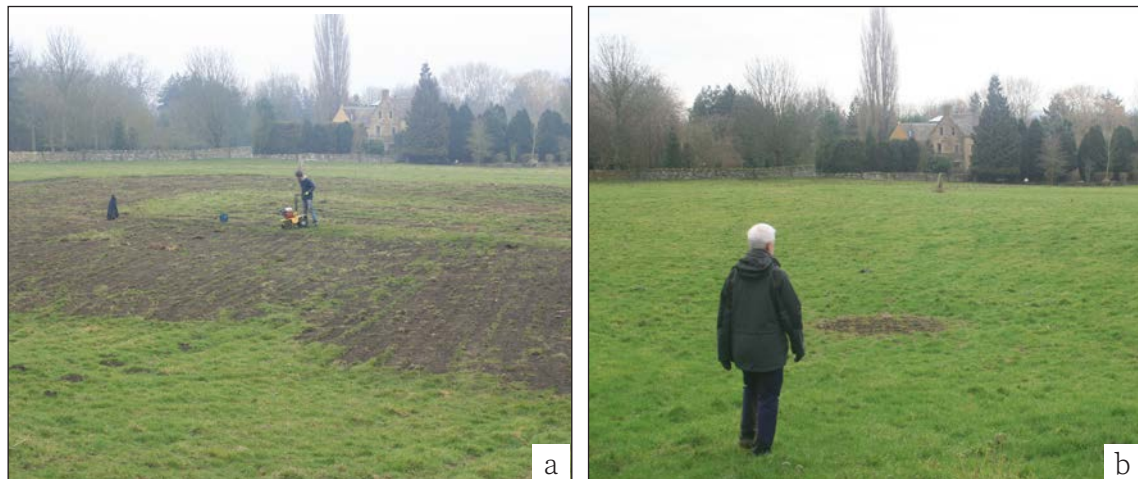
Figure 8.2 Area of adjacent field, from where turf was removed, (a) at completion of works in March 2013, and (b) 9 months after restoration works in January 2014. (both ©Alan Cathersides)

Turf for the soft capping was taken from a field adjacent to the monument. Approximately 2,300 m² was used in the works. Following completion of the work, the cleared area was lightly rotovated and seeded. Recovery was very good, as can be seen in Figures 8.2a and 8.2b

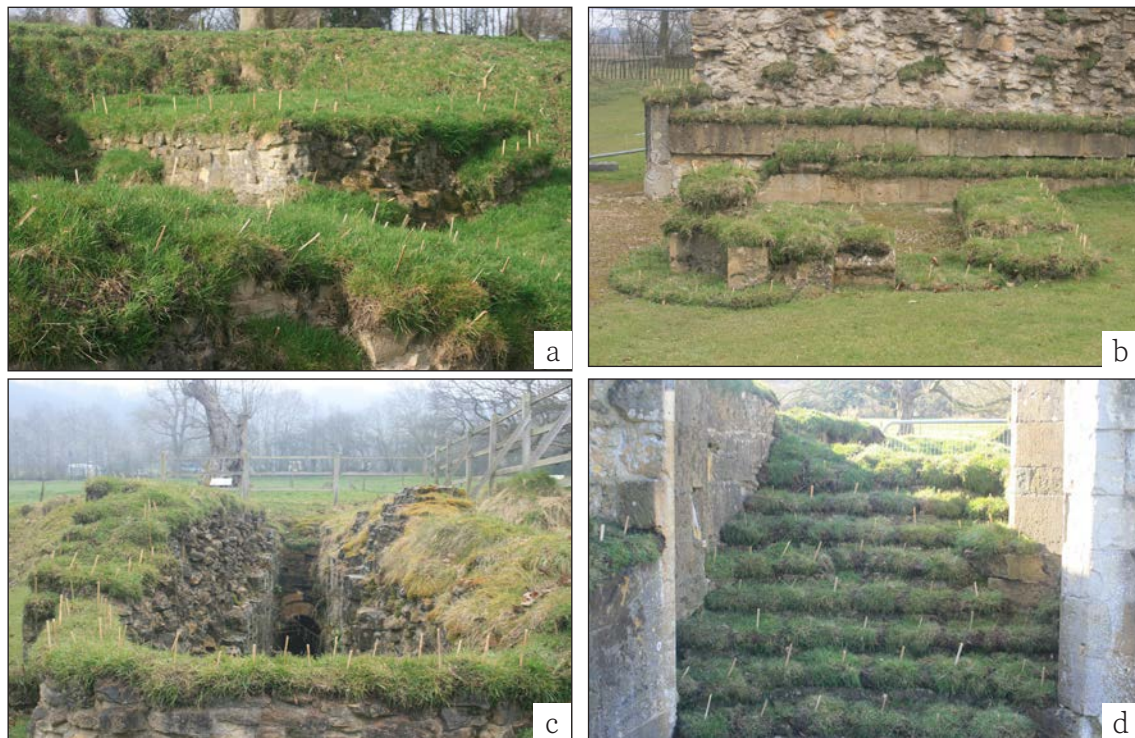
Figure 8.4 (a-d) showing bamboo canes considered to be intrusive. (all ©Alan Cathersides)

When the soft capping was first installed, bamboo canes were put in place to stop turfs from blowing or falling off before they had established. They also prevented animals from burrowing and people from sitting or walking on the newly laid turf. As the beginning of the spring was cold, the grass grew slowly, which did little to conceal the canes. Many visitors found the ‘forest of split bamboo canes’ to be visually very intrusive, particularly at lower levels (see Figure 8.4). However, after the turf had rooted, the canes were removed from the lower level caps. Then most of the visitors, especially those who had not visited the ruins before, found nothing untoward about the appearance of the ruins. Some, particularly those who had visited the site previously, questioned the changes, but most were satisfied when the reasoning behind soft capping was explained. The general consensus was that over all, the protection of the fabric warranted the change in the appearance of the site.
