SOUTHALL MANOR HOUSE, EALING, LONDON

An historical assessment

Building & Landscape
Survey & Investigation
Reports and Papers B/004/2005

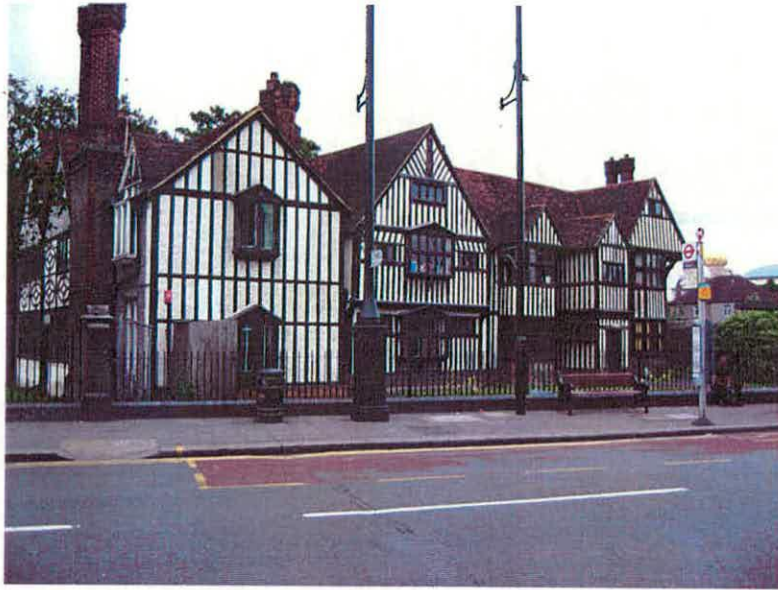
Figure 1

View of house from north-west. The North Range was extended to the west in the eighteenth century, but truncated in the early twentieth century to allow for the road in front of the house to be widened.

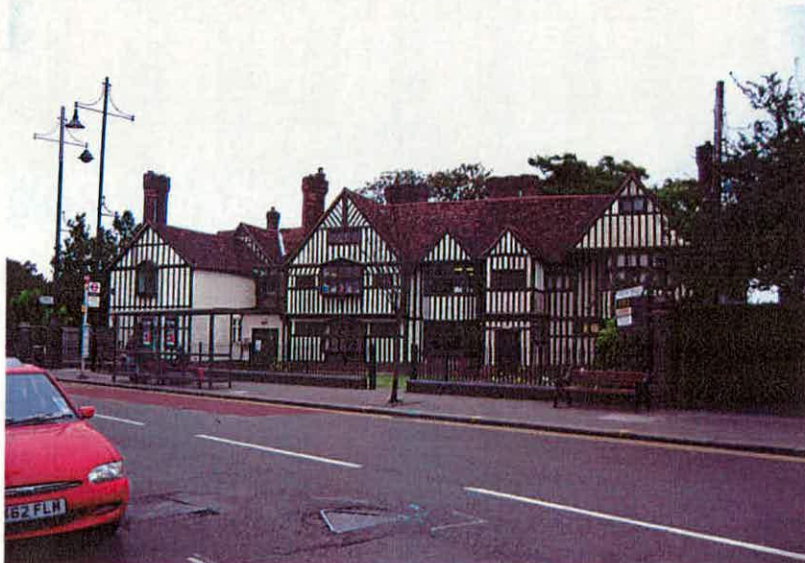
Figure 2

Front (W) elevation of house. The top of the original front gable of the North Range can be seen projecting above the roof line of the eighteenth-century addition at the far end of the building.

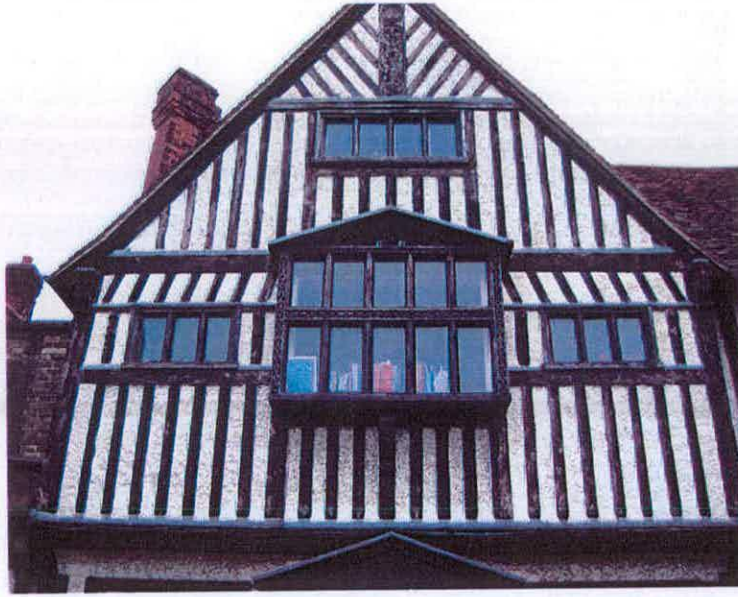
Figure 3

Gable of north cross wing of main house. Many of the framing elements have been renewed, however much original carved decoration still survives. There is date inscription of 1587 in the pediment above the projecting window.

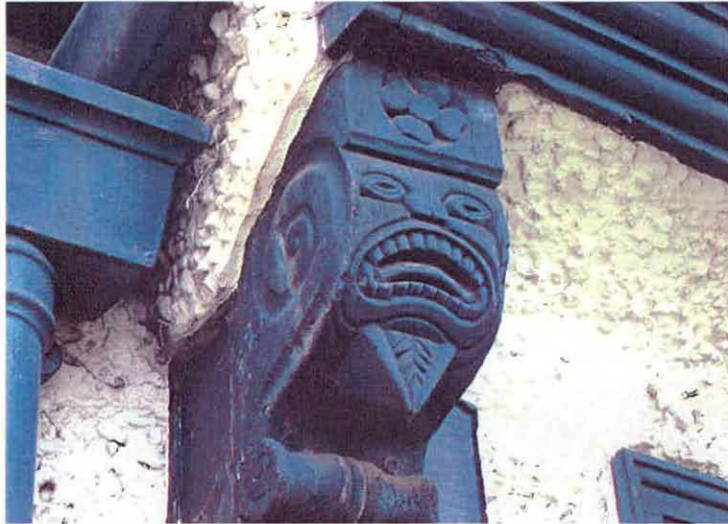
Figure 5
Carved timber bracket supporting first floor jetty of north cross wing of main house. The scroll ornament seen at the base of the bracket is also a feature of the brackets supporting the first floor ceiling over the west (original front) bay of the North Range.

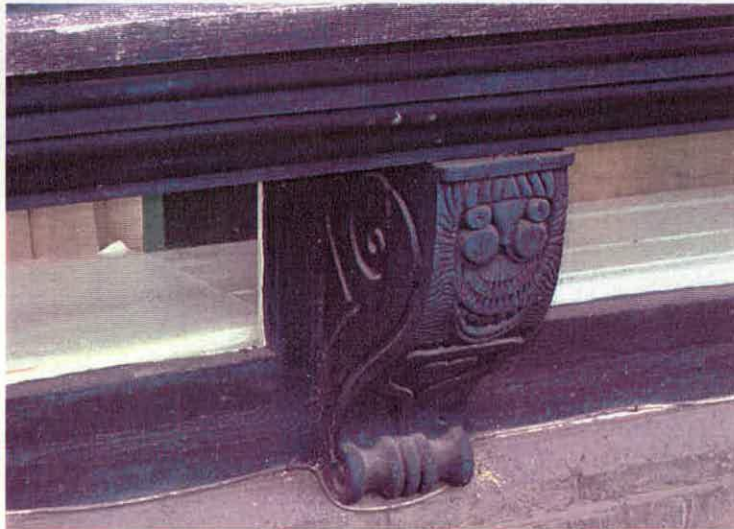
Figure 6
Carved timber bracket supporting projecting front ground floor window of north cross wing of main house.

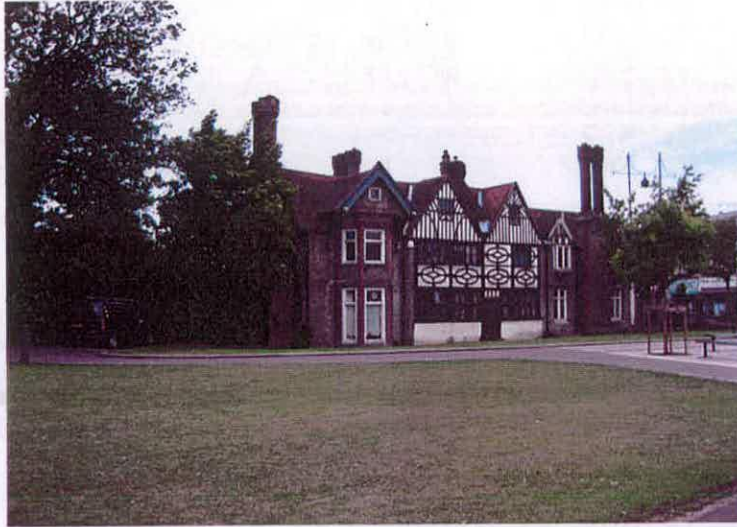
Figure 7

View of house from north-east.

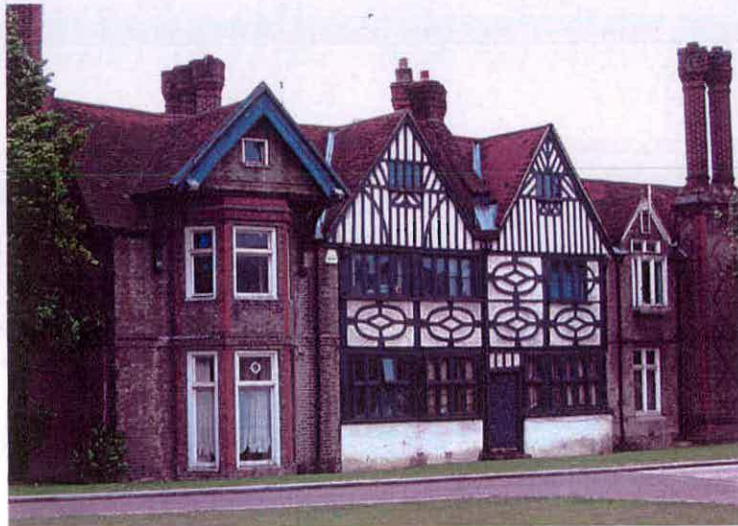
Figure 8

North elevation of North Range. The late-sixteenth building was extended to the front (W) in the eighteenth century. The original building was a three-bay structure and extended from the present east gable chimney to the end of the timber-framed section seen in the centre of the photograph. The timber-framing is largely artificial and dates from the nineteenth century. The twin timber-framed gables are also of this date; the North Range had a simple pitched roof originally.

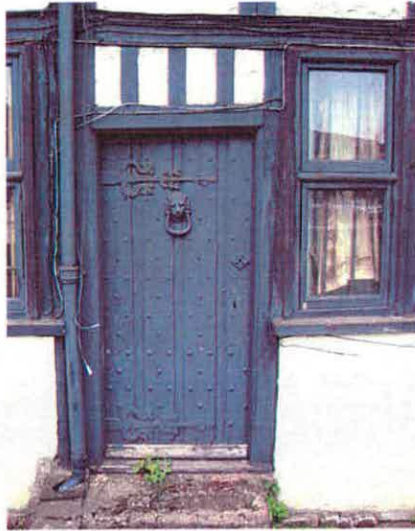
Figure 9

Door in north side wall of North Range. The door and adjacent moulded timber windows may in large part date from the original construction of the house.

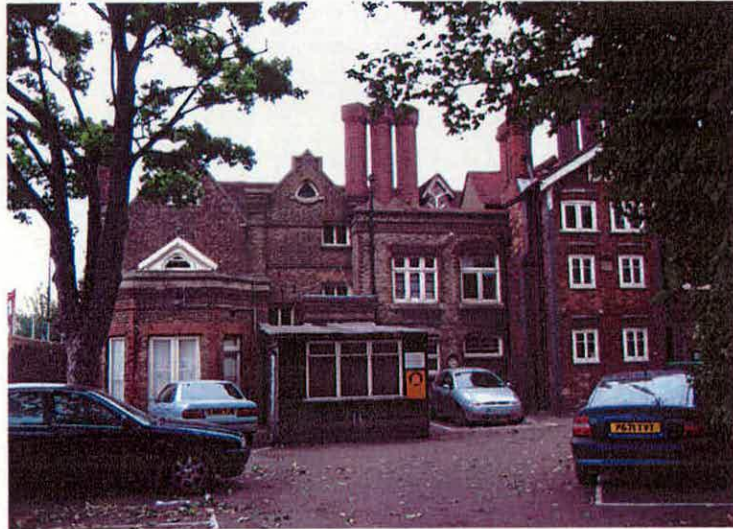
Figure 10

Rear (E) elevation of house. On the left is seen the gable of the south cross wing; the ground floor of the cross wing was extended rearwards in the nineteenth century. Next to this is the gable of the late-sixteenth century staircase bay. Immediately to the right of the staircase bay are the three brick shafts of the rear chimney stack heating the hall range. To the right of this is a nineteenth-century addition built onto the rear of the late-sixteenth century Link Range.

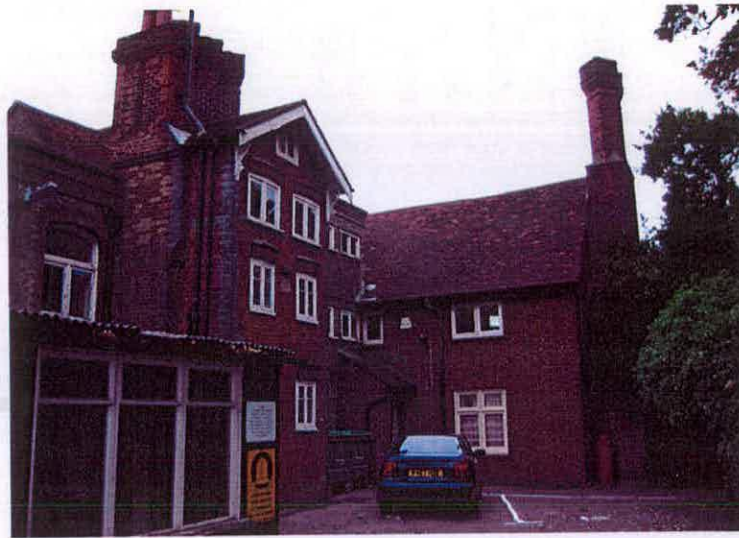
Figure 11

Rear (E) elevation of house looking northwards towards east end of the North Range. The gable chimney and exterior wall of the end bay of the North Range were rebuilt in brick in the early or mid-twentieth century. Many of the alterations and extensions at the rear of the house probably date from its use as a school in the nineteenth century.

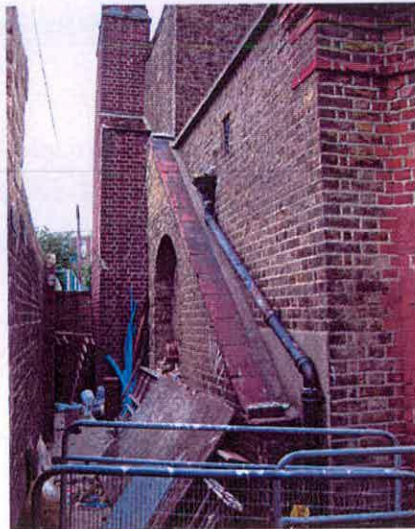
Figure 12

South elevation of south cross wing of main house looking westwards from rear of house. The chimney stack heating the cross wing dates from the original construction of the house but was rebuilt in brick in the early or mid-twentieth century.

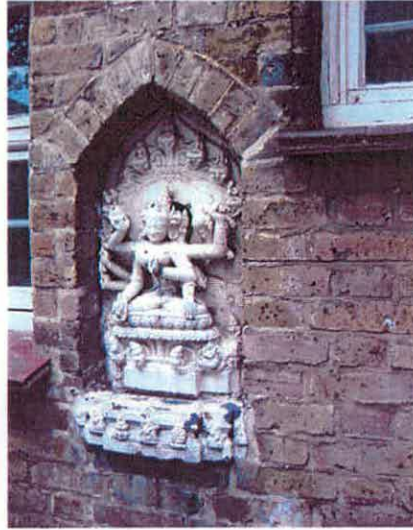
Figure 13

One of a pair of metal sculptures set into face of nineteenth-century brickwork at rear of house. The sculptures appear to be made of lead and were probably cast from an original stone sculpture of Indian or far eastern origin.

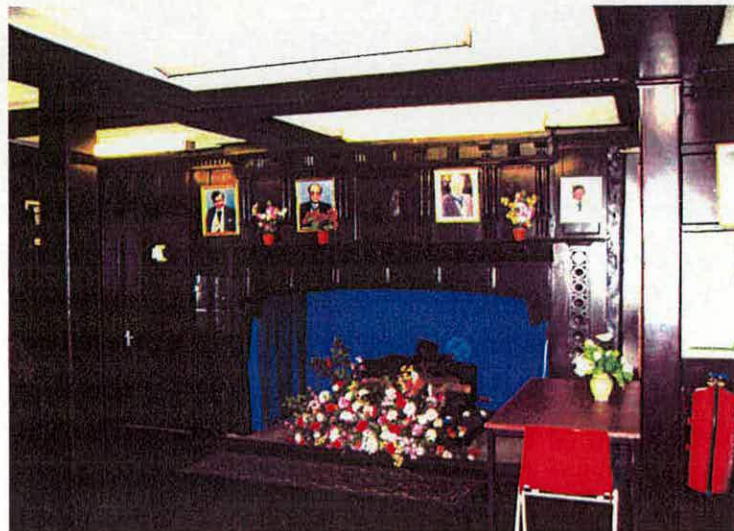
Figure 14

View of ground floor hall looking east towards fireplace. The partition wall on the right of the fireplace is a modern addition. The layout of first floor beams produced a coffered ceiling effect. The wall panelling and chimneypiece, although much restored, appear to be original features dating from the initial period of construction of the house or soon after. To the right of the fireplace, and almost directly opposite the main entrance, was a wide doorway opening into the rear staircase bay. A short passageway beside the staircase led to an external rear doorway, creating what was in effect a cross passage.

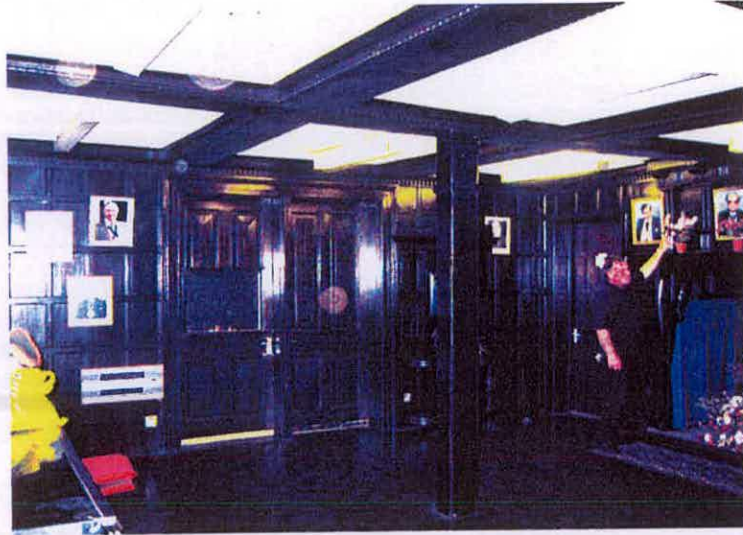
Figure 15

View of ground floor hall looking northwards towards the north cross wing. The existing paired doorway arrangement at the north end is probably not original but the result of a remodelling of the house in the nineteenth century.

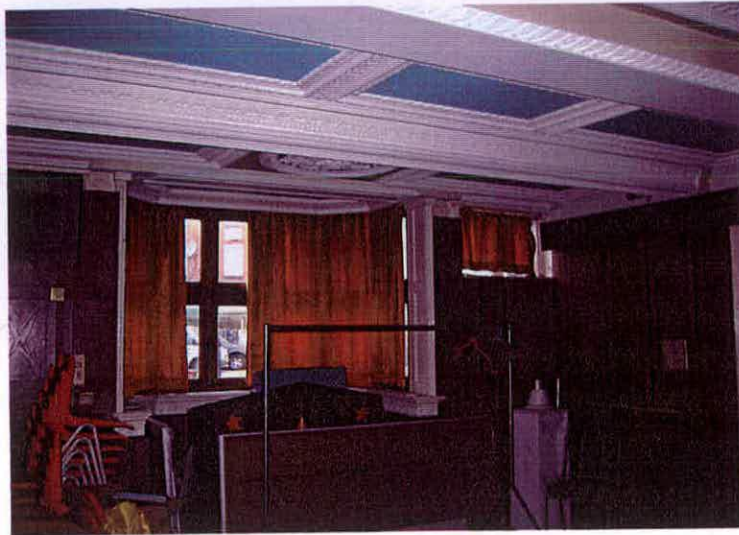
Figure 16

Ground floor room in south cross wing ('Conference Room') looking westwards towards front of house. In a typical late-medieval hall house the room leading of the 'low end' of the hall would have been a service room; the room was often subdivided to make two separate rooms, a 'buttery' for making and storing bread, and a 'pantry' for keeping drink. At Southall Manor, by contrast, the room appears to have served as a parlour or else had some other 'polite' function from the outset.

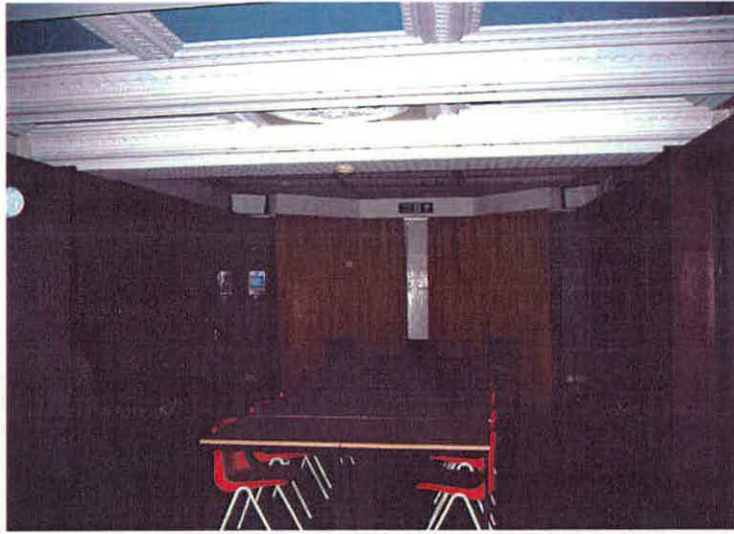
Figure 17

Ground floor room in south cross wing ('Conference Room') looking eastwards towards rear of house. The room was extended to the rear in the nineteenth century.

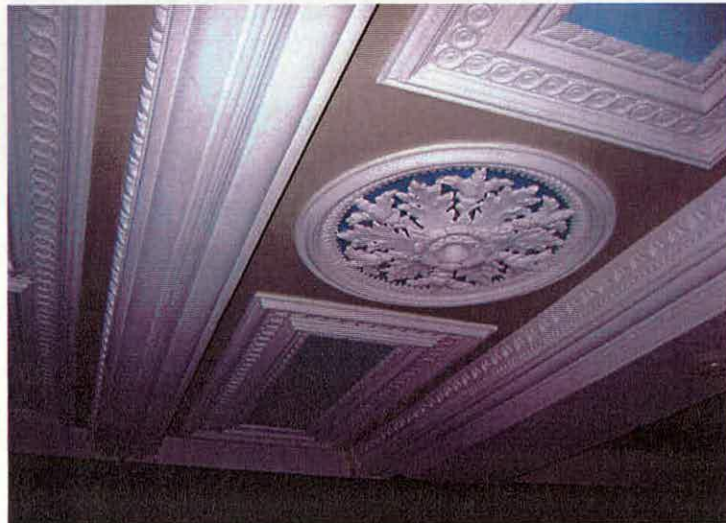
Figure 18

Ceiling of ground floor room in south cross wing ('Conference Room'). The beam on the left and that on the right date from the original construction of the house. The beam on the right follows the line of the rear gable; the beam is much wider than the other first floor beams overhead, probably due to the fact that there was a wall underneath originally.

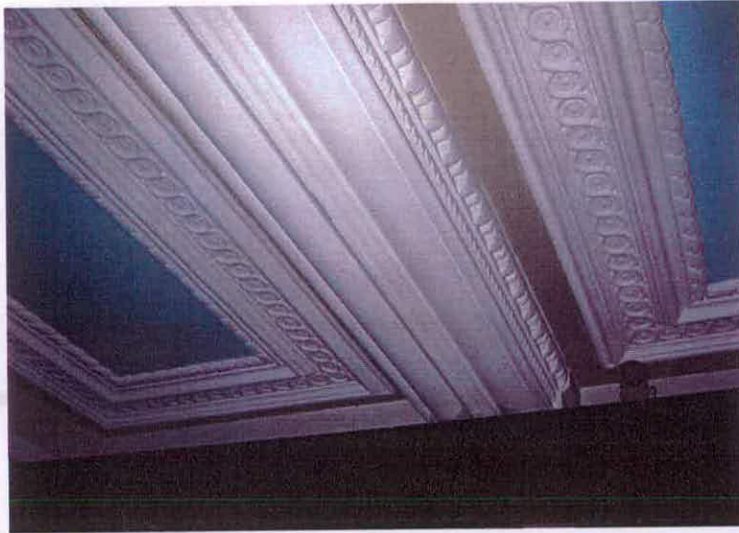
Figure 19

Ceiling of ground floor room in south cross wing ('Conference Room'). The timber beams have quasi-Classical mouldings of sixteenth-century early Renaissance character. The raised plaster ceiling panels between the floor beams, by contrast, have pure Classical mouldings and were probably added in the late eighteenth or nineteenth centuries.

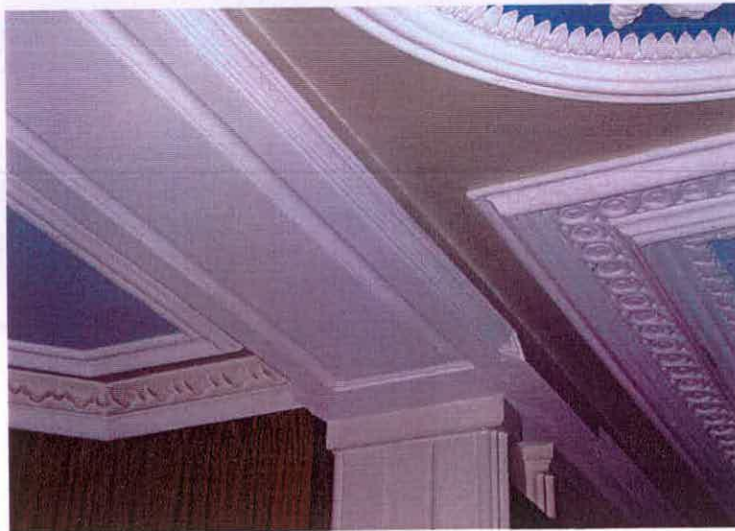
Figure 20

Ceiling of ground floor room in south cross wing ('Conference Room') looking into front (W) window bay. The same repeating pattern of mouldings used to ornament the floor beams were used to decorate the cornice running around the top of the window bay. The chamfer mouldings to the beam are wholly 'vernacular' in character; this particular chamfer moulding is found throughout England in late-medieval farm houses and manor houses.

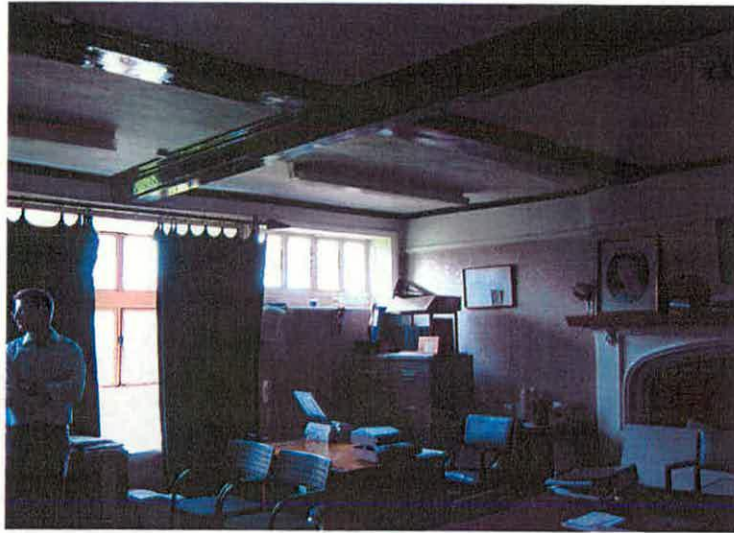
Figure 21

Ground floor room of north cross wing looking towards north-west.

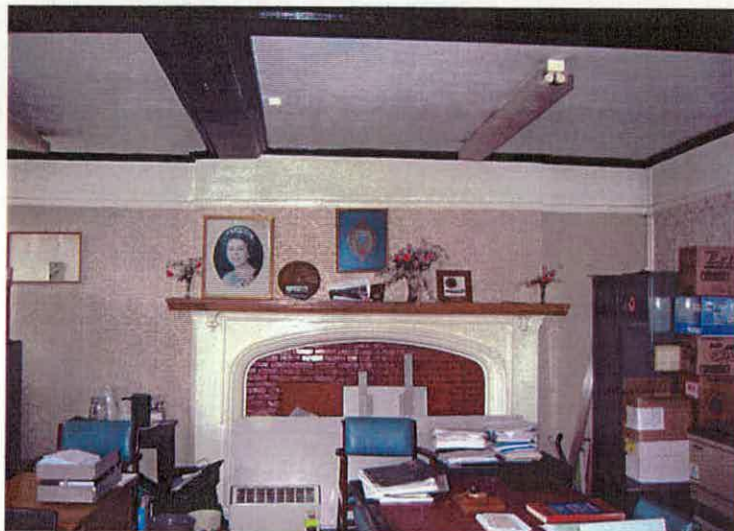
Figure 22

Ground floor room of north cross wing looking north. The stone fireplace probably dates from the late eighteenth or nineteenth century. It probably replaces an earlier stone fireplace dating from the initial period of construction of the house.

Probably few, if any, of the stone fireplaces to be seen in the house date from the original construction of the building. Although most of the fireplace surrounds are four-centered they are generally lacking in late sixteenth century decoration; generally speaking the mouldings are plain and rather simple in design. Most, if not all, of the fireplaces in the house probably date from the late eighteenth or nineteenth-century and are based (very loosely) on the design of the original late-sixteenth fireplaces.

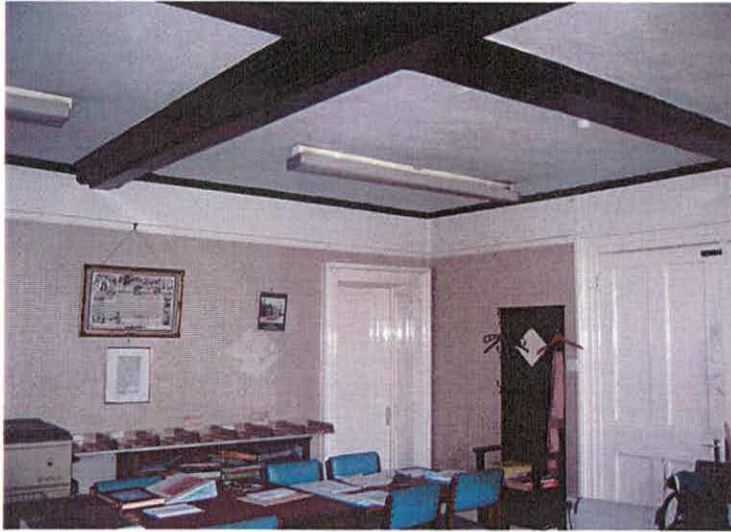
Figure 25

Ground floor room of north cross wing looking towards south-east. The doorway on the left leads into the Link Range. The double doors on the right open into the hall.

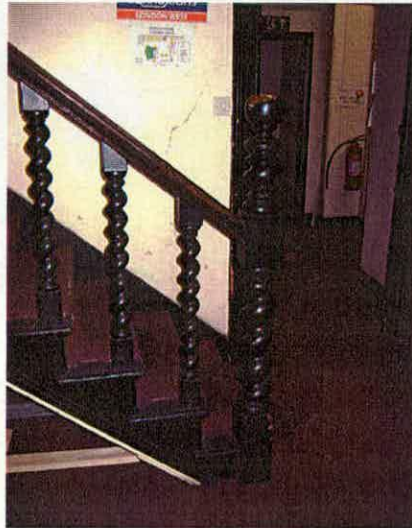
Figure 26

Ground floor of Link Range looking east.
Detail of staircase. The staircase probably replaces an earlier staircase situated within the Link Range. The present staircase probably dates from the eighteenth century and may have been inserted when the Link Range was extended to the west.

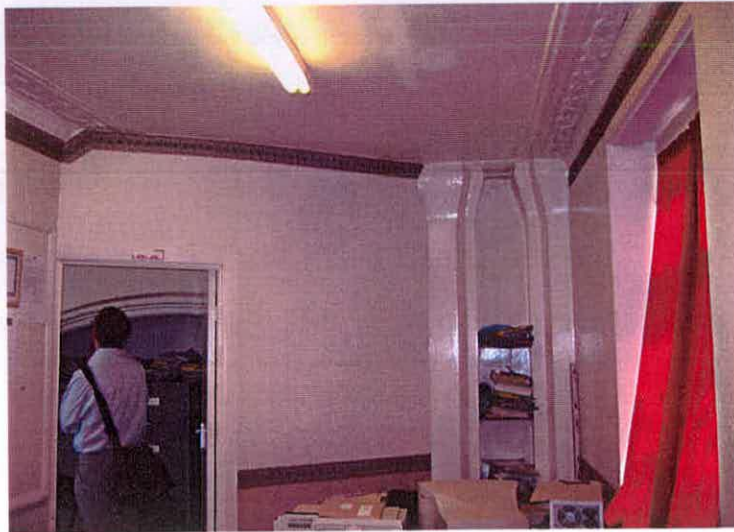
Figure 28

North Wing. Ground floor room at east end of range looking eastwards towards the fireplace. The room may originally have served as the kitchen of the house. It was remodelled in the late eighteenth or nineteenth century. The shaped pilasters on the right (there is a matching pair at the opposite side of the fireplace), stone fireplace surround and moulded plaster cornice probably date from the remodelling of the North Wing. The room has subsequently been sub-divided and converted to office accommodation.

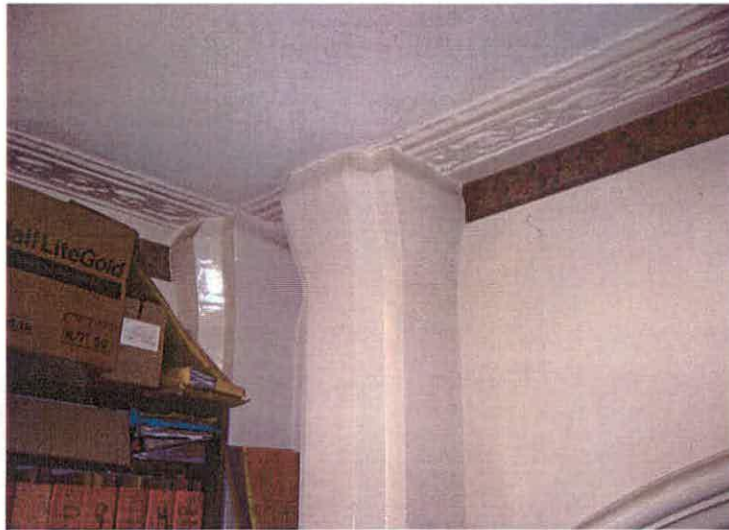
Figure 29

North Wing. Ground floor room at east end of range. North-east corner. Detail of moulded pilasters flanking fireplace.

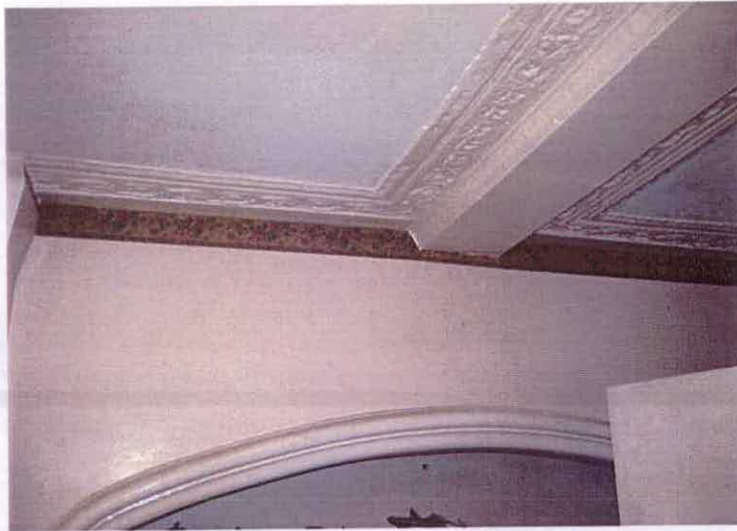
Figure 31

North Wing. Ground floor room at east end of range. East (gable) wall. Detail of fireplace and longitudinal first floor beam.

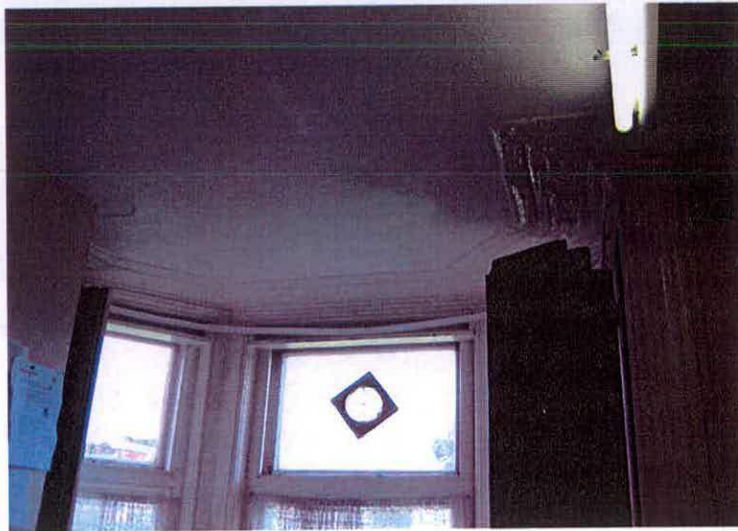
Figure 32

North Wing. Ground floor room at east end of range. North wall. Detail of projecting window bay. Notice that moulded cornice is continuous around top of bay.

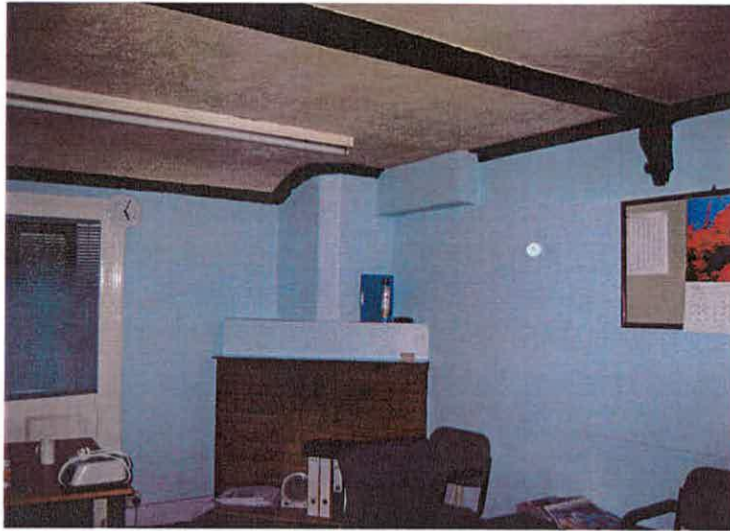
Figure 33

North Wing. First floor room at east end of original late sixteenth-century range looking towards north-east corner. The corner fireplace is probably a nineteenth-century addition. The longitudinal second floor beam and supporting brackets date from the original construction of the house. The cornice extending around the tops of the walls is a later addition.

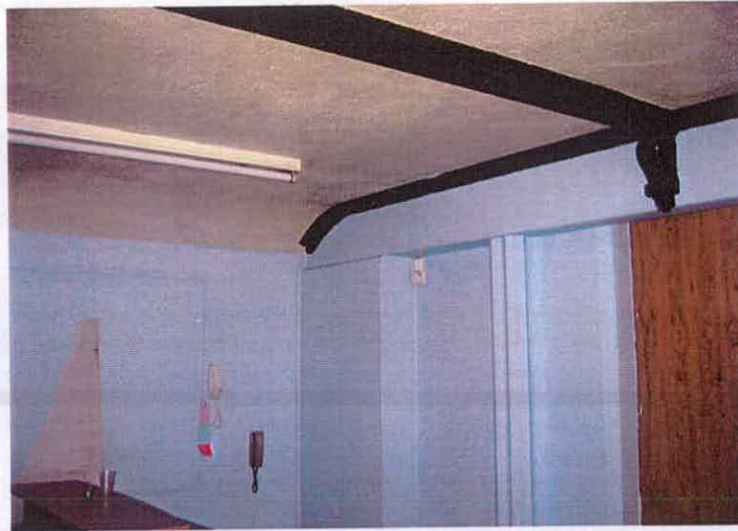
Figure 35

North Wing. First floor room at east end of original late sixteenth-century range looking towards south-west corner. The wall on the right of the photograph was formerly the gable wall of the late sixteenth-century North Wing. The moulded vertical timber seen on the right of the photograph probably flanked a first floor window. The longitudinal beam and moulded bracket support a coved plaster ceiling dating from the late sixteenth century. The cornice extending around the top of the west wall is a later addition.

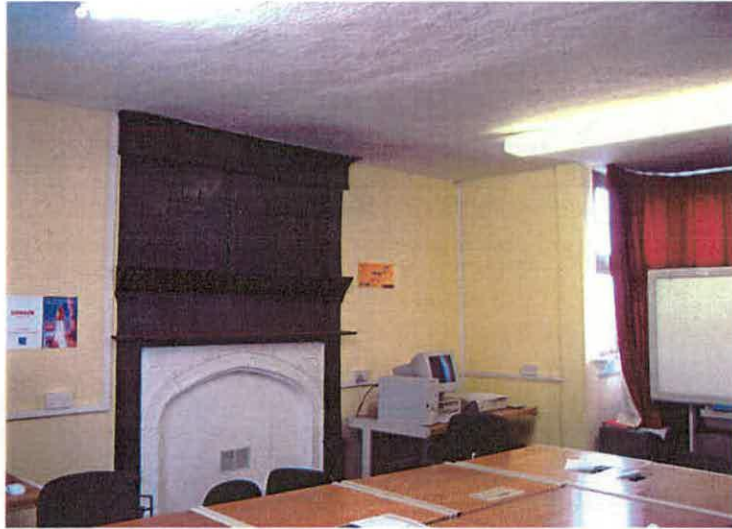
Figure 37

First floor room in south cross wing looking towards south-west. The present stone fireplace (now blocked) and wooden chimney piece probably date from the late eighteenth or nineteenth century but may be based on an original late sixteenth-century fireplace and overmantle.

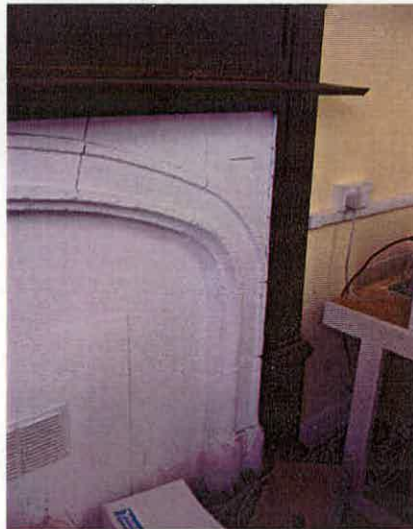
Figure 38

First floor room in south cross wing. Detail of fireplace.

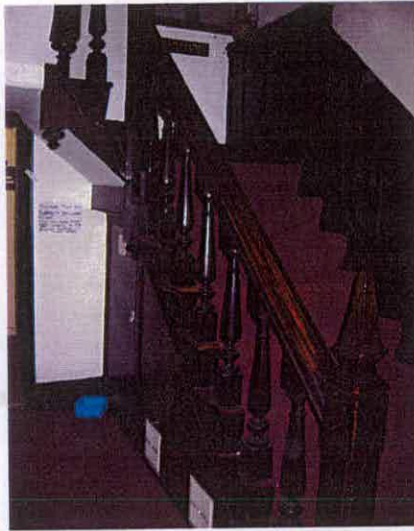
Figure 39

Staircase at south end of hall. The staircase dates from the nineteenth or early twentieth century but is probably based on an original late sixteenth-century staircase. In the original house, the passageway to the left of the staircase led to a rear doorway.

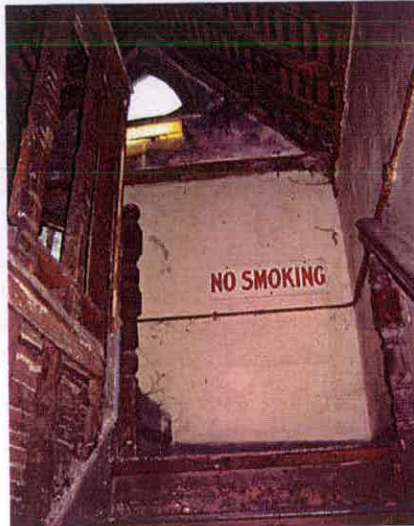
Figure 40

Staircase at south end of hall. View from first floor looking upwards towards half-landing level. The staircase stands within a separate bay which is attached to the rear of the hall range. The ground to first floor staircase below has been rebuilt, but is probably based on an original late sixteenth-century staircase in the same position. The present staircase linking the first floor and attic is likely to have been inserted in the eighteenth-century when the roof spaces over the hall and cross wings of the main house were converted to attic accommodation.

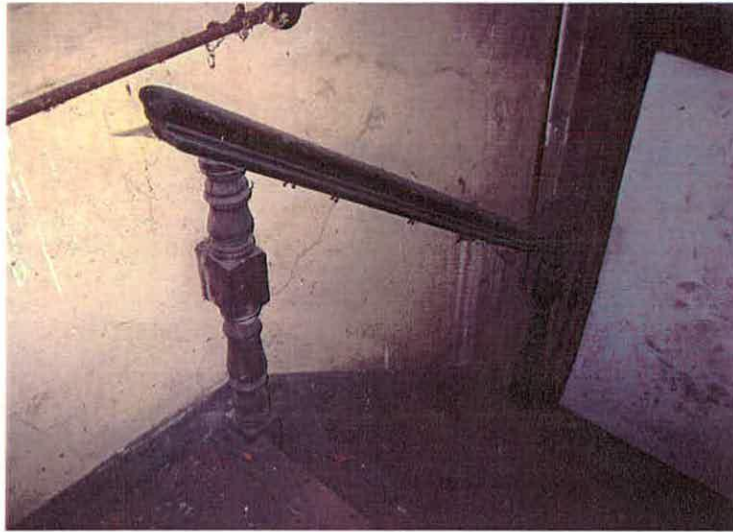
Figure 41

Staircase at south end of hall. View looking downwards to first floor from half-landing level. The handrail seen in the photograph has been raised, and the balusters supporting the handrail are now missing. The staircase at this level (i.e. between first floor and attic) probably dates from the eighteenth century. It appears to have been made up from both new and reused elements. The turned newel post shown in the photograph probably dates from the late sixteenth or early seventeenth century.

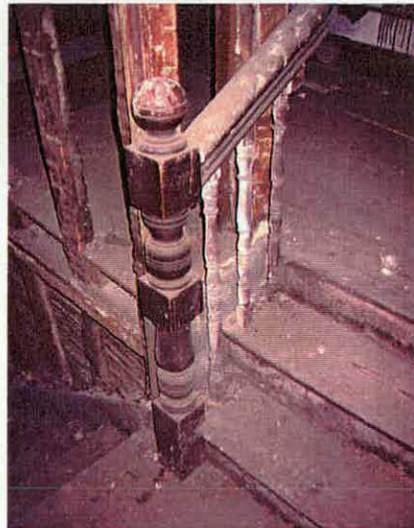
Figure 42

Staircase at south end of hall. Detail of newel post and balusters at half-landing level between first floor and attic. The newel post is probably a reused element and originally formed part to a late-sixteenth or early seventeenth-century staircase. The smaller balusters are more likely to be new elements dating from the original construction of the present staircase in the eighteenth century.

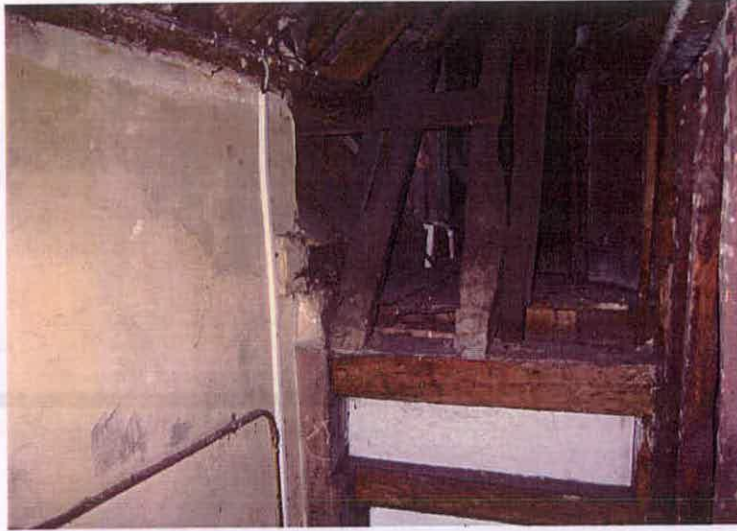
Figure 43

Staircase at south end of hall. View from half-landing between first floor and attic looking eastwards towards hall range. In the centre of the photograph can be seen the west end of the north (inner) wall plate of the south cross wing. The end of the wall plate is decorated with a carved ovolo moulding. Notice that there is no end roof truss at this end of the hall range.

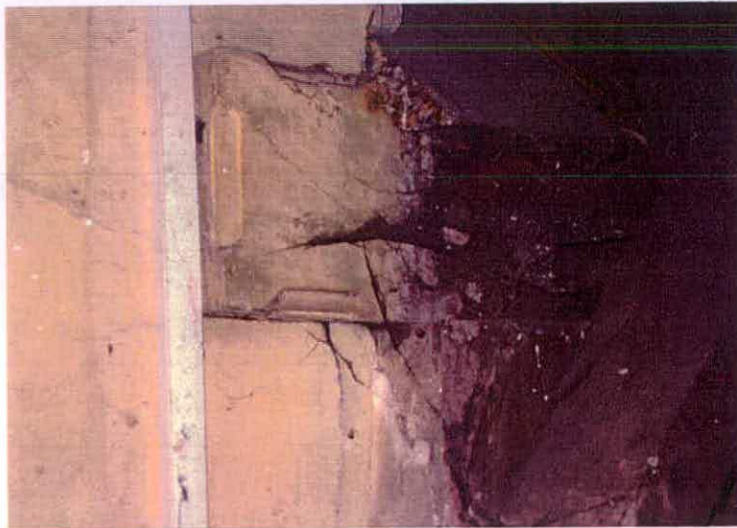
Figure 44

Staircase at south end of hall. Detail of carved decoration applied to east end of north (inner) wall plate of south cross wing. The end of the wall plate would have projected into the staircase bay at first floor ceiling level and was clearly intended to be seen from below.

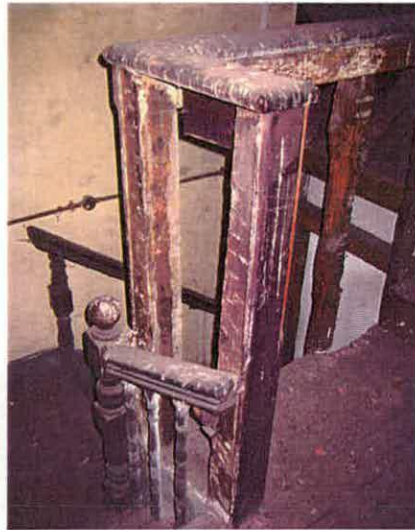
Figure 45

Staircase at south end of hall. Detail of handrail arrangement at half-landing level between first floor and attic.

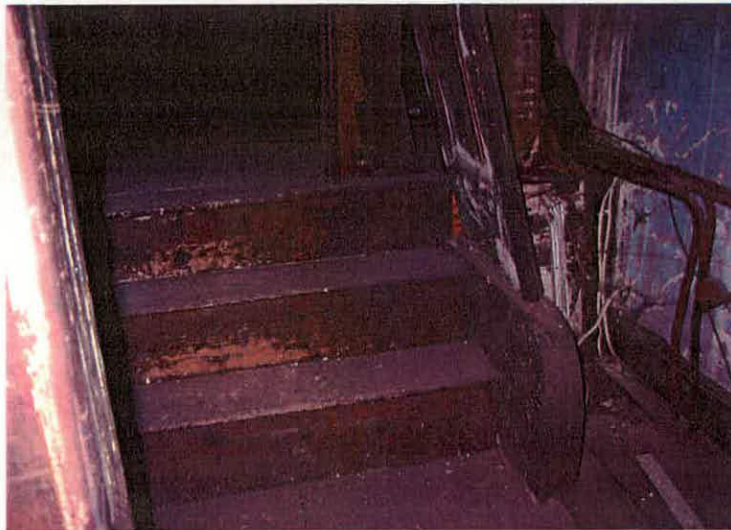
Figure 46

Staircase at south end of hall. Detail of upper flight of steps leading to attic.

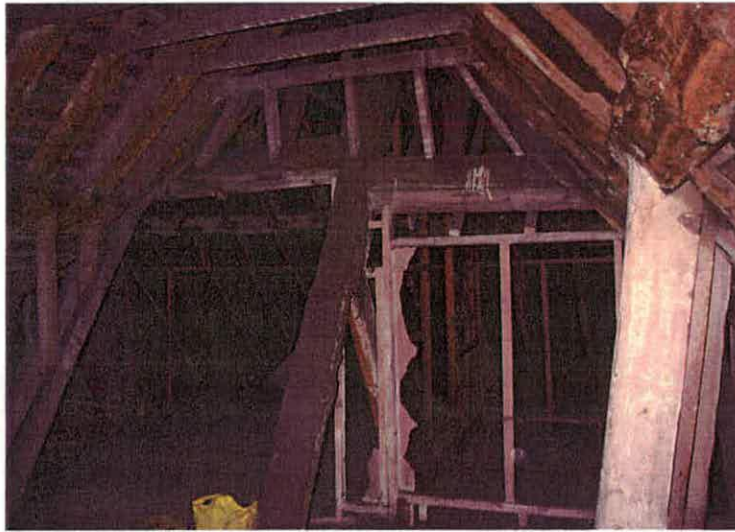
Figure 49

Roof of hall range. View towards south cross wing.

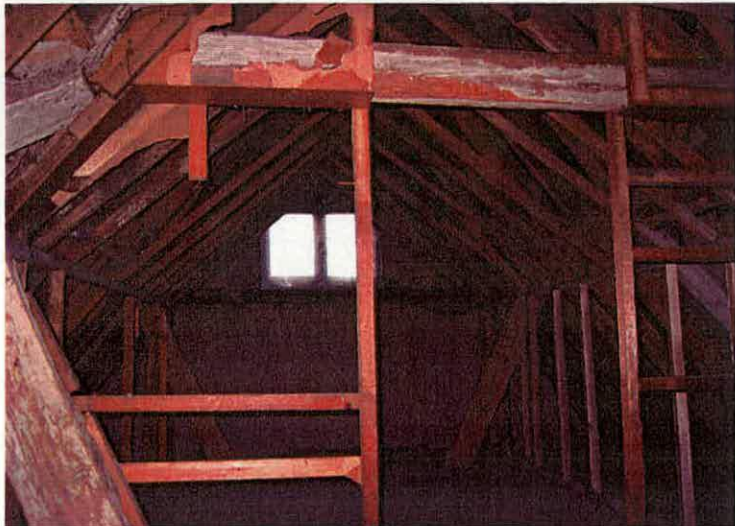
Figure 50

Roof of south cross wing. View looking westwards towards front of house. A second internal framework of thin battens has been constructed to serve as a support for a modern plasterboard ceiling (now missing).

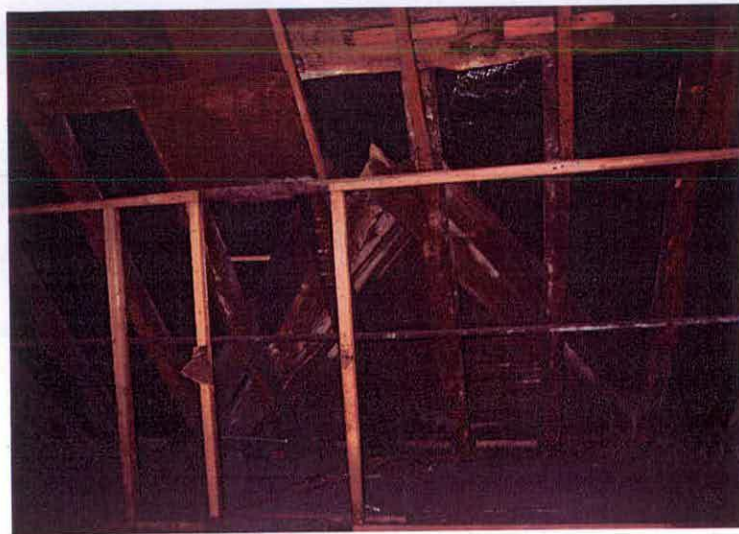
Figure 52

Roof of hall range. View looking westwards towards roof of projecting hall window bay.

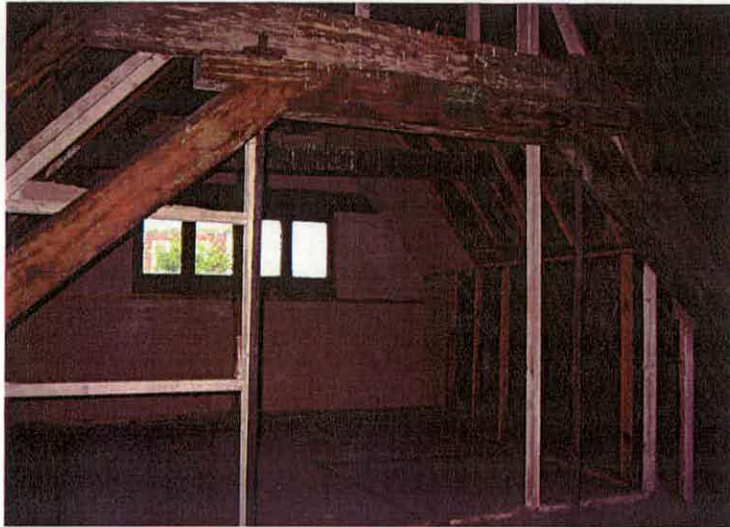
Figure 54

Roof of north cross wing looking westwards towards front of house. The central truss (in foreground of photograph) has been given further support by means of an additional supporting framework. View towards north cross wing.

The roof of the main house comprises three separate single-pitched roof structures: that of the central hall range, the north cross wing and the south cross wing. All three roofs are of the same basic constructional form as the roof of the North Range, i.e. staggered tenoned purlins, common rafters (with pegged mortice and tenoned joints between them and the purlins) and straight collars, with raking queen struts linking the collars and tie beams. The roofs remain largely intact; however there is some evidence of later repairs. For example, at the front (W) end of the roof of the north cross wing the rafters along the north roof slope are not morticed into the purlin, but simply rest upon its back. The purlin is not the original purlin (the empty mortice for the original purlin can still be seen) but a replacement timber that was inserted when the present pair of long rafter braces were inserted, probably in the eighteenth or nineteenth century. In the central hall range, the longitudinal second floor beam seen running along the centre of the attic floor, has an iron bolt running up through it and has extra timbers and wedges attached to it as a means of strengthening and re-tensioning the beam.

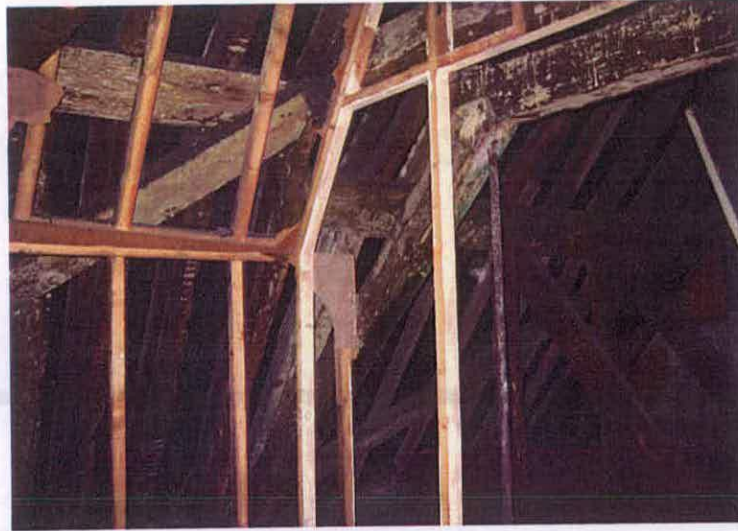
Figure 55

Roof of north cross wing looking north-eastwards. The north roof slope of the cross wing includes two 'rafter braces' (seen running diagonally across the lower part of the roof in the above photograph). These are not original elements of the roof frame but were added probably in the late eighteenth or nineteenth century. As seen in the hall range and south cross wing, the roof of the north cross wing has until recently had a plasterboard lining applied to the underside of its timbers. The plasterboard panels have been taken down but the battens which supported the panels remain *in situ*.

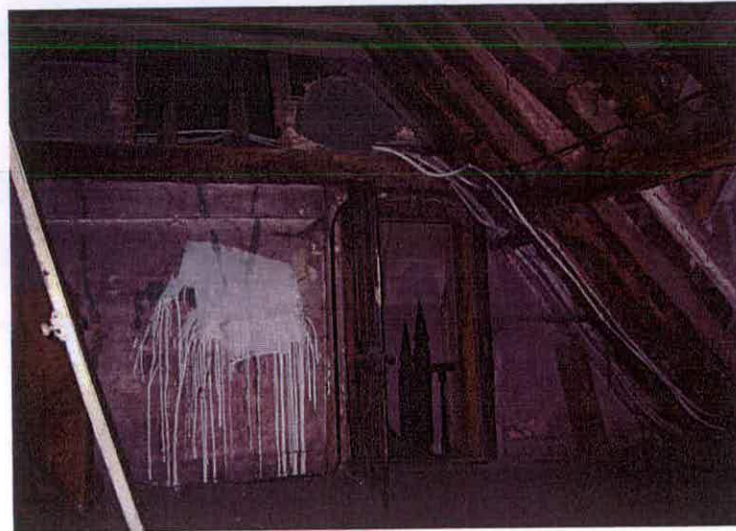
Figure 56

Roof of north cross wing looking eastwards. The east (rear) gable of the north cross wing serves to separate the wing from the Link Range. The present door opening in the wall was probably created in the eighteenth or nineteenth century when the roof spaces over the main house were converted to attic accommodation, and the present staircase was inserted (and the attic staircase at the south end of the house) linking the first floor of the Link Range and the attic floor. Beside the door opening, through a hole in the lath and plaster wall infilling, can be seen the feet of the rafters in the roof of the Link Range.

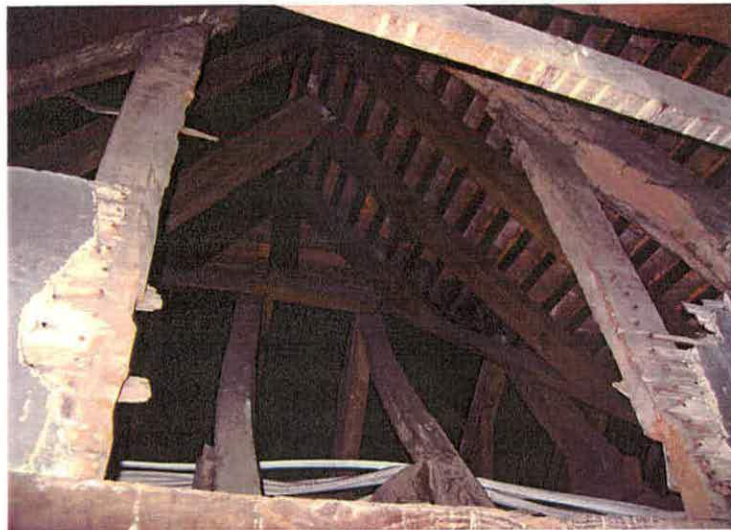
Figure 57

View of roof of Link Range, looking through the hole in the rear gable wall of the north cross wing. The rafters of the Link Range rest upon the collar of the gable wall. The present lath and plaster infilling probably dates from the construction of the house and extended to the apex of the roof of the cross wing originally. Fragments of laths survive on the reverse (east) faces of the studs rising above the collar, showing that both sides of the wall were plastered over originally.

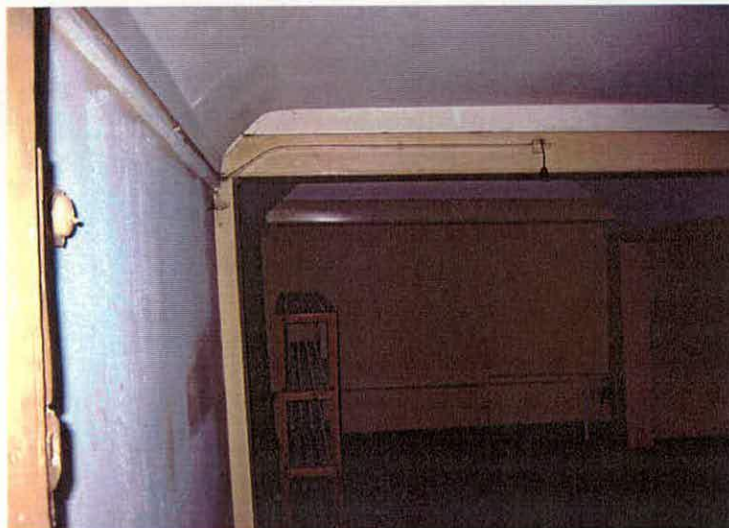
Figure 58

Second (attic) floor of Link Range, looking northwards towards the south wall of the North Range.

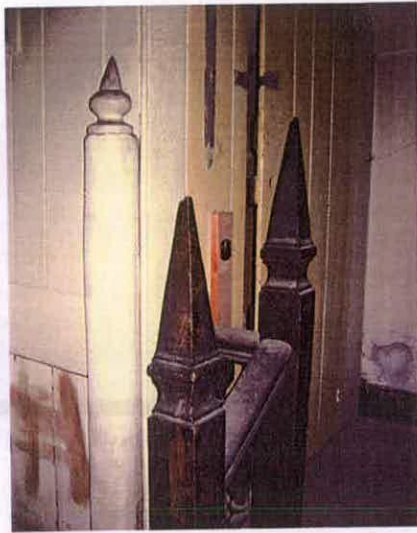
Figure 59

Top of attic staircase in Link Range. Detail of late eighteenth or nineteenth-century newel posts, and somewhat curious mast-like timber post.

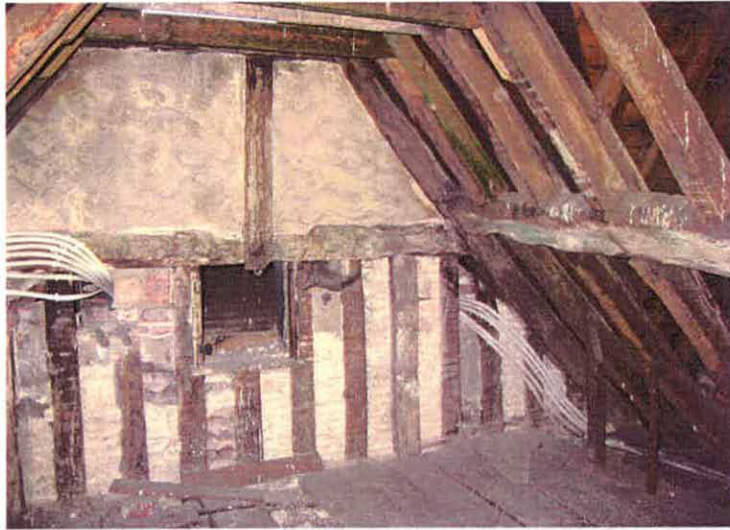
Figure 61

Roof of North Range looking westwards towards the front of the house. The photograph shows the interior of the west (front) gable truss of the North Range. The North Range was extended to the west in the late eighteenth century, making the gable no longer an external wall. The gable was close-studded below collar-level originally; the wall above the collar has been rebuilt.

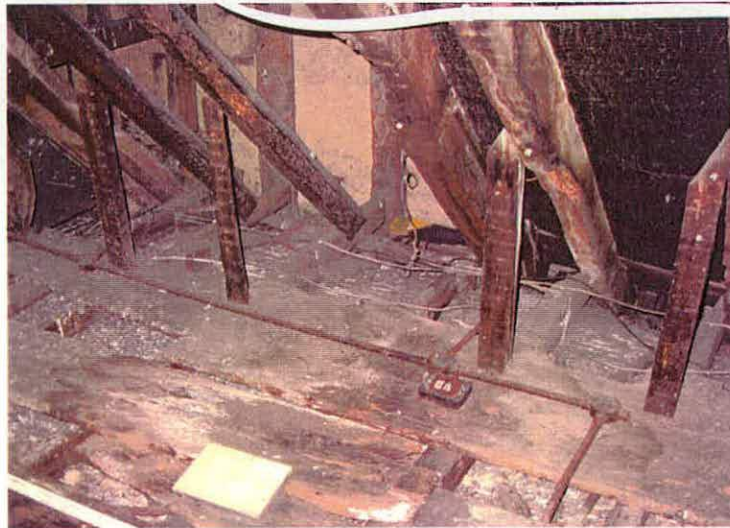
Figure 62

Roof of North Range. Detail of ceiling construction over the first floor room at the west (front) end of the North Range. The ceiling joists are simply nailed to the sides of the rafters. Short, curved timbers attached to the outer ends of the joists give the ceiling a coved profile.

common ceiling joists, the inner ends of which are tenoned into a longitudinal central floor beam. The outer ends of the ceiling joists are reduced in width and simply nailed to the (E) sides of the common rafters. The joists themselves are straight but carry curved timbers at their outer ends; it is these curved timbers that give the ceiling below its coved form. The soffit of the central ceiling beam extends below the line of the plaster ceiling and is visible within the first floor room below. The ends of the beam are supported on decorative moulded brackets of similar type to those found on the front of the building supporting the projecting windows of the north and south cross wings.
