SOUTHALL MANOR HOUSE, EALING, LONDON

An historical assessment

Building & Landscape
Survey & Investigation
Reports and Papers B/004/2005

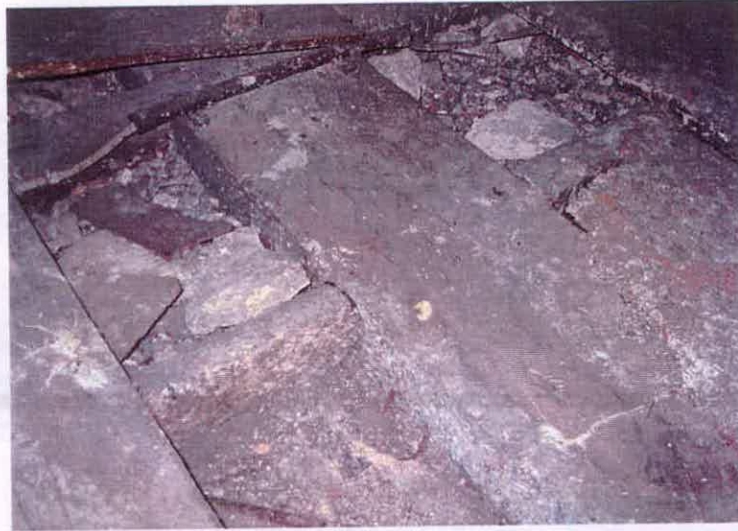
Figure 63

Roof of North Range. Detail of ceiling construction over the first floor room at the west (front) end of the North Range. Intersection of ceiling joists and central ceiling beam. The ceiling beam is supported on carved brackets (*see fig. 34*).

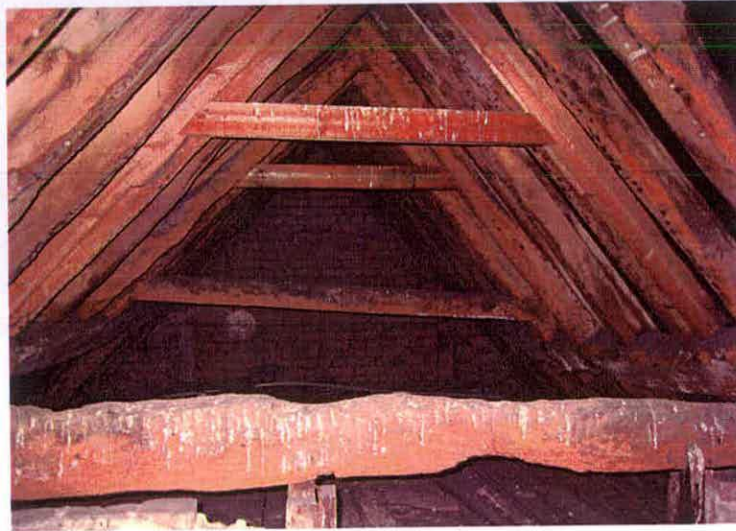
Figure 64

Roof of North Range looking eastwards towards the rear gable. At the far end of the range can be seen the brickwork of the (reconstructed) gable chimney.

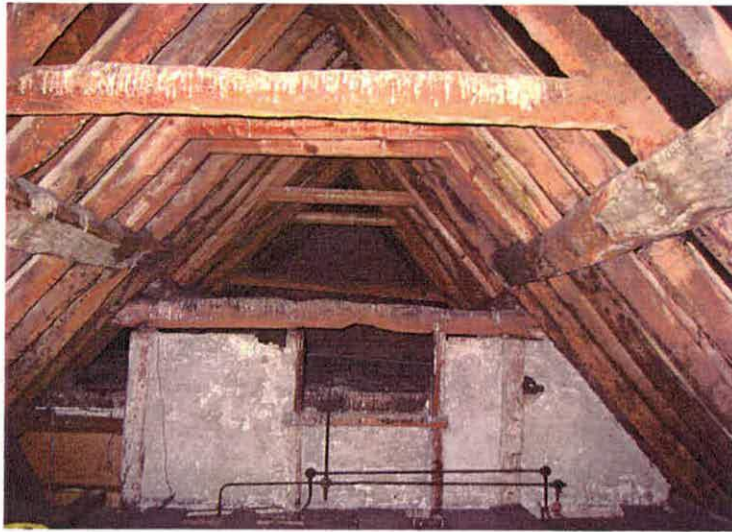
Figure 65

Roof of North Range looking eastwards. The eastern intermediate truss retains its original lath and plaster infilling. It is likely that the first floor rooms in the central bay and rear (kitchen) bay would have remained open to the roof originally, in contrast to the front bay which was ceiled from the outset.

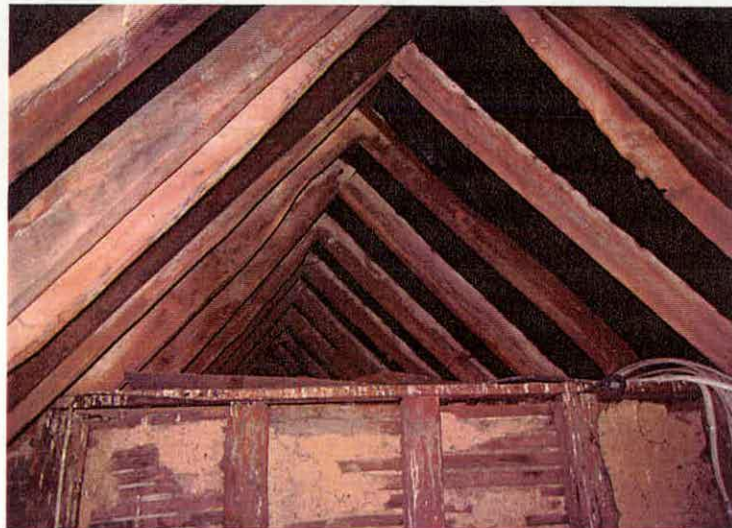
Figure 66

Roof of Link Range looking southwards from North Range. The roof frame appears to be wholly intact. The partition wall in the photograph separates the Link Range from the North Range at roof level. The wall is infilled with lath and plaster and may date from the original construction of the house, or shortly after. If so, the Link Range must have included attic accommodation more or less from the outset, served by a staircase rising from first floor level (presumably occupying the same position as the present attic stair in the Link Range).

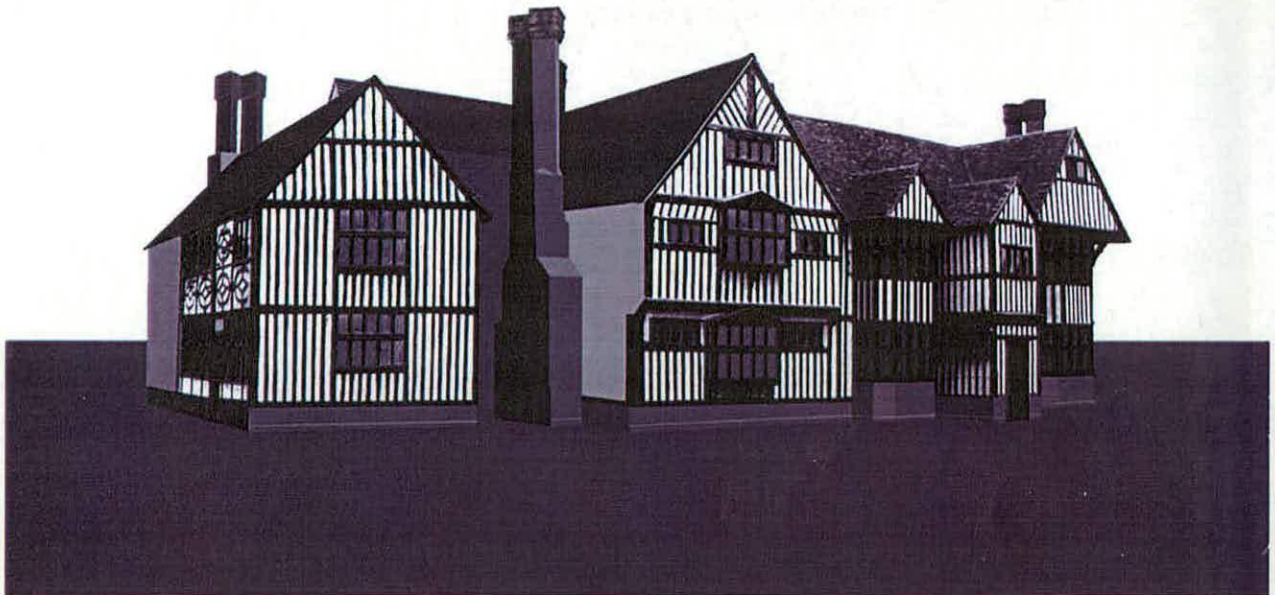
Plate 7

Southall Manor as it may have appeared when first constructed in c.1587 (conjectural reconstruction)
