Wharram Percy
deserted medieval village,
North Yorkshire:
archaeological investigation
and survey

SURVEY REPORT

Archaeological Investigation Report Series AI/19/2004

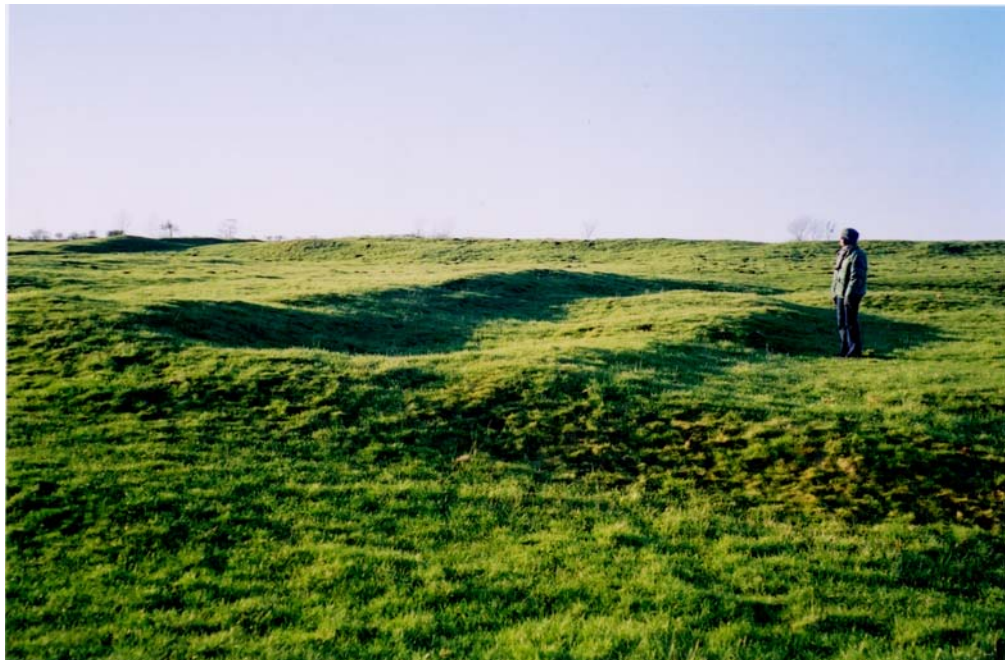
Figure 21
*View of Building 13
from the east*

Toft 16 contains the building formerly identified as Building 13, which has clear evidence of a tripartite division of its interior. It also includes an area of very slight and evidently disturbed earthworks which may represent the remains of two or more other structures, not necessarily all contemporary, but apparently enclosing a small central courtyard. The nature of the later disturbance is unclear, but one circular mound is reminiscent of a small spoil heap. Whether this is the result of stone robbing or unrecorded excavation is uncertain.
