**Catley Priory,  
Lincolnshire: a  
Gilbertine House  
in the Witham  
Valley**

**SURVEY REPORT**

Archaeological Investigation Report Series AI/11/2005

**CATLEY PRIORY,  
WALCOTT, LINCOLNSHIRE**

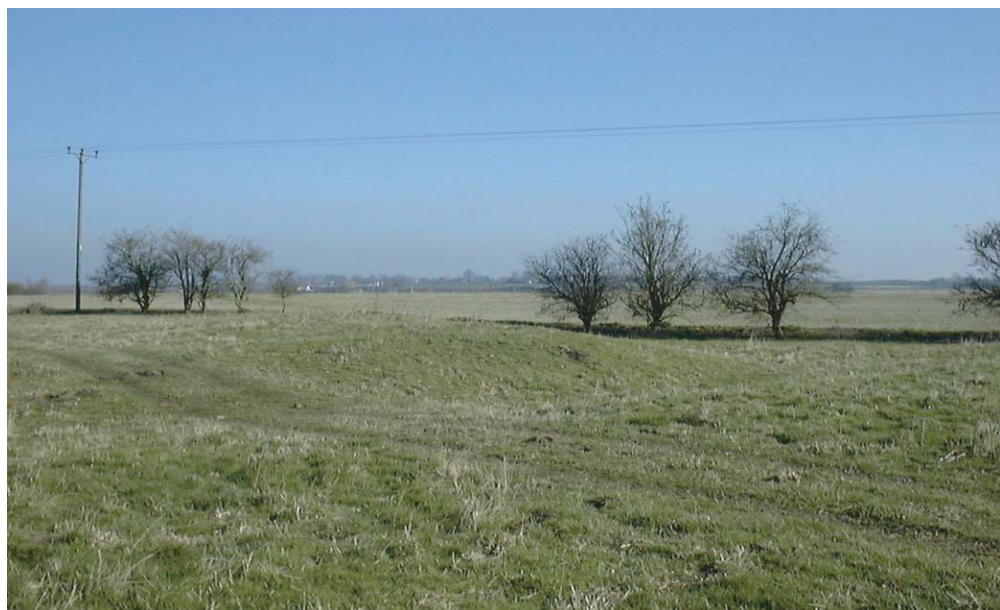
**Figure 7** Photograph of the southern part of the inner precinct boundary (1), surviving as a substantial earthwork bank

The focus of any medieval religious house was the inner precinct; the spiritual heart of the foundation which would have housed all the important buildings. This was almost invariably defined by some form of physical boundary, either a bank or a wall. The surviving evidence shows that Catley was no exception. A sub-rectangular feature (1), enclosing an area of roughly 1.2ha, can be traced for part of its length as an earthwork bank and also as a crop-mark. The feature has been cut through by the modern boundary defining the eastern edge of the main field, while that part beyond the boundary in the eastern field has been comprehensively ploughed and can now only be seen as a crop-mark on aerial photographs. In June 2004, following a period of dry weather, parched grass was visible on the ground along its line. Within the main field parts of the northern and southern edges of the precinct boundary survive as earthwork banks or scarps but the western edge is intermittent (Figure 7). This seems to be as a result of later activity, which has disturbed its course.

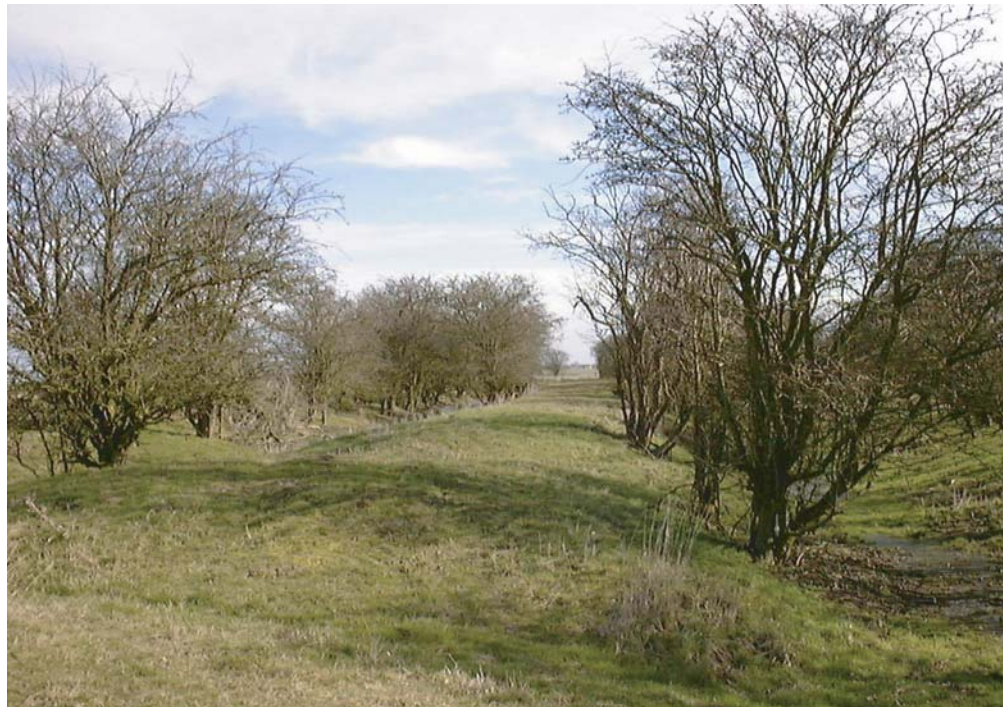
**Figure 8** The boundary ditch (right) at the southern end of the main field (22), with the southern part of the D-shaped channel (23) running parallel (left)

The western and southern perimeter of the main field is marked by a fence inside and along the edge of which are two substantial ditches (23 and 24; Figure 8), up to 1.5m in depth. The western boundary ditch (23), virtually dry at the time of the present survey, has a rounded terminal at its northern end, while to the south it curves slightly south-east, apparently feeding into another watercourse (25). The southern boundary ditch (24) was originally part of a watercourse called the Queen's Dyke (Landscape Research Centre Ltd 1997, 2). This is shown on the First Edition County Series map flowing from some distance to the west of the main field along its southern edge and then beyond the field in a south-easterly direction

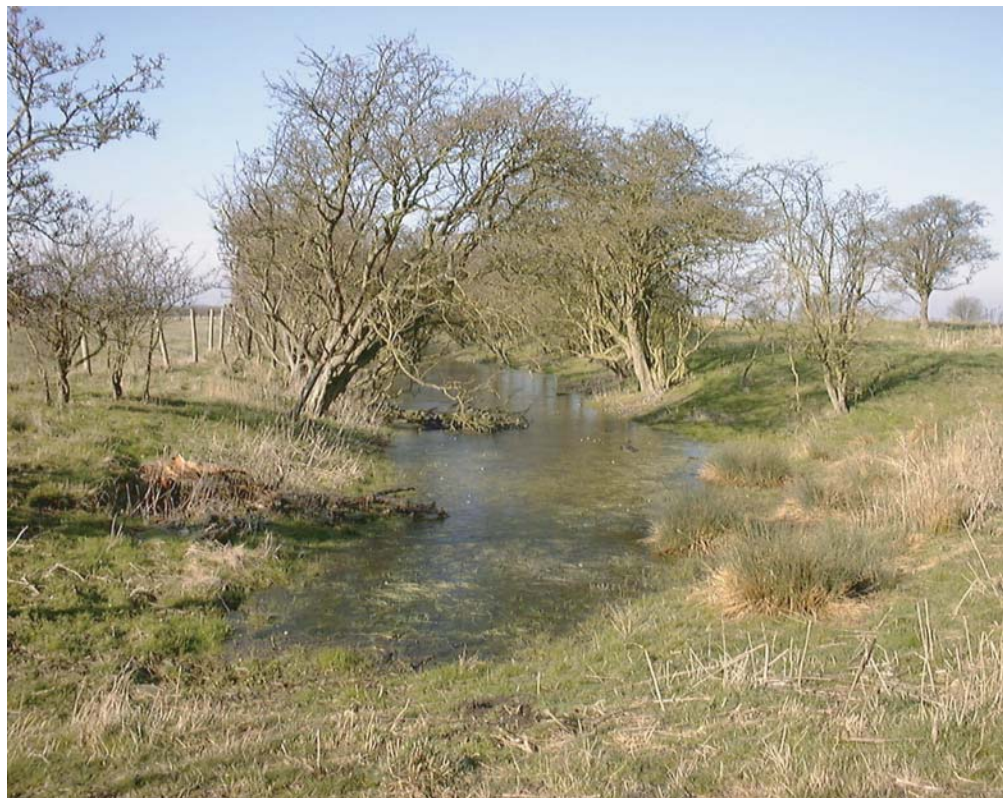
**Figure 9** View to the west along the southern boundary ditch

Within the area of the present survey, the southern boundary ditch (24) begins to broaden to the east, approximately halfway along (Figure 9). This broader section is some 45m long and adjacent to its northern edge are some relatively well-defined earthworks. These comprise, on the east, a sub-square area with a smaller rectilinear platform (29) occupying its south-eastern corner, defined by a depression around the northern and western sides. The platform may have supported a structure or it could have been used as a loading area. To the west of the platform is a more complex group of earthworks (30), bordered on the west and the north by a bank, which appear to represent the remains of at least one rectilinear structure. There is a possibility that (29) and (30) together formed a wharf or dock serving the priory, to and from which goods were delivered, perhaps using shallow, flat-bottomed boats to navigate the watercourses which cross the fenland landscape.

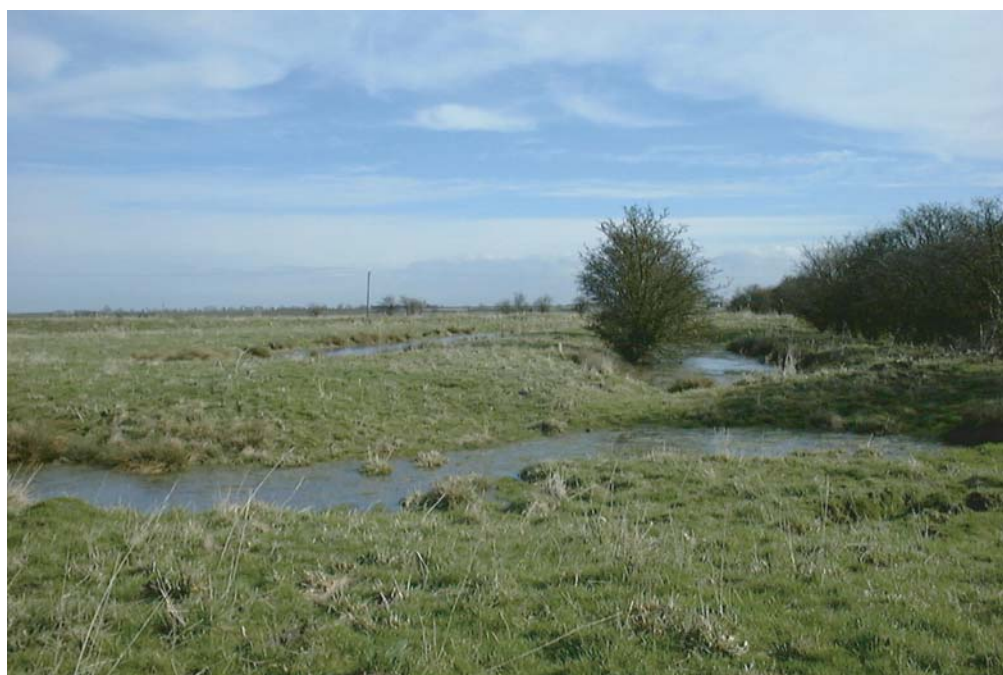
**Figure 10** Photograph looking east at the south-west corner of the D-shaped channel (23). The dip to the right of the tree is where the western and southern arms of the channel meet.

All other watercourses and ponds are concentrated in the south-western quarter of the main field. Surrounding two ponds is an irregular 'D'-shaped channel, made up of a series of six straight interlinked arms at different angles, forming what may have been a discrete enclosure (25). The western arm of this channel, parallel to the western boundary ditch (23), has a broadening at the southern end, with a narrow gap through an earthen bank to allow water to pass through and join the rest of the feature flowing to the east (Figure 10). A small channel has been cut between this broader area and the western end of the smaller, southern pond (27; discussed below), allowing the transfer of water between the two features. The southern and eastern arms of the channel are still fairly well defined, but the rest of the feature is somewhat degraded, particularly the northernmost arm. The point at which the water entered the 'D'-shaped channel was probably at the northern end of the western arm, as this extends further to the north here and appears to be linked to the western boundary ditch by a further shallow channel.

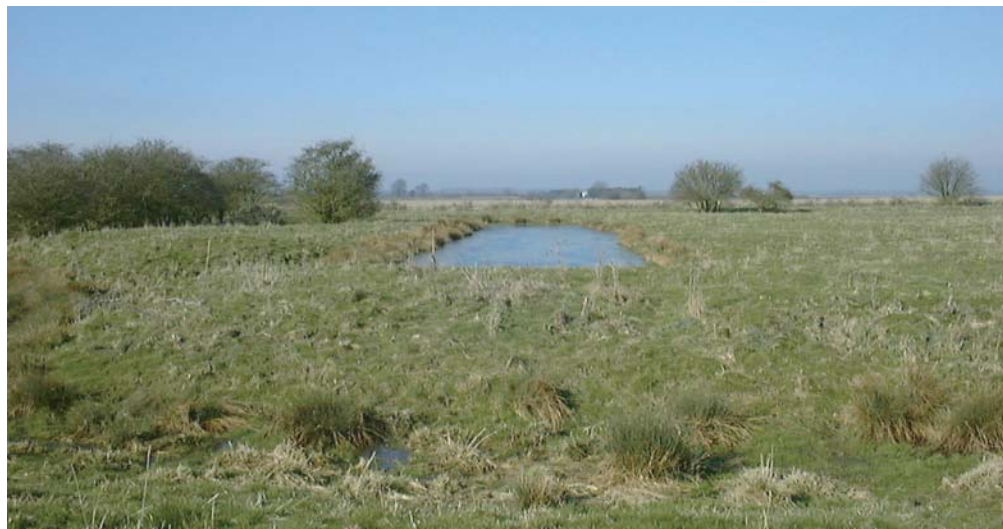
**Figure 11** Large rectangular pond (24) surrounded by the D-shaped channel (23). This photograph was taken in February 2004 and demonstrates that the pond still holds water.

In the middle of the area enclosed by (25) is a large rectangular pond (26), which is c 1m deep. It has a regular outline and is well-defined, suggesting a re-cut in modern times; it still holds water throughout the year (Figure 11). From its south-western corner, a narrow cut, some 0.6m deep, connects it to the surrounding channel (25). To the south, a smaller, rectangular pond (27) adopts a parallel alignment. A narrow cut at its western end links to the surrounding channel. The rest of the area enclosed by the channel (25) is relatively flat and contains some slight scarps, possibly related to the cutting or re-cutting of the ponds and the periodic clearing out of the channel.

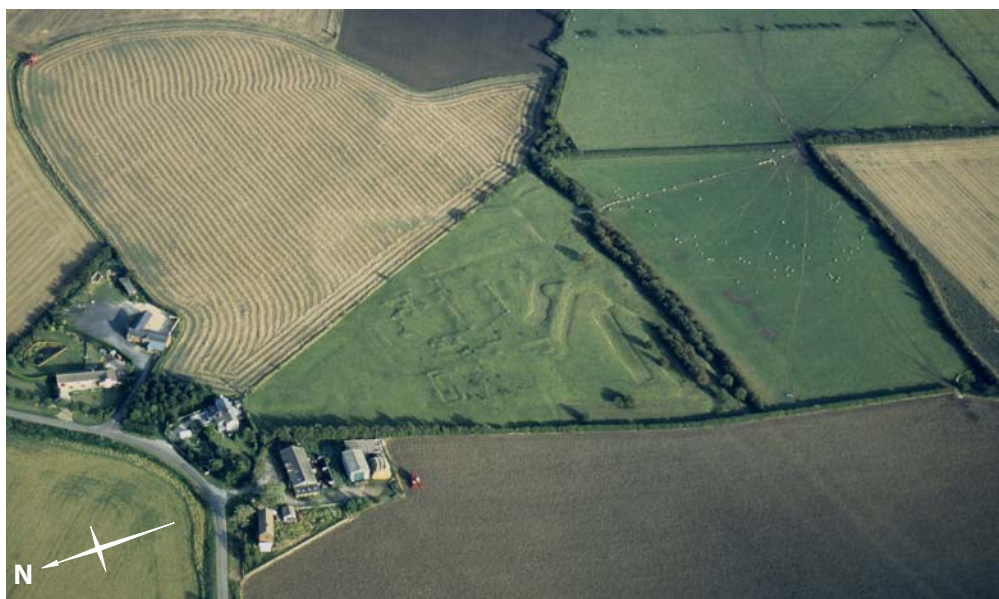
**Figure 12** Aerial photograph of Catley Priory and the surrounding fields. Of particular interest is the curving boundary of the field adjacent to the west of the site. NMR 12606/02 TF1155/16 5-Sep-94. © English Heritage NMR.

In terms of earthwork remains, there is little to suggest the original course of the priory's outer precinct boundary. However the unusual outline of the field immediately to the west may represent part of its course (Figure 12). The eastern half of this field boundary follows a curving course, which sits somewhat incongruously in a landscape of regular, straight fences and hedges. Given the shape of this boundary, it is undoubtedly of some antiquity. The boundary is presently defined by a drain, which follows the curve of the field, before turning sharply to the south and joining the dyke which flows away from the south-eastern corner of the main field. This short north-south stretch of the drain may be a modern diversion and it is possible that the original route of the ditch continued on the curving course, which would have brought it around towards the south-eastern corner of the main field. At this point the line of the outer precinct boundary seems to have been picked up by the southern boundary ditch (24), with its associated bank. If there was originally an earthwork bank associated with the boundary and watercourse around the field to the east, then this would have created a continuous boundary with the southern boundary ditch. However, there is now no surviving evidence of such a feature.
