ENGLISH HERITAGE

Loftus Alum Works, Redcar and Cleveland, Cleveland: an archaeological and historical survey

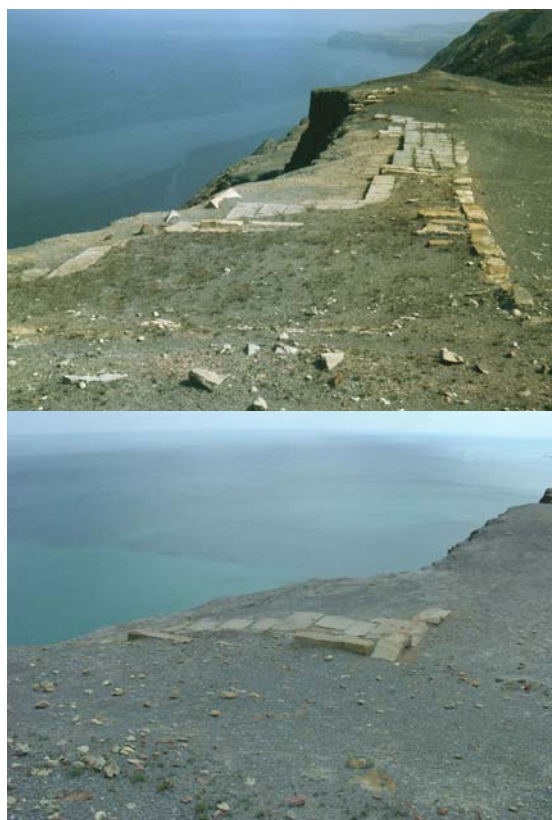
Figure 5.
Photographs of a steeping pit in area 1; the upper one was taken in 1975, the lower in 2003. This demonstrates the rate at which stone has disappeared from the site in relatively recent times. 1975 photograph reproduced by kind permission of Mr K Chapman.

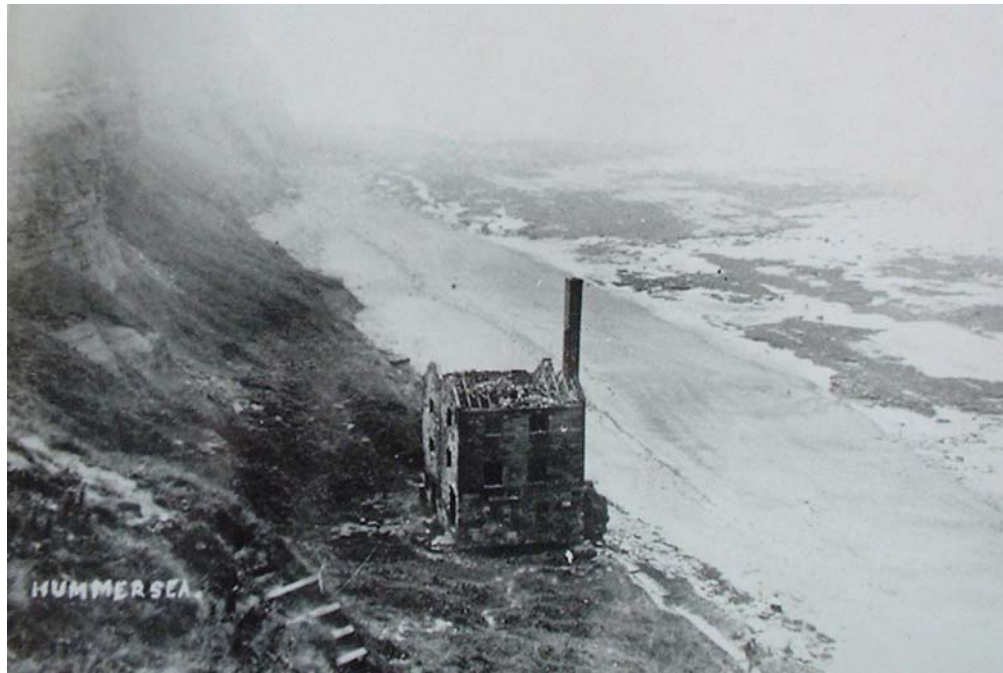
Figure 10.
*Photograph of the
alum house at
Hummersea, believed
to date to the 1890s.
Reproduced by kind
permission of Mr K
Chapman.*

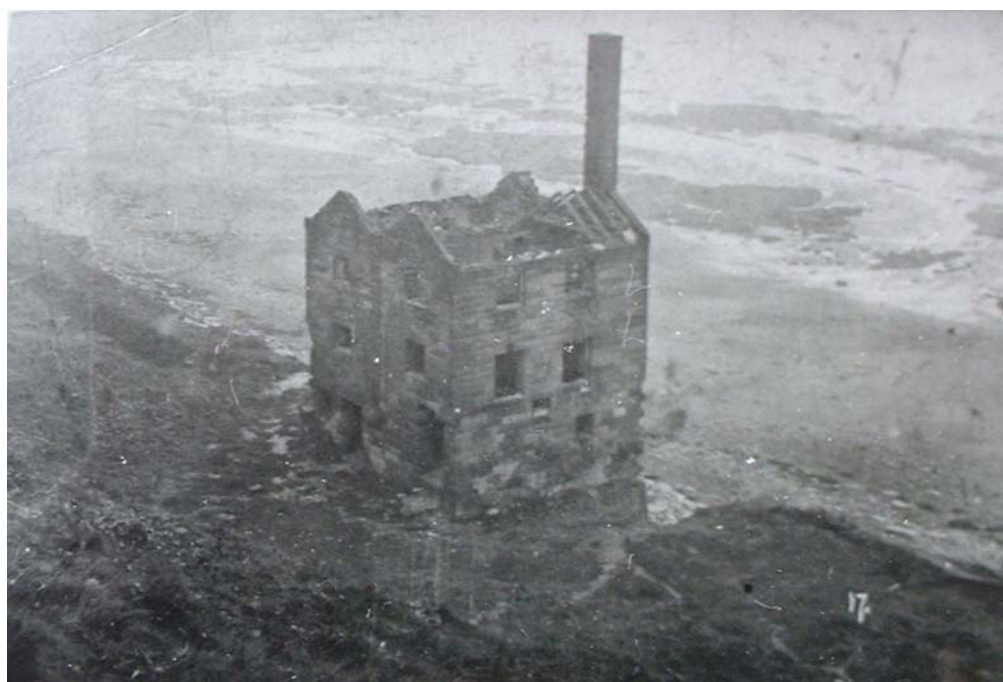
difficult to be sure of exactly what they are or what they represent. What is clear from the image is that the structure illustrated was situated on a flat area that seems to have been cut back into the cliff, apparently for the specific purpose of accommodating the building.

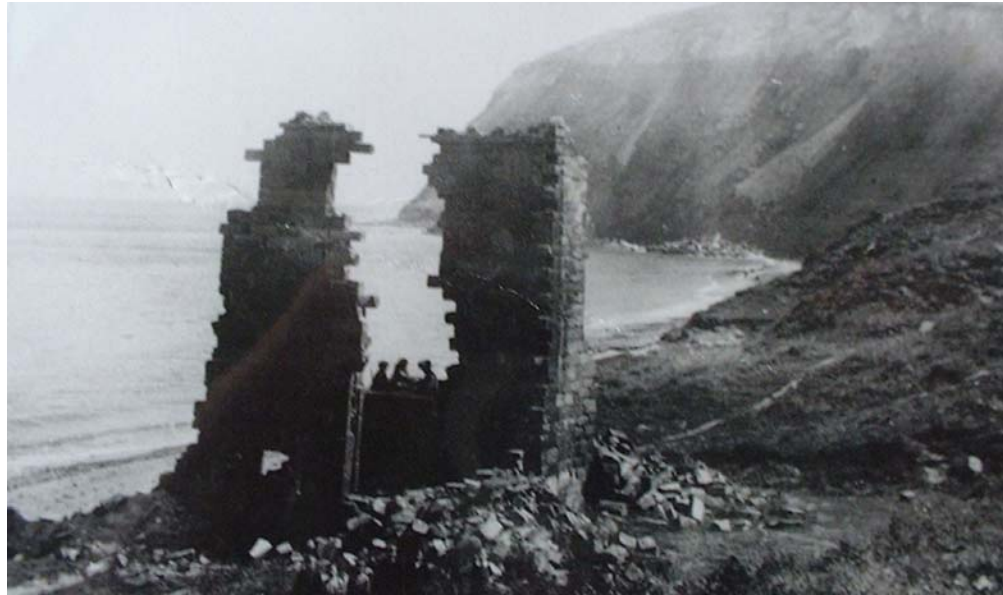
Figure 13.
*Photograph of the
alum house at
Hummersea, possibly
dating to c1910.
Reproduced by kind
permission of Mr K
Chapman.*

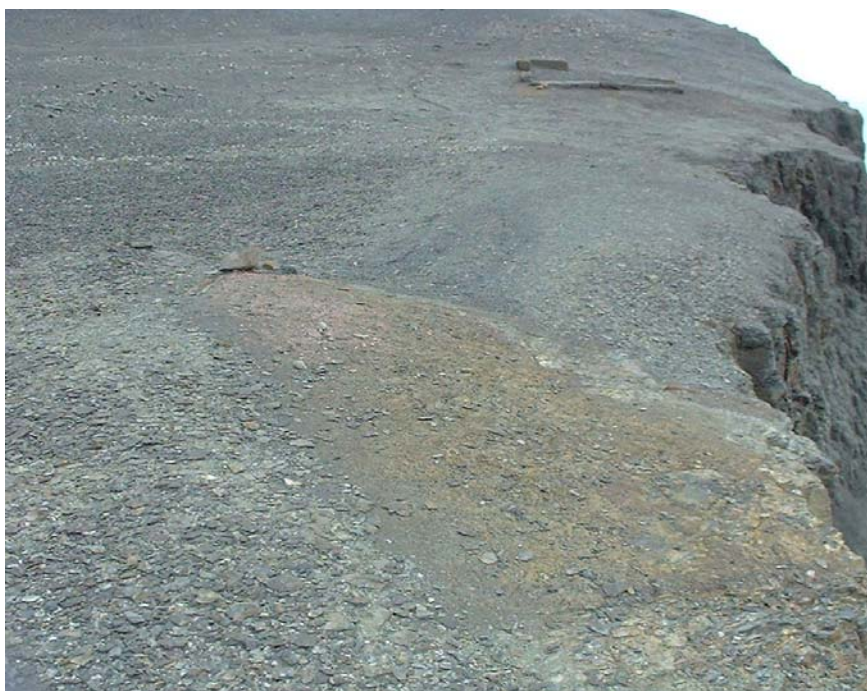
Figure 20. *Clay base upon which a steeping pit would have stood. In the distance the structural remains of a steeping pit can be seen, which was probably part of the same range.*

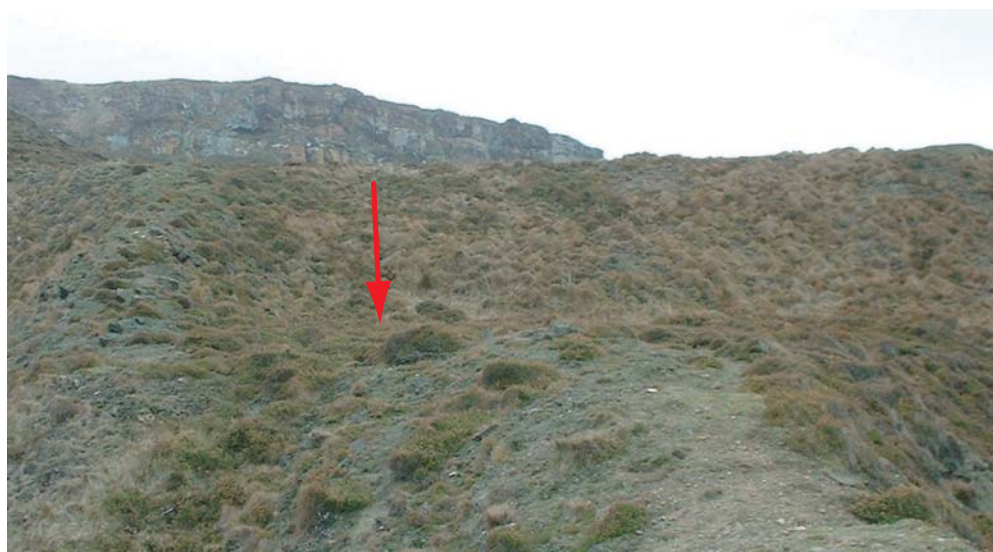
Figure 27. Platform (indicated by the arrow) within area 4

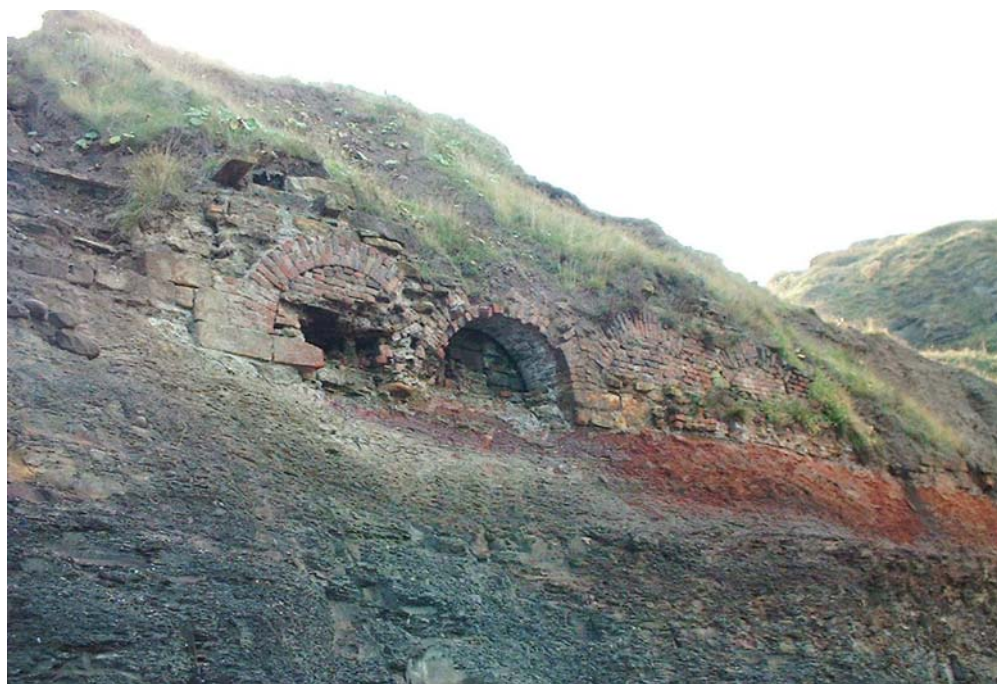
Figure 34. The remains of bricked-up arches in the cliff face at Hummersea, formerly part of the alum house complex

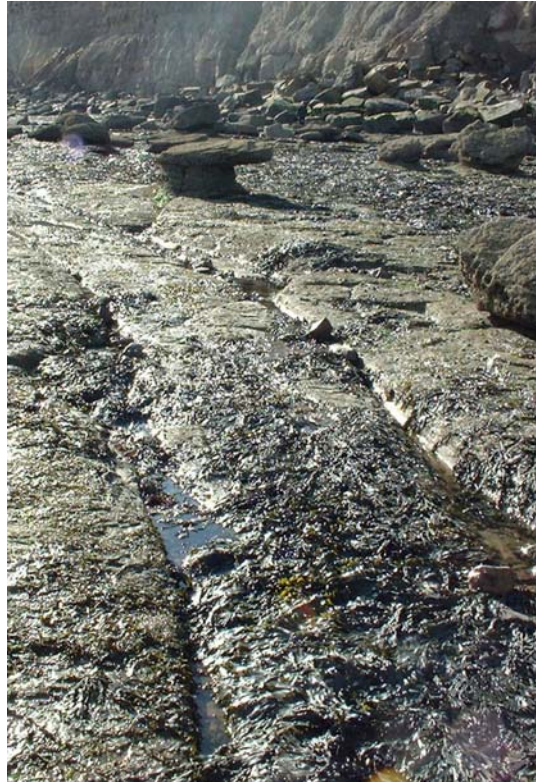
alum house and the docks (Figure 39). They would also have been utilised to unload coal from ships delivering supplies to the works. Due to the dense seaweed cover at the time of this survey, these features were recorded from aerial photography. The rutways are cut into the exposed bedrock of the foreshore, and are generally a standard distance of 4 feet and 4 inches (approximately 1.3m), which matches the distance between the wheels of a typical agricultural cart, of a type probably used to transport the alum (Owen 1986, 25). The concentration of these rutways is on the foreshore to the west of the alum house, leading towards Skinningrove. There are apparently no records of the use of Skinningrove for the transport of
