Lowwood Gunpowder Works and Ironworks and the workers' hamlet of Low Wood, Cumbria: an archaeological and architectural survey

SURVEY REPORT

Archaeological Investigation Report Series Al/35/2004

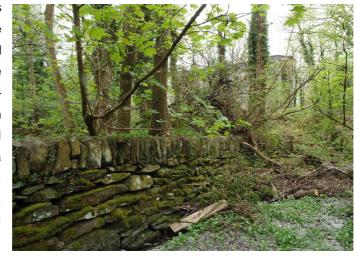
Fig 10. The front face of the unnamed, early weir between Ford Island and Bleaberry Holme. The outline of the lower corning house mark IV is just visible behind.
(NMR: DP003526)

Cartographic evidence suggests that much of the weir had already disappeared - presumably washed away by the river - before the end of the 19th century, therefore, but a c 23m length is still preserved to its full original height adjacent to the left bank where protected from the full force of the Leven by gravel banks upstream; an additional few metres of the rear basal courses are also visible in the bed of the river beyond the upstanding section. The weir is stone-built, 4m wide at its base, and roughly triangular in section comprising a near-vertical wall facing downstream backed by a 'wedge' of masonry upstream; the front face is constructed of roughly-coursed rubble flagstones, bedded on a natural rock outcrop and topped by a single course of flagstones set vertically (Fig 10),

while the upstream side is formed from the same rubble flagstones laid horizontally, edge-on to the river, but dipping in cross-section at a c 45° angle in relation to the front vertical wall face to create a battered surface (Fig 142). Its elevation is c7.3m AOD, or some 1.6m above normal (modern) water level.

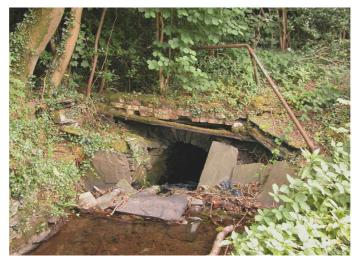
Fig 11. The entrance to the covered section of the ironworks headrace leading to the blast furnace. (Christopher Dunn, July 2005)

map (Fig 3), field evidence shows it took the form of a covered leat with the race disappearing into a stonearched culvert near the stable/cart house (Fig 11), and re-joining the present tailrace close to where the latter discharges into the Leven (Fig 12). The present investigation has not traced the culvert's course underground between these two points, but it must pass beneath what is now the Clocktower complex in order for power to have been delivered to the bellows at the blastfurnace. The most likely course of the race is discussed as part of the description of the blast furnace below (this section).

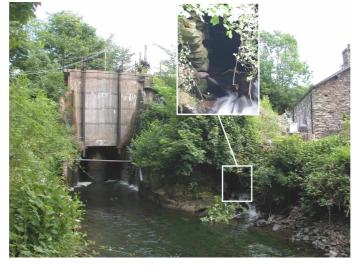
Fig 12. The outfall of the covered section of the ironworks headrace (shown in detail at inset) back into the main tailrace. The modern hydroelectricity station is visible at left of frame. (Christopher Dunn, July 2005)

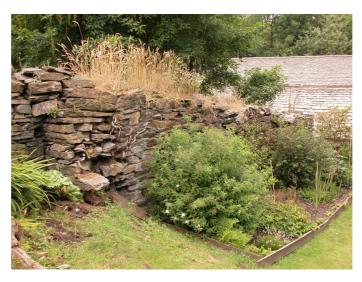
All that remains of the Lowwood bridge house is the south-west side wall almost to firstfloor level, and the return of the south-east end wall (Figs 14 and 27), although the continuation of the wall-line is marked on the ground by a steep scarp (Fig 142). Two partly-blocked window openings survive in the side wall, both with in-situ external slate cills and

Fig 14. The interior of the ironworks bridge house viewed from the east. (Christopher Dunn, July 2005)

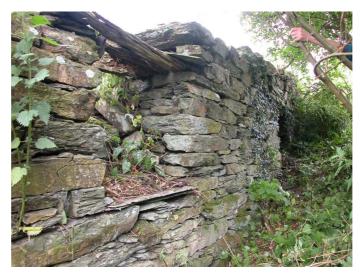
wooden lintels (Fig 15); they lit what may have been a small bothy sited below the charging house, similar to the arrangement which existed at Duddon, although if so the floor of the bothy now lies buried beneath earth brought in to raise the ground level and create the modern garden which occupies the interior of the

Fig 15. Exterior face of the surviving side wall of the ironworks bridge house viewed from the west. (Christopher Dunn. July 2005)

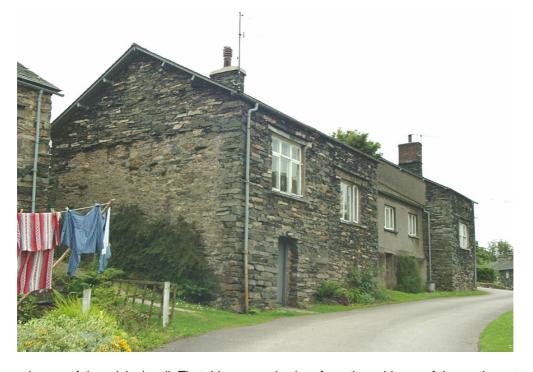
The lower parts of five of the six compartments in the Lowwood ore store survive: nos. 1 and 2 under the two-bay offices at its north-east end, nos. 3, 4 and 5 (the last one curtailed) under the narrow, lower, central part of the building. Compartment 6, however, was destroyed when the south-west office building was constructed. Compartments 1 and 2 were successively altered when this end of the ore store was converted into offices over basements: both bays were extended out on the downhill side (their original downhill walls being demolished), but on the uphill side only the wall of the first bay was rebuilt, slightly in

Fig 16. The iron-ore store from the north-east. (NMR DP006441)

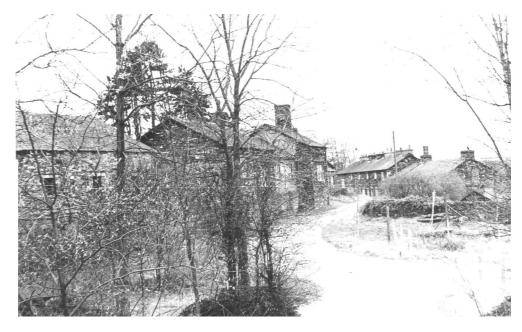
Fig 17.
View south-west from the modern site entrance towards Low Wood hamlet in 1957. Part of the 'large' charcoal barn before its conversion into residential housing is visible at left of frame. (Ron Mein Collection, copyright reserved)

sacks of charcoal to be delivered into it through taking-in doors in the rear, uphill elevation as well as through openings in the front elevation. A photograph of it taken in 1957 (Fig 17) before its conversion into houses, shows part of its downhill elevation with just a few small openings in the upper levels of the wall. There are now so many doors, garage doors and windows in the front and rear elevations that it is impossible to know what might be old. The downhill wall has a slight change of angle south of centre, and it is possible that it was built in two stages. Whether this is so or not, the interior would originally have been open to the roof, with timber storage racks for the sacks of charcoal.

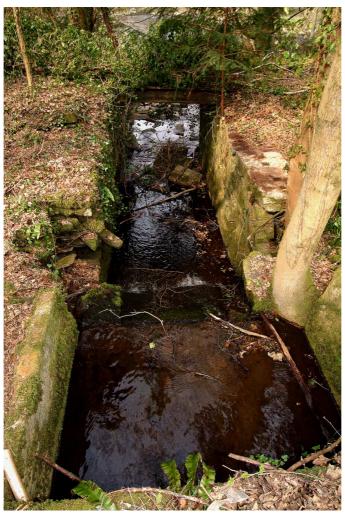
Fig 21.
The reel-and-glaze-house leat and waterwheel-pit from the south-east. Note the steel girders (one obscured by the fallen tree) for the tramway bridge.
(NMR DP003484)

leat was presumably maintained rather than blocked off at that time in order to act as an overflow channel in periods when too much water entered the headrace), but the stone sides and floor of the leat between the modern sluice and the rear curve of the waterwheel-pit are faced in concrete (Fig 21), which by comparison with other leats on the site (for example, the glazing-house leat, this section below) can be dated to 1928/9. In contrast the side walls of the wheel-pit and those of the tailrace all survive as bare stone as originally built. An artificial spit of river cobbles extends out into the Leven on the north side of the tailrace

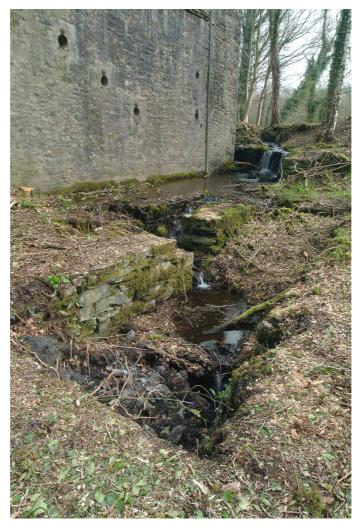
Fig 23. The infilled waterwheelpit at the lower corning house mark IV. (NMR DP003476)

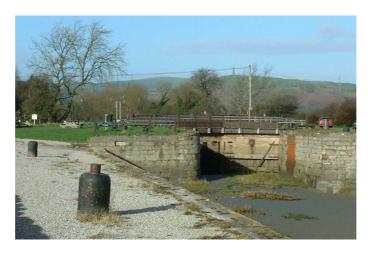
Fig 26.
Charcoal retorts
reused as bollards at
the entrance to the
Ulverston Canal.
(Marcus Jecock,
February 2005)

No above-ground trace of the retort house survives, although according to Tyler (2002, 154) the old cylinders were taken away to be set into the ground for reuse as mooring bollards at the entrance to the Ulverston Canal, where they may still be seen (Fig 26).

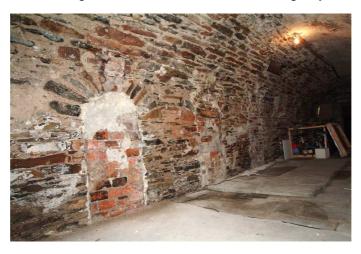
Fig 29.
The boilerman's passage from the south-east, showing furnaces nos. 1-3 with no. 4 just visible behind the crates. (NMR DP003505)

of stone rubble; they and the furnaces are here numbered 1-6 from south-east to northwest. Furnace 1 has the least altered opening (Fig 29): it is now blocked, but still retains its stone-voussoired arched head which is unaltered but for the insertion of a square vent (also now blocked) immediately above its apex.

early 20th century, when new iron grates were installed to heat the boiling pans and new airflow patterns created to increase the draw of the furnaces. The work, undertaken in red brick (Figs 29 and 31), involved the substantial rebuilding of most of the stoking areas. The upper parts of the sides

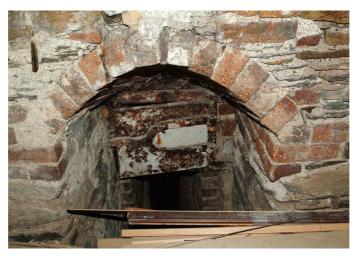
Fig 31. The stoking area and fire-box door to furnace no. 5. (NMR DP003508)

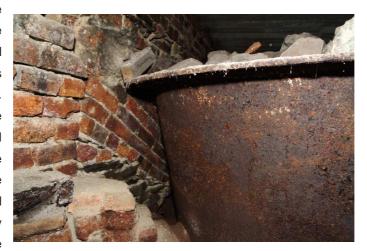
Fig 33.
One of the boiling vats sealed beneath the modern inserted floor of the saltpetre refinery. (NMR DP003514)

opposite, south-west side of the block (Fig 30). The vats are circular in shape and have gently-tapering sides and flat bottoms (Fig 33). They have 0.15m wide flanges, an upper internal diameter of 2.28m, and are 1.30m deep. The vats are now filled with rubble, and it is not known whether they have perforated false

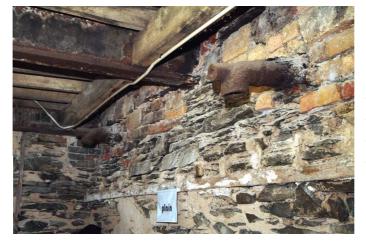
Fig 34.
The taps for draining the boiling vats above furnaces nos. 5 and 6 into the filters.
(NMR DP003504)

After the saltpetre solution in the vats had been boiled sufficiently, the refining process involved drawing the resultant liquor off into filters. The large cast-iron taps associated with furnaces 5 and 6 survive and project through the rear wall supporting the boiling vats (Fig 34), into a wide

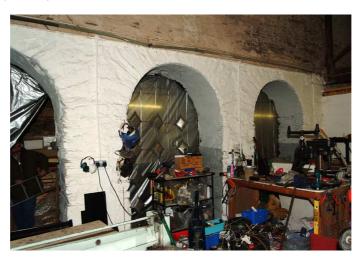
Fig 35.
Part of the pierced wall between the main block of the saltpetre refinery and the more westerly of the two southern wings.
(NMR DP003519)

wings beyond (Fig 35), but to understand how this area was used it is first necessary to consider in more detail how the English saltpetre refining process was ordered.

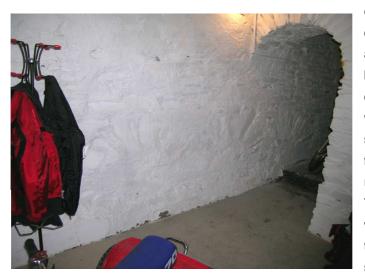
Fig 38.
The three blocked,
arched openings in the
south-west ground-floor
wall of the Clock tower.
(Tony Berry, June 2005)

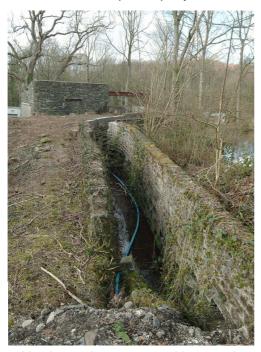
Fig 57. The relined leat to incorporating mill 35 mark II. (NMR DP003441)

(Fig 55). The sides of the leat were evidently relined and raised using identical materials at the same time (Fig 57), suggesting that this phase is contemporary with the heightening of the main headrace in the mid-1960s. The turbine may also have been relocated to its present position from elsewhere within the factory, for it is known that under ICI management an Armfield turbine of 'River' design was purchased for use at Lowwood in 1928 (sections 4.2 and 6.2.1 above), but if it is the same turbine there is presently no evidence for where it was moved from. A large I-section steel gallows beam set into the north wall of incorporating mill 35 above the turbine-house roof and supported at its other end by a steel stanchion, spans the entire

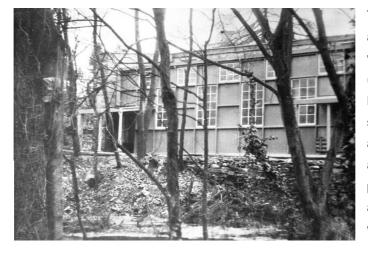
Fig 60. Lower corning house mark IV, viewed from the north in November 1928. (Patterson Collection, © English Heritage.NMR)

The mark III corning house and its attendant building(s) were still extant in 1926 (Fig 9). However, by November 1928 all had been swept away and replaced by a totally new, mark IV, house as shown by a contemporary photograph (Fig 60) and accompanying caption which describes the

The three standing walls of the main corning chamber (Fig 61) are built of slate rubble with rock-faced quoins at the corners and concrete coping along the top; they are 0.92m thick and belong to a building which was 16m wide and 7.6m deep. The rear wall is 6.9m high, but the side walls slope gently down to the front where they stand 5.5m high implying that the building had a single-pitch roof; this is confirmed by the 1928 photograph (Fig 60) and by the

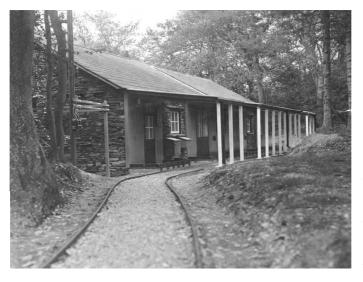
The building was altered as part of ICI's general modernisation of Lowwood in 1928-9, for a slightly later photograph captioned 'Reconstructed Glazing House' shows the building with a new open-fronted covered canopy supported on fourteen timber posts (the central eight posts set slightly forward of the three at either end) running the full length of the building, protecting and sheltering the tram line (Imperial Chemical Industries 1929, 341 bottom; a

Fig 66.
The glazing house as reconstructed in 1929, viewed from the south.
(Patterson Collection, ©English Heritage.NMR)

copy of the photograph also forms part of the Patterson Collection at the NMRC and is here reproduced as Fig 66). Both doorways in each compartment were retained - all with part-glazed doors with rectangular overlights - and a fixed-frame window with small-pane glazing inserted between each pair; the windows have timber

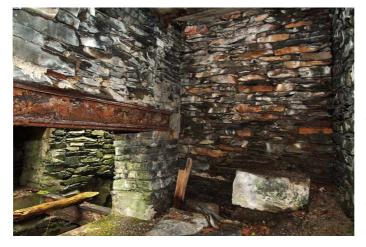
supporting flat central concrete panels and inclined outer panels (Fig 69). There is no accommodation for drive shafts rising up through these concrete panels, suggesting that power was delivered by a vertical shaft rising within the area of the waterwheel-pit and driving a line shaft at wall-head height.

Fig 70.
Inside the reduced basement beneath the south-western compartment of the glazing house, showing the stone block incorporated within the rear wall and the inspection opening for the turbine occupying the waterwheel-pit. (NMR DP003531)

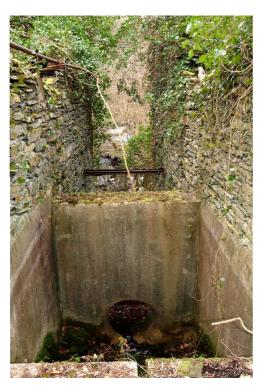
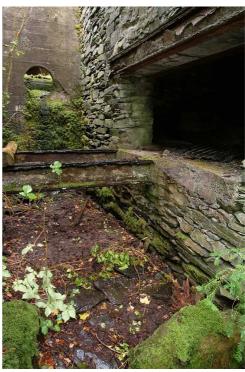
Fig 71.
Two views of the glazing-house waterwheel-pit:
a (left) looking northwest down the pit, showing the cross-wall for the turbine supply-pipe.(NMR DP003480) b (right) looking south up the pit, showing the joists for the turbine and the imprint of the discharge-pipe.
(NMR DP006449)

cross-wall, set towards the upper end of the wheel-pit, which has a circular aperture for the supply pipe which fed water to the turbine. Steel joists across the wheel-pit supported the lost turbine, and curved shaping in the concrete base of a wide inspection opening created

The original waterwheel does not survive. However, the side walls of the central wheel-pit have tall, opposed rectangular openings with stone lintels in which the waterwheel axle was formerly set; these are now blocked. Another blocked opening in the south-west wall of the wheel-pit, west of the axle opening, suggests that power take-off from the wheel may have been by ring drive, via a spur wheel, to a vertical shaft which then powered line shafts in both compartments. The wheel-pit was subsequently extensively altered to take a water turbine, although if a unit was installed as early as 1903, as documents suggest, then it is the concrete and steel fittings of its more powerful successor, installed as part of the remodelling of 1928-9, which survive (Fig 71). These take the form of an intermediate, flat-topped, concrete

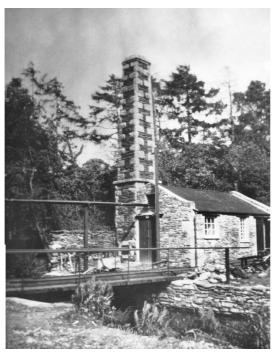
Fig 72.
The enlarged boiler house at the lower stove, and the new tramway bridge across the headrace in 1929.
(Patterson Collection, ©English Heritage.NMR)

indicated by a photograph entitled 'Lowwood. New boiler house & bridge for tramway. June 1929' (Fig 72) which shows the building had been extended, presumably to accommodate a larger boiler. The fact that the photograph also shows a steam pipe exiting the boiler house through the louvred vent above the doorway in the north-west gable wall and crossing the headrace, indicates that the reason for the improvement was because the boiler house was now used to send steam to the higher stove, whose own boiler house had been converted to accommodate a steam turbine blowing hot air (higher stove, this section below).

Davies). It must, therefore, have been purchased second-hand by the Lowwood company sometime in the early 20th century, quite possibly in 1929 specifically for the rebuilt boiler house. The boiler, which stands over a brick-lined channel, has its firebox at its south-east end - well-placed for obtaining fuel through the wide doorway - a cylindrical, timber-lined boiler, and an exhaust chamber with a cranked flue which leads into the side of the chimney in the north corner. A water tank stands in the west corner of the boiler house. This is supported on a brick base, and pipes lead from it to the boiler. The 1929 photograph (Fig 72) suggests that it was replenished from the headrace using a portable pump.

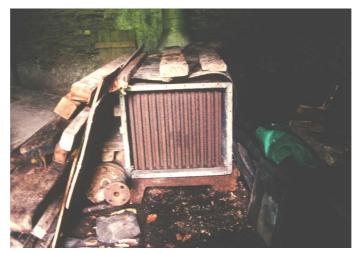
Fig 86.
The Blackman plant in the heater house (building 47a) at the higher stove in 1991. (Davies-Shiel Collection, copyright reserved)

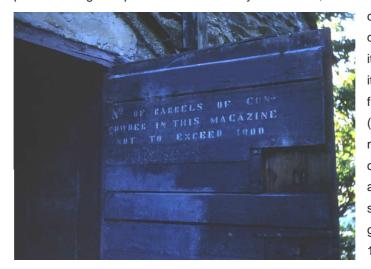
construction beneath a double-pitched roof, and that it was rendered internally; it is likely that it was also fitted with an outer door (see below). In 1969 the magazine still retained its original inner door: a notice attached to the inside stated 'N° of barrels of gunpowder...not to exceed 1000' (Fig 91).

Fig 91. Noticeboard on the inside of the door to the '1798' Roudsea magazine in 1969. (Palmer Collection, copyright reserved)

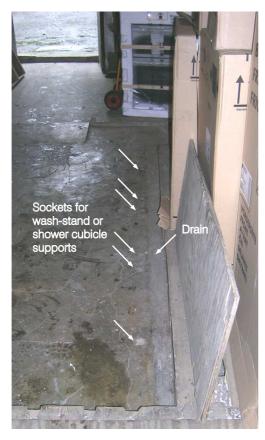
Fig 97.
The shallow drain and sockets for wash-stand or shower cubicle supports (arrowed) in building 11b. (Tony Berry, June 2005)

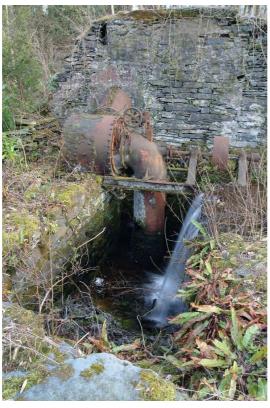
Fig 102. Gilkes turbine no. 2065 at the sawmill. (NMR DP003446)

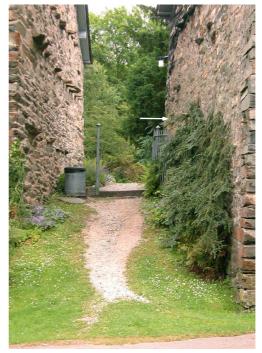
A pair of cast-iron gate piers with squaresectioned bases, slender tapering octagonal-sectioned shafts and moulded caps stand between the uphill corner of the north-east office and building 100 to the north (Fig 107); the existing wroughtiron gate is not original. Railings to either side have been lost, but the gate was clearly meant to mark an entrance into the gunpowder works from the road outside it. A wooden box attached to the wall of the office just on the works side of the gate, has a sloping roof projecting out over an outer face fashioned as a hinged flap (Fig 108); it is alleged to have been where keys to the various parts of the factory were passed out to workers (information from Ron Mein).

Fig 107.
The entrance into the works between buildings 100 and 101a, showing the cast-iron gate piers and key-box (arrowed) on the wall.
(Christopher Dunn, July 2005)

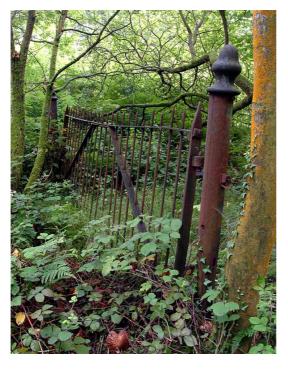
lost. A similar pair of gate posts, this time with the iron gate still *in situ* between them (Fig 110), survive on the Stang End side of the river (Fig 142). The gate does not mark the edge of gunpowder company property, nor where the line emerged on to the public highway, nor even where the tramway passed out of the licensed area; the exact rationale behind it is unknown, although it must have been intended either to control access or mark a point

Fig 110.
The iron gate on the
Stang End side of the
river across the tram
line up to Haverthwaite
Station.
(NMR DP006422)

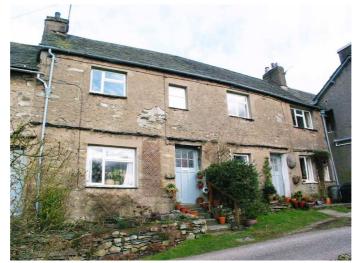
Fig 115.
The front elevation of nos. 2 and 3 Low Wood. (Simon Taylor, March 2004)

the fenestration largely dates from this remodelling. The visible front elevation, consisting of the fronts of nos. 2 and 3 Low Wood (Fig 115), is very irregular. The windows are all secondary insertions or enlargements, rectangular and lacking the heavy stone lintels that characterise the mid-19th-century terraced houses that make up most of the rest of the hamlet, and the doors give access to the individual dwellings into which the farmhouse has been subdivided. At first floor the elevation is four windows long, the second window from the left being narrower than the rest and

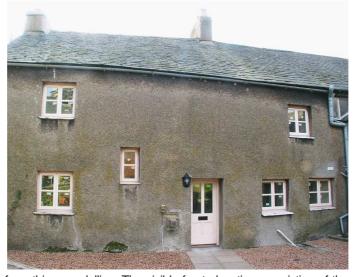
Fig 116. The rear elevation of no. 5 Low Wood. (NMR DP006436)

possibly lighting a stair or landing. At ground floor the pattern is window, door, window, door, window, window. The rear elevation of no. 5 Low Wood (Fig 116), to the left of the rear wing, is also irregular and heavily rendered. There are two windows at first-floor level, three at ground-floor level and a single doorway, probably original and once opening onto the cross passage. Above and to

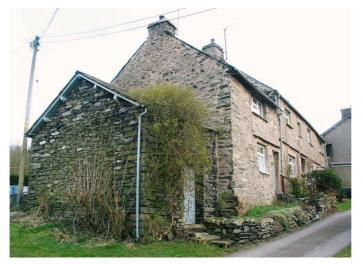
No. 1 Low Wood (Fig 118) is a single-fronted, two-storeyed house of rendered stone rubble, with a gabled slate roof, which butts against the north end of the old farmhouse. It was probably built when the farmhouse was converted into several dwellings and appears to be shown on the

1796-9 Bigland estate map (Fig 3). It has a single end stack and the front elevation has single ground- and first-floor windows - which, like the farmhouse itself, lack large stone lintels - and a partial course of watertabling at first-floor level. The gable end appears originally to have been blind although a single ground-floor window

Fig 118.
No. 1 Low Wood and
peat house attached to
the end of the old
farmhouse.
(Simon Taylor,
March 2004)

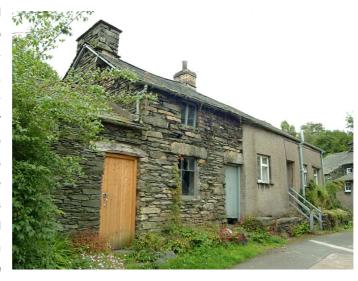
The 1796-9 Bigland estate map (Fig 3) depicts a building (or buildings) in the position now occupied by Garden Cottage and an unnumbered house attached to its northern end, although the form of the present buildings (Fig 119) suggests that much is likely to be of mid- to late 19th-century date. The unnumbered house at the northern end of the range, however, appears to be considerably earlier and consists of a small, two-storeyed, single-fronted, two-roomed house built of stone rubble with a single end stack, single ground- and first-floor windows to front and rear, and a front entrance which is off-set to the right. The ground-floor windows and door all

have large, roughly-dressed stone lintels, similar to those of nos. 7-10 and 12-16 Low Wood (see below), suggesting an early 19th-century rebuilding or remodelling date for the house. The front door opens directly into the single ground-floor room which has a fireplace positioned centrally against the north wall. To the left of the fireplace

Fig 119. The front (west) elevation of Garden Cottage. (NMR DP006437)

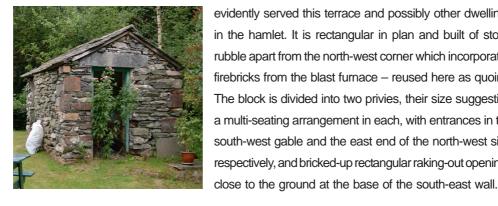
A little to the east of the terrace is a small gabled block (Fig 121) containing two privies that

evidently served this terrace and possibly other dwellings in the hamlet. It is rectangular in plan and built of stone rubble apart from the north-west corner which incorporates firebricks from the blast furnace - reused here as quoins. The block is divided into two privies, their size suggesting a multi-seating arrangement in each, with entrances in the south-west gable and the east end of the north-west side respectively, and bricked-up rectangular raking-out openings

Fig 121. The privy block associated with nos.7-10 Low Wood. (NMR DP006433)

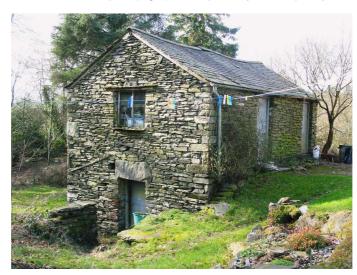
The 1799 lease granted gunpowder workers who lived in the hamlet the right to cut peat in nearby mosses, and each house now has a dedicated peat house. Some of these are within buildings originally constructed for different purposes, especially when they belong to dwellings established in former industrial buildings (for example the lower-floor area of the former iron-ore store opposite the modern Clocktower complex has been allocated as three peat houses, although it is possible that the middle one of these was already in use as a peat house in the 19th century (building 101b, section 6.2.7 above)), but there are a number in the hamlet which appear to be purpose-built. As well as that attached to no. 1 Low Wood (Fig 118) - which contains two stores and has opposing entrances in the east and west elevations - and that adjacent to the numberless house next to no. 12 Low Wood (Fig 124), there is a gabled stone-rubble rectangular block (Fig 127) at the south end of the green which is the peat house serving nos. 7-10 Low Wood. It is constructed like a bank barn, back to earth for half its height, and has two storeys. Each dwelling has its own individually-accessed store within the peat house, two on each floor. The ground-floor stores are accessed

by doorways in the opposing gables while the upper-floor stores are reached from upper-floor doorways in the north-east wall which can be reached because of the back-to-earth method of construction. This building is shown on the 1846 plan (Fig 4) and is probably contemporary with

Fig 127.
Peat houses serving
nos. 7-10 Low Wood.
(Simon Taylor,
March 2004)
