CANAL BRIDGE

BISHOP'S BRIDGE ROAD

Preliminary Archaeological Report

English Heritage
Historic Buildings and Areas Research Department, London Team
Reports and Papers B/019/2003
October 2003

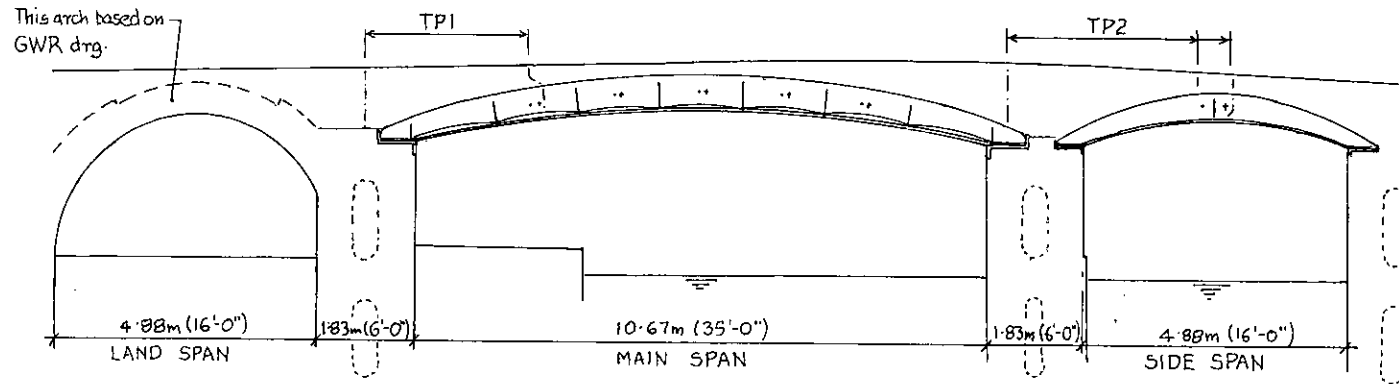
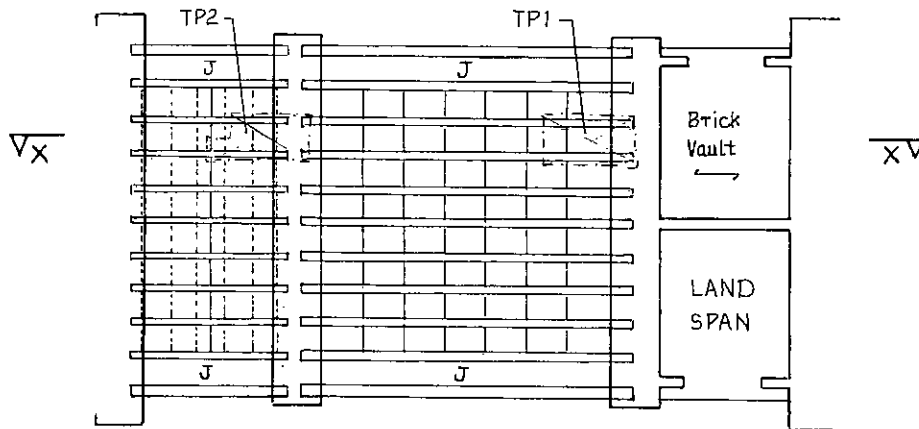
DRG. NO 1

- 9 no. Main Girders Type A
- 2 no. Edge Girders Type B
- 6 no. Cross Beams } in 8 bays
- 7 no. Soffit Plates }
- 2 no. brick arches J

REFLECTED PLAN (1:200)

BISHOP'S BRIDGE ROAD CANAL BRIDGE
KEY PLAN

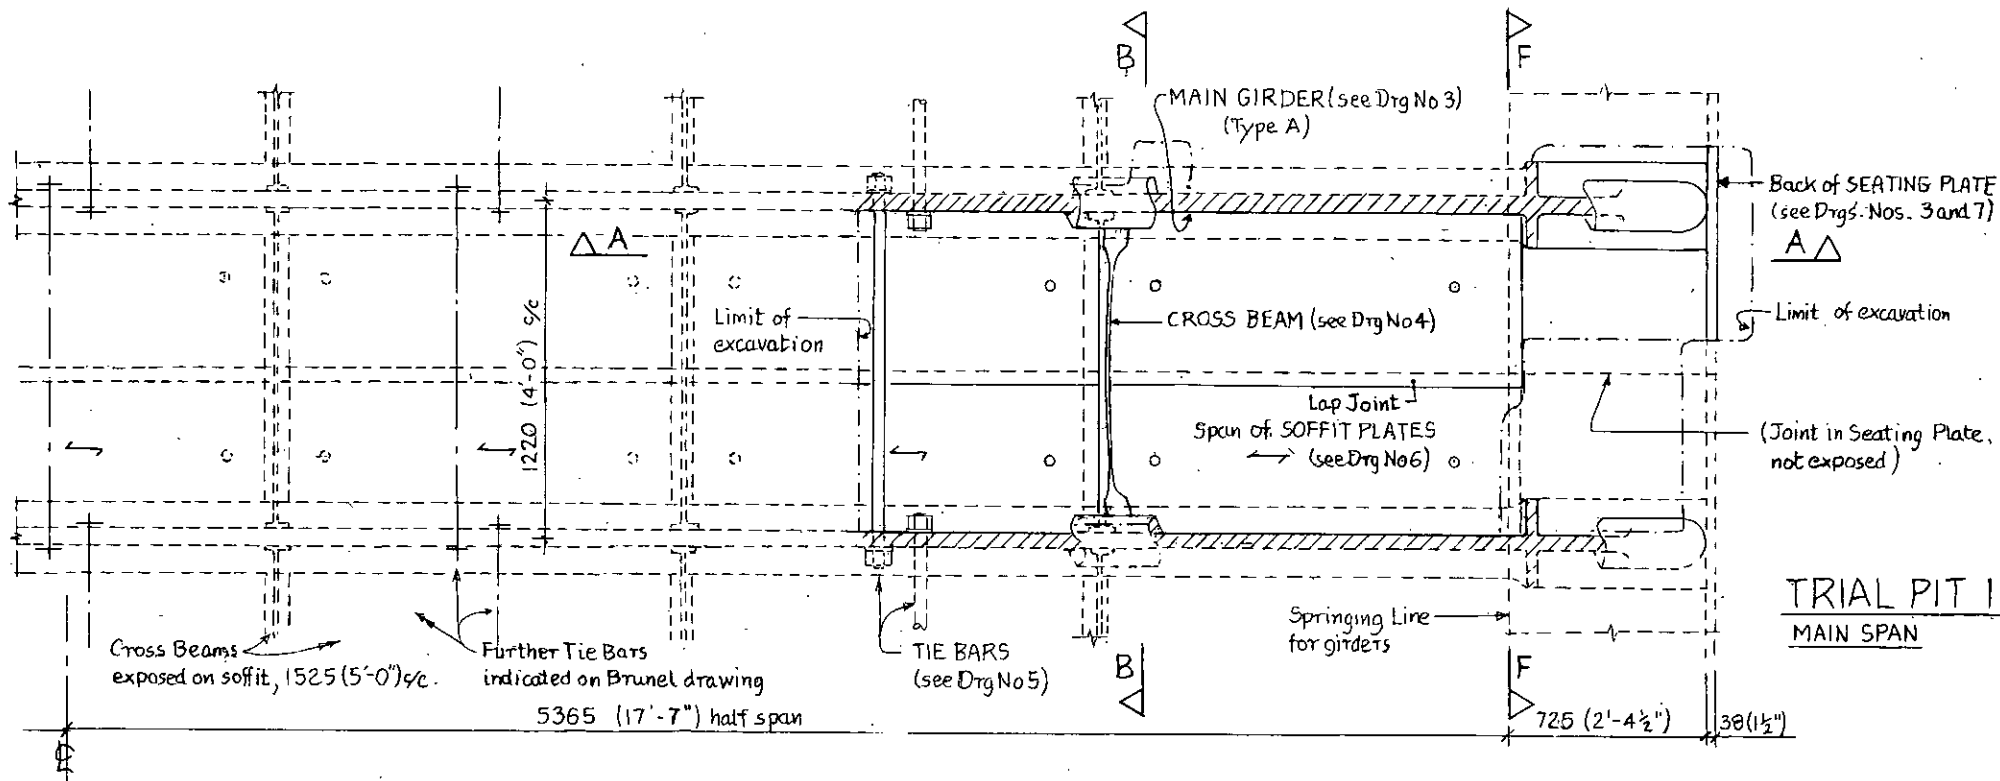
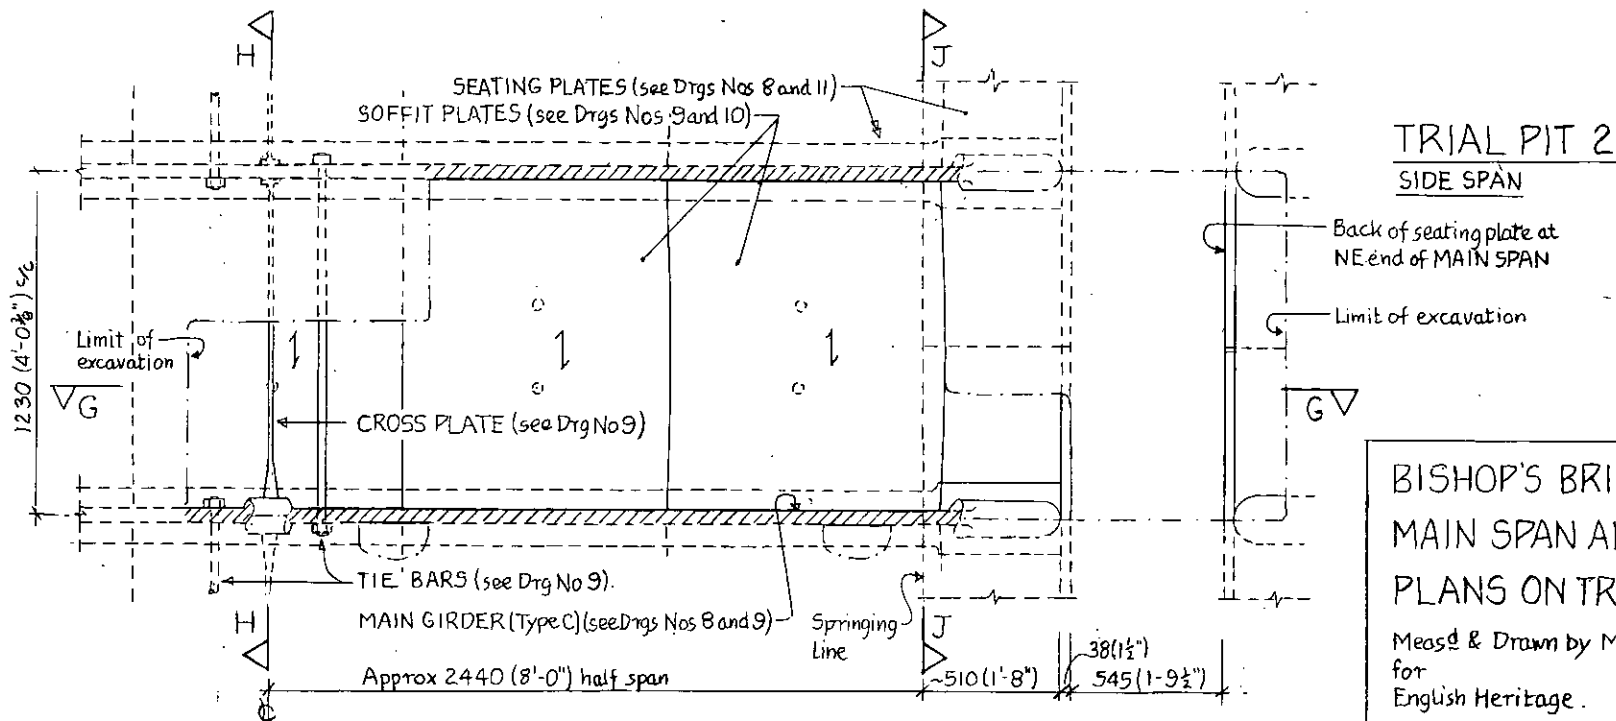
PLANS DRAWN GENERALLY AT LEVEL OF SOFFIT PLATES

BISHOP'S BRIDGE ROAD CANAL BRIDGE
 MAIN SPAN AND SIDE SPAN
 PLANS ON TRIAL PITS

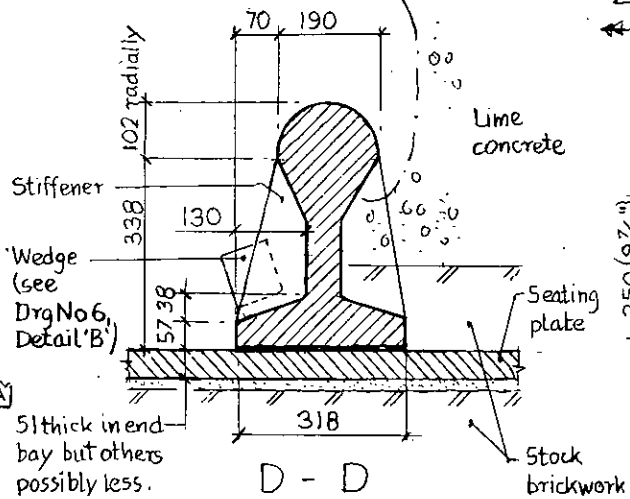
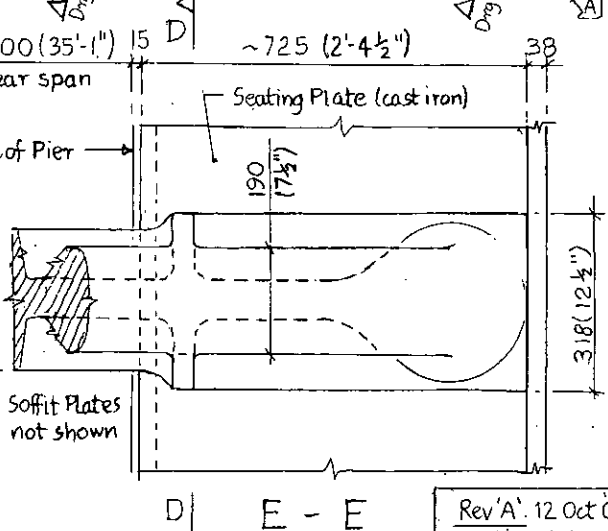
BISHOP'S BRIDGE ROAD CANAL BRIDGE
 MAIN SPAN, Trial Pit 1
 GIRDER ELEVATION & END DETAILS
 Meas'd & Drawn by M.T Tucker, August 2003
 for
 English Heritage. 1:10 on A3. DRG. No 3A

Roman Cement bedding.

Stock brickwork, in lime mortar with sharp sand & coal fragments.

- 3.2 The typical girders of the main span clear span 10.73 metres (35ft 2in) between the seating plates, and the lower flange rises approximately 590 millimetres (1ft 11in) in a shallow circular arc that subtends an angle of 25°. Beyond the springing line at each end, the flange turns horizontal and widens out to bear on the level surface of the seating plates.

The bulbed top of the girder rises in a steeper, compound curve (with decreasing radius near the ends), giving a distinctive banana-like side elevation. Brunel's notebook shows a mid-span depth of 2 feet 2 inches (660mm), or 1/16 of the clear span. With their shallow rise and level ends, these girders are conceived structurally as beams, not arches, although there may be incidental arching and stiffening action through the mass concrete deck.

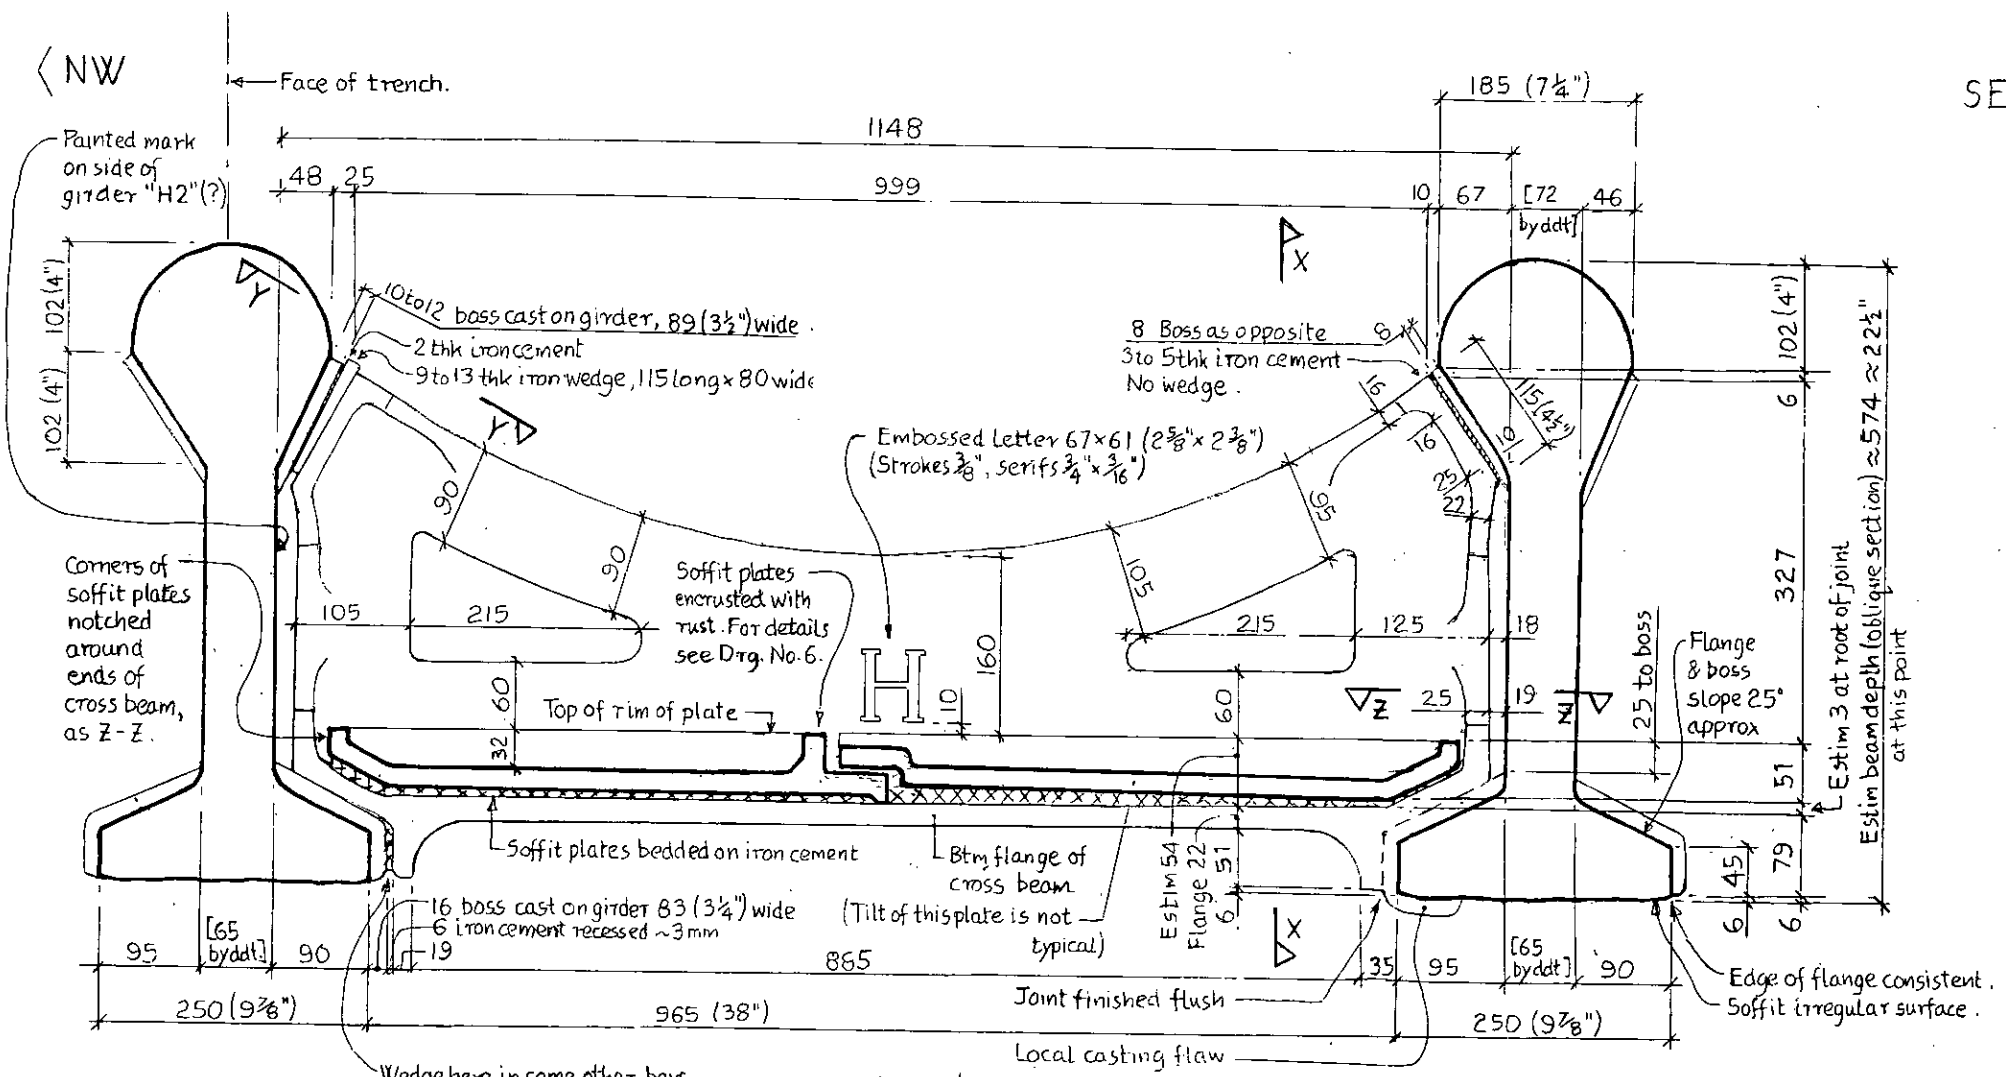
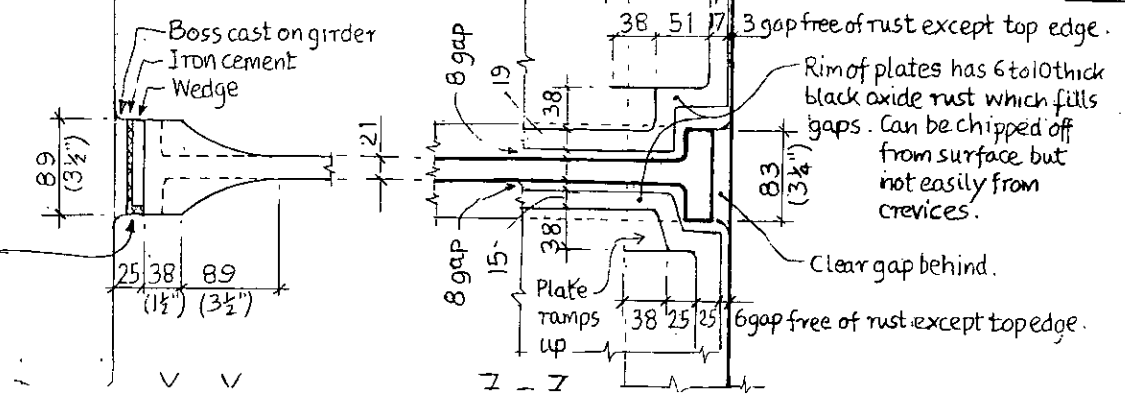
BISHOP'S BRIDGE ROAD CANAL BRIDGE
 MAIN SPAN, Trial Pit 1
 DETAILS of CROSS BEAM (Sht 1)
 Meas'd & Drawn by MTTucker, August 2003
 for
 Finnish Heritage 1:5 at A2 DRG NO 1 A

Wedge here in some other boys, where joint is wider.

Rev A, Oct '03 : Soffit plates adjusted

- 3.9 The crossbeams are flat plates with discontinuous flanges at each end, at the top and bottom corners. They are shaped to fit the profile of the sides of the girders. In the main span, but not in the smaller span, there are widened strips, or 'bosses', of matching width, cast on the sides of the girders to receive the crossbeam flanges. The mating surfaces were bedded to each other with iron cement (traditionally, an expansive paste made of iron filings and ammonium chloride), and the whole tightened with an iron wedge. In the example opened up in the main span, there was a wedge in one top corner, while some other crossbeams, visible from beneath, have a wedge in a bottom corner. (In the smaller span, only one end of the crossbeam was opened up, so the presence of a wedge is not verified but it is presumed.) The re-entrant wedge shape of the girder sides also helps to locate the crossbeams. The embossing of the bearing surfaces may have allowed dressing to shape, if necessary, while it will have provided clearance for driving the wedges with a hammer.

- 3.10 The crossbeam that was opened in the main span was embossed with a letter 'H', which may denote the eighth bay from the north-west face. It was slightly asymmetrical. The bulbs of the heavy girders of the main span have bulged slightly wider than the 7 inches (178mm) shown in Brunel's notebook and they are not centred at all accurately over the webs and flanges below, so that the slope of the tapered face of the bulb varies. This evident difficulty in producing a regular girder casting probably necessitated the tailoring of the crossbeams to the individual bays, following measurement in a trial assembly.

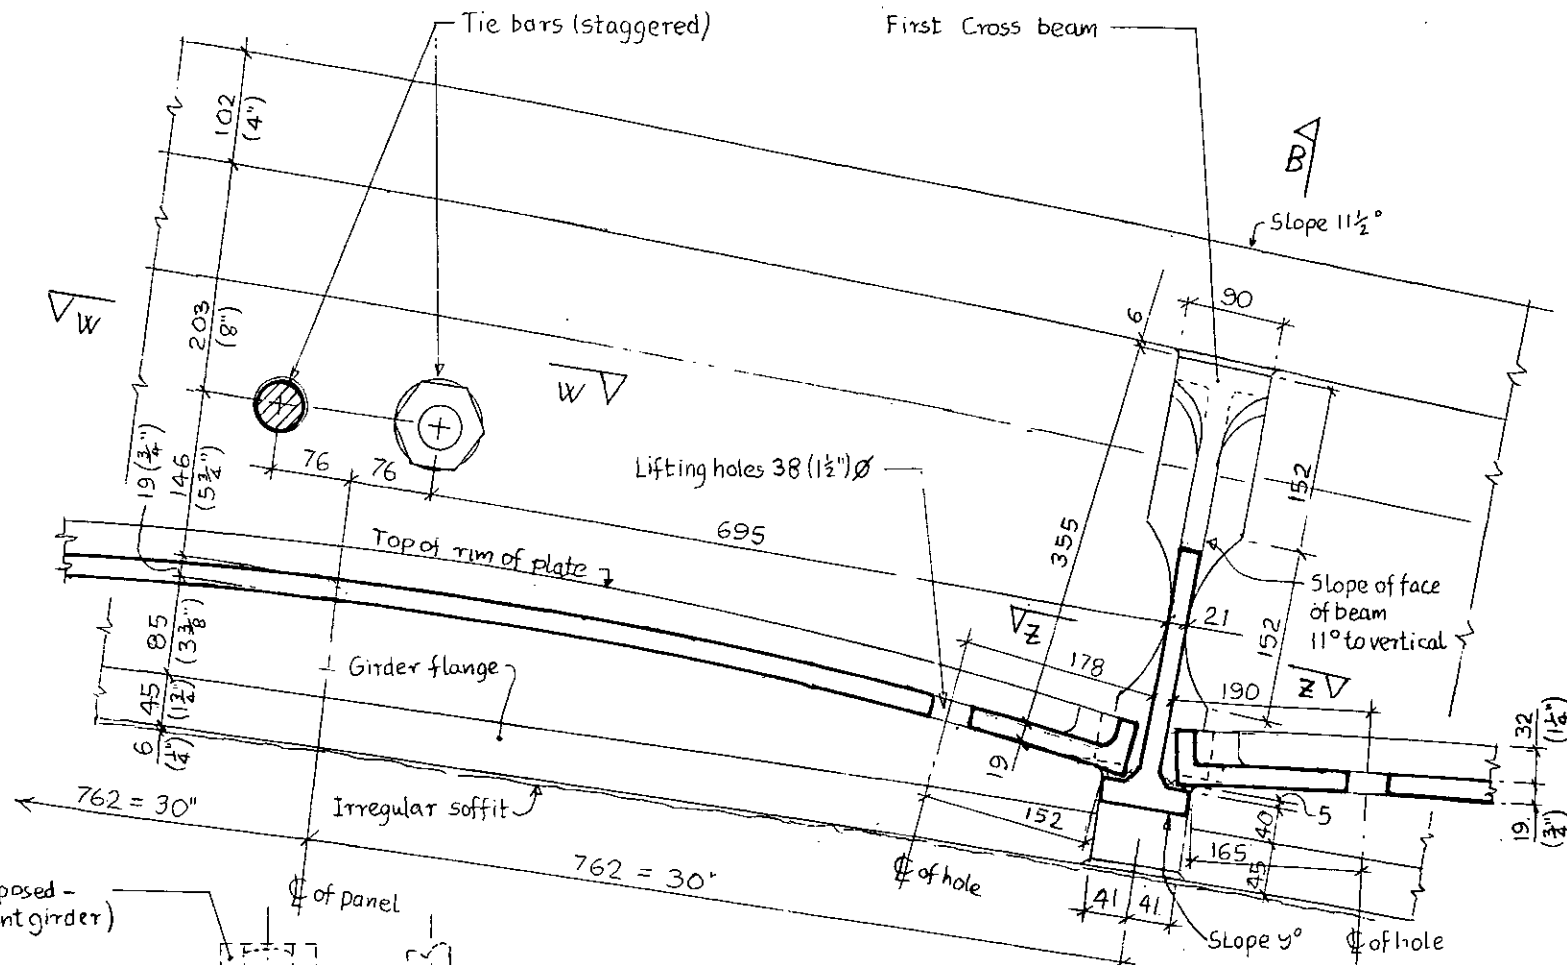
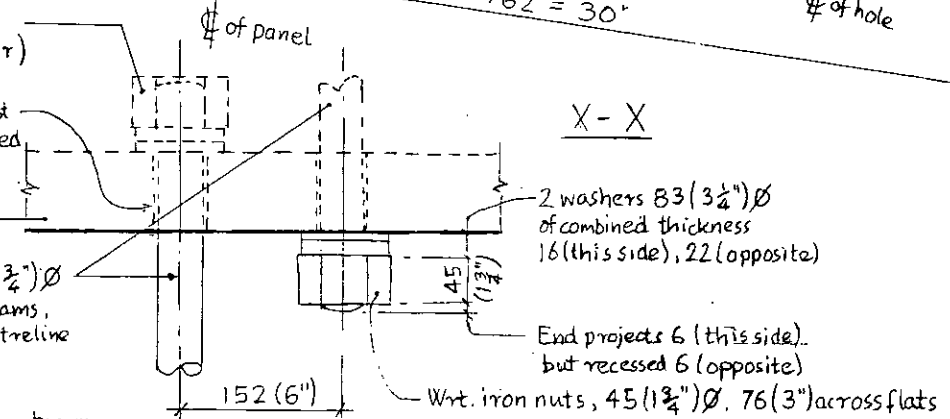
BISHOP'S BRIDGE ROAD CANAL BRIDGE
 MAIN SPAN, Trial Pit 1
 DETAILS, CROSS BEAM and TIE BARS
 Meas'd & Drawn by M.T. Tucker, August 2003
 for English Heritage 1:5 at A3 DRG NO 5

Hole 51 (2") ϕ , clear of rust when external rust removed.

Wrought iron tie bars 45 (1 3/4") ϕ between single pairs of beams, staggered either side of centreline of panel.

Wrt. ironwork encrusted with rust > 5mm thick, plus embedded aggregate. Cleans up readily with chisel.

- 4.2 The 1¼ inch (45mm) wrought-iron tie bars in the first trial pit had a significant build-up of about 5 to 10mm of rust, including embedded aggregate, but when this was removed, the holes through the webs were seen to be crisp and clean. The large nuts were easily cleaned up with a chisel and the ends of the bars within the nuts could then be seen sharply as if they might readily unscrew.

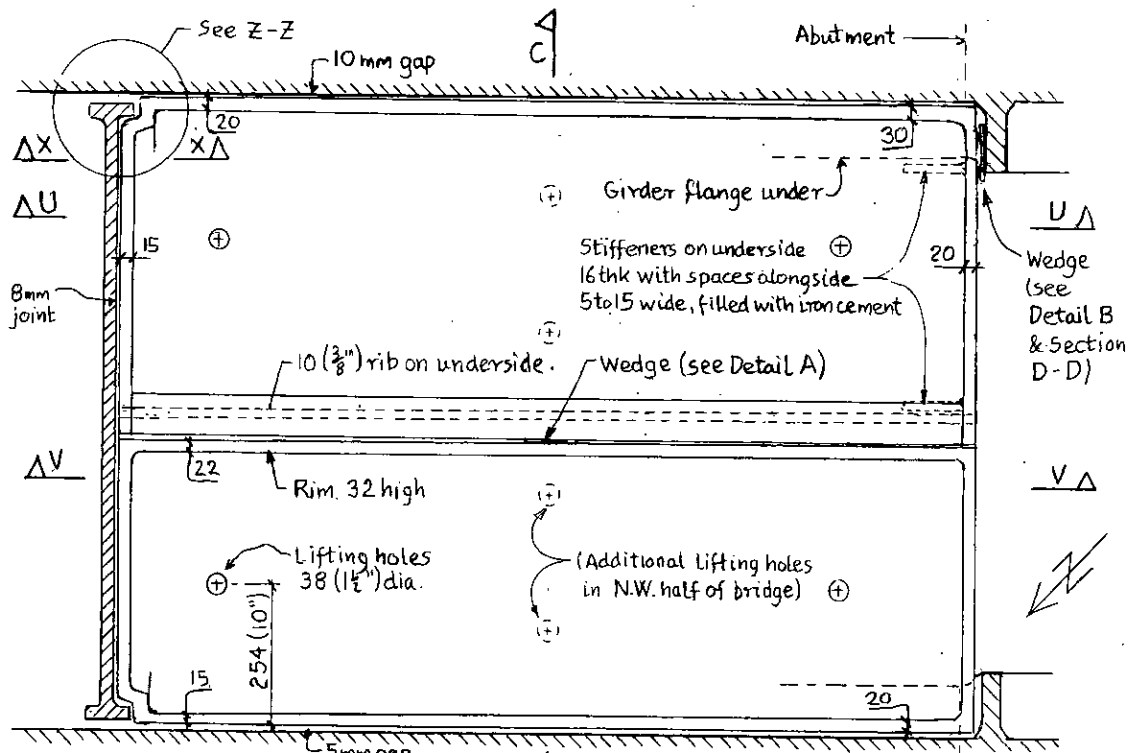
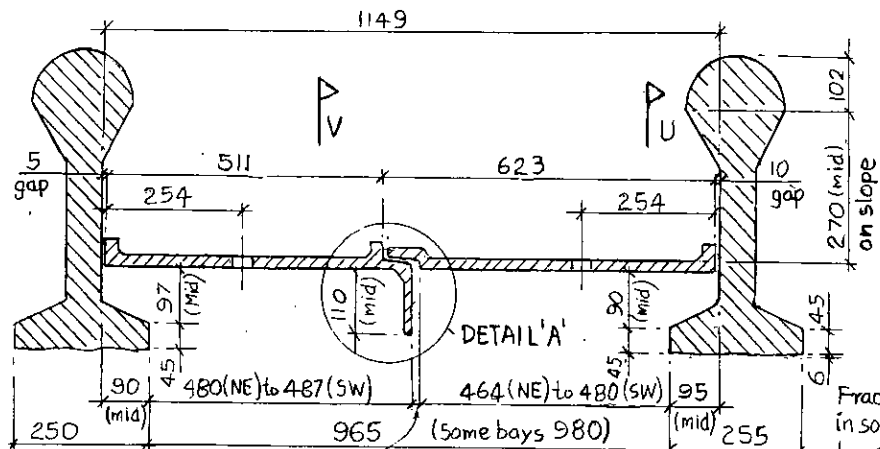
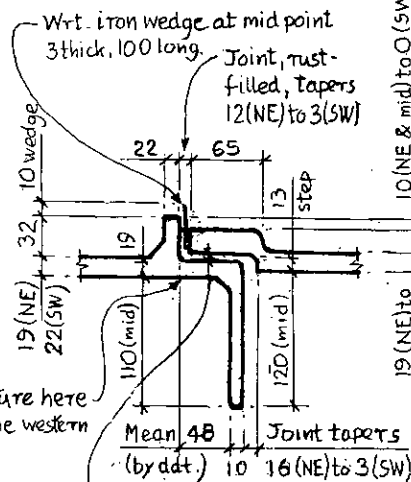
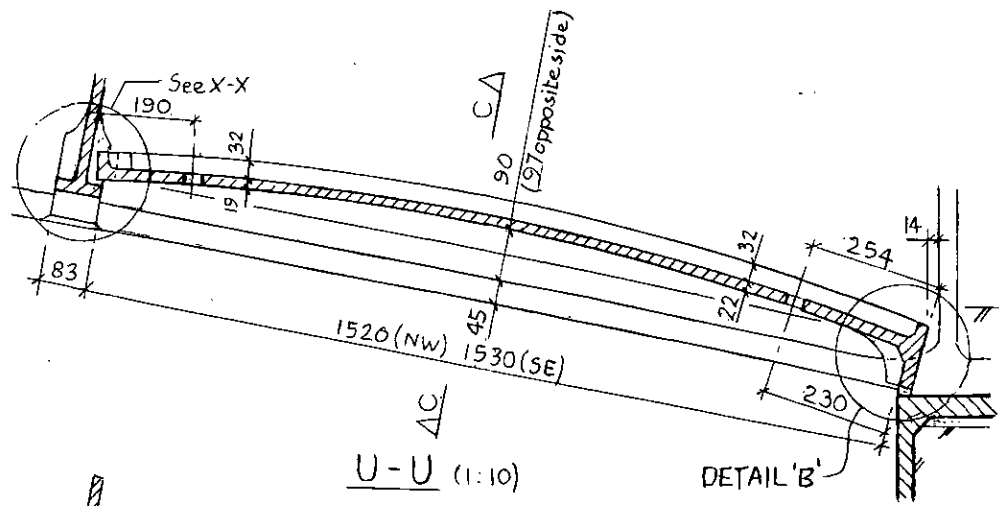
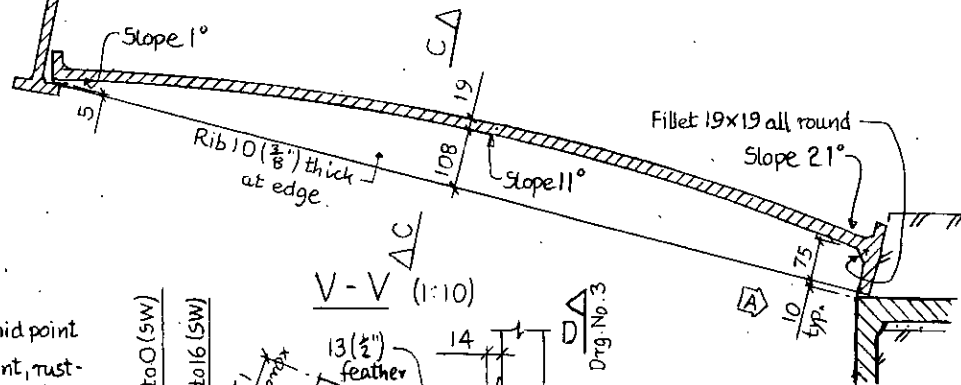
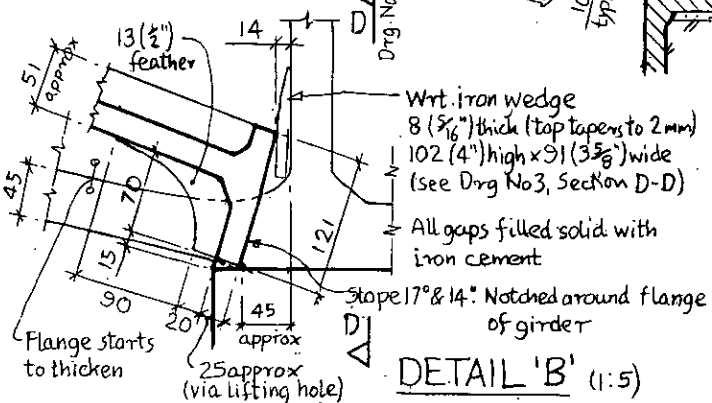
BISHOP'S BRIDGE ROAD CANAL BRIDGE
MAIN SPAN, Trial Pit 1
SOFFIT PLATE DETAILS (First Panel)

DEVELOPED VIEW ON TOP OF SOFFIT PLATES (1:10)

C - C (1:10)
"mid" = at mid-length of plate

Note: Dimensions recorded for the SW panel of Trial Pit 1. Other bays may vary slightly.

DETAIL 'A' (1:5)

Fracture here in some western bays.

- 4.5 In some soffit plates in the main span in the north-western half of the bridge, there is a longitudinal crack adjacent to the downstand rib, which has propagated from one end of the plate towards the centre, or beyond. This should not impair the arching action of the plate but it may reflect some incompatibility of stiffness or support between different parts of the plate, or a hidden thinning of the plate at the longitudinal lap joint. A few of these soffit plates also have exposed areas of blow holes.

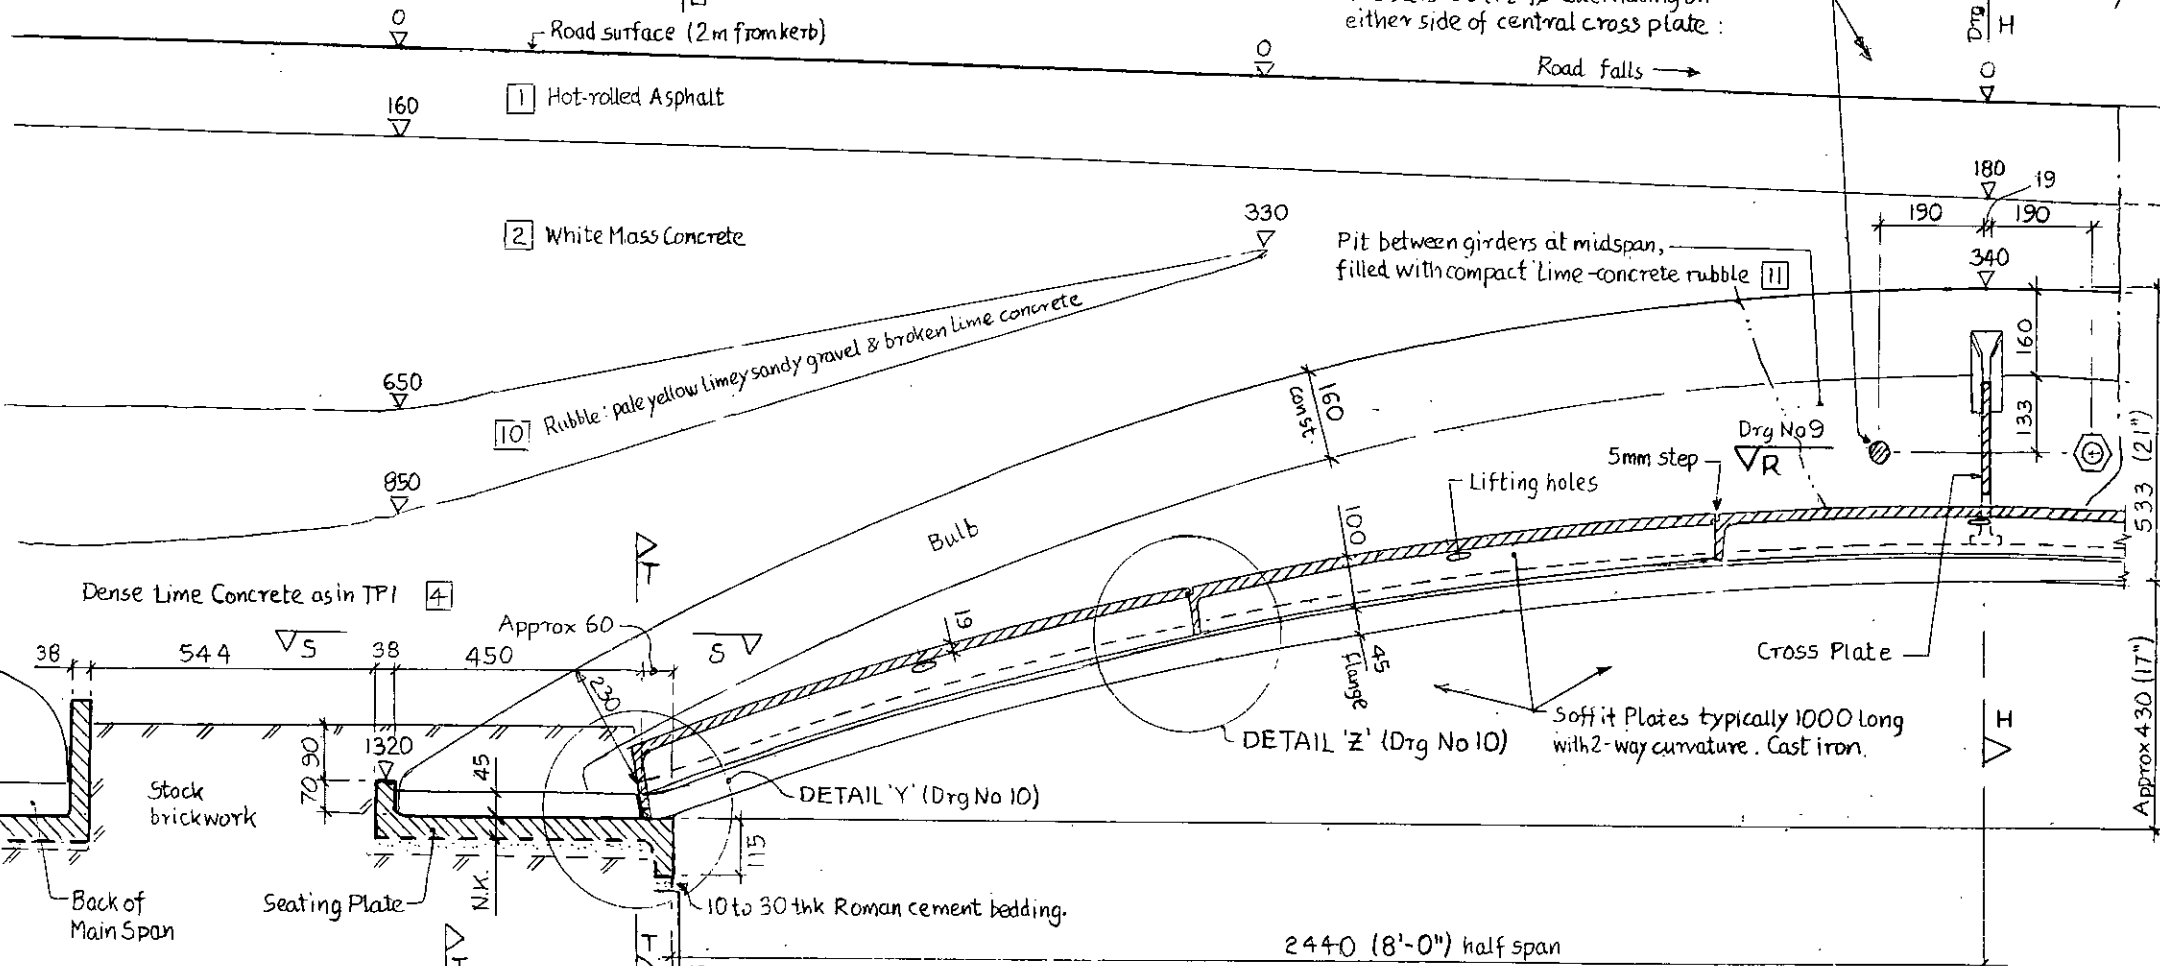
BISHOP'S BRIDGE ROAD CANAL BRIDGE
 SIDE SPAN, Trial Pit 2
 GIRDER ELEVATION & END DETAILS
 Meas'd & Drawn by M.T. Tucker, August 2003.
 for
 English Heritage. 1:10 at A3 DRG. NO 8A

G-G : GIRDER HALF-ELEVATION (1:10)

- 3.3 The typical girders of the side span, clear-spanning 4.87 metres (16ft) between the seating plates, have a similar but less elongated side profile, with a more uniform top curvature. The rise of the lower flanges is approximately 430 millimetres (1ft 5in), subtending an arc of 40°, and the mid-span depth measures approximately 530 millimetres (1ft 9in), or 1/9 of the clear span.

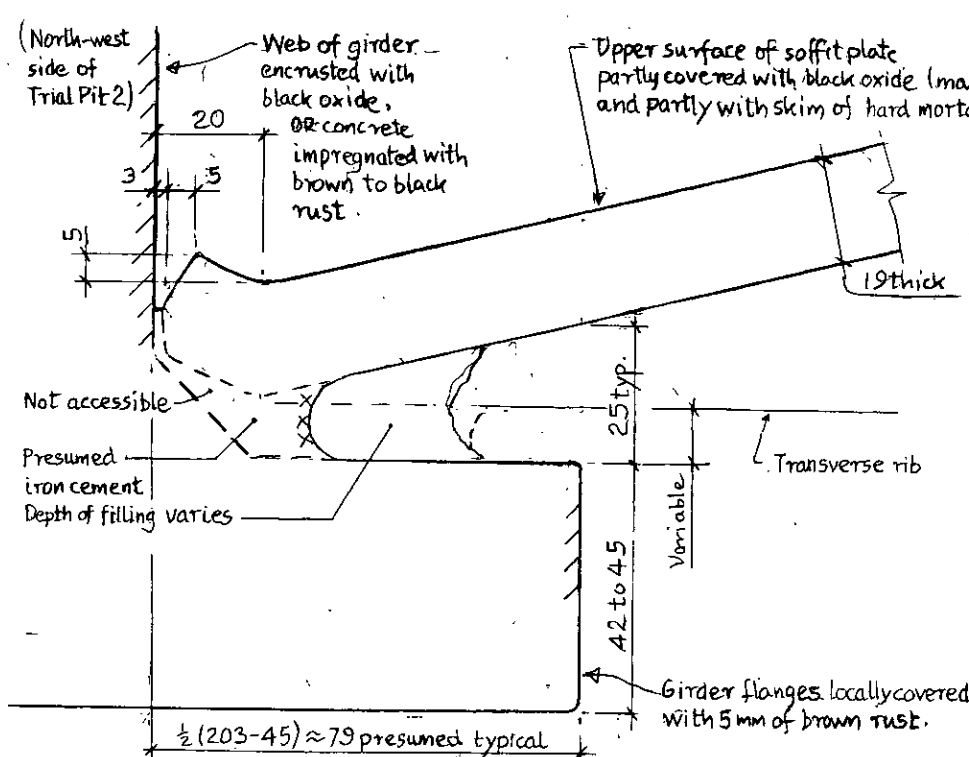
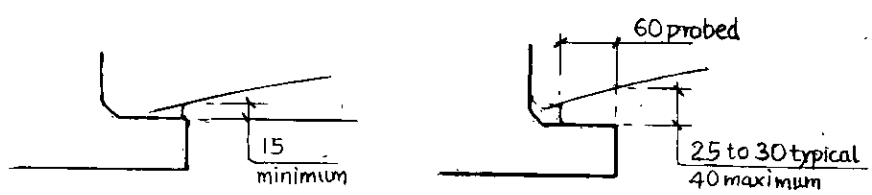
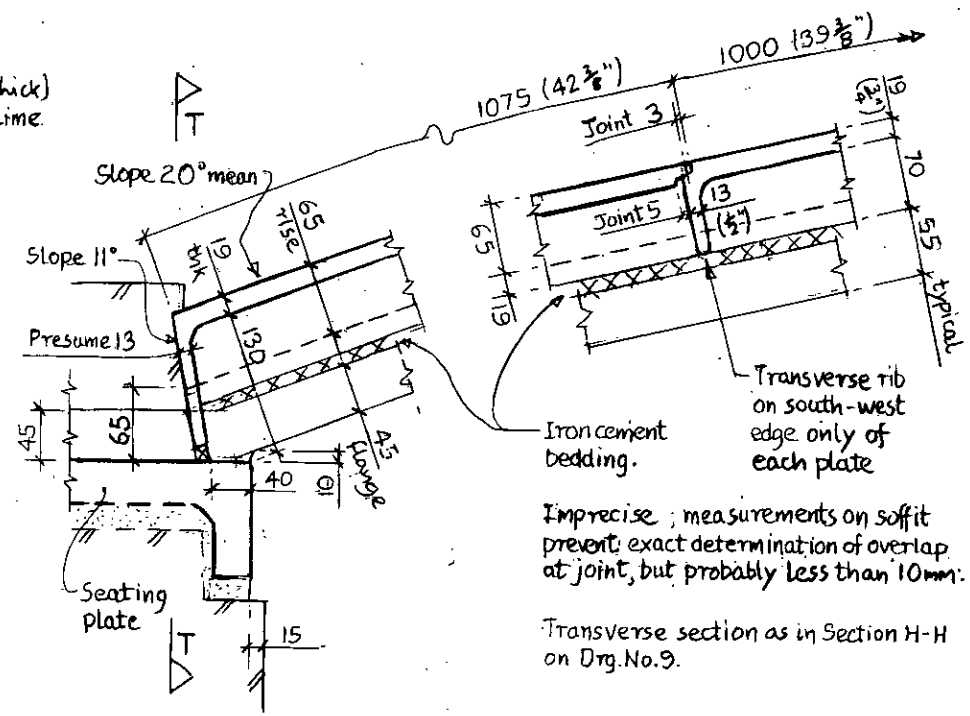
BISHOP'S BRIDGE ROAD CANAL BRIDGE
 SIDE SPAN, Trial Pit 2
 DETAILS OF SOFFIT PLATES
 Meas'd & Drawn by M.T. Tucker, August 2003
 for
 English Heritage, 1:5 & 1:1 at A3 DRG. NO 10^A

DETAIL 'X'
 JUNCTION OF SOFFIT PLATE & GIRDER (FULL SIZE)

VARIATIONS ON SOFFIT AT DETAIL 'X' (1:5)

DETAIL 'Y' (1:5)

DETAIL 'Z' (1:5)

- 3.14 The five soffit plates in the smaller span are supported in the other direction, on the lower flanges of the main girders without the use of crossbeams. They are therefore arched transversely, like jack-arches, while they also have a slight curvature longitudinally, following that of the girder, i.e. their curvature is two-way. There is a transverse joint every 3 feet 3 inches (0.99m), with a downstanding stiffening rib on one side, and the top surface is flush. The lap at this joint is only nominal, filled with iron cement or natural rust. These plates are again $\frac{3}{4}$ inch (19mm) thick, with two lifting holes. Where they meet the girder flange, the edge turns up slightly to avoid the fillet at the bottom of the girder web. There appears to be filling of iron cement beneath, particularly at the corners of the plates. The example that was opened up from above had about 3mm of lateral separation between the plate edge and the face of the web, filled with iron cement or rust that was soft to the chisel. Inspection of the underside showed variations in the lateral positioning of the plates, and the lateral separation is likely to be wider, but not smaller, in some other bays.

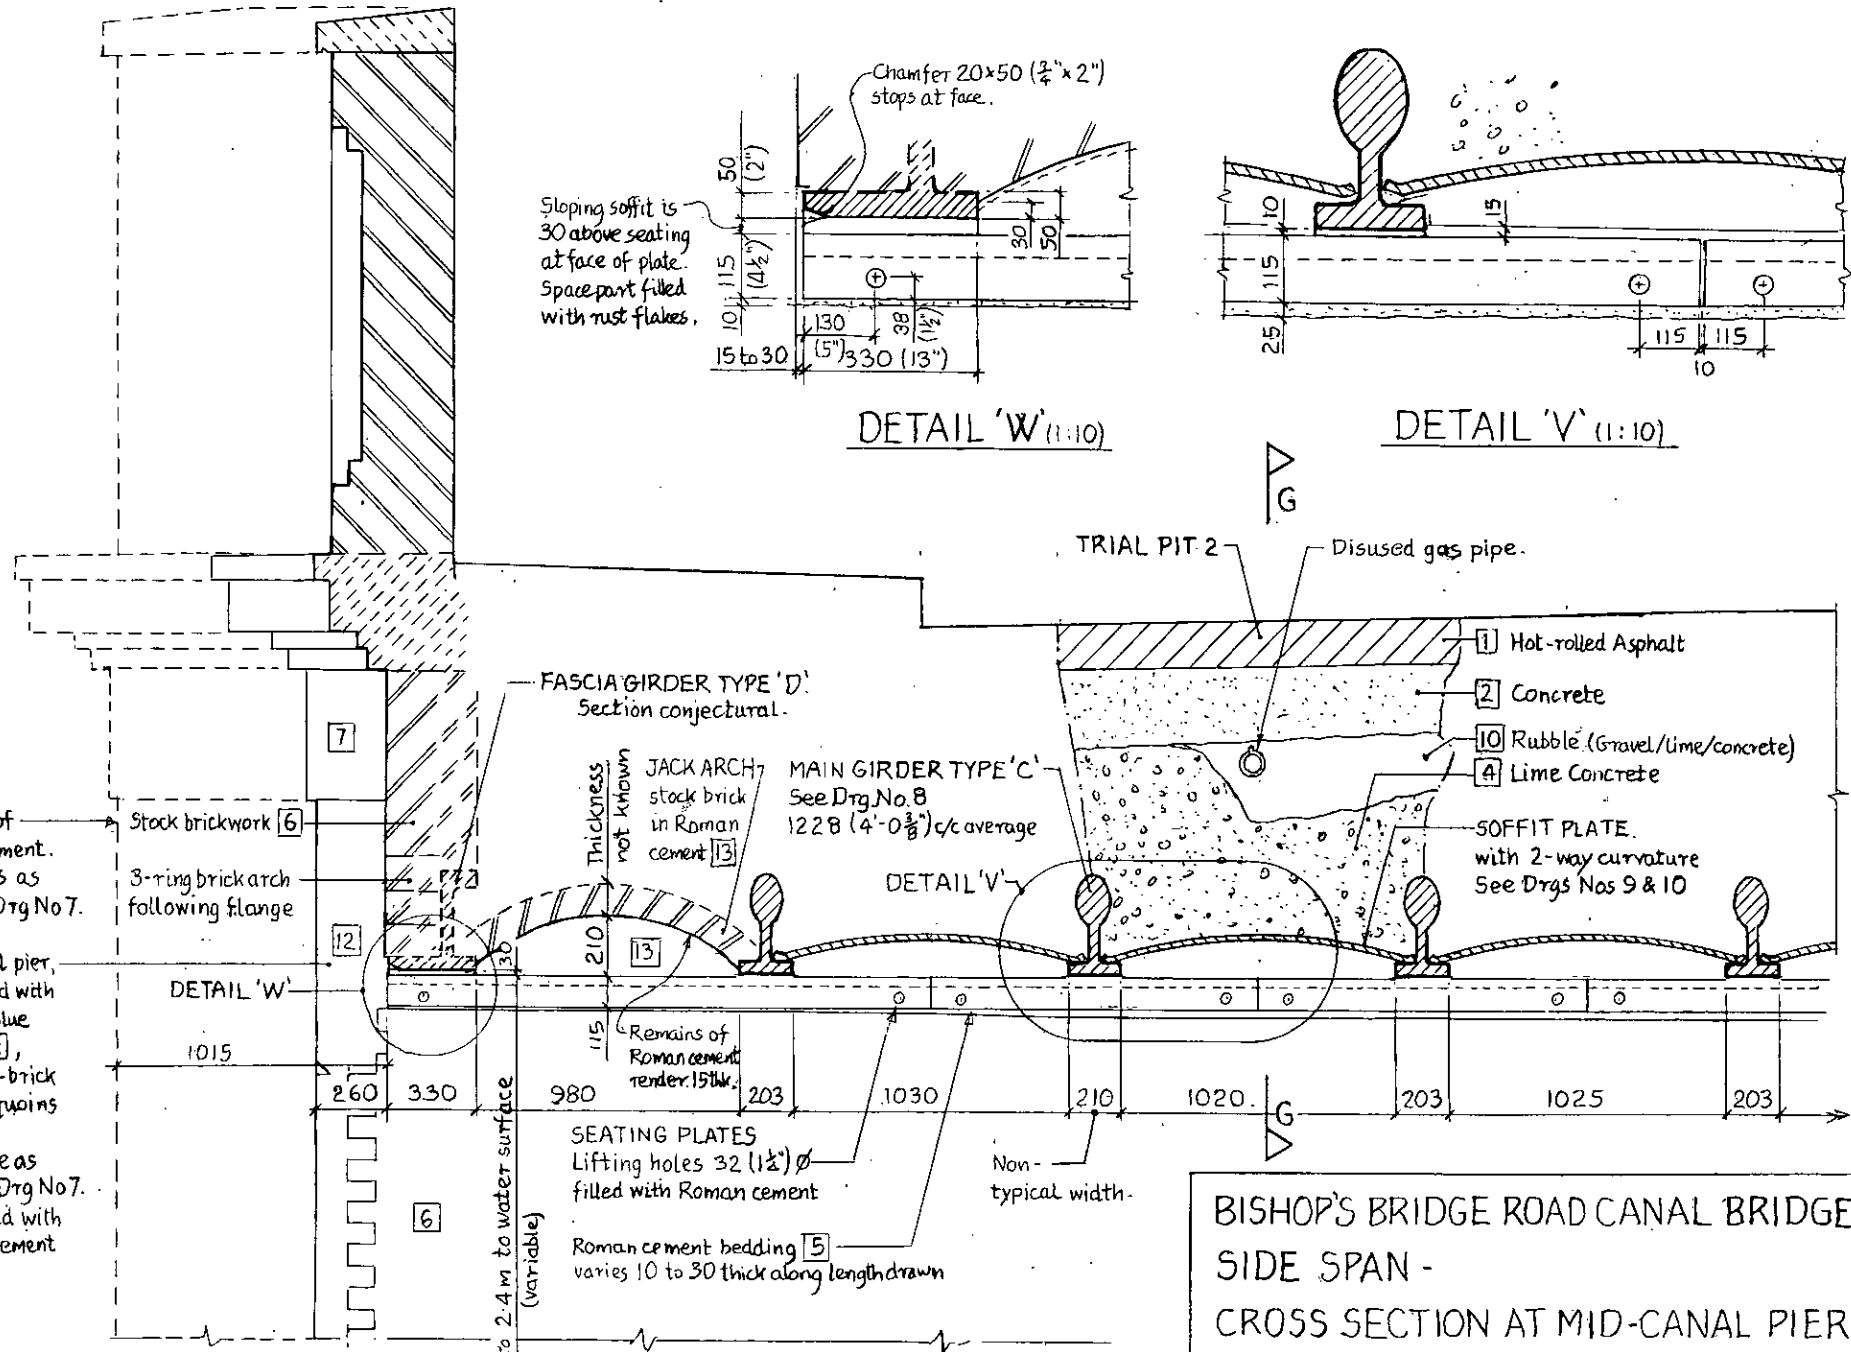
BISHOP'S BRIDGE ROAD CANAL BRIDGE
 SIDE SPAN -
 CROSS SECTION AT MID-CANAL PIER
 Measd & Drawn by MTTucker, October 2003
 for
 English Heritage. 1:20at A3. DRG. No 11.

J - J (1:20)

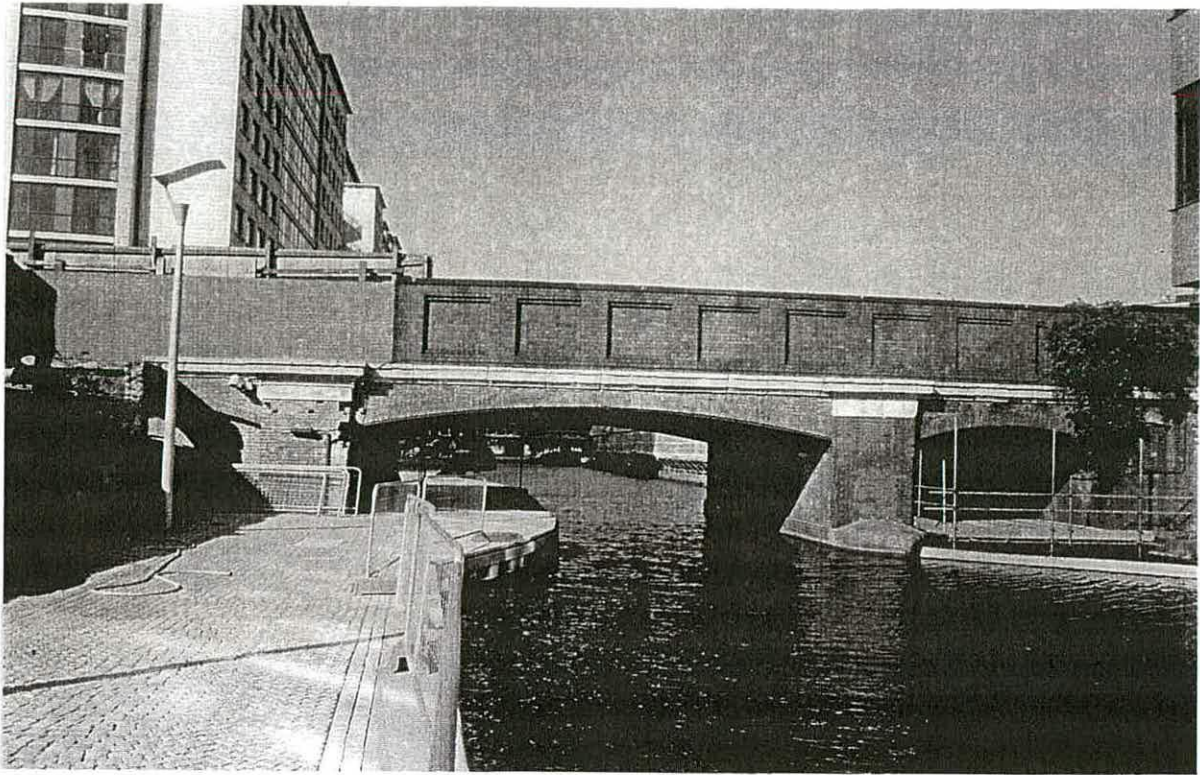
General view from SE

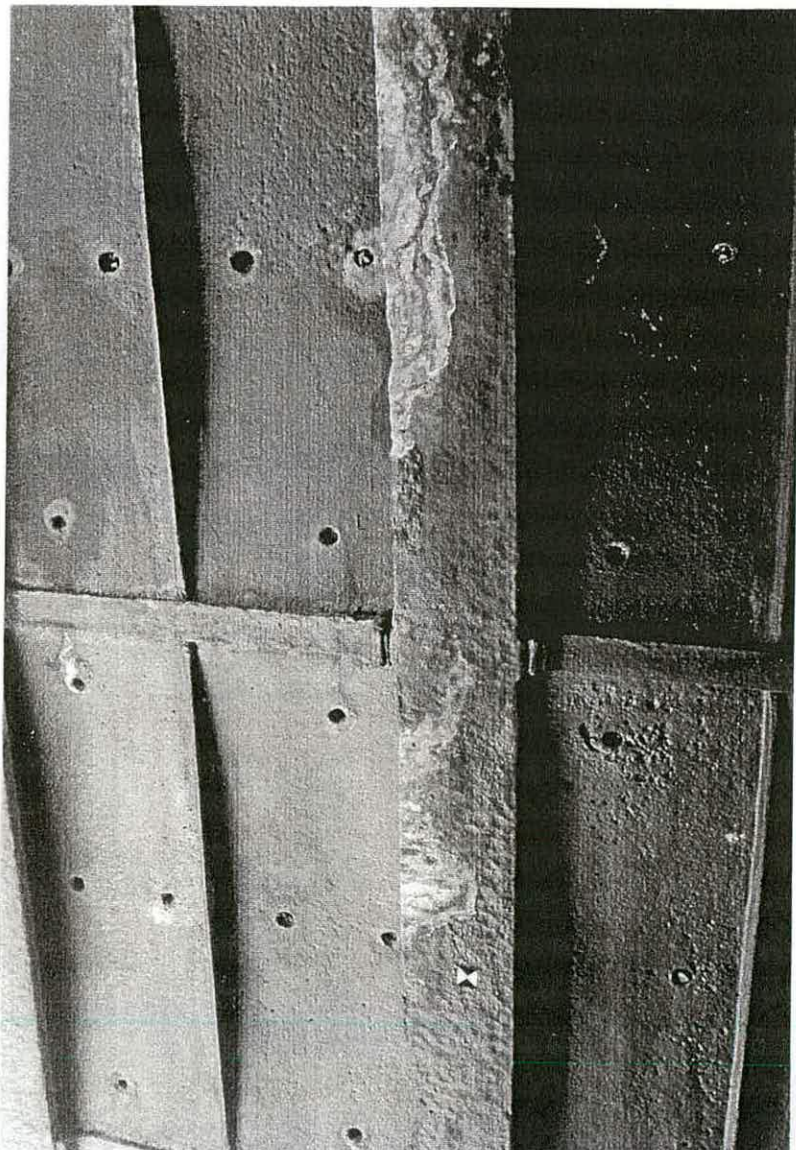
Close view of
Main span soffit NW side

- 4.4 The soffits of the main-span girders show an irregular, pitted and scalloped surface which is not seen on other ironwork. There are chips and other flaws in at least one flange edge. Both effects may be associated with the casting process, since the soffit plates are not affected. Various triangular notches in the flange edges may have been caused by impact damage, yet they are distant from the edge girders and at points where the headroom is highest. The bottom of one crossbeam appears to have been replaced, however, and another has split.

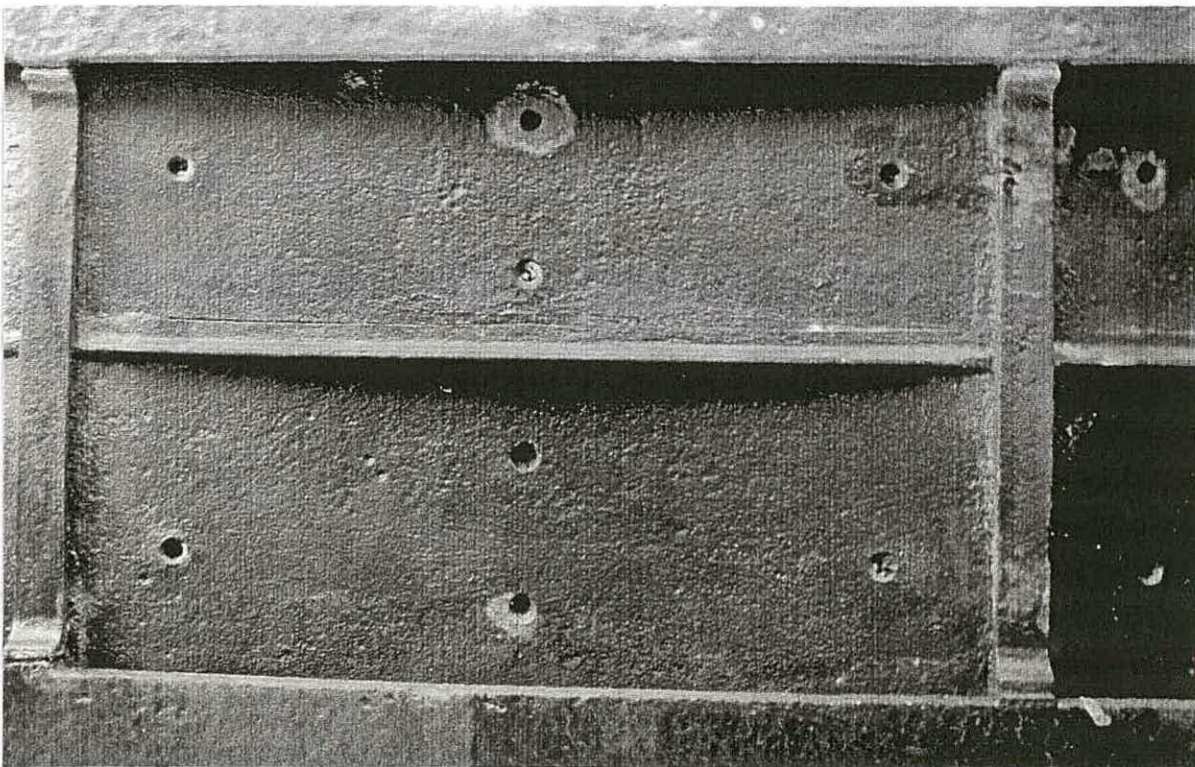
Main span, soffit plates in NW half from below
