CANAL BRIDGE

BISHOP'S BRIDGE ROAD

Preliminary Archaeological Report

English Heritage
Historic Buildings and Areas Research Department, London Team
Reports and Papers B/019/2003
October 2003

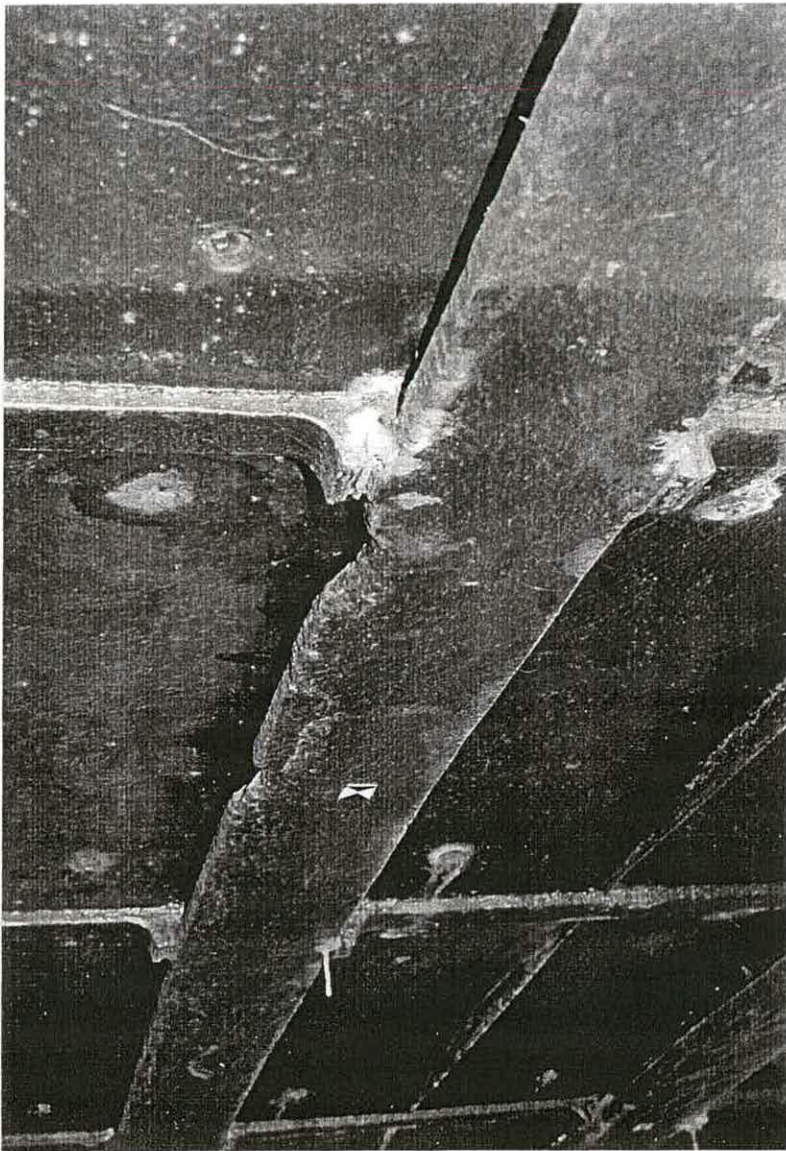
Main span girder with defects
in one flange.

- 4.4 The soffits of the main-span girders show an irregular, pitted and scalloped surface which is not seen on other ironwork. There are chips and other flaws in at least one flange edge. Both effects may be associated with the casting process, since the soffit plates are not affected. Various triangular notches in the flange edges may have been caused by impact damage, yet they are distant from the edge girders and at points where the headroom is highest. The bottom of one crossbeam appears to have been replaced, however, and another has split.

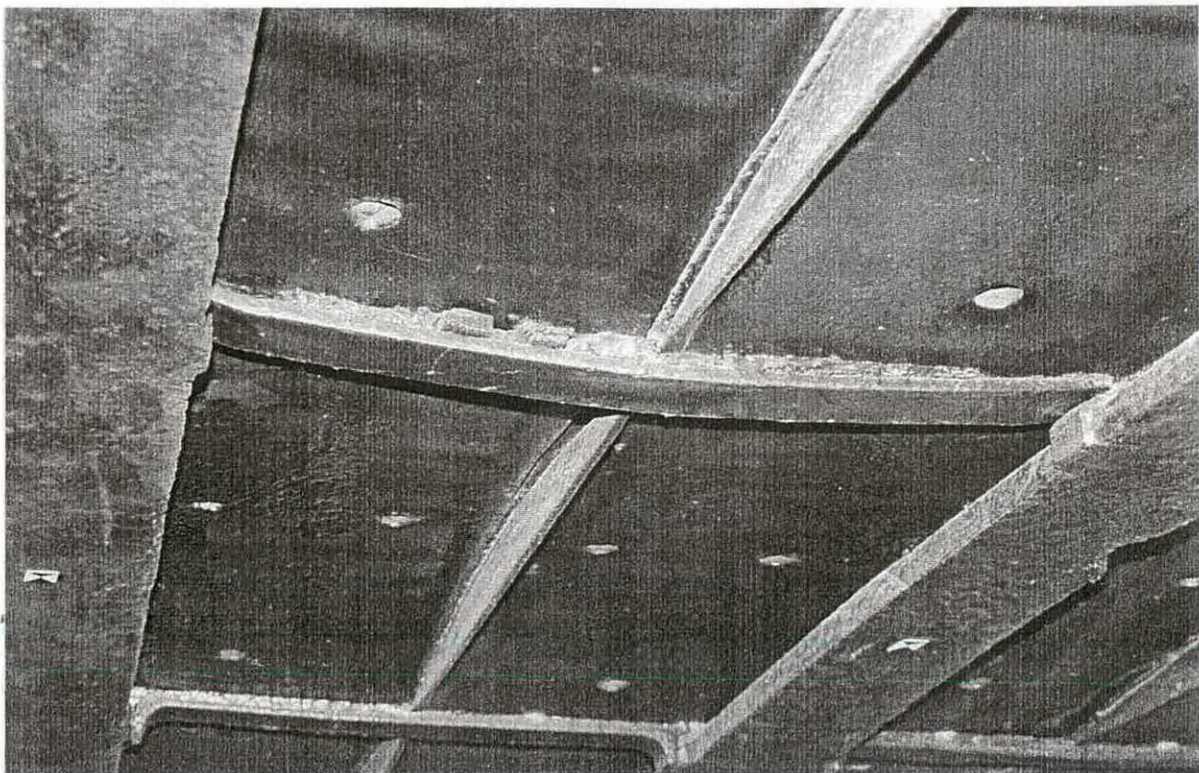
Main span, cross beam replaced

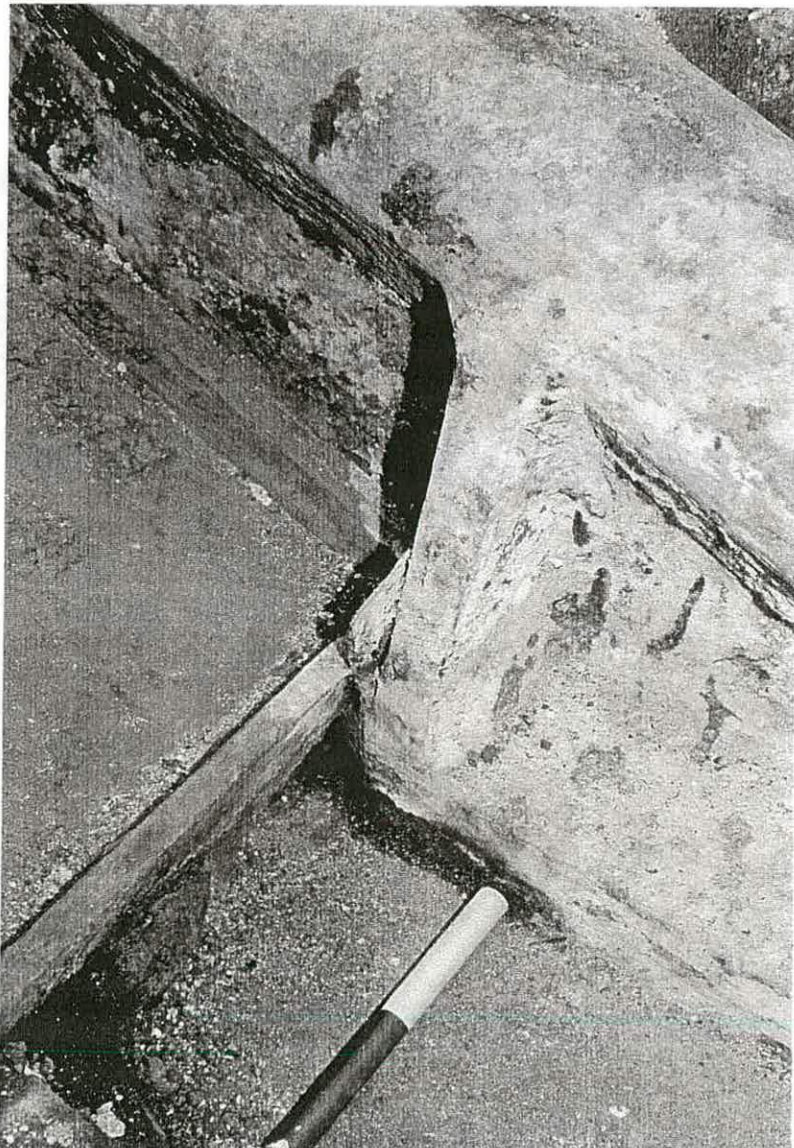
Main span girder,
stiffener and wedge

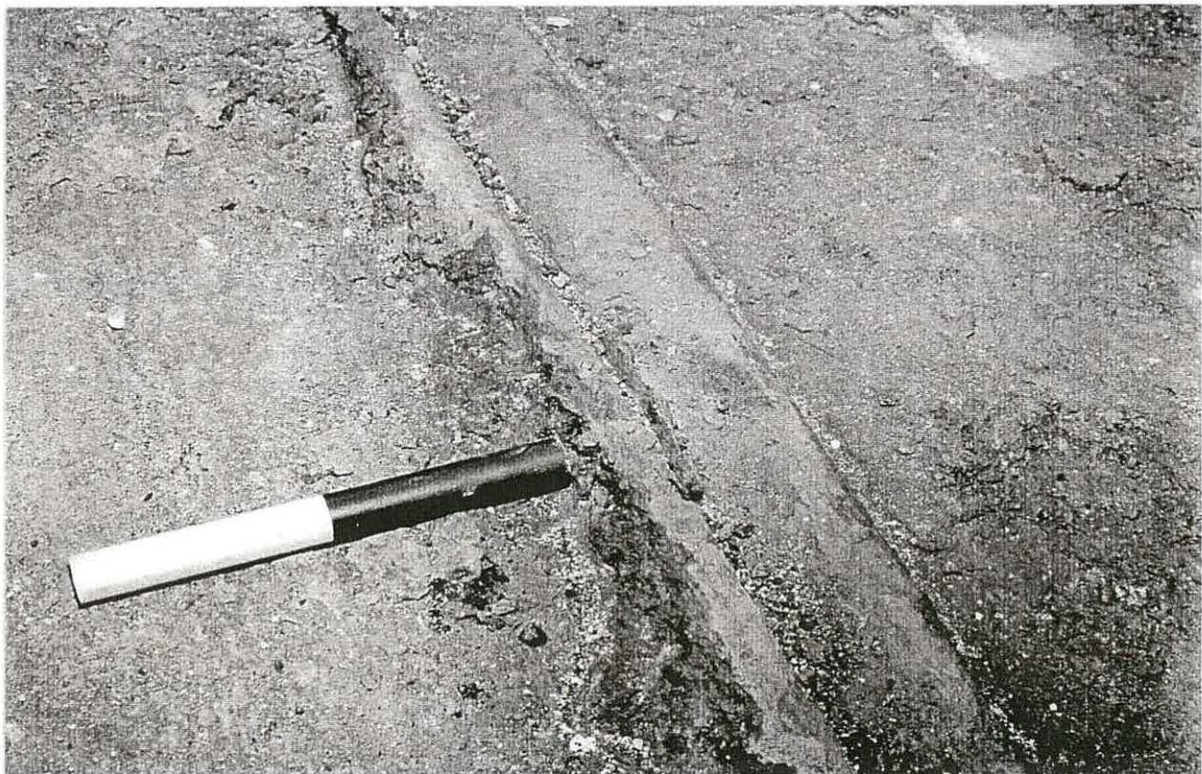
Main span, wedge in joint of soffit plates

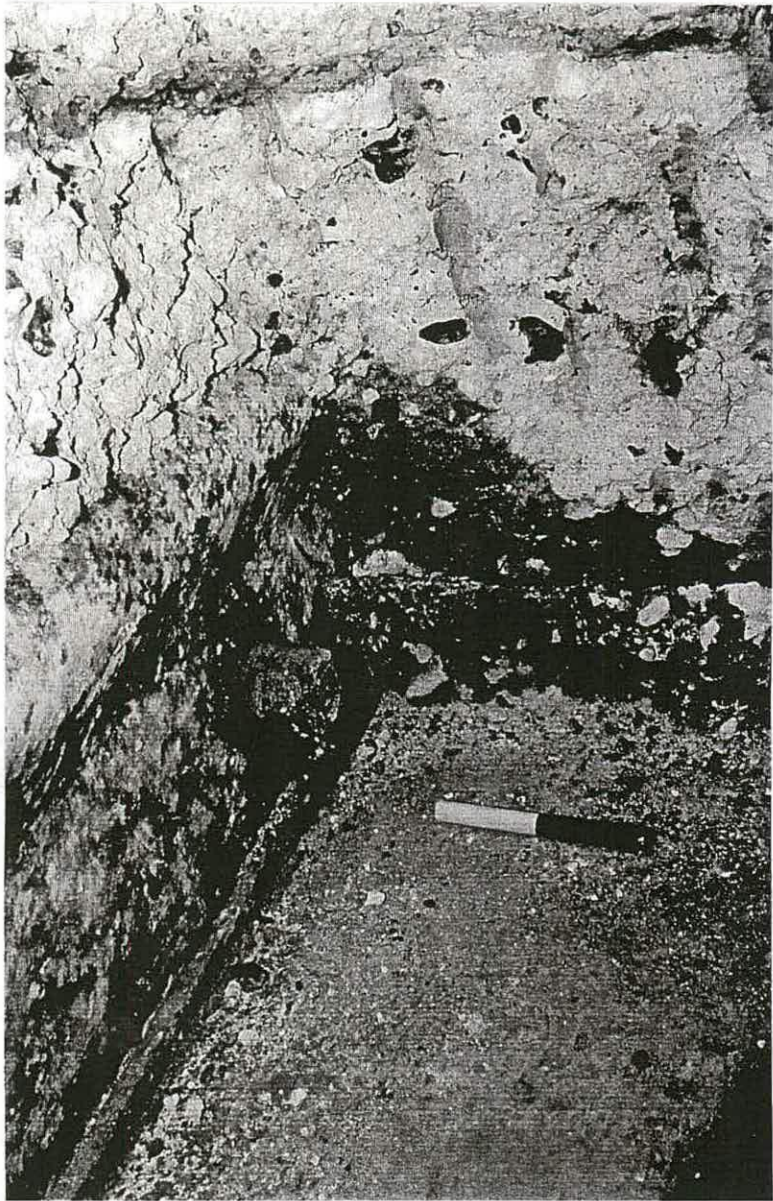
Main span tie bars NW side

- 4.2 The 1¼ inch (45mm) wrought-iron tie bars in the first trial pit had a significant build-up of about 5 to 10mm of rust, including embedded aggregate, but when this was removed, the holes through the webs were seen to be crisp and clean. The large nuts were easily cleaned up with a chisel and the ends of the bars within the nuts could then be seen sharply as if they might readily unscrew.

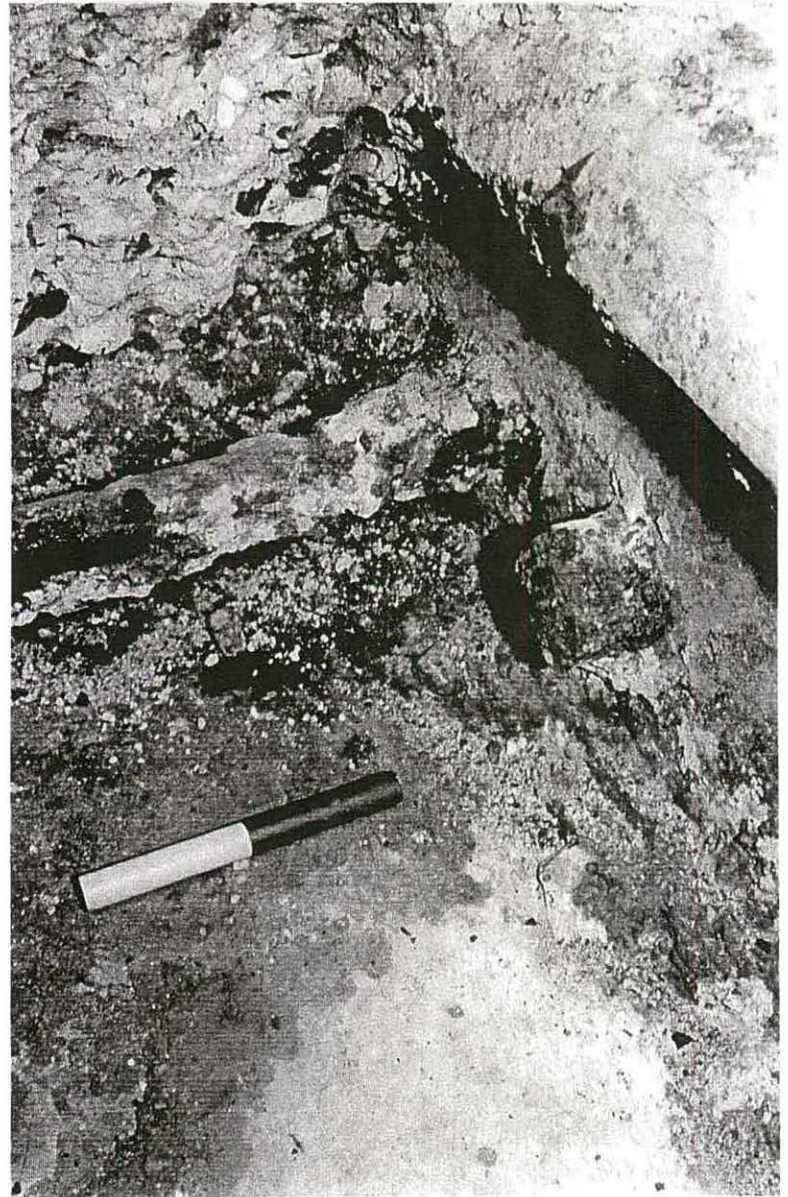
Main span tie bars SE side

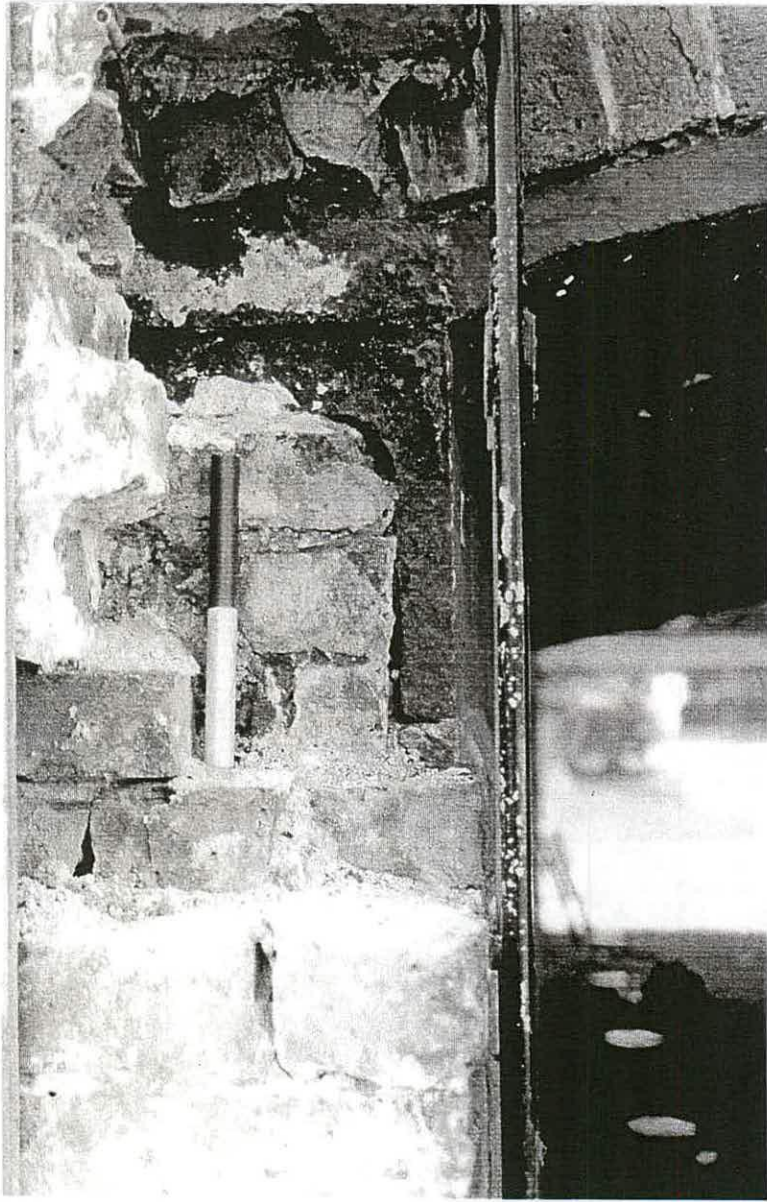
Main span, SW seating plate end opened up, from SE

- 3.7 The girders are probably bedded onto the seating plates with a coating of iron cement to take up irregularities in the castings. But this is difficult to discern because of the hardness of the filling. Although the springing points of the girders are raised typically 10 millimetres above the front edge of the seating plates, no gap is generally visible and no impression could be made on the suspected filling with a light hammer and chisel, except to raise a metallic lustre. This may suggest that there are iron plates used as packings, yet the surfaces are smooth and rounded, without signs of edges. It is possible that the iron cement used here has a graded aggregate with large iron particles. Further exploration with an abrasive disc may be appropriate.

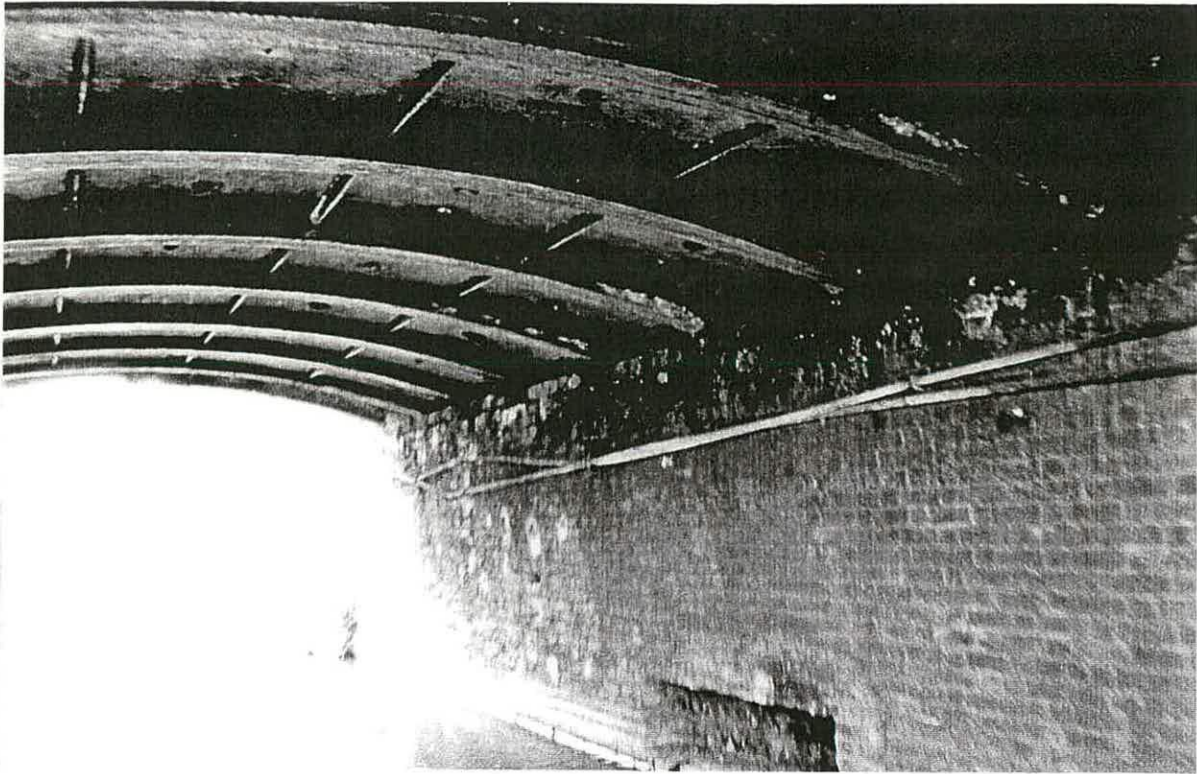
Side span underside from SSE

- 4.6 The shorter span appears from the underside to be in less good condition, particularly on the north-east side, with about 5 millimetre build-up of brown rust and lime scale on some edges of the girder flanges. The configuration of the soffit plates here channels any water within the deck sideways towards the girders. The corrosion has not caused significant loss of section. Considerable areas are also encrusted with lime that has percolated out of the bridge deck.

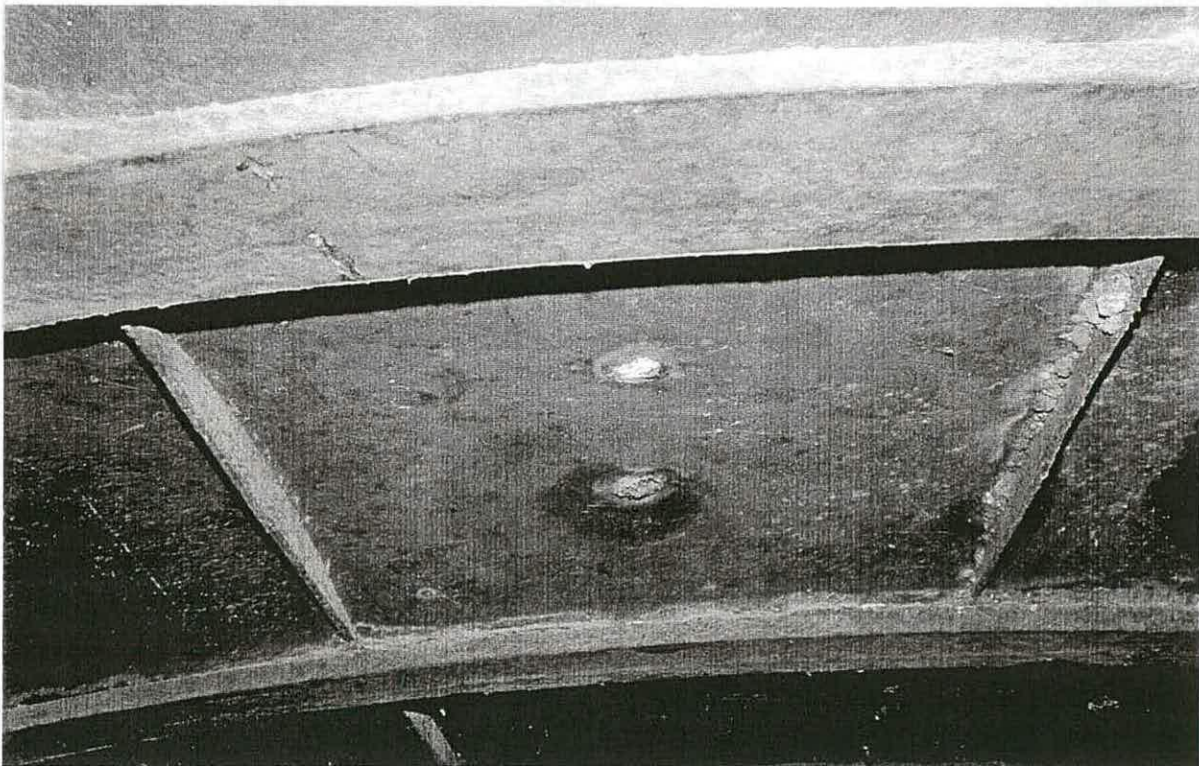
Side span, soffit plates from SE

- 4.7 On the upper side, in Trial Pit 2, the corrosion was evidenced by a 10mm or so build-up of black rust over much of the surface of the soffit plates, concealing the joints and largely blocking the lifting holes. The rust was able to be removed with careful chiselling. At the bottom corners, next to the springing line, a coating of Roman cement beneath a layer of mortar had protected the plate from rust but itself needed effort for its removal. The joints, about 3mm wide, were filled with rust or iron cement.

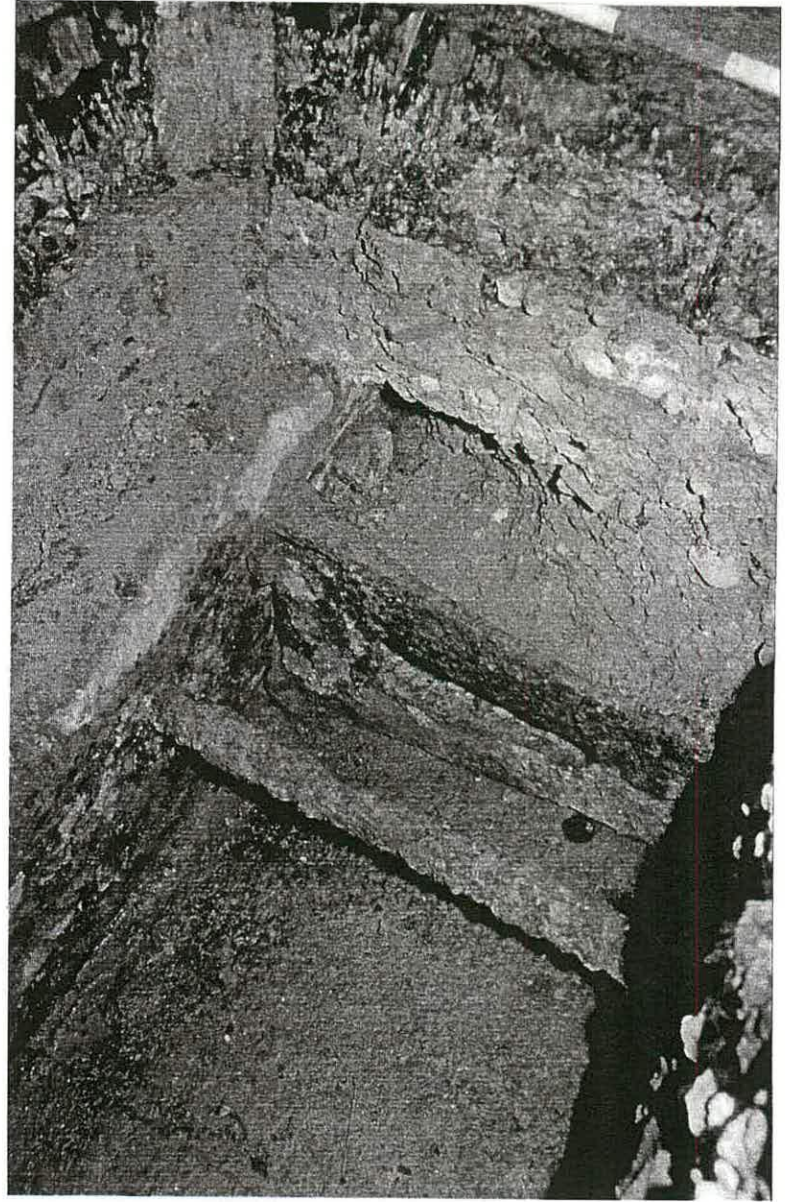
Side span, spacer plate tie bar and nut from S

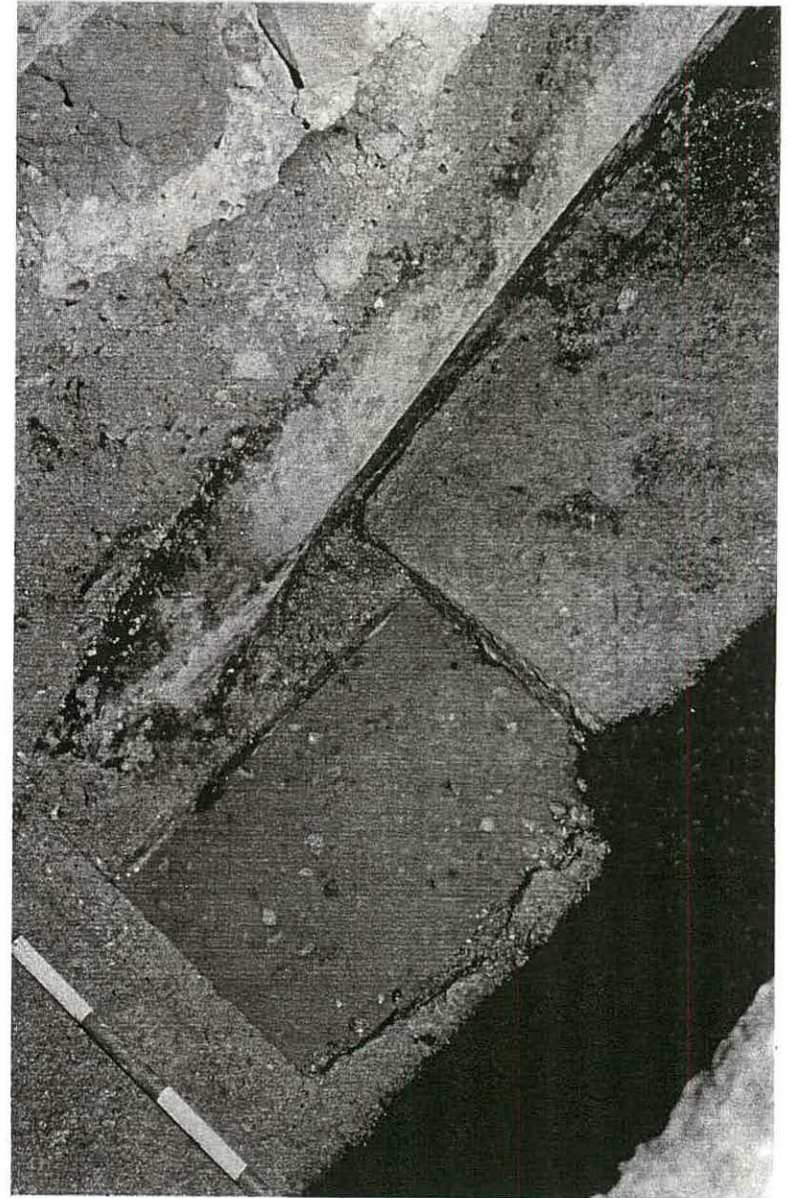
Side span, end of girder and corner of soffit plate from S
