COALHOUSE POINT:
Archaeological features in
the inter-tidal zone,
East Tilbury, Essex

SURVEY REPORT

ARCHAEOLOGICAL INVESTIGATION SERIES

7/2003

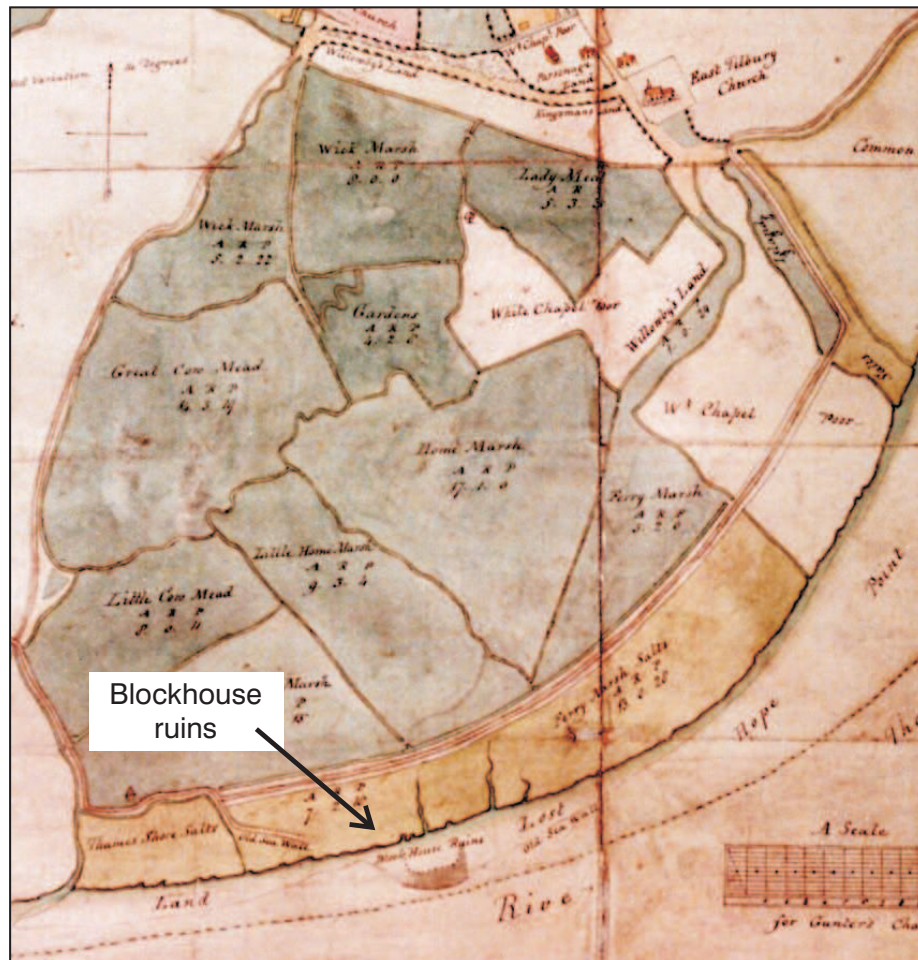
Figure 6
Coalhouse Point in 1735. Note the area marked 'blockhouse ruins' on the foreshore, and also note the loss of land behind and to the right of the ruins (labelled 'land lost') compared with the situation in 1594 (by permission of the Wardens and Assistants of Rochester Bridge in the County of Kent; ref: E11/1/37 (a copy is held at the Essex Record Office; ref: T/M 528/2))

In the 18th century, only the blockhouses at Gravesend and West Tilbury were still in use (Smith 2002, 7). An estate map of 1735 shows the site of the East Tilbury blockhouse, defined by an area of ruins and parts of the earlier river wall on the foreshore, as well as a new river wall slightly further inland. By this date land had been lost to the river and is labelled as ‘land lost’ (figure 6).

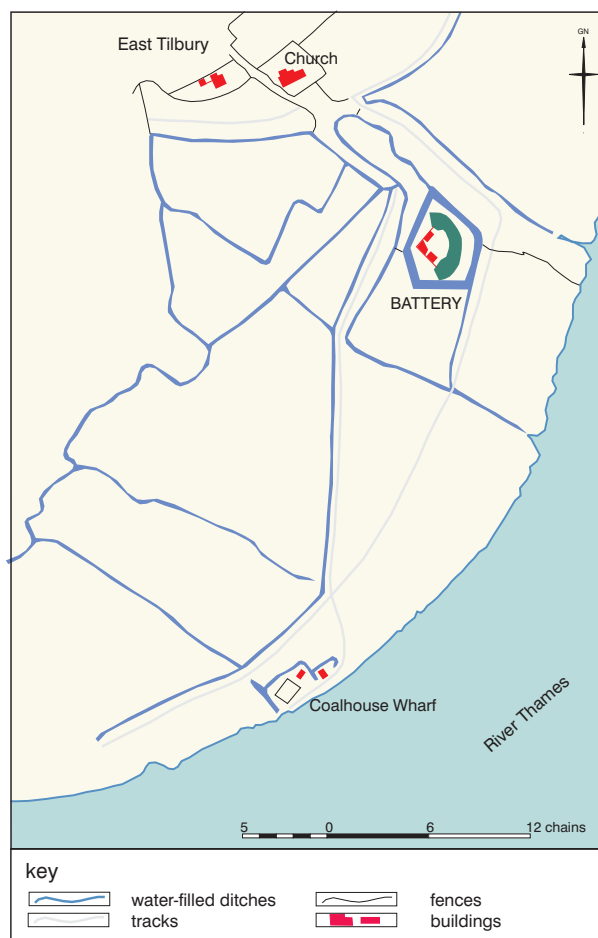
Figure 7
Coalhouse Point
in 1838, showing
the wharf at the
point and a new
battery built in
1799 on the site of
what would later
become
Coalhouse Fort.
Note no sign of
the blockhouse
(after ERO:
D/CT 359B)

There is some suggestion that both ferries had fallen out of regular use by about 1530 (Ormston 1998, 5). However, map evidence demonstrates that there was a ferry house on the Point in 1777 and possibly in 1731 (ERO: Chapman and André 1777, plate 22; T/M 528/3; T/M 528/6). It appears to have been succeeded by the development of a coal wharf, shown on maps from 1838, and 1838 (figure 7). In 1864 a Coastguard’s Lookout is shown next to the coal wharf (Ordnance Survey 1864).

south-westwards from the junction of the tramway and the river wall to the mudflats. It meanders only slightly and the south-western half is relatively straight. Versions of this creek are shown on maps from 1838 onwards (see figures 7 and 9), and it seems likely that it formed part of the perimeter of Coalhouse Wharf. A small **platform** at the western end of the creek measures 16.2m by 15.8m by 0.3m high. The ground surface is very rough and no internal features are visible, but it may have once supported a structure.

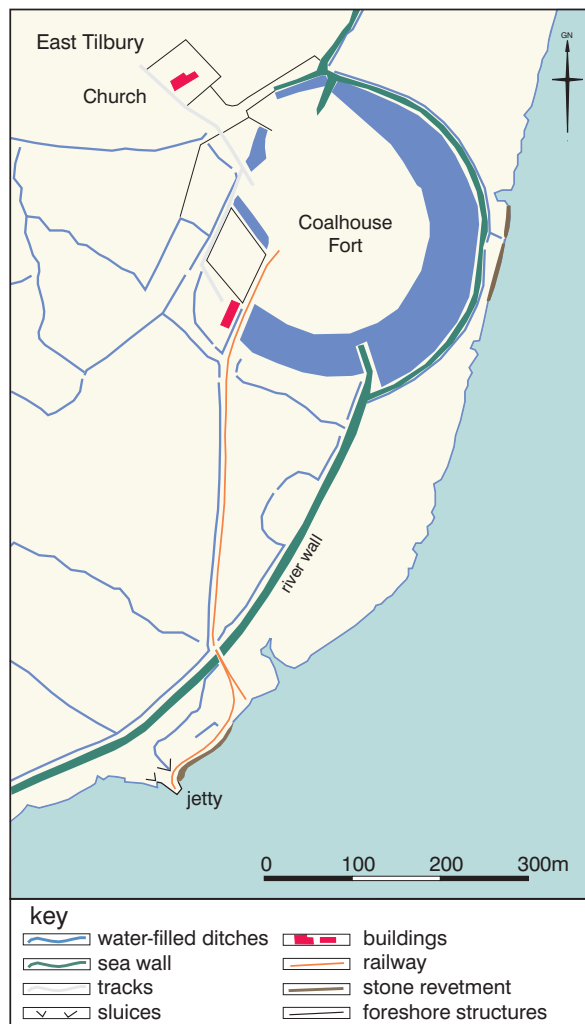
Figure 9
Coalhouse Point in
1897, showing the
jetty and two
sluices but no
buildings (after
Ordnance Survey
1897)

Work began in 1861-2 on the massive casemated Coalhouse Fort which survives today (figure 9). The coal wharf was used for the delivery of guns and stores to the fort via the short tramway established for the purpose in the 1860s (ERO: D/CT 359B). In 1897 the tramway extended right onto a jetty forming part of the coal wharf (Ordnance Survey 1897).

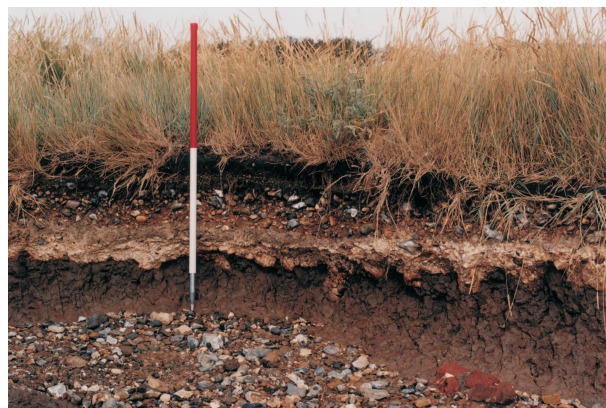
Figure 12
Section of the salt marsh at Coalhouse Point, clearly showing the redeposited layers of chalk, mud and coal (©Crown copyright NMR: AA/046710)

The extent of survey comprised a small strip of salt marsh and part of the mudflats immediately in front of the present river wall, covering an area of approximately 1.63 hectares (4.02 acres), defined also by the former tramway to the north-east and a jetty to the south-west. In general terms, the tidal action of the river is eroding the salt marsh, which is on average only

0.4m higher than the highest point on the mud flats. However, between the jetty and the radar tower, it is apparent that there is a considerable depth of made ground which is also being eroded. This comprises clear stratification in the form of layers of redeposited chalk and clay mixed with various inclusions including coal, earthenware pipes, bricks and other debris, probably the result of made up ground for the buildings on the coal wharf and, before it, the ferry (figure 12). Similar erosion is evident elsewhere along the salt marsh but without any evidence for made ground. Immediately west of the radar tower in late 2002, sherds of pottery were discovered within a scatter of domestic ceramic types dating from c1680 to the later 18th century. The pieces were reconstructed and formed a Georgian chamber pot bearing a royal cipher and crown upon an oval escutcheon (figure 13; for full details see Appendix two).

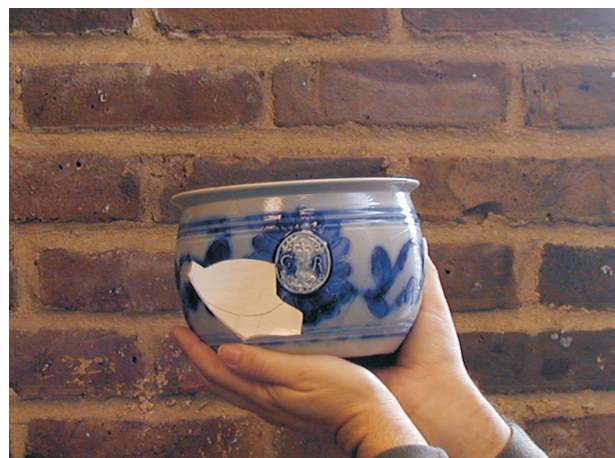
Figure 13
Georgian chamber pot recovered from the salt marsh at Coalhouse Point and reconstructed. Note the royal cipher and crown upon the oval escutcheon (Thurrock Museum, Acc No 3706)

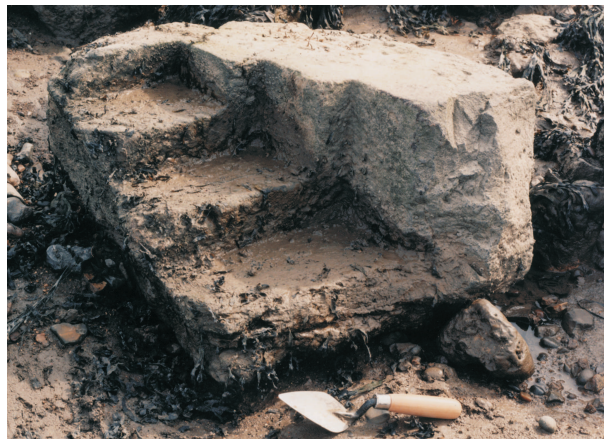
Figure 14
A fragment of worked stonework on the foreshore at Coalhouse Point
(©Crown copyright NMR: AA/046707)

The lengths of stone revetment are approximately *in situ* but the material that formed the main structure has been eroded out, causing the stonework to slump onto a bed of clay beneath. The most southerly section (1) corresponds with a length of stonework on the 1897 map (Ordnance Survey 1897). The stones are generally sub-angular, the largest approximately 0.85m by 0.65m by 0.40m deep. In the

absence of a detailed examination of the stones it was nevertheless clear that some had been shaped and may have been re-used (figure 14).

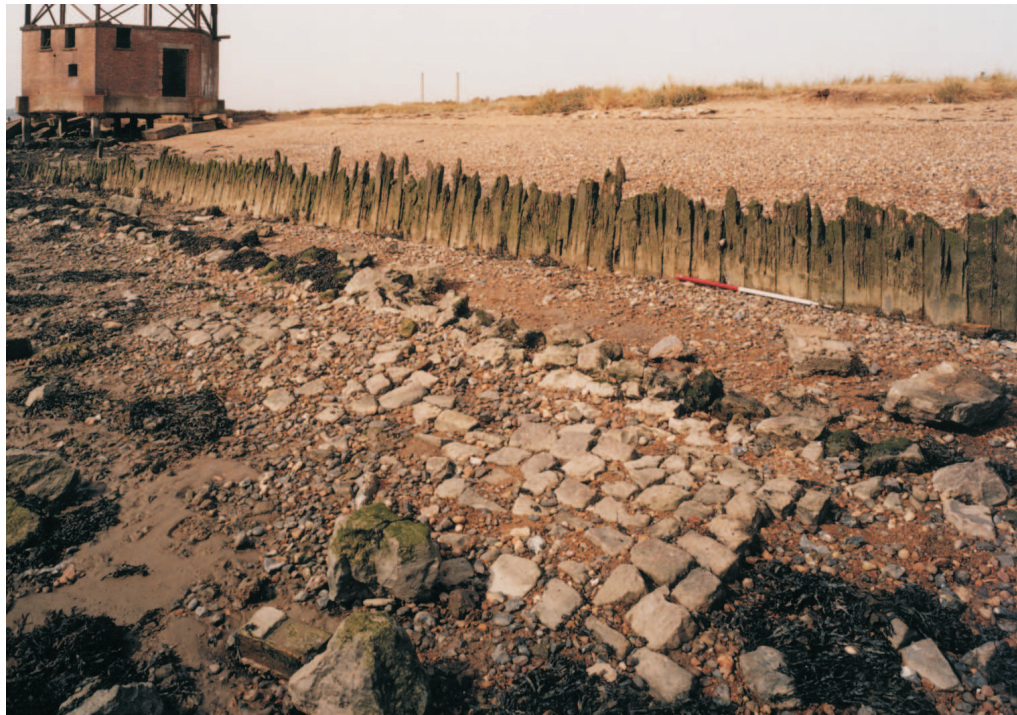
Figure 15
Revetment 2,
showing collapsed
wall in front
(©Crown copyright
NMR: AA/046704)

Revetment 2: two lines of upright timbers, forming a continuous revetment. The first comprises 127 uprights, each measuring 0.75m high by 0.26m by 0.11m, while the 20 uprights of the second each measure 1.10m high by 0.31m by 0.11m. The ground behind the larger group is 0.45m higher than the ground in front (figure 15).

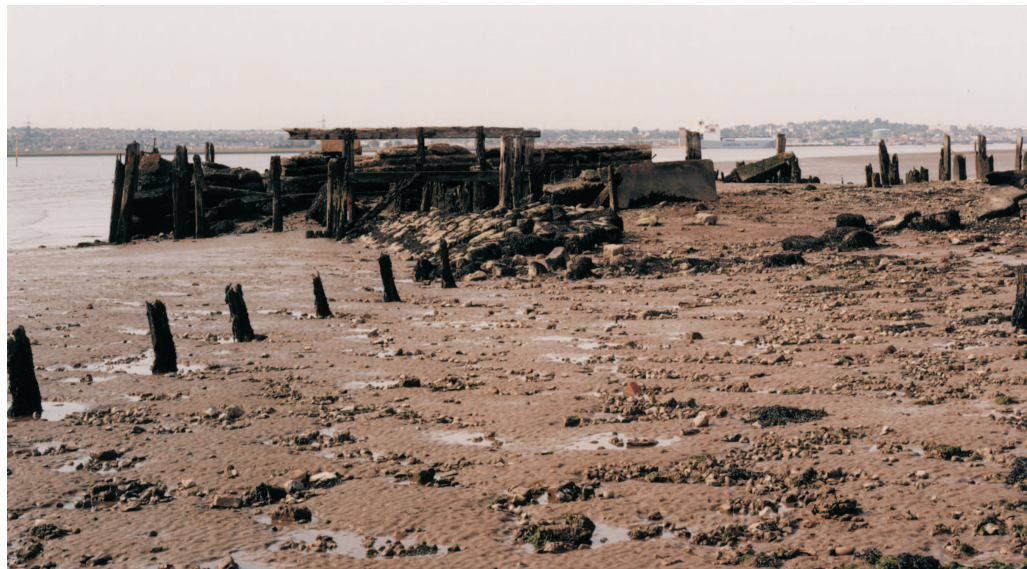
Figure 16
*The jetty at
Coalhouse Point*
©Crown copyright
(NMR:
AA/046706)

The surviving remains of the **jetty**, which formed part of the coal wharf, comprise principally the main structural timbers (figure 16). These are a series of uprights of heavy scantling, each 2.25m high by 0.35m square, and almost equally substantial cross-members, each with a cross-section of 0.38m by 0.21m, the whole structure secured by heavy iron bolts and plates into a sturdy framework. On top of the uprights, small square tenons formerly secured the jetty's decking.

Along the southern side of the jetty, a hard standing, 18.2m by 4.7m by 1.2m deep, consists of four layers of mass concrete lying on a raft of timbers. The concrete is defined on two sides by the jetty timbers, with additional concrete patches between each of the uprights, presumably providing additional support and strength. Hollow metal rods

between the layers were bolted into the timber uprights to strengthen the hard standing.

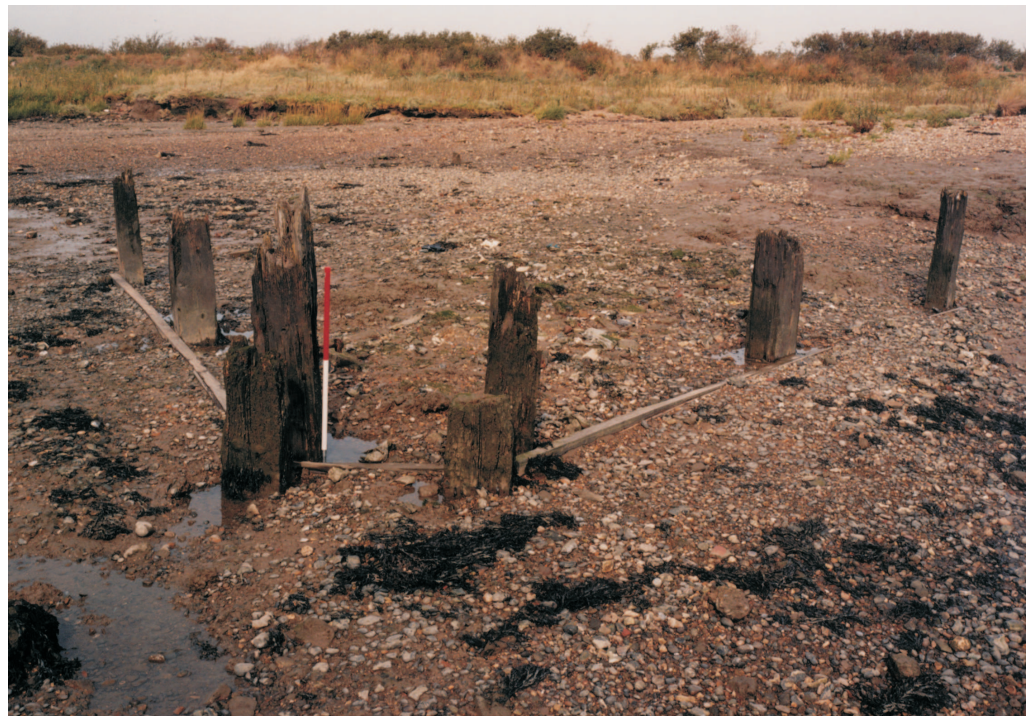
Figure 17
The probable remains of one of the sluices which during the 19th century controlled the flow of water between the river and the salt marsh
(©Crown copyright NMR: AA/046708)

Water issuing from these creeks was controlled by **sluices**. Although the details of these have disappeared, sufficient of the surrounding structures survive to provide a clear understanding of how they worked. A V-shaped arrangement of timber uprights linked by horizontal planking which survives only at ground level would have funnelled the water into the sluice, and a corresponding arrangement on the other side of the sluice effected efficient despatch of the water into the Thames.

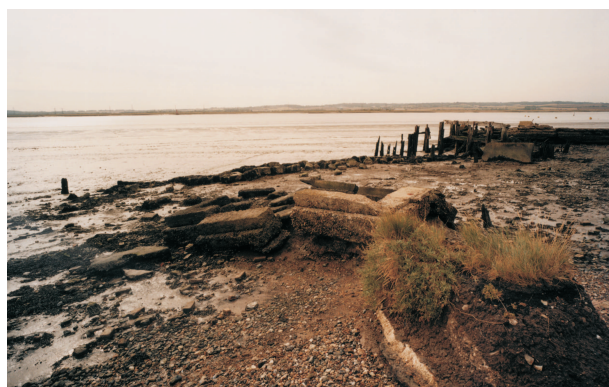
Figure 18
*Remains of one of
the two Defence
Electric Lights at
Coalhouse Point*
(©Crown copyright
NMR: AA046711)

North-east of the jetty are the remains of a concrete structure resting on the mudflats (6) with walls of mass concrete containing pebble and flint (figure 18). Although partially broken-up, its rectilinear plan, measuring approximately 5.2m by 4.3m externally, is still apparent. The walls are 0.8m-wide at foundation level, capped by narrower structural walls, in smoother concrete, approximately 0.4m wide. The interior has a broken concrete floor, and in the centre of the west wall is an area of smooth concrete, possibly the base of a doorway or window. It is a Defence Electric Light (Smith 1985, 37).

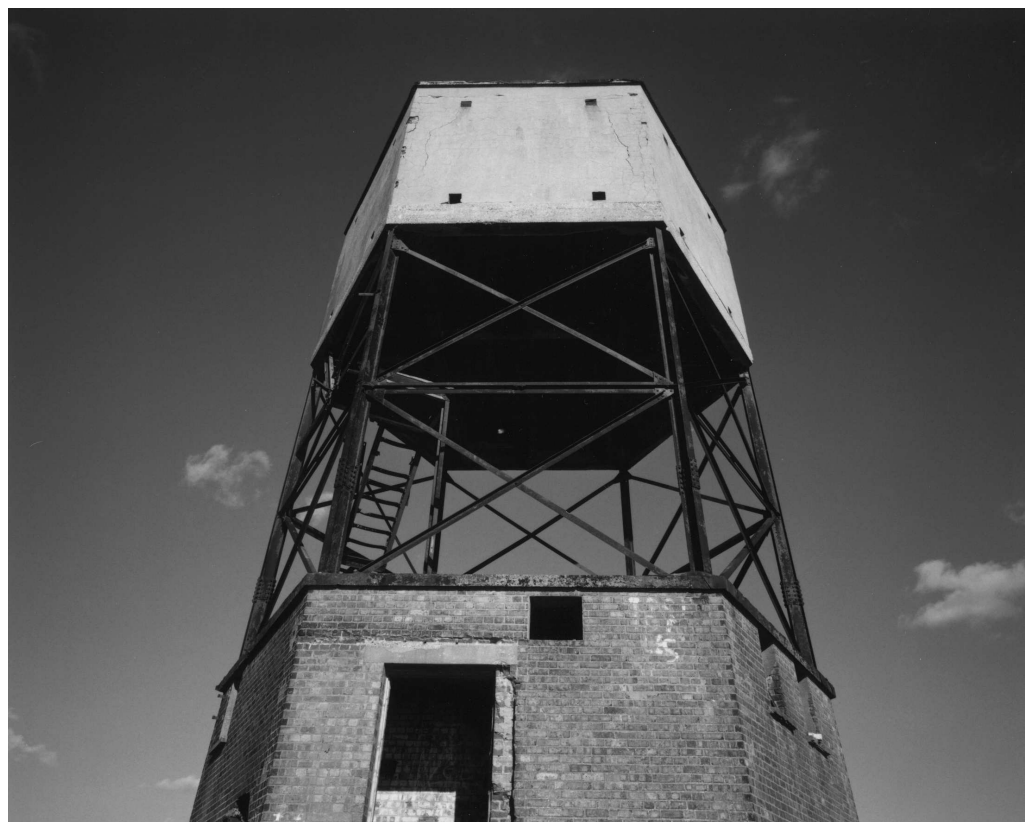
Figure 19
The Second World War radar tower at Coalhouse Point. Note the unusual raising of the upper level, probably necessitated by the low lying location on the mudflats
(©Crown copyright NMR: AA/031291)

The principal survival from the Second World War is the brick and steel **radar tower**, situated midway between the jetty and the tramway and currently being undermined by the river (figure 18). This general form of hexagonal tower is found elsewhere (for example at Beacon Hill Fort, Harwich) but the low-lying situation of Coalhouse Point meant that the upper level - which supported the radar array - had to be elevated by means of a steel framework.

The tower has a concrete floor, raised and supported on concrete piers; all of this has been undermined by tidal action, making the whole structure unsafe. Additionally, the metal stairs leading to the upper level are badly rusted and damaged, making investigation impossible. As a result, survey was confined to the lower level (figure 19).
