WIMPOLE PARK,
Wimpole, Cambridgeshire

Medieval settlement,
post-medieval park and gardens

SURVEY REPORT

ARCHAEOLOGICAL INVESTIGATION REPORT SERIES 15/2003

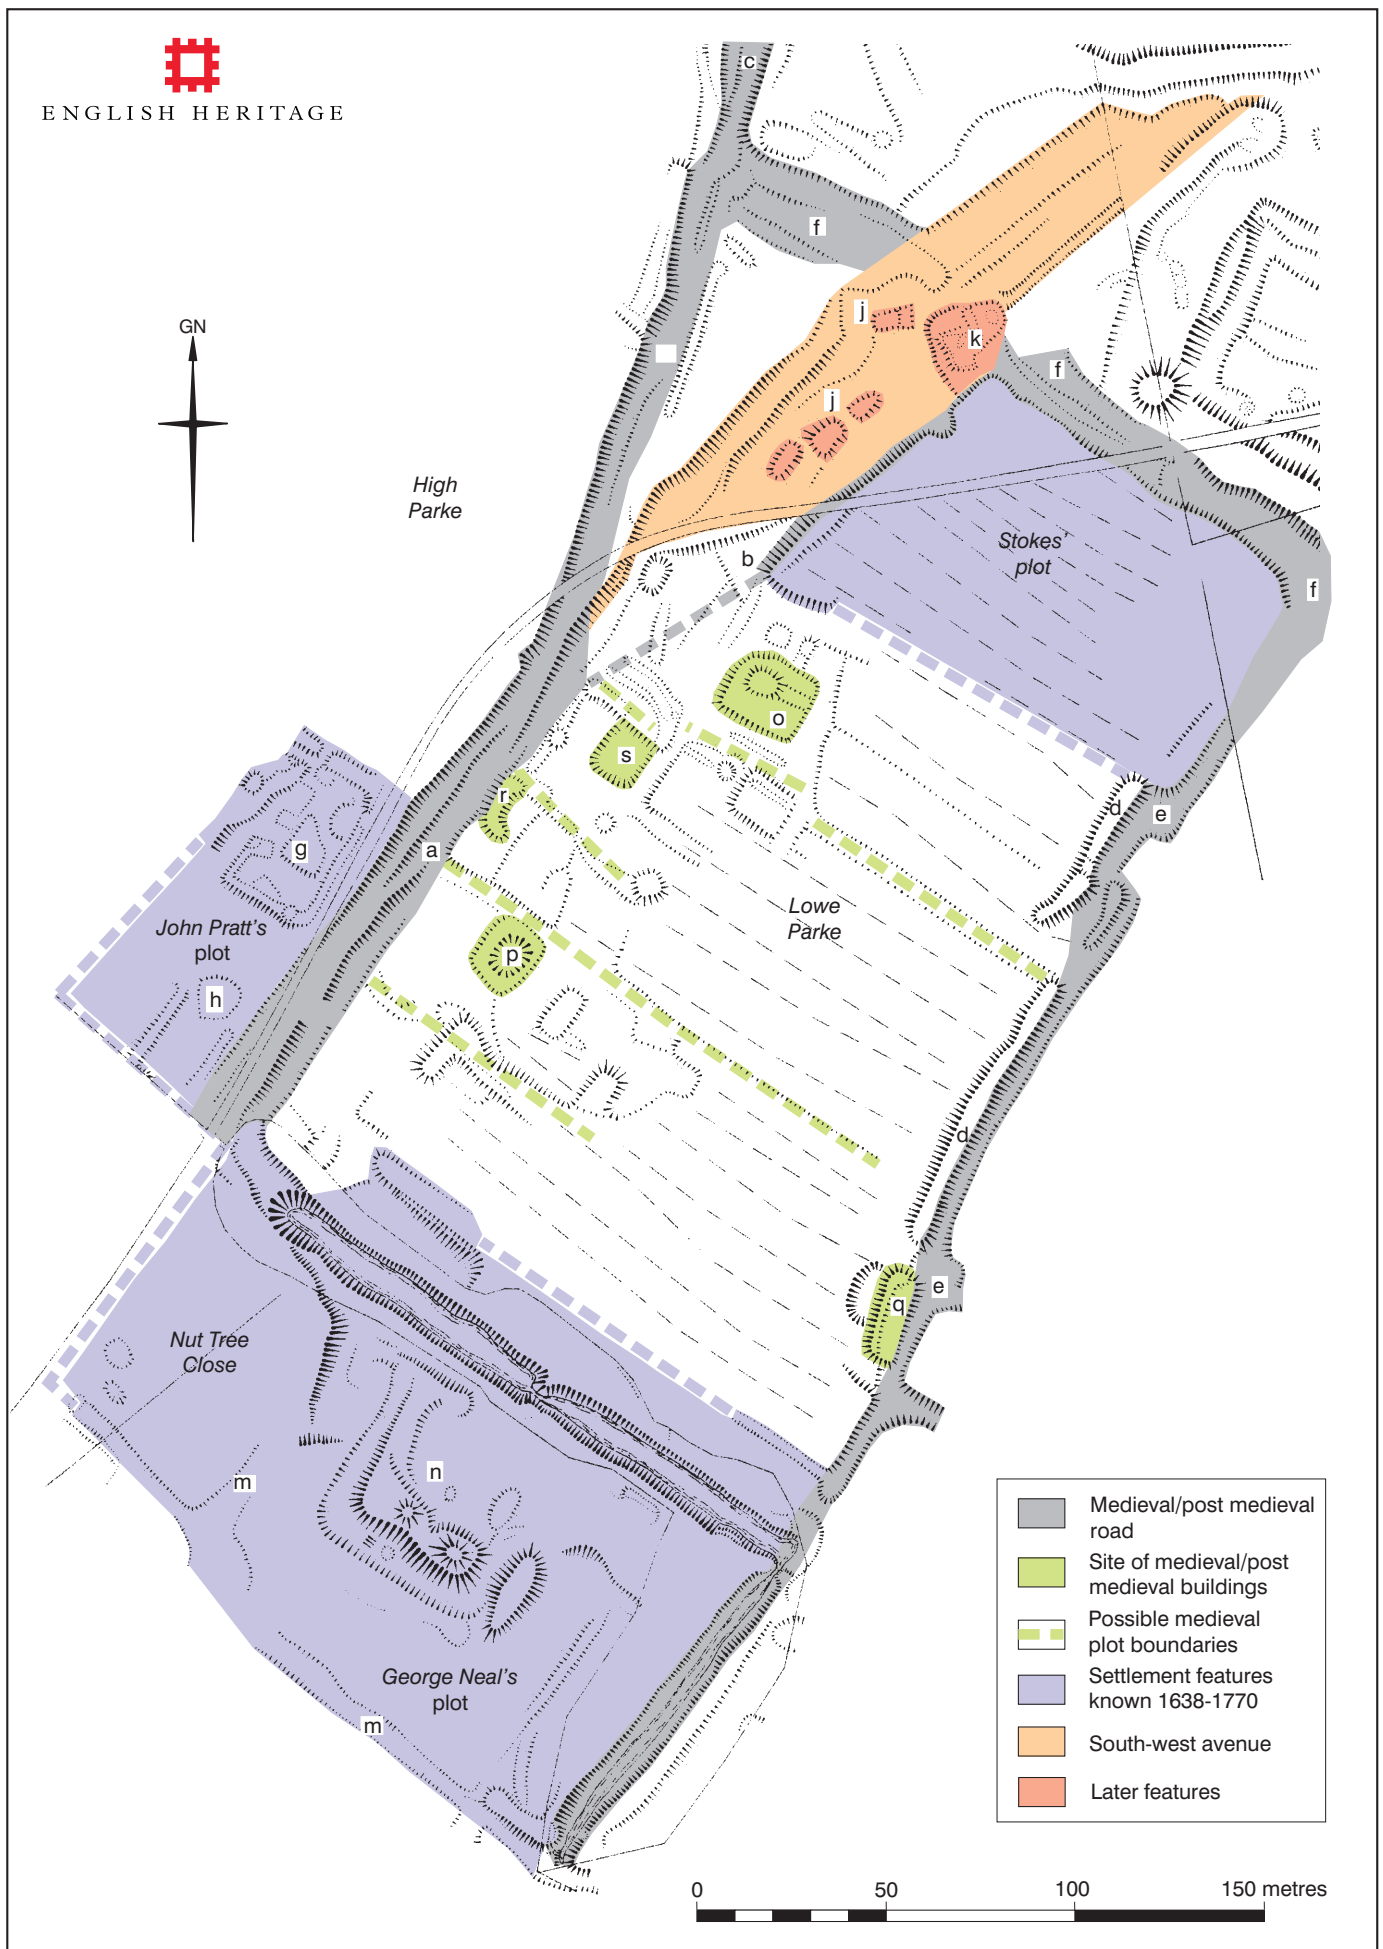
Figure 5a Extract of figure 5, showing earthworks at the former hamlet of Bennall End (1:2000 scale, reduced from original at 1:1000)

The settlement covers an area roughly 200m north-east to south-west by 100m and overlies a single furlong of ridge and furrow. The Arrington to Wimpole road (**a**), which also formed the settlement's main street, is reduced to a fragmentary hollow-way of varying width and depth, now largely obscured by the later park road and landscaping. The road divides into two, one branch (**b**) curving east towards the church, the other (**c**) continuing to the settlement sites north of Wimpole Hall. The north-western branch is the older, originally serving the common fields and its settlements but made redundant by emparkment; only a short section of it survived to be depicted on the 1638 map, the remainder incorporated into a boundary separating *High Parke* and *Lowe Parke*. In turn, this was to become the line of the Walnut Avenue in the later 17th century (see below). The eastern branch formed the main street of the settlement in 1638. Not only does it cut across the block of ridge and furrow but also the northern corner of the settlement, leaving a very small triangle of land within which the 1638 map depicts three buildings. This realignment probably followed emparkment.

The long south-eastern boundary of the settlement is formed by a headland (**d**) and a hollow way (**e**). This joins another hollow way, (**f**), which formed the north-eastern boundary, and in 1638 representing the division between agricultural land and the Park. Both of these hollow ways originated as field roads. Something of the structure of the settlement, in terms of property boundaries and building platforms, survive as slight earthworks, generally no more than 0.2m high.

There is some correlation between these earthworks and the 1638 plan. Particularly clear is the plot of John Pratt, cut into a second furlong of ridge and furrow on the western side of the main street, the only plot outside the original settlement envelope. Its construction, therefore, relates either to a phase of maximum growth in the village when expansion spilled over the previously defined boundary, or to a relocation resulting from emparkment. The site of the *home stall* or smallholding is defined by a bank enclosing a rectangular area some 46m by 27m. Entranceways through the north-eastern and south-eastern sides lead into a yard area where there are a several undiagnostic scarps, together with a sub triangular platform (**g**), 14m by 12m, probably the site of the cottage. To the south-west, a low sub-circular platform (**h**), 14m in diameter, is of unknown origin.

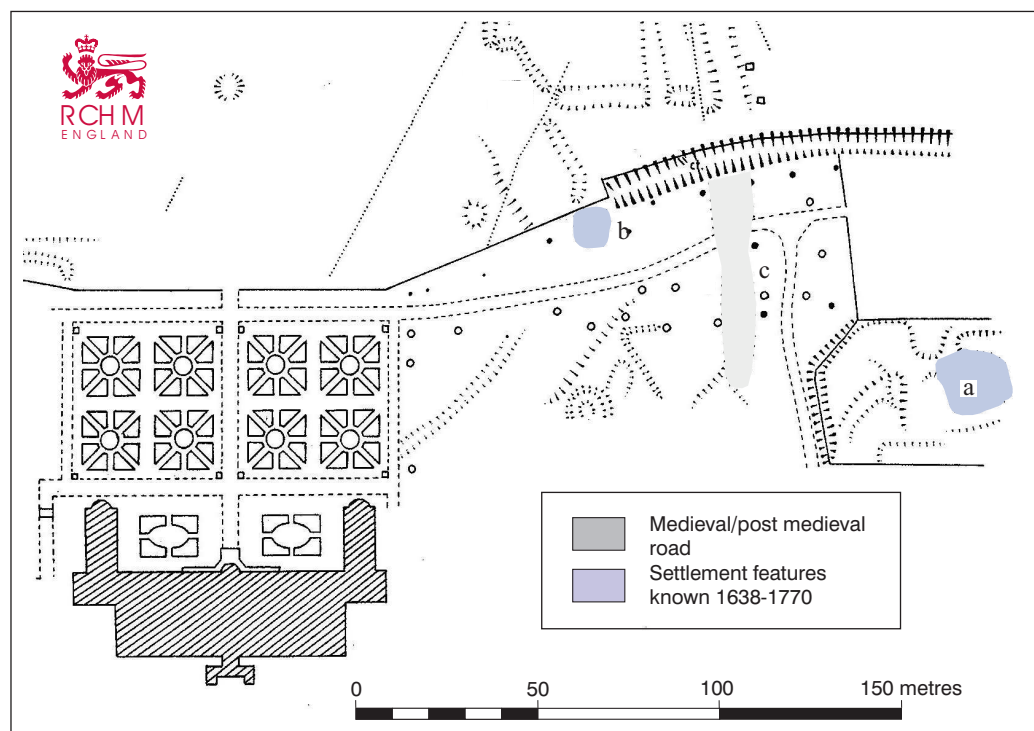
Figure 6a
Extract of Fig 6,
showing earthworks
inside the present hall
garden (reduced from
original at 1:1000
scale)

0.5m high, and associated earthworks may be part of that complex. Nearby, formerly on the other side of the road and now just within the enclosed garden of the Hall, a low squarish mound (b), possibly marks the western end of the large barn depicted on the 1638 map. The barn is shown also on the Kip engraving and it survived until the later 18th century (frontispiece; Fig 3). The northward route from the crossroads survived until Capability Brown's changes in the mid 1760s but prior to this, by the early part of the 18th century, and possibly late in the 17th, it had been straightened to run outside and along the eastern edge of the hall's formal gardens (Fig 4). The line of this late version of the road is just visible on the present enclosed lawn north-east of the hall as a much-degraded scarp (c), with a slight hollow along its eastern side.

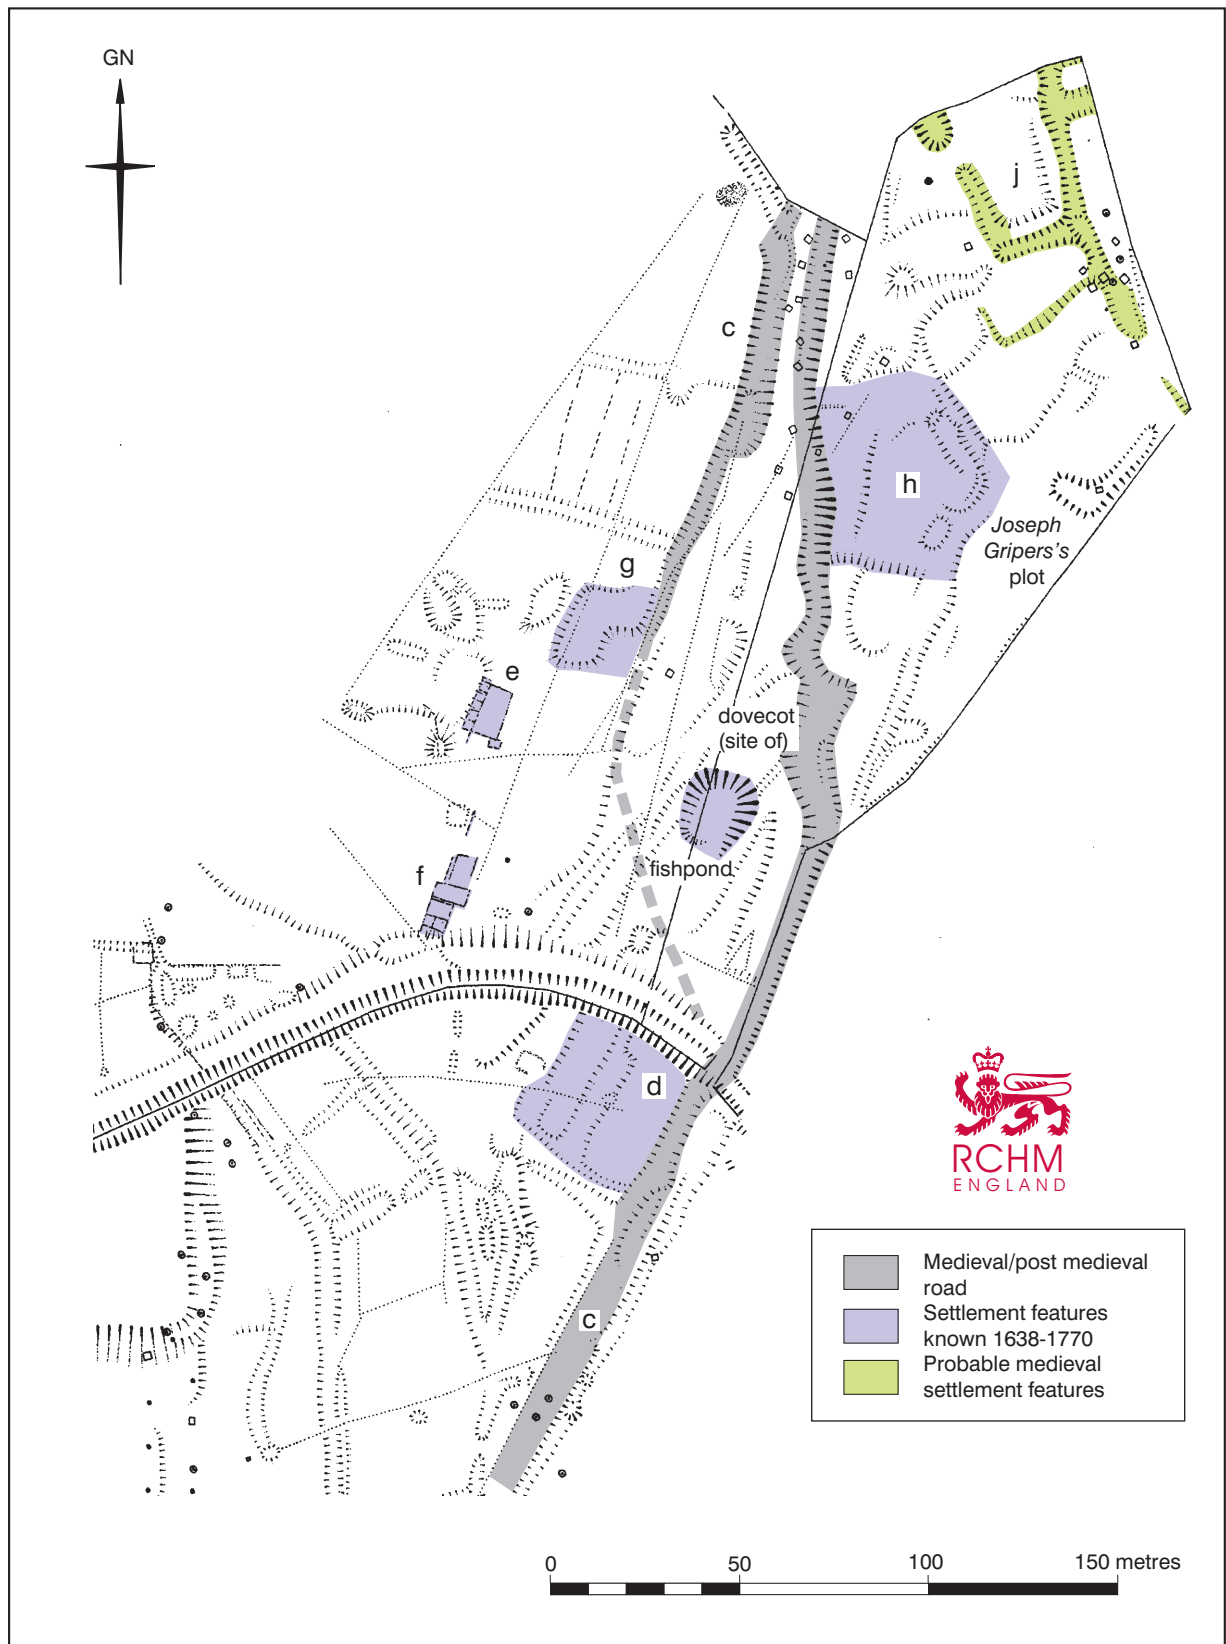
Figure 6b:
Extract of Fig 6, showing earthworks of former settlement in north park (1:2000 scale, reduced from original at 1:1000)

Beyond the present Hall garden, the road (c) follows a straight course, its carriageway between 5.0m and 7.0m wide, contained between flanking ditches 4.0m - 5.0m wide and averaging 0.3m deep. After some 110m the road turns sharply to the north-east and at this point in 1638, a branch road also diverged across fields to the north-west; a cottage stood in the angle (Fig 7). The branch is now lost under later garden earthworks but the main course of the road can still be traced downhill to the deep ha-ha built in the later 18th century.

North of the ha-ha the road (c) is recut as a field ditch for some 60m, before emerging to follow an original, unformalised and sinuous course through degraded settlement earthworks down the slope towards the eastern end of the lower lake. Along this last stretch its varying dimensions are the result of partial infilling but where best preserved it averages 10.0m wide and 1.0m deep. In 1638, the road skirted the eastern side of an open area resembling a small 'green', referred to as a *pound*, around which were only three cottages. Probably by c 1700, during the creation of more extensive formal gardens, this 'green' and its cottages had been largely eclipsed and partially remodelled as a yard around which several farm buildings were concentrated, shown clearly on Bridgeman's plan of c 1720 immediately outside the north garden wall, and surviving until Brown's alterations of the 1760s (Figs 7 and 8). By that time probably a reasonably prosperous tenant farm, the group was neatly described as:

To the north of the ha-ha, parchmarks observed in dry conditions in July 1996 marked the walls of two buried structures (e and f), the one rectangular comprising a larger single cell with a range of five small cells along its western side, and looking very much like an animal pen; the other a more complex range of at least six rooms, probably a dwelling. Several low mounds and a shallow depression to the north represent the locations of further buildings or heaps of rubble from demolished structures and there are significant amounts of crushed brick in this area, in bare soil exposed by cattle wear. A squarish

depression and mound (g) may represent one of the two cottages shown on the 1638 map, while the other mounds and parchmarks probably equate to the 18th-century farm group.

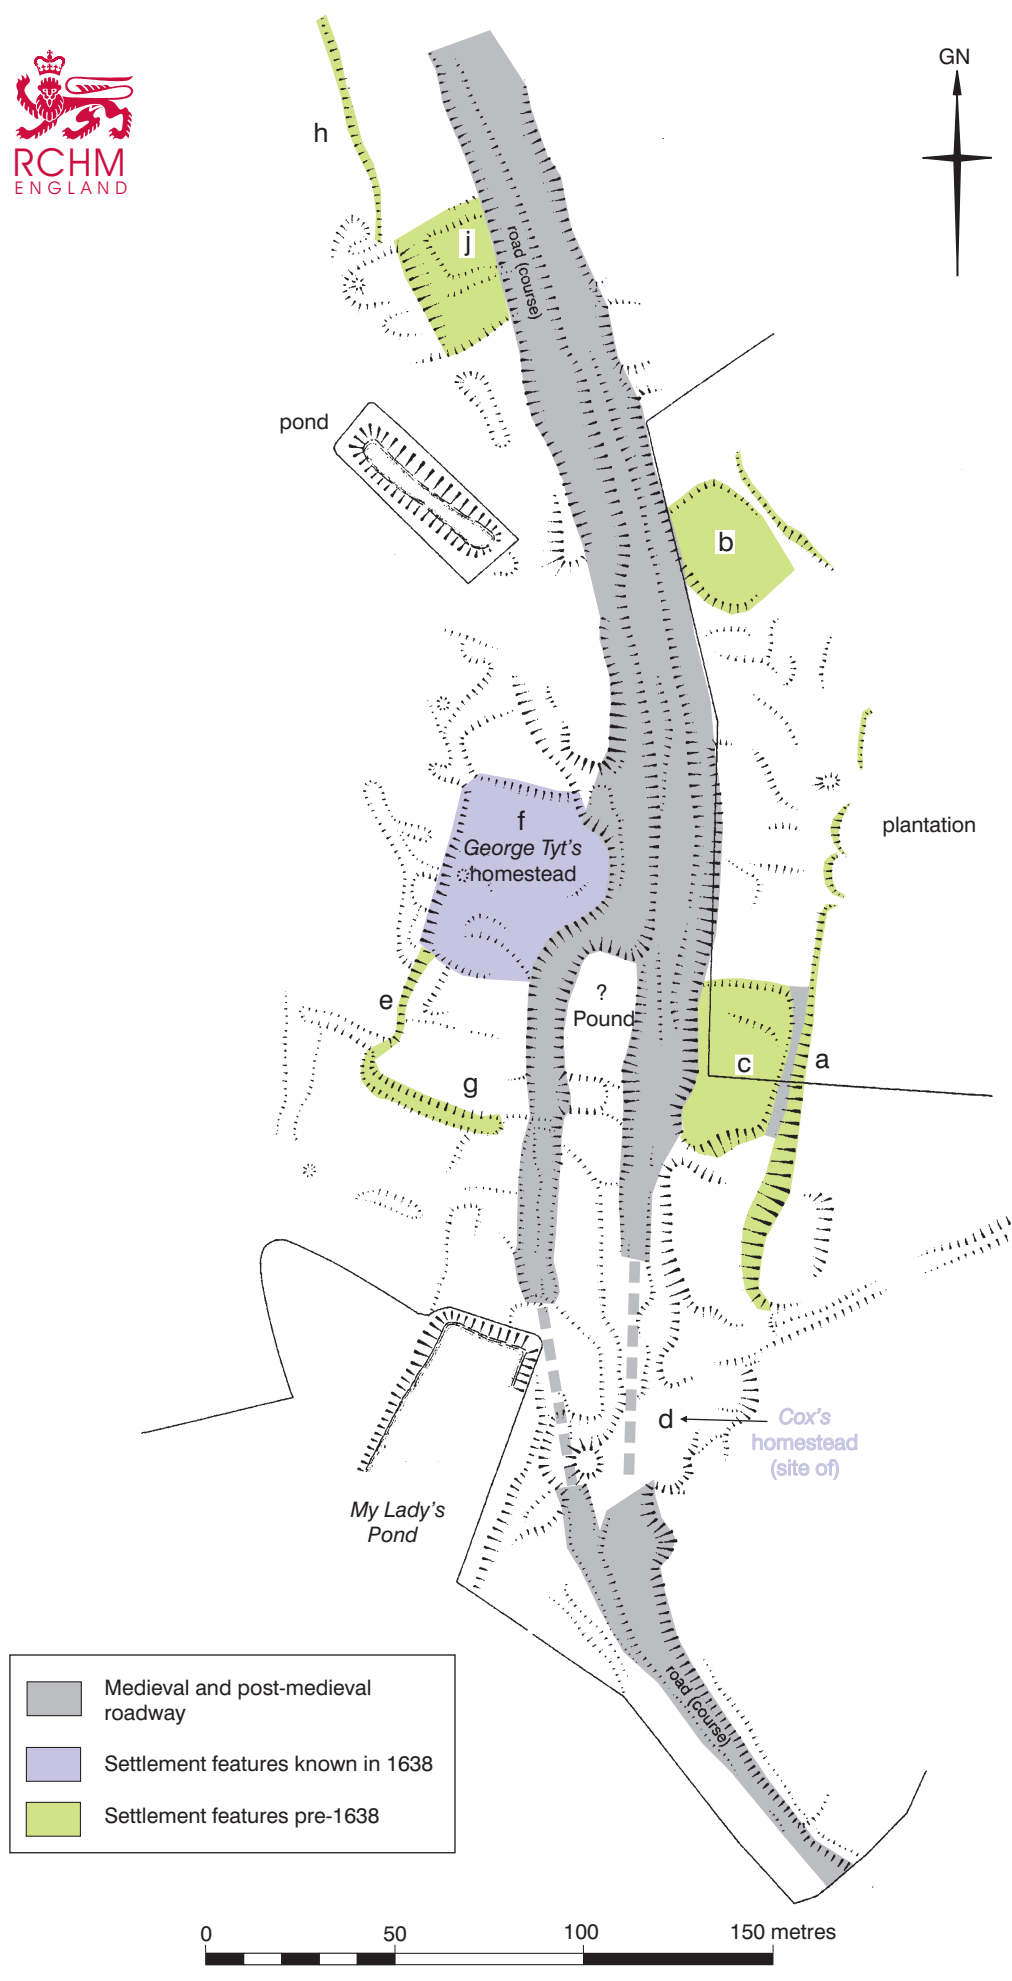
Figure 11
Survey plan showing
earthworks of the
former settlement of
Thresham End (reduced from
original at 1:1000 scale)

Emerging south of the present stables, the road is reasonably straight, up to 25.0m wide and 0.5m deep, with two hollowed tracks at the margins and a slightly raised central spine: the eastern track was re-used as a major drain, for the Hall and Park in the 18th century (SMD6 S1 I18). In the central part of the settlement, the two tracks further divide leaving an elongated 'island' rather like the *pound* in the settlement north of the hall, and is shown with trees in 1638 (see above). Beyond it the tracks re-unite into a single road, curving away to the south-east; the eastern side marked by a prominent scarp up to 1.0m high. In 1638 the road continued to join *Wimble Way*, a short distance further on.

East of the road, the boundary of the settlement is clearly defined by a straight scarp (**a**), 0.4m high, broadly parallel to the road and 30m from it. Two probable house plots can be identified (**b** and **c**), the latter apparently with a back lane. Between them are several slight scarps, probably the remains of other subdivisions into properties, but the vegetation here is too long to enable clear interpretation. Three such property boundaries remained in use in 1638, extending up the hill to the east but only one habitation remained, in a plot towards the southern end belonging to someone with the surname *Cox*; its position, not marked by an obvious earthwork today, is at (**d**).

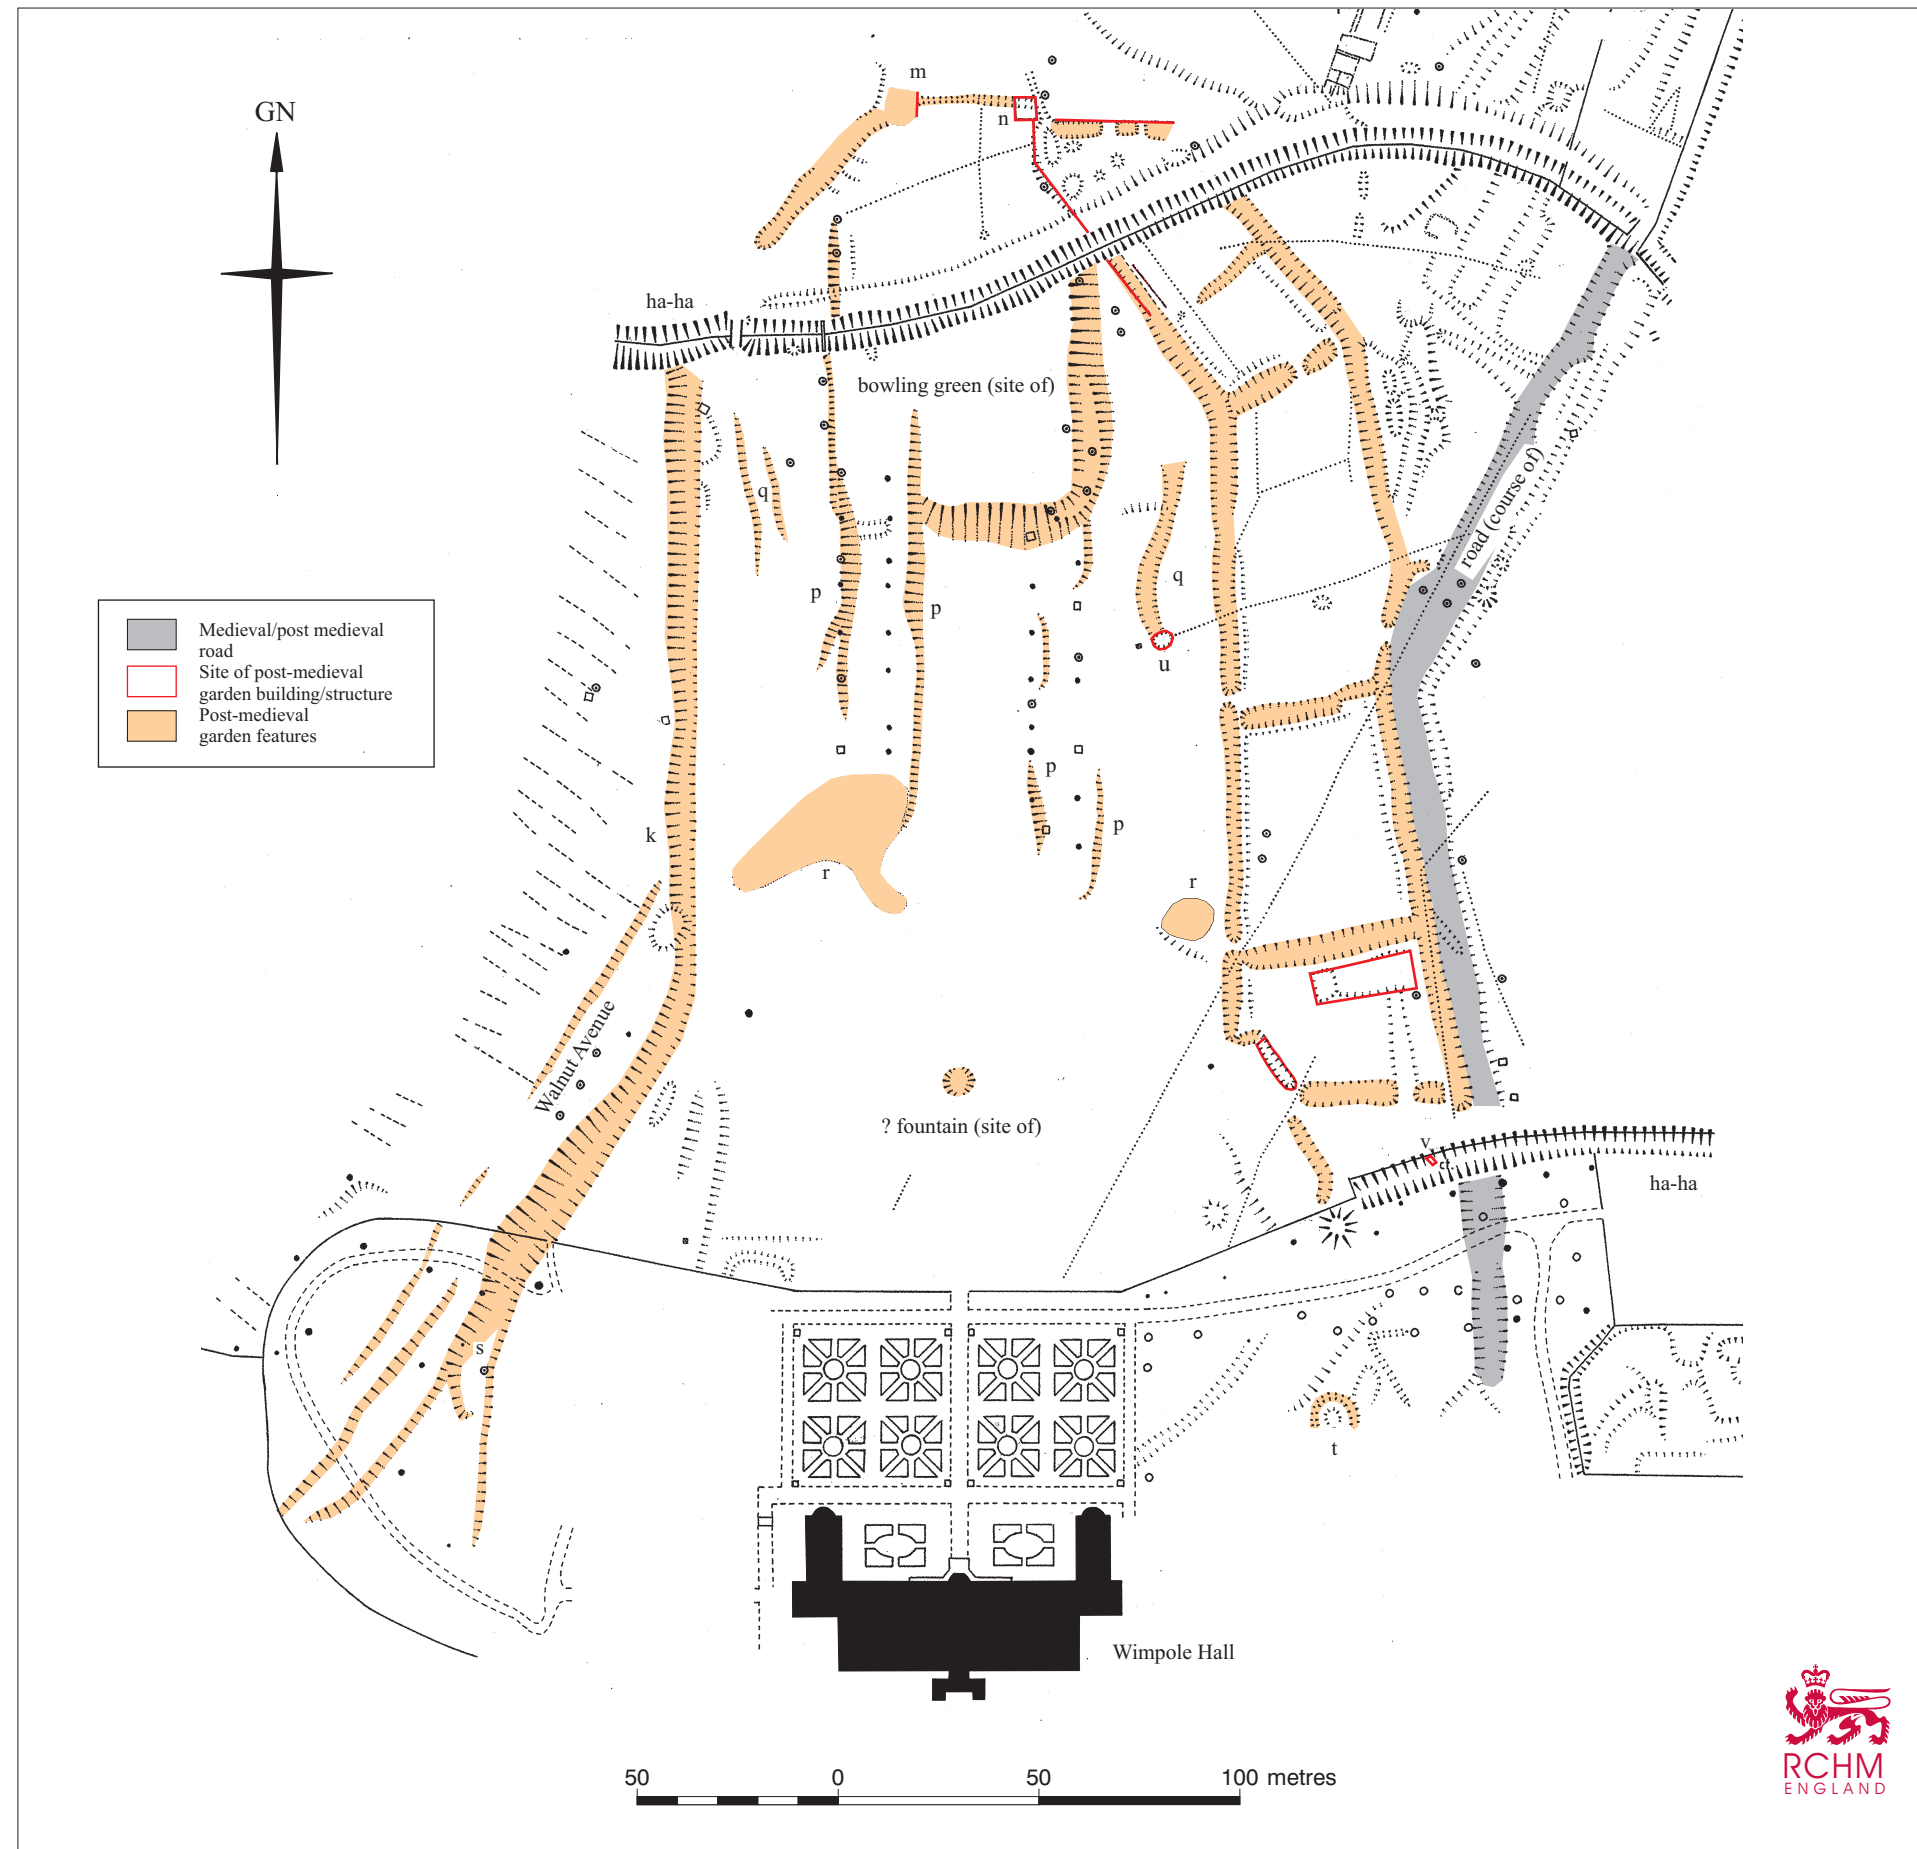
Figure 6c
RCHME survey plan of the north
gardens (original at 1:1000 scale)

The western boundary of the garden survives as a long degraded scarp (**k**), up to 1.5m high with a slight ditch along its base: the latter is an infilled ha-ha established to a design by Robert Greening c 1752 (Fig 13). It can be seen both within the present Hall garden and for some 75m beyond, aligned north-east to south-west, but thereafter it deviates by 45 degrees towards due north. Prior to this change of angle, the boundary had adopted the line of an old arable headland and the ends of the furrows approaching it are still visible, just, in low-angled light. North of the angle, the boundary cut across and destroyed the headland, continuing to the present ha-ha and resuming, beyond, as a shallow ditch on a

north-east to south-west alignment as far as a shallow subrectangular hollow (**m**). This feature marks the western of two small summerhouses which stood at the extreme northern end of the garden for much of the 18th century: the foundation of its eastern partner (**n**) survives below ground because it was revealed as a parchmark in July 1996. The two are connected by a shallow trench, the robbed course of the garden end wall.

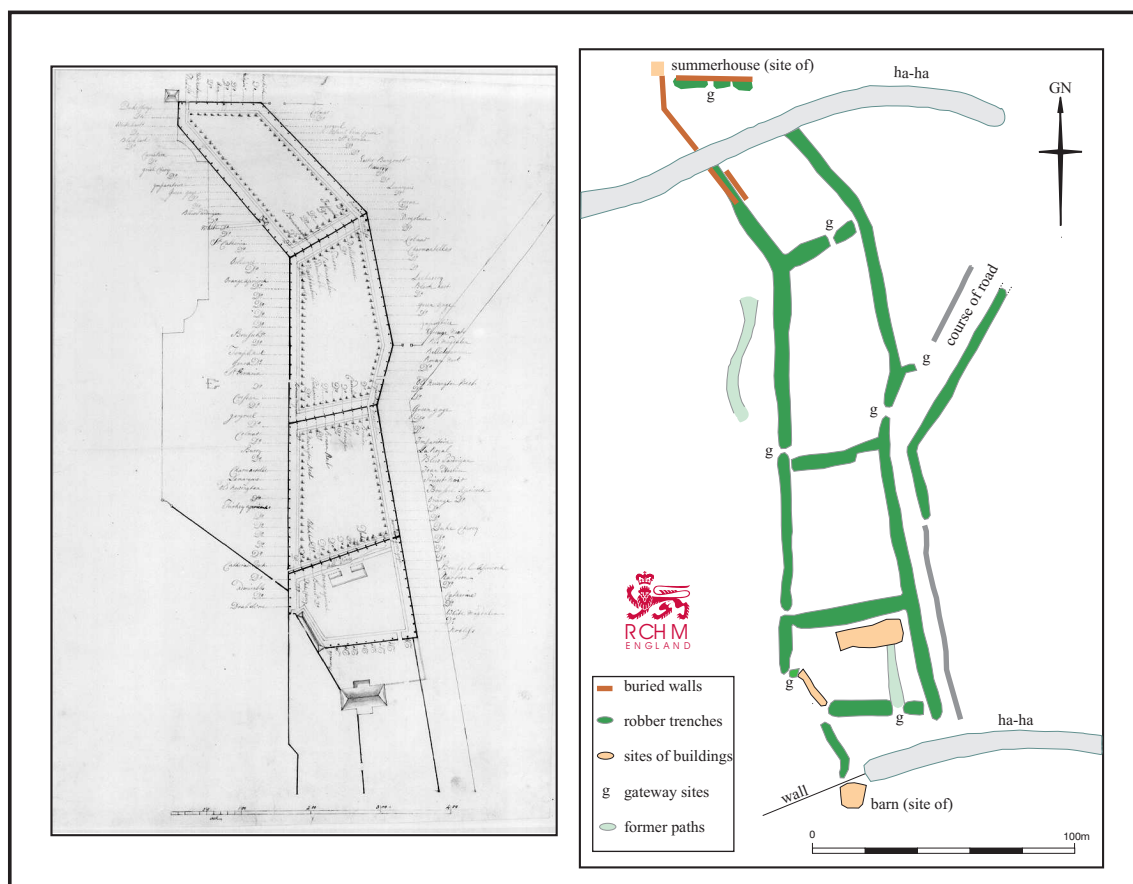
Figure 13
Left: Robert Greening's design for a walled fruit and kitchen garden c 1752 (by kind permission of the National Trust); **Right:** RCHME interpretation plan showing earthwork remains of Greening's works

Earthworks on the eastern side of the formal garden are equally clear, principally the framework of a compartmented fruit garden designed *c* 1752, also by Greening (Fig 13). Because it had to fit in the narrow strip between the road and the formal garden, an unusual shape was proposed: the result was a series of five compartments of irregular form. The earthworks are shallow trenches 5.0m to 7.0m wide and 0.3m deep, the result of thorough dismantling and robbing of the garden walls and foundations later in the 18th century. In several places, there are very slight 'banks' on the inside of the robber trenches, perhaps composed simply of spoil but possibly remains of paths or borders. The earthworks, although cut across at the northern and southern ends by the present ha-ha,

match Greening's design very closely, even to the positions of entrances which show as 'causeways' on the ground, where there were no walls to rob. Furthermore, Greening's plan shows three buildings within the walled garden, one in the north compartment over

an entrance and two in the southern compartment, possibly greenhouses. The latter are marked respectively by a shallow depression and a slight trench where robbing has taken place: the northern building has left no surface trace.

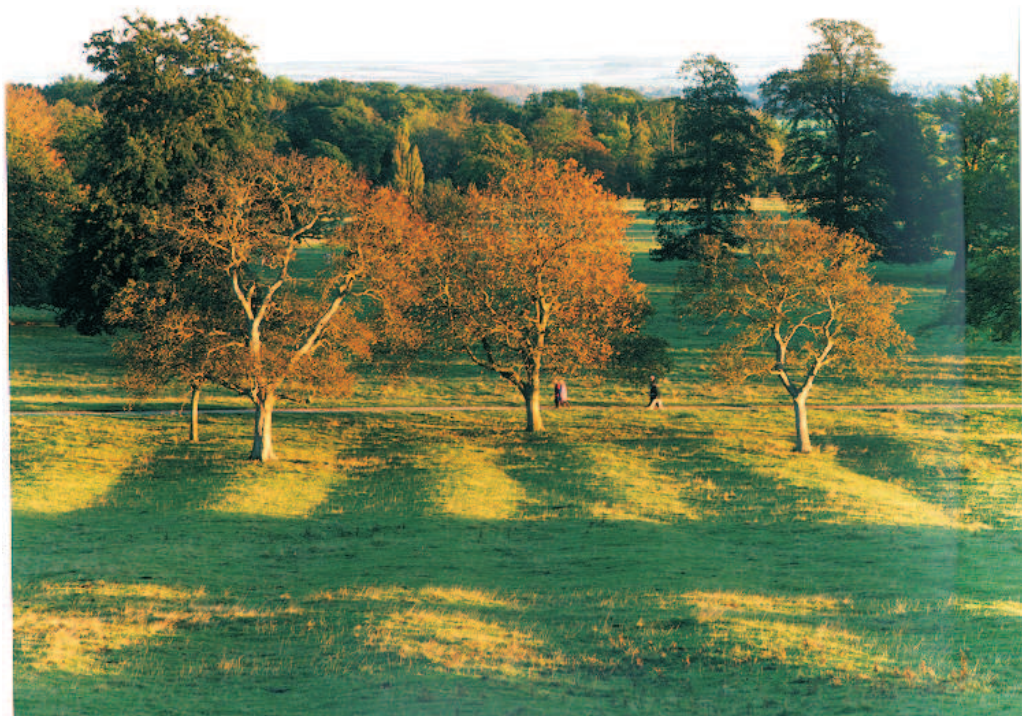
Figure 15
*Ridge and furrow in
High Parke, from the
north-west (NMR
AA96/3000)*

Much of the ridge and furrow shows a clear curvature, either the classic 'reversed-S' or a simple shallow curve, the latter occurring only in the shorter furlongs. There are no truly straight furlongs and all the ridge and furrow in the park was probably no longer tilled for arable crops by the late 17th or early 18th century.

Amplitude is most pronounced on the slope and summit of the hill west of the hall, the *Mill Field* and *High Parke* of the 1638 map. Elsewhere the lands are not so well-defined and it is the furrows which can be more easily traced. In this case the generally slight amplitude may be due to several factors: post-enclosure agriculture may have flattened the lands (but note that Hall (1993, 11-12) has shown that ridge and furrow of low amplitude is generally of early date); varying soil type on the higher and lower ground; and some ridge and furrow beside the lakes was damaged by ploughing in recent years. Note also that the ground surface of a large area on the western side of the park was completely obliterated or severely broken up by the construction of a military hospital during the Second World War, and its subsequent demolition.

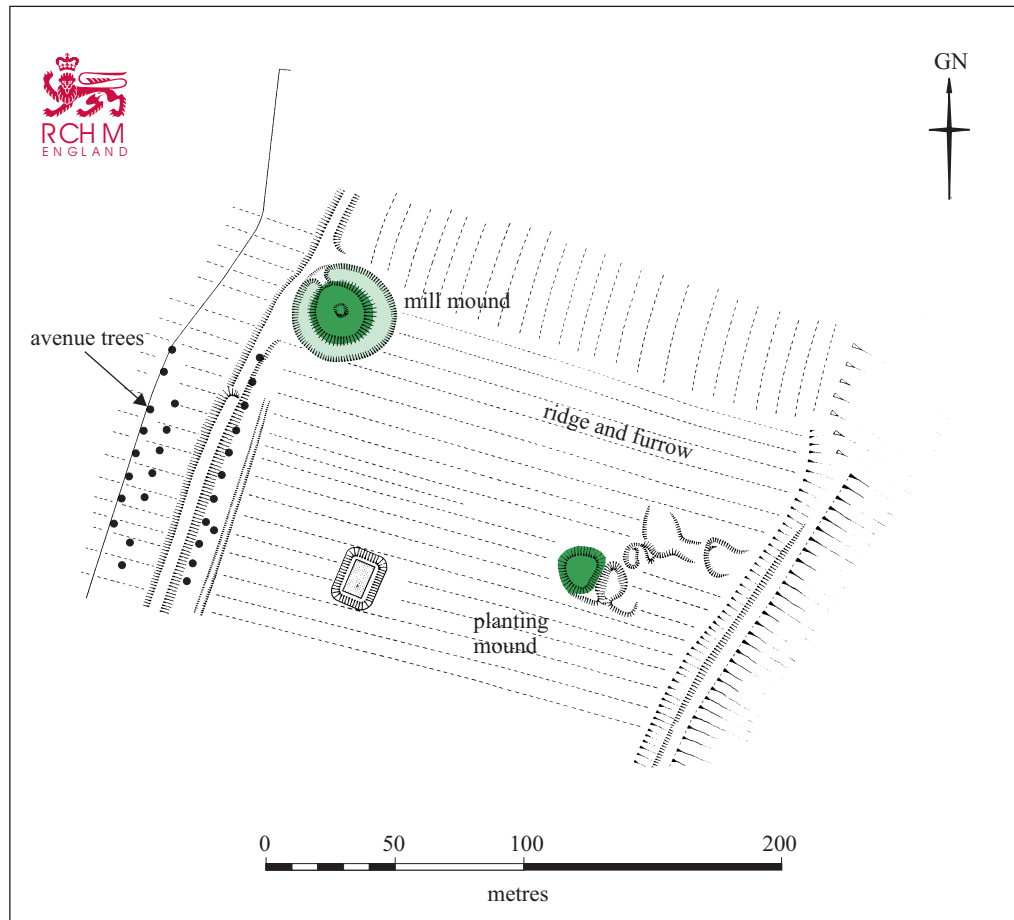
Figure 16
RCHME survey
plan of the windmill
mound, surveyed in
1984 (reduced from
original at 1:1000
scale)

This mound was surveyed in 1984 and the following account builds on the original report. The mound sits in the park on the hill north-west of Wimpole Hall, at the northern end of a flat-topped spur. It is a prominent circular feature, 26.0m in diameter, up to 1.2m high with a top 19.0m across. It is encircled by a broad ditch, averaging 5.0m across its flat bottom, and up to 0.9m deep: this presumably is the source of material for raising the mound. The ditch is crossed by a well-defined causeway, 3.0m to 4.0m wide, in the north-western quarter. A rough hollow 6.0m north-east to south-west by 5.0m and 0.7m deep lies roughly central to the mound.

The post-mill probably ceased to operate as a manorial corn mill in the later 17th or early 18th century when the land was no longer farmed in common and the park was developing. Subsequently, the mound became a convenient site for an estate icehouse. It is depicted as such on Robert Greening's design for the North Park, *c* 1752, and may date from this time, a typically circular chamber with short access tunnel reached from the surviving causeway across the ditch, and is specifically labelled on Robert Withers' map of the Wimpole estate, of *c*1815 (WH (e); Figure 17). The central hollow in the mound is therefore, not the result of the removal of the post-mill cross-trees, but followed dismantling of a brick-lined ice chamber. Like many icehouses its semi-remote location is not unusual, in this case overlooking the source of ice in the lakes at Wimpole a few hundred metres away.

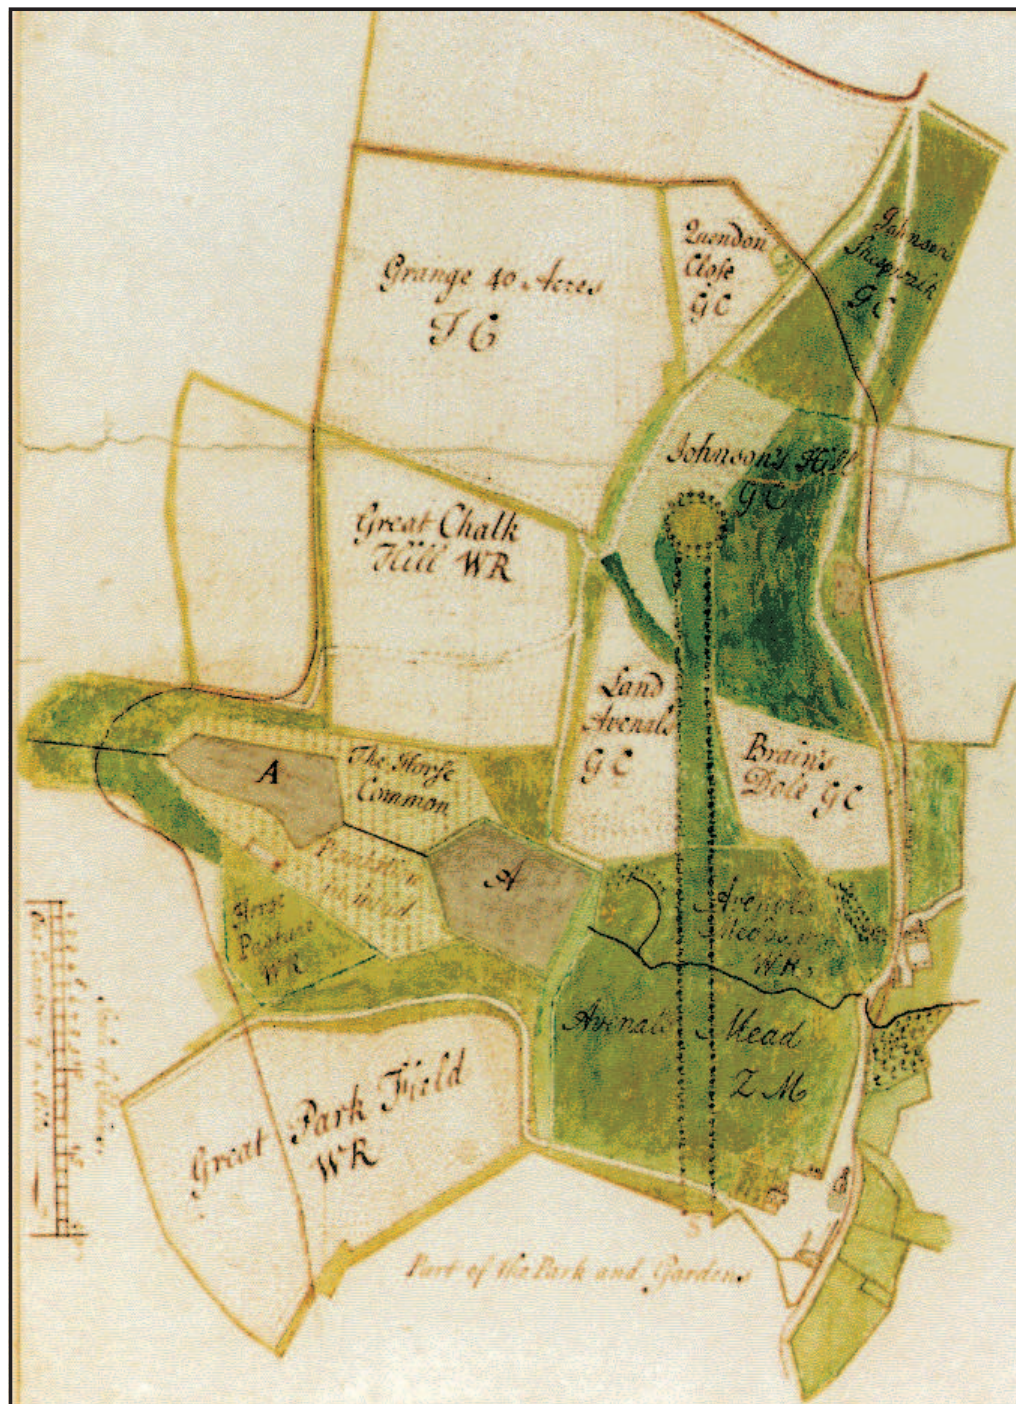
Figure 18
 Earl Radnor's
 upper fishpond
 (marked by the
 left-hand 'A')
 prior to
 Capability
 Brown's changes
 (by kind
 permission of the
 National Trust)

The site of Thomas Chicheley's **stable block** is marked by a concentration of undiagnostic earthworks, possibly formed following its demolition in 1850. Knyff and Kip's engraving (frontispiece) depicts a building aligned north to south, in the south-eastern corner of the walled garden. The addition of an extra building is indicated on both Repton's 1801 and Withers' 1815 maps (WH (e) and (g); Fig 18).

The upper lake, situated immediately west of the two surviving examples, seems to have originated as the upper of two ornamental fishponds *c*1700, probably as part of the garden works instigated by the 2nd Earl of Radnor (Fig 18). It was re-shaped in the later 18th century, probably during the parkland changes of Capability Brown. However, by 1810, it had dried up and was used only as a reed bed (Phibbs 1980, 11).

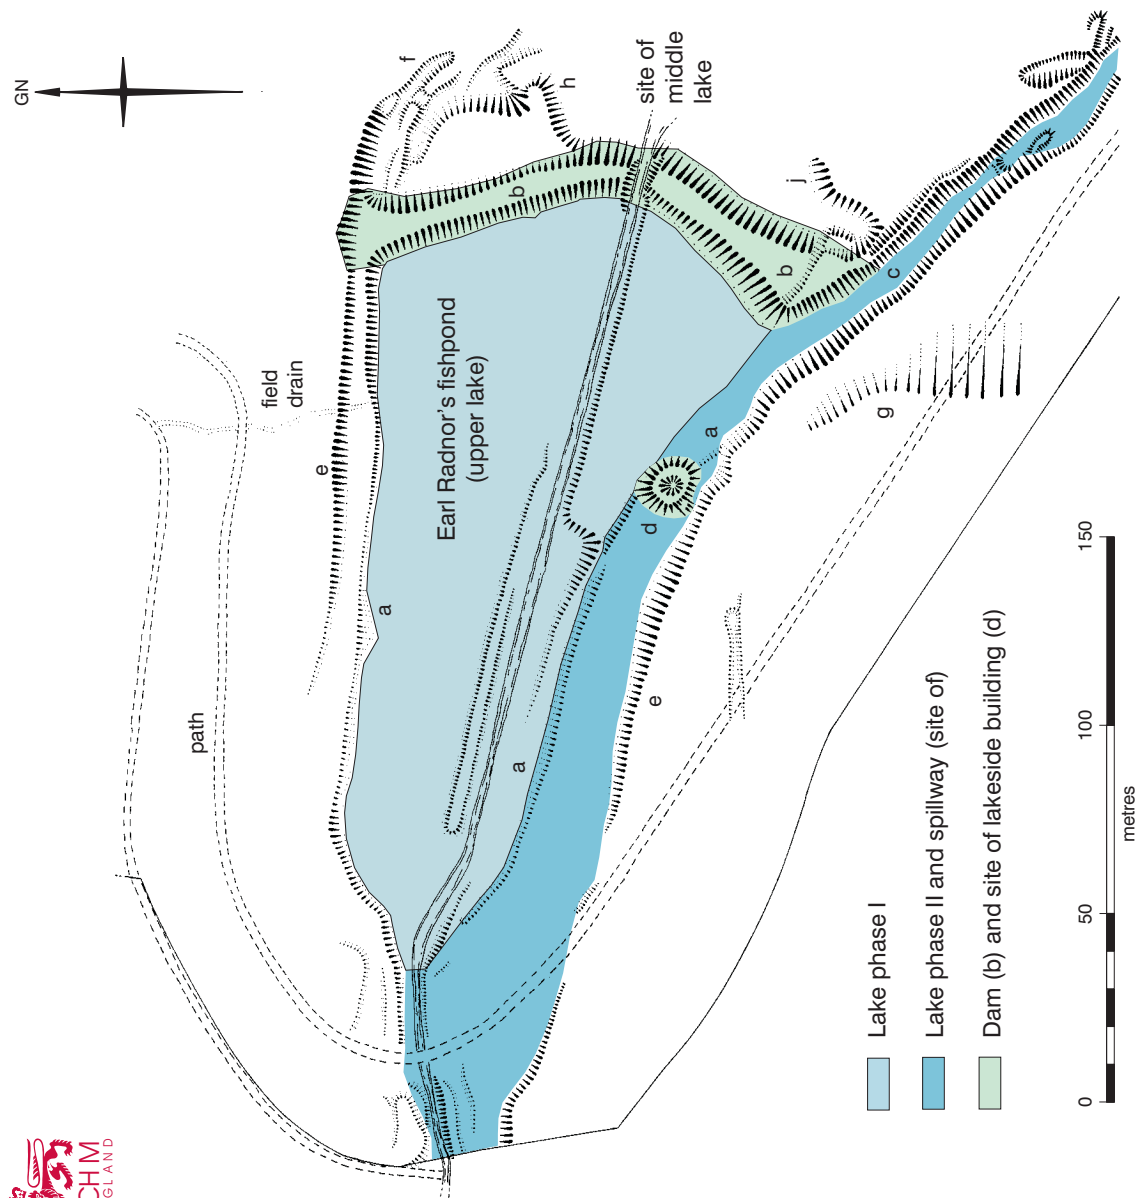
Figure 19
RCHME survey
of the upper lake,
incorporating
survey by Brian
Cushion
(reduced from
original at
1:1000 scale)

An inner series of scarps (**a**), represents the first phase, Earl Radnor's upper fishpond, and the full extent of its angular shape can be traced still: it is 220m long and between 50m and 110m wide. At its eastern end, the scarps rise to form a substantial bank (**b**) 13.0 - 24.0m wide and 1.8m high, constructed in two straight lengths which form a salient angle: this is the former dam. The stream flowed through the dam at this angle but the present cut is modern. A roughly circular mound (**d**), 18.0m across and up to 2.0m high, stands on the southern shore and was perhaps an ornamental or functional building beside the fishpond. The outer scarps (**e**) represent a second phase. They are clear on the northern and southern sides, and represent part of a slightly larger lake with a similar but more wavy outline. A well-defined channel (**c**), 13.0m across with steep sides up to 2.0m deep, leads out of the south-east corner of the fishpond, running eastward down the valley for some 120m: this appears to be a spillway. This second phase (and its spillway) would fit best as the work of Capability Brown, as the lake appears on a survey plan dated to the 1770's, together with two lower lakes which were created by adapting and extending Lord Radnor's lower fishpond (Fig 20; WH (h)).

Other features of note are at (f) where the prominent scarp (e), here up to 1.2m high, has a channel along its base, apparently fading into a marshy area. It is probably an overflow channel into the middle lake, the end of which is marked by scarps (h) and (j).
