WIMPOLE PARK,
Wimpole, Cambridgeshire

Medieval settlement,
post-medieval park and gardens

SURVEY REPORT

ARCHAEOLOGICAL INVESTIGATION REPORT SERIES 15/2003

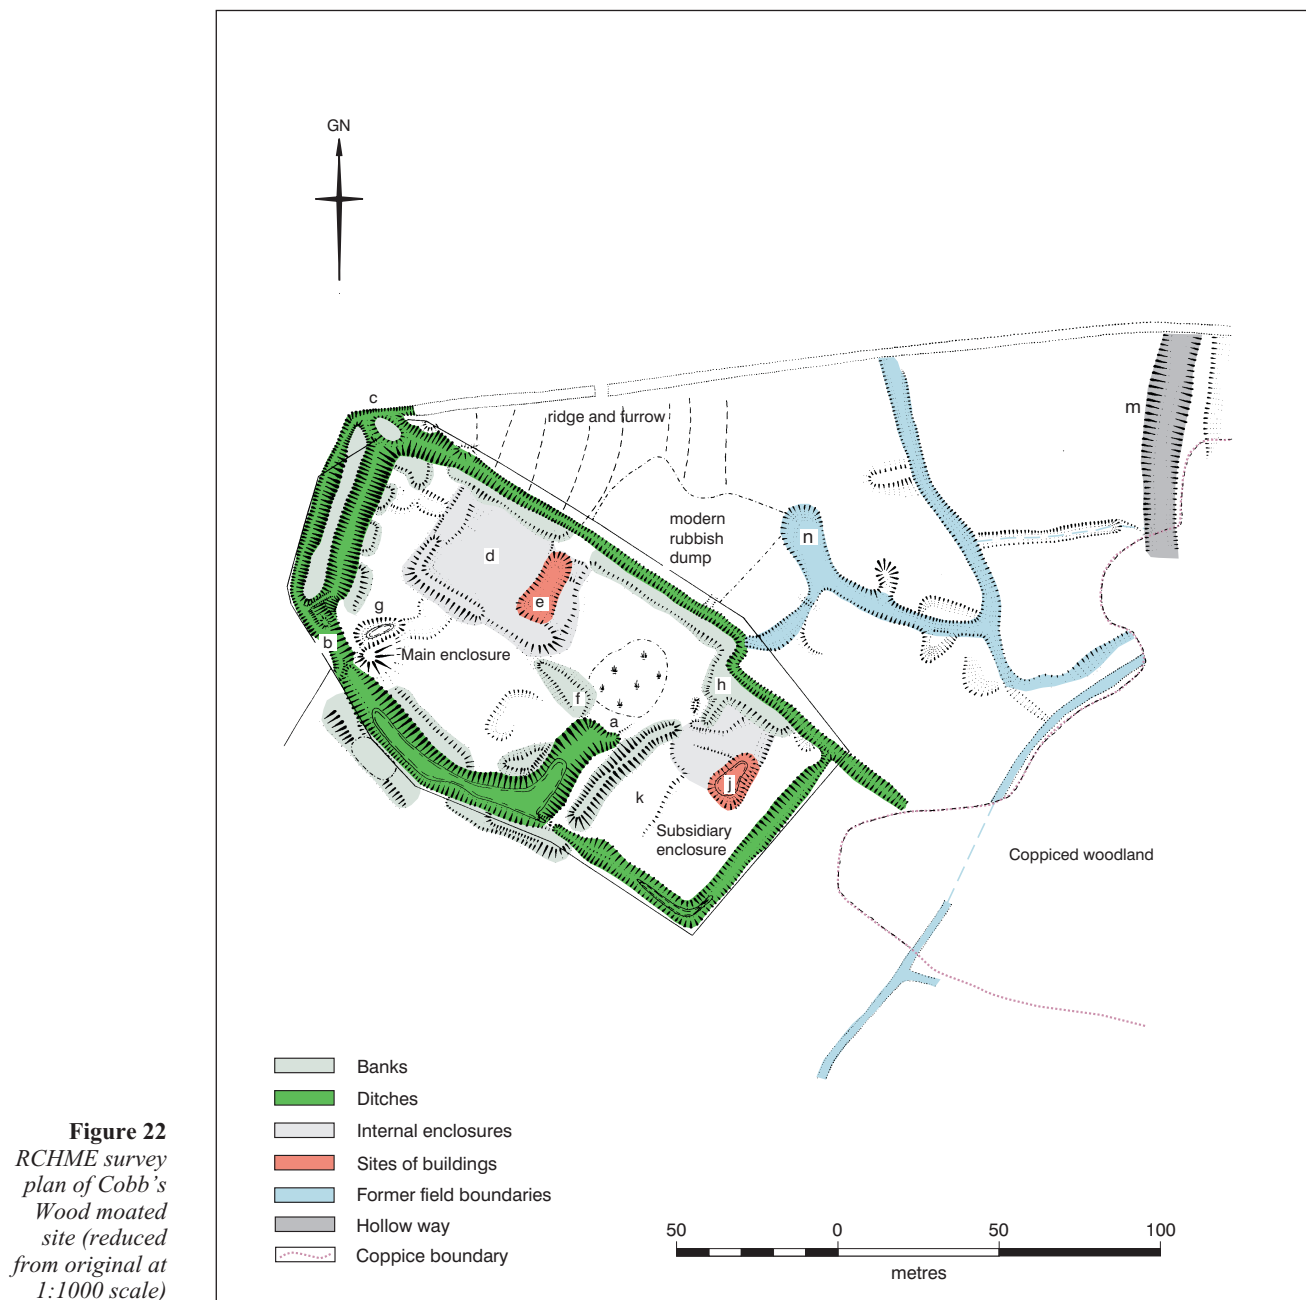
south-western side the ditch is broadest and still holds some water. The ditch on the south-east extends for only half of the side and although there has been some infilling, at (a), with a marshy patch beyond, there is no real indication that it extended to the eastern corner. The most likely explanation is that the original ditch did extend along the whole south-eastern side but was partially infilled following construction of the subsidiary enclosure (see below).

The straight side of the D has a much slighter ditch than the curving section, averaging 5.0m wide and 0.6m deep, very similar to that of the subsidiary enclosure (see below) with which it is continuous. There is a slight internal bank along its full length but no external bank.

The north-western side has an additional, external ditch which has a very sharply defined and deep V-profile. It forms the modern boundary on the north-western edge of Cobb's Wood and its clean profile is due to continuing maintenance as a drain. Nevertheless, it is unusual that the main enclosure ditch was not adapted for this use and it implies, perhaps, that the main ditch had some other function when the external ditch was dug.

There is no trace of an original entrance, which may in fact have been via a timber bridge, but the enclosure bank is breached at the western corner (**b**) and a causeway formed by depositing spoil in the ditch. Some of the ditch scarp remains, confirming the infilling.

The interior is characterised by a surface which undulates gently and is pockmarked by slight depressions, mounds and tree stumps. This irregular surface is the result of successive tree plantings, culminating in clear-felling, grubbing up and burning. Despite this, several features remain, principal among which is a broad bank or scarp forming a small rectangular enclosed yard (**d**) against the straight side of the D. This bank is generally broad and low, averaging 10.0m by 0.5m but the western corner appears to have been raised to form a more substantial feature, 0.8m high. Occupying the full width at the south-eastern end of (**d**), perpendicular to its axis, there is a shallow subrectangular depression (**e**) with maximum dimensions of 22.0m by 11.0m and 0.7m deep. This can plausibly be interpreted as the hollow left by the robbing-out of a building with stone foundations. The remaining area of (**d**), approximately 30m square, may have contained less substantially-built structures.

One final feature is a slight scarp (**k**), defining a raised area to its western side, much of which is covered by exposed soil containing large amounts of burnt clay and charcoal. This may be the product of recent burning of felled trees.

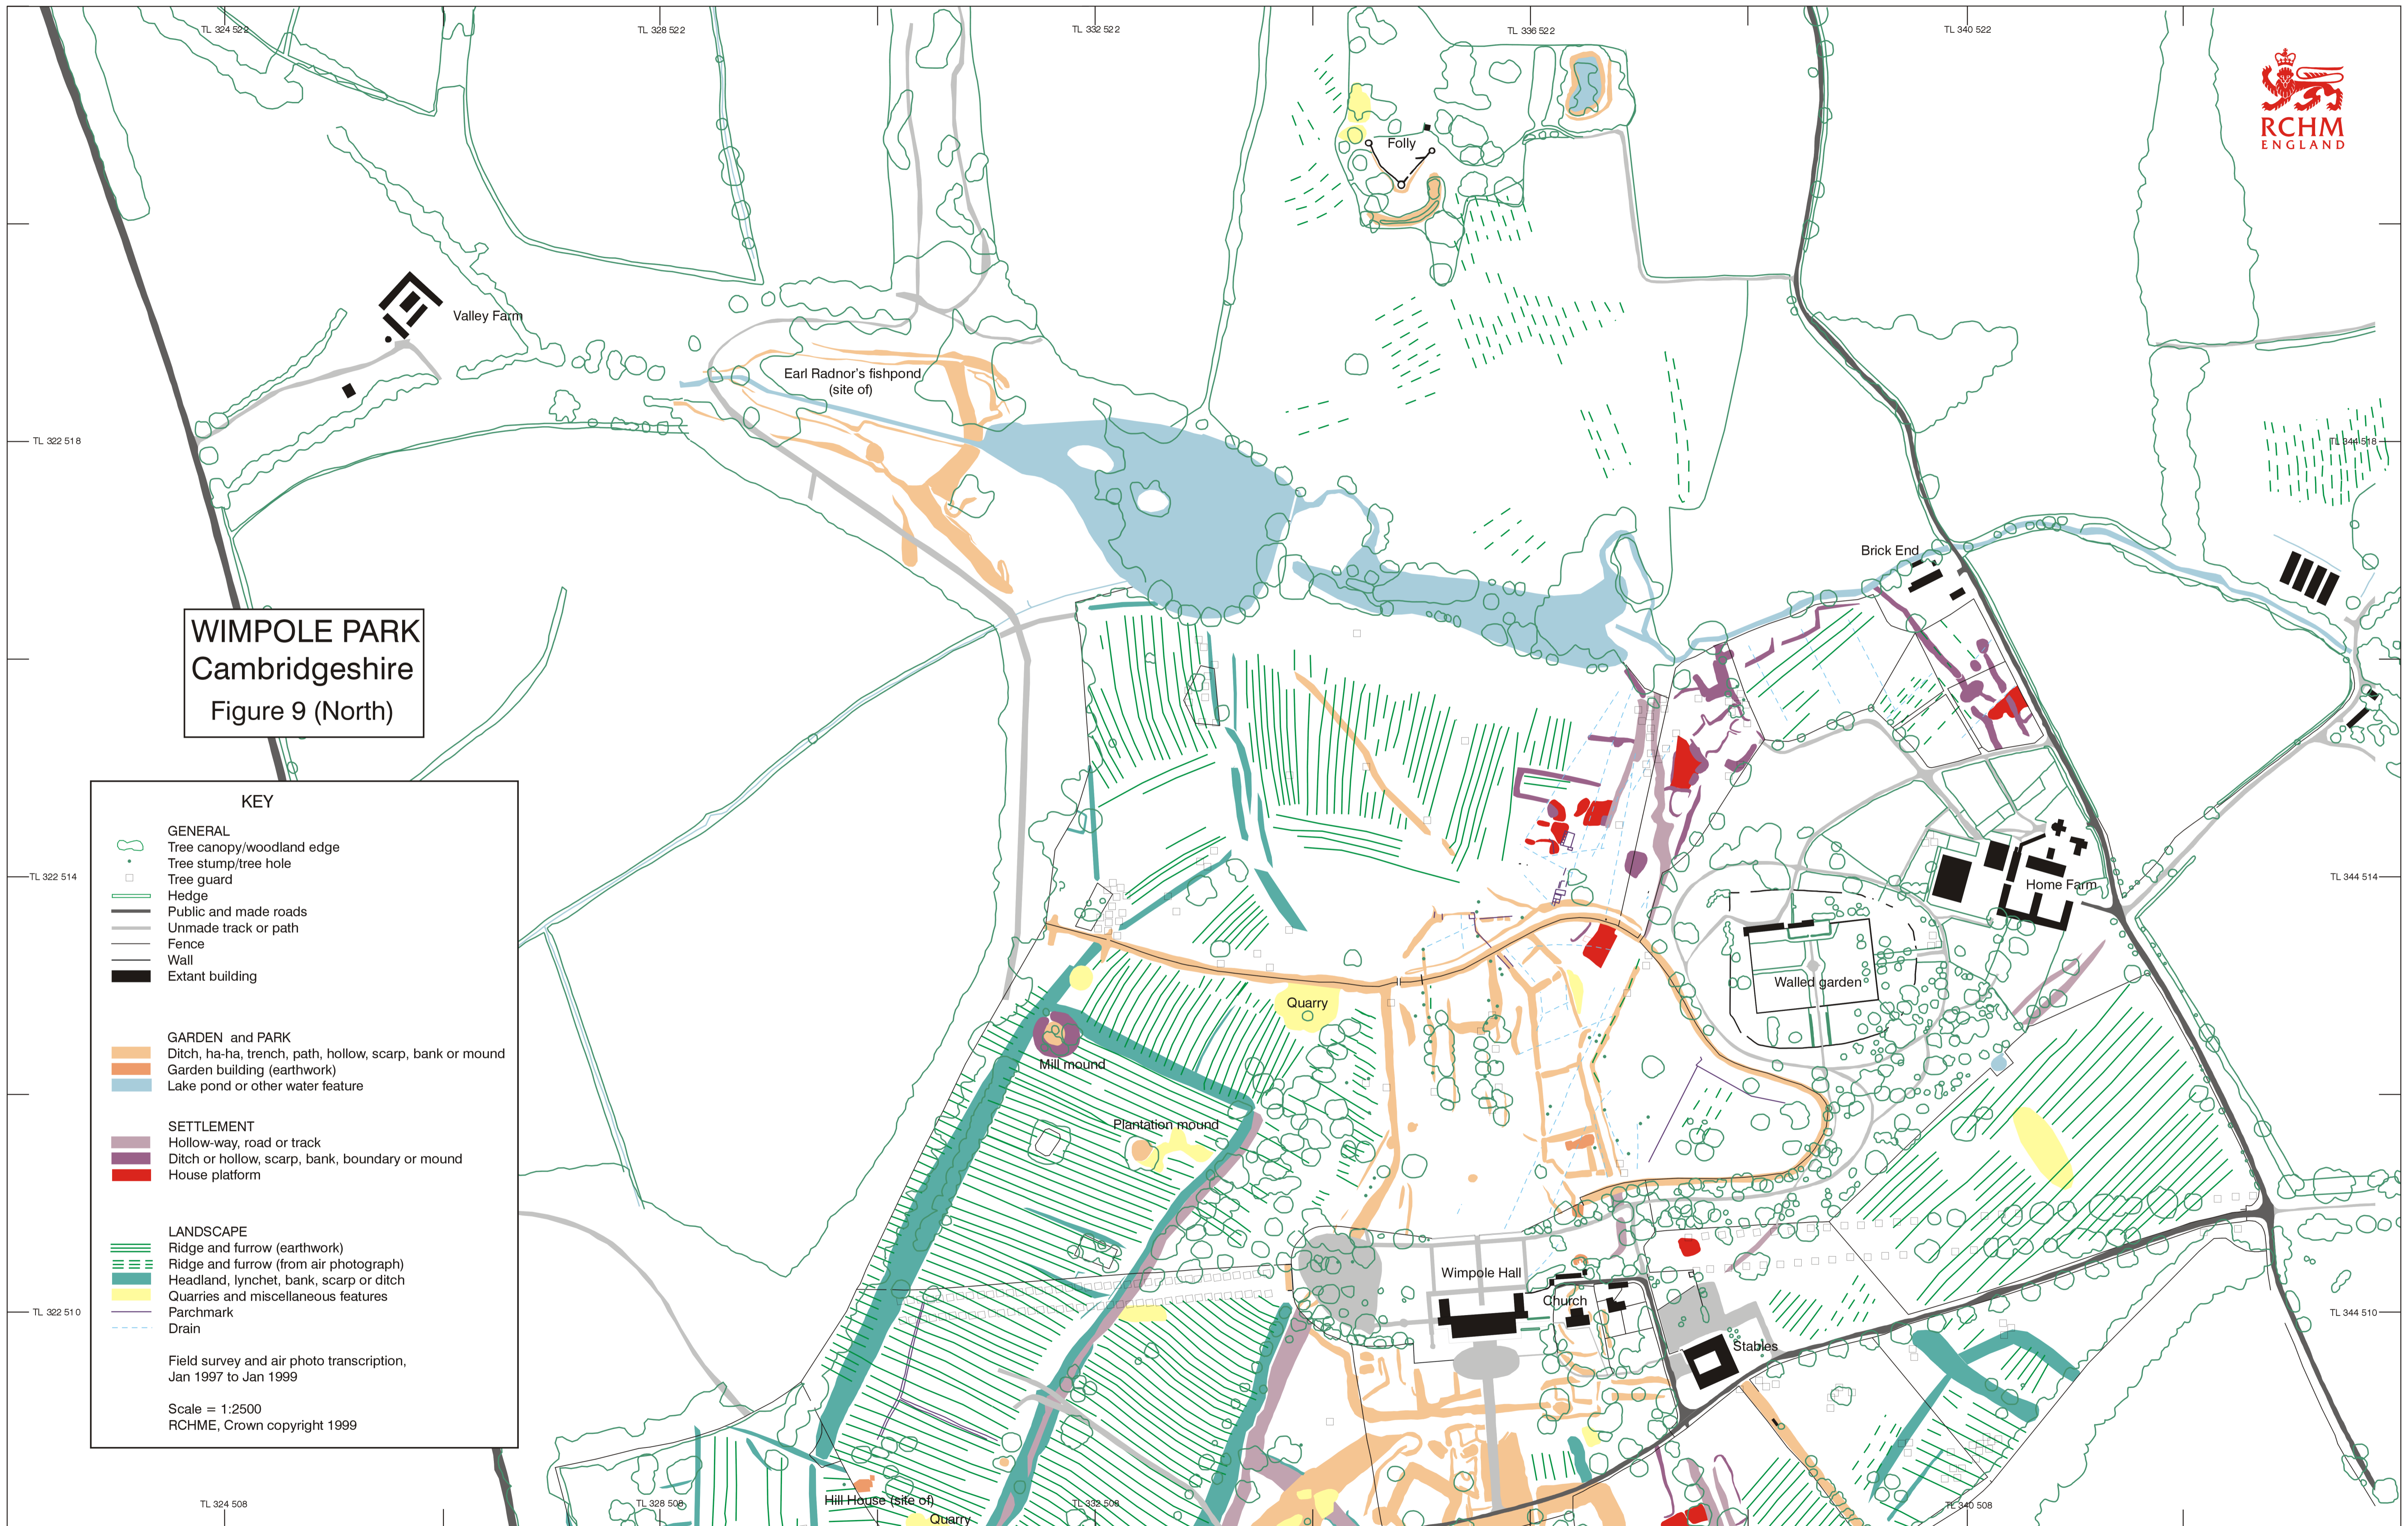
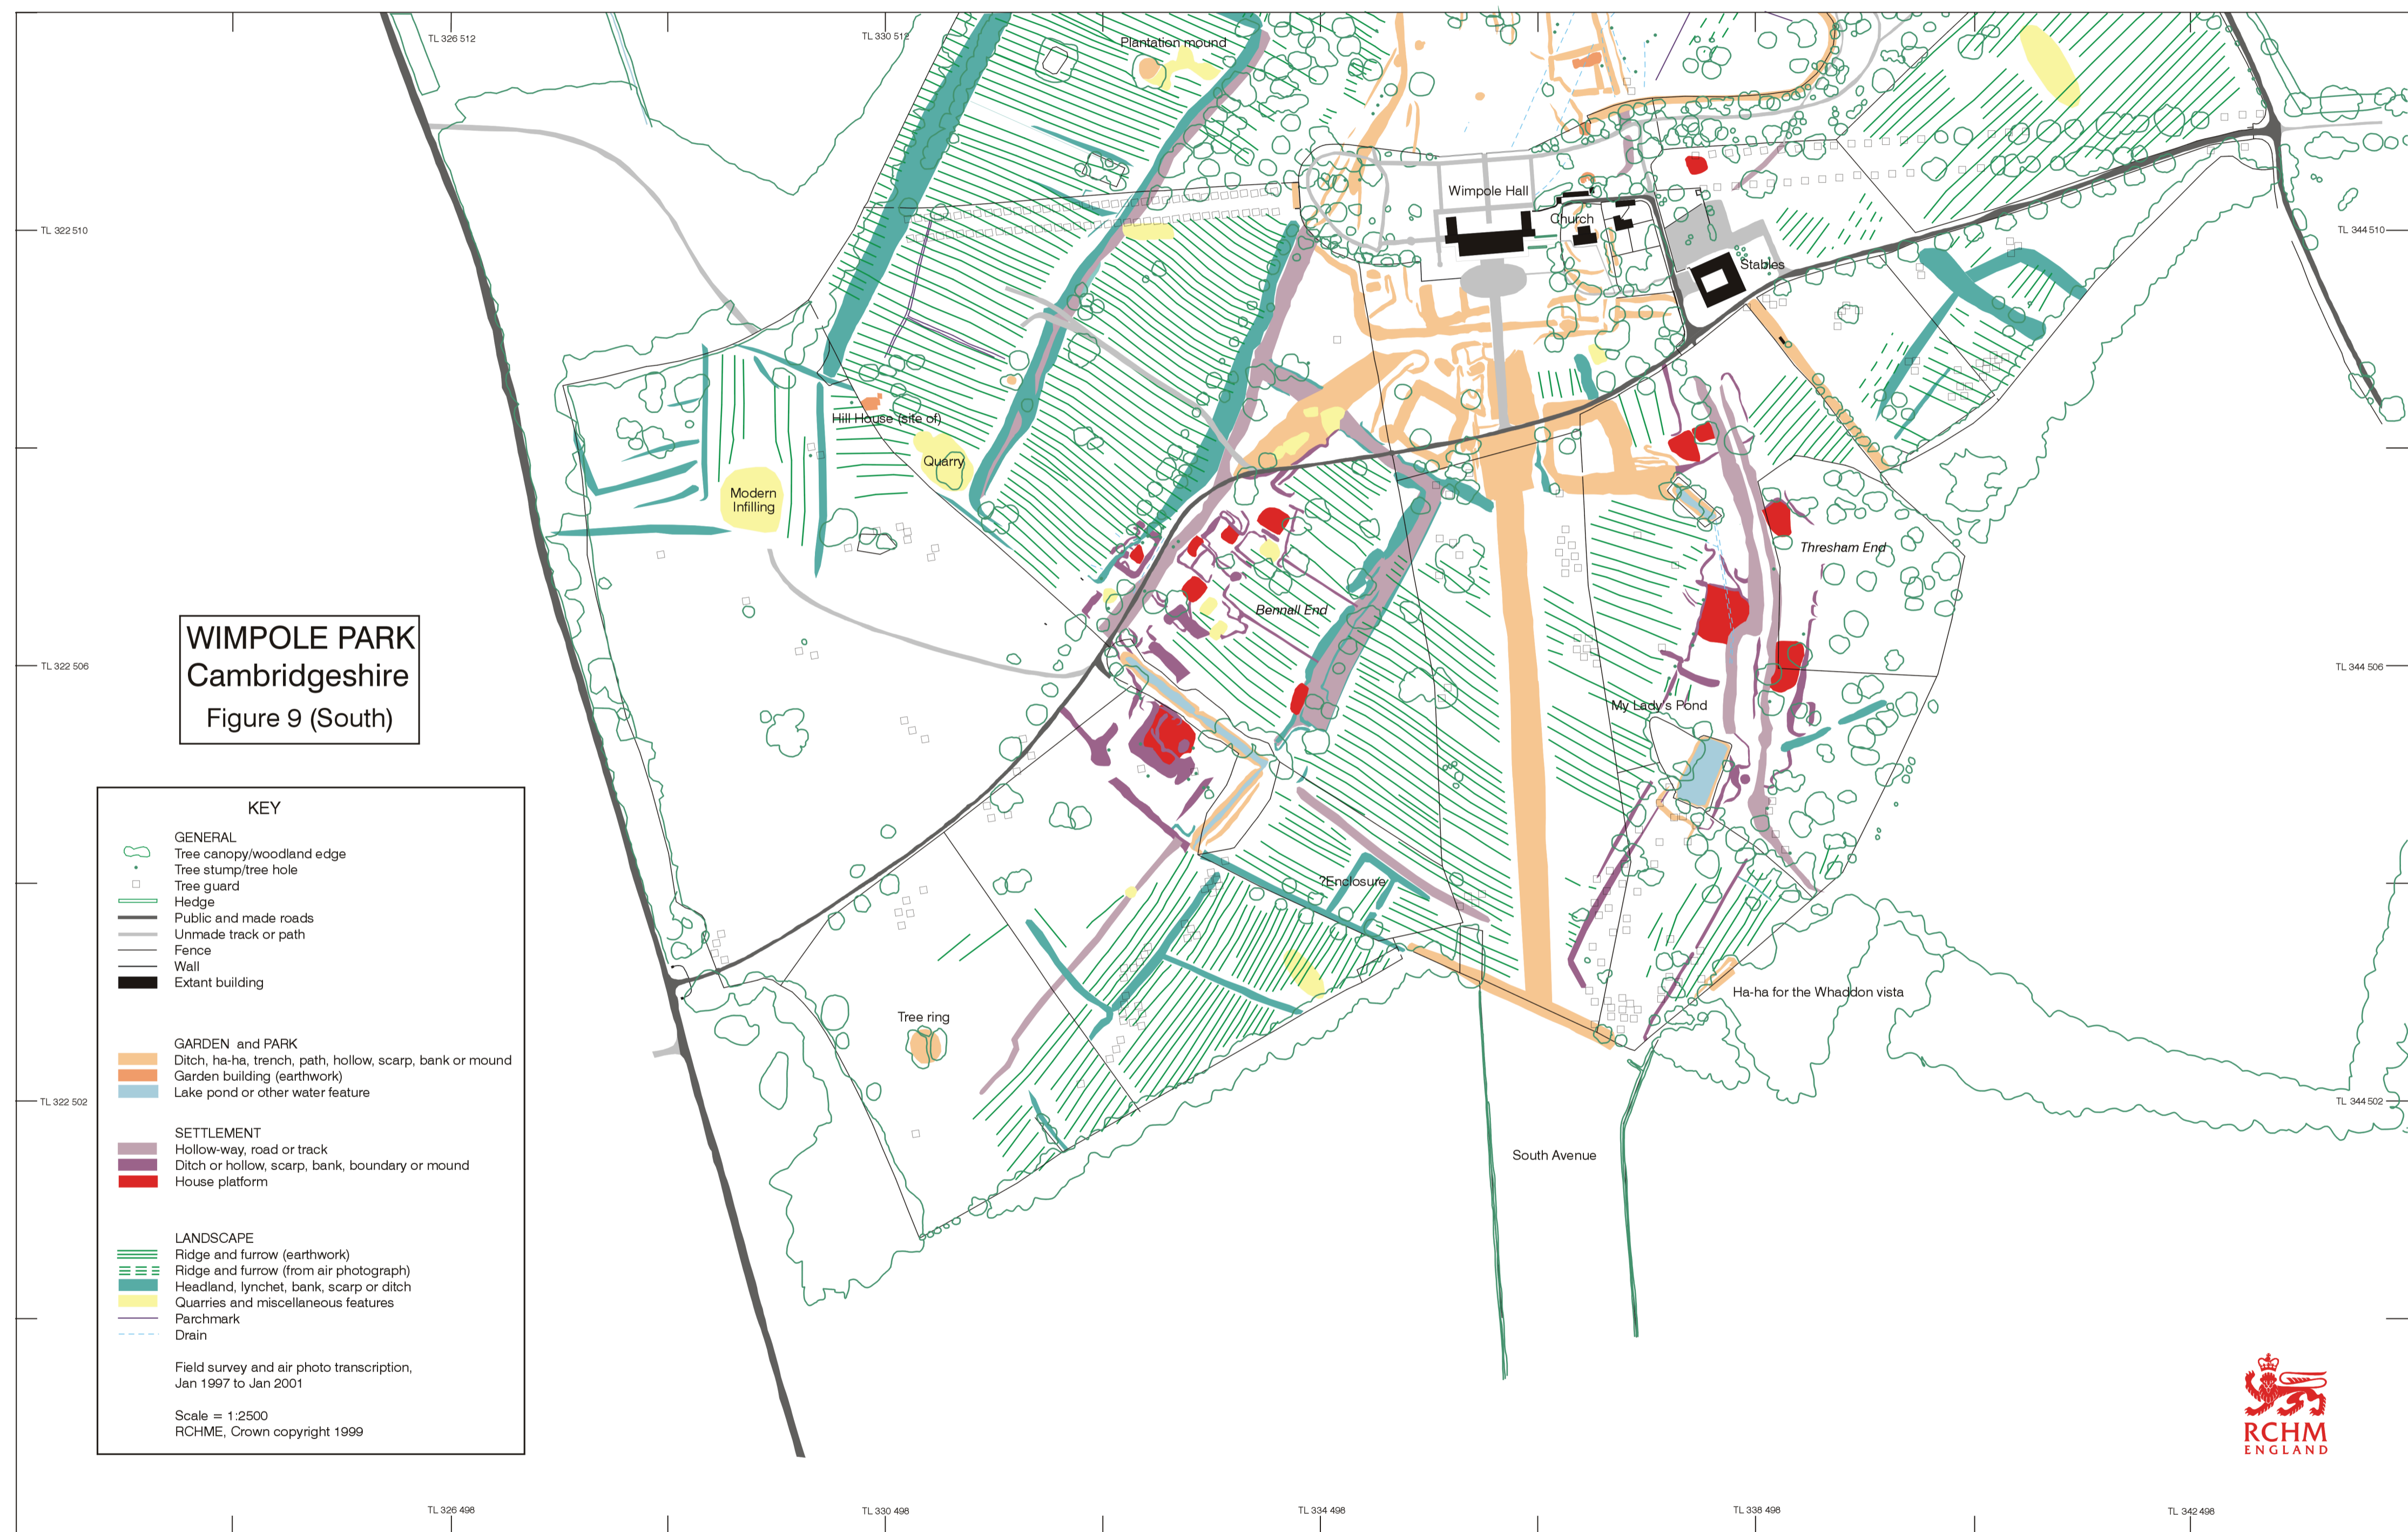
Scale = 1:2500
RCHME, Crown copyright 1999

Field survey and air photo transcription,
Jan 1997 to Jan 1999
