ENGLISH HERITAGE

Haughmond Abbey, Shropshire

SURVEY REPORT

Archaeological Investigation Report Series AI/10/2003

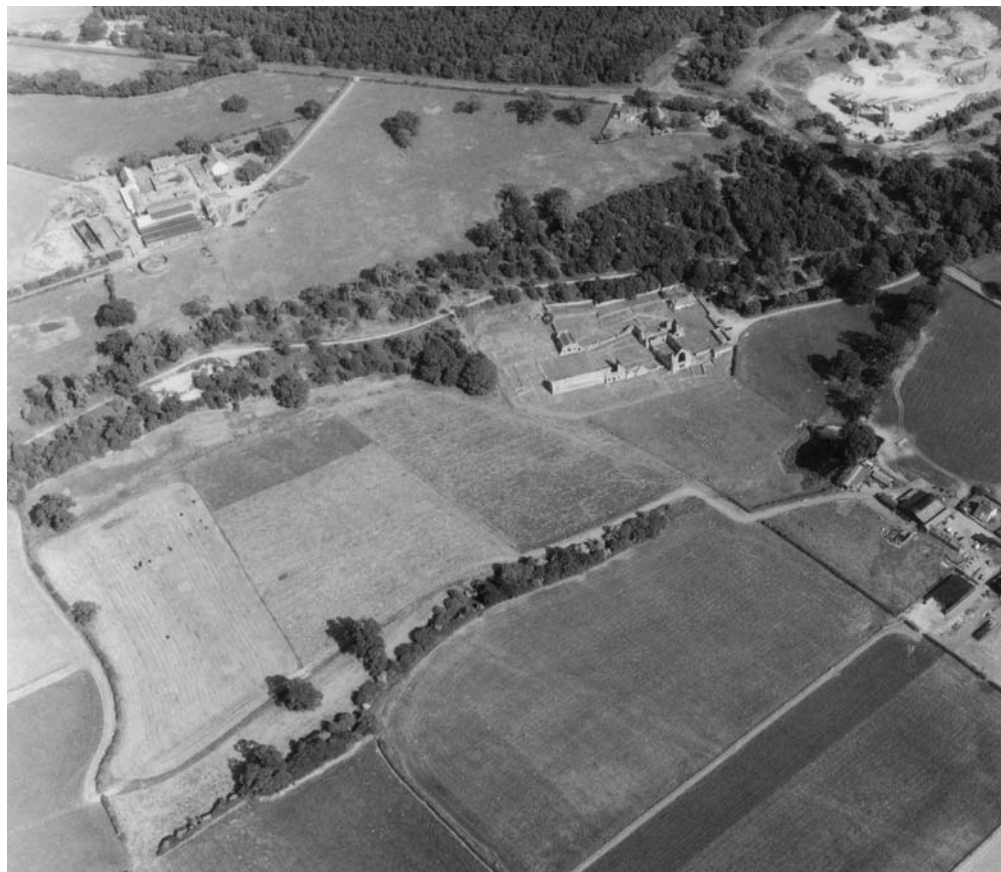
*Figure 3.
Aerial photograph of
Haughmond Abbey
looking east
(NMR ref 15308
© Crown Copyright.
NMR)*

The abbey is sited on the crest of a gentle west-facing slope at a height of between 90 and 95m above Ordnance Datum (OD) immediately below the wooded west side of Haughmond Hill (Figure 3). The lowlands to the west of the abbey stretch as far as the foothills of the Welsh Mountains and are based on deposits of glacial boulder clay whilst Haughmond Hill itself is formed from pre-Cambrian gritstones and conglomerates belonging to the Long Myndian formation (Toghill 1990, 38). The stone has a distinctive red-brown colour when freshly exposed but changes to a dull grey after weathering and was used extensively in the construction of the abbey, mainly for rubble walling and core material. There is widespread evidence of quarrying on the hillside immediately to the east and north-east of the abbey church. The stone is not suitable for fine working or tooling, consequently for architectural details and wall faces the abbey builders widely employed better quality freestone from the Grinshill quarries, 8km to the north. Haughmond Hill is now being actively quarried for road stone immediately to the south of the survey area.

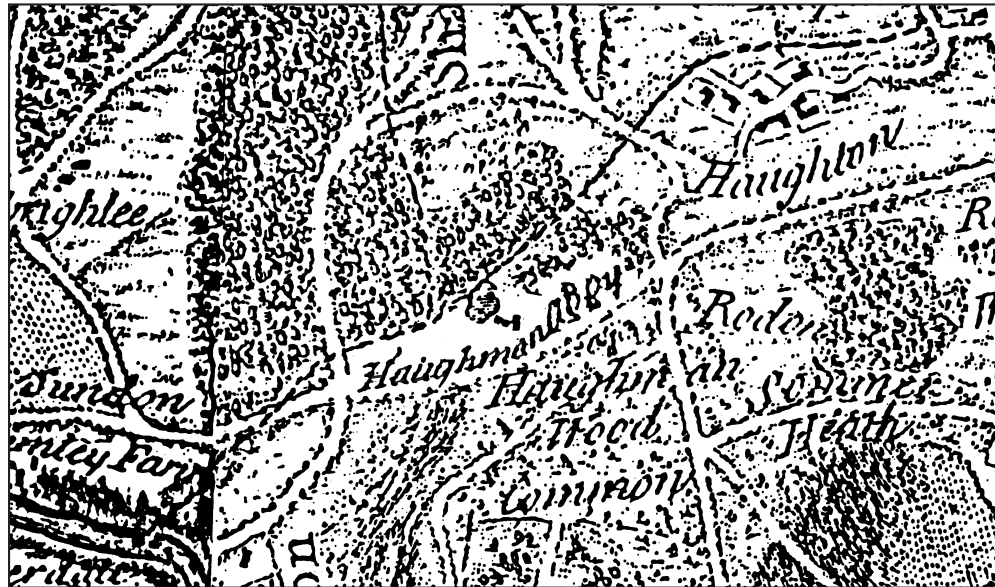
Figure 10. Haughmond Abbey and its environs in 1752 from Rocque's map of Shropshire (north to the top). The abbey is represented by the two buildings at the centre of the illustration with the lake immediately adjacent to the north-west

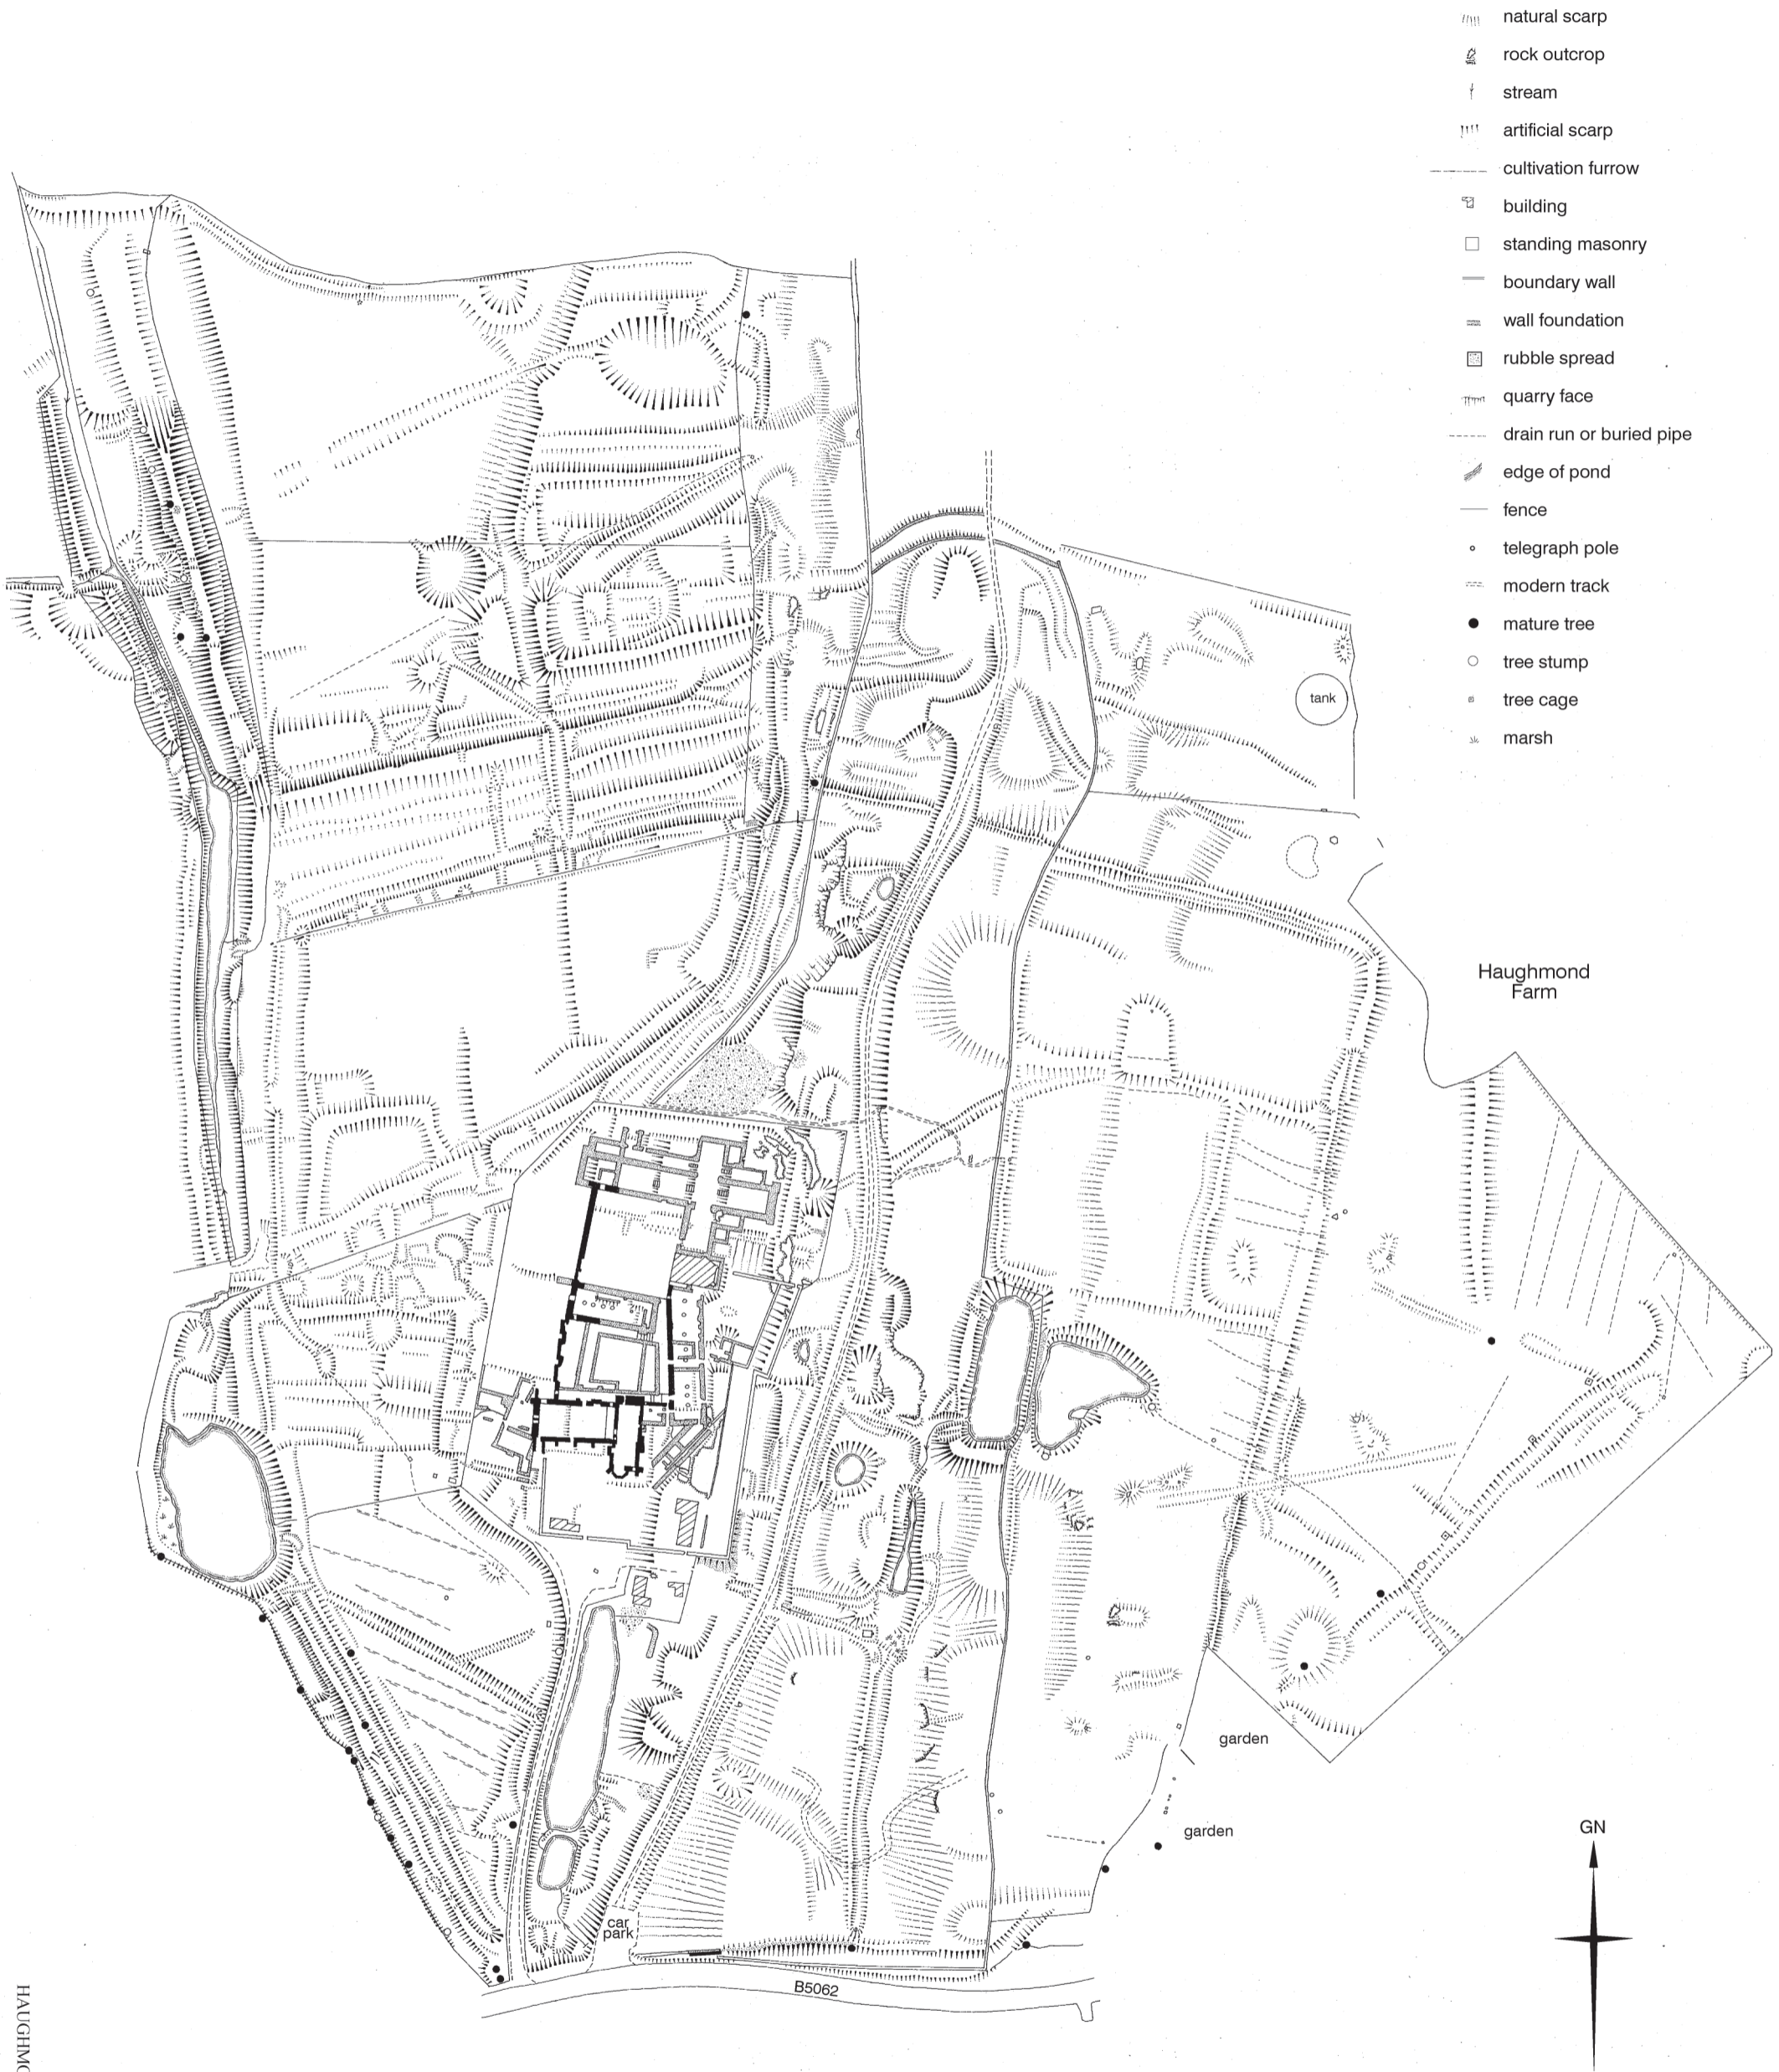
Figure 11. English Heritage plan of Haughmond Abbey and its immediate environs (reduced from 1:1000 scale original)

The English Heritage analytical field survey of Haughmond Abbey has recorded a complex, multi-period landscape, many elements of which are new discoveries (Figure 11). The remains divide into four broad chronological groups with phasing based mainly on observed stratigraphical relationships between features, supported by an analysis of the documentary sources, in particular the cartographic evidence relating to the site. The survey found no pre-medieval remains and therefore the first earthwork phase relates to the period of the medieval abbey.

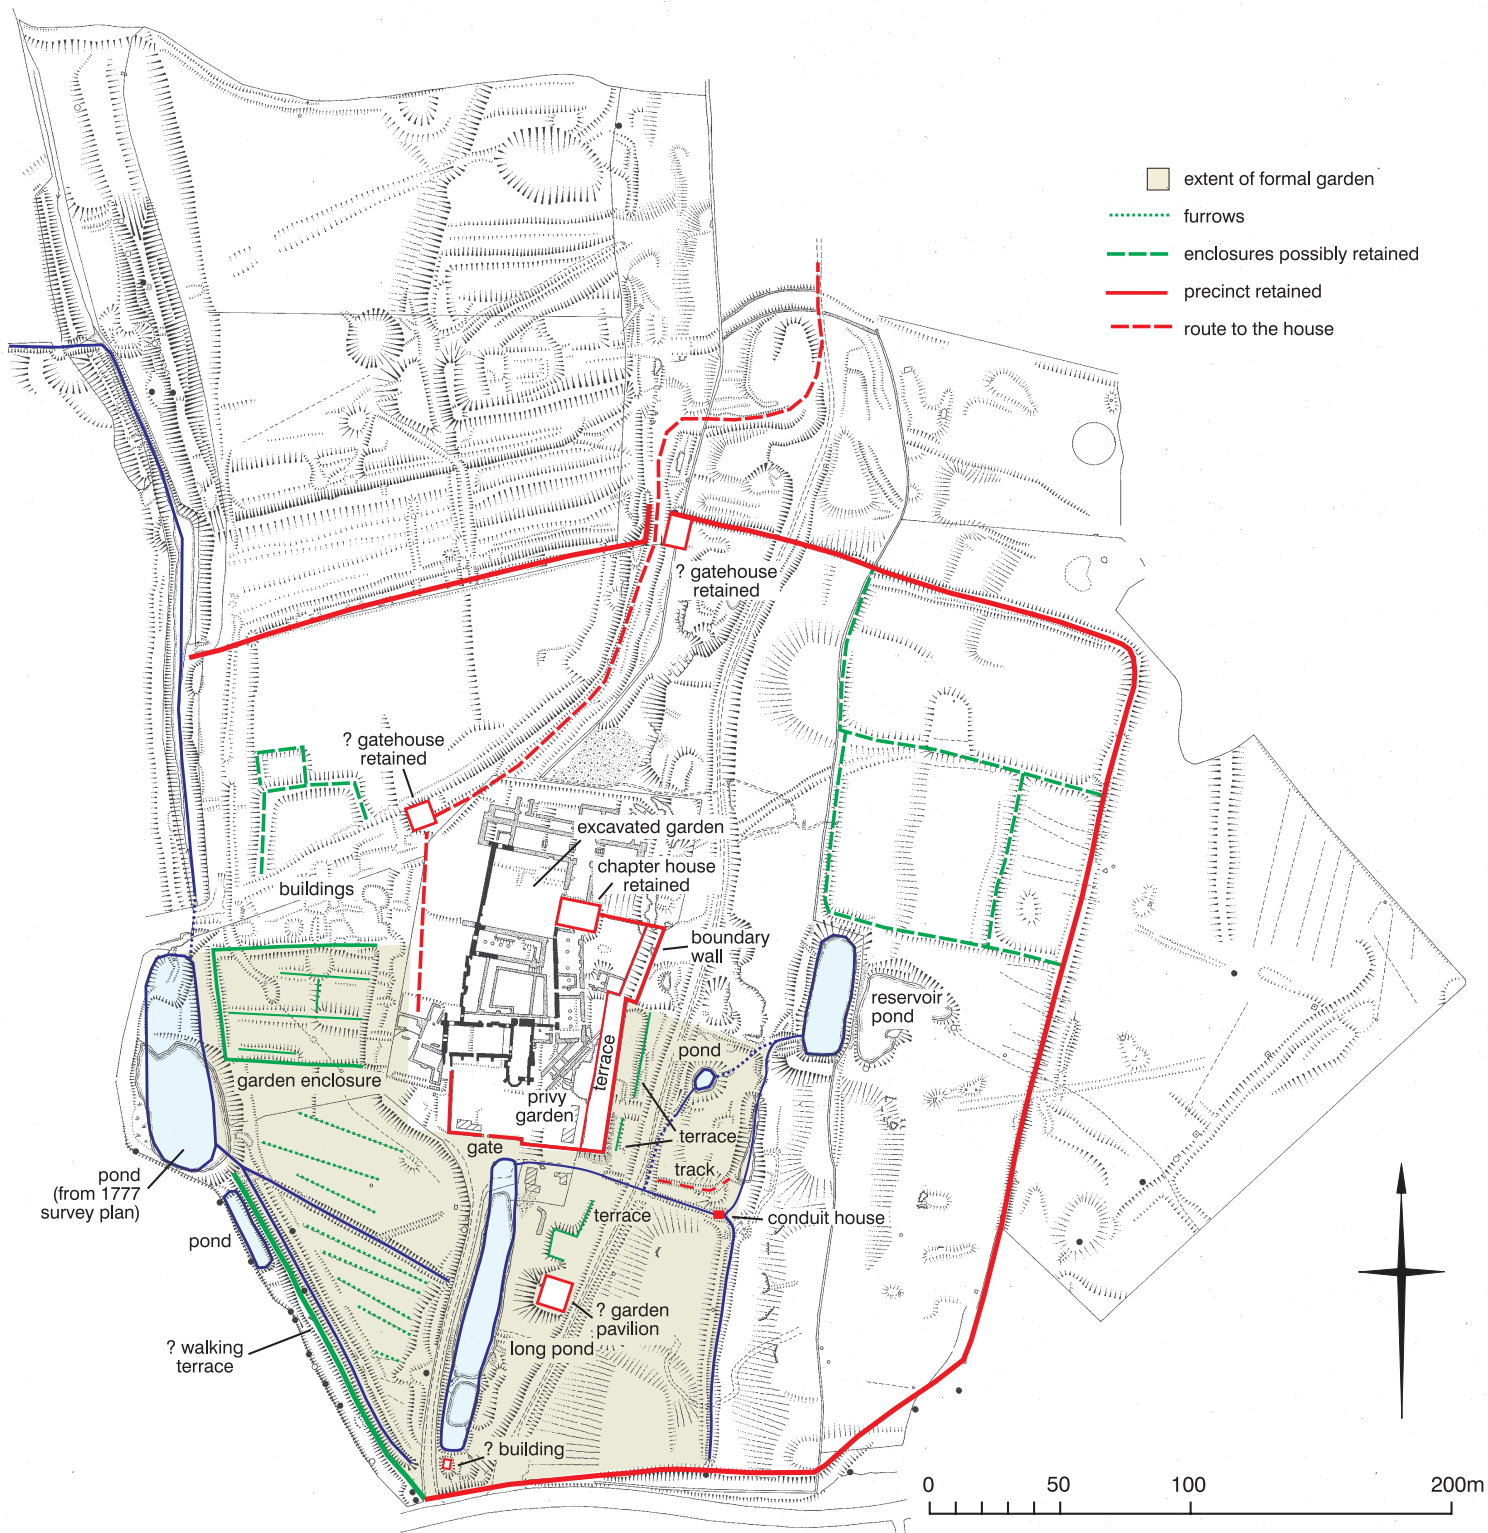
Figure 15. Plan showing features associated with the Barker residence

The boundary wall defining the south and east sides of the privy garden is the only major feature constructed by the Barker family to have survived above ground, and apart from some minor repairs, appears to be all of one period and of reasonably uniform construction. The boundary wall begins outside the south-west corner of the former abbot's hall and continues around the south and east side of the main house to end on the east side of the chapter house. It is built of uncoursed stone rubble from the abbey ruins with re-used ashlar masonry principally at the corners and laid in courses in the body of the wall. The boundary was originally topped by one, and in places two courses of coping stones to create an ornamental effect. The 1777 map indicates a formal garden arrangement of rectangular compartments subdivided by paths to the south and east of the house. Given that the map was surveyed over a century after the Barkers had left the site, it is not suggested that it is their layout which is depicted, but there is the possibility of some continuity of use. For example, the north-south terrace within this area is depicted on the 1777 map and may have been part of the Barkers' garden design, created by landscaping and straightening an

existing quarry face (see Section 5.2.3). Its line is almost exactly parallel to the stone boundary wall suggesting the two might be contemporary and it is possible that the top was used as a viewing terrace from which to look out over the house and the garden below.

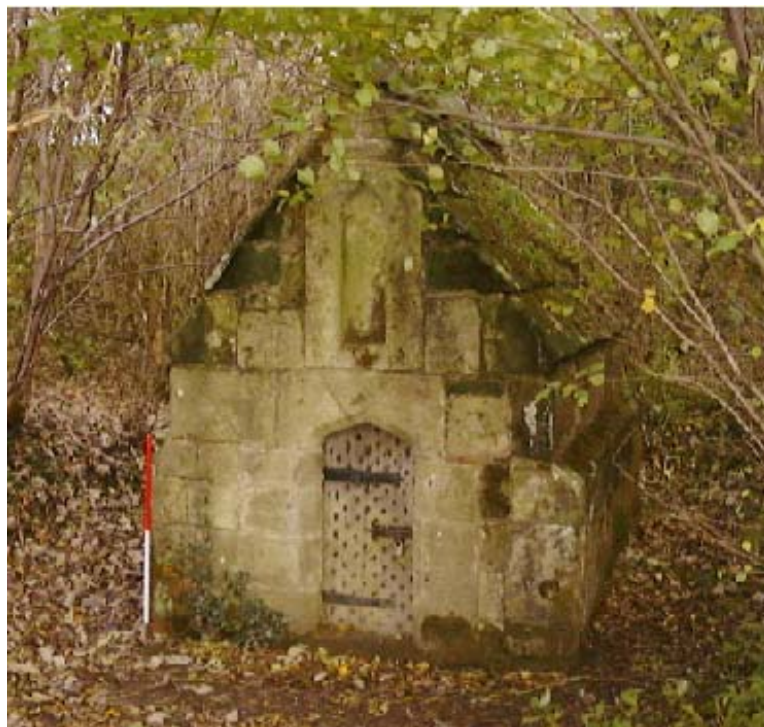
The engineered water supply to the long pond is the main evidence that the garden to the south of the house extended eastwards up the slope of the escarpment. The conduit house is the key element in the design as it is sited at a nodal point in the leat system whilst the leats themselves impose rectangular divisions on the slope and probably defined subdivisions within the garden. However there are no definite garden earthworks surviving within the areas bordered by the leats. The conduit house probably acted as an ‘eye-catcher’ in the garden although this does not mean the building was purely ornamental since it is sited at the head of the channel carrying water down the slope to the long pond and probably had a practical role in regulating the flow. Equally, the conduit house and its associated system of leats and channels have no role in supplying water to the abbey and therefore the previous interpretation of the building as the source of the monastic water supply has nothing to recommend it. The building is constructed of re-used ashlar masonry indicating it is later than the abbey whilst a stone niche above the door on the west side of the conduit house is clearly a re-used medieval architectural fragment (Figure 16). Previous authorities

*Figure 16.
The conduit
house viewed
from the west*

have presumably used this fragment to date the building to the 14th century. There remains a possibility that the structure is a re-built medieval cistern, moved by the Barker family from elsewhere within the claustral complex such as from the head of the reredorter drain (Section 5.2.3).

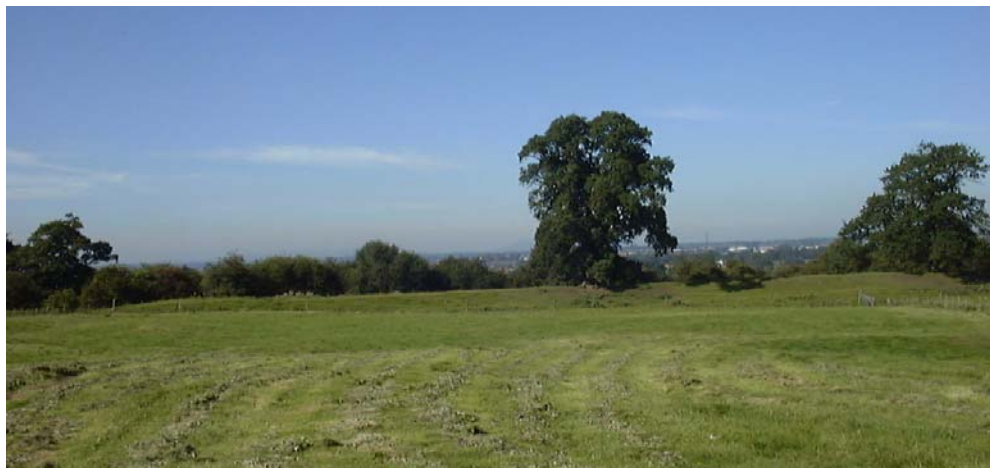
*Figure 18.
Dam 2 viewed
from the east*

Dam 2 is aligned north-south and is up to 3m high and has an overall length of 130m. It is a steep-sided embankment with a broad and level top around 5m wide though at the south end the summit steps up slightly to create a distinct platform some 0.5m high. The south end of the dam slopes off quite gently and a break of slope towards the bottom indicates where it incorporates the south face of the southernmost of the earlier plough ridges. Towards the north end there is a small patch of cobble stones on the top of the dam which along with the uniformly broad and level character of the summit may indicate the existence of a formal walk along the crest. The 1777 map shows a woodland belt along the approximate line of the dam suggesting it may have been planted with trees at this date. The several mature oak trees on the top of the dam are unlikely to be this old, but nevertheless probably represent ornamental planting connected with the later stages of the park.

The south end of the dam has been partially cut away by the widening of the stream channel on its west side. Further south, on the same side, there is a wide erosion hollow at the base of the earthwork caused by groundwater seepage along the line of the former north stream, which probably also represents the line of the outfall from the pond. Minor slippages have occurred along the sides of the earthwork and there is also some damage from rabbits.

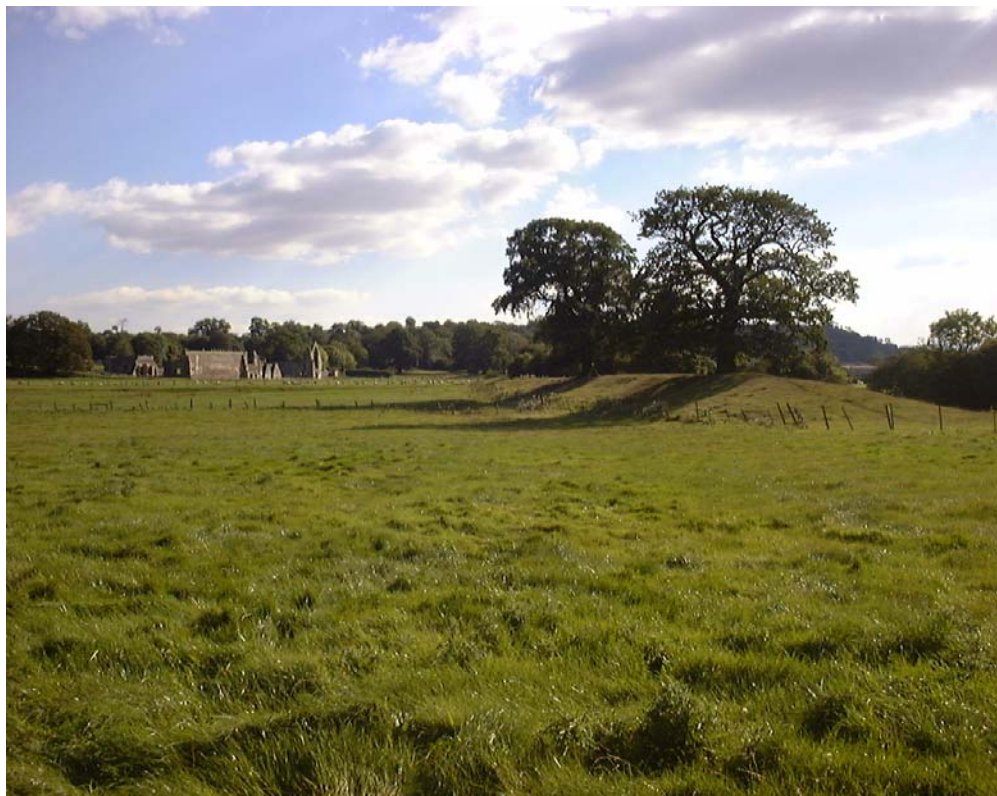
With a length of just over 200m, Dam 2 would have created a pond stretching back up the valley of the north stream for 100m. This equates to the relatively featureless expanse of ground in the western half of the two pasture fields to the east of the dam and there is little doubt that this represents the bed of the former pond. The edge of the pond is not particularly clear on the south where there are later drainage channels and evidence of minor landscaping. However at the east, a distinct terrace indicates where the ground has been cut back to create the edge of the pond and at the north, the present hedge line defines the limit, which explains its slightly curving alignment. The same boundary additionally preserves the line of the bypass channel for the pond. This begins some 90m to the east where the water of the north stream diverts from its natural course across the pasture field to flow along the field boundary. It is carried over a hollow at the north edge of the field in an embankment, and further west the south side of the channel survives as a slight bank to one side of the field boundary. At the east end of this bank the water now enters a culvert and is piped underground but originally it would have continued along the line of the bank and around the north edge of the new dam. The hollow mentioned above is not definitely an artificial feature although there are vestiges of a bank around the south and east sides which might be upcast from digging it out. If the feature is artificial, it is difficult to explain other than as a pond along the line of the bypass channel.

*Figure 19.
The view south
from the north end
of Dam 2*
